付 属 資 料

付属資料-3 Bridge Damage Assessment

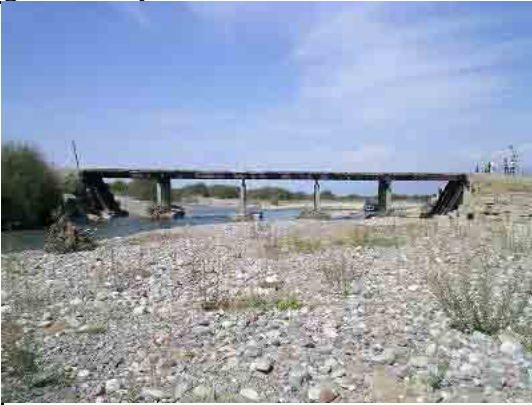
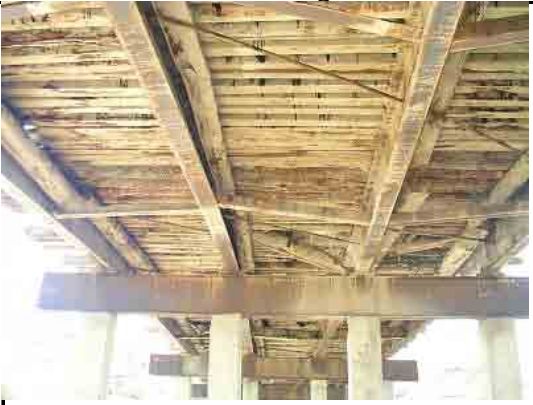
NO.24 Bridge

General Information	Name of Bridge		NO.24	
	Name of Road		Tyup-Kegan road	
	Chainage (km)		40+200	
	Location (District)		Issyk-Kul	
	Administrator		MOTC	
	Year of Construction		1964	
	Donor		Unknown	
	Design Report		Not Available	
Bridge	Type of Bridge	Superstructure		precast RC T beam bridge (6 girder)
		Substructure		concrete wall abutment, concrete wall pier
		Foundation		concrete pile (square pile)
	Applied Design Specification		Unknown	
	Design Live Load		Unknown	
	Regulated Traffic Load		No Regulation	
	Bridge Length (m)		38.1	
	Span Length (m)		5@7.6	
	Skew (°)		90	
	Girder Height (m)		0.6	
	Width	Full Width (m)		5.2
		Carriageway (m)		4.8
		Pedestrian way (m)		0.0
	Type of Pavement		Asphalt	
Affixed Articles and Buried Article (Items, Administrator)		Non		
Repair Works by MOTC (Items, Year)		Non		
River	Name of River		Jyrgalang River	
	Station (River)		Unknown	
	Administrator		MWR	
	Information of River Conditions		Non

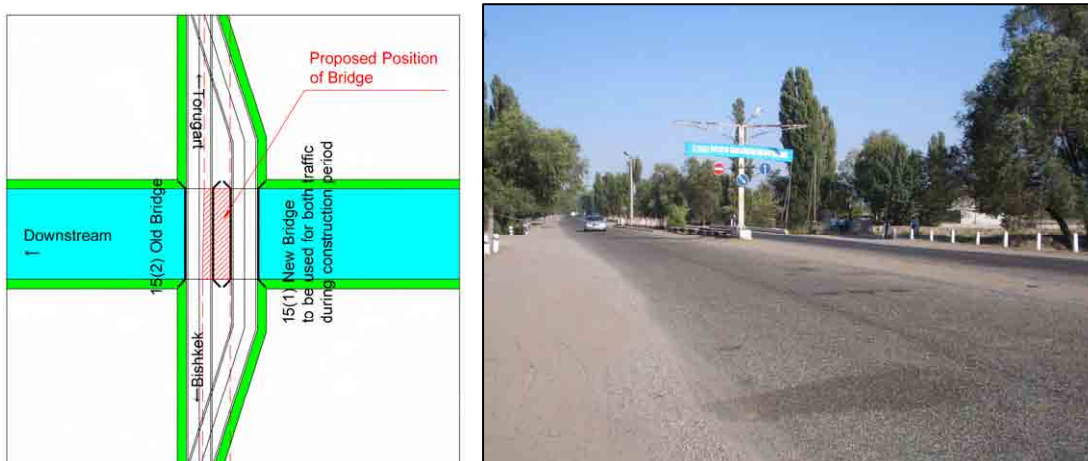
No.15(2)橋梁は No.14(1)と同じ形態である。No.14(1)ではビシュケク方向の車線に新橋梁が建設されていたが、本橋梁では Torugarut 方向に新橋梁が建設されている。No.14(1)と同様、

交通安全に対する配慮が橋梁計画に必要とされることから、改修橋梁を可能な限り No.15(1) 橋梁に近づけるものとする。

改修橋梁の架橋位置は、現況橋梁位置を提案する。

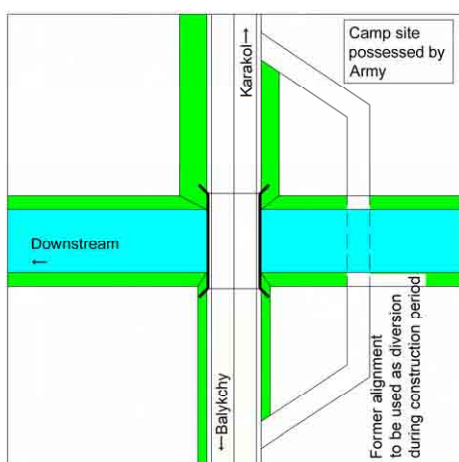
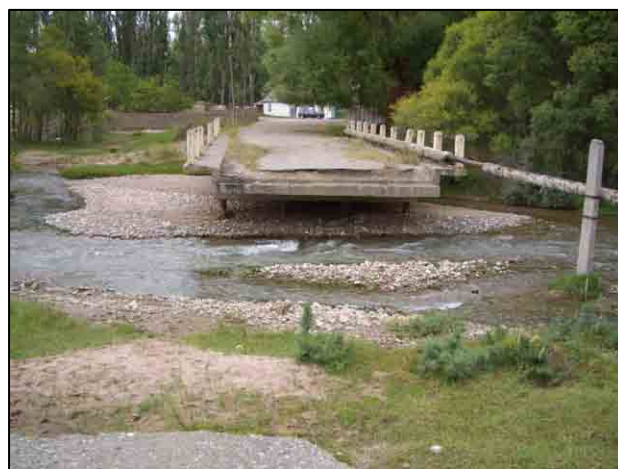
旧道部（橋梁部）

No.19 橋梁位置周辺には、薬草として価値のあるグミ科植物 (*Hyppophae rhamnoides*) が見られる他、多くの樹木がある。これらの既存の植物の伐採を最小限とするため、現橋梁位置で付け替えを計画する。工事中の現況交通の処理は、河川上流部にある旧道を利用する。旧道の河川横断部の橋梁は一部欠落しているが、欠落部分に Pipe Culvert を設置してその上に仮舗装を設けるなどの対策により、通行を確保する。

改修橋梁の架橋位置は、現況橋梁位置を提案する。

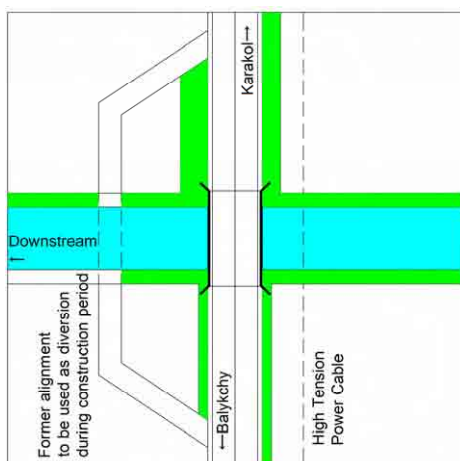
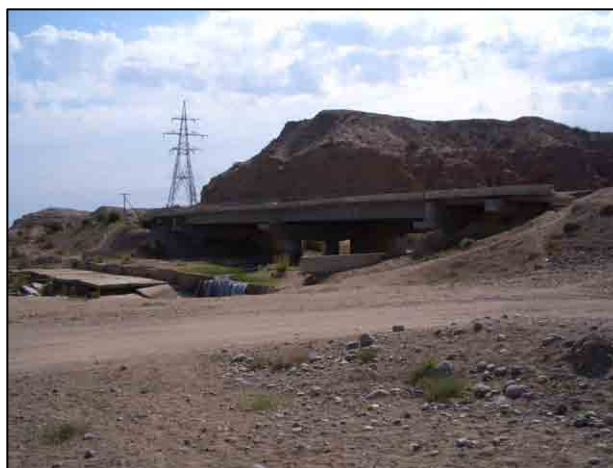
No.22 橋梁は道路中心で旧橋梁と新橋梁に分かれている。今回改修の対象となる橋梁 22(1) (旧橋梁) は道路の左側(Karakol に向かって)にあり、現況位置で改修しない場合、橋梁部で道路を上下線に分離する必要がある。No.14、15 橋梁で要請があったように、上下線を分離することは交通安全上の問題が発生が予見されるため、現況位置での改修を計画する。工

事期間中の現況交通処理は、No.22(2)(新橋)を利用する計画とする。

改修橋梁の架橋位置は、現況橋梁位置を提案する。

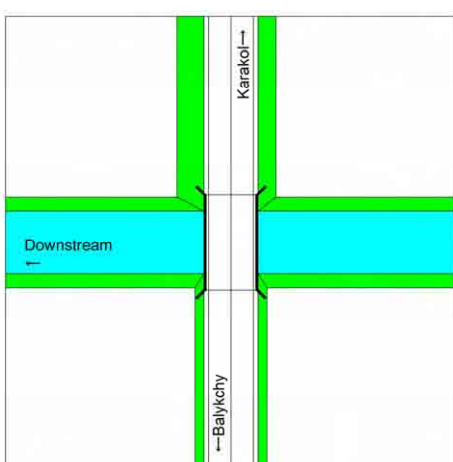
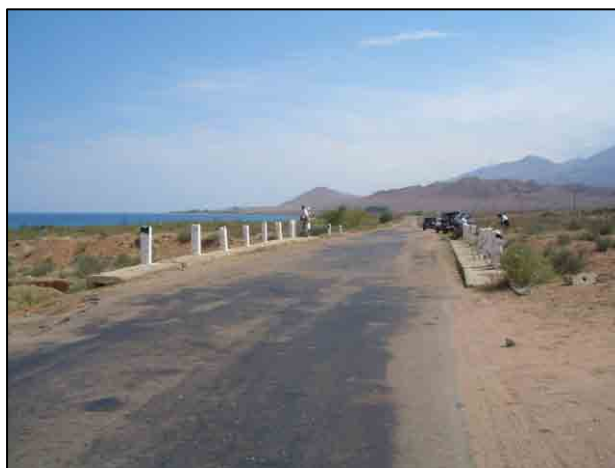
橋梁付け替え計画を行う上でのコントロールになる障害物はない。現況位置、河川の上流側、下流側のいずれにも付け替え可能である。しかしながら No.23 橋梁を含むイシクリ湖地域は環境保護区に指定されており、環境への負担の軽減を考慮し、現況橋梁位置での改修を提案する。

改修橋梁の架橋位置は、現況橋梁位置を提案する。

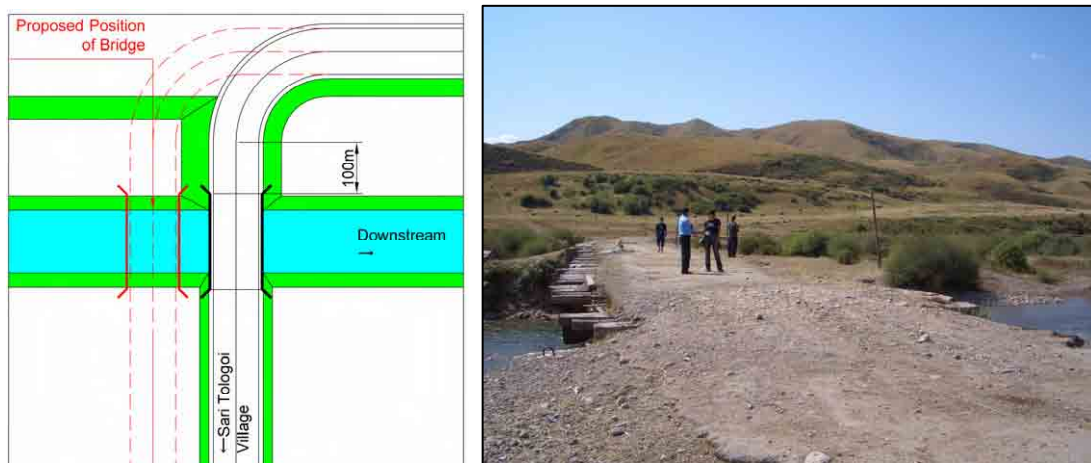
河川左岸側（上図の上側）の現況線形を考慮すると、河川上流部での付け替えが提案されるが、現橋梁の取り壊しの手間、また現在通行止めの処置が行われていること、代替ルートがあることを考慮すると、現況位置での付け替えも可能である。

改修橋梁の架橋位置は、河川上流側を提案する。
