CHAPTER 3

LANDSLIDE DISASTER MANAGEMENT

3. Landslide Disaster Management

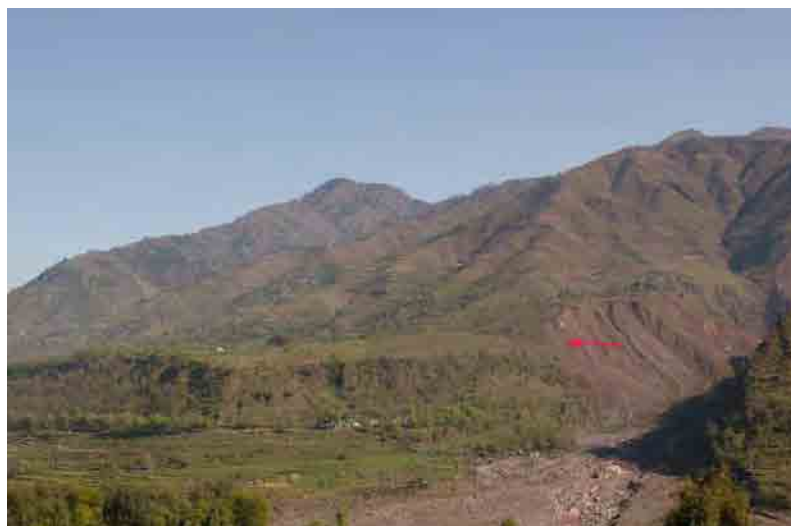
Northwestern part of the Balakot-Garhi Fault is located along a western wing of the Hazara-Kashmir Syntaxis. It, however, becomes independent from the MBT in the southeastern part from Muzaffarabad, and is marked by flexural scarps along the piedmont line on the right bank of the Jhelum River (Photo 3.2.3). The flexural scarps deformed fan surfaces formed by tributary rivers of the Jhelum River. Maximum displacement for the fan surfaces due to active faulting ranges 30-50 meters since the last glacial age. The fault line crosses the Jhelum River at Naushana and runs via Dhallan to enter to mountains near Chikar Kas.

Photo 3.2.3 Flexural scarp of the Balakot-Garhi Fault along the piedmont line on the right bank of the Jhelum River

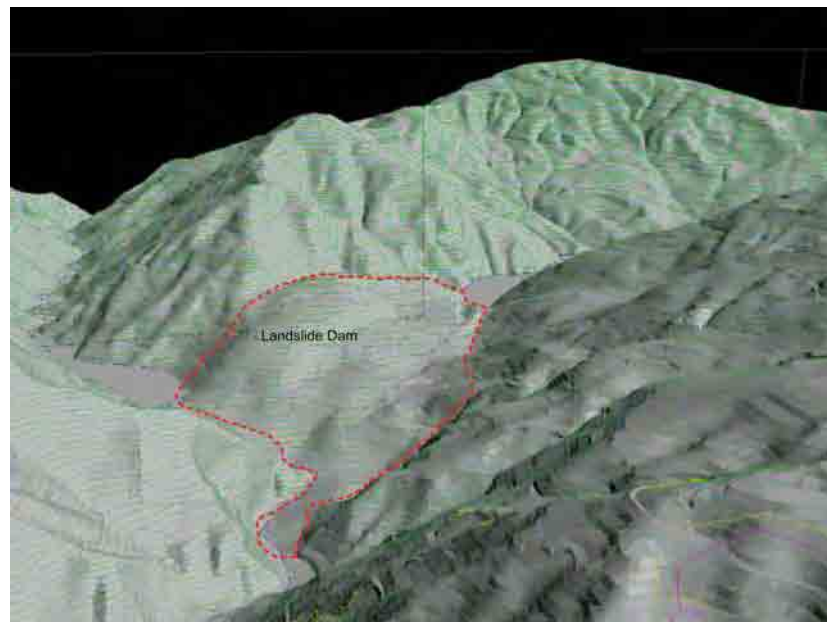
Bird's eye view from northeast

Figure 3.2.5 Dandbeh landslide as a catastrophic event triggered by the 2005 Pakistan Earthquake

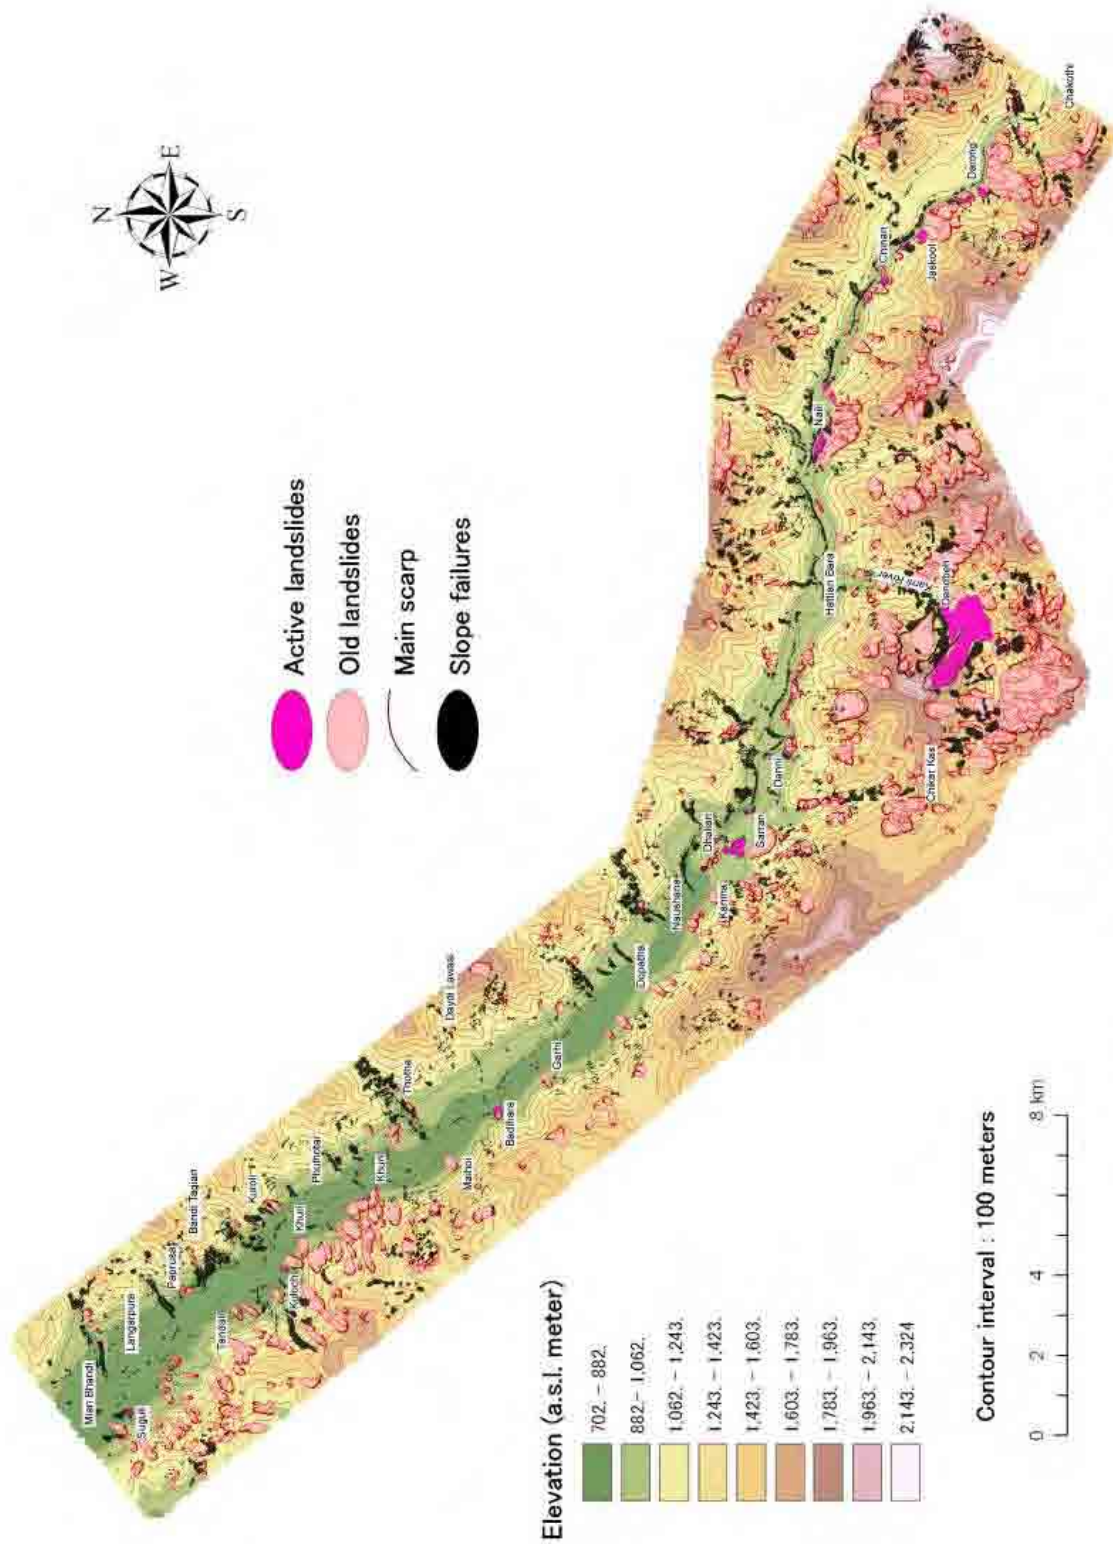
Slope failures of 4671 sites, newly formed active landslides of 76 sites and old landslides of 838 sites were recognized through this study (Figure 3.5.2).

Slope failures are usually marked by scars without vegetation on the slopes. Old landslides are marked by horseshoe shaped main scarps and ragged terrain of sliding mass in front of the scarp. Active landslides are noted by field studies.

Figure 3.5.2 Distribution map of landslides and slope failures

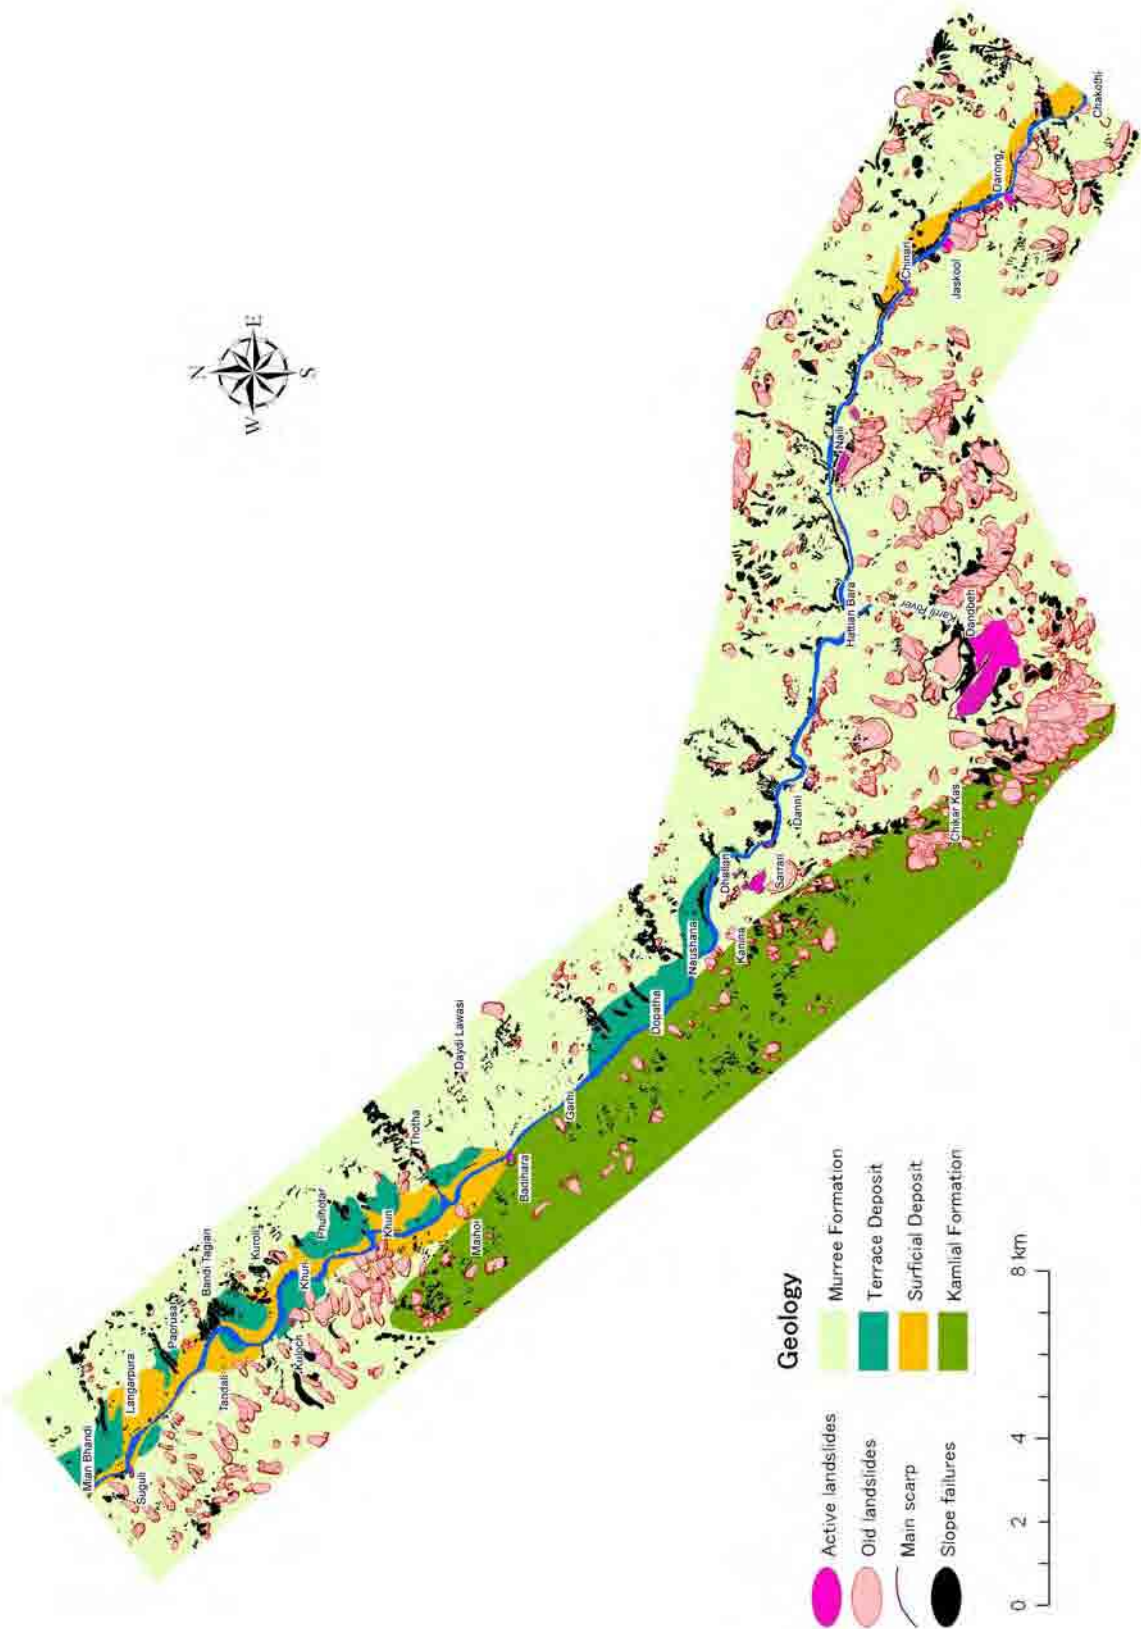
Figure 3.5.3 Landslide and slope failure distribution superimposed on a geological map

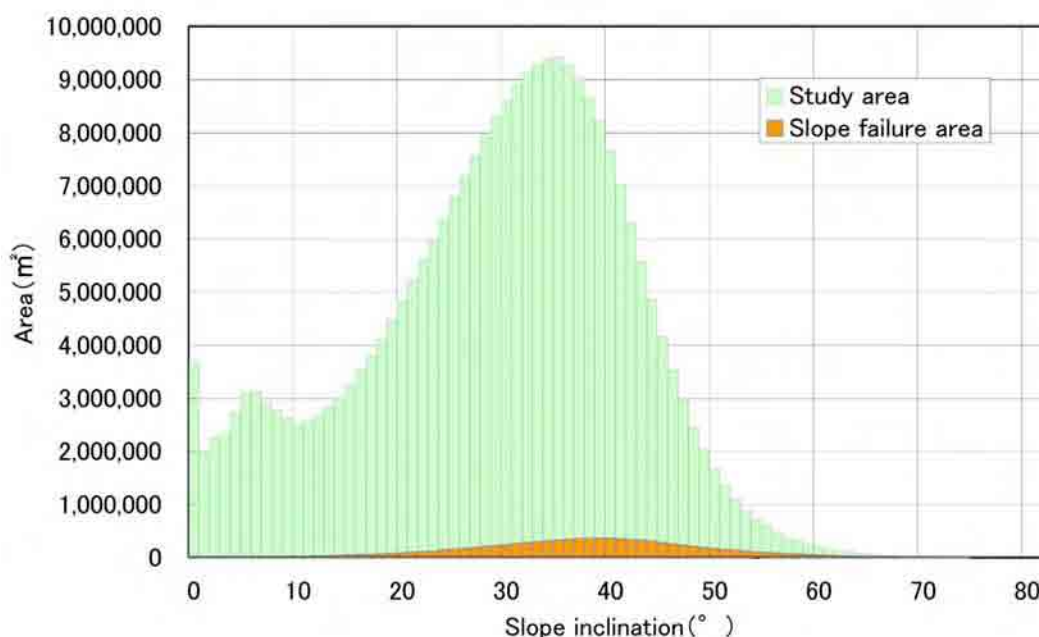
Scale of slope failure is relatively small compared with that of landslide. Average area of slope failure is 0.294 ha. Slope failure occurs on a relatively steep slope. Average slope inclination is 37.4 degrees and its mode is 37 degree (Fig.3.5.4). The number of slope failure increases, according to increase of slope gradient.

Figure 3.5.4 Occupancy rate of slope failures and slope inclination

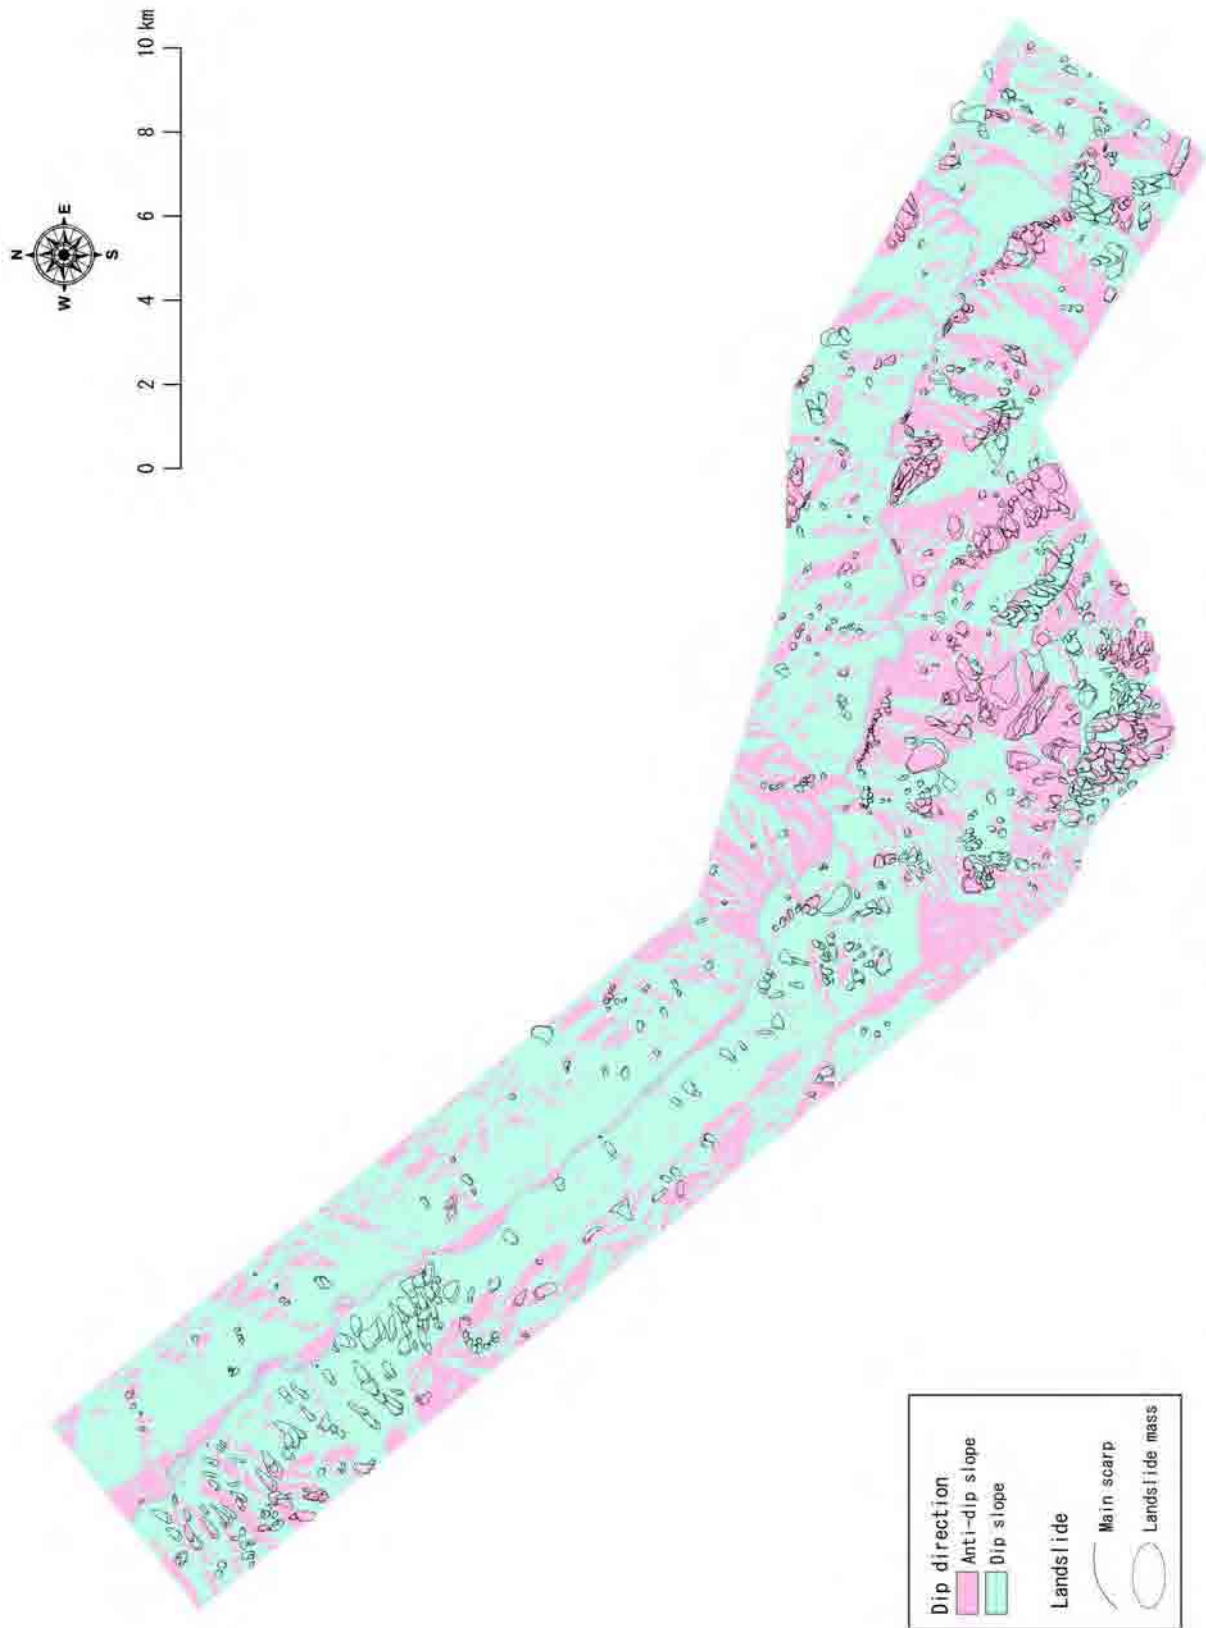
Average area of old landslides is 3.3 ha, however, relatively large landslides occur in the upper course area from Naushana. This difference is attributed to difference of cross section type of the Jhelum Valley. In the upper stream from Dhallan it shows the gorge type deeper than 100 meters, steep and deep side slope along the gorge have moved gradually.

Figure 3.5.5 Distribution of old landslides on a slope-structure map

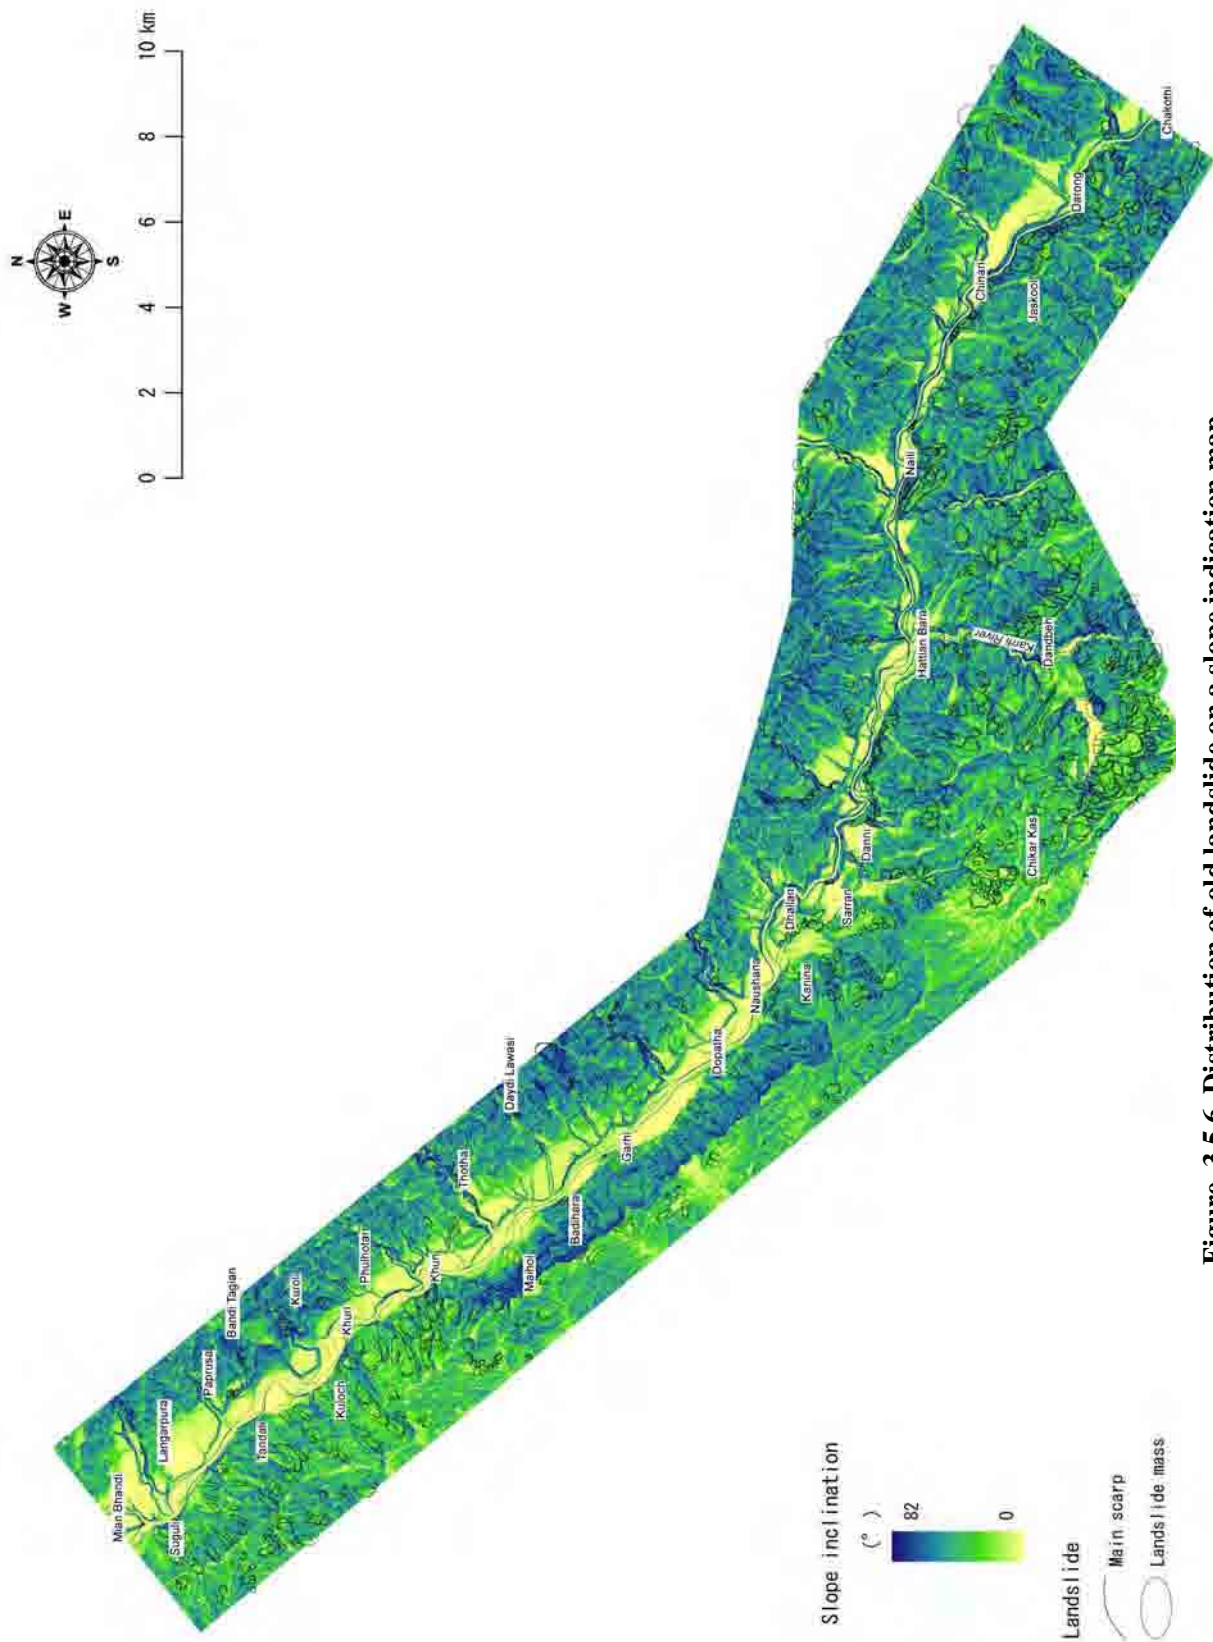
Average inclination of landslide mass is 30.9 degrees and its mode is 29 degrees. Namely deep landslides occur on relatively gentle slope compared with slope failure (Figure 3.5.6).

Figure 3.5.6 Distribution of old landslides on a slope inclination map

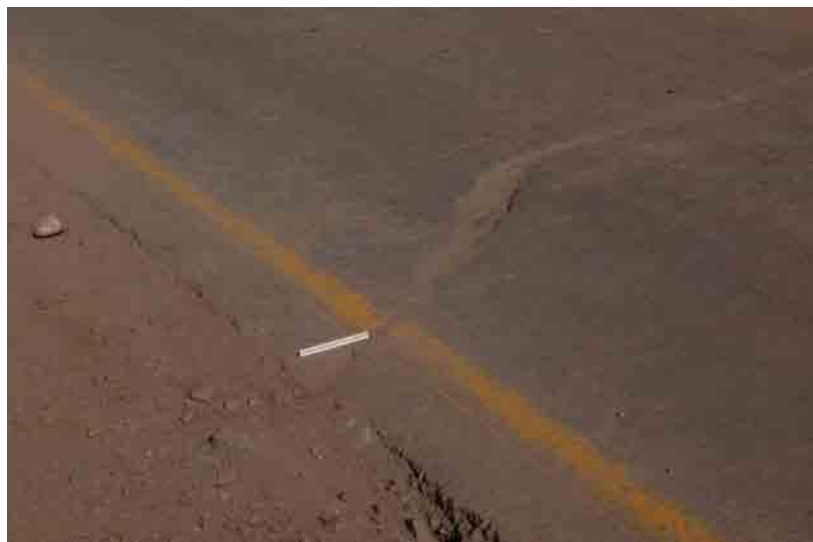
Photo.3.5.12 Slight displacement of road pavement as a sign of a deep active landslide

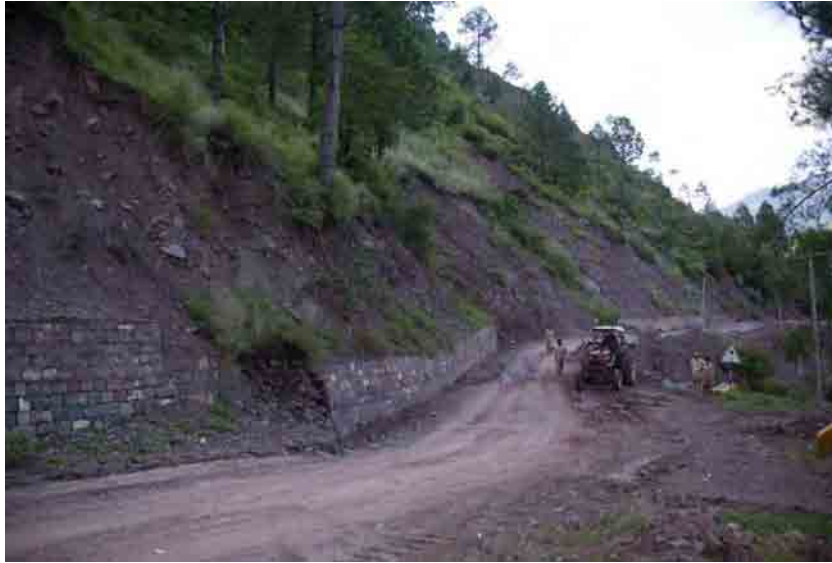
Photo.3.5.13 Dislocation of retaining wall due to active land-sliding of weathered rock or earth

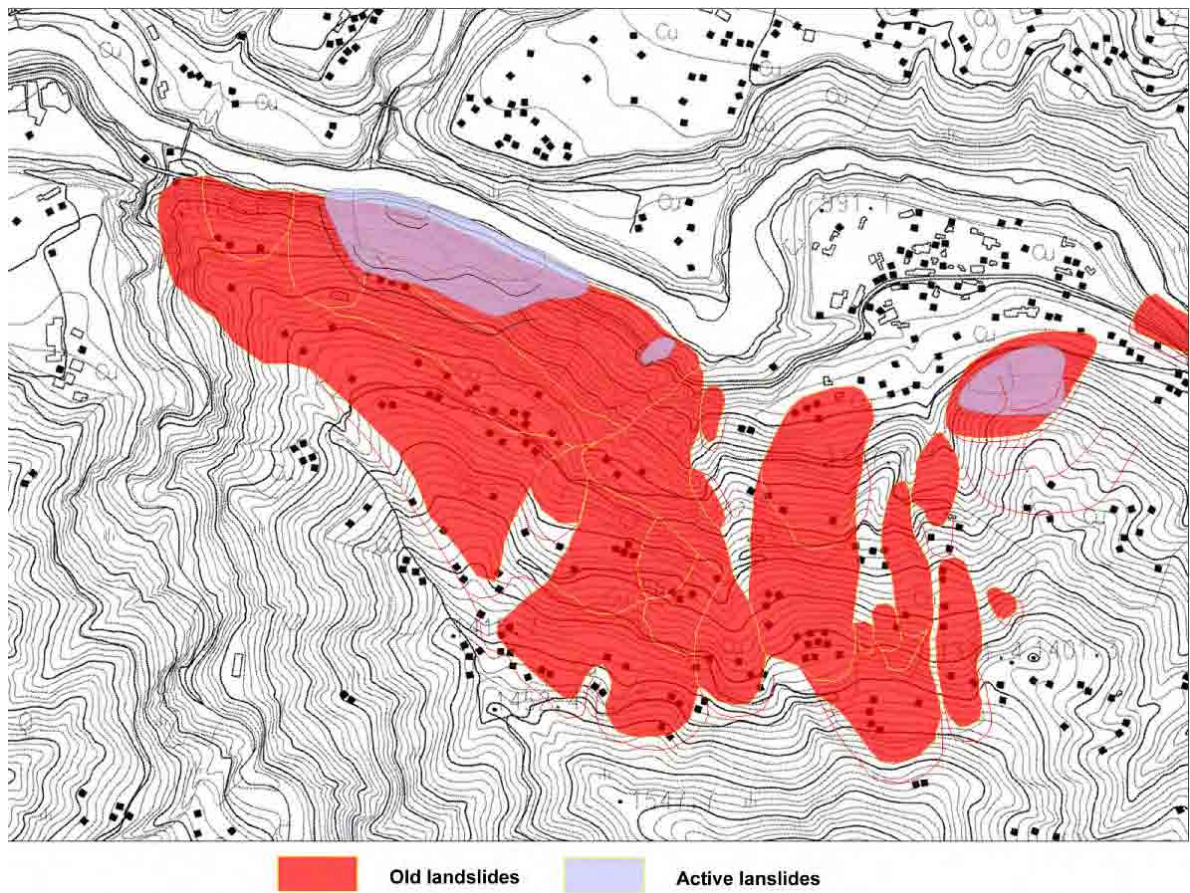
Figure 3.5.7 Plane map of Naili landslide

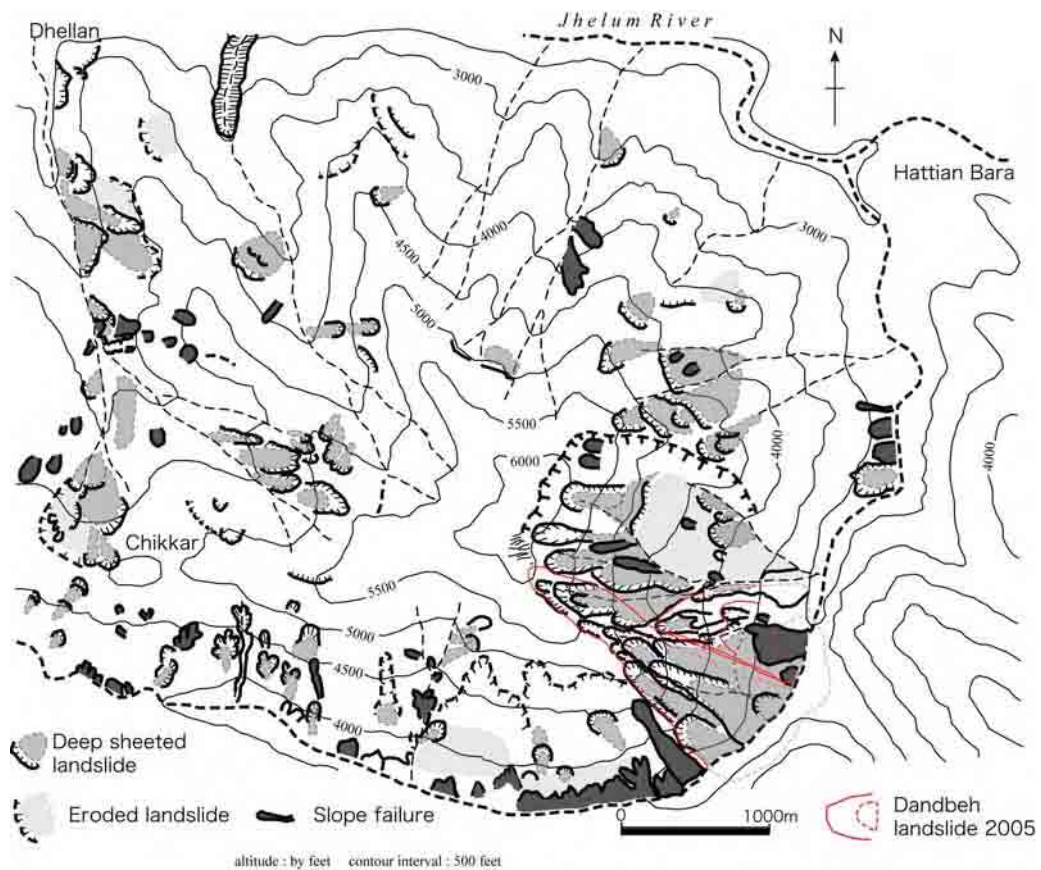
The most distinct example of the reactivated landslide is the Dandbeh landslide (Photo 3.5.15). Geomorphological map made by interpretation of aerial photographs taken in 1978 clearly shows pre-existed slope dislocation marked by cracks and small cliff on the original slope and ridge (Figure 3.5.8).

Figure 3.5.8 Geomorphological map in the vicinity of Dandbeh and Chikkar (after Yagi & Chigira, 2006)

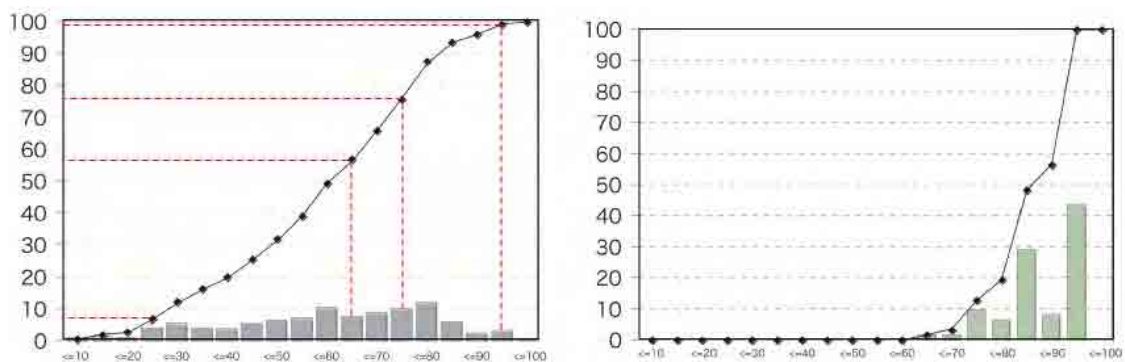
The cumulative curve of frequency distribution shows some knick points in its inclination. Based on it, we classified the scores for each landslide into five degrees of hazard from high scores to lower which are very high, high, moderate, slight and very slight respectively(Fig. 3.6.2a). The rank of scores for each hazard level is: very high: $S > 90$, high: $90 \geq S > 70$, medium: $70 \geq S > 60$, slight: $60 \geq S > 20$ and very slight: $20 \geq S$.

Figure 3.6.2 Frequency distribution of the scores for (a) whole landslides detected (left) and (b) the active landslides (right)

Active landslides where recent landslide phenomena such as cracks, steps and other symptom of displacement have been observed after the earthquake are mostly evaluated to be urgent or dangerous (Figure 3.6.2(b)). This indicates that the adopted method can evaluate landslide hazard properly.

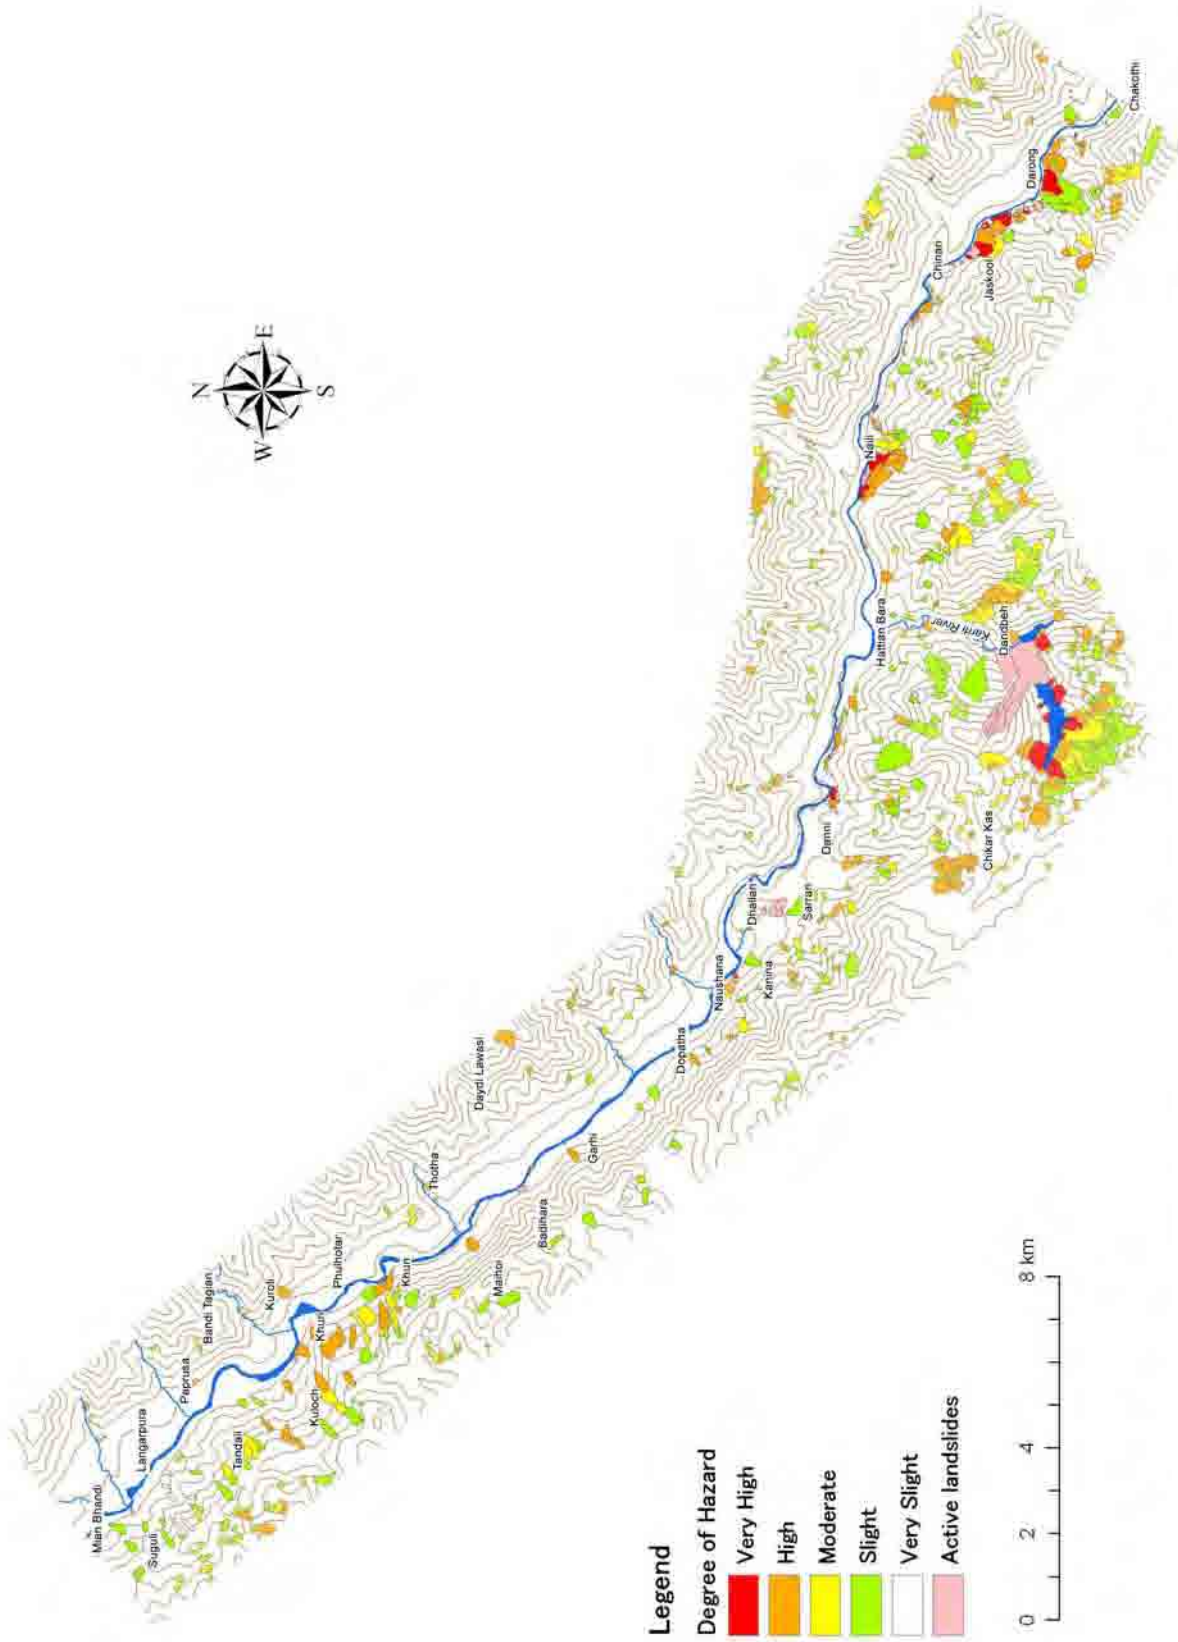
Figure 3.6.3 Landslide hazard assessment by AHP (Analytical Hierarxhy Process)

As above mentioned, this study has already clarified that key words related to dislocation of slopes due to the 2005 Pakistan earthquake are reactivation of the old landslides. Consequently, paying much attention to the old landslides that have high potentiality of reactivation in future is a priority matter, especially for the personnel of Pakistan Government in charge of rehabilitation and reconstruction programs in this area. From this point of view, degrees of landslide hazard were assessed for all old landslides distributed in the study area of the Jhelum Valley. All old landslides were checked every weighting items of AHP analysis by interpretation of stereo paired IKONOS images in scale of 1/10,000. Fig.3.6.3 shows the degree of landslide hazard for each old landslide by

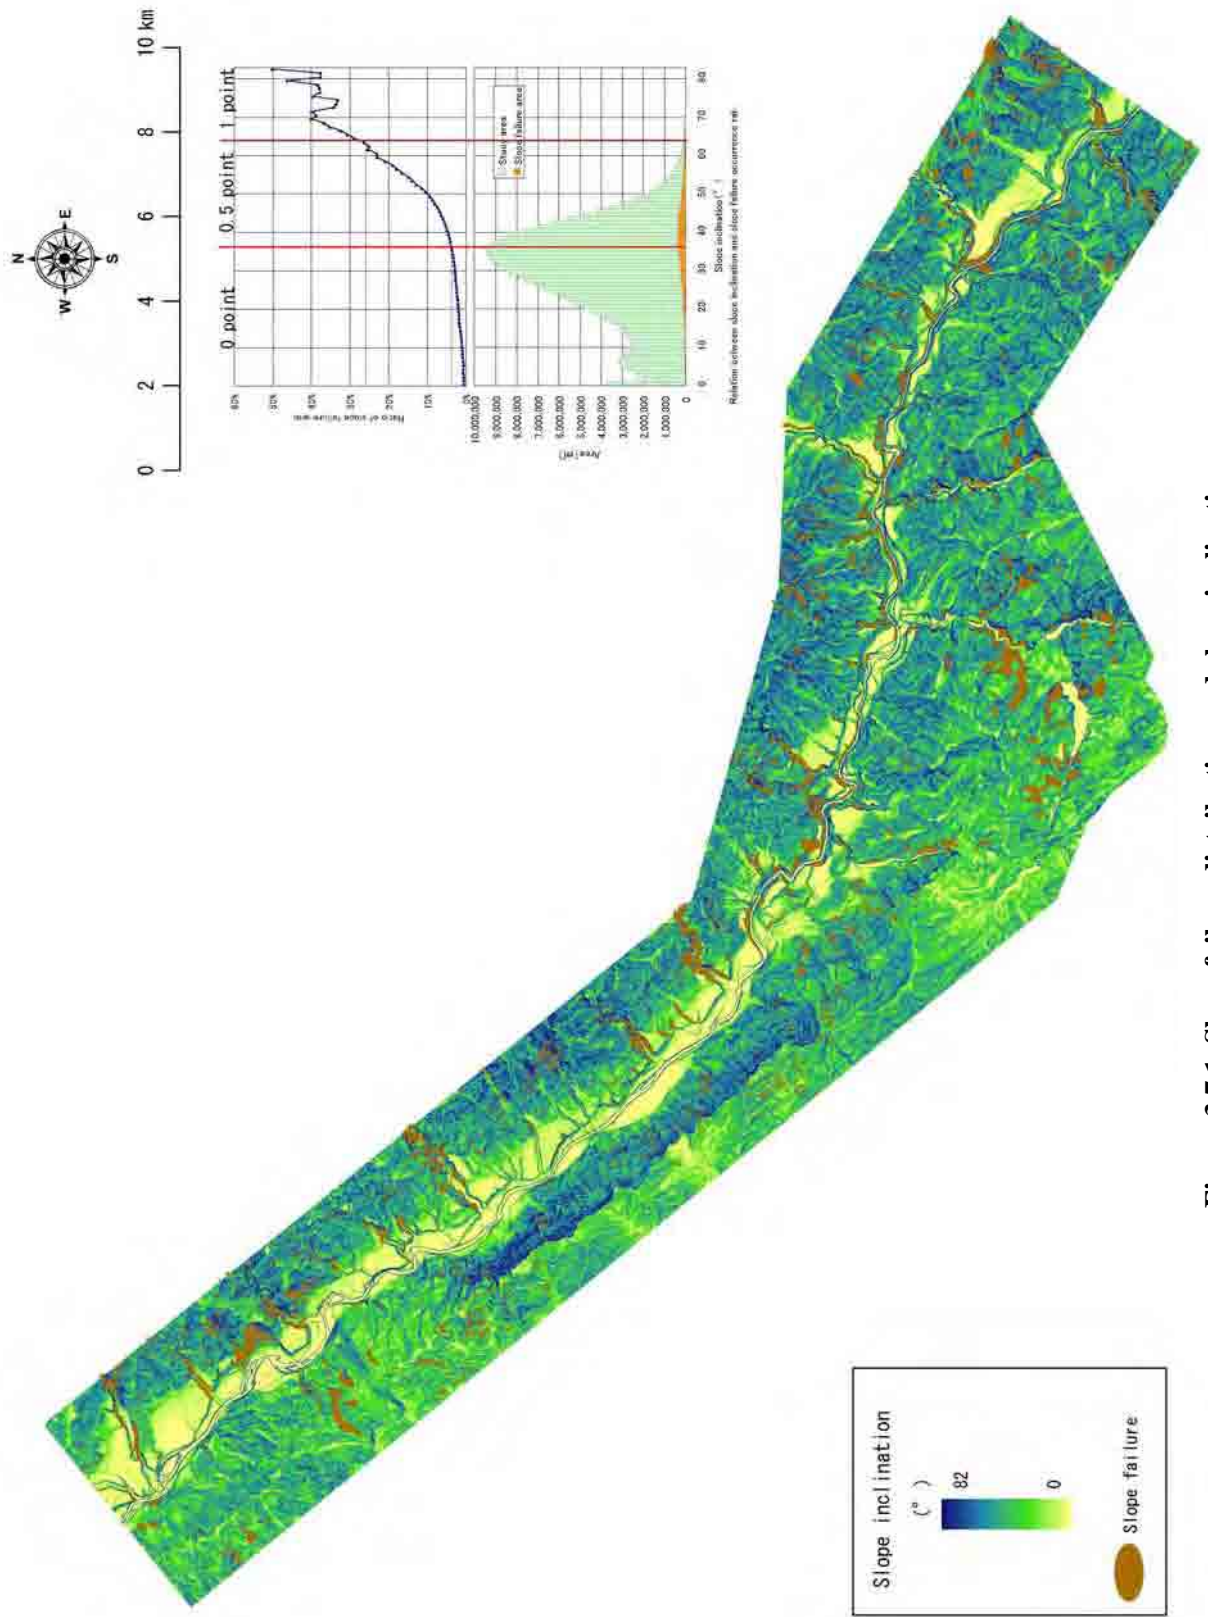
Figure 3.7.1 Slope failure distribution and slope inclination

Distribution of slope failures and classification of slope inclination are shown in Figure 3.7.1 (Slope failure distribution and slope inclination). The ratio of slope failure area to the total area in each slope inclination class increases with the increase of slope inclination. The ratio amounts to only several percents among slopes with inclination of 0 – 36 degrees. However, the ratio amounts to 30 – 50 percent among slopes steeper than 60 degrees. In consideration of these results, the allocated point for the slopes steeper than 64 degrees was determined to be 1 point. The allocated point for the slopes with inclination of 36 – 64 degrees was determined to be 0.5 point. The allocated point for the slopes gentler than 36 degrees was determined to be 0 point.

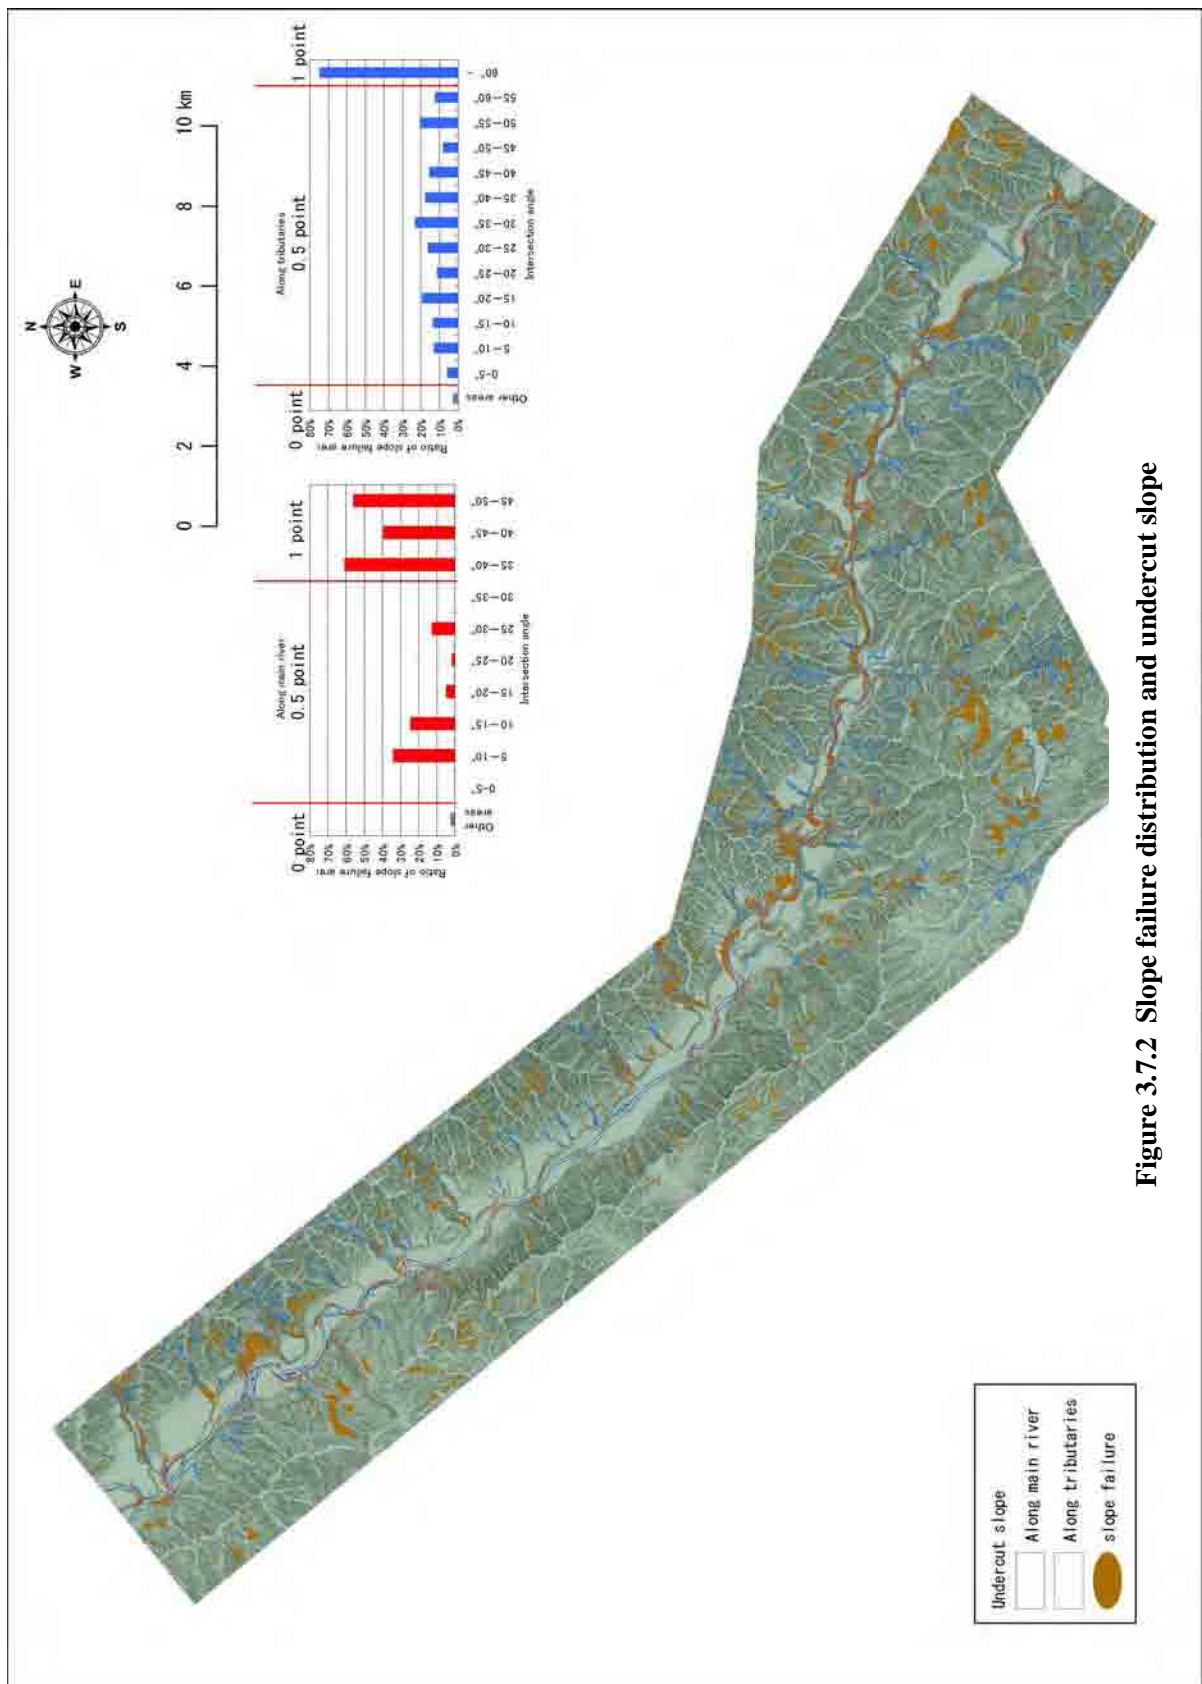
Figure 3.7.2 Slope failure distribution and undercut slope

Distribution of slope failures and distribution of undercut slopes are shown in Figure 3.7.2 (Slope failure distribution and undercut slope). It is clearly observed that the probability of slope failure occurrence is significantly high at undercut sections. It is also clearly observed that the probability of slope failure occurrence is significantly high at critical undercut sections with intersection angle larger than 35 degrees along the main river and at critical undercut sections with intersection angle larger than 60 degrees along the tributaries. Therefore, for the main river, the allocated point for undercut sections with intersection angle larger than 35 degrees was determined to be 1 point and the allocated point for undercut sections with intersection angle smaller than 35 degrees was determined to be 0.5. For the tributaries, the allocated point for undercut section with the intersection angle larger than 60 degrees was determined to be 1 point and the allocated point for undercut sections with intersection angle smaller than 60 degrees was determined to be 0.5.

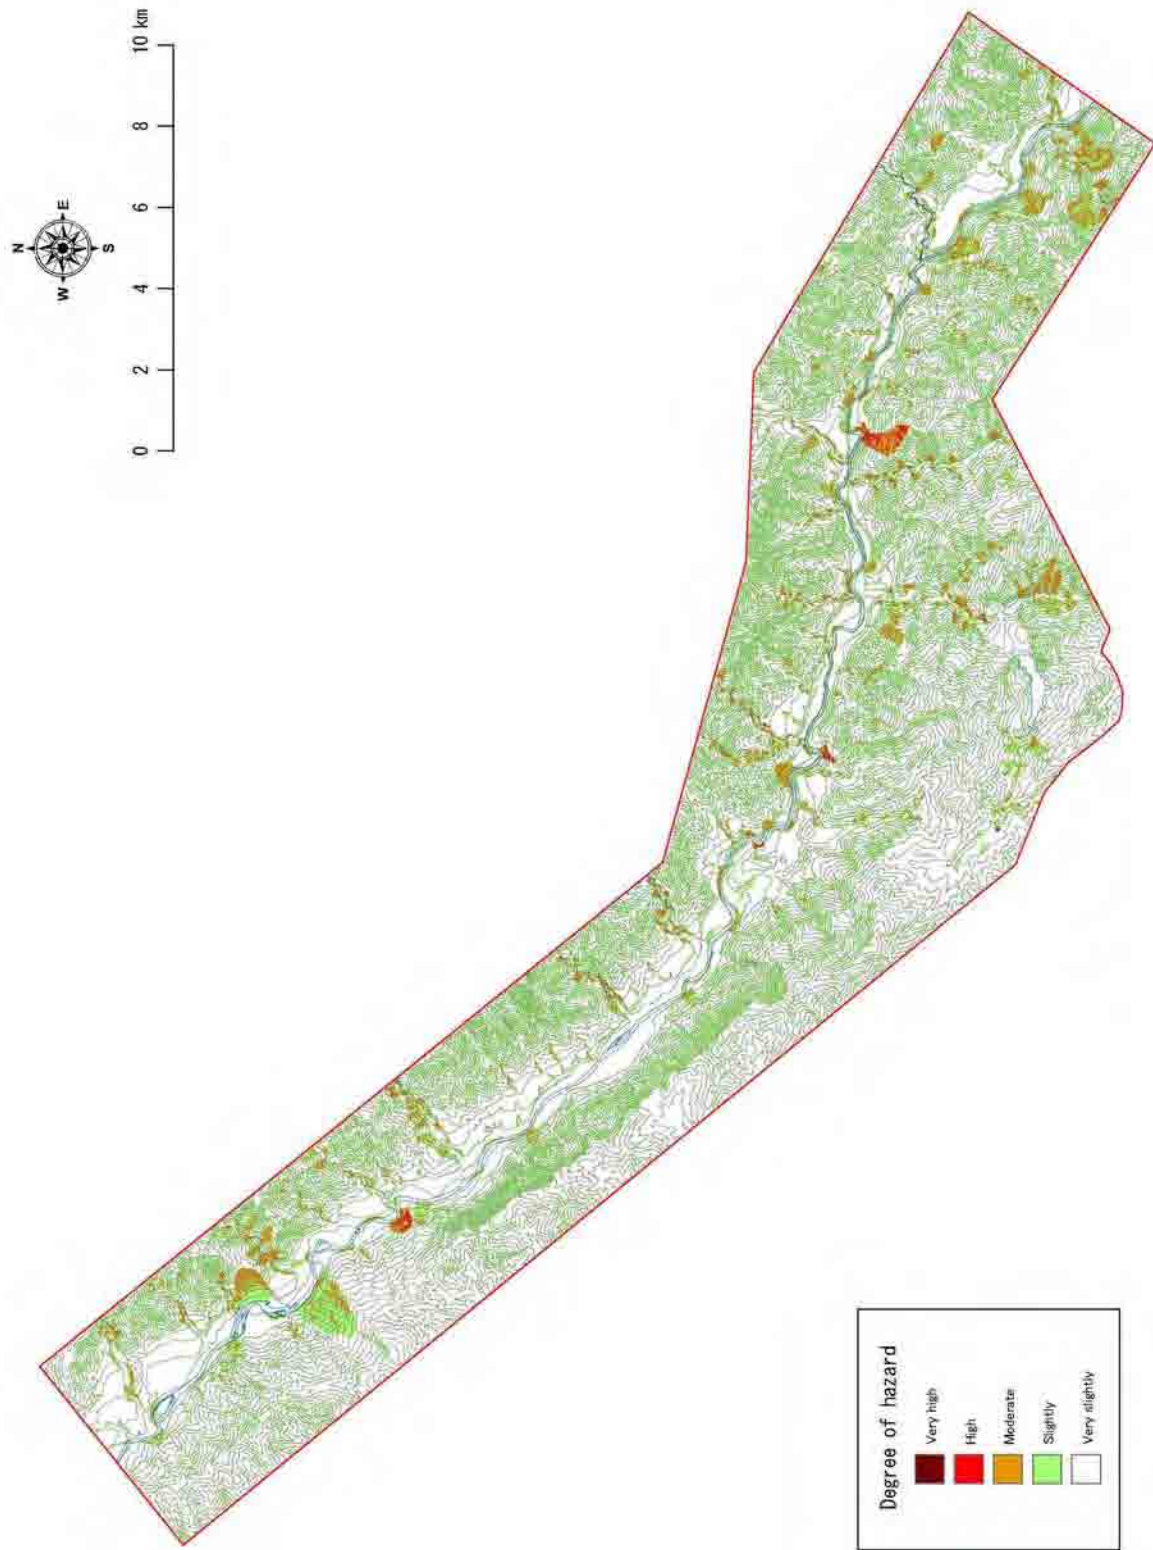
Figure 3.7.6 Slope failure hazard assessment map

As a result, the degrees of hazard from slope failures were assessed on each individual 5m mesh unit by the total allocated points on topographical factors only. The hazard assessment map is shown in Figure 3.7.6 (Slope failure hazard assessment map). The slopes which have similar topographical characteristics with the failed slopes by the Northern Pakistan Earthquake, such as steep slopes in mountainous areas, terrace scarps

along river courses and slopes at undercut sections, were assessed to have high degrees of hazard from slope failures in the future.
