CHAPTER 3

LANDSLIDE DISASTER MANAGEMENT

3. Landslide Disaster Management

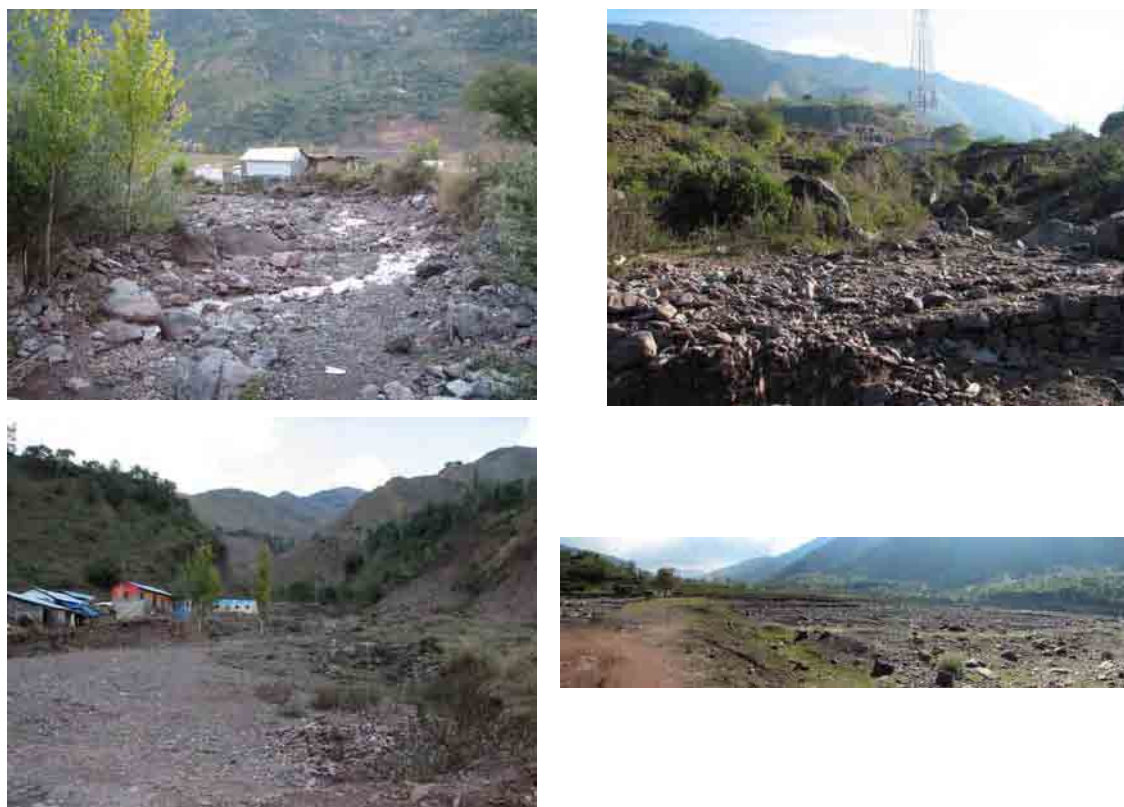
Figure 3.9.2 Debris flows in the candidate sites.

Sites from 4 to 7 have alluvial cones, where recent debris flows came down (Figure 3.9.2). Particularly, site 4 has the largest cone on which many currently abandoned channels. The channel wall heights in these alluvial cones are not high enough, so some consideration should be made, including stream control by concrete walls or just avoiding the alluvial cones.

Upper left: No. 4; Lower left: No. 5; Upper right: No. 7; Lower right: No. 6 (NW end, looking to SE). These should be avoided.

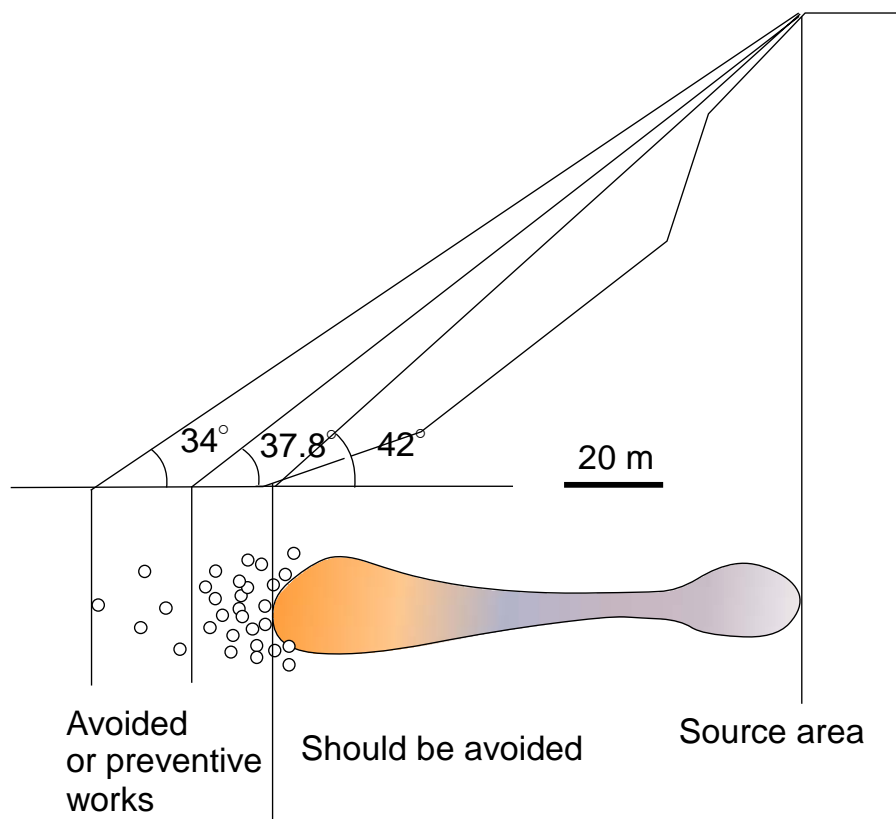
Figure 3.9.4 Cross section along the source and depositional areas of a slope failure at an edge of a steep terrace scarp at site 7.

All sites except for site 2 have steep terrace scarps, below which lower terraces are planned to be used. A slope failure of the scarp was seen at site 7; rock debris flowed down the slope and stone blocks scattered around on the lower terrace at the foot of the scarp. It is not possible to predict potential site of this kind of a failure, so it is to be recommended to make some criteria to set a safety area from the failure of the scarp. One option is to take account of angles to the edge of a terrace scarp. From the observation of the deposits by the failure at site 7, the depositional area can be divided into three: areas of massive debris, densely scattered debris, and sparsely scattered debris (Figure 3.9.3). Figure 3.9.4 is a cross section showing this idea on the basis of the data obtained at site 7. Forty two degrees was an angle connecting the edges of the scarp and the massive debris area in this case. Massive debris areas should be avoided but other areas may be protected by some kind of walls or nets. Collecting this kind of data would be helpful to set some criteria for safety.

The depositional area can be divided into three zones by the density of debris: massive area, densely scattered area, and sparsely scattered area. The inclination of the lines connecting these edges and the top of the source area could be used to delineate safety zones.

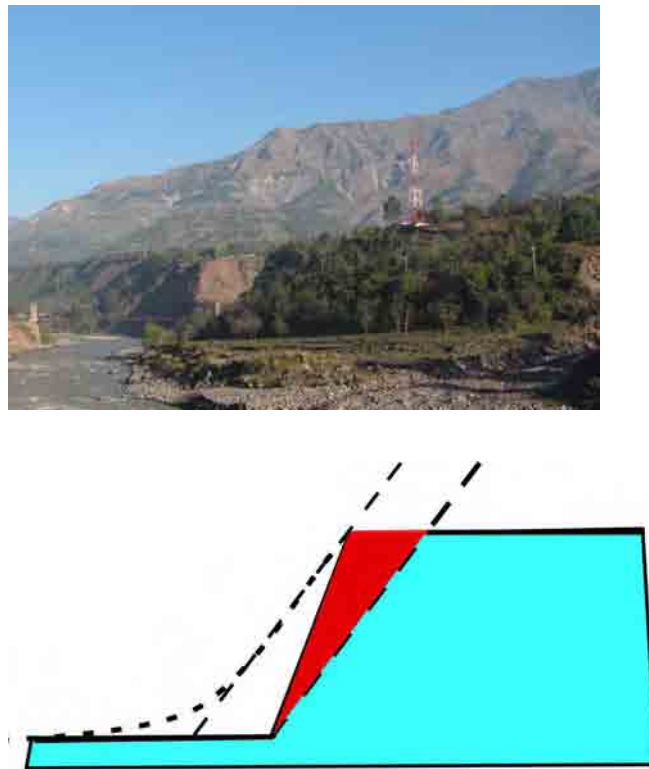
All sites will use higher terraces surrounded by steep terrace scarps, which failed in some parts by the earthquake. Careful examination should be made whether cracks are made or not near the edges of the terraces. For the safety, it is to be recommended to take some distance, security fringe, from the edges of the terraces. This distance could be determined by the stable inclination (maybe around 40°) of the scarps. Figure 3.9.5 shows an idea to set a security fringe from the edge of a terrace above a steep scarp. Draw a line with an inclination of long-term stable terrace scarp from the foot of a steep scarp and obtain an intersection point with the terrace surface. The area between the terrace edge to the intersection could be a security fringe.

Figure 3.9.5 Over steepened terrace scarp and stable terrace scarp around the Muzaffarabad airport (above) and a schematic sketch for the setting of security fringe. (See text for the detail.)
