# **CHAPTER 4**

# **RECOMMENDATION**

### 4.1 Recommendation about mitigation measures against landslide hazards along the national highway near the Jhelum River

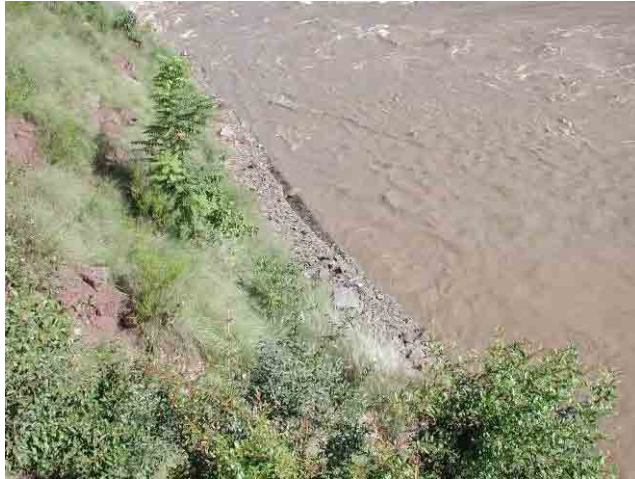
**Photo 4.1.5 Gabion type revetment works near Supdgiran**

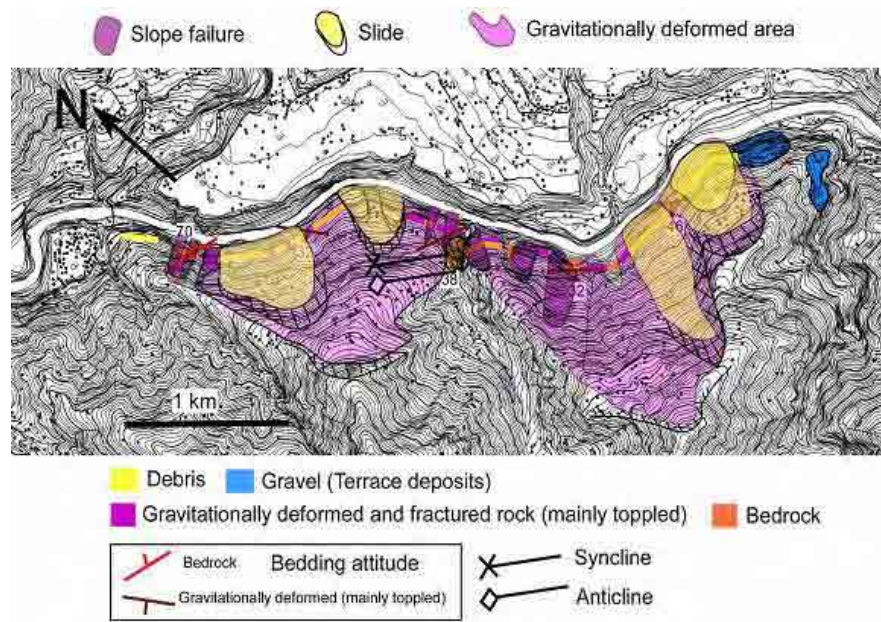
**Figure 4.1.4 Distribution map showing the slope deformation, slides and slope failure in the Jaskool area**

Slope failures occurred mostly in the lower part of the gravitationally deformed slopes (Figure 4.1.4) and the displaced soil masses consist of toppled rock mass and overlying debris. Toppled rock mass is more or less fractured, fragmented and loosened (photo 4.1.11), but these fragments still keep their interlocking. The topography can therefore keep steep slopes in comparison with common depositional debris. However, if the toe of the slope of toppled rock mass is removed, the slope will be destabilized. Finally, in addition to the conditions mentioned above, earthquake shaking triggered failure of the surface parts of the slopes.

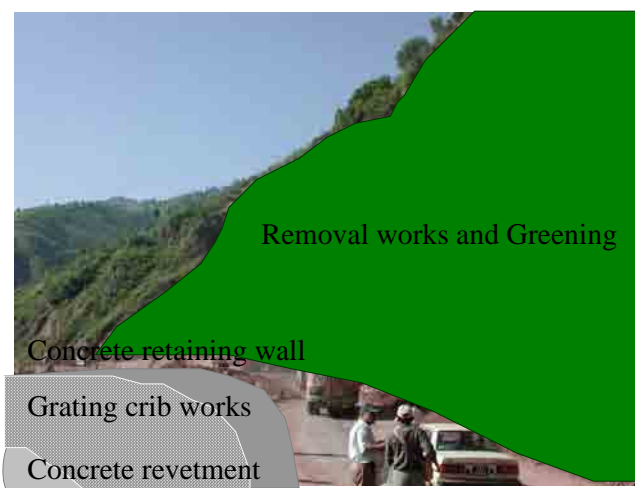
Toppled rock mass generally sustain large strain in its inside, so it is to be recommended to remove unstable part of rocks and construct some retaining wall at the toe of the slopes (Figure 4.1.5). However, toppling is expected to continue slowly in general and temporarily accelerated by earthquake shaking, so it is necessary to pay attention to the slope condition. Traffic control according to slope deformation and rainfall should be arranged in case of necessity.

**Figure 4.1.5 Recommendation of countermeasures against slope failures of toppled rock mass and overlying debris**

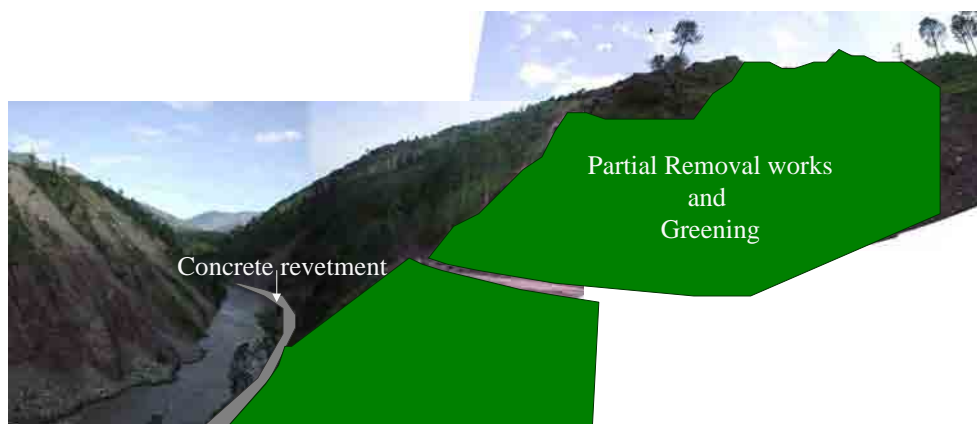
**Figure 4.1.7 Recommendable countermeasure against slope failure preceded by buckling**

It is to be recommended to monitor the deformation of the strata exposed by the road and to pay attention to adjacent slopes and the road surface after execution of partial soil removal works and vegetation works. If significant movement is observed, traffic control should be arranged.

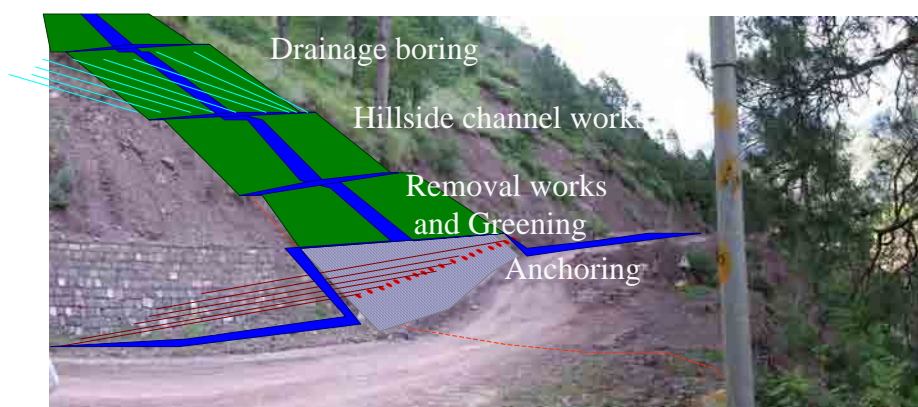
**Figure 4.1.8 Typical counter measures against landslides in order to secure the definite stability**

It is to be recommended to monitor the displacement along the cracks, and if displacement accelerates traffic control should be arranged. Moreover, in case definite stability of slope is needed, anchoring works, drainage boring and hillside channel works should be installed after installation of soil removal works and vegetation works (Figure 4.1.8)

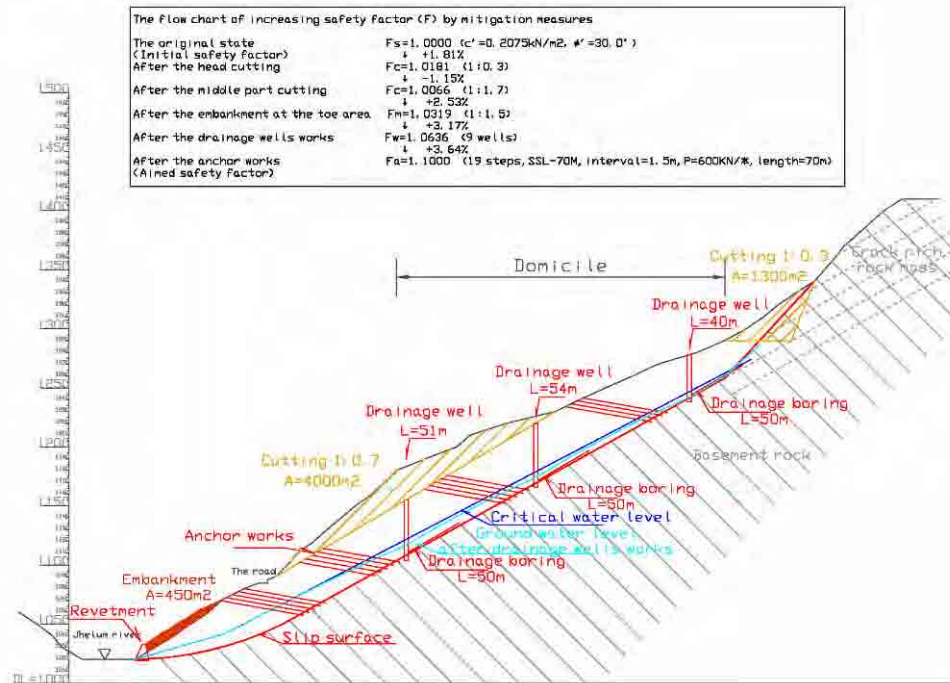
For one of landslides at Jaskool area, slope stability is examined for planning of. If the safety factor of original state is assumed to be 1.0, the safety factor after operation of head cutting works is calculated to be 1.0181. Although middle part cutting works bring decrease of slope stability (-1.15%), the driving force of the reshaped landslide mass decreases remarkably. If a part of the cutting mass is removed to the toe area for the embankment works, the safety factor increases to be 1.0319. After those operations, if the drainage wells and boring are installed additionally, the safety factor increases to be 1.0636. If anchor works are also installed, the slope stability increases to be 1.10 of the targeted value. Figure 4.1.8 shows the schematic cross section including results of slope stability analysis and designed counter measures.

Figure 4.1.9 Schematic cross section of Jaskool landslide

However, it requires huge total costs to carry out the whole stages of the countermeasures described above. It is practically not realistic to carry out this kind recommendation even in Japan (Figure 4.1.9).

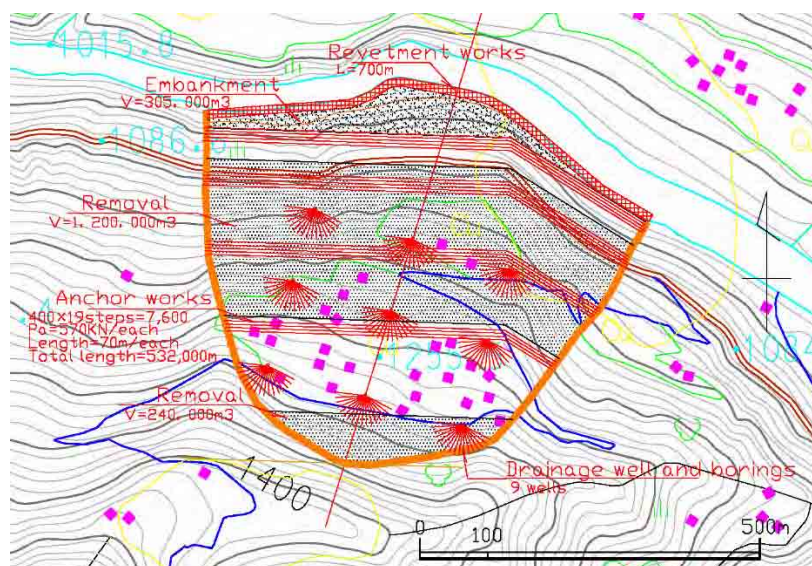
Figure 4.1.10 Recommendation of measures against Jaskool landslide

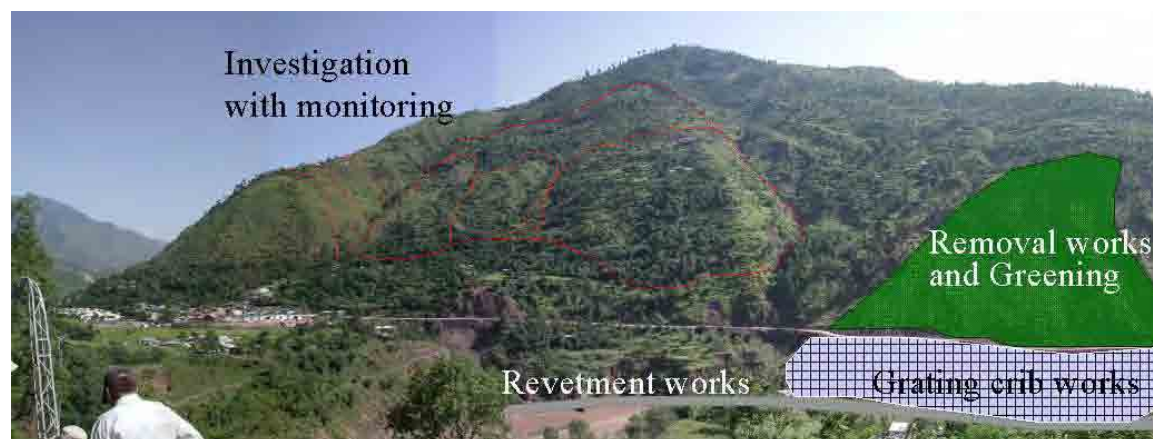
These slope failures have similar geologic features. The strata in the slopes are toppled and intensively fractured, providing debris for near surface (Figure 4.1.13). The loosened rock mass and debris failed during the earthquake. Important point is that the failed slopes have narrow but horizontally long gentle slopes on top of them and they are the result of gravitational flexural toppling. Toppled rock mass is exposed along the highway almost continuously. They are fractured but still hard and keep interlocking. Therefore, they would not fail suddenly. However, the toppling deformation would continue for a long time, even slowly.

**Figure 4.1.14 Counter measures against slope failures at the Naili area;**

Rerouting is recommended if it is possible, because the deformation would continue for long time and the maintenance cost may not decrease. If it is not possible soil, removal works and vegetation with partial grating crib works should be installed to the slope where a risk of rock fall is extremely high. Monitoring of the failure scars and traffic control should be arranged (Figure 4.1.14).

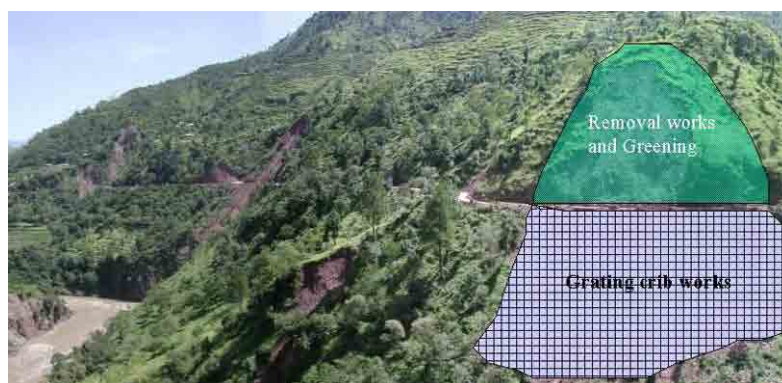
Slope failure of the terrace deposits, cracks on the road, and bumpy deformation of the road are due to the subsidence described above. Unstable materials still remain on the upper part of the scar and would slide down.

**Figure 4.4.16 Recommendation on No.21 slope failure**

Removing the unstable materials and vegetation works are recommended. If possible, grating crib works at the lower parts of landslide is effective for increase of stability. After then monitoring the cracks and traffic control should be arranged.

Retaining wall should be avoided so as not to decrease slope stability on failure.
