APPENDIX - B

B-1: As Build Drawings (Summary)

Technical Assistance for Reconstruction Project
of Bridges Damaged by October 8th Earthquake
on The Jhelum Valley Road
SITE NO.1 BRIDGE WORKS

The No.3 Seri Bridge on Km31+200 is situated on the left bank of the Jhelum River. As a consequence of the October 8 Earthquake (M-7.6), the approach road of the No.3 Seri Bridge was either destroyed by landslides or blocked by landslide materials. Even now some collapse-prone slopes are the existent hazard along the road.

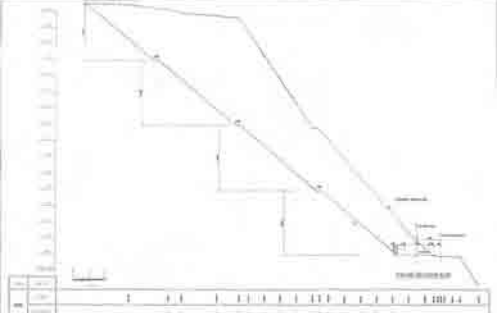
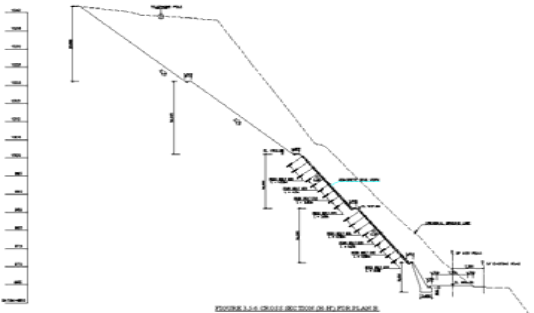
Plan	Plan A Cutting work + Vegetation + Retaining wall						Plan B Cutting work + Concrete Crib work with Rock Bolt + Retaining wall							
Cross Section

Technical Description	<ol style="list-style-type: none"> 1. This plan is to form a stable cut slope with a standard gradient, by cutting the overall unstable parts of the slopes above the road. 2. Vegetation work is used to prevent the cut slope from erosion and associated local collapses. 3. This plan will cause a great quantity of excavation volume and topographic change because of the overall cut of the unstable parts. 4. Construction cost of this plan is cheapest among the three plans, but this plan involves land acquisition of big area. 5. After excavation, the road traffic possibly suffers due to the rock falls until a full recover of vegetation. 						<ol style="list-style-type: none"> 1. The plan is to cut the partial unstable parts of the slope and then stabilize it by concrete crib work with rock bolt. 2. Compared to Plan A, this will lead to largely reduced excavation volume and topographical change. 3. Large quantities of big boulders will make the execution of rock bolt difficult. 4. After excavation, the road traffic possibly suffers due to the rock falls until a full recover of vegetation.

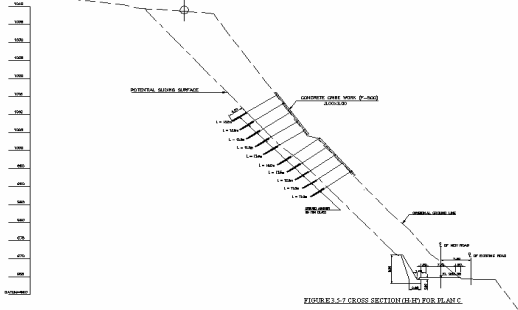
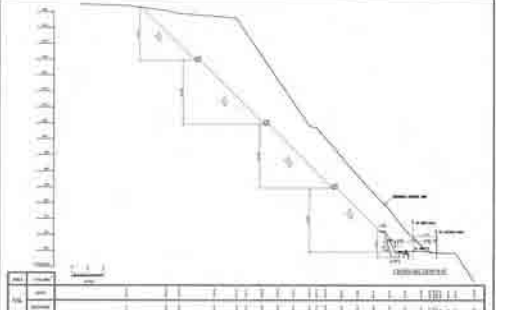
Plan	Plan C Ground Anchor +Retaining Wall	Plan D Cutting work +Mortar spray with wire mesh + Retaining wall																																																																								
Cross Section

Technical Description	<ol style="list-style-type: none"> 1. This plan is to stabilize the overall unstable parts of the slope by ground anchor work. 2. Estimation of the skin friction resistance between the ground (soil mass) and therefore the safety of the ground anchor is unreliable. 3. Execution of ground anchor is not only costly but also difficult. 4. After excavation, the road traffic possibly suffers rock falls until a full recover of vegetation. 	<ol style="list-style-type: none"> 1. This plan is to form a stable cut slope, by cutting the overall unstable parts of the slopes above the road. 2. Mortar spray is used to prevent the cut slope from erosion and associated local collapses. 3. Compared to Plan A, this will lead to largely reduced excavation volume and topographical change. 4. Compared with Plan B and C, this is relative easy to be conducted and widely applicable also for similar type slope failures 5. This plan will not cause any soil collapse after excavation.

As a result of evaluation, the plan D as being most appropriate, technically and economically, is recommended for implementation, because all plans except plan D are unreliable for slope stability until a full recover of vegetation... Furthermore the plan A involves large quantities of excavation material and paddy field, and plan B and C are difficult for construction as well as are low in cost performance.

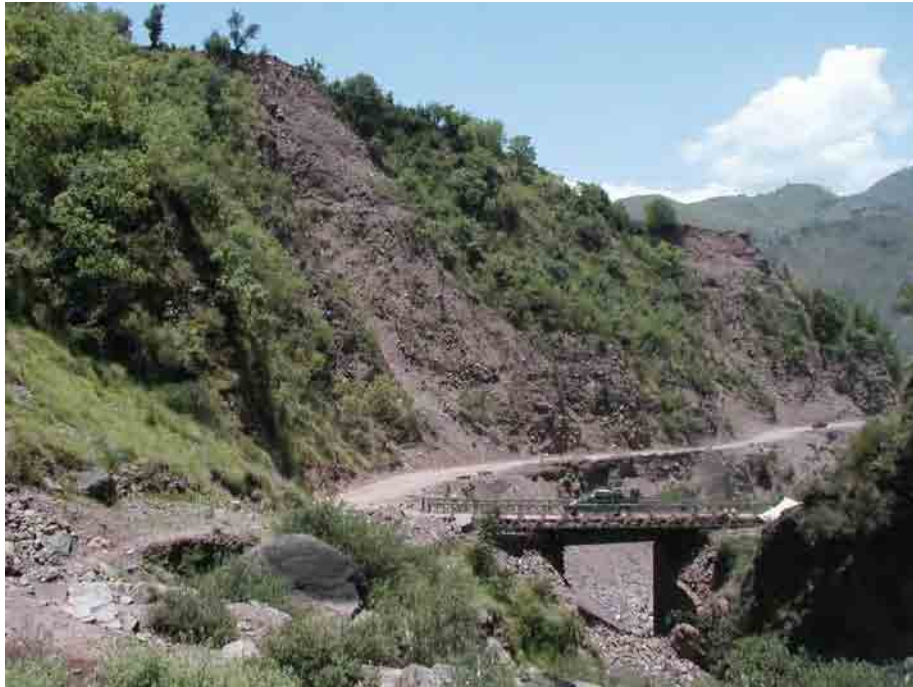
No.3 Seri Bridge and its Approach Road

This picture shows the Seri Bridge and natural slope prior to the slope cutting work

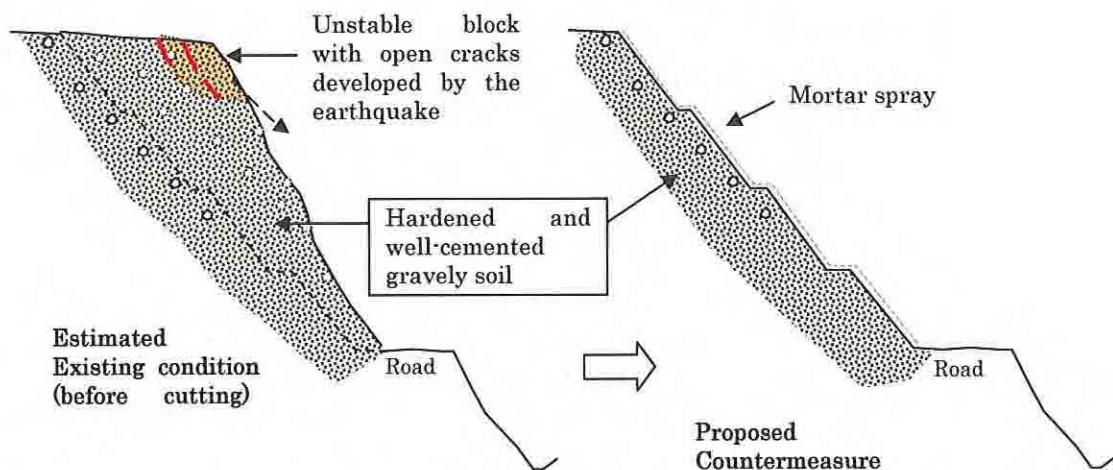
Figure 1 Anticipated geological condition and proposed slope stabilization works at the No.3 Seri Bridge Site Slope in the Detailed Design Stage

In the Detailed Design, cut slope of 1:1.0 with mortar spray was selected for slope stabilization of the No.3 Seri Bridge Site slope, taking into consideration of the following geological conditions and the selection criteria of Slope Protection Works as recommended by Japan Road Association (JRA).

[Geological Condition of the No.3 Seri Bridge Site Slope]

- Natural slope gradient: 1:0.8 to 1:1.0 (V:H)
- Hardened and well-cemented gravelly soil can be classified as “Soft Rock” based on the observation of the existing slope surface.

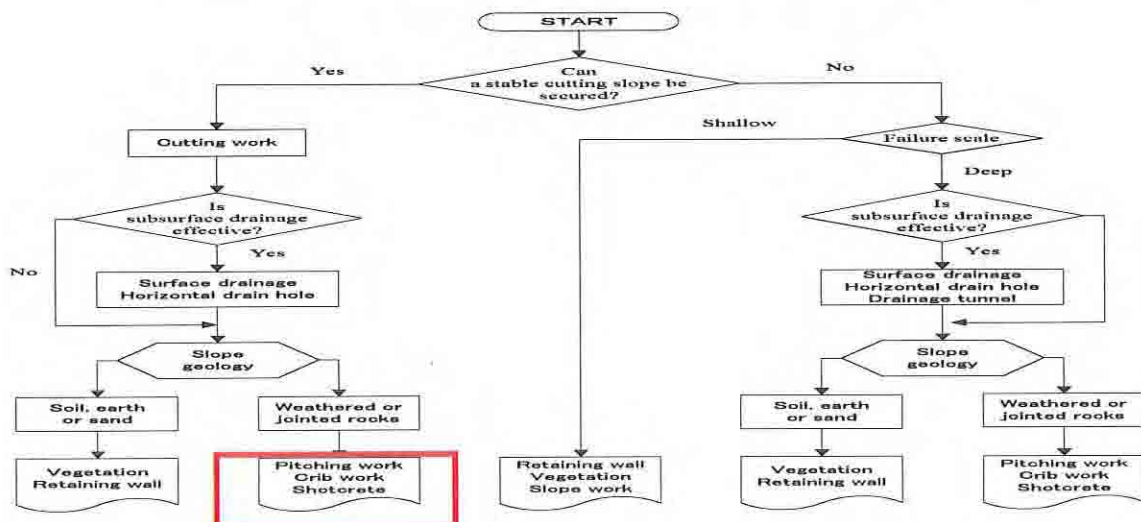
Figure 2 Selection Criteria of Slope Protection Works Recommended by JRA

For such loose stiff clayey soil with sub-angular boulders, Mortar Spray Work is not applicable and the Crib Works should be selected as the countermeasure for slope stabilization in consideration to frequent rock falling due to erosion of soil surface as described in Figure 2 and Table 1 below.

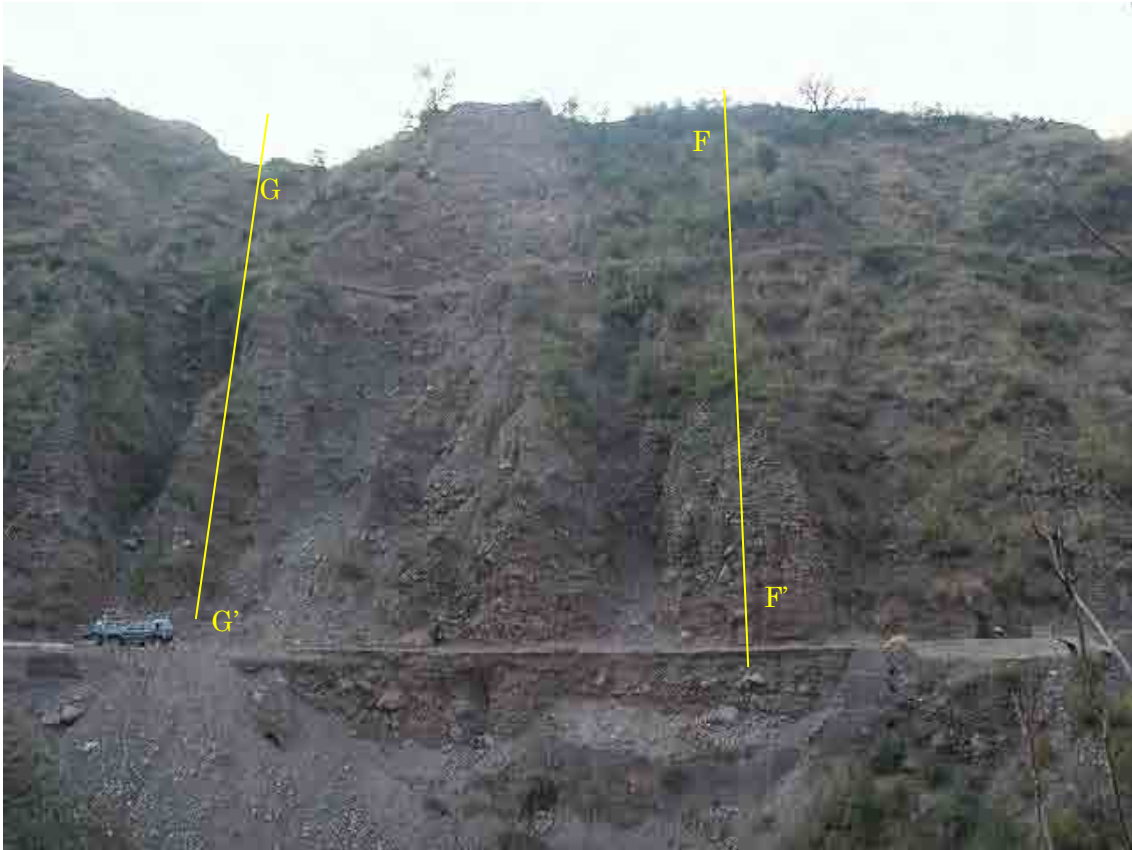
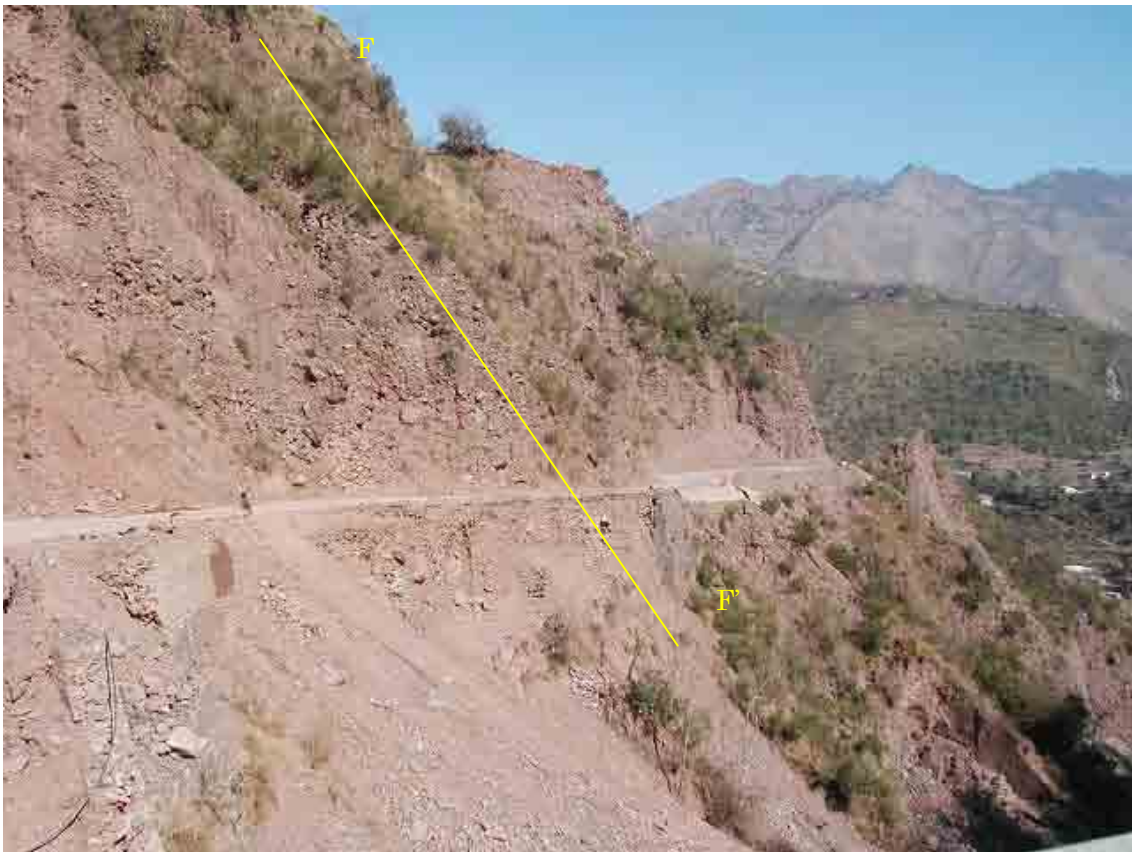
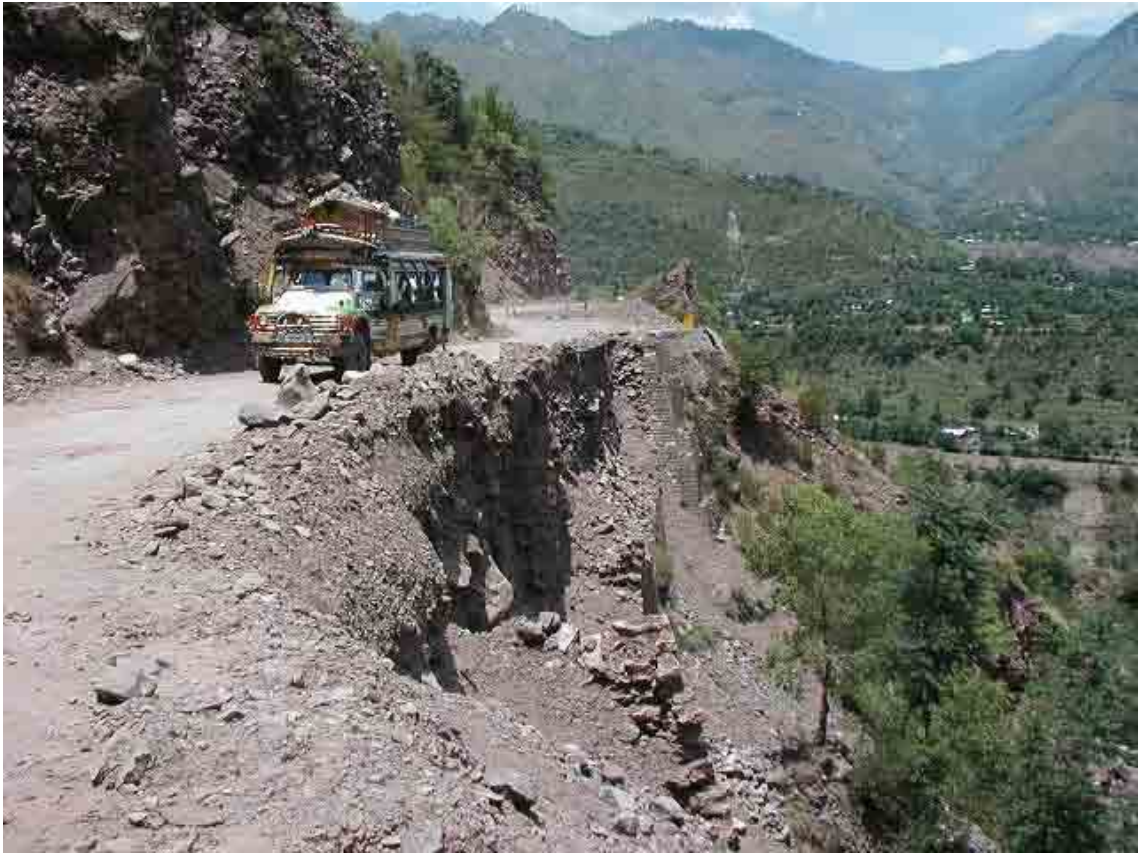
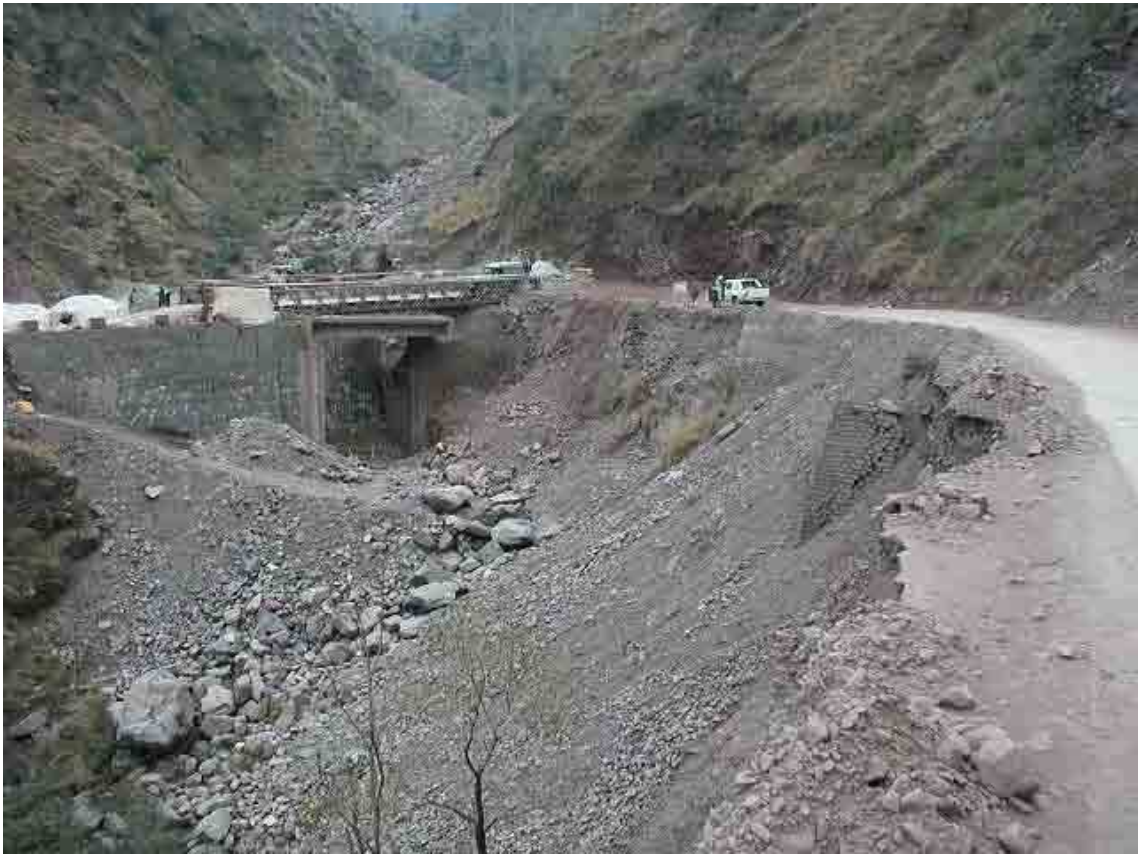
Photograph

Above photographs show the actual cut slope condition with boulders of 1-2 m in diameter.

Above photographs show the surface condition observed along the existing road. The slopes are covered by sub-angular to sub-rounded gravels (average size: 2-10 cm in diameter, maximum: 200 cm in diameter) with hardened and well-cemented gravelly soil.

Since existing slope gradient is 1:0.8 to 1:1.0 (V:H) and it's surface are covered by sub-angular to sub-rounded gravel (average size: 2-10cm in diameter, maximum 20cm in diameter) with hardened and well-cemented gravel soil, it is not anticipated to have serious slope failures by normal natural forces basically. However, remaining of the risk and occurrences of minor slope failures and rock fallings are not avoidable in the geological and topographical circumstance of the site.

Taking into account the budgetary constraint and cost-efficiency, it is recommendable to modify the concept of improvement of the site (the slope protection section) as below.

- To stabilize the existing slope by removal of the top soil loosened by the earthquake,
- To apply the suitable slope protection works for the cutting slope established by the above top soil removal work,
- To minimize cutting works along the existing road and carry out widening as much as possible within the existing road using common and locally available methods.

- To sift the alignment at the corner using 25m radius curvature to avoid the massive cutting in the JICA Section,
- To extend the box-culvert about 5m in length and construct U shaped channel (Log Chute) about 66m in length,
- To widen the narrow section (G-F-E section) of the existing road toward valley side by filling work protected by gabion and founded on the U shaped channel,
- To widen the existing road (A-E section) as much as possible within the existing road using wet-masonry wall at mountain and valley side (see Figure 7, 8 and 9).
