CHAPTER 2 CREEK CONDITIONS

2.2 River / Creek Condition

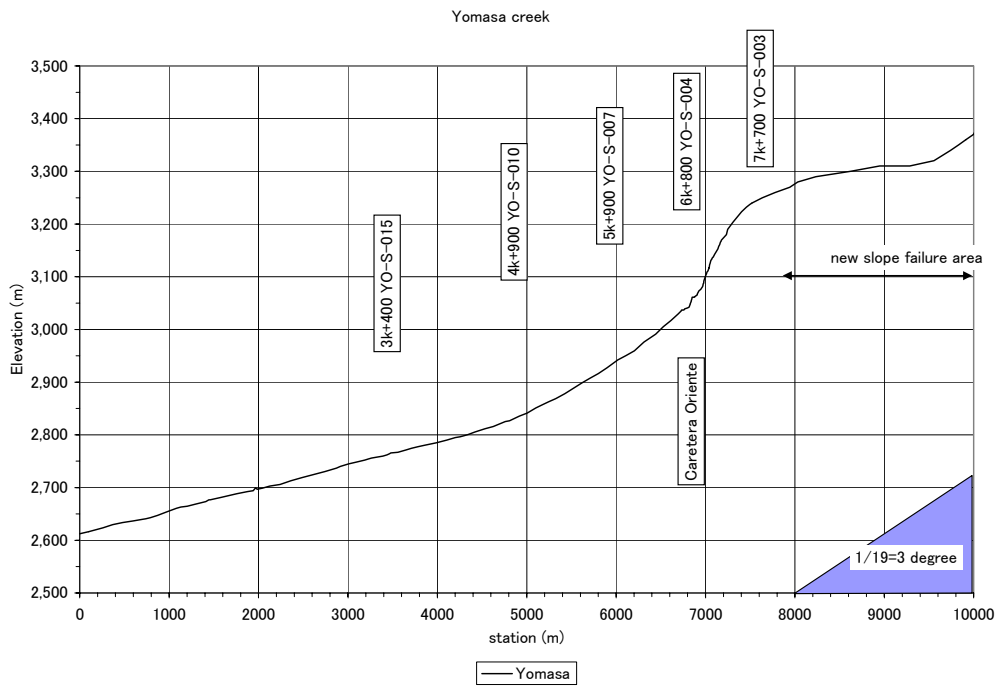
Figure S3-2-16 Longitudinal Profile and Location of Creek Condition Survey of Yomasa creek

In Yomasa creek, Aleman is located on the mild slope reach having lower than 3 degree. In this reach the debris flow deposits. The bed materials are composed of large boulder and smaller ones such as cobbles. Figure S3-2-16 is the longitudinal profile of the Yomasa creek in which the creek condition survey points are indicated. One of the important features of the Yomasa creek is that it has a mild slope reach in the upstream area. YO-S-003 which is located on the downstream end of the mild slope reach is shown in Figure S3-2-17. Because of its mild slope, the deposit on the creek is few although the upper area has a lot of new slope failures. The surrounding area is said to have security problems so that the detailed site investigation was very difficult.

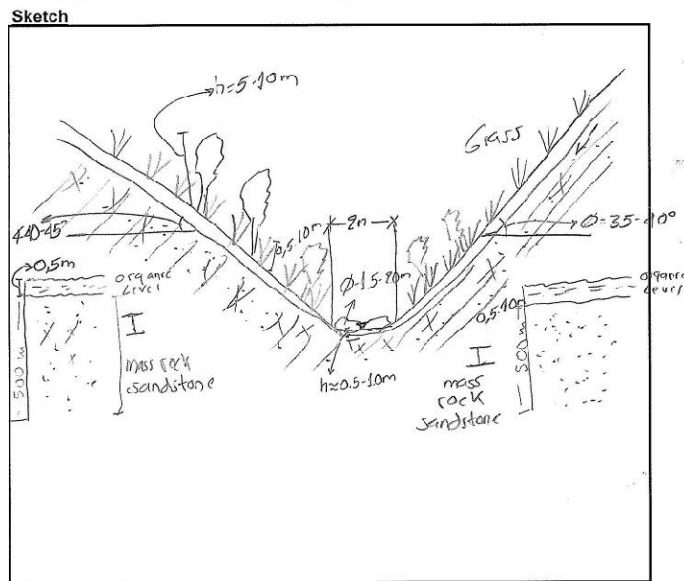
Figure S3-2-17 Sketch of Cross Section of Yomasa Creek (YO-S-003)

jica INSPECTION SHEET			
SHEET NO. 1 YO-S-003			
Location Name:	Puente Verde sector	Date:	08/30/06
Coordinates:	X: 100.550 Y: 989.000	Inspected by:	Nakano/Foreiro
