Attachments IIIC-1
Inventory of Existing Irrigation Facility
on South Main Canal

Inventory of Existing Irrigation Facilities on the South Main Canal

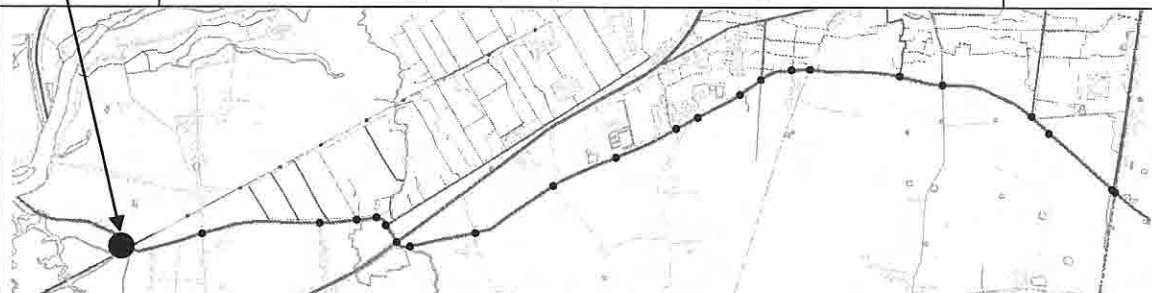
Description of the Structure					
<p>Since axis of the bridge is consistent with a route of power-transmission line, the bridge must be provided for construction and maintenance of the power-transmission line. The elevation of top slab is EL.37.443m; Elevation at bottom is 34.075m.</p>					
Observation					
<p>Height of the bridge road surface is same with the canal bank level. On the survey date, water level at the bridge was 1.6 m lower than the bridge road surface. On the same date, overflow from the Roleang Chrey Regulator gate was estimated at 20cm and it seemed maximum water level. Higher water level than this level make the upstream area of regulator submerged.</p>

Improvement Plan					
<p>Width of the south approach channel at this bridge is not enough for let design discharge flow. Clearance between water level and top slab is also not enough. It is required to re-construct new concrete bridge with width of 3.5m after demolishing the existing bridge.</p>

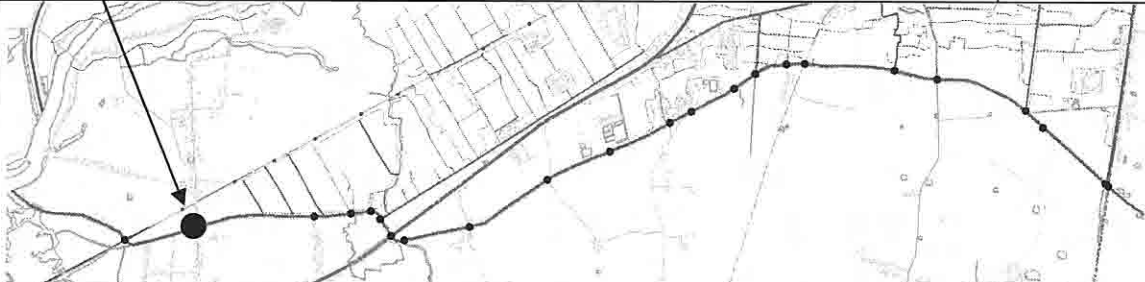
Description of the Structure					
<p>The Vat Krouch intake was constructed to regulate inflow to the South Main Canal from the Roleang Chrey Regulator.</p>					
Observation					
<p>According to PDOWRAM staff, the gate is working well at present. However, gate wire rope was damaged and repaired with temporary manner.</p> <p>The existing gate with four sealing edges contributes to the head loss at this intake. This is one of the reasons to be difficult to introduce the gravity irrigation.</p>					
Improvement Plan

<p>The new intake with two gates of 4.0m wide will be re-constructed at same place after demolishing the existing structure.</p>

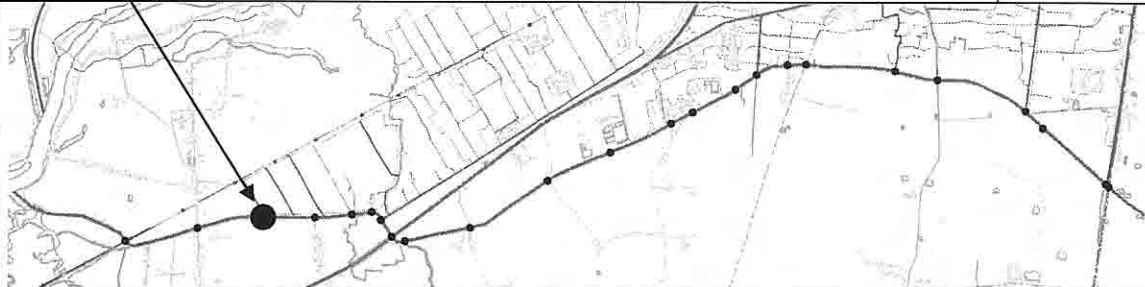
Description of the Structure					
The secondary canal (RS-0) was excavated from the South Main Canal to the paddy field.					
Observation					
The secondary canal was not used yet, since no turnout structure was provided.					
Improvement Plan					
The new turnout will be constructed to conduct water to tertiary canal. The existing canal will be rehabilitated by proper way using adequate soil. This canal will be tertiary canal named SMC-T-①.

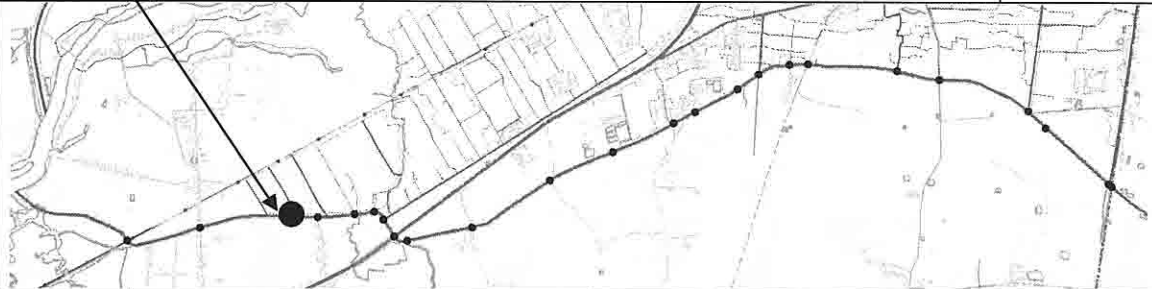
Description of the Structure					
The secondary canal (RS-0.1) was excavated from the South Main Canal to the paddy field.					
Observation					
The secondary canal was not used yet, since no turnout structure was provided.					
Improvement Plan

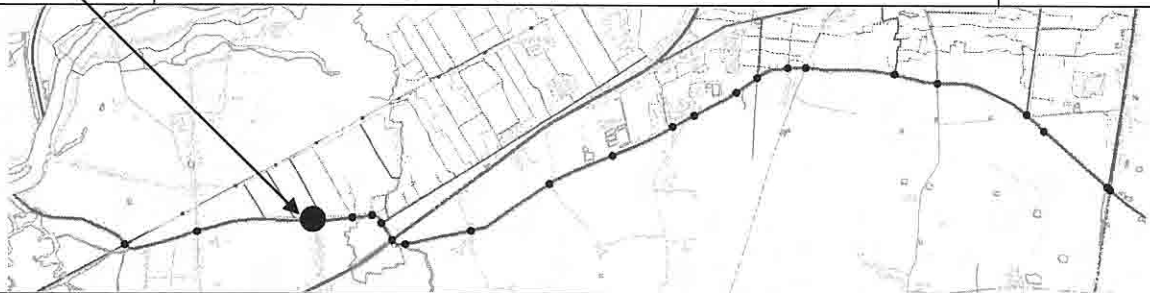
Description of the Structure					
The bridge was provided by Ou Veaeng village people by their own effort to go across the South Main Canal to the irrigation area.					
Observation					
Height of the bridge is same as the canal bank level. It is dangerous to go across the bridge.					
Improvement Plan					
The concrete foot path with effective width of 2.2m will be constructed with canal protection by concrete lining at upstream and downstream of 5m each. The foot path should have a clearance of 1.0m above design water level.

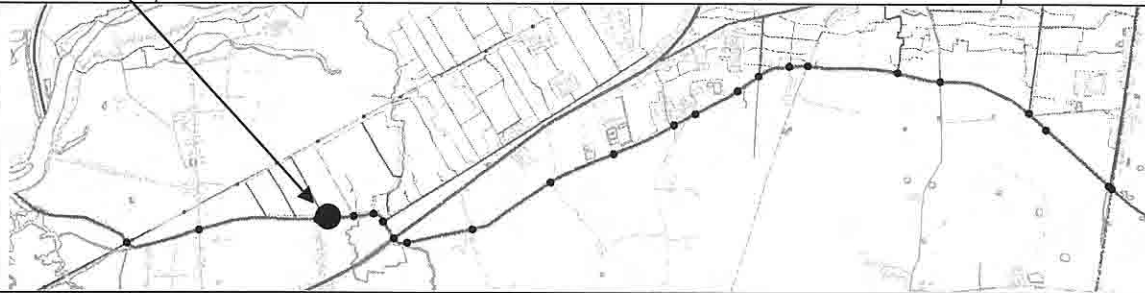
Description of the Structure					
The secondary canal (RS-1) was excavated from the South Main Canal to the paddy field.					
Observation					
The secondary canal was not used yet, since no turnout structure was provided.					
Improvement Plan

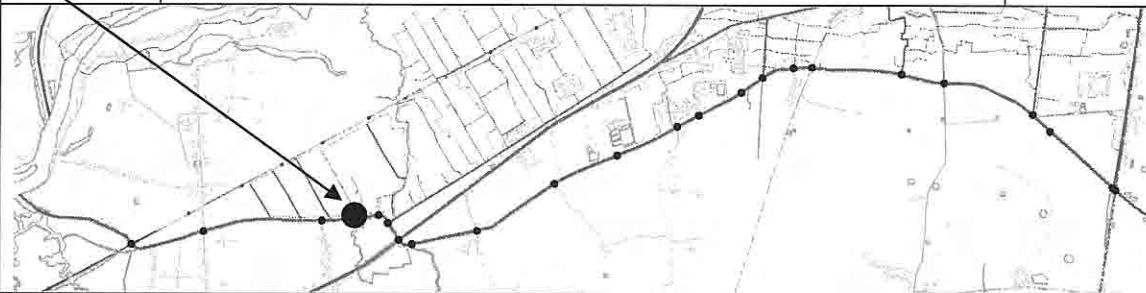
Description of the Structure					
<p>According to PDOWRAM staff, the turnout structure was used before. However, it is not used any more. The concrete pipe with diameter of 0.8m is installed.</p>					
Observation					
Improvement Plan					
<p>The new turnout with a concrete pipe with diameter of 0.5m will be constructed after demolishing of existing structure. The existing canal will be rehabilitated by proper soil, and is used as tertiary canal named SMC-T-②.</p>

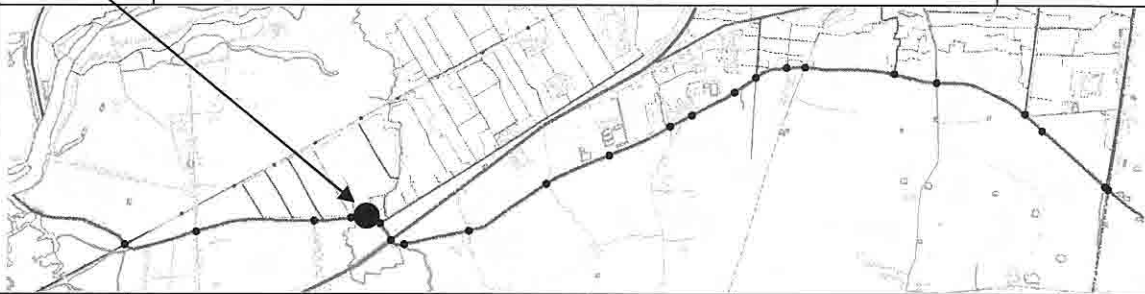
Description of the Structure					
<p>According to MOWRAM and PDOWRAM staff, before construction of the South Main Canal, a labyrinth type spillway was provided to spill out flood water from the Ou Veang pond. However, it was not used after the main canal construction.</p>					
Observation					
<p>Height of the spillway crest is about at 35.28m. (About 1 meter lower than left bank elevation).</p>					
Improvement Plan					
<p>The design water level at this spillway is 35.44m. The crest of spillway should be heightened about 20cm.</p>

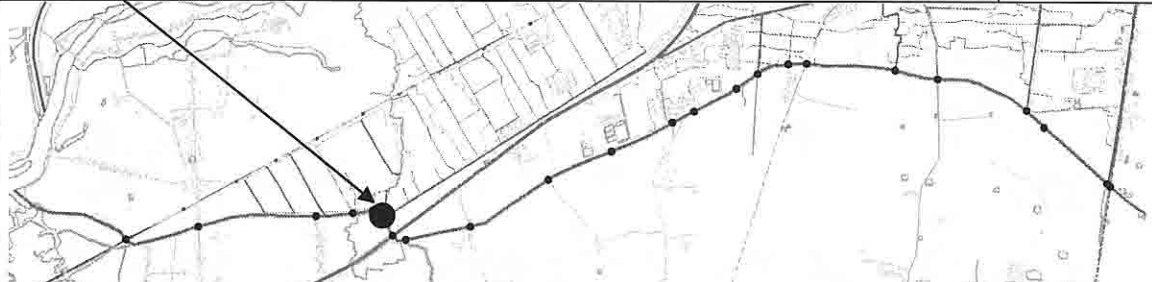
Description of the Structure					
Turnout structure with two slide gates (size: 1.0m width x 1.6m height x 2 nos.) was provided to divert water from the South Main Canal to the secondary canal No. RS-3.					
Observation					
It was observed that upstream gate is always closed and inflow to the secondary canal is regulated by the downstream gate. The bed elevation of gate is 33.59m.					
Improvement Plan					
The height of existing gate is not enough to design water level. The new gate with 1.0m width and 1.85m height will be installed. The existing canal will be rehabilitated with proper way, and is used for secondary canal named SMC-S-1.

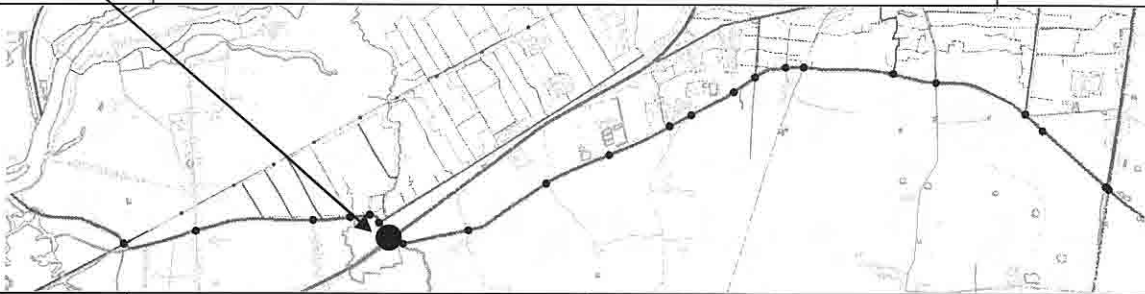
Description of the Structure					
The road crossing culvert with 3 m in width and 2 m in depth (according to PDOWRAM staff) was provided at the crossing point of the South Main Canal with national road No. 4.					
Observation					
The size of existing box culvert is too small for design discharge.					
Improvement Plan					
The new box culvert will be constructed along the existing one.

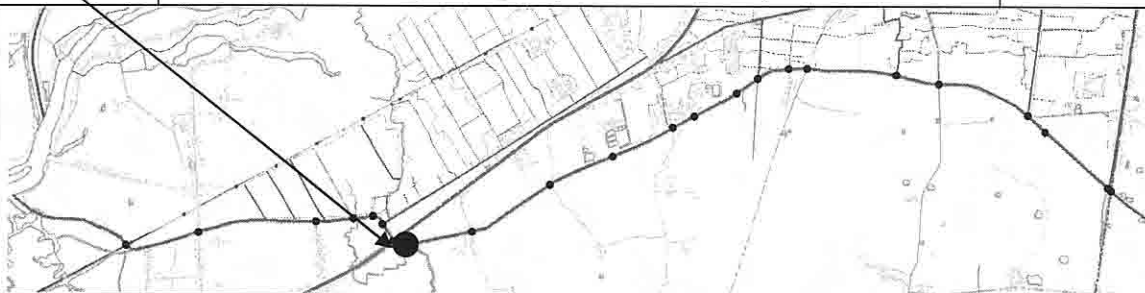
Description of the Structure					
<p>According to MOWRAM and PDOWRAM staff, before construction of the South Main Canal, a gate type spill way (size: 1.6m width x 1.2m height x 1 nos.) was provided at the downstream end of the Ou Veang pond to spill out the flood water from the pond. However, it was not used after the main canal construction.</p>					
Observation					
Improvement Plan					
Existing structure will be used without rehabilitation.

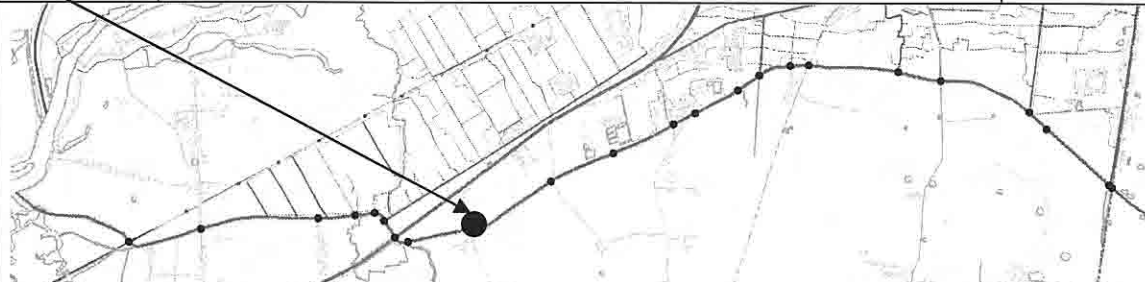
Description of the Structure					
Wooden bridge was provided by villagers to connect village road from the south with the village road from the north.					
Observation					
Height of the bridge is same as the canal bank level. It is dangerous to go across the bridge.					
Improvement Plan					
The concrete Bridge with effective width of 3.5m will be constructed with canal protection by concrete lining at upstream and downstream of 5m each after demolishing of existing wooden bridge. The concrete bridge should have a clearance of 1.0m above design water level.

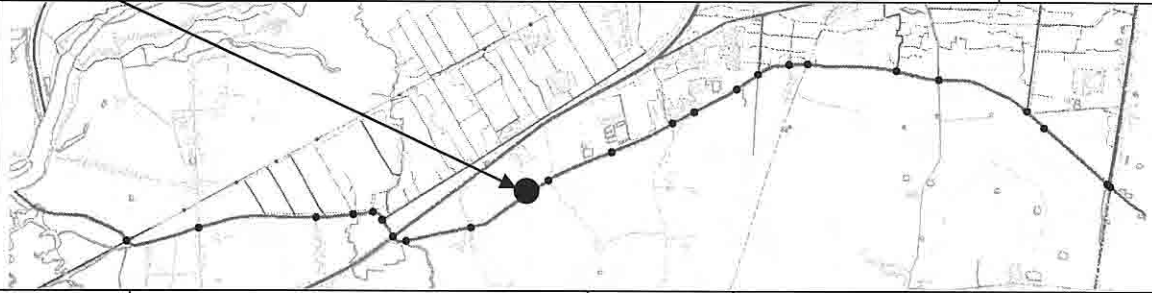
Serial No.	13				
Type or Name of Structure	Drain inlet			Survey Date	2006/06/25
Location	Coordinates in UTM Indian Thailand grid	North	1263555	East	0443012
	Station No. refer to the Report for Topographic Survey carried out by Khmer Consultant Engineering Corporation Ltd. 30 September 2006				3+920

Description of the Structure					
<p>Drain inlet structure was provided on the right bank of the South Main Canal to drain unnecessary water from the paddy field to the canal.</p>					
Observation					
<p>The structure is not functioning since the inlet part was clogged up by siltation. The canal slope around outlet has eroded heavily.</p>					
Improvement Plan					
<p>The small rehabilitation with canal slope protection such as masonry works will be done.</p>

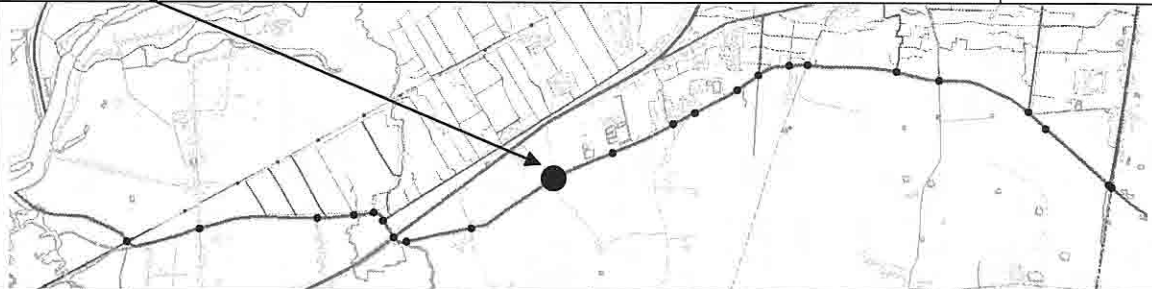
Description of the Structure					
The bridge was provided to connect Bos Ta Ney village located the left bank of the South Main Canal to the right bank of the canal.					
Observation					
Height of the bridge is same as the canal bank level. It is dangerous to go across the bridge.					
Improvement Plan					
The concrete Bridge with effective width of 3.5m will be constructed with canal protection by concrete lining at upstream and downstream of 5m each after demolishing of existing bridge. The concrete bridge should have a clearance of 1.0m above design water level.

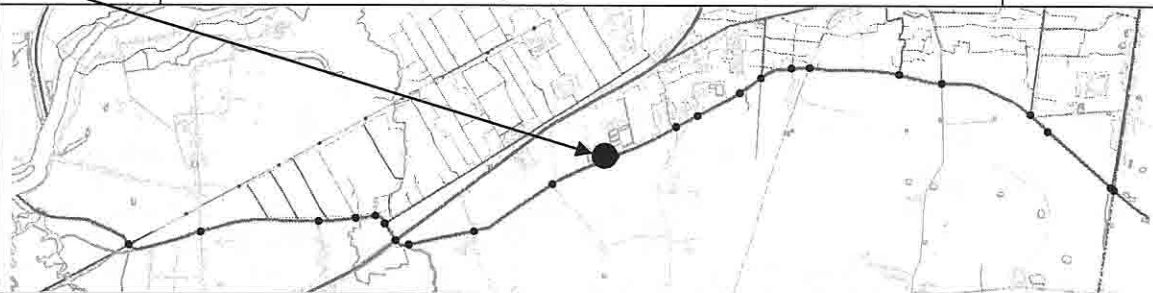
Description of the Structure					
<p>The check structure was provided by owner of the pig raising farm located right bank of the South Main Canal. Two numbers of steel gates of which sizes 1.8m width x 1.7m height are provided. A turnout for pig raising farm was also provided on the left bank.</p>					
Observation					
<p>The side slope at downstream has eroded heavily.</p>					
Improvement Plan					
<p>To be removed. The side slope at both upstream and downstream should be rehabilitated by embankment using clayey soil.</p>

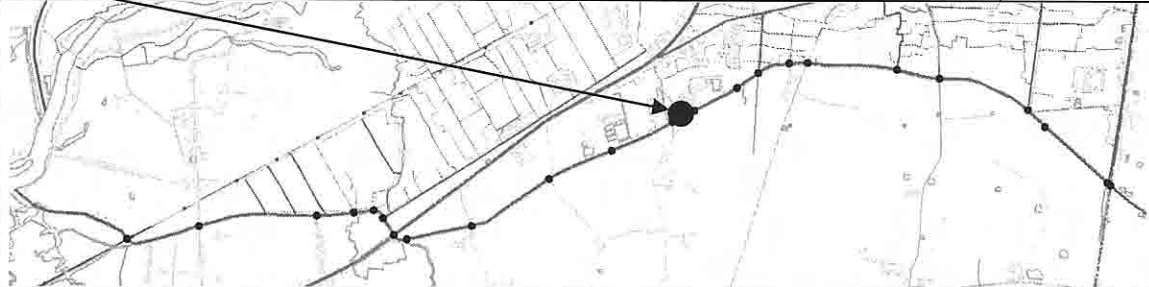
Description of the Structure					
The wooden bridge is supported by concrete column.					
Observation					
Height of the bridge is same as the canal bank level. It is dangerous to go across the bridge.					
Improvement Plan					
The concrete Bridge with effective width of 3.5m will be constructed with canal protection by concrete lining at upstream and downstream of 5m each after demolishing of existing wooden bridge. The concrete bridge should have a clearance of 1.0m above design water level.

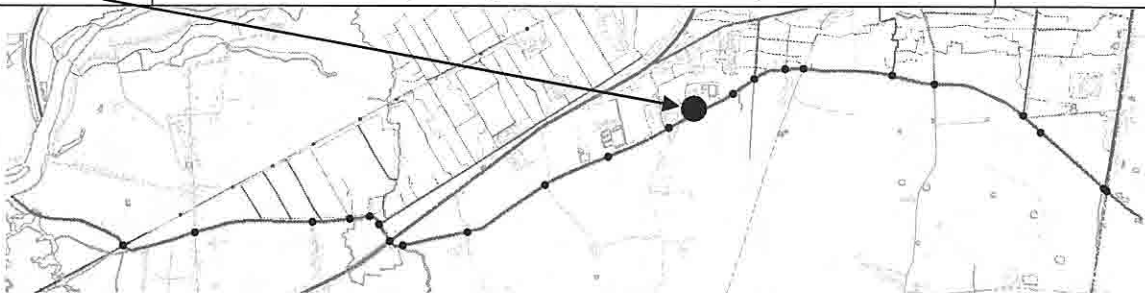
Description of the Structure					
Observation					
<p>Height of the bridge is same as the canal bank level. The side slope at downstream has eroded heavily. It is dangerous to go across the bridge.</p>					
Improvement Plan					
<p>The concrete foot path with effective width of 2.2m will be constructed with canal protection by concrete lining at both upstream and downstream of 5m each. The foot path should have a clearance of 1.0m above design water level.</p>

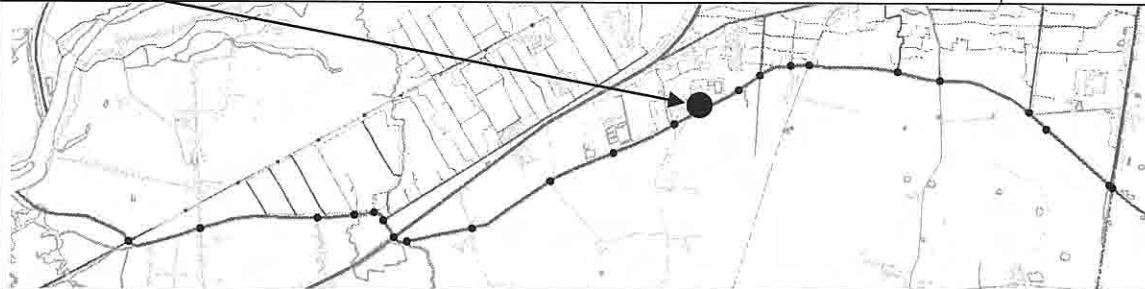
Description of the Structure					
Observation					
<p>Height of the bridge is same as the canal bank level. The side slope at both upstream and downstream has eroded heavily.</p> <p>It is dangerous to go across the bridge.</p>					
Improvement Plan					
<p>The check structure with three gates of which sizes 2.0m wide x 3.2m height and two overflow weir will be constructed at this place to regulate water. The concrete foot path will be constructed also on check structure.</p>
