CHAPTER 3

HAZARD AND RISK ASSESSMENT ON SLOPE DISASTERS

3.1 Slope Disaster Types along Narayangharh – Mugling Highway

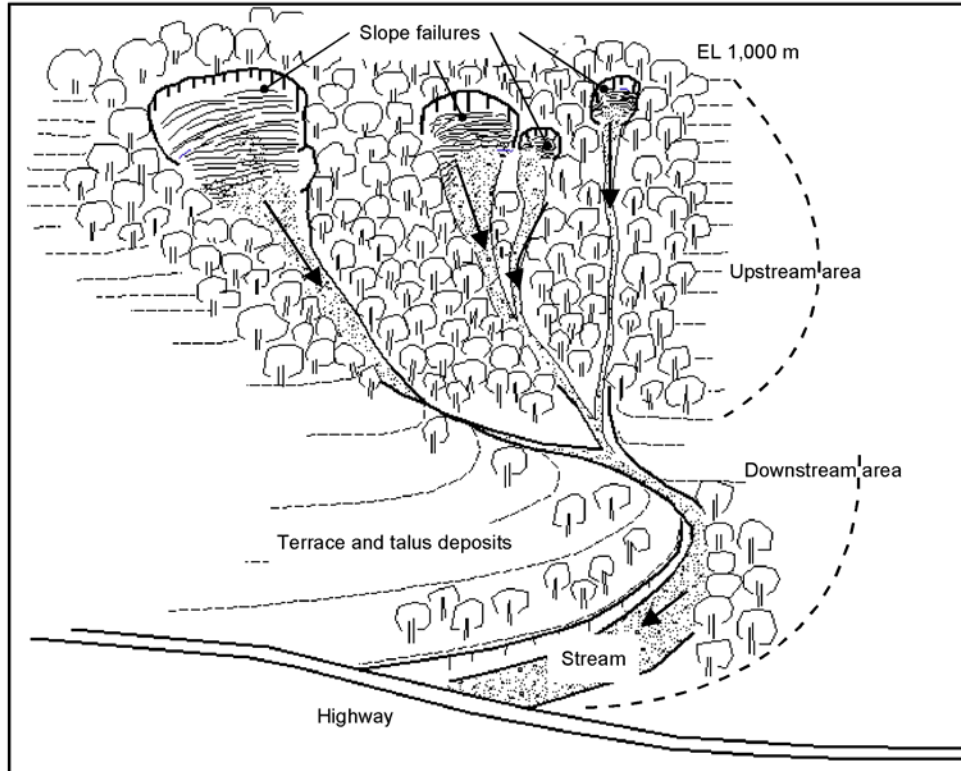
Figure 3.1.5 Schematic Illustration of Slope Failure – Debris Flow Succession

Each stream (khola) has generally big watershed (3 – 5 km² or more), and reaches at an elevation of 1000 m. In upstream areas composed of rock slopes, many big slope failures had occurred near the ridges. In downstream areas, a number of slope failures have been observed on river terrace slopes. Such a big amount of slope failure materials are potential source of debris flows to rush into the Trishuli River.

Figure 3.1.5 below shows a schematic illustration of debris flows for the section CH 10 + 100 – CH 14+100.

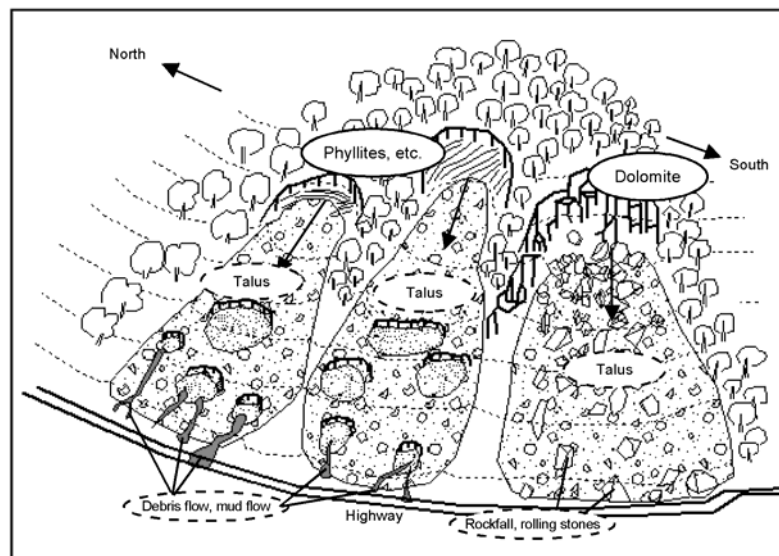
Figure 3.1.6 Schematic Illustration of Slope Failure – Debris Flow Succession

The slopes are categorized into transverse-slip slip. Within this section, large-scale slope failures are often observed around an elevation of 700 m. And rock falls or rock mass falls from dolomite cliffs frequently occur. Dolomite is usually hard and massive. Therefore dolomite rock falls can easily reach near to the highway. Small-scale debris flows are observed commonly. Source material of debris flows are mainly collapsed bedrocks fallen down from its original positions. Figure 3.1.6 shows typical slope hazards in this section.

In this section, slope failure and landslide are common hazards. Small-scale debris flows are observed commonly, too (See Figure 3.1.6 above).

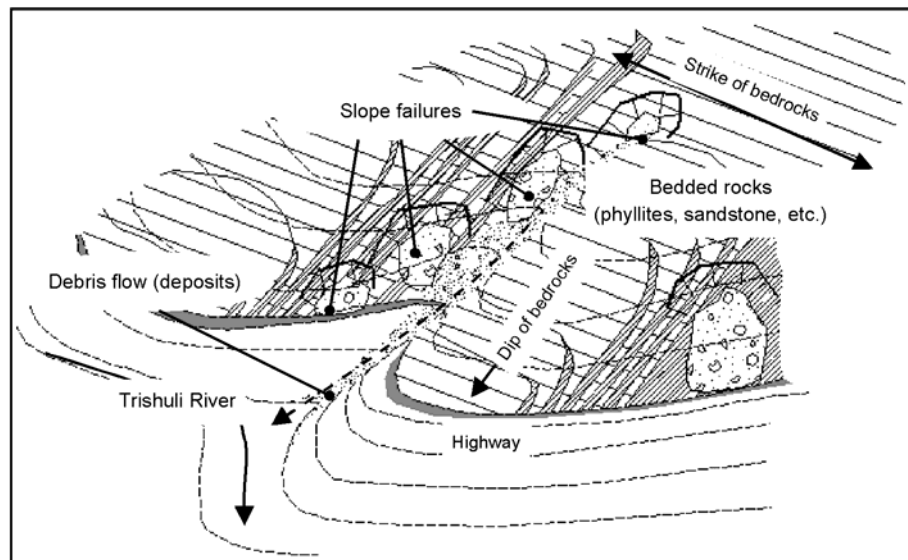
Figure 3.1.7 Schematic Illustration of Dip-Slip Slope

A section of CH 19+500 – CH 22+000 is located on north-facing and dip-slip slopes (See Figure 3.1.7). Road slope geology of this section comprises of phyllites and sandstone of the Nourpul Formation.

This section of 2.5 km is one of hazardous sections of the highway. Slope failures and landslides are often recognized along the road, and also debris flows have affected the road, too.

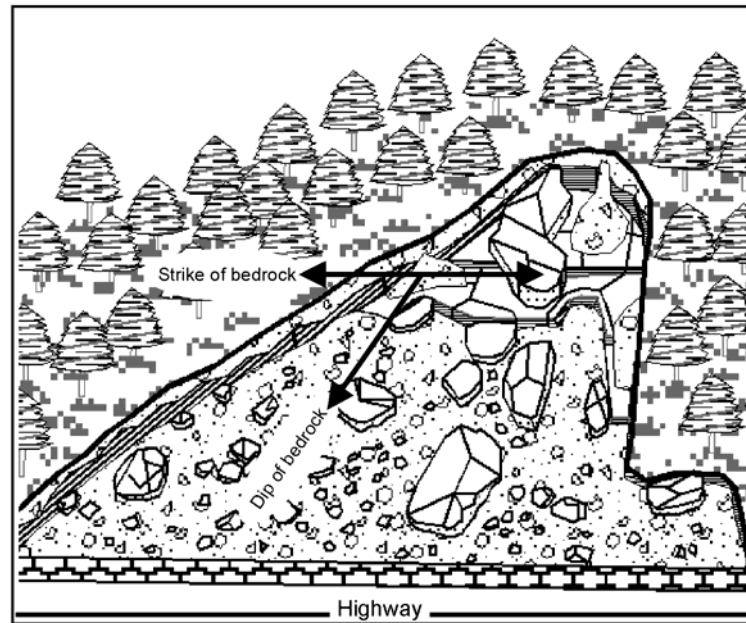
Figure 3.1.11 Schematic Illustration of Bedding-parallel Slip along Highway

Within this section, there are three slopes having landslide potential. They are named SL-2, SL-3, and SL-4 respectively, and studied in detail as the F/S sites as well as SL-1. Excluding these selected sites, there are many bedding-slip landslides (rock slides) and can be observed along the highway as shown in Figure 3.1.11 and Figure 3.1.12.

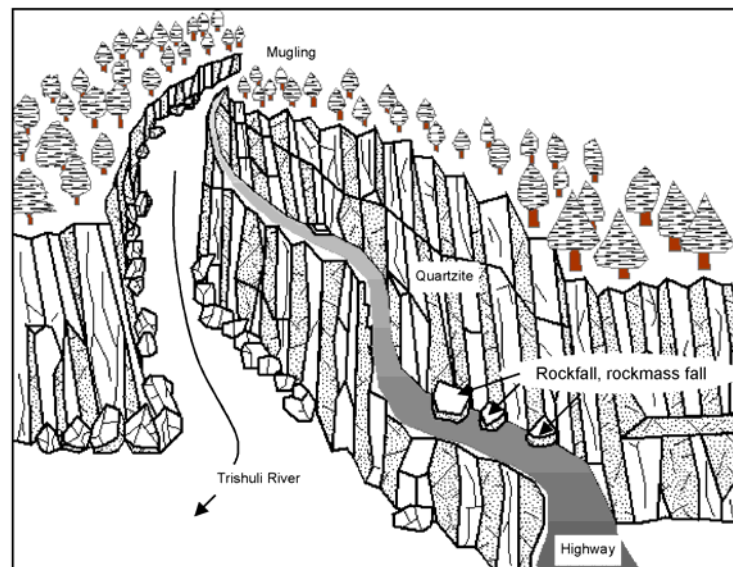
Figure 3.1.14 Schematic Illustration of Rock fall from Cut-Slope of Quartzite

Typical slope hazards within this 2800 m section are rock fall from quartzite slopes, and slope failures on other meta-sedimentary rock slopes.

Steep cut-slope of the Fagfog Quartzite seems to be stable. However it might be collapsed toward the highway in case of a big earthquake.
