Supporting Report N

Study on Sediment Disaster

N.1 Classification of Sediment Disasters

N.2 Past Sediment Disasters and Rainfall

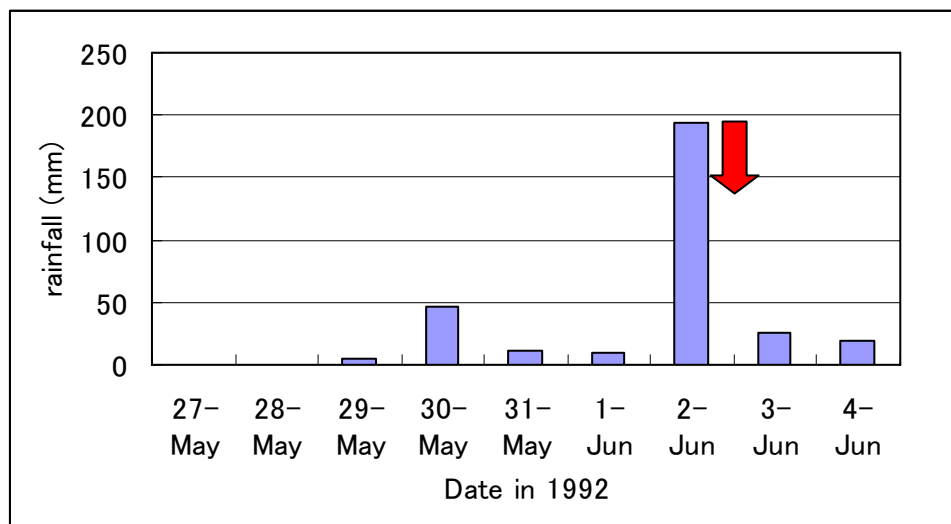
Figure N.2.3 Daily Rainfall at the time of the Watawala Sediment Disaster (3 June 1992)

Annual mean rainfall in Watawala is approximately 5,200mm, which is a higher value than in other areas in Sri Lanka. Daily rainfall on 2 June 1993, the day before the landslide, was recorded at 196mm. Due to heavy rain on the previous day, the landslide occurred early the next morning.

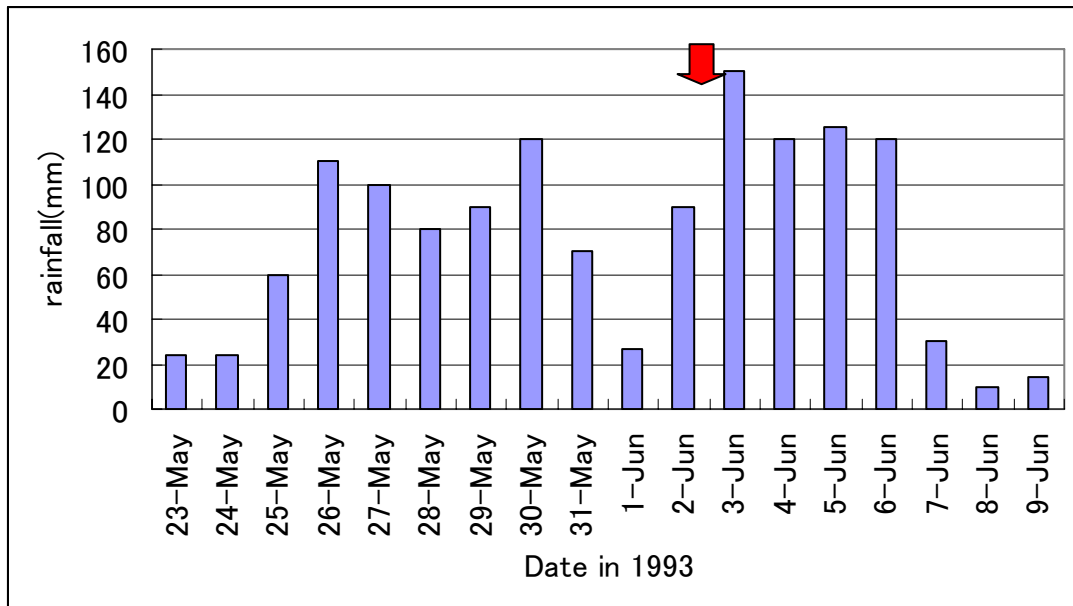
Figure N.2.4 Daily Rainfall at the time of the Watawala Sediment Disaster
(3 June 1993)

The same landslide was reactivated exactly one year later on 3 June 1993. The preceding 6 days of rainfall exceeded 500mm, and rainfall of the day was 147mm.

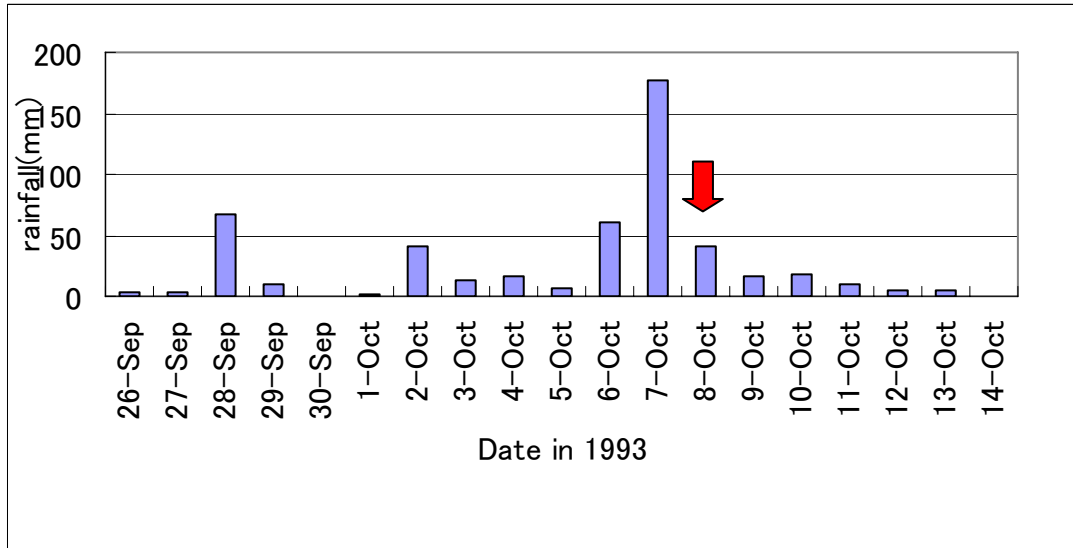
Figure N.2.6 Daily Rainfall at the time of the Helauda Sediment Disaster (8 October, 1993)

The killer earthflow occurred around 7 AM on 8 October. One of the causative factors was heavy rain exceeding 177mm on the previous day. The three day cumulative rainfall was 280mm at Ratnapura city. Though the landslide occurred in the morning on the day of 41mm daily rainfall, the heavy rain of the previous day seemed to have influenced the earthflow.

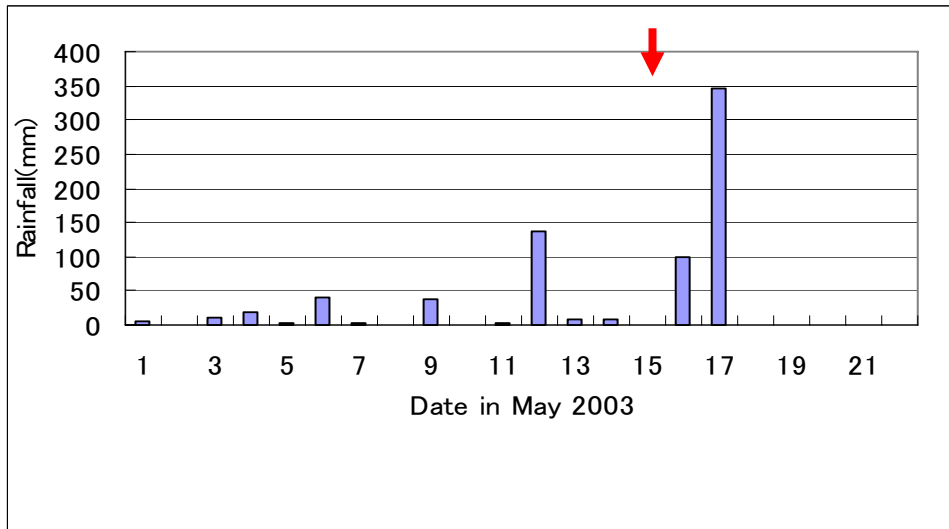
Figure N.2.7 Daily Rainfall at Ratnapura at the time of Palawela Sediment Disaster, (17 May 2003)

Starting on 12 May, continual rainfall lasted until the 17 May, reaching 600 mm, and particularly, on the day of the 17th when 345mm of rainfall was recorded. According to the NBRO's investigation report, the sediment disasters occurred 9 AM to 12 Noon.

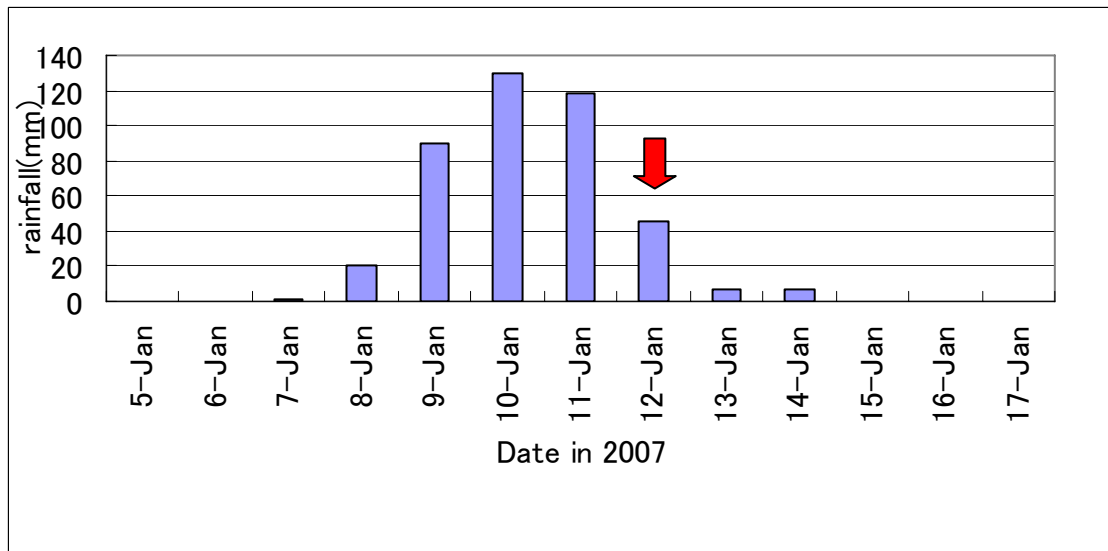
Figure N.2.9 Daily Rainfall at Liddesdale at the time of Walapane Landslide (12 January 2007)

This time, the landslide disaster occurred due to the heavy rains from 9 -12 January. Daily rainfall during this period at the Liddesdale Observatory, closest to this disaster location, is shown in Figure N.2.9. It is notable that the rainfall of the two days preceding the landslide disaster both exceeded 100 mm. During the peak of the storm, the conditions were such that nothing other than the sound of rain

was audible. This landslide which caused the deaths of 10 people occurred 2 days after peak rainfall was recorded.

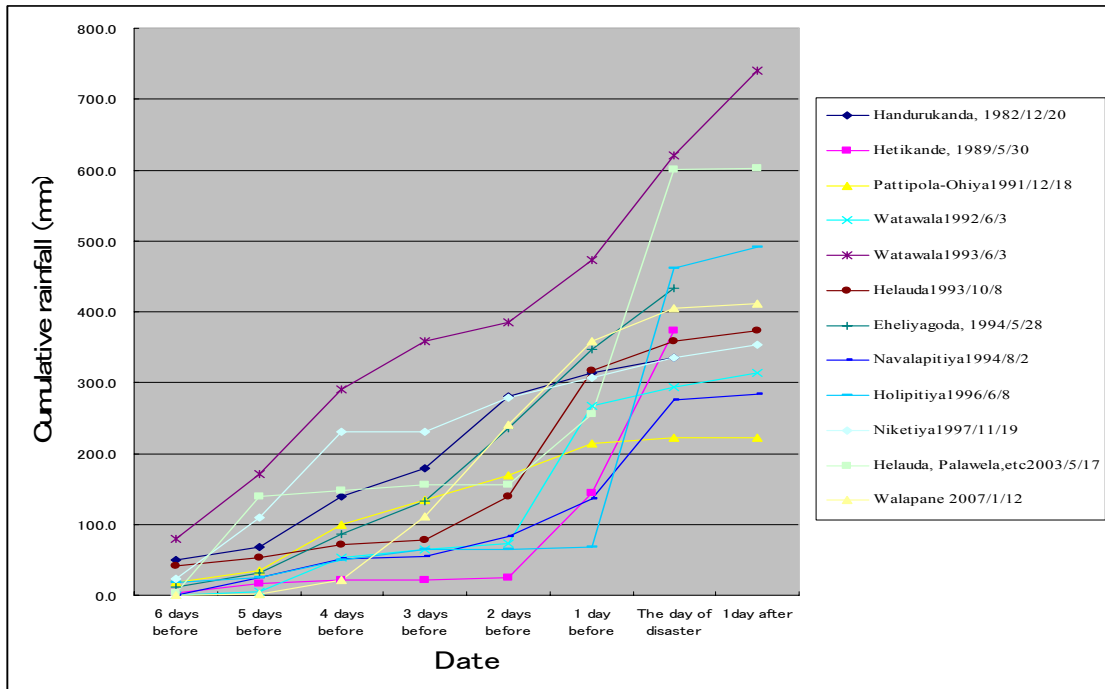
Figure N.2.13 Rainfall in the Case of 12 Major Sediment Disasters (7 Days Cumulative Rainfall)

There was a remarkably heavy rainfall on the day sediment disasters occurred at Holipitiya (8 June 1996) with 392mm, and Helauda, Palawela, etc (17 May 2003) with 345mm. Heavy rainfall on the same day was concluded to be the cause of these two disasters, and thus it is possible to categorize these as "same day heavy rainfall". Also, heavy rain fell the day prior to sediment disasters which occurred in Watawala (2 June 1992) with 194mm, and Helauda (7 October 1993) with 177mm. Nonetheless, these two disasters occurred in the early morning of the same day, and thus fundamentally fit into the above-mentioned "same

day heavy rainfall" category. Another category, "continual rainfall", where heavy rains fall 1 week or 3 days prior, includes Pattipola-Ohiya (18 December 1991), Watawala (May to June 1993), Navalapitiya (July to August 1994), Neketiya (November 1997), and Walapane (January 2007). Among these, Pattipola-Ohiya (18 December 1991) and Neketiya (November 1997) were sediment disasters with comparatively little antecedent rainfall.

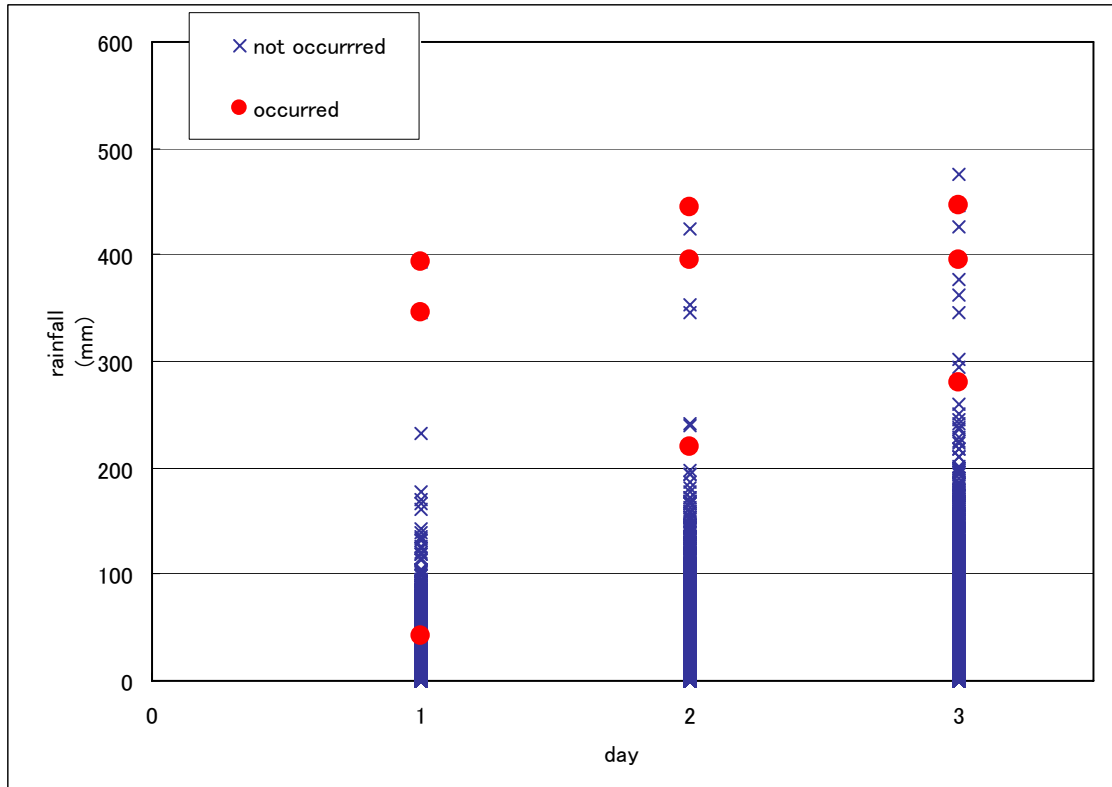
Figure N.2.18 Relationship between Plotted Rainfall Data of Sediment Disaster Occurrence at Ratnapura (From 1991 to October 2006)

In addition, frequent occurrence of rainfall for one day, 2 days and 3 days are expressed in Figure N.2.15 through Figure N.2.17. After that, Figure N.2.18 shows the daily rainfall at the Ratnapura Observatory in relationship to landslide disaster recorded as "occurred" or "not occurred". The day before the 1993 earthflow at Helauda, heavy rains amounted to 177.6 mm and because the earthflow occurred around 7:30 AM, it can be deduced that the torrential rains of the preceding day had an influence.

Due to the few "occurred" samples, it was not possible to separate the "occurred" and "not occurred" data according to amount of rainfall; however, when daily rainfall rises above 200 mm, it can be said that the danger of landslide disaster occurrence increases.

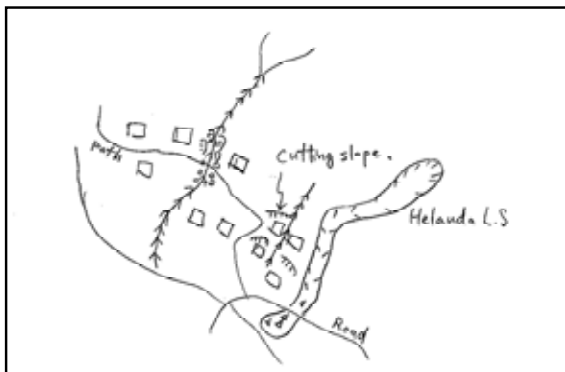
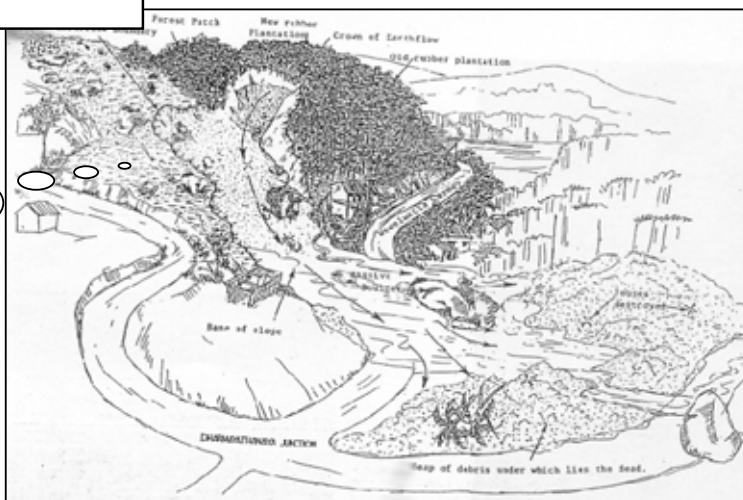
Illustration (plane and profile)

District:Ratnapura	D.S. Division	G.N.Division	Location
	Ratnapura	Mawala	Helauda
Site Information (Risk objects)	Number of families	Number of evacuated families	Number of warned families
	20	0	20
Landuse	rubber plantation		
Landform/Topography	slope with 25 to 35 degree, gullies developed		
Geology	fresh rock and talus deposit		
Type of disaster	Landslide <u>Slope failure</u> <u>Debris flow</u> Rockfall Flood Other ()		
Hazard level by NBRO	high		
Comments on damage	At Helauda debris flow, 31 people killed by debris flow. Some people heard the big sound of landslide. That event occurred 3 times. Current damage is none, but people still scare about landslide.

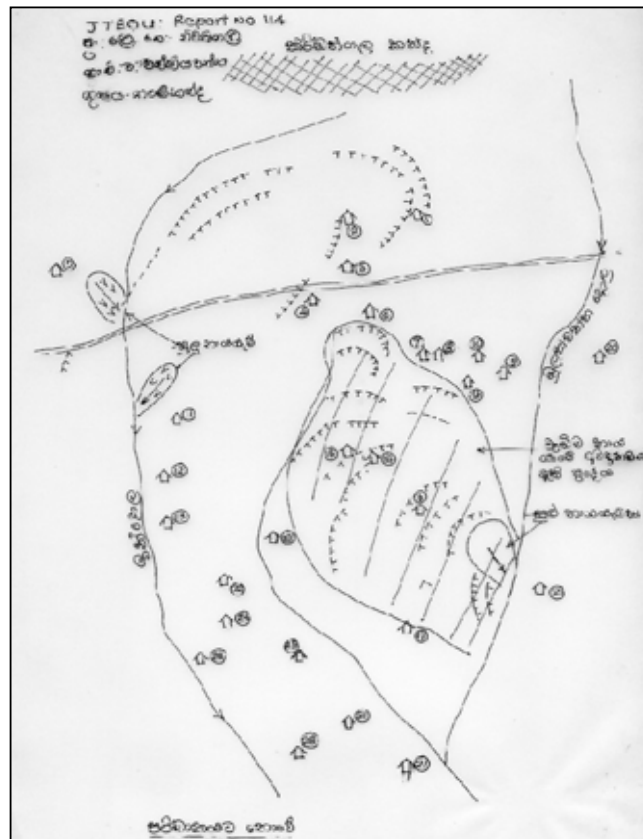
Illustration (plane and profile)

District:Ratnapura	D.S. Division	G.N.Division	Location
	Nivithigala	Kiribathgala	Kiribathgala
Site Information (Risk objects)	Number of families	Number of evacuated families	Number of warned families
	23	3	4
Landuse	tea plantation		
Landform/Topography	landslide slope with 10 to 15 degree, and steep cliff behind		
Geology	fresh rock, weatherd red soil and talus deposit		
Type of disaster	<input checked="" type="checkbox"/> Landslide <input type="checkbox"/> Slope failure <input type="checkbox"/> Debris flow <input type="checkbox"/> Rockfall <input type="checkbox"/> Flood <input type="checkbox"/> Other ()		
Hazard level by NBRO	high		
Comments on damage	Some tensional cracks were observed above the Kahawatta Road and some cracks in houses. Two small scale landslides with clear scarp is observed in the tea plantation. As there were 3 major zones in this area which have a risk of landslides. 3 houses were at high risk and recommended to be evacuated.

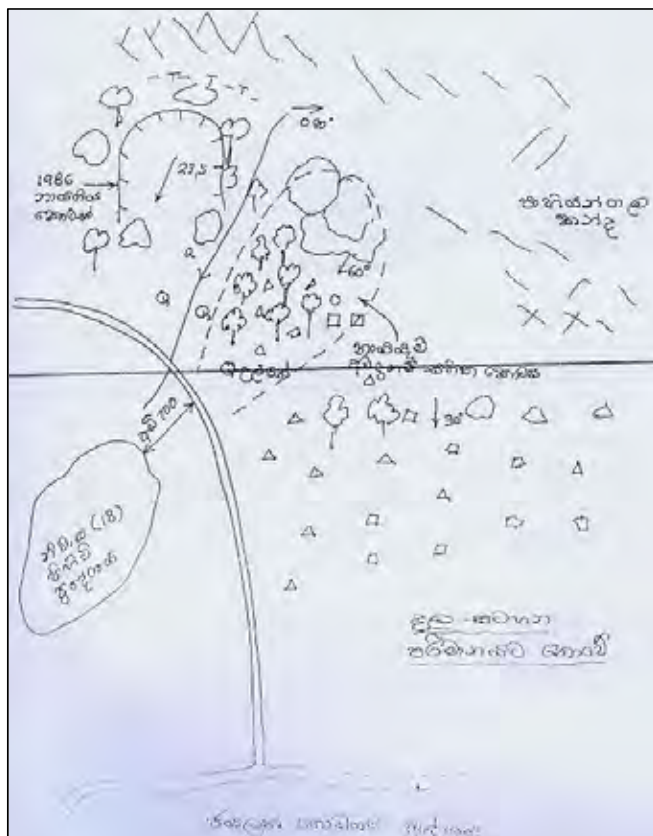
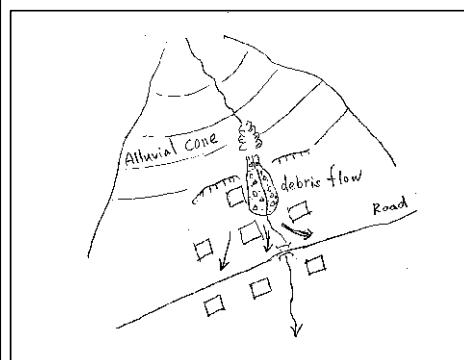
Illustration (plane and profile)

District:Kalutara	D.S. Division	G.N.Division	Location
	Bulathsinhala	Niggaha	Niggaha
Site Information (Risk objects)	Number of families	Number of evacuated families	Number of warned families
	15 to 20		
Landuse	tea and rubber plantation		
Landform/Topography	landslide slope with 30 to 40 degree, and torrent flow down and formed clear alluvial cone. Alluvial cone is dissected and formed gully, recently.		
Geology	weathered rock, weathered red soil and debris flow deposit		
Type of disaster	Landslide Slope failure Debris flow Rockfall Flood Other ()		
Hazard level by NBRO	high		
Comments on damage	Early landslide occurred in 1986 of width 300 ft. and length 500 ft. There was a tension crack appeared beyond the slide. Few boulders are located at the east. The soil below the slope is unconsolidated and that may be due to the removal of rubber and tea plantation. Water springs can be observed during rainy days. There are two houses directly below the torrent. This community is high hazard for debris flow.
