## **CHAPTER 3    LARGE-SCALE RC BUILDING DAMAGE SURVEY**

### **3.1    Outline**

### **3.2    Features of Major Damage to RC Building Structures**

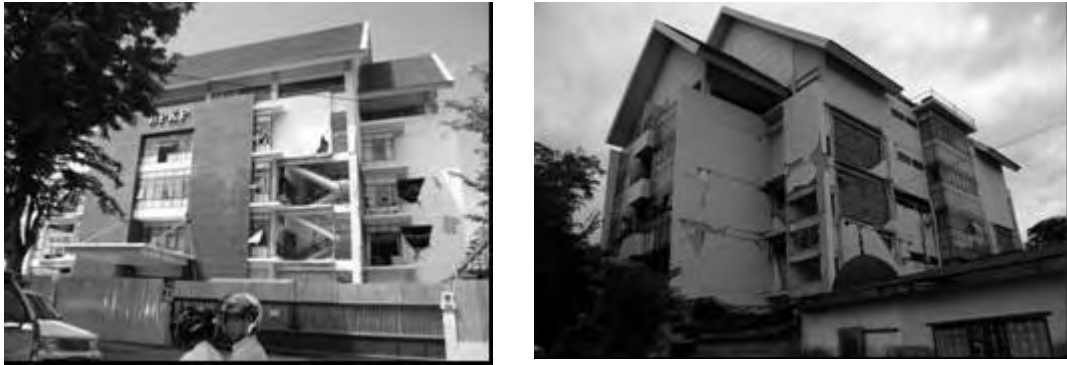
**Figure 3.2.5 Exterior View of BPKP Building**

The detailed investigation of BPKP building was conducted based on the request from PU. As a backgrounder, construction of the building was completed in 2003, but was partially damaged by Bengkulu earthquake in 2007. However, the damage of the structures at that time was minimal and only the brick walls of the second floor and the fourth floor were damage and repaired for use thereafter.

The second floor as shown in Figure 3.2.6 incurred the heaviest damage.

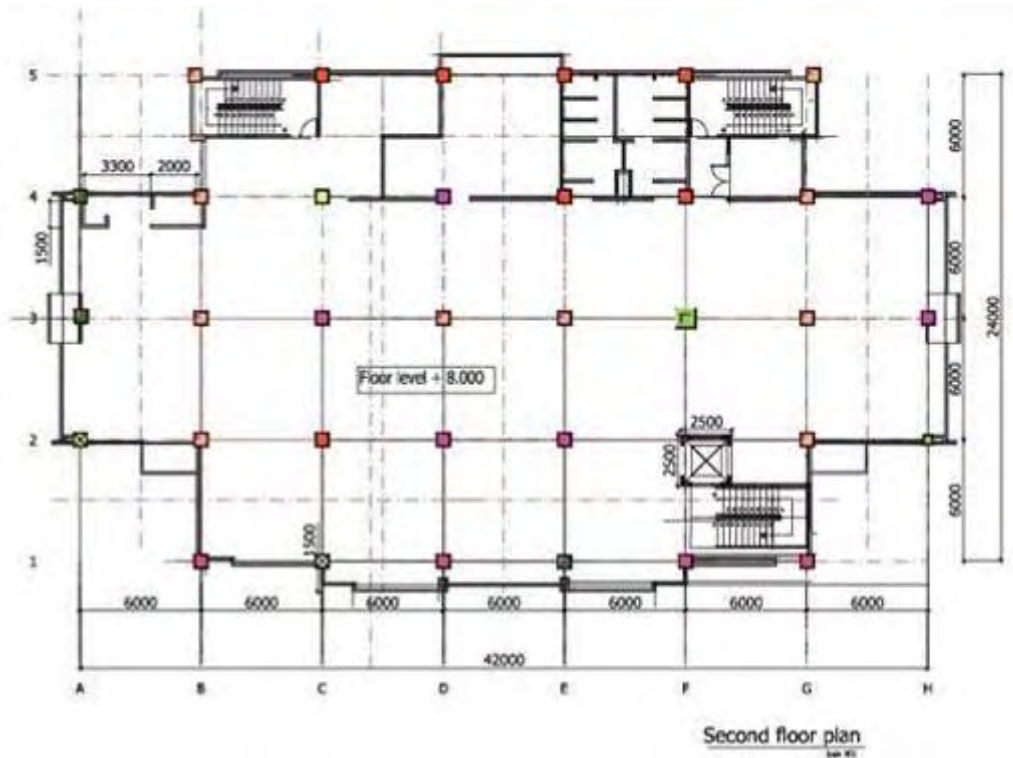
Figure 3.2.6 BPKP Second Floor Plan

Based on the result of the damage assessment as shown in Table 3.2.2, the second floor incurred the heaviest at an estimated level of 77.371. The result shows that when the value of Di damage level exceeds 50, it is considered as “Severe” as shown in Table 3.2.3. Therefore, the 2F floor of the building is considered to be Severely Damaged because it exceeded the 50 factor.

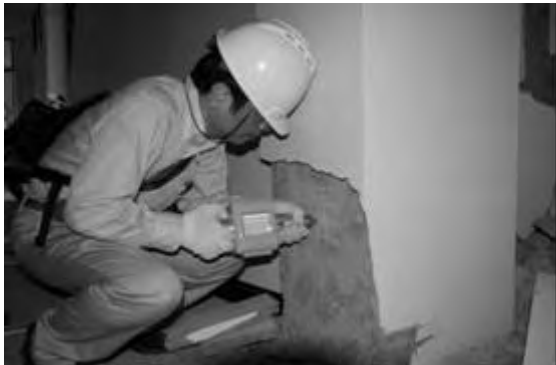
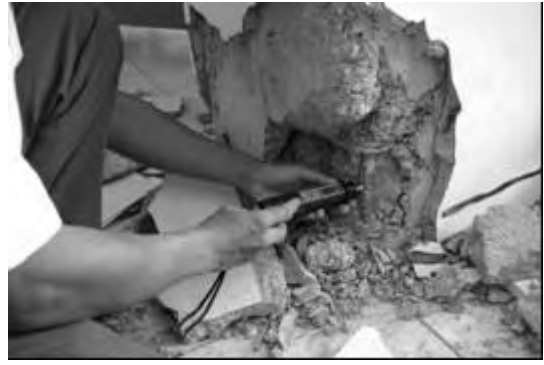
**Figure 3.2.9 Field Materials Strength Testing by Nondestructive Testing Method**

In addition, the lack of materials strength is difficult to consider other than the inadequacy of steel bars as pointed out earlier, taking into account that based on the results of the Vickers hardness measurement and the Schmidt hammer measurement as shown in Figure 3.2.9 concreting appears to have passed specification requirements. Nevertheless, casting of e concrete for the connection of the column and the beam is difficult, and poor construction appears to be the most likely caused of failure because that segment of the structure requires high structural resistance/strength.

Concrete Compressive Strength	Re-bar Tensile Strength
33N/mm	340Mpa

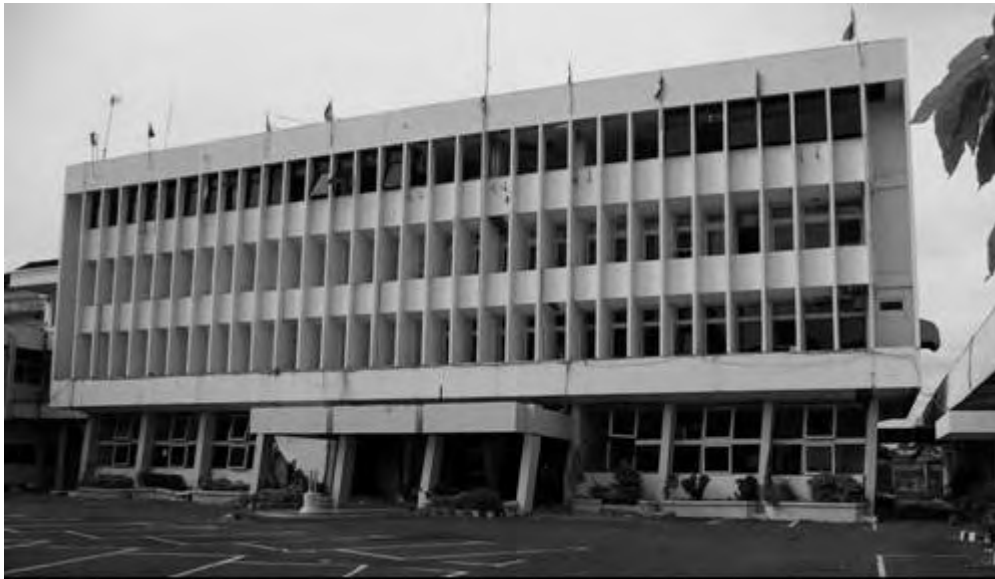
**Figure 3.2.10 Exterior Appearance of PU Building**

This building was completed in 1970. As can be seen, the entire first floor incurred severe damage and is almost in the state of collapsed and therefore is no longer usable because of its detrimental condition. All the column were distorted as shown in Figure 3.2.11 and the inadequacy of hardness in this direction appears to be overwhelmingly large considering the low resistance to secondary moment at the crossbeam area direction. Therefore, the building is about to collapse like a domino as shown in Figure 3.2.12.

Due to the higher height of the second floor, more walls were provided than the first floor, and as a result hardness has risen, and the resultant is a reversal of layer hardness. Due to this development, the first floor became a soft layer of the building segment and with the inertial force, the concentrated between the two layers, had caused the transformation.

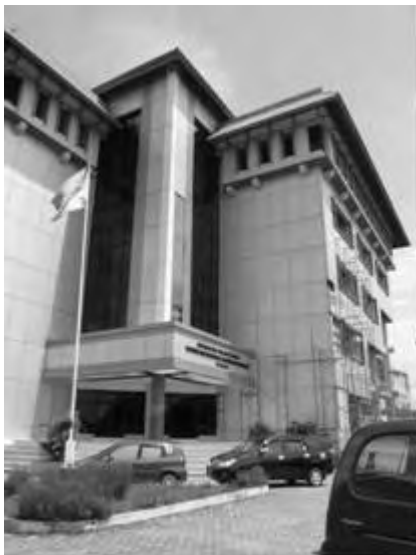
**Figure 3.2.13 Outdoor View of UNP Building**

earthquake that occurred in 2007. The primary structural components of the building, however, were totally undamaged (Damage Level at 0). However, the tremors that occurred in the upper floors of the building, had displaced the exterior brick wall due to inertial force acting towards the right angle direction, had distorted the exterior appearance/ aesthetics of the building. .

In a sense, the horizontal direction inertial force of the earthquake caused the disintegration of the brick wall but could have prevented damage to the structural frames of the building. This phenomenon appears to be a contributory factor to quake resistance of buildings but falling of debris is hazardous to pedestrians below.

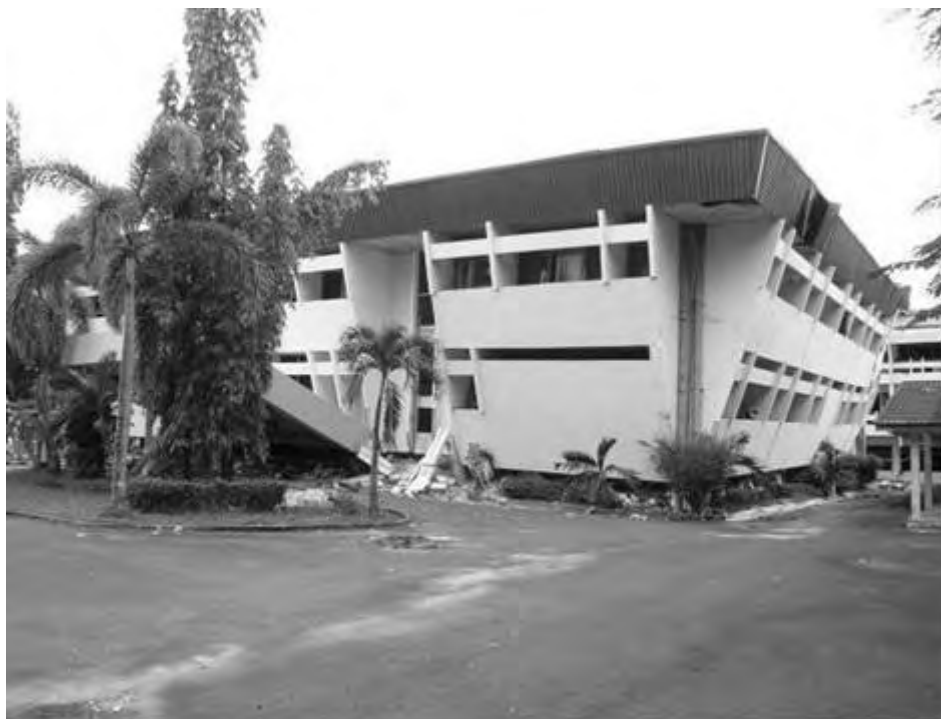
**Figure 3.2.15 Outdoor View of BAPPEDA MAIN Building**

The first floor of this 3 stories high building completely had collapsed. The brick wall of the first floor with the top not connected to the upper structure had collapsed inwards as shown in Figure 3.2.15 above. As a result, most of the brick walls of the first floor did not contribute to the hardness of the structure. On the one hand, the hardness of the floors on the 2<sup>nd</sup> and 3<sup>rd</sup> floors rose because of the presence of RC walls. Consequently, the first floor became a Soft segment. It is noted in this connection that the inertial force acting on irregular shaped buildings of this type, particularly at the transformation area of the center of the layers between the soft segment and the hard segment has tendencies to amplify thus facilitating the collapsed.

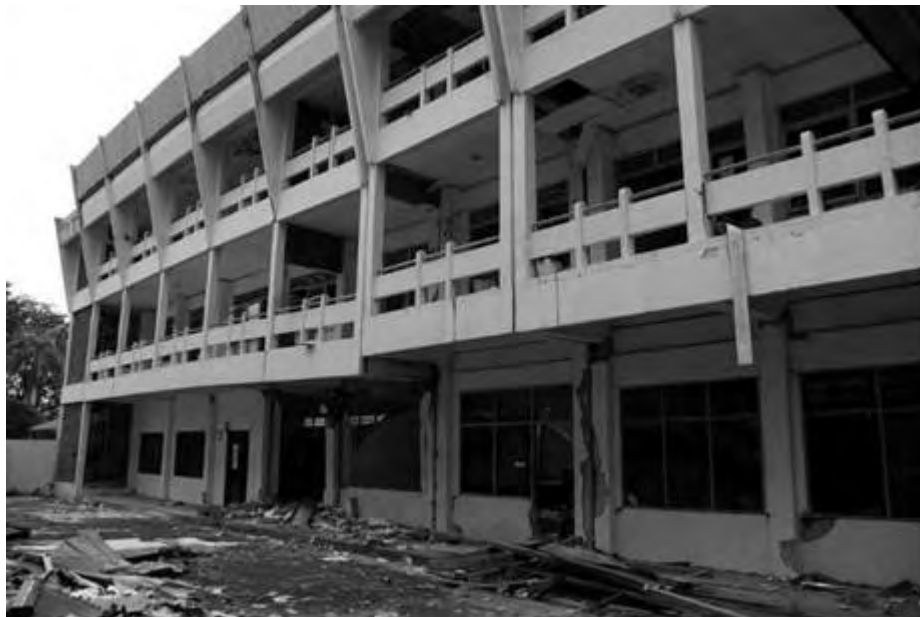
**Figure 3.2.17** Outdoor View of BAPPEDA-SUB Building

The building was separated into three segments along the expansion joints. The column broke down due to the destruction of the top of the sixth column from the left side. The brick walls which did not contribute in restraining the transformation between layers, separated along the joints.

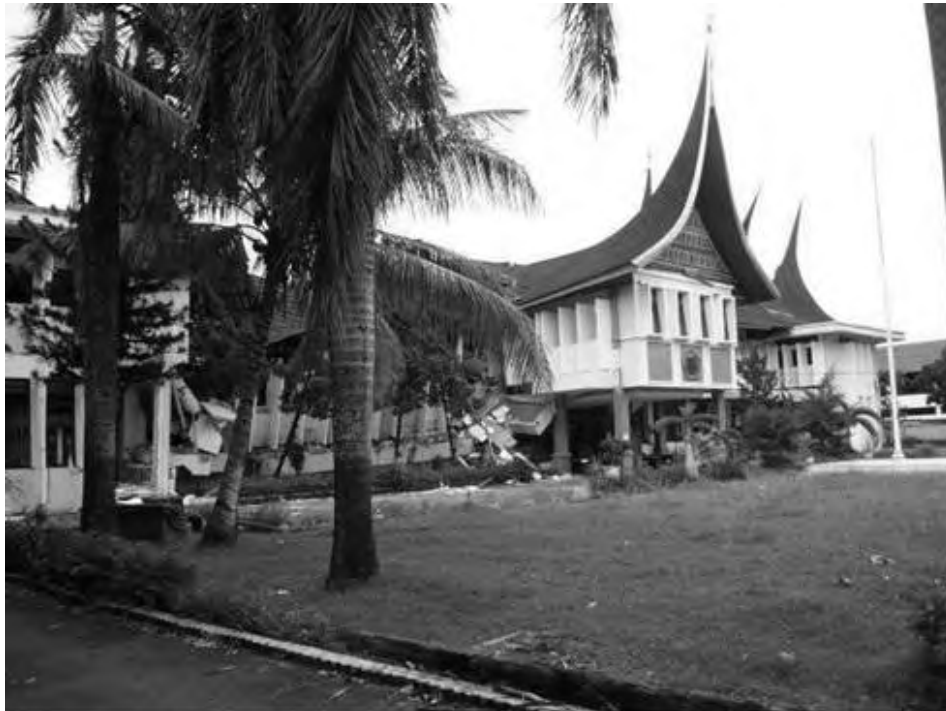
**Figure 3.2.18 Outdoor View of DEPARTMEN KEUANGAN R.I. Building**

Destruction of the left side ridge is particularly intense in addition to the destruction incurred to the right side ridge as shown in the photos hereunder. The building is irregularly shaped, but considering the segments to have been separated by expansion joints, it is difficult to imagine the cause to be due to asymmetrical form. Rather, the inadequate sectional dimensions, and insufficiency of Re-bars coupled with deficient Re-bar arrangement particularly at the column / beam joint could most likely be the causes of the destruction as shown in Figure 3.2.19, and Figure 3.2.20 hereunder.

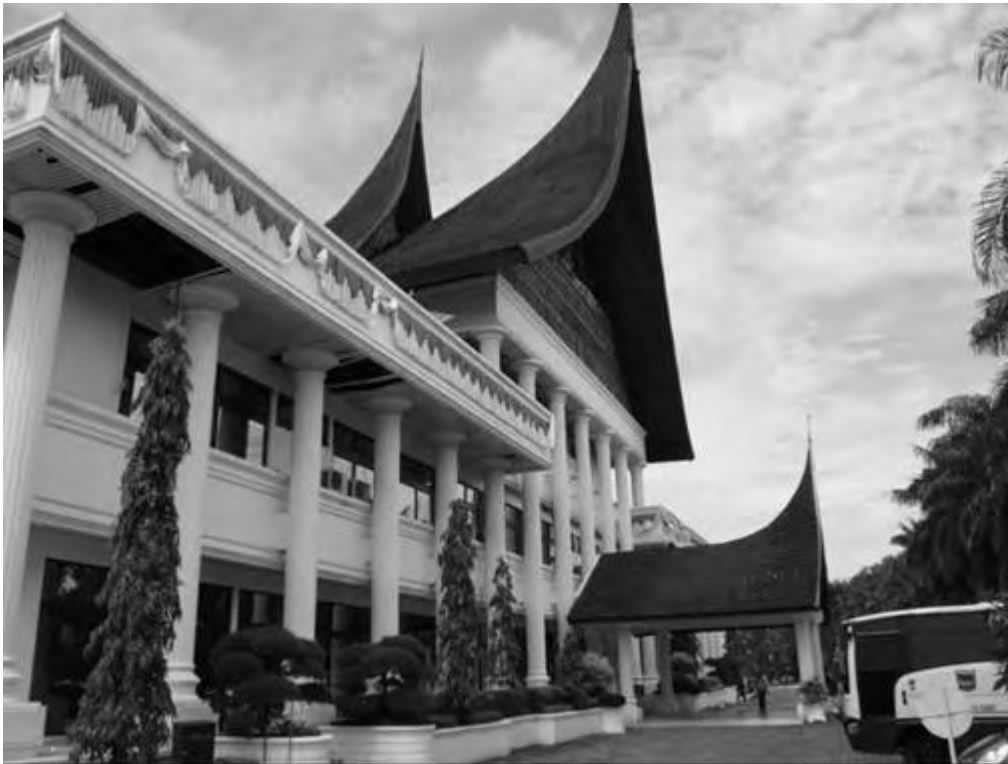
**Figure 3.2.22 Outdoor View of the DPRD Building**

This building was completed in 1995 but was partly damaged by Bengkulu Earthquake of in 2007. The building was in used while the repairs were being conducted. Consequently, the building was devastated by the occurrence of the last earthquake. The destruction of structural members of the building was partially limited. The damage large visual damage is the southeast side brick wall in front of the assembly hall which was blown out by an inertial force. The remarkable destructions to the structural components is the level IV damage of the columns supporting the roofs at the right side of the entrance hall as shown in Figure 3.2.23. Moreover, destruction to other columns is slight. This building appears to have been elaborately constructed with good quality materials and based on the results of field testing concrete strength is 33MPa, while tensile strength of re-bars is 400 MPa.

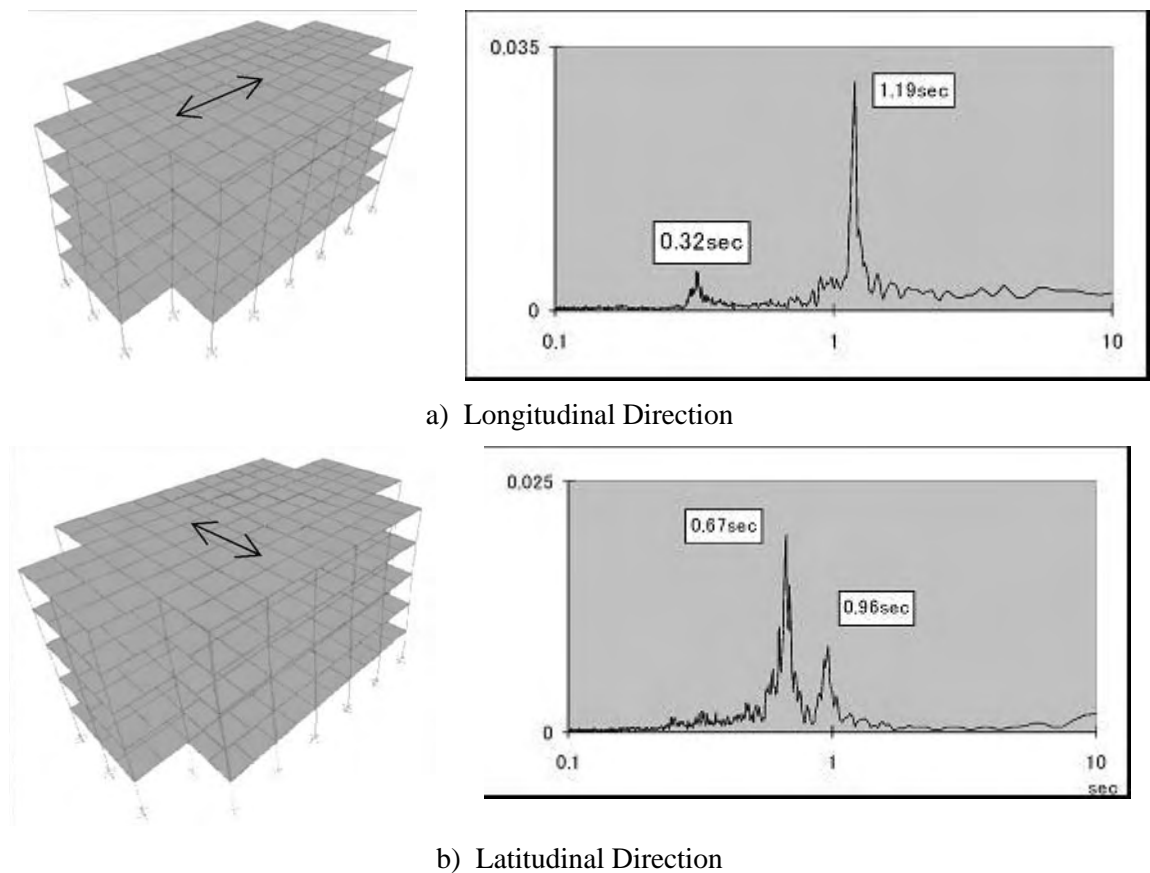
**Figure 3.2.25 Vibration Characteristic in BKP Building (five stories)**

The vibration characteristic of the BPKP building is shown in Figure 3.2.25 for purposes of this examination.

The predominant period of the tremor is about 1 second. This is considerably longer than the generally recognized value. Based on Japanese structural engineering, the fundamental natural period for 5-storey high building of *RC Moment Resisting Frame with RC Shear wall* could be assumed at about 0.5 second.

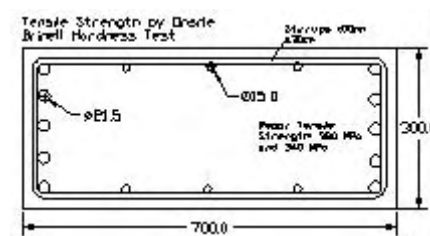
**Figure 3.2.27 Column Section of PU Building**

The geometrical moment of inertia of the columns in the PU building has a big difference depending on the direction because it is very flat as shown in Figure 3.2.27

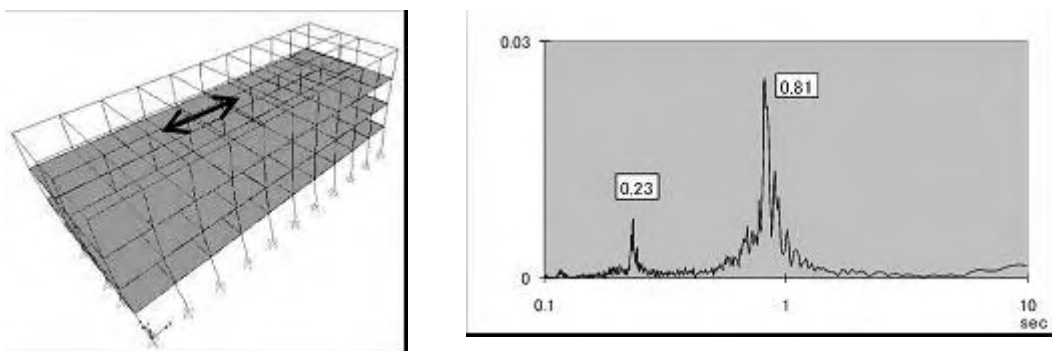
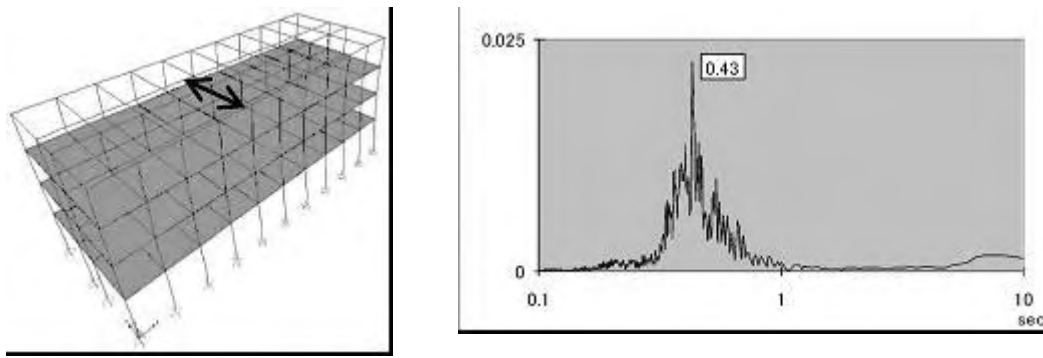
**Figure 3.2.28      Vibration Characteristic of PU Building**

The predominant period of longitudinal direction is remarkably longer than that of latitudinal direction due to stiffness difference brought about by the building direction.

The result of the micro tremor measurement also brings a good suggestion for this respect.

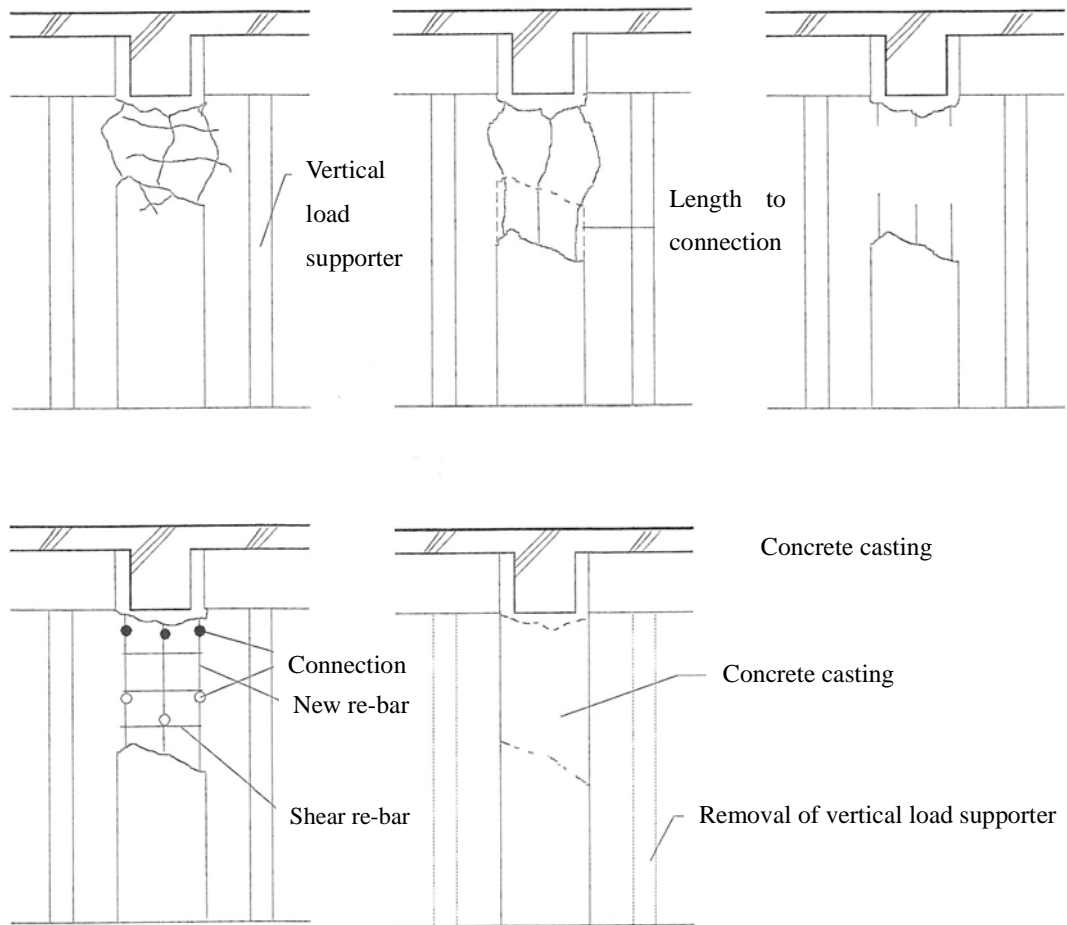
**Figure 3.4.2 Restoration Columns**

##### **A. The repair/restoration work for columns which sustained remarkable buckling is shown hereunder.**

The sequence to repair the severely damaged column should be conducted as follows (to be read in conjunction with the illustrations):

- a. Provide vertical load supporters as shown.
- b. Remove damaged portions of the concrete.
- c. Cut the column rebars (jack-up the beams if necessary).
- d. Place reinforcing bars.
- e. Cast concrete

- f. Remove the supporters after the concrete gained sufficient strength.

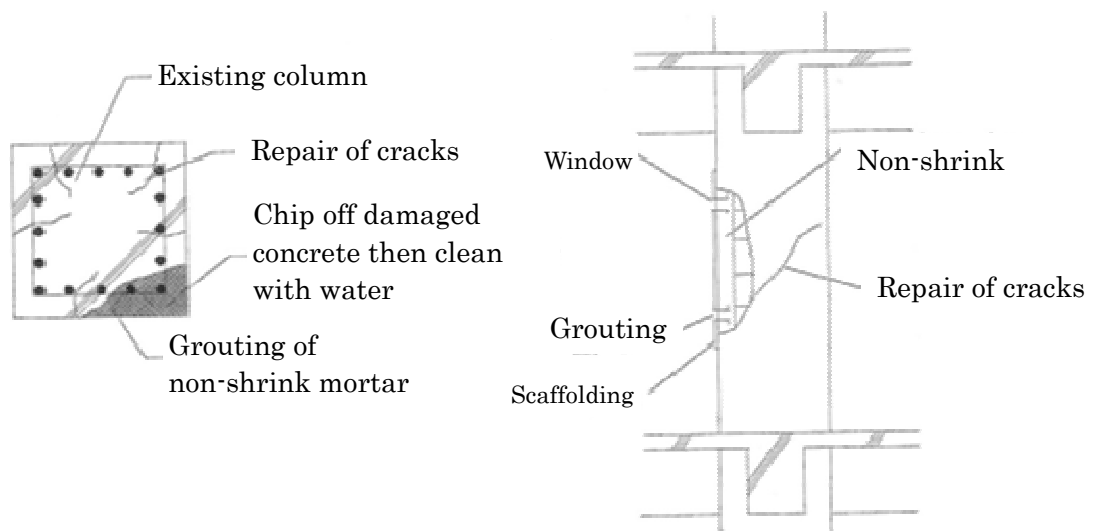
**Figure 3.4.3 Restoration of Column Rebars (filling of cracks)**

### **B. Restoration work of columns with crack(s)**

Sequence of restoration works to columns with cracks shall be as follows:

- Remove damaged concrete by chipping. Clean chipped off surface concrete with water.
- Place Mortar Grout to prepared cracked sections.
- Repair damaged existing hoops (Damaged reinforcing bars should be welded if necessary).
- Place scaffolding/mould.
- Place/cast mortar or concrete.

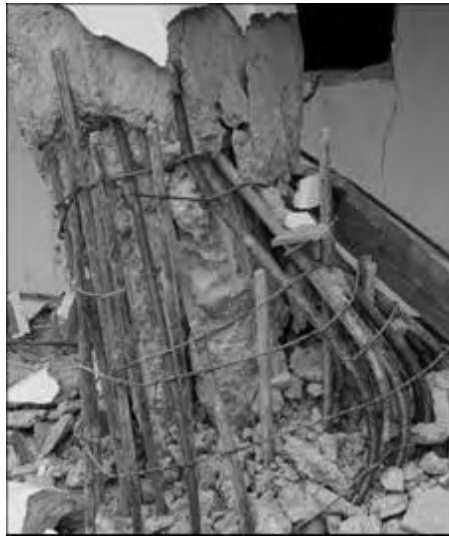
**Figure 3.5.6 Detachment of tie hoop head**

Shear failure will cause sudden brittle failure when the inertia force exceeds a certain limit.

For the effective prevention of shear failure, anti-shear failure rebars, including the hoops in beams and tie hoops in columns should be carefully provided and properly arranged.

The head of each tie hoop should be roundly bended to prevent detachment even when the column section is swollen by compression. (see Figure 3.5.6)
