**THE PREPARATORY STUDY  
ON  
DISASTER MANAGEMENT PROGRAM  
FOR  
INDONESIA**

**SUPPLEMENT REPORT**

**- FINDINGS FROM WEST SUMATRA EARTHQUAKE -  
- 30 SEPTEMBER 2009 -**

## **Appendix-1**

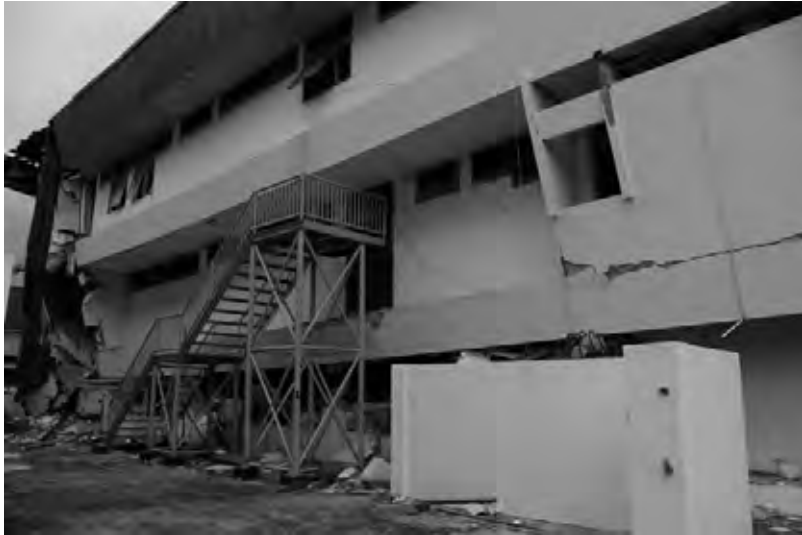
In 2009 earthquake, damage was so severe that the first story (front part) was practically disappeared. The back part dropped as well but not as severe as the front part.

The first floor height was measured based on height of standing stairways at the back part of the building. The steel stairways was not connected to the main building so that it was not broken by the drop of the building. The height of first story is found to be 4.4 meter. The second and third story height was measured at 3.8 meter.

Original height of second floor at the back part is shown by the height of stairways

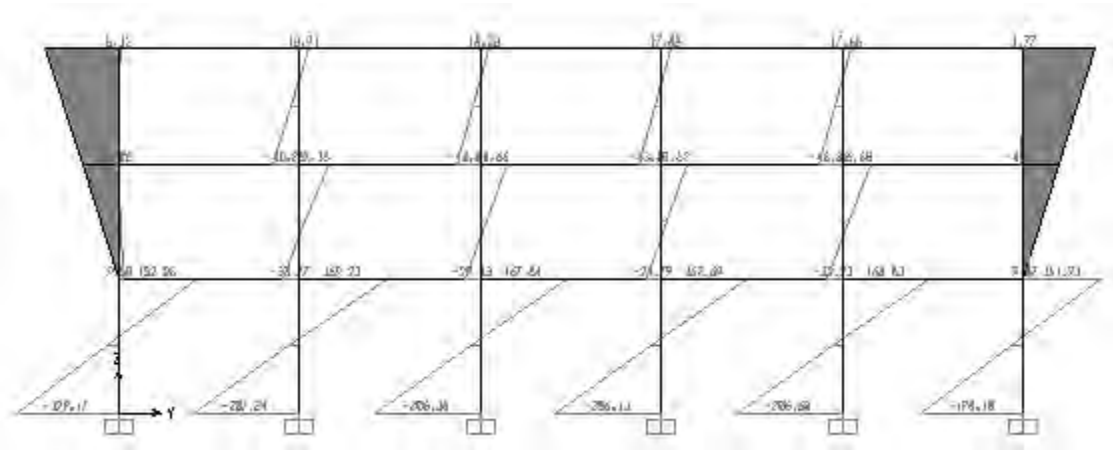
Maximum Moment (206 kN.m) at Column Base

Under Seismic Equivalent Static Loading (SNI-03-1726-2002)

The demand of 206 kN.m at the base at one column under seismic static loading is still below the moment capacity of column at Floor-1 (400 kN.m). From the survey, the column shows heavy damage at the first floor so that soft-story mechanism occurred.

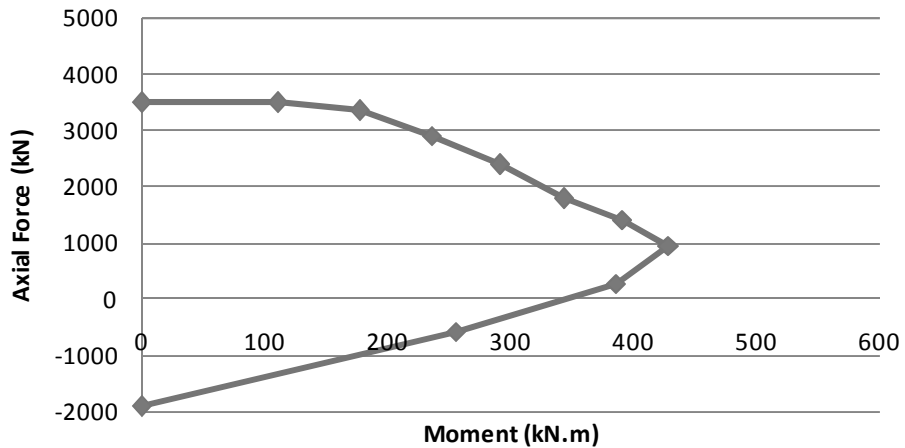
Interaction Diagram of Column at BAPPEDA Building

With the load at column Floor-1 at 403 kN by the Dead Load, the moment capacity of the base of column at longitudinal direction is around 400 kN.m.

The results show that the damage of columns at Floor-1 is due to column rebars were overlapped at maximum moment region, smooth type of rebars, and too-small stirrups. Therefore real capacity is lower than the calculated capacity.

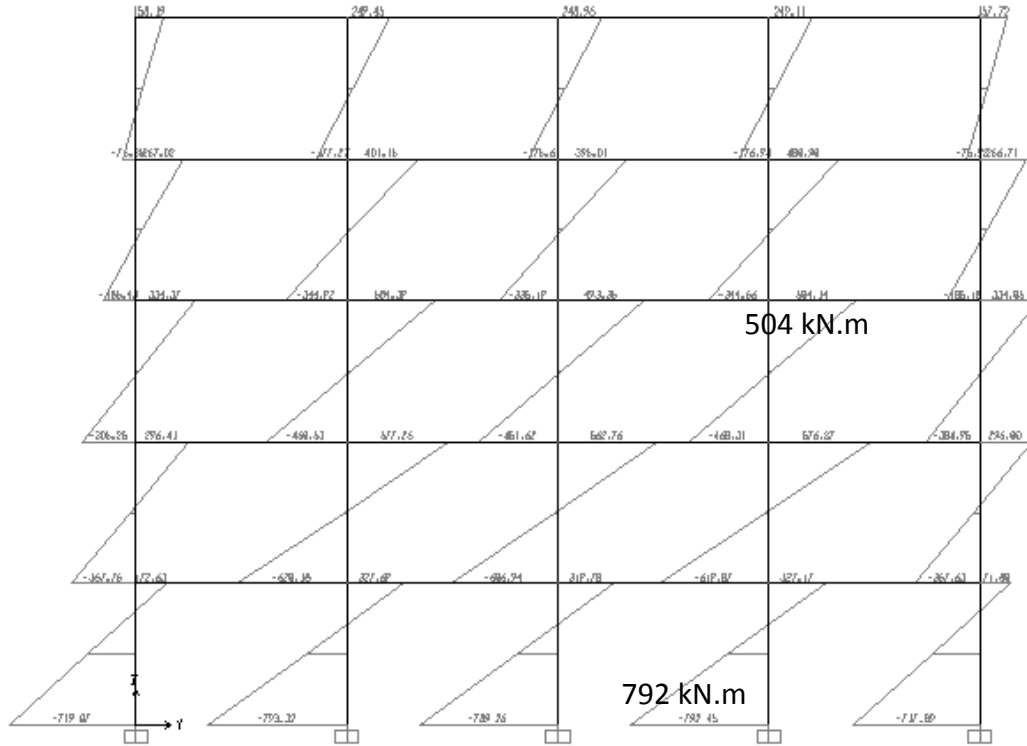
Moment of 792 kN.m at Column Base and 504 kN.m at upper Column Floor-2  
Under Seismic Equivalent Static Loading (SNI-03-1726-2002)

Therefore the demand of 792 kN.m at the base at one column by the seismic static loading is beyond the moment capacity of 515 kN.m at the base column. From the survey, the column shows little damage at the base floor (see figure below).

Therefore the demand of 504 kN.m at upper part of columns at Floor-2 by the seismic static loading is beyond the moment capacity (230 kN.m) of the column at Floor-2. From the survey, the column shows severe damage at upper part of column.

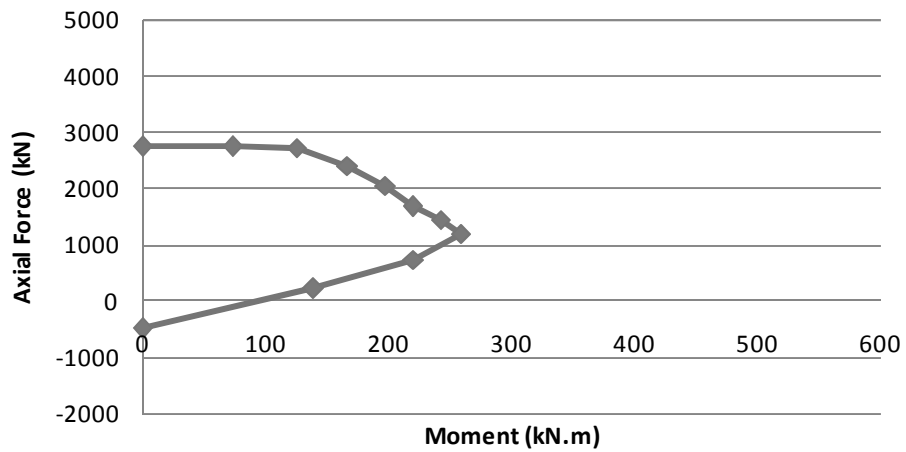
P-M Interaction Diagram of Column at Floor-2

The results show that the damage of columns at Floor-2 is due to the “too early” reduction of column size at Floor-2. The seismic moment demand is higher than the capacity of columns at Floor-2.

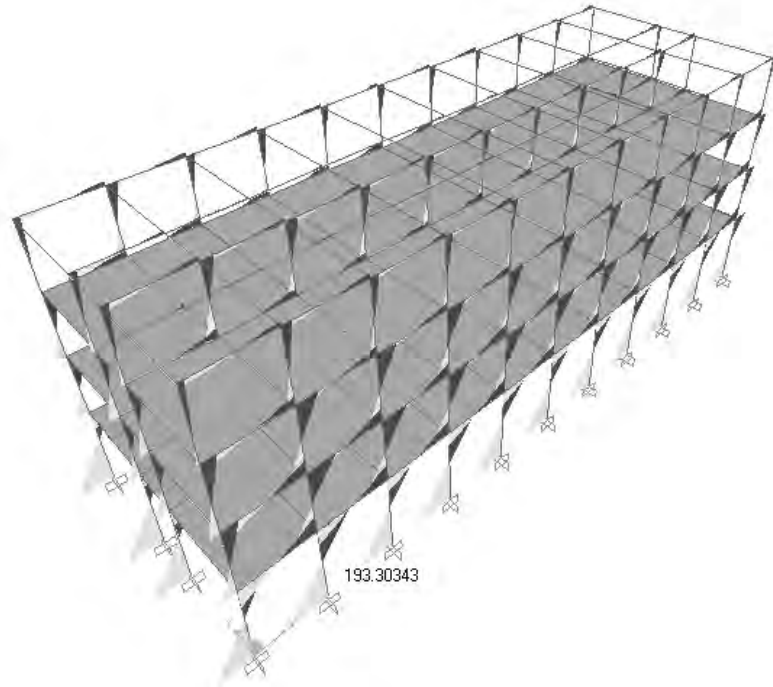
Maximum Moment (193 kN.m) at Column Base (front)  
Under Seismic Equivalent Static Loading (SNI-03-1726-2002)

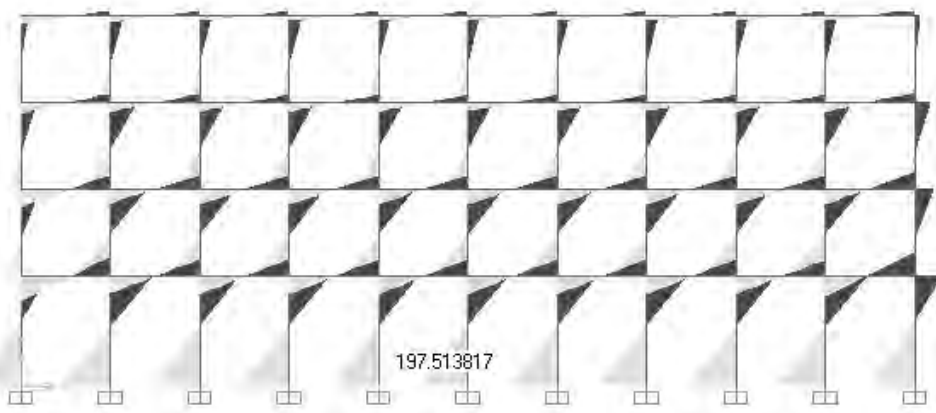
Maximum Moment (198 kN.m) at Column Base (middle)  
Under Seismic Equivalent Static Loading (SNI-03-1726-2002)

Therefore the demand of 198 kN.m at the base at one column under seismic static loading is beyond the moment capacity of column at Floor-1 (180 kN.m). From the survey, the column shows heavy damage at the first floor so that soft-story mechanism occurred.

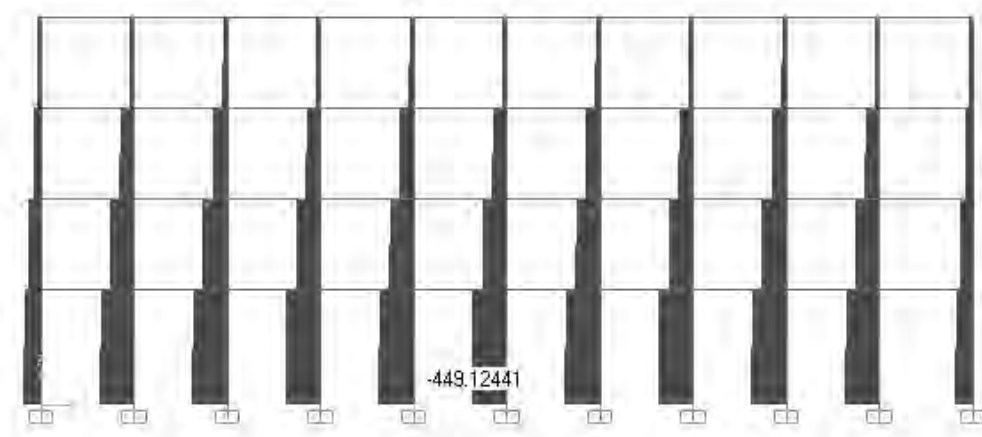
Axial Force Diagram at Column under Dead Load

With the load at column Floor-1 at 450 kN by the Dead Load, the moment capacity of the base of column at longitudinal direction is around 180 kN.m.
