インド国 火力発電所運用改善計画調査

ファイナルレポート Volume II

平成 22 年 11 月 (2010 年)

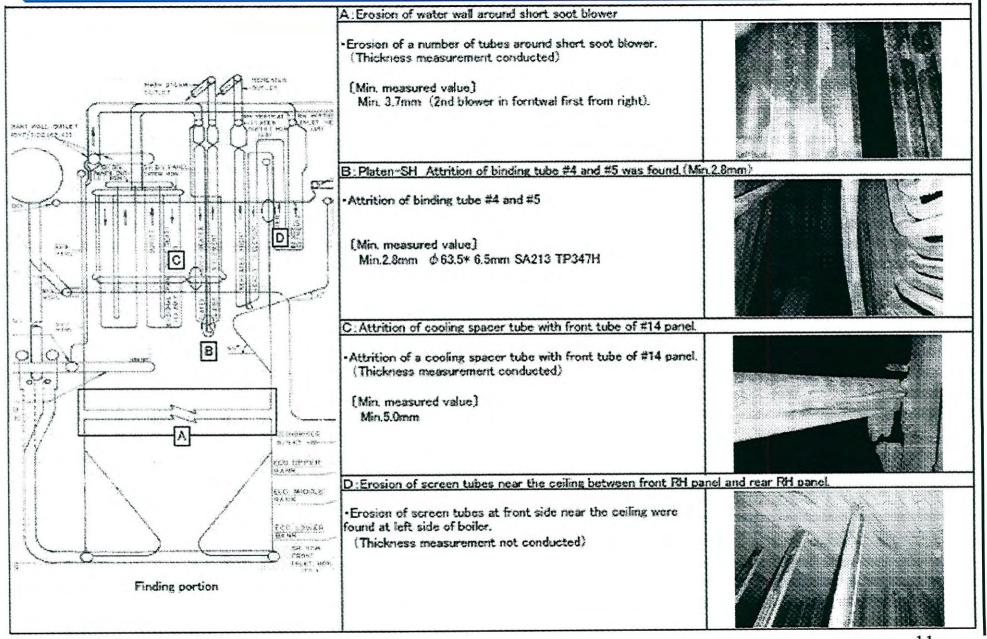
Visual inspection (Singrauli #6)

Components	Inspection method	Findings
Water wall tube	Visual check	 Erosion of a number of tubes around short soot blower were found. No erosion at any other portions. No erosion and decease in thickness around burners.
		Thickness was measured at erosion regions around soot blowerrs near each 4 corner. Min. thickness was 3.7mm(2nd blower in forntwal first from right. f 51* 5.6mm, SA210 Gr.C
	Visual check	 Attrition of binding tube #4 and #5 was found. (Min.2.8mm) Attrition of cooling spacer tubevwith front tube of #14 panel (Min.5.0mm) Disorder of arrangement at lower part of panel with distortion to adjacent panel. A number of disjointed slide spac
Platten SH	Thickness measurement of tubes	•1:Outer tube of rear side portion at sootblower level [24points] ⇒ Min.6.3mm φ 63.5* 6.3mm SA213 TP347H •2:Outer bottom tube [24points] ⇒ Min.9.8mm φ 54.0* 9.5mm SA213 TP347H •3:Attrition of coolin
Timon 511	SUS scale deposition inspection	Nos. exceeding 10% fullness: 7 /50 (magnetized effect of material)

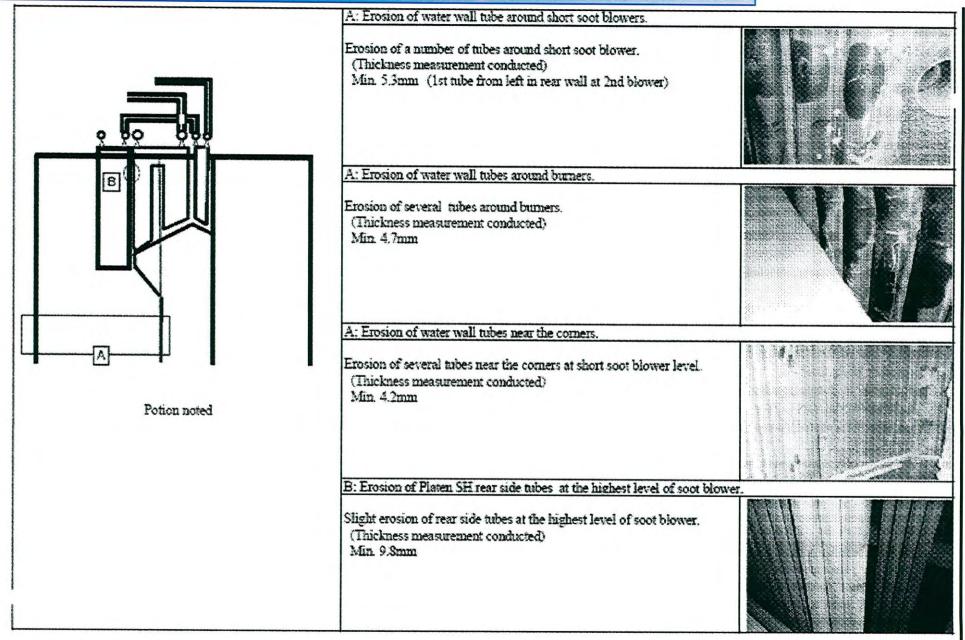
Visual inspection (Unchahar #2)

Components	INSPECTION	Unchahar #2 Brief comment
WATER WALL	VT	Erosion of a number of tubes around short soot blower were found. Erosion of corner tubes at soot blower level.(Thickness measurement 28points (Min.4.2mm)
	THICKNESS MEASUREMENT	Eroded tubes around short soot blower were meareured .(69points measured) Min 5.3mm (2nd short blower rear wall #1 form left)
	VT	Disorder of arrangement at lower part of panel with disjointed slide spacers. Slight erosion of rear tubes at the highest level of short soot blower.
	THICKNESS MEASUREMENT	Rear tubes at the highest level of short soot blower.(29points, Min.9.8mm) 2nd tubes from rear tubes at the highest level of short soot blower.(3points, Min.10.0mm) Rear tubes at the second highest level of short soot blower.(29points, Min.9.8mm)
SUPER HEATER	SAMPLE TUBE INSPECTION *	1 sample tube from Platen-SH in furnace (#3panel- 8th tube from rear) 2 sample tubes from Final-SH in furnace (#1-3rd tube from rear, #119-3rd tube from rear)

CREEP RUPTURE TEST*	1 sample tube from Platen-SH in furnace (#3panel- 8th tube from rear), 1 sample tubes from Final-SH in furnace (#119-3rd tube from rear)
	SUS SCALE DEPOSITION INSPECTION	3 tubes with 15% fullness and 2 tubes with 10% fullness at front bend portion. 1 tube with 15% fullness and the others with less than 10%.
REHEATER	VT	No abnormality with panel ar r angement Slight erosion of tubes at the highest level of short soot blower.

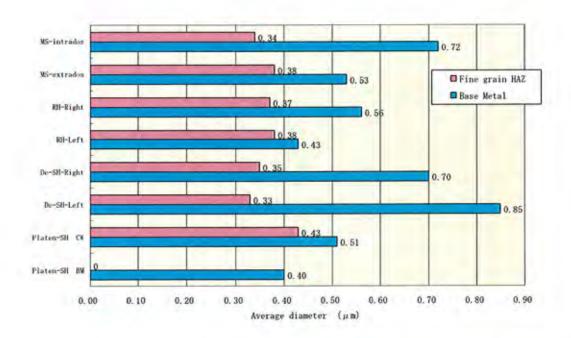
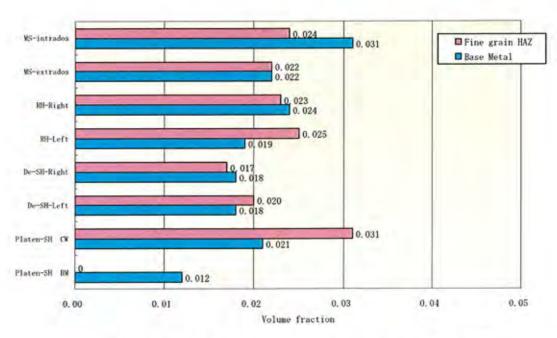
Quantitative evaluation of grain boundary precipitates [extracted Table I -7]

- The Max. value of average diameter of grain boundary precipitates was 0.85 μ m in base metal at De-Superheater-Left, 0.43 μ m in fine grain HAZ at Platen-SH Outlet Header-Left circumferential weld.
- ➤ The max. value of volume fraction of grain boundary precipitates was 0.031 in base metal at Main Steam Pipe-Intrados, 0.031 in fine grain HAZ at Platen-SH Outlet Header-Left circumferential weld.

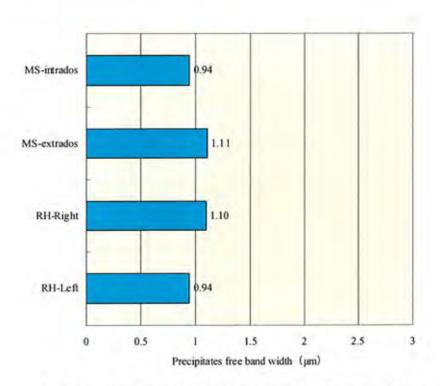
Precipitates free band width along grain boundary (extracted Table I -8)

- 7-3 Quantitative evaluation of precipitates free band width along grain boundary The results of quantitative evaluation of precipitates free band width along grain boundary are shown in Table I -8.
 - > The quantitative evaluation was focused on base metal of SA 335 P22.
 - The Max. value of precipitates free band width along grain boundary was 1.11 μ m at Main Steam Pipe-Extrados.

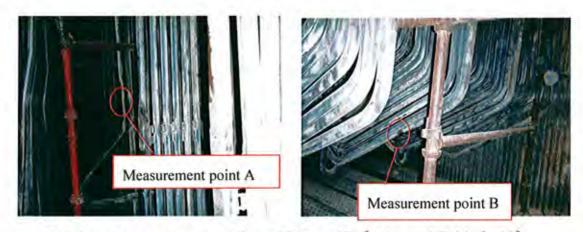
Thickness measurement portion of Platen-SH [extracted Table I -18]

- ➤ Thickness was measured mainly for outer tubes of rear side portion at soot blower level and outer bottom tubes as shown in Table I -18.
- ➤ Min.thickness at soot blower level (measurement point A) was 6.3mm, that was not less than the designed value 6.3mm.
- Min.thickness at outer bottom tubes (measurement point B) was 9.8mm, that was larger than the designed value 9.5mm.

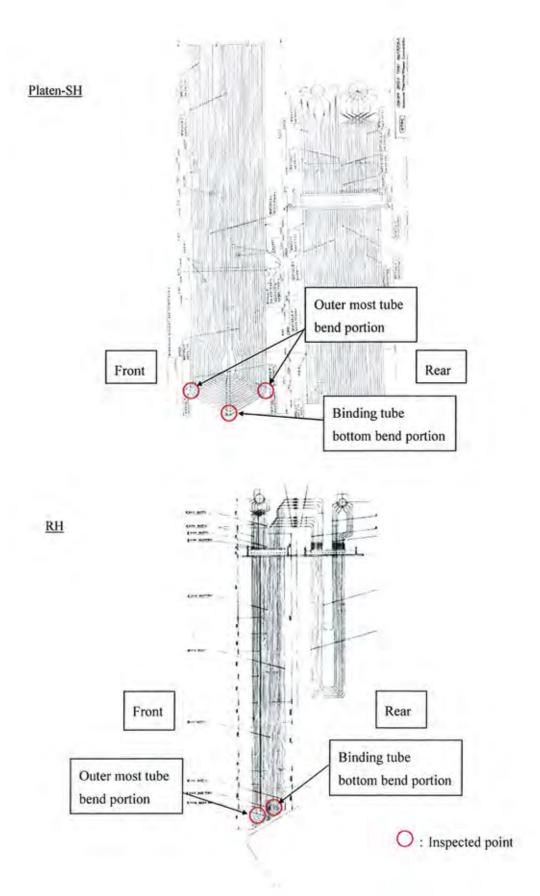
Fig. I -2 Inspection location

SUS scale deposition inspection results are shown in Table I -25.

The signal by magnetization of tube material with heat was recognized at front side outermost tubes in Platen-SH except #1,2,5,7 \sim 11 panel from left and at rear side tubes in Platen-SH except #7 \sim 11 from left.

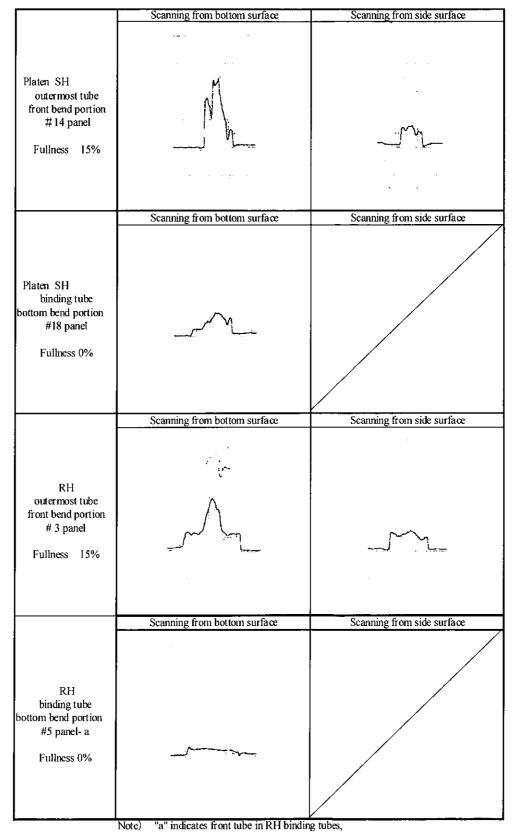
Fig. I -3 The representative deposition signal

The representative deposition signal for this inspection is shown in Fig. I -3. The standard curve used is shown in Fig. I -4.

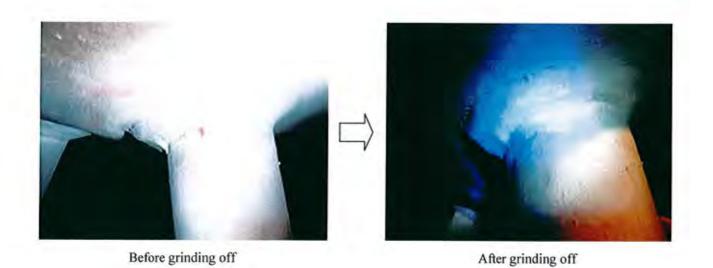
An indication with 2mm in length was found in 3rd stub weld portion from front. The indication disappeared after grinding off the tube 1mm in depth.

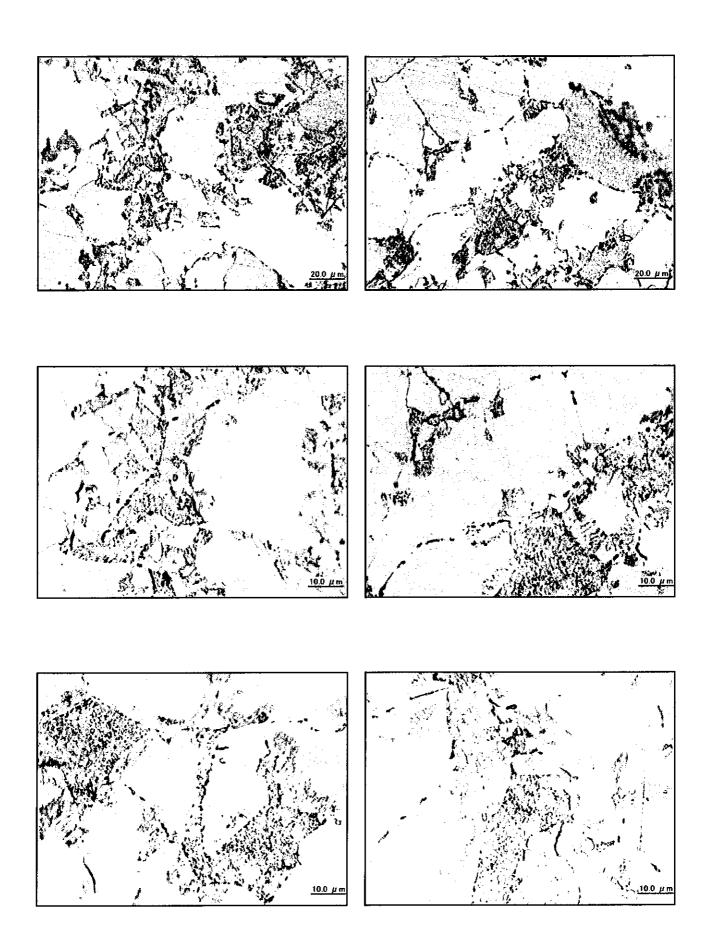
$\label{lem:photo} Photo\ I\ -6-2\quad Microstructure\ observation \\ \ De-Superheater-Right\ (Circumferential\ weld\ :\ Intercritical\ zone\)$

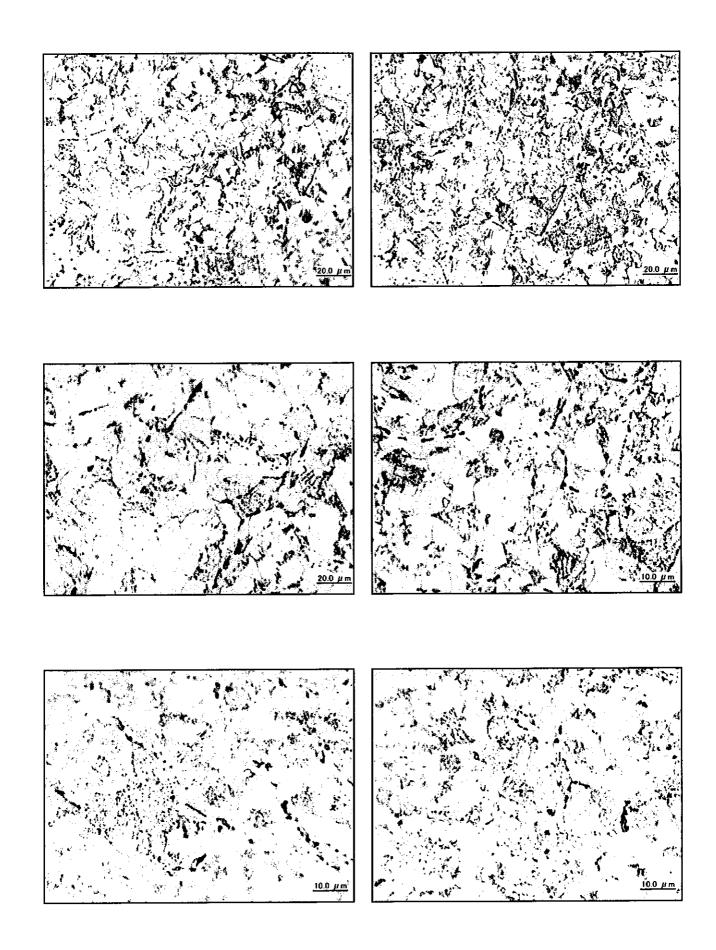
Photo I -6-3 Microstructure observation De-Superheater-Right (Circumferential weld : Fine grain HAZ)

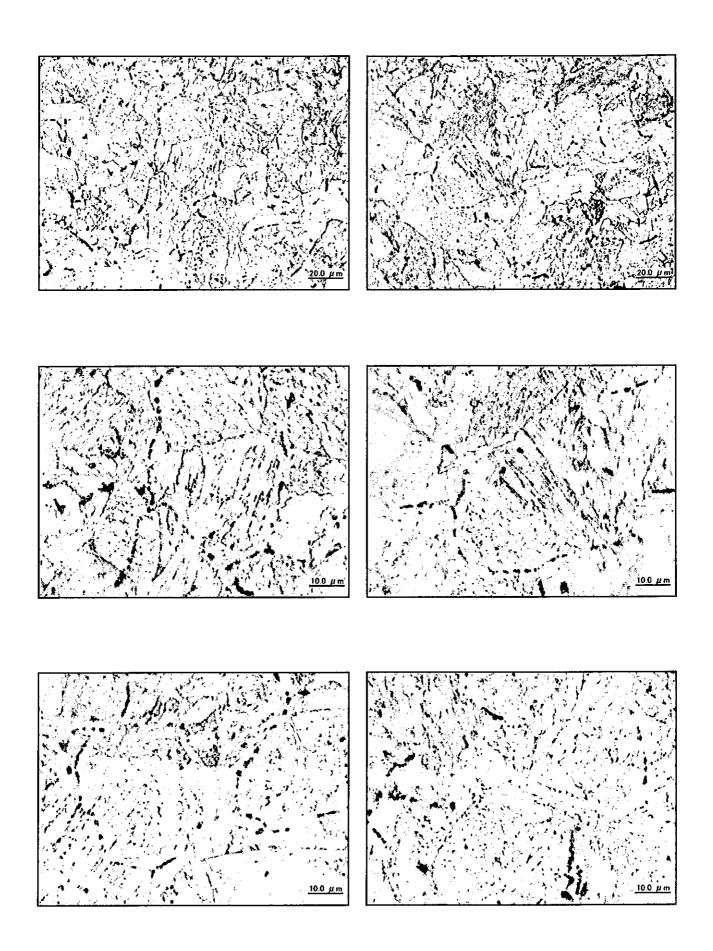
$\begin{array}{cccc} Photo \ I - 6 - 4 & Microstructure \ observation \\ De-Superheater-Right \ (Circumferential \ weld \ : Coarse \ grain \ HAZ \) \end{array}$

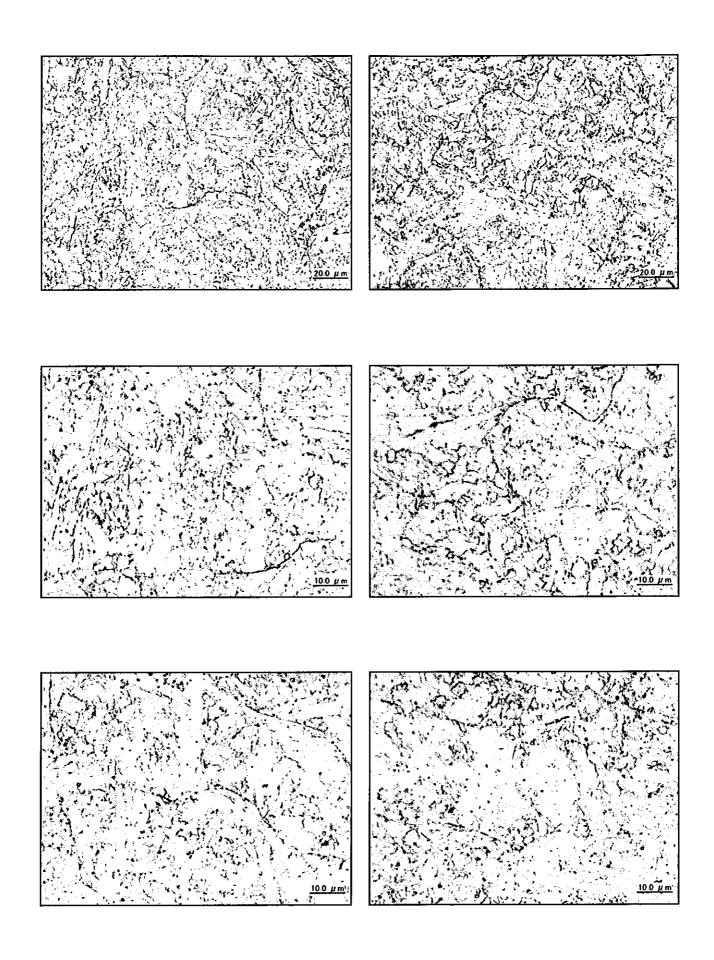
$\begin{array}{cccc} Photo \ I -6-5 & Microstructure \ observation \\ De-Superheater-Right \ (Circumferential \ weld \ : \ Weld \ metal \) \end{array}$

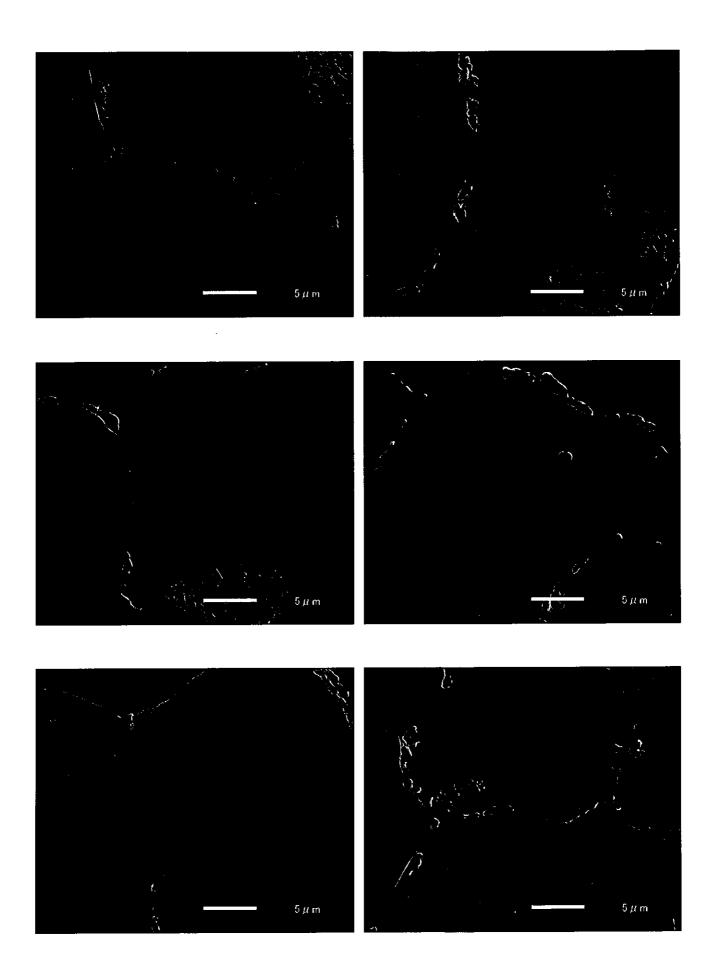
Photo I -6-9 Precipitates along grain boundary by SEM observation De-Superheater-Right(Circumferential weld: Base metal)

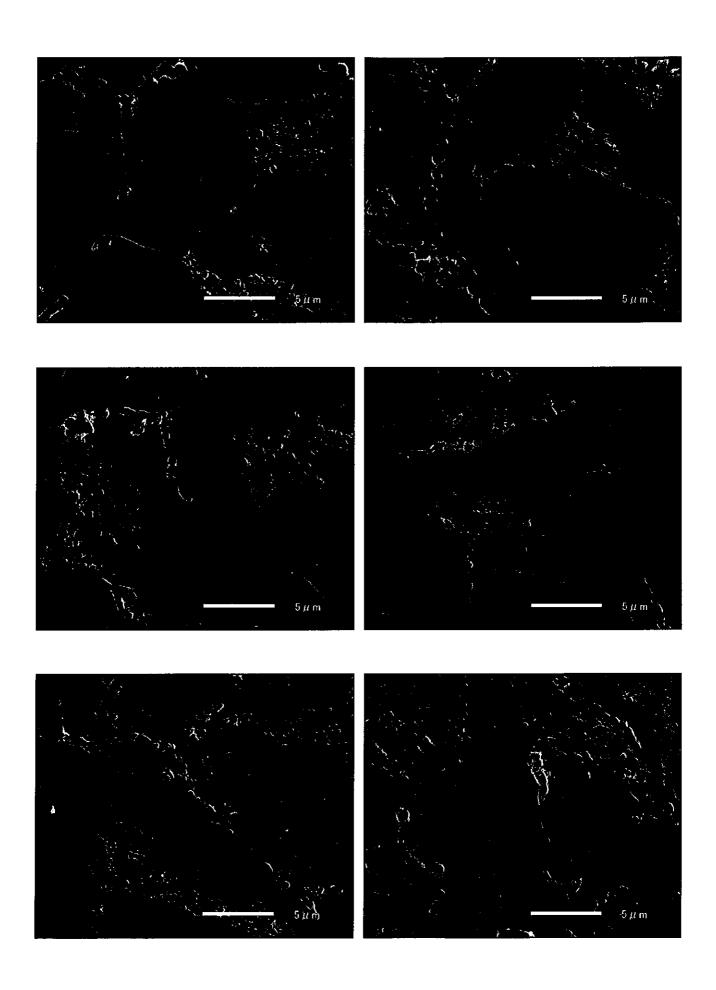
Photo I -6-10 Precipitates along grain boundary by SEM observation De-Superheater-Right (Circumferential weld: Fine grain HAZ)

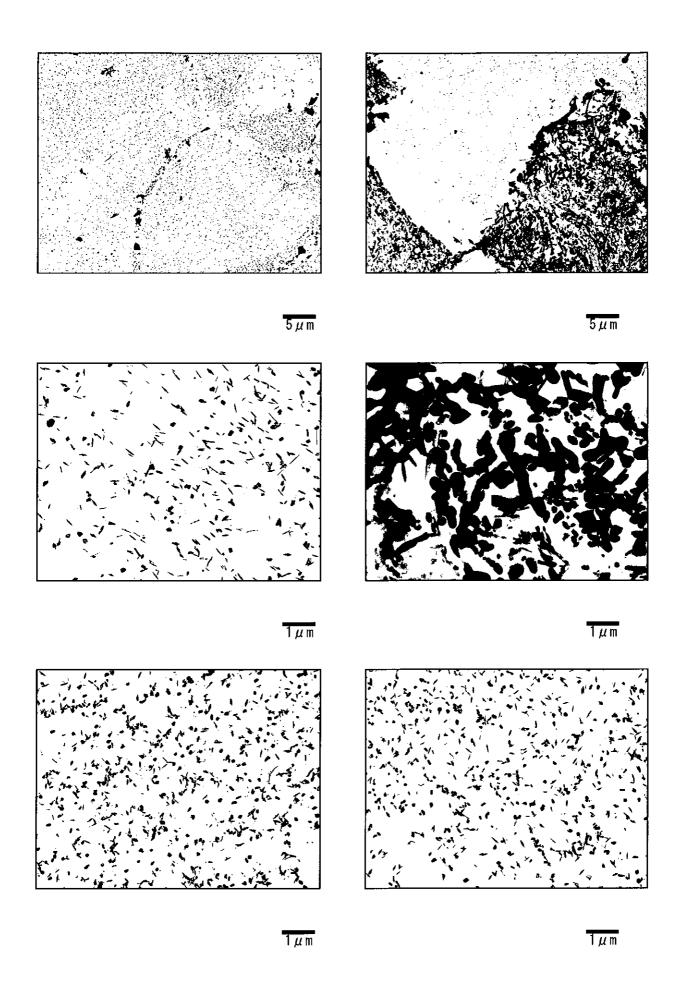
Photo I -6-11 Precipitates by TEM (Transmission electron microscope) observation De-Superheater-Right(Circumferential weld: Base metal)

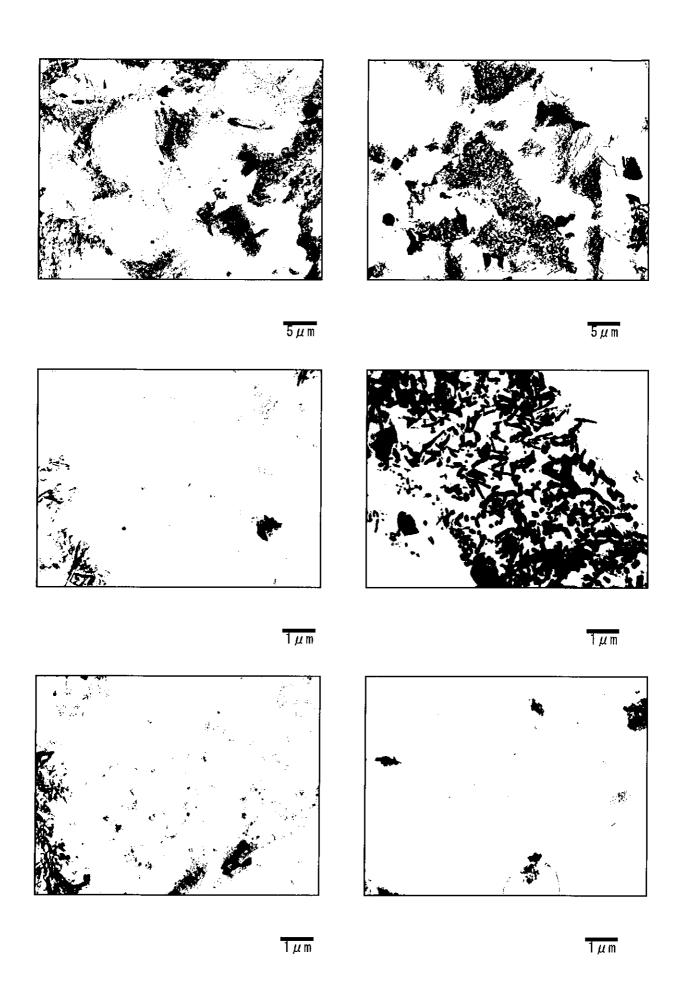
Photo I -6-12 Precipitates by TEM (Transmission electron microscope) observation De-Superheater-Right (Circumferential weld: Fine grain HAZ)

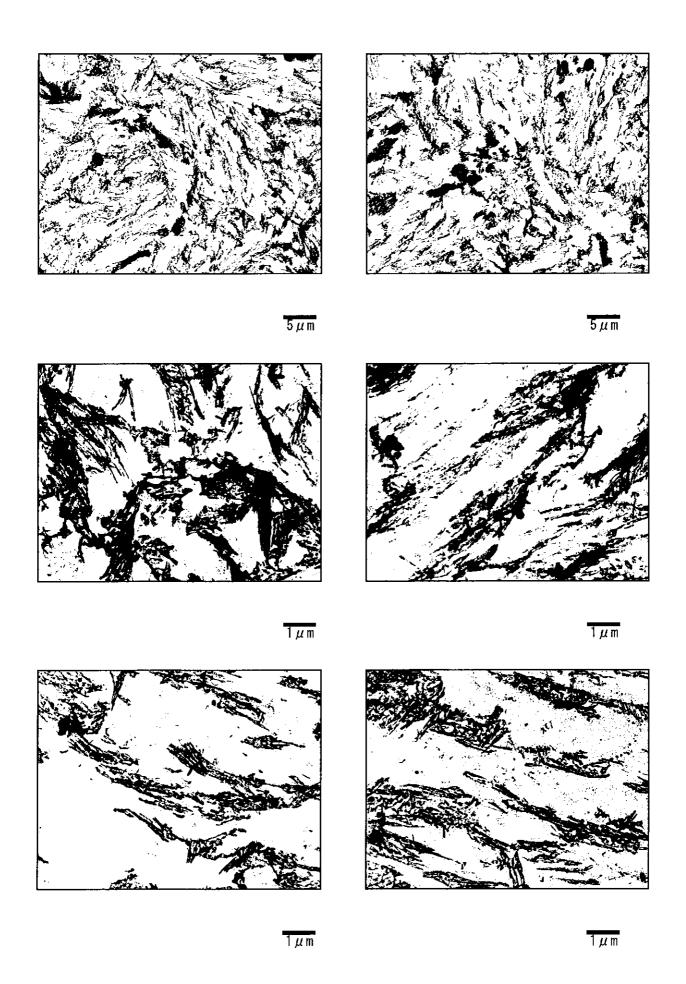
Photo I -6-13 Precipitates by TEM (Transmission electron microscope) observation De-Superheater-Right (Circumferential weld: Coarse grain HAZ)

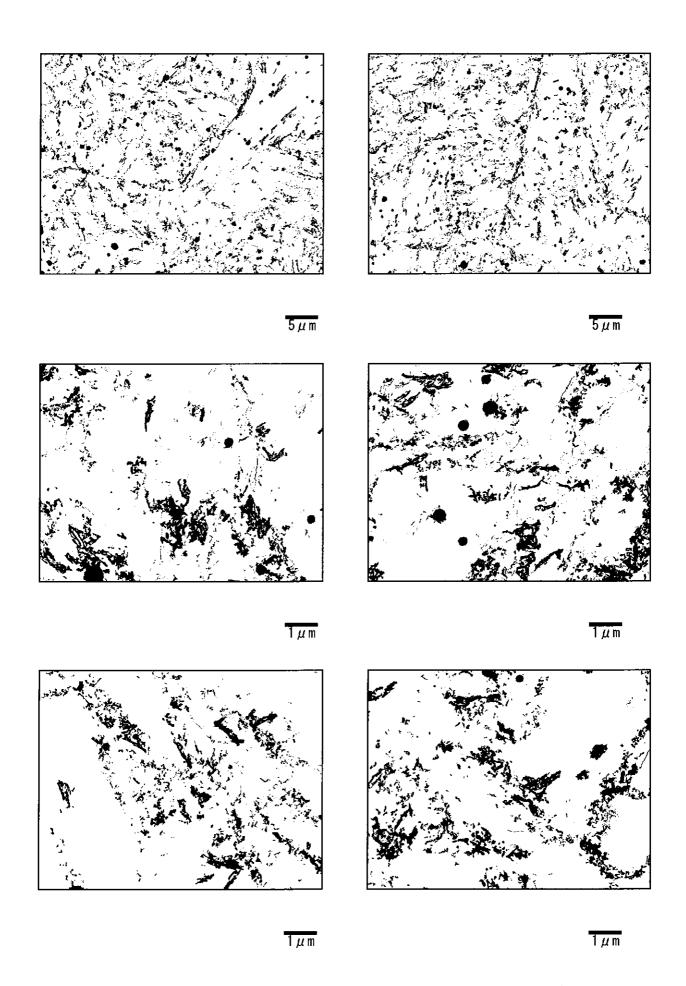
Photo I -6-14 Precipitates by TEM (Transmission electron microscope) observation De-Superheater-Right (Circumferential weld: Weld metal)

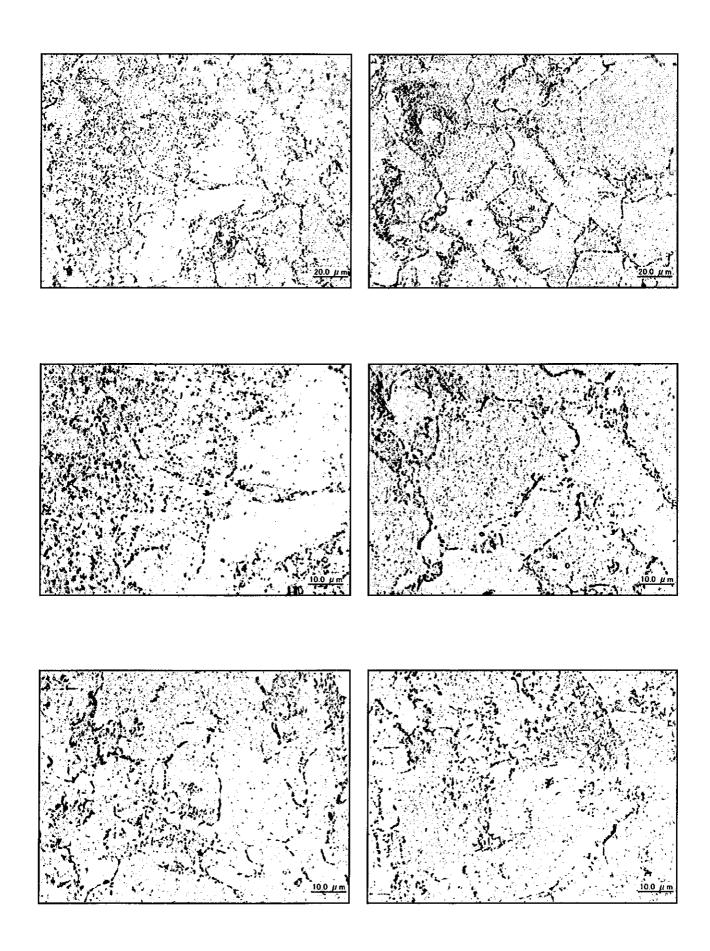
$\label{lem:photo} Photo\ I\ \mbox{-7-2}\quad Microstructure\ observation \\ RH\ Outlet\ Header-Left\ (\mbox{Circumferential weld at left side}\ : Intercritical\ zone\)$

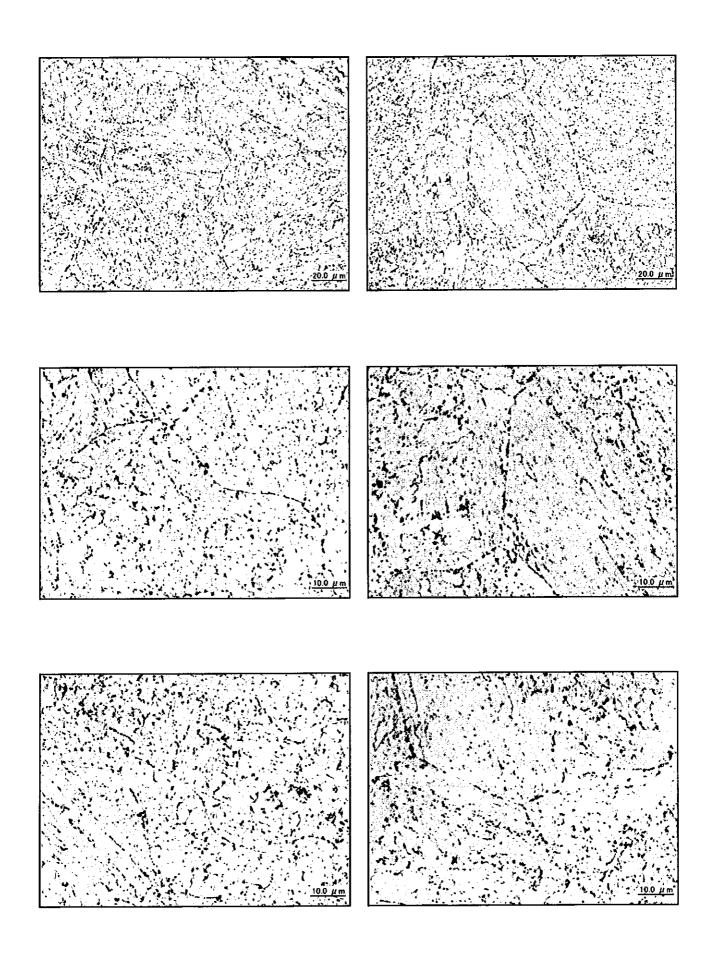
$\label{lem:photo} Photo\ I\ \mbox{-}7\mbox{-}4\ \ \mbox{Microstructure observation} \\ RH\ Outlet\ Header-Left\ (\mbox{Circumferential weld at left side : Coarse grain HAZ}\)$

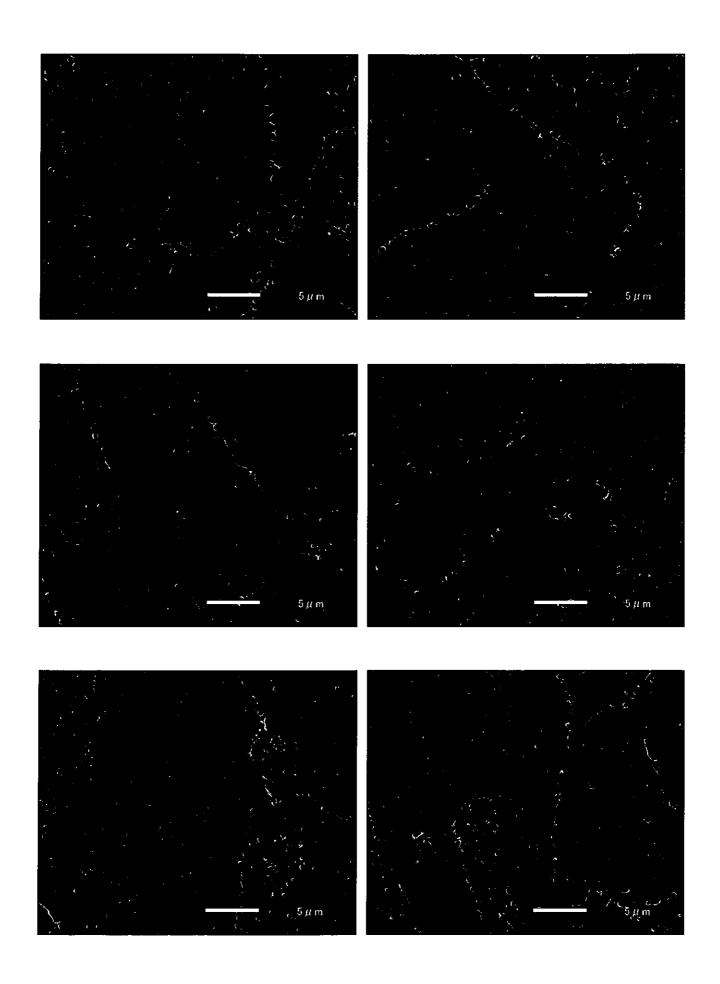
Photo I -7-9 Precipitates along grain boundary by SEM observation RH Outlet Header-Left (Circumferential weld at left side: Base metal)

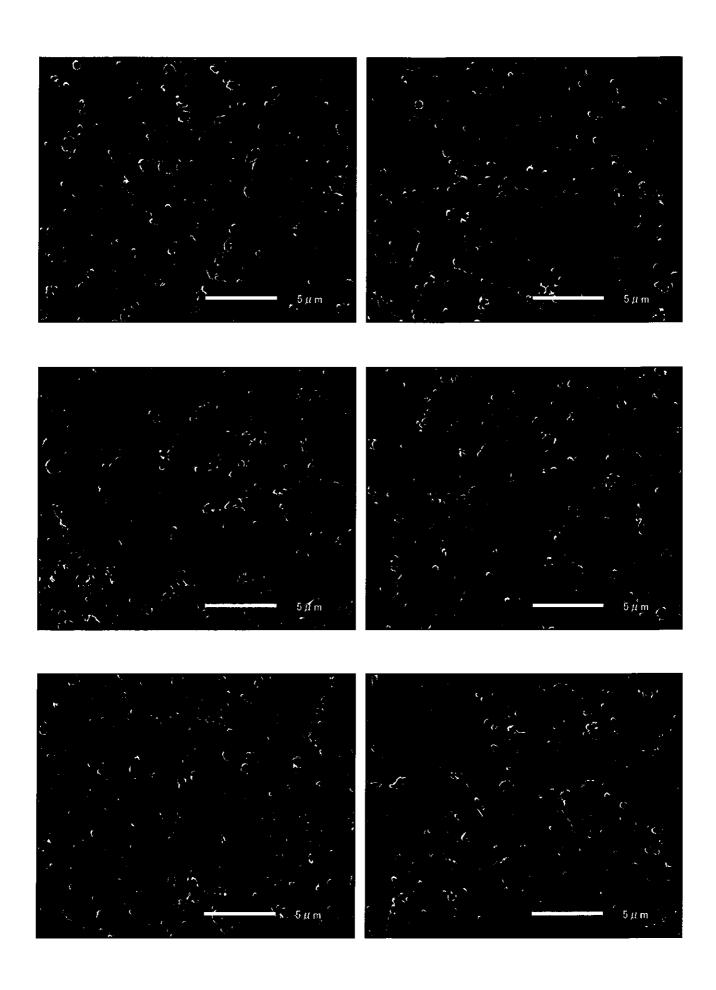
Photo I -7-10 Precipitates along grain boundary by SEM observation RH Outlet Header-Left (Circumferential weld at left side: Fine grain HAZ)

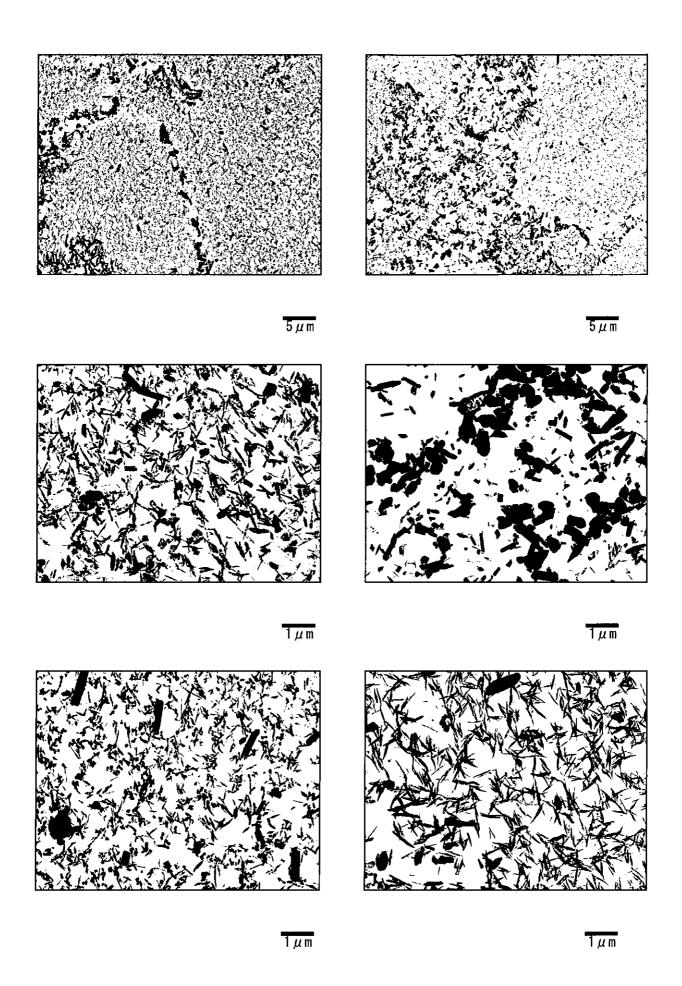
Photo I -7-11 Precipitates by TEM (Transmission electron microscope) observation RH Outlet Header-Left(Circumferential weld at left side: Base metal)

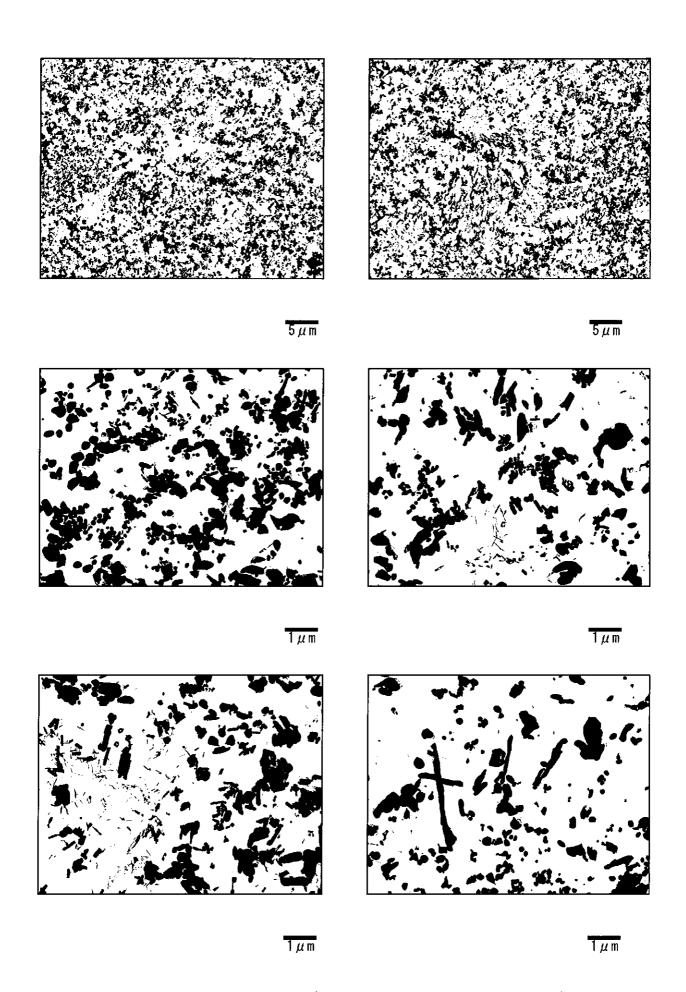
Photo I -7-12 Precipitates by TEM (Transmission electron microscope) observation RH Outlet Header-Left(Circumferential weld at left side: Fine grain HAZ)

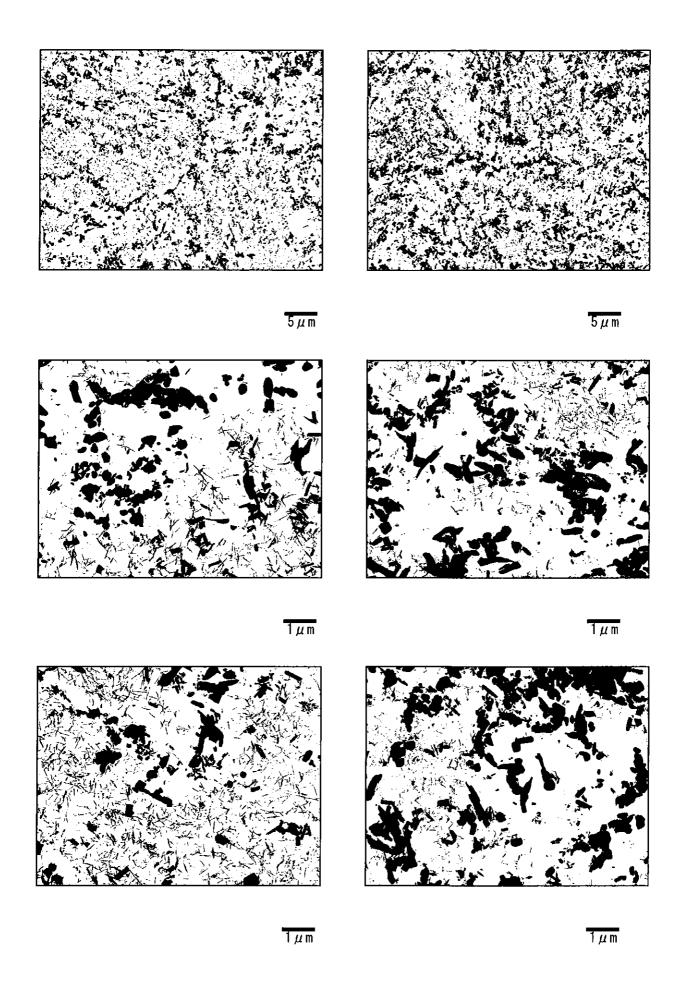
Photo I -7-13 Precipitates by TEM (Transmission electron microscope) observation RH Outlet Header-Left (Circumferential weld at left side: Coarse grain HAZ)

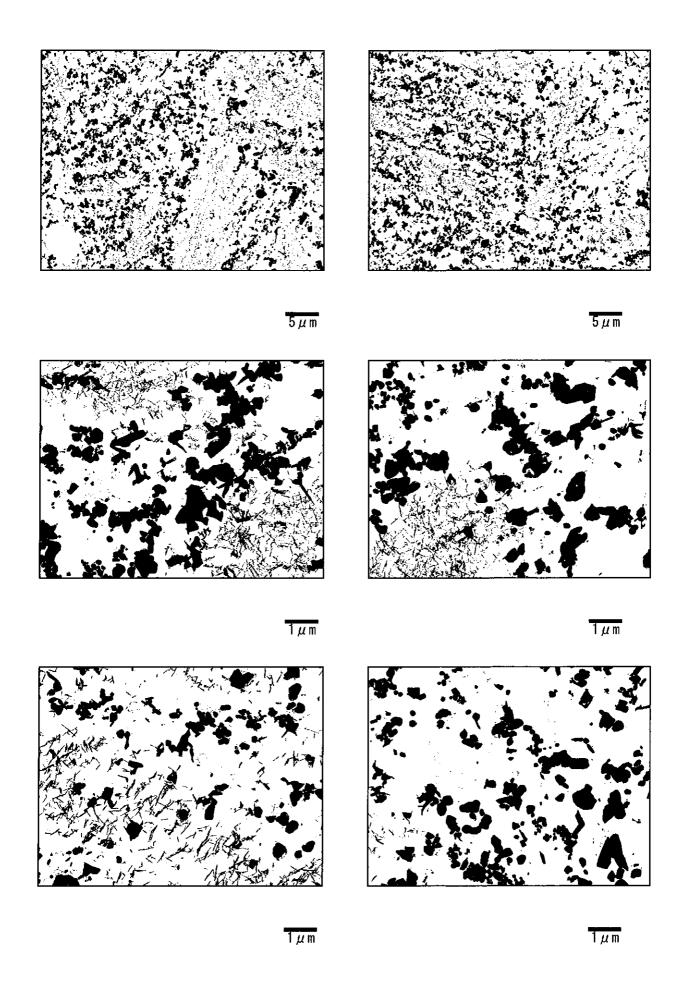
Photo I -7-14 Precipitates by TEM (Transmission electron microscope) observation RH Outlet Header-Left(Circumferential weld at left side: Weld metal)

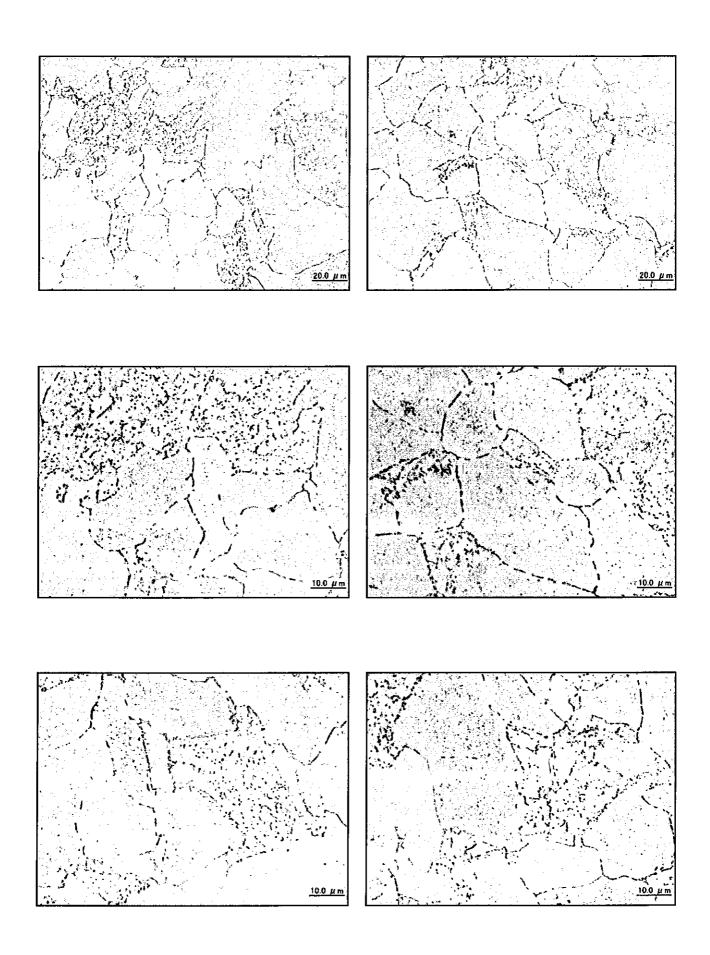
$Photo\ I\ -8-1\quad Microstructure\ observation\\ RH\ Outlet\ Header-Right\ (Circumferential\ weld\ at\ right\ side\ : Base\ metal\)$

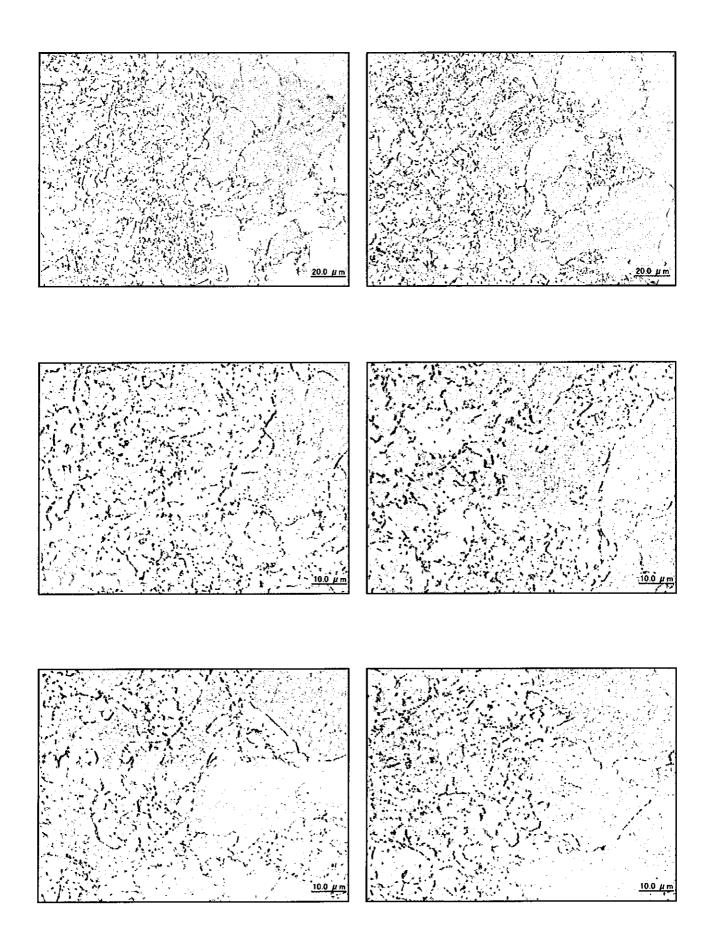
$\label{lem:photo} Photo \ I-8-2 \quad Microstructure \ observation \\ RH \ Outlet \ Header-Right \ (Circumferential \ weld \ at \ right \ side \ : Intercritical \ zone \)$

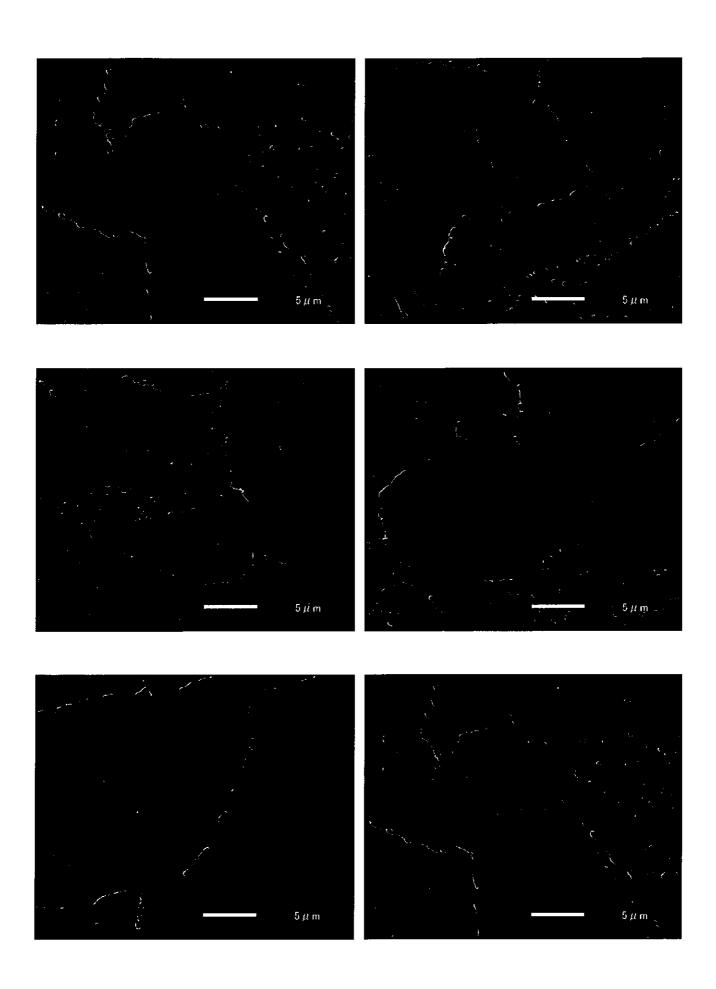
Photo I -8-9 Precipitates along grain boundary by SEM observation RH Outlet Header-Right (Circumferential weld at right side: Base metal)

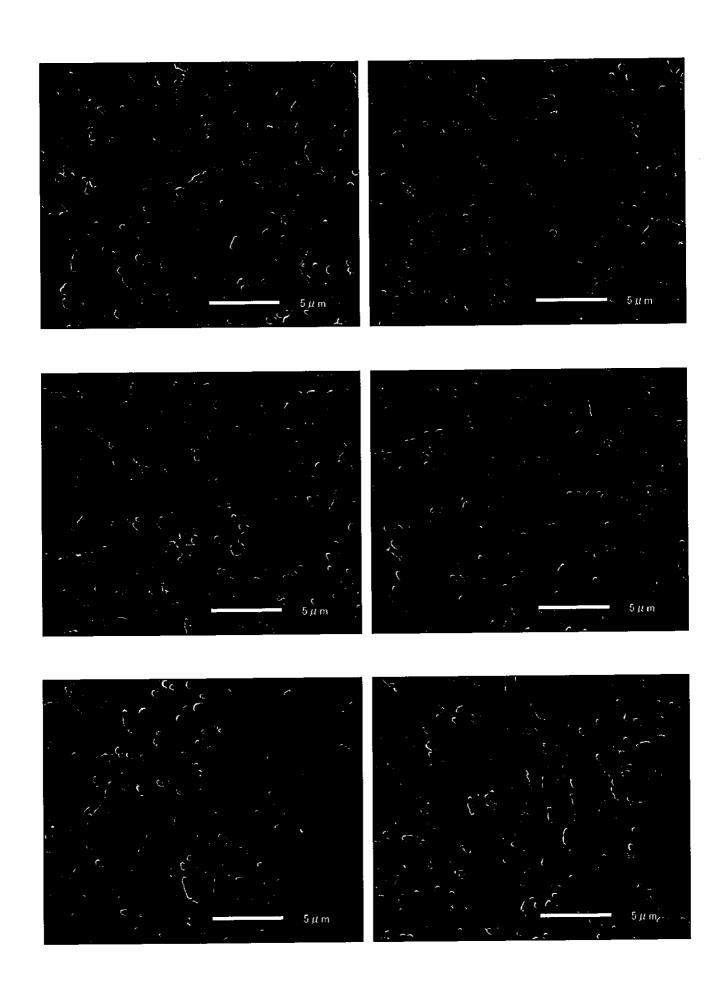
Photo I -8-10 Precipitates along grain boundary by SEM observation RH Outlet Header-Right (Circumferential weld at right side: Fine grain HAZ)

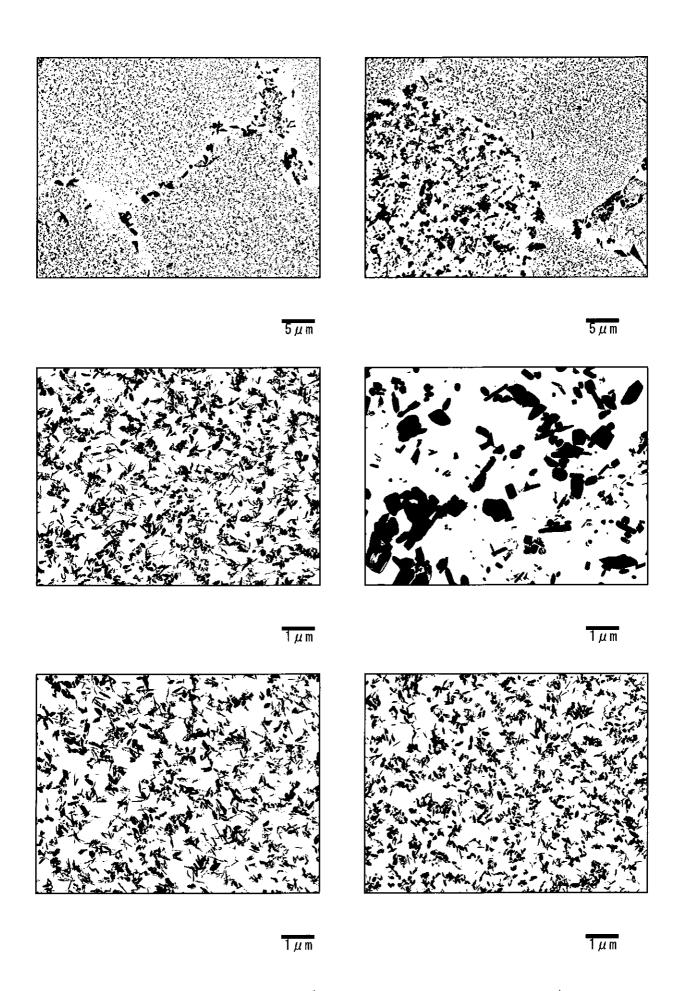
Photo I-8-11 Precipitates by TEM (Transmission electron microscope) observation RH Outlet Header-Right (Circumferential weld at right side: Base metal)

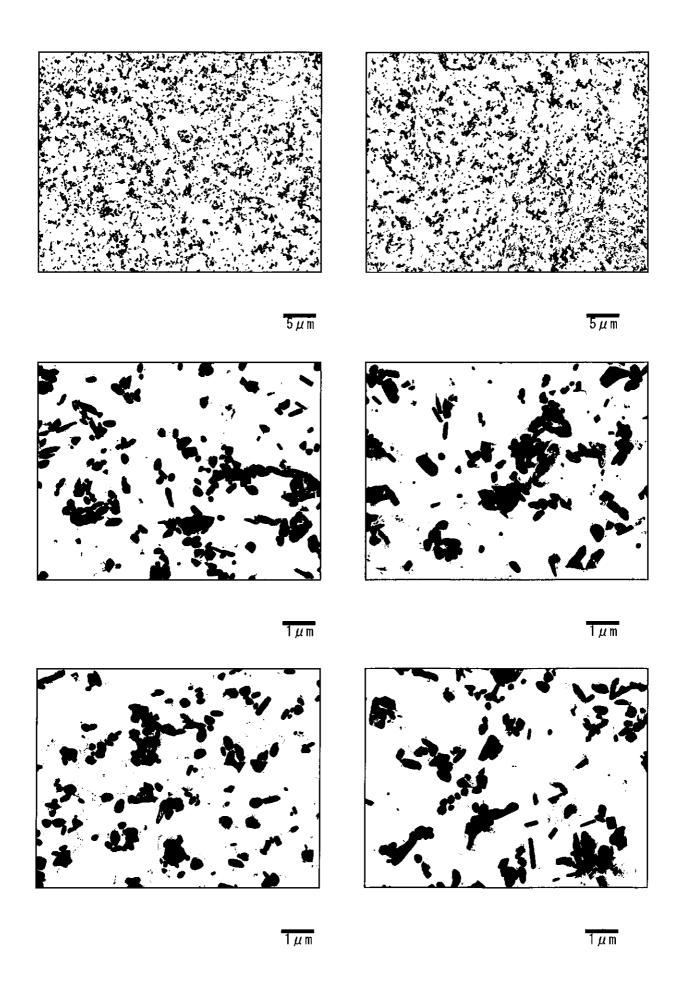
Photo I -8-12 Precipitates by TEM (Transmission electron microscope) observation RH Outlet Header-Right (Circumferential weld at right side: Fine grain HAZ)

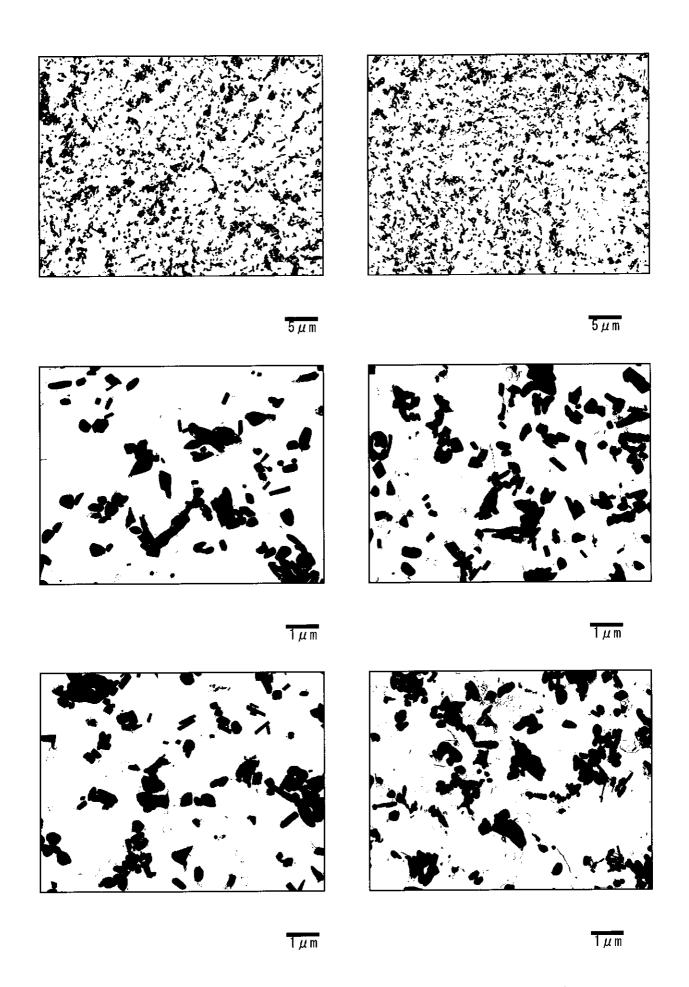
Photo I -8-13 Precipitates by TEM (Transmission electron microscope) observation RH Outlet Header-Right(Circumferential weld at right side: Coarse grain HAZ)

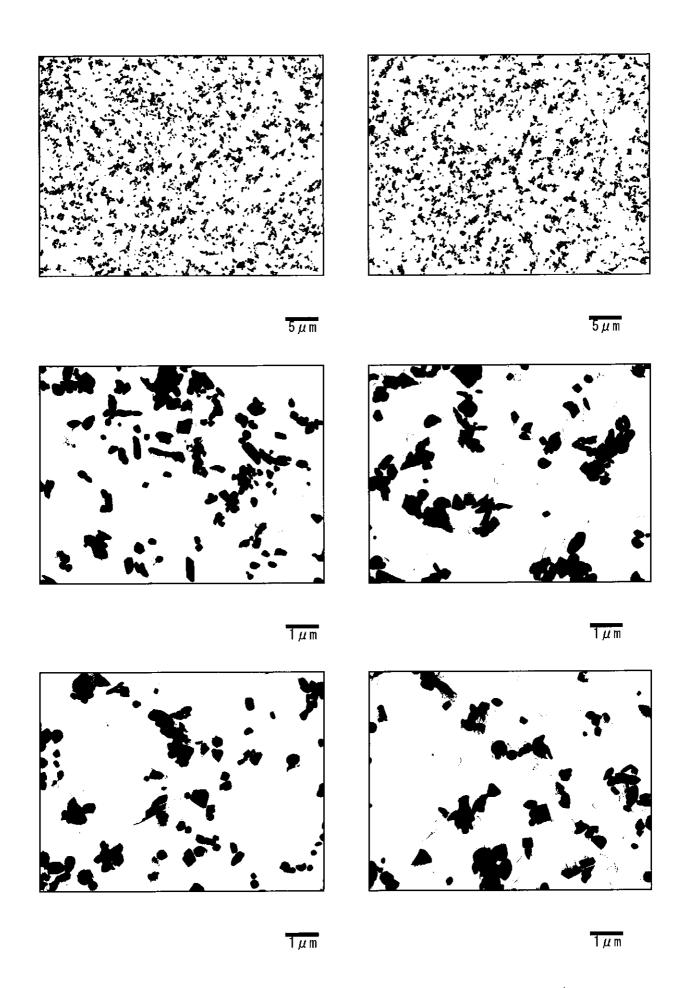
Photo I-8-14 Precipitates by TEM (Transmission electron microscope) observation RH Outlet Header-Right(Circumferential weld at right side: Weld metal)
