インド国 火力発電所運用改善計画調査

ファイナルレポート Volume II

平成 22 年 11 月 (2010 年)

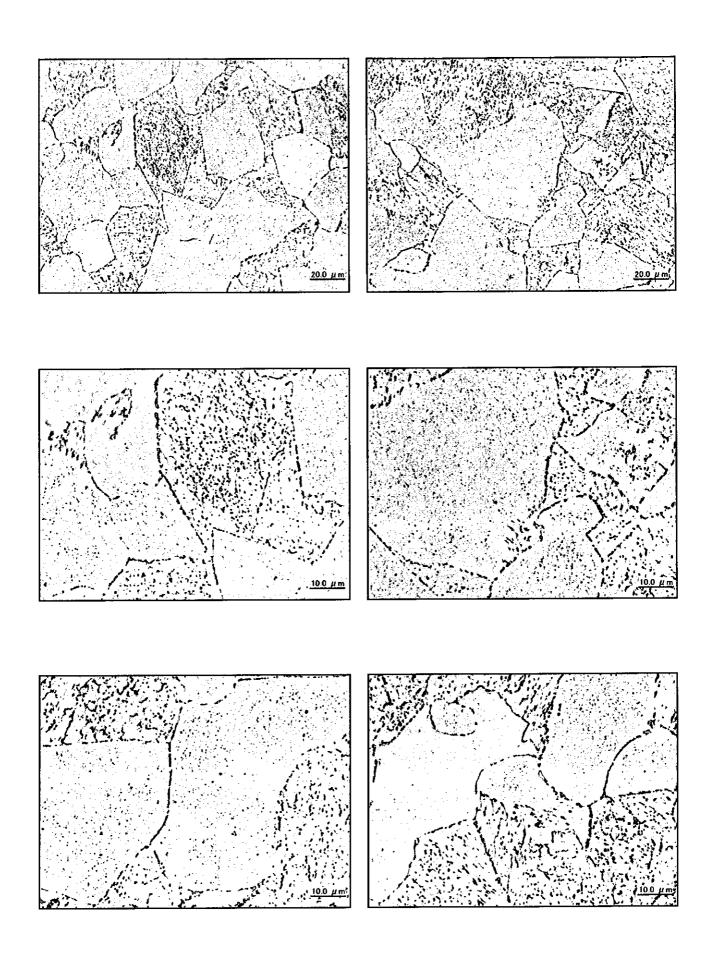
$\begin{array}{cccc} & Photo \ I - 9 - 1 & Microstructure \ observation \\ Main \ Steam \ Pipe-Left \ (Circumferential \ weld, extrados \ : Base \ metal \) \end{array}$

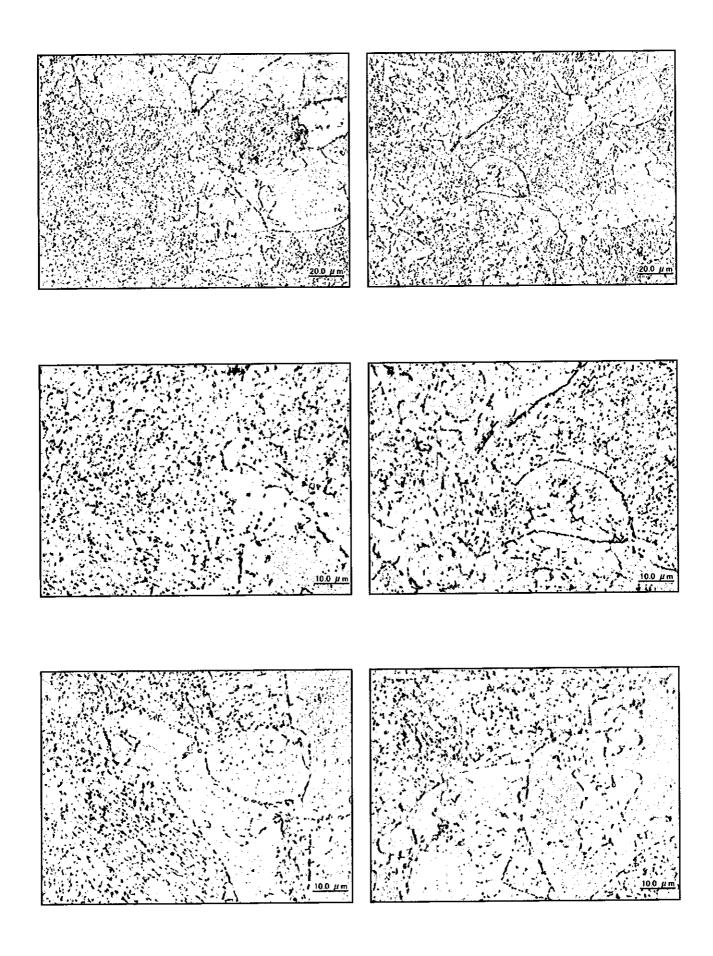
$\begin{array}{cccc} & Photo \ I - 9 - 2 & Microstructure \ observation \\ Main \ Steam \ Pipe-Left \ (Circumferential \ weld, extrados \ : Intercritical \ zone \) \end{array}$

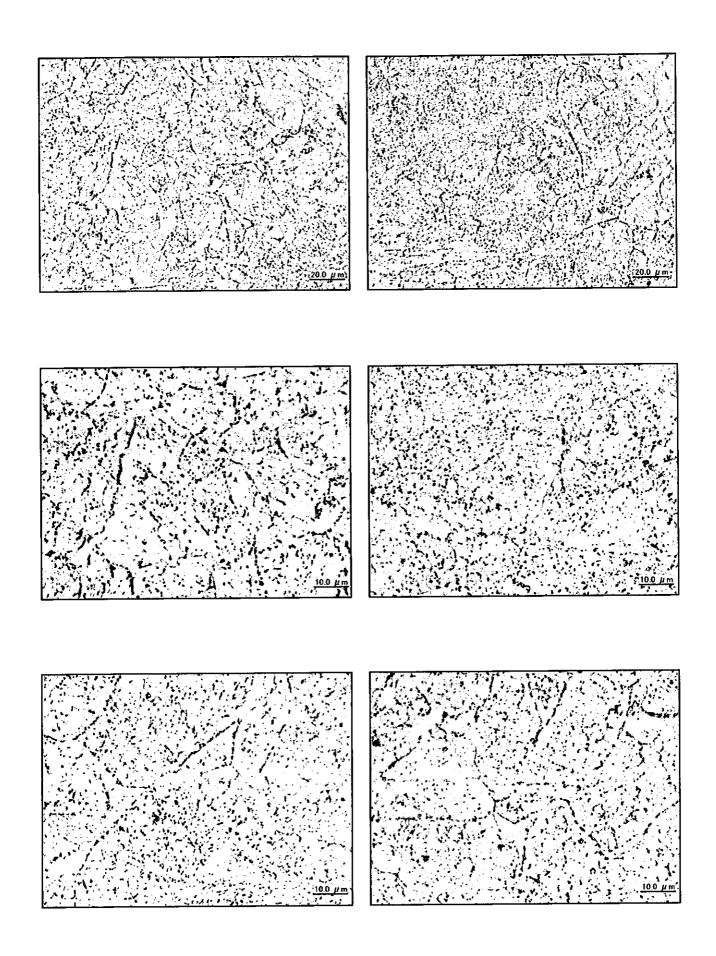
$\begin{array}{ccc} Photo\ I-9-3 & Microstructure\ observation \\ Main\ Steam\ Pipe-Left\ (Circumferential\ weld, extrados\ : Fine\ grain\ HAZ\) \end{array}$

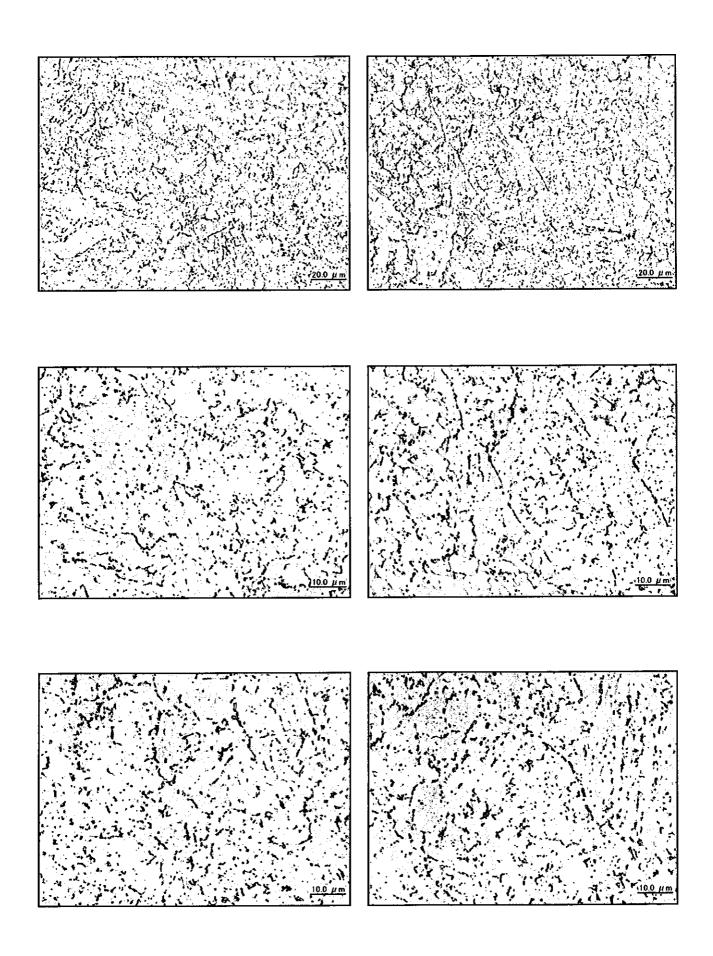
Photo I -9-5 Microstructure observation Main Steam Pipe-Left (Circumferential weld, extrados : Weld metal)

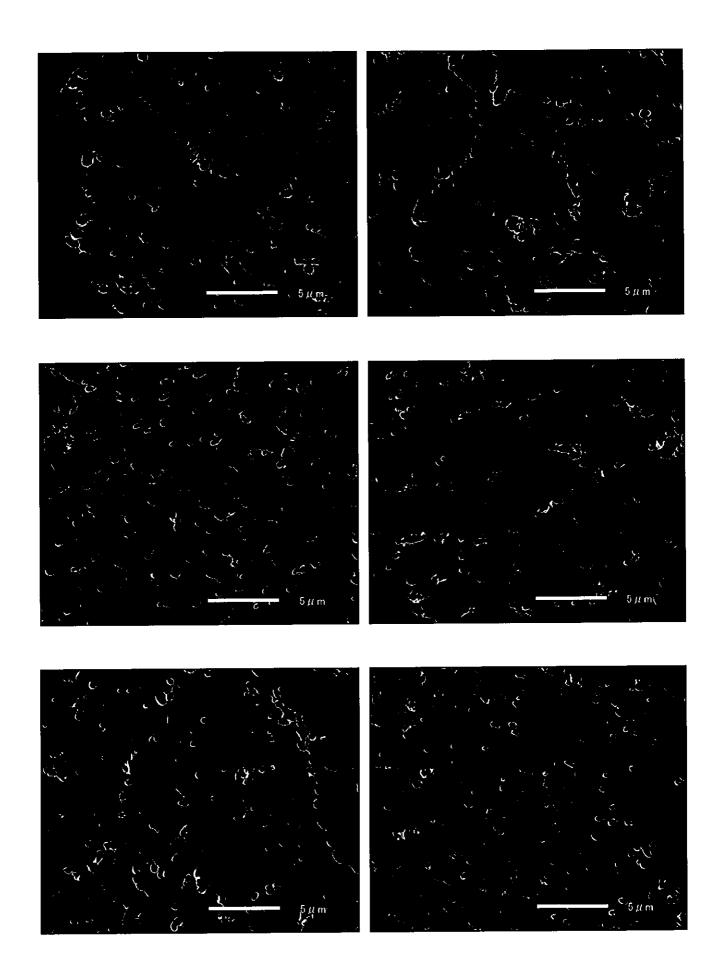
Photo I -9-10 Precipitates along grain boundary by SEM observation Main Steam Pipe-Left (Circumferential weld, extrados: Fine grain HAZ)

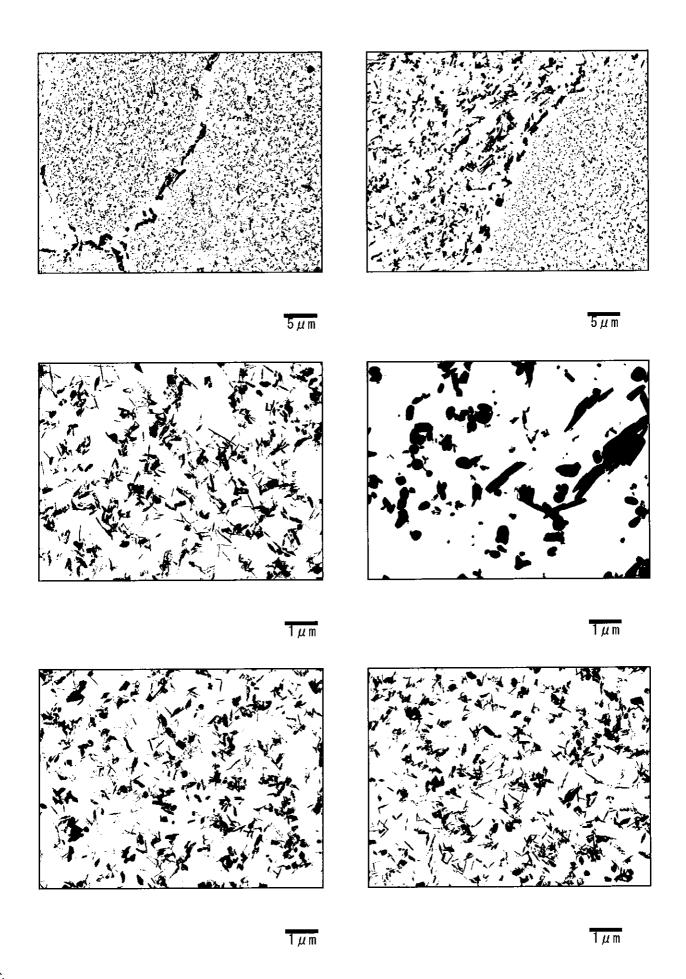
Photo I -9-11 Precipitates by TEM (Transmission electron microscope) observation Main Steam Pipe-Left(Circumferential weld, extrados: Base metal)

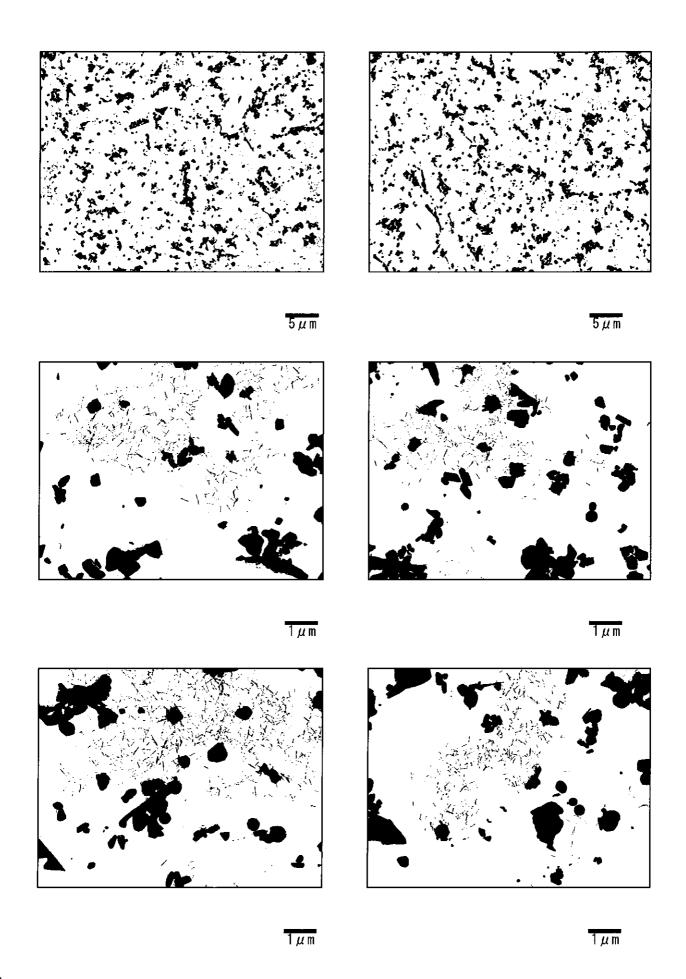
Photo I -9-12 Precipitates by TEM (Transmission electron microscope) observation Main Steam Pipe-Left(Circumferential weld, extrados: Fine grain HAZ)

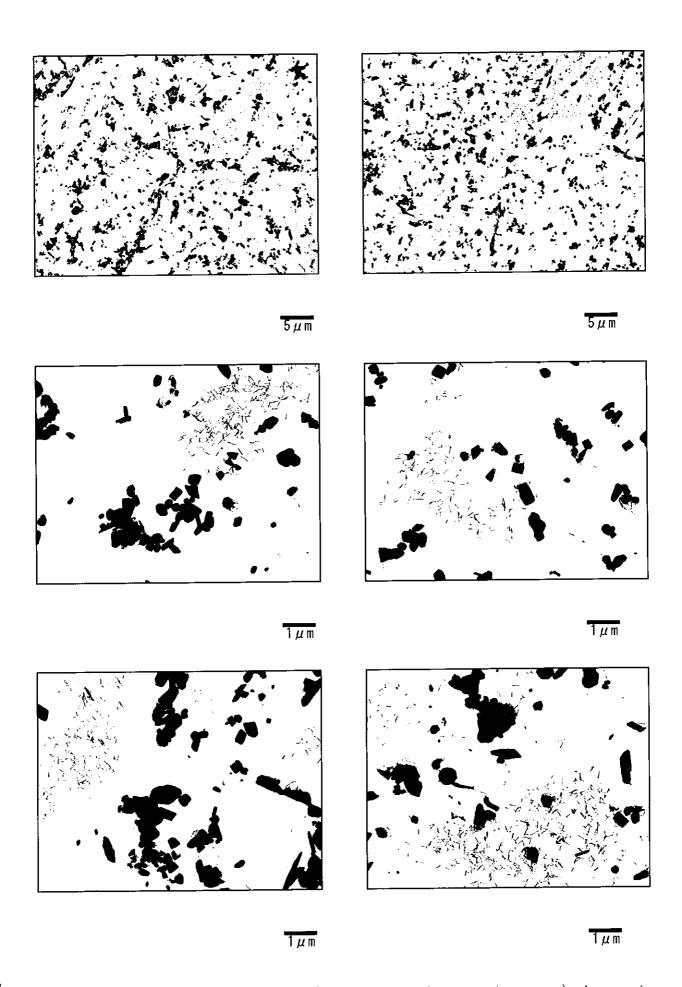
Photo I -9-13 Precipitates by TEM (Transmission electron microscope) observation Main Steam Pipe-Left(Circumferential weld, extrados : Coarse grain HAZ)

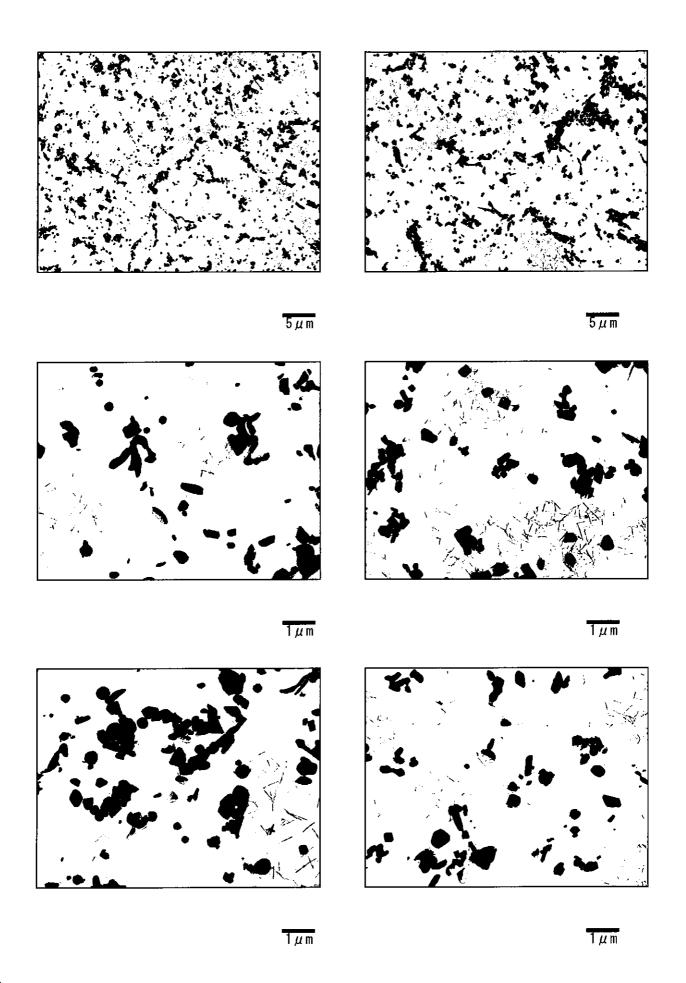
Photo I -9-14 Precipitates by TEM (Transmission electron microscope) observation Main Steam Pipe-Left(Circumferential weld, extrados: Weld metal)

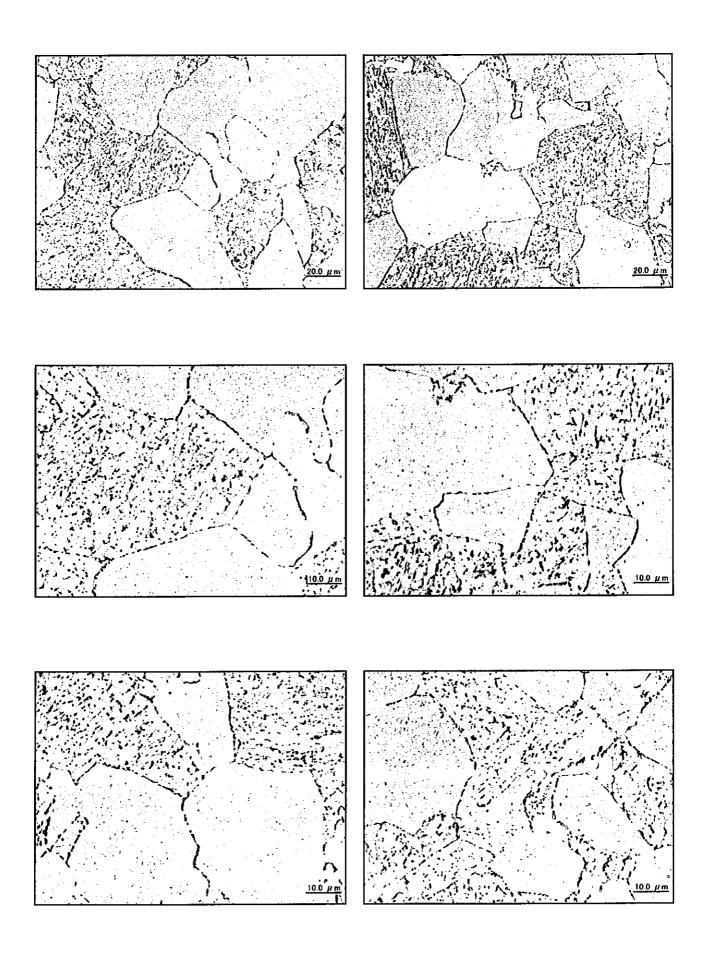
$\begin{array}{cccc} Photo \ I \ \hbox{--}10 \hbox{--}1 & \ Microstructure observation} \\ Main \ Steam \ Pipe-Left \ (Circumferential \ weld, intrados \ : Base \ metal \) \end{array}$

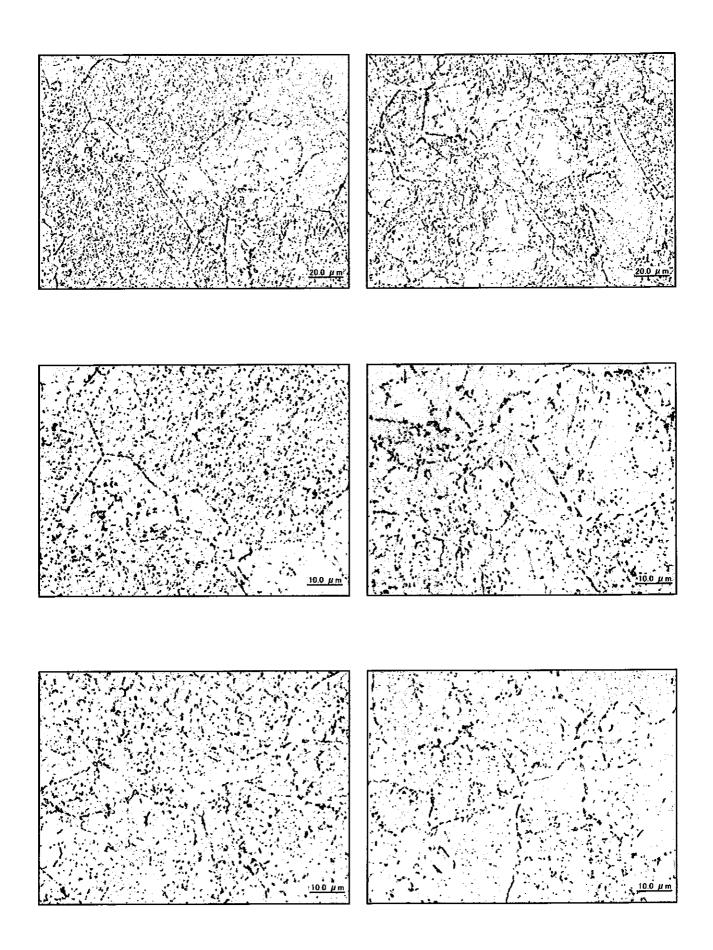
$\begin{array}{cccc} & Photo \ I\ -10-2 & Microstructure\ observation \\ Main\ Steam\ Pipe-Left\ (Circumferential\ weld, intrados\ : Intercritical\ zone\) \end{array}$

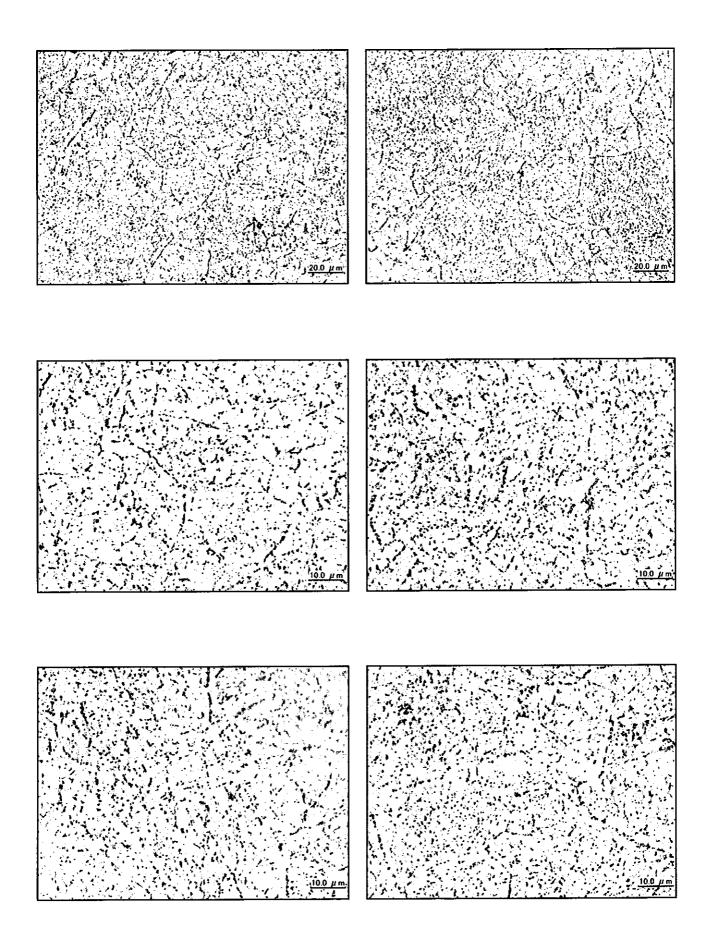
$\label{lem:photoI-10-3} Photo\ I\ -10-3\ \ \ Microstructure\ observation$ Main Steam Pipe-Left (Circumferential weld, intrados : Fine grain HAZ)

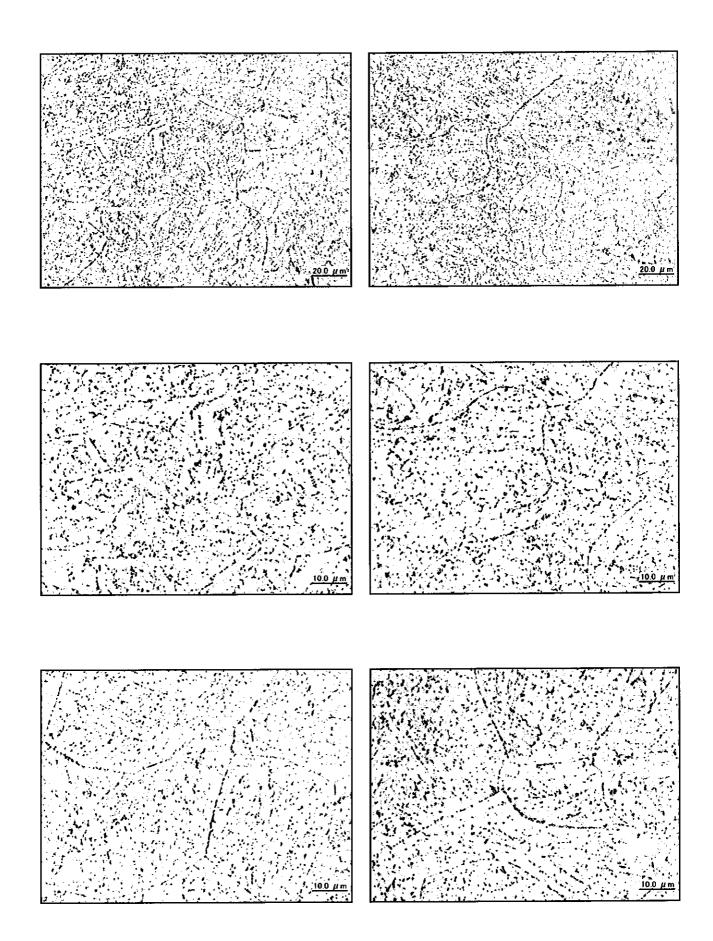
Photo I -10-4 Microstructure observation

Main Steam Pipe-Left (Circumferential weld, intrados : Coarse grain HAZ)

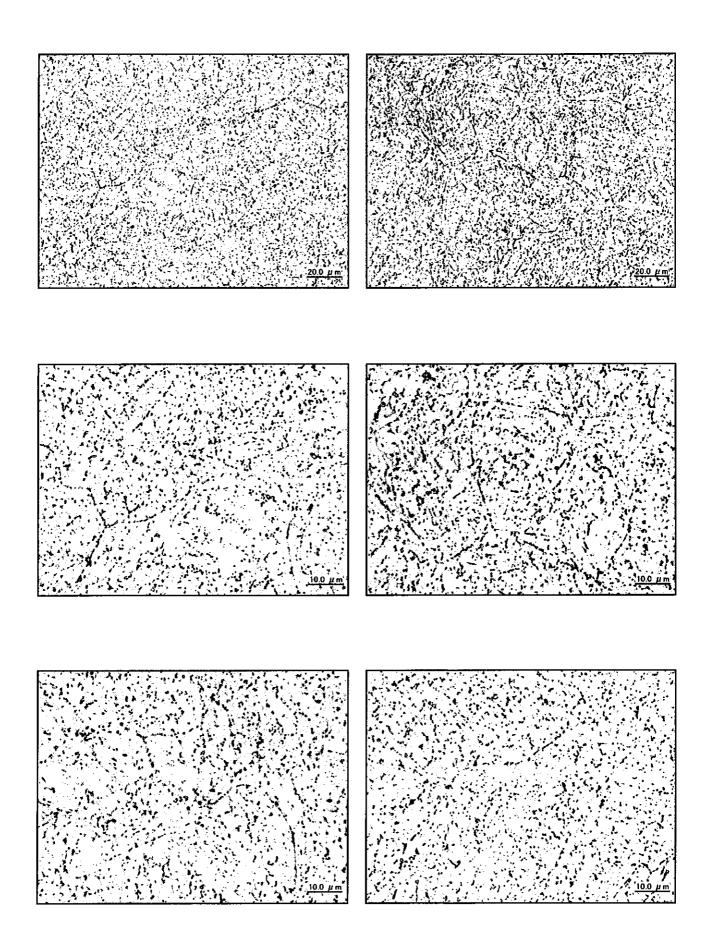
Photo I -10-5 Microstructure observation Main Steam Pipe-Left (Circumferential weld, intrados : Weld metal)

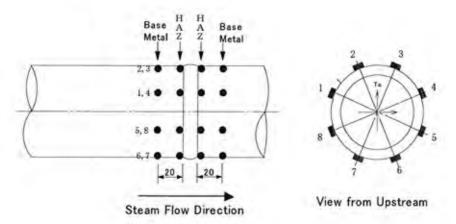
.0	Designed				Measured	value (mm)	Averaged	(Averaged measured
Components	Material	OD	Position	Region	1⇔5	2⇔6	3⇔7	4⇔8	(mm)	value-Designed OD) /Designed OD(%)
		Upstream side	Base metal	521.45	525.17	527.46	531.70	526.45	+1.24*	
. ren	C 1 222 D 22	***	(Elbow side)	HAZ	520.20	520.80	522.38	521.84	521.31	+0.25*
MSP	SA335 P-22	35 P-22 520.0mm	Downstream side (Straight pipe	Base metal	520.15	520.19	520.58	520.79	520.43	+0.08
				HAZ	520.15	520.52	519.92	520.61	520.30	+0.06

^{*:} Upstream side value is reference because of elbow side.

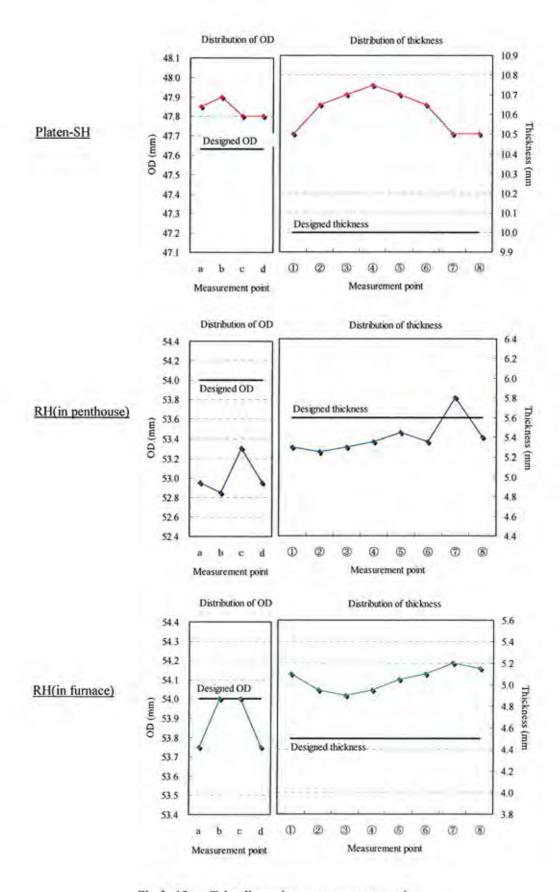
Fig I -12 Tube dimension measurement results

C1- 4-1	6		DD (mm)		Thickness (mm)							
Sample tube	Specification	Direction	OD	ID	1	2	3	4	6	6	7	8
		a	47.85	26.60	10.50				10.70			
Platen-SH	Φ47.63×t10.0	b	47.90	26.60		10.65				10.65		
Fiaten-3H	Ψ47.03^110.0	С	47.80	26.60			10.70				10.50	
		d	47.80	26.60				10.75				10.50
		a	52.95	42.25	5.30				5.45			
RH(in penthouse)	Φ54.0×t5.6	b	52.85	42.25		5.25				5.35		
Kri(iii pentilouse)	Ψ34.0^(3.0	С	53.30	42.15			5.30				5.80	
		d	52.95	42.15				5.35				5.40
		a	53.75	43.65	5.10				5.05			
RH(in furnace)	Φ54.0×t4.5	b	54.00	43.95		4.95				5.10		
Kii(iii iui iiace)	Ψ34.0^ι4.3	C	54.00	43.95			4.90				5.20	
		d	53.75	43.65				4.95				5.15

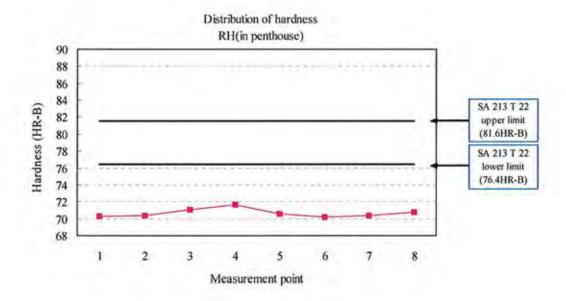
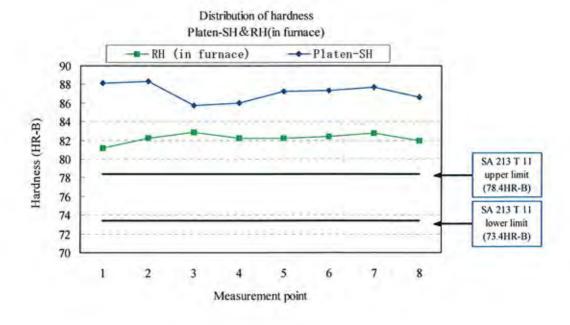
Fig 1 -25 Hardness measurement results

- (4) Hardness measurement (Fig. 1 -25~24, Table I -35)
 - The hardness of RH tube (in penthouse, SA213T22) was lower than the normal value of virgin material by Japanese steel manufacturer.
 - ➤ The hardness of Platen-SH tube (SA213T11) and RH tube (in furnace, SA213T11) were higher than the normal value of virgin material by Japanese steel manufacturer.

Hardness value of vigin material by fabricator : SA 213 T 22;76.4~81.6(HR-B) SA 213 T 11:73.4~78.4(HR-B)

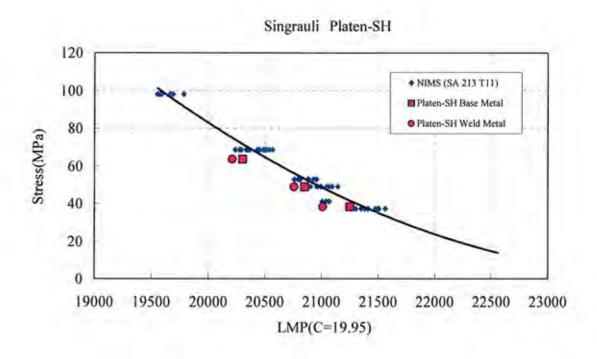
Fig I -27 The comparison of the test results with the creep rupture data of virgin materials by NIMS (National Institute for Materials science)

The test results for base metal and weld joint in Platen-SH tube indicate the lower creep rupture strength than NIMS data, and those in RH tube (in furnace) indicate almost same creep rupture strength as NIMS data.

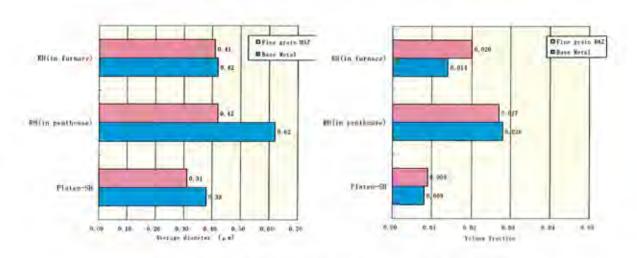
Quantitative evaluation of grain boundary precipitates [extracted Table I -41]

- The max. value of average diameter of grain boundary precipitates was 0.62 μ m in base metal at RH tube(in penthouse), 0.42 μ m in fine grain HAZ at RH tube(in penthouse).
- ➤ The max. value of volume fraction of grain boundary precipitates was 0.028 in base metal at RH tube(in penthouse), 0.027 in fine grain HAZ at RH tube(in penthouse).

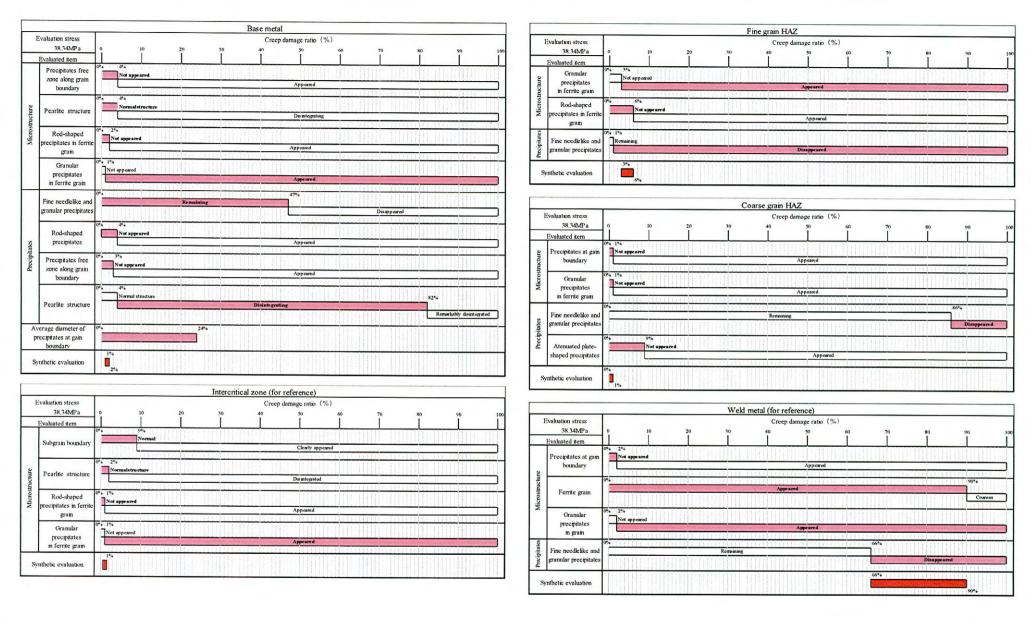
Fig I -28 Evaluation Results

The evaluated residual life (half of residual life evaluated by creep rupture test) of Platen-SH tube was 750,000 hours for base metal, 380,000 hours for weld joint portion at designed temperature 540°C of Platen-SH outlet header.

The evaluated residual life (half of residual life evaluated by creep rupture test) of RH tube in furnace was 1,300,000 hours for base metal, 1,200,000 hours for weld joint portion at designed temperature 540°C of RH outlet header.
