Client	J-Power (Electric Power Development Co. Ltd.,)
	Project	Turbine and System Assessment for NTPC-Korba Unit #4
	Order No.	CGP10028C
	Contractor	ALSTOM K.K. NASL Ltd. (Nominated subcontractor in India)

Document	<b>FINAL REPORT VOL. I B(RLA OF TURBINE)</b>

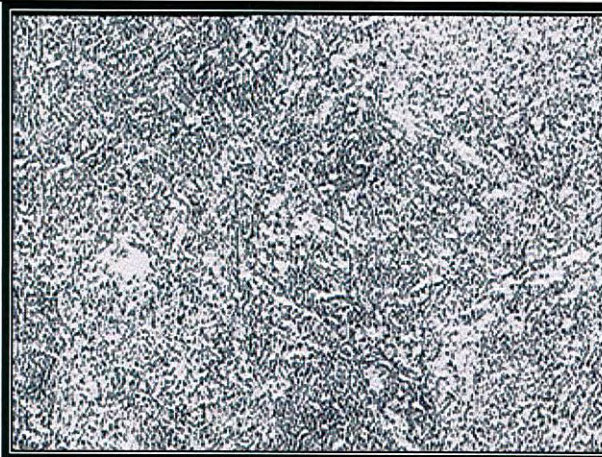
Fig: 84

**Name of Component:** IP Steam Inlet  
**Location:** IP Steam Inlet T joint \_ Weld Metal \_ Replica No. 13  
 Hardness: 180-186HB.

**Observation:** Microstructure shows tempered Bainite with spheroidisation carbides.

Degradation Level- IIL

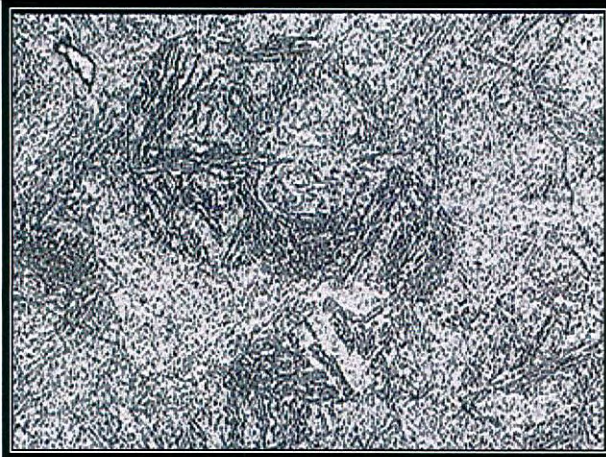
**Name of Component:** IP Steam Inlet  
**Location:** IP Steam Inlet \_ Parent Metal \_ Replica No. 12  
 Hardness: 203-209HB.

**Observation:** Microstructure shows tempered Bainite with spheroidisation carbides.

Degradation Level- IIL

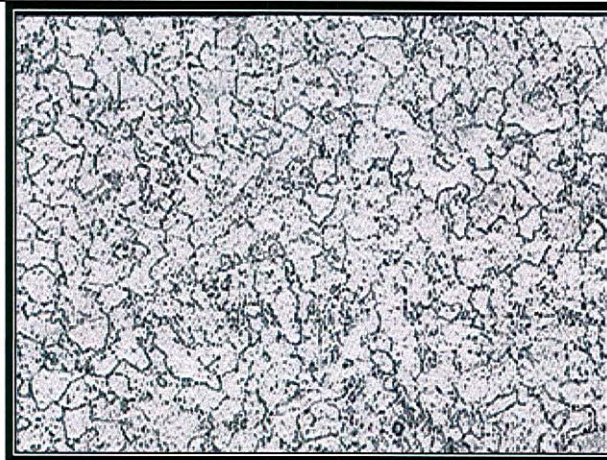
**Name of Component:** Main Steam Line  
**Location:** Main Steam Line LHS on Bend\_ Parent Metal \_ Replica No. 11  
 Hardness: 130-134HB.

**Observation:** Microstructure shows ferrite and Bainite with precipitation of carbides at grain boundary. Degradation Level- IVL

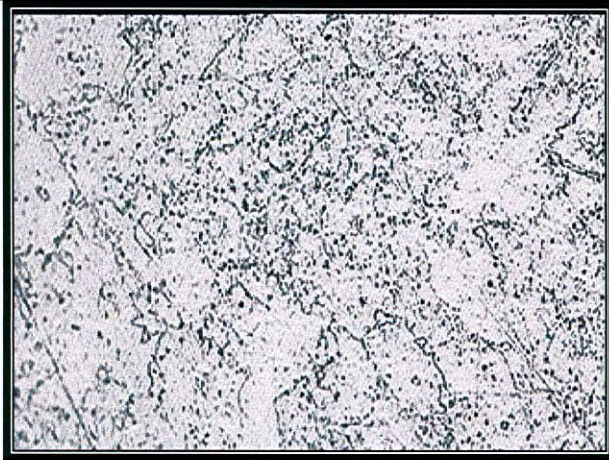
**Name of Component:** HPCV-2 Body  
**Location:** HPCV-2 Body outer \_ Parent Metal \_ Replica No. 18  
 Hardness: 171-187HB.

**Observation:** Microstructure shows tempered bainite and carbides precipitation at grain boundary is observed.

Degradation Level- IVL

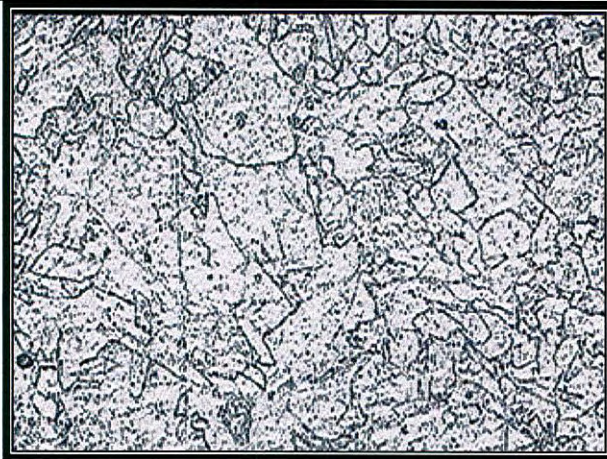
**Name of Component:** IPCV-1 Body  
**Location:** IPCV-1 Body Inner\_ Parent Metal \_ Replica No. 19  
 Hardness: 175-178HB.

**Observation:** Microstructure shows ferrite and bainite and carbides at grain boundaries. Degradation Level- IVL

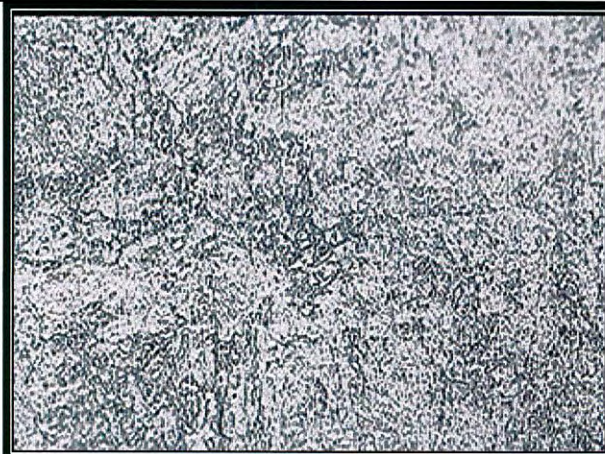
**Name of Component:** LP Bypass  
**Location:** LP Bypass con \_ Parent Metal \_ Replica No. 38  
 Hardness: 171-181HB.

**Observation:** Microstructure shows tempered Bainite with spherodisation carbides. Degradation Level- IIL

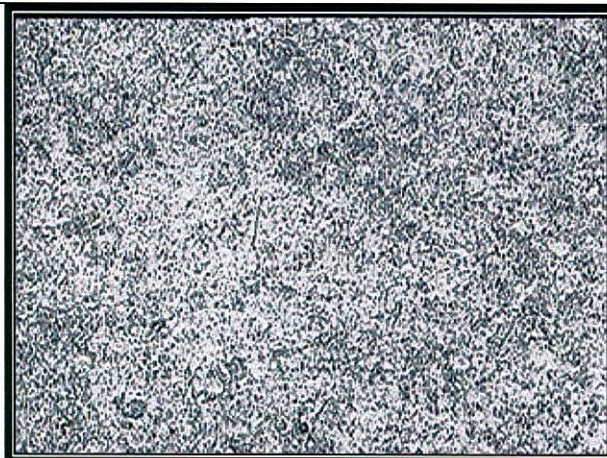
**Name of Component:** LP Bypass valve  
**Location:** LP Bypass Body\_ Parent Metal \_ Replica No. 51  
 Hardness: 185-196HB.

**Observation:** Microstructure shows tempered Bainite with spheroidisation carbides.

Degradation Level- IIL

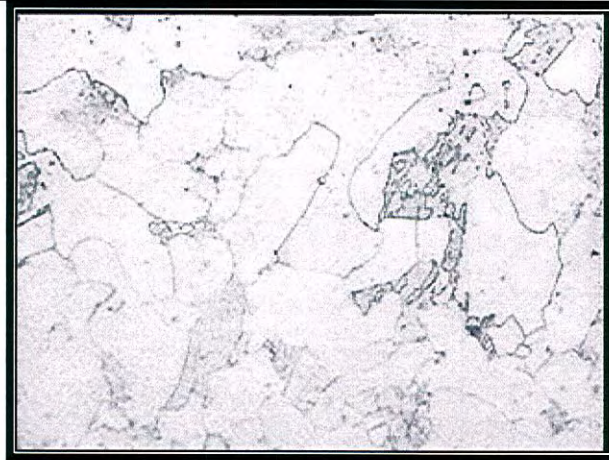
**Name of Component:** HP Bypass valve  
**Location:** HP Bypass Body\_ Parent Metal \_ Replica No. 52  
 Hardness: 122-138HB.

**Observation:** Microstructure shows tempered Bainite with spheroidisation carbides. Degradation Level- IIL

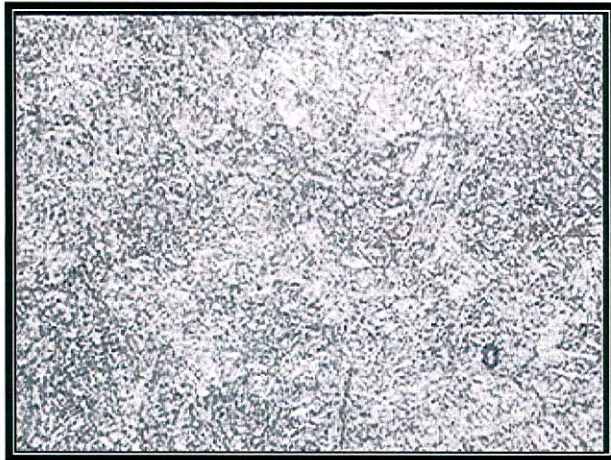
**Name of Component:** IPCV-3  
**Location:** IPCV-3 Inner body\_ Parent Metal \_ Replica No. 54  
 Hardness: 181-187HB

**Observation:** Microstructure shows ferrite and Bainite with precipitation of carbides at grain boundary.

Degradation Level- IVL

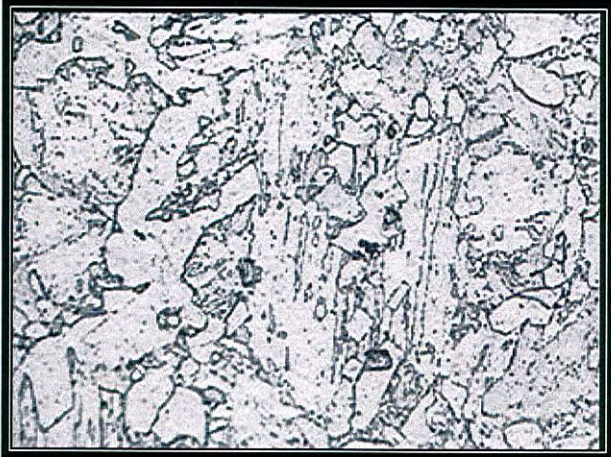
**Name of Component:** HPCV-3  
**Location:** HPCV-3 outer body\_ Parent Metal \_ Replica No. 56  
**Hardness:** 186-196HB

**Observation:** Microstructure shows ferrite and Bainite with precipitation of carbides at grain boundary.

Degradation Level- IVL

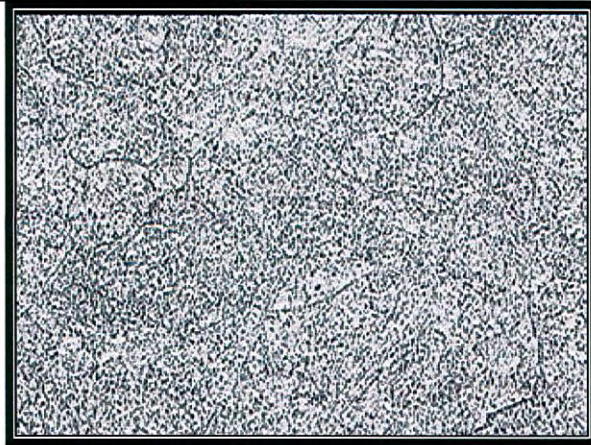
**Name of Component:** HPSV-2  
**Location:** HPSV con-2 \_ Parent Metal \_ Replica No. 58  
 Hardness: 180-192HB

**Observation:** Microstructure shows ferrite and Bainite with precipitation of carbides at grain boundary.

Degradation Level- IVL

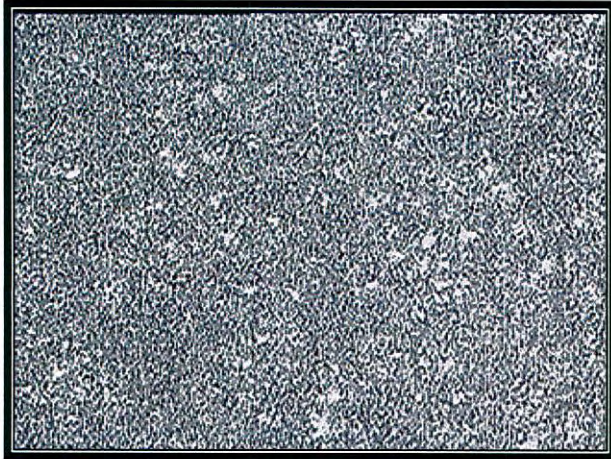
**Name of Component:** HPSV-4  
**Location:** HPSV con-4 \_ Parent Metal \_ Replica No. 60  
 Hardness: 199-201HB

**Observation:** Microstructure shows tempered Bainite with spherodisation carbides.

Degradation Level- IIL

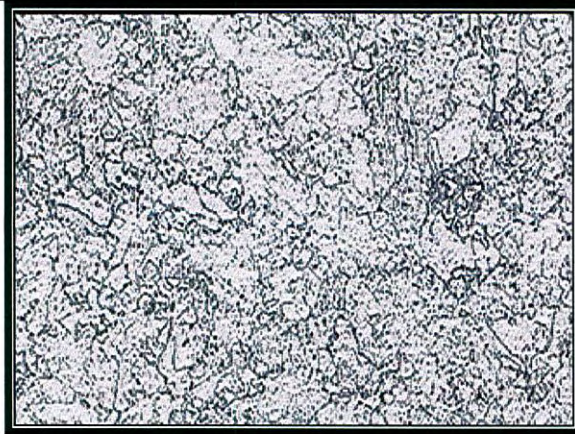
**Name of Component:** IPSV-4  
**Location:** IPSV-4 con \_ Parent Metal \_ Replica No. 4  
 Hardness: 148-151HB

**Observation:** Microstructure shows ferrite and Bainite with precipitation of carbides at grain boundary..

Degradation Level- IVL

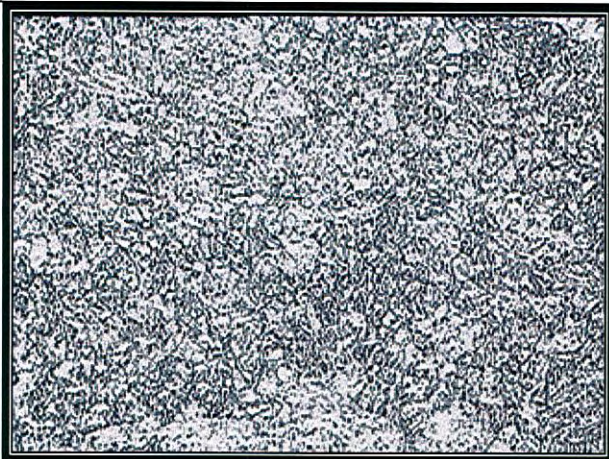
**Name of Component:** IPCV-3  
**Location:** IPCV-3 con \_ Parent Metal \_ Replica No. 7  
 Hardness: 168-171HB.

**Observation:** Microstructure shows tempered Bainite with spheroidisation carbides. Degradation Level- III

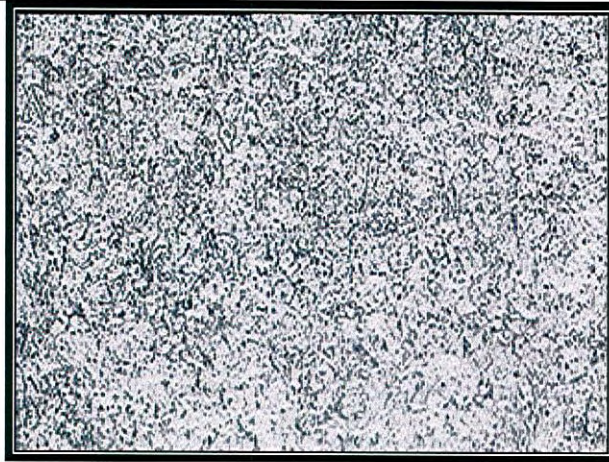
**Name of Component:** IPCV-1  
**Location:** IPCV-1 con \_ Parent Metal \_ Replica No. 8  
 Hardness: 171-178HB.

**Observation:** Microstructure shows tempered Bainite  
 precipitation of carbides at grain boundary. Degradation Level- IVL

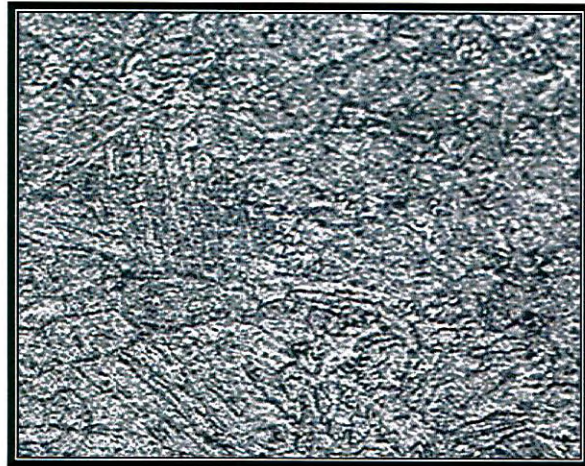
**Location:** HP CV-1\_BUSH

Hardness: 165-168HB

**Observation:** Microstructure shows tempered Bainite with precipitation of carbides.

Degradation Level- IIL

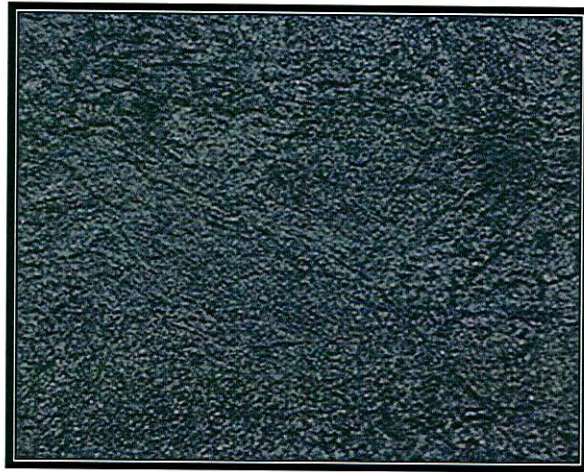
**Name of Component:** HP CV-3  
**Location:** HP CV-3\_CONE  
 Hardness: 161-162HB

**Observation:** Microstructure shows tempered Bainite with precipitation of carbides.

Degradation Level- IIL

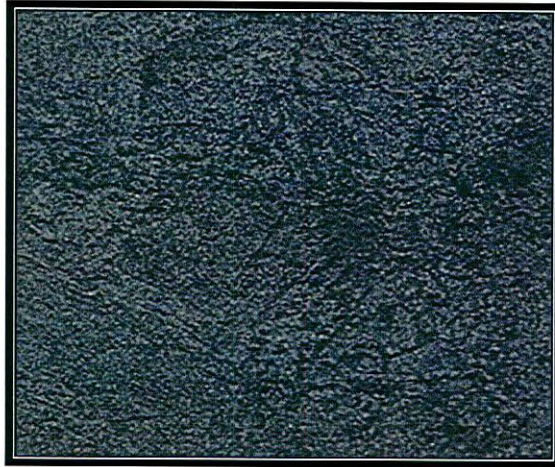
**Name of Component:** HP CV-4  
**Location:** HP CV-4\_CONE  
Hardness: 163-165HB

**Observation:** Microstructure shows tempered Bainite precipitation of carbides at grain boundary. Degradation Level- IVL

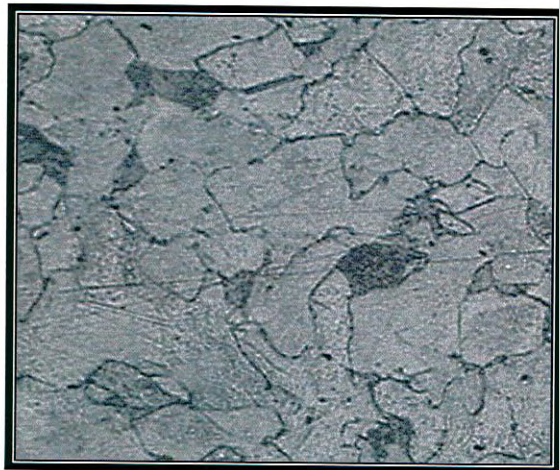
**Name of Component:** IP CV-1  
**Location:** IP CV-1\_BUSH  
 Hardness: 135-139HB

**Observation:** Microstructure shows tempered Bainite precipitation of carbides at grain boundary.

Degradation Level- IVL

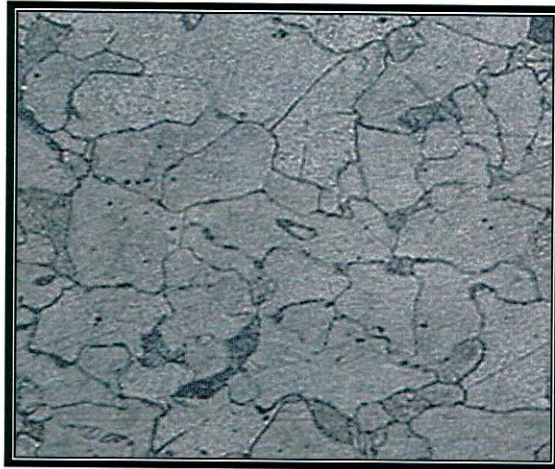
**Name of Component:** IP CV-1  
**Location:** IP CV-1\_BUSH  
**Hardness:**136-138HB

**Observation:** Microstructure shows tempered Bainite precipitation of carbides at grain boundary. Degradation Level- IVL

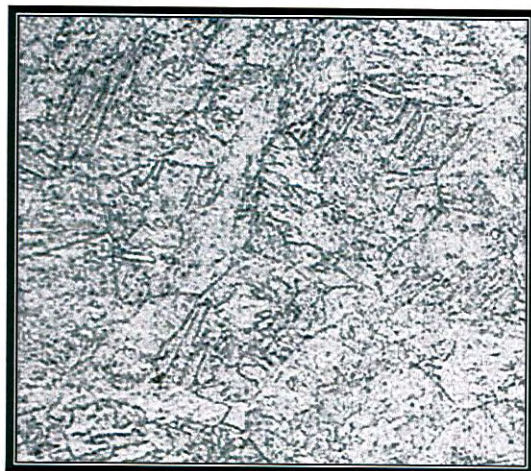
**Location:** IP CV-2\_CONE

Hardness: 155-156HB

**Observation:** Microstructure shows ferrite and Bainite with precipitation of carbides at grain boundary.

Degradation Level- IVL

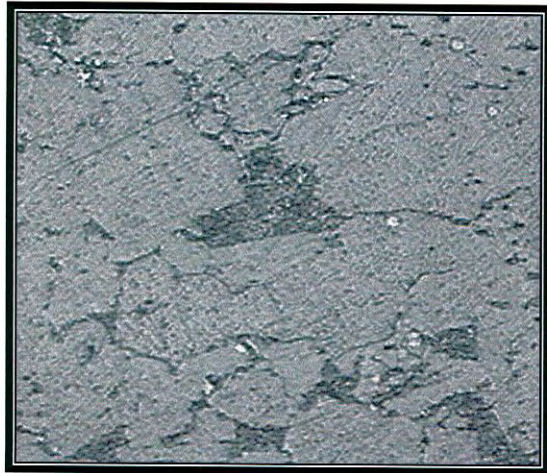
**Name of Component:** IP CV-3  
**Location:** IP CV-3\_CONE  
Hardness: 145-150HB
