Boiler RLA

Singrauli Unit 6 (500MW Drum Boiler) Cumulative operation hours: 172,000 hours (27th October to 1st November, 2009)

Unchahar Unit 2 (200MW Drum Boiler) Cumulative operation hours: 139,098 hours (4th November to 9th November, 2009)

JICA Study Team for Enhancing Efficiency of Operating Thermal Power Plant in NTPC-India Boiler RLA

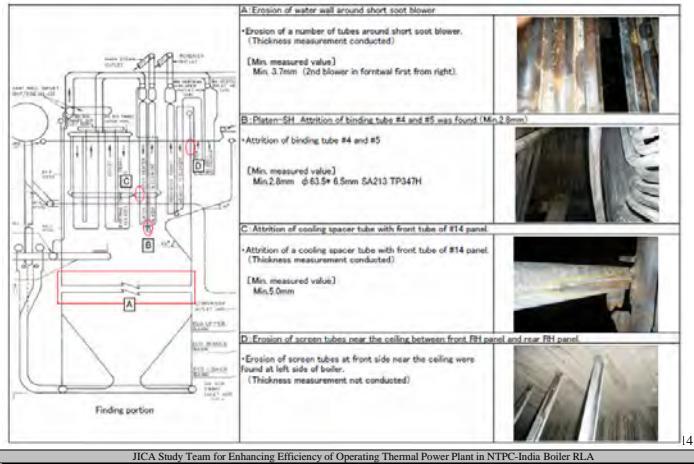
Visual inspection (Singrauli #6)

Components	Inspection method	Findings
Water wall tube	Visual check	Erosion of a number of tubes around short soot blower were found. •No erosion at any other portions. •No erosion and decease in thickness around burners.
	Thickness measurement of tubes	Thickness was measured at erosion regions around soot blowerrs near each 4 corner. Min. thickness was 3.7mm/2nd blower in forntwal first from right. f 51* 5.6mm, SA210 Gr.C
	Visual check	Attrition of binding tube ≇4 and ≇5 was found. (Min.2.8mm) Attrition of cooling spacer tubewith front tube of ≇14 panel (Min.5.0mm) Disorder of arrangement at lower part of panel with distortion to adjacent panel. A number of disjointed slide spac
Distion CU	Thickness measurement of tubes	1:Outer tube of rear side portion at sootblower level[24points]→Min.6.3mm φ63.5#6.3mm SA213 TP347H -2:Outer bottom tube [24points]→Min.9.8mm φ54.0#9.5mm SA213 TP347H -3:Attrition of colin

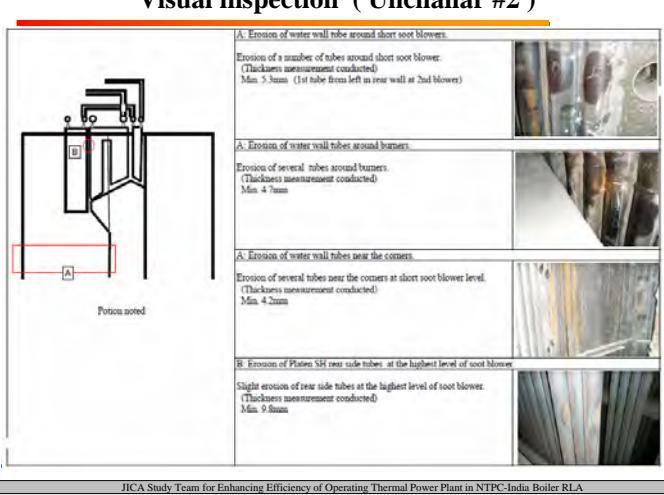
Visual inspection (Unchahar #2)

Components	INSPECTION	Unchahar #2 Brief comment
WATER WALL	VT	Erosion of a number of tubes around short soot blower were found. Erosion of corner tubes at soot blower level.(Thickness measurement 28points (Min.4.2mm)
	THICKNESS MEASUREMENT	Eroded tubes around short soot blower were meareured .(69points measured) Min 5.3mm (2nd short blower rear wall #1 form left)
	VT	Disorder of arrangement at lower part of panel with disjointed slide spacers. Slight erosion of rear tubes at the highest level of short soot blower.
	THICKNESS MEASUREMENT	Rear tubes at the highest level of short soot blower.(29points, Min.9.8mm) 2nd tubes from rear tubes at the highest level of short soot blower.(3points, Min.100mm) Rear tubes at the second highest level of short soot blower.(29points, Min.9.8mm)
SUPER HEATER	SAMPLE TUBE INSPECTION *	1 sample tube from Platen-SH in furnace (#3panel- 8th tube from rear) 2 sample tubes from Final-SH in furnace (#1-3rd tube from rear, #119-3rd tube from rear)

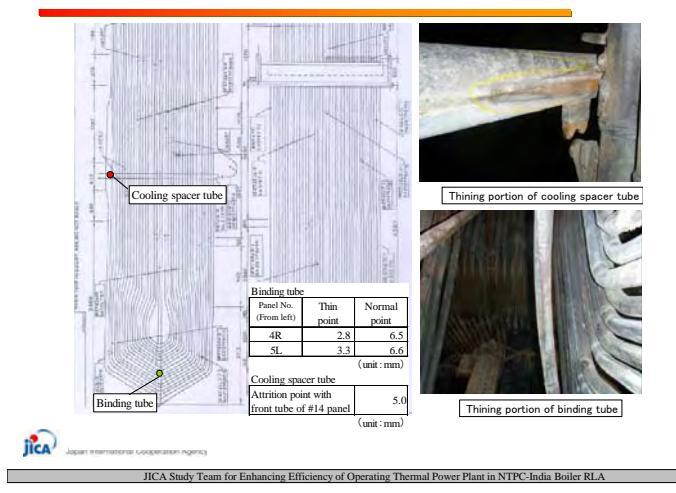
Thickness measurement results of Platen SH (Singrauli #6)

Thickness measurement of tubes (Singrauli #6)										
			Desi	igned	Allowable		Measured			
Tube	Material	OD	t	Pressure	Temp.	Stress	tsr	(Min)	Note	
		(mm)	(mm)	P (kg/cm2)	(°C)	S (MPa)	(mm)	(mm)		
Water wall	SA210 Gr.C	51.0	5.6	197.3	416	90.1	5.2	3.7	Erosion around short soot blower	
PLATEN SH ST- II	SA213 TP347H	54.00	9.50	178	540*	92	> 4.9	9.8		
	SA213 TP347H	63.50	6.30	178	540*	92	> 5.8	2.8	Attrition with bind tubes	
	SA213 TP347H	63.50	6.30	178	540*	92	> 5.8	6.3	Soot blower level (#1 from rear side)	
	SA213 TP347H	54.00	6.00	178	540*	92	> 4.9	6.3	Soot blower level (#2 from rear side)

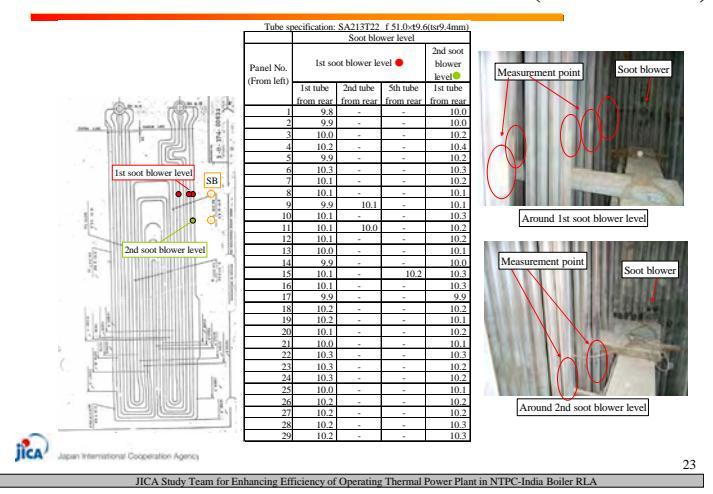
Thickness measurement results of Platen SH (Unchahar #2)

Thickness measurement of tubes (Unchahar #2)										
			Desi	igned		Allowable	ter	Measured		
Tube	Material	OD	t	Pressure	Temp.	Stress	(mm)	(Min)	Note	
		(mm)	(mm)	P (kg/cm2)	(°C)	S (MPa)	(mm)	(mm)		
	CA 210 CD 41	62.5	6.2	175.8	404	02.0	61	4.2	Erosion around	
water wall	SA-210, GR.A1	03.5	0.5		404	00.0	0.1		short soot blower	
	EA 212 T 22	3 T 22 51	9.6	175.8	544	20.7	39.7 9.4	0.8	Highest soot	
PLATEN SH (ELE I)	SA 215 1 22				500	39.7		9.0	blower level	
DI ATEN SUL (ELE 1)	EA 212 T 22	£1	51 0.4	175 0	566	20.7	9.4	9.8	Second highest	
FLATEN SH (ELE I)	3A 213 1 22	51	9.0	175.8		39.7			soot blower level	
	EA 212 T 22	£1	9.6	185.0	566	20.7	9.4	10.0	Highest soot	
FLATEN SR (ELE 2)	SA 215 1 22	51		1/5.0		39.7			blower level	
		t:Thickne	ss			tsr = PD/	(2S+P)+0	.005D

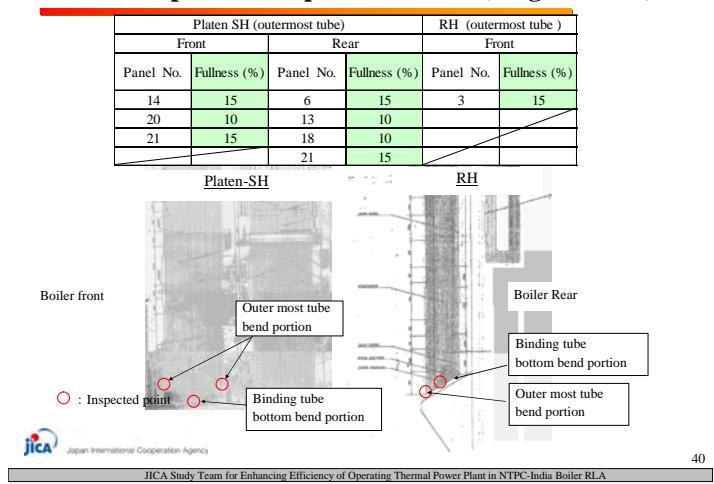
SUS scale deposition inspection results (Singrauli #6)

i atten Sir	SUS scale deposition inspection	Nos. exceeding 10% fullness : 7 /50 (magnetized effect of material)
	Tube sampling for sample tube inspection (inspected in Japan).	#12-3(from leftside) f 47.63*8.6-f 47.63*10, SA213 T22
	Creep rupture test (inspected in Japan)

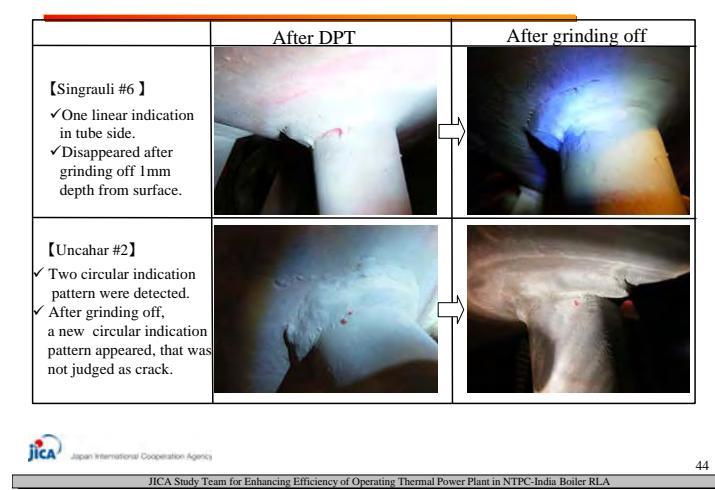
DPT results (Platen SH inlet header 4 stub weld portion)

INSPECTION	Unchahar #2 Brief comment
VT	No appearance abnormality in stubs and other weld portion.
PT(DPT)	3 small circular indication patterns by ark strike at 4th tube from front.
υr	No detection of flaw which echo exceeds L-line by UT. Continuous indication with fine flaws detected at 80mm depth from surface by TOFD.
REPLICA INSPECTION	No crack in Base metal, HAZ(Heat Affected Zone) and weld metal. More detail microstructural observation is required in labo.
REPLICA INSPECTION	No crack in Base metal, HAZ(Heat Affected Zone) and weld metal. More detail microstructural observation is required in labo.
VT	No appearance abnormality in stubs and other weld portion.
REPLICA INSPECTION	No crack in Base metal, HAZ (Heat Affected Zone) and weld metal. Abnormal microstructure observed in base metal region of right-hand weld of header, which is considered to be the effect of ark during welding. More detail microstructural observation.

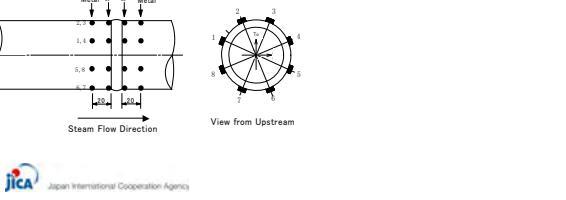
Creep strain evaluation by OD measurement (Singrauli #6)

Components	(Averaged measured value-Designed OD) /Designed OD (%)
-91	Platen SH Outlet Header-Left	0.10
The second secon	De-Superheater-Left	0.94
Steam flow	De-Superheater-Right	0.55
	RH Outlet Header-Left	0.37
Weld potion	RH Outlet Header-Right	0.52
measured	Main Steam Pipe-Left	0.08
Base H H Metal Z Z Metal 2	3	•

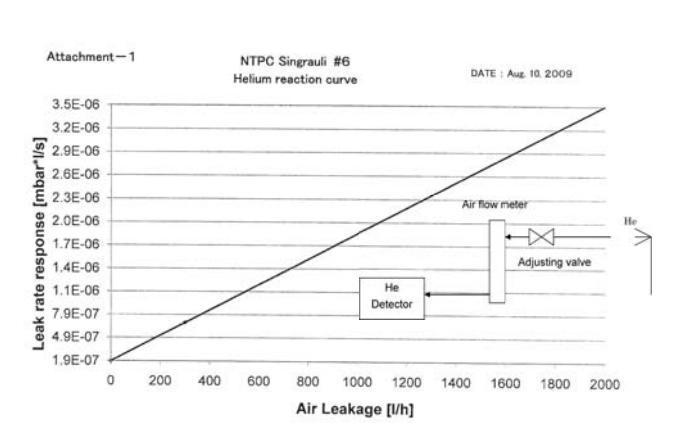
Approx. air leak-in rate : 23.5 kg/h
