7. Results of each observation and quantitative evaluation

8. Residual life assessment results

9. The other inspection results

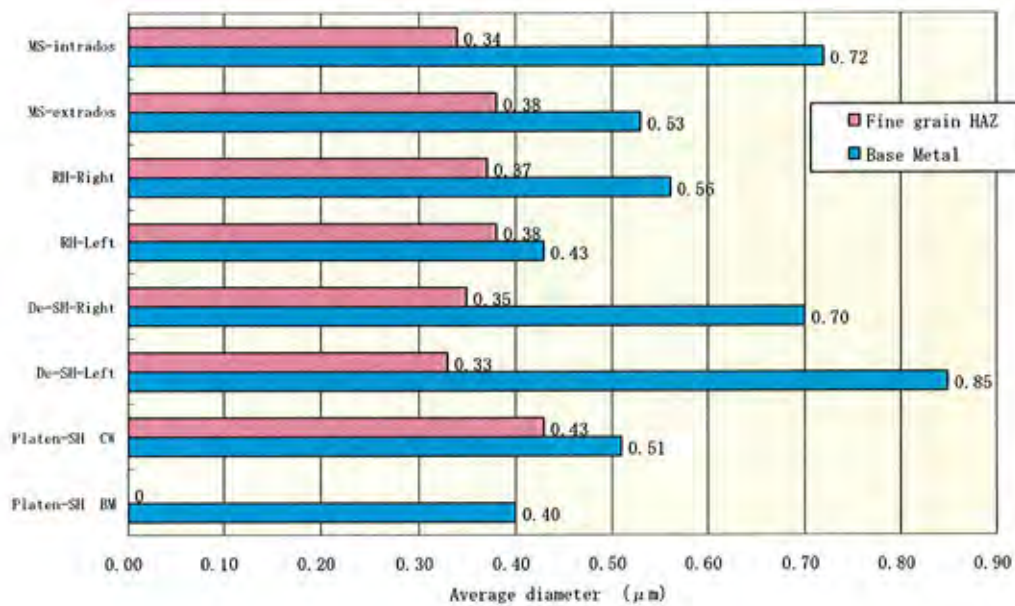
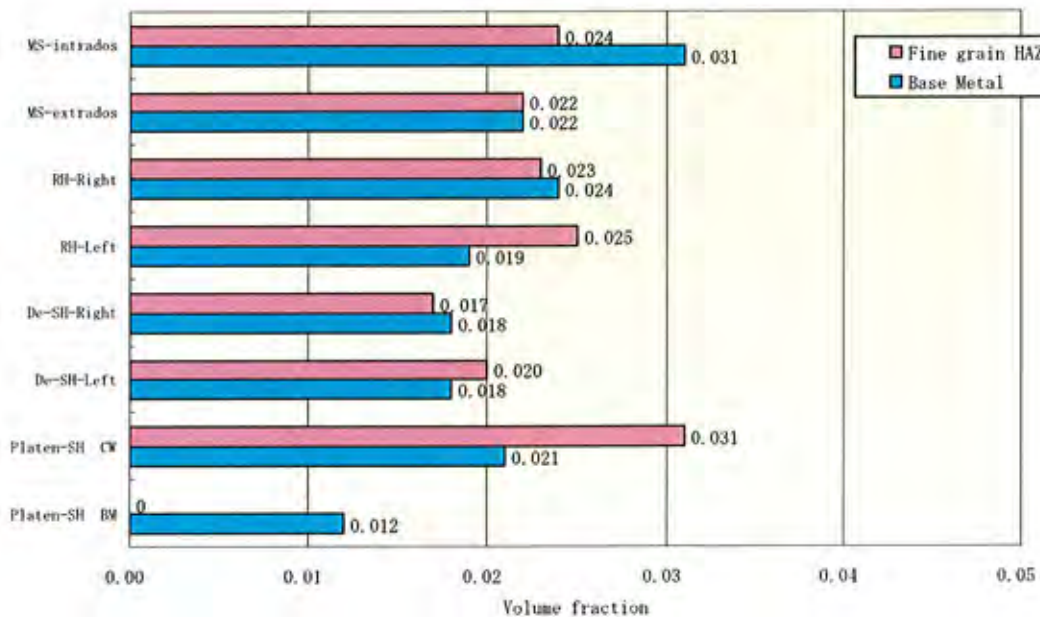
Quantitative evaluation of grain boundary precipitates [extracted Table I -7]

- The Max. value of average diameter of grain boundary precipitates was $0.85 \mu\text{m}$ in base metal at De-Superheater-Left, $0.43 \mu\text{m}$ in fine grain HAZ at Platen-SH Outlet Header-Left circumferential weld.
- The max. value of volume fraction of grain boundary precipitates was 0.031 in base metal at Main Steam Pipe-Intrados, 0.031 in fine grain HAZ at Platen-SH Outlet Header-Left circumferential weld.

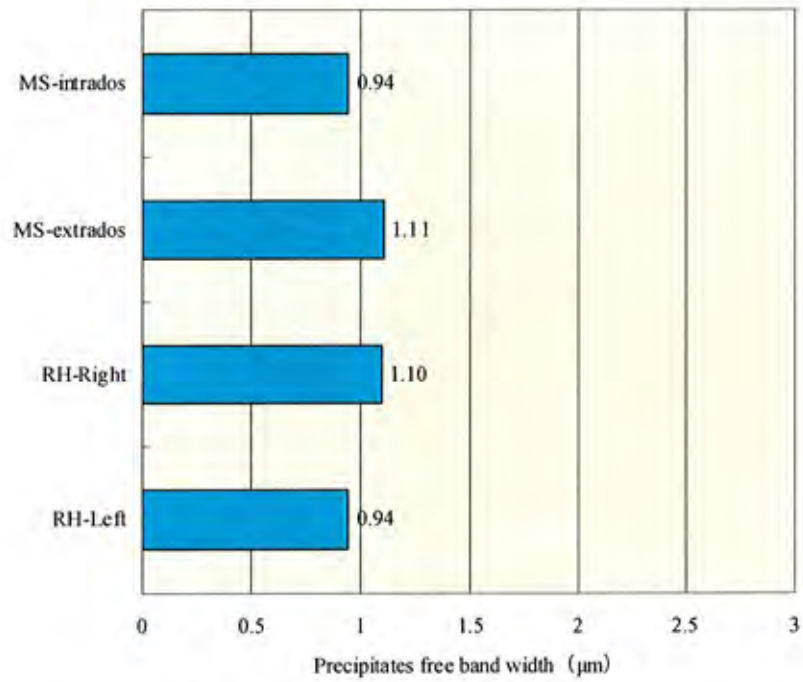
Precipitates free band width along grain boundary [extracted Table I -8]

- The quantitative evaluation was focused on base metal of SA 335 P22.
- The Max. value of precipitates free band width along grain boundary was 1.11 μm at Main Steam Pipe-Extrados.

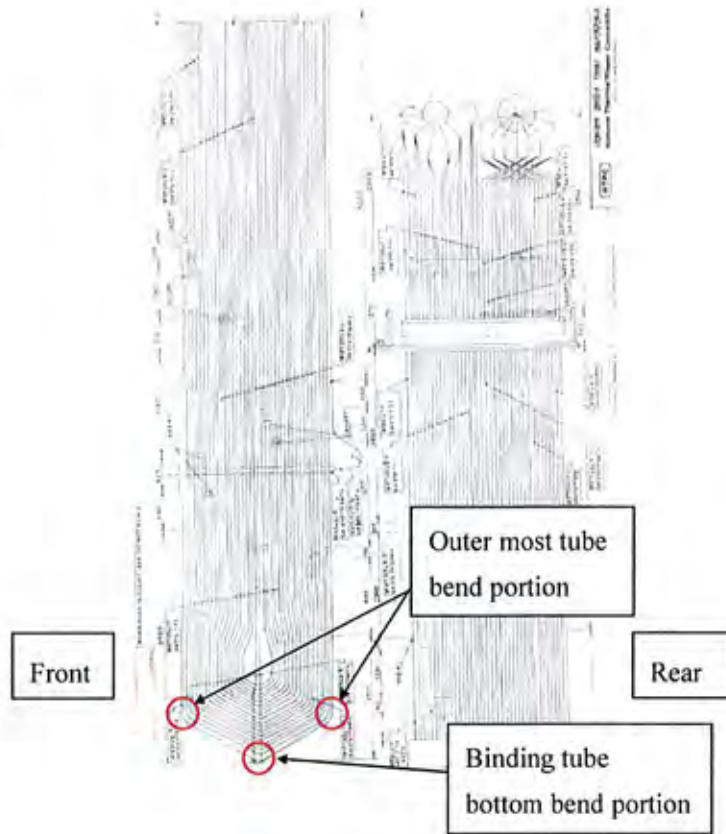
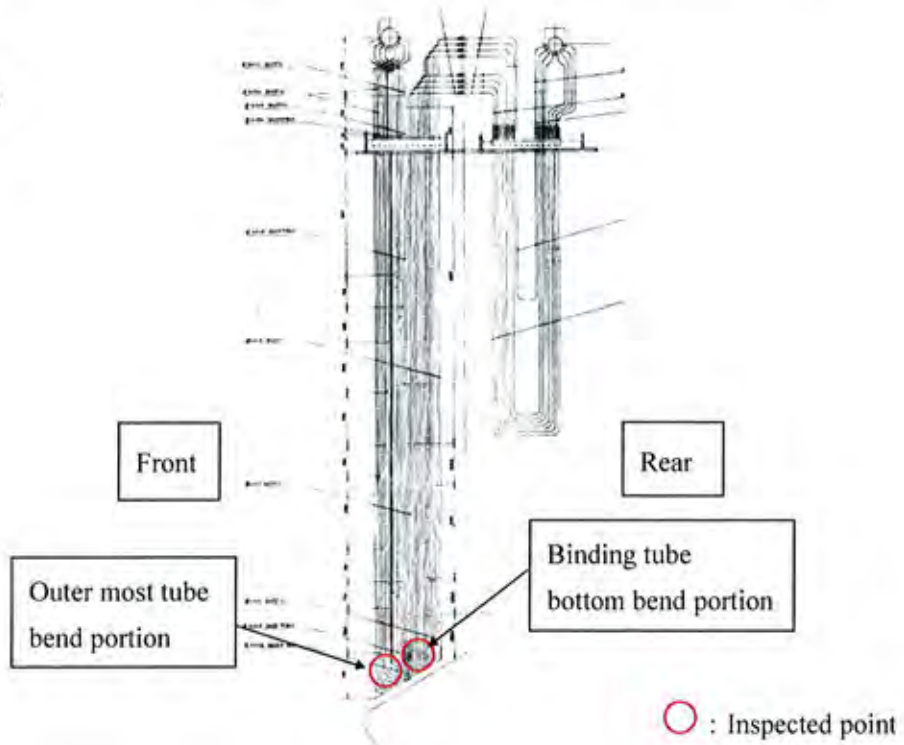
Fig. I -2 Inspection location

SUS scale deposition inspection results are shown in Table I -25.

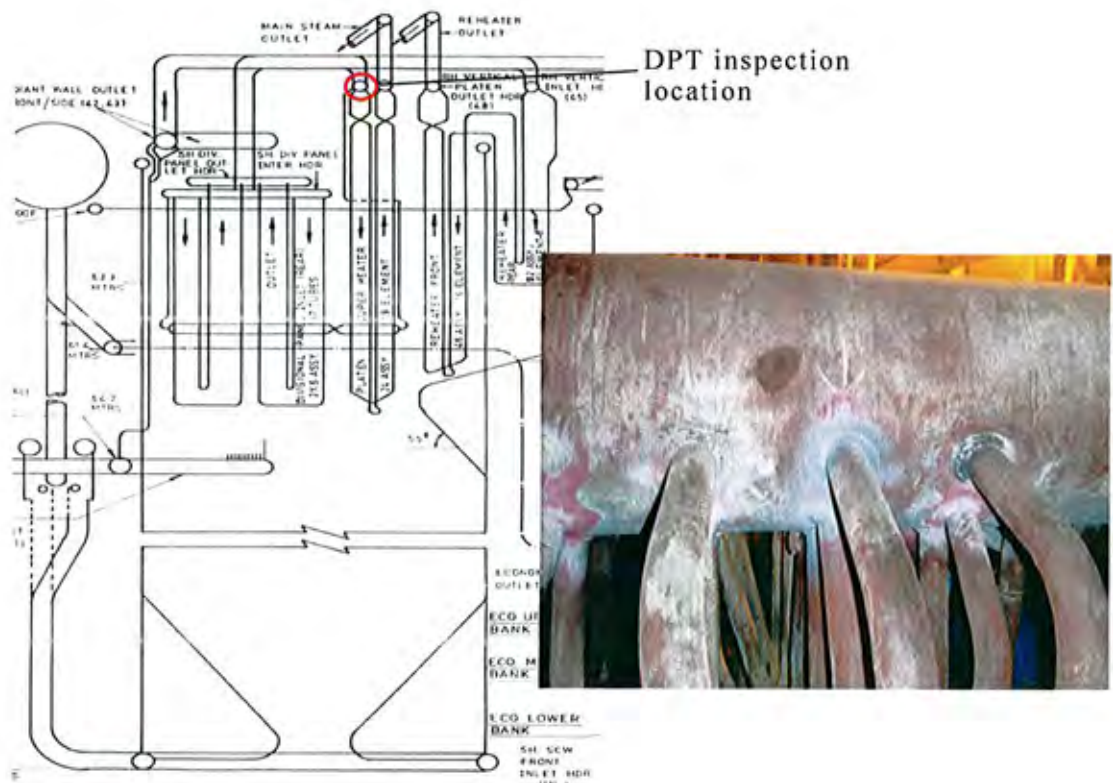
Fig. I -5 DPT inspection location

An indication with 2mm in length was found in 3rd stub weld portion from front. The indication disappeared after grinding off the tube 1mm in depth.

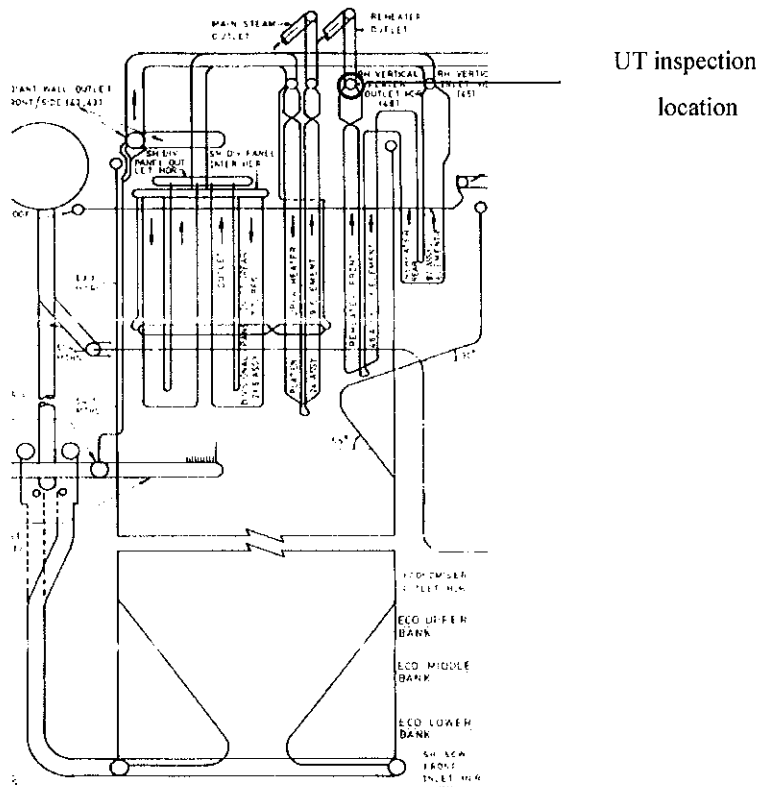
Fig. I -6 Inspected location of UT

UT detection results are shown in Table I -28.
