## Inspection at Unchahar #2

Boiler residual life assessment was carried out as one of the activities to improve the efficiency of coal-fired thermal power plants in NTPC-India and transfer to counterpart the technology.

Feroze Gandhi Unchahar Thermal Power Station #2 unit

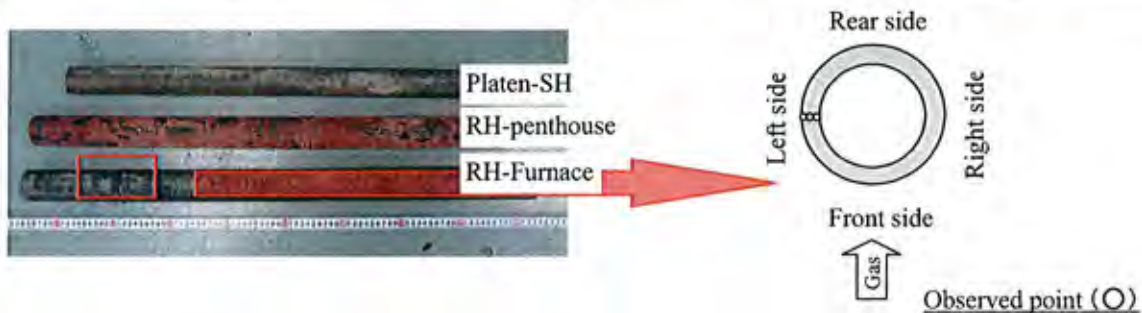
Photo I -25 Microstructure observation at cross section of sample tube  
[RH-Furnace (left side, Base Metal) ]

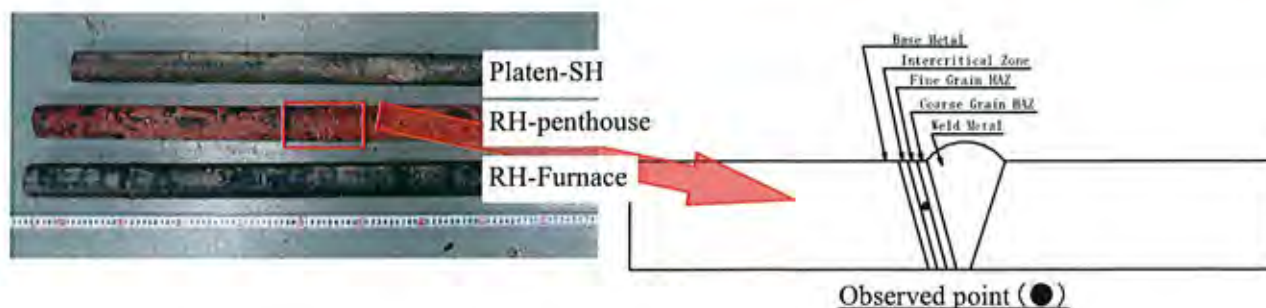
Photo I -39 Microstructure observation at cross section of sample tube  
[RH-Penthouse (Fine Grain HAZ) ]

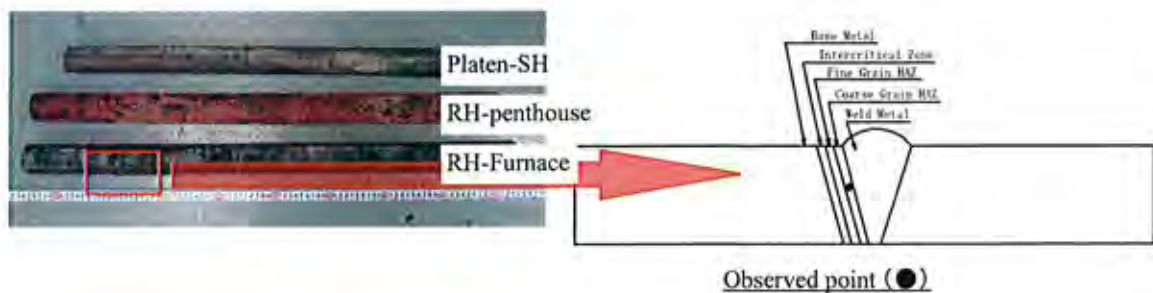
Photo I -57 Precipitates distribution by TEM observation [RH-Furnace (Coarse Grain HAZ) ]
