## 9. The other inspection results

### 9-1 Visual inspection, Thickness measurement

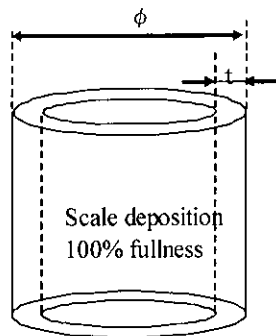
Shape of reference test piece and wave form

Wave form by reference test piece

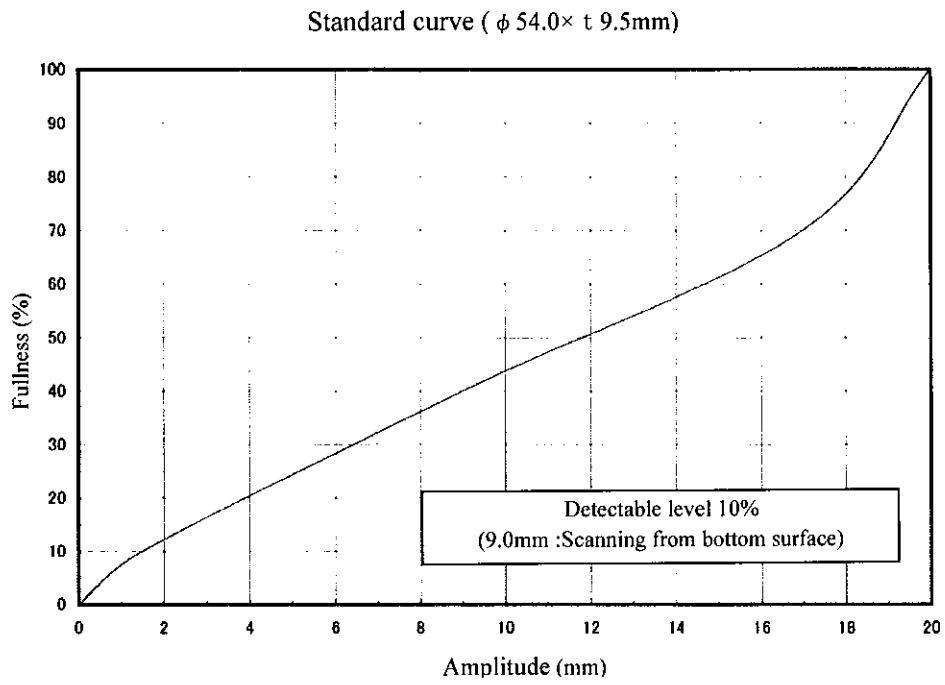
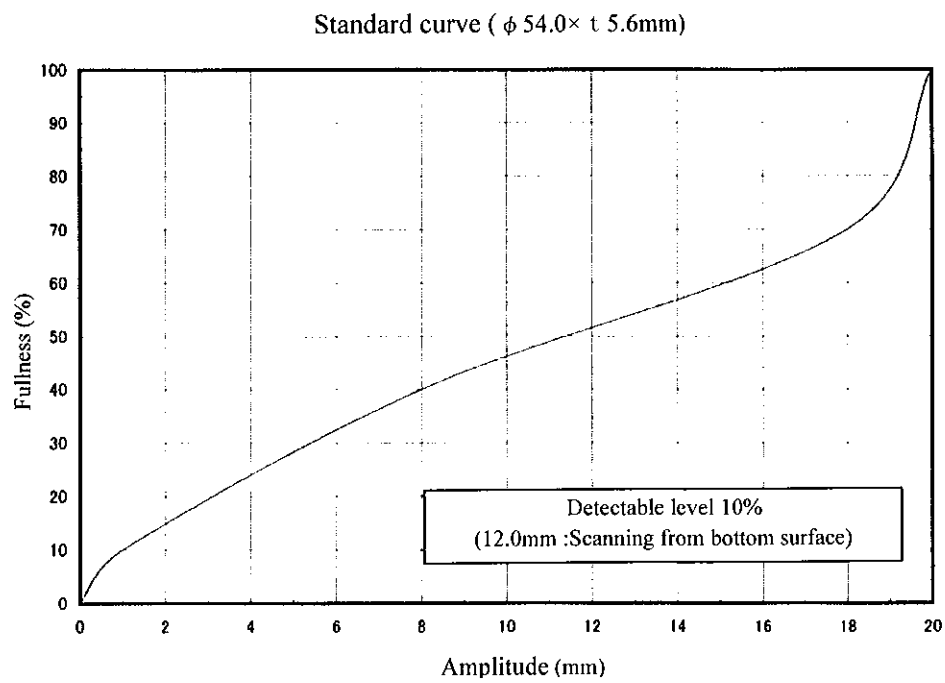
Fig. II -4 Standard curve used for evaluation

The representative deposition signal for this inspection is shown in Fig. II-3.

The standard curve used is shown in Fig. II-4.
