**THE STUDY
ON
ENHANCING EFFICIENCY
OF
OPERATING
THERMAL POWER PLANTS
IN
NTPC-INDIA**

Final Report

Volume IV

Volume- I-B
RLA of Turbine
(IP & LP)

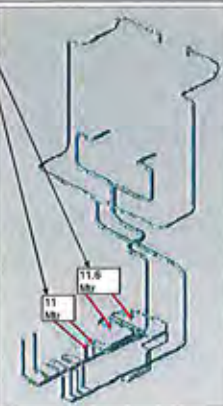
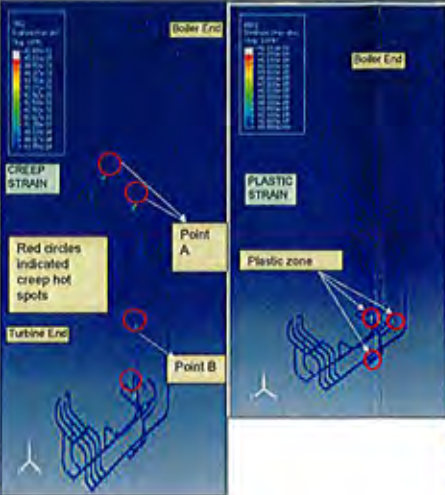
Sl No	Component	Findings from Destructive Test (DT) / Non-Destructive Test (NDT)	CAESAR II / Hot & Cold Walk Down Findings		Remaining Life & Other Findings			Conclusions	Recommendations	
			Key Observational Findings/ condition assessment	Reference Location/Sketch	Larson Miller Parameters (LMP)	In-situ Metallography (IM)	Finite Element Analysis (FEA)			
1	MS-CRH-HPBP	<p>Visual observations do not show any surface damage. During MPI and UT no significant defect was observed.</p> <p>Partial Bainite and Pearlite Degradation were observed in MS pipe lines. The spheroidisation level (diffusion degradation) observed is II-L to IV L. No creep cavities have been observed.</p>	<p>1) The maximum risk node points having highest stress components are marked with elevation.</p> <p>2) In pipe support No.MST-18, the hanger scale is damaged.</p> <p>3) In HPBP-02 the spring is topped out. In HPBP-18 the spring casing is missing.</p> <p>4) Hanger no CRH-17 has no load on the spring.</p> <p>5) Hanger no CRH-20 is found missing.</p>	<p>Code Stress Ratio (%) 58.5 @Node 2140 Code Stress: 66.9132 MPa Allowable: 114.453 MPa (Sustained Load)</p>

<p>Remaining Life of Piping System based LMP is: For MS Line is 5.91 yrs. For CRH line is > 20 years. For HPBP line is > 20 years.</p>	<p>Based on Microstructural degradation of II-L to IV L & the degree of life expended come to be 0.45 thus confirming the damage level-2 with expended creep life fraction as 0.442, which proves that the 44% of the life is over of the component.</p>	<p>Conclusions: From the above Analysis and based on Miner's Rule, Remaining life is 21 years.</p>	<p>1) Maximum Stress due thermo mechanical load is 168 MPa (localised Point A) average stress value is 60 to 70 MPa which is within allowable limit & strain observed is 0.00112. (Elastic Strain 0.001 + Plastic Strain 0.00012)</p> <p>2) Maximum Permanent Deformation after 25 Yrs of open due to Creep is 88 mm (Point B)</p> <p>3) Displacement (plastic) of following hangers over a period of 25 years is more than 60 mm. a) MST 044, b) HPB 012, c) CRH 030, d) CRH 032</p>

<p>1) Evaluated Remaining Life through FEA & IM is >20 years (Lower amongst the two). 2) Evaluated Remaining Life through LMP is 5.91 years.</p> <p>The wide difference between the evaluated remaining life as above is due to a conservative approach taken in LMP methodology. A safety factor of 1.25 upon operating pressure is taken to cover the probability of variation in operation, undue stresses due to change in loading pattern & spent life of the pipe. It may be noted that probability of failure is generally located in the hot spot zone as identified in FEA analysis. However evaluated life changes drastically to 25 yrs if 10% safety factor is taken or in other words if pressure does not rise above design pressure.</p> <p>Based upon above result, we conclude that the expected remaining life could be prolonged up to 20 years under strict compliance of the following: 1) Operating pressure will not exceed design pressure 2) Corrective action of resetting the hangers and supports are taken 3) Close monitoring of weak zones are carried out as recommended.</p> <p>Please note that CRH & HPBP line is evaluated that the remaining life is >20 years.</p>	<p>It is suggested that the critical locations identified be subjected to the following tests in every annual overhauling, mandatory at next annual overhauling: 1. In situ Metallography (IM) to know the material degradation level. 2. Thickness Survey. 3. Online line monitoring systems using the installation of the High temperature strain gauges at identified hot spot locations & thus the real time strain data will be acquired and used for further life estimations. 4. EMAT - Electromagnetic acoustic transducer test / high frequency (20MHz) small diameter probe UT, can be implemented to check the state of steam side surface corrosion, / pitting of the main steam pipe in the critical locations. 5. Indicated hangers required to be corrected.</p>

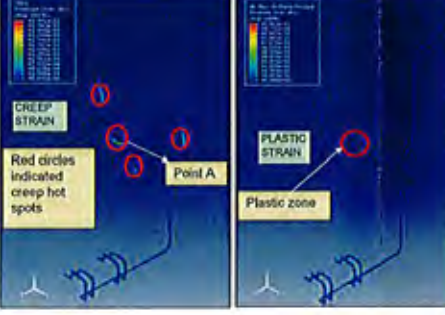
2	HRH-LPBP	<p>Visual observations do not show any surface damage. During MPI and UT no significant defect was observed.</p> <p>Partial bainite and pearlite degradation was observed in HRH pipe lines. The spheroidisation level (diffusion degradation) observed is II-L to III L. No creep cavities have been observed.</p>	<p>1) The maximum risk node points having highest stress components are marked with elevation.</p> <p>2) A horizontal restraint provided between LPBH13 and LPBP14 is in dismantled condition. Bolts to be tightened.</p>	<p>Code Stress Ratio (%) 71.8 @Node 279 Code Stress: 33.5433 MPa Allowable: 46.7189 MPa (Sustained Load)</p> <p>Code Stress Ratio (%) 82.9 @Node 8005 Code Stress: 102.8691 MPa Allowable: 124.3414 MPa (Expansion Load)</p>

<p>Remaining Life of Piping System based on LMP is: For HRH > 20 years. For LPBP > 20 years.</p>	<p>Based on Microstructural degradation of II-L to III-L & the degree of life expended come to be 0.45 thus confirming the damage level-2 with expended creep life fraction as 0.442, which proves that the 44% of the life is over of the component.</p>	<p>Conclusions: From the above Analysis and based on Miner's Rule, Remaining life = 13.6 years.</p>	<p>1) Maximum Stress due thermo mechanical load is 102 MPa (localised Point A) average stress value is 50 to 70 MPa which is within allowable limit & strain observed is 0.00018. (Elastic Strain 0.00012 + Plastic Strain 0.00006)</p> <p>2) Maximum Permanent Deformation after 25 Yrs of open due to Creep is 100 mm (Point A)</p> <p>3) Displacement (plastic) of HRH hangers over a period of 25 years is less than 5 mm.</p>

<p>Based on the overall analysis, the condition of piping system is satisfactory. Remaining life is evaluated to 13.6 years.</p>	<p>Run-Component fit for further operation and re-inspection of the component is recommended after 5 years of further operation to monitor the extent and trend in service induced damage and assess its fitness for further service.</p> <p>Repair / Replace: Indicated hangers required to be corrected.</p>

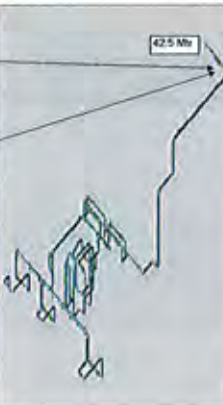
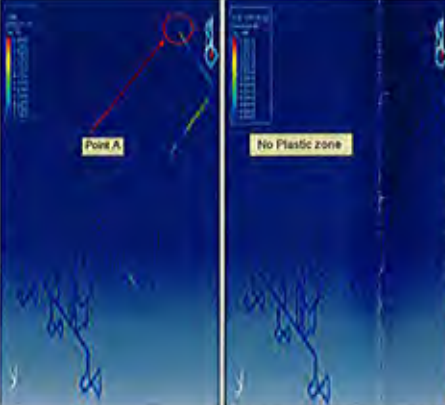
3	BFD	<p>Visual observations do not show any surface damage. During MPI and UT no significant defect was observed.</p>	<p>1) The maximum risk node points having highest stress components are marked with elevation.</p> <p>2) Spring supports below the Feed control station at about 20 M elevation are not accessible for hanger measurements. However, visual inspection in this region shows no damages.</p>	<p>Code Stress Ratio (%) 35.6 @Node 1175 Code Stress: 43.1281 MPa Allowable: 121.8951 MPa (Sustained)</p> <p>Code Stress Ratio (%) 13.1 @Node 1195 Code Stress: 38.8209 MPa Allowable: 296.8034 MPa (Expansion)</p>

<p>Not considered</p>	<p>Not considered</p>	<p>Remaining Life of Piping System based on FEA is > 20 Years.</p>	<p>1) Maximum Stress due thermo mechanical load is 142 MPa (localised Point A) average stress value is 60 to 70 MPa which is within allowable limit & strain observed is 0.00066. (Elastic Strain 0.00064 + Plastic Strain 0.0)</p>

<p>Based on the overall analysis, the condition of piping system is satisfactory. Remaining life may be concluded > 20 years.</p>	<p>Run-Component fit for further operation and re-inspection of the component is recommended after 5 years of further operation to monitor the extent and trend in service induced damage and assess its fitness for further service.</p>

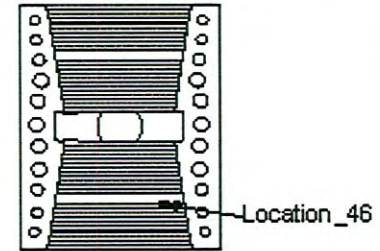
Location: IP Bottom inner Casing Blade stage-3 _ Replica No. 46

Hardness: -144-146HB
