Characteristics of PSPP Potential Site

Site Name		No.19
Location (River name)		Upper Dam / Reservoir : Burdur Bucak Kocayer (Curukini River) Lower Dam / Reservoir : Burdur Bucak (Karacaoren II Lake)
Profile	Installed Capacity P (MW)	1,000
	Design Discharge Q (m ³ /s)	249
	Effective Head H (m)	507
	Peak Duration Hour (hrs)	7
Geography / Geology	General Geology	<ul style="list-style-type: none"> - The regional geology belongs to the upper Miocene series. Only geology of right bank of Existing Karacaoren II lake is Cretaceous system, and they lay from the west to the east sequentially, Karpuzcay formation (Tmkp) of upper Burdigalian to Serravallian age, Aksu formation (Tma) of Tortonian to Serravallian age. - Karpuzcay formation (Tmkp) consists of sandstone, claystone, siltstone, and conglomerate. Aksu formation (Tma) consists of conglomerate. - N50W/30NE strike and dip was measured at a conglomerate outcrop where southern part of Karacaoren II dam site which geology belongs to Karpuzcay formation. On the other hand, N15W/35NE strike and dip was measured at a calcilutite outcrop on the slope of northern national road, and a fossil of bivalve was found in the outcrop.

Appendix 5-5

R

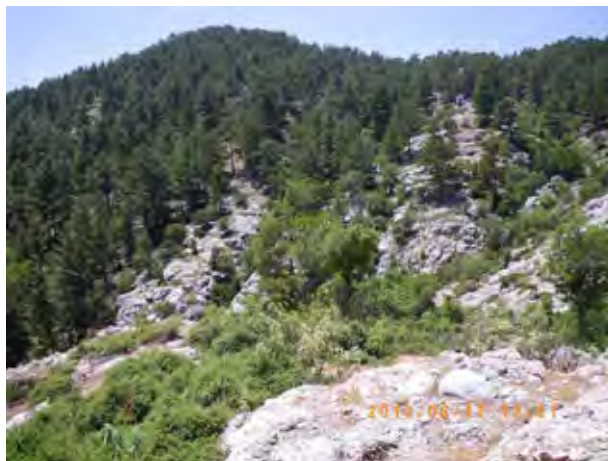
Photo 3 Joints of N30E strike at intervals of 30-50 meters developed in the Conglomerate
 (Right bank of the upper reservoir)

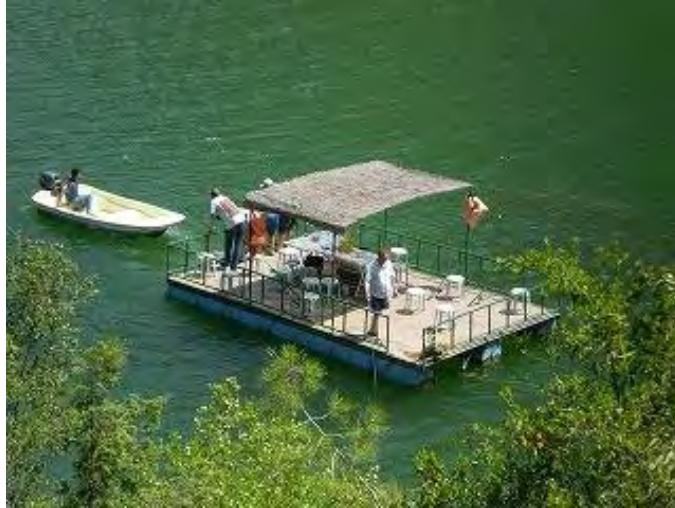
Photo 7 Leisure facility (restaurant) on the existing reservoir at the outlet site

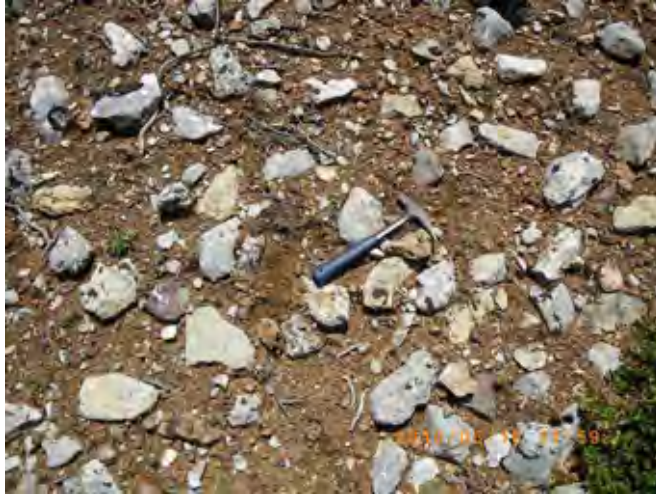
Gravelly soil distributes on the uneven ground surface. The material seemed to be transferred from upper reach by mudflow and consists of silty sand.

Photo 4 In the upper reservoir

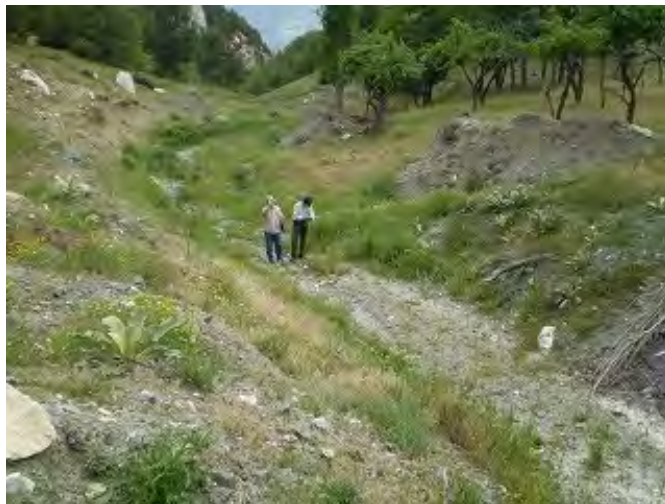
Photo 3 A river at the upper dam site (There is no river flow at the ground surface of the river.)

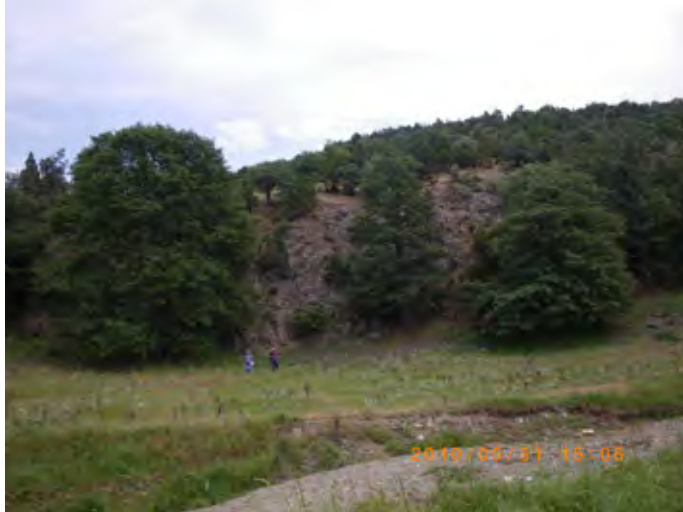
Photo 7 Outcrop of sandy schist on the left bank of the dam

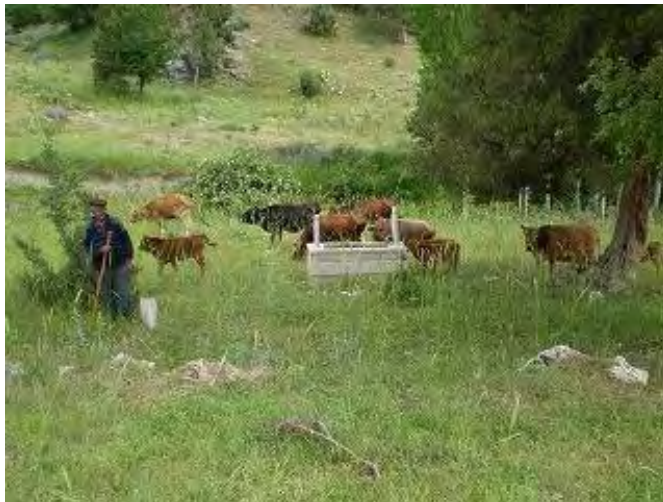
Photo 11 Local residents are raising their livestock (cows) in the upper reservoir. There are several tombs.

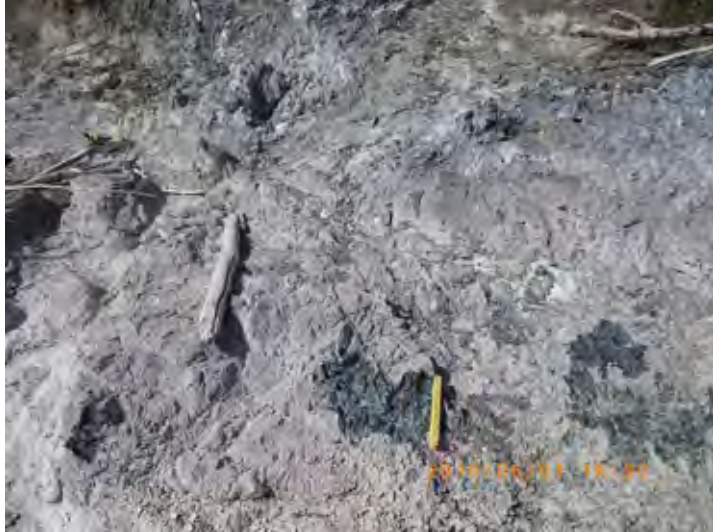
Photo 13 Serpentinized basic rock around the outlet site

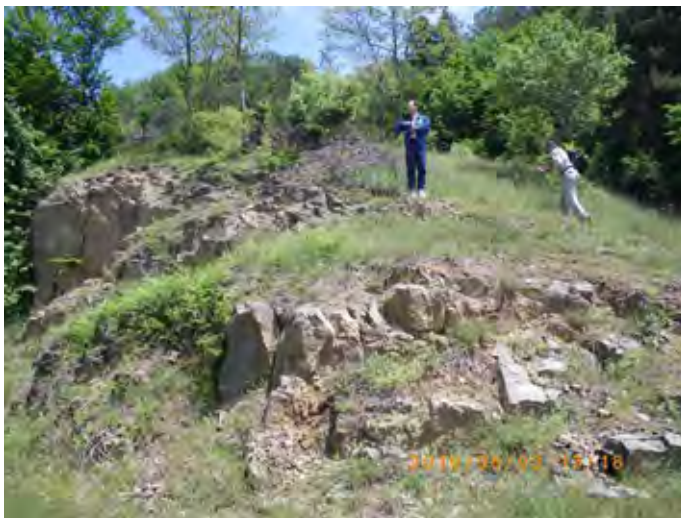
Photo 3 Sandstone cropped out on the slope of logging road at the right bank of Upper dam site

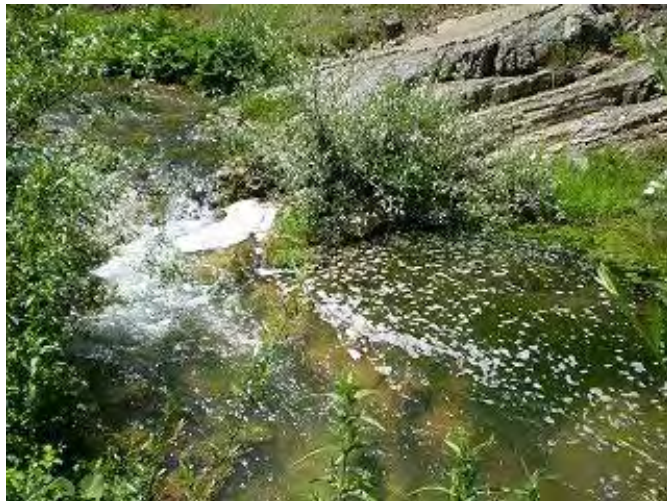
Photo 5 The river flow at the upper dam site

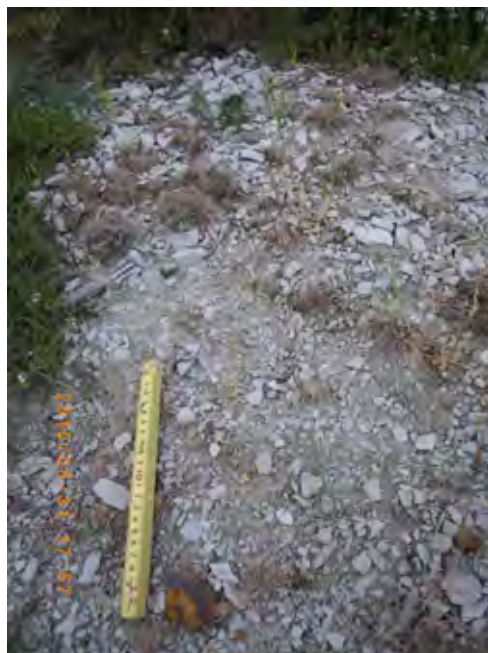
Photo 3 Strongly weathered tuff of "Temg" on the ridge of the upper dam site

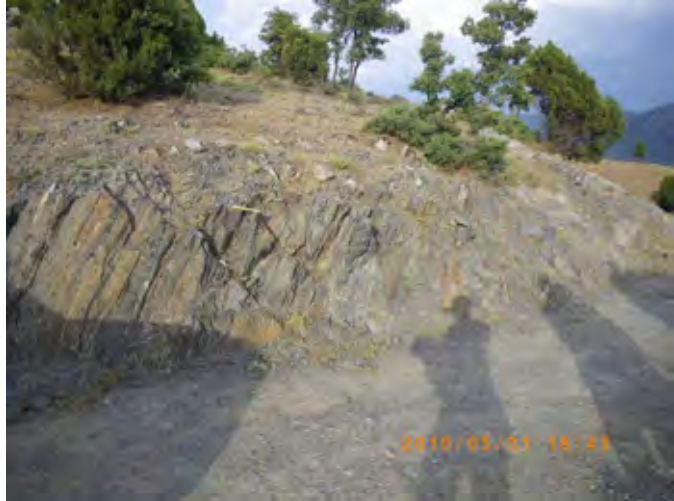
Photo 7 Hard metamorphic rock cropped out along the waterway route
