4.4 Water Quality and Bottom Sediments

Structures along the coast of the lagoon in Funafuti could have a great influence on transport of sand and gravel on the atoll side. A study will be conducted on the current conditions of those structures to examine their influence on coastal erosion and sedimentation. The figure below shows the locations of the major port facilities and coastal protection works constructed on Fongafale Islet and Tengako Islet, located to the north of Fongafale Islet.

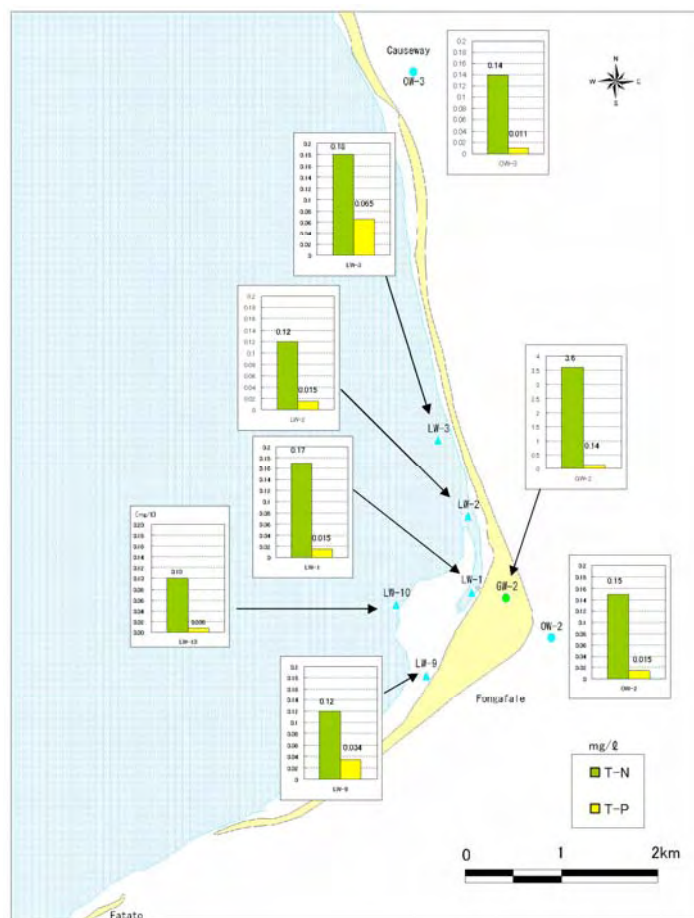
Figure 4.35 Distribution Map of T-N and T-P

The results of water quality measurements were shown in **Table 4.19** for salinity, water temperature, turbidity, color and chlorophyll-a. **Table 4.20** and **Figure 4.35** show the analyzed result and distribution of nitrogen and phosphorus by the high-precision water quality analysis in Japan. A coral eco-system commonly distributed in an oligotrophic area is said to be seriously influenced by the eutrophication of the sea area due to the inflow of inland water that contains a large amount of phosphorus, nitrogen, etc.. For the conservation of coral reef, Japan has such environmental water quality criteria as T-N \leq 0.2 mg/l and T-P \leq 0.02 mg/l. When the coastal seawaters in the area concerned are compared with these criteria, all the T-N values meet the criterion but some of the T-P values on lagoon side near the coast (LW-3 & LW-9) do not meet the criterion.

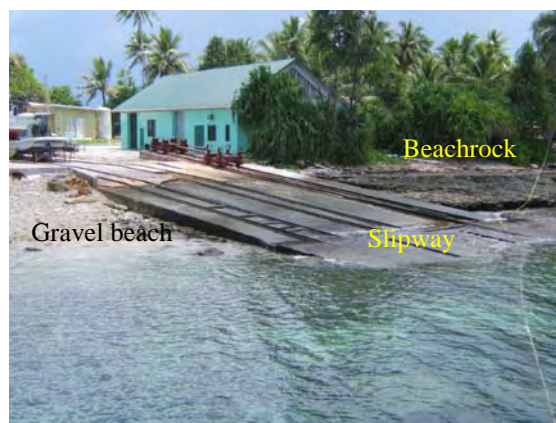
Photo 5.3 Slipway

The slipway was constructed by scraping beach rocks. Because it is at almost the same elevation as the beach rock shoreline nearby, no significant erosion or sedimentation is observed. However, when a tropical depression or a cyclone passes through and brings strong westerly wind and high waves, the gravel stirred up from the seabed off the far end of the slipway will be deposited on the northern side of the slipway.

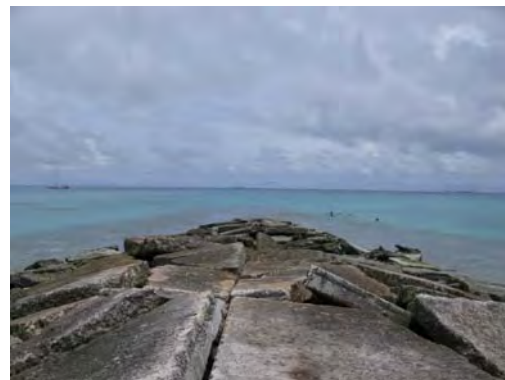
Photo 5.6 The Top of the Ramp

This is a jetty-type ramp to haul seaplanes constructed hastily by the American troops in 1943 during the Pacific War. Several attacks by cyclones caused cracks on its concrete floor. Earth packed inside the ramp has flowed through the cracks and the jetty has been completely

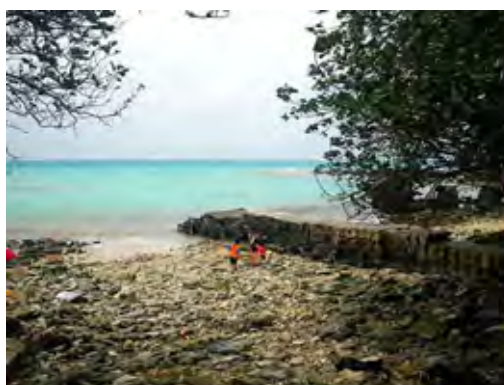
Photo 5.7 Small Boat Jetty (to the South of Catalina Ramp)

As seen in Photo 5.7 above, beach rocks in the water areas to the south and north of Catalina Ramp were dredged deep and the areas were used for docking and unloading of the US military boats. At present, although littoral drift is gradually filling the dredged places, the area is still deep enough for the use by small boats. Because public facilities including government offices, schools, churches, a meeting place, hospitals, supermarkets, and stores are located in the hinterland few minutes' walk from the jetty, small boats equipped with outboard motors owned by area residents and cutters equipped with outboard motors commuting to and from the Marine Institute in Amatuku Islet in the atoll and small islets in the atoll including Funafala Islet dock at Small Boat Jetty mentioned below and use this place as a boat basin.

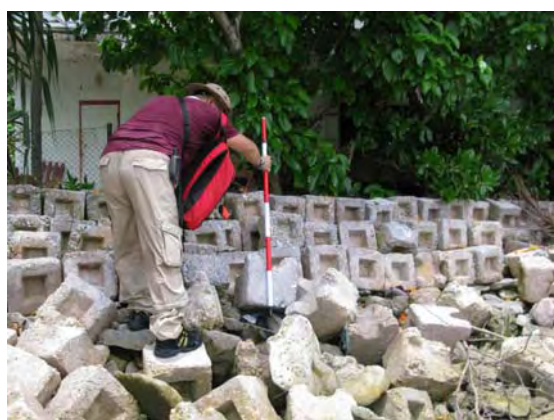
Photo 5.10 Close-up View of Catalina Ramp

Slight erosion and slight sedimentation of sand gravel are observed on the northern and southern sides of Catalina Ramp, respectively.

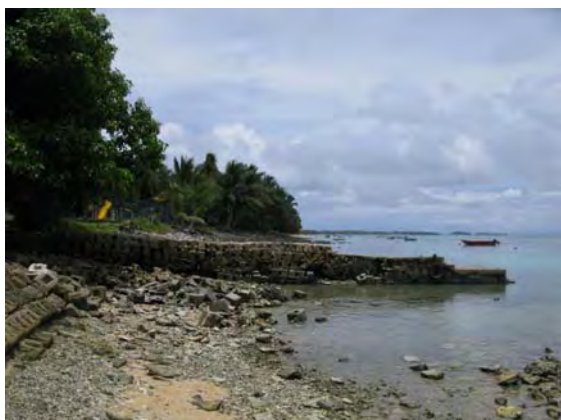
Photo 5.22 A Jetty Constructed with Recycled Concrete Blocks

The concrete block seawalls constructed with concrete cubes with sides of 30 cm found along the coast near Catalina Ramp seem to have been the ones constructed as public works. However, most of them have disintegrated into disorderly rubble-mound seawalls scattered with concrete blocks and gravel. The condition of such areas is so poor that it is difficult even to walk there. Some residents along the coast recycled the disintegrated concrete blocks to construct ramps for landing boats and small jetties. Photo 5.22 shows a jetty to the south of Catalina Ramp constructed by laying up the concrete cubes, while Photo 5.23 shows a private boat landing ramp north of Catalina Ramp constructed by laying the concrete blocks.

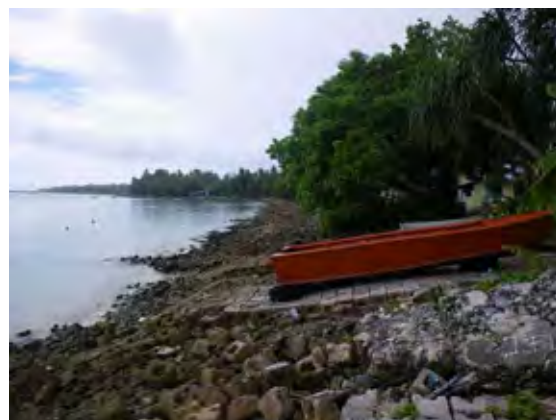
Photo 5.23 A Boat Landing Ramp

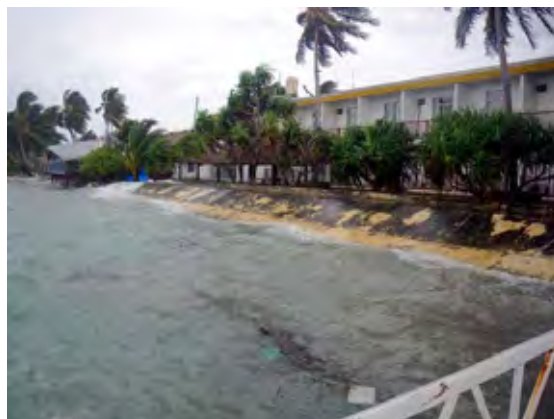
The seawalls at the side of Vaiaku Wharf and in front of the former government building and the government-owned hotel have a structure similar to a vertical concrete seawall. At many places, this structure causes scour by creating reflected waves and downward flow of water when wave run-ups fall in front of the seawall, instead of having a wave absorption effect, and, thus, makes sedimentation of gravel and sand on the foreshore difficult. Many places were observed where the seawalls were the very cause of the erosion in the surrounding area.

Most of these seawalls constructed as public works are vertical seawalls which do not have a wave absorption effect. Therefore, when a high wave hits a seawall, a large amount of sea spray is produced. Such spray washes ashore gravel and rubbish and is the main cause of salt damage to structures. Photos 5.26 and 5.27 were taken at the same locations as the photographs in the figure above at the end of January 2010 when a low pressure system went through the area at the time of a spring tide.

Photo 5.27 Wave Run-ups in front of a Vertical Seawall – A vertical Seawall on the Northern Side of Vaiaku Wharf

(The photograph taken when a low pressure system passed through the area at the time of a spring tide.)

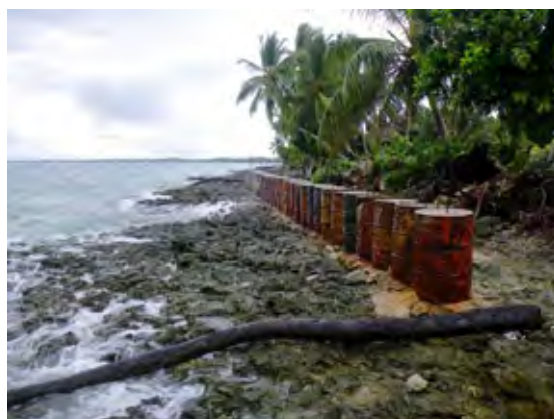
Photo 5.29 A Privately-Implemented Seawall – a Seawall at the Coastal Area at the Southern End of Funafuti Constructed with Concrete-Filled Oil Drums

Almost all of the privately constructed seawalls are causing erosion and sedimentation in the surrounding shoreline areas by blocking littoral drift because they were constructed on the seaward side of the shorelines. In addition, most of them are structurally inappropriate: some have structurally insufficient wave tolerance. Others have cross-sections similar to a vertical seawall, which are likely to cause scour at their base, to create a large amount of sea spray when waves hit them, and/or to cause disturbance of waves by generating reflected waves. Yet others facilitate erosion of the surrounding shorelines. For these reasons, many of them have collapsed even before their construction has been completed. The condition in which people are taking their own initiatives to construct seawall structures with their haphazard reclamation/seawall plans will be a problem in formulating a coastal protection program in future.

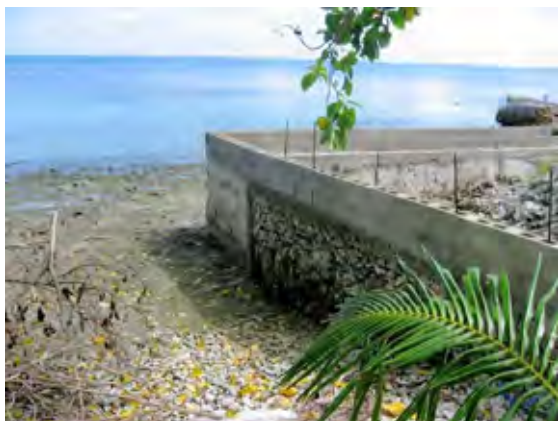
Photo 5.30 A Privately-Implemented Seawall – The Lower and Upper Parts Constructed with Gabions and Coping Concrete, Respectively

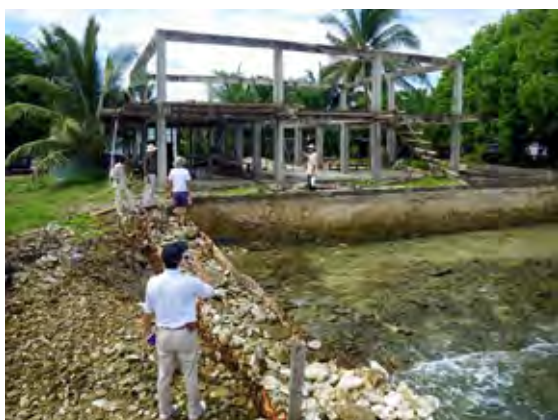
Photo 5.32 A Privately-Implemented Seawall – a Work Aimed at Land Development

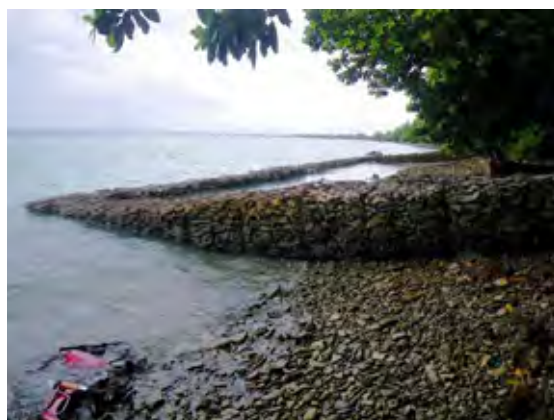
Photo 5.33 A Privately-Implemented Seawall – only Gabion Work Has Been Completed

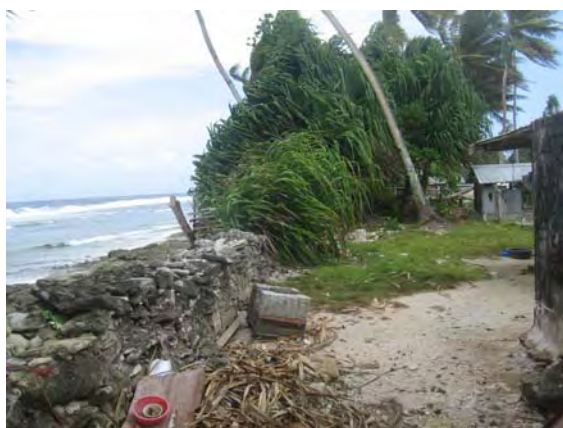
Ocean Side No.1

As can be seen in photos 5.34 to 5.37 there are several seawalls, both stacked rocks and concrete, along parts of the ocean coastline in Fakai Fou, north of the airstrip. In particular, along the

In the case of stacked-rock walls, this is a result of the bedrock fragments having been gathered to make the rock wall, moreover, the seawalls are jutting out seaward of the original coastline in order to increase the area of usable land. Also, most of the beach ridge is very low having been excavated.

Photo 5.34 Private Seawall of Stacked-up Beachrock Fragments

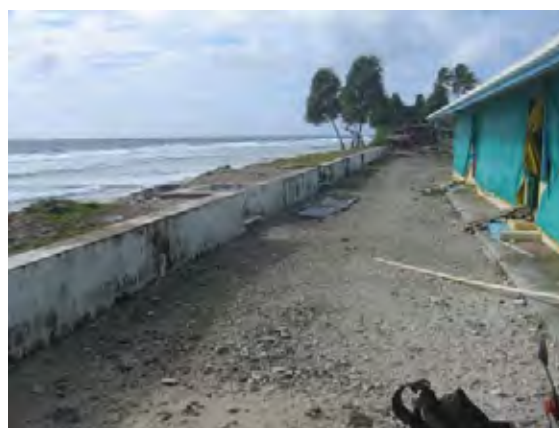
Ocean Side No.3

Photo 5.35 shows the concrete seawall constructed in front of the church where all of the vegetation (coconut and pandanus trees) has been cut down. As a result, the church receives the full impact of winds from the ocean, so has had to put up tarpaulins as windbreaks.

Photo 5.35 Concrete seawall in front of Church

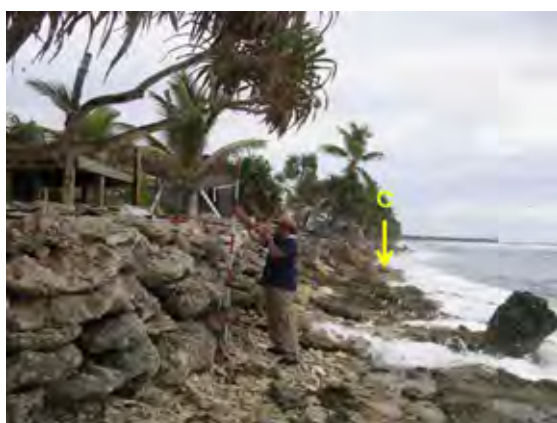
Ocean Side No.2

narrow strip of coastline between the Pacific to the east and the ponds formed in borrow pits to the west—photos 5.36 and 5.37—the beachrock is exposed immediately in front of these walls, where normally a gravel slope would have formed as a result of wave action.

Photo 5.36 Private Seawall of Sacked-up Beachrock Fragments

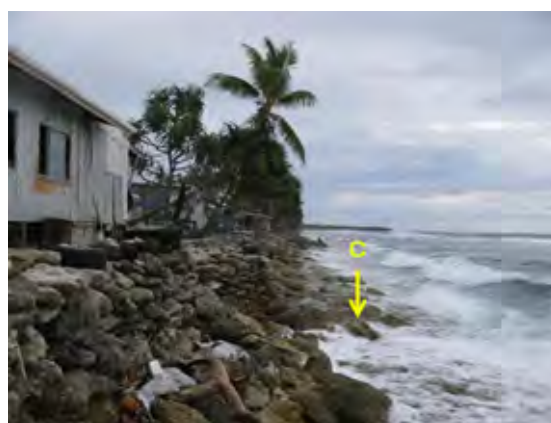
Ocean Side No.2

Photo 5.37 Private Seawall of Stacked-up Beachrock Fragments and Tyres

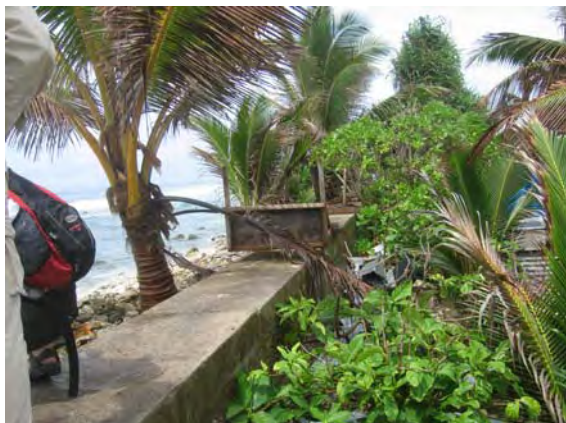
Ocean Side No.4

Along the ocean side coastline south of the airstrip in Kavatoetoe, photos 5.38 to 5.40, there is a 1.2 m high by 50 cm wide concrete seawall and one made of cemented rocks. Further, in this area south of the airstrip vegetation, such as pandanus and coconut tress, grow immediately

behind the storm ridge, however, around these seawalls vegetation is very sparse. It is therefore apparent that the seawalls are extending past the original shoreline to increase the area of land right up to the storm ridge and that the vegetation has been cut down.

Photo 5.38 Concrete Seawall at Private Residence

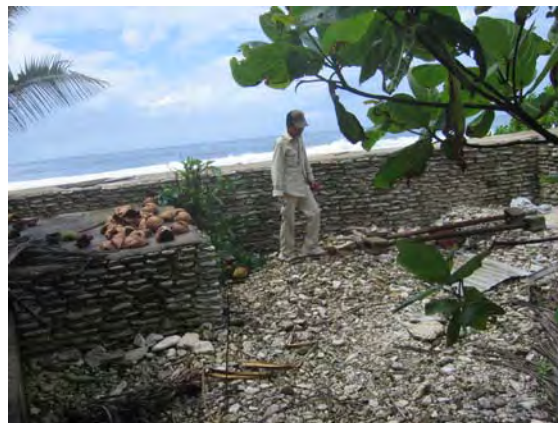
Ocean Side No.4

Photo 5.39 Cemented-Rock Seawall at Private Residence

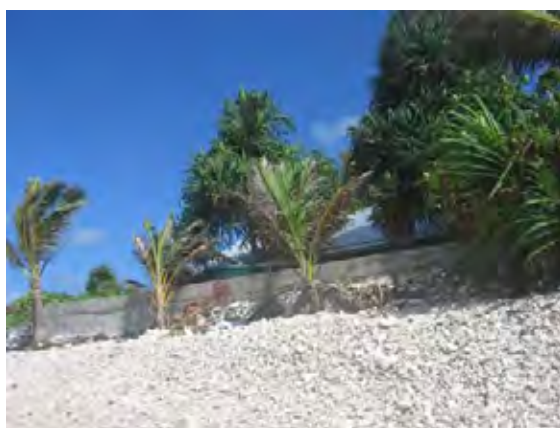
Ocean Side No.4

Photo 5.40 Concrete Seawall at Private Residence

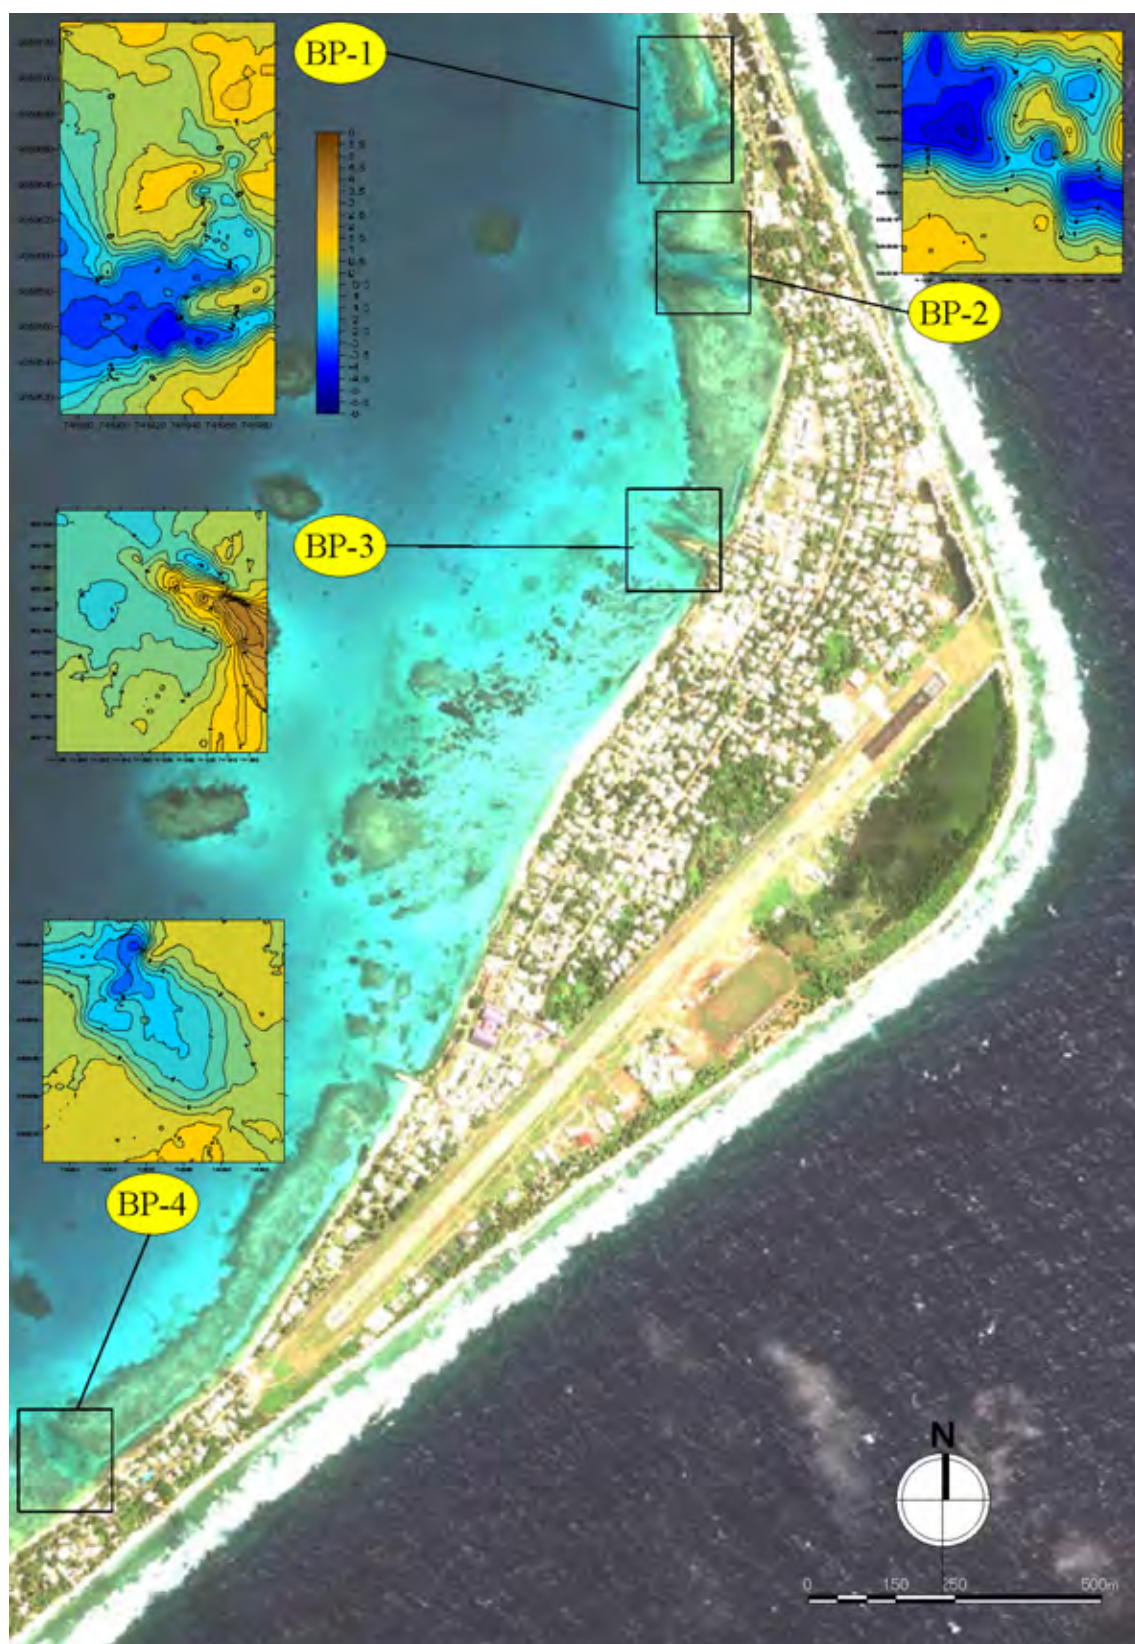
Figure 5.7 Location of Borrow Pits and Bathymetric Maps

The beachrock in the shallows of central Fongafale was excavated in four locations—during WWII by the US military to land equipment for the construction of the airstrip—the remains of which can be seen in **Figure 5.7**. These anthropogenic seafloor depression remaining in the littoral zone, are known as coastal borrow pits, similar to those on land. The detailed bathymetric survey shows that the seabed around the borrow pits is from C.D.L.±0 m to +1 m, meanwhile the maximum depth of the borrow pits is below C.D.L. –3 m.

Incoming waves on the lagoon side break on the flat shallows offshore and their energy dissipates. In the deeper water of the borrow pits, however, this does not occur, meaning the waves break further up the shore. Also, wave height is increased due to this localised and complex seabed terrain combined with waves reflected from the shore. These borrow pits also generate fast outflowing currents during high seas that wash sand offshore, which has accreted in the pits during calm periods as a result of longshore drift. As such, sand naturally accumulates in the borrow pits, which is hindering the rehabilitation of the surrounding seabed height.

An effective long-term measure to promote accretion on the beach without impeding longshore drift is to refill the borrow pits, thereby restoring the seabed topography to its original flat state.

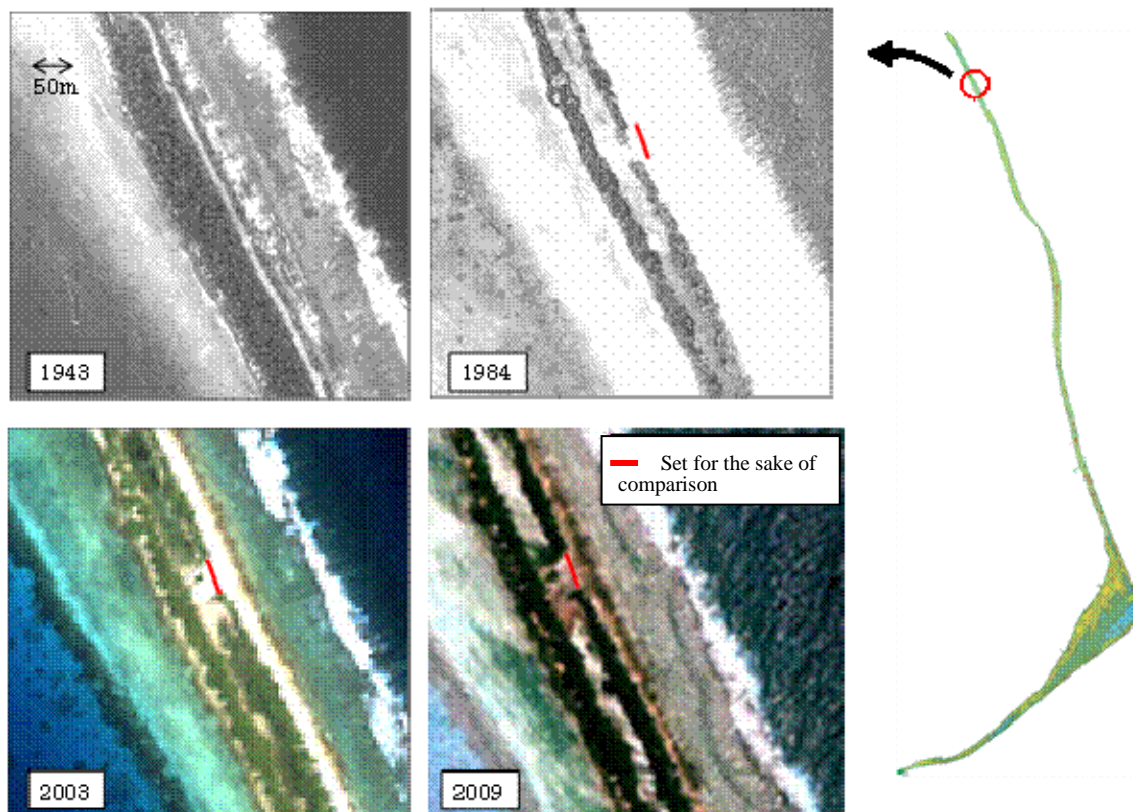
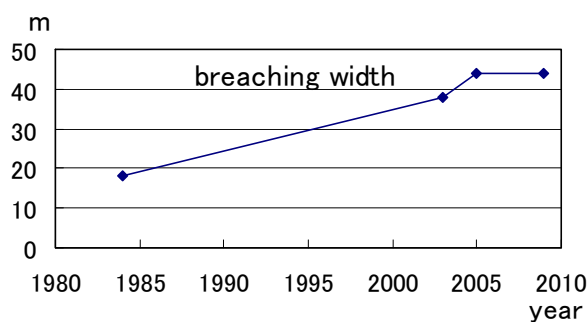
Figure 5.8 Changes in the Breaching Opening

As can be seen in **Figure 5.8**, the breaching is a result of the storm ridge along the eastern coast collapsing and sand and gravel flowing into the borrow pit running along the centre of the islet, which was dug out by the US military during WWII to obtain gravel for the construction of the airstrip. This area is uninhabited; however, there is concern over the expansion of the breach, which has shown a tendency of expansion until recently, and also possible impact on the lagoon side.

- It is apparent that the beach ridge on the ocean side has been breached and massive amounts of sand/gravel have been washed into the long, narrow borrow pit in the middle of the islet. Breaching is when a barrier is cut and seawater and sediment is washed from the ocean into a lagoon, therefore, this case is technically not breaching. The beach ridge has collapsed, however, and the fact that large quantities of sediment has been washed into the borrow pit is very similar to breaching. As such, the observed phenomenon can be included in breaching in the wider sense of the word.

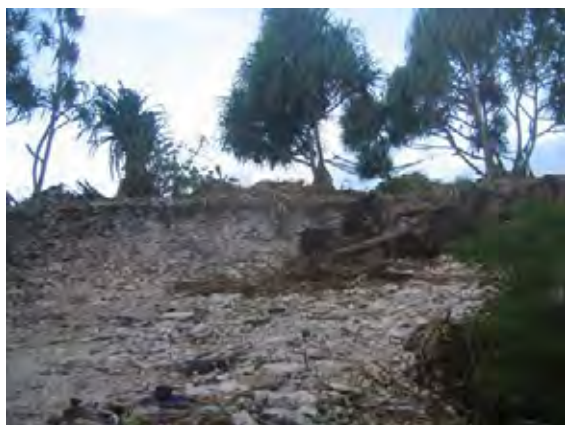
The areas currently being affected by ocean wave overtopping are where the storm ridge is relatively low. The main cause of this is the residents in the hinterland expanding the flat land on their properties by cutting down the vegetation growing around the storm ridge, leveling the ridge, and using gravel from it for construction (Photo 5.46 and Photo 5.47). Further, some areas of the backshore are extremely narrow where the landward side of the storm ridge has been excavated away to increase the area of flat land (Photo 5.46). The storm ridge is vulnerable and in danger of collapsing in these areas and on Tengako Islet near the waste disposal site (Photo 5.47) and near the area of breaching.

Photo 5.46 Excavated Area behind the Storm Ridge

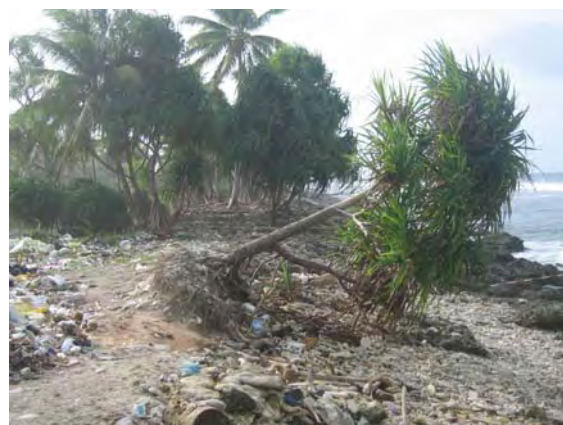
Photo 5.47 Coastline at Waste Disposal Site
