**THE PREPARATORY SURVEY  
ON  
THE PROJECT  
FOR  
COUNTERMEASURE CONSTRUCTION  
FOR  
THE LANDSLIDES  
ON  
SINDHULI ROAD (SECTION II)**

March 2011

JAPAN INTERNATIONAL COOPERATION AGENCY  
NIPPON KOEI CO., LTD.

Main Report

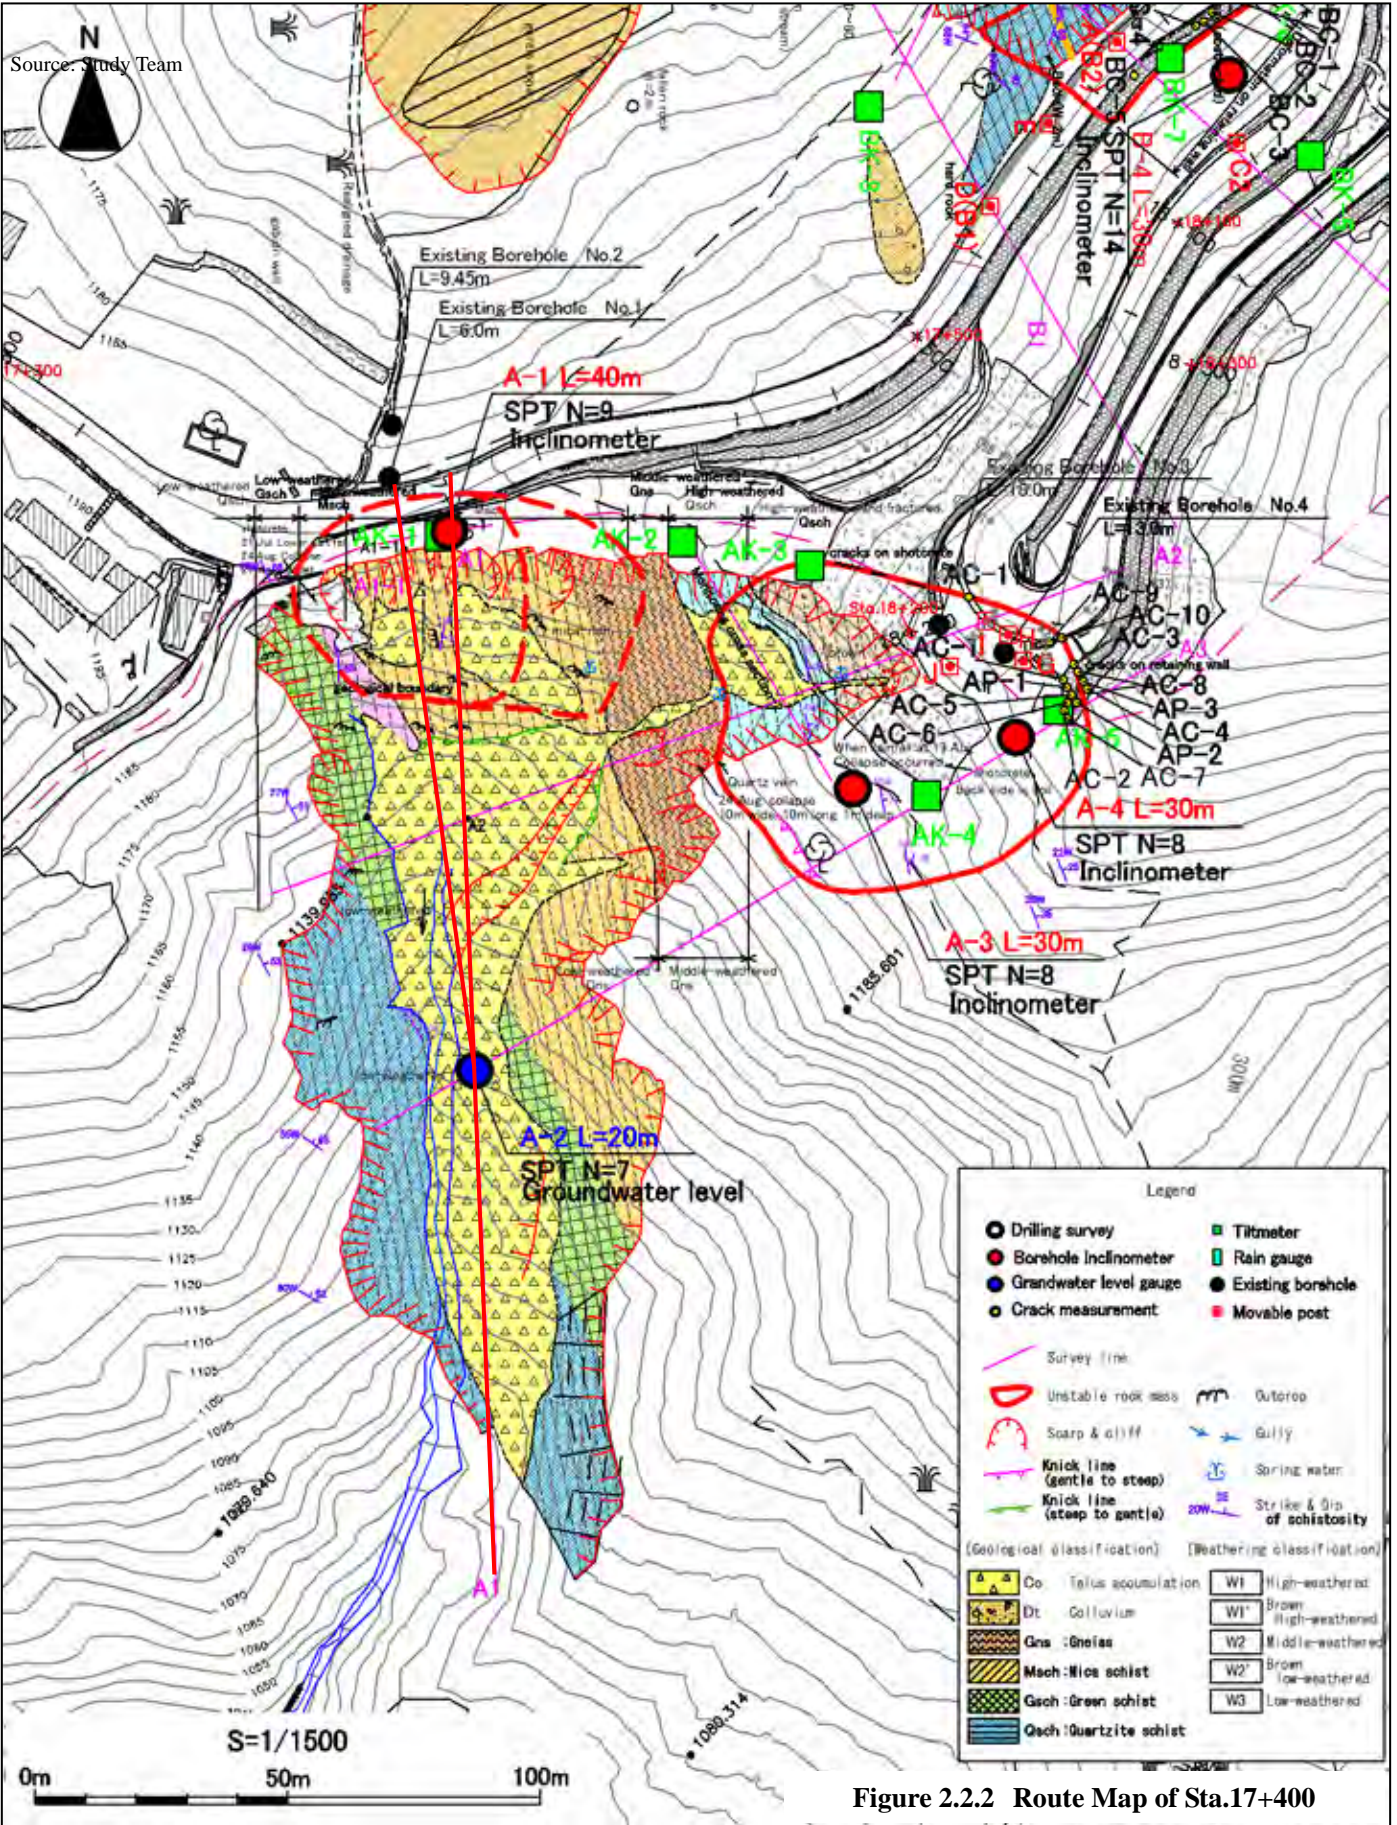
Figure 2.2.2 Route Map of Sta.17+400

After the first failure on June 2003, subsequent failures occurred in July 2004 and August 2005 at the south-facing slope on narrow ridge where Sta.17+400 of the road is located.. The ridge width has narrowed from around 15 m to about 10 m due to these intermittent collapses. Moreover, the road shoulder is likely to be further damaged by future failures. Therefore, the road section was realigned to the north side (mountain side) in 2006. Refer to the Appendix I for details.
