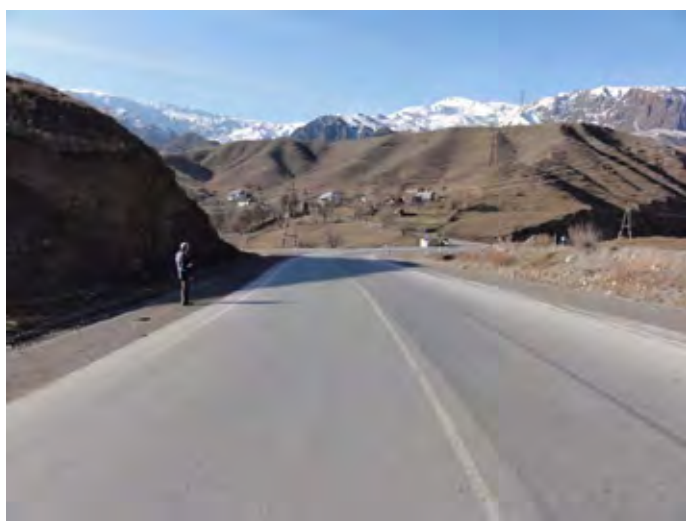
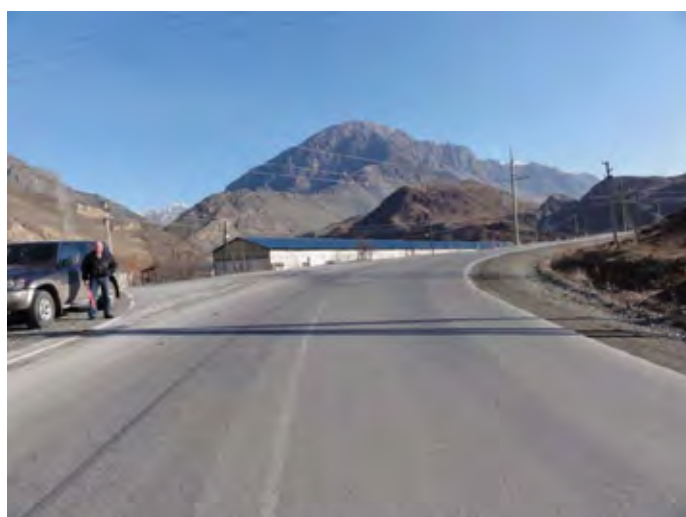
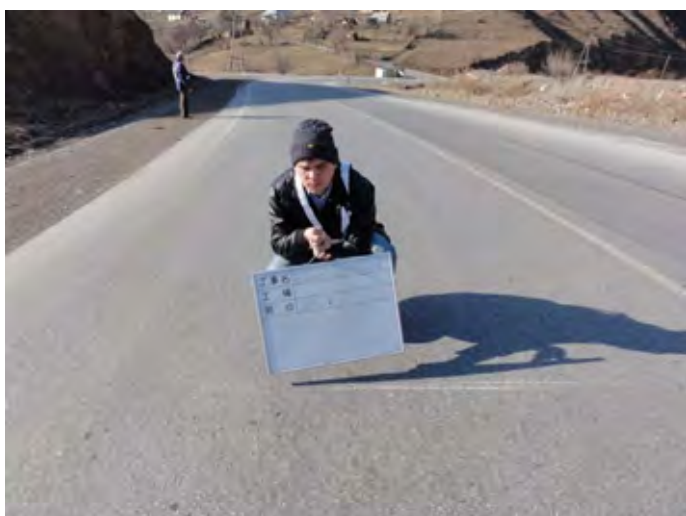
395K+000

路面状況は良好

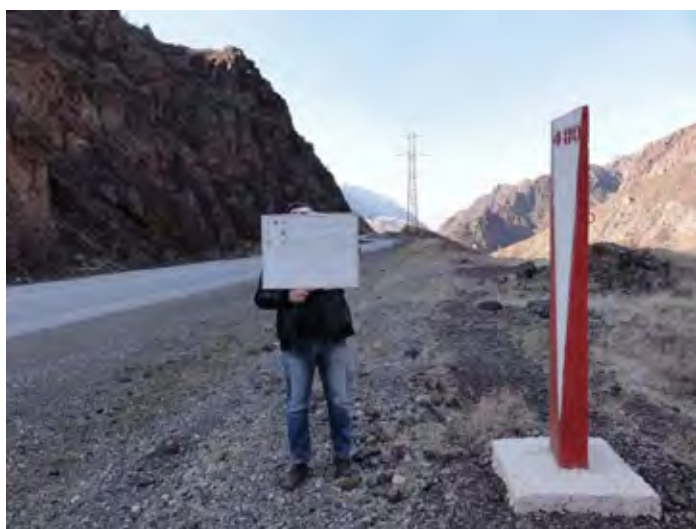
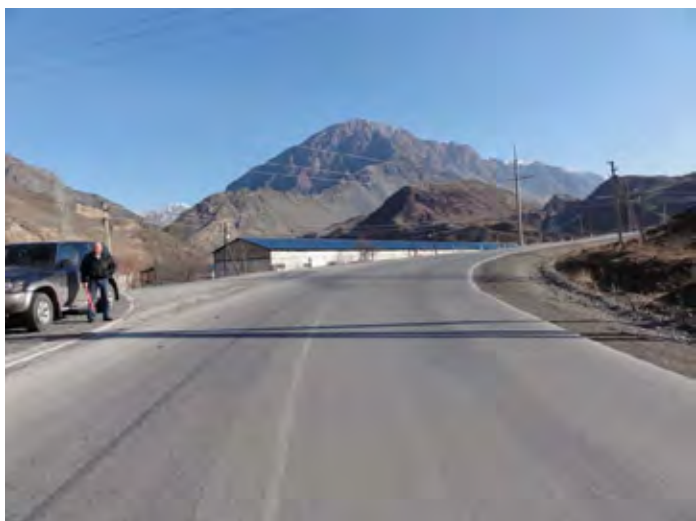
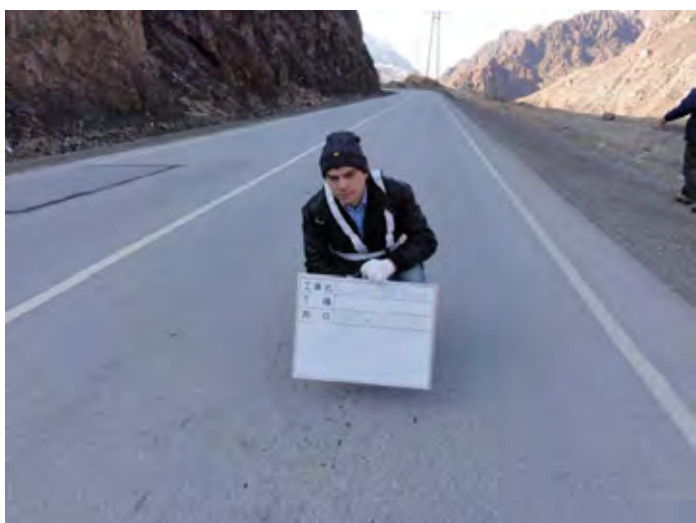
400K+000

路面状況は良好

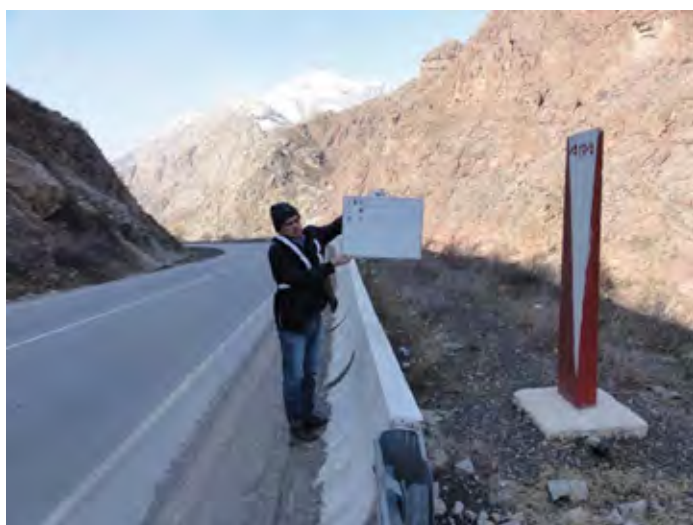
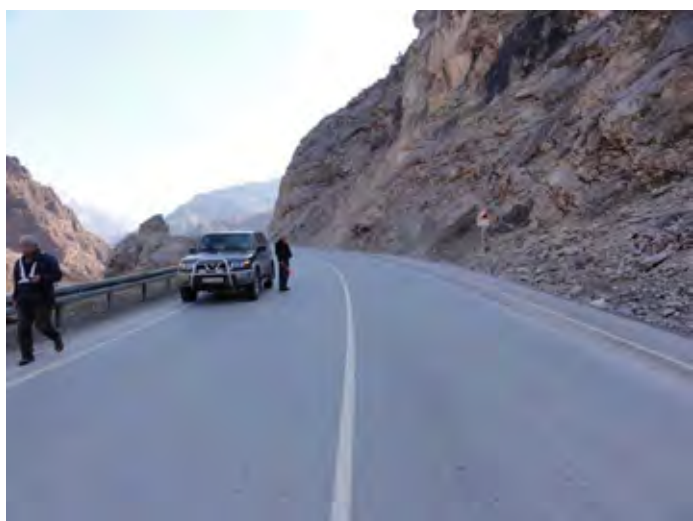
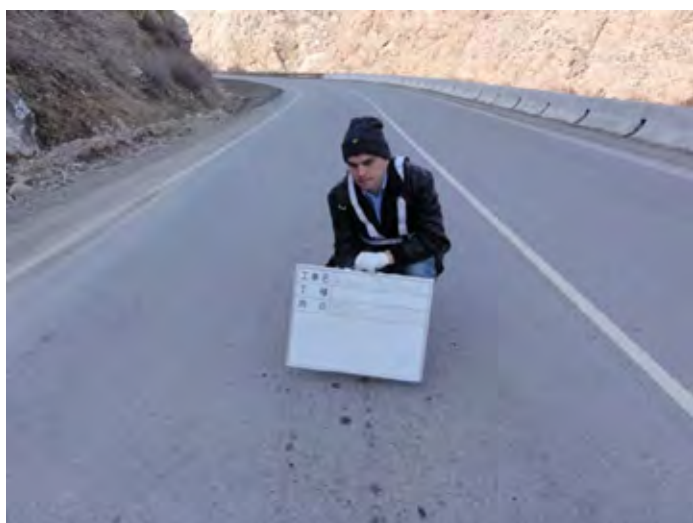
405K+000

路面状況は良好

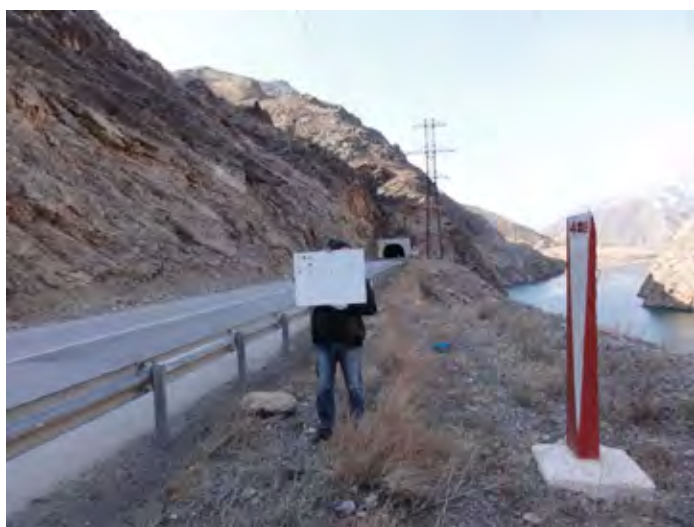
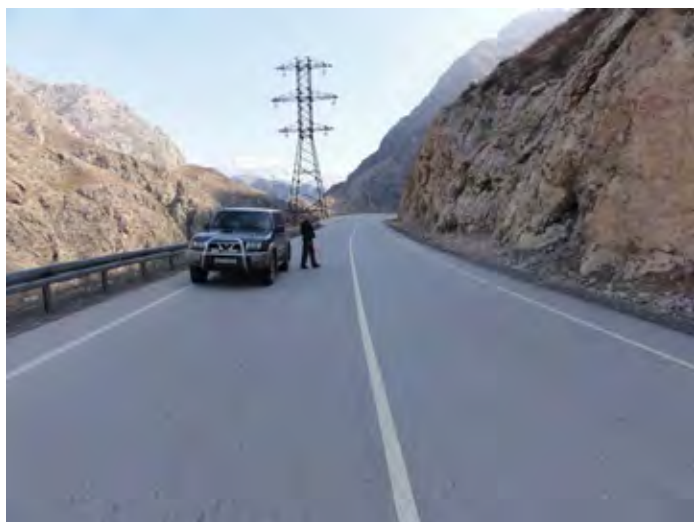
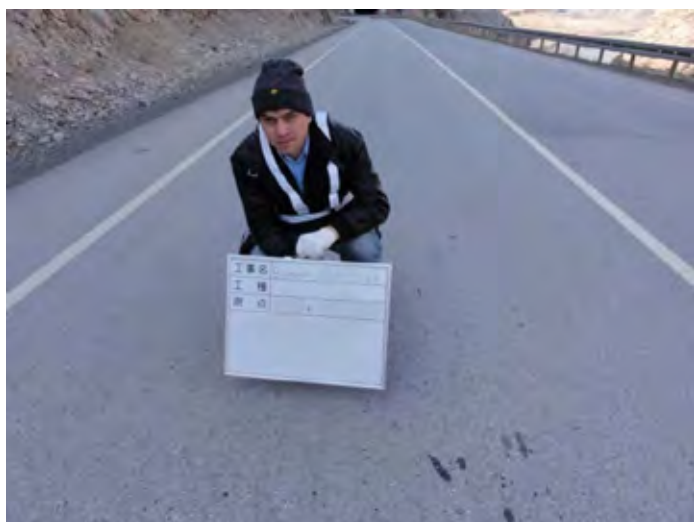
410K+000

路面状況は良好

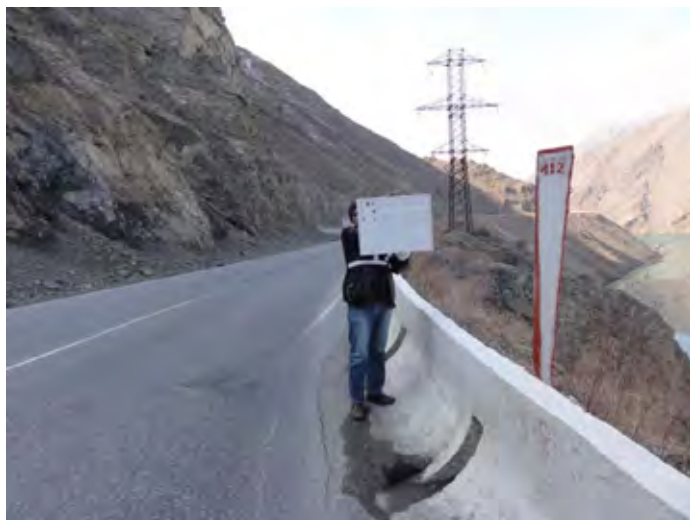
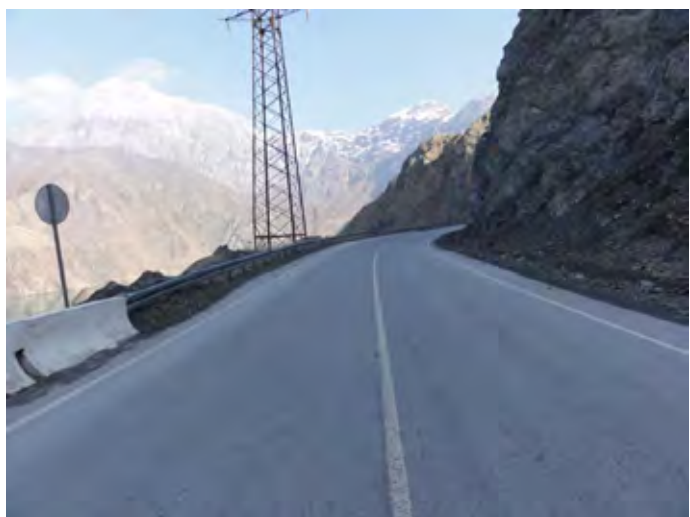
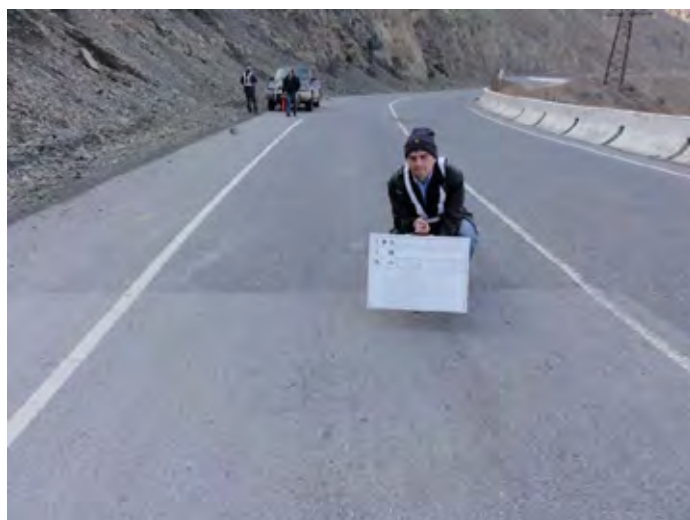
4 1 2 K + 0 0 0

路面状況は良好

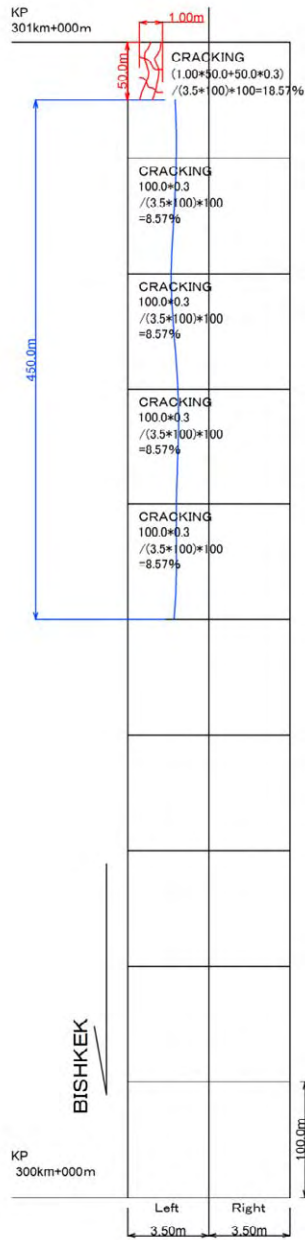
longitudinal and transverse crack
 LEFT length=450 m RIGHT length= m
 alligator crack
 LEFT length=50 m RIGHT length= m
 area=50m² area=m²
 repaired
 LEFT length= m RIGHT length= m
 area=m² area=m²
 depression
 LEFT length= m RIGHT length= m
 area=m² area=m²
 rutting
 LEFT length= m RIGHT length= m
 area=m² area=m²
 corrugation
 LEFT length= m RIGHT length= m
 area=m² area=m²

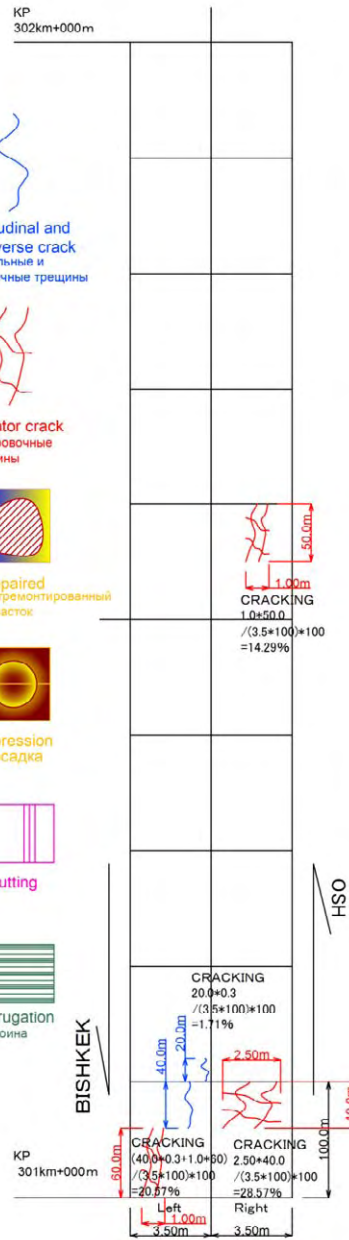
longitudinal and transverse crack
 LEFT length=60 m RIGHT length= m
 alligator crack
 LEFT length=60 m RIGHT length=90 m
 area=60m² area=150m²
 repaired
 LEFT length= m RIGHT length= m
 area=m² area=m²
 depression
 LEFT length= m RIGHT length= m
 area=m² area=m²
 rutting
 LEFT length= m RIGHT length= m
 area=m² area=m²
 corrugation
 LEFT length= m RIGHT length= m
 area=m² area=m²

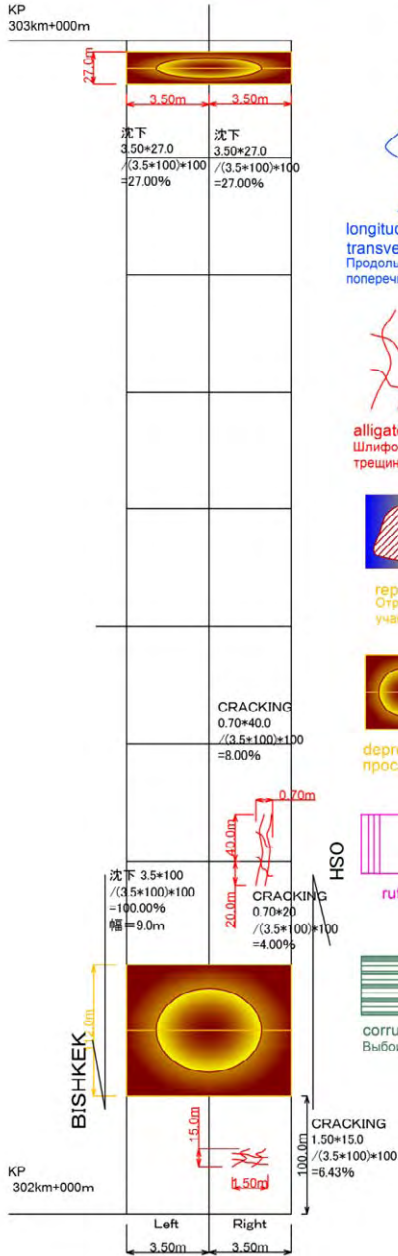
longitudinal and transverse crack	LEFT length= m	RIGHT length= m
alligator crack	LEFT length= m	RIGHT length=75 m
	area=m ²	area=64.5m ²
repaired	LEFT length= m	RIGHT length= m
	area=m ²	area=m ²
depression	LEFT length=139 m	RIGHT length=139 m
	area=486.5m ²	area=486.5m ²
rutting	LEFT length= m	RIGHT length= m
	area=m ²	area=m ²
corrugation	LEFT length= m	RIGHT length= m
	area=m ²	area=m ²

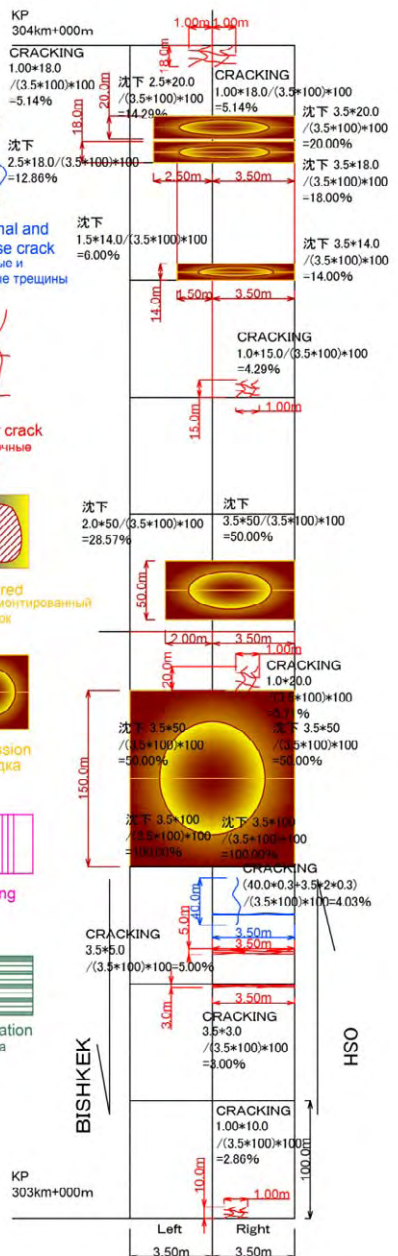
longitudinal and transverse crack	LEFT length= m	RIGHT length=47 m
alligator crack	LEFT length=18 m	RIGHT length=71 m
	area=18m ²	area=91m ²
repaired	LEFT length= m	RIGHT length= m
	area=m ²	area=m ²
depression	LEFT length=252 m	RIGHT length=252 m
	area=741m ²	area=882m ²
rutting	LEFT length= m	RIGHT length= m
	area=m ²	area=m ²
corrugation	LEFT length= m	RIGHT length= m
	area=m ²	area=m ²

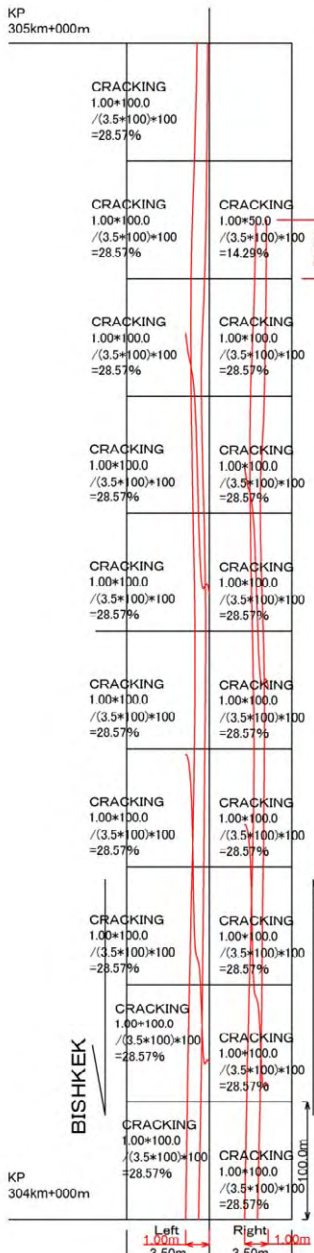
Defect Type	LEFT length= m	RIGHT length= m	LEFT area= m ²	RIGHT area= m ²
longitudinal and transverse crack	length=1000 m	length=850 m	area=1000m ²	area=850m ²
alligator crack	length= m	length= m	area= m ²	area= m ²
repaired	length= m	length= m	area= m ²	area= m ²
depression	length= m	length= m	area= m ²	area= m ²
rutting	length= m	length= m	area= m ²	area= m ²
corrugation	length= m	length= m	area= m ²	area= m ²

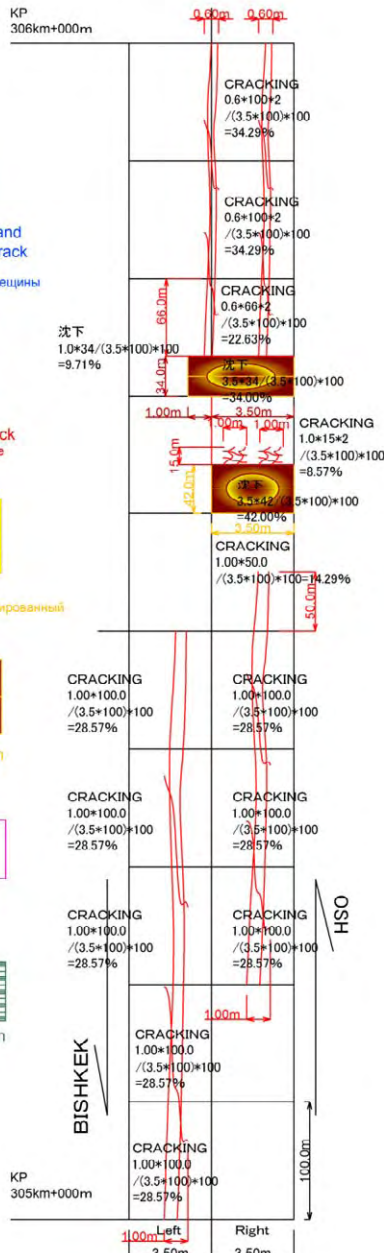
Defect Type	LEFT length= m	RIGHT length= m	LEFT area= m ²	RIGHT area= m ²
longitudinal and transverse crack	length=500 m	length=646 m	area=500m ²	area=699.2m ²
alligator crack	length= m	length= m	area= m ²	area= m ²
repaired	length= m	length= m	area= m ²	area= m ²
depression	length=34 m	length=76 m	area=34m ²	area=268m ²
rutting	length= m	length= m	area= m ²	area= m ²
corrugation	length= m	length= m	area= m ²	area= m ²
