**FOLLOW-UP COOPERATION STUDY
ON
THE PROJECT FOR CONSTRUCTION
OF
THE SUEZ CANAL BRIDGE**

**FOLLOW-UP COOPERATION
STUDY REPORT**

NOVEMBER 2011

JAPAN INTERNATIONAL COOPERATION AGENCY

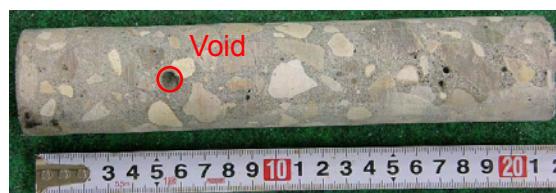
Figure 3 Core Sample in Japanese Section in the West Side (PW39CS0.5)

Negative conditions such as gel deposition around aggregates, expansion of aggregates and unusual crack were not found in all concrete core samples.

More voids in concrete cores from the Japanese section are observed than in those from the local section.

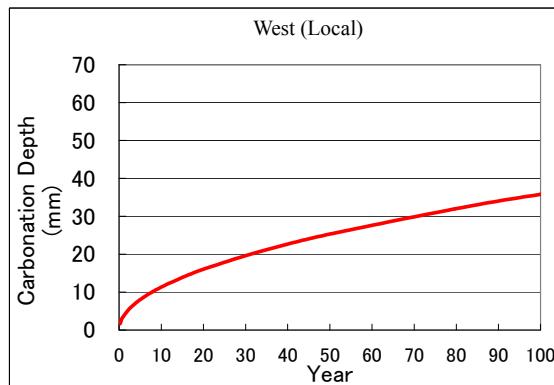
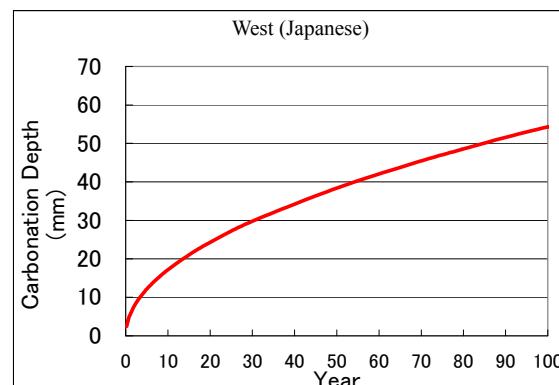
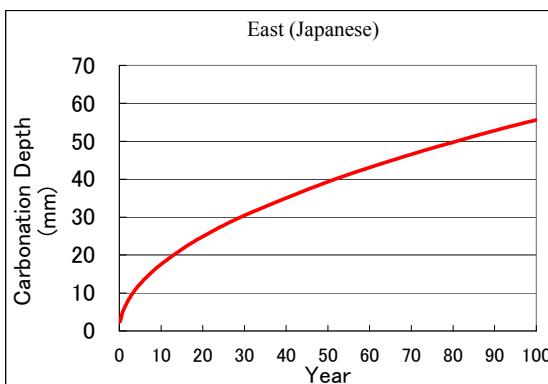
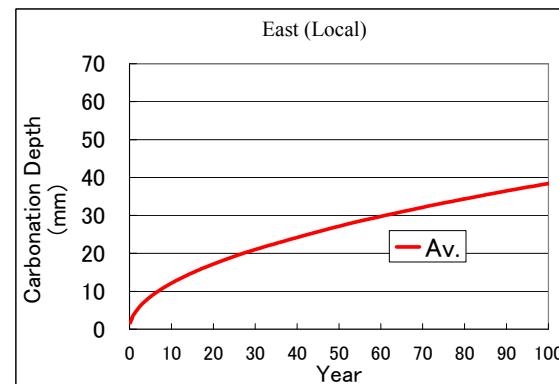
Figure 5 Relation between Carbonation Depth and Service Period

Carbonation Depth	Carbonation Depth + 15 mm
10 year later	16.0 mm	31.0 mm
20 year later	25.3 mm	40.3 mm
90 year later	35.8 mm	50.8 mm

Carbonation Depth	Carbonation Depth + 15 mm
10 year later	24.3 mm	39.3 mm
20 year later	38.4 mm	53.4 mm
90 year later	54.3 mm	69.3 mm

Carbonation Depth	Carbonation Depth + 15 mm
10 year later	17.2 mm	32.2 mm
20 year later	27.2 mm	42.2 mm
90 year later	38.4 mm	53.4 mm

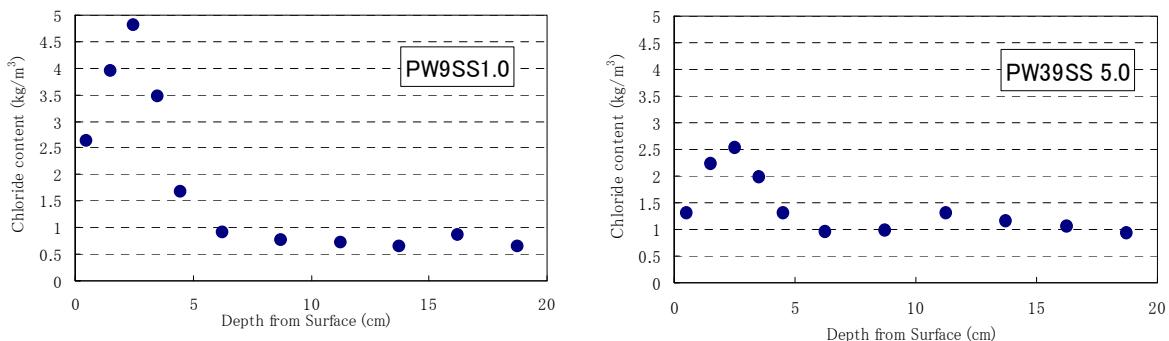
Figure 8 Chloride Contents by Depth

The highest chloride content in deeper than 60 mm is approximately 1.5 kg/m^3 at PE21SS0.5². In other locations, chloride contents were approximately 1.0 kg/m^3 in average.

There is no clear distinction on chloride content depending on heights or sections.

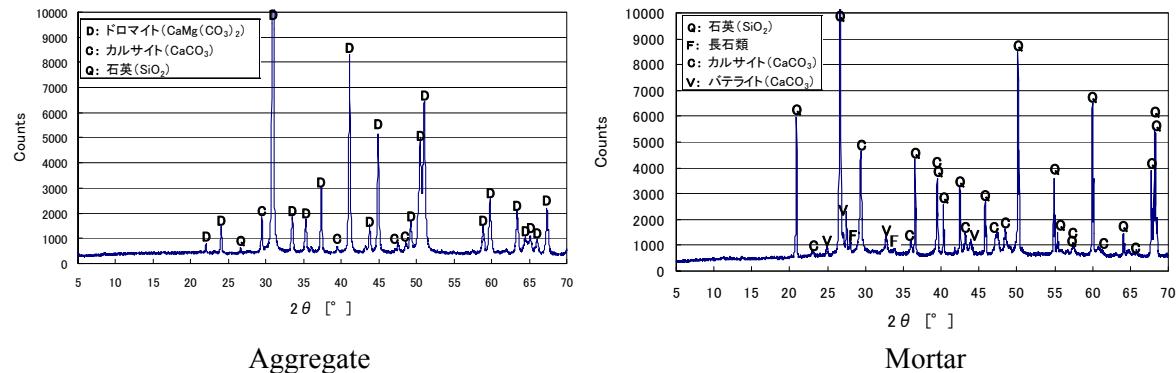
Figure 10 XRD Result

Major component of aggregate is dolomite, and major components of mortar are quartz and calcite.

Ettringite and calcium sulfate, which are produced in case sulfate deterioration is made, were not found.

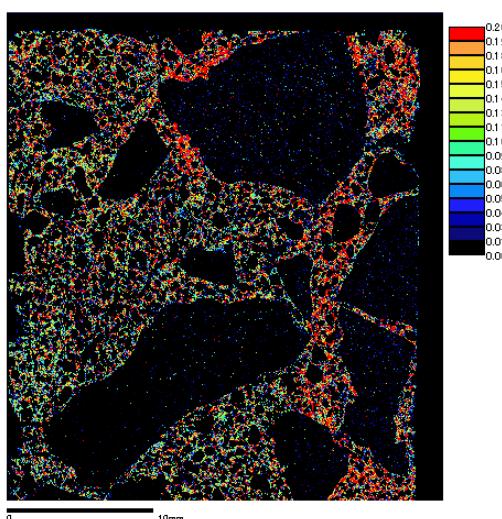
Figure 12 EPMA Result (Detail)

It is considered that chloride has been transferred from coarse aggregates since high chloride contents were found around some coarse aggregates.

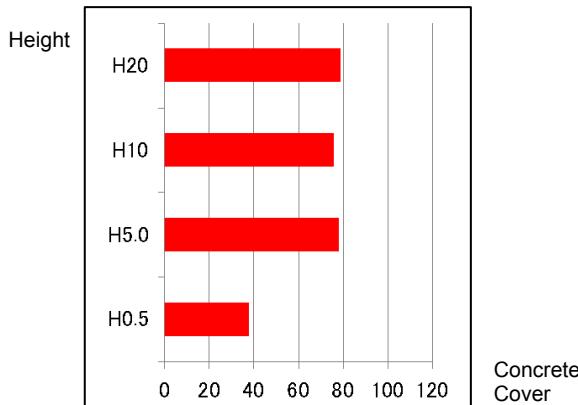
Figure 13 Concrete Cover

- Protection will be provided for the bottom of piers since insufficient concrete cover is mainly located there.
- First lift height is 4 m in local section.
- Lift height by slip form is 7 m in Japanese section, however the height of the fixing point of longitudinal reinforcing bar is 2.2 m.
- Damage has occurred mainly near the ground surface.
- Sufficient concrete cover is secured at 5 m in height.

The height of protection is set as 4 m from the top of pile cap from the following aspects.

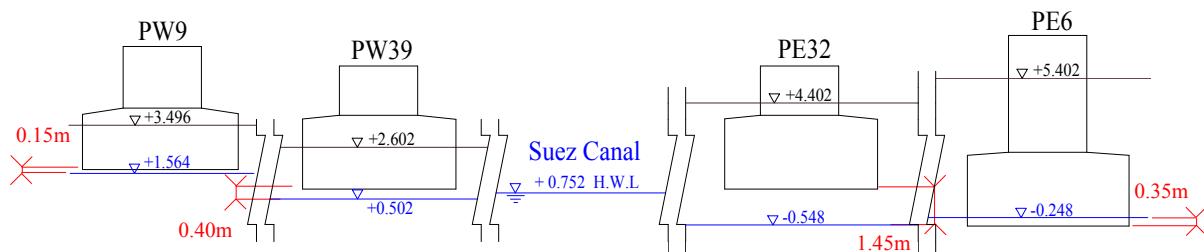
Figure 2.2.1 Relationship between Underground Water Level and Suez Canal Water Level

Pier No.		Depth of Underground Water Level from Ground Surface	Depth of Underground Water Level from Bottom Level of Pile Cap	Measurement Date
PW9	West Side	-1.95	-0.15	2011/04/27
		-2.10	-0.40	2011/04/27
PE6	East Side	-5.65	0.35	2011/04/26
		-4.95	-1.45	2011/04/26

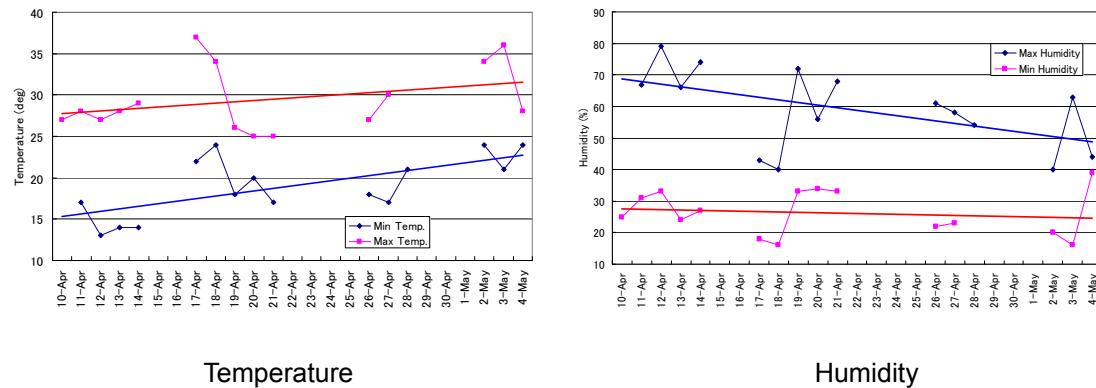
Figure 2.2.5 Meteorological Condition at Site

- Few rain-fall was observed. It should be the same as the whole country.
- Large daily temperature range observed is shown in Figure 2.2.5.
- High temperature and low humidity observed are shown in Figure 2.2.5.

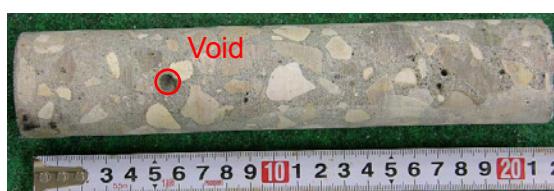
Figure 3.1.2 Core Sample in Japanese Section in the West Side (PW39CS0.5)

Negative conditions such as gel deposition around aggregates, expansion of aggregates and unusual crack were not found in all concrete core samples.

More voids in concrete cores from the Japanese section are observed than in those from the local section.

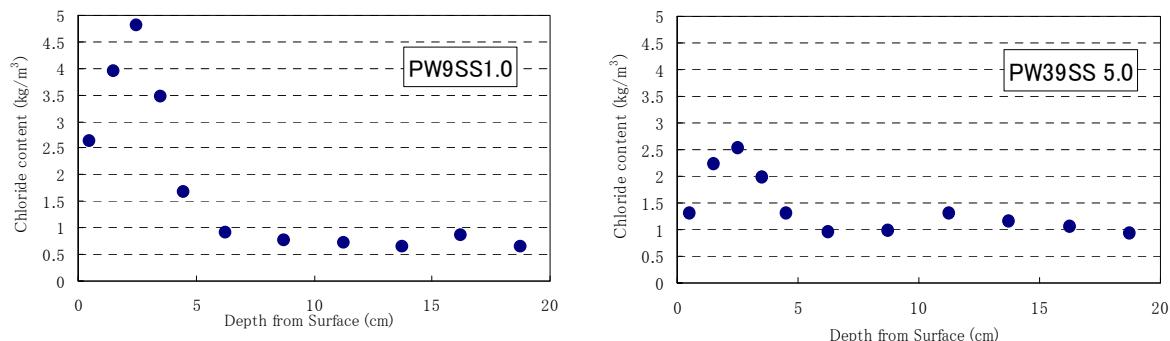
Figure 3.1.11 Chloride Contents by Depth

The highest chloride content in deeper than 60 mm is approximately 1.5 kg/m^3 at PE21SS0.5². In other locations, chloride contents were approximately 1.0 kg/m^3 in average.

There is no clear distinction on chloride content depending on heights or sections.

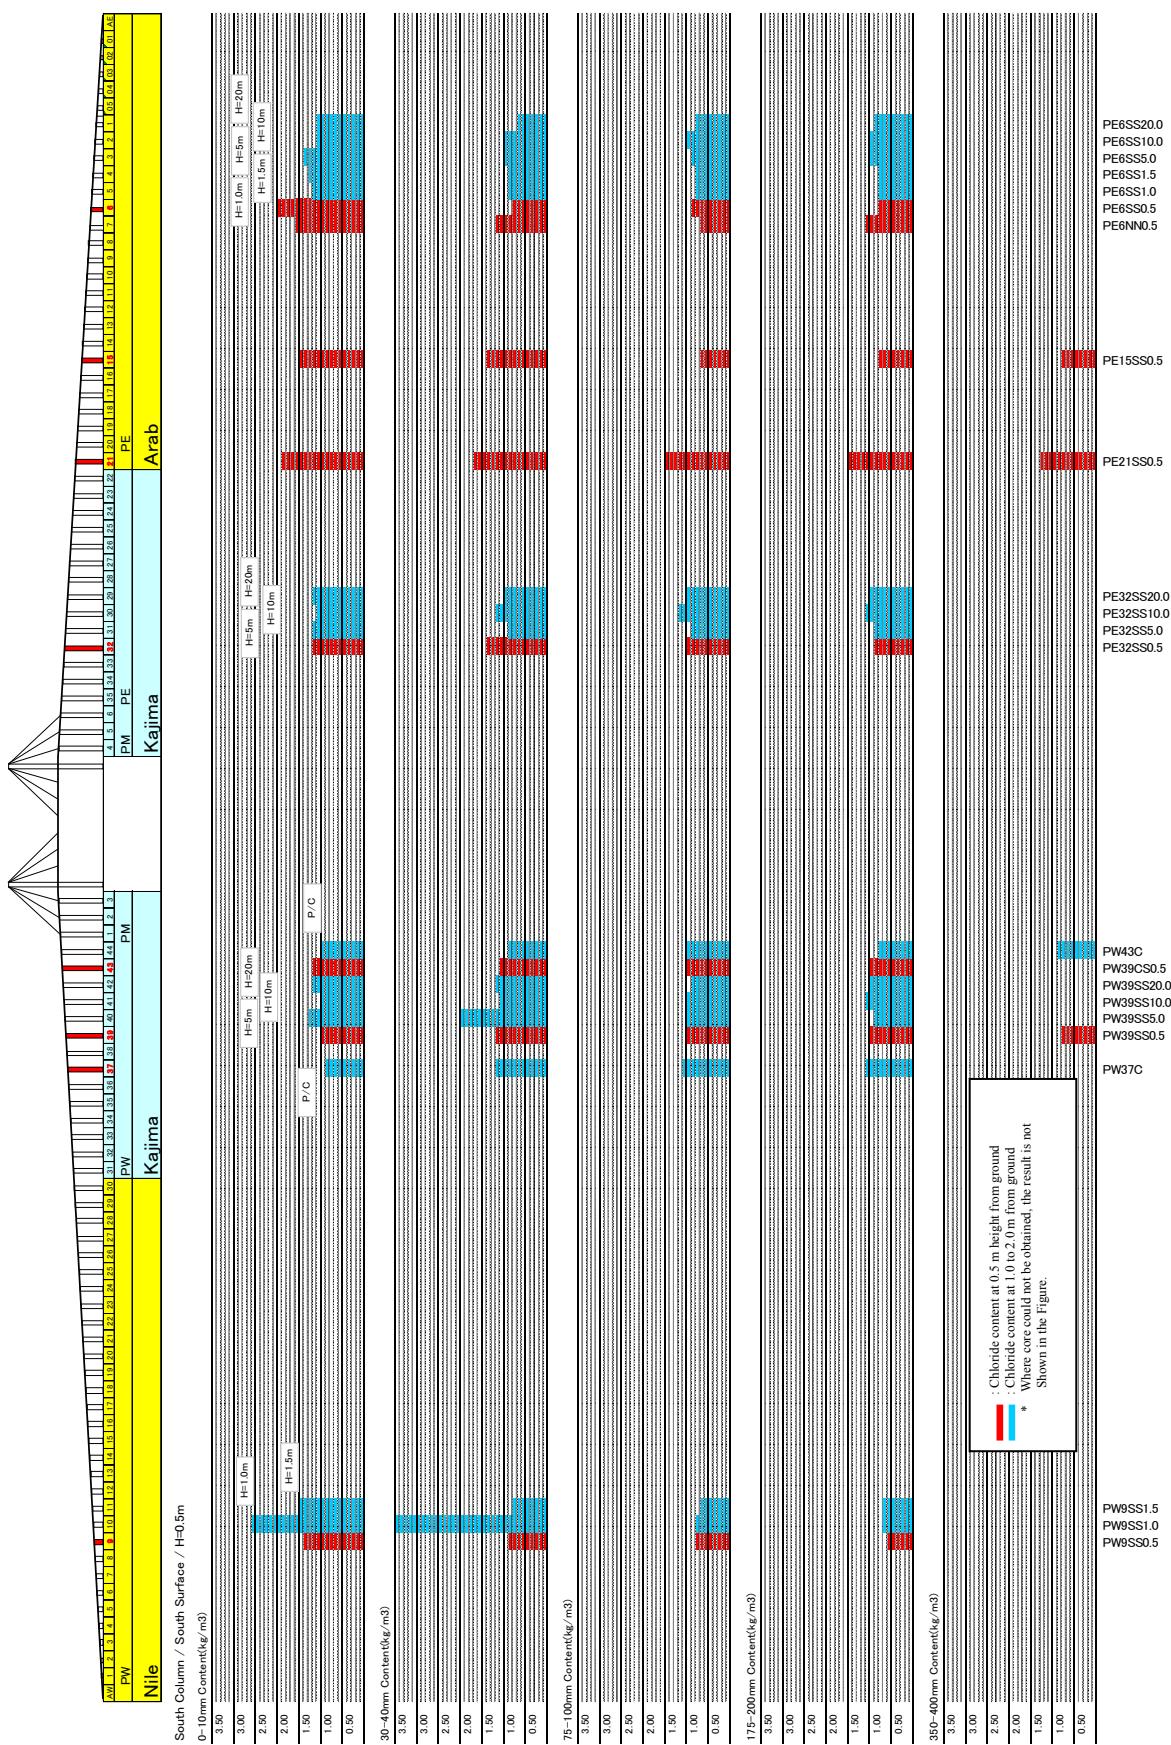
Figure 3.1.12 Chloride Content

² PE21SS0.5 means P: Pier, E: East Section, 21: Pier Number 21, S: South Pier, S: South Face, and 0.5: Height from the ground is 0.5 m.

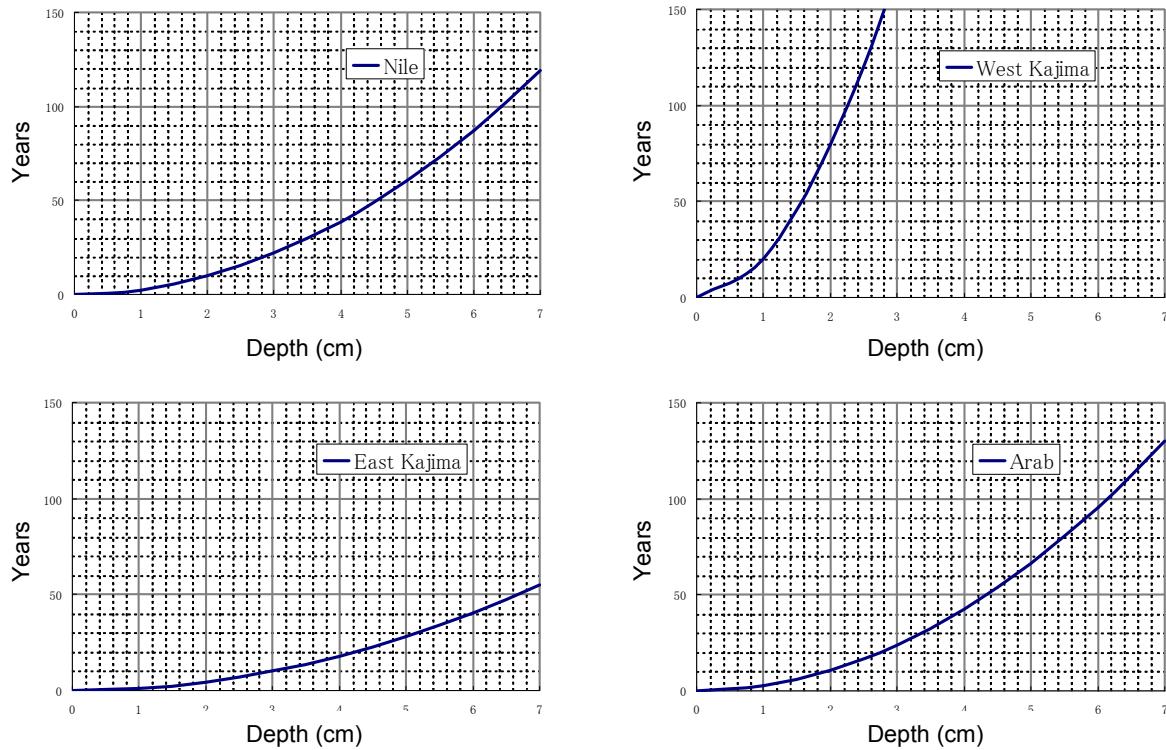
Figure 3.1.13 Period for Chloride Content to Reach 1.2 kg/m^3

Section	Sample	Chloride Content at Surface $C_0 (\text{kg/m}^3)$	Initial Chloride Content $C_i (\text{kg/m}^3)$	Chloride Ionic Diffusion Coefficient $D (\text{cm}^2/\text{year})$	Period for Chloride Content to reach 1.2 kg/m^3 at Concrete Cover Depth (7 cm) (Year)
West (Local)	PW9SS 0.5 PW9SS 1.0 PW9SS 1.5	1.073 3.750 1.060	0.671 0.551 0.693	0.531 1.489 0.357	98.2 8.9 136.0
West (Japanese)	PW37C No.2 PW39SS 0.5 PW39SS 5.0 PW39SS 10.0 PW39SS 20.0 PW39CS 0.5 PW43C No.5	0.282 0.370 1.111 0.164 0.296 0.403 0.542	1.035 0.849 0.991 1.016 0.954 0.949 0.827	1.811 16.477 2.094 1.513 1.788 1.297 1.273	45.1 311.9 6.8 not convergent 293.9 77.6 119.0
East (Japanese)	PE32SS 0.5 PE32SS 5.0 PE32SS 10.0 PE32SS 20.0	0.484 0.361 0.024 0.253	0.860 0.868 1.163 1.050	5.380 0.161 1.003 0.718	31.2 not convergent not convergent 117.8
East (Local)	PE21SS 0.5 PE15SS 0.5 PE6 SS 0.5 PE6 SS 1.0 PE6 SS 1.5 PE6 SS 5.0 PE6 SS 10.0 PE6 SS 20.0 PE6 NN 0.5	0.435 1.063 1.532 0.455 0.603 0.633 0.230 0.547 1.176	1.499 0.738 0.798 0.799 0.752 0.923 0.967 0.795 0.766	0.317 1.027 0.247 0.722 0.679 0.072 0.199 0.038 0.650	0.0 38.9 78.9 1488.9 333.2 561.3 not convergent 5938.7 46.5

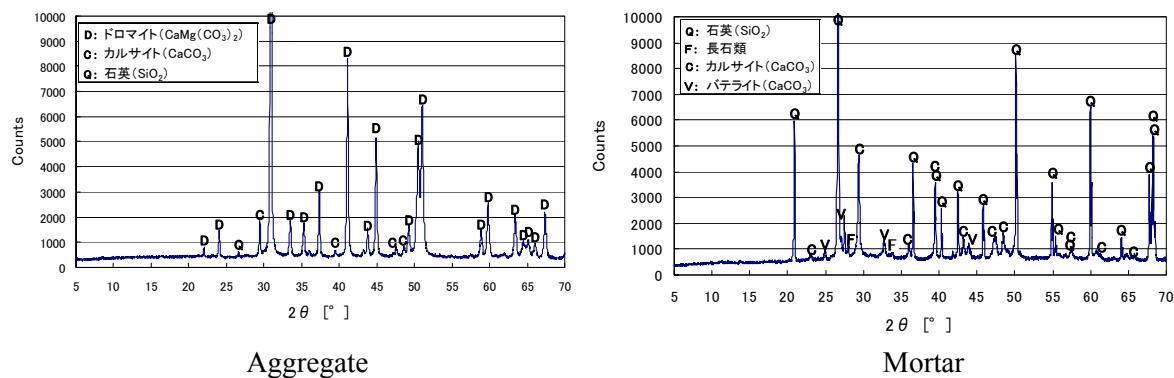
Figure 3.1.14 XRD Result

Major component of aggregate is dolomite, and major components of mortar are quartz and calcite.

Ettringite and calcium sulfate, which are produced in case sulfate deterioration is made, were not found.

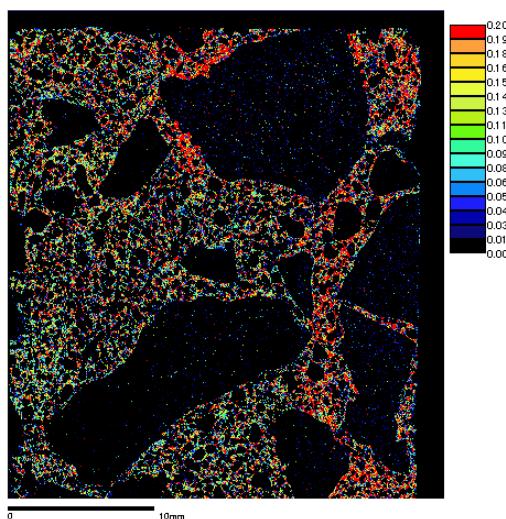
Figure 3.1.16 EPMA Result (Detail)

It is considered that chloride has been transferred from coarse aggregates since high chloride contents were found around some coarse aggregates.

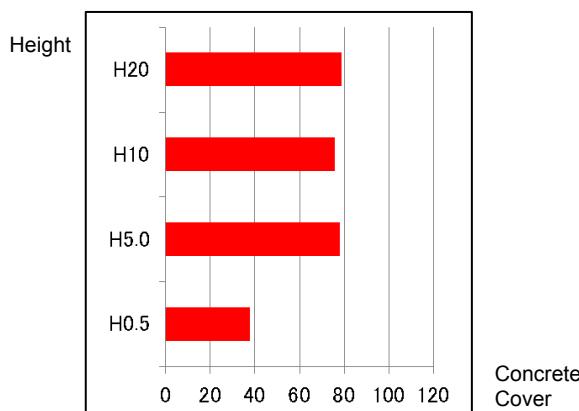
Figure 3.3.2 Concrete Cover

- Protection will be provided for the bottom of piers since insufficient concrete cover is mainly located there.
- First lift height is 4 m in local section.
- Lift height by slip form is 7 m in Japanese section, however the height of the fixing point of longitudinal reinforcing bar is 2.2 m.
- Damage has occurred mainly near the ground surface.
- Sufficient concrete cover is secured at 5 m in height.

The height of protection is set as 4 m from the following aspects.

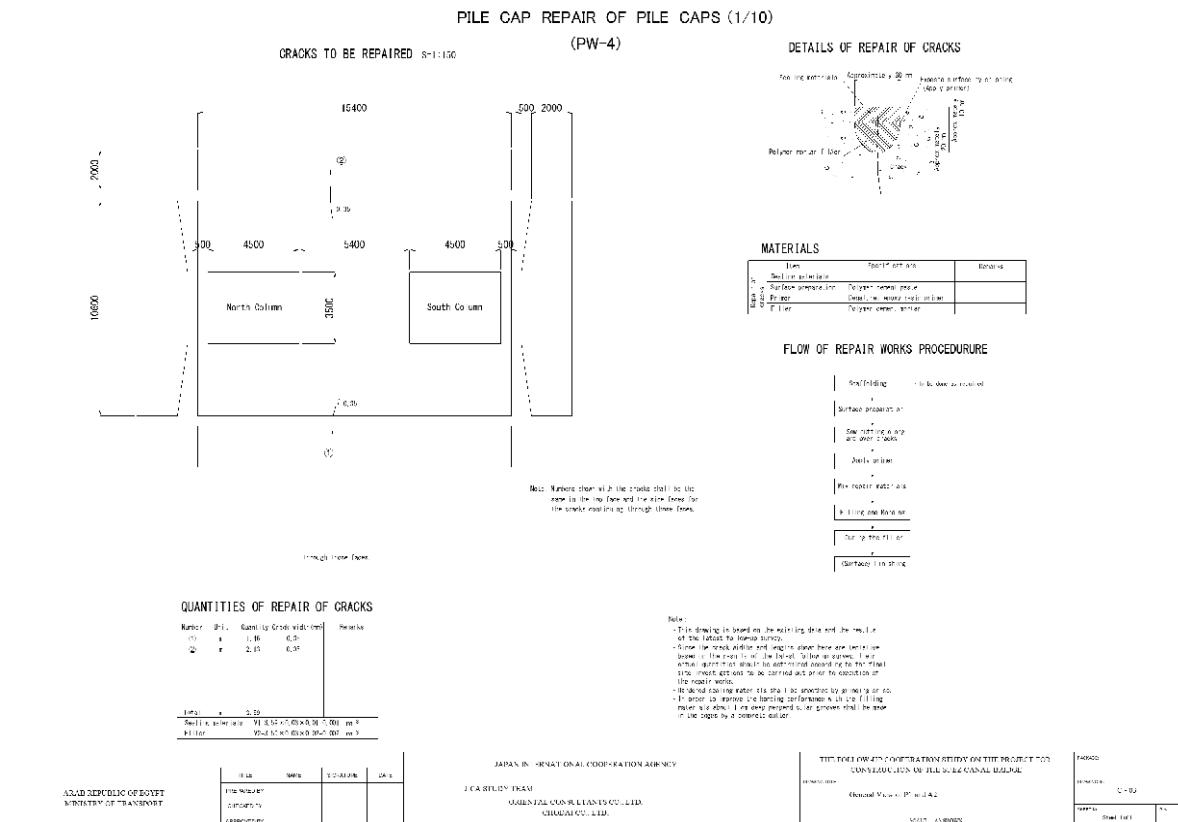
Figure 3.4.3 Repair of Crack

Cracks on upper surface have grillage-like regular pattern, namely, at orthogonal regular intervals (1 to 2 m).

Depth of crack exceeds 200 mm at the 0.5 mm width of crack.

It is considered that cracks have occurred by not corrosion of reinforcing bar but thermal restraint with heat of cement hydration.

For pile caps, it is evaluated as “B or C”, therefore, repair work is necessary for pile caps with wider than 0.35 mm of cracks.
