**JAPAN INTERNATIONAL COOPERATION AGENCY  
GEOLOGICAL SURVEY OF ETHIOPIA**

**THE PROJECT FOR DEVELOPING  
COUNTERMEASURES AGAINST LANDSLIDERS IN  
THE ABAY RIVER GORGE**

**FINAL REPORT**

**January 2012**

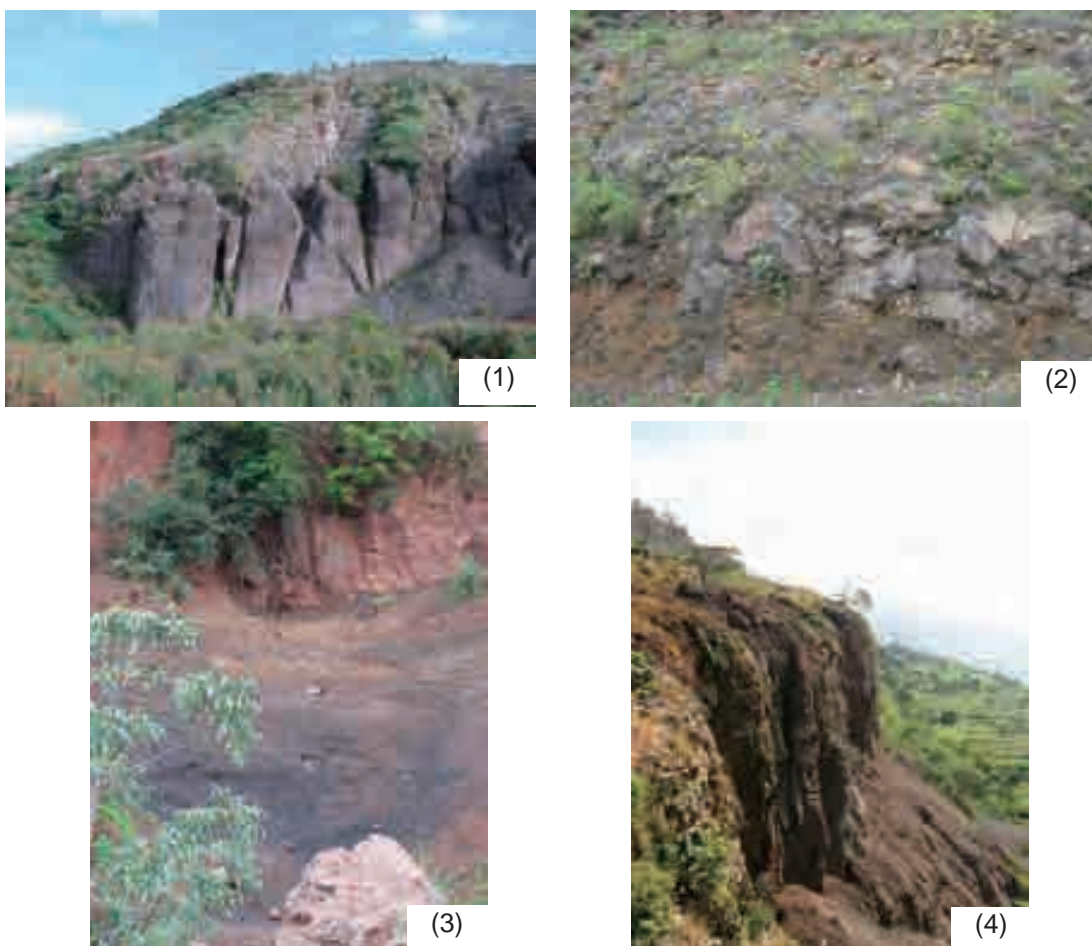
Photo 3.4.6 View of the basalt on Ashangi Formation

The upper part is constituted by basaltic lava and pyroclastic rocks. The basalt is over 80 m thick, whereas the pyroclastic is up to 40 m thick. The basalt is mainly black to dark grey and has clearly developed columnar joints (30-50 cm). A flow breccia is observed in the lowest part (Photo 3.4.6 (2)).

Pyroclastic rocks are observed under this lava unit (Photo 3.4.6 (3)). The pyroclastic rocks unit contains lapili tuff, tuff breccia, tuffaceous sandstone and mudstone, which are susceptible to slaking erosion. The slaking erosion means that rock collapse by alternate wetting and drying. The characteristic that the pyroclastic change to a soil by the slaking would be one of the triggering factor of landslides in this area. The pyroclastic unit basically forms gentle slopes, however sometimes makes a steep slope (Photo 3.4.6 (4)). The color is varied depending on the materials and weathering oxidation reaction.

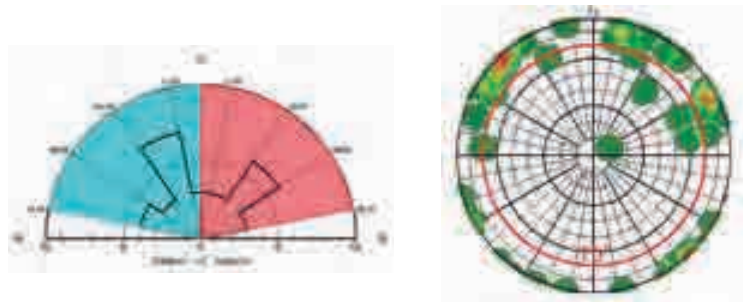
Figure 3.4.7 The tendency of the basaltic lava joint set

The Ashangi Formation has clearly developed columnar joints (20-50cm). The strike of the joints is trending NW and NE with over 70 degree dip (Figure 3.4.7). The two joint sets with

both closely and widely spaced cracks would result in huge rock failures especially at these intersections.

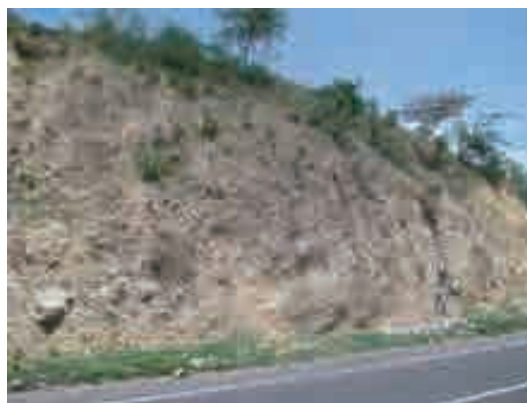
Photo 3.4.7 Thick colluvial deposit, along the road in Filiklik,

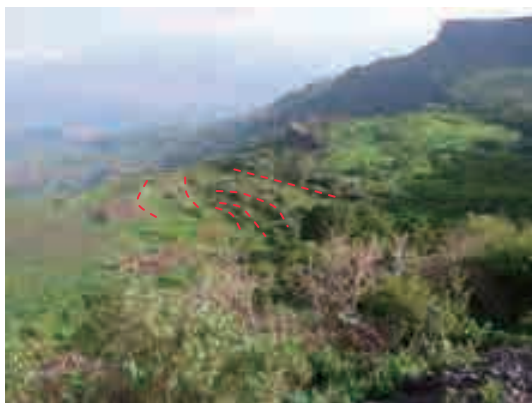
Photo (1)  
Distant view near the boundary of the lower part of L/S00-1 and L/S00-5  
Wrinkle-like irregular land features running in parallel.  
Deformation seems to be occurring in L/S00-5 due to movement of L/S00-1.

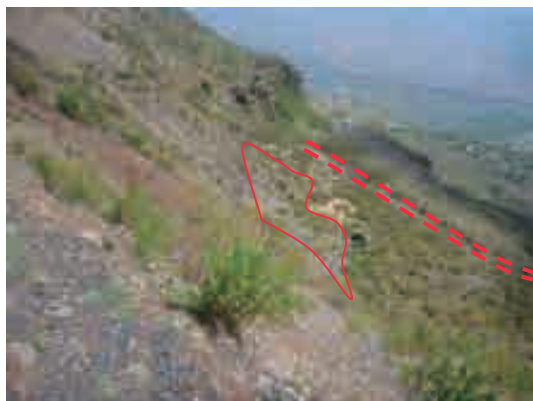
Photo (1)  
L/S05-1 block as viewed from the top  
An old channel crosses the L/S05-1, and debris from the upper part is piled up on the block. The debris is a load on the L/S05-1 block.

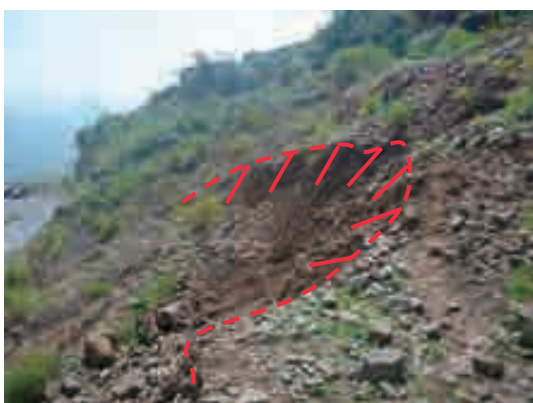
Photo (5)  
Small collapses on the mountain side of the toe of the L/S05-1 (2)  
Small collapses as viewed from inside the block.

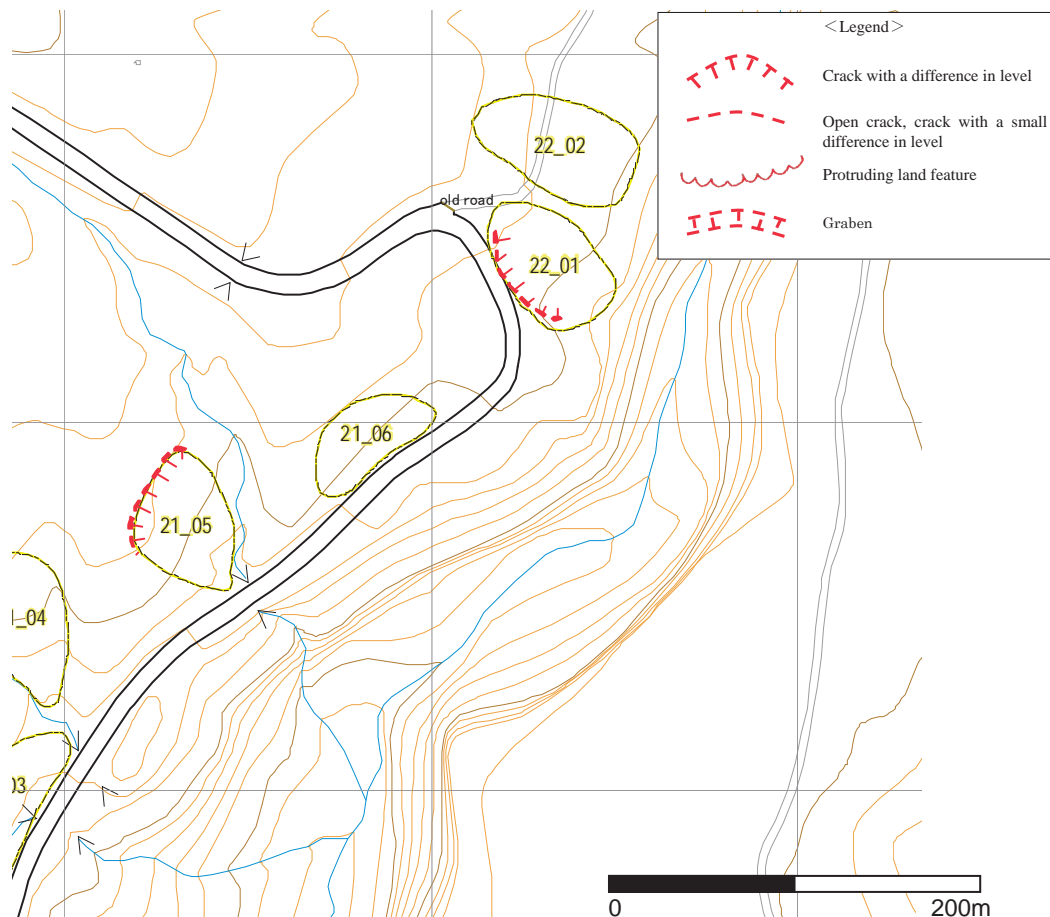
Figure 3.4.10 Surface anomalies in L/S22 (ST.21+600 to 22+300)

In this area, there are two blocks that are believed to have been active in recent years; a predominant displacement is the L/S22-1. This block could have resulted from events that occurred when the toe of the block has been eroded by surface water.

The main scarp and cracks 1 to 2 m in height on the valley side are quite close to the new road.

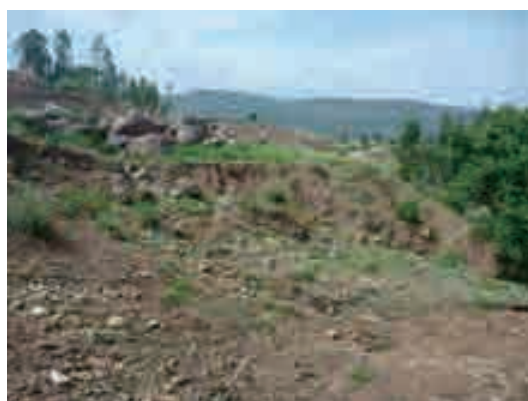
Photo (6)  
The top of the L/S27-2

The area from the L/S27-3 to the top of the L/S27-2 devastated due to erosion and small collapses.

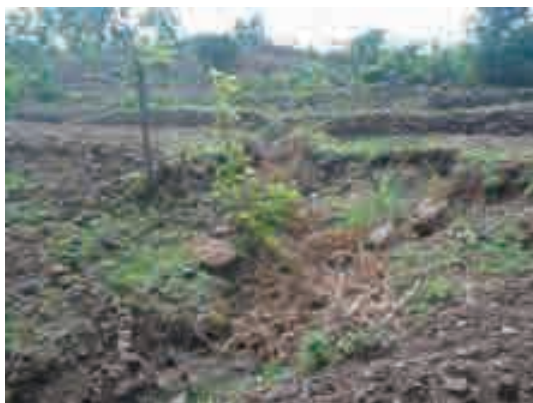
Photo (7)  
Gully erosion on the L/S27-2.  
A channel with developed gullies appears on the slope.

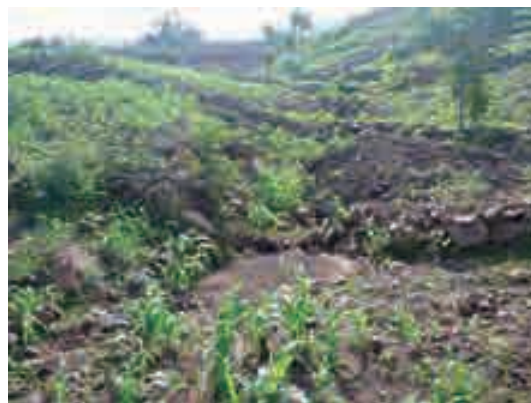
Photo (8)  
Channel on the L/S27-2.  
There is a series of small channel.

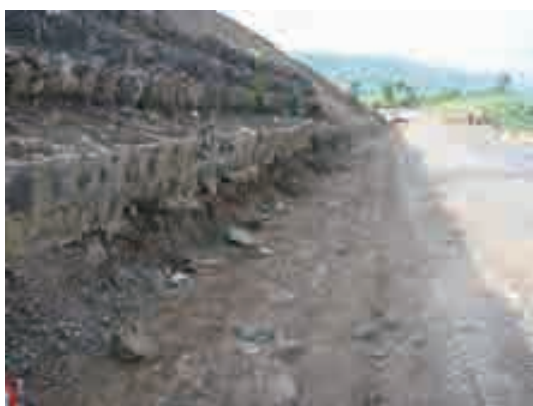
Photo (9)  
Top of the L/S27-2.  
The road surface is sinking at the top of the block, causing a maximum difference in altitude of 1m from the former roadside channel. It can be seen that the top of the block has sunken due to the landslide.

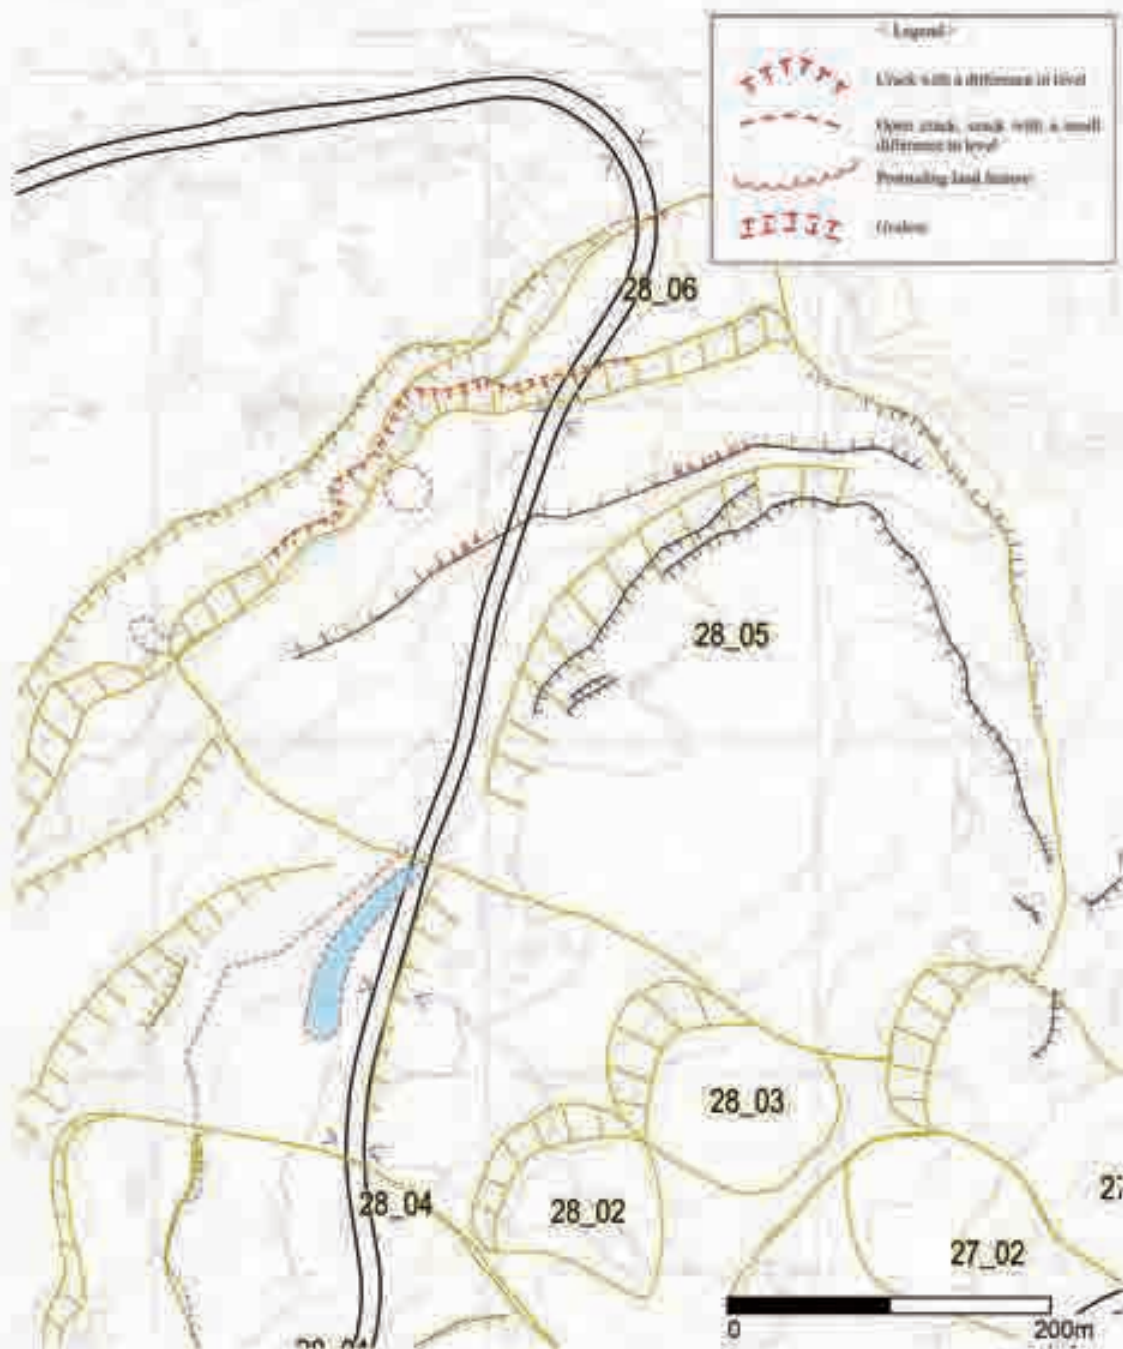
Figure 3.4.12 Surface anomalies in L/S28 (ST.28+400 to 28+800)

This area is positioned at the head of a large landslide covering the whole region. There are continuous clear main scarps and cracks, whose mountain side is sinking, that runs roughly in parallel with the main scarps. L/S28-2 is one of the multiple landslide blocks in the area.

However, as to whether the current L/S28-3 block is a part of the huge landslide or is independent from the big one, it is difficult to judge only through satellite image interpretation and reconnaissance. Considering the size of the subsidence, however, it can be estimated that a moving block is at least 300 m wide.
