# Chapter 4

*Landslide Analysis and Interpretation*

## 4 Landslide Analysis and Interpretation

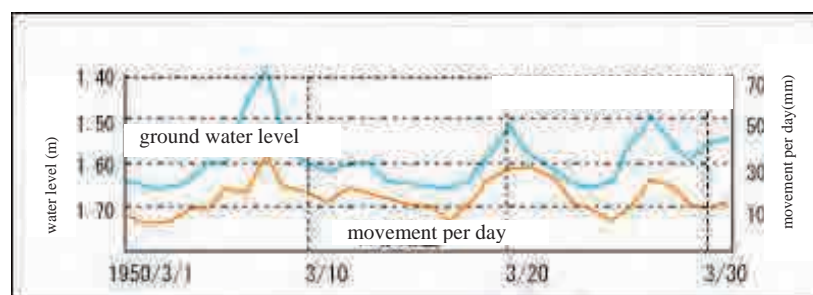
Figure 4.1.4 Example of landslide measurement vs. Groundwater level

The following figure is an example of landslide measurement (Takano, 1960). The groundwater level and the amount of movement correlate splendidly.

Note: Correlation between groundwater level (blue) and movement (orange) of a chronic landslide. The left Y-axis represents groundwater level (m) and the right,

daily movement (mm) of the landslide; while the X-axis is the date  
(year/month/day).

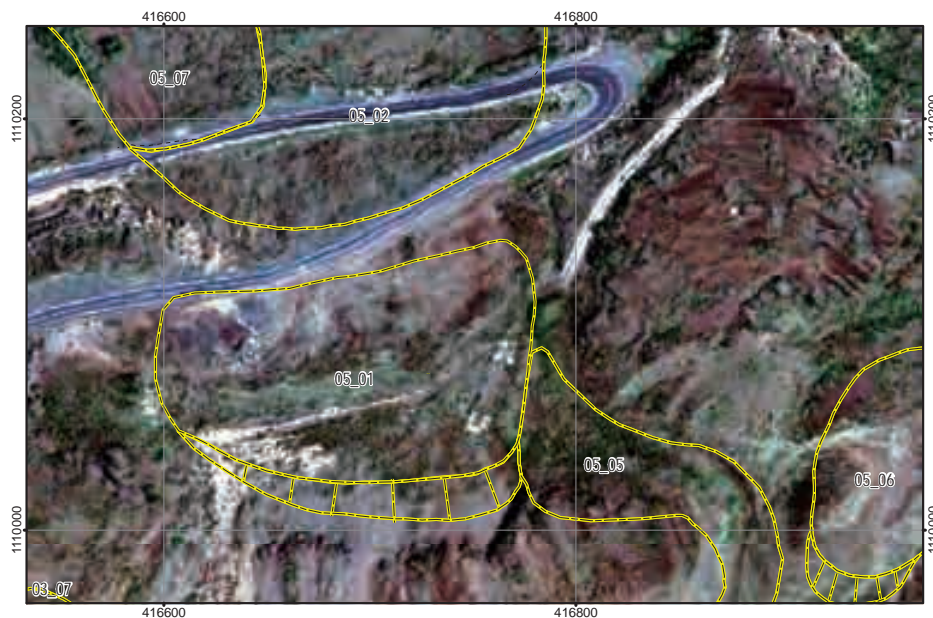
Figure 4.3.1 Examples of old landslides (L/S05-01)

Figure 4.3.1 shows the result of satellite imagery interpretation near L/S05-01. The horseshoe-shaped steep cliff surrounding the landslide block at L/S05-01 is the main scarp of the old huge landslide that formed this horseshoe-shaped cliff in ancient times. Thereafter, moving mass by a landslide that occurred on the upper part (L/S03-01, etc.) was piled up at the head of the lower landslide, and then a secondary landslide occurred. The secondary landslide can be interpreted as being at L/S05-01.

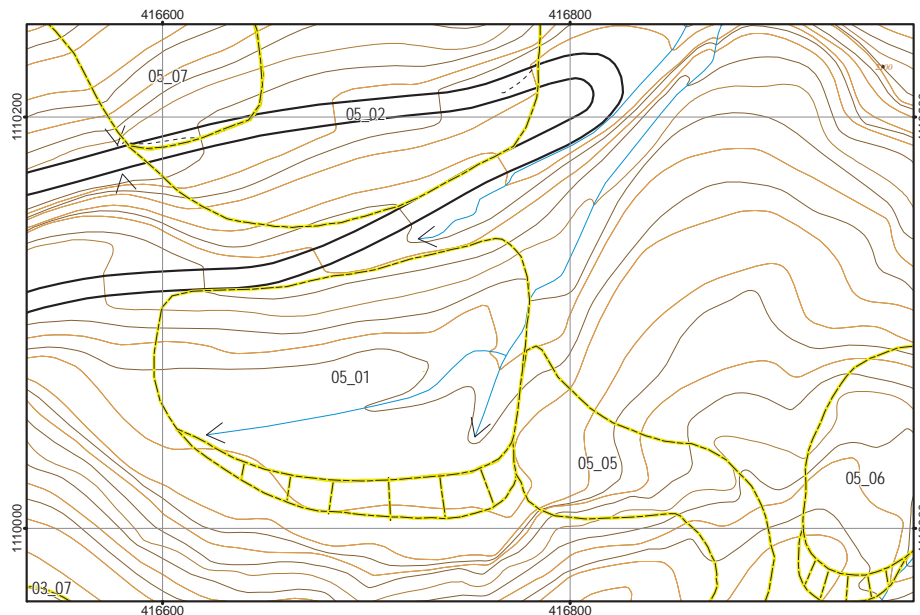
Figure 4.3.2 Interpreted landslide map around station (L/S05-01)

Figure 4.3.2 shows map of landslides from the satellite imagery interpretation around the landslide block at L/S05-01. Here, the main scarp of the old landslide is not interpreted as a main scarp of the current landslide; a main scarp in the Project is defined as a head crown of a landslide which is moving at the moment.

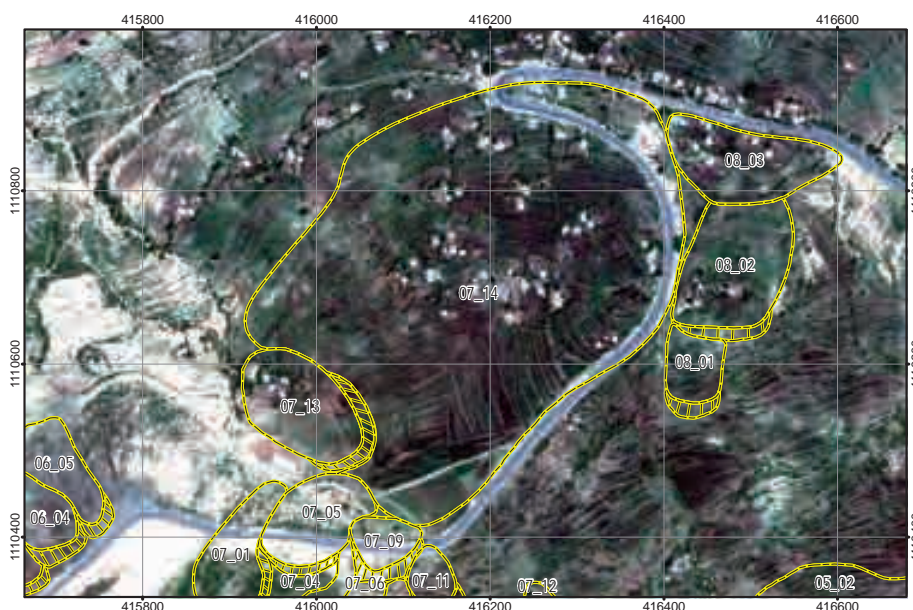
Figure 4.3.3 Examples of old landslide (L/S07-14)

As a similar example, Figure 4.3.3 shows the result of satellite imagery interpretation near L/S07-11. The round hill at the center of the figure represents an old landslide. The steep cliff behind it, on the southern side of the road (lower-right portion of the photo), can be interpreted as the old main scarp. Figure 4.3.4 shows map of landslides from the satellite imagery interpretation. The moved portion of the old landslide is interpreted as a landslide block. However, the main scarp of the old landslide is not interpreted as a main scarp of a current landslide.

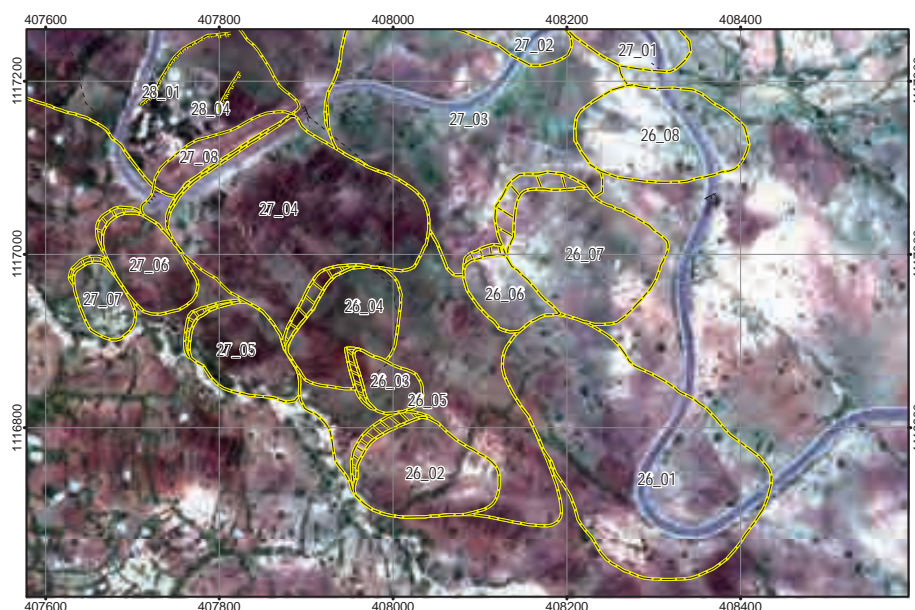
Figure 4.3.5 Satellite imagery interpretation and mapping of landslides (L/S26 to L/S27)

The area from L/S26 to L/S28 has a widely distributed colluvial deposit and contains multiple landslides, these are distributed in multiple layers, so it is difficult to identify and extract single landslides.

Among the landslide topographies that can be identified from satellite imagery, (1) the range where a landslide can be clearly identified and (2) the range where a moving block can be identified as an event on the ground surface, such as deformation of a road or formation of a new main scarp, are interpreted as a landslide block. Global Positioning System (hereafter GPS) measurements were used when the boundary between two landslide blocks was not clear only from interpretation of satellite imagery. The boundary between the blocks was determined using the road deformation and the crack distributions by GPS measurements. The landslides identified in this area are showed in Figure 4.3.6.

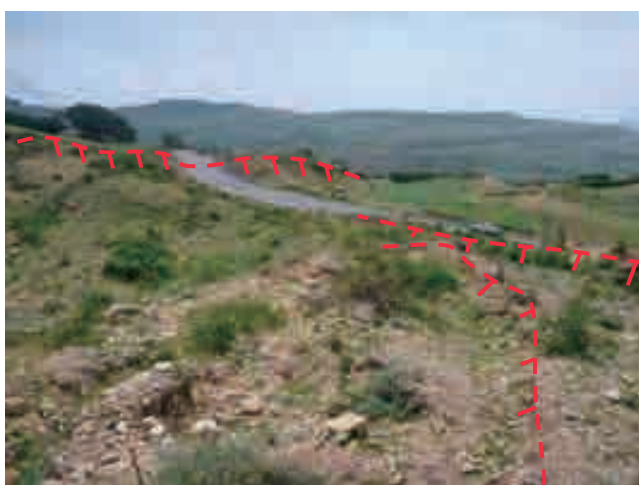
Photo 4.3.1 Depression Zone at Upper part of Landslide

Photo 4.3.1 shows a depression zone commonly found at the upper part of a landslide. There are two or more parallel normal steps confronting each other and a belt-shaped low-lying area is often observed. There is a depression zone at point ST.28. There are multiple depressions on the mountain side and the area between the steps and the main scarp is the depression zone. The high-lying area consists of an isolated hummock.

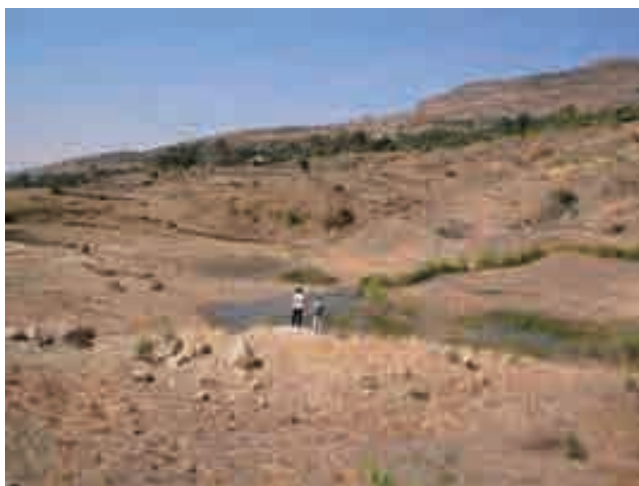
Photo 4.3.2 Pond that Appeared in Field near Kurar Village

A pond is sometimes observed in the depression zone at the upper part of a landslide. Photo 4.3.2 shows the pond that appeared in a field near Kurar Village. Due to the ridges caused by the landslide, the bottom of the landslide was uplifted. As a result, a relatively depressed area was formed where water gathered. Nearly 10 ponds and ground depressions with traces of water build-up are observed scattered around this area.

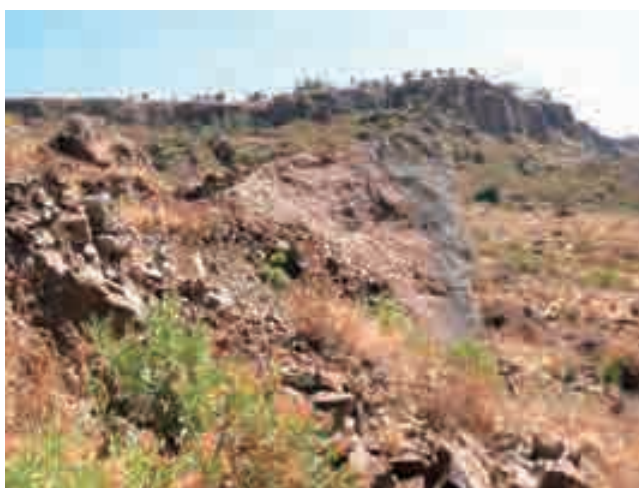
Photo 4.3.4 Ridge Caused by Compression Force of Landslide

Landforms at the end of a landslide include pressure ridges and pressure wrinkles caused by the compression force of the landslide. The soil mass at the rear has been uplifted onto the land (Photo 4.3.4). Also, the end of the landslide tends to be unstable and collapse is liable to occur on steep slopes consisting of landslide mass. Collapse is liable to occur at the end of an active landslide as well as at the end of a steep landslide.

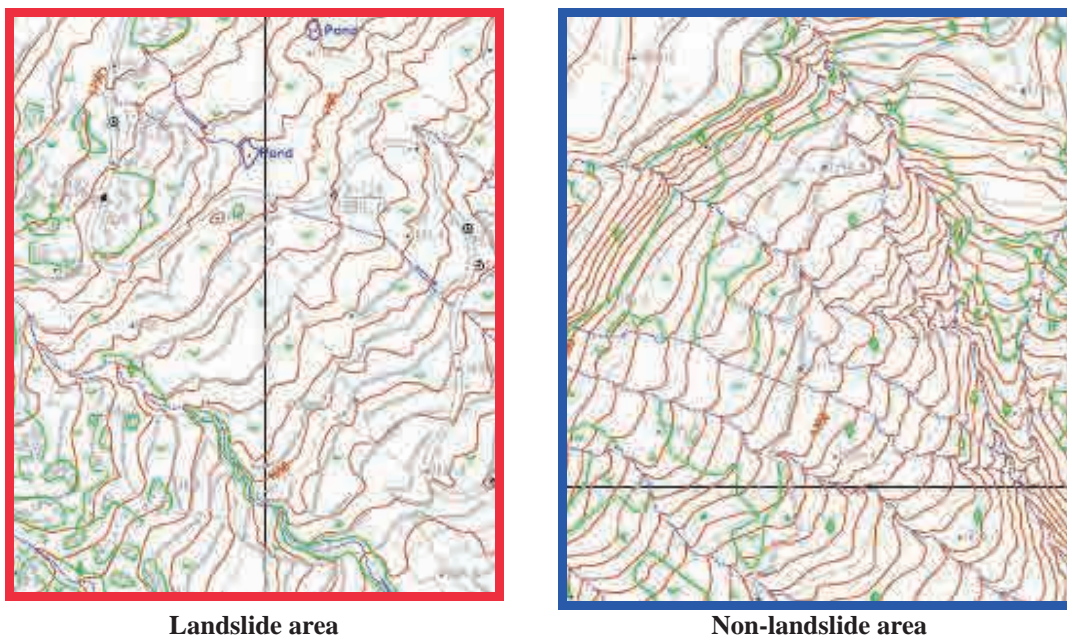
Figure 4.3.11 Comparison of Contour Lines in Landslide Area and Non-landslide Area

When interpreting topographic maps, it is possible to deduce the existence of landslides from the irregular contour lines. Figure 4.3.11 is a topographic map of the vicinity of Kurar Village on the Dejen side. The area to the left is not a landslide area. The contour lines are parallel and drawn in an orderly manner. The rivers flow relatively straight. On the other hand, the area to the right is a landslide area. The contour lines are irregular and the river courses are often interrupted. Since surface water easily permeates through cracks in a landslide area, the water spreads underground, making it difficult for rivers to form.

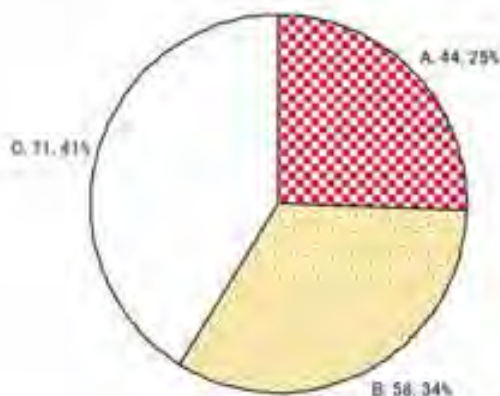
Figure 4.3.13 Landslide Hazard Rank and the Number of Landslide Blocks

Figure 4.3.13 is a graph showing the relationship between the landslide hazard rank and the number of landslide blocks. Of the 167 landslide locations, 23% are ranked A (highest risk).

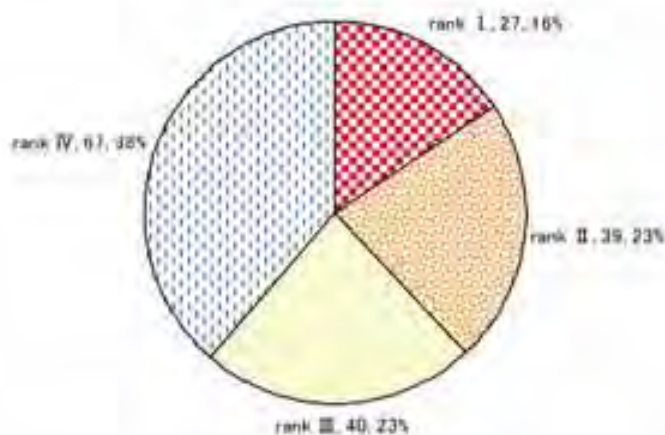
Figure 4.3.14 Rank of Risk on Roads and the Number of Landslide Blocks

Figure 4.3.14 is a graph showing the relationship between the risk level considering the influence on roads and the number of landslide blocks. 13% of the blocks are ranked I (highest risk), while 24% are ranked II.

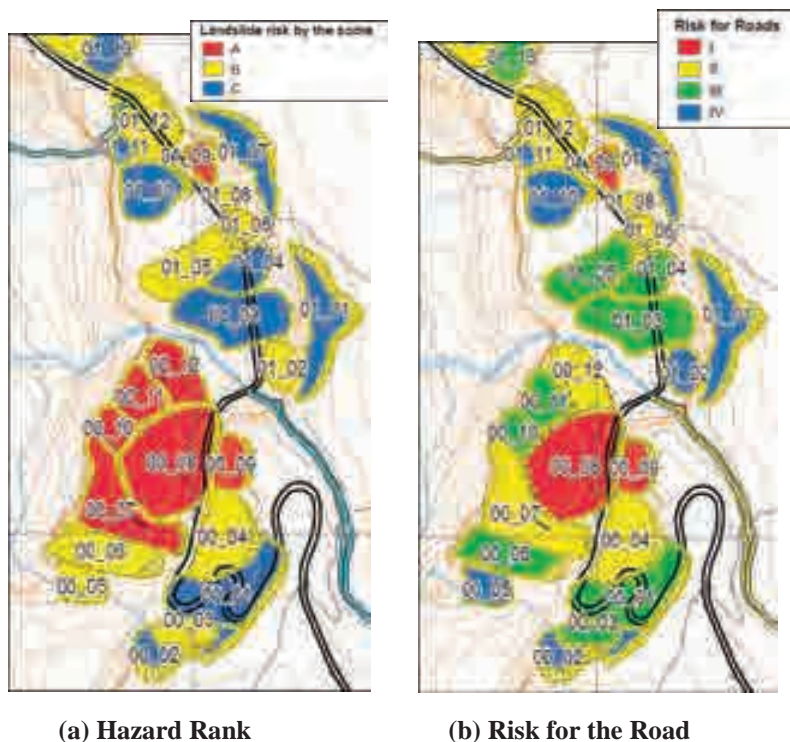
Figure 4.3.15 Area of Particularly High Risk for the Road (L/S00 to L/S01)

Figure 4.3.15 shows a distribution chart of the landslides around L/S00 and L/S01 indicating differences in their influences on the road. Figure 4.3.15 (a) shows the hazard rank based on the evaluation score, and (b) shows that for the risk for the road. It can be seen that there are many landslides with a high hazard rank at L/S00. When influence on the road is considered, the risk is high at monitoring sites L/S00-08 and L/S00-09.

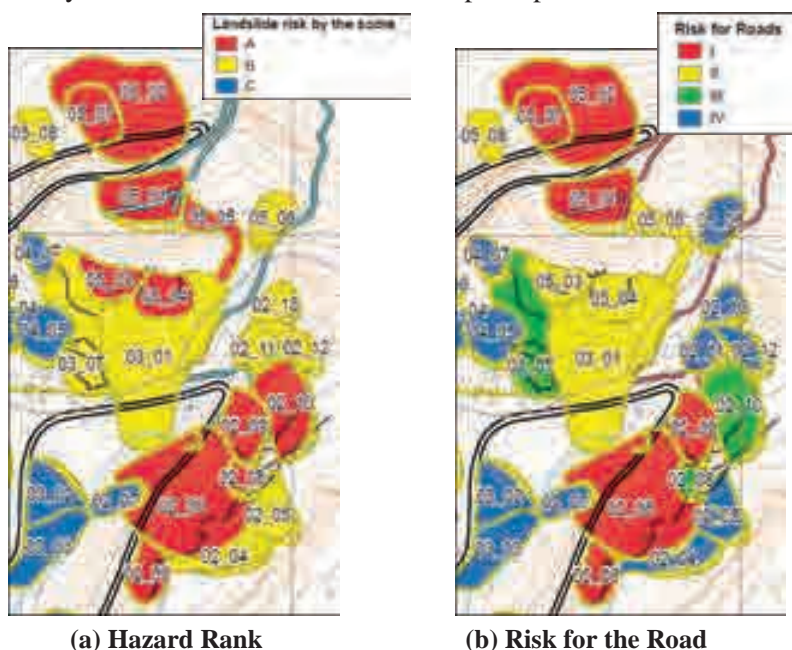
Figure 4.3.17 Area of Particularly High Risk for the Road (L/S02 to L/S05)

Figure 4.3.17 shows a distribution chart of landslides around L/S02 to L/S05 indicating differences in their influences on the road. It can be seen that there are many landslides with a high hazard rank around L/S02-06 and L/S05-01. When their influences on the road are considered, there are many (a total of six) high priority landslides such as L/S02-09 and L/S05-01 as showed in Figure 4.3.17 (b).

There are many stepped cracks and currently active landslide blocks (five locations) on the upper portion of the slope at L/S02. Figure 4.3.18 shows a new crack at the head of L/S02-03. There are many new cracks with a maximum step of up to 2m.

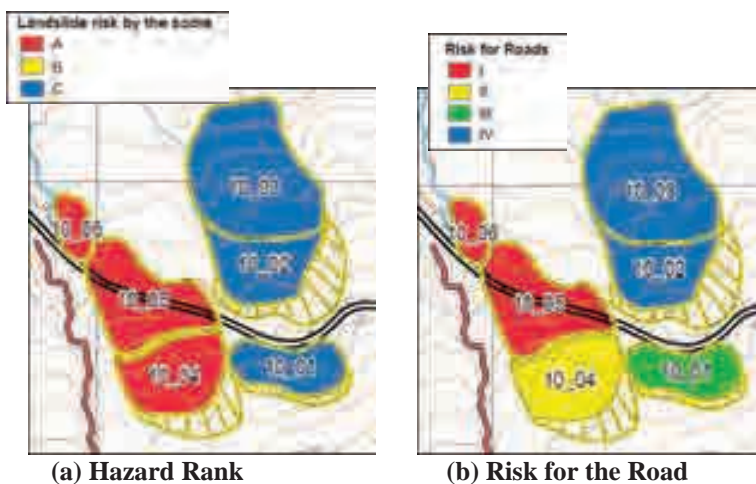
Figure 4.3.23 shows a distribution chart of the landslides around L/S10 indicating differences in their influences on the road. The risk is high at L/S10-05, where the deformation of the road is increasing. However, the speed of movement will not change significantly in the future because the slope of the whole area around this landslide is gentle. Therefore, repair of the road once every several years is sufficient.

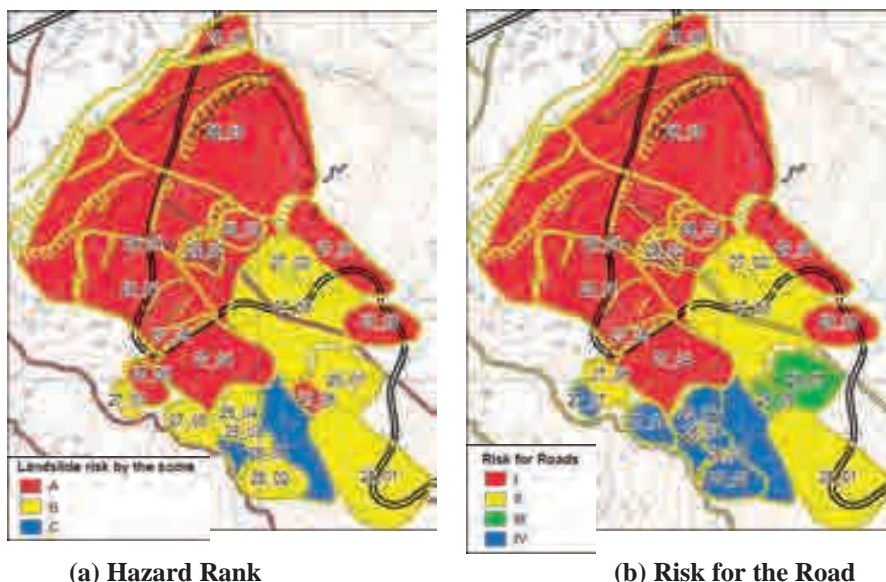
Figure 4.3.25 Area of Particularly High Risk for the Road (L/S26 to L/S28)

Figure 4.3.25 shows a distribution chart of the landslides around L/S26 to L/S28 indicating differences in influences on the road. In this area, there are many small landslide blocks (20 to 30) in a large landslide block. The area has active landslide blocks in multiple layers. Therefore, there are many high priority landslides (11 locations).

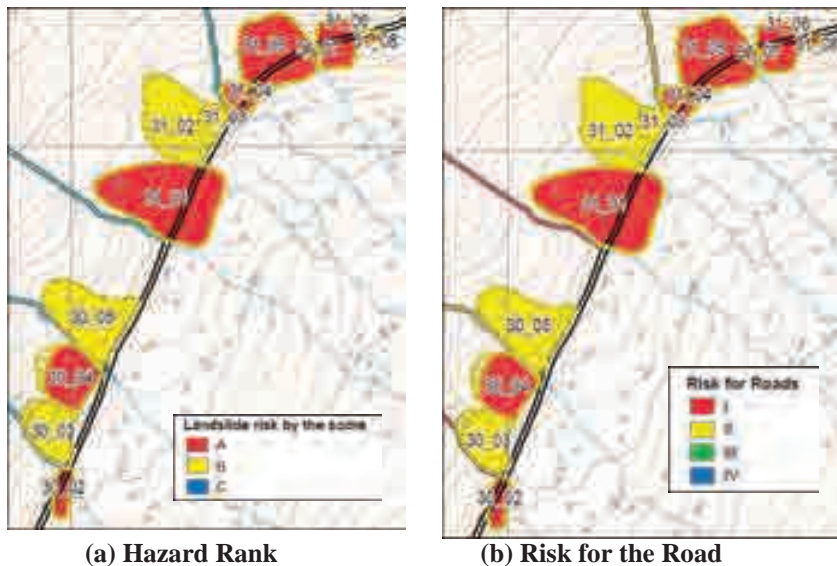
Figure 4.3.29 Area of Particularly High Risk for the Road (L/S30 to L/S31)

Figure 4.3.29 shows a distribution chart of the landslides around L/S30 to L/S31 to indicate differences in their influences on the road. The risk is high at locations where the deformation of the road is increasing. However, the displacement rate is small, and the current slow movement will continue. Therefore, repair of the road once every several years is sufficient.

Near L/S31-06, the road deforms on the boundary between the embankment and the slope. A shortage of the strength of embankment may have caused the deformation. The lower portion of the slope may become unstable due to the weakened embankment, inducing a new landslide.

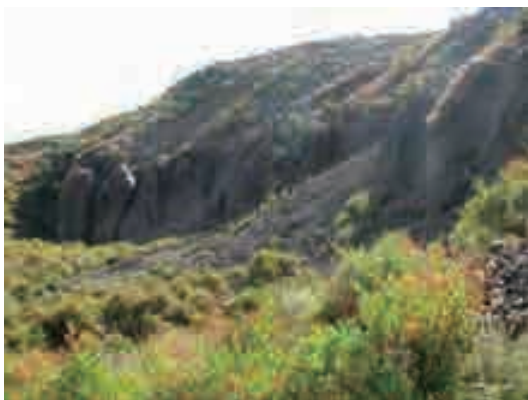
Colluvial deposit is mainly composed of basalt cobbles/boulders (5-500 cm), gravel, sand, mud and clay including black and organic soil as “black cotton soil”, which have come from the mountainous side cliff (Photo 4.4.12). The deposit is considered to overly on the surface with 0-25 m thickness. The deposit is source of the rockfalls and slope failures affecting the main road, especially in the rainy season.

Photo 4.4.12 Colluvial deposit which have come from the mountainous side cliff

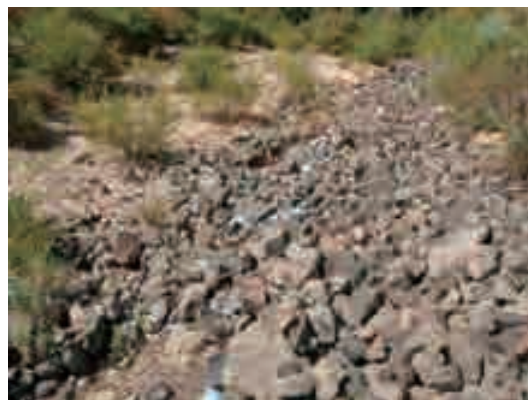
The upper surface of the deposit is a flat plane, which consists of gravels both basalt and limestone. The limestone gravel is considered to have been brought from other areas because the limestone is exposed on lower parts than there. An old drainage ditch having artificial plastic sheets is located on the deposit (Photo 4.4.13).

Photo 4.4.13 An old drainage ditch having artificial blue plastic sheets

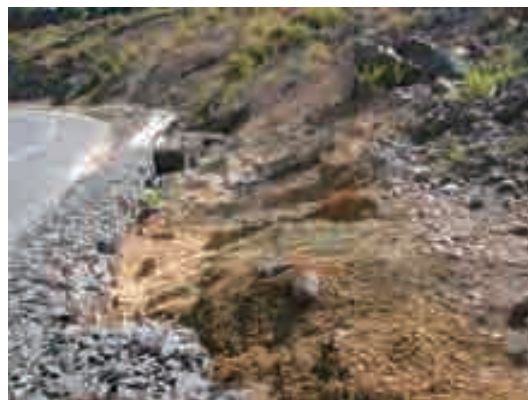
Tuff, which might be highly weathered basalt, is intercalated between the basalt and the limestone (Photo 4.4.15). It is sand or mud of soft particles prone to liquefying in the case of containing water. The color is yellowish brown over time due to oxidation. The layer is very soft and erosive, which would trigger slope collapses (Photo 4.4.16). The thickness is not large and is a few meters at a maximum. Water permeability of the layer is relatively high.

Photo 4.4.16 The layer is very soft and erosive, which trigger slope collapses

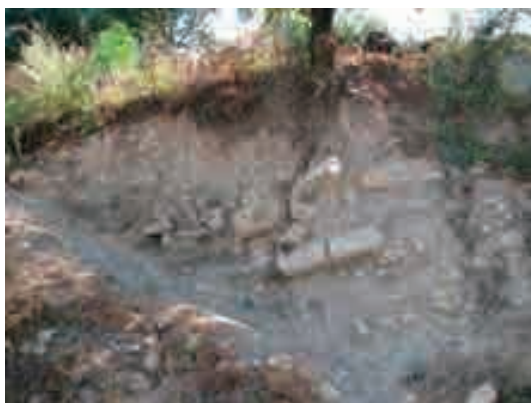
Photo 4.4.26 The colluvial deposit mixed up with sliding soil

The colluvial deposit is mixed up with sliding soil mass in the area where landslides frequently happen, especially in the rainy season; therefore it is difficult to clearly classify the colluvial deposit and the sliding soil (Photo 4.4.26)

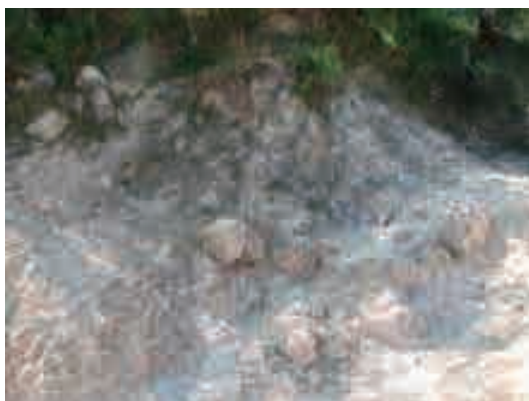
The siltstone unit is composed of silt/clay particles cemented together. It is found intercalated with shale, mudstone and sandstone with calcite and/or gypsum veins in places. The color is white brown to reddish brown which have been weathered and yellowish green to brownish grey which are relatively fresh. The shale unit is argillaceous clastic sedimentary rock which contains a lot of clay minerals. A part of the shale is totally changed to clay by weathering, which is relatively soft and weak due to weathering.

Photo 4.4.28 The silt and shale unit mixed up with sliding soil mass

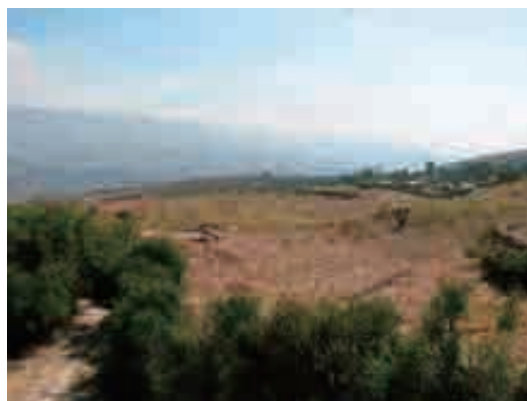
The layers are susceptible to weathering and erosion, therefore the area shows an almost flat plane and/or gentle slope in the village area (Photo 4.4.29). In this area a gentle slope is formed by removed soil and has lots of landslide forms.

Photo 4.4.29 The silt and shale layers show flat plane and/or gentle slope

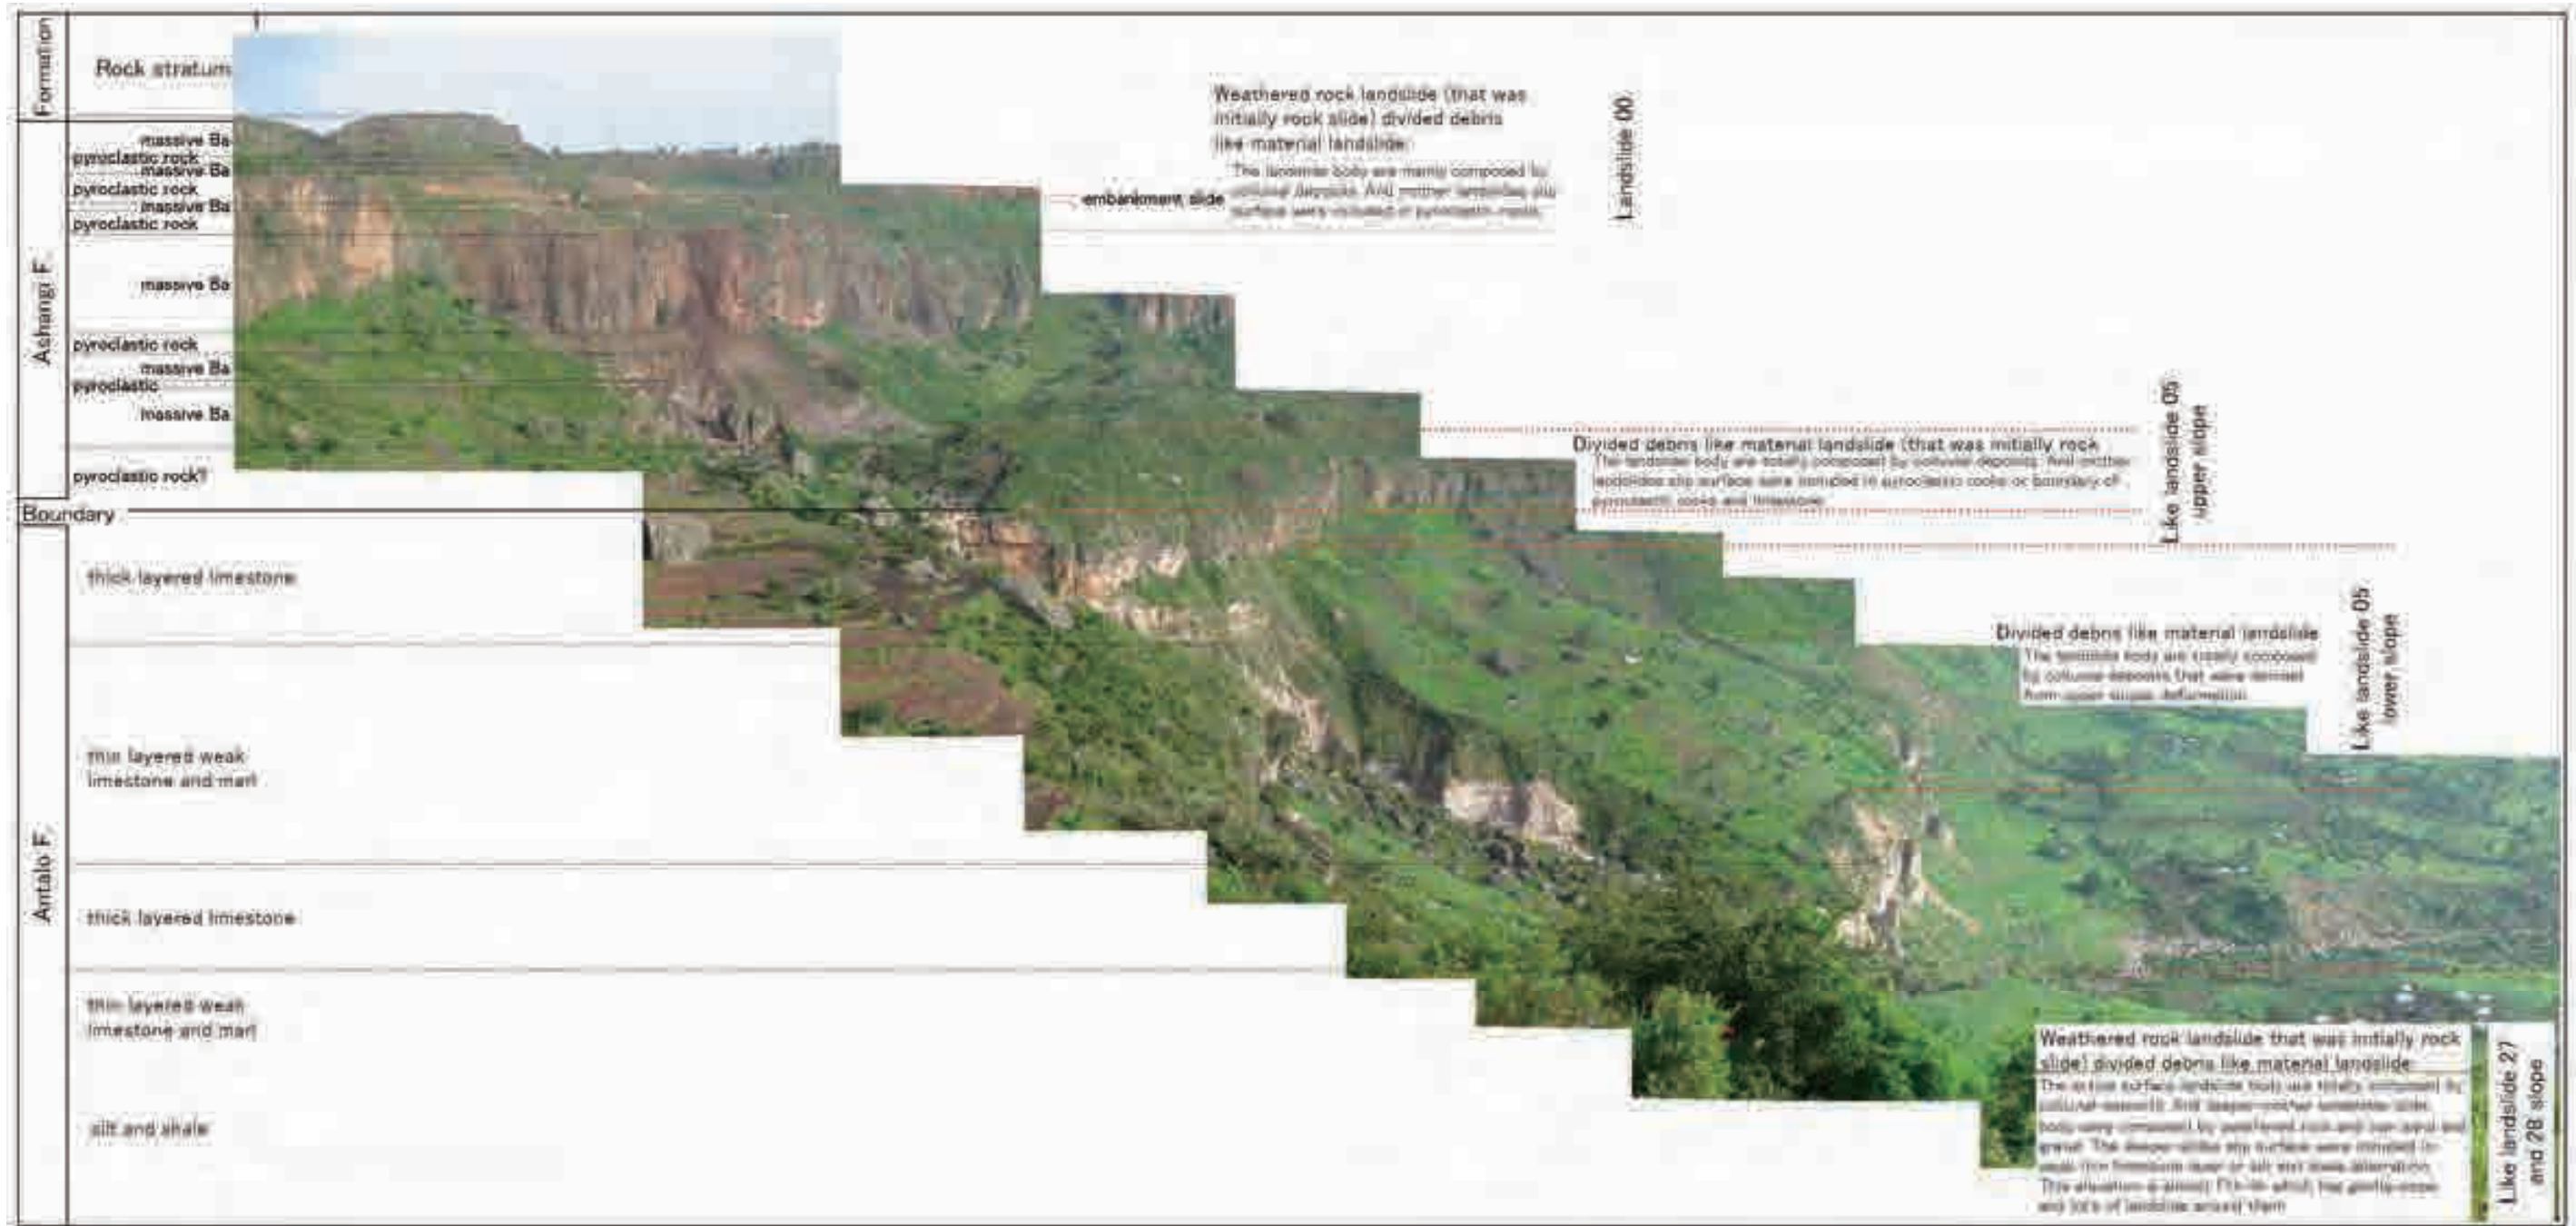
Figure 4.4.5 describes the relation that geological succession and landslide setting on the upper slope of Abay Valley and the geological cross sections are displayed in the following figures

Figure 4.4.5 The relation of geological succession and landslide setting on the upper slope of Abay Gorge.

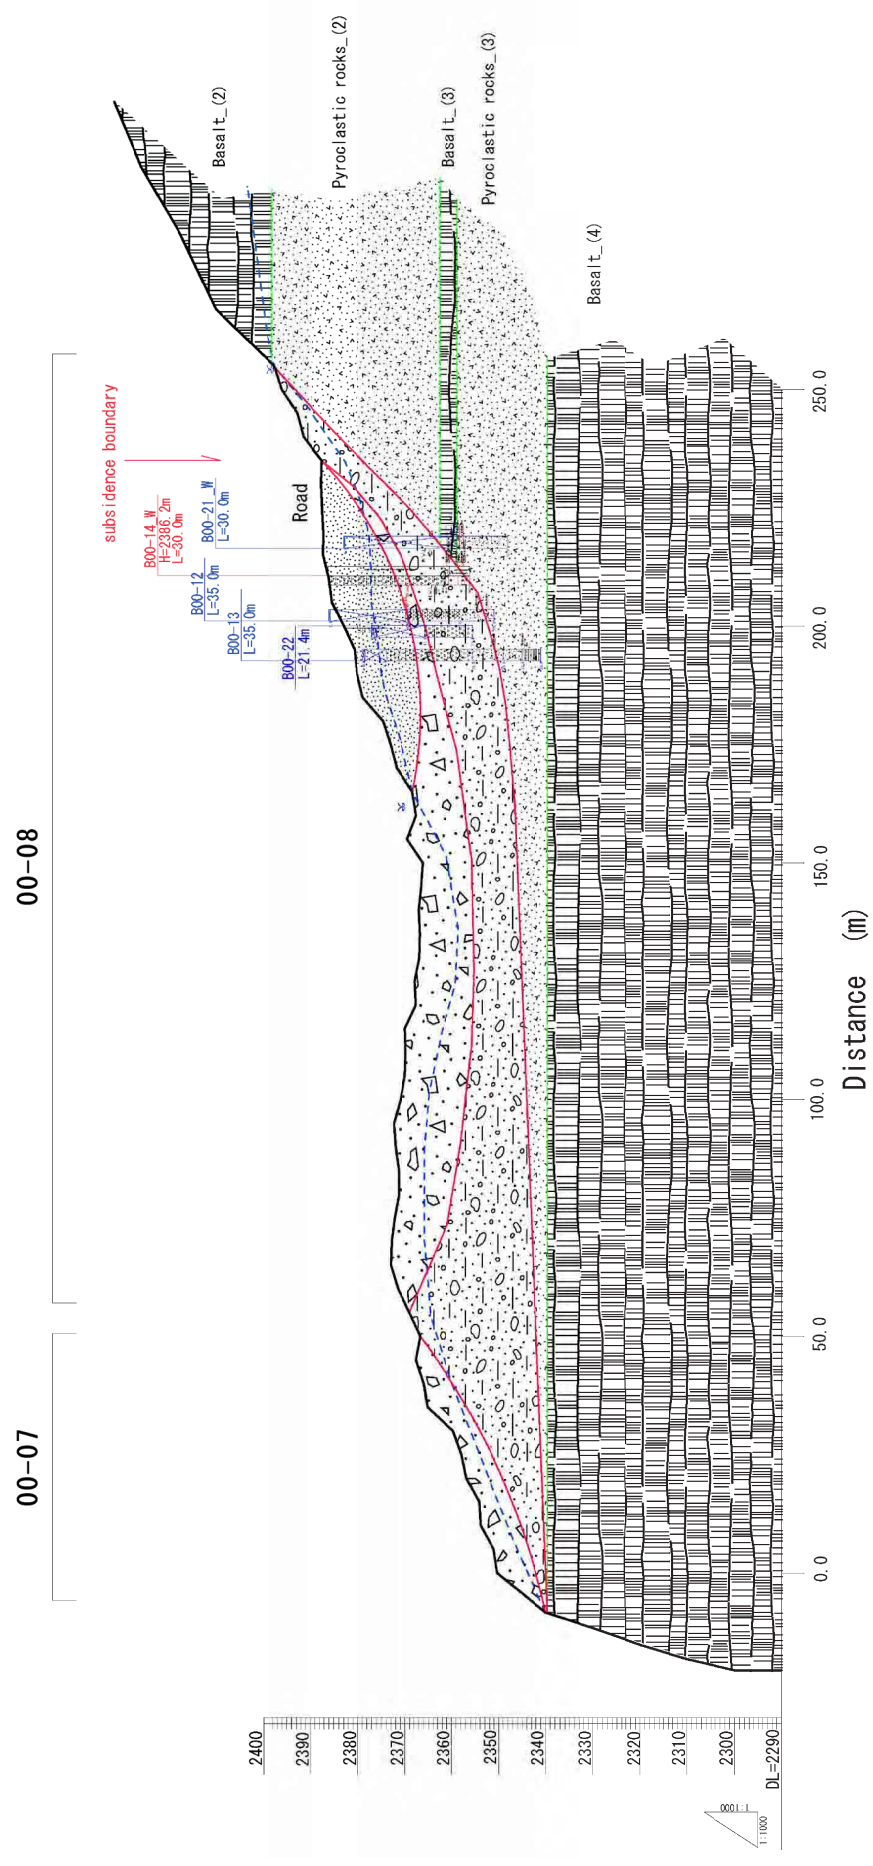
Figure 4.4.7 Geological cross section in L/S00 (B0-12)

In this area, three kinds of landslide classification were exposed. The biggest one is a weathered rock landslide that was initially a rockslide. This landslide body is mainly composed of colluvial deposits. And its slip surface was within a pyroclastic rock layer. The slip surface was observed as slickenside in pyroclastic mudstone layers core sample for this project. This block's main scarp and topographic features had already almost disappeared so this block was estimated to be in an almost stable condition.

Second landslide was a part of a former landslide. This block is classified as a debris movement of past landslide materials, and is composed of colluvial deposits. These deposits contain sand and soil to huge boulders that are over 5m in diameter. That's why, it is too difficult to find slip surface from the core samples. This block's toe was observed at the 00-07 block's scarp on field observation, and the depth of the slip surface is estimated from the inclinometer monitoring result. The geophysical exploration results and estimation by type classification were used to fill the gap between both of these results.

The most active block was an embankment partial slide. The reasons for the landslide are not only groundwater level difference caused by rain, but also unstable condition of the ground. However, the main trigger is groundwater level rising, so during the dry season road deformation almost stopped. The embankment part is mainly composed of sand and gravel. That is why the water permeability is relatively high and the groundwater level monitoring results show hardly any change.

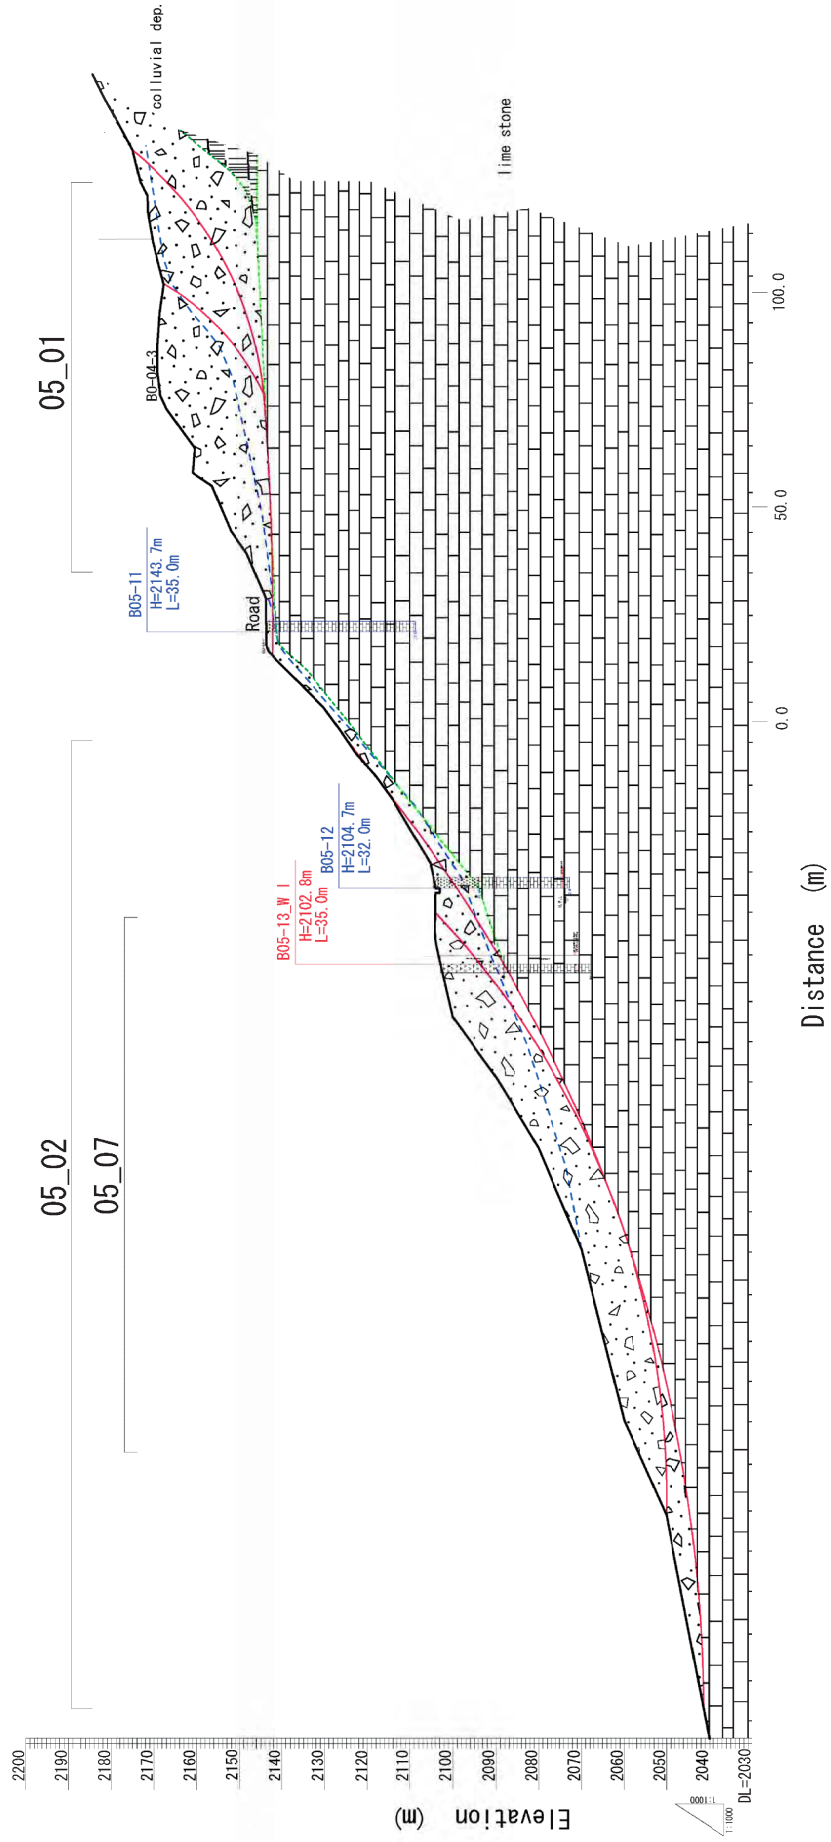
Figure 4.4.9 Geological cross section in L/S05 (B0-04)

The landslide 05-02 and 05-07 are totally composed of colluvial deposits. The landslide 05-07, which is a small block within Landslide 05-02, is the most active part of this lower slope landslide. The landslide shape is estimated by aerial photograph interpretation and reconnaissance. The monitoring results are used for the slip surface estimation. The type classification of these landslides fills a gap between both these results. These landslides are considered to be debris movement of past landslide materials, that's why the slip surface is estimated as an arc like shape.

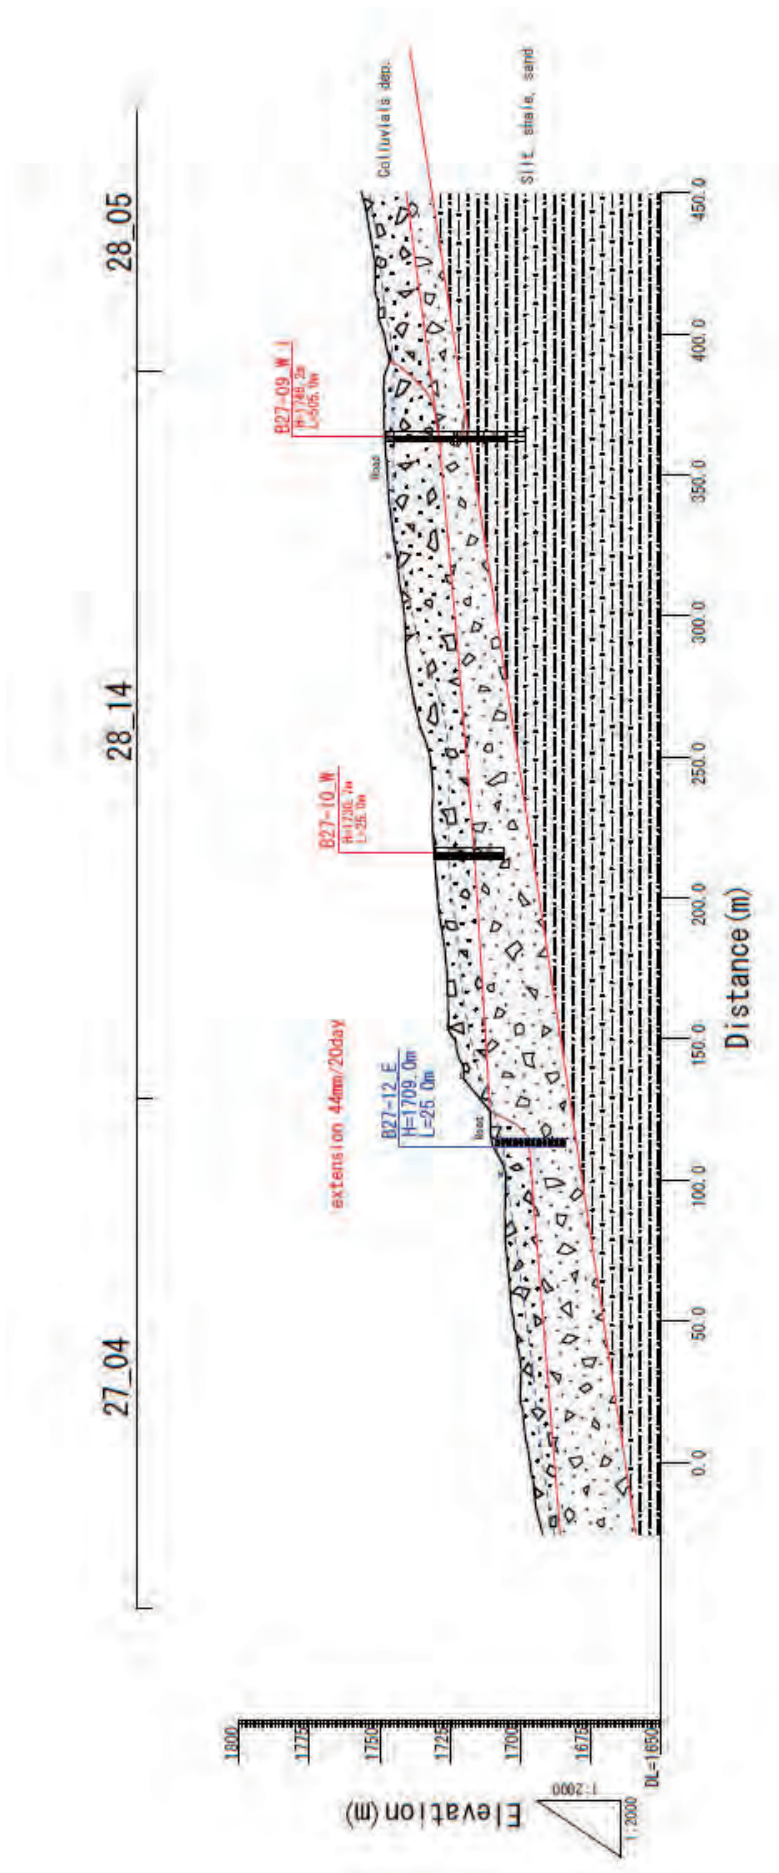
Figure 4.4.13 Geological cross section in L/S27/28 (B0-08)

The deeper mother landslide bodies were composed of soil and gravel derived from “upper limestone” and disturbed silt and shale layer colored greenish grey to reddish brown. The slides slip surface is within a weak thin limestone layer or silt and shale alternation, and non disturbed silt and shale and sandstone were observed under the slip surface. The landslide area was estimated by aerial photograph interpretation.

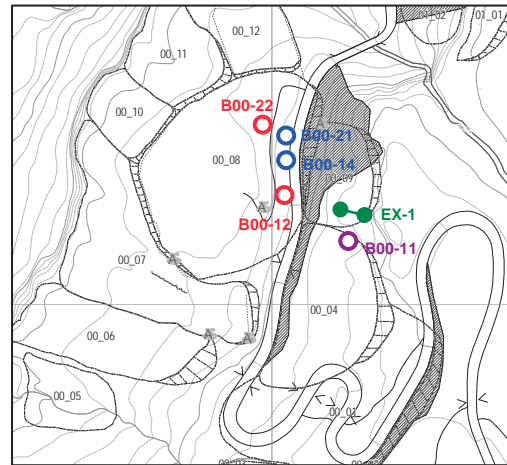
Figure 4.4.17 Location map of monitoring devices in L/S00

At extensometer EX-1 installed on gentle slope on the top of the basaltic escarpment, 42.4 mm extension movement on early October 2010 was monitored; however, this value has the possibility by an artificial one or impact. 26.6mm compression movement was observed on

The cracks in the area extend in the rainy season and compress in the dry season. The movement (opening and closing) of the cracks in this block, therefore, is considered to be notably related with the precipitation (and/or the temperature). The further discussion about the movement of the cracks on the block will be needed with the continuous monitoring.

At borehole extensometer B00-11 installed on gentle slope on the top of the basaltic escarpment in August 2010, there has been no movement even throughout the rainy season. It is considered, therefore, that there are no landslide activities above 50m depth. Continued monitoring is required for confirmation.

At borehole inclinometer B00-12 installed on the roadside on July 2010, the casing pipe was broken by the movement of the landslide at 16.2m depth in August 2010. The measurement has not been implemented since October 2010 because of the breaking of the pipe. At borehole inclinometer B00-22 installed on downside of the road, the measurement has not been able to be implemented since the collapse of the borehole at 10.5m depth when the casing pipe was installed in the middle of October 2010. Not only the broken pipe but the collapsed borehole is attributed to landslide movement, so that it is considered that there are slip surfaces around these depths accompanying active landslide movement.

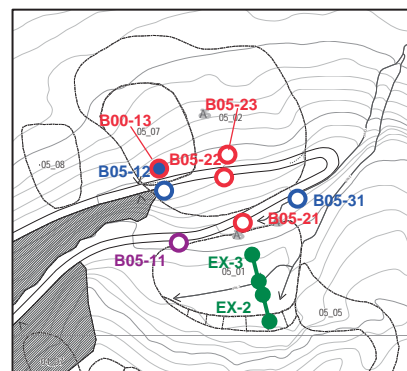
Figure 4.4.18 Location map of monitoring devices in L/S05

At extensometer EX-2 installed the upper part on the gentle slope, 45.5 mm extension movement during middle August to end of September 2010 was monitored, in contrast to little movement in the dry season. At extensometer EX-3 installed around the channel of the lower part on the gentle slope, extension movement started in middle August and is occurring not only in the rainy season but in the dry season as well, and the extension movement has become 57.6mm. It is considered, therefore, that the landslide activates in the rainy season and is continuously moving even in the dry season in the lower part near the road.

At borehole extensometer B05-11 installed on the roadside, 7.1mm extension movement during early September to late November 2010 was monitored. It reached 7.5mm on November 2010. However, movement hardly appears after that.

At borehole inclinometer B05-13 installed on the downward roadside on July 2011, minute movement at around 12.5m depth are observed. Continued monitoring will make clear slip surface in the area. At borehole inclinometer B05-21 installed on the upward roadside, small movement at around 7.5m depth and minute movement at around 29.8m depth are observed. The measurement has not been implemented since November 2010 because of the breaking of the pipe. Similarly, at borehole inclinometer B05-22 installed on the downward roadside, small movement at around 11.0m depth and minute movement at around 29.0m depth are observed. At borehole inclinometer B05-23 installed on the downward roadside on July 2011, landslide movement at 17.0m depth and minute movement at around 29.0m depth are observed. Continued monitoring will make clear slip surface in the area. It is considered, therefore, that active landslides are around both the upward road and the downward road.

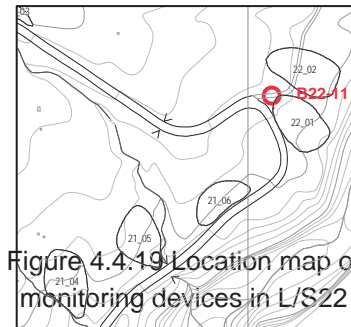
Figure 4.4-19 Location map of monitoring devices in L/S22

At borehole inclinometer B22-11 installed on September 2010, minute movement at around 5.5m depth is observed, and the bending of pipe occurred around 18m depth in February 2011. It is considered, therefore, that landslide is confirmed around this area. Continued monitoring is required for confirmation.

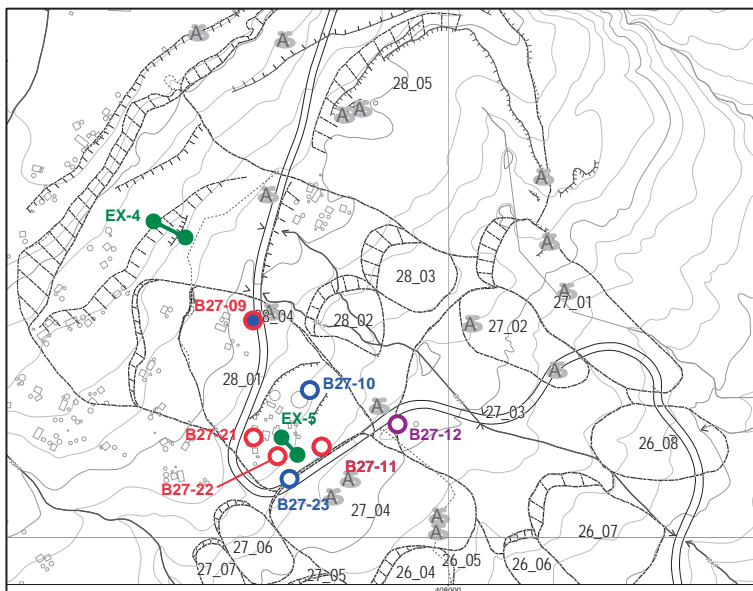
Figure 4.4.20 Location map of monitoring devices in L/S27

At borehole inclinometer B27-09 installed on the roadside in July 2011, the measurement has not been able to be implemented since the first measurement because the bending of pipe occurred at around 19.2m depth. At borehole inclinometer B27-11 installed on the roadside in October 2010, the measurement has not been able to be implemented since November 2010 because the bending of pipe occurred at around 8.3m depth.

At borehole inclinometer B27-22 installed next to a church in September 2010, a distinct slip surface was confirmed at around 15.4m depth, and the measurement has not been able to be implemented since November 2010 because of a deep bending of the pipe. It is considered, therefore, that there are slip surfaces around these depths accompanying active landslide movement.
