# Chapter 4

*Landslide Analysis and Interpretation*

## 4 Landslide Analysis and Interpretation

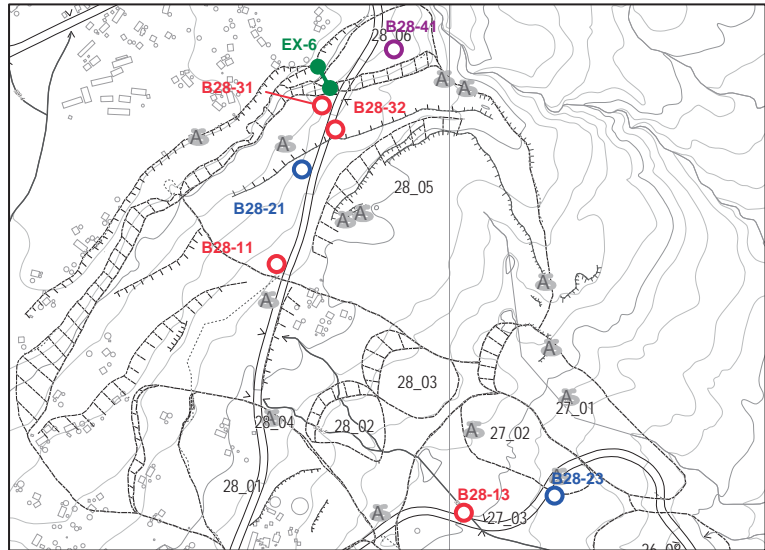
Figure 4.4.21 Location map of monitoring devices in L/S28

At borehole inclinometer B28-11 installed on the roadside on September 2010, the measurement has not been able to be implemented since October 2010 because the bending of pipe occurred at around 14.7m depth. At borehole inclinometer B28-13 installed on the roadside in July 2011, the measurement has not been able to be implemented since the first measurement because the bending of pipe occurred at around 9.6m depth.

At borehole inclinometer B28-31 installed on the roadside in September 2010, a distinct slip surface was confirmed at around 14.0m depth, and the measurement has not been able to be implemented since December 2010 because of a deep bending of the pipe. At borehole inclinometer B28-32 installed on the roadside in October 2010, the measurement has not been able to be implemented since November 2010 because the bending of pipe occurred at around 24.5m depth. It is considered, therefore, that there are slip surfaces around these depths accompanying active landslide movement.

At water level meter B28-21 (25m depth) installed on the roadside in September 2010, both the steady water level and the high water level keeps around -20m. However, there is no data after November 24 because the equipment was stolen. At water level meter B28-23 (30m depth) installed on the roadside in June 2011, the rising up according to the rain and the high water level at -14.7m observed. The steady water level of -15 to -17m has been recorded after that.
