8. Satellite image interpretation for geomorphologic survey

Geomorphological Survey  
Satellite image interpretation

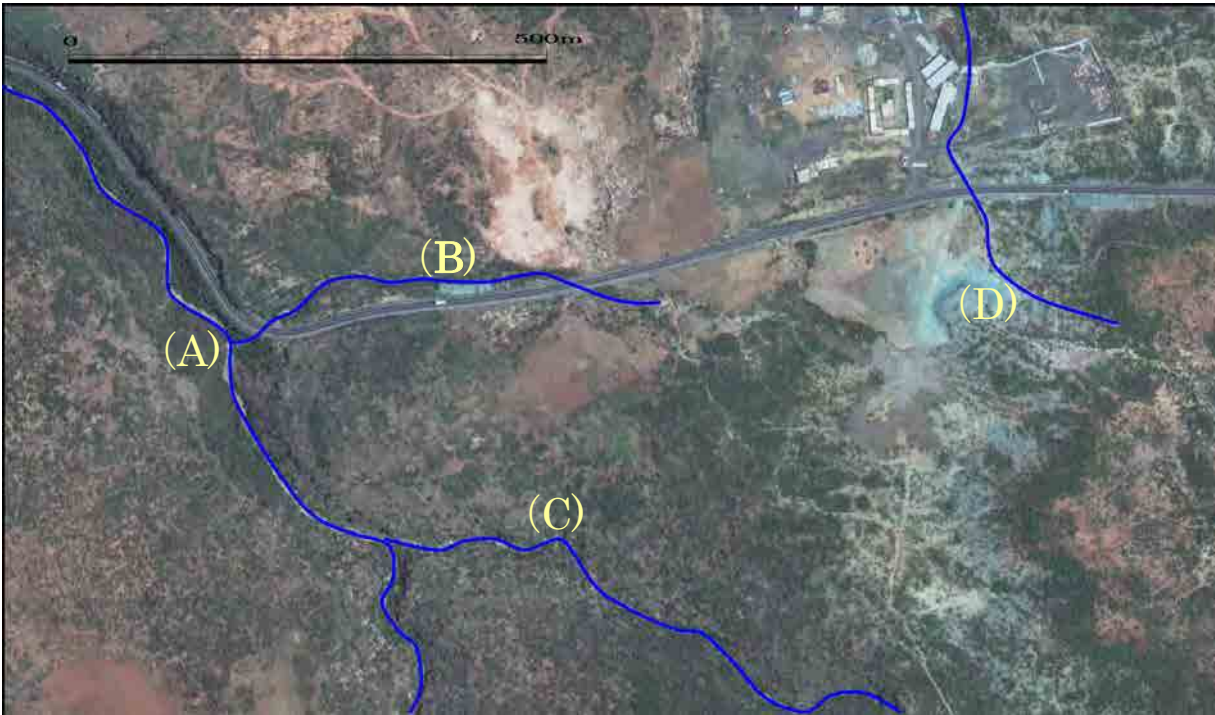
Fig.3.3.17 Satellite image interpretation ST.17+000 to ST.18+000

No landslides can be confirmed along the main road. In this area, two tributaries (B, C) flow into river system (A), while (D) is a separate system.

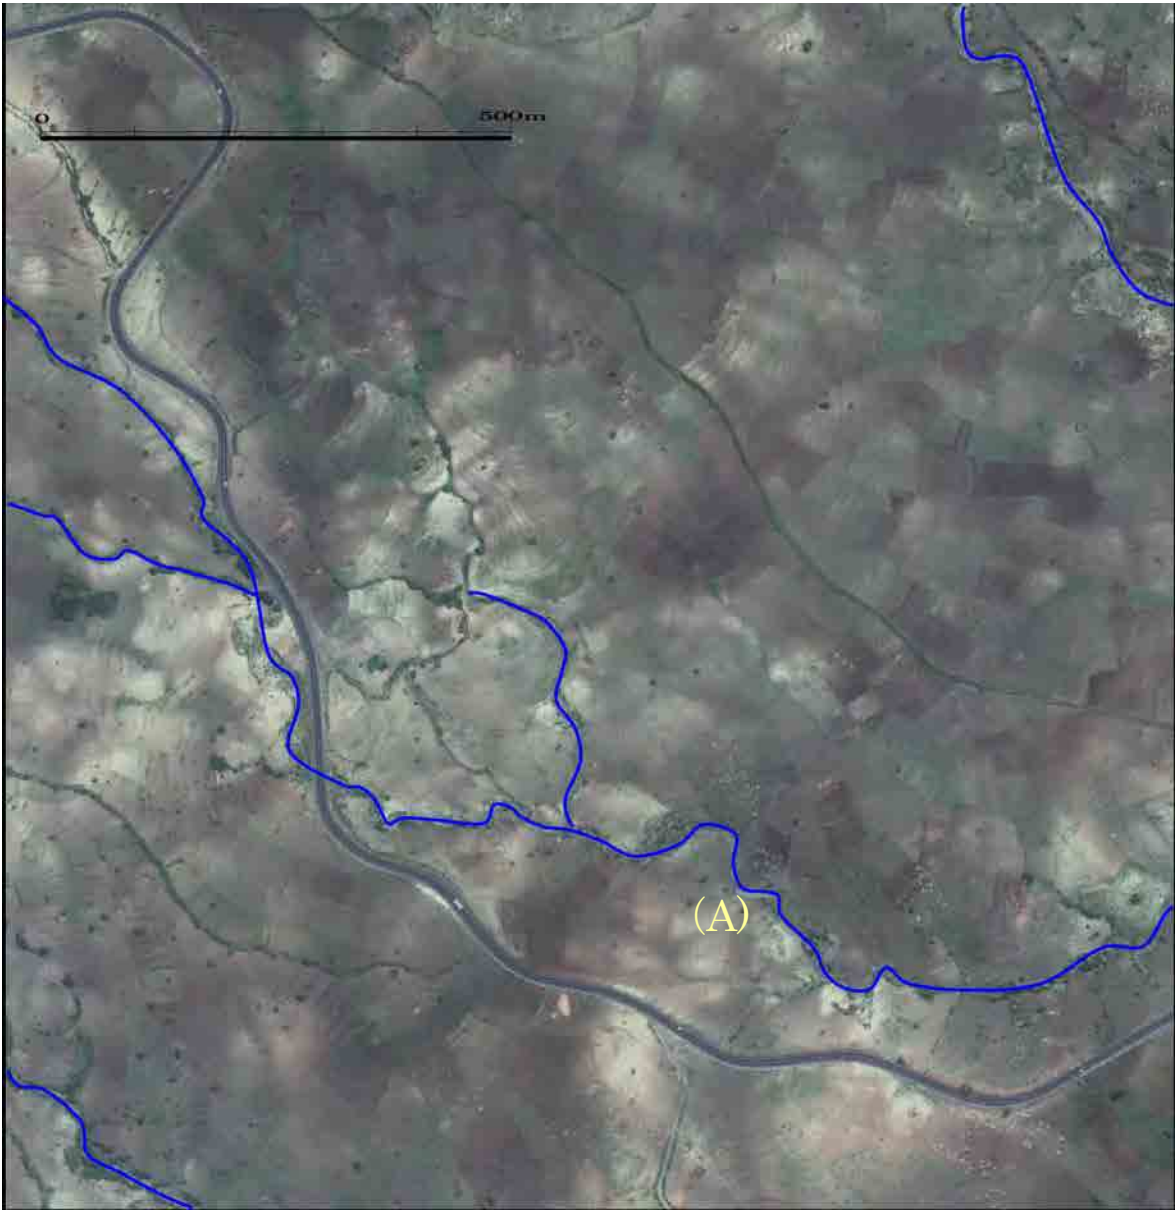
Fig.3.3.22 Satellite image interpretation ST.25+700 to ST.26+200

Dissection is apparent in this entire area. There are no pronounced landslides. A large river system, (A), flows along the main road.

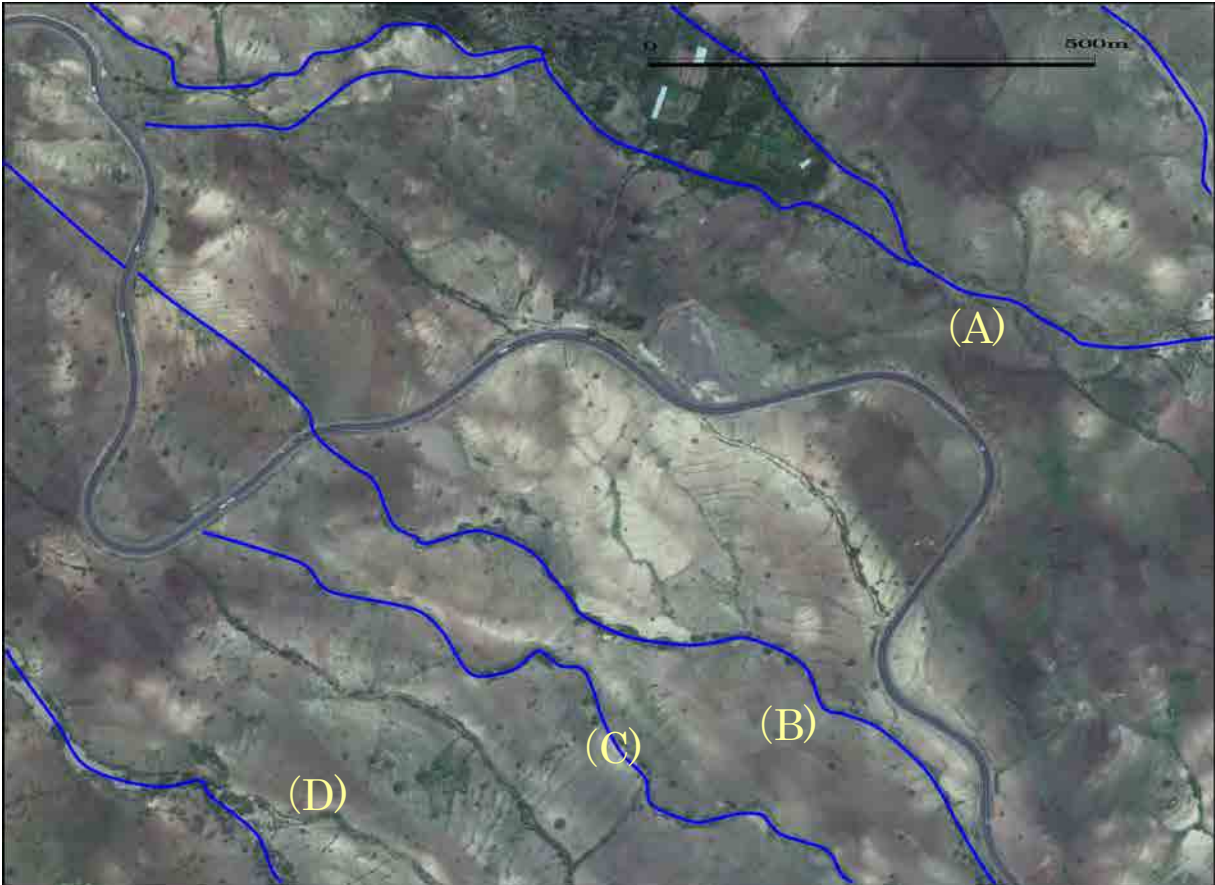
Fig.3.3.23 Satellite image interpretation ST.26+000 to ST.27+200

Dissection is apparent in this entire area. There are no pronounced landslides. Several river systems (A to D) flow in the same general direction as the main road.
