11. Debris flow survey

3.9 Debris Flow Survey

3.9.1 Debris flow site identification

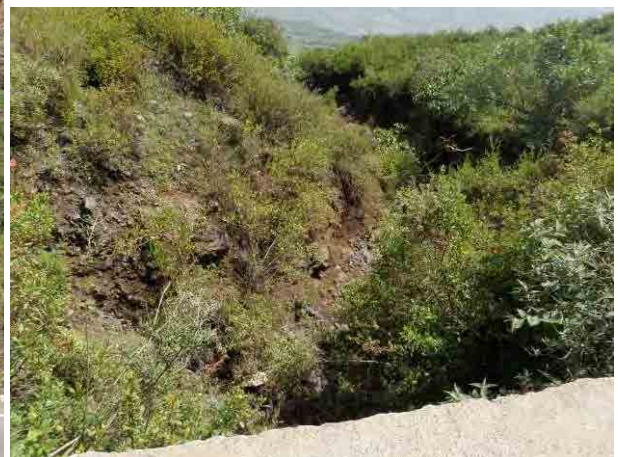
This section is located in a Rockfall hazard area where sediment runoffs are observed in addition to Rockfalls. Unstable sediment consists mainly of fallen rocks that have been exfoliated and detached from the basaltic cliff walls. They are deposited near the road.

Water flow condition during heavy rainstorm was not clear or there was no water flow when this survey took place. Nonetheless, rock blocks deposited in the box culvert installed at the end of the channel, and sediment runoff was confirmed.

Photo 3. 9.5 Entire picture of MS002 (the downstream from the road)

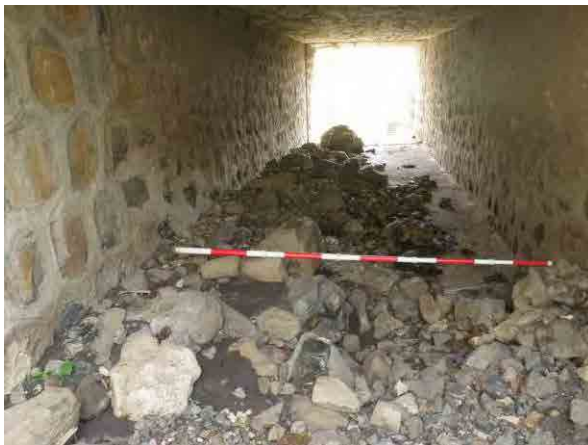
Rock blocks are deposited in the box culvert installed under the road while sediment runoff is also taking place. As gullies develop, sediment runoff increases which eventually get transported down the river during heavy rainstorm and/or rainy seasons. Many rock blocks which are distributed in the channel are 10 to 50cm in diameter.

Photo 3. 9.7 Sediment which is deposited in the box culvert installed under the road (1.6m high and 2.0m wide)

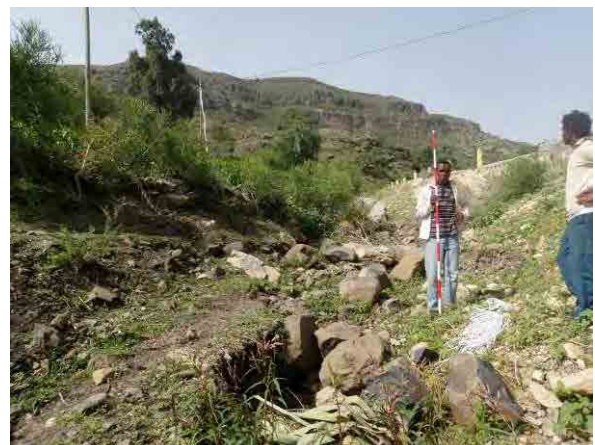
The channel bed gradient is approximately 12° and the channel width is 1.0 to 3.0m. Top of the channel is at the drainage gutter and crossing drainage pipe, and surface water flows into this small channel. In fact, gullies have developed over time to form the channel. There are houses and fields on the side of the channel closest to the road and the side erosion is in progress.

Photo 3. 9.8 Channel upstream (located at the drainage of traversing drainage systems and road)

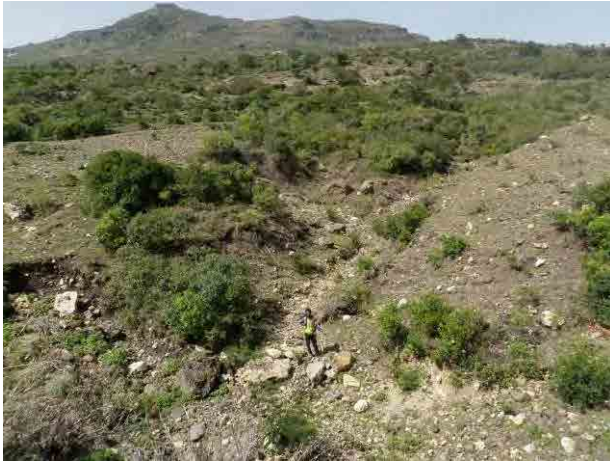
Photo 3. 9.21 Entire picture of MS008
(upstream from the road; no water flow confirmed)

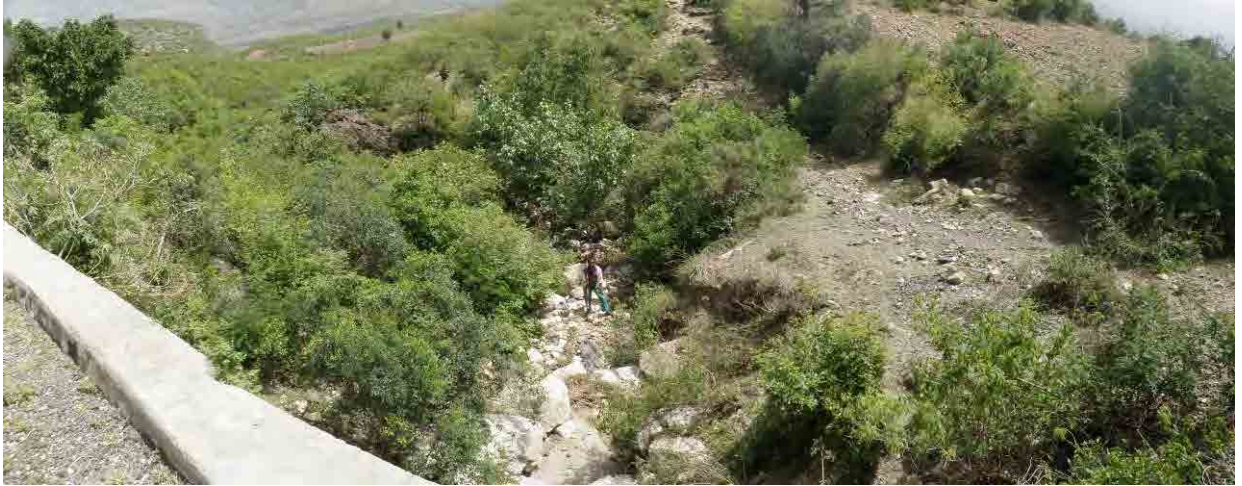
Photo 3. 9.29 Entire picture of MS010 (at downstream from the road)

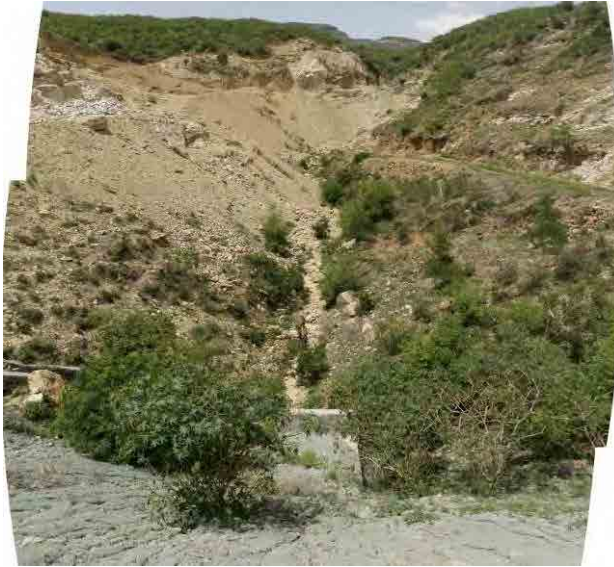
Photo 3. 9.34 Entire picture of MS012 (upstream from the road)

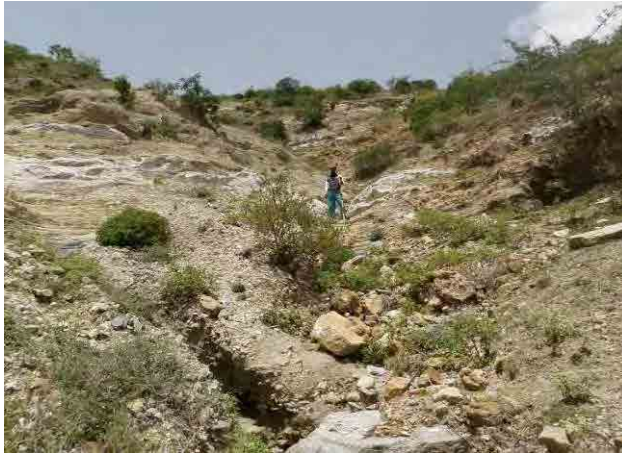
Photo 3. 9.37 Channel upstream (Limestone is exposed)

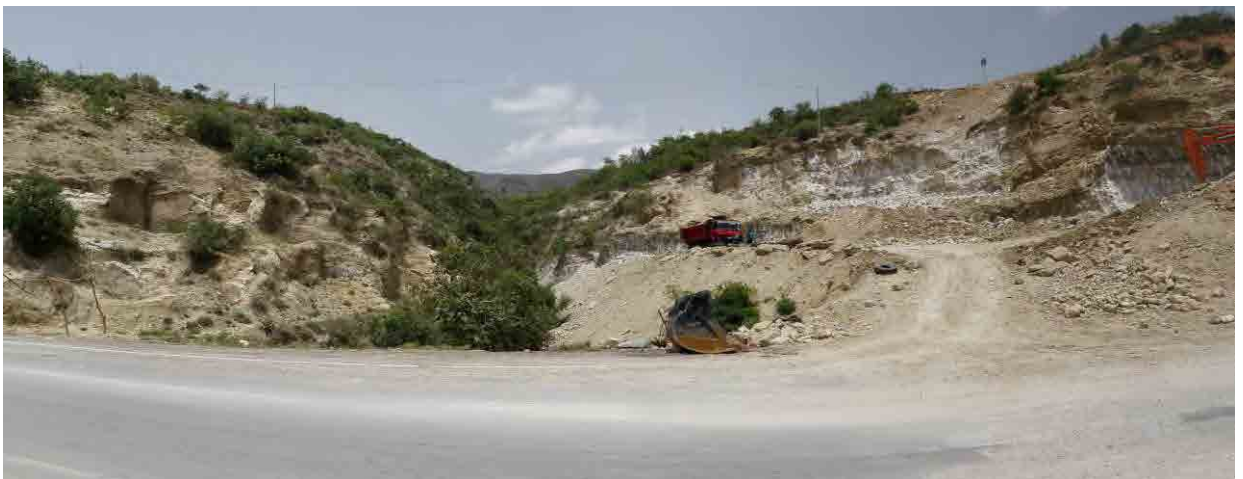
Photo 3. 9.39 Entire picture of MS014 (upstream from the road; the quarry is located on the left bank)

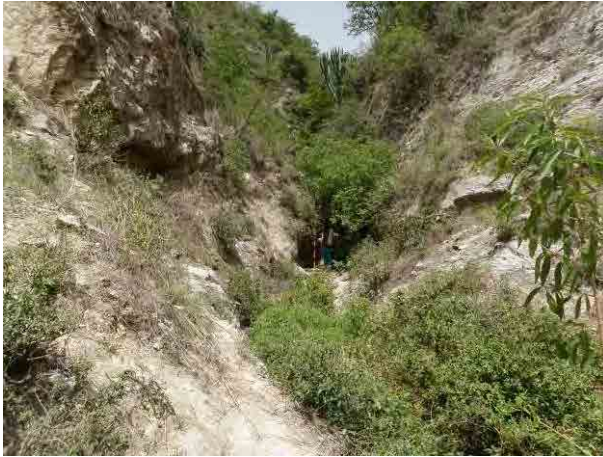
Photo 3. 9.40 Channel upstream (Limestone is exposed)

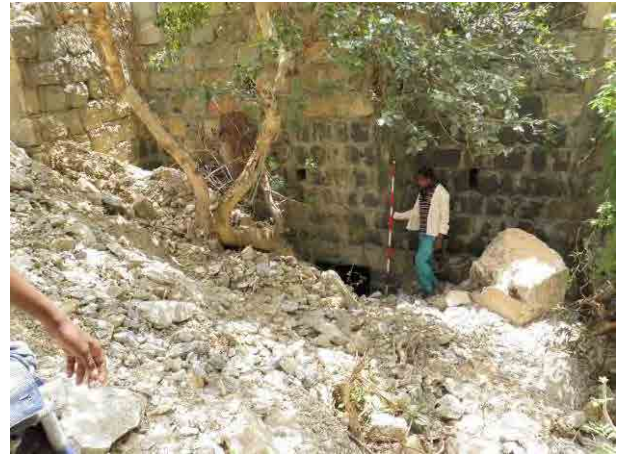
Photo 3. 9.41 Box culvert installed under the road

The box culvert under the road has been blocked half-way up by sediment debris from the quarry. As a result, ability of the culvert to flush down the stream gets significantly decreased. If the volume of sediment runoffs from the quarry increased, the box culvert would be completely blocked. It is desirable to remove sediment as soon as possible.

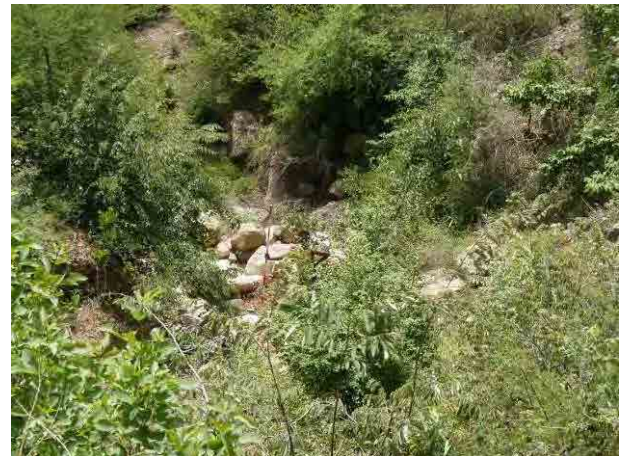
Photo 3. 9.42 Entire picture of MS015 (upstream from the road)

This channel flows along a flank scarp and joins together with the channel MS016 at a point downstream from the road. The channel banks are covered with vegetation, and shrubs densely cover the upstream area. There is no evidence of failures in the area upstream. Sediment supply would be low.

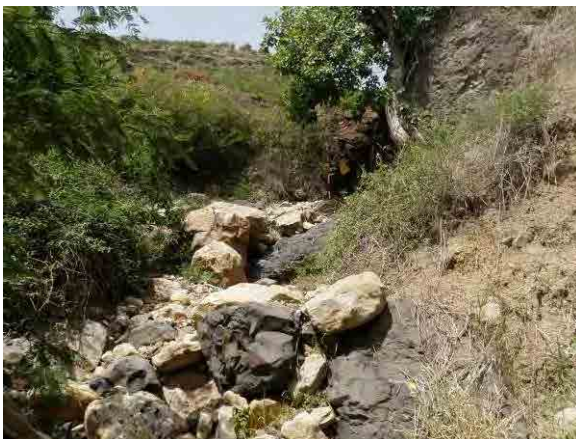
Photo 3. 9.43 Channel upstream (large rocks are scattered)

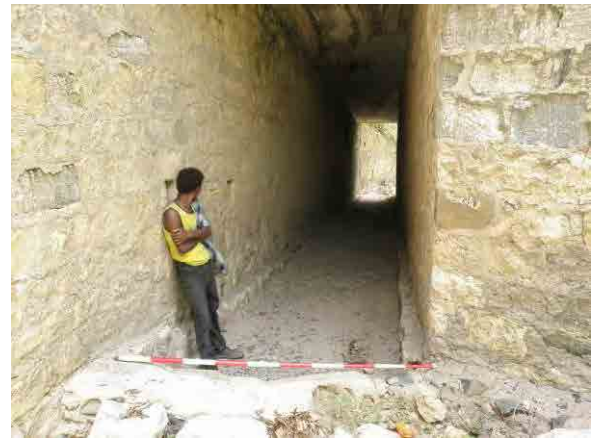
Photo 3. 9.44 Box culvert installed under the road

Slight deposit is observed in the box culvert (4.0m high and 2.0m wide) installed under the road.

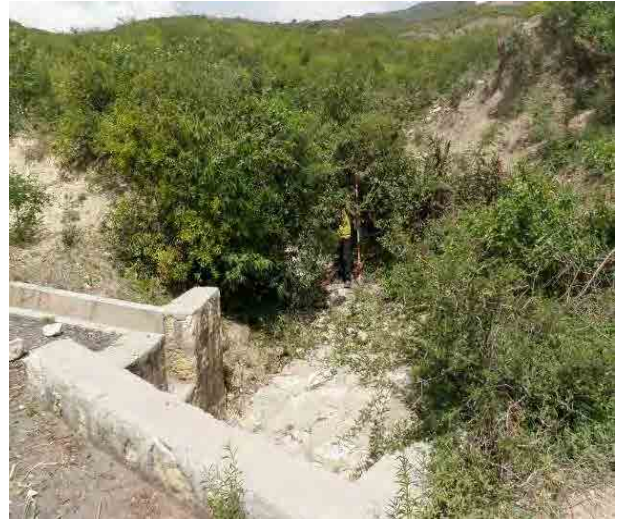
Photo 3. 9.45 Entire picture of MS016 (upstream from the road)

This small channel is located near the channel MS015, with a channel bed gradient of 11.3° (20%, read from the topographic map) while its width ranging between 1.0m to 1.5m. Gravels around 20 to 40cm in diameter are distributed in the channel bed. The surrounding of the channel is covered with shrubs.

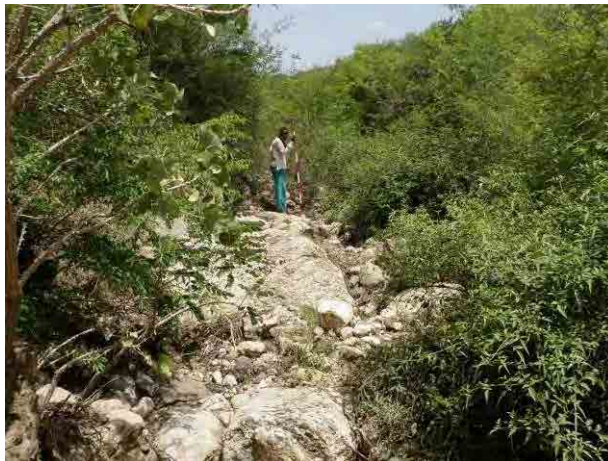
Only a small amount of sediment deposit exists in the drainage work and its upstream indicating a comparatively small supply of sediment. As is the case with the previous channel, no water flow was confirmed when this survey took place.

Photo 3. 9.46 Channel upstream (large rocks are scattered)

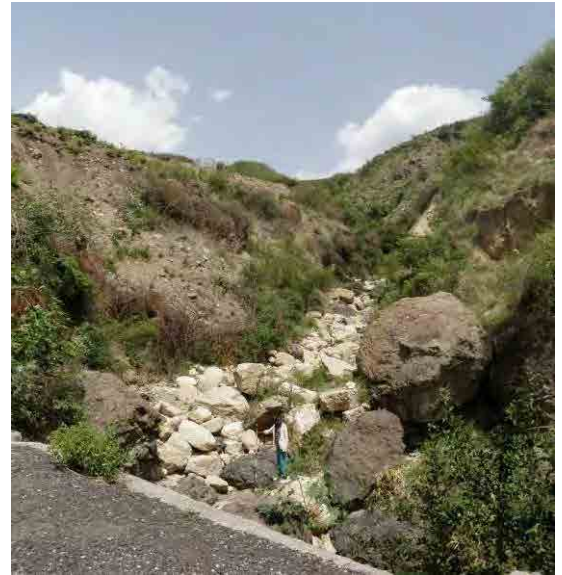
Photo 3. 9.49 Entire picture of MS017

Upstream of the channel flows along basaltic cliff walls, and branching streams are seen approximately 300m upstream of the road. It can be speculated that there is a comparatively large amount of sediment supply.

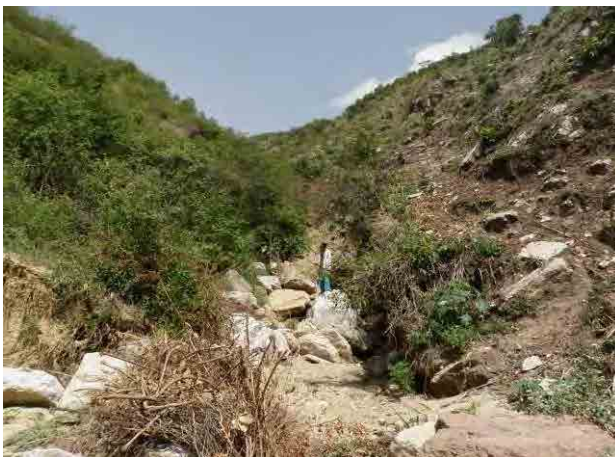
Photo 3. 9.50 Channel upstream (large rocks are scattered)

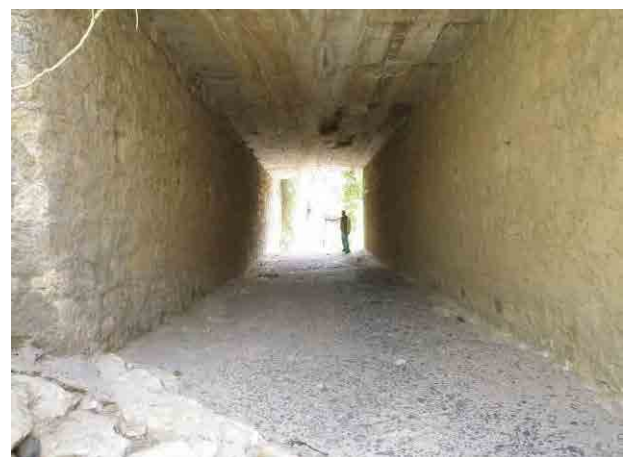
Photo 3. 9.51 Box culvert installed under the road

The box culvert (4.0m high and 4.0m wide) installed under the road has a large inner space, representing a large basin area. Sediment and gravel deposits are not currently seen; however, the accumulated large rocks in the channel bed indicate a high potential of debris flow.

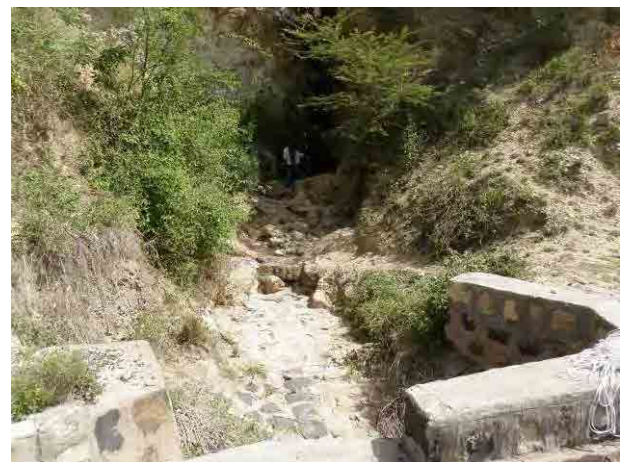
Photo 3. 9.52 Entire picture of MS018 (upstream from the road)

This small channel is located immediately after the end point of channel MS017, with a channel bed gradient of 18.0° (33%, read from the topographic map) and a width between 1 and 3m. This channel meets with channel MS017 downstream of the road, while it flows along a landslide wall upstream from the road.

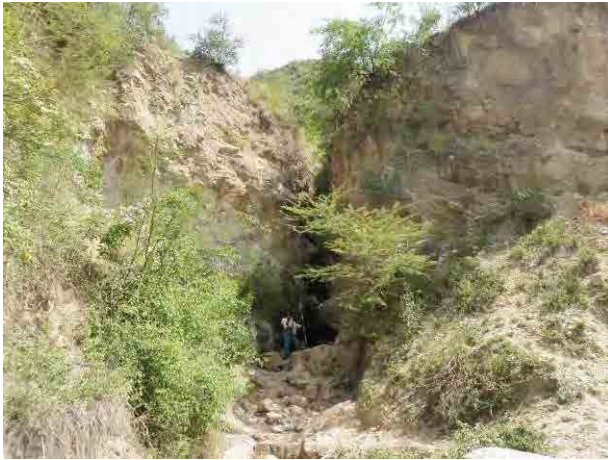
Photo 3. 9.53 Channel upstream

A cliff wall with an elevation of approximately 12m stands at approximately 40m upstream from the road and the channel width further upstream is smaller than 1.0m. Although this channel is likely to have been developed

from gullies into a channel, bank erosion is also in progress.

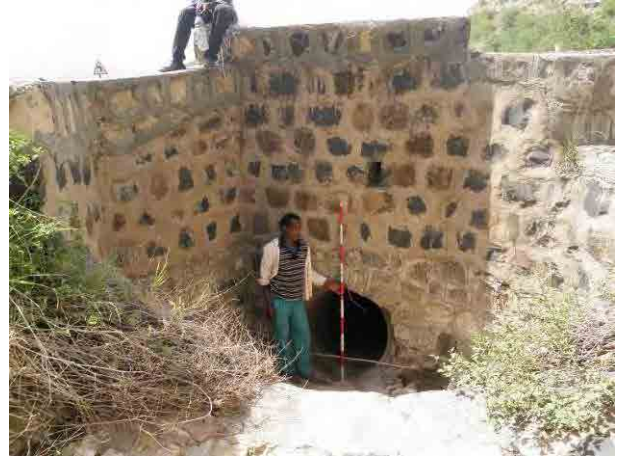
Photo 3. 9.54 Drainage pipe installed under the road

A crossing drainage work of 1.0m in diameter is installed under the road and almost no sediment deposit is confirmed.

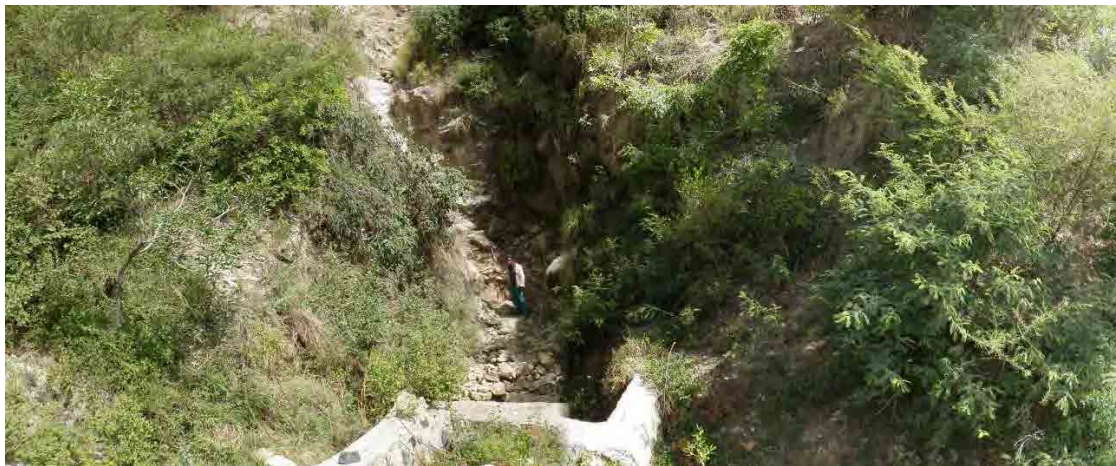
Photo 3. 9.55 Entire picture of MS019 (upstream from the road)

According to our references, this channel is recognized as a channel with a high potential of debris flow. Judging from the channel bed gradient, this channel is potential debris flow source. Nonetheless, the basin area is small and the average height between the road and the channel bed is approximately 8m. Hence, we determined the possibility of sediment runoffs spilling onto the road is small.

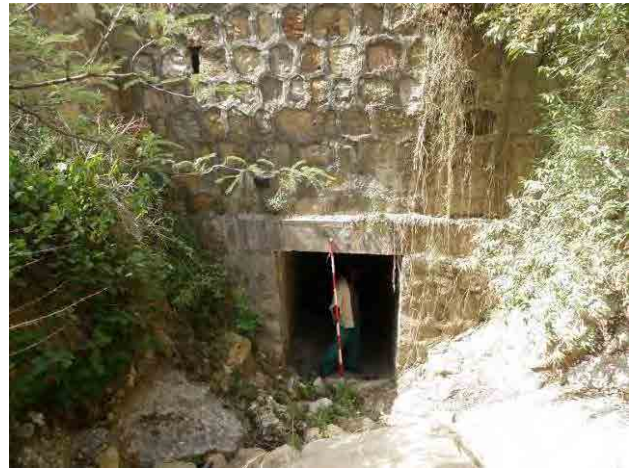
Photo 3. 9.57 Box culvert installed under the road

Almost no sediment deposit is seen in the box culvert (2.0m high and 1.5m wide) installed under the road. However, the steep channel bed gradient indicates great velocity of sediment runoff.

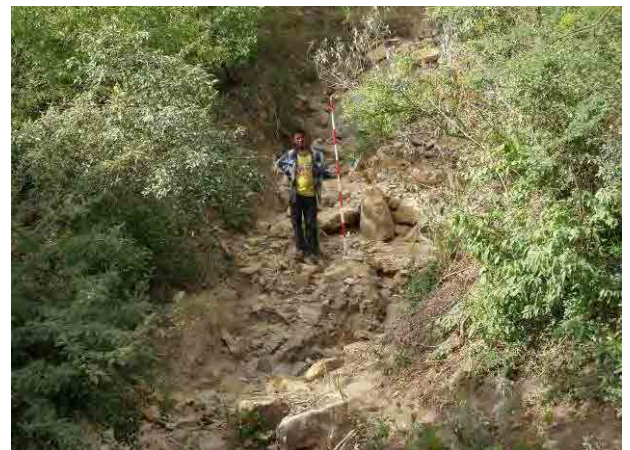
Photo 3. 9.58 Entire picture of MS020 (upstream from the road)

Vegetation grows upstream of the channel; however, the progressive bank erosion is causing stream destabilization. No water flow was confirmed when this survey took place. However, amount of sediment runoff is presumably large during rainstorm or rainy season for the surface of the quarry is bare.

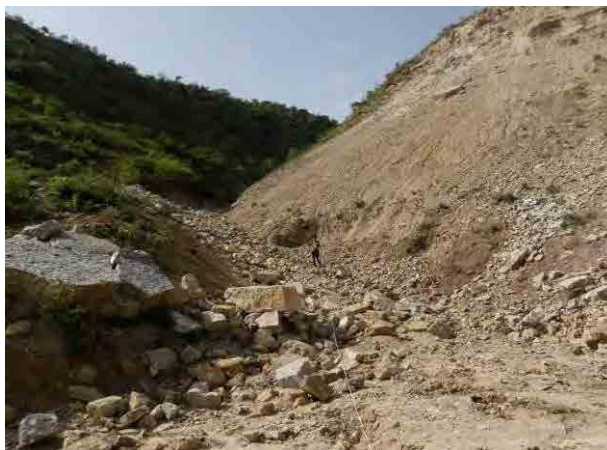
Photo 3. 9.59 Quarry on the left bank

Sediment and gravel discharged from the quarry are deposited in the channel bed. This accumulated sediment is blocking part of the crossing drainage work installed under the road.

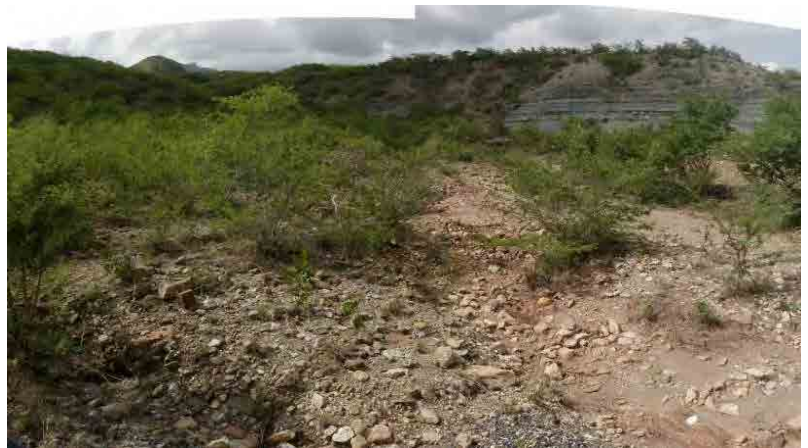
Photo 3. 9.62 Entire picture of MS021 (upstream from the road)

Flow path is unclear upstream from the road which rather forms a irregular terrain (or channel) surface. Nonetheless, gravels are scattered around. On the other hand, the terrain downstream from the road is almost flat with very little relief.

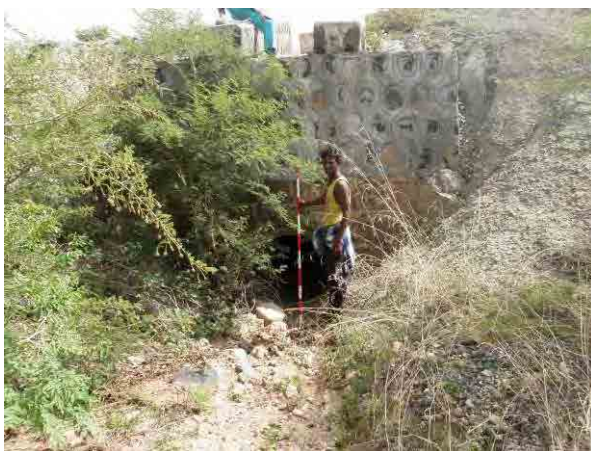
Photo 3. 9.63 Drainage pipe installed under the road

No sediment deposit is observed in the crossing drainage work installed under the road, showing that sediment runoff is limited.

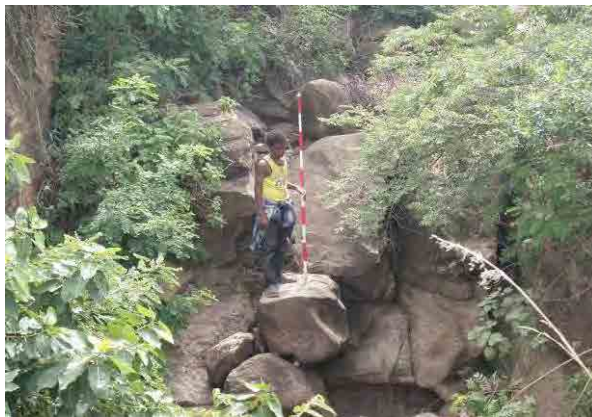
Gravels are deposited in the box culvert (3.0m in height and 2.0m in width) installed under the road and large rocks are distributed upstream. However, at a point approximately 50m upstream from the box culvert, the gradient becomes moderate and sandstone is exposed in the channel bed.

Photo 3. 9.65 Large rocks near the box culvert

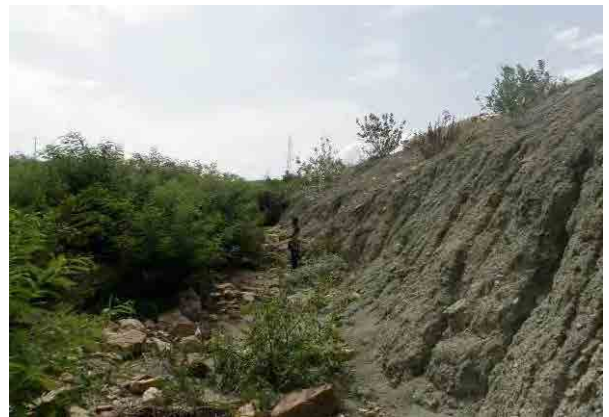
We speculate that as surface water from the road enters into the channel, sediment is also discharged during heavy rain or rainy season.

Photo 3. 9.66 Channel upstream (located on the road side)

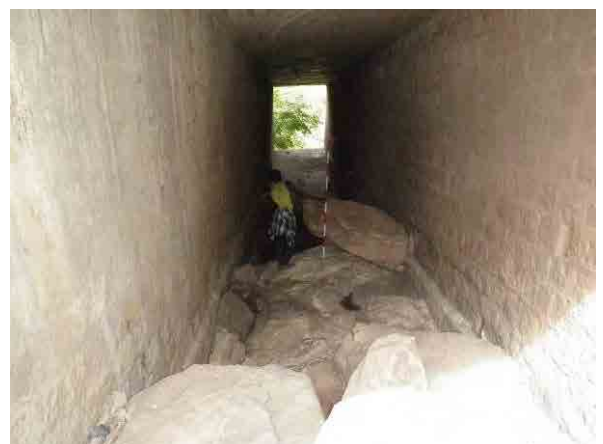
Photo 3. 9.68 Large rocks in the box culvert

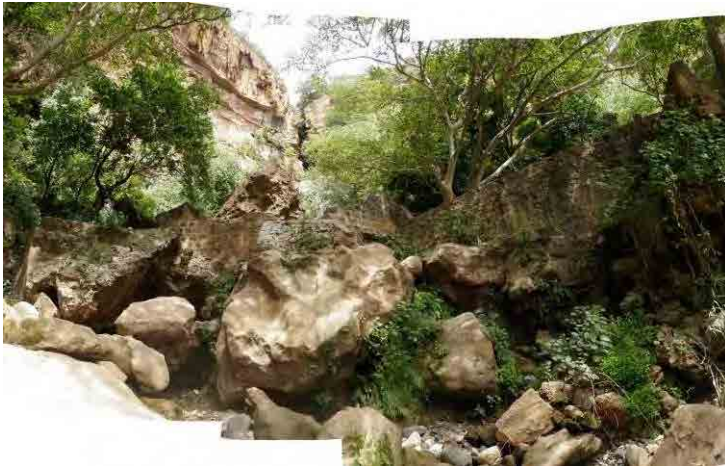
Photo 3. 9.70 Entire picture of MS023 (upstream from the road)

A dam (discharge channel being approximately 2m in width and 0.6m in height) is installed near the road whose arm on the right bank has been scoured by Rockfall or debris flow.

Large rocks distributed in the channel bed are sandstone, basalt, and limestone. During rainy season, it is likely to be that sediment containing gravels are transported from upstream. The inner space of the box culvert installed under the road is smaller than the large sandstone rocks which are spread out upstream. This blocks the box culvert. If a debris flow occurs, there is the threat that the large rocks will totally block the box culvert and force sediment runs off onto the country road.

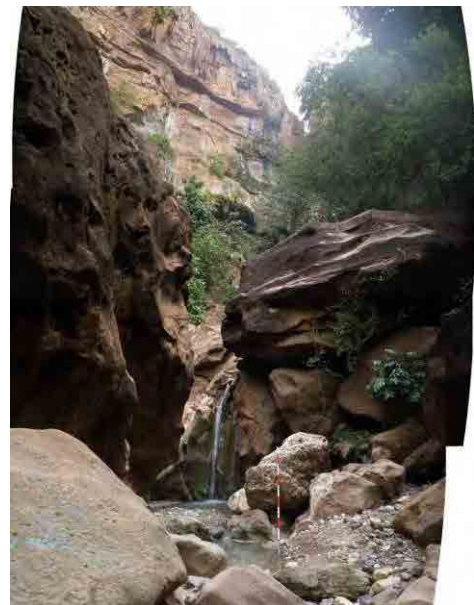
This channel has a channel bed gradient between 25° to 35° and is 5.0 to 10.0m in width. This is a long channel that runs through the Kurare or Endejen village close to Dejen eventually flows into the ABAY Valley. There is a waterfall with approximately 65m in height located upstream of the road, which is within a Rockfall hazard location. As there is abundant water in this waterfall, there is constant flow of water throughout the year.

Photo 3. 9.71 Waterfall upstream from the road

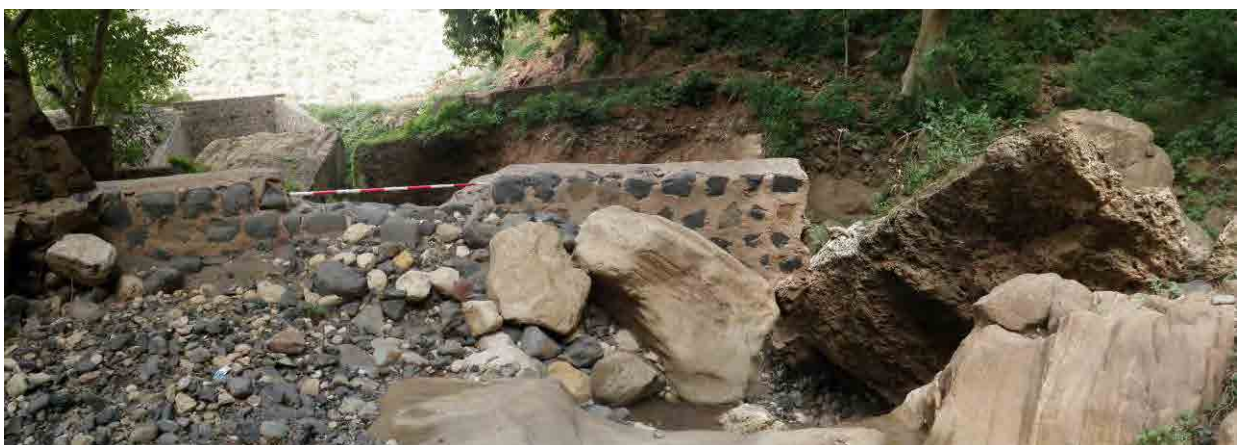
Photo 3. 9.72 Dam built upstream from the road (picture taken from the upstream)

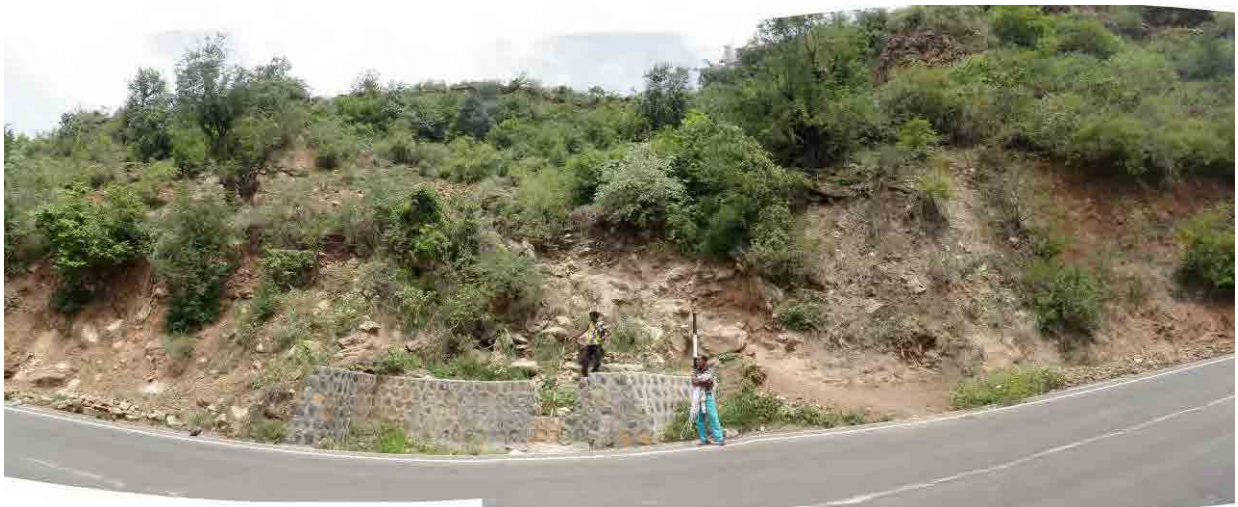
This small channel has a channel bed gradient of 32° and is 1.0 to 1.5m in width. This channel does not exhibit the characteristics of a general mountain stream.

The channel bed gradient indicates as potential debris flow source, hence there is a relatively higher possibility of debris flow occurrence. This channel is usually used for a pathway by local people, and no water flow was confirmed when this survey took place.

Sediment control structures have been installed near the road which indicates the previous experience of sediment run off in the past. Presumably, in a rainy season (or seasons), surface water flowed along gullies which also transported to sediment onto the road.

Photo 3. 9.75 Entire picture of M024 (upstream from the road)

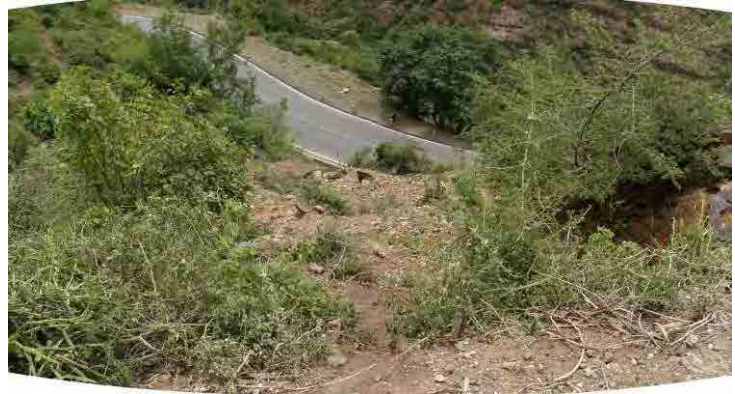
Although vegetation grows upstream, fallen stones from 30 to 50cm in diameter are distributed along the gullies. There is a possibility that these fallen stones may fall onto the road transported by sediment runoff.

Photo 3. 9.77 Entire picture of M024 (channel view from upstream)

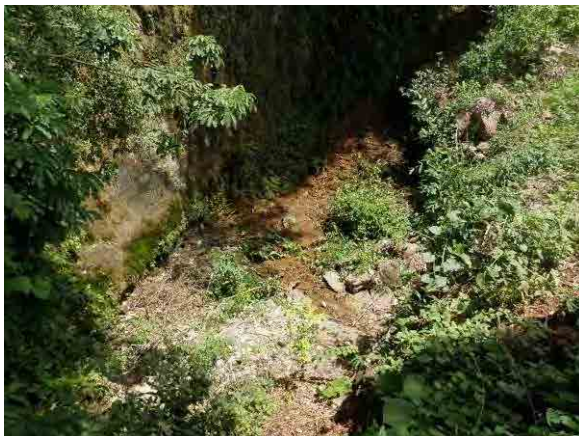
This small channel is located in a Rockfall hazard location, where water flow is confirmed. Although small amount of gravels are distributed in the channel bed, no signs of scouring or large rocks are present.

Photo 3. 9.78 Channel bed

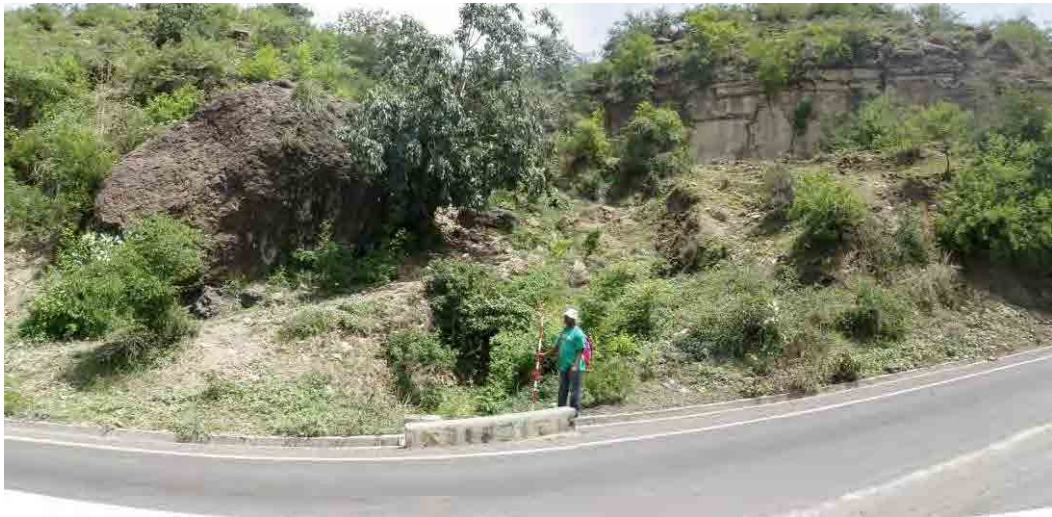
This small channel has a channel bed gradient of approximately 15° and is 1.0 to 2.0m in channel width, where gullies have developed.

There is no water flow, and fallen stones from 30 to 50cm in diameter are distributed along the gullies. Surface of the area around the gullies are bare due to erosion, and large basaltic rocks are present in the channel upstream. As is the case of channel MS024, sediment control structures have also been installed indicating that there has been sediment run off in the past.

The steep channel bed poses a potential risk of overland flow of unstable sediment and gravels from the stream during rainy season.

Photo 3. 9.80 Entire picture of M026 (upstream from the road)

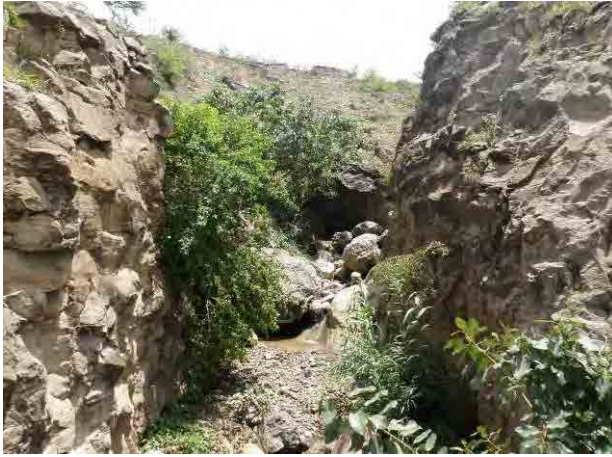
The channel bed gradient is 5.5° for the length of approximately 2.8km upstream from the road and the gradient becomes 10° further upstream. Compared to the channel length, its width is narrow which is between 1 and 4m wide. Both of the channel banks consist mainly of deposited sediment.

Gravels from 10cm to a few meters in diameter are distributed in the channel bed. Bank erosion is also significant. This channel goes under the road several times through the box culverts and drainage pipes, and then joins together with some branch flows that have developed gullies. The channel upstream is connected to the end of a water path, so that the surface water above the water path also flows into the channel.

Although the channel bed has a moderate gradient, the channel is long and bank erosion supplies a large amount of sediment. Hence, risk of debris flow is high.

Photo 3. 9.83 Entire picture of MS027 (upstream from the road)

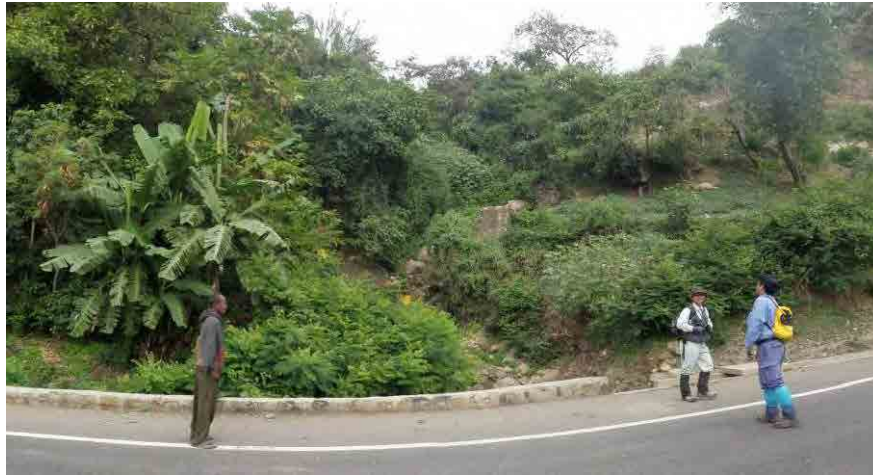
This small channel is located on the landslide, with a channel bed gradient of 14.0° (25%, read from the topographical map) and width of 1.0 to 2.0m. Vegetation is present around the channel, and upstream of the road is covered with shrubs. A dam is installed on the road side; however, this dam has been totally damaged to the point where it no longer retains its original form.

There is a large amount of sediment deposit in the box culvert installed under the road causing occasional overland flow of sediment onto the road in the rainy season according to the interviews conducted. Water flow was observed in the channel during the survey. Spring water occurring upstream is used for daily water consumption.

Photo 3. 9.87 Entire picture of M028 (upstream from the road)

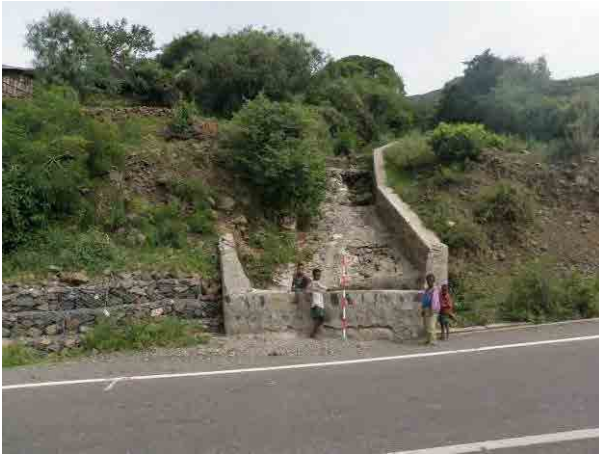
This channel has a channel bed gradient of 16.7° (30%, read from the topographic map) and 3 to 5 m in channel width. This is a small to medium-sized channel flowing along the side of the landslide wall. A water channel work is installed at the end of the channel beside which gabions are set along the stream to prevent surface erosion.

The flow path is used for a walkway leading to a water point, and large rocks over 1m in diameter are scattered in the channel bed. The entire channel bed of the upstream side is covered with gravels deposits.

Photo 3. 9.91 Entire picture of MS029 (upstream from the road)

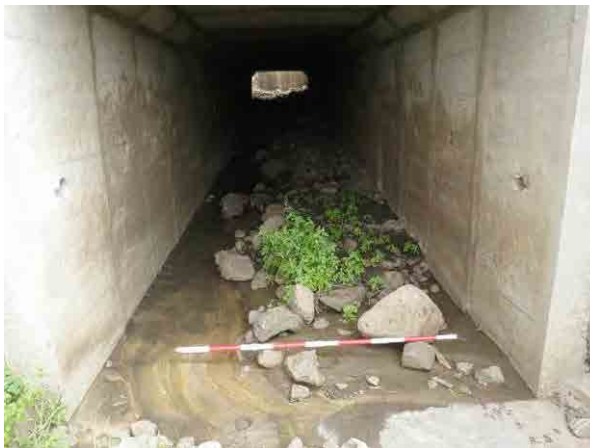
Gravels deposited in the box culvert under the road (2.5m high and 2.5m wide) are presumably transported down during rainstorm or rainy seasons.

Photo 3. 9.94 Box culvert (upstream direction)

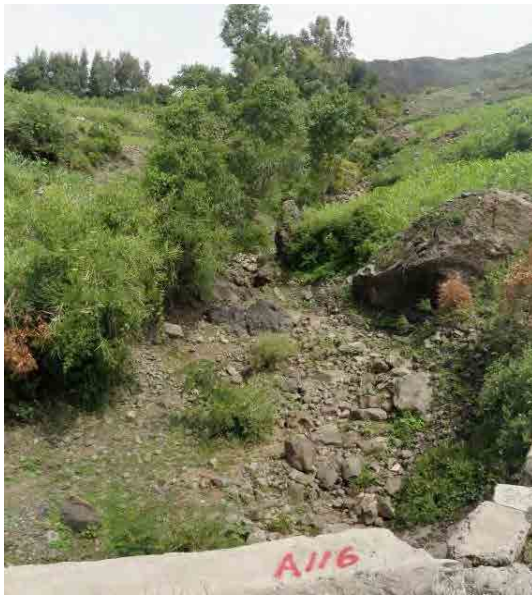
This small channel has a channel bed gradient of 13.2° (23%, read from the topographic map) and 1.0m in channel width, having developed gullies. The channel length is short, and this channel flows along the side of the landslide wall. Houses are scattered along the flow path downstream from the road.

Photo 3. 9.96 Entire picture of MS030
(upstream from the road)

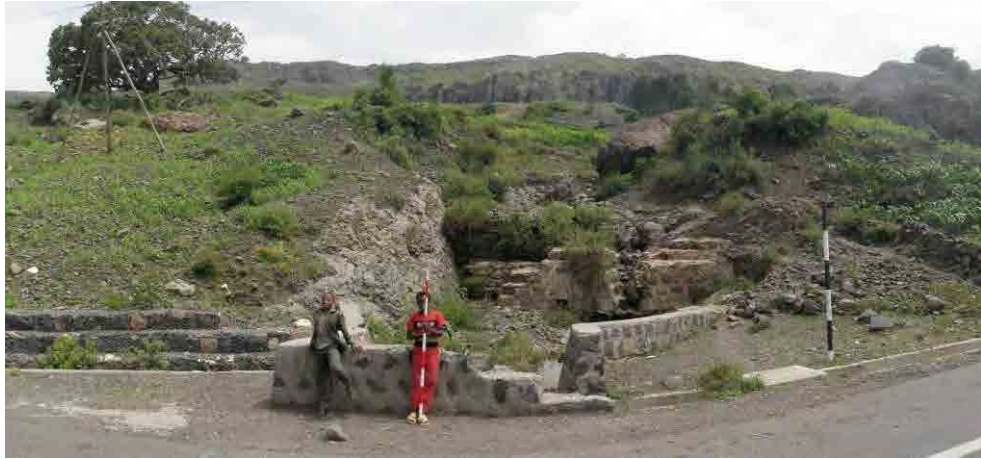
This small to medium-sized channel has a channel bed gradient of 10.6° (19%, read from the topographic map) and 3 to 5m in channel width, flowing along the side of the landslide wall. A sediment control work is installed at the end of the flow on the road side. Damages observed on the structure are presumably done by large rocks.

Large rocks over 1m in diameter are distributed in the channel bed, and the bed is covered with gravels. Very little vegetation grows along the flow path, which is used as a walkway. As is the case of the previous channel, there is a spring occurring upstream which is used as a water point.

Photo 3. 9.99 Entire picture of MS031 (upstream from the road)

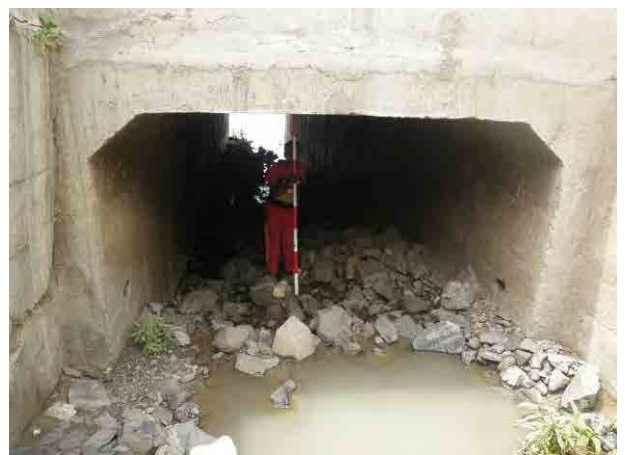
Gravels are deposited in the box culvert installed under the road indicating large amount of sediment runoff. In this channel, occasional sediment runoff has been reported in the past.

Photo 3. 9.101 Box culvert (crushed rocks deposit)

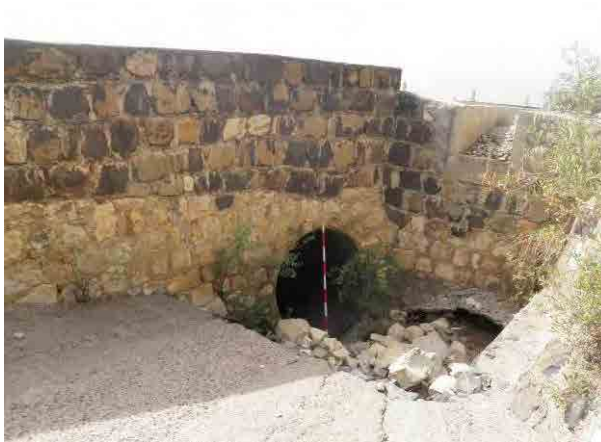
Photo 3. 9.104 Traversing drainage system (crushed rocks deposit) Photo 3. 9.105 Traversing drainage pipe (drainage pipe shape has been altered)

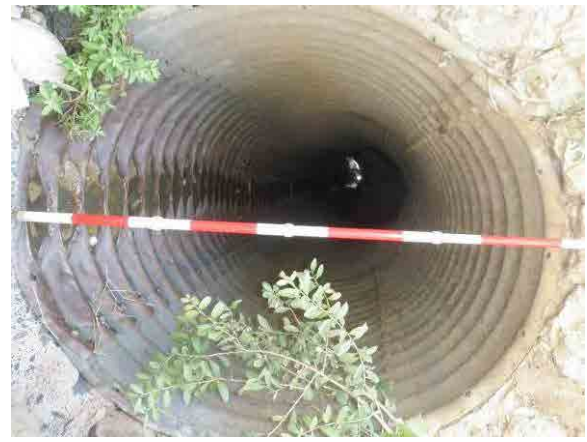
No water flow was confirmed when this survey took place. Even when there is a flow, discharge is likely to be small judging from the size of the crossing drainage work. However, this drainage structure has become deformed whose ability is now limited. In addition, as there are no structures at the drainage for directing the flow, developing gullies are leading to significant surface erosion. Although the channel is relatively close to the road, the risk of sediment runoff is low as catchment basin is small.

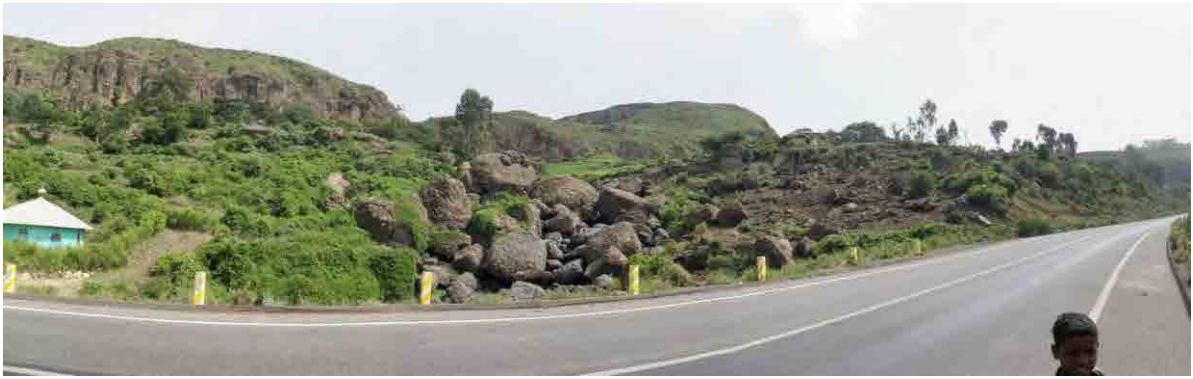
Upstream from the road, large basaltic rocks are seen, and some of them have 5m or larger in diameter. Basaltic cliff walls appear around 350m upstream from the road, and there is a waterfall in the channel. Large rocks are densely distributed around the waterfall presumably deposited there by Rockfalls or debris flows. Public facilities and other buildings in need of protection during disasters such as churches and houses are scattered in the area downstream near the road.

Judging from the size of the basin area, channel extension, and gradient, this channel has a high risk of debris flow.

Photo 3. 9.106 Entire picture of MS033 (upstream from the road)

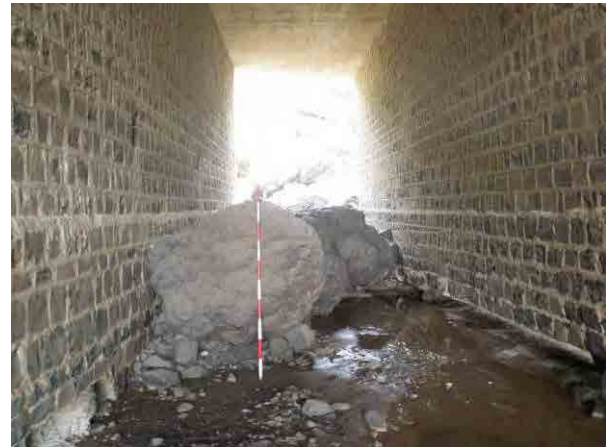
Large rocks about 2.0m are observed in the box culvert (7.0m high and 3.0m wide) installed under the road. In the past, the slope on the side close to the road failed, causing large rocks to fall. Large basaltic rocks are distributed in the area downstream from the road, which seems to have been transported and deposited by debris flow.

Photo 3. 9.109 Large rock in the box culvert

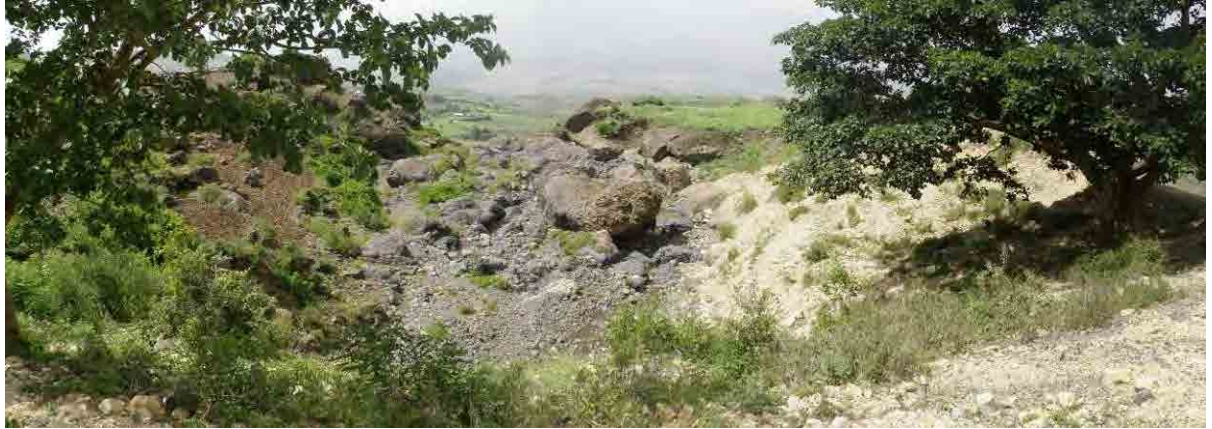
Photo 3. 9.110 Entire picture of MS033 (at downstream from the road)

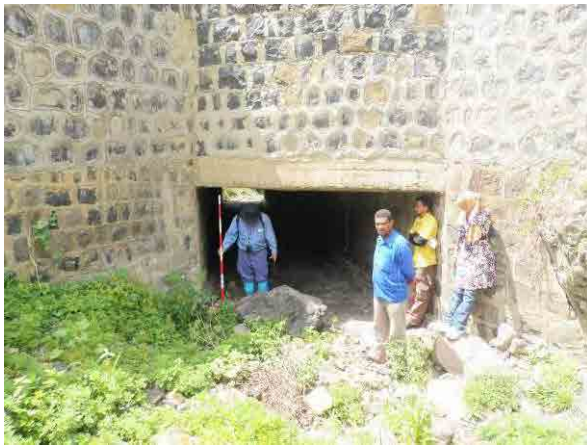
No sediment is deposited in the box culvert under the road indicating small amount of sediment runoff during the last few years. However, depending on the precipitation level during the rainy season, there is a possibility of sediment runoff.

Photo 3. 9.113 Box culvert installed under the road
