sedapal **REPUBLICA DEL PERU** **jica**
SERVICIO DE AGUA POTABLE Y ALCANTARILLADO DE LIMA

FIGURE 2.5.8-14: DISTRIBUTION OF SECONDARY PIPES BY MATERIAL

GRAFICO 2.5.8-15: REDES SECUNDARIAS DE AGUA POTABLE SEGUN ANTIGUEDAD DE TUBERIAS
FIGURE 2.5.8-15: DISTRIBUTION OF SECONDARY PIPES BY AGE

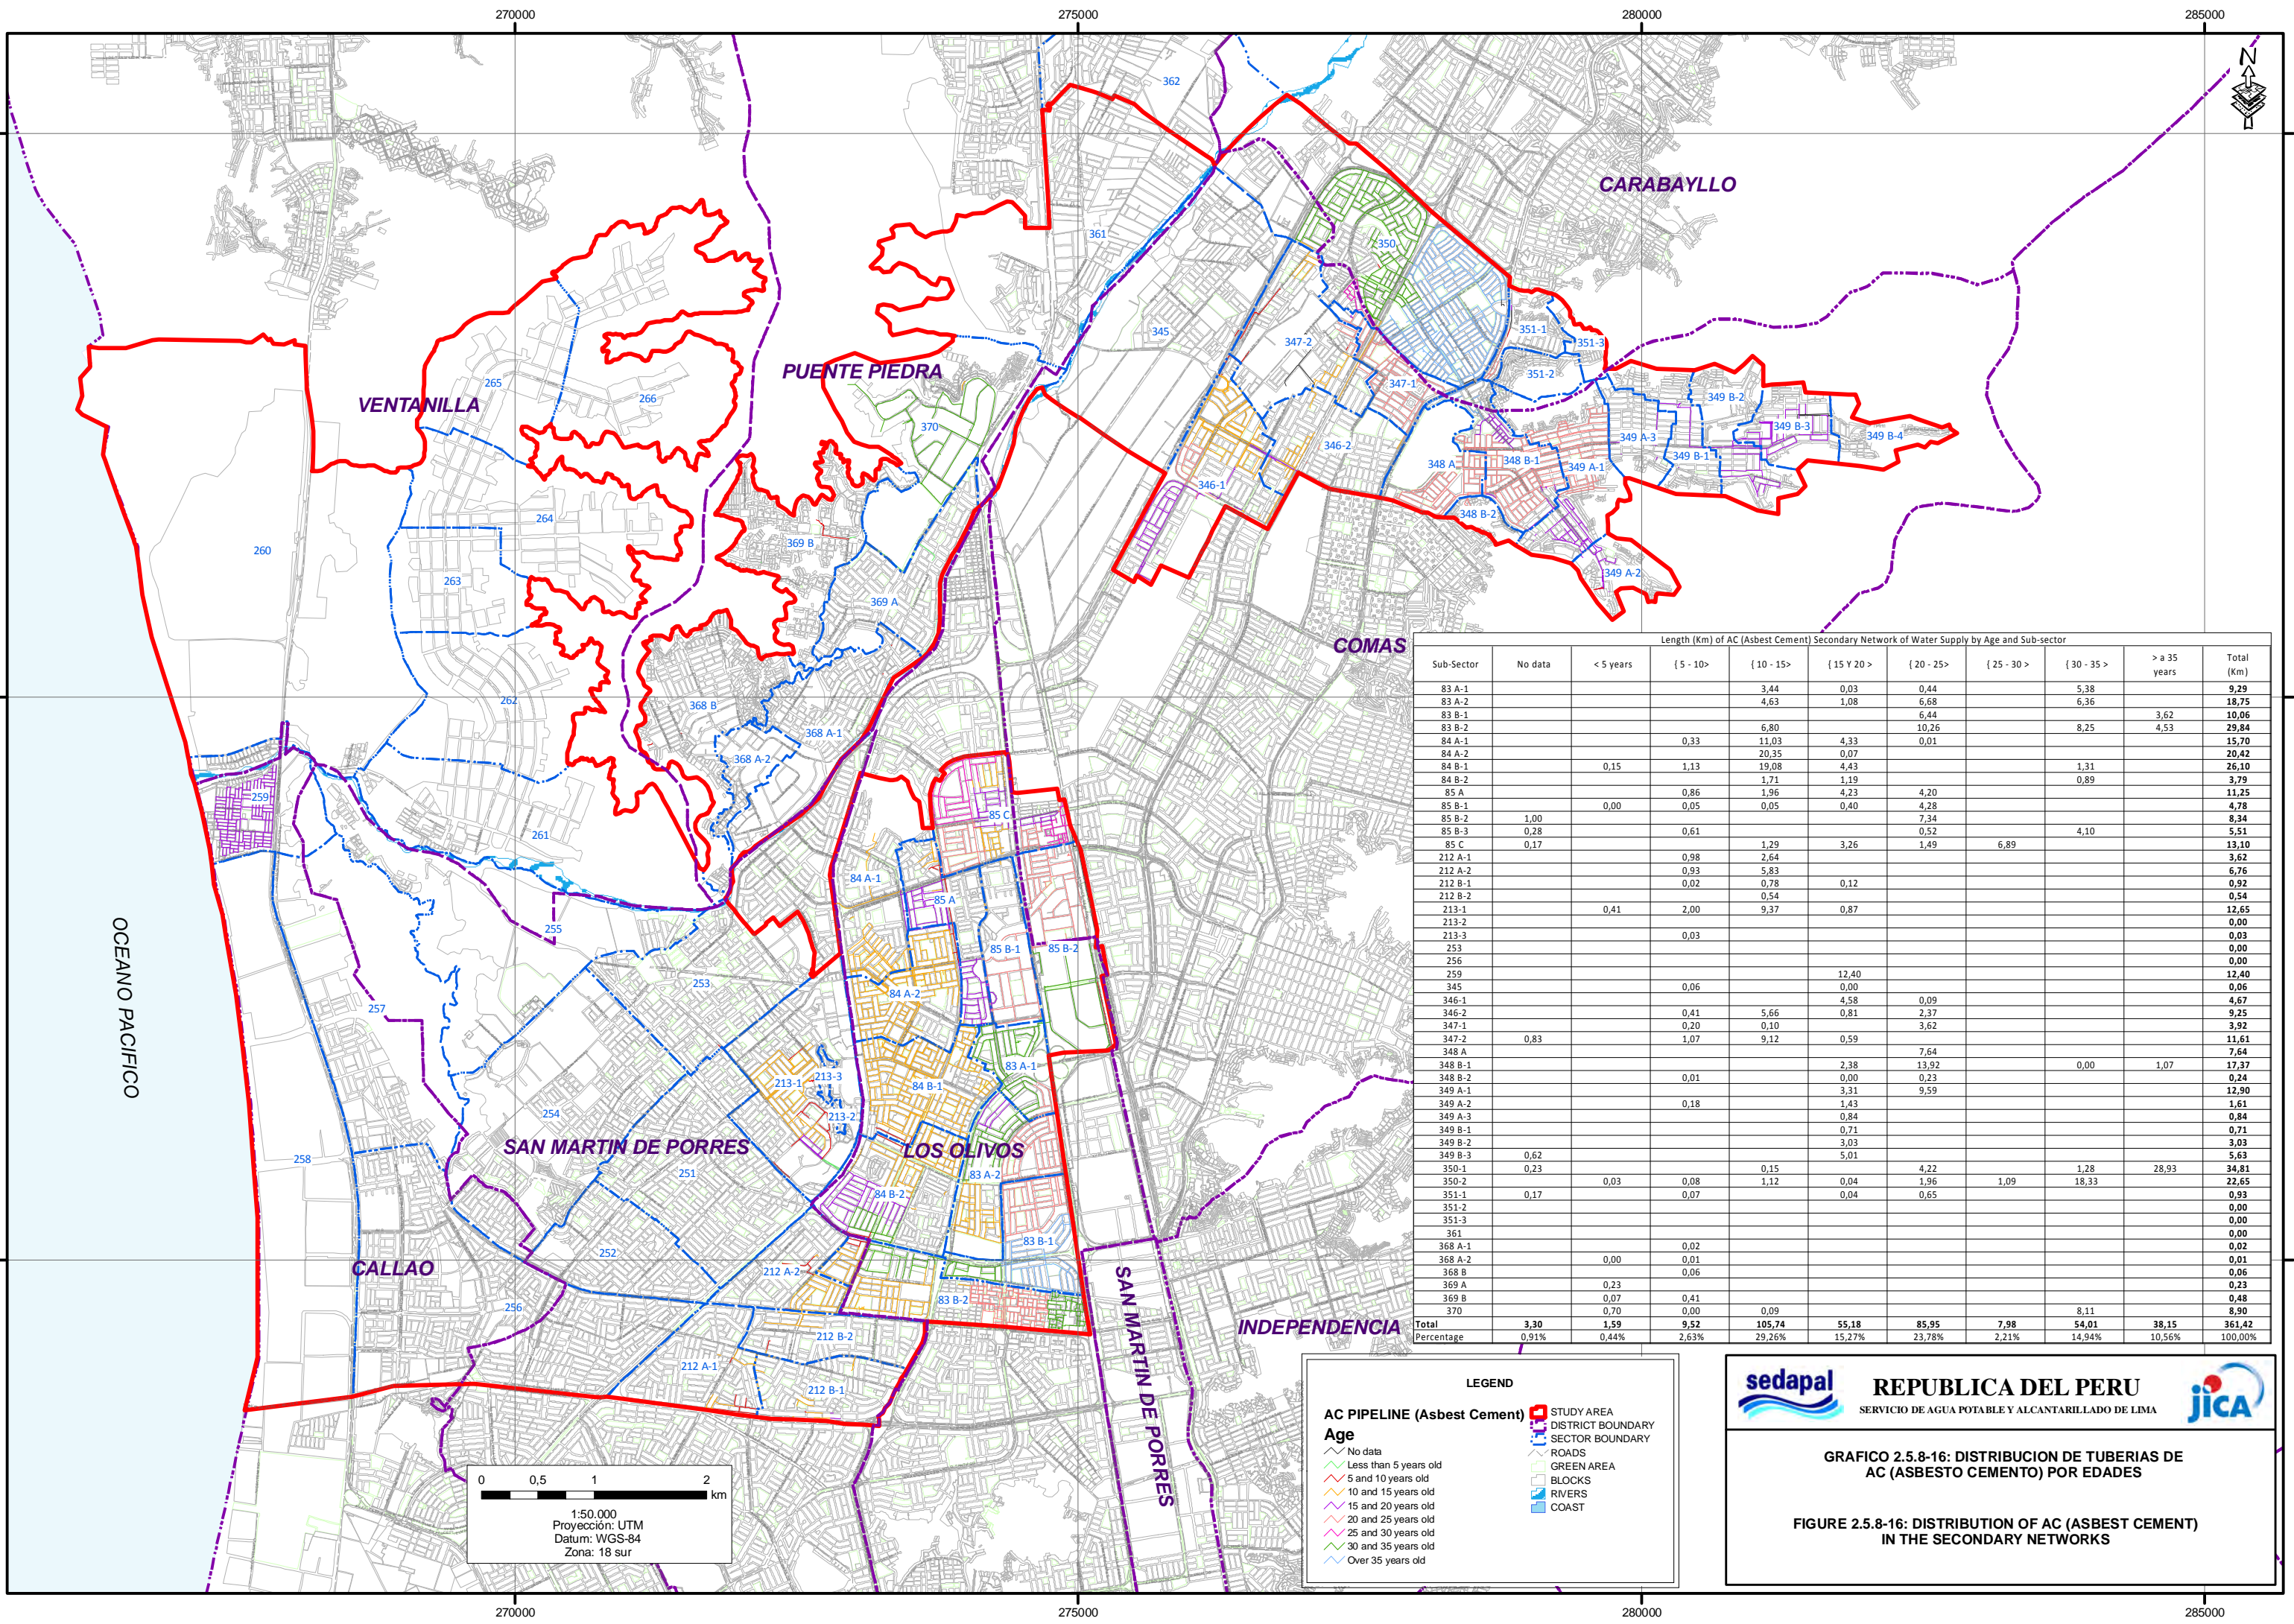
FIGURE 2.5.8-16: DISTRIBUTION OF AC (ASBEST CEMENT) IN THE SECONDARY NETWORKS

- About 50 % of AC pipes were installed more than 20 years ago, but more than 30 %, on the other hand, have been installed in the last 15 years.
- AC pipes are distributed throughout the whole Study Area except in the newly developed area in Puente Piedra.
- Asbestos cement is a kind of cement reinforced by asbestos. According to the Rehabilitation Guideline (2005, Japan Waterworks Association), the strength of asbestos cement deteriorates over time. As shown below, the tensile strength of asbestos cement deteriorates by 30% in 20 years and by 50% in 30 years. Moreover, ratio of accidents of asbestos cement tends to increase, especially 25 years after installation.

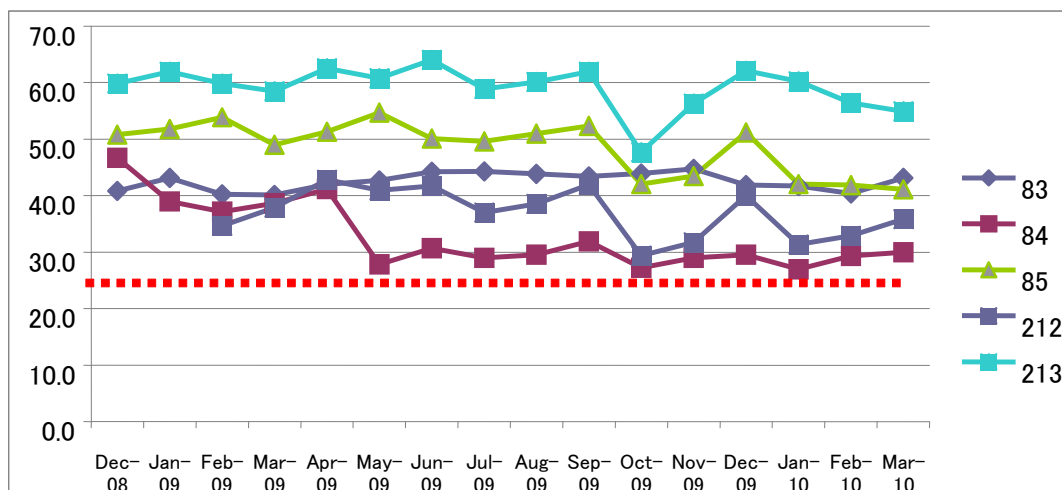
Figure 2.5.8-19 Non Revenue Water Ratio in Five Sectorized Area

Figure 2.5.8-19 shows NRW ratio of five sectorized area in the Study Area. In NRW ratio, the Sector 213 has the highest NRW (average 57%), which is more than the average, and the Sector 84 (average 30%) has the lowest NRW, which sometime almost achieve the target of 25%. However, as shown in Table 2.5.8-28, the worst area, Sector 213 has AC pipes (34%) and PVC pipes (66%), and the best area, Sector 84 has AC pipes (65%) and PVC pipes (35%). Sector 83, where 37% of pipes are more than 25 years AC pipes, has much lower NRW ratio than Sector 213. It does not show any relationship between NRW and ratio of AC pipe ratio/ pipe age, also.
