(4) Diagnosis of Condition of Sewerage Networks

The following criteria have been considered in defining the condition of the sewerage pipes in the Lima Norte II Study Area:

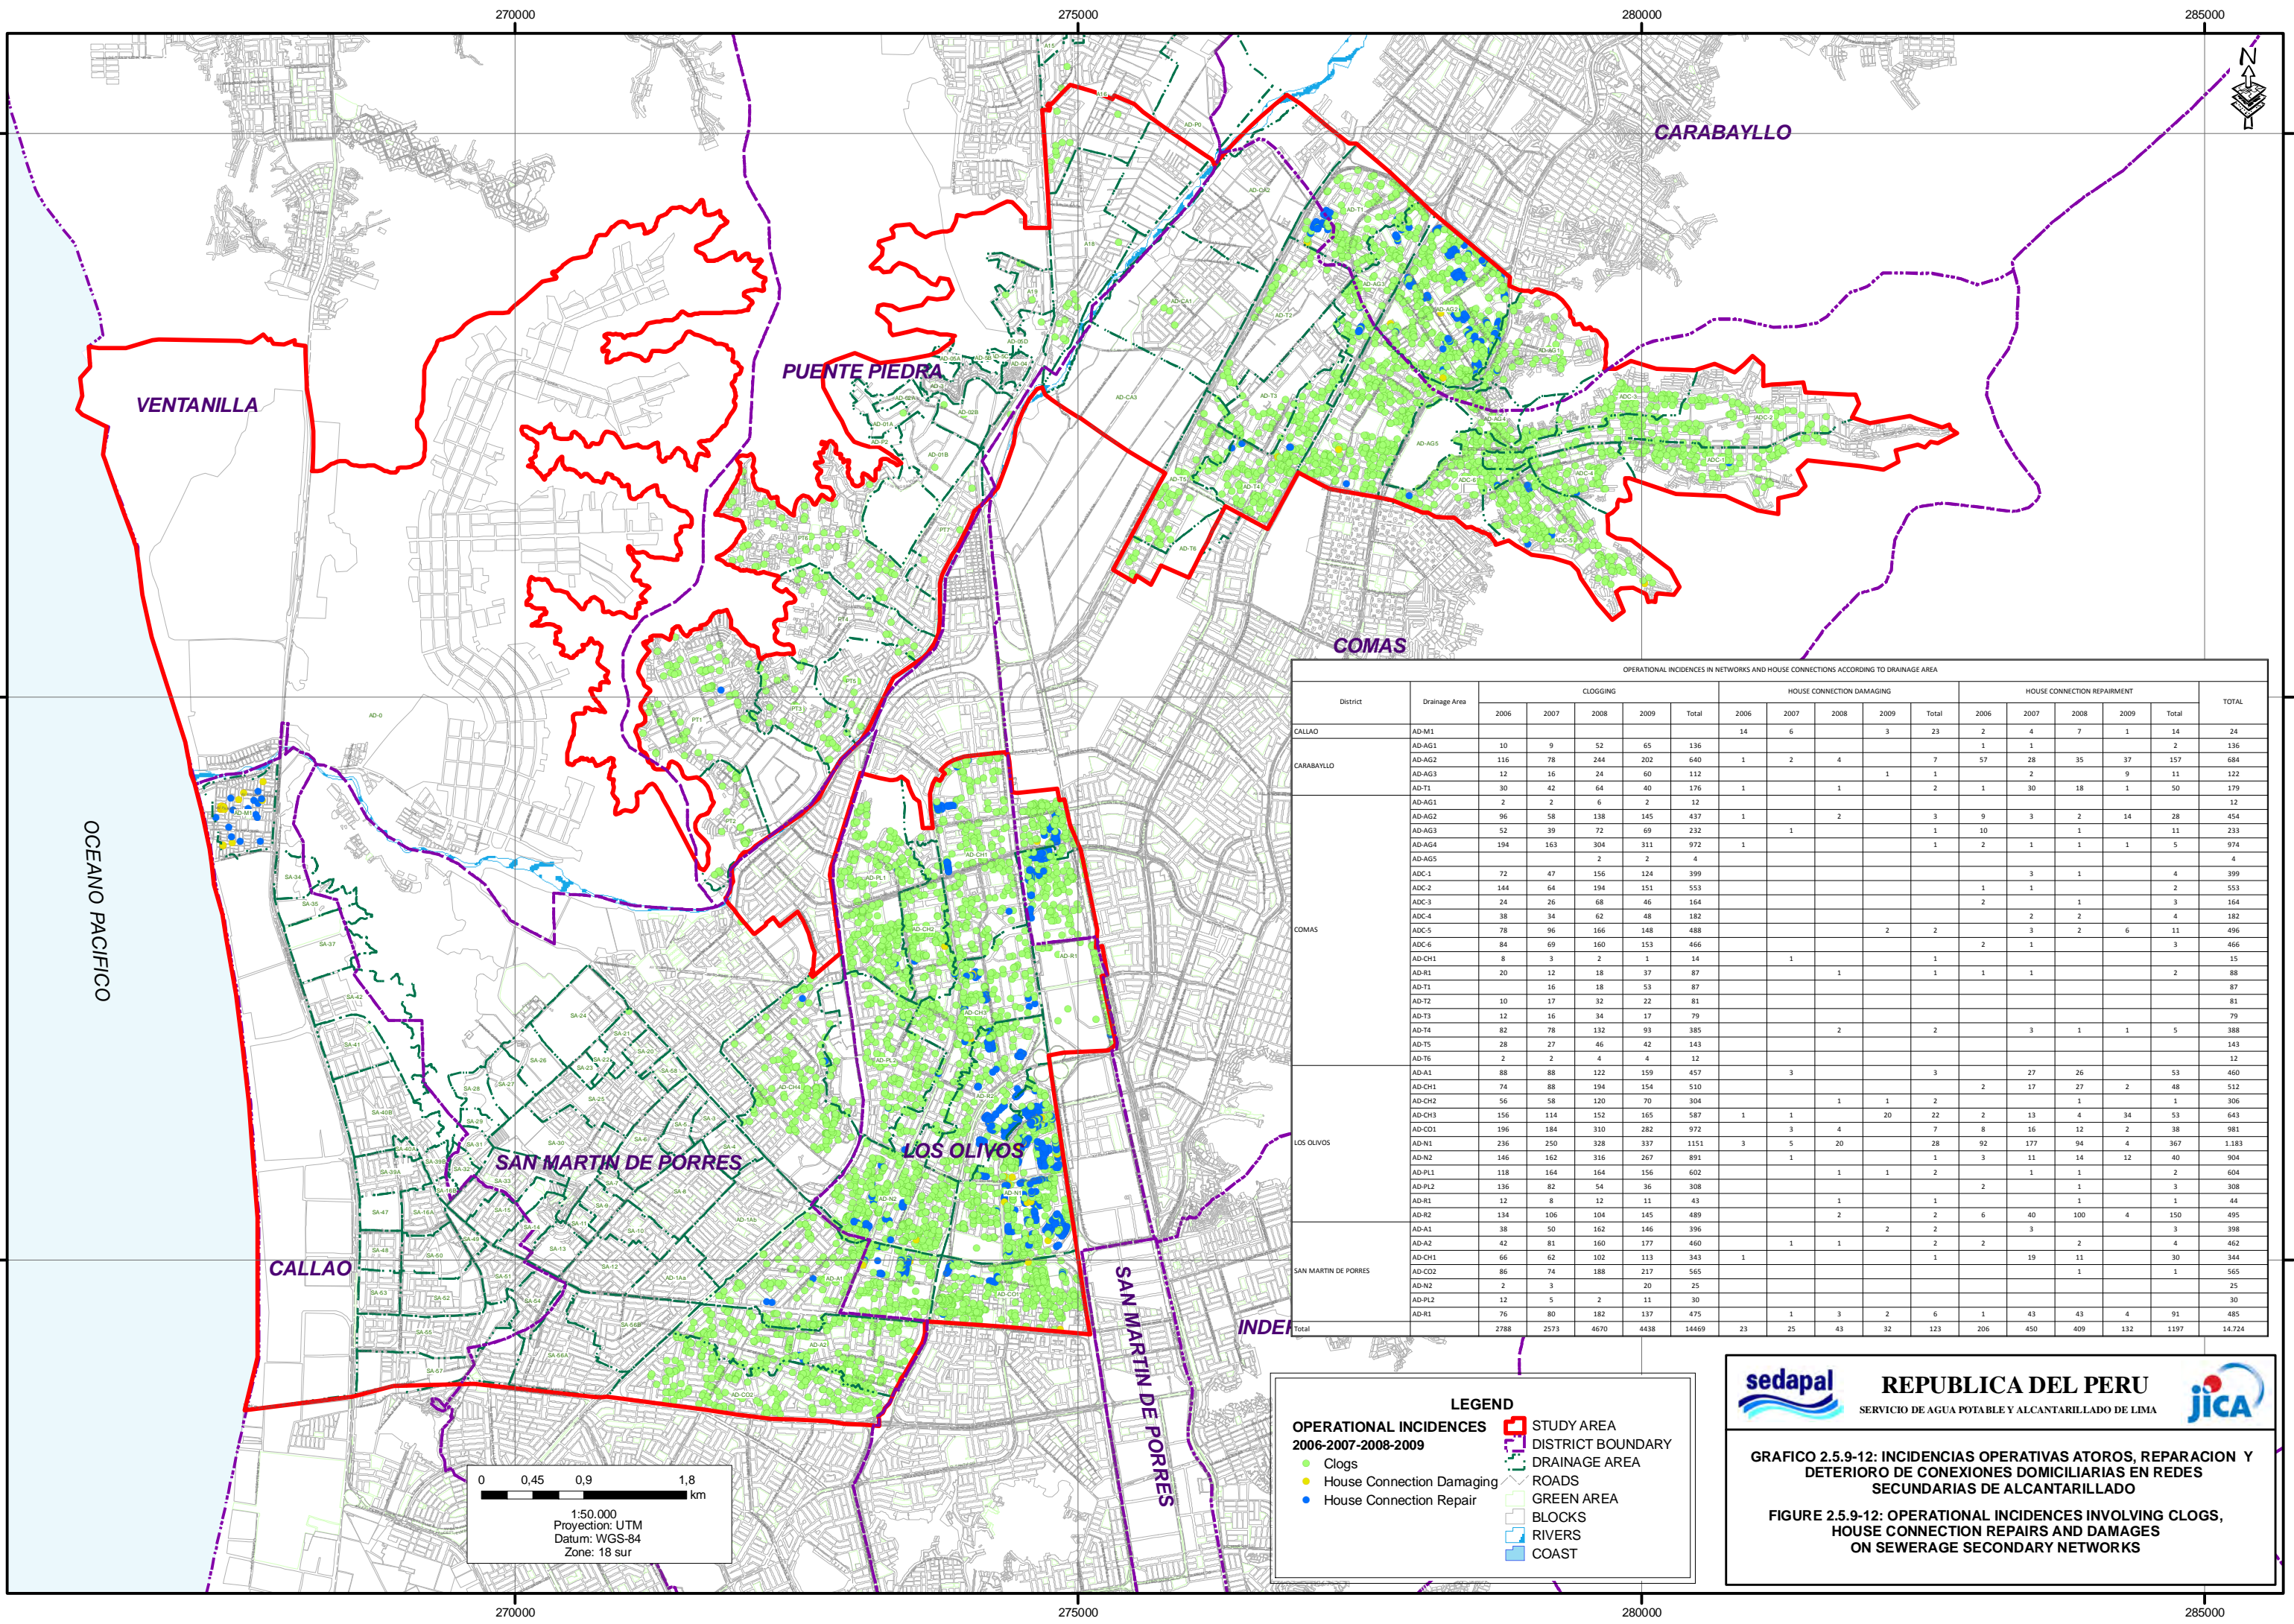
OPERATIONAL INCIDENCES IN NETWORKS AND HOUSE CONNECTIONS ACCORDING TO DRAINAGE AREA

Figure 2.5.9-12 shows all the description by type of incidents presented according to the SEDAPAL's NIS.

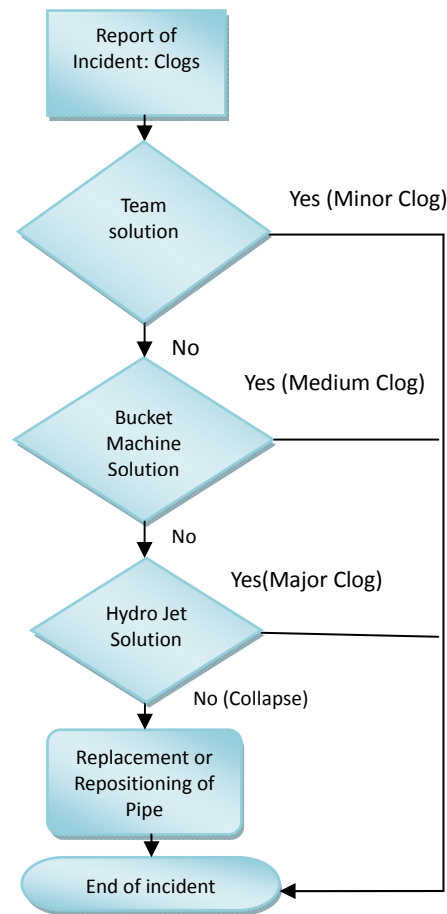
Figure 2.5.9-13: Flow Chart for Collapses

Figure 2.5.9-13 is a flow diagram showing the way to distinguish the types of incidents

directly relevant to the condition of the pipes. The “Replacement or repositioning of pipe” is the activity that allows to infer the condition of the pipes in adjacent zones.

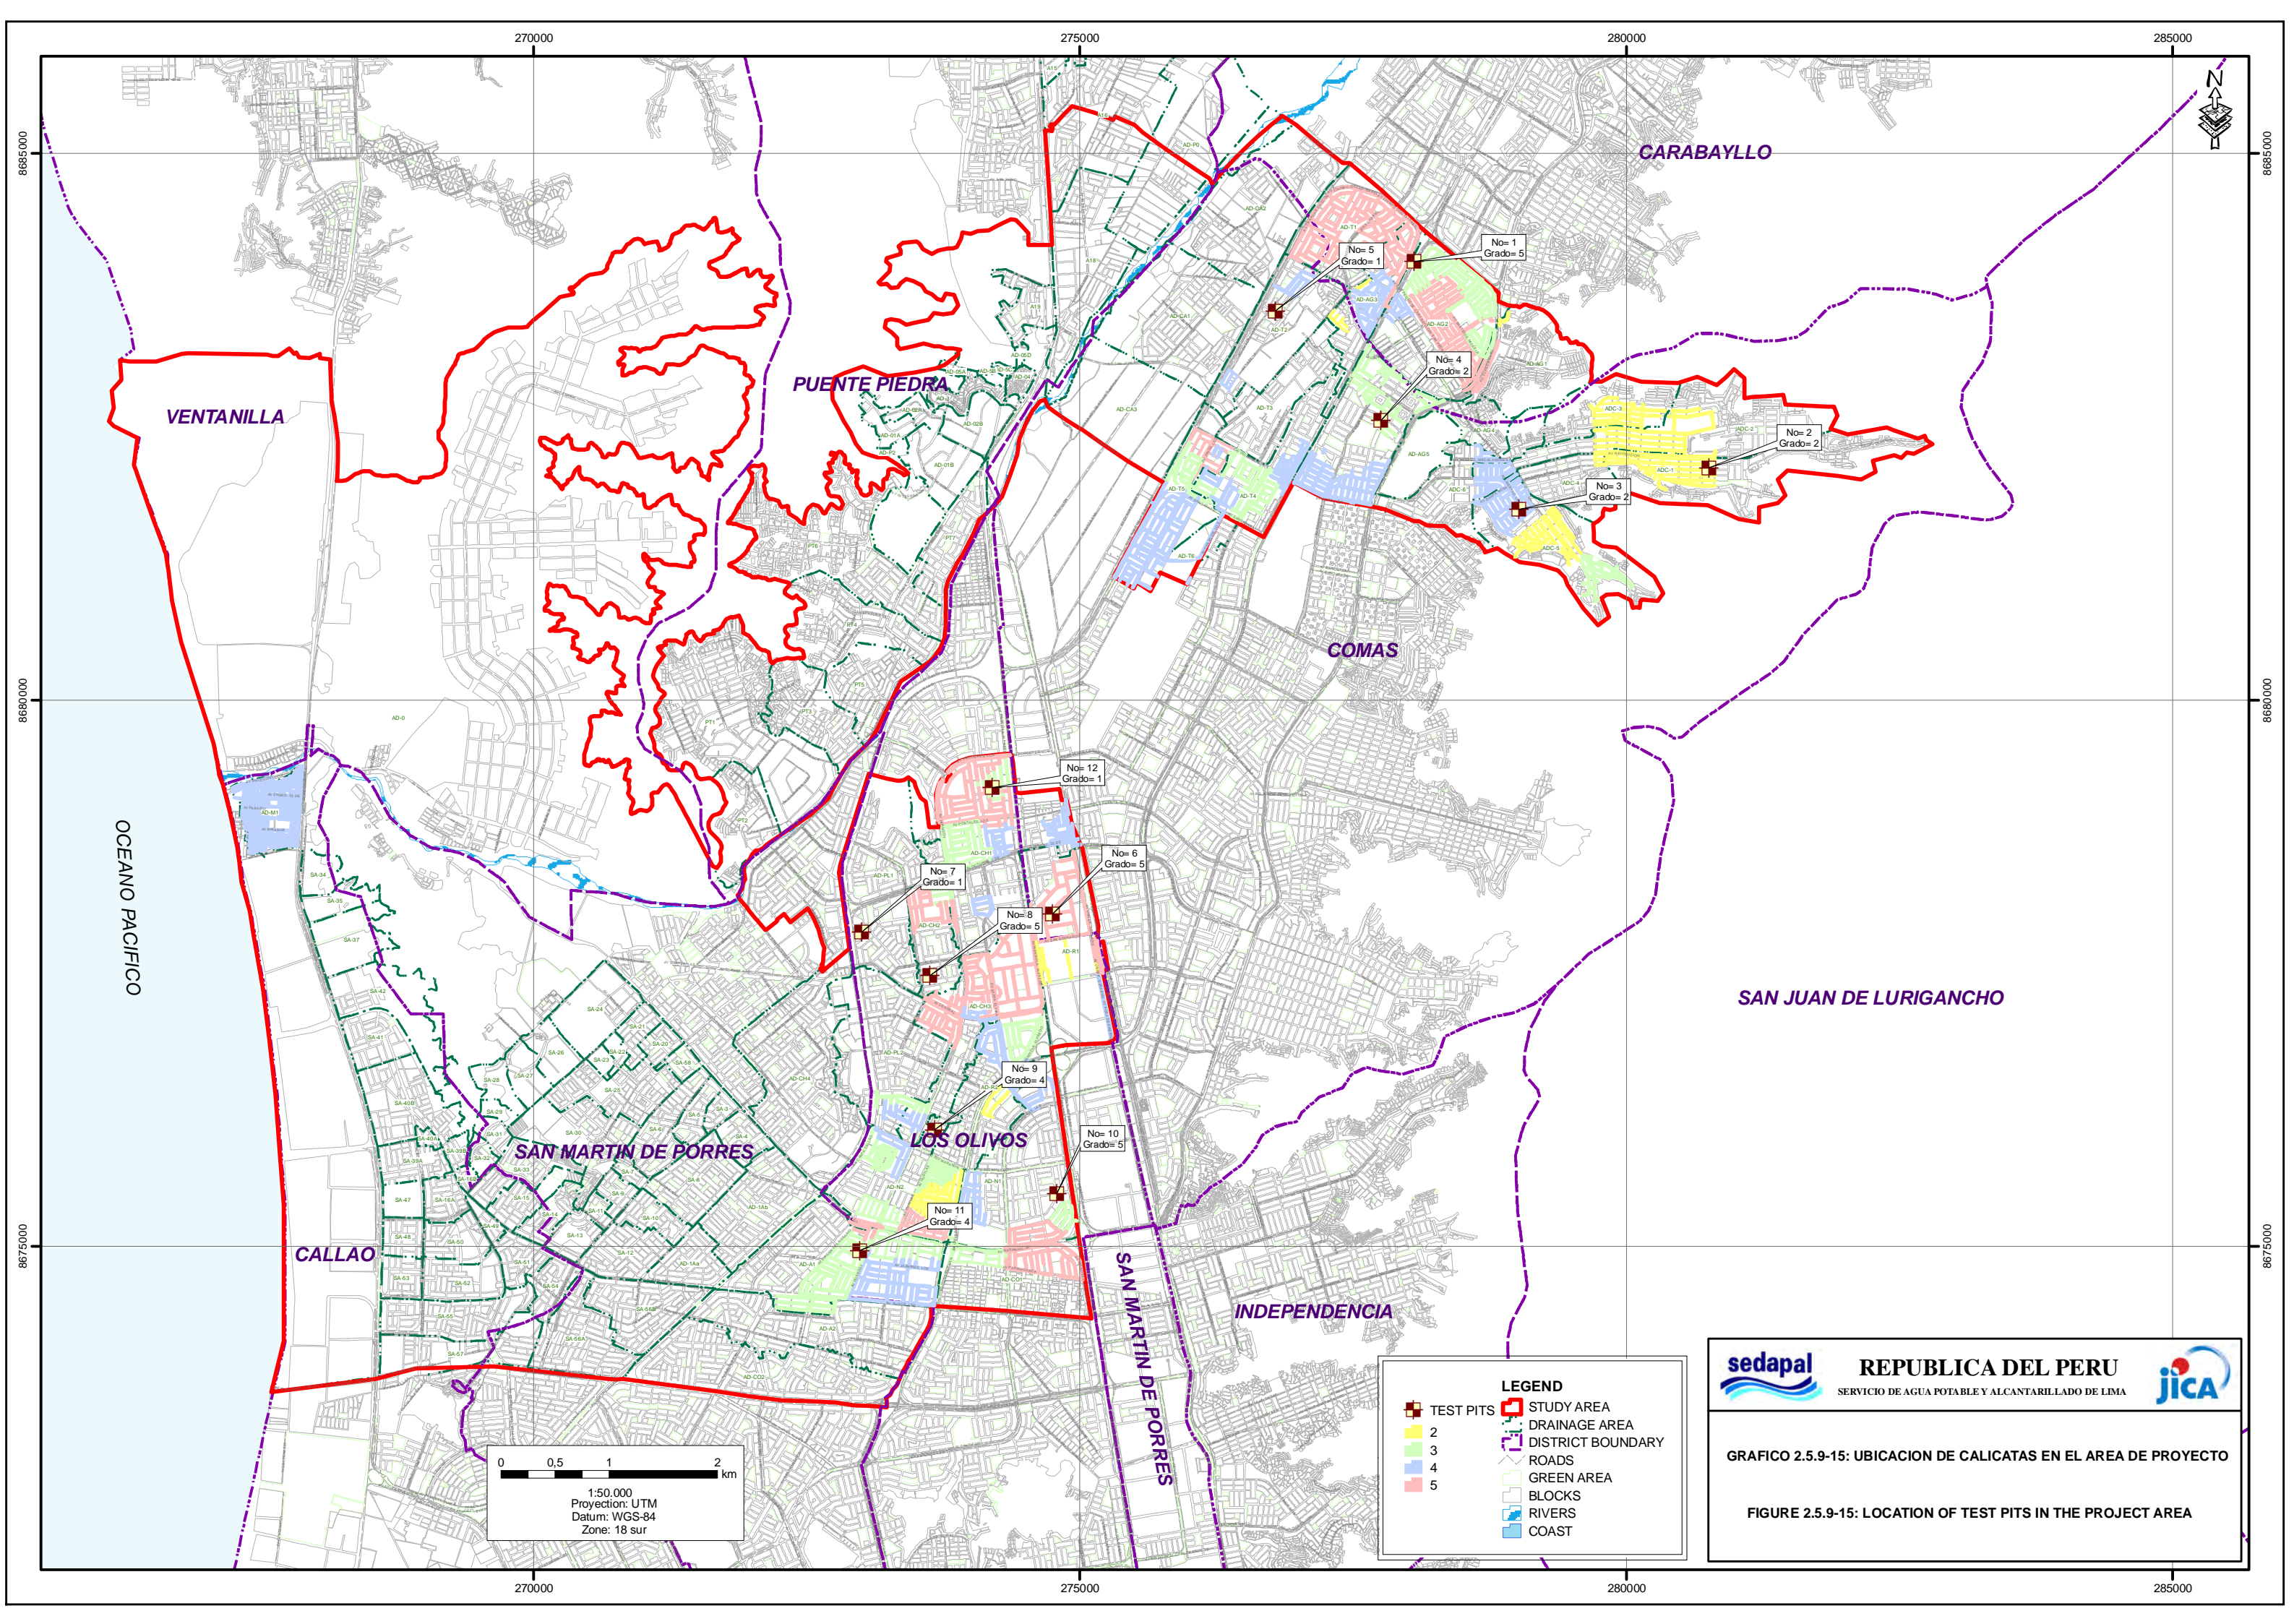
GRAFICO 2.5.9-15: UBICACION DE CALICATAS EN EL AREA DE PROYECTO

The results of these exploration pits confirmed the results obtained in the 'manholes and pipes study'.

Figure 2.5.9-15 shows the location of the exploration pits in the Study area.
