List of Field Survey Results (1/3)

List of Field Survey Results (2/3)

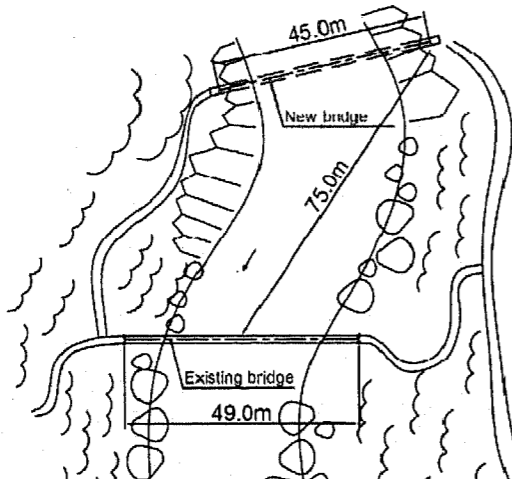
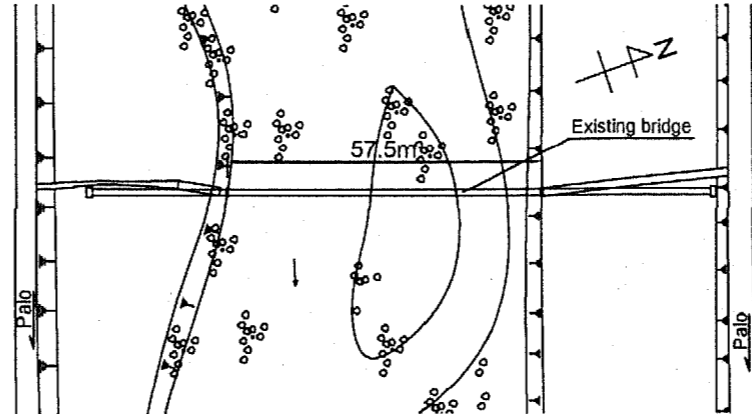
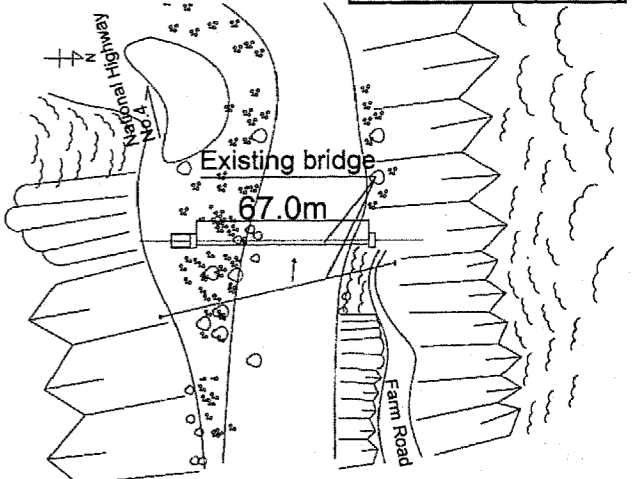
<p>Status just after flood</p> <p>Road bridge</p> <p>Pedestrian bridge washout</p> <p>Existing bridge status</p> <p>Bridge pier washed out</p>
Schematic plan view

Use status	Few users (No pedestrians passed in 30 minutes.)	About one pedestrian every 30 minutes	About 10 pedestrians every 30 minutes On the opposite shore of the bridge, there is a settlement consisting of 210 households and about 3,000 persons.
Bridge status quo	Although the existing bridge is significantly superannuated, the construction of a new bridge has started at a location 75 m upstream.	The narrow width of the main tower foundation and insufficient embedding has resulted in riverbed scouring, which is causing the main tower to slant. The significant damage poses a danger to passing pedestrians.	Cyclone Aila damaged the slab of the existing pedestrian suspension bridge and washed out the Bailey bridge that had been constructed in a lower position. The piers of the Bailey bridge were also washed out because the construction joints were weak. As for the bridge piers, insufficient joint treatment and low quality concrete casting such as honeycombs have been confirmed. At present, a makeshift pedestrian suspension bridge has been constructed using the substructure of the Bailey bridge.
