(7) Myaungmya Br.

(9) Panmawaday Br.

4. Field survey: Expressway structures (river bridges, interchange bridge, etc.)

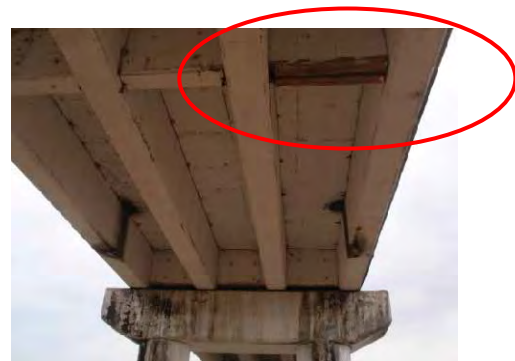
- There is no drainage pipe from roadway drainage along the pier.

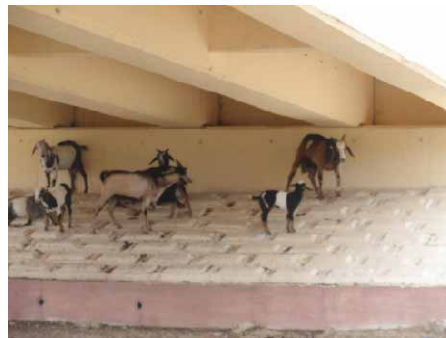
Bridge abutment

- Neither special steps nor damage are seen.

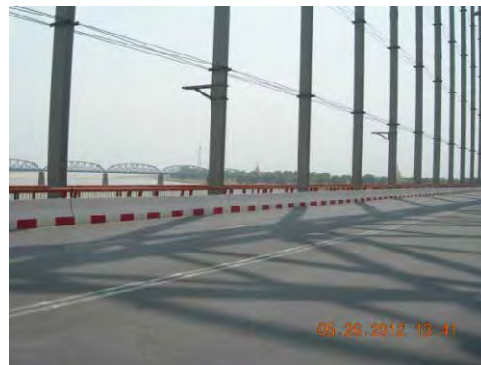
I type section of suspension device is covered with the steel board.

- To enlarge the rigidity because the vibration by the wind was generated in the construction stage, it is adopted the box section (from PW interview).
- The Stiffening girder is set up.

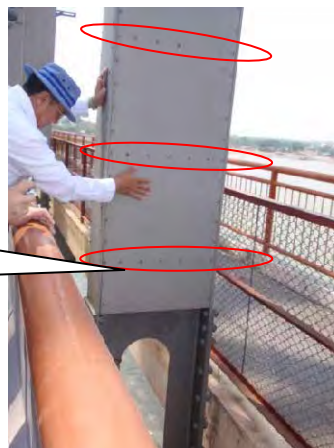
Construction accuracy of bolt alignment

- There are enough space form a bolt to the edge of plate.

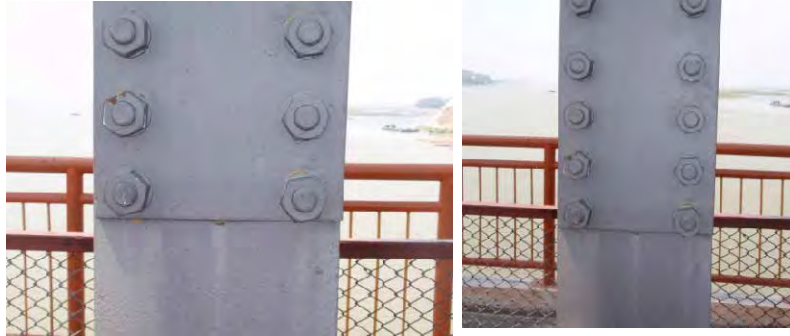
Situation of joining part

- The bolt is missed.

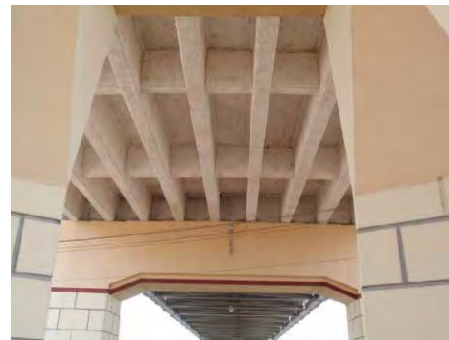
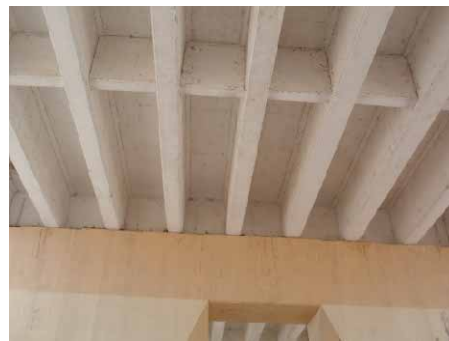
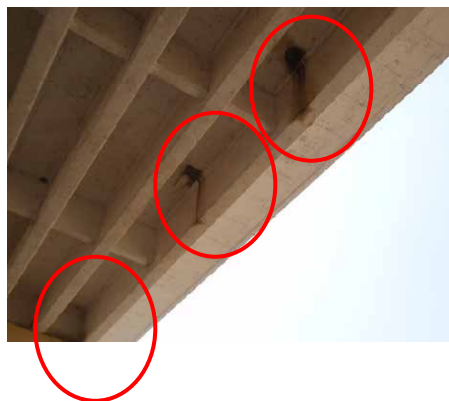
Approach girder

- Drainage from deck slab falls down to web parts.

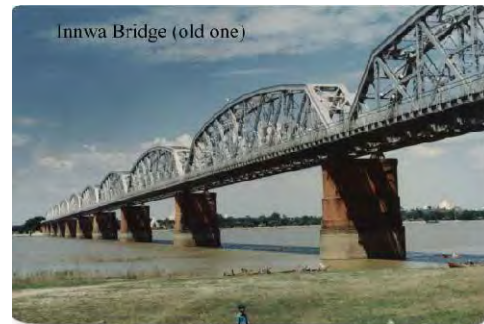
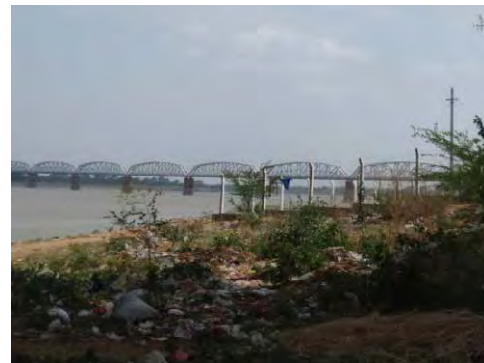
Old bridge (Innwa Bridge)

- Construction in 1934, a combined road-railway bridge , 1188m in length
- 78 years have passed since a bridge was constructed.
- The passing car is limited to 15t or less in 1992.

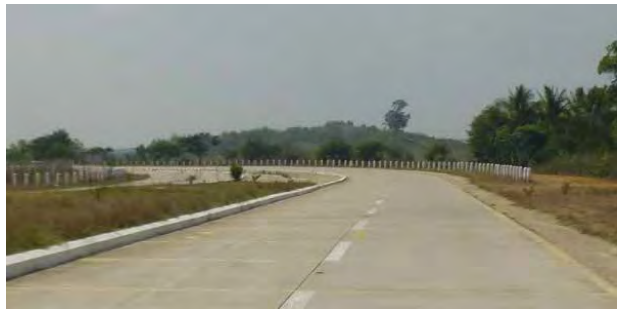
Entrances to curves give the impression of being too sharp

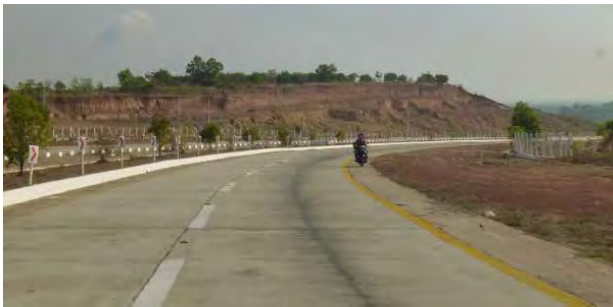
In sharply curving sections, there are arrow signs installed (Motorcycle is going the wrong direction)

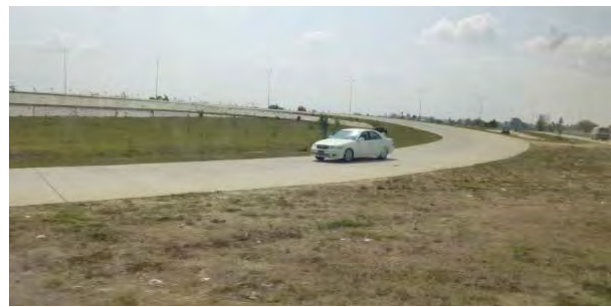
Some interchange ramps have no safety facilities whatsoever Nay Pyi Taw interchange ramp (extremely poor visibility)

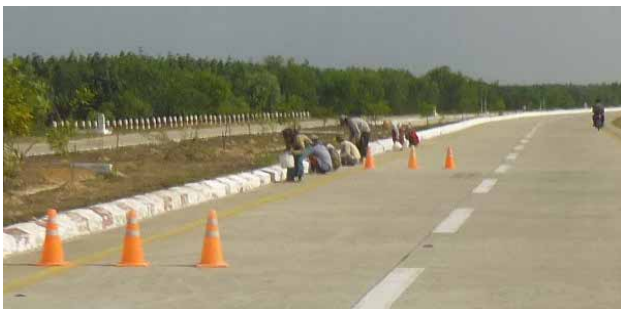
Painting curbstone along the median. Traffic regulations are extremely rudimentary

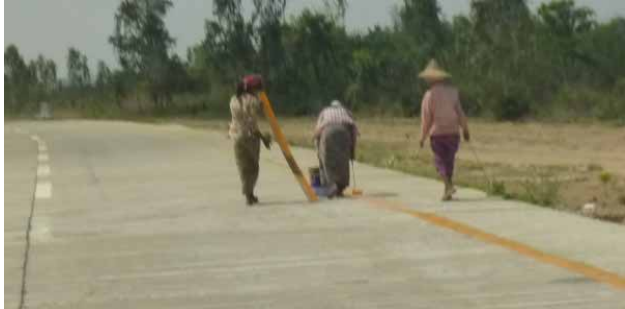
Workers repainting lane marker No regulations, no guard for the rear

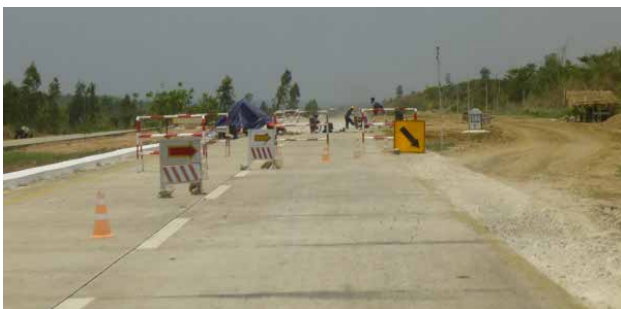
Both two lanes closed. Vehicles directed to detour on unpaved part

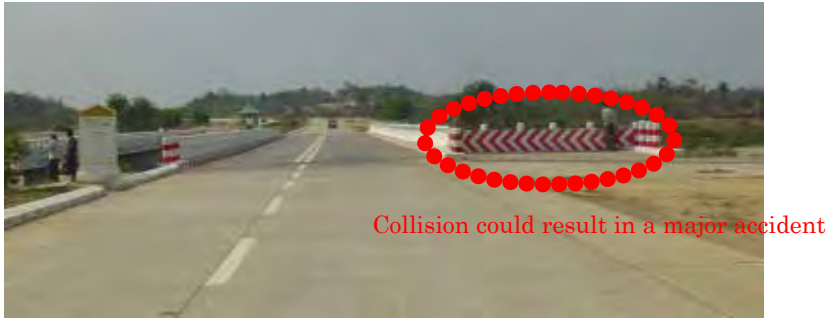
Bridge area with high risk of collision

At the ends of bridges, there are walls or concrete poles to prevent vehicles from falling in rivers. Since the expressway has no guardrails, there is a risk that cars could go out of the lane and collide with these walls, resulting in major, fatal accidents. Particularly at small bridges without light facilities such as the one shown in the photo below, this risk becomes greater after nightfall. There is an urgent need to take measures such as installation of reflectors and cushion drums, etc.

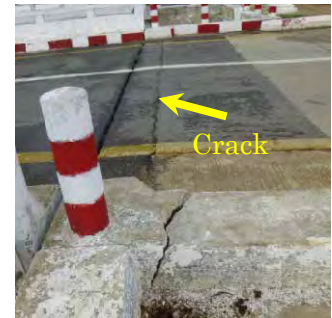
Near 51 miles 1 furlongs post

- In wide sections, steel bars of pier beams and pier bases are cured with concrete.
- Abutments are moving toward the river, meaning that the earthwork behind the abutments is loosening. The shift behind the abutments generates cracks in the pavement.

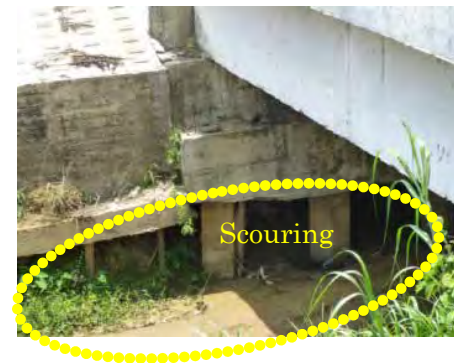
Scouring

- Steel beams of floor slabs for widening are protruding and not protected, therefore they are rusting.
- The riverbed has sunk drastically, exposing the abutment pilings and making the retaining wall foundation appear to float.
- The joints are butt joints where floor slab ends are fitted with angle bars, and rainwater easily seeps below the road surface.

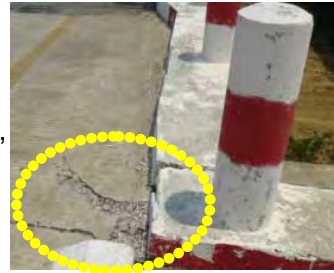
- In wide sections, steel bars of pier beams and pier bases are cured with concrete.
- Abutment has fallen and is interfering with the girder. This causes damage to the concrete paving.
- Stiffener for connecting parts, used during widening, is applied to the steel girder web.

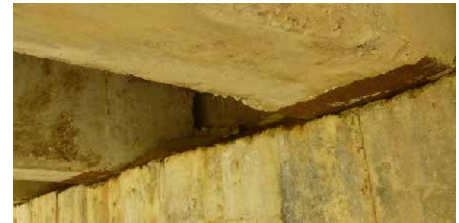
Near 77 miles 3 furlongs post

- Support bearing is in the form of a horizontal steel plate. Earth and sand has accumulated in the gaps between joints, and the steel plates themselves are rusting.

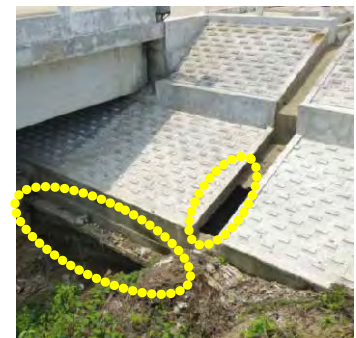
Near 93 miles 3 furlongs post

- There is a vertical ditch to drain water away from the median, but it is broken. As it is broken yet stays in place, the bottom of the block pitching is greatly scooped out. The hollowed-out part extends to beneath the abutments, and further damage is feared.

(It is not clear which the damage to the vertical ditch or the scouring of bottom of block pitching came first. However, it is evident that insufficient periodic inspections have made the damage worse.)

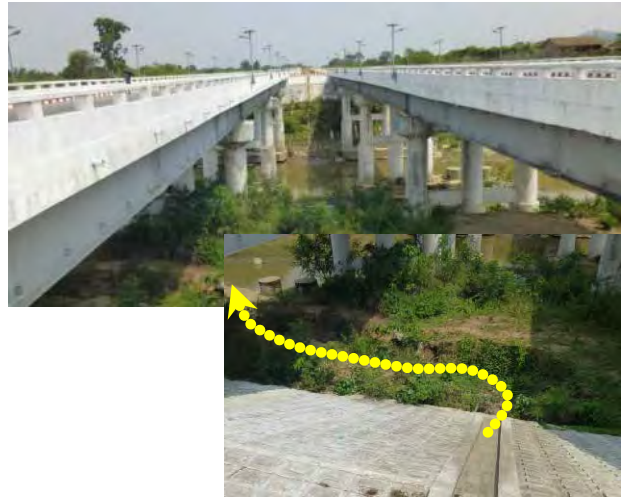
Near 145 miles 1 furlongs post

- There is no drainage ditch to conduct water from the vertical ditch in the block pitching to the river. This results in severe erosion of the soil, digging a natural channel for the water.

As the position of the abutments' footing is high, it is feared that damage to the block embankment and abutments such as that seen at the 33 miles 3 furlongs location could develop.

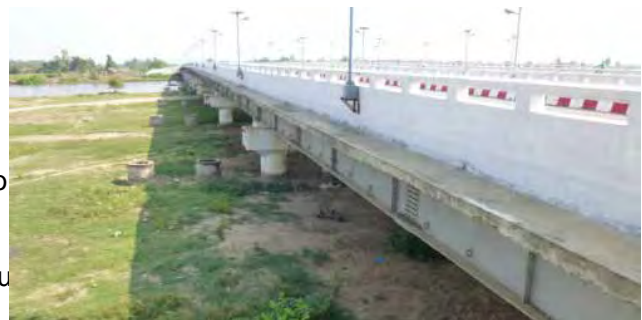
Near 164 miles 3 furlongs post

On the piers, the main steel bars are protected, but the structure causes water to build up.

- In the widened area, only the single edges of finger joints are mounted. These have already begun deteriorating, and it is advisable to start widening work right away.

- There is a stiffener for connecting parts, with a hole in it, installed in the steel girder web for widening.

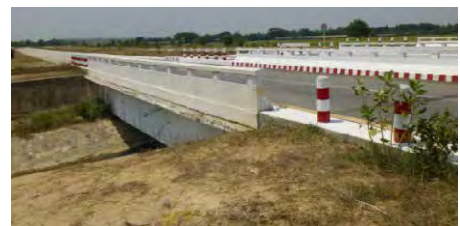
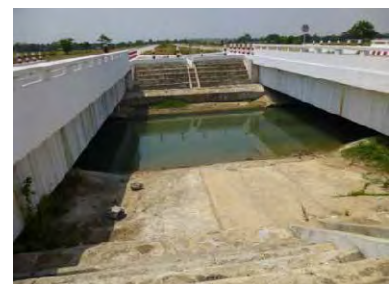
Near 165 miles 3 furlongs post

- As water is conducted to the flowing portion of the river and the girder is protected with concrete blocks or sealed with concrete, this bridge has not suffered damage like the other bridges.

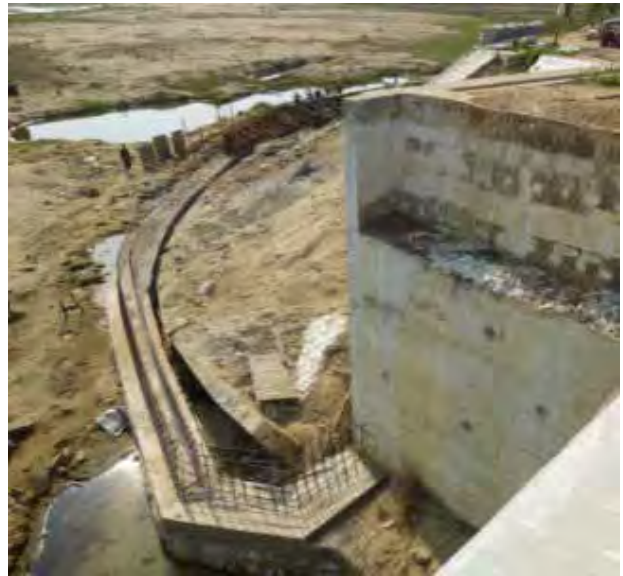
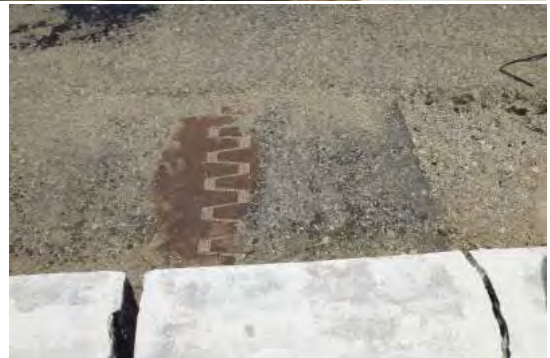
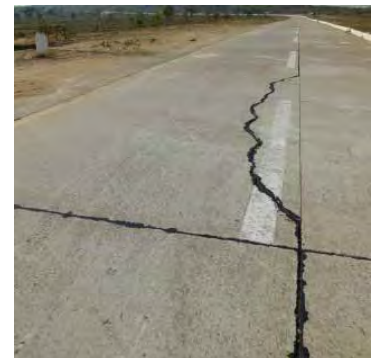
Near 208 miles 7 furlongs post

- The concrete pedestal of the support bearing is broken. Although the pedestal is high, there are no steel reinforcing bars.

- The main girder flange width is compressed at the girder end, possibly with the intention of making the support bearing smaller. This is not a desirable structure.

- A curb blocks the upper end of a block pitching, meaning water does not drain through the ditch. For this reason, the edge of the curb is eroded by water

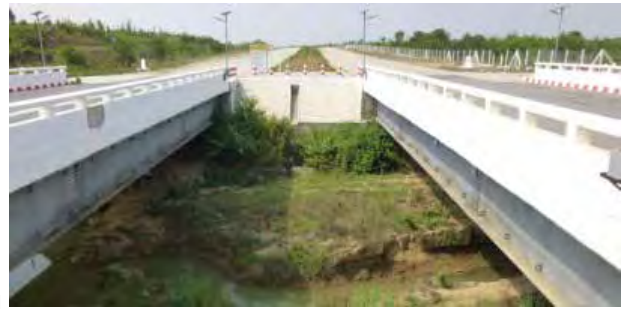
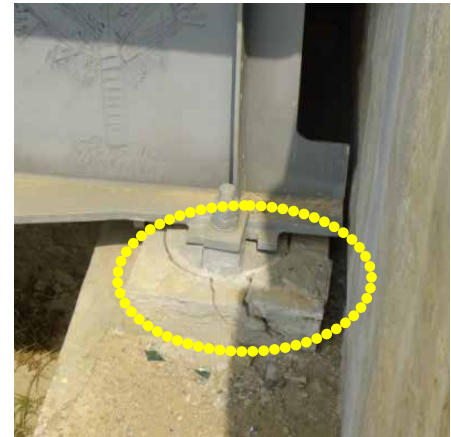
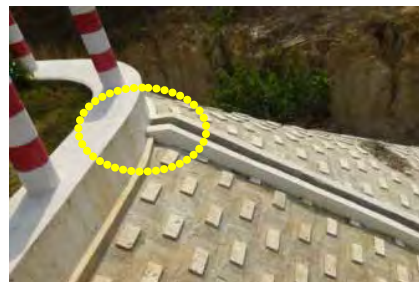
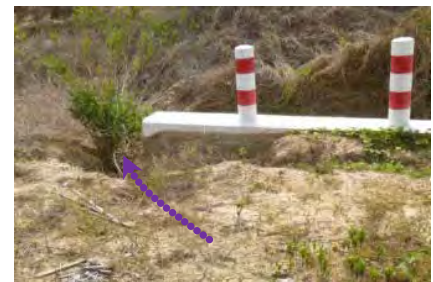
Near 214 miles 5 furlongs post

There is no drainage device to conduct water from the vertical ditch in the block pitching to the river. This results in severe erosion of the soil, digging a natural channel for the water.

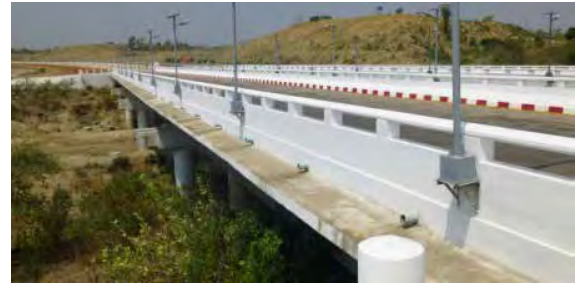
- Anchor bolts are boxed out so as to install support bearing for widening.
- The drainpipe for the road surface is laid atop the bridge railing. This appears to be a temporary measure, as the bridge railing will removal when the road is widened.

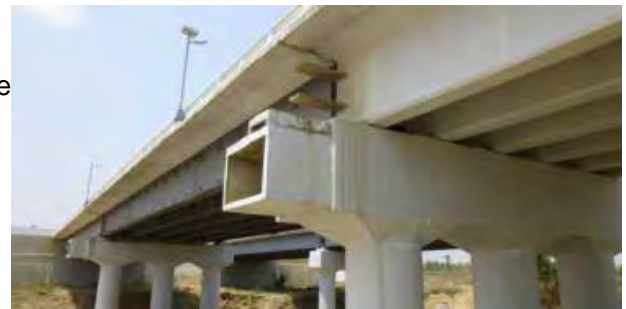
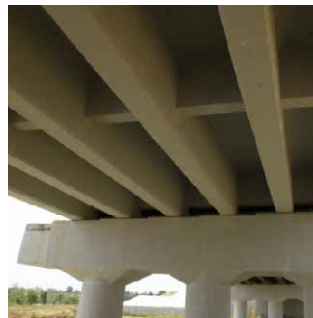
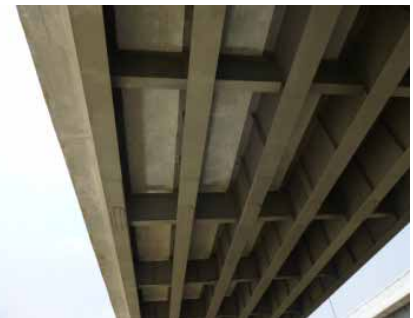
- This bridge is completed, with the steel bars for widening protected, and relatively sturdy construction.

- (Photo at right) The steel girder work consists only of crossbeams, with no sway bracing or lateral bracing.

The flanges are of consistent width, and plate thicknesses are modified accordingly.

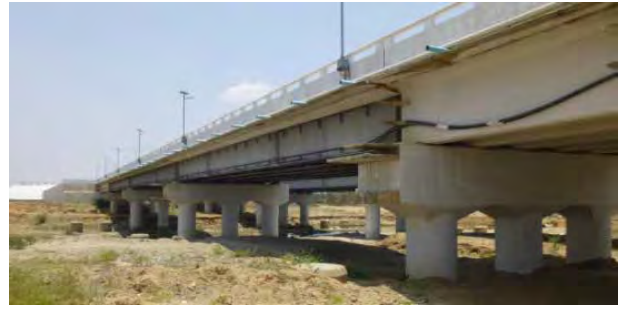
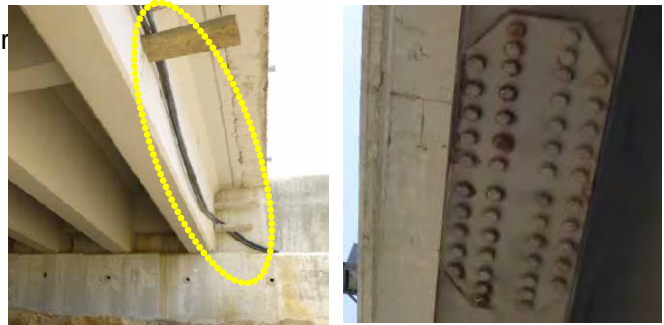
Near 294 miles 5 furlongs post

- A cable is clamped to the girder, but it appeared to be only temporary.
- Some of the bolts on the splice sections are starting to rust.

- The paving of the IC bridges has particularly severe height differentials compared to the rest of this expressway. For this reason, the pavement is being repaired as a sinking measure both on the main road and on the road it intersects with.

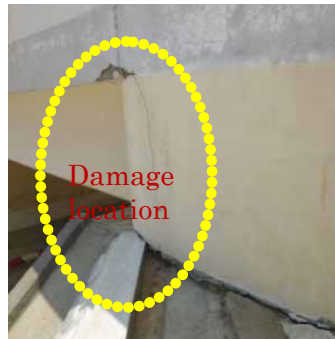
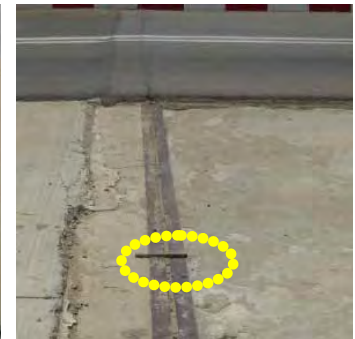
Near 341 miles 4 furlongs post

However, irregular sinking has caused the abutments to fall over as if bowing. Both the abutment parapets and girders are cracked.

- Steel bars used for holding in place during attachment of joint are still welded on and have not been removed. Even though this is a driving surface, this situation has been left as is for over a year, and no inspections appear to have been performed whatsoever.

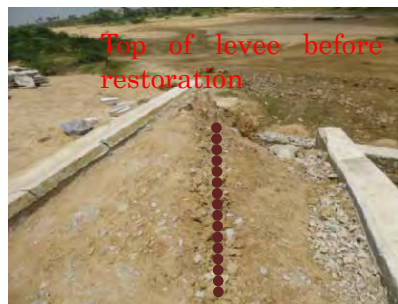
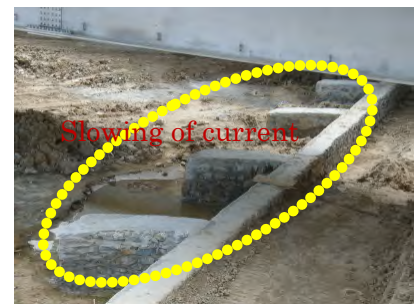
- This bridge is located at a major bend in the river. For this reason, in areas of fast current near the edge of the river, slopes (block embankments, etc.) have been destroyed, and restoration work has already been performed.
- This restoration work entails the deployment of structures which appear intended to slow the river current (it is questionable whether these are effective.)

- The abutment is falling forward, and have collided with the upper sections of the girders.
- The boxed-out protective coverings of the support bearing anchor bolts for widening have broken.

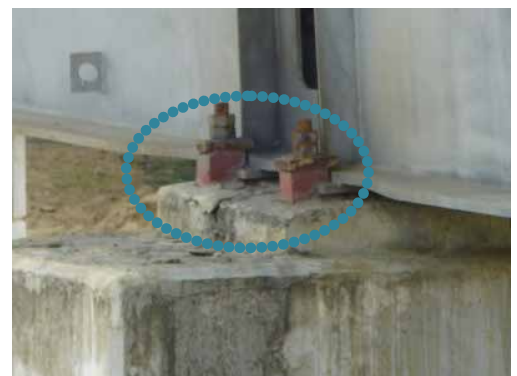
Near 358 miles 2 furlongs post

- Mechanisms to halt shifting are attached to the support bearing at right angles to the bridge axis. However, the construction measure of the bridge seat section is not good.

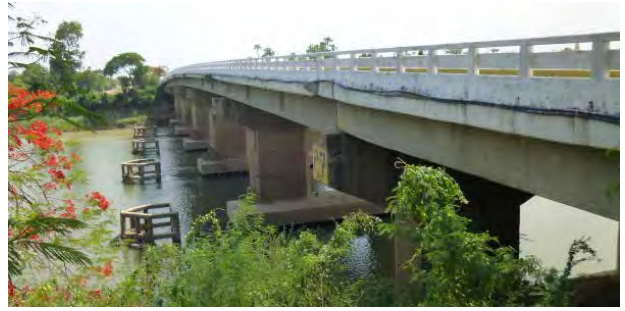
- This was the only PC-structure bridge covered in this part of the expressway survey.

- On the upstream side of the piers in the river, buffers are deployed to protect the piers from collisions with ships.

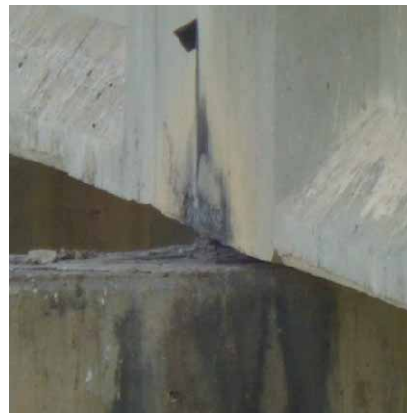
Near 360 miles 1 furlongs post

- Water leakage from the joint sections has caused blackening of the support bearings of the steel plates. Water drainpipes are protruding, and their positioning should be reconsidered.

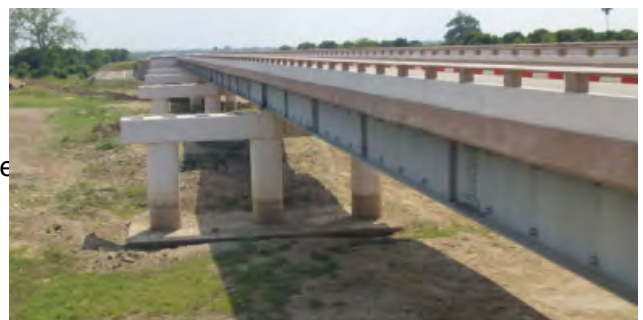
- The piers for widening of the road have already been completed on this bridge.

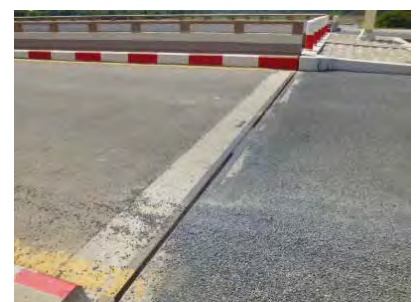
- Butt joint : Height differential is not severe, as it has been only five months since this bridge opened to traffic

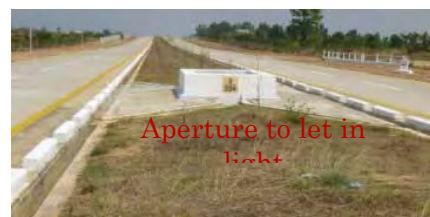
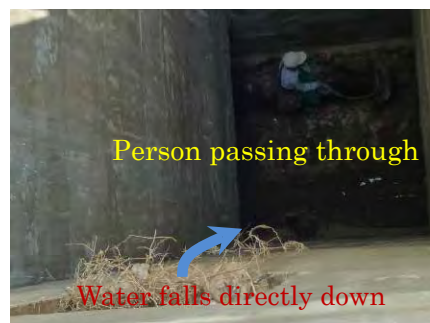
Near 280 miles 5 furlongs post

- The earth covering is made quite high.
- Vertical shafts in the median let in light as well as draining water.
- A man leading livestock passed through the tunnel while the survey was being conducted this time.
- As there is no pipe or channel, etc., water draining from the median falls directly into the culvert box.
- Water channels in the vicinity of the culvert box are not connected to plumbing, and at the ends of the ditches, erosion has occurred, and the drainage devices are broken.
(Removed from carriageway , no immediate influence on expressway)

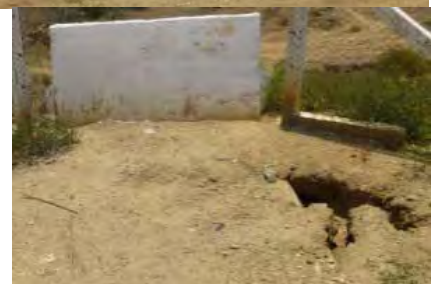
Near 280 miles 6 furlongs post

- This water channel underpass has a 1.5m-square cross section.
- As it is a small-scale culvert box, there are no water conduit facilities. For this reason, eroded soil accumulates around the entrances to the underpass.
- Due to the sinking of structures (culvert boxes), the road surface has sunk, and repairs are underway. It is likely that weight has caused the bottom plates to sink. This indicates that work on the bottom plates was not properly constructed.
- As there are no water drainage or collection facilities, erosion is progressing on the top of the slope.

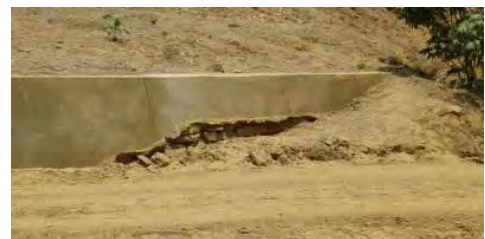
Near 325 miles 6 furlongs post

- Walkway underpass with 2m-square cross section
- As described above, the slope surface shows marks of erosion.
- The end of the wraparound section shows damage

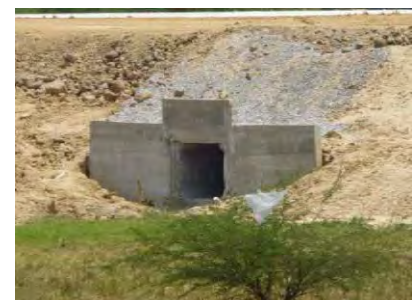
- Eroded areas of slope surface are filled in with stone fragments.
- Essential repairs have not been implemented, so soil continues to build up inside the underpass.
