# ***ANNEX D***

## ***Attachment – 1***

*Results of Inventory Survey for  
Proposed Rehabilitation Works in  
Roleang Chrey Headworks Rehabilitation Sub-project*

**Results of Inventory Survey for Proposed Rehabilitation Works on North Main Canal (1/12)**

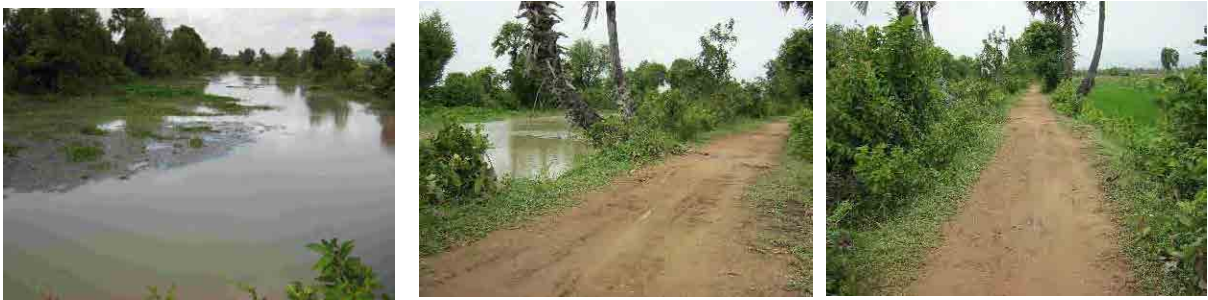
Canal No.: NMC	Proposed Works	Improvements of Kraing Speu embankment		Remarks: Raising of Kraing Speu embankment L = 1 km, W = 3 m, H = additional 1 m
Station: 0.00+600	Map Ref. NAC-3	Coordinate	X: Y:

Upstream View (Inundation area)		Existing embankment		Existing embankment

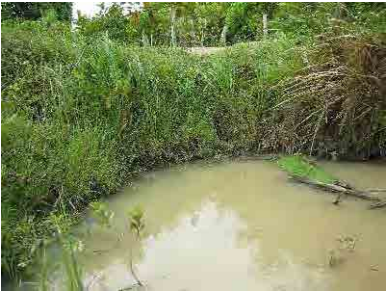
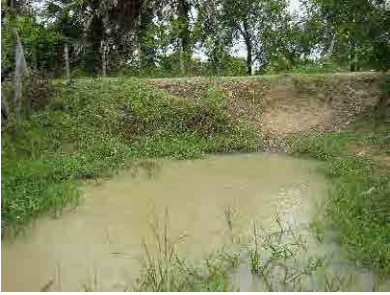
Canal No.: NMC	Proposed Works	Replacement of turnout for Andong Thor SC		Remarks: Replacement of concrete pipe for turnout for Andong Thor SC (A = 120 ha)
Station: 0.00+680	Map Ref. NAC-5	Coordinate	X: 0439125 Y: 1265416

Upstream View		Downstream View

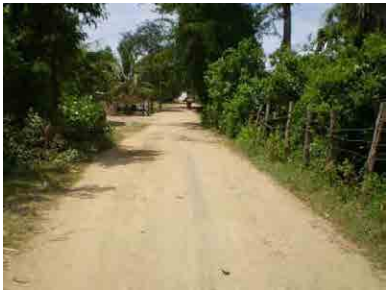
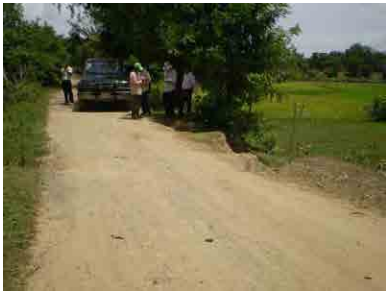
Canal No.: NMC	Proposed Works	Repair of embankment for flood protection dike		Remarks: L = 350 m, W = 6m, H = 2m (Additional)
Station: 0.00+680	Map Ref. NAC-6	Coordinate	X: Y:

Upstream View		Downstream View

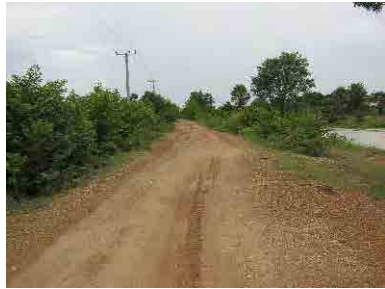
Canal No.: NMC	Proposed Works	Improvement of embankment	Remarks: Repair and provision of laterite pavement (both sides)
Station: 0.00 ~ 10.0 +0	Map Ref. NMC-1	Coordinate X: Y:

General View

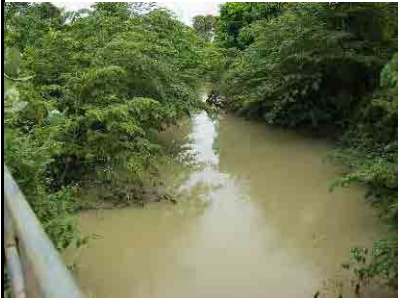
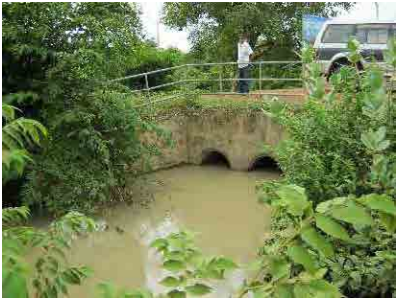
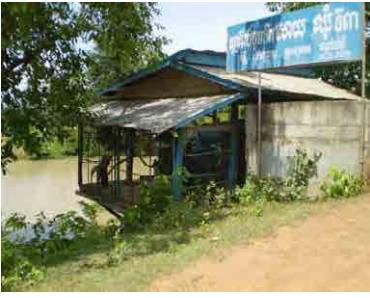
Canal No.: NMC	Proposed Works	Rehabilitation of Thmey-1 SC and construction of structures	Remarks: L = 2.5 km (A = 125 ha) 3 outlets and 3 drain inlets
Station: 1.00+950	Map Ref. NMC-2	Coordinate X: 0441188 Y: 1266620

Existing secondary canal		Outlet (View from downstream)

Existing pump station

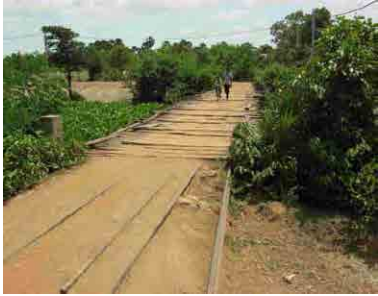
Canal No.: NMC	Proposed Works	Improvement of bridge		Remarks: Replacement of abatement of bridge
Station: 2.00+000	Map Ref. NMC-3	Coordinate	X: 0441313 Y: 1266615

Upstream View		Downstream View		Existing bridge

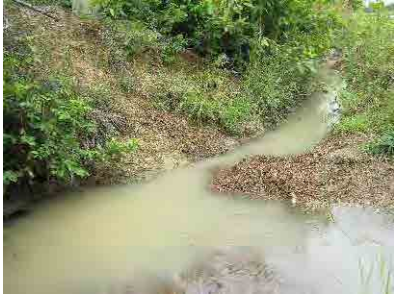
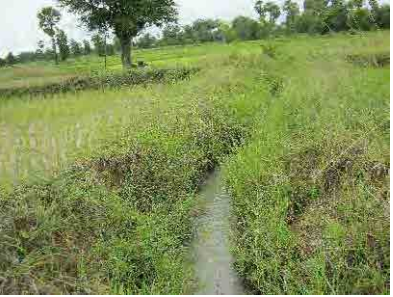
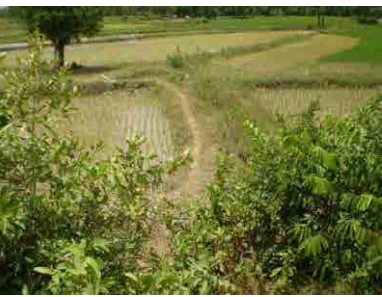
Canal No.: NMC	Proposed Works	Rehabilitation of Thmey-2 SC		Remarks: L = 850 m, A = 13 ha 2 checks/diversions
Station: 2.00+400	Map Ref. NMC-4	Coordinate	X: 0441656 Y: 1266846

Existing secondary canal		Existing secondary canal		Existing secondary canal

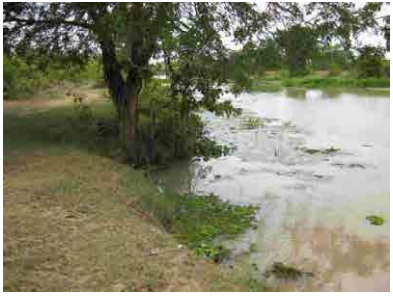
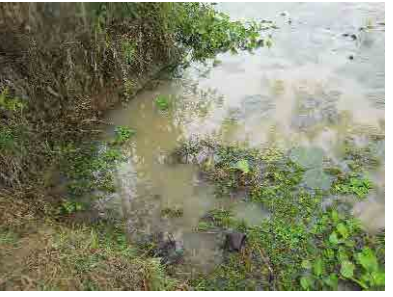
Canal No.: NMC	Proposed Works	Improvement of turnout for Phum Thmey-2 SC		Remarks: Provision of pipe culvert for Phum Thmey-2 SC (A = 13 ha)
Station: 2.00+400	Map Ref. NMC-5	Coordinate	X: 0441656 Y: 1266846

Existing turnout (Inlet)		Existing turnout (Outlet)

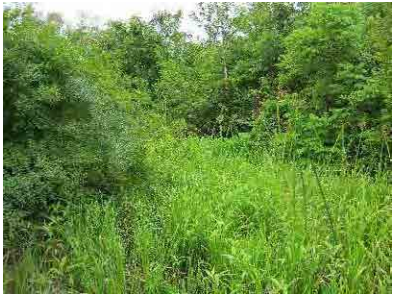
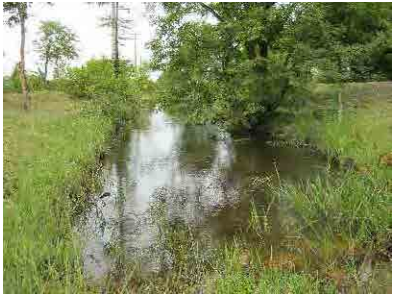
Canal No.: NMC	Proposed Works	Rehabilitation of Kravein-1 SC with construction of structures		Remarks: L = 2.45 km (A = 120 ha), 3 drainage and 8 outlet structures
Station: 3.00+350	Map Ref. NMC-8	Coordinate	X: 0442340 Y: 1267398

Upstream View		Existing secondary canal

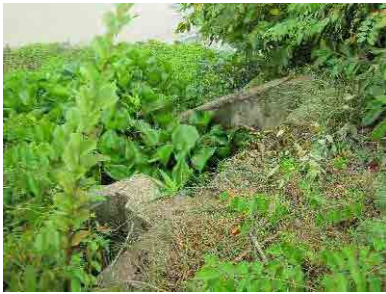
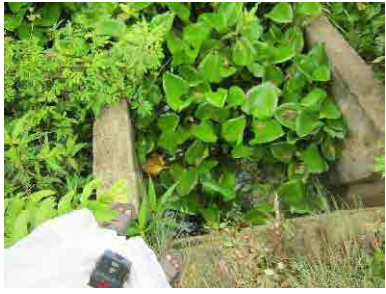
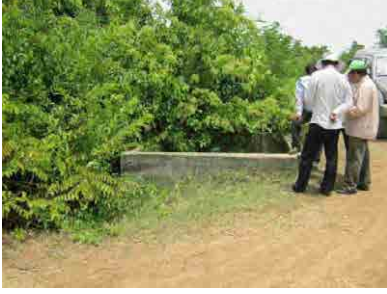
Canal No.: NMC	Proposed Works	Repair of turnout for Kravein SC	Remarks: Turnout for Kravein SC (A = 160 ha)
Station: 3.00+350	Map Ref. NMC-10	Coordinate X: 0442340 Y: 1267398

Existing turnout (Inlet)		Existing turnout (Inlet)

Existing turnout (Outlet box)

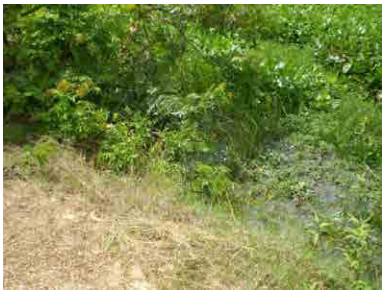
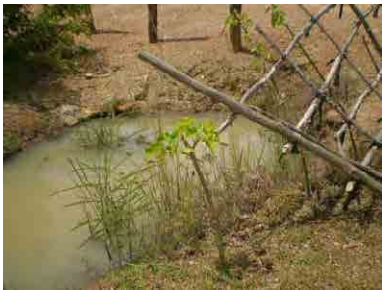
Canal No.: NMC	Proposed Works	Replacement of turnout for Sampove-1 SC	Remarks: Turnout for Sampove-1 SC (A = 100 ha)
Station: 3.00+450	Map Ref. NMC-11	Coordinate X: 0442385 Y: 1267452

Existing turnout (Inlet box)		Existing turnout (Outlet)

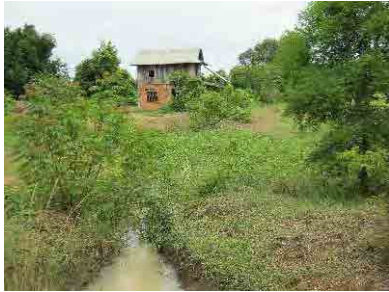
Canal No.: NMC	Proposed Works	Rehabilitation of Sampove-1 SC and construction of structures	Remarks L = 5 km (A =100 ha) 2 Checks/Turnout
Station 3.00+450	Map Ref. NMC-12	Coordinate X: 0442385 Y: 1267452

Existing secondary canal

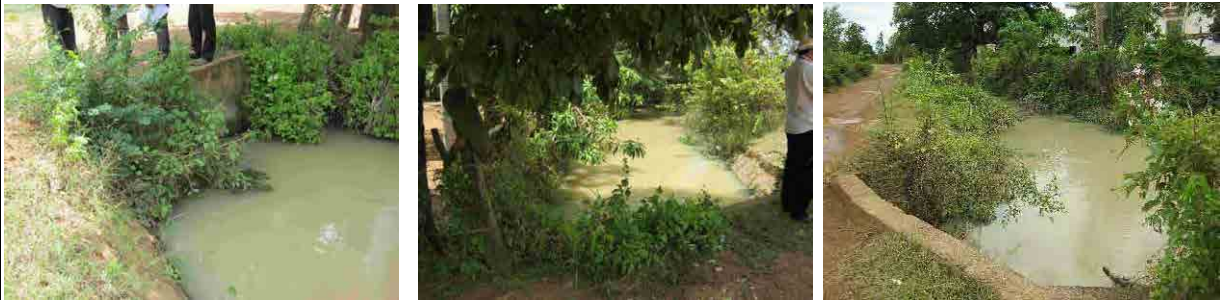
Canal No.: NMC	Proposed Works	Rehabilitation of Prey Beng-1 SC	Remarks: L = 1.64 km (A = 60 ha) 6 Checks/Turnout
Station: 5.00+100	Map Ref. NMC-14	Coordinate X: 0444065 Y: 1267913

Existing turnout (Outlet)		Existing secondary canal	Existing secondary canal

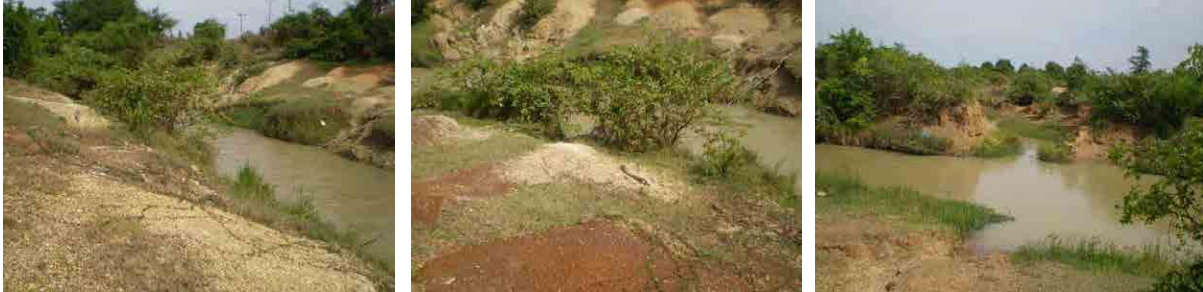
Canal No.: NMC	Proposed Works	Enlargement of canal section with improvement of both canal banks	Remarks:
Station: 5+250 ~ 7+750	Map Ref. NMC-18	Coordinate X: 0445272 Y: 1268599

Existing narrow section	Existing narrow section	Existing narrow section

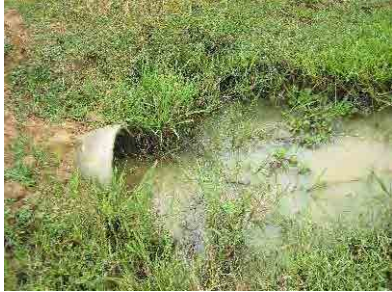
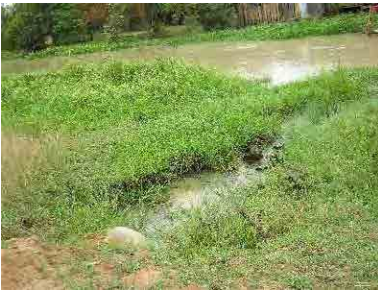
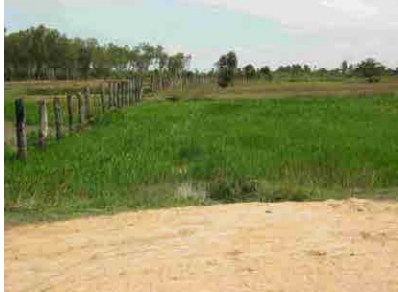
Canal No.: NMC	Proposed Works	Provision of drain inlet		Remarks:
Station: 5.00+300	Map Ref. NMC-21	Coordinate	X: 0444186 Y: 1268033

Existing drain inlet pipe (View from downstream)		Existing drain inlet pipe (View from upstream)		Drainage area

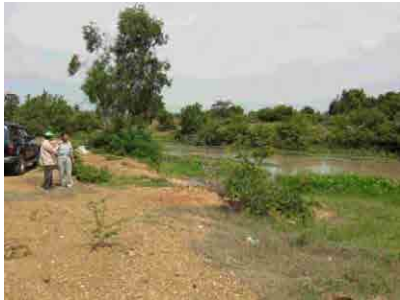
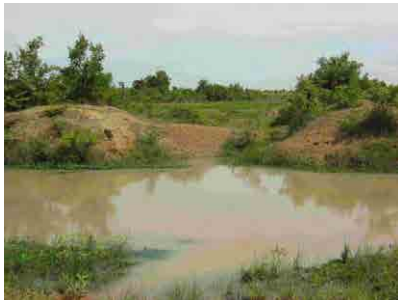
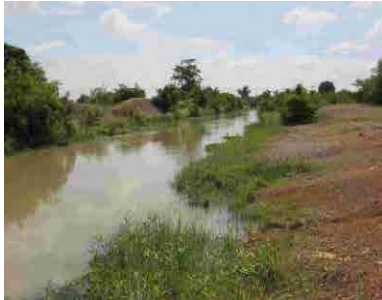
Canal No.: NMC	Proposed Works	Provision of drain inlet		Remarks:
Station: 6.00+000	Map Ref. NMC-21	Coordinate	X: 0444828 Y: 1268349

Upstream View		Upstream View		Downstream View

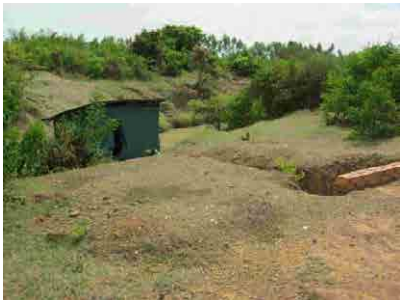
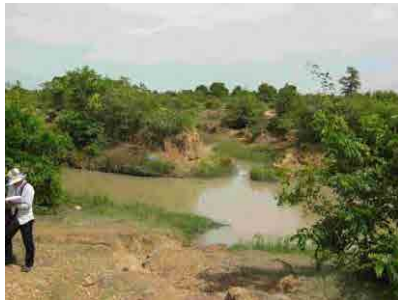
Canal No.: NMC	Proposed Works	Provision of drain inlet		Remarks:
Station: 6.00+250	Map Ref. NMC-21	Coordinate	X: 0444883 Y: 1268374

Drainage area		Proposed site of drain inlet

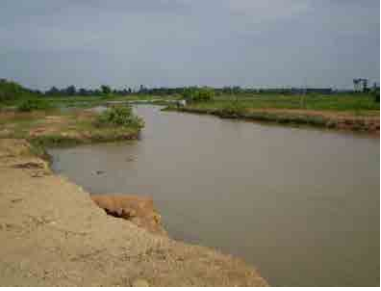
Canal No.: NMC	Proposed Works	Construction of embankment with flood spillway	Remarks:
Station: 8+550 ~ 9+100	Map Ref. NMC-23	Coordinate X: 0447680 Y: 1269034	L = 1.1 km at level crossing reservoir with flood spillway structure (Siphon is proposed by PDOWRAM)
<div style="display: flex; justify-content: space-around;">

</div> <div style="display: flex; justify-content: space-around; margin-top: 10px;"> <span>Upstream View</span> <span>Downstream View</span> </div>

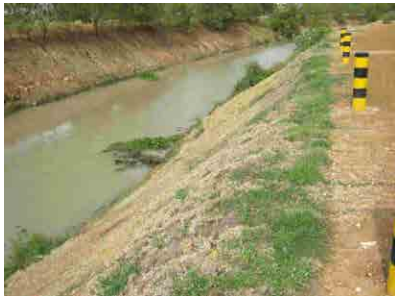
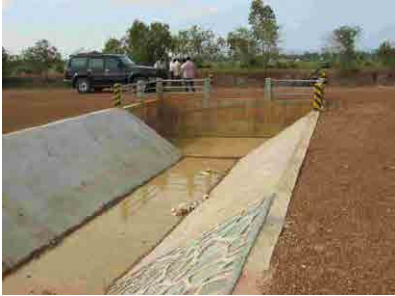
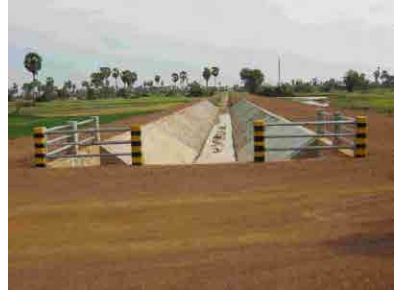
Canal No.: NMC	Proposed Works	Construction of New Pumping Station		Remarks : Off taking secondary canal has already been constructed
Station: 10+000(E.P.)	Map Ref. NMC-25	Coordinate	X: 0448778 Y: 1269033

<p style="text-align: center;">Proposed site of pump station              Downstream View of proposed pump station site              Existing secondary canal</p>

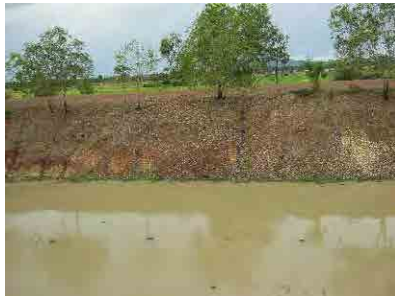
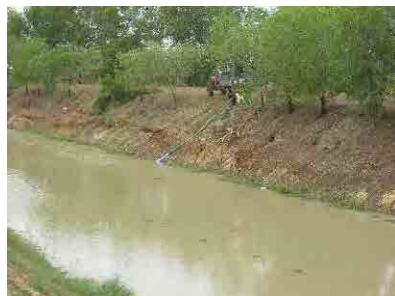
Canal No.: NMC	Proposed Works	Provision of a drain inlet		Remarks:
Station: 10+00	Map Ref. NMC-26	Coordinate	X: 0448778 Y: 1269033

<p style="text-align: center;">Upstream View                      Downstream View</p>

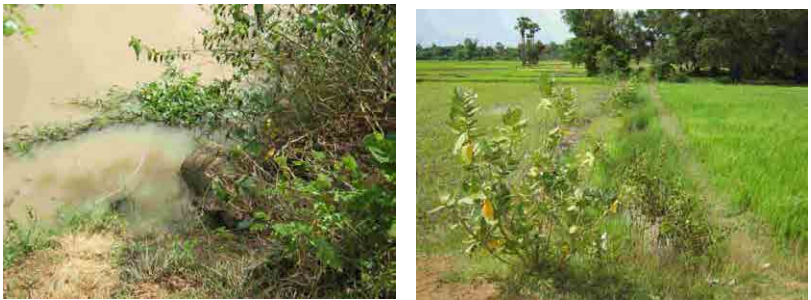
Canal No.: SMC	Proposed Works	Improvement of turnout (Concrete pipe)		Remarks: Turnout for Tompoung SC-1 (A = 10 ha) Provision of pipe culvert
Station: 0.00+950	Map Ref. SAC-3	Coordinate	X: 0439581 Y: 1263963

Existing turnout (Upstream View)		Downstream View

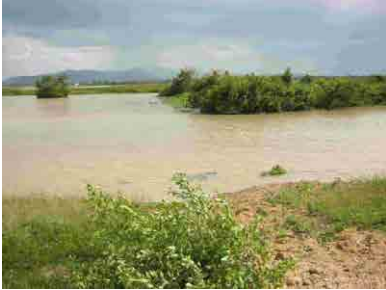
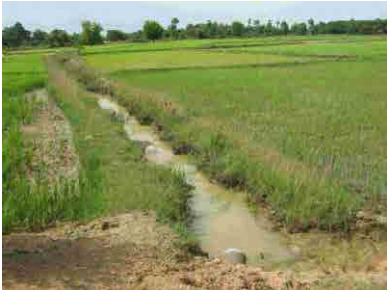
Canal No.: SMC	Proposed Works	Improvement of turnout (Concrete pipe)		Remarks: Turnout for Tompoung -2 SC (A=10 ha) Provision of pipe culvert
Station: 1.00+350	Map Ref. SAC-4	Coordinate	X: 0439231 Y: 1264040

Upstream View (Inlet side)		Downstream View (Tompoung -2 SC)

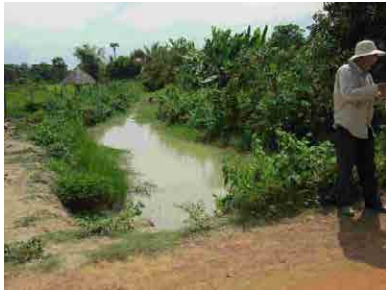
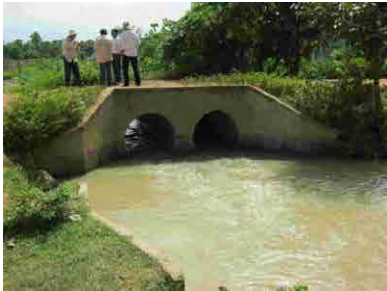
Canal No.: SMC	Proposed Works	Rehabilitation and Construction of structures of Kraheng SC		Remarks: L = 1.75 km (A = 125 ha) 4 Checks/Turnouts
Station: 2.00+600	Map Ref. SAC-5	Coordinate	X: 0439553 Y: 1265107

Existing Kraheng SC		Existing Kraheng SC

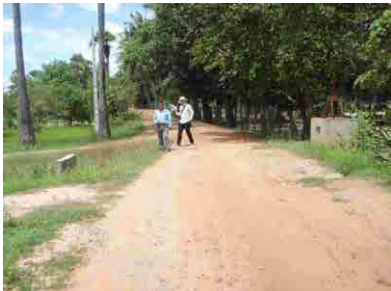
Canal No.: SMC	Proposed Works	Laterite pavement with raising of embankment		Remarks: Repair and provision of laterite pavement (both sides) H = 1 m (additional), W = 6 m
Station: 1+ 650 ~ 2+600	Map Ref. SAC-6	Coordinate	X: Y:

Existing embankment

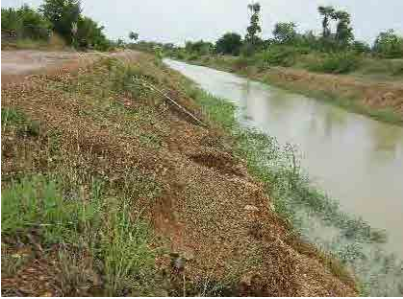
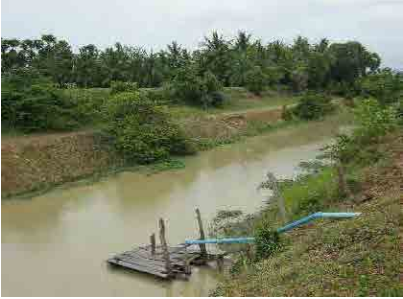
Canal No.: SMC	Proposed Works	Improvement of canal section (Excavation of canal bottom)	Remarks: Excavation : 1 m depth
Station: 0.00 ~ 1+650	Map Ref. SAC-7	Coordinate X: Y:

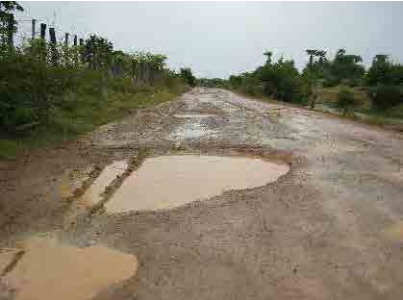
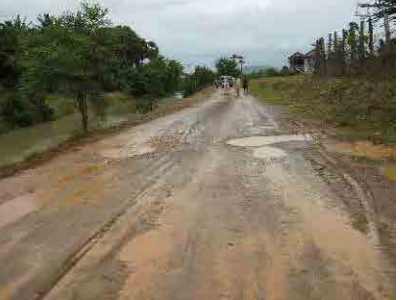
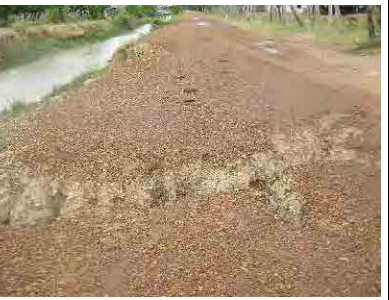
Canal No.: SMC	Proposed Works	Laterite pavement with improvement of embankment	Remarks:
Station: 0.00 ~7+800	Map Ref. SMC-1	Coordinate X: Y:

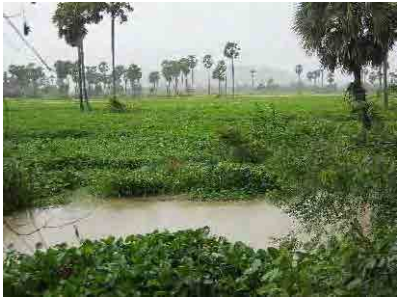
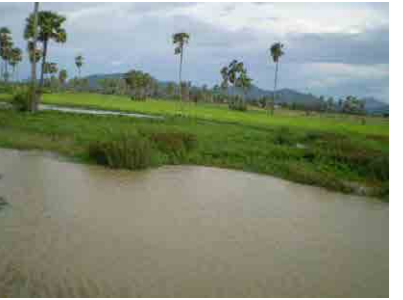
Canal No.: SMC	Proposed Works	Construction of embankment with flood spillway	Remarks: Left side : Enlargement of embankment (W = 6 m) Right side : new embankment at level crossing reservoir
Station: 7+800 ~ 9+620	Map Ref. SMC-2	Coordinate X: Y:

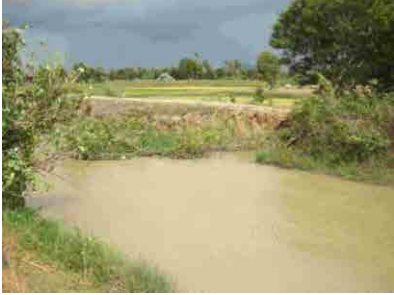
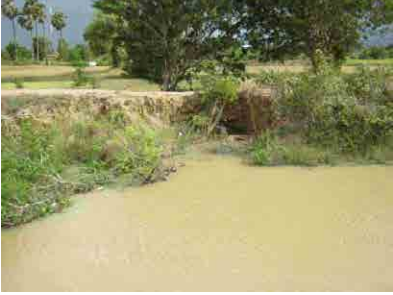
Canal No.: SMC	Proposed Works	Provision of drain inlet		Remarks: Diameter of pipe : 0.8 m to 1 m
Station: 0.00+ 600	Map Ref. SMC-3	Coordinate	X: 0441034 Y: 1263964

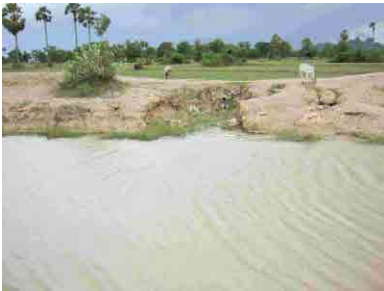
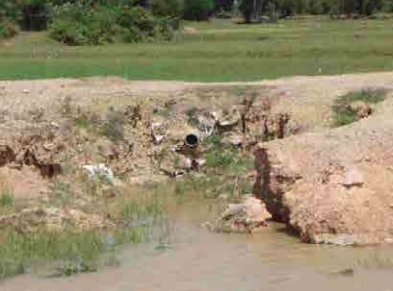
Canal No.: SMC	Proposed Works	Provision of drain inlet		Remarks: Diameter 0.8 m to 1 m (both sides)
Station: 2.00 + 700	Map Ref. SMC-4	Coordinate	X: 0442935 Y: 1264112

Existing condition (SMC right bank)		Existing condition (SMC side, zoomed in)

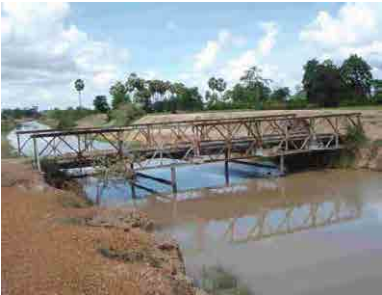
Canal No.: SMC	Proposed Works	Construction of check structure		Remarks: Check structure with new bridge at existing steel bridge
Station: 2.00 + 950	Map Ref. SMC-5	Coordinate	X: 0443137 Y: 1264220

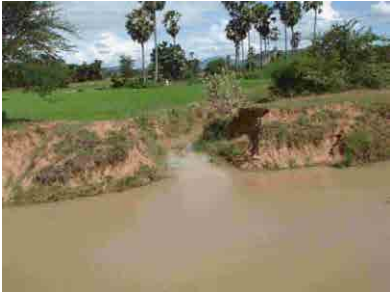
Canal No.: SMC	Proposed Works	Construction of turnouts (Right side)		Remarks: Turnout for Koh Té-2 SC (A = 110 ha)
Station: 4.00 + 750	Map Ref. SMC-9	Coordinate	X: 0444752 Y: 1265073

Present condition (No structure)

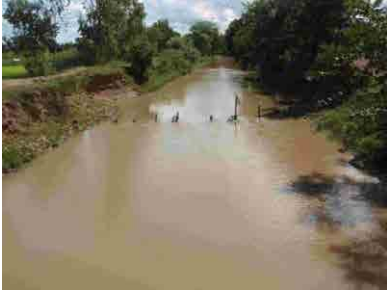
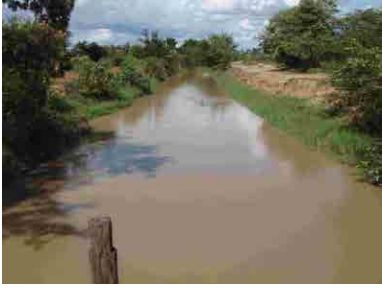
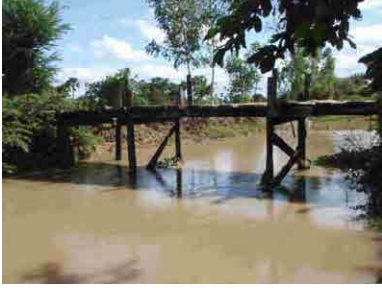
Canal No.: SMC	Proposed Works	Construction of check structure		Remarks:
Station: 5.00 + 0.00	Map Ref. SMC-12	Coordinate	X: 0444986 Y: 1265147

<p style="text-align: center;">Upstream View                      Downstream View                      Existing bridge</p>

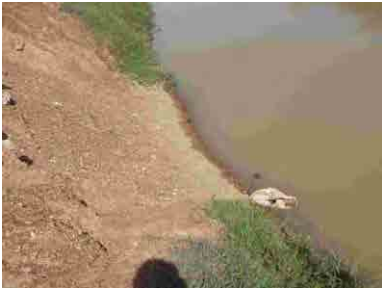
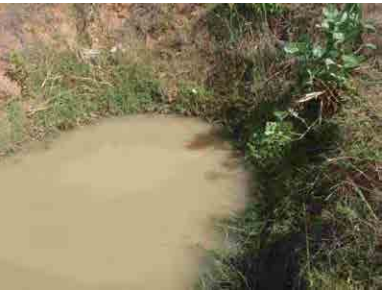
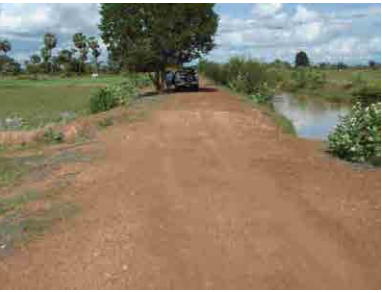
Canal No.: SMC	Proposed Works	Construction of turnout and drain inlet		Remarks: Left side: Turnout for Thnol Bom Bek SC (A = 100 ha) Right side : Construction of drain inlet
Station: 5.00+850	Map Ref. NMC-13	Coordinate	X: 0445815 Y: 1265104

<p style="text-align: center;">Inlet of existing turnout                      Outlet of existing turnout                      Existing turnout</p>

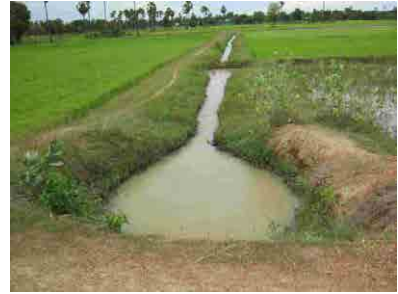
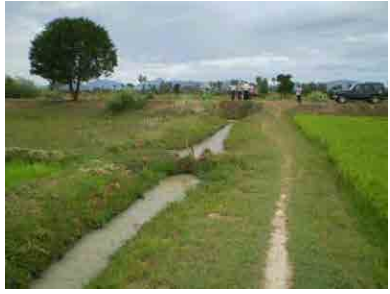
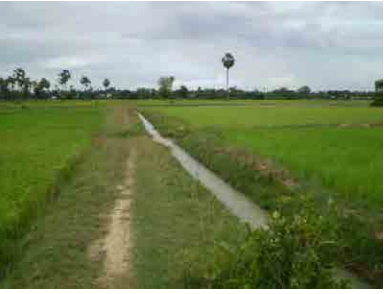
Canal No.: SMC	Proposed Works	Rehabilitation of Thnol Bom Bek SC with construction of structures		Remarks: L = 2.15 km (A = 100 ha) 6 Checks / Turnouts
Station: 5.00 +850	Map Ref. NMC-14	Coordinate	X: 0445815 Y: 1265104

<p style="text-align: center;">Thnol Bom Bek SC just after turnout                      Upstream of Thnol Bom Bek SC                      Downstream View</p>

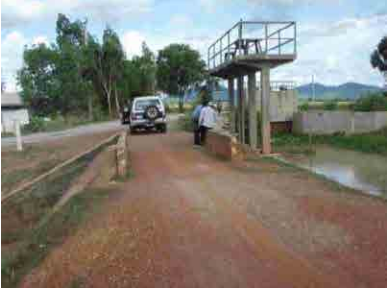
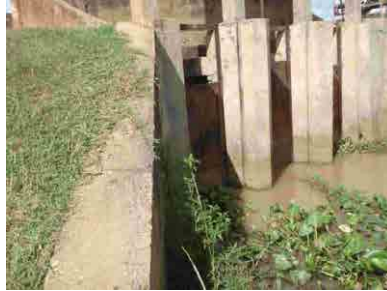
Canal No.: SMC	Proposed Works	Replacement of turnout		Remarks: Replacement of Turnout for Road-110 SC (A = 20 ha)
Station: 7.00+800	Map Ref. SMC-19	Coordinate	X: 0447469 Y: 1264229

<p style="text-align: center;">Existing turnout                      View from Upstream                      View from Downstream</p>

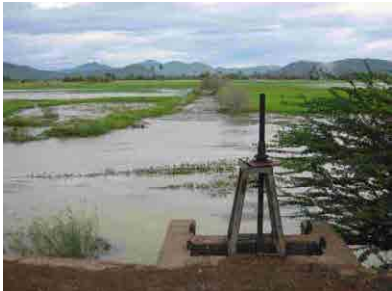
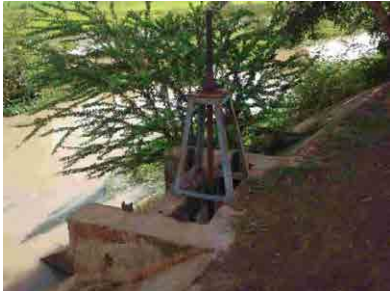
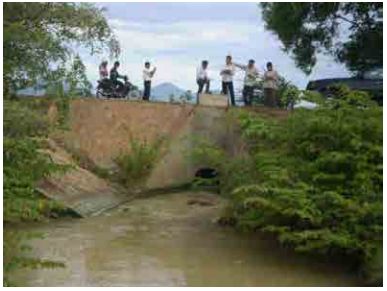
Canal No.: SMC	Proposed Works	Replacement of turnout for Phum Skous-1 SC		Remarks: Turnout for Phum Skous-1 SC (A = 25 ha)
Station: 8.00+400	Map Ref. SMC-20	Coordinate	X: 0447980 Y: 1263876

<p style="text-align: center;">Existing turnout                      Existing turnout (Inlet)                      Existing turnout (Outlet)</p>

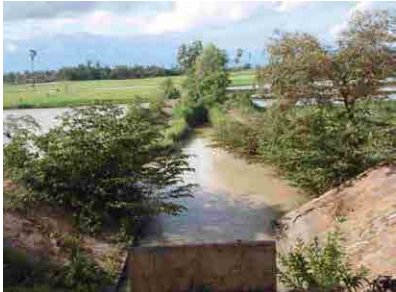
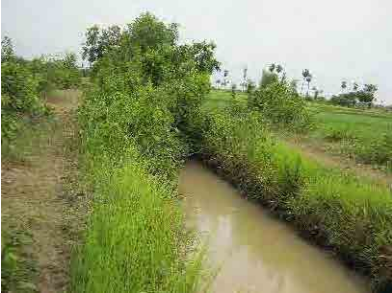
Canal No.: SMC	Proposed Works	Rehabilitation of Phum Skous-1 SC with construction of structures	Remarks: L = 2 km (A = 25 ha) 2 Checks/Turnouts
Station: 8.00+400	Map Ref. SMC-21	Coordinate X: 0447980 Y: 1263876

Existing Phum Skous-1 SC		Existing Phum Skous-1 SC

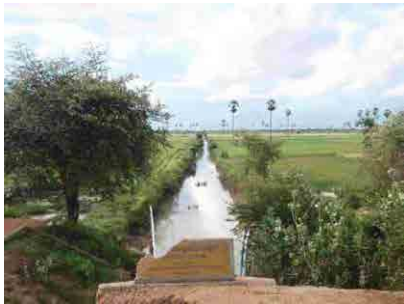
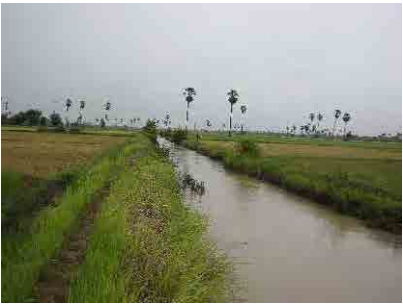
Canal No.: SMC	Proposed Works	Rehabilitating of Phum Skous-2 SC with construction of structures	Remarks: L = 2.8 km (A =100 ha) 5 Checks/Turnouts and 2 drain inlets
Station: 8.00+700	Map Ref. SMC-23	Coordinate X: 0448274 Y: 1263799

Existing Phum Skous-2 SC (View from turnout)		Existing Phum Skous-2 SC

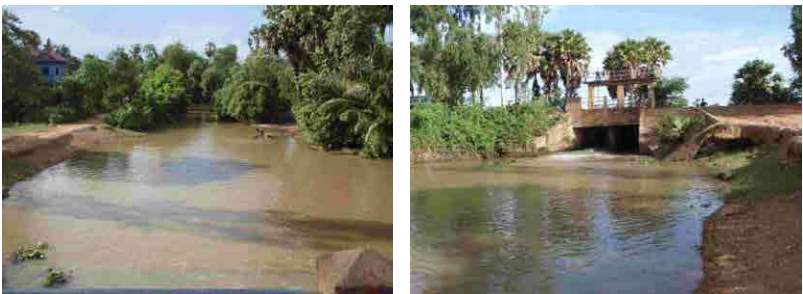
Canal No.: SMC	Proposed Works	Rehabilitation of Bak Thmenh S.C	Remarks: L = 6 km SC in downstream (A = 60 ha)
Station: 9.00+620	Map Ref. SMC-26	Coordinate X: 0448981 Y: 1263728

Downstream view from drainage gate	Turnout (View form Downstream)

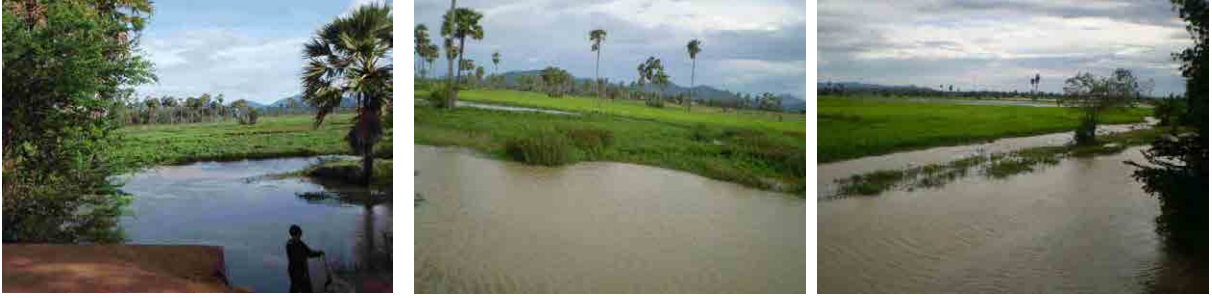
Canal No.: SMC	Proposed Works	Construction of embankment and spillway		Remarks: Construction of embankment and spillway at level crossing reservoir
Station: 9.00+620	Map Ref. SMC-27	Coordinate	X: 0448981 Y: 1263728

Level crossing reservoir		Level crossing reservoir (Upstream view)		Level crossing reservoir (Downstream view)

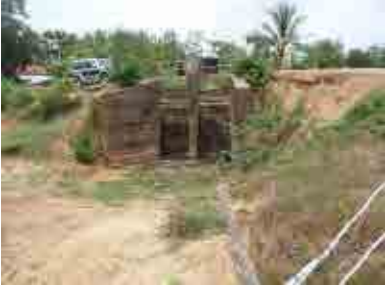
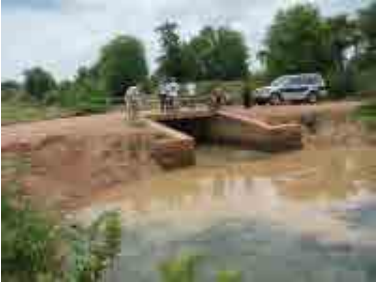
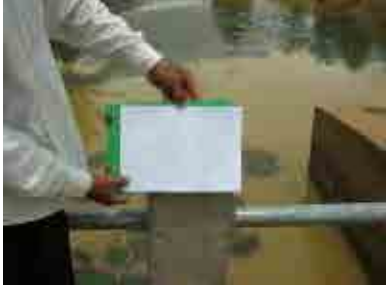
### Result of Inventory Survey of Diversion Canal (1/5)

Canal No.: D.C.	Kind of structure(s): Gate	Remarks:
Station: 0.00(B.P.)	Coordinate< Northing: 1229277 Easting: 440717	Check Gate

Up Stream View	Down Stream View	B.P.

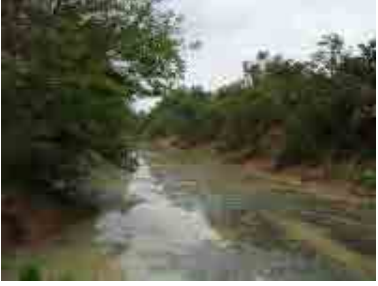
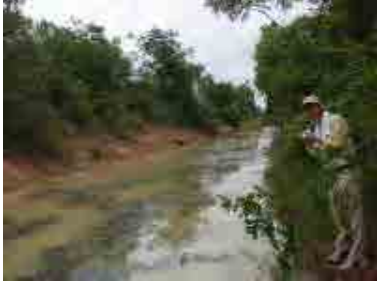
Canal No.: D.C.	Kind of structure(s): Canal	Remarks:
Station: 0.00+410	Coordinate< Northing: 1229045 Easting: 440753	Routine Survey

Up Stream View	Down Stream View

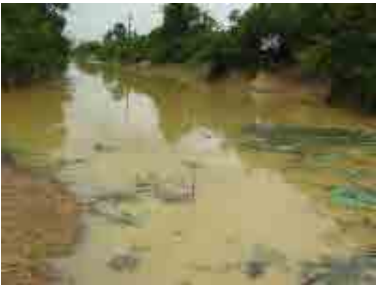
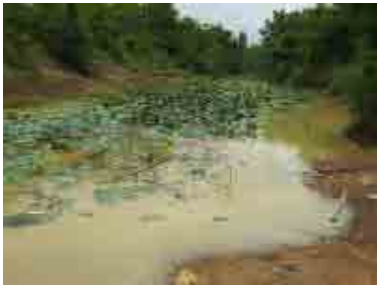
Canal No.: D.C.	Kind of structure(s): Canal	Remarks:
Station: 1.00+390	Coordinate< Northing: 1228585 Easting: 440826	Routine Survey

Up Stream View	Down Stream View

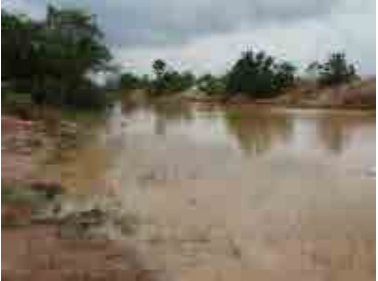
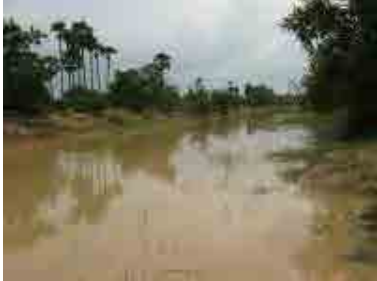
Canal No.: D.C.	Kind of structure(s): Canal	Remarks: Routine Survey
Station: 2.00+680	Coordinate< <div style="display: inline-block; vertical-align: middle; margin-left: 5px;">                     Northing: 1227390                      Easting: 441020                 </div>

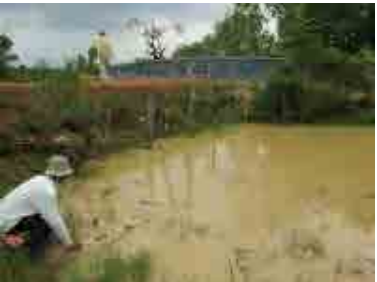
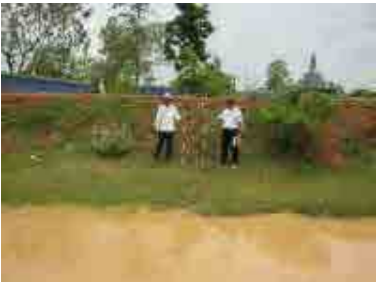
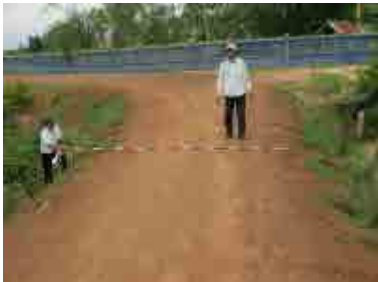
Canal No.: D.C.	Kind of structure(s): Landfill Road	Remarks: Road to Pagoda
Station: 3.00+180	Coordinate< <div style="display: inline-block; vertical-align: middle; margin-left: 5px;">                     Northing: 1226910                      Easting: 441135                 </div>

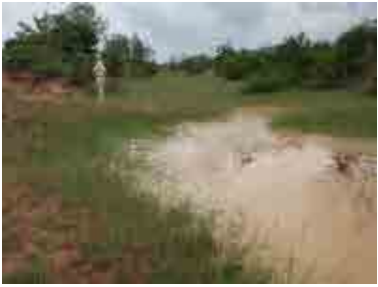
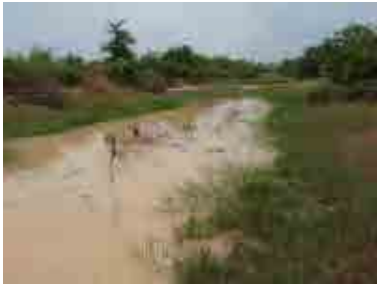
Canal No.: D.C.	Kind of structure(s): Canal	Remarks:
Station: 3.00+680	Coordinate< Northing: 1226554 Easting: 441475	Routine Survey

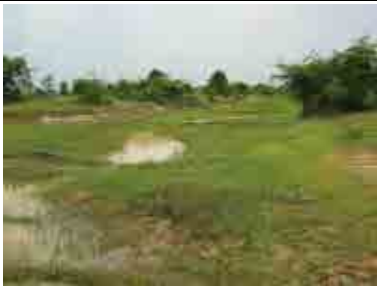
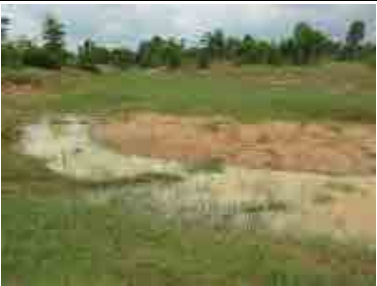
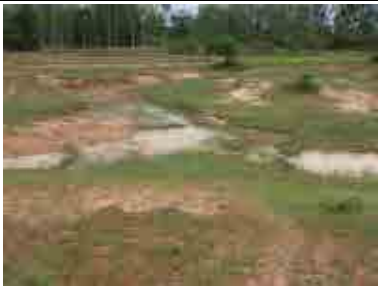
Canal No.: D.C.	Kind of structure(s): Canal	Remarks:
Station: 4.00+180	Coordinate< Northing: 1226194 Easting: 441816	Inflow from right bank

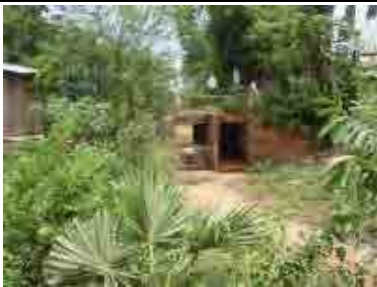
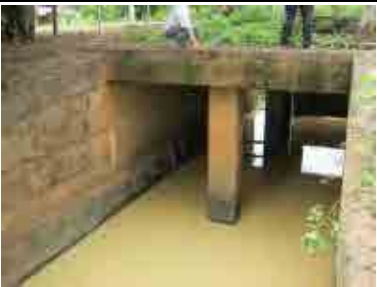
Canal No.: D.C.	Kind of structure(s): Concrete Bridge	Remarks:
Station: 4.00+580	Coordinate< Northing: 1225862 Easting: 442031	National Road Crossing D.C.

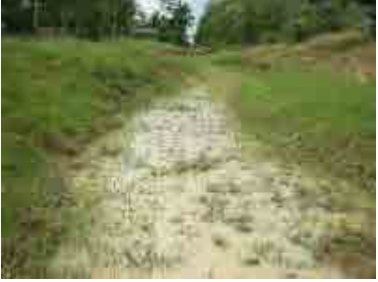
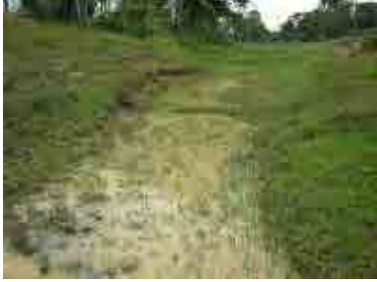
Canal No.: D.C.	Kind of structure(s): Canal	Remarks:
Station: 5.00+220	Coordinate< Northing: 1225476 Easting: 442509	Routine Survey

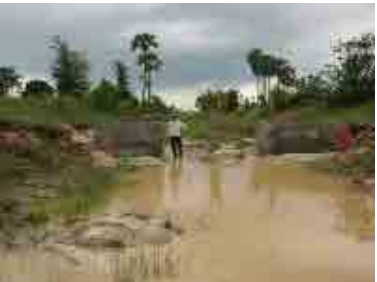
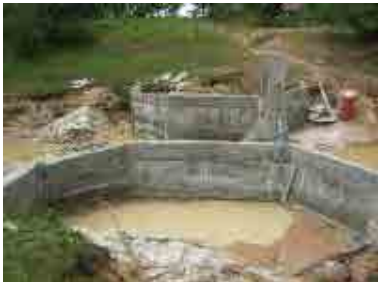
Canal No.: D.C.	Kind of structure(s): Bridge	Remarks:
Station: 5.00+800	Coordinate< Northing: 1225144 Easting: 442963	Private Concrete Bridge under Construction

Up Stream View		Concrete Bridge under Construction
Down Stream View

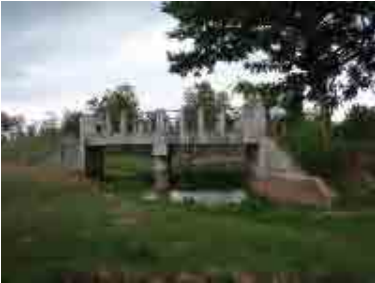
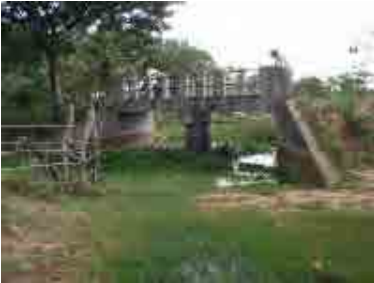
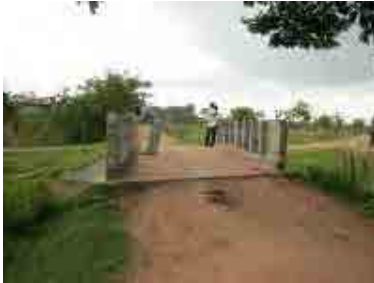
Canal No.: D.C.	Kind of structure(s): Concrete Bridge	Remarks:
Station: 8.00+200	Coordinate< <div style="display: inline-block; vertical-align: middle; margin-left: 10px;">                     Northing: 1223936                      Easting: 444028                 </div>	Constructed in 2000

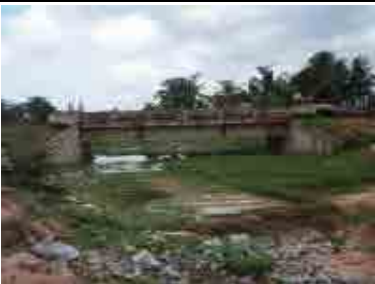
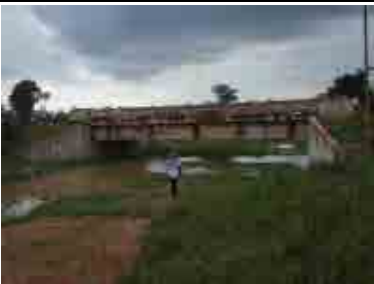
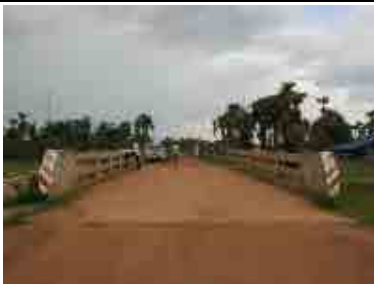
Canal No.: D.C.	Kind of structure(s): Concrete Bridge	Remarks:
Station: 9.00	Coordinate< <div style="display: inline-block; vertical-align: middle; margin-left: 10px;">                     Northing: 1223317                      Easting: 445169                 </div>	Constructed in 2006 ~ 2007

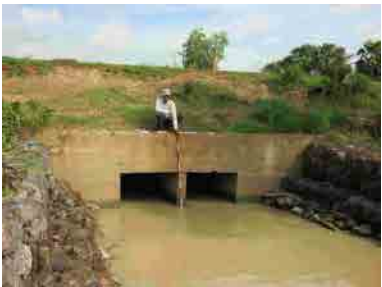
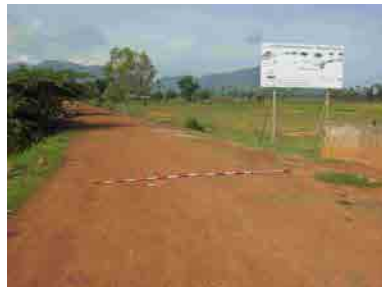
Canal No.: MC33	Kind of structure: Gate (Intake)	Remarks:
Station: 0.00(B.P.)	Coordinate< <div style="display: flex; flex-direction: column; align-items: flex-start;"> <span>Northing: 1223190</span> <span>Easting: 448349</span> </div>	Cross the national road

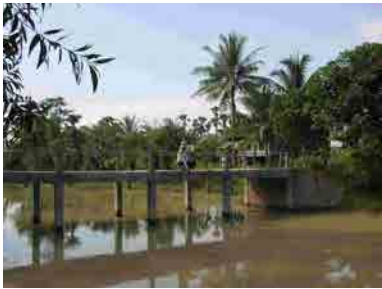
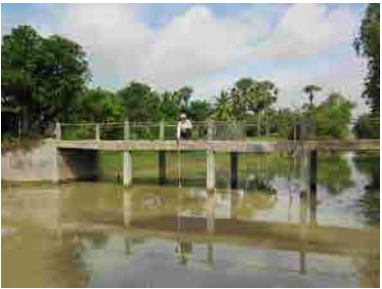
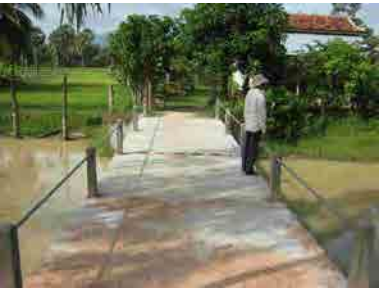
Canal No.: MC33	Kind of structure: Bridge (Private Concrete)	Remarks:
Station: 0.00+240	Coordinate< <div style="display: flex; flex-direction: column; align-items: flex-start;"> <span>Northing: 1223143</span> <span>Easting: 448556</span> </div>	Routine survey

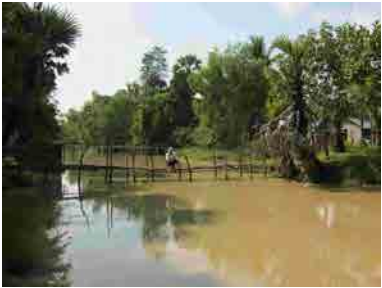
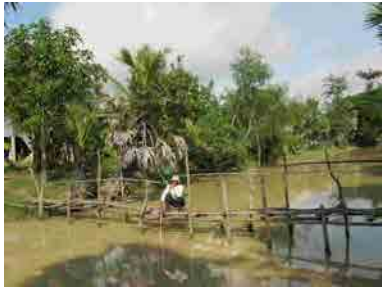
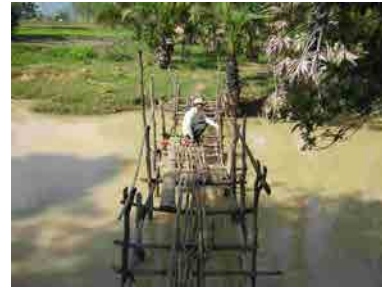
Canal No.: MC33	Kind of structure: Bridge (Private )	Remarks:
Station: 0.00+440	Coordinate< <div style="display: flex; flex-direction: column; align-items: flex-start;"> <span>Northing: 1223111</span> <span>Easting: 448760</span> </div>	Made by wood

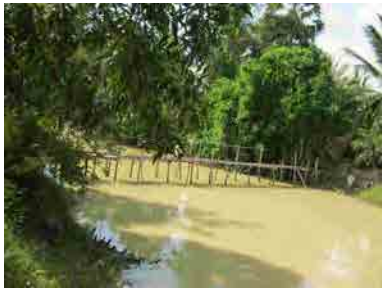
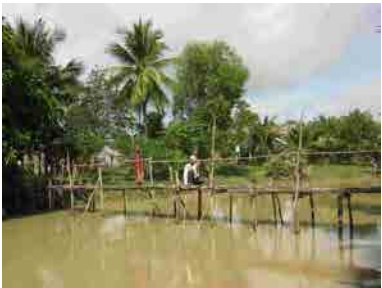
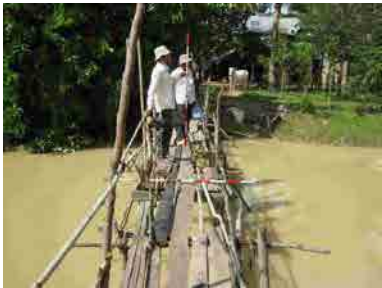
Canal No.: MC33	Kind of structure: Bridge (Private)	Remarks:
Station: 0.00+470	Coordinate< <div style="display: flex; flex-direction: column; margin-left: 10px;"> <span>Northing: 1223104</span> <span>Easting: 448793</span> </div>	Made by wood

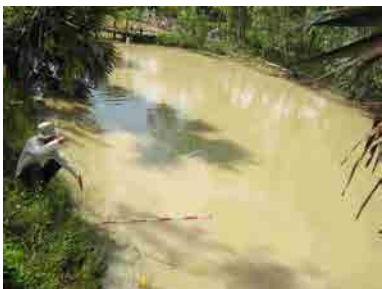
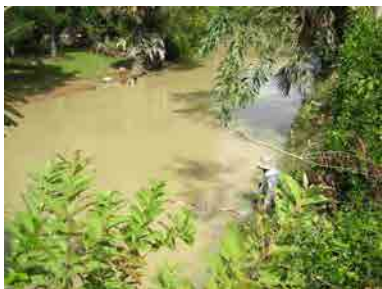
Canal No.: MC33	Kind of structure: Canal	Remarks:
Station: 0.00+500	Coordinate< <div style="display: flex; flex-direction: column; margin-left: 10px;"> <span>Northing: 1223097</span> <span>Easting: 448834</span> </div>	Routine survey Length: 500m

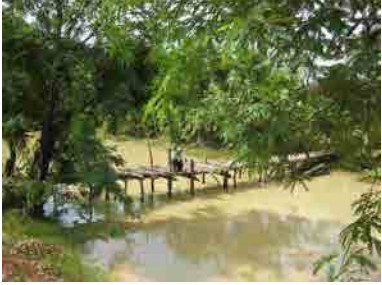
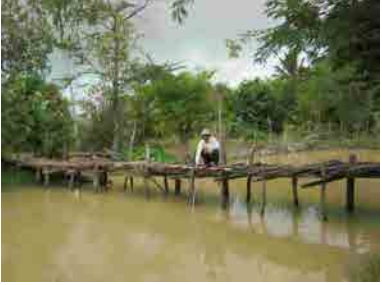
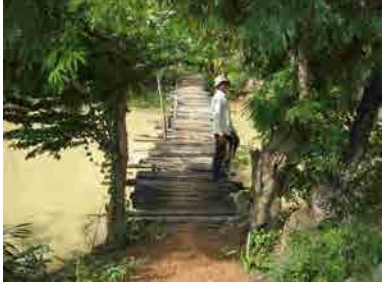
Canal No.: MC33	Kind of structure: Bridge (Private)	Remarks:
Station: 0.00+540	Coordinate< Northing: 1223087 Easting: 448878	Made by wood

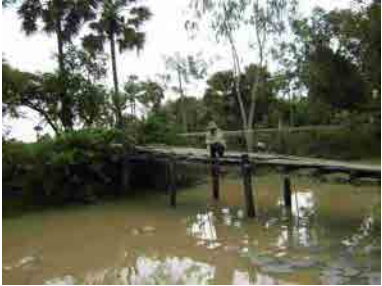
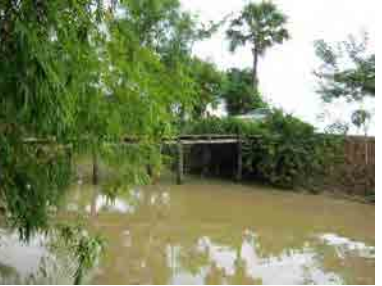
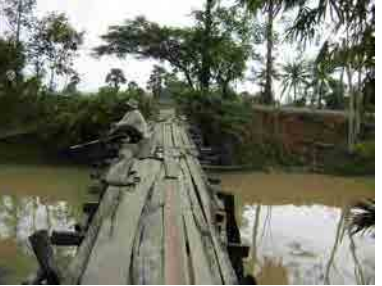
Canal No.: MC33	Kind of structure: Bridge (Private)	Remarks:
Station: 0.00+580	Coordinate< Northing: 1223074 Easting: 448918	Made by wood

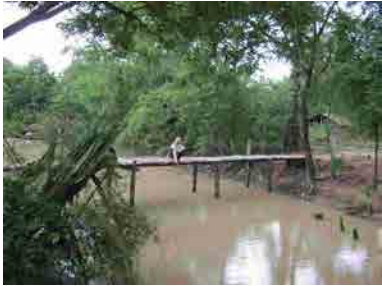
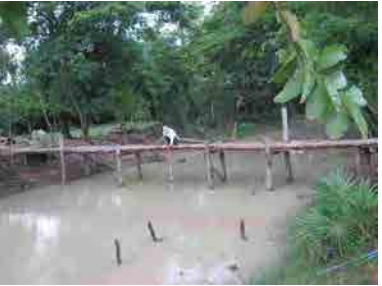
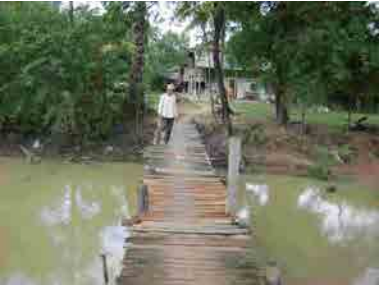
Canal No.: MC33	Kind of structure: Bridge (Private)	Remarks:
Station: 0.00+640	Coordinate< Northing: 1223066 Easting: 448974	Made by wood

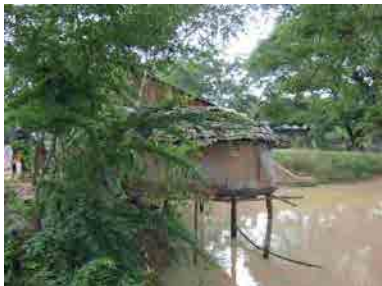
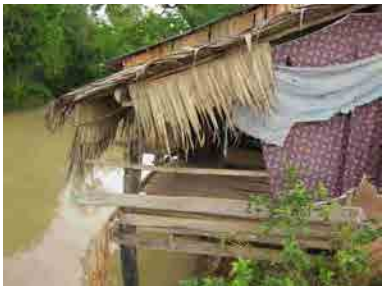
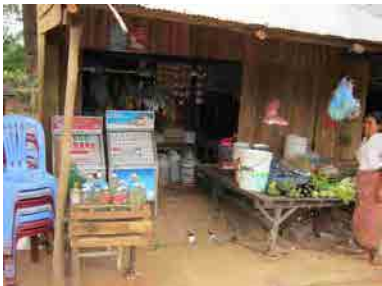
Canal No.: MC33	Kind of structure: House (Double)	Remarks:
Station: 0.00+740	Coordinate< Northing: 1223069 Easting: 449071	Routine survey

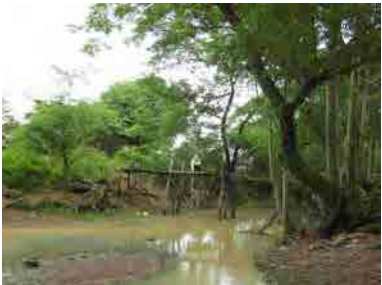
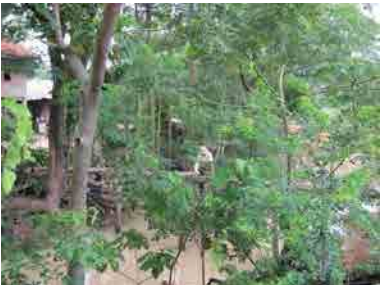
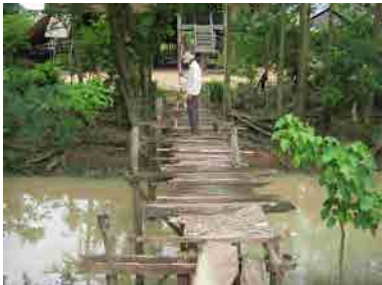
Canal No.: MC33	Kind of structure: Bridge (Private)	Remarks:
Station: 0.00+800	Coordinate< Northing: 1223068 Easting: 449125	Routine survey

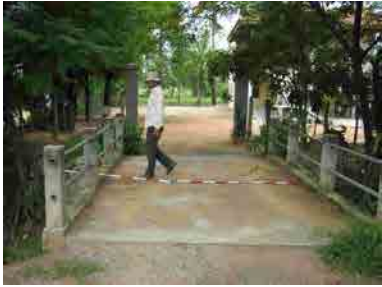
Canal No.: MC33	Kind of structure: Bridge (Private)	Remarks:
Station: 0.00+860	Coordinate< Northing: 1223070 Easting: 449178	Routine survey

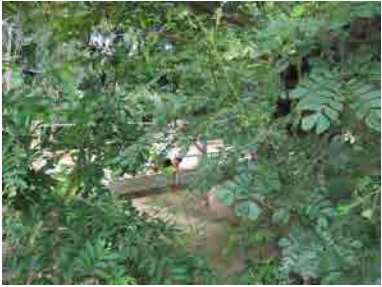
Canal No.: MC33	Kind of structure: Bridge (Private)	Remarks:
Station: 0.00+900	Coordinate< Northing: 1223066 Easting: 449220	Routine survey

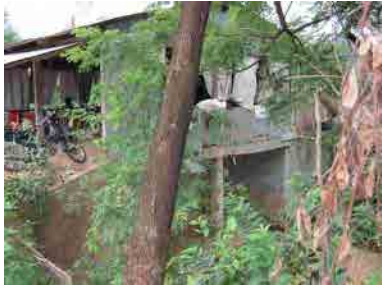
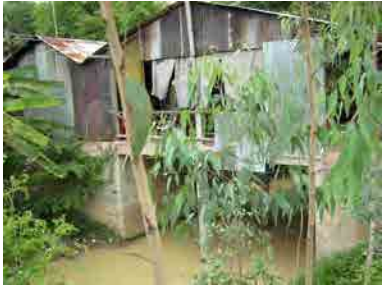
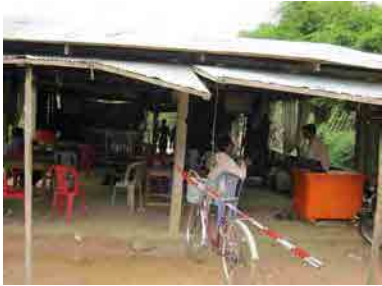
Canal No.: MC33	Kind of structure: Bridge (Private)	Remarks:
Station: 0.00+930	Coordinate< Northing: 1223070 Easting: 449239	There is a house on the bridge

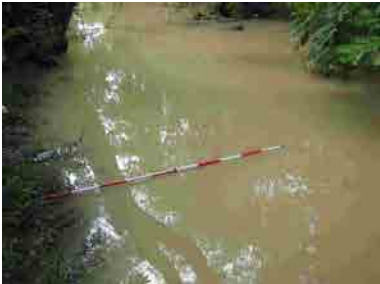
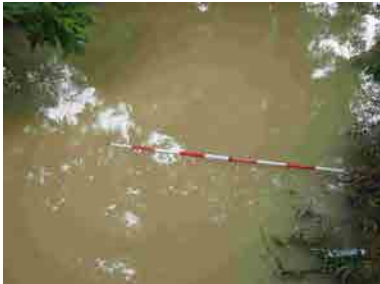
Canal No.: MC33	Kind of structure: Canal	Remarks: Routine survey Length: 1000m
Station: 1.00	Coordinate< <div style="display: flex; flex-direction: column; gap: 5px;"> <span>Northing: 1223076</span> <span>Easting: 449313</span> </div>	
<div style="display: flex; justify-content: space-around;">

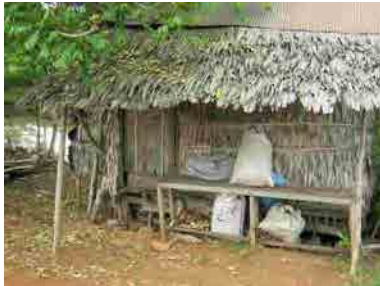
Canal No.: MC33	Kind of structure: House	Remarks:
Station: 1.00+130	Coordinate Northing: 1223083 Easting: 449416	Routine survey

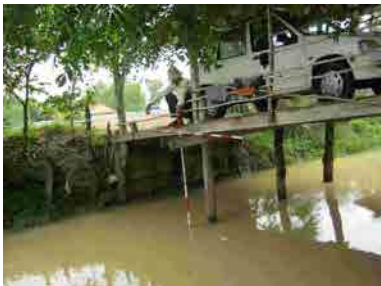
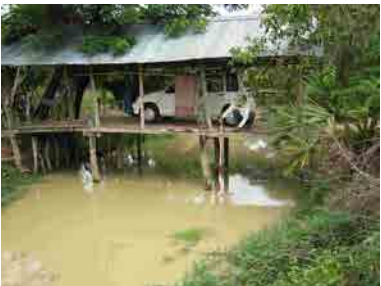
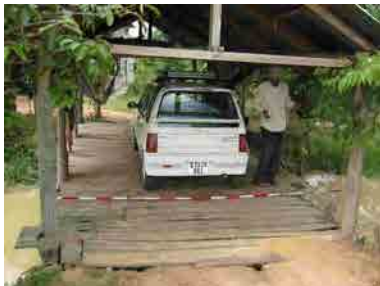
Canal No.: MC33	Kind of structure: Bridge (Private)	Remarks:
Station: 1.00+190	Coordinate Northing: 1223073 Easting: 449463	Routine survey

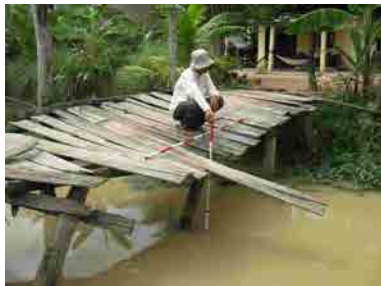
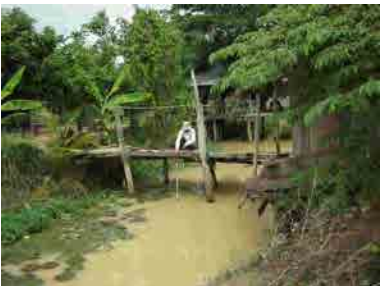
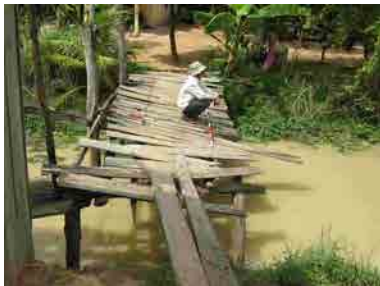
Canal No.: MC33	Kind of structure: Bridge (Private)	Remarks:
Station: 1.00+190	Coordinate Northing: 1223075 Easting: 449478	There is a house

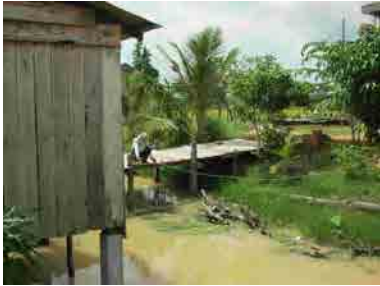
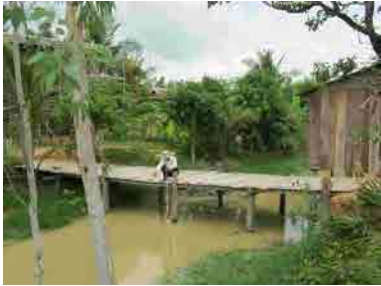
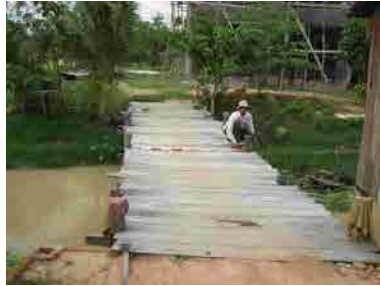
Canal No.: MC33	Kind of structure: Bridge (Private)	Remarks:
Station: 1.00+190	Coordinate< Northing: 1223083 Easting: 449498	There is a house
