# ***ANNEX D***

## ***Attachment – 1***

*Results of Inventory Survey for  
Proposed Rehabilitation Works in  
Roleang Chrey Headworks Rehabilitation Sub-project*

**Results of Inventory Survey for Proposed Rehabilitation Works on North Main Canal (1/12)**

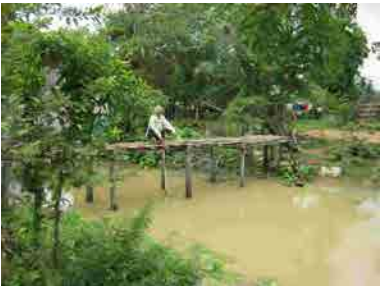
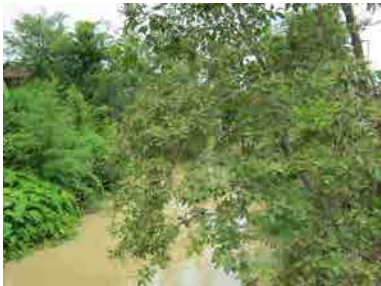
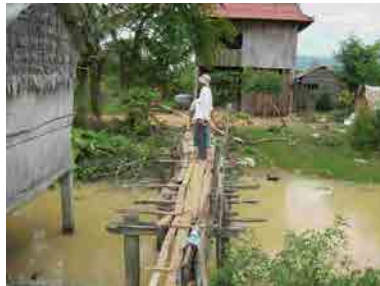
Canal No.: MC33	Kind of structure: Bridge (Private)	Remarks:
Station: 1.00+240	Coordinate< Northing: 1223087 Easting: 449557	There is a house

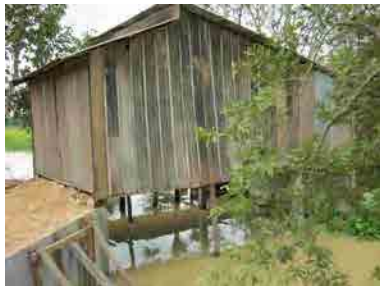
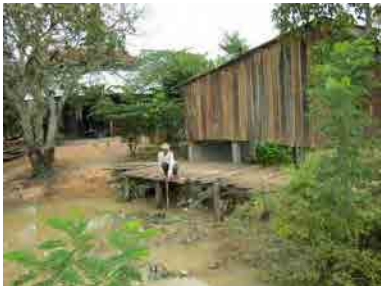
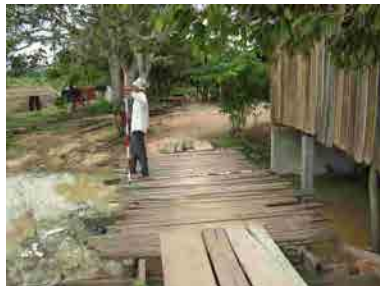
Canal No.: MC33	Kind of structure: Bridge (Private)	Remarks:
Station: 1.00+260	Coordinate< Northing: 1223090 Easting: 449591	There is a house

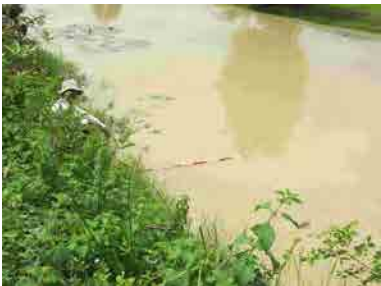
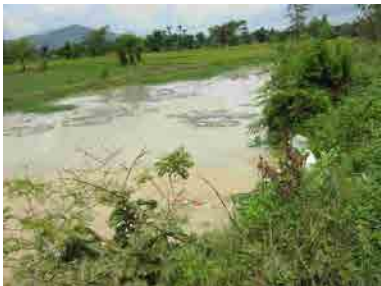
Canal No.: MC33	Kind of structure: Canal	Remarks: Routine survey Length: 1500m
Station: 1.00+500	Coordinate< Northing: 1223100 Easting: 449835	
<div style="display: flex; justify-content: space-around; align-items: center;">

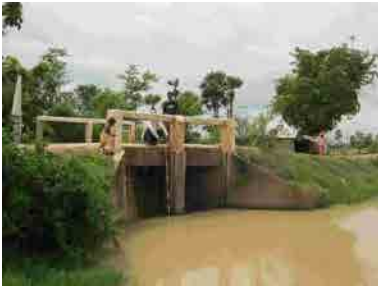
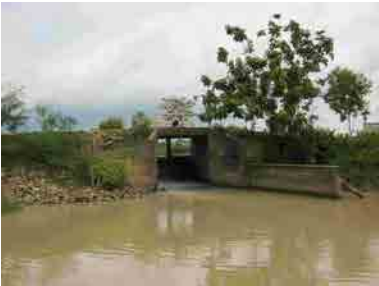
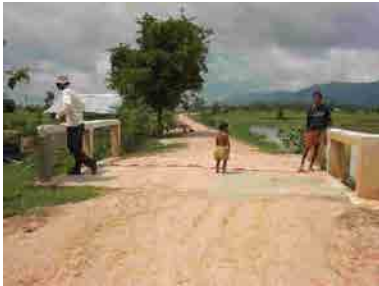
Canal No.: MC33	Kind of structure: Bridge (Ta Mek)	Remarks:  There is a groove
Station: 1.00+660	Coordinate< Northing: 1223096 Easting: 449981	
<div style="display: flex; justify-content: space-around; align-items: center;">

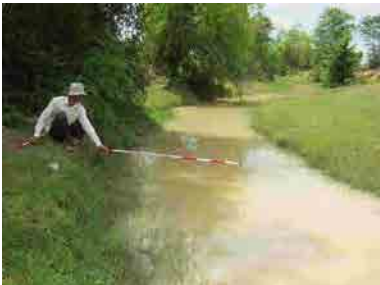
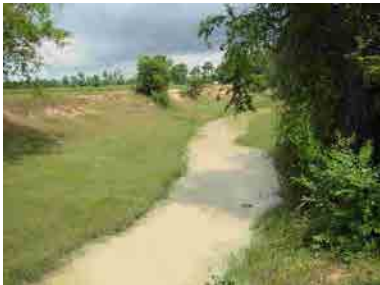
Canal No.: MC33	Kind of structure: Canal	Remarks: Routine survey Length: 2000m
Station: 2.00+20	Coordinate< Northing: 1223101 Easting: 450317	
<div style="display: flex; justify-content: space-around; align-items: center;">

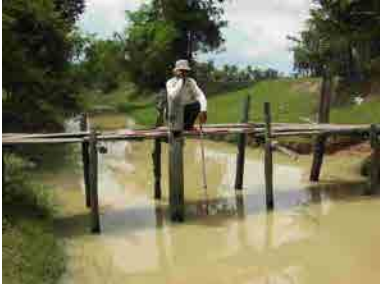
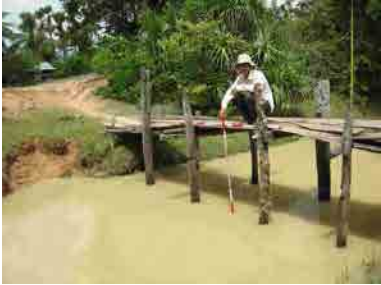
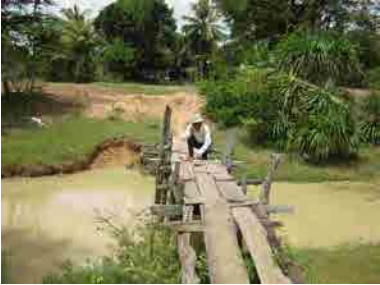
Canal No.: MC33	Kind of structure: Bridge (Private)	Remarks:
Station: 2.00+170	Coordinate< Northing: 1223048 Easting: 450453	Routine survey

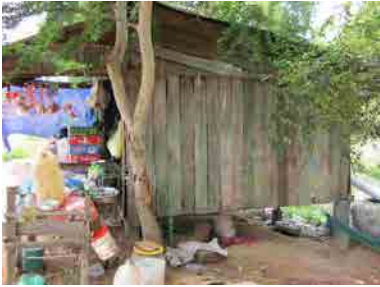
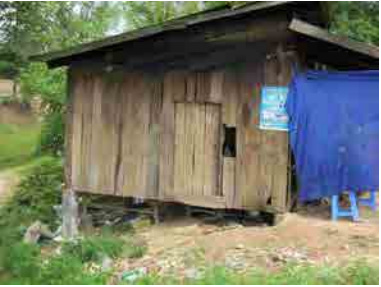
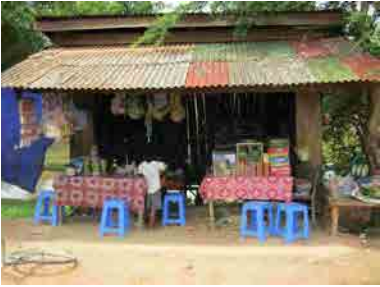
Canal No.: MC33	Kind of structure: House	Remarks:
Station: 2.00+180	Coordinate< Northing: 1223052 Easting: 450465	Routine survey

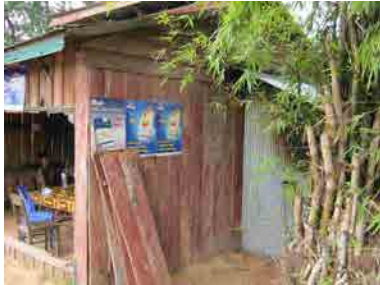
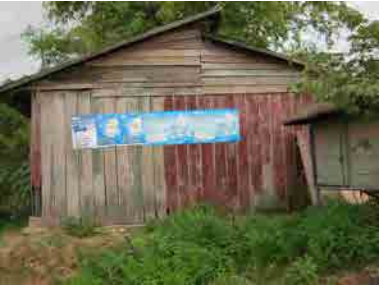
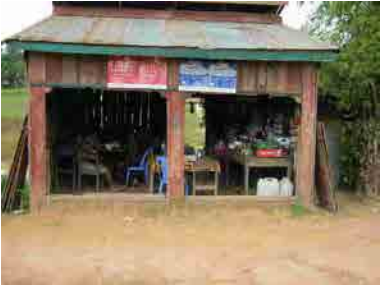
Canal No.: MC33	Kind of structure: House	Remarks:
Station: 2.00+210	Coordinate< Northing: 1223044 Easting: 450500	Routine survey

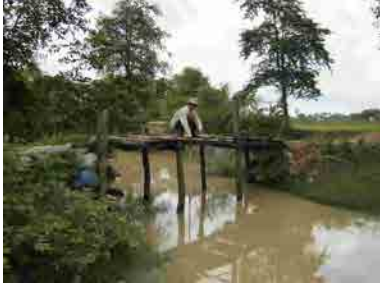
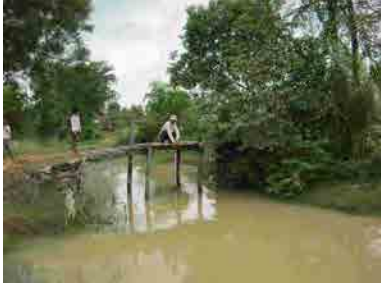
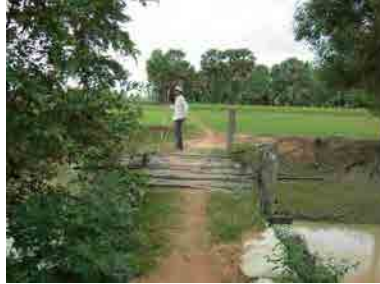
Canal No.: MC33	Kind of structure: Bridge (Private)	Remarks:
Station: 2.00+260	Coordinate< Northing: 1223026 Easting: 450558	There are houses in double

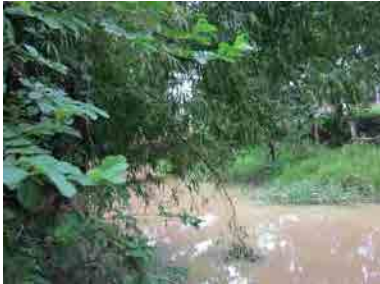
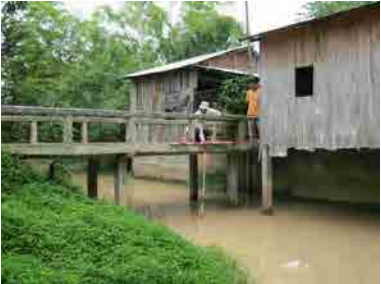
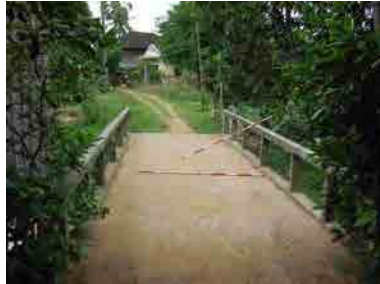
Canal No.: MC33	Kind of structure: Bridge (Private)	Remarks:
Station: 2.00+430	Coordinate< Northing: 1222979 Easting: 450703	There are houses in double

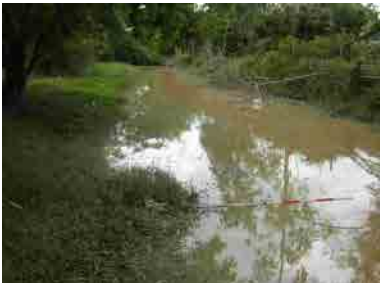
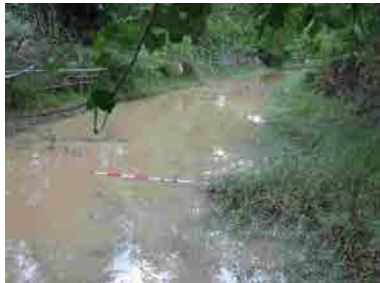
Canal No.: MC33	Kind of structure: Canal	Remarks:
Station: 2.00+530	Coordinate< Northing: 1222950 Easting: 450792	Routine survey Length: 2500m

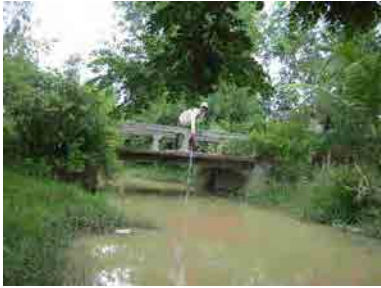
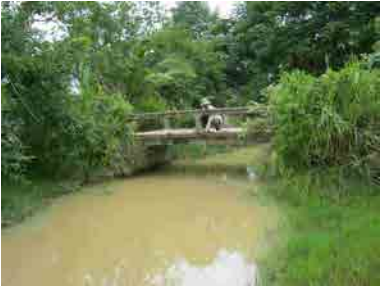
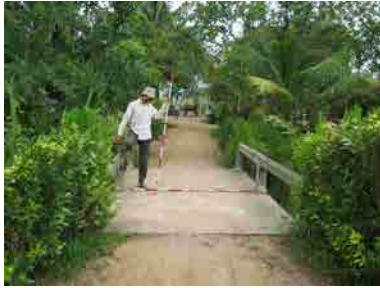
Canal No.: MC33	Kind of structure: Bridge (Private)	Remarks:
Station: 2.00+610	Coordinate< Northing: 1222922 Easting: 450852	Routine survey

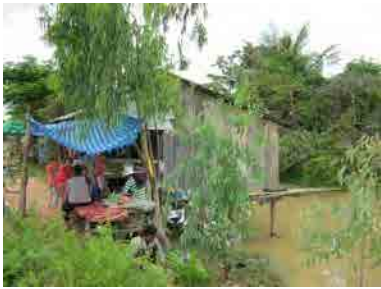
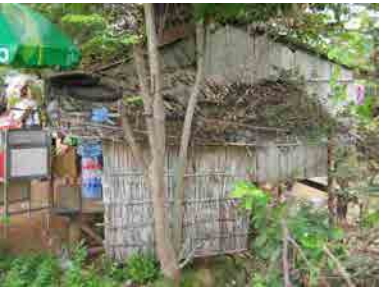
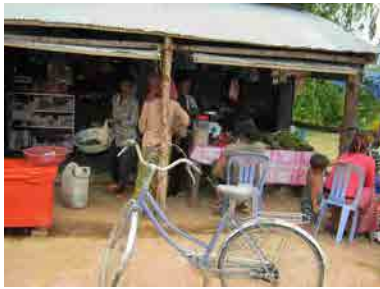
Canal No.: MC33	Kind of structure: House	Remarks:
Station: 2.00+700	Coordinate< Northing: 1222904 Easting: 450935	Routine survey

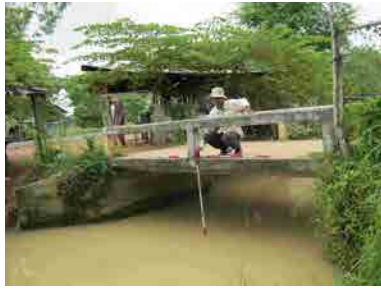
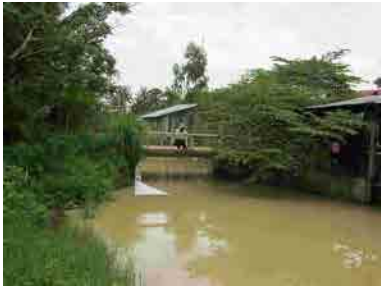
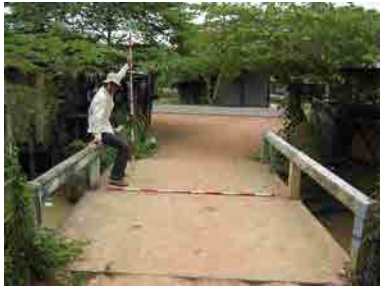
Canal No.: MC33	Kind of structure: Bridge (Private)	Remarks:
Station: 2.00+700	Coordinate< Northing: 1222896 Easting: 450953	There are houses in triple

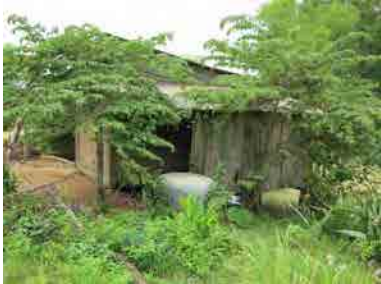
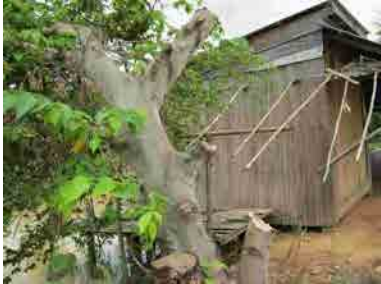
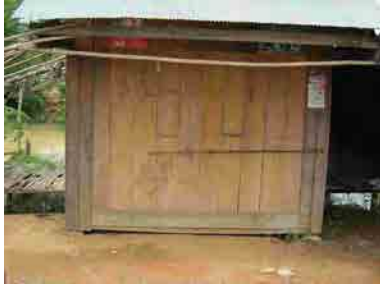
Canal No.: MC33	Kind of structure: House	Remarks:
Station: 2.00+730	Coordinate< Northing: 1222884 Easting: 450995	Routine survey

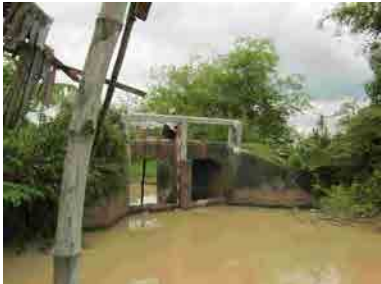
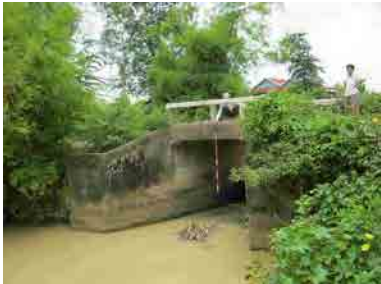
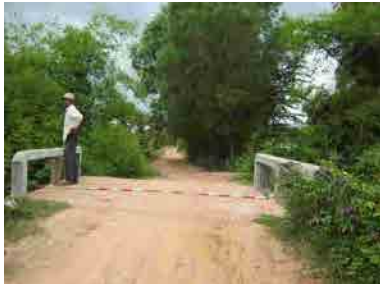
Canal No.: MC33	Kind of structure: Bridge (Private)	Remarks:
Station: 2.00+ 730	Coordinate< Northing: 1222873 Easting: 451005	There is a groove

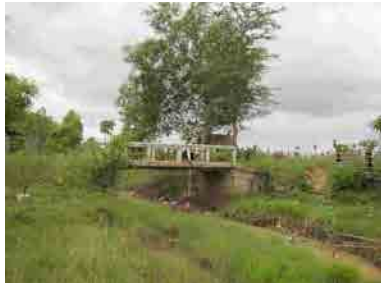
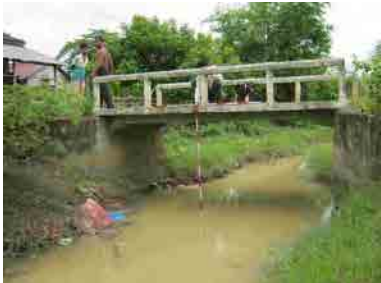
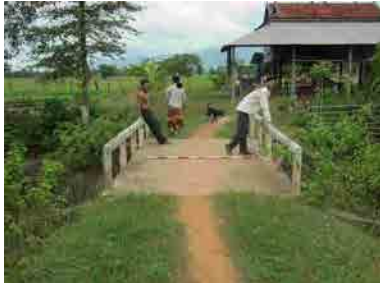
Canal No.: MC33	Kind of structure: Bridge (Private)	Remarks:
Station: 2.00+850	Coordinate< Northing: 1222846 Easting: 451096	There are houses in double

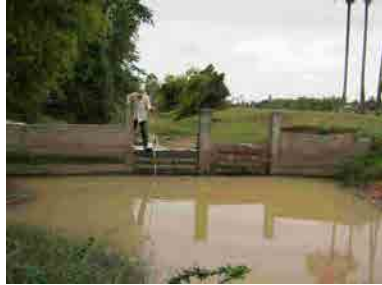
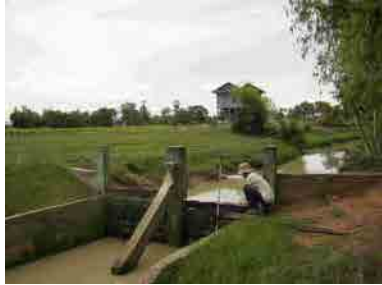
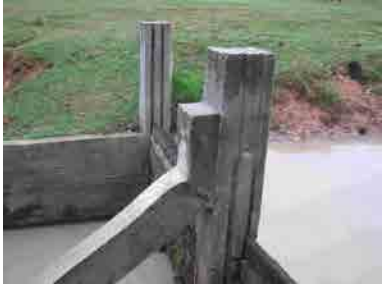
Canal No.: MC33	Kind of structure: Water obstruction (community)	Remarks: There are 3 columns with groove to obstruct the water
Station: 3.00+90	Coordinate< Northing: 1222758 Easting: 451262

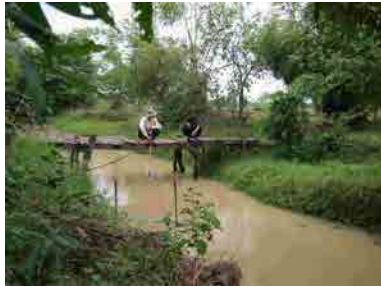
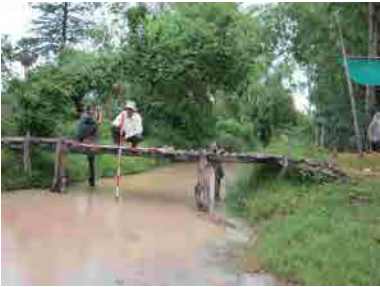
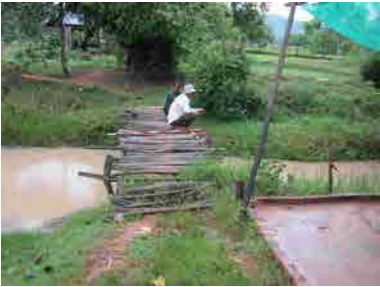
Canal No.: MC33	Kind of structure: Bridge (Private)	Remarks:
Station: 3.00+950	Coordinate< Northing: 1222329 Easting: 451880	There is a house

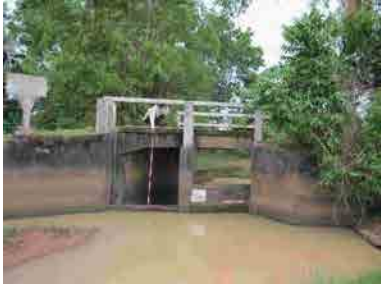
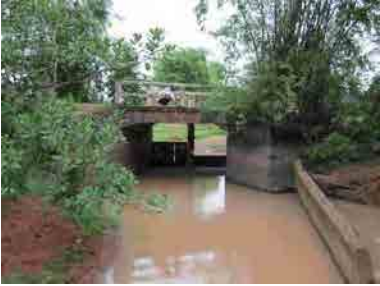
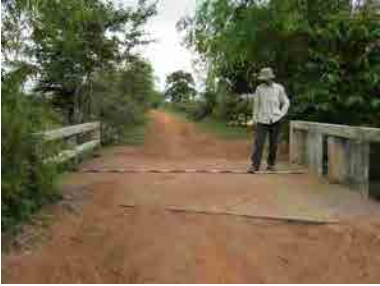
Canal No.: MC33	Kind of structure: Bridge (Commune)	Remarks:
Station: 4.00+140	Coordinate< Northing: 122215 Easting: 452037	There are groove and pipe culvert

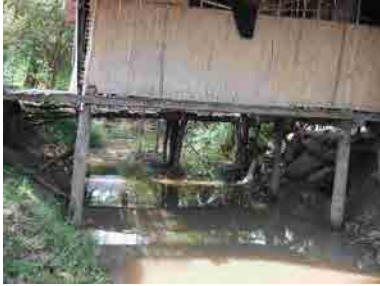
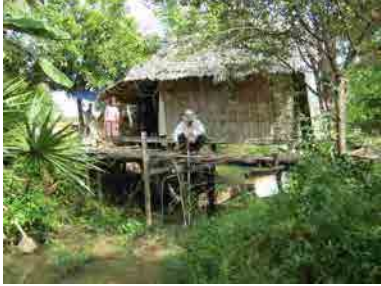
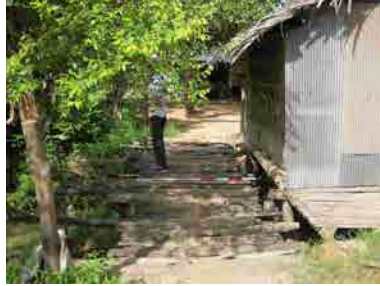
Canal No.: MC33	Kind of structure: Bridge (Private)	Remarks:
Station: 4.00+330	Coordinate Northing: 1222099 Easting: 452201	There is a house

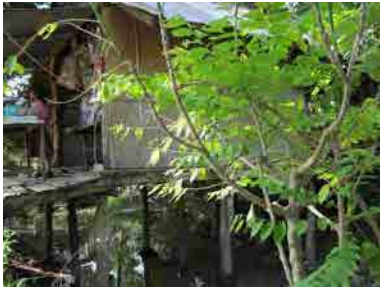
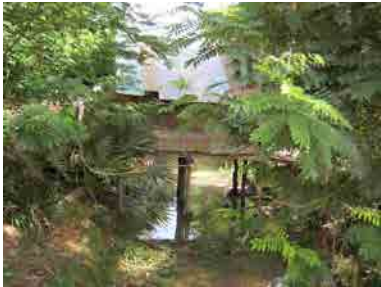
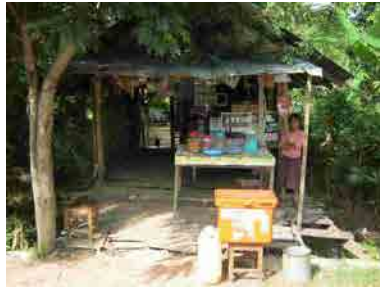
Canal No.: MC33	Kind of structure: Bridge (Private)	Remarks:
Station: 4.00+350	Coordinate Northing: 1222076 Easting: 452230	There is a house

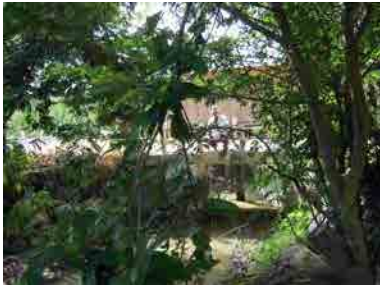
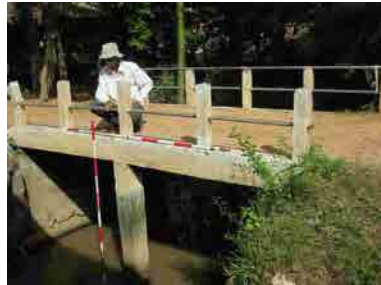
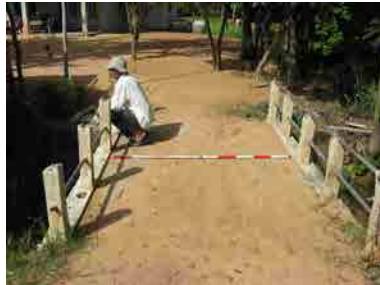
Canal No.: MC33	Kind of structure: Bridge (Private)	Remarks:
Station: 4.00+420	Coordinate< Northing: 1222041 Easting: 452271	Routine survey

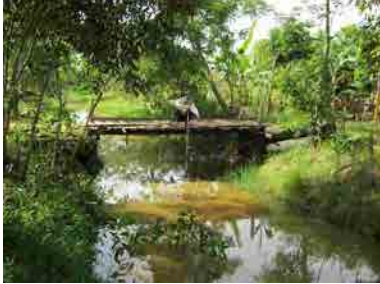
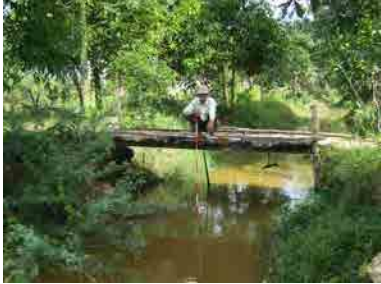
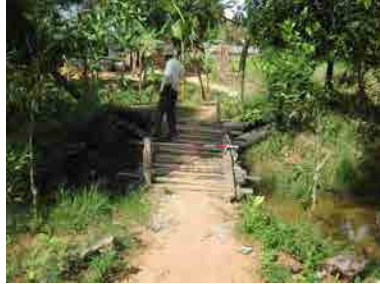
Canal No.: MC33	Kind of structure: Bridge (Private)	Remarks:
Station: 4.00+510	Coordinate< Northing: 1221998 Easting: 452330	There are houses in triple

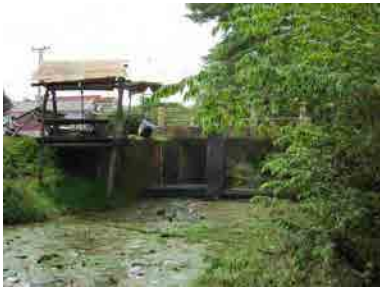
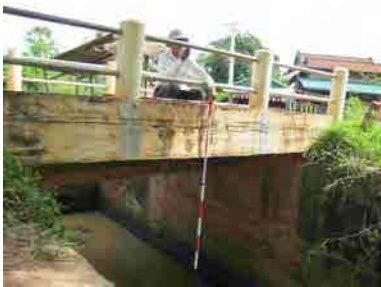
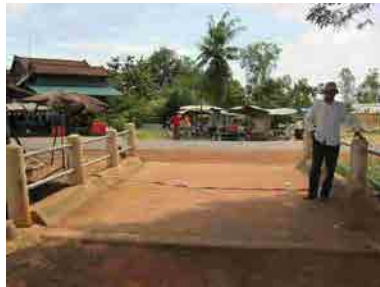
Canal No.: MC33	Kind of structure: Bridge (Commune)	Remarks:
Station: 6.00+200	Coordinate< Northing: 1220918 Easting: 453494	There are a house and groove

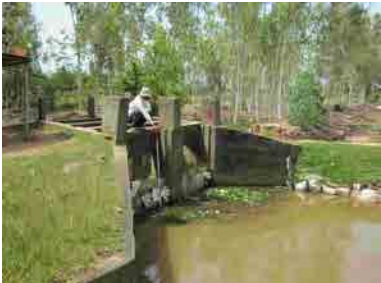
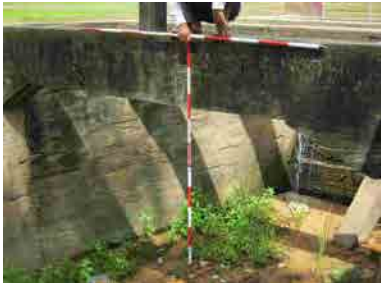
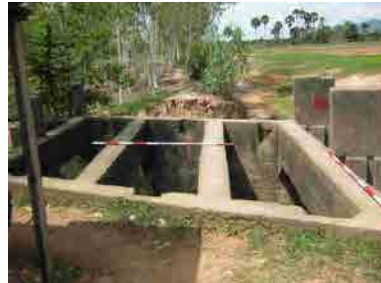
Canal No.: MC33	Kind of structure: Bridge (in Pol Pot regime 25-05-1977)	Remarks: Routine survey
Station: 6.00+930	Coordinate< Northing: 1220569 Easting: 454046

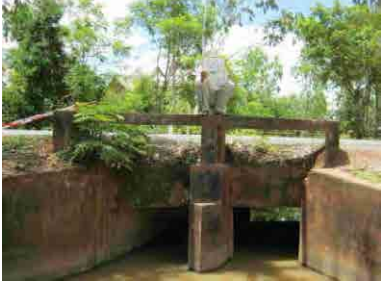
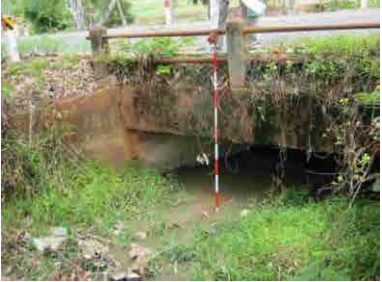
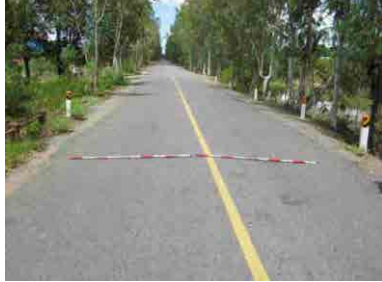
Sta.	E	N	Structure	Condition	Evaluation*	Flow Capacity	Remarks
0	454696	1220124	B.P (Bridge 1 & Groove)	Entrance of inlet on main canal is checked by earth dike to divert water, since no regulator on main canal is available	D		
70	454736	1220137	Culvert 1	Single pipe with 0.6 m dia and 4 m long	B	c	house access
360	454996	1220136	Culvert 2	Single pipe with 0.8 m dia and 6 m long	B	c	on village road
460	455100	1220131	Culvert 3	Single pipe with 0.6 m dia and 2 m long	B	c	house access
500	455133	1220135	Culvert 4	Single pipe with 0.6 m dia and 4 m long	B	c	house access
570	455209	1220134	Double Culvert 5	Two pipes with 0.2 m dia and 4 m long	D	c	house access pipe size is too small
680	455323	1220128	Culvert 6	Single pipe with 0.6 m dia and 4 m long	B	c	farm access
760	455408	1220125	Culvert 7	Single pipe with 0.4 m dia and 3 m long	B	c	farm access
1,000	455642	1220117	Bridge 2 & Culvert 8 (Commune)	Bridge with 1 m span and 6 m width, and pipe with 0.4 m dia	B	c	on commune road

Canal No.: C20	Kind of structure(s): Bridge	Remarks: - Under National Road 130A - There is a Groove
Station: 0.00(B.P.)	Coordinate< Northing: 1220130 Easting: 0454695

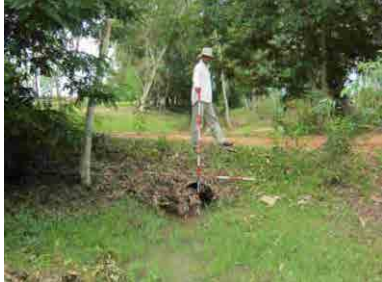
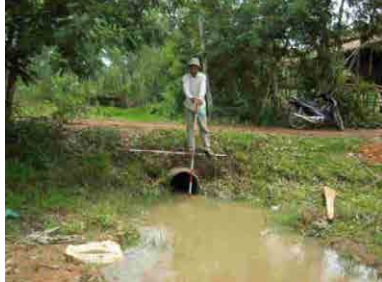
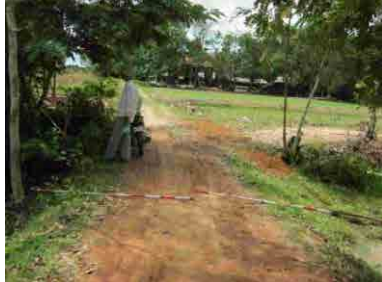
Canal No.: C20	Kind of structure(s): Pipe culvert	Remarks: Routine survey Under village road
Station: 0.00+70	Coordinate< Northing: 1220137 Easting: 0454736

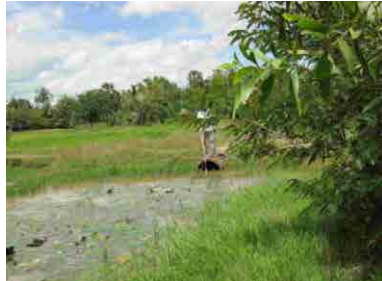
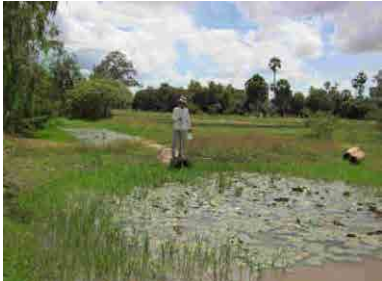
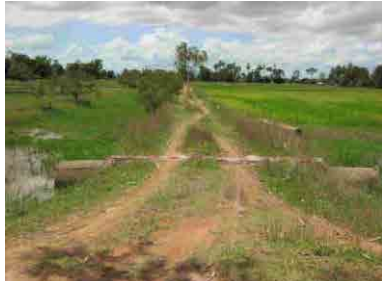
Canal No.: C20	Kind of structure(s): Pipe culvert	Remarks: Routine survey Under cart road
Station: 0.00+360	Coordinate< Northing: 1220136 Easting: 454996

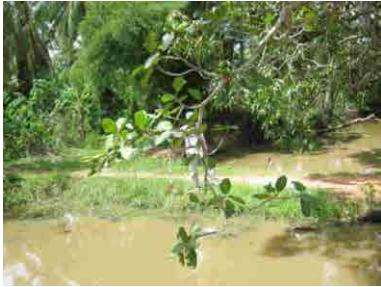
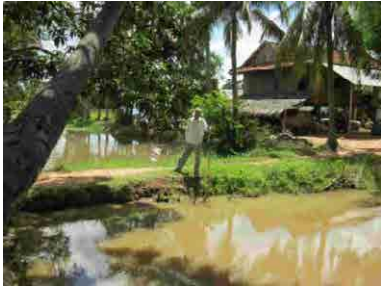
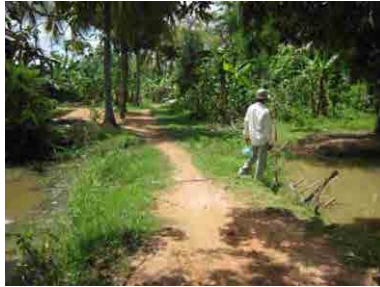
Canal No.: C20	Kind of structure(s): Pipe culvert	Remarks:
Station: 0.00+460	Coordinate< Northing: 1220131 Easting: 0455100	Routine survey

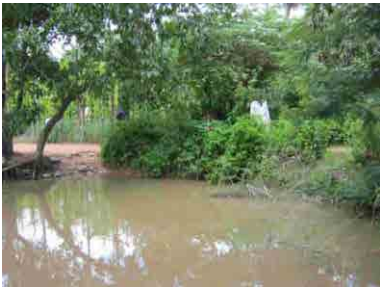
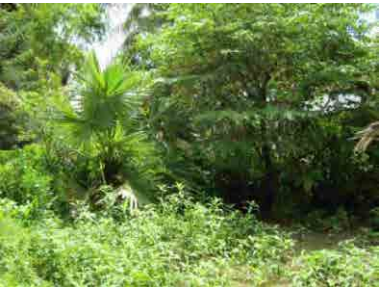
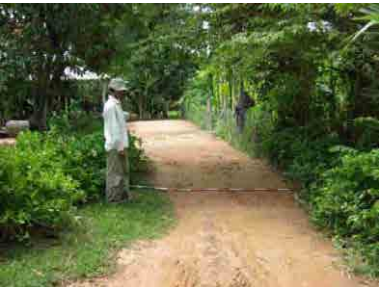
Canal No.: C20	Kind of structure(s): Pipe culvert	Remarks:
Station: 0.00+500	Coordinate< Northing: 1220135 Easting: 0455133	Routine survey Length: 500m

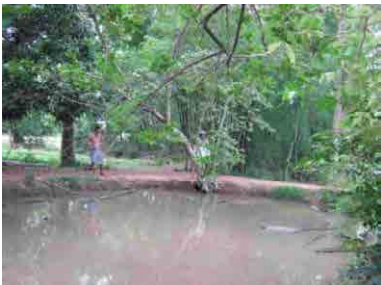
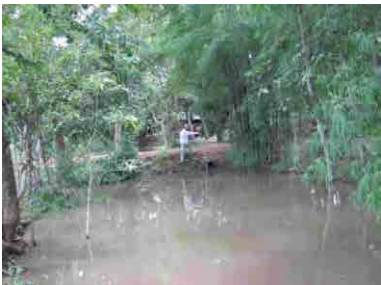
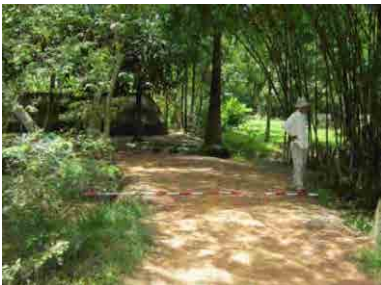
Canal No.: C20	Kind of structure(s): Pipe culvert (Double)	Remarks:
Station: 0.00+570	Coordinate< Northing: 1220134 Easting: 0455209	Routine survey

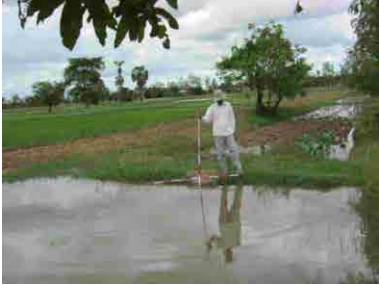
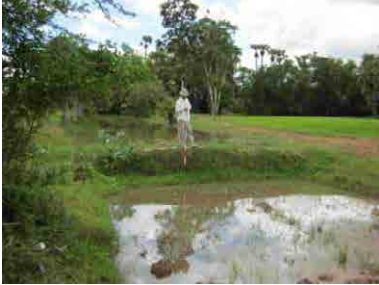
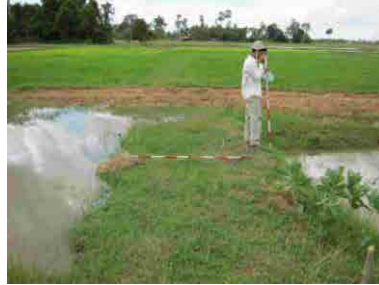
Canal No.: C20	Kind of structure(s): Pipe culvert	Remarks:
Station: 0.00+680	Coordinate< <div style="display: flex; flex-direction: column; gap: 5px;"> <span>Northing: 1220128</span> <span>Easting: 0455323</span> </div>	Routine survey

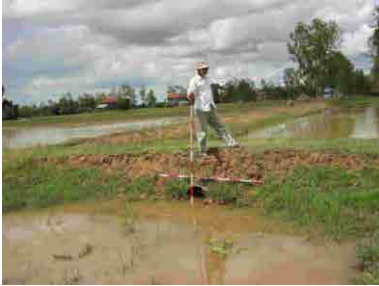
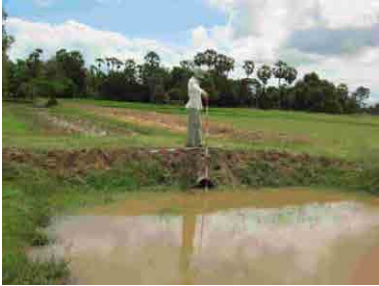
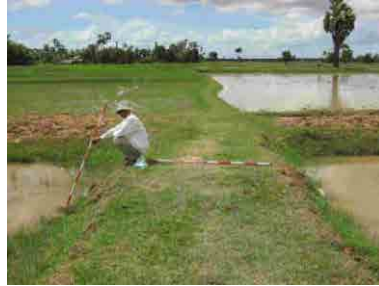
Canal No.: C20	Kind of structure(s): Pipe culvert	Remarks:
Station: 0.00+760	Coordinate< <div style="display: flex; flex-direction: column; gap: 5px;"> <span>Northing: 1220125</span> <span>Easting: 0455408</span> </div>	Routine survey

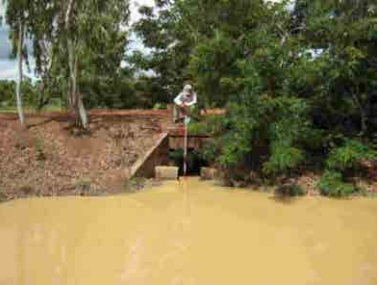
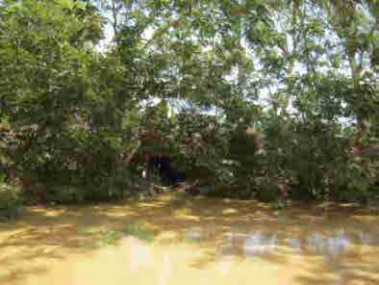
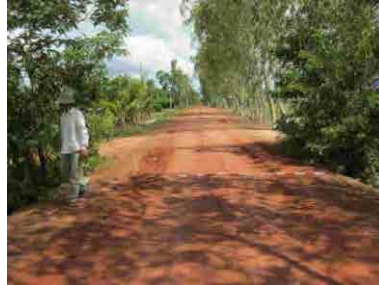
Canal No.: C20	Kind of structure(s): Bridge (Commune)	Remarks:
Station: 1.00	Coordinate< <div style="display: flex; flex-direction: column; gap: 5px;"> <span>Northing: 1220117</span> <span>Easting: 0455642</span> </div>	There is a pipe culvert under the bridge Length: 1000m

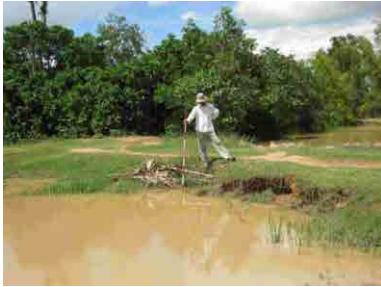
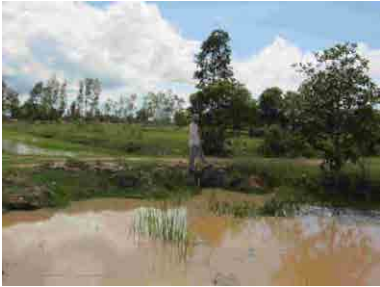
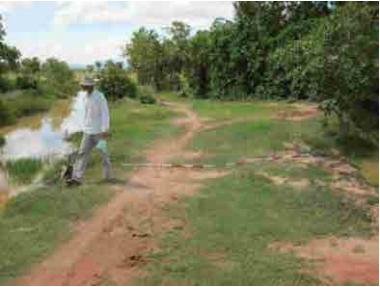
Canal No.: C20	Kind of structure(s): Pipe culvert	Remarks:
Station: 1.00+160	Coordinate< Northing: 1220124 Easting: 0455788	Routine survey

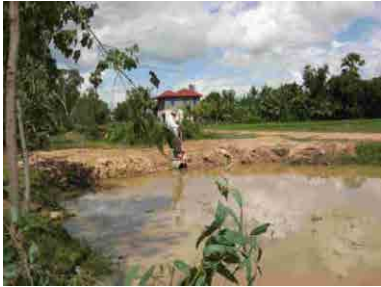
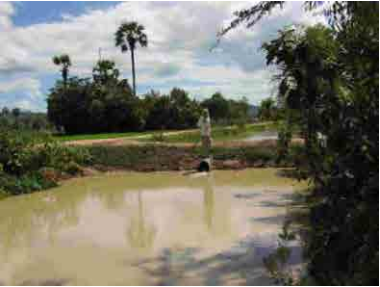
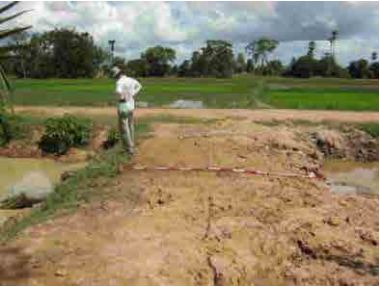
Canal No.: C20	Kind of structure(s): Pipe culvert	Remarks:
Station: 1.00+270	Coordinate< Northing: 1220119 Easting: 0455902	Routine survey

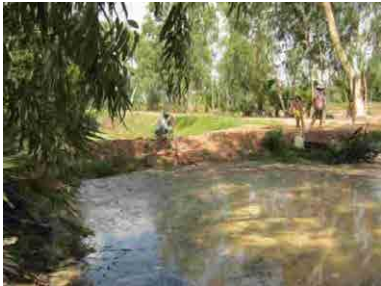
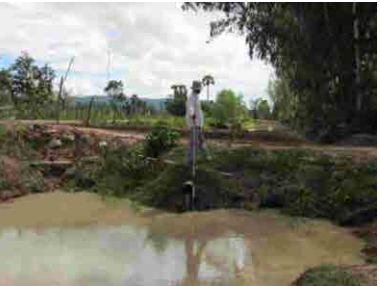
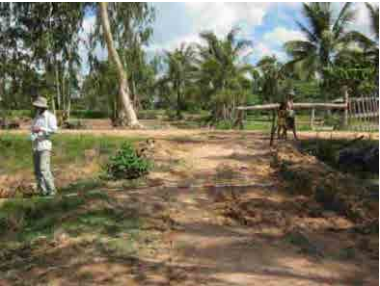
Canal No.: C20	Kind of structure(s): Pipe culvert	Remarks:
Station: 1.00+400	Coordinate< Northing: 1220119 Easting: 0456009	Routine survey

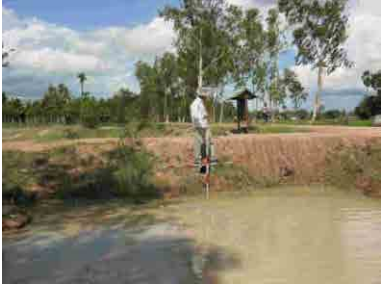
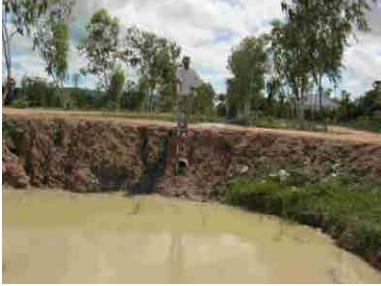
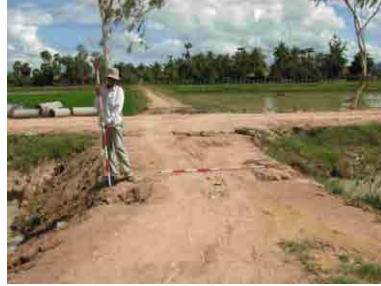
Canal No.: C20	Kind of structure(s): Pipe culvert	Remarks:
Station: 1.00+700	Coordinate< Northing: 1220116 Easting: 0456284	Routine survey

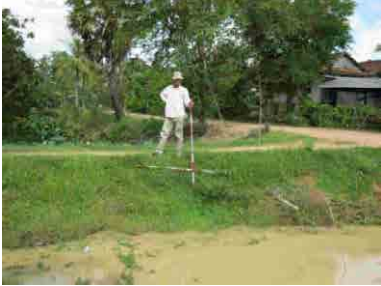
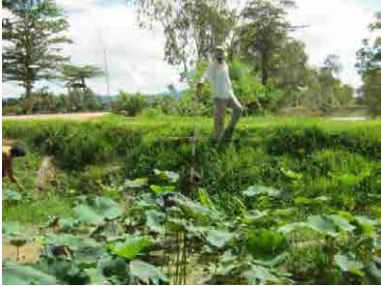
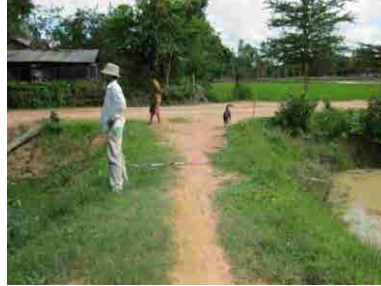
Canal No.: C20	Kind of structure(s): Pipe culvert	Remarks:
Station: 1.00+850	Coordinate< Northing: 1220114 Easting: 0456415	Routine survey

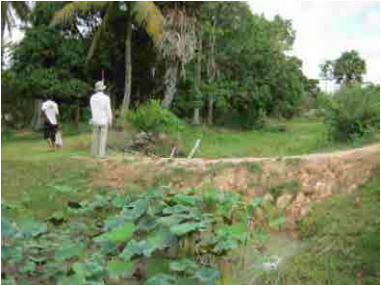
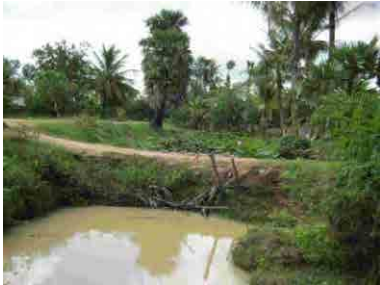
Canal No.: C20	Kind of structure(s): Embankment	Remarks:
Station: 1.00+950	Coordinate< Northing: 1220078 Easting: 0456497	Routine survey

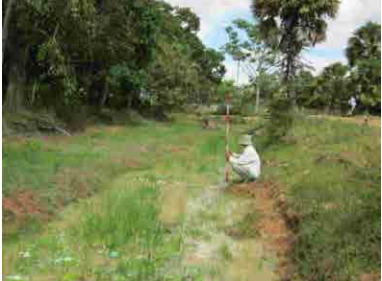
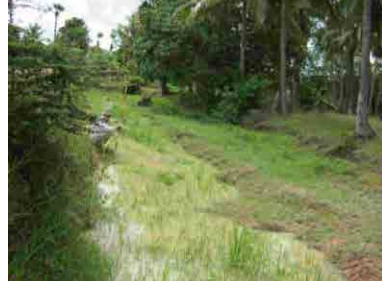
Canal No.: C20	Kind of structure(s): Canal	Remarks: Routine survey Length: 2000m
Station: 2.00	Coordinate< <div style="display: flex; flex-direction: column; gap: 5px;"> <span>Northing: 1220045</span> <span>Easting: 0456522</span> </div>	
<div style="display: flex; justify-content: space-around; align-items: center;">

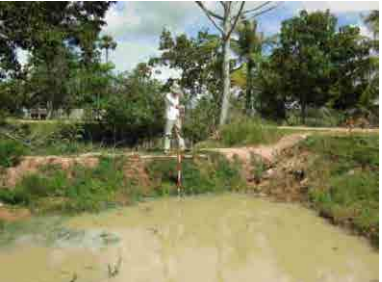
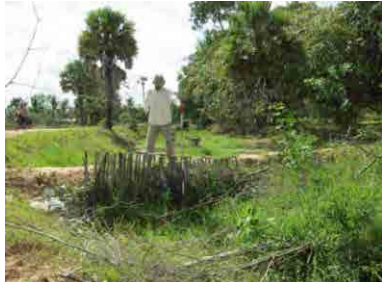
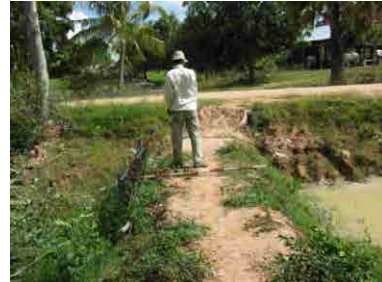
Canal No.: C20	Kind of structure(s): Pipe culvert	Remarks: Routine survey
Station: 2.00+50	Coordinate< <div style="display: flex; flex-direction: column; gap: 5px;"> <span>Northing: 1220021</span> <span>Easting: 0456555</span> </div>	
<div style="display: flex; justify-content: space-around; align-items: center;">

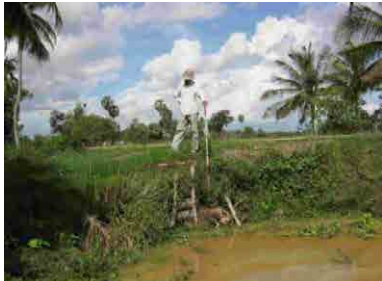
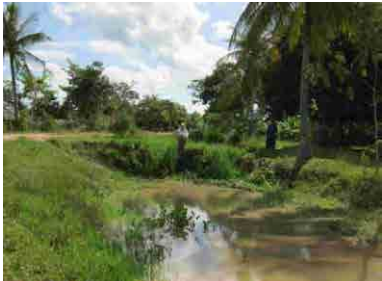
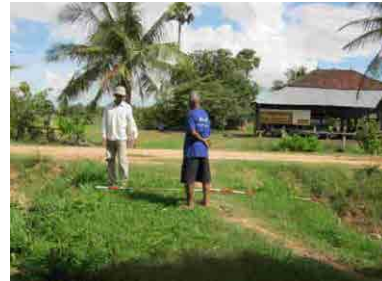
Canal No.: C20	Kind of structure(s): Pipe culvert	Remarks: Routine survey
Station: 2.00+120	Coordinate< <div style="display: flex; flex-direction: column; gap: 5px;"> <span>Northing: 1220015</span> <span>Easting: 0456618</span> </div>	
<div style="display: flex; justify-content: space-around; align-items: center;">

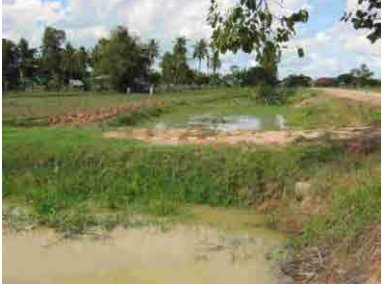
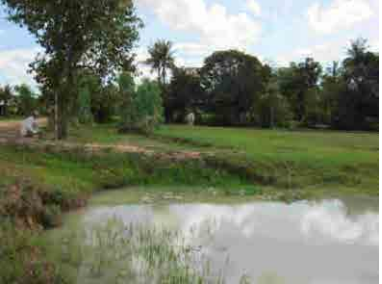
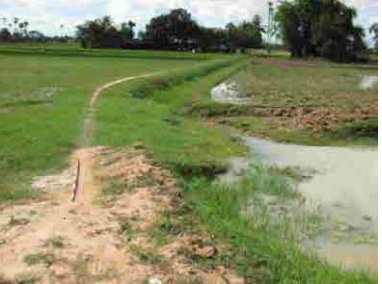
Canal No.: C20	Kind of structure(s): Embankment	Remarks:
Station: 2.00+200	Coordinate Northing: 1220050 Easting: 0456694	Routine survey

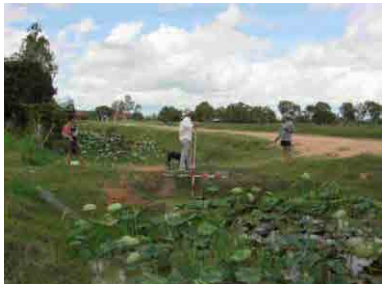
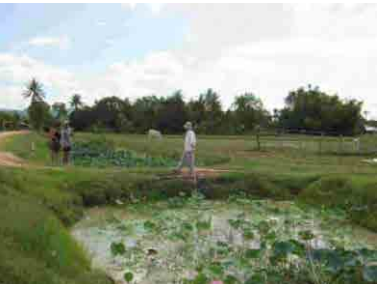
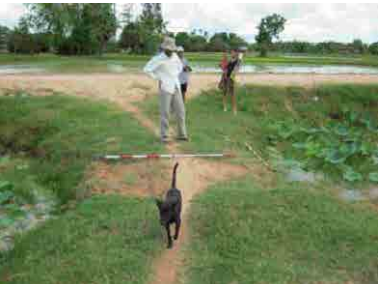
Canal No.: C20	Kind of structure(s): Pipe culvert	Remarks:
Station: 2.00+270	Coordinate Northing: 1220079 Easting: 0456762	Routine survey

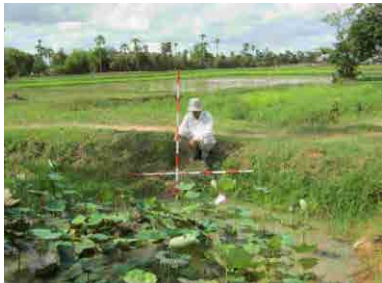
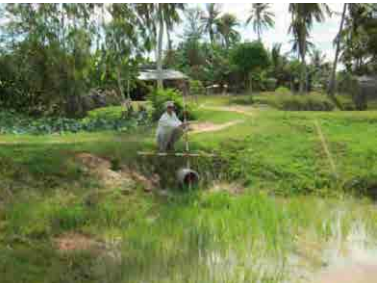
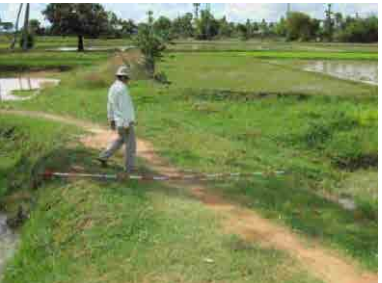
Canal No.: C20	Kind of structure(s): Pipe culvert	Remarks:
Station: 2.00+330	Coordinate Northing: 1220105 Easting: 0456820	Routine survey

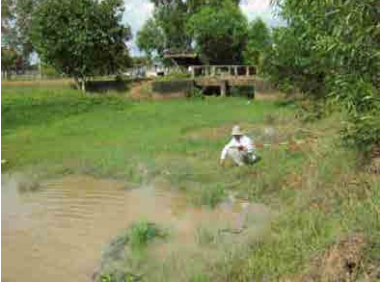
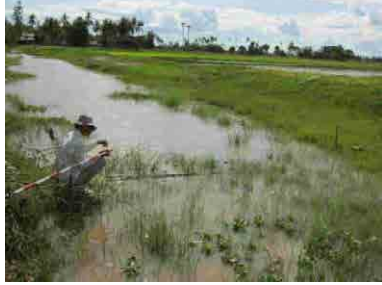
Canal No.: C20	Kind of structure(s): Canal	Remarks: Routine survey Length: 2500m
Station: 2.00+500	Coordinate< Northing: 1220096 Easting: 0456982	
<div style="display: flex; justify-content: space-around; align-items: center;"> <div style="text-align: center;">

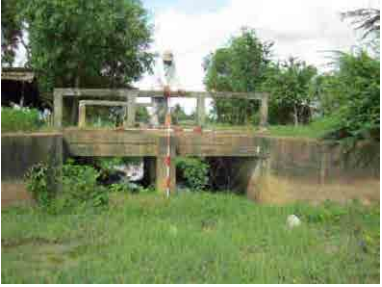
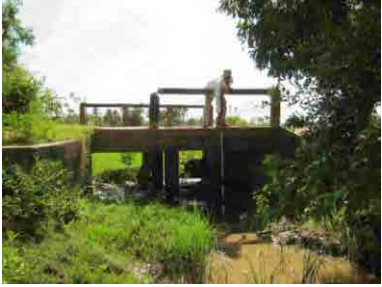
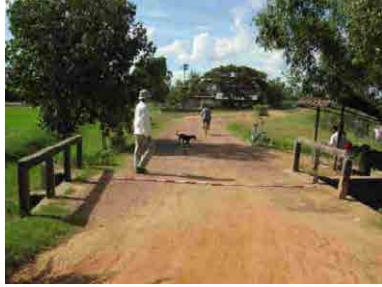
Canal No.: C20	Kind of structure(s): Bridge (Commune)	Remarks: Routine survey There is a Groove
Station: 2.00+520	Coordinate< Northing: 1220106 Easting: 0457008	
<div style="display: flex; justify-content: space-around; align-items: center;"> <div style="text-align: center;">

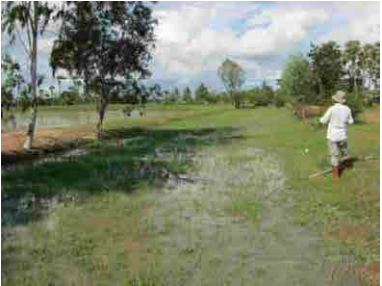
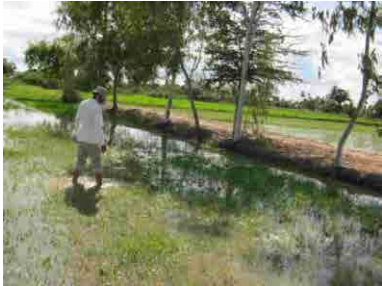
Canal No.: C20	Kind of structure(s): Canal	Remarks: Routine survey Length: 3000m
Station: 3.00	Coordinate< Northing: 1220091 Easting: 0457448	
<div style="display: flex; justify-content: space-around; align-items: center;"> <div style="text-align: center;">

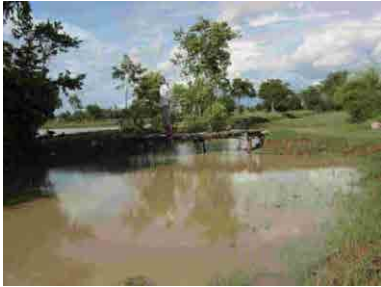
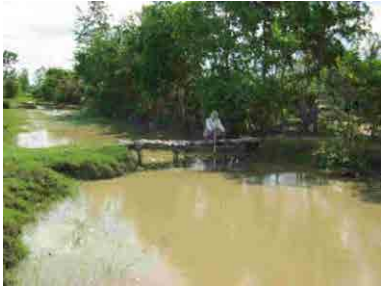
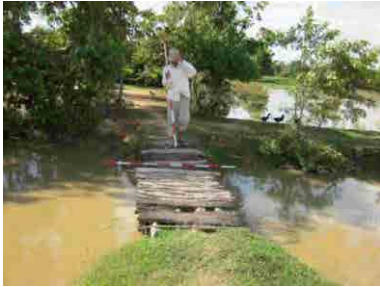
Canal No.: C20	Kind of structure(s): Bridge (Private)	Remarks:
Station: 3.00+240	Coordinate< Northing: 1220093 Easting: 0457676	Routine survey

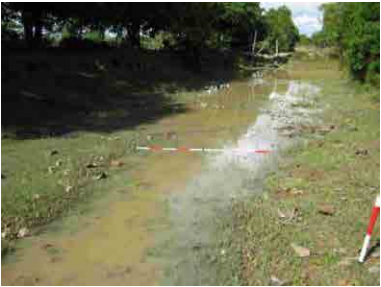
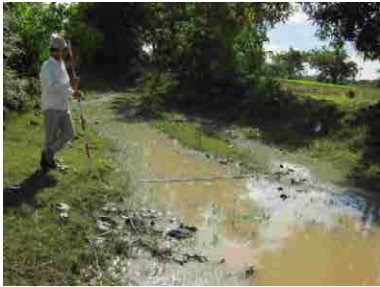
Canal No.: C20	Kind of structure(s): Canal	Remarks:
Station: 3.00+500	Coordinate< Northing: 1220084 Easting: 0457916	Routine survey Length: 3500m

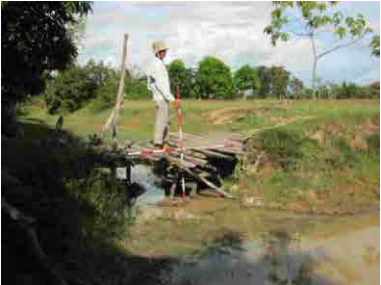
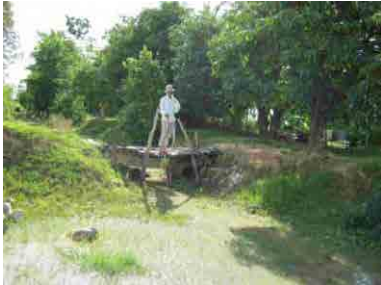
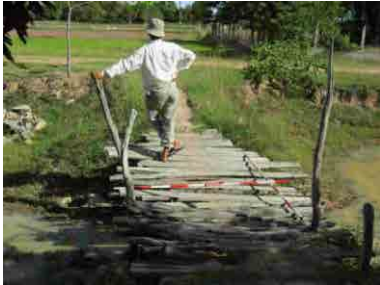
Canal No.: C20	Kind of structure(s): Bridge (Private)	Remarks:
Station: 3.00+550	Coordinate< Northing: 1220093 Easting: 0457939	There is a pipe culvert under the bridge

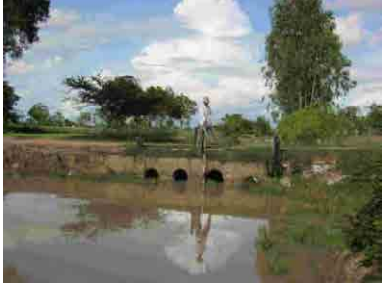
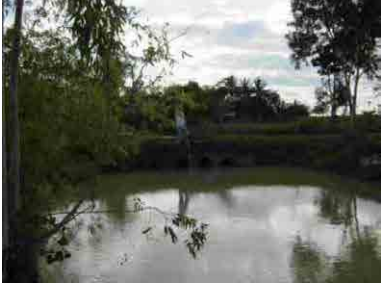
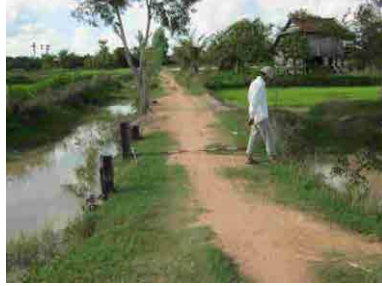
Canal No.: C20	Kind of structure(s): Pipe culvert (4 Units)	Remarks:
Station: 3.00+640	Coordinate< <div style="display: flex; flex-direction: column; margin-left: 10px;"> <span>Northing: 1220090</span> <span>Easting: 0458021</span> </div>	Routine survey

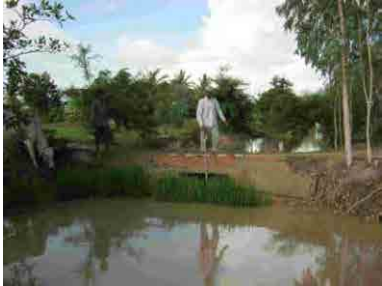
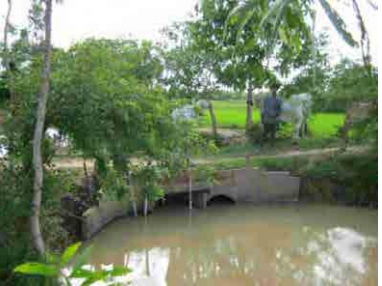
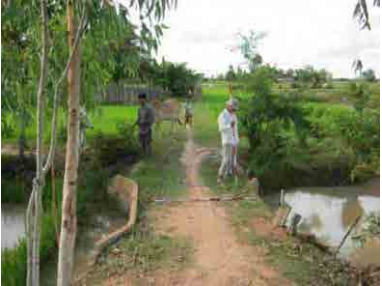
Canal No.: C20	Kind of structure(s): Canal	Remarks:
Station: 4.00+10	Coordinate< <div style="display: flex; flex-direction: column; margin-left: 10px;"> <span>Northing: 0458363</span> <span>Easting: 1220080</span> </div>	Routine survey Length: 4000m

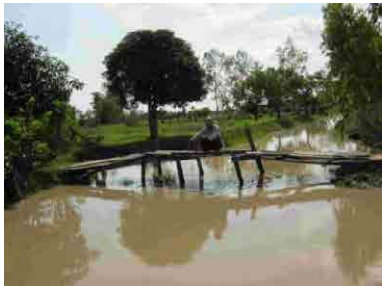
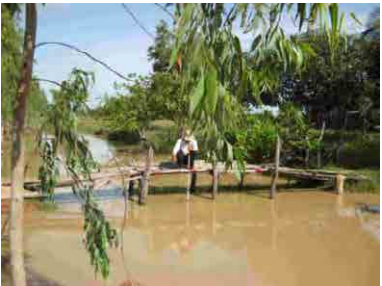
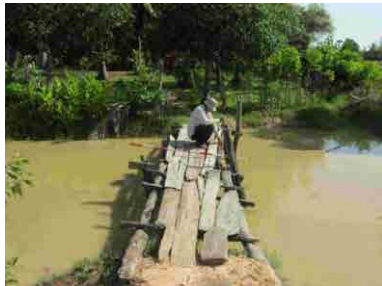
Canal No.: C20	Kind of structure(s): Bridge (Private)	Remarks:
Station: 4.00+370	Coordinate< <div style="display: flex; flex-direction: column; margin-left: 10px;"> <span>Northing: 1220079</span> <span>Easting: 0458691</span> </div>	Routine survey

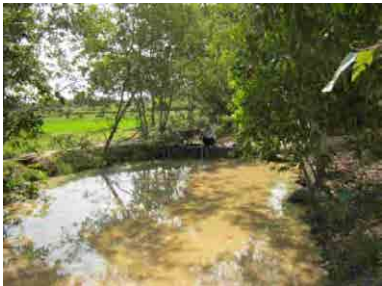
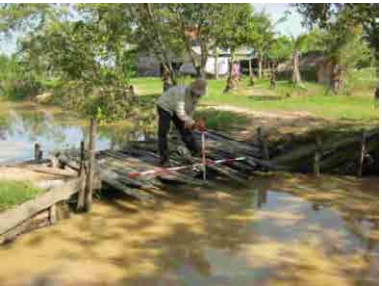
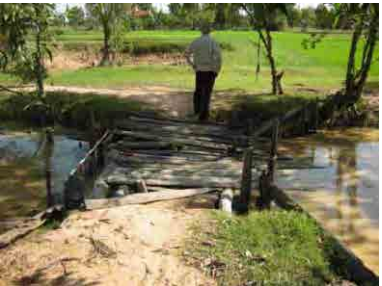
Canal No.: C20	Kind of structure(s): Bridge (Private)	Remarks:
Station: 4.00+460	Coordinate< <div style="display: flex; flex-direction: column; margin-left: 10px;"> <span>Northing: 1220080</span> <span>Easting: 0458775</span> </div>	Routine survey Made by Concrete (incomplete)

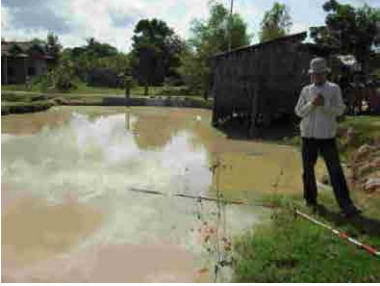
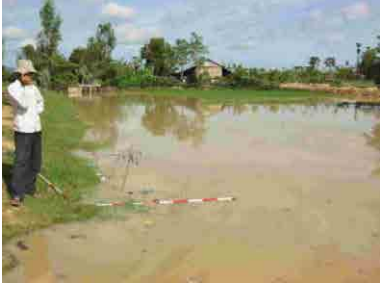
Canal No.: C20	Kind of structure(s): Canal	Remarks: Routine survey Length: 4500m
Station: 4.00+510	Coordinate< <div style="display: flex; flex-direction: column; margin-left: 10px;"> <span>Northing: 1220075</span> <span>Easting: 0458825</span> </div>	
<div style="display: flex; justify-content: space-around; align-items: center;">

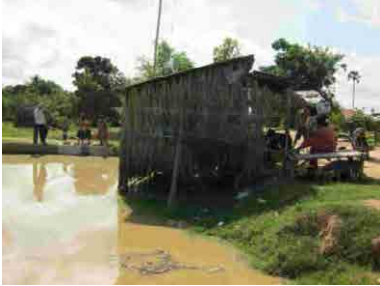
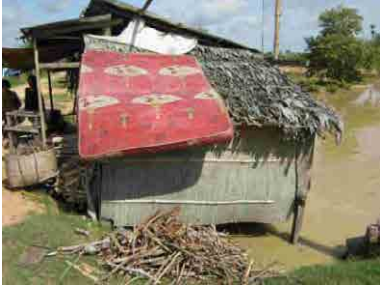
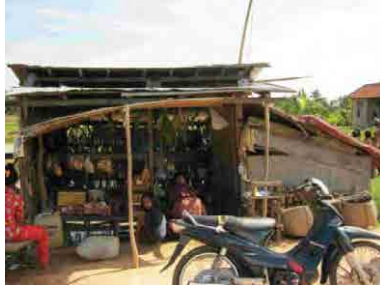
Canal No.: C20	Kind of structure(s): House	Remarks: Routine survey
Station: 4.00+520	Coordinate< <div style="display: flex; flex-direction: column; margin-left: 10px;"> <span>Northing: 1220073</span> <span>Easting: 0458838</span> </div>	
<div style="display: flex; justify-content: space-around; align-items: center;">

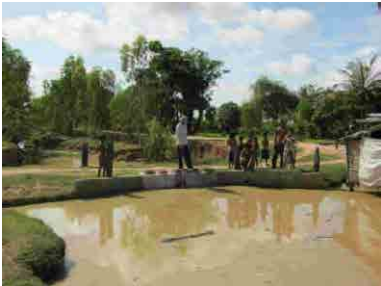
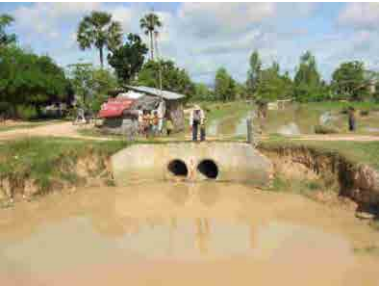
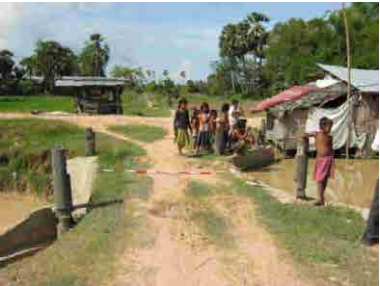
Canal No.: C20	Kind of structure(s): Pipe culvert (Double)	Remarks: Routine survey
Station: 4.00+530	Coordinate< <div style="display: flex; flex-direction: column; margin-left: 10px;"> <span>Northing: 1220083</span> <span>Easting: 0458844</span> </div>	
<div style="display: flex; justify-content: space-around; align-items: center;">

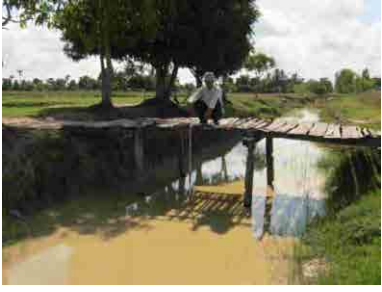
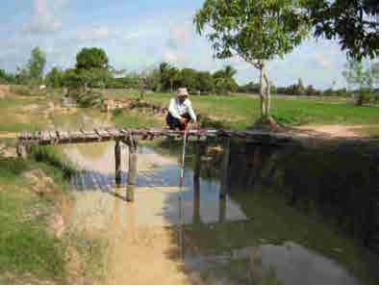
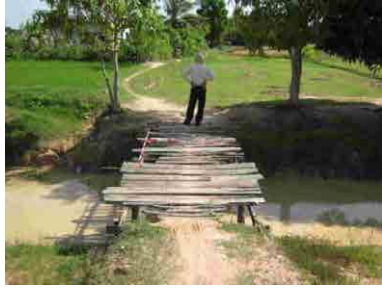
Canal No.: C20	Kind of structure(s): Bridge (Private)	Remarks: Routine survey Length: 5000m
Station: 5.00+10	Coordinate< Northing: 1220078 Easting: 0459278

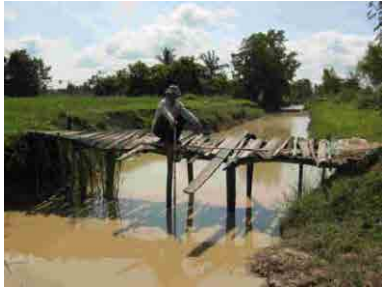
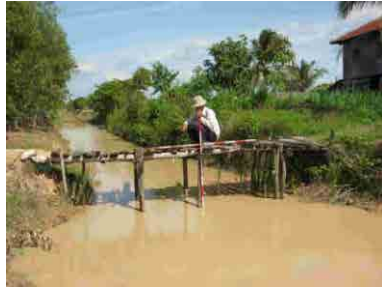
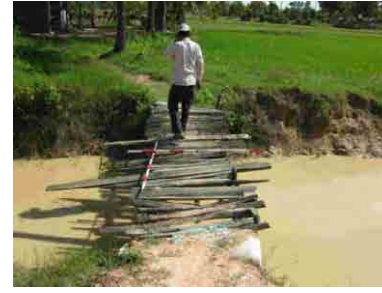
Canal No.: C20	Kind of structure(s): Bridge (Private)	Remarks: Routine survey
Station: 5.00+200	Coordinate< Northing: 1220070 Easting: 0459461
