# ***ANNEX D***

## ***Attachment – 1***

*Results of Inventory Survey for  
Proposed Rehabilitation Works in  
Roleang Chrey Headworks Rehabilitation Sub-project*

**Results of Inventory Survey for Proposed Rehabilitation Works on North Main Canal (1/12)**

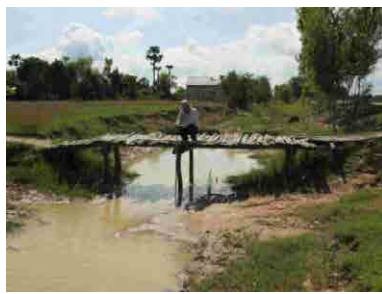
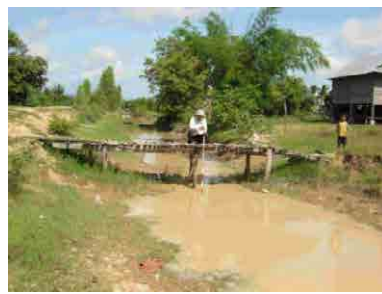
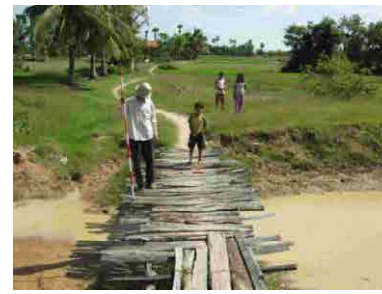
Canal No.: C20	Kind of structure(s): Bridge (Private)	Remarks: Routine survey
Station: 5.00+290	Coordinate< Northing: 1220068 Easting: 0459543

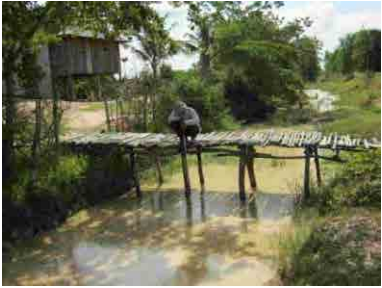
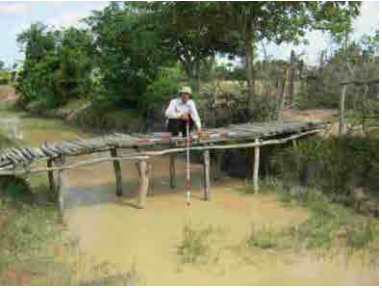
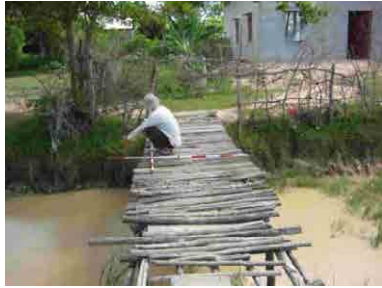
Canal No.: C20	Kind of structure(s): Bridge (Private)	Remarks:
Station: 5.00+380	Coordinate< Northing: 1220071 Easting: 0459637	Routine survey

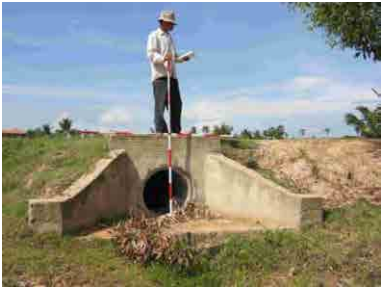
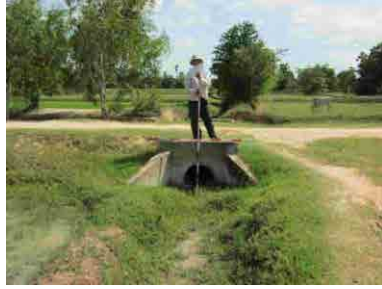
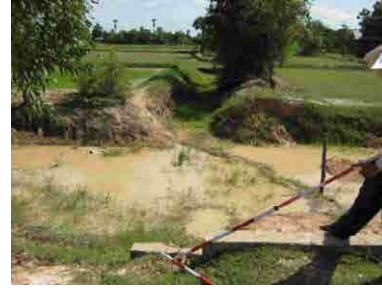
Canal No.: C20	Kind of structure(s): Division structure	Remarks:
Station: 5.00+470	Coordinate< Northing: 1220065 Easting: 0459717	Routine survey There a pipe culvert under the road

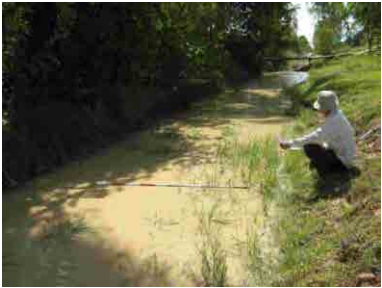
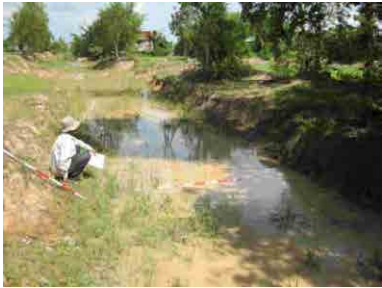
Canal No.: C20	Kind of structure(s): Canal	Remarks:
Station: 5.00+510	Coordinate< Northing: 1220069 Easting: 0459753	Routine survey Length: 5500m

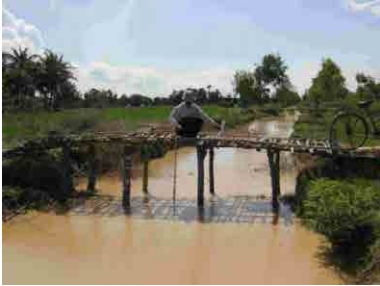
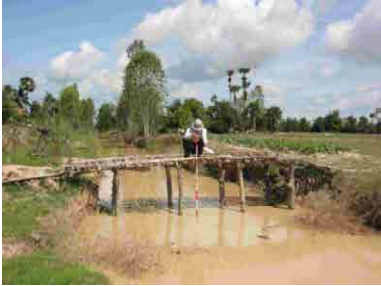
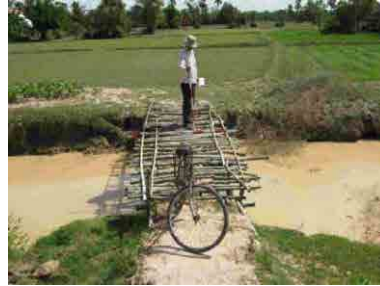
Up Stream View	Down Stream View	Side View

Canal No.: C20	Kind of structure(s): Bridge (Private)	Remarks:
Station: 5.00+760	Coordinate< Northing: 1220061 Easting: 0459986	Routine survey

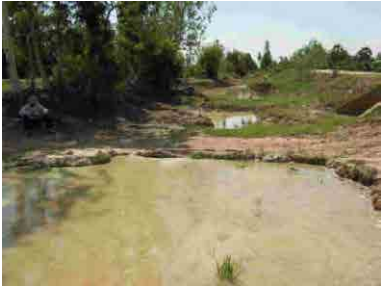
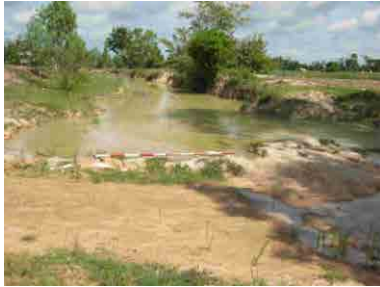
Up Stream View	Down Stream View

Canal No.: C20	Kind of structure(s): Canal	Remarks:
Station: 5.00+980	Coordinate< Northing: 1220060 Easting: 0460183	Routine survey Length: 6000m

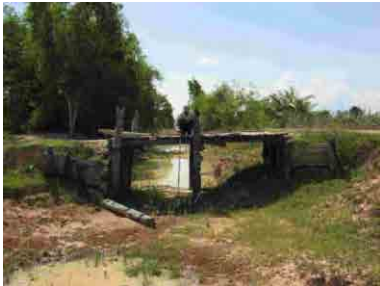
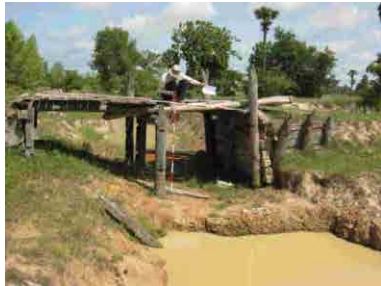
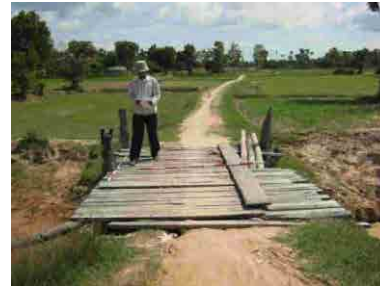
Up Stream View	Down Stream View	Side View

Canal No.: C20	Kind of structure(s): Bridge (Village)	Remarks:
Station: 6.00+220	Coordinate< Northing: 1220061 Easting: 0460399	Routine survey Made by wood

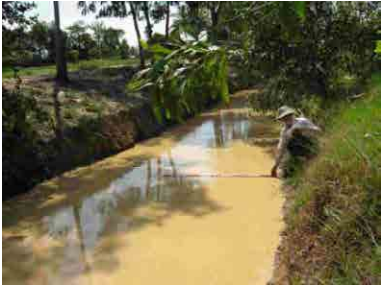
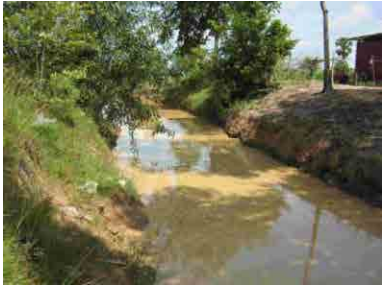
Canal No.: C20	Kind of structure(s): Canal	Remarks: Routine survey Length: 6500m
Station: 6.00+480	Coordinate< <div style="display: flex; flex-direction: column; margin-left: 10px;"> <span>Northing: 1220058</span> <span>Easting: 0460652</span> </div>	
<div style="display: flex; justify-content: space-around; align-items: center;"> <div style="text-align: center;">

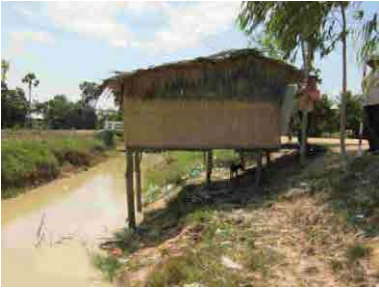
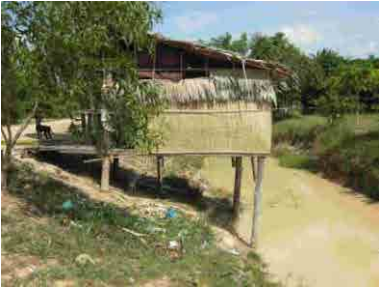
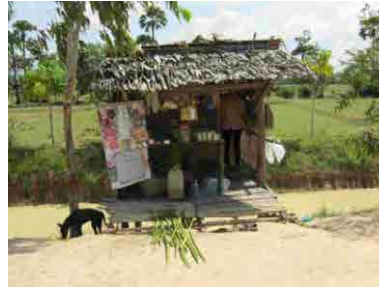
Canal No.: C20	Kind of structure(s): House	Remarks: Routine survey
Station: 6.00+670	Coordinate< <div style="display: flex; flex-direction: column; margin-left: 10px;"> <span>Northing: 1220054</span> <span>Easting: 0460832</span> </div>	
<div style="display: flex; justify-content: space-around; align-items: center;"> <div style="text-align: center;">

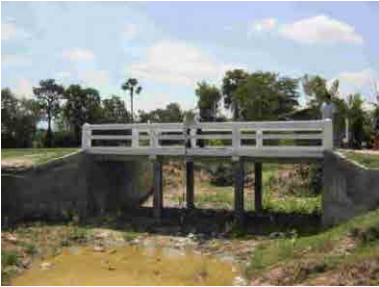
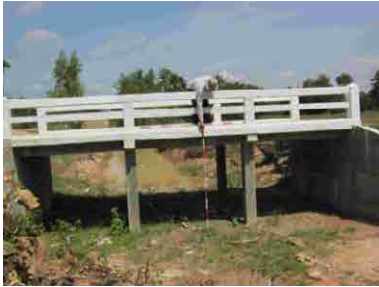
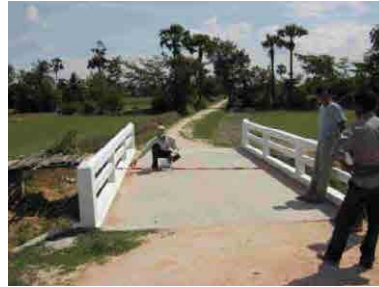
Canal No.: C20	Kind of structure(s): Bridge (Community)	Remarks: Bridge: L= 7m, W= 3m, H= 2m
Station: 6.00+690	Coordinate< <div style="display: flex; flex-direction: column; margin-left: 10px;"> <span>Northing: 1220058</span> <span>Easting: 0460865</span> </div>	
<div style="display: flex; justify-content: space-around; align-items: center;"> <div style="text-align: center;">

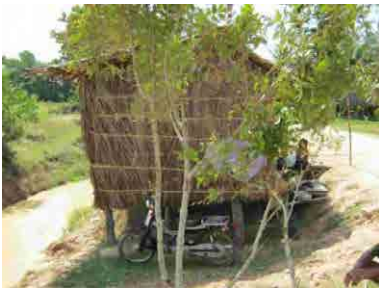
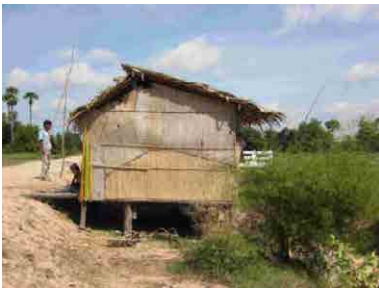
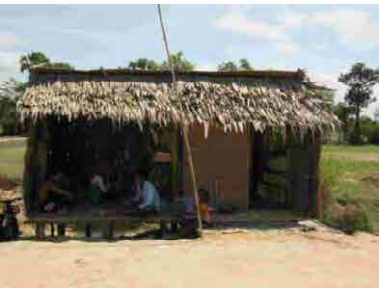
Canal No.: C20	Kind of structure(s): House	Remarks:
Station: 6.00+690	Coordinate< <div style="display: flex; flex-direction: column; margin-left: 10px;"> <span>Northing: 1220053</span> <span>Easting: 0460871</span> </div>	Routine survey
<div style="display: flex; justify-content: space-around; align-items: center;">

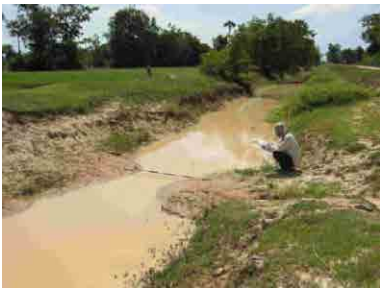
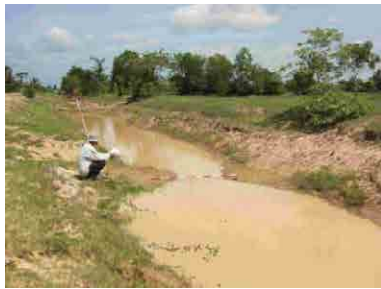
Canal No.: C20	Kind of structure(s): Canal	Remarks:
Station: 6.00+980	Coordinate< <div style="display: flex; flex-direction: column; margin-left: 10px;"> <span>Northing: 1220052</span> <span>Easting: 0461151</span> </div>	Routine survey Length: 7000m
<div style="display: flex; justify-content: space-around; align-items: center;">

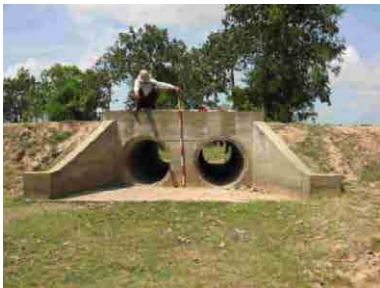
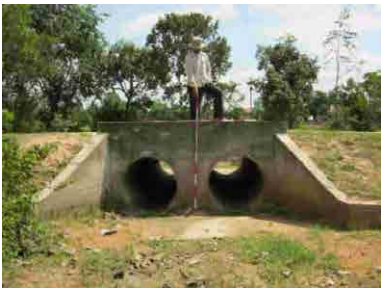
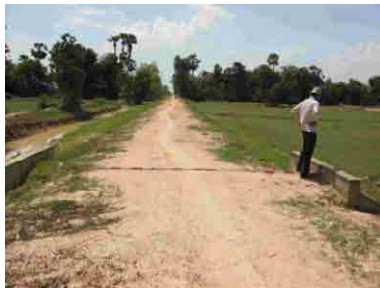
Canal No.: C20	Kind of structure(s): Pipe culvert	Remarks:
Station: 7.00+220	Coordinate< <div style="display: flex; flex-direction: column; margin-left: 10px;"> <span>Northing: 1220048</span> <span>Easting: 0461380</span> </div>	Diameter of pipe culvert = 1 m There is a crossing point
<div style="display: flex; justify-content: space-around; align-items: center;">

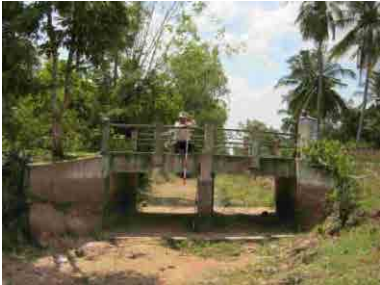
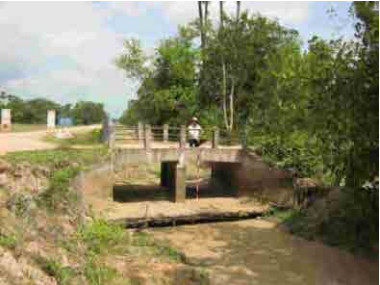
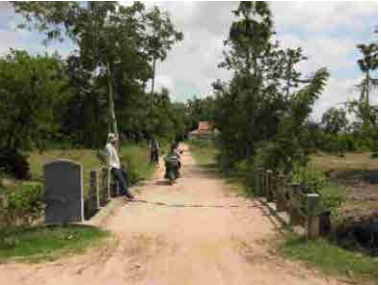
Canal No.: C20	Kind of structure(s): Bridge (Commune)	Remarks: There is a Groove Bridge was built in Pol Pot Regime
Station: 7.00+390	Coordinate< <div style="display: flex; flex-direction: column; margin-left: 10px;"> <span>Northing: 1220049</span> <span>Easting: 0461541</span> </div>	
<div style="display: flex; justify-content: space-around; align-items: center;">

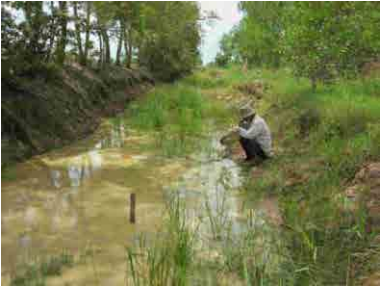
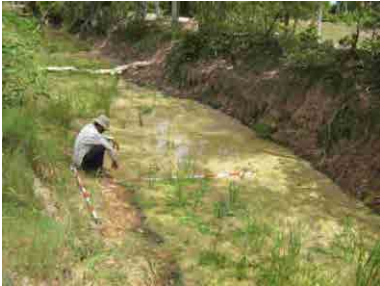
Canal No.: C20	Kind of structure(s): Canal	Remarks: Routine survey Length: 7500m
Station: 7.00+480	Coordinate< <div style="display: flex; flex-direction: column; margin-left: 10px;"> <span>Northing: 1220048</span> <span>Easting: 0461625</span> </div>	
<div style="display: flex; justify-content: space-around; align-items: center;">

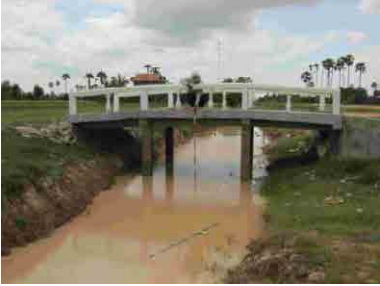
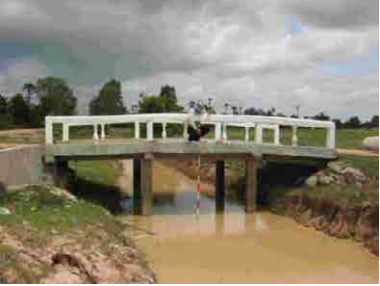
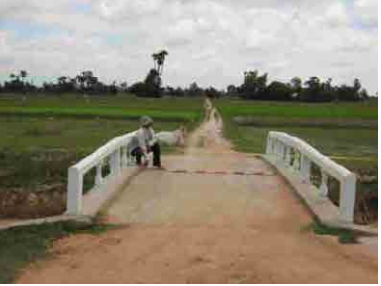
Canal No.: C20	Kind of structure(s): Bridge (Village)	Remarks: Routine survey
Station: 7.00+720	Coordinate< <div style="display: flex; flex-direction: column; margin-left: 10px;"> <span>Northing: 1220045</span> <span>Easting: 0461839</span> </div>	
<div style="display: flex; justify-content: space-around; align-items: center;">

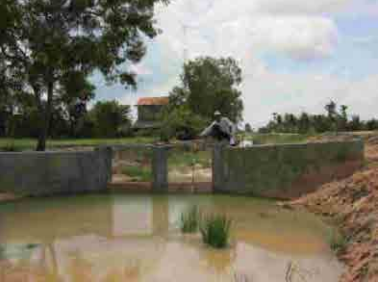
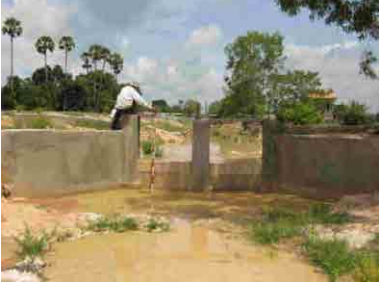
Up Stream View		Down Stream View

Canal No.: C20	Kind of structure(s): Water Blockade	Remarks: Routine survey Length: 8000m End point of Canal 20
Station: 7.00+930(EP)	Coordinate< Northing: 1220040 Easting: 0462027

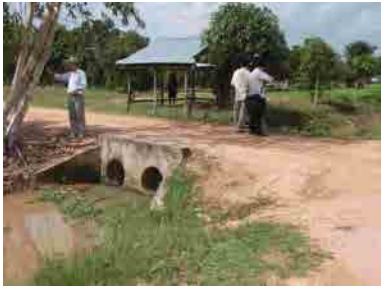
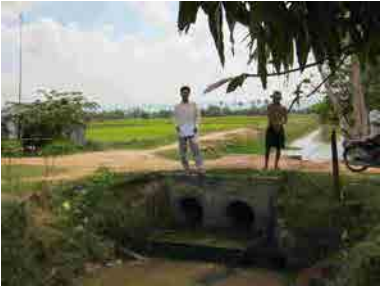
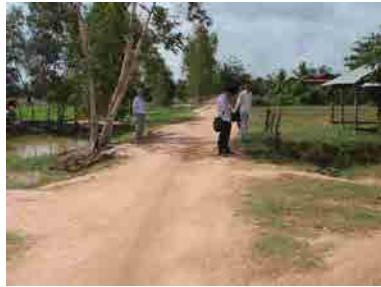
Canal No.: C20S	Kind of structure: Pipe culvert(Double)	Remarks:
Station: 0.00(B.P.)	Coordinate< <div style="display: flex; flex-direction: column; gap: 5px;"> <span>Northing: 1219045</span> <span>Easting: 460168</span> </div>	Along the village road

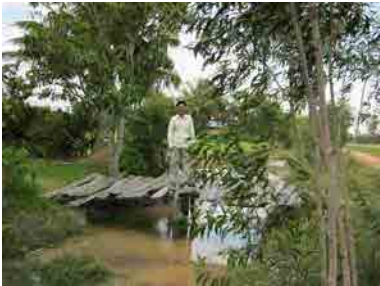
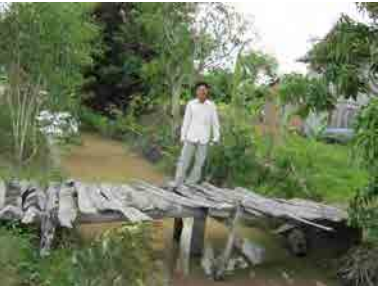
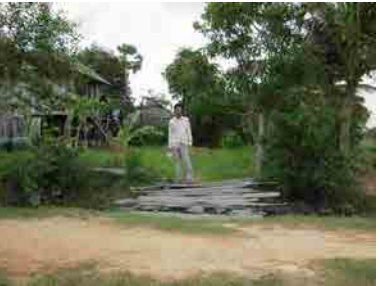
Canal No.: C20S	Kind of structure: Bridge (Private)	Remarks:
Station: 0.00+210	Coordinate< <div style="display: flex; flex-direction: column; gap: 5px;"> <span>Northing: 1219055</span> <span>Easting: 460368</span> </div>	Routine survey

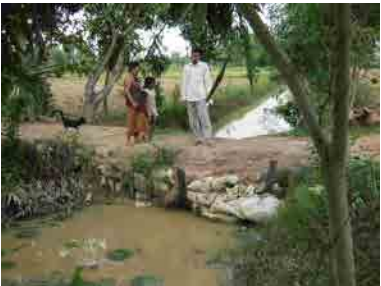
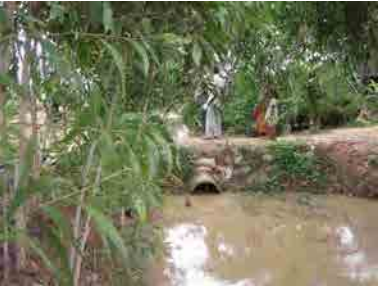
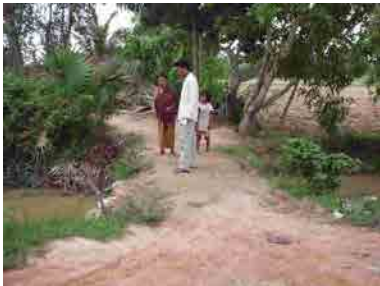
Canal No.: C20S	Kind of structure: Pipe culvert	Remarks:
Station: 0.00+310	Coordinate< <div style="display: flex; flex-direction: column; gap: 5px;"> <span>Northing: 1219057</span> <span>Easting: 460458</span> </div>	Routine survey

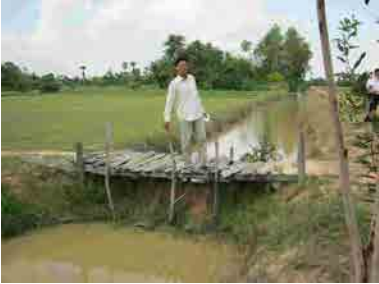
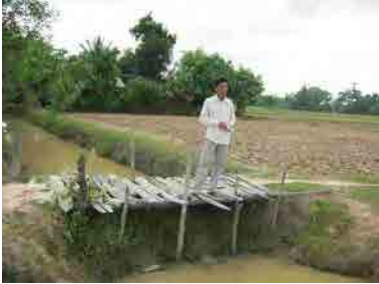
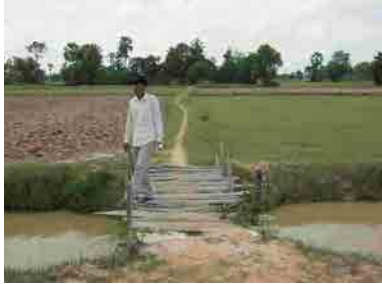
Canal No.: C20S	Kind of structure: Bridge (Private)	Remarks: There is a pipe culvert under the bridge
Station: 0.00+350	Coordinate< <div style="display: flex; flex-direction: column; gap: 5px;"> <span>Northing: 1219058</span> <span>Easting: 460502</span> </div>	
<div style="display: flex; justify-content: space-around;">

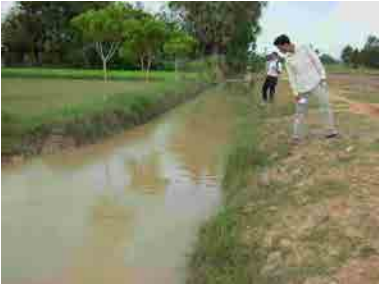
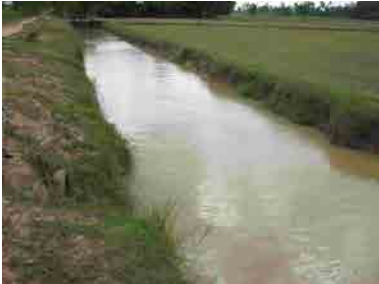
Canal No.: C20S	Kind of structure: Right Bank Culvert	Remarks: Routine survey
Station: 0.00+390	Coordinate< <div style="display: flex; flex-direction: column; gap: 5px;"> <span>Northing: 1219061</span> <span>Easting: 460554</span> </div>	
<div style="display: flex; justify-content: space-around;">

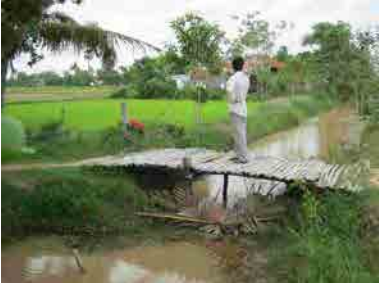
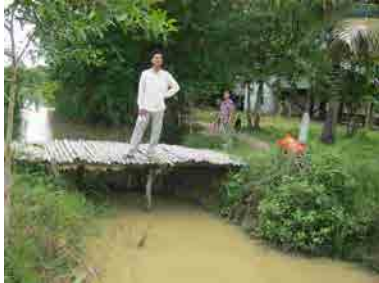
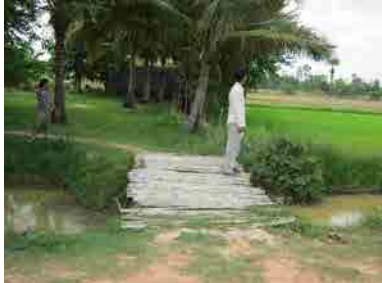
Canal No.: C20S	Kind of structure: Bridge (Private)	Remarks: Routine survey Length: 500m
Station: 0.00+500	Coordinate< <div style="display: flex; flex-direction: column; gap: 5px;"> <span>Northing: 1219066</span> <span>Easting: 460637</span> </div>	
<div style="display: flex; justify-content: space-around;">

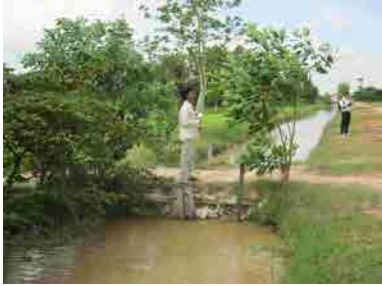
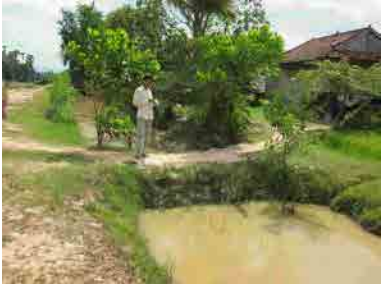
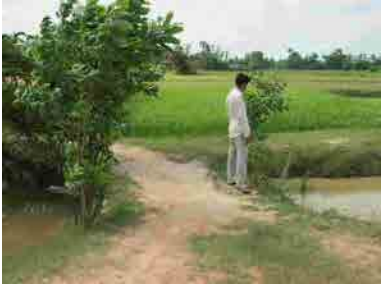
Canal No.: C20S	Kind of structure: Pipe culvert	Remarks:
Station: 0.00+550	Coordinate Northing: 1219070 Easting: 460698	Routine survey

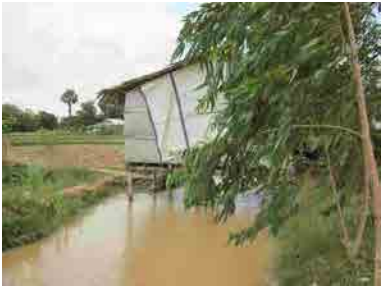
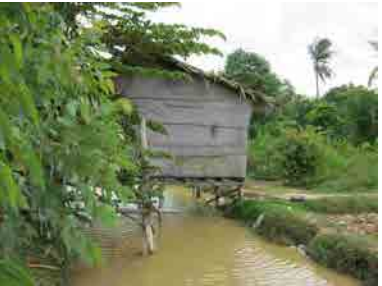
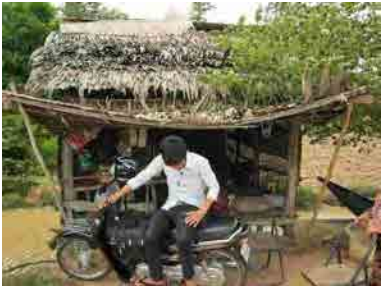
Canal No.: C20S	Kind of structure: House (Cottage)	Remarks:
Station: 0.00+700	Coordinate Northing: 1219078 Easting: 460838	Routine survey

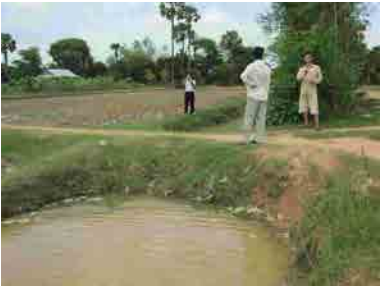
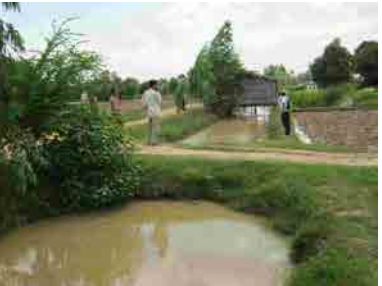
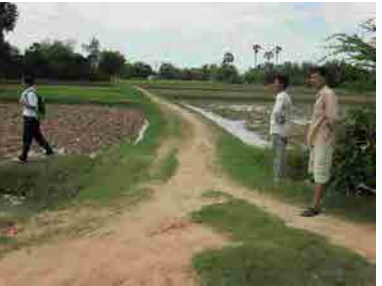
Canal No.: C20S	Kind of structure: Pipe culvert	Remarks:
Station: 0.00+740	Coordinate Northing: 1219077 Easting: 460862	Routine survey

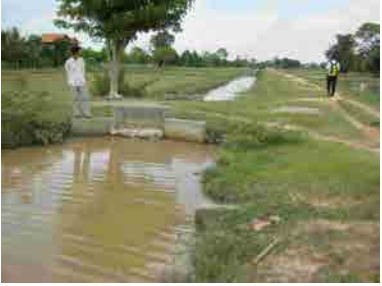
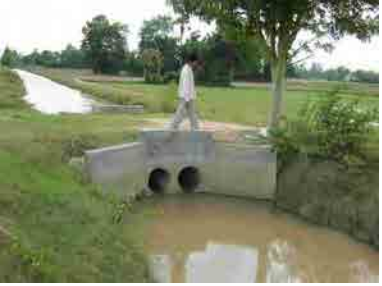
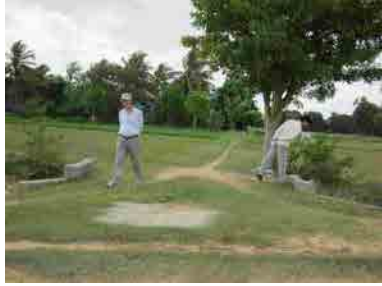
Canal No.: C20S	Kind of structure: Pipe culvert (Double)	Remarks:
Station: 0.00+950	Coordinate Northing: 1219089 Easting: 461061	Routine survey

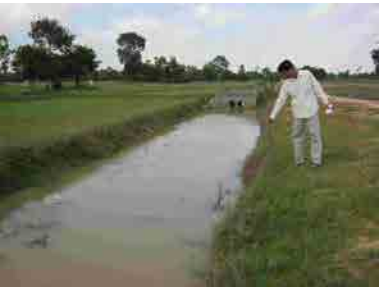
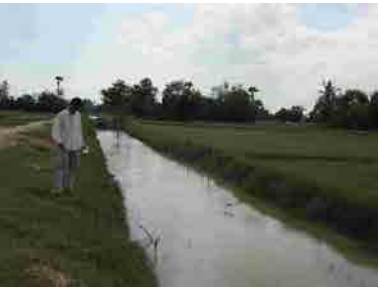
Canal No.: C20S	Kind of structure: Canal	Remarks:
Station: 1.00	Coordinate Northing: 1219091 Easting: 461125	Routine survey Length: 1000m

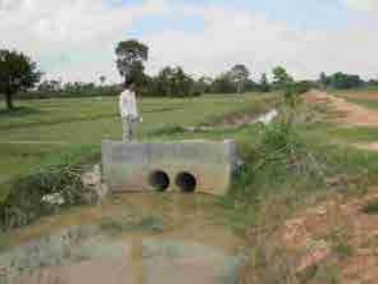
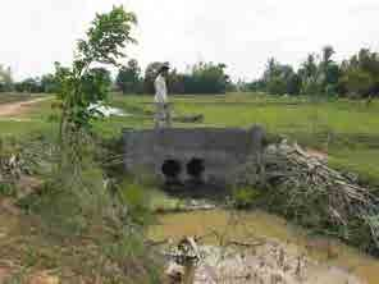
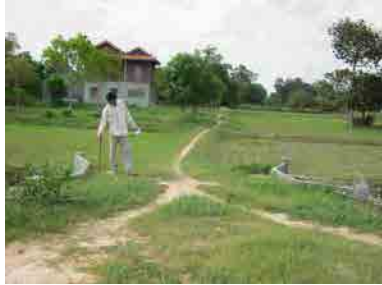
Canal No.: C20S	Kind of structure: Pipe culvert (Double)	Remarks:
Station: 1.00+20	Coordinate Northing: 1219094 Easting: 461150	Routine survey

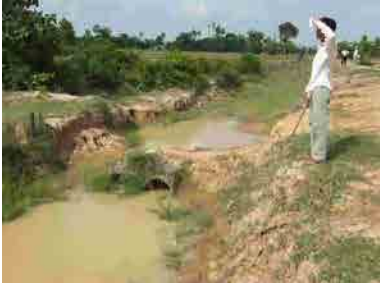
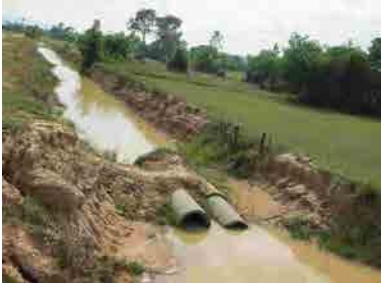
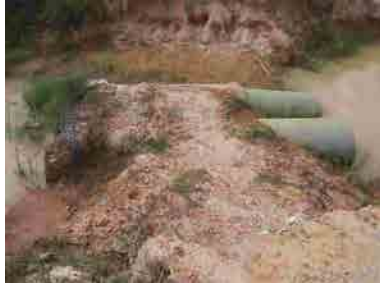
Canal No.: C20S	Kind of structure: Pipe culvert (Double)	Remarks:
Station: 1.00+280	Coordinate< <div style="display: flex; justify-content: space-between; padding: 0 5px;"> <span>Northing: 1219106</span> <span>Easting: 461405</span> </div>	Routine survey
<div style="display: flex; justify-content: space-around;">

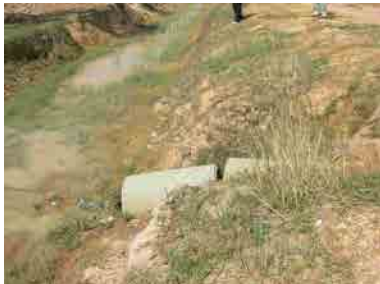
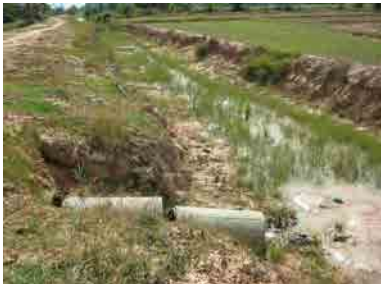
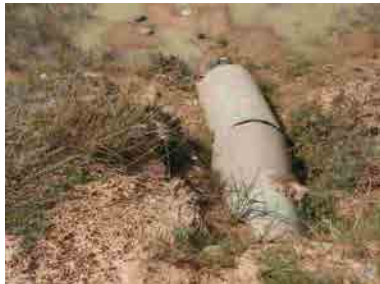
Canal No.: C20S	Kind of structure: Pipe culvert	Remarks:
Station: 1.00+380	Coordinate< <div style="display: flex; justify-content: space-between; padding: 0 5px;"> <span>Northing: 1219111</span> <span>Easting: 461509</span> </div>	Routine survey
<div style="display: flex; justify-content: space-around;">

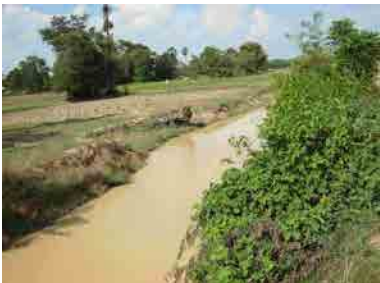
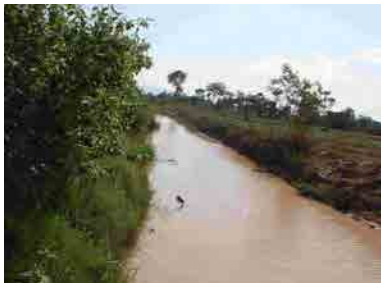
Canal No.: C20S	Kind of structure: Canal	Remarks:
Station: 1.00+500	Coordinate< <div style="display: flex; justify-content: space-between; padding: 0 5px;"> <span>Northing: 1219117</span> <span>Easting: 461625</span> </div>	Routine survey Length: 1500m
<div style="display: flex; justify-content: space-around;">

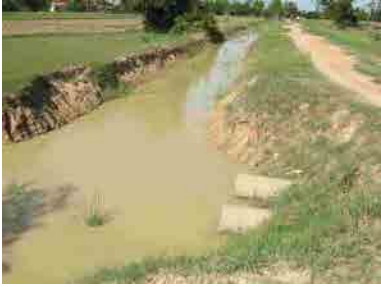
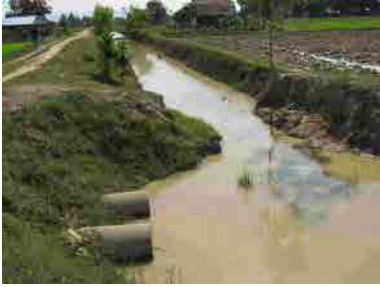
Canal No.: C20S	Kind of structure: Canal	Remarks:
Station: 1.00+890(EP)	Coordinate< Northing: 1219138 Easting: 462012	Routine survey

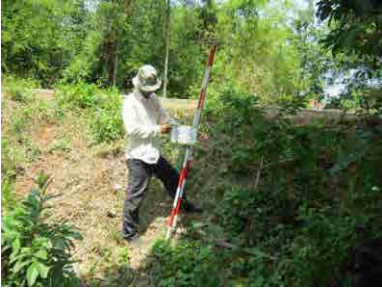
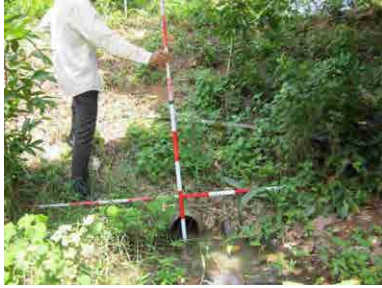
Canal No.: C21	Kind of structure: Pipe culvert	Remarks:  - Cross the national road N° 2
Station: 0.00(B.P.)	Coordinate< <div style="display: flex; flex-direction: column; gap: 5px;"> <span>Northing: 1220976</span> <span>Easting: 0453448</span> </div>	
<div style="display: flex; justify-content: space-around; align-items: center;"> <div style="text-align: center;">

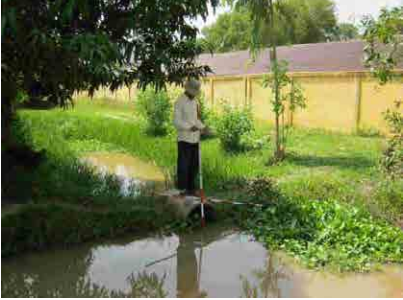
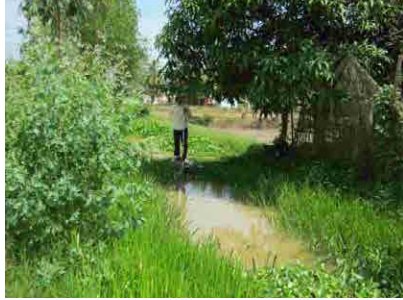
Canal No.: C21	Kind of structure: Pipe culvert	Remarks:  Routine survey
Station: 0.00+200	Coordinate< <div style="display: flex; flex-direction: column; gap: 5px;"> <span>Northing: 1221006</span> <span>Easting: 0453578</span> </div>	
<div style="display: flex; justify-content: space-around; align-items: center;"> <div style="text-align: center;">

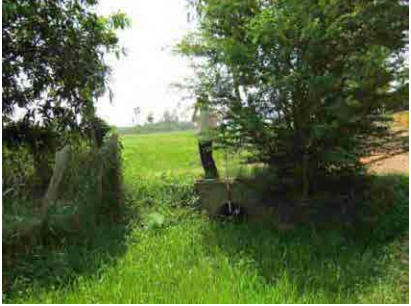
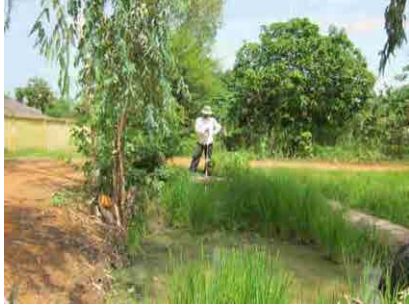
Canal No.: C21	Kind of structure: Pipe culvert	Remarks:  Under commune road
Station: 0.00+220	Coordinate< <div style="display: flex; flex-direction: column; gap: 5px;"> <span>Northing: 1221002</span> <span>Easting: 0453609</span> </div>	
<div style="display: flex; justify-content: space-around; align-items: center;"> <div style="text-align: center;">

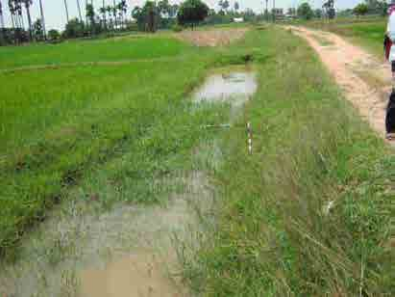
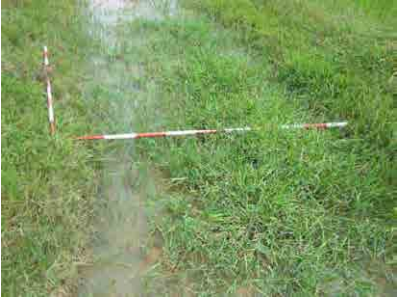
Canal No.: C21	Kind of structure: Canal	Remarks: Routine survey Length: 500m
Station: 0.00+500	Coordinate< Northing: 1221001 Easting: 0453889	
<div style="display: flex; justify-content: space-around;"> <div style="text-align: center;">

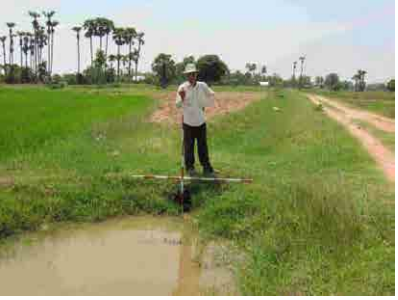
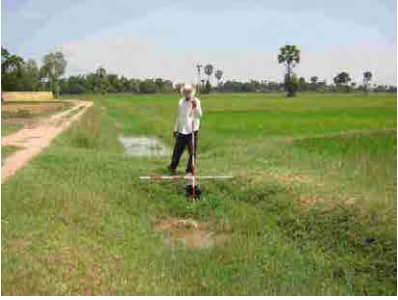
Canal No.: C21	Kind of structure: Pipe culvert	Remarks: Routine survey
Station: 0.00+510	Coordinate< Northing: 1220997 Easting: 0453903	
<div style="display: flex; justify-content: space-around;"> <div style="text-align: center;">

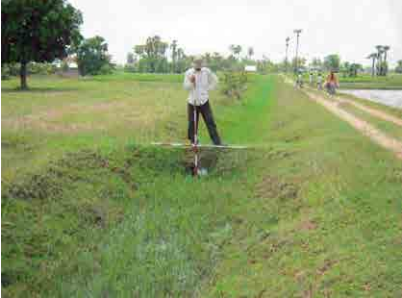
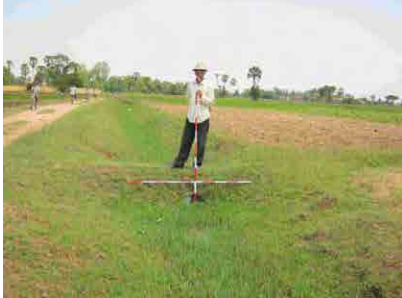
Canal No.: C21	Kind of structure: Pipe culvert	Remarks: Routine survey
Station: 0.00+570	Coordinate< Northing: 1220983 Easting: 0453969	
<div style="display: flex; justify-content: space-around;"> <div style="text-align: center;">

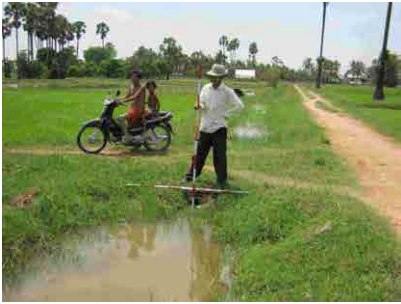
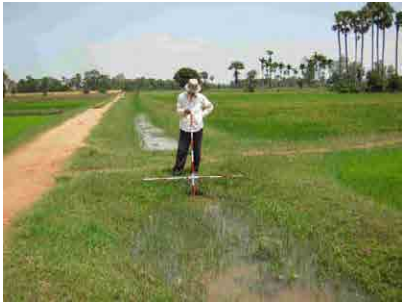
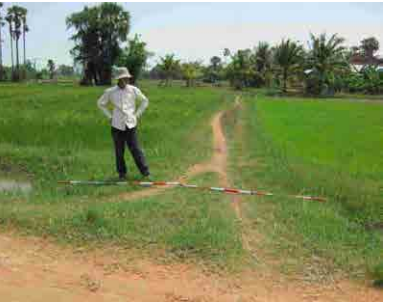
Canal No.: C21	Kind of structure: Pipe culvert	Remarks:
Station: 0.00+710	Coordinate< Northing: 1220957 Easting: 0454106	Routine survey

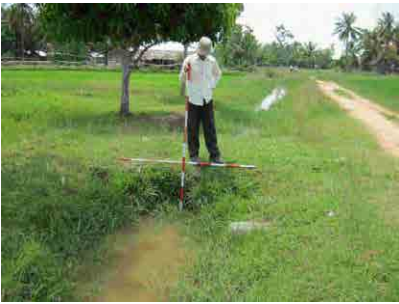
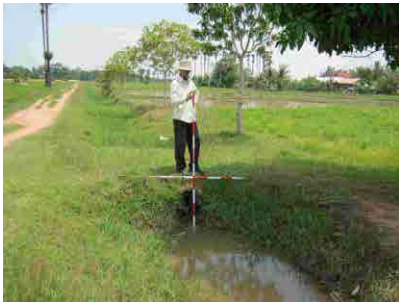
Canal No.: C21	Kind of structure: Pipe culvert	Remarks:
Station: 0.00+830	Coordinate< Northing: 1220938 Easting: 0454222	Routine survey

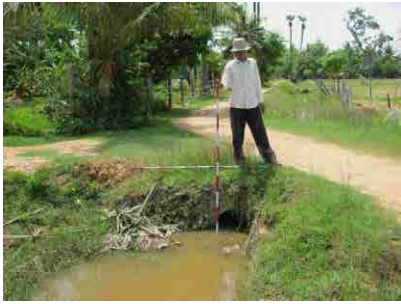
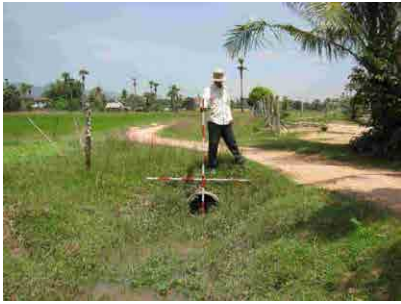
Canal No.: C21	Kind of structure: Pipe culvert	Remarks:
Station: 0.00+900	Coordinate< Northing: 1220930 Easting: 0454288	Routine survey

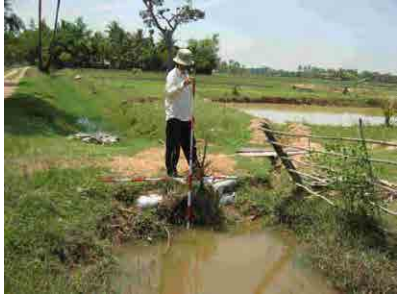
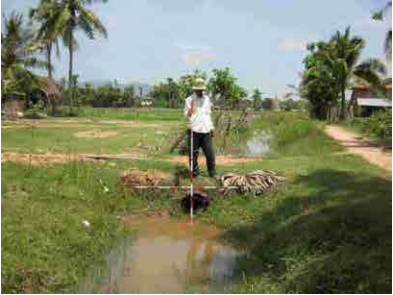
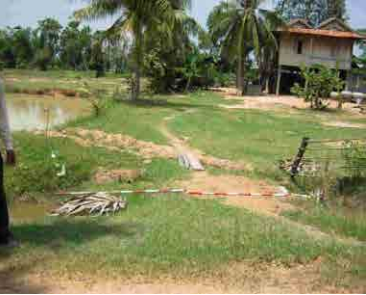
Canal No.: C21	Kind of structure: Pipe culvert	Remarks:  Under house entrance road
Station: 0.00+940	Coordinate< <div style="display: flex; flex-direction: column; gap: 5px;"> <span>Northing: 1220930</span> <span>Easting: 0454335</span> </div>	
<div style="display: flex; justify-content: space-around;">

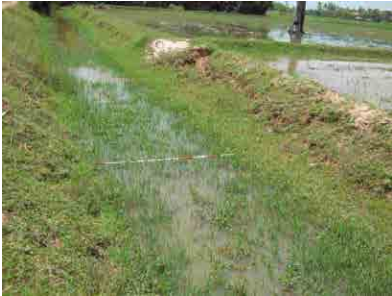
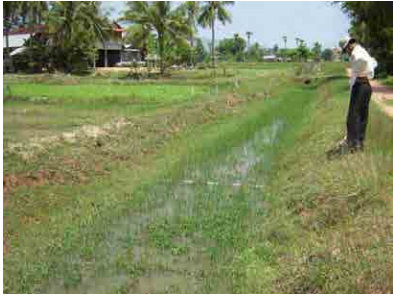
Canal No.: C21	Kind of structure: Canal	Remarks: Routine survey Length: 1000m
Station: 0.00+970	Coordinate< <div style="display: flex; flex-direction: column; gap: 5px;"> <span>Northing: 1220933</span> <span>Easting: 0454363</span> </div>	
<div style="display: flex; justify-content: space-around;">

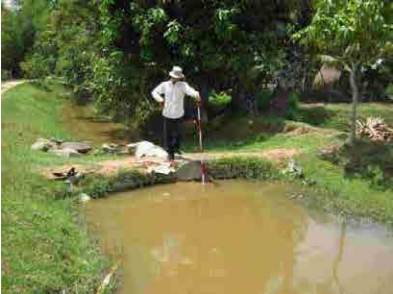
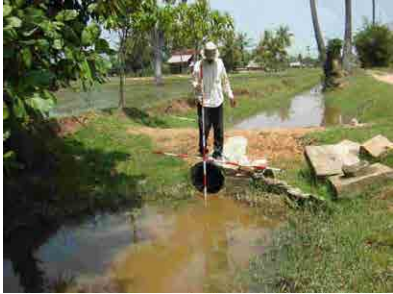
Canal No.: C21	Kind of structure: Pipe culvert	Remarks:  Routine survey
Station: 1.00+30	Coordinate< <div style="display: flex; flex-direction: column; gap: 5px;"> <span>Northing: 1220932</span> <span>Easting: 0454423</span> </div>	
<div style="display: flex; justify-content: space-around;">

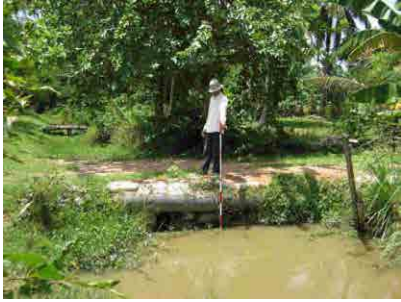
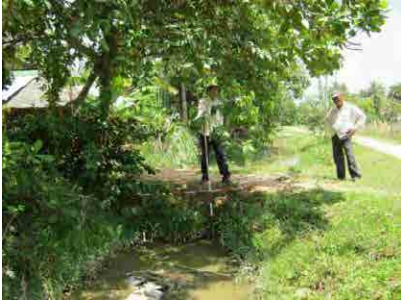
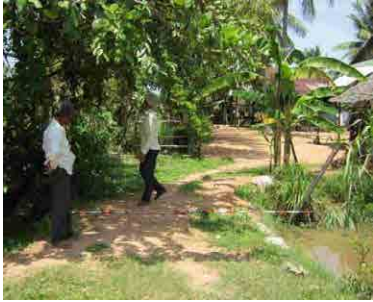
Canal No.: C21	Kind of structure: Pipe culvert	Remarks: Routine survey Under house entrance road
Station: 1.00+80	Coordinate< Northing: 1220929 Easting: 0454470

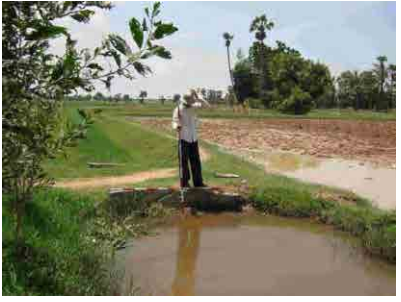
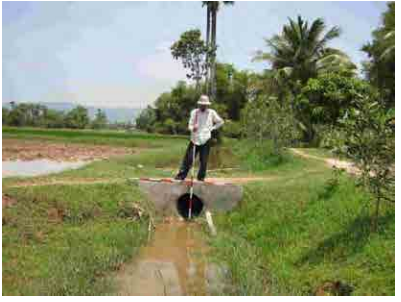
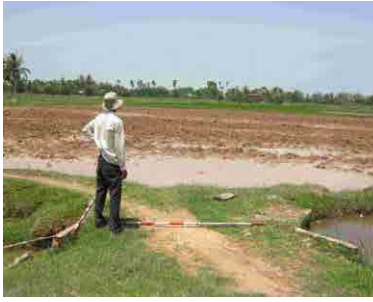
Canal No.: C21	Kind of structure: Pipe culvert	Remarks: Routine survey Under small carte road
Station: 1.00+80	Coordinate< Northing: 1220938 Easting: 0454654

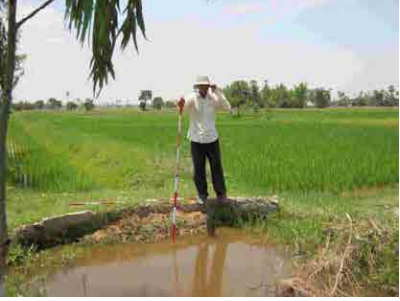
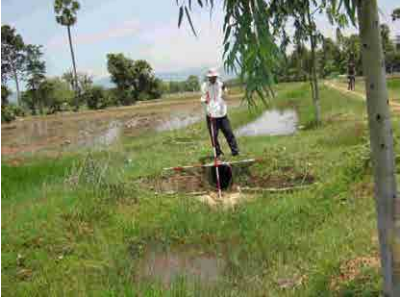
Canal No.: C21	Kind of structure: Pipe culvert	Remarks: Routine survey
Station: 1.00+210	Coordinate< Northing: 1220960 Easting: 0454787

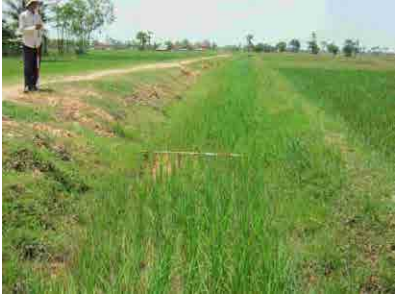
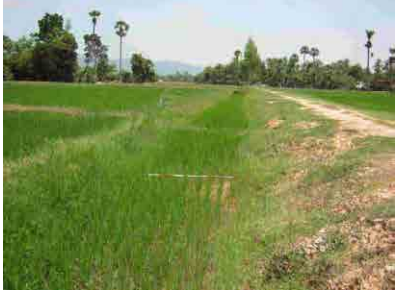
Canal No.: C21	Kind of structure: Canal	Remarks: Routine survey Length: 1500m
Station: 1.00+280	Coordinate< Northing: 1220971 Easting: 0454851	
<div style="display: flex; justify-content: space-around;">

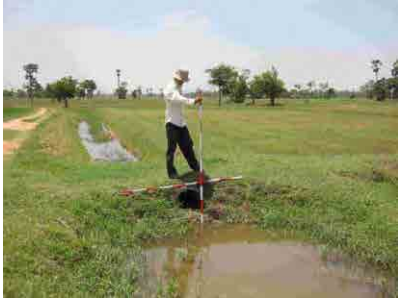
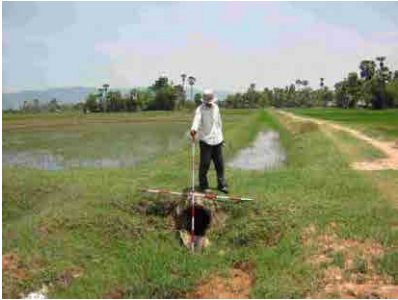
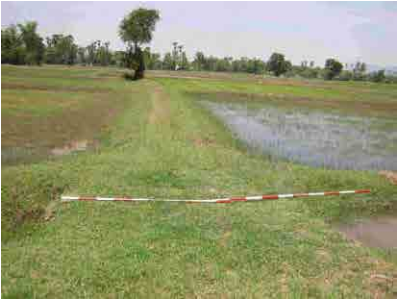
Canal No.: C21	Kind of structure: Pipe culvert	Remarks: Routine survey Under a hill
Station: 1.00+400	Coordinate< Northing: 1220978 Easting: 0454969	
<div style="display: flex; justify-content: space-around;">

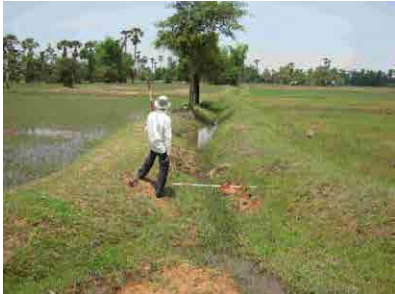
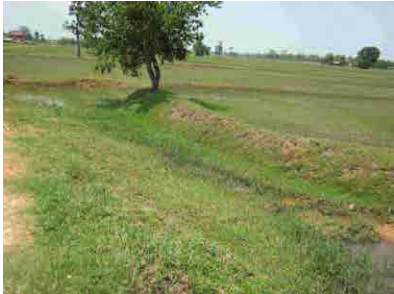
Canal No.: C21	Kind of structure: Canal	Remarks: Routine survey
Station: 1.00+450	Coordinate< Northing: 1220983 Easting: 0455016	
<div style="display: flex; justify-content: space-around;">

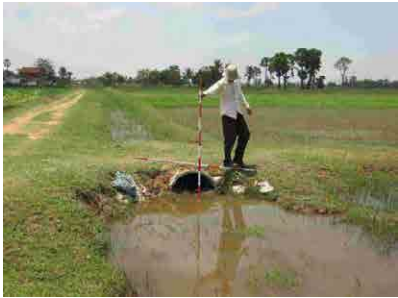
Canal No.: C21	Kind of structure: Pipe culvert	Remarks: Routine survey
Station: 1.00+610	Coordinate< Northing: 1221019 Easting: 0455163	
<div style="display: flex; justify-content: space-around; align-items: center;"> <div style="text-align: center;">

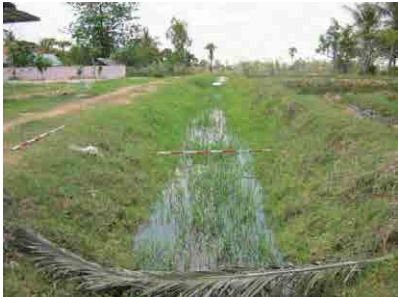
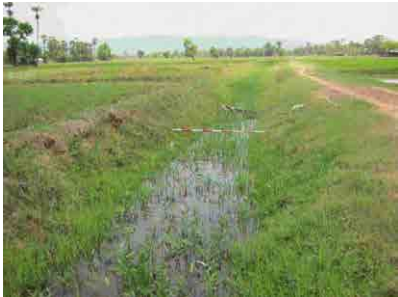
Canal No.: C21	Kind of structure: Canal	Remarks: Routine survey Length: 2000m
Station: 1.00+780	Coordinate< Northing: 1221053 Easting: 0455330	
<div style="display: flex; justify-content: space-around; align-items: center;"> <div style="text-align: center;">

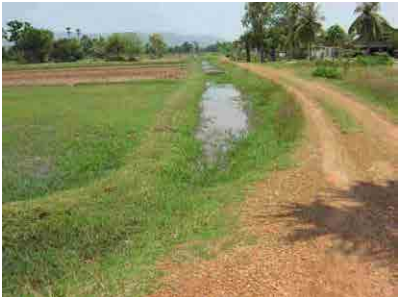
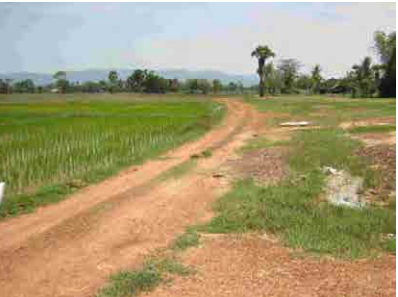
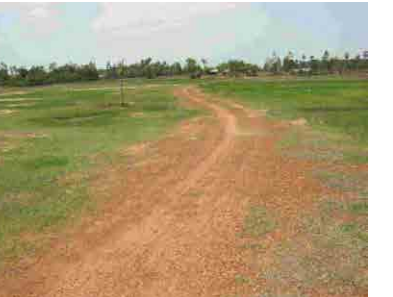
Canal No.: C21	Kind of structure: Pipe culvert	Remarks: - Routine survey - Canal is filled by road soil
Station: 1.00+930	Coordinate< Northing: 1221080 Easting: 0455472	
<div style="display: flex; justify-content: space-around; align-items: center;"> <div style="text-align: center;">

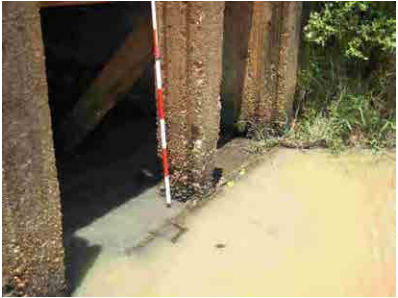
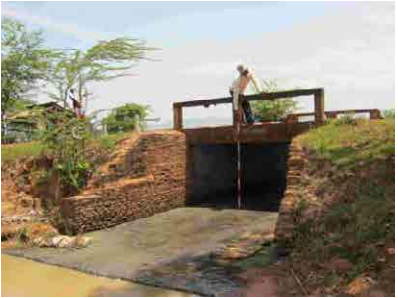
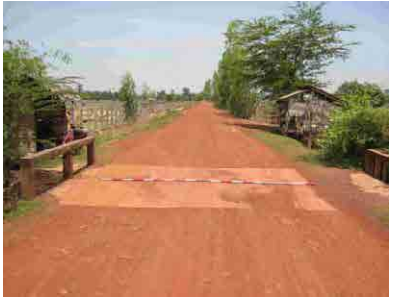
Canal No.: C21	Kind of structure: Bridge	Remarks: - Under commune road - There is a groove
Station: 2.00+280	Coordinate< Northing: 1221137 Easting: 0455718

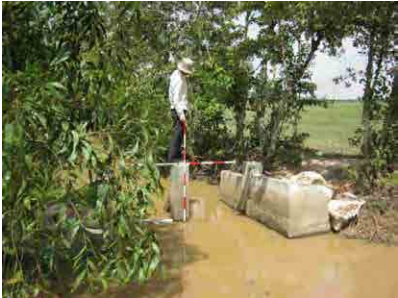
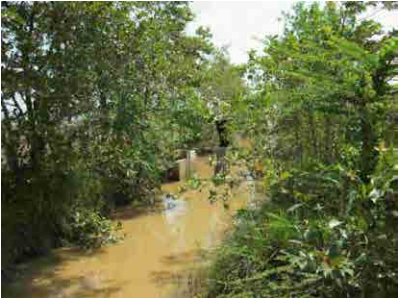
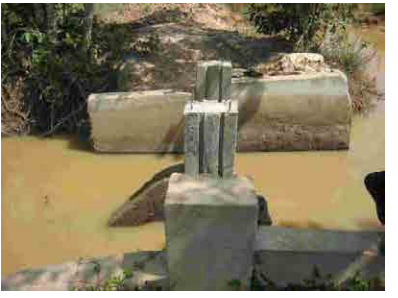
Canal No.: C21	Kind of structure: Check structure	Remarks: - Concrete column used for obstruction of water
Station: 2.00+360	Coordinate< Northing: 1221133 Easting: 0455790

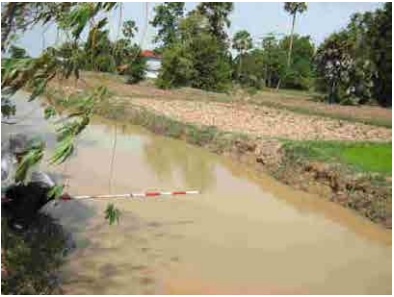
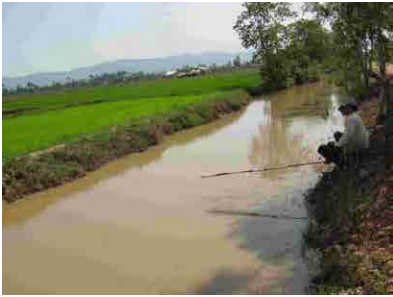
Canal No.: C21	Kind of structure: Canal	Remarks: Routine survey Length: 2500m
Station: 2.00+580	Coordinate< Northing: 1221135 Easting: 0456003

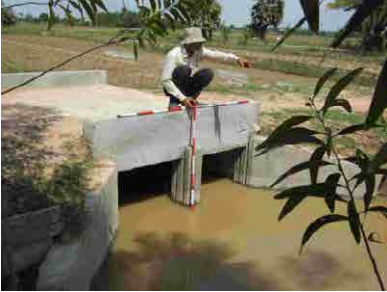
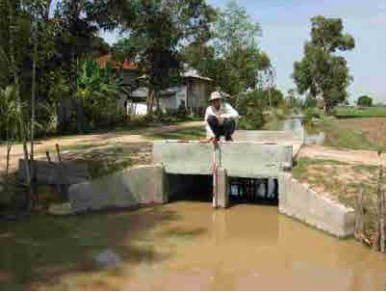
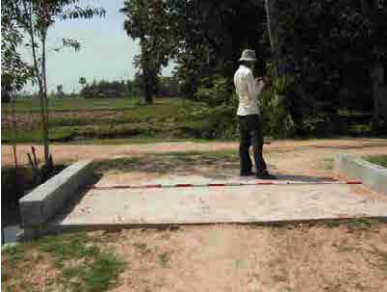
Canal No.: C21	Kind of structure: Bridge (Box culvert)	Remarks: - Under a village road - There is a groove
Station: 2.00+720	Coordinate< Northing: 1221128 Easting: 0456142

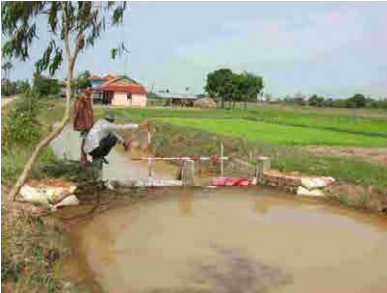
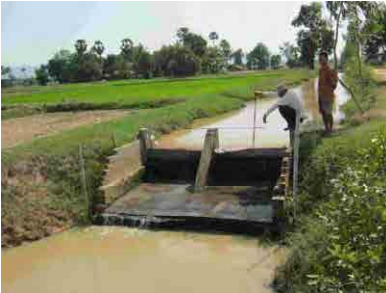
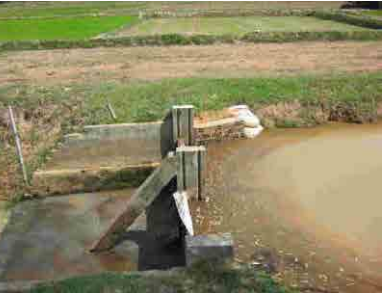
Canal No.: C21	Kind of structure: Water obstruction	Remarks: - Concrete column - Wood and plastic - There are grooves
Station: 2.00+880	Coordinate< Northing: 1221130 Easting: 0456282

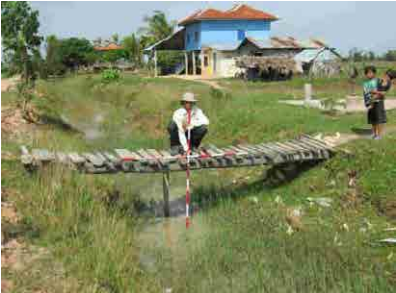
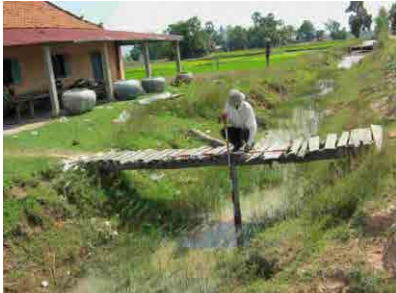
Canal No.: C21	Kind of structure: Wooden Bridge (Private)	Remarks: Routine survey
Station: 2.00+960	Coordinate< Northing: 1221130 Easting: 0456350

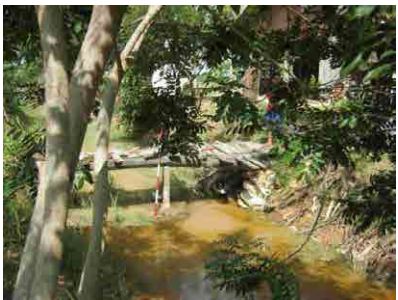
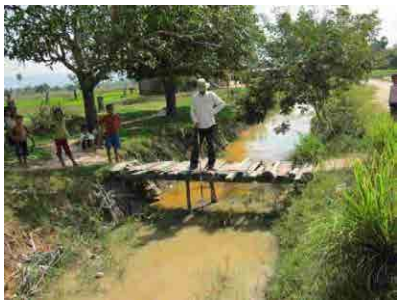
Canal No.: C21	Kind of structure: Wooden Bridge (Private)	Remarks: Routine survey Length: 3000m
Station: 3.00+60	Coordinate< Northing: 1221130 Easting: 0456444	
<div style="display: flex; justify-content: space-around; align-items: center;"> <div style="text-align: center;">

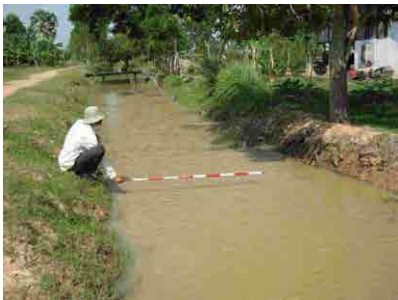
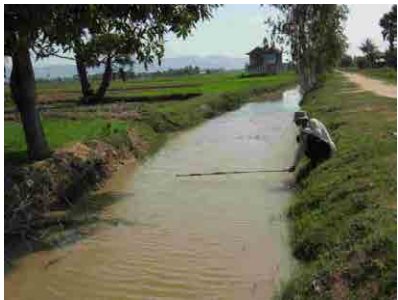
Canal No.: C21	Kind of structure: Canal	Remarks: Routine survey Length: 3500m
Station: 3.00+560	Coordinate< Northing: 1221129 Easting: 0456914	
<div style="display: flex; justify-content: space-around; align-items: center;"> <div style="text-align: center;">

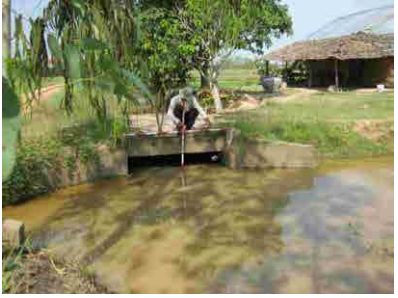
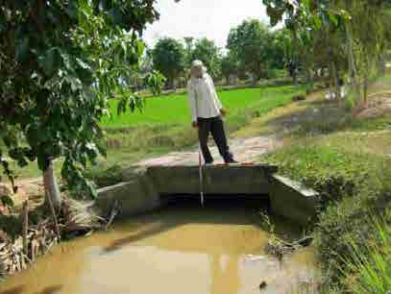
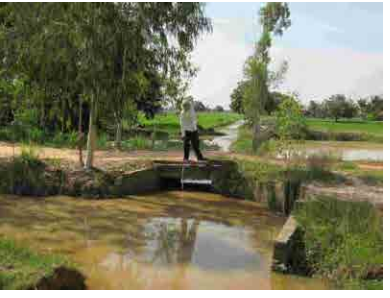
Canal No.: C21	Kind of structure: Bridge	Remarks: There is a groove which is box culvert
Station: 3.00+660	Coordinate< Northing: 1221128 Easting: 0457020	
<div style="display: flex; justify-content: space-around; align-items: center;"> <div style="text-align: center;">

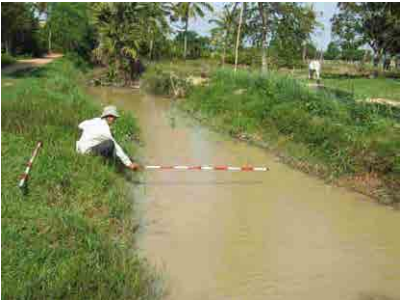
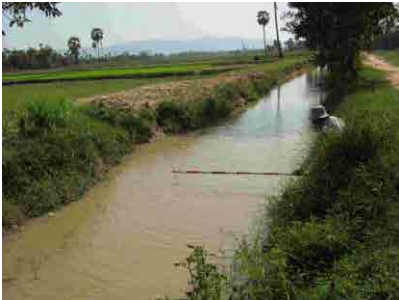
Canal No.: C21	Kind of structure: Canal	Remarks: Routine survey Length: 4000m
Station: 4.00+60	Coordinate< Northing: 1221130 Easting: 0457390
