# ***ANNEX D***

## ***Attachment – 1***

*Results of Inventory Survey for  
Proposed Rehabilitation Works in  
Roleang Chrey Headworks Rehabilitation Sub-project*

**Results of Inventory Survey for Proposed Rehabilitation Works on North Main Canal (1/12)**

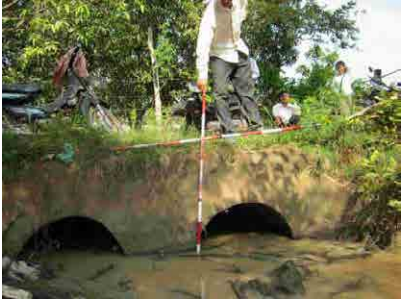
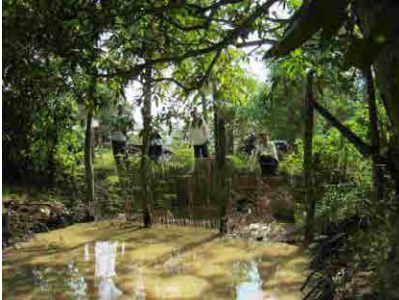
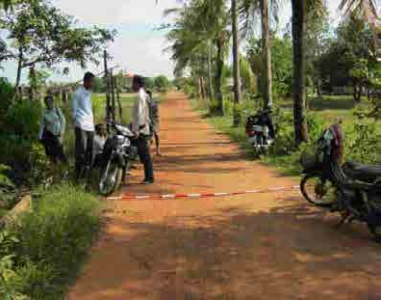
Canal No.: C21	Kind of structure: Pipe culvert (Double)	Remarks: Routine survey Under commune road
Station: 4.00+130	Coordinate< Northing: 1221124 Easting: 0457445

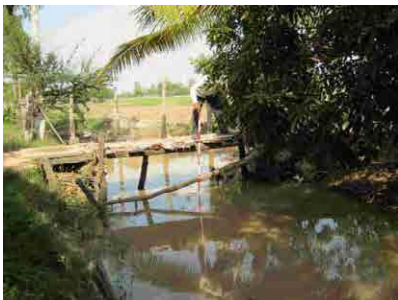
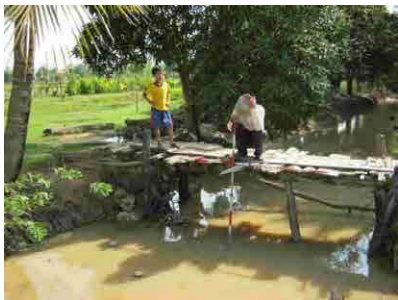
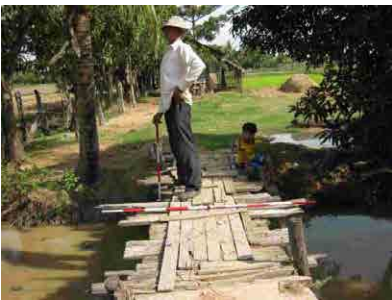
Canal No.: C21	Kind of structure: Wooden Bridge (Private)	Remarks:
Station: 4.00+210	Coordinate< Northing: 1221126 Easting: 0457519	Routine survey

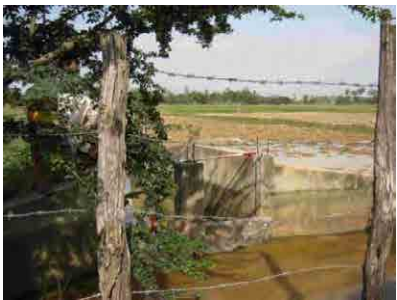
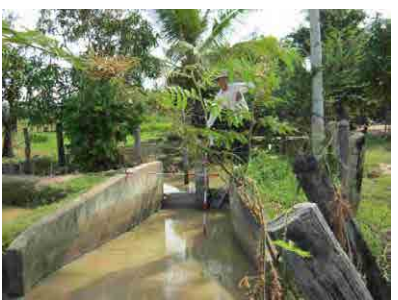
Canal No.: C21	Kind of structure: Water obstruction structure	Remarks:
Station: 4.00+220	Coordinate< Northing: 1221124 Easting: 0457526	Routine survey

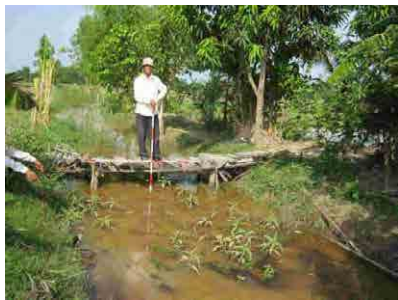
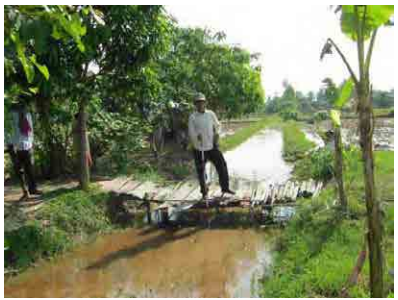
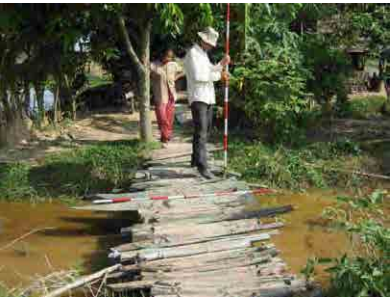
Canal No.: C21	Kind of structure: Wooden Bridge (Private)	Remarks:
Station: 4.00+390	Coordinate< Northing: 1221124 Easting: 0457704	Routine survey

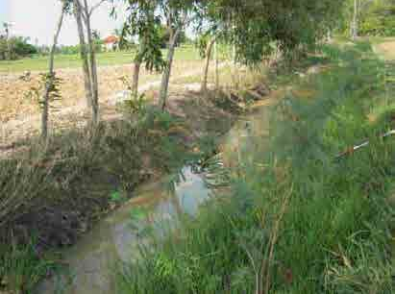
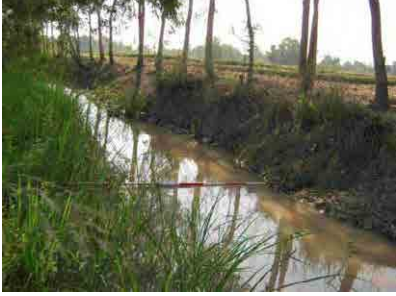
Canal No.: C21	Kind of structure: Canal	Remarks: Routine survey Length: 4500m
Station: 4.00+560	Coordinate< Northing: 1221121 Easting: 0457862	
<div style="display: flex; justify-content: space-around; align-items: center;"> <div style="text-align: center;">

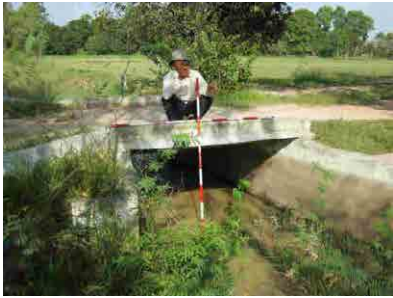
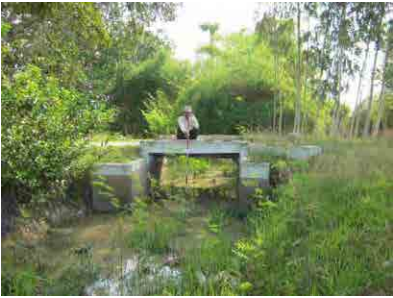
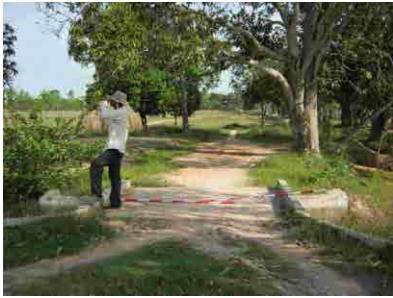
Canal No.: C21	Kind of structure: Bridge	Remarks: - Routine survey - Under a village road
Station: 4.00+770	Coordinate< Northing: 1221124 Easting: 0458044	
<div style="display: flex; justify-content: space-around; align-items: center;"> <div style="text-align: center;">

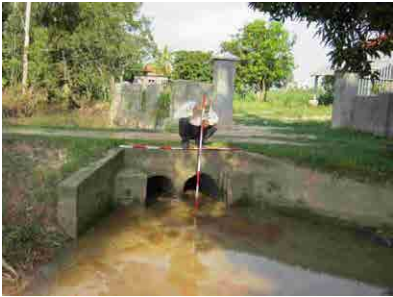
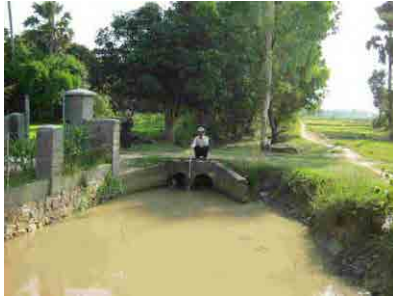
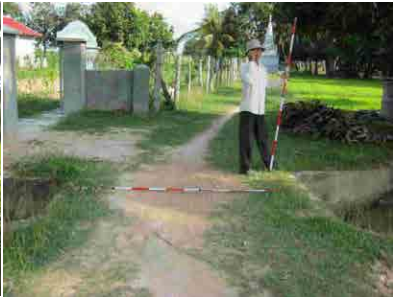
Canal No.: C21	Kind of structure: Bridge (Double culvert)	Remarks: Under house entrance road
Station: 4.00+970	Coordinate< Northing: 1221123 Easting: 0458230	
<div style="display: flex; justify-content: space-around; align-items: center;"> <div style="text-align: center;">

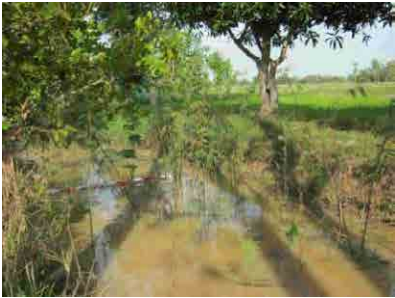
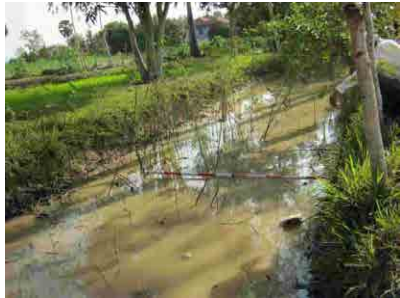
Canal No.: C21	Kind of structure: Canal	Remarks: Routine survey Length: 5000m
Station: 5.00+60	Coordinate< <div style="display: flex; flex-direction: column; margin-left: 10px;"> <span>Northing: 1221126</span> <span>Easting: 0458339</span> </div>	
<div style="display: flex; justify-content: space-around; align-items: center;"> <div style="text-align: center;">

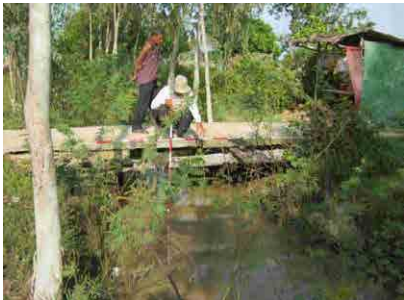
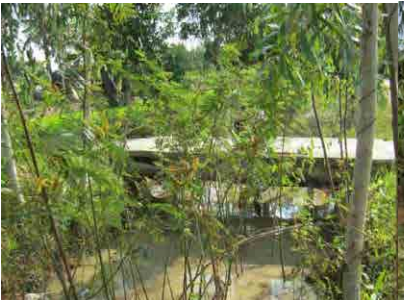
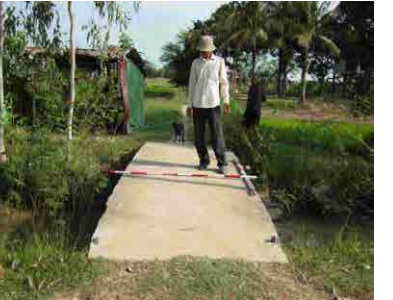
Canal No.: C21	Kind of structure: Bridge (Private)	Remarks: Routine survey
Station: 5.00+80	Coordinate< <div style="display: flex; flex-direction: column; margin-left: 10px;"> <span>Northing: 1221124</span> <span>Easting: 0458361</span> </div>	
<div style="display: flex; justify-content: space-around; align-items: center;"> <div style="text-align: center;">

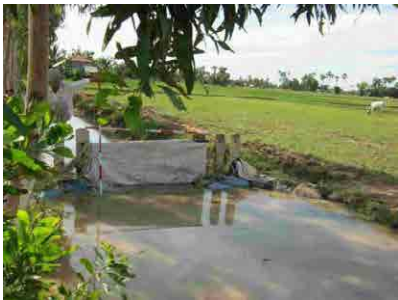
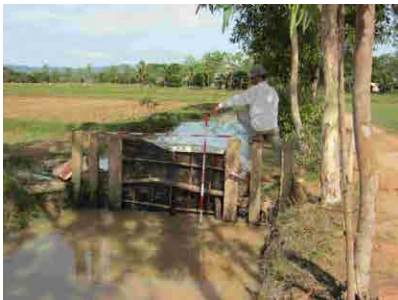
#REF!	458361	1221124	Bridge 10 (Private)	Concrete bridge of 1.8 m wide	B	b	House access
#REF!	458505	1221126	Water Blockade	Temporary Regulator with plastick sheet and planks	D	-	Tempo regulator to be replaced proper structure

Canal No.: C21	Kind of structure: Water blockade	Remarks: - Concrete column with plastic
Station: 5.00+230	Coordinate< <div style="display: flex; flex-direction: column; margin-left: 10px;"> <span>Northing: 1221126</span> <span>Easting: 0458505</span> </div>	
<div style="display: flex; justify-content: space-around; align-items: center;"> <div style="text-align: center;">

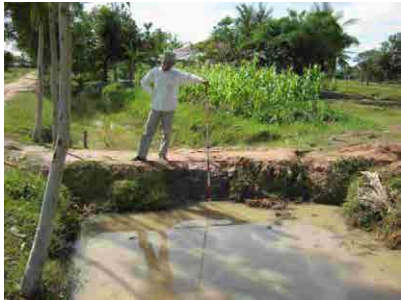
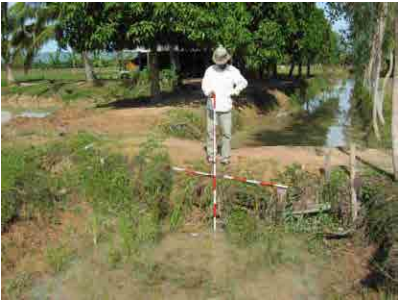
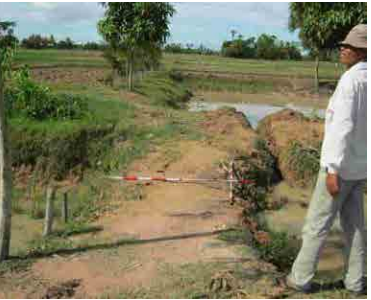
Canal No.: C21	Kind of structure: Embankment	Remarks:
Station: 5.00+380	Coordinate< <div style="display: flex; flex-direction: column; align-items: flex-start;"> <span>Northing: 1221126</span> <span>Easting: 0458642</span> </div>	- Embankment is soil

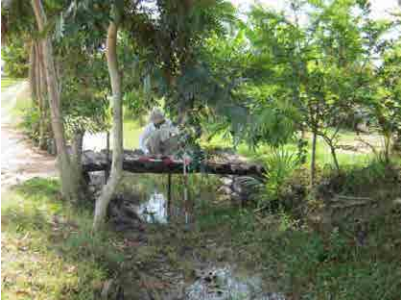
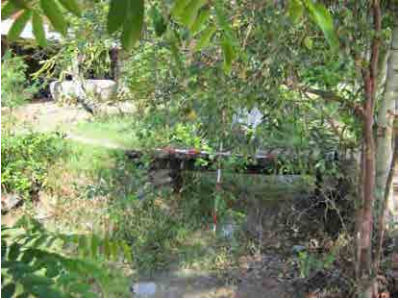
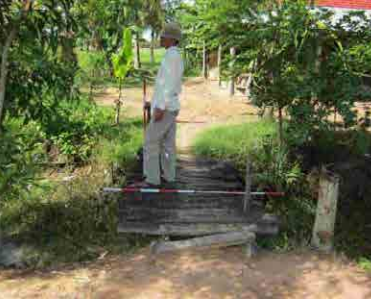
Canal No.: C21	Kind of structure: Wooden Bridge (Private)	Remarks:
Station: 5.00+420	Coordinate< <div style="display: flex; flex-direction: column; align-items: flex-start;"> <span>Northing: 1221124</span> <span>Easting: 0458682</span> </div>	Routine survey

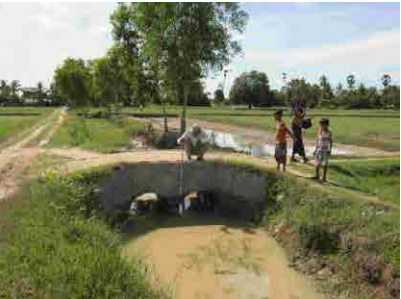
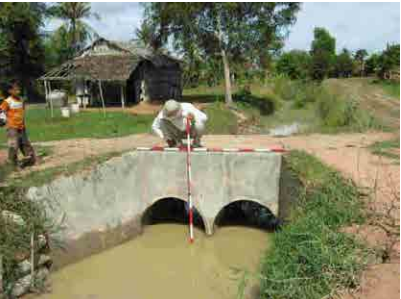
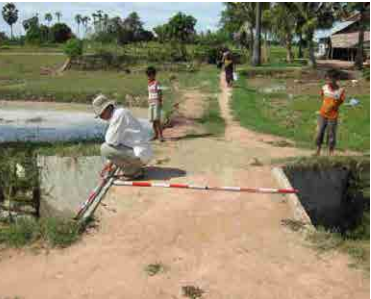
Canal No.: C21	Kind of structure: Pipe culvert (Double)	Remarks:
Station: 5.00+500	Coordinate< <div style="display: flex; flex-direction: column; align-items: flex-start;"> <span>Northing: 1221124</span> <span>Easting: 0458771</span> </div>	<ul style="list-style-type: none"> <li>- Routine survey</li> <li>- Under a village road</li> </ul>

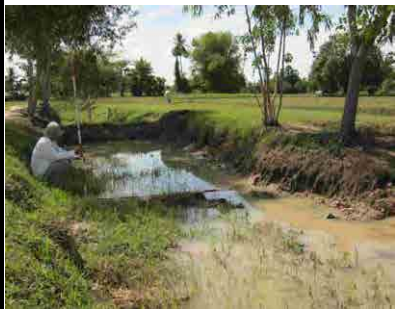
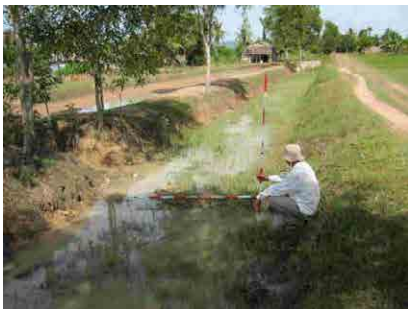
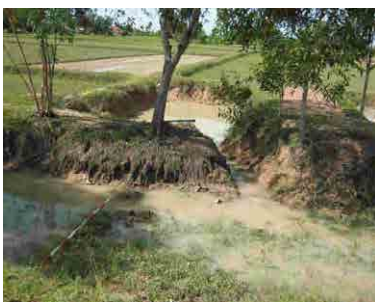
Canal No.: C21	Kind of structure: Canal	Remarks: - A groove takes water to fields - Length: 5500m
Station: 5.00+560	Coordinate< Northing: 1221127 Easting: 0458821

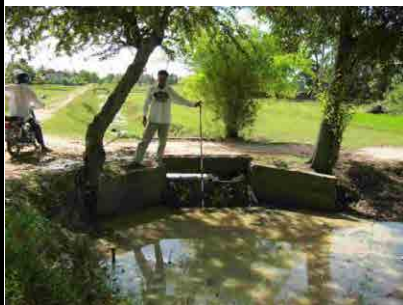
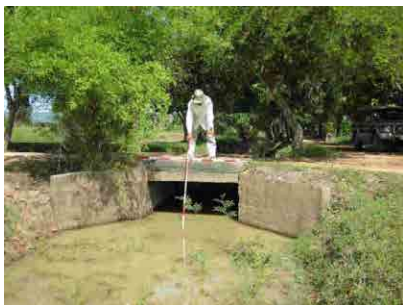
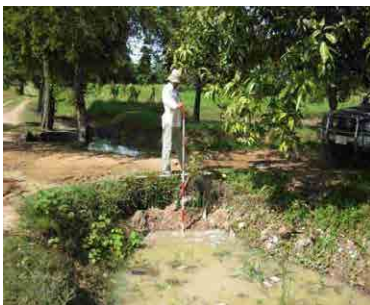
Canal No.: C21	Kind of structure: Bridge	Remarks: - Under a village road - There is a groove
Station: 5.00+780	Coordinate< Northing: 1221124 Easting: 0459034

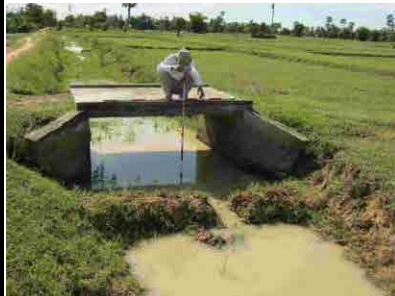
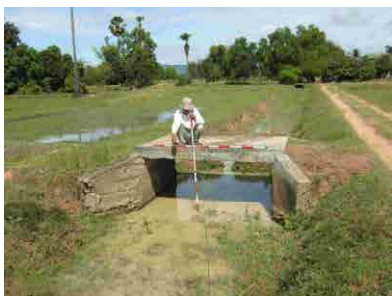
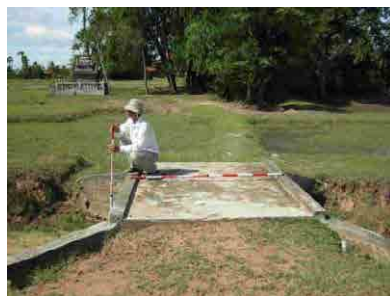
Canal No.: C21	Kind of structure: Bridge (Private)	Remarks:  Under a carte road
Station: 5.00+870	Coordinate< Northing: 1221125 Easting: 0459119

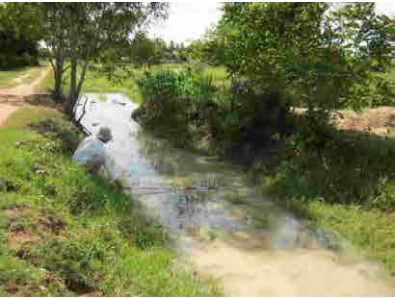
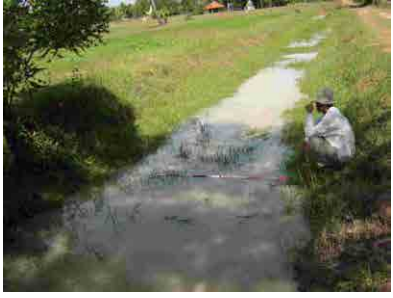
Canal No.: C21	Kind of structure: Canal	Remarks: Routine survey Length: 6000m
Station: 6.00+60	Coordinate< Northing: 1221127 Easting: 0459304

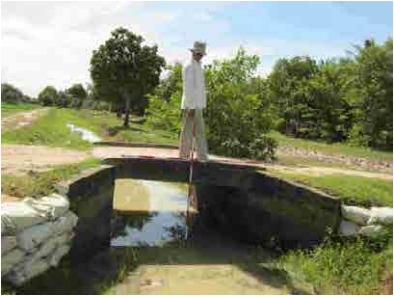
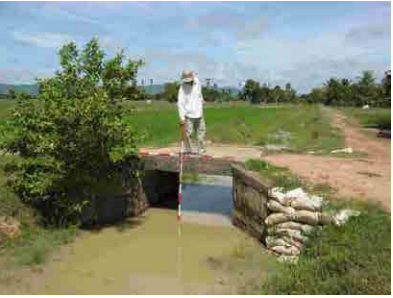
Canal No.: C21	Kind of structure: Bridge (Private)	Remarks: Routine survey
Station: 6.00+280	Coordinate< Northing: 1221124 Easting: 0459521

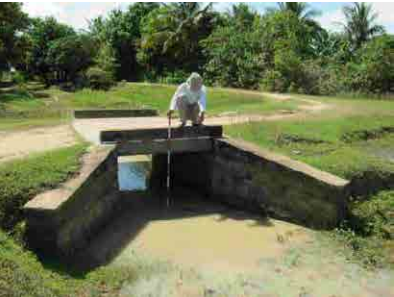
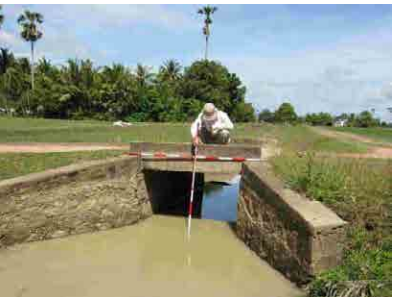
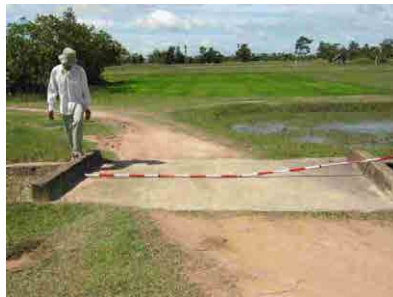
Canal No.: C21	Kind of structure: Bridge (Brasac Organization)	Remarks: Under a village road
Station: 6.00+490	Coordinate< Northing: 1221123 Easting: 0459733

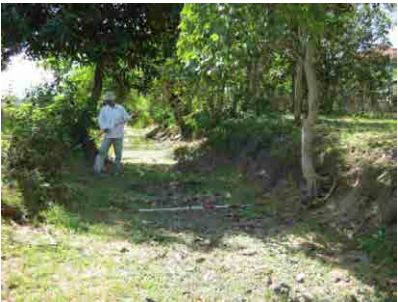
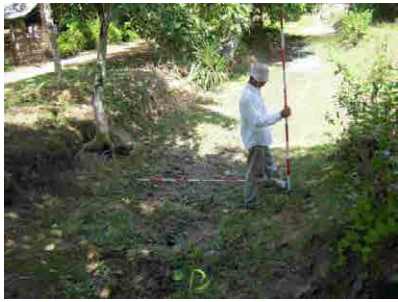
Canal No.: C21	Kind of structure: Canal	Remarks: Routine survey Length: 6500m
Station: 6.00+560	Coordinate< <div style="display: flex; flex-direction: column; gap: 5px;"> <span>Northing: 1221126</span> <span>Easting: 0459809</span> </div>	
<div style="display: flex; justify-content: space-around; align-items: center;"> <div style="text-align: center;">

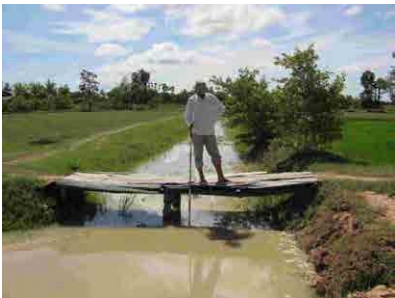
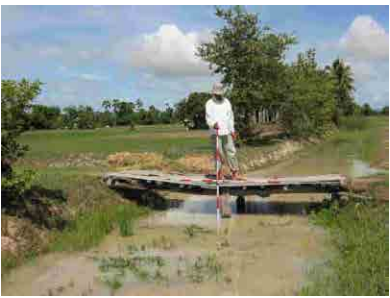
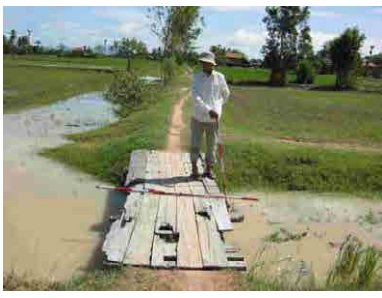
Canal No.: C21	Kind of structure: Wooden Bridge (Private)	Remarks: - Routine survey - There is a secondary canal
Station: 6.00+970	Coordinate< <div style="display: flex; flex-direction: column; gap: 5px;"> <span>Northing: 1221116</span> <span>Easting: 0460214</span> </div>	
<div style="display: flex; justify-content: space-around; align-items: center;"> <div style="text-align: center;">

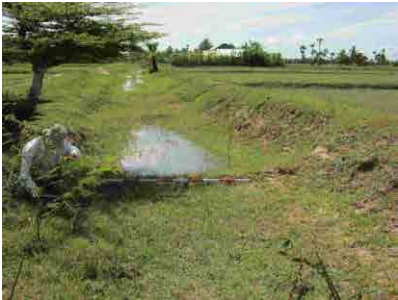
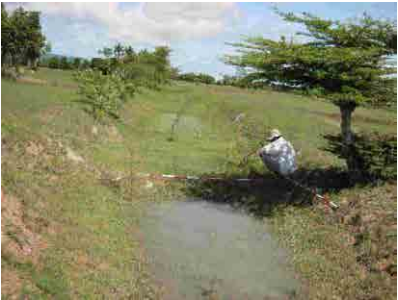
Canal No.: C21	Kind of structure: Canal	Remarks: Routine survey Length: 7000m
Station: 7.00+70	Coordinate< <div style="display: flex; flex-direction: column; gap: 5px;"> <span>Northing: 1221121</span> <span>Easting: 0460308</span> </div>	
<div style="display: flex; justify-content: space-around; align-items: center;"> <div style="text-align: center;">

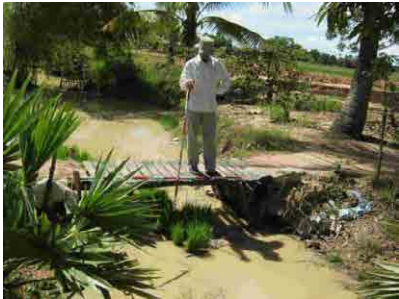
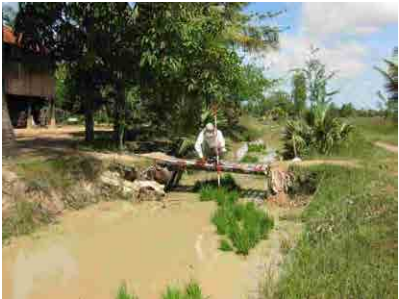
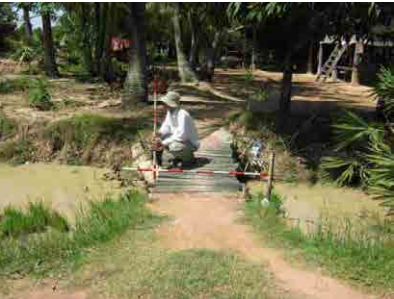
Canal No.: C21	Kind of structure: Wooden Bridge (Private)	Remarks:
Station: 7.00+530	Coordinate< Northing: 1221120 Easting: 0460746	Under house entrance road

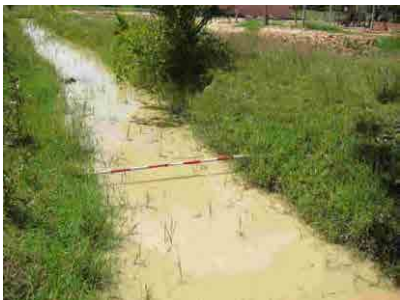
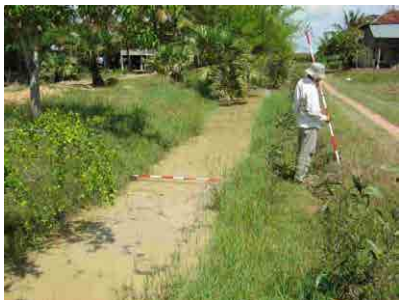
Canal No.: C21	Kind of structure: Canal	Remarks:
Station: 7.00+570	Coordinate< Northing: 1221119 Easting: 0460790	Routine survey Length: 7500m

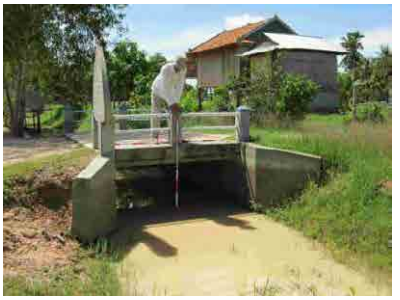
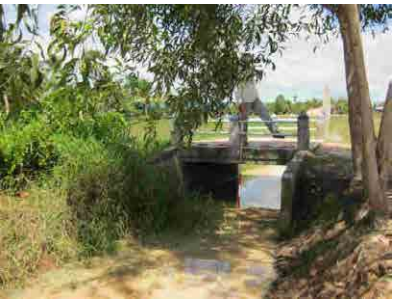
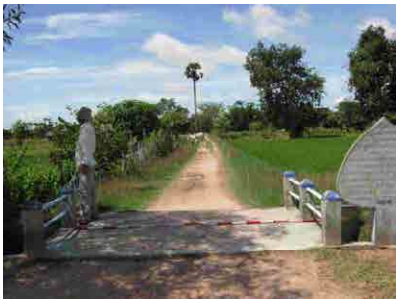
Canal No.: C21	Kind of structure: Bridge (Commune)	Remarks:
Station: 7.00+810	Coordinate< Northing: 1221115 Easting: 0461020	Under a village road

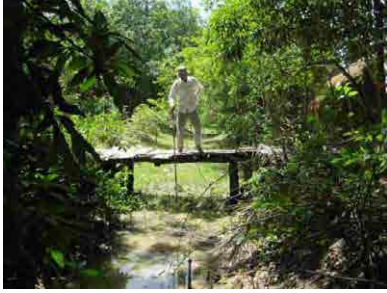
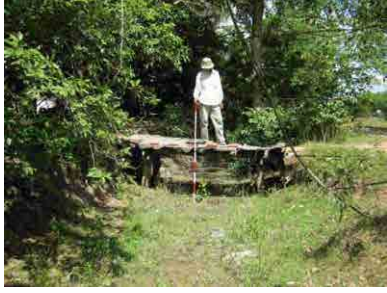
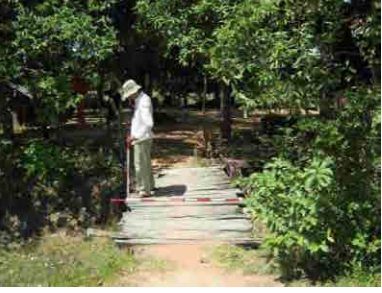
Canal No.: C21	Kind of structure: Wooden Bridge (Private)	Remarks:
Station: 7.00+950	Coordinate< Northing: 1221117 Easting: 0461166	Under house entrance road

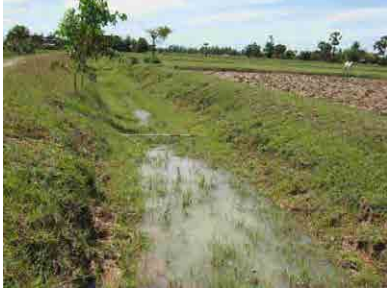
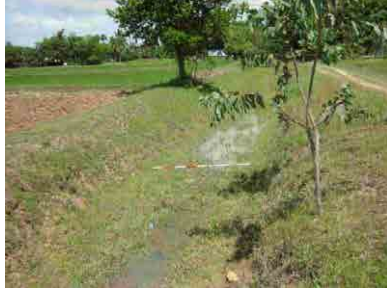
Canal No.: C21	Kind of structure: Canal	Remarks:
Station: 8.00+70	Coordinate< Northing: 1221114 Easting: 0461284	Routine survey Length: 8000m

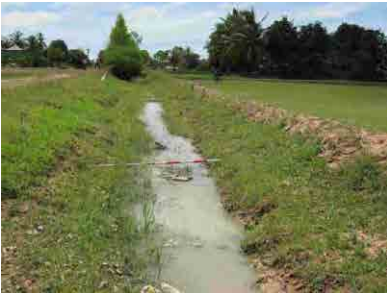
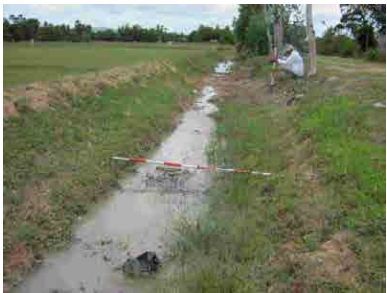
Canal No.: C21	Kind of structure: Canal	Remarks:
Station: 8+280(E.P)	Coordinate< Northing: 1221112 Easting: 0461500	Routine survey

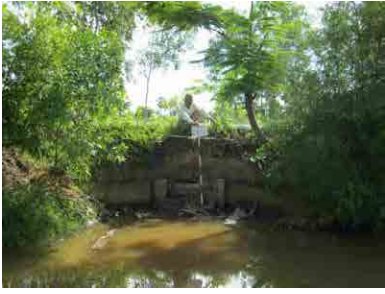
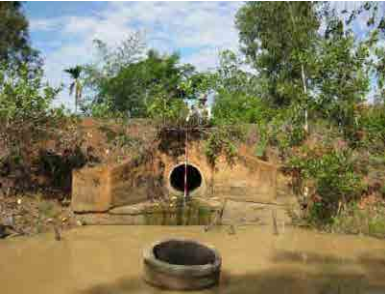
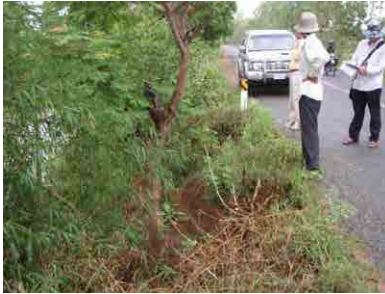
Canal No.: C22	Kind of structure(s): Pipe culvert	Remarks: - Groove - Under national road N0 2
Station: 0.00(B.P.)	Coordinate< Northing: 1222016 Easting: 0452306

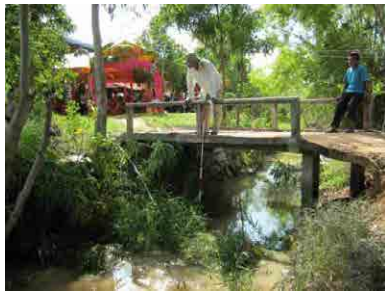
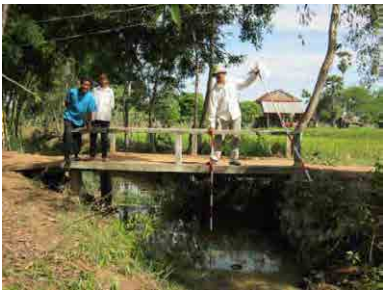
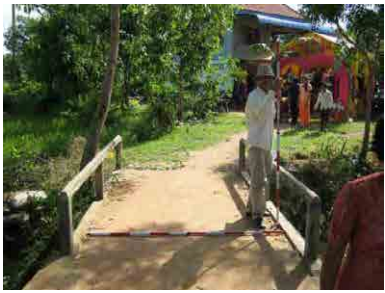
Canal No.: C22	Kind of structure(s): Bridge (Concrete)	Remarks: Under house entrance road
Station: 0.00+50	Coordinate< Northing: 1222025 Easting: 0452367

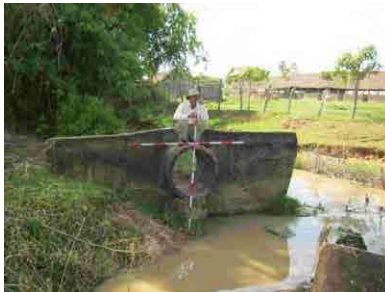
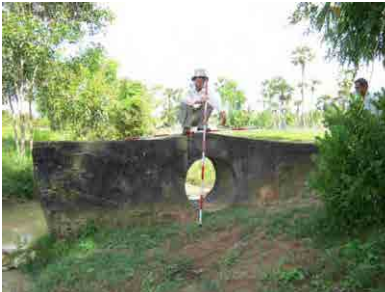
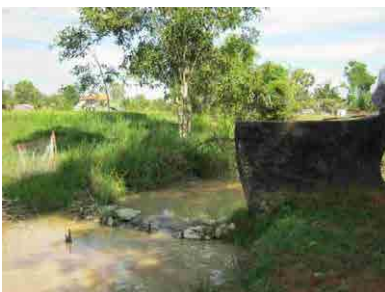
Canal No.: C22	Kind of structure(s): Pipe culvert	Remarks: - Totally broken - Water flows out of culvert
Station: 0.00+230	Coordinate< Northing: 1222032 Easting: 0452534

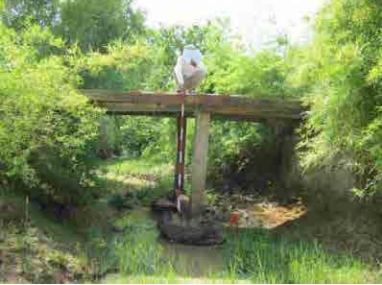
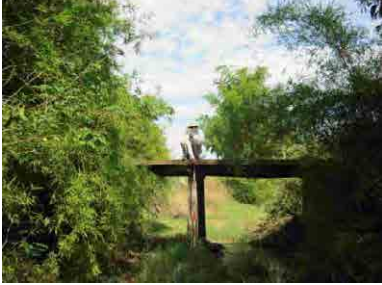
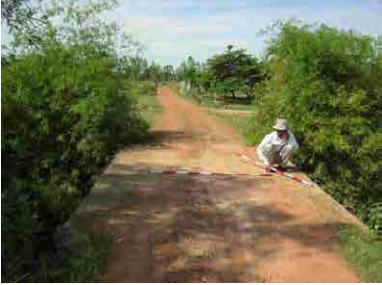
Canal No.: C22	Kind of structure(s): Concrete bridge	Remarks: Under commune road
Station: 0.00+340	Coordinate< Northing: 1222036 Easting: 0452635

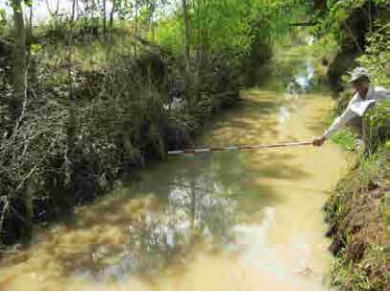
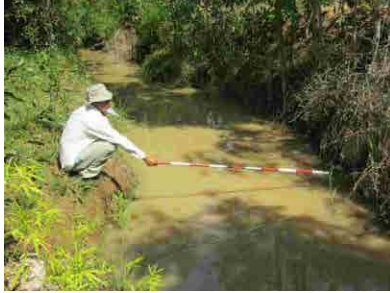
Canal No.: C22	Kind of structure(s): Canal	Remarks: Routine survey Length: 500m
Station: 0.00+620	Coordinate< Northing: 1222030 Easting: 0452758

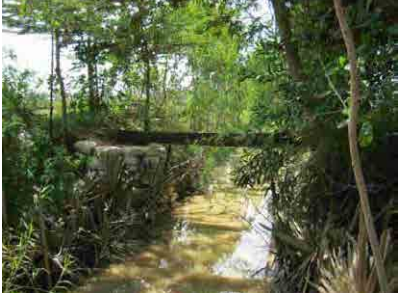
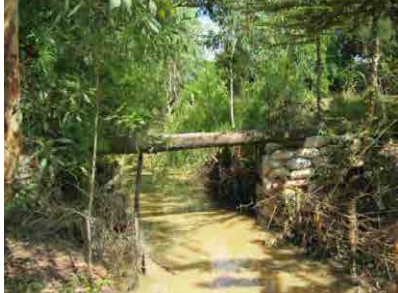
Canal No.: C22	Kind of structure(s): Crossing pipe	Remarks: Routine survey
Station: 0.00+650	Coordinate< Northing: 1222036 Easting: 0452793

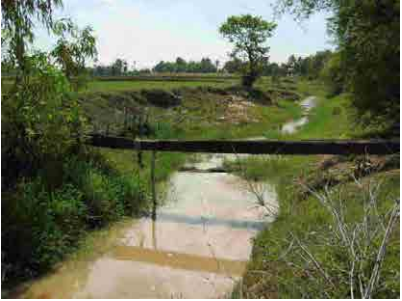
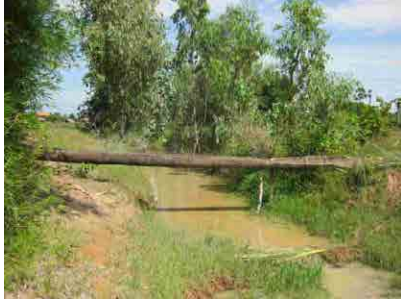
Canal No.: C22	Kind of structure(s): Crossing Pipe	Remarks: - Made by wood (palm tree)
Station: 0.00+720	Coordinate< Northing: 1222036 Easting: 0452860	
<div style="display: flex; justify-content: space-around; align-items: center;"> <div style="text-align: center;">

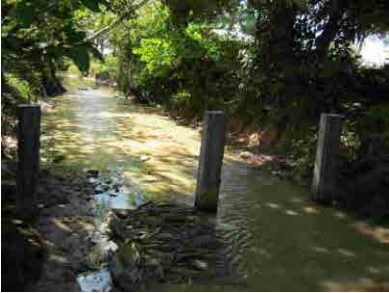
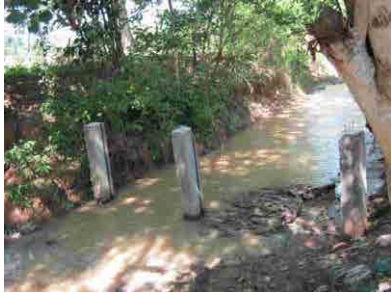
Canal No.: C22	Kind of structure(s): Future bridge	Remarks: - Routine survey - Concrete column
Station: 0.00+990	Coordinate< Northing: 1222050 Easting: 0453118	
<div style="display: flex; justify-content: space-around; align-items: center;"> <div style="text-align: center;">

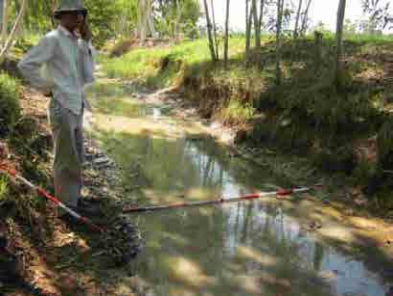
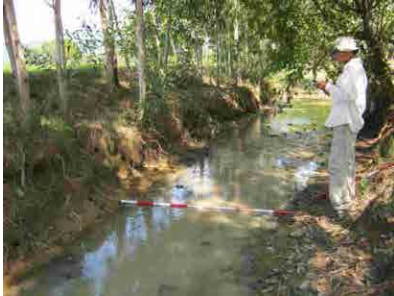
Canal No.: C22	Kind of structure(s): Canal	Remarks: Routine survey Length: 1000m
Station: 1.00+120	Coordinate< Northing: 1222049 Easting: 0453240	
<div style="display: flex; justify-content: space-around; align-items: center;"> <div style="text-align: center;">

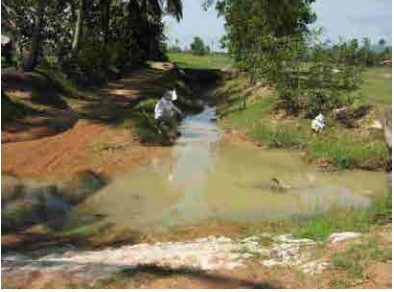
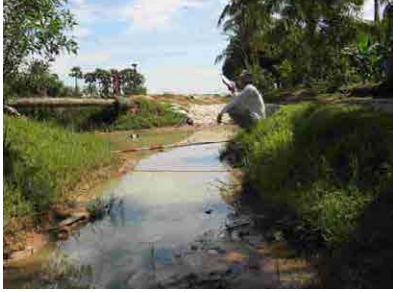
Canal No.: C22	Kind of structure(s): Tertiary crossing point	Remarks: Routine survey
Station: 1.00+240	Coordinate< Northing: 1222051 Easting: 0453366	
<div style="display: flex; justify-content: space-around; align-items: flex-end;"> <div style="text-align: center;">

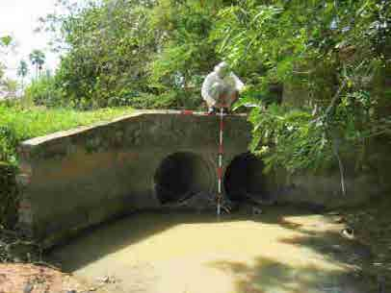
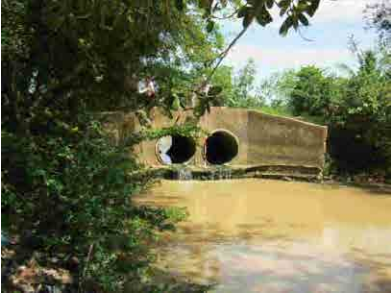
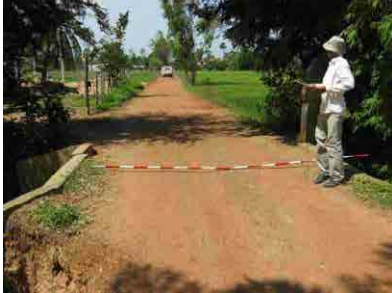
Canal No.: C22	Kind of structure(s): Pipe culvert (Double)	Remarks: Under commune road
Station: 1.00+500	Coordinate< Northing: 1222045 Easting: 0453598	
<div style="display: flex; justify-content: space-around; align-items: flex-end;"> <div style="text-align: center;">

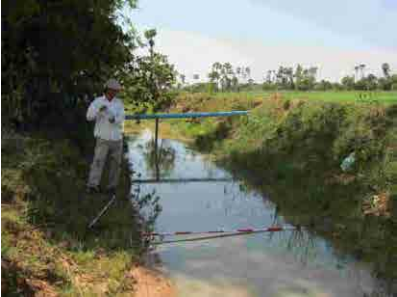
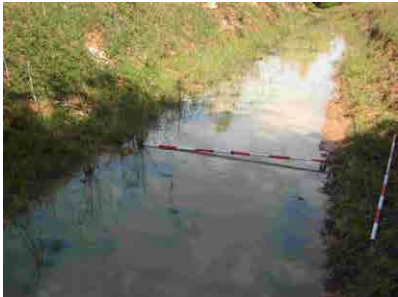
Canal No.: C22	Kind of structure(s): Canal	Remarks: Routine survey Length: 1500m
Station: 1.00+630	Coordinate< Northing: 1222046 Easting: 0453717	
<div style="display: flex; justify-content: space-around; align-items: flex-end;"> <div style="text-align: center;">

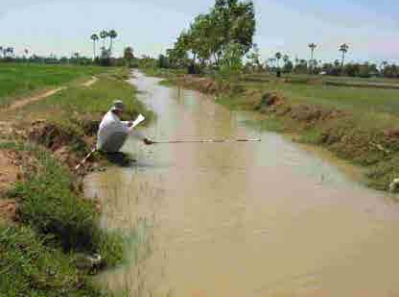
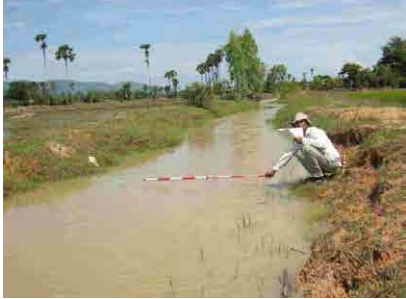
Canal No.: C22	Kind of structure(s): Canal	Remarks: Routine survey Length: 2000m
Station: 2.00+140	Coordinate< Northing: 1222039 Easting: 0454183	
<div style="display: flex; justify-content: space-around; align-items: center;"> <div style="text-align: center;">

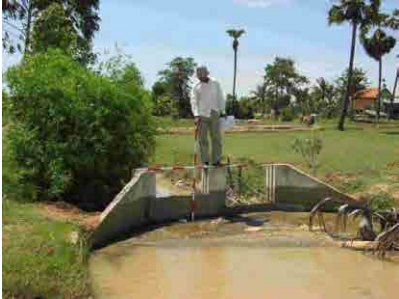
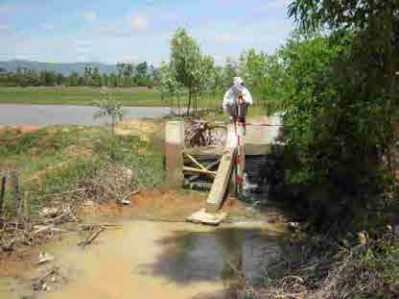
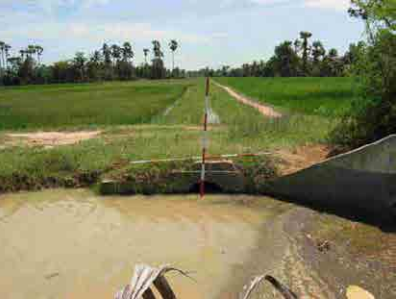
Canal No.: C22	Kind of structure(s): Blockade	Remarks: - Groove takes water into secondary canal
Station: 2.00+420	Coordinate< Northing: 1222026 Easting: 0454450	
<div style="display: flex; justify-content: space-around; align-items: center;"> <div style="text-align: center;">

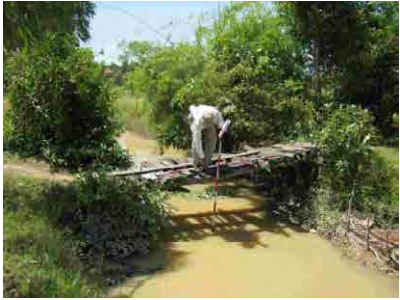
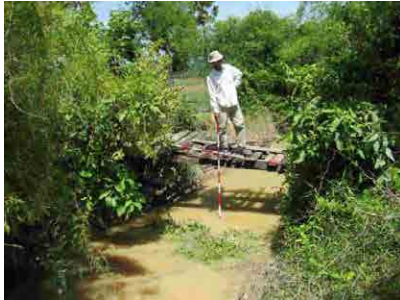
Canal No.: C22	Kind of structure(s): Wooden Bridge	Remarks: - Made by wood
Station: 2.00+510	Coordinate< Northing: 1222024 Easting: 0454530	
<div style="display: flex; justify-content: space-around; align-items: center;"> <div style="text-align: center;">

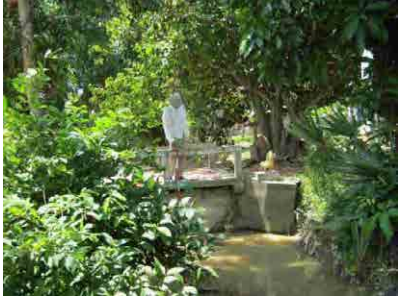
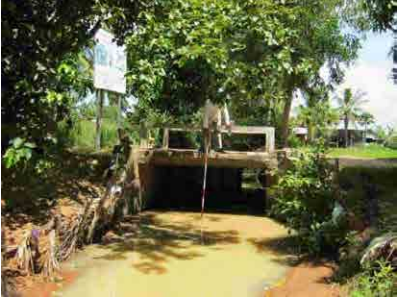
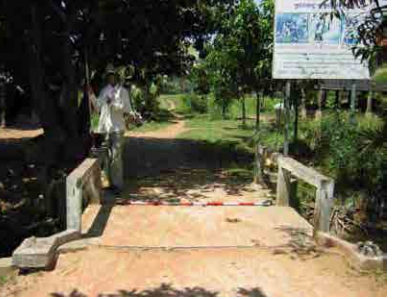
Canal No.: C22	Kind of structure(s): Concrete Bridge	Remarks: - Under village road - Length: 2500m
Station: 2.00+650	Coordinate< Northing: 1222023 Easting: 0454677

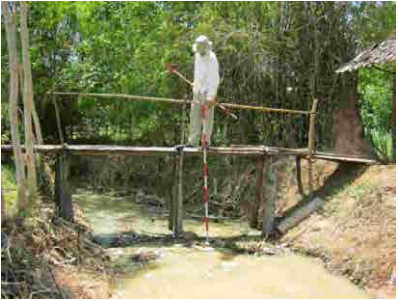
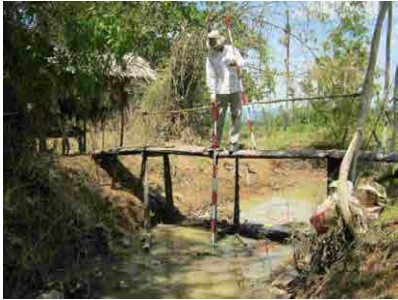
Canal No.: C22	Kind of structure(s): Bridge (Wooden)	Remarks: - Made by wood
Station: 2.00+900	Coordinate< Northing: 1222015 Easting: 0454916

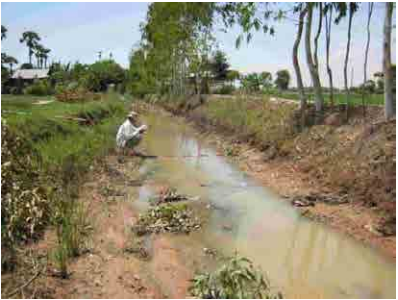
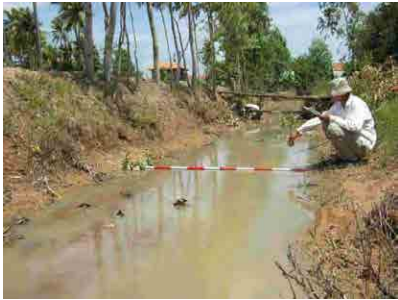
Canal No.: C22	Kind of structure(s): Canal	Remarks: Routine survey Length: 3000m
Station: 3.00+150	Coordinate< Northing: 1222009 Easting: 0455077

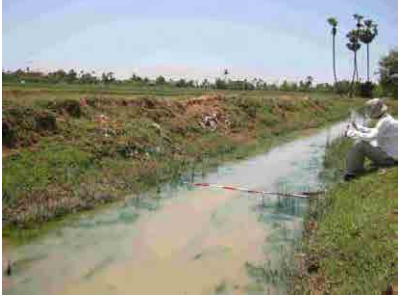
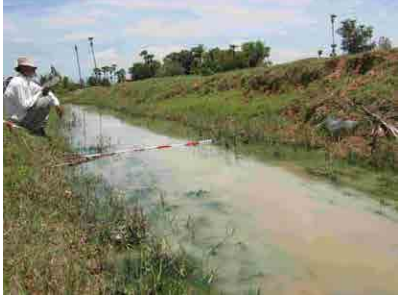
Canal No.: C22	Kind of structure(s): Canal	Remarks: Routine survey Length: 3500m
Station: 3.00+680	Coordinate< Northing: 1221989 Easting: 0455524	
<div style="display: flex; justify-content: space-around; align-items: center;"> <div style="text-align: center;">

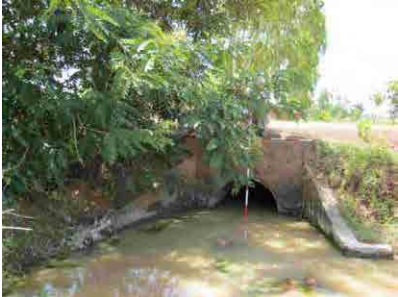
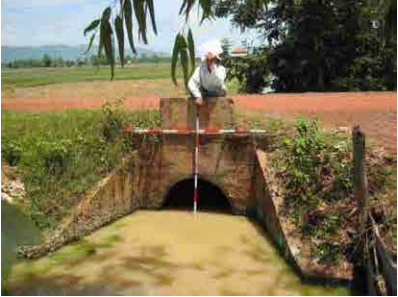
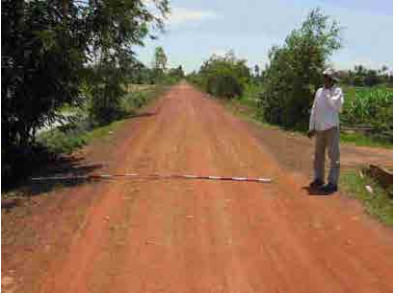
Canal No.: C22	Kind of structure(s): Pipe culvert (Commune)	Remarks: - Under commune road
Station: 3.00+950	Coordinate< Northing: 1221982 Easting: 0455782	
<div style="display: flex; justify-content: space-around; align-items: center;"> <div style="text-align: center;">

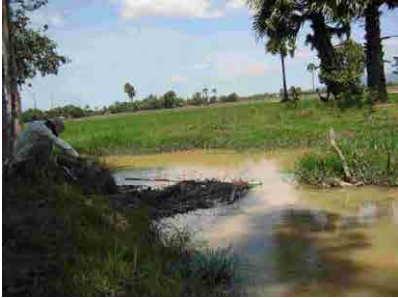
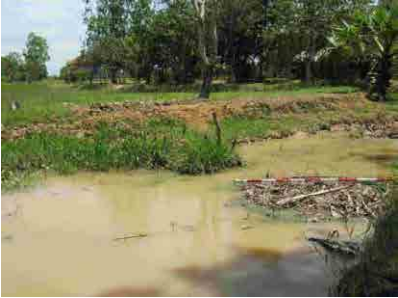
Canal No.: C22	Kind of structure(s): Canal	Remarks: Routine survey Length: 4000m
Station: 4.00+190	Coordinate< Northing: 1221961 Easting: 0455996	
<div style="display: flex; justify-content: space-around; align-items: center;"> <div style="text-align: center;">

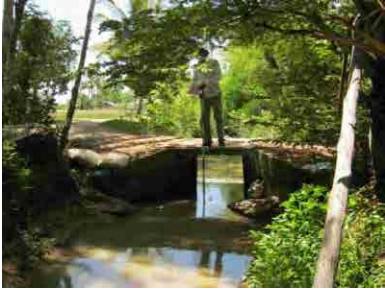
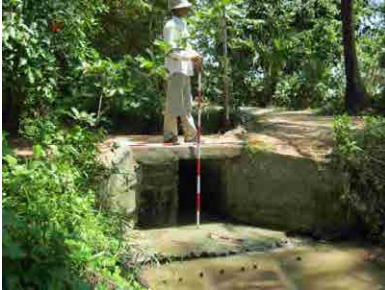
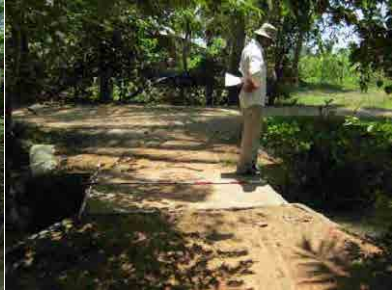
Canal No.: C22	Kind of structure(s): Bridge	Remarks: - Under house entrance road - There is a groove
Station: 4.00+500	Coordinate< Northing: 1221938 Easting: 0456299

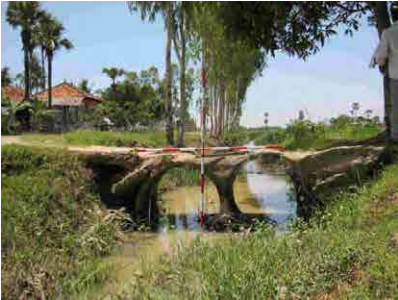
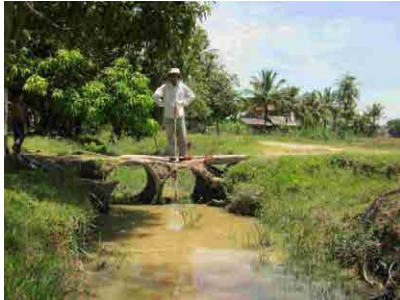
Canal No.: C22	Kind of structure(s): Pipe culvert (Double)	Remarks: Routine survey
Station: 4.00+570	Coordinate< Northing: 1221939 Easting: 0456361

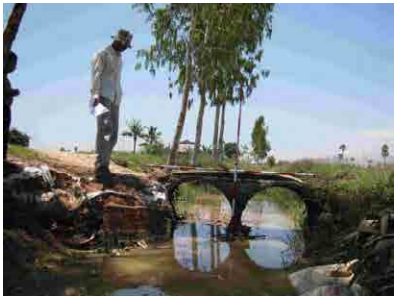
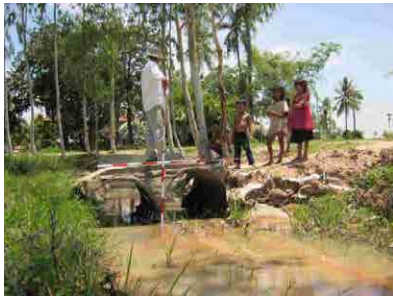
Canal No.: C22	Kind of structure(s): Pipe culvert (Double)	Remarks: Routine survey Length: 4500m
Station: 4.00+690	Coordinate< Northing: 1221960 Easting: 0456457

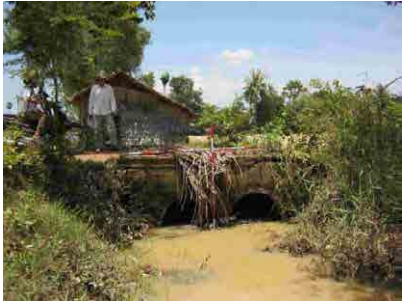
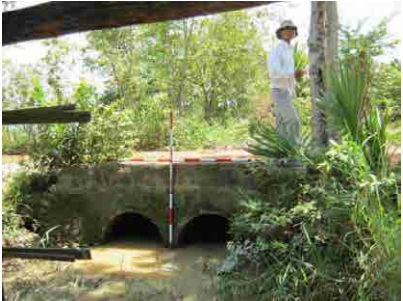
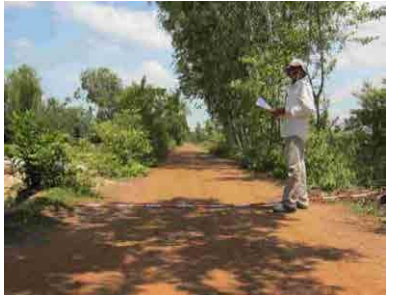
Canal No.: C22	Kind of structure(s): Pipe culvert (Double)	Remarks: Routine survey Under commune road
Station: 5.00+990	Coordinate< Northing: 1221914 Easting: 0457652

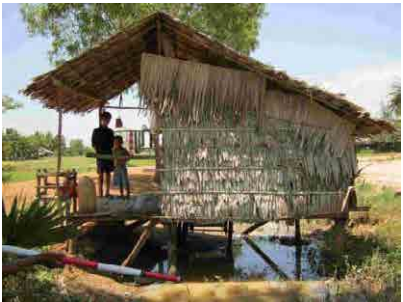
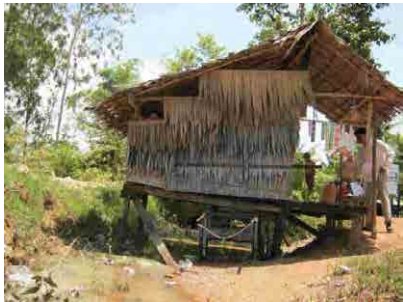
Canal No.: C22	Kind of structure(s): House (Cottage)	Remarks: Routine survey
Station: 5.00+990	Coordinate< Northing: 1221911 Easting: 0457658

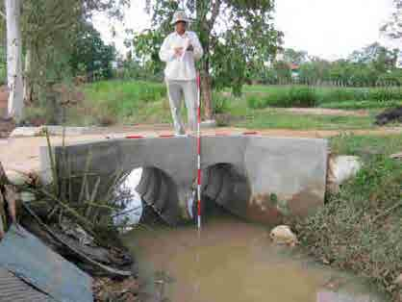
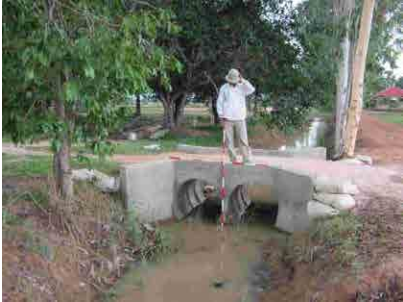
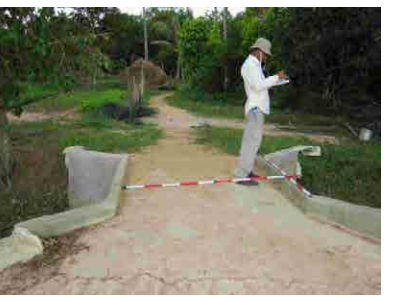
Canal No.: C22	Kind of structure(s): Pipe culvert (Double)	Remarks: - Under village road
Station: 6.00+90	Coordinate< Northing: 1221908 Easting: 0457755

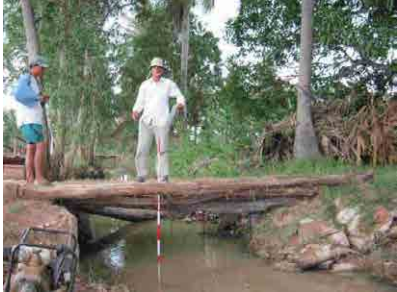
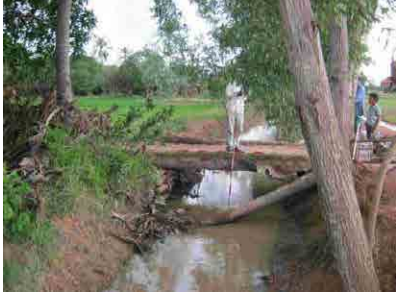
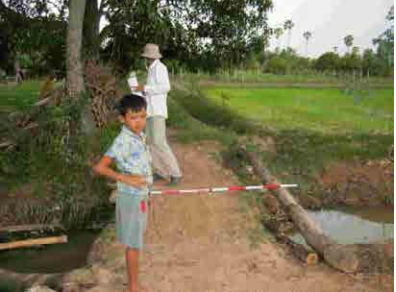
Canal No.: C22	Kind of structure(s): Wooden Bridge	Remarks: - Under a small bicycle road - Length: 6000m
Station: 6.00+170	Coordinate< Northing: 1221908 Easting: 0457838

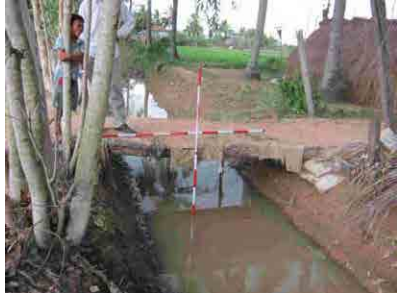
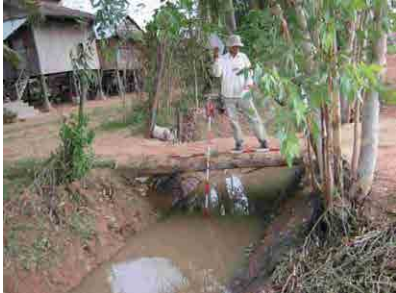
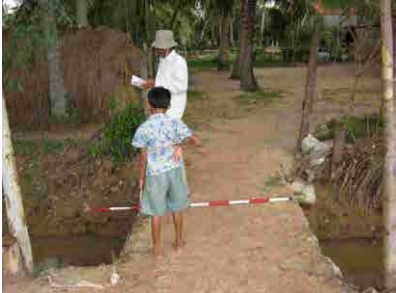
Canal No.: C22	Kind of structure(s): Bridge	Remarks: Under house entrance road
Station: 6.00+210	Coordinate< Northing: 1221906 Easting: 0457878

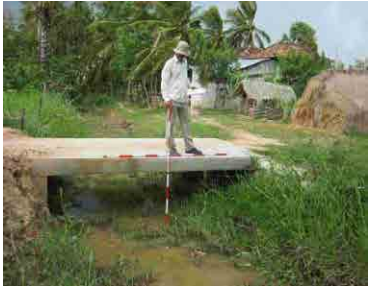
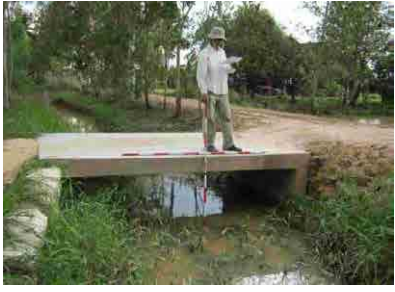
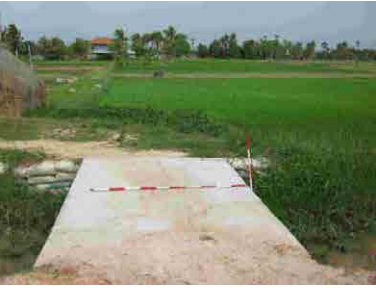
Canal No.: C22	Kind of structure(s): Bridge (Private)	Remarks: Under small bicycle road
Station: 6.00+320	Coordinate< Northing: 1221898 Easting: 0457985

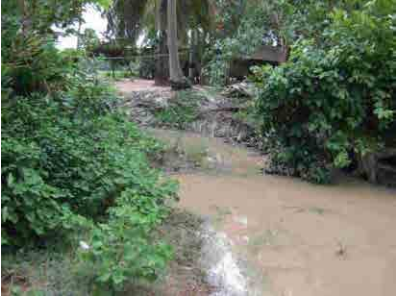
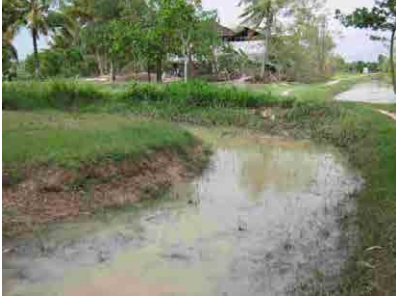
Canal No.: C22	Kind of structure(s): Turning point	Remarks:
Station: 6.00+370	Coordinate< Northing: 1221883 Easting: 0458040	Routine survey
<div style="display: flex; justify-content: space-around; align-items: flex-end;"> <div style="text-align: center;">

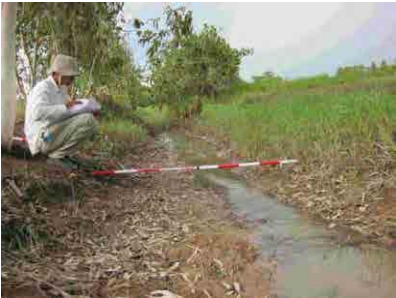
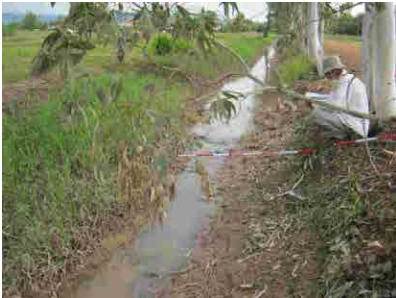
Canal No.: C22	Kind of structure(s): Canal	Remarks:
Station: 6.00+670	Coordinate< Northing: 1221907 Easting: 0458295	Routine survey Length: 6500m
<div style="display: flex; justify-content: space-around; align-items: flex-end;"> <div style="text-align: center;">

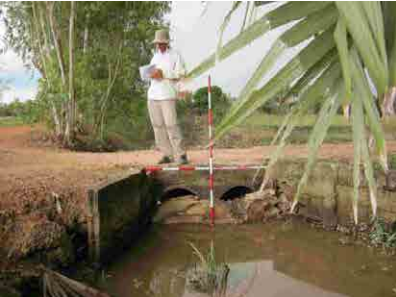
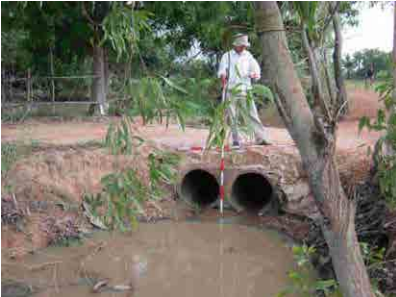
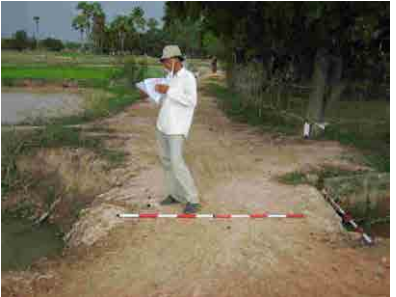
Canal No.: C22	Kind of structure(s): Pipe culvert (Double)	Remarks:
Station: 7.00+50	Coordinate< Northing: 1221887 Easting: 0458644	Under a village road
<div style="display: flex; justify-content: space-around; align-items: flex-end;"> <div style="text-align: center;">

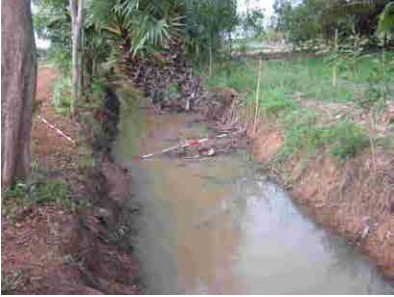
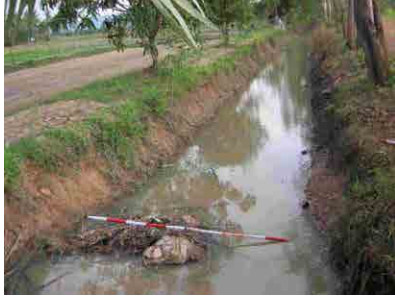
Canal No.: C22	Kind of structure(s): Canal	Remarks: Routine survey Length: 7000m
Station: 7.00+170	Coordinate< Northing: 1221889 Easting: 0458759	
<div style="display: flex; justify-content: space-around; align-items: center;"> <div style="text-align: center;">

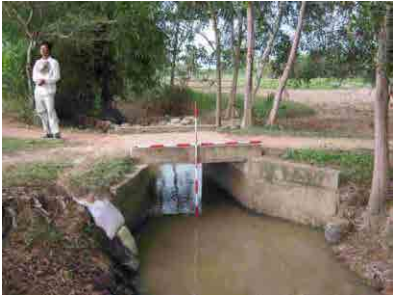
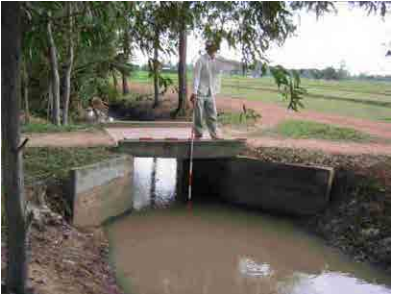
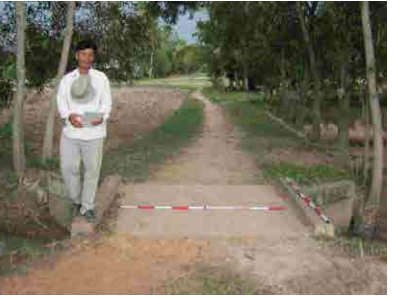
Canal No.: C22	Kind of structure(s): Bridge	Remarks: - Box culvert - Under a small road
Station: 7.00+200	Coordinate< Northing: 1221887 Easting: 0458803	
<div style="display: flex; justify-content: space-around; align-items: center;"> <div style="text-align: center;">
