# ***ANNEX D***

## ***Attachment – 1***

*Results of Inventory Survey for  
Proposed Rehabilitation Works in  
Roleang Chrey Headworks Rehabilitation Sub-project*

**Results of Inventory Survey for Proposed Rehabilitation Works on North Main Canal (1/12)**

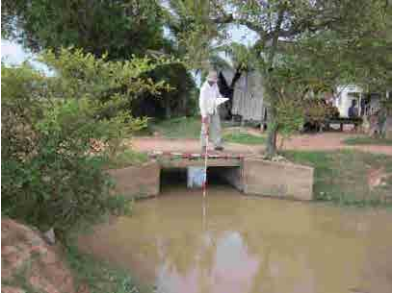
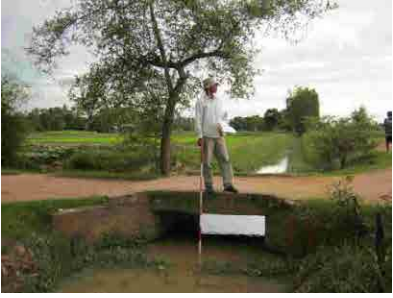
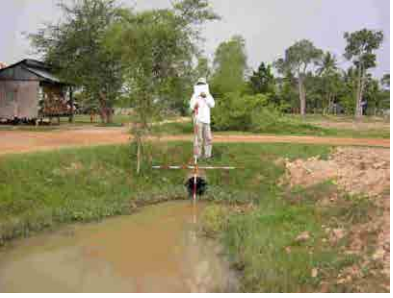
Canal No.: C22	Kind of structure(s): Bridge	Remarks: - Under a village road - Groove (pipe culvert) take water to secondary canal
Station: 7.00+440	Coordinate< Northing: 1221887 Easting: 0459033	
<div style="display: flex; justify-content: space-around; align-items: center;"> <div style="text-align: center;">

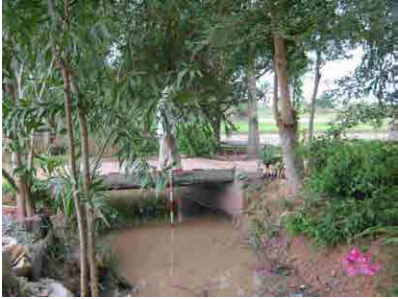
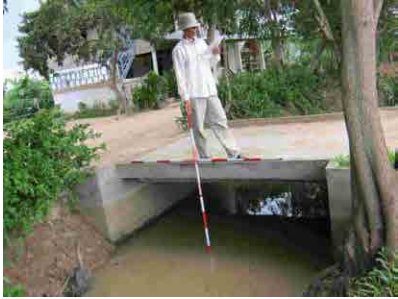
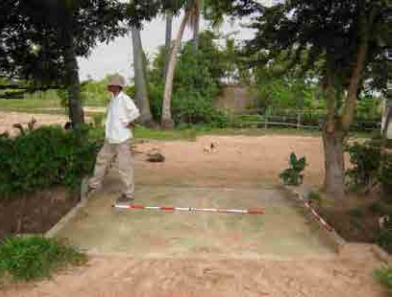
Canal No.: C22	Kind of structure(s): Bridge	Remarks: Under village road Length: 7500m
Station: 7.00+680	Coordinate< Northing: 1221890 Easting: 0459254

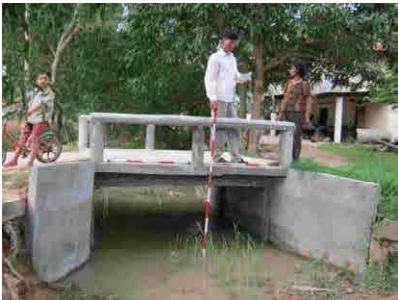
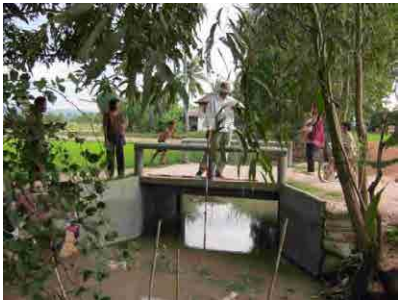
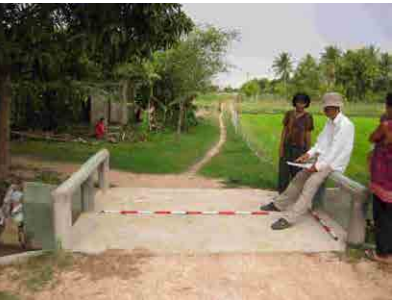
Canal No.: C22	Kind of structure(s): Bridge (Village)	Remarks: Under small village road
Station: 7.00+930	Coordinate< Northing: 1221886 Easting: 0459490

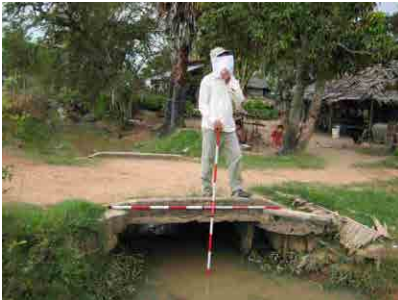
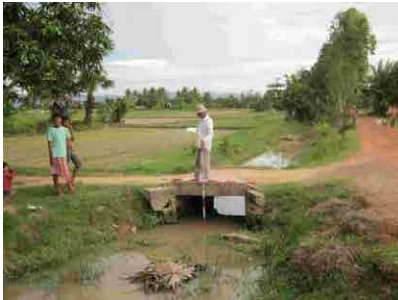
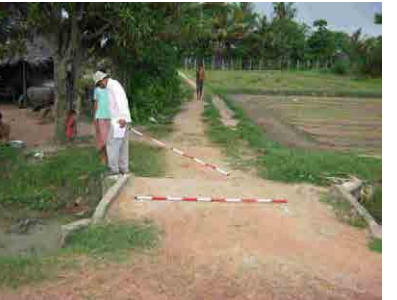
Canal No.: C22	Kind of structure(s): Canal	Remarks: Routine survey Length: 8000m
Station: 8.00+200	Coordinate< Northing: 1221887 Easting: 0459754	
<div style="display: flex; justify-content: space-around; align-items: center;"> <div style="text-align: center;">

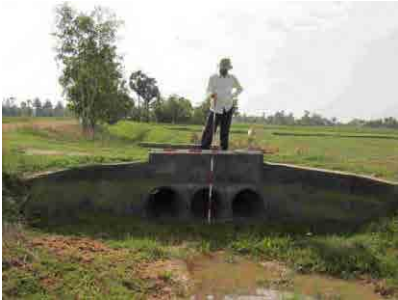
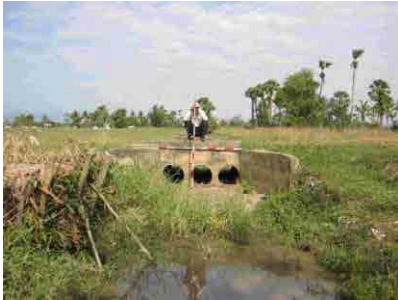
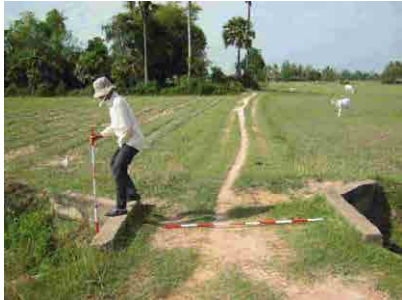
Canal No.: C22	Kind of structure(s): Pipe culvert (Triple)	Remarks: Under a small carte road
Station: 8.00+210	Coordinate< Northing: 1221887 Easting: 0459852	
<div style="display: flex; justify-content: space-around; align-items: center;"> <div style="text-align: center;">

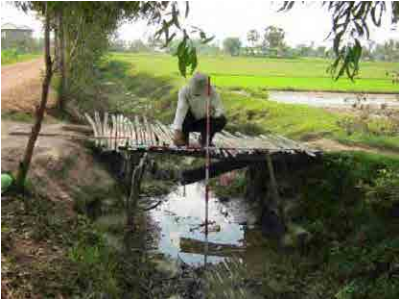
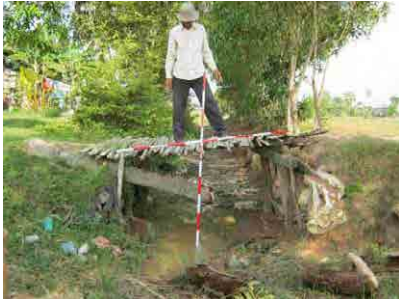
Canal No.: C22	Kind of structure(s): Wooden Bridge (Private)	Remarks: Routine survey
Station: 8.00+360	Coordinate< Northing: 1221891 Easting: 0459998	
<div style="display: flex; justify-content: space-around; align-items: center;"> <div style="text-align: center;">

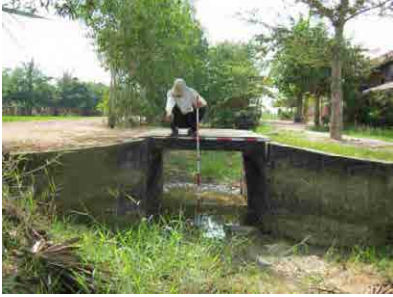
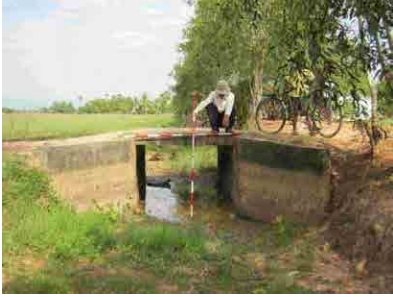
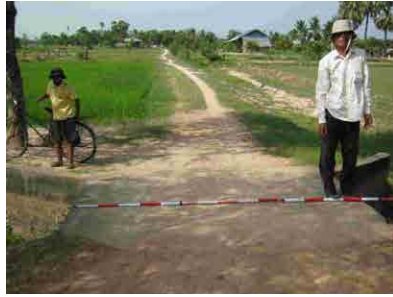
Canal No.: C22	Kind of structure(s): Bridge (Private)	Remarks: Under small bicycle road Length: 8500m
Station: 8.00+610	Coordinate< Northing: 1221889 Easting: 0460221

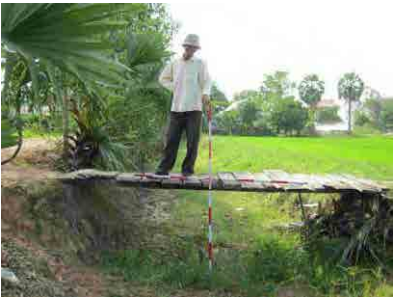
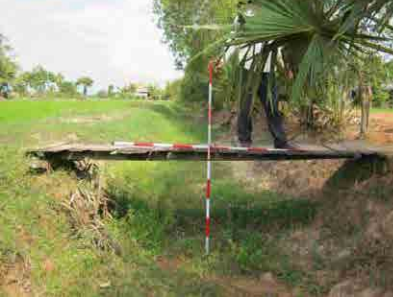
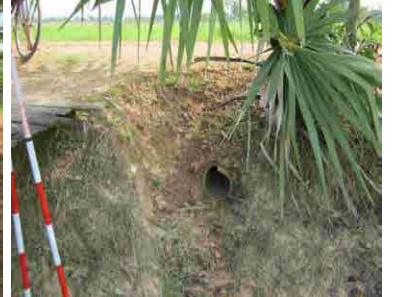
Canal No.: C22	Kind of structure(s): Bridge (Private)	Remarks: Routine survey
Station: 8.00+810	Coordinate< Northing: 1221889 Easting: 0460405

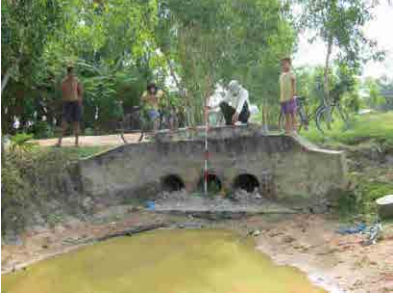
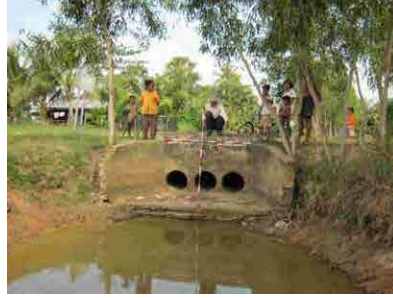
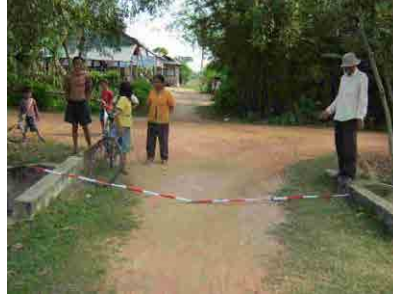
Sta.	E	N	Structure	Condition	Evaluation*	Flow Capacity	Remarks
9,010	460591	1221880	Culvert 11 (Triple)	Three pipes of 0.5 m dia each, 3 m long	C	c	on village road
9,110	460679	1221893	Canal section	Canal section remain with bottom width of 2 m	C		
9,180	460749	1221891	Culvert 12 (Private)	Wooden bridge of 2 m wide	D	-	House access
9,250	460822	1221893	Tertially Crossing Point				
9,410	460976	1221892	Culvert 13 (Double)	Two pipes of 0.7 m dia each and 2.8 m long	C	b	on village road
9,550	461114	1221898	Bridge 19 (private)	Wooden bridge of 1 m wide	D	-	Wooden bridge, house access
9,650	461199	1221897	Culvert-14 (private)	2 m span and 2.5 m wide with grooves for planks	B	b	House access
9,690	461237	1221900	Canal section	Canal section remain with bottom width of 2 m	B		
9,980	461517	1221900	E.P (Bridge 19)	1.8 m span and 3 m wide with grooves for planks	B		House access

Canal No.: C22	Kind of structure(s): Pipe culvert (Triple)	Remarks: Under a village road
Station: 9.00+10	Coordinate< Northing: 1221880 Easting: 0460591

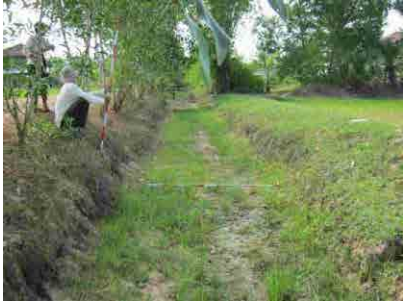
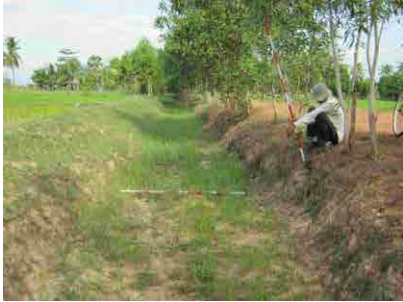
Canal No.: C22	Kind of structure(s): Canal	Remarks: Routine survey Length: 9000m
Station: 9.00+110	Coordinate< Northing: 1221893 Easting: 0460679	
<div style="display: flex; justify-content: space-around; align-items: center;"> <div style="text-align: center;">

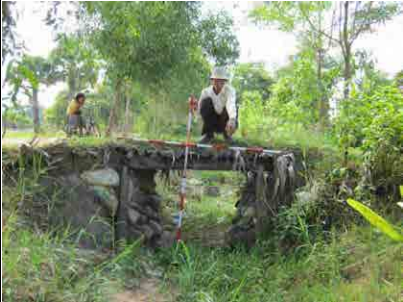
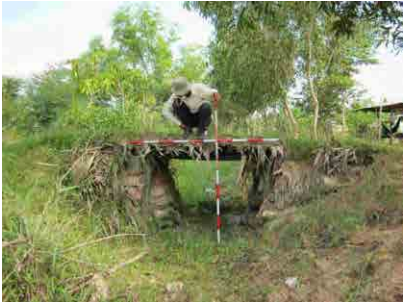
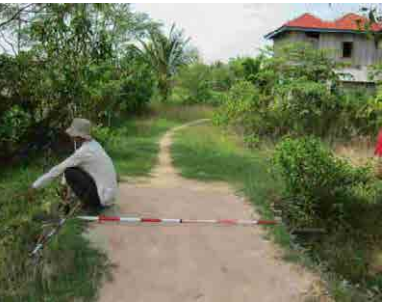
Canal No.: C22	Kind of structure(s): Bridge (Private)	Remarks: - Routine survey - Under house entrance road
Station: 9.00+180	Coordinate< Northing: 1221891 Easting: 0460749	
<div style="display: flex; justify-content: space-around; align-items: center;"> <div style="text-align: center;">

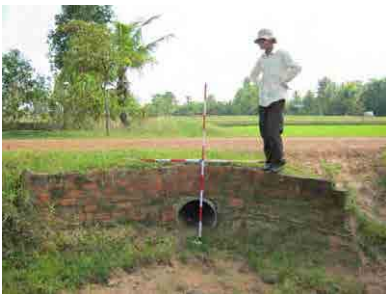
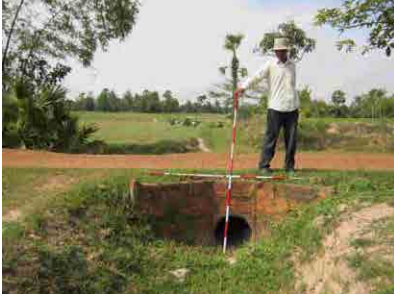
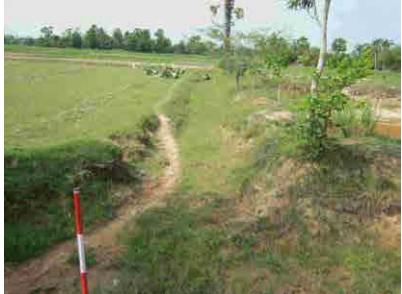
Canal No.: C22	Kind of structure(s): Pipe culvert	Remarks: Routine survey Tertiary crossing
Station: 9.00+250	Coordinate< Northing: 1221893 Easting: 0460822	
<div style="display: flex; justify-content: space-around; align-items: center;"> <div style="text-align: center;">

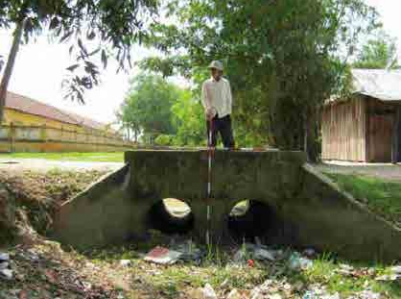
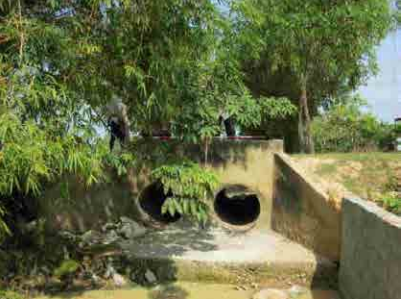
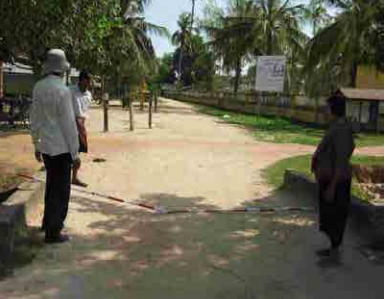
Canal No.: C22	Kind of structure(s): Pipe culvert (Double)	Remarks: Under commune road
Station: 9.00+410	Coordinate< Northing: 1221892 Easting: 0460976

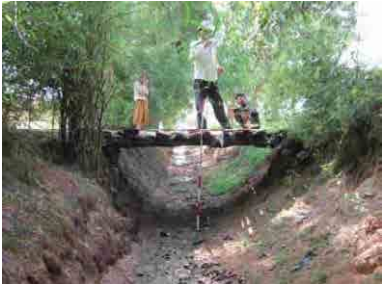
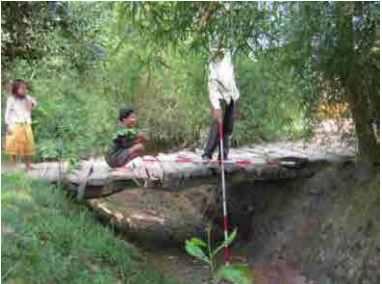
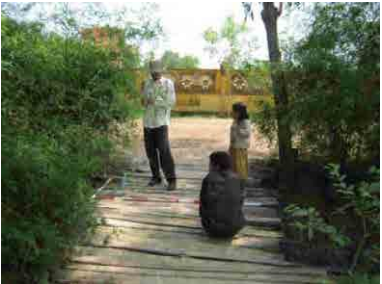
Canal No.: C22	Kind of structure(s): Bridge (Private)	Remarks: - Routine survey - Made by wood
Station: 9.00+550	Coordinate< Northing: 1221898 Easting: 0461114

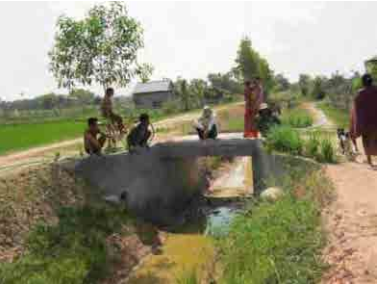
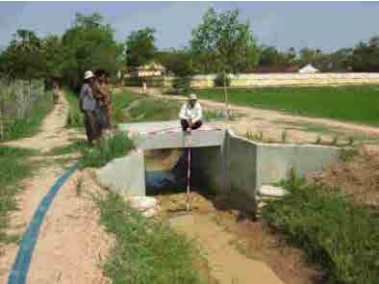
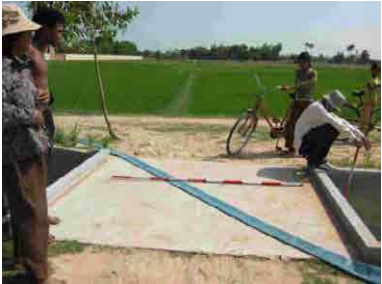
Canal No.: C22	Kind of structure(s): Bridge (Private)	Remarks: Routine survey
Station: 9.00+650	Coordinate< Northing: 1221897 Easting: 0461199

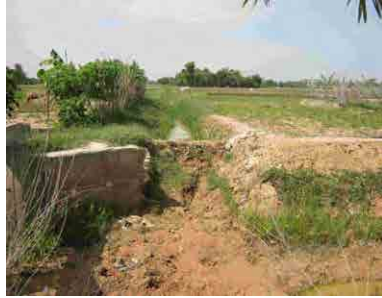
Canal No.: C22	Kind of structure(s): Check structure	Remarks: - Totally broken - Groove takes water into secondary canal, Length: 9500m
Station: 9.00+690	Coordinate< Northing: 1221900 Easting: 0461237

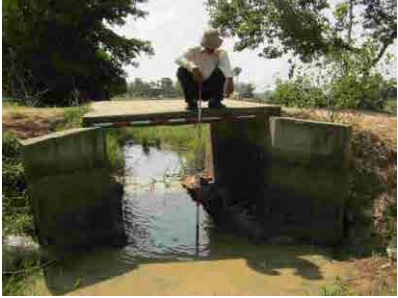
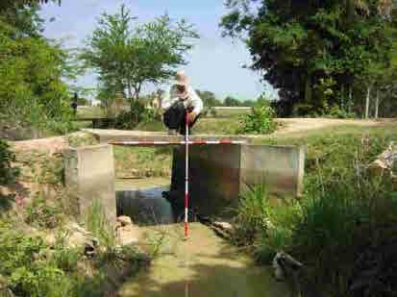
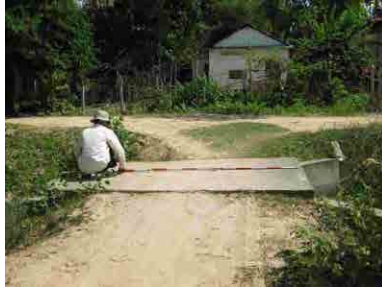
Canal No.: C22	Kind of structure(s): Bridge	Remarks: Under small village road (E.P.)
Station: 9.00+980(EP)	Coordinate< Northing: 1221900 Easting: 0461517

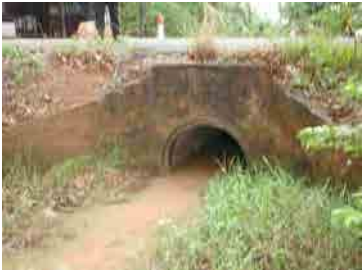
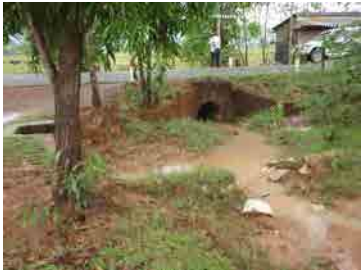
Canal No.: C23	Kind of structure: Pipe culvert	Remarks: Under National Road 130A
Station: 0.00(B.P.)	Coordinate< <div style="display: flex; justify-content: space-between; padding: 0 5px;"> <span>Northing: 1222762</span> <span>Easting: 451255</span> </div>	
<div style="display: flex; justify-content: space-around; align-items: center;">

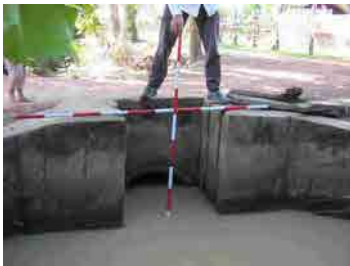
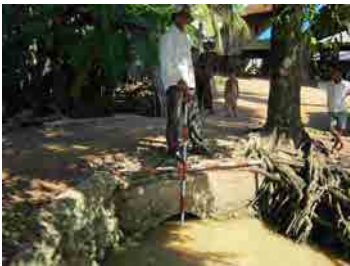
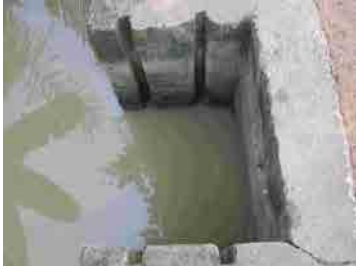
Canal No.: C23	Kind of structure: Pipe culvert	Remarks: Under house entrance road
Station: 0.00+40	Coordinate< <div style="display: flex; justify-content: space-between; padding: 0 5px;"> <span>Northing: 1222801</span> <span>Easting: 451274</span> </div>	
<div style="display: flex; justify-content: space-around; align-items: center;">

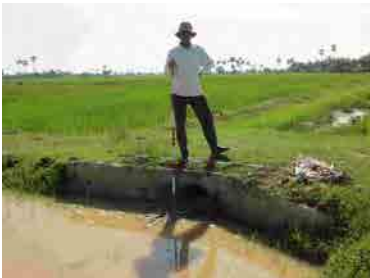
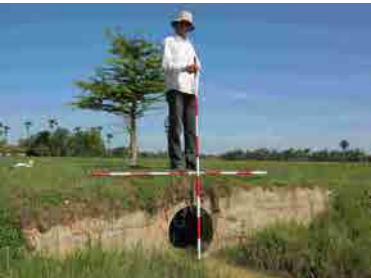
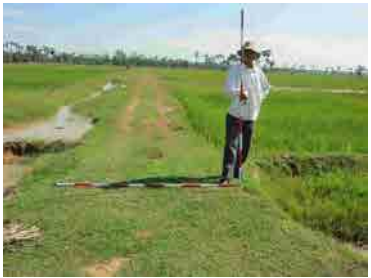
Canal No.: C23	Kind of structure: Pipe culvert	Remarks: Pipe culvert under carte road
Station: 0.00+290	Coordinate< <div style="display: flex; justify-content: space-between; padding: 0 5px;"> <span>Northing: 1222792</span> <span>Easting: 451513</span> </div>	
<div style="display: flex; justify-content: space-around; align-items: center;">

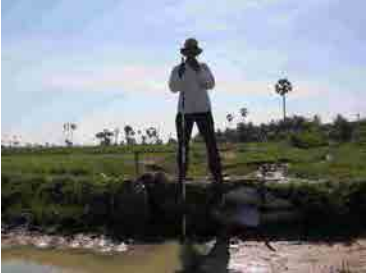
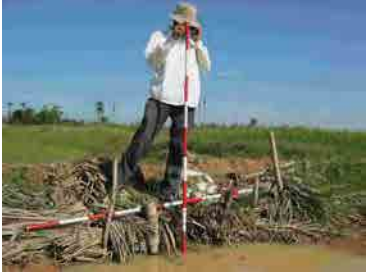
Canal No.: C23	Kind of structure: Pipe culvert	Remarks: Routine survey
Station: 0.00+400	Coordinate< <div style="display: inline-block; vertical-align: middle; margin-left: 10px;">                     Northing: 1222783                      Easting: 451614                 </div>	
<div style="display: flex; justify-content: space-around; align-items: center;"> <div style="text-align: center;">

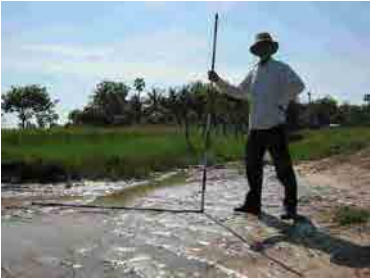
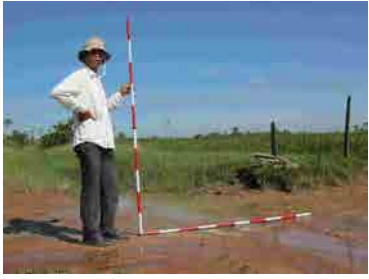
Canal No.: C23	Kind of structure: Dry canal	Remarks: Dry canal Length: 500m
Station: 0.00+500	Coordinate< <div style="display: inline-block; vertical-align: middle; margin-left: 10px;">                     Northing: 1222779                      Easting: 451715                 </div>	
<div style="display: flex; justify-content: space-around; align-items: center;"> <div style="text-align: center;">

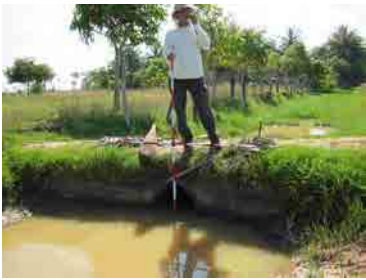
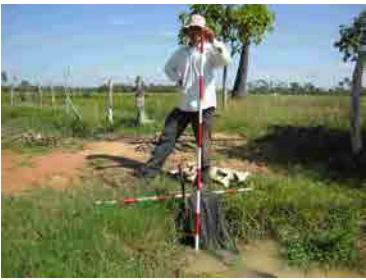
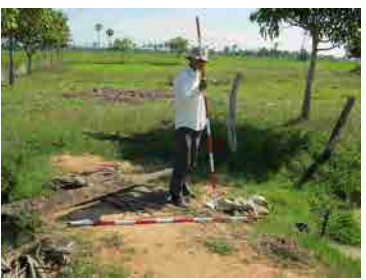
Canal No.: C23	Kind of structure: Pipe culvert	Remarks: Routine survey
Station: 0.00+520	Coordinate< <div style="display: inline-block; vertical-align: middle; margin-left: 10px;">                     Northing: 1222781                      Easting: 451738                 </div>	
<div style="display: flex; justify-content: space-around; align-items: center;"> <div style="text-align: center;">

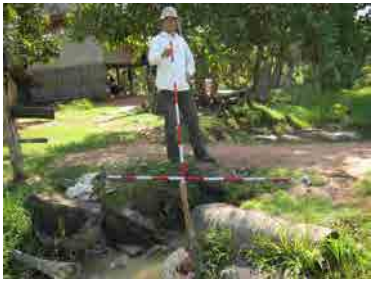
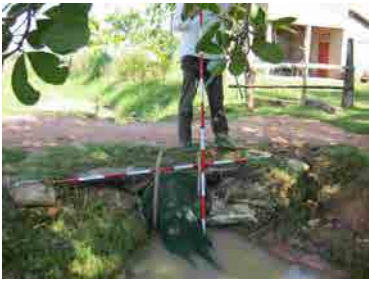
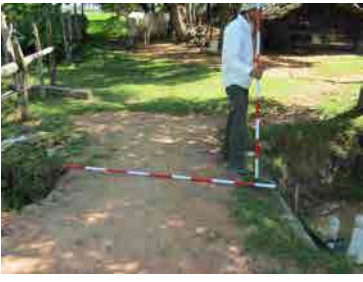
Canal No.: C23	Kind of structure: Pipe culvert	Remarks:
Station: 0.00+600	Coordinate< <div style="display: flex; flex-direction: column; gap: 5px;"> <span>Northing: 1222780</span> <span>Easting: 451821</span> </div>	Routine survey Under house entrance road

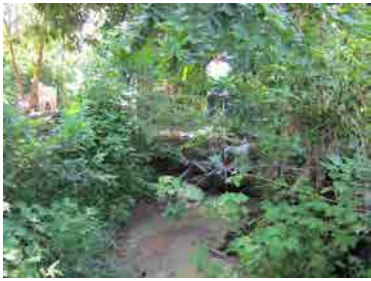
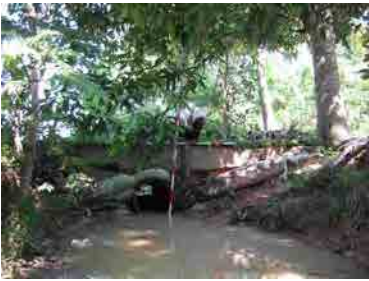
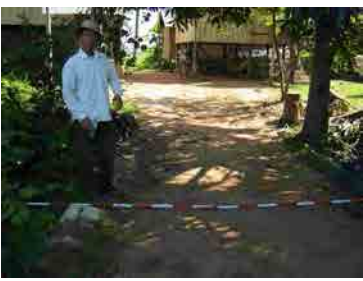
640	451859	1222776	Culvert 6	Culvert of 50 cm dia with 3.6 m long for house access, condition is rather in good condition	C	c	Private house access
670	451902	1222774	Culvert 7	Culvert of 50 cm dia with 3.6 m long for house access, condition is rather in good condition	B	c	Private house access
740	451948	1222809	Culvert 8	Culvert of 50 cm dia with 3 m long for house access, condition is rather in good condition	C	c	Private house access
770	451974	1222813	Culvert 9	Culvert of 50 cm dia with 3.6 m long for house access, condition is rather in good condition	C	c	Private house access
780	451992	1222814	Culvert 10	Culvert of 50 cm dia with 2.5 m long for house access, condition is rather in good condition	C	c	Private house access
850	452056	1222811	Culvert 11	Culvert of 30 cm dia with 2.5 m long for house access, condition is rather in good condition	D	c	Private house access
930	452108	1222774	Earth Check	Canal section is obstructed by earth embankment	D		Temporary measure

Canal No.: C23	Kind of structure: Pipe culvert	Remarks:
Station: 0.00+640	Coordinate< <div style="display: flex; flex-direction: column; gap: 5px;"> <span>Northing: 1222776</span> <span>Easting: 451859</span> </div>	Under house entrance road

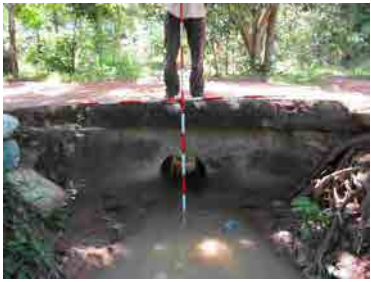
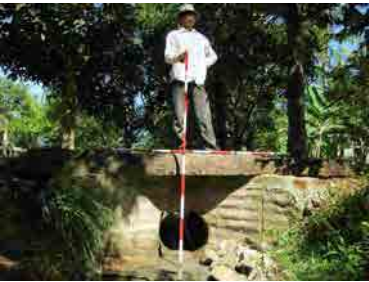
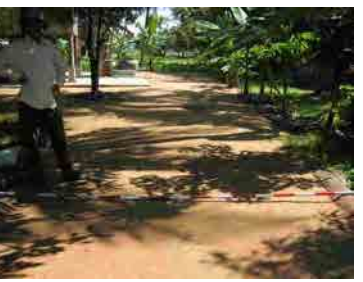
Canal No.: C23	Kind of structure: Pipe culvert	Remarks:
Station: 0.00+670	Coordinate< <div style="display: flex; flex-direction: column; gap: 5px;"> <span>Northing: 1222774</span> <span>Easting: 451902</span> </div>	Under house entrance road

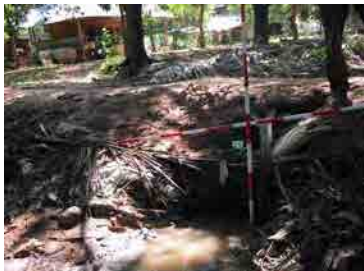
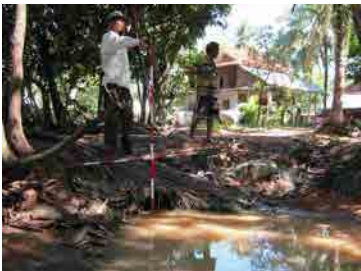
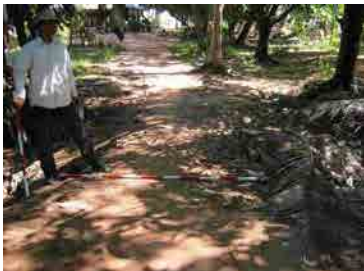
Canal No.: C23	Kind of structure: Pipe culvert	Remarks:
Station: 0.00+740	Coordinate< Northing: 1222809 Easting: 451948	Routine survey

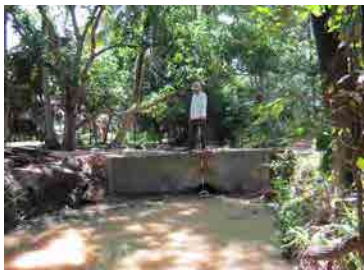
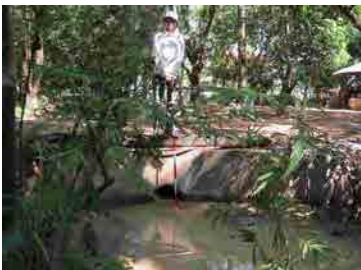
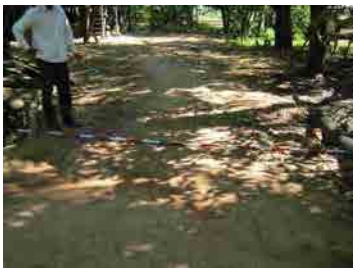
Canal No.: C23	Kind of structure: Pipe culvert	Remarks:
Station: 0.00+770	Coordinate< Northing: 1222813 Easting: 451974	Under house entrance road

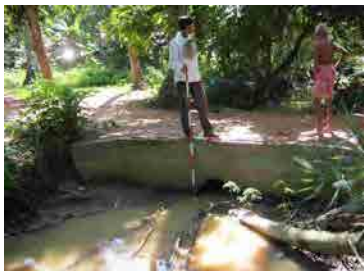
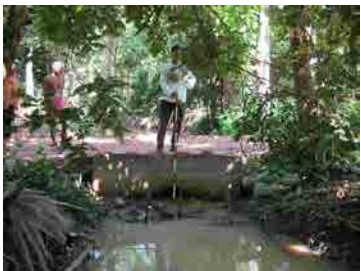
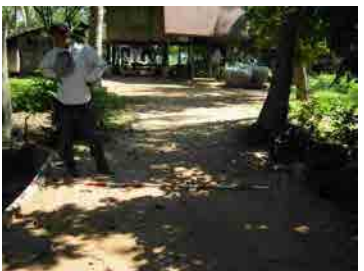
Canal No.: C23	Kind of structure: Pipe culvert	Remarks:
Station: 0.00+780	Coordinate< Northing: 1222814 Easting: 451992	Under house entrance road

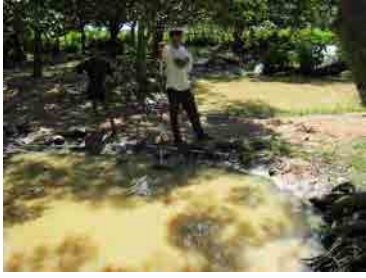
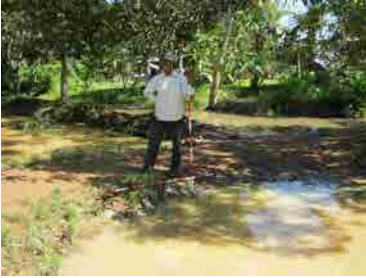
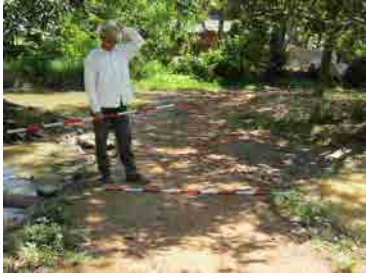
Canal No.: C23	Kind of structure: Pipe culvert	Remarks: Under house entrance road
Station: 0.00+850	Coordinate< <div style="display: flex; justify-content: space-between; padding: 0 5px;"> <span>Northing: 1222811</span> <span>Easting: 452056</span> </div>	
<div style="display: flex; justify-content: space-around;">

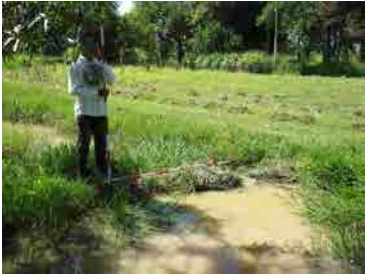
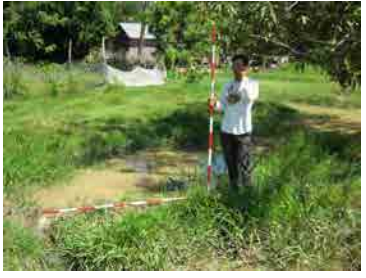
Canal No.: C23	Kind of structure: Earth Check	Remarks: Earth check cross C23
Station: 0.00+930	Coordinate< <div style="display: flex; justify-content: space-between; padding: 0 5px;"> <span>Northing: 1222774</span> <span>Easting: 452108</span> </div>	
<div style="display: flex; justify-content: space-around;">

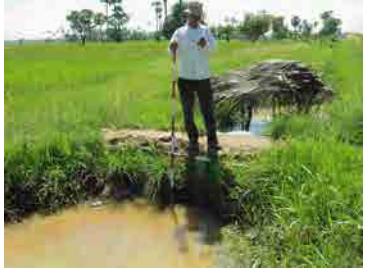
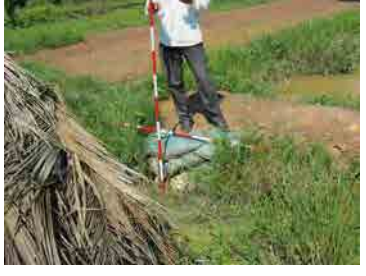
Canal No.: C23	Kind of structure: Pipe culvert	Remarks: Routine check
Station: 0.00+970	Coordinate< <div style="display: flex; justify-content: space-between; padding: 0 5px;"> <span>Northing: 1222774</span> <span>Easting: 452164</span> </div>	
<div style="display: flex; justify-content: space-around;">

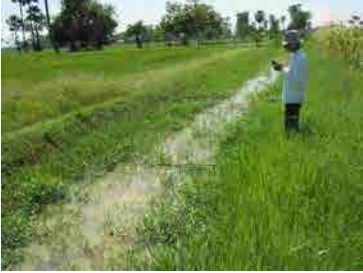
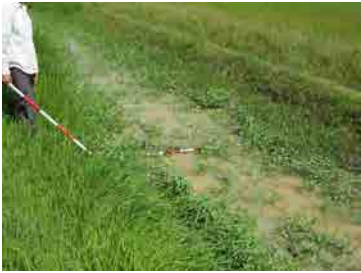
Canal No.: C23	Kind of structure: Secondary Canal	Remarks:
Station: 1.00	Coordinate< <div style="display: flex; justify-content: space-between; padding: 0 10px;"> <span>Northing: 1222770</span> <span>Easting: 452190</span> </div>	Routine survey Length : 1000m
<div style="display: flex; justify-content: space-around; align-items: center;"> <div style="text-align: center;">

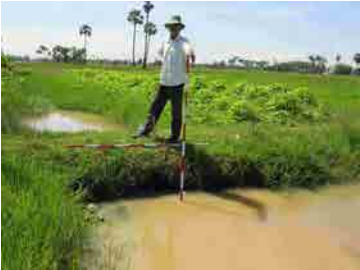
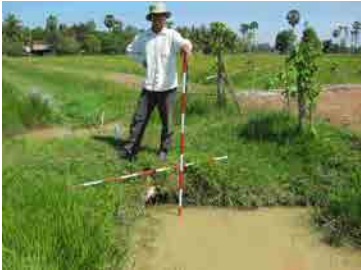
Canal No.: C23	Kind of structure: Pipe culvert	Remarks:
Station: 1.00+100	Coordinate< <div style="display: flex; justify-content: space-between; padding: 0 10px;"> <span>Northing: 1222777</span> <span>Easting: 452237</span> </div>	Routine survey
<div style="display: flex; justify-content: space-around; align-items: center;"> <div style="text-align: center;">

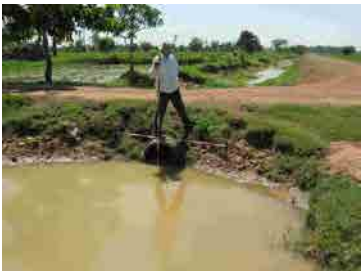
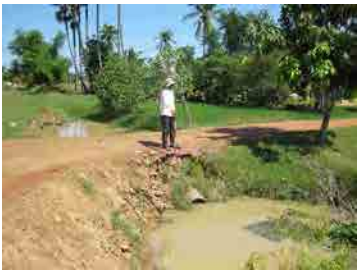
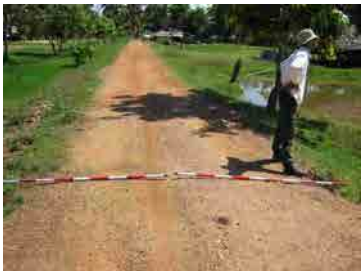
Canal No.: C23	Kind of structure: Pipe culvert	Remarks:
Station: 1.00+420	Coordinate< <div style="display: flex; justify-content: space-between; padding: 0 10px;"> <span>Northing: 1222780</span> <span>Easting: 452538</span> </div>	Under commune road (laterite road)
<div style="display: flex; justify-content: space-around; align-items: center;"> <div style="text-align: center;">

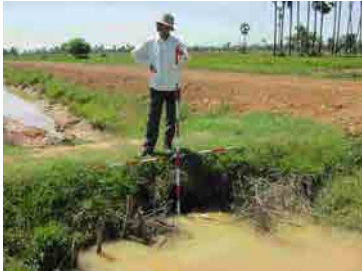
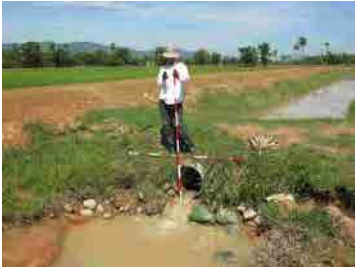
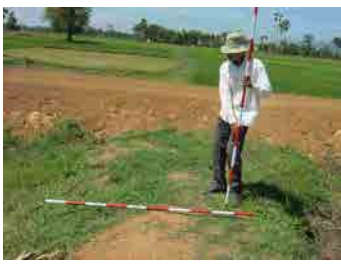
Canal No.: C23	Kind of structure: Pipe culvert	Remarks:
Station: 1.00+470	Coordinate< <div style="display: inline-block; vertical-align: middle; margin-left: 10px;">                     Northing: 1222777                      Easting: 452649                 </div>	Along commune road

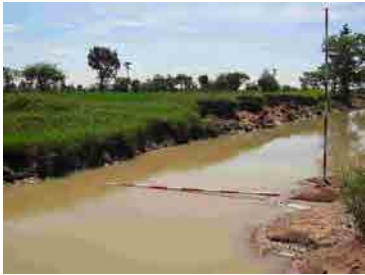
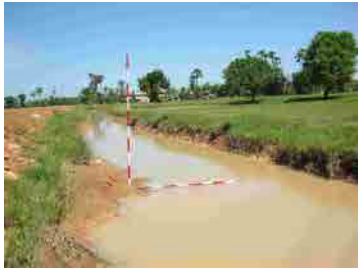
Canal No.: C23	Kind of structure: Canal	Remarks:
Station: 1.00+500	Coordinate< <div style="display: inline-block; vertical-align: middle; margin-left: 10px;">                     Northing: 1222773                      Easting: 452749                 </div>	Big erosion Length : 1500m

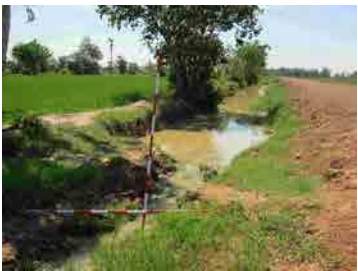
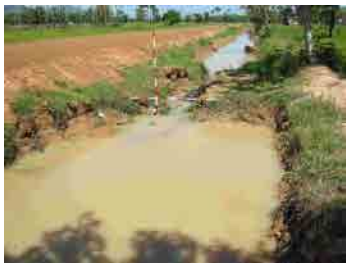
Canal No.: C23	Kind of structure: Embankment	Remarks:
Station: 1.00+580	Coordinate< <div style="display: inline-block; vertical-align: middle; margin-left: 10px;">                     Northing: 1222774                      Easting: 452830                 </div>	Routine survey

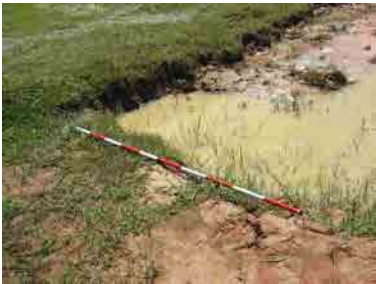
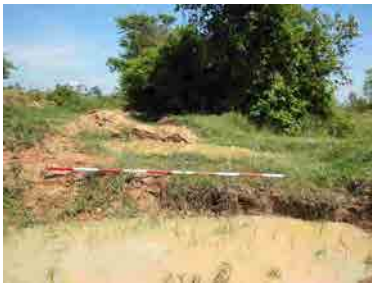
Canal No.: C23	Kind of structure: Canal	Remarks:
Station: 2.00+10	Coordinate< <div style="display: inline-block; vertical-align: middle; margin-left: 10px;">                     Northing: 1222779                      Easting: 453242                 </div>	Routine survey Length: 2000m

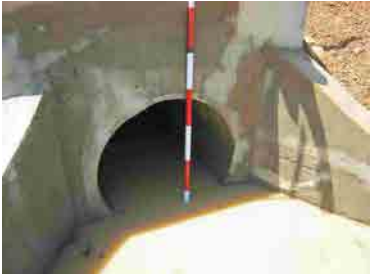
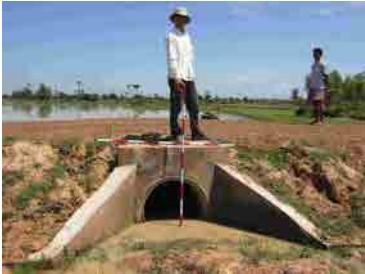
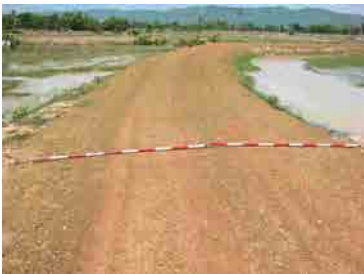
Canal No.: C23	Kind of structure: Pipe culvert	Remarks:
Station: 2.00+130	Coordinate< <div style="display: inline-block; vertical-align: middle; margin-left: 10px;">                     Northing: 1222806                      Easting: 453350                 </div>	Under commune road

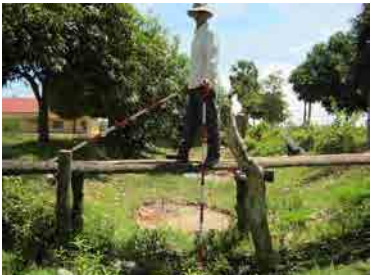
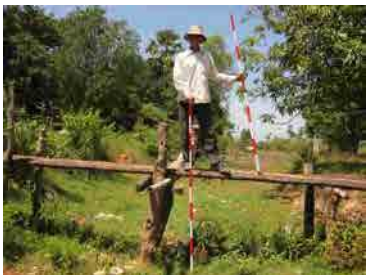
Canal No.: C23	Kind of structure: Bridge	Remarks:
Station: 2.00+460	Coordinate< <div style="display: inline-block; vertical-align: middle; margin-left: 10px;">                     Northing: 1222792                      Easting: 453610                 </div>	Routine survey Wooden bridge

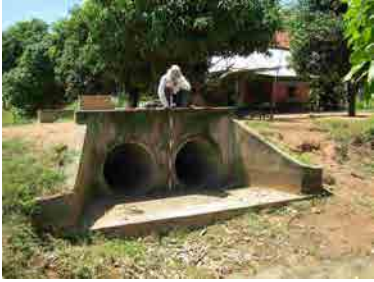
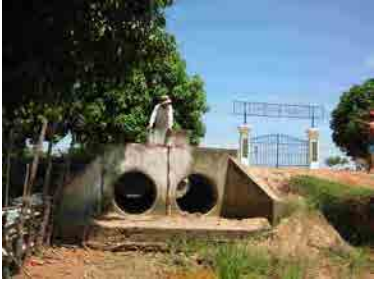
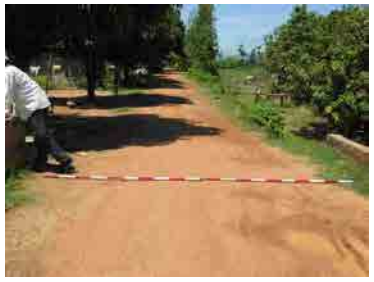
Canal No.: C23	Kind of structure: Pipe culvert (Double)	Remarks:
Station: 2.00+490	Coordinate< <div style="display: inline-block; vertical-align: middle; margin-left: 10px;">                     Northing: 1222818                      Easting: 453619                 </div>	Under commune road

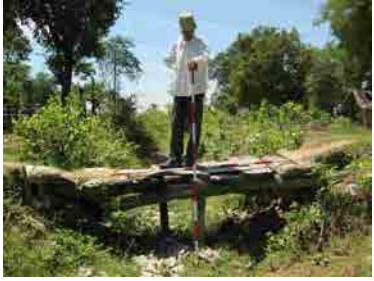
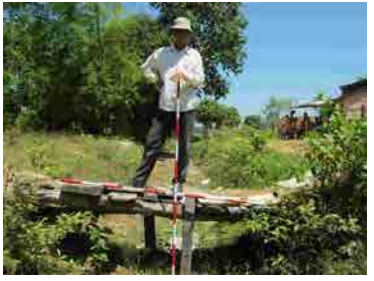
Canal No.: C23	Kind of structure: Wooden Bridge	Remarks:
Station: 2.00+590	Coordinate< <div style="display: inline-block; vertical-align: middle; margin-left: 10px;">                     Northing: 1222805                      Easting: 453714                 </div>	Routine survey

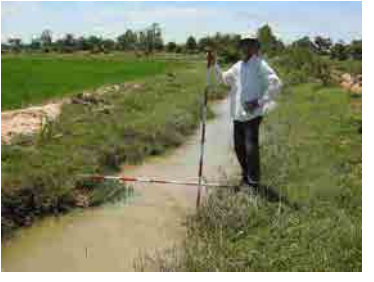
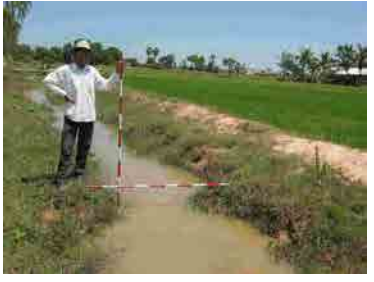
Canal No.: C23	Kind of structure: Canal	Remarks:
Station: 2.00+990	Coordinate< <div style="display: inline-block; vertical-align: middle; margin-left: 10px;">                     Northing: 1222794                      Easting: 454081                 </div>	Routine survey Length: 3000m

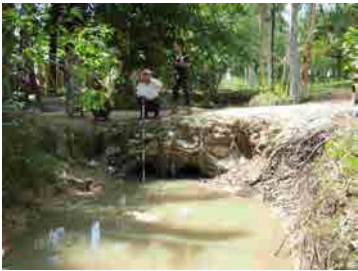
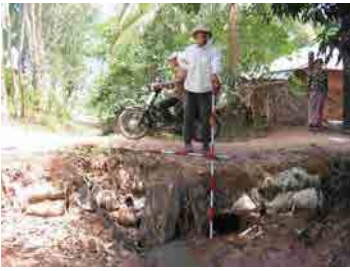
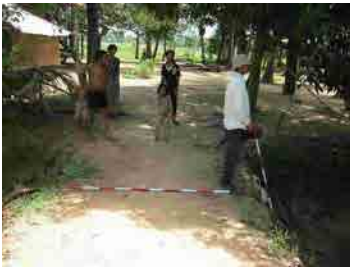
Sta.	E	N	Structure	Condition	Evaluation*	Flow Capacity	Remarks
3,260	454357	1222806	Culvert 18 (Double)	Double pipe culvert, 0.4 m dia, for house access; no riprap protection at inlet and outlet	B	c	Private house access
3,290	454375	1222806	Culvert 19	Culvert of 60 cm dia with 2 m long for house access, no protection for inlet and outlet	B	c	Private house access
3,300	454395	1222806	Culvert 20 (Double)	Double pipe culvert, 0.4 m dia, for house access; no riprap protection at inlet and outlet	B	c	Private house access
3,510	454595	1222811	Canal section	Canal section remains as canal, but not used, bottom width is 4 m and canal height is 1 m	B		
3,940	455011	1222822	Culvert 21	Culvert of 60 cm dia with 4 m long for village road, no inlet and outlet structure	B	c	Culvert on public road
4,010	455089	1222824	Canal section	Canal section remains as canal: rain water is ponded	B		
4,140	455214	1222828	Culvert (22)	Culvert of 50 cm dia with 2 m long for house access, no protection for inlet and outlet	B	c	Private house access Road along the canal seems be well maintained and functional

Canal No.: C23	Kind of structure: Pipe culvert (Double)	Remarks: Under house entrance road
Station: 3.00+260	Coordinate< <div style="display: flex; flex-direction: column; gap: 5px;"> <span>Northing: 1222806</span> <span>Easting: 454357</span> </div>

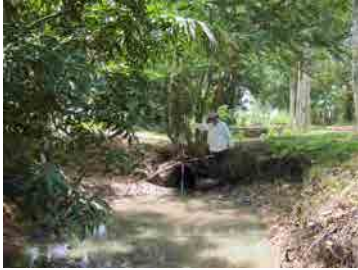
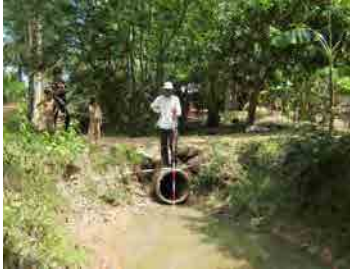
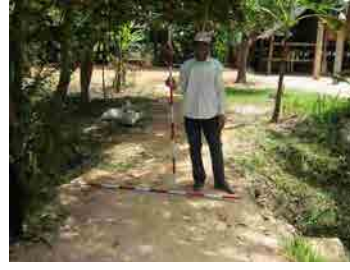
Canal No.: C23	Kind of structure: Pipe culvert	Remarks: Under house entrance road
Station: 3.00+290	Coordinate< <div style="display: flex; flex-direction: column; gap: 5px;"> <span>Northing: 1222806</span> <span>Easting: 454375</span> </div>

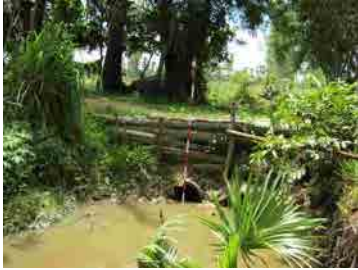
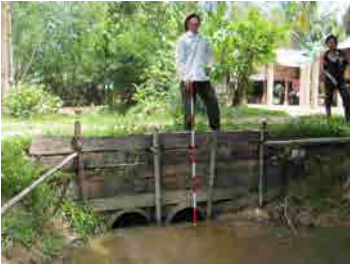
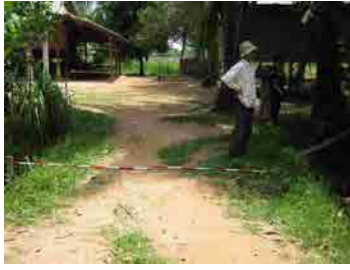
Canal No.: C23	Kind of structure: Pipe culvert (Double)	Remarks: Under house entrance road
Station: 3.00+300	Coordinate< <div style="display: flex; flex-direction: column; gap: 5px;"> <span>Northing: 1222806</span> <span>Easting: 454395</span> </div>

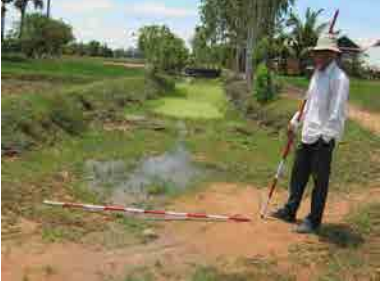
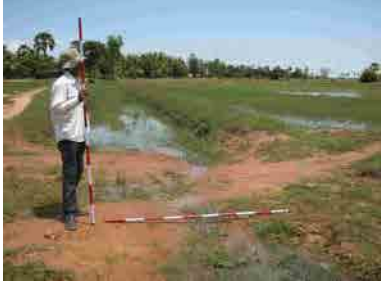
Canal No.: C23	Kind of structure: Pipe culvert	Remarks: Under small village road
Station: 3.00+510	Coordinate< Northing: 1222811 Easting: 454595

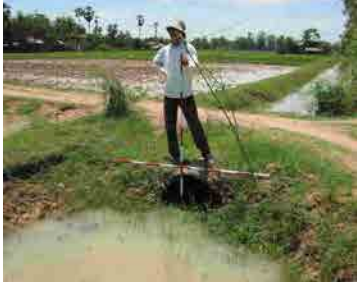
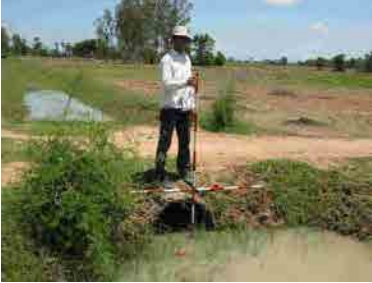
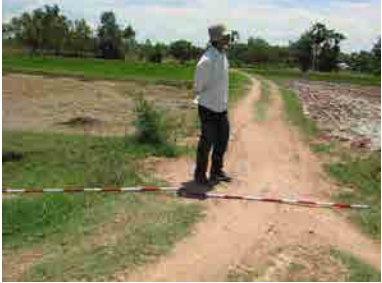
Canal No.: C23	Kind of structure: Pipe culvert	Remarks: Routine survey
Station: 3.00+940	Coordinate< Northing: 1222822 Easting: 455011

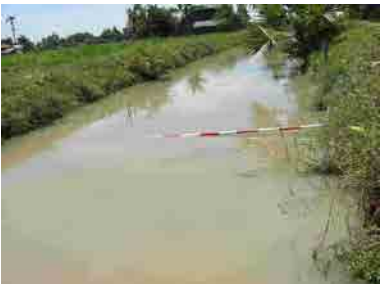
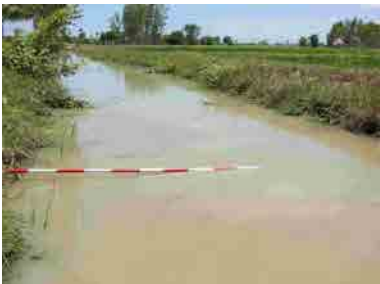
Canal No.: C23	Kind of structure: Canal	Remarks: Routine survey Length: 4000m
Station: 4.00+10	Coordinate< Northing: 1222824 Easting: 455089

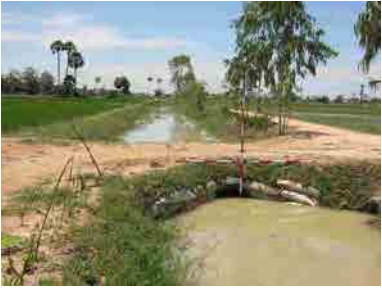
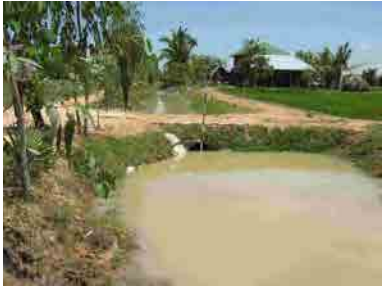
Canal No.: C23	Kind of structure: Bridge (Commune)	Remarks: Under commune road
Station: 4.00+140	Coordinate< <div style="display: flex; flex-direction: column; gap: 5px;"> <span>Northing: 1222828</span> <span>Easting: 455214</span> </div>	
<div style="display: flex; justify-content: space-around; align-items: center;"> <div style="text-align: center;">

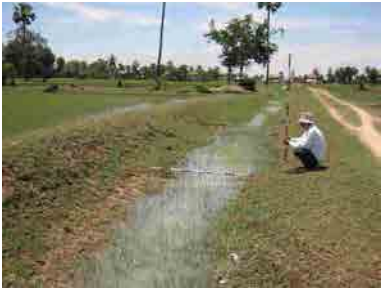
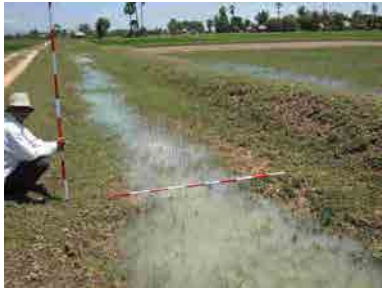
Canal No.: C23	Kind of structure: Canal	Remarks: Routine survey Length : 4500m
Station: 4.00+440	Coordinate< <div style="display: flex; flex-direction: column; gap: 5px;"> <span>Northing: 1222834</span> <span>Easting: 455529</span> </div>	
<div style="display: flex; justify-content: space-around; align-items: center;"> <div style="text-align: center;">

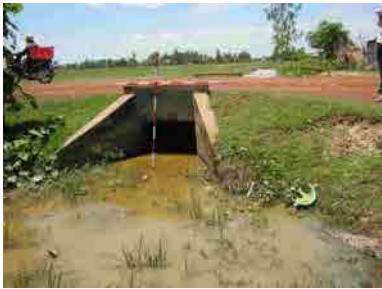
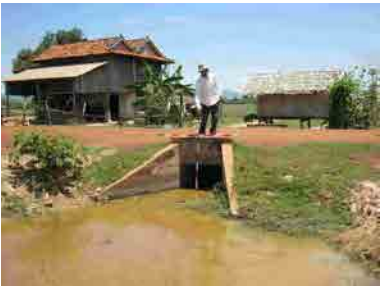
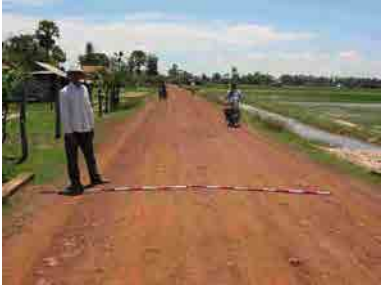
Canal No.: C23	Kind of structure: Bridge (Commune)	Remarks: Under commune road
Station: 4.00+780	Coordinate< <div style="display: flex; flex-direction: column; gap: 5px;"> <span>Northing: 1222842</span> <span>Easting: 455851</span> </div>	
<div style="display: flex; justify-content: space-around; align-items: center;"> <div style="text-align: center;">

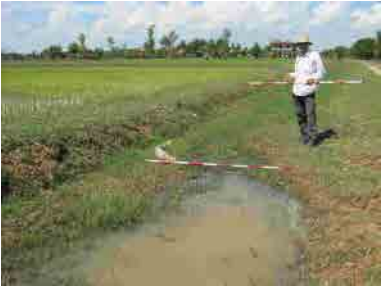
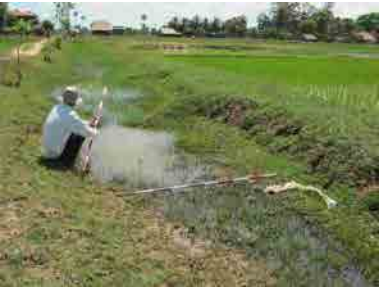
Canal No.: C23	Kind of structure: Canal	Remarks: Routine survey Length : 5000m
Station: 5.00	Coordinate< Northing: 1222845 Easting: 456002

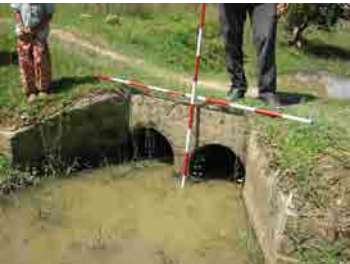
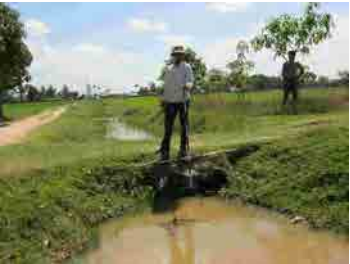
Canal No.: C23	Kind of structure: Pipe culvert (Double)	Remarks: Routine survey
Station: 5.00+160	Coordinate< Northing: 1222851 Easting: 456172

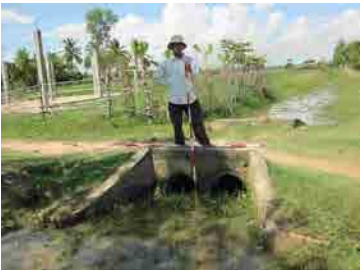
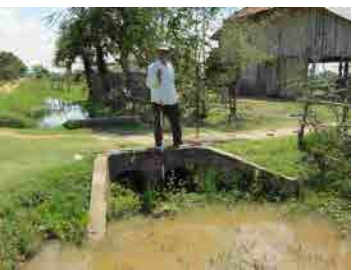
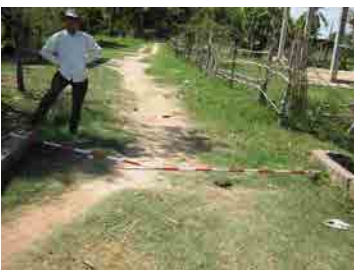
Canal No.: C23	Kind of structure: Pipe culvert (Double)	Remarks: Under village road
Station: 5.00+330	Coordinate< Northing: 1222857 Easting: 456326

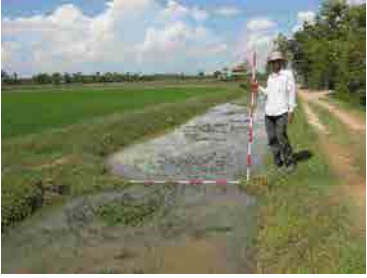
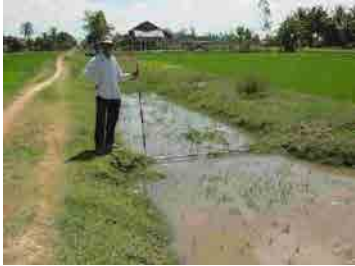
Canal No.: C23	Kind of structure: Canal	Remarks: Length : 5500m
Station: 5.00+400	Coordinate< <div style="display: flex; flex-direction: column; gap: 5px;"> <span>Northing: 1222853</span> <span>Easting: 456398</span> </div>	
<div style="display: flex; justify-content: space-around; align-items: center;"> <div style="text-align: center;">

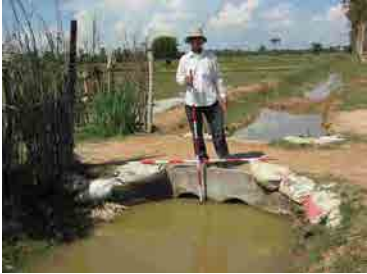
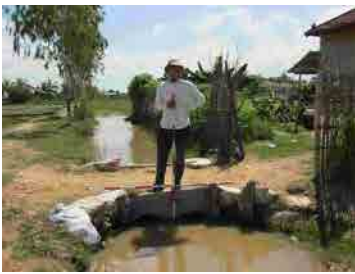
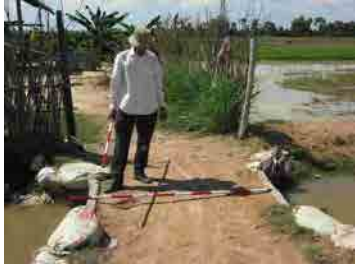
Canal No.: C23	Kind of structure: Pipe culvert (Double)	Remarks: Under house entrance road
Station: 5.00+590	Coordinate< <div style="display: flex; flex-direction: column; gap: 5px;"> <span>Northing: 1222860</span> <span>Easting: 456577</span> </div>	
<div style="display: flex; justify-content: space-around; align-items: center;"> <div style="text-align: center;">

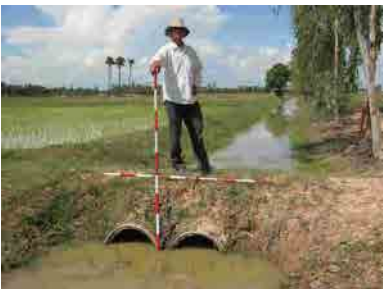
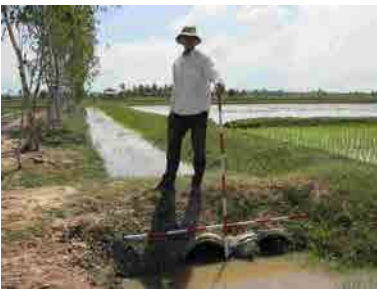
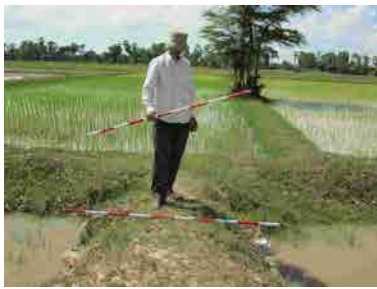
Canal No.: C23	Kind of structure: Pipe culvert (Double)	Remarks: Routine survey
Station: 5.00+820	Coordinate< <div style="display: flex; flex-direction: column; gap: 5px;"> <span>Northing: 1222865</span> <span>Easting: 456806</span> </div>	
<div style="display: flex; justify-content: space-around; align-items: center;"> <div style="text-align: center;">

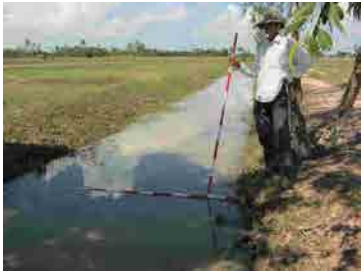
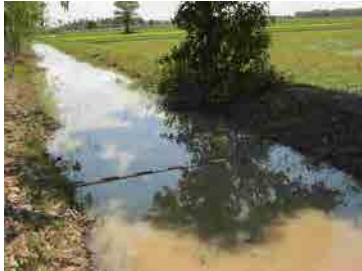
Canal No.: C23	Kind of structure: Canal	Remarks: Routine survey
Station: 5.00+910	Coordinate< <div style="display: flex; flex-direction: column; gap: 5px;"> <span>Northing: 1222867</span> <span>Easting: 456891</span> </div>	
<div style="display: flex; justify-content: space-around; align-items: center;"> <div style="text-align: center;">

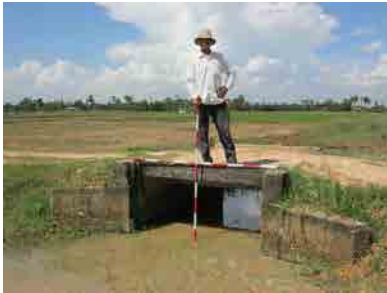
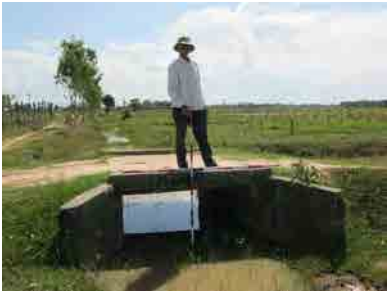
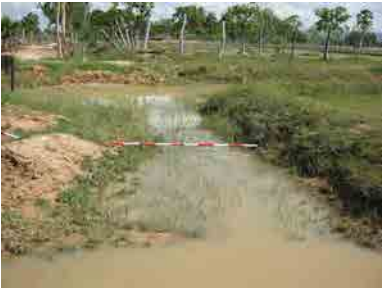
Canal No.: C23	Kind of structure: Bridge & groove	Remarks: Bridge is under village road
Station: 6.00+70	Coordinate< <div style="display: flex; flex-direction: column; gap: 5px;"> <span>Northing: 1222872</span> <span>Easting: 457046</span> </div>	
<div style="display: flex; justify-content: space-around; align-items: center;"> <div style="text-align: center;">

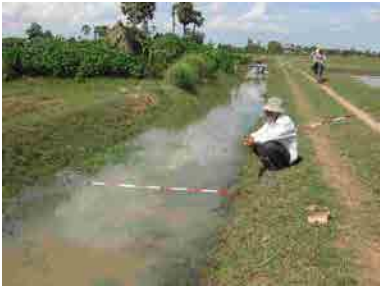
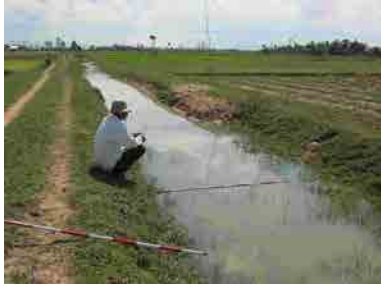
Canal No.: C23	Kind of structure: Canal	Remarks: Length of canal : 6500m
Station: 6.00+410	Coordinate< <div style="display: flex; flex-direction: column; gap: 5px;"> <span>Northing: 1222882</span> <span>Easting: 457373</span> </div>	
<div style="display: flex; justify-content: space-around; align-items: center;"> <div style="text-align: center;">
