# ***ANNEX D***

## ***Attachment – 1***

*Results of Inventory Survey for  
Proposed Rehabilitation Works in  
Roleang Chrey Headworks Rehabilitation Sub-project*

**Results of Inventory Survey for Proposed Rehabilitation Works on North Main Canal (1/12)**

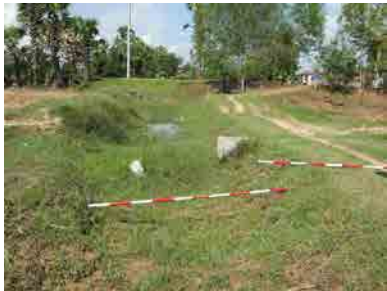
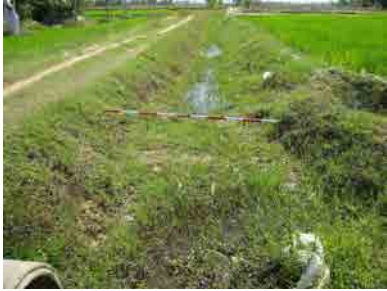
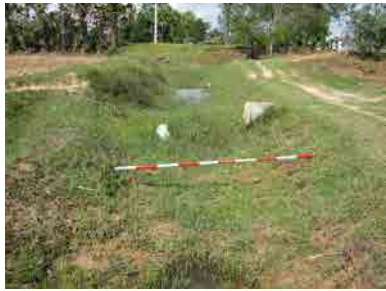
Up Stream View	Down Stream View	Side View

Canal No.: C23	Kind of structure: Canal	Remarks: Length : 7000m
Station: 6.00+910	Coordinate< <div style="display: flex; flex-direction: column; gap: 5px;"> <span>Northing: 1222899</span> <span>Easting: 457857</span> </div>

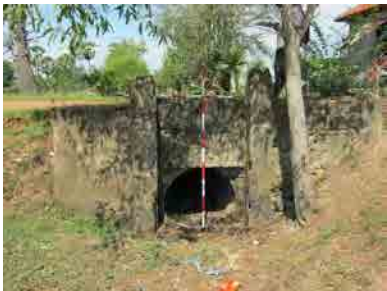
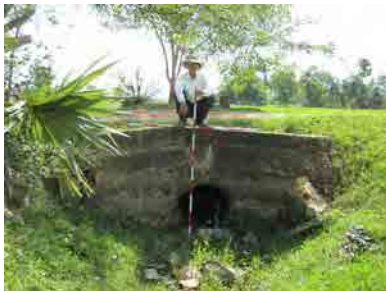
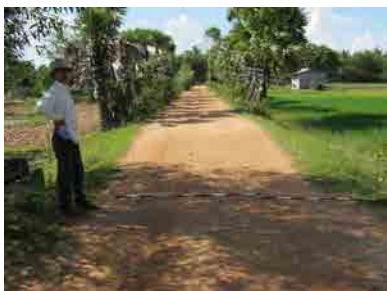
Up Stream View	Down Stream View	Side View

Canal No.: C23	Kind of structure: Bridge	Remarks: Under commune road
Station: 6.00+940	Coordinate< <div style="display: flex; flex-direction: column; gap: 5px;"> <span>Northing: 1222898</span> <span>Easting: 457883</span> </div>

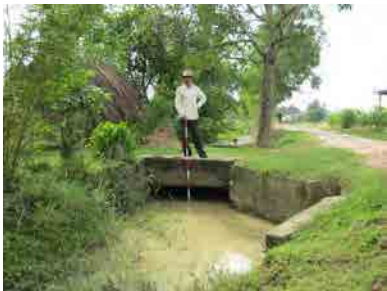
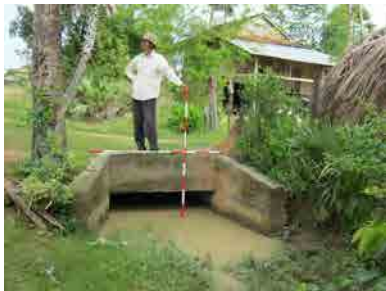
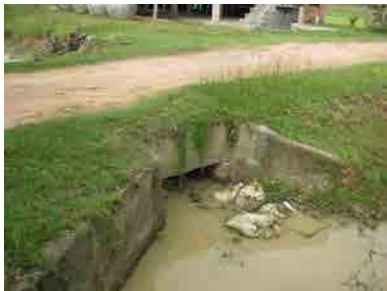
Up Stream View	Down Stream View	Structure

Canal No.: C23	Kind of structure: Bridge & groove	Remarks: Under house entrance road Groove : water flow into pond
Station: 7.00+150	Coordinate< <div style="display: flex; flex-direction: column; gap: 5px;"> <span>Northing: 1222873</span> <span>Easting: 458052</span> </div>

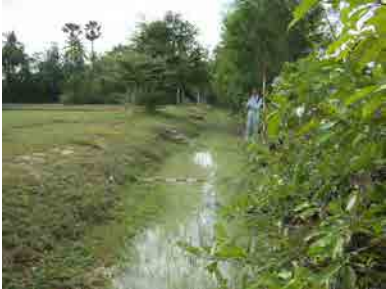
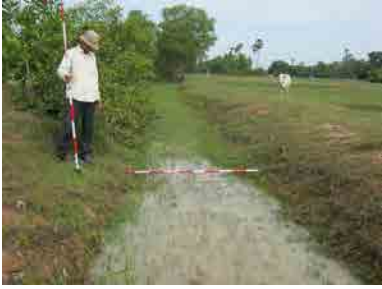
Up Stream View		Down Stream View

Canal No.: C23	Kind of structure: Canal	Remarks:
Station: 7.00+440	Coordinate< <div style="display: flex; flex-direction: column; gap: 5px;"> <span>Northing: 1222832</span> <span>Easting: 458309</span> </div>	Routine survey Length : 7500m

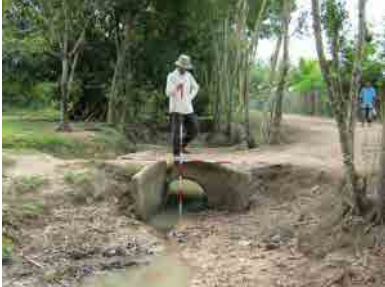
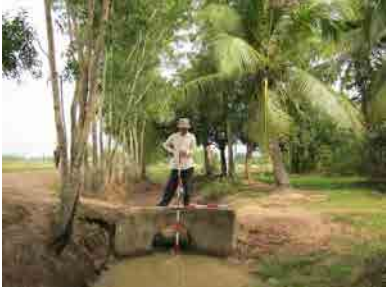
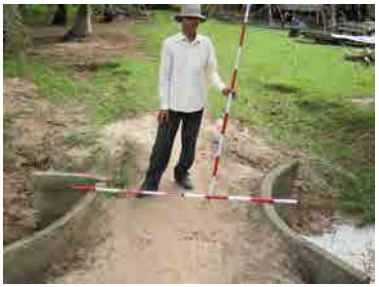
Up Stream View		Down Stream View

Canal No.: C23	Kind of structure: Pipe Culvert	Remarks:
Station: 7.00+570	Coordinate< <div style="display: flex; flex-direction: column; gap: 5px;"> <span>Northing: 1222816</span> <span>Easting: 458429</span> </div>	Under house entrance road

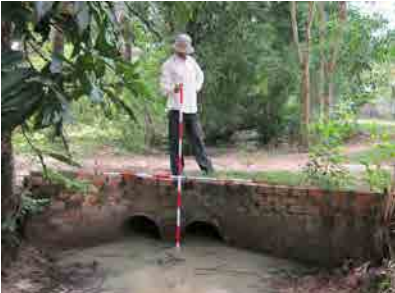
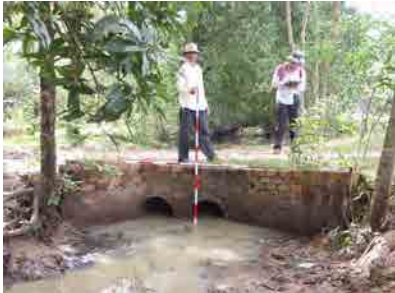
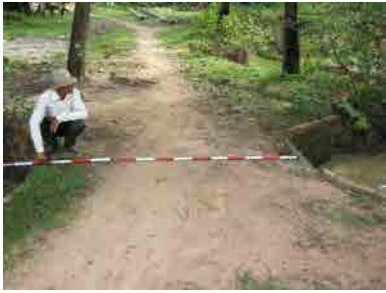
Up Stream View		Down Stream View

Canal No.: C23	Kind of structure: Pipe Culvert (Double)	Remarks:
Station: 7.00+590	Coordinate< <div style="display: flex; flex-direction: column; gap: 5px;"> <span>Northing: 1222812</span> <span>Easting: 458449</span> </div>	Under house entrance road

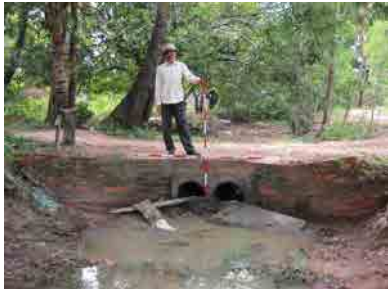
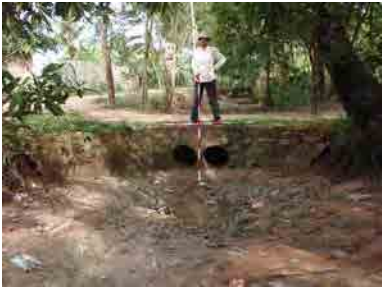
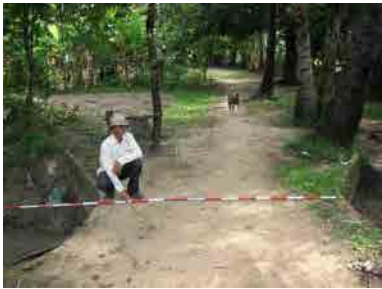
Up Stream View	Down Stream View	Side View

Sta.	E	N	Structure	Condition	Evaluation*	Flow Capacity	Remarks
7,660	458508	1222798	Culvert 29 (Double)	Two pipes with 50 cm dia, 2.8 m long for house access, no protection for inlet and outlet; wingwall is made by bricks	B	c	Private house access The canal is used as draiange canal
7,720	458569	1222784	Culvert 30 (Double)	Two pipes with 50 cm dia, 2.8 m long for house access, no protection for inlet and outlet; wingwall is made by bricks	B	c	Private house access The canal is used as draiange canal
7,820	458652	1222774	Bridge 8 (Private)	Bridge of 2.5 m wide and 1.6 m span for private access	B	b	Private house access
7,970	458778	1222774	Culvert 31 (Dia.=1m)	Culvert of 80 cm dia with 2.8 m long for house access, no inlet and outlet are made by hollow bricks	B	b	Private house access
8,020	458829	1222769	Culvert 32 (Double)	Two pipes with 50 cm dia, 2.6 m long for house access, no protection for inlet and outlet	B	c	Private house access

Canal No.: C23	Kind of structure: Pipe Culvert (Double)	Remarks: Under house entrance road
Station: 7.00+660	Coordinate< <div style="display: flex; flex-direction: column; gap: 5px;"> <span>Northing: 1222798</span> <span>Easting: 458508</span> </div>

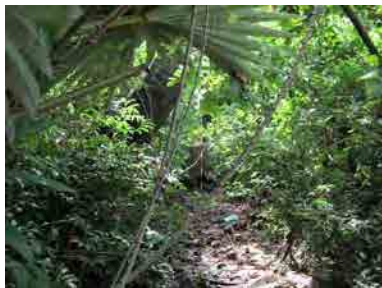
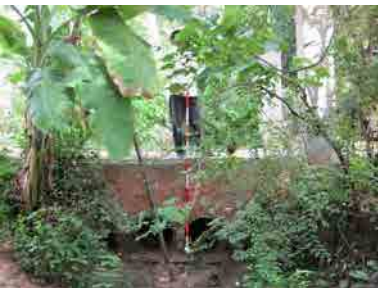
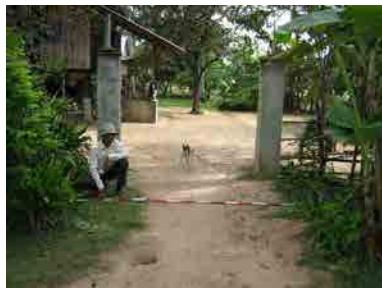
Up Stream View	Down Stream View	Side View

Canal No.: C23	Kind of structure: Pipe Culvert (Double)	Remarks: Routine survey Under house entrance road
Station: 7.00+720	Coordinate< <div style="display: flex; flex-direction: column; gap: 5px;"> <span>Northing: 1222784</span> <span>Easting: 458569</span> </div>

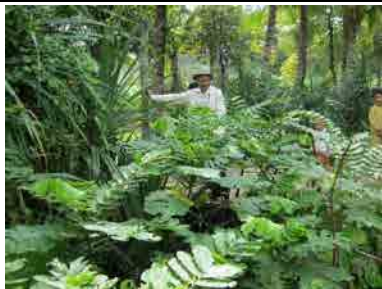
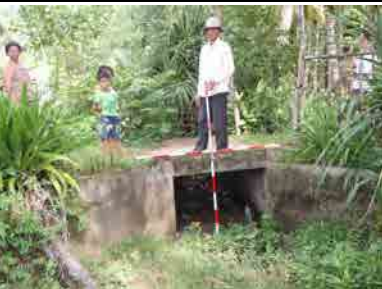
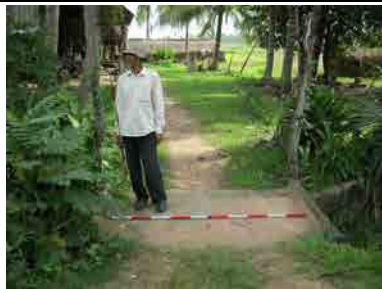
Up Stream View	Down Stream View	Side View

Canal No.: C23	Kind of structure: Bridge (Box culvert)	Remarks: Under house entrance road
Station: 7.00+820	Coordinate< <div style="display: flex; flex-direction: column; gap: 5px;"> <span>Northing: 1222774</span> <span>Easting: 458652</span> </div>

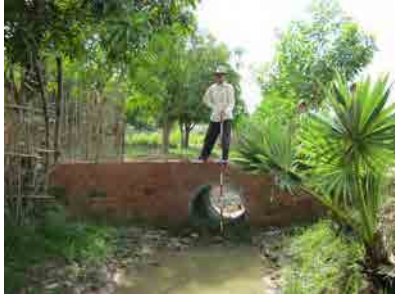
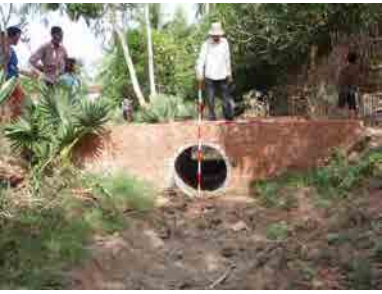
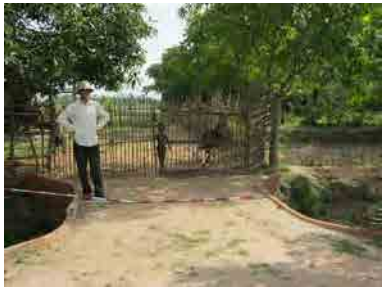
Up Stream View	Down Stream View	Side View

Canal No.: C23	Kind of structure: Pipe culvert	Remarks: Under house entrance road Diameter of pipe : 1m
Station: 7.00+970	Coordinate< Northing: 1222774 Easting: 458778

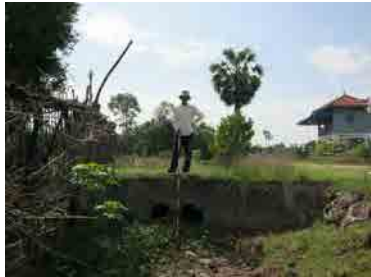
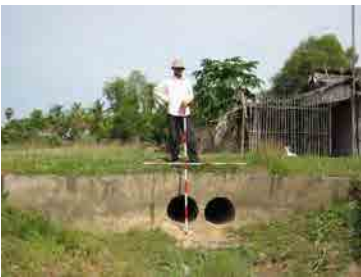
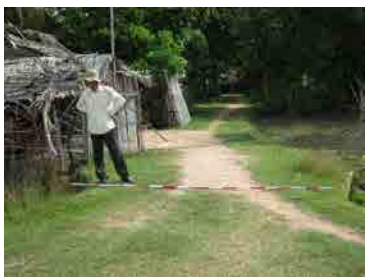
Up Stream View	Down Stream View	Side View

Canal No.: C23	Kind of structure: Pipe culvert (Double)	Remarks: Under house entrance road
Station: 8.00+20	Coordinate< Northing: 1222769 Easting: 458829

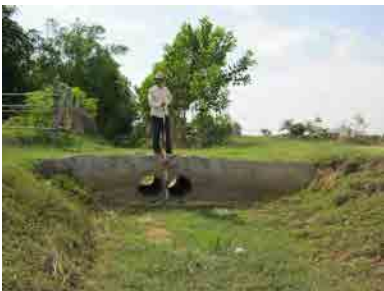
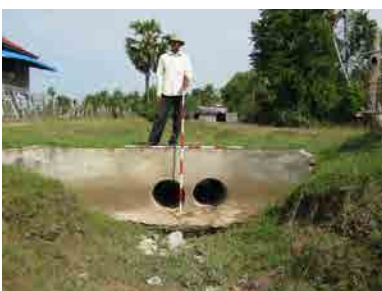
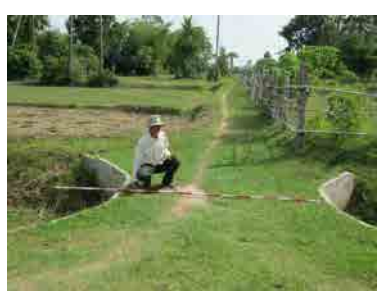
Up Stream View	Down Stream View	Side View

Canal No.: C23	Kind of structure: Pipe culvert (Double)	Remarks: Under small bicycle road There is a groove (to pond)
Station: 8.00+100	Coordinate< Northing: 1222760 Easting: 458904

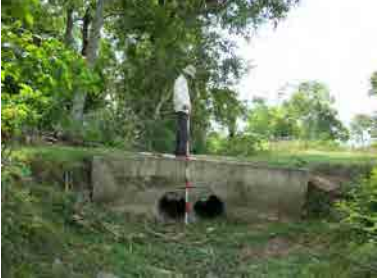
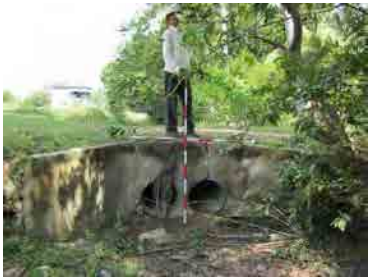
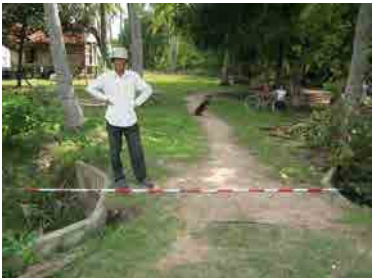
</div> <div style="display: flex; justify-content: space-around; margin-top: 10px;"> <span>Up Stream View</span> <span>Down Stream View</span> <span>Side View</span> </div>

Canal No.: C23	Kind of structure: Pipe culvert (Double)	Remarks: Under house entrance road
Station: 8.00+180	Coordinate< <div style="display: flex; flex-direction: column; gap: 5px;"> <span>Northing: 1222758</span> <span>Easting: 458978</span> </div>	
<div style="display: flex; justify-content: space-around;">

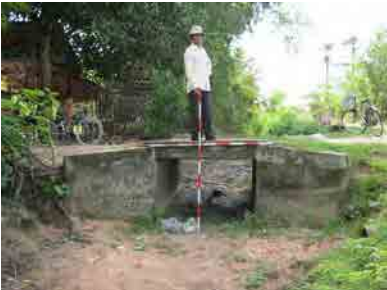
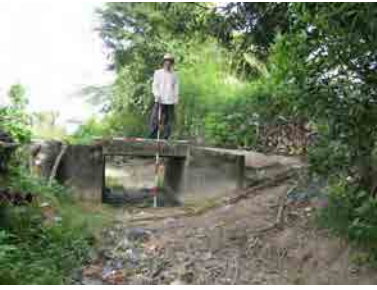
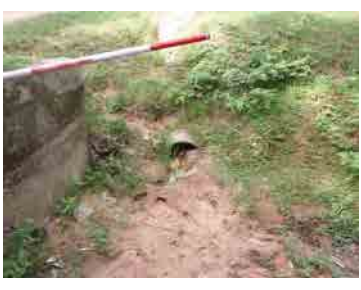
Canal No.: C23	Kind of structure: Bridge (Private)	Remarks: Under house entrance road A groove (to secondary canal)
Station: 8.00+250	Coordinate< <div style="display: flex; flex-direction: column; gap: 5px;"> <span>Northing: 1222753</span> <span>Easting: 459038</span> </div>	
<div style="display: flex; justify-content: space-around;">

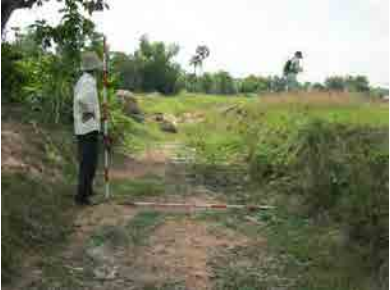
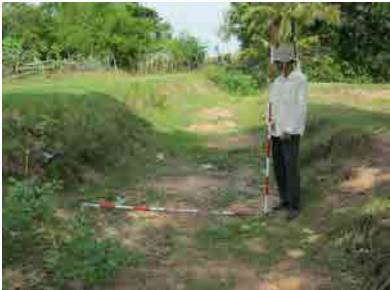
Canal No.: C23	Kind of structure: Canal	Remarks: Length : 8500m
Station: 8.00+320	Coordinate< <div style="display: flex; flex-direction: column; gap: 5px;"> <span>Northing: 1222743</span> <span>Easting: 459115</span> </div>	
<div style="display: flex; justify-content: space-around;">

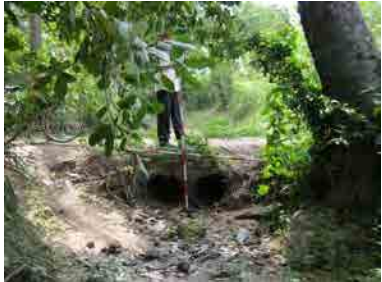
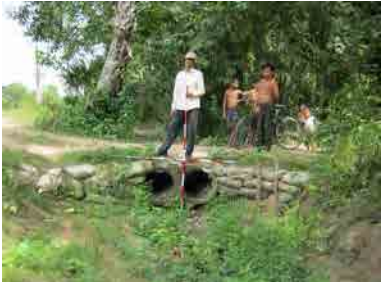
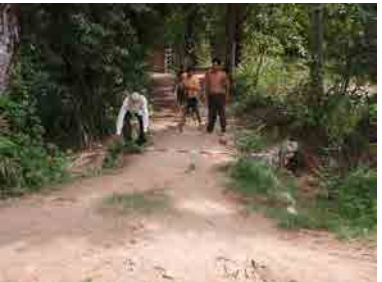
Canal No.: C23	Kind of structure: Pipe culvert (Double)	Remarks: Under village road
Station: 8.00+540	Coordinate< <div style="display: flex; flex-direction: column; gap: 5px;"> <span>Northing: 1222728</span> <span>Easting: 459315</span> </div>

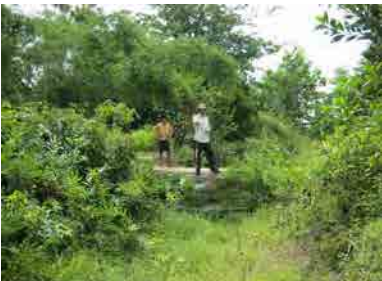
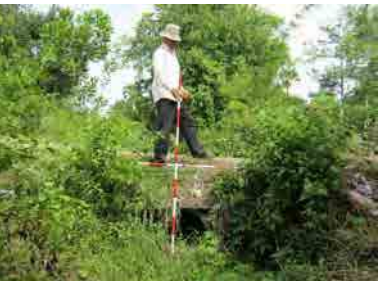
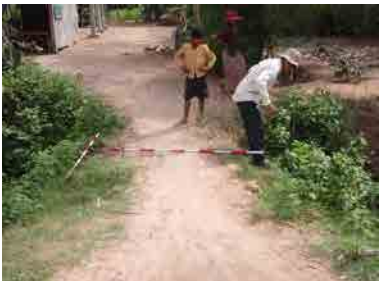
Canal No.: C23	Kind of structure: Pipe culvert (Double)	Remarks: Under house entrance road
Station: 8.00+630	Coordinate< <div style="display: flex; flex-direction: column; gap: 5px;"> <span>Northing: 1222721</span> <span>Easting: 459392</span> </div>

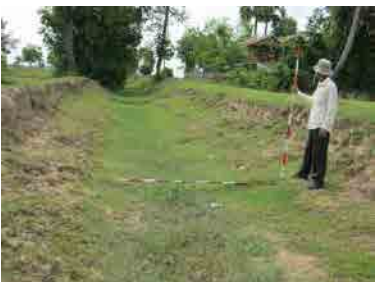
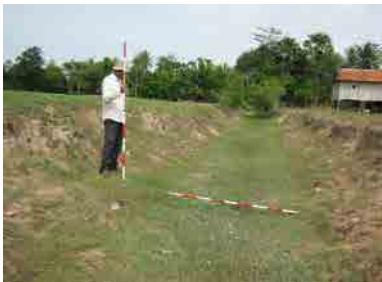
Canal No.: C23	Kind of structure: Canal	Remarks: Routine survey Length : 9000m
Station: 8.00+820	Coordinate< <div style="display: flex; flex-direction: column; gap: 5px;"> <span>Northing: 1222705</span> <span>Easting: 459565</span> </div>

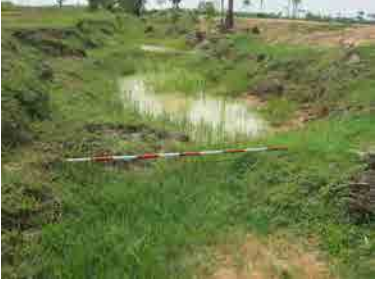
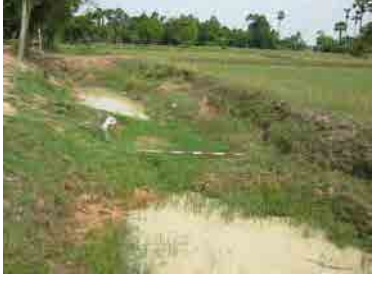
Canal No.: C23	Kind of structure: Canal	Remarks:
Station: 9.00+70	Coordinate< <div style="display: flex; justify-content: space-between; padding: 0 10px;"> <span>Northing: 1222684</span> <span>Easting: 459794</span> </div>	Routine survey Length : 9250m

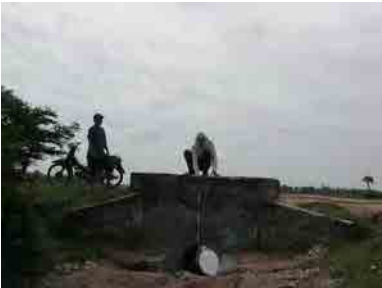
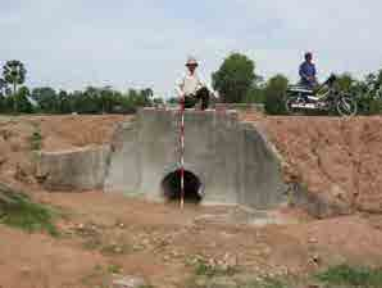
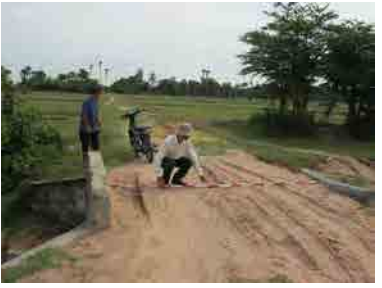
Canal No.: C23	Kind of structure: Pipe culvert	Remarks:
Station: 9.00+220	Coordinate< <div style="display: flex; justify-content: space-between; padding: 0 10px;"> <span>Northing: 1222677</span> <span>Easting: 459943</span> </div>	Under bicycle road

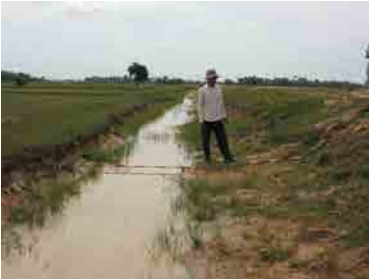
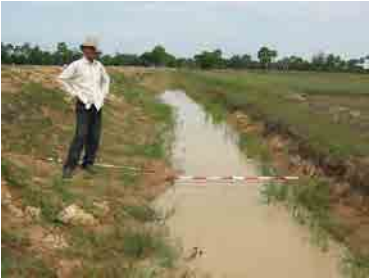
Canal No.: C23	Kind of structure: Canal	Remarks:
Station: 9.00+370	Coordinate< <div style="display: flex; justify-content: space-between; padding: 0 10px;"> <span>Northing: 1222667</span> <span>Easting: 460093</span> </div>	Routine survey Length :9750m

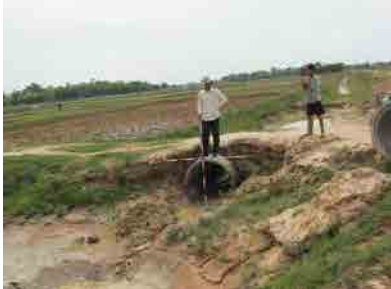
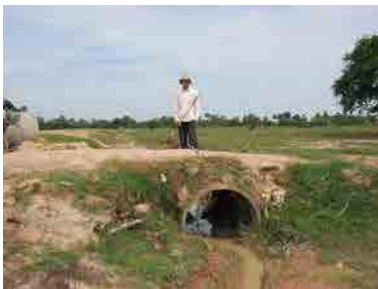
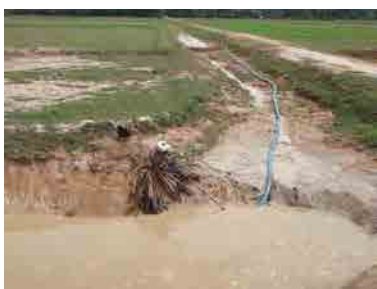
Canal No.: C23	Kind of structure: Pipe culvert	Remarks:
Station: 9.00+510	Coordinate< <div style="display: flex; justify-content: space-between; padding: 0 10px;"> <span>Northing: 1222667</span> <span>Easting: 460239</span> </div>	Routine survey Pipe for Pumping up

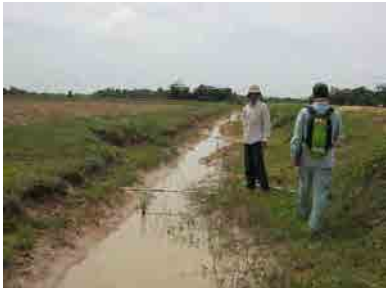
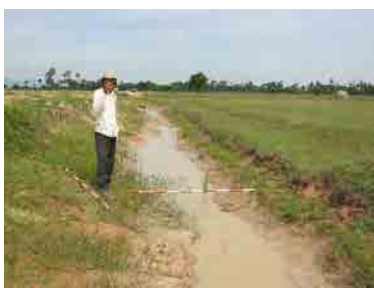
Canal No.: C23	Kind of structure: Canal	Remarks:
Station: 9.00+630	Coordinate< <div style="display: flex; justify-content: space-between; padding: 0 10px;"> <span>Northing: 1222659</span> <span>Easting: 460350</span> </div>	Routine survey Length : 10,000m

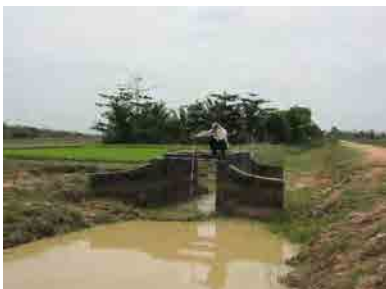
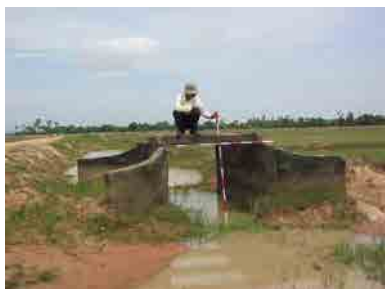
Canal No.: C23	Kind of structure: Bridge (Unused)	Remarks:
Station: 9.00+760	Coordinate< <div style="display: flex; justify-content: space-between; padding: 0 10px;"> <span>Northing: 1222660</span> <span>Easting: 460486</span> </div>	There is a groove

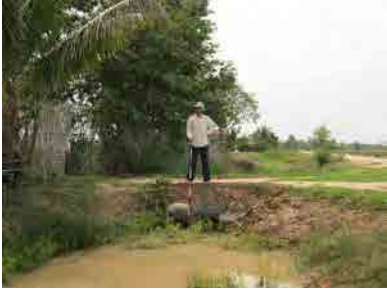
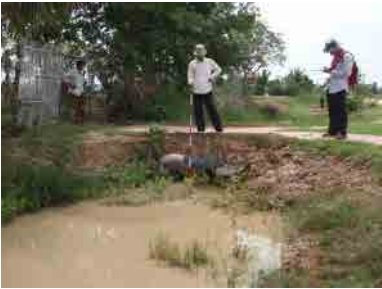
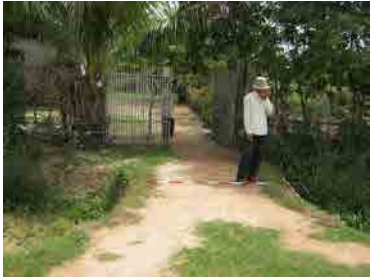
Canal No.: C23	Kind of structure: Pipe culvert (Double)	Remarks: Under house entrance road
Station: 9.00+830	Coordinate< Northing: 1222666 Easting: 460563

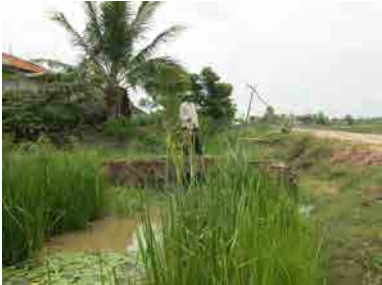
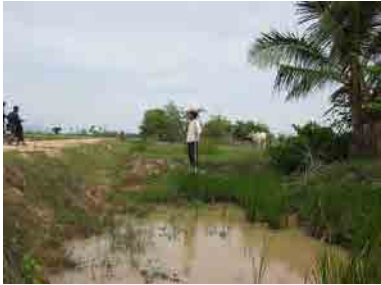
Canal No.: C23	Kind of structure: Pipe culvert	Remarks: Routine survey
Station: 9.00+930	Coordinate< Northing: 1222666 Easting: 460650

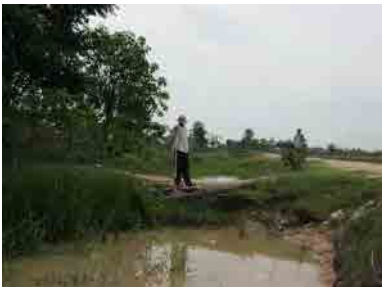
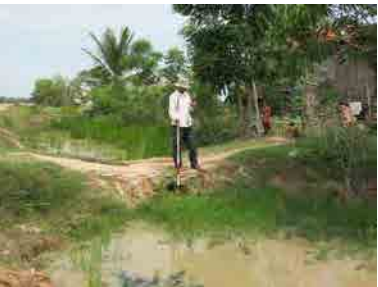
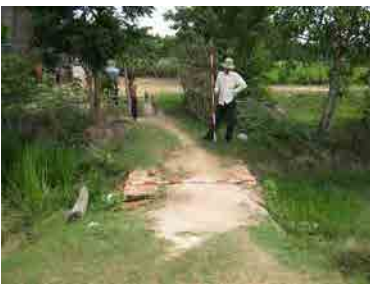
Canal No.: C23	Kind of structure: Pipe culvert	Remarks: Under house entrance road
Station: 9.00+970	Coordinate< Northing: 1222663 Easting: 460677

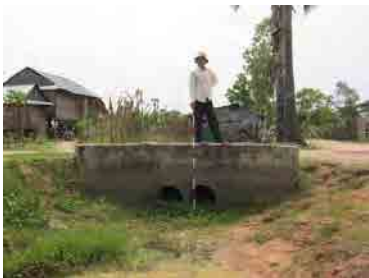
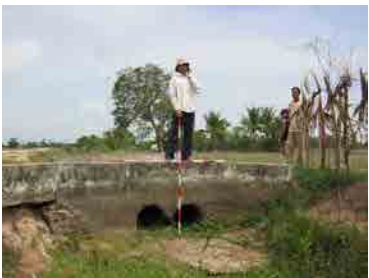
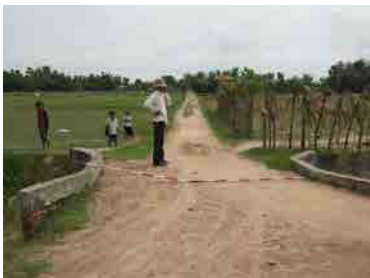
Canal No.: C23	Kind of structure: Pipe culvert (Double)	Remarks: Under village road
Station: 10.00+140	Coordinate< <div style="display: inline-block; vertical-align: middle; margin-left: 10px;">                     Northing: 1222668                      Easting: 460854                 </div>

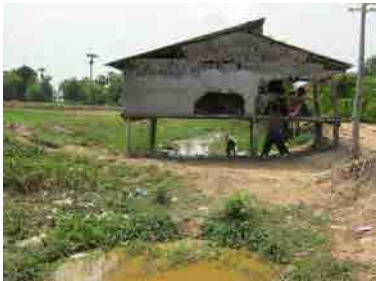
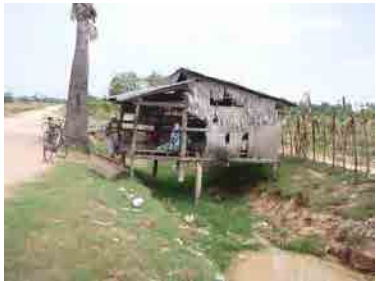
Canal No.: C23	Kind of structure: House	Remarks: House is under canal
Station: 10.00+200	Coordinate< <div style="display: inline-block; vertical-align: middle; margin-left: 10px;">                     Northing: 1222667                      Easting: 460921                 </div>

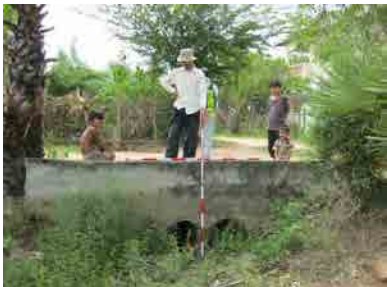
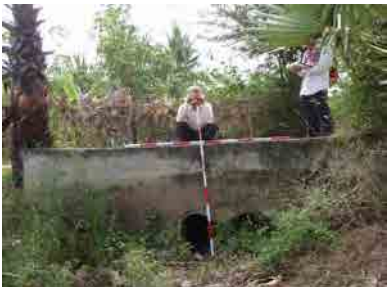
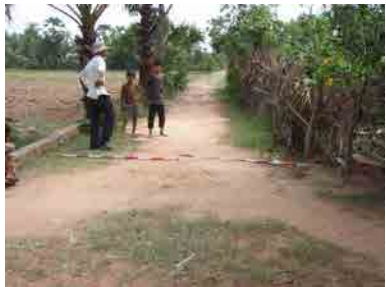
Canal No.: C23	Kind of structure: Pipe culvert (Double)	Remarks: Routine survey Under village road
Station: 10.00+300	Coordinate< <div style="display: inline-block; vertical-align: middle; margin-left: 10px;">                     Northing: 1222671                      Easting: 461009                 </div>

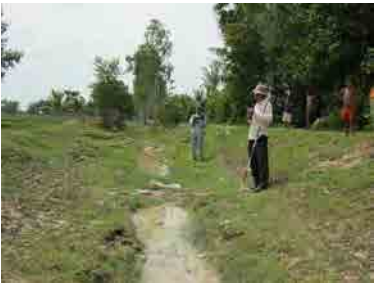
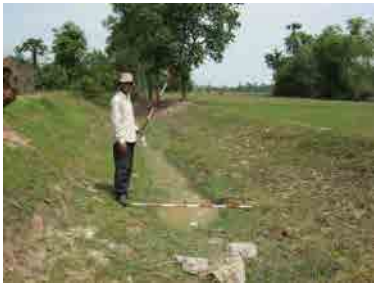
Canal No.: C23	Kind of structure: Canal	Remarks: Routine survey Length : 10,500m
Station: 10.00+470	Coordinate< <div style="display: flex; justify-content: space-between; padding: 0 10px;"> <span>Northing: 1222674</span> <span>Easting: 461176</span> </div>

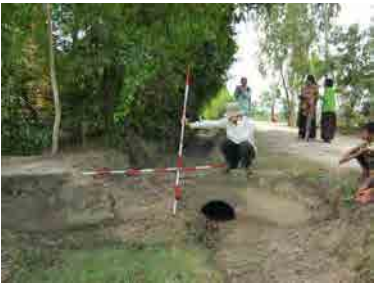
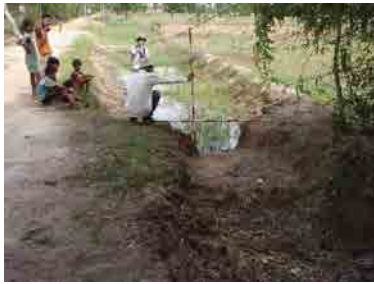
Canal No.: C23	Kind of structure: Pipe culvert	Remarks: All pipe culverts are broken
Station: 10.00+670	Coordinate< <div style="display: flex; justify-content: space-between; padding: 0 10px;"> <span>Northing: 1222680</span> <span>Easting: 461373</span> </div>

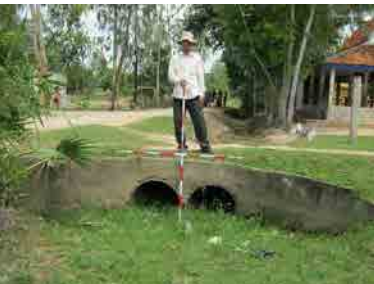
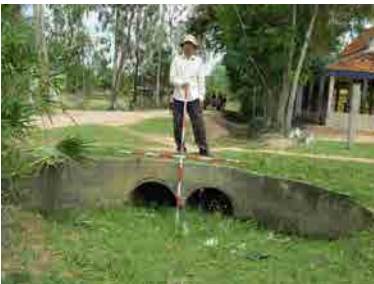
Canal No.: C23	Kind of structure: Pipe culvert (Double)	Remarks: Under village road
Station: 10.00+700	Coordinate< <div style="display: flex; justify-content: space-between; padding: 0 10px;"> <span>Northing: 1222680</span> <span>Easting: 461409</span> </div>

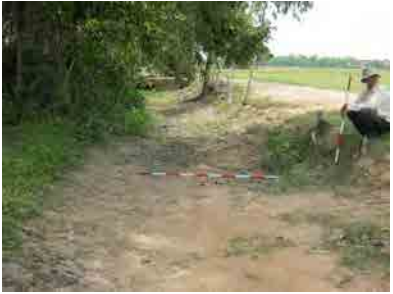
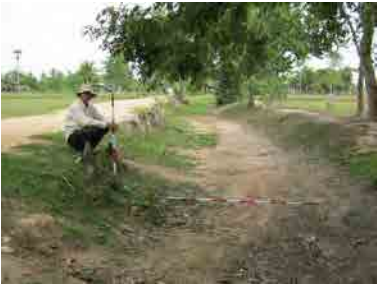
Canal No.: C23	Kind of structure: Canal	Remarks:
Station: 10.00+830 (EP)	Coordinate< Northing: 1222682 Easting: 461544	Routine survey End Point of canal

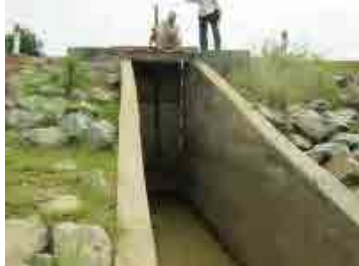
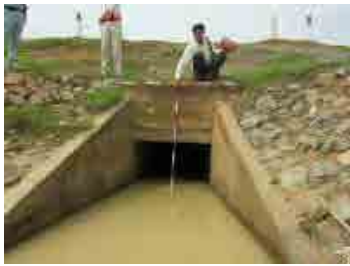
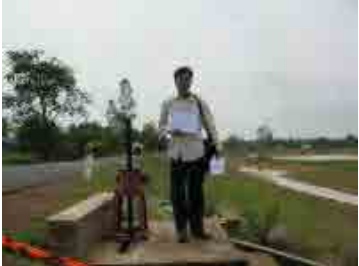
Canal No.: C24	Kind of structure(s): Gate	Remarks: Intake Gate
Station: 0.00(B.P.)	Coordinate< Northing: 1223268 Easting: 447987

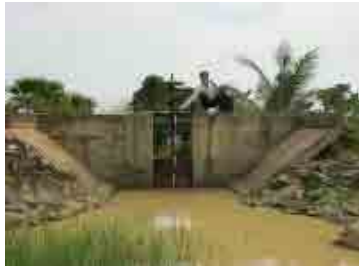
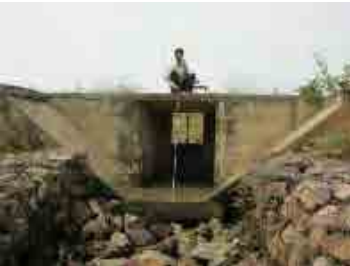
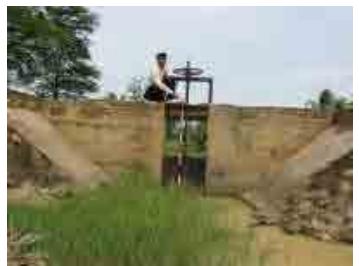
Sta.	E	N	Structure	Condition	Evaluation	Flow Capacity	Remarks
0	447987	1223268	B.P.		A		On the reservoir
50	447998	1223308	Division Structure with gate	Gates are functional, outlet is eroded a little	A		Constructed under Urgent rehabilitation work by MOWRAM in 2005
250	448003	1223436	Pipe Culvert 1	Single pipe of 0.9 m dia and 3 m long	B	c	Hosue access
340	448011	1223508	Pipe Culvert 2	Single pipe of 0.9 m dia and 3 m long	B	c	Hosue access
420	448015	1223581	Pipe Culvert 3 & Groove	Division structure for two canals, culvert of 0.9 m dia and 3 m long, inlet of culvert has grooves	D	c	Division structure and CV on village road
500	448015	1223667	Canal section	Canal section is well maintained; water surface width is about 2 m	B		
810	448029	1223888	Pipe Culvert 4	Single pipe of 0.7 m dia and 2.2 m long	D	c	on inspection road
1,000	448240	1223883	Pipe Culvert 5 & Groove	Single pipe of 0.6 m dia and 4 m long, grooves on the inlet	C	c	Farm access

Canal No.: C24	Kind of structure(s): Gate	Remarks: Inflow from Left(westward) Gate
Station: 0.00+50	Coordinate< Northing: 1223308 Easting: 447998

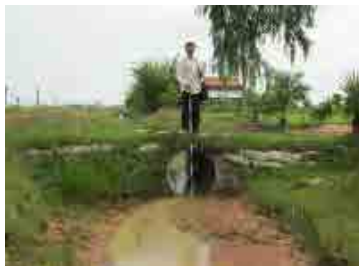
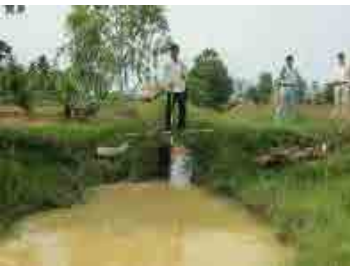
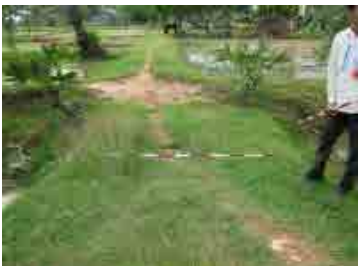
Canal No.: C24	Kind of structure(s): Pipe Culvert	Remarks:
Station: 0.00+250	Coordinate< Northing: 1223436 Easting: 448003

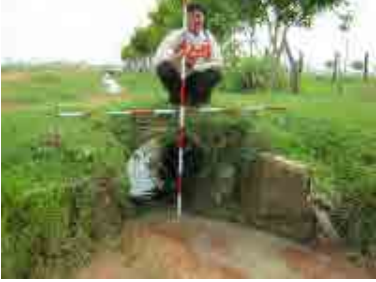
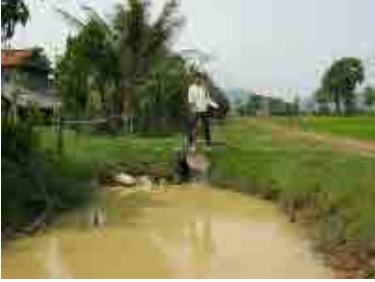
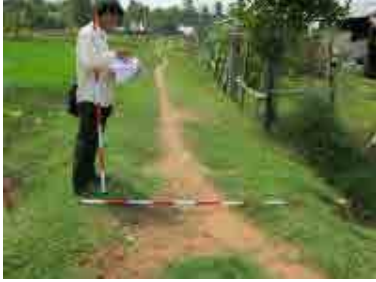
Canal No.: C24	Kind of structure(s): Pipe Culvert	Remarks:
Station: 0.00+340	Coordinate< Northing: 1223508 Easting: 448011

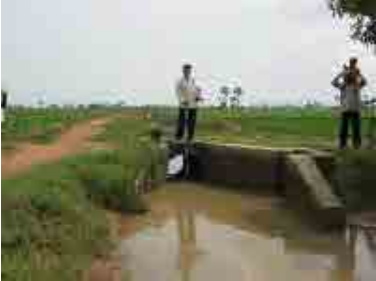
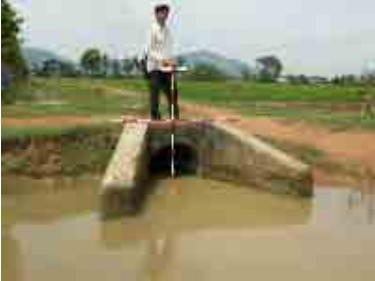
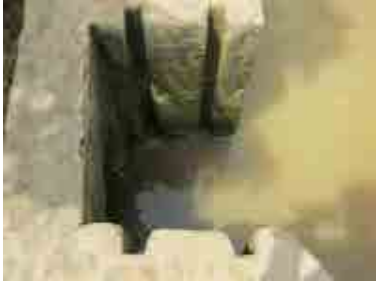
Canal No.: C24	Kind of structure(s): Pipe Culvert	Remarks: In/Out-flow from both bank
Station: 0.00+420	Coordinate< Northing: 1223581 Easting: 448015

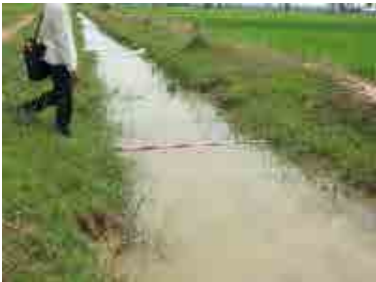
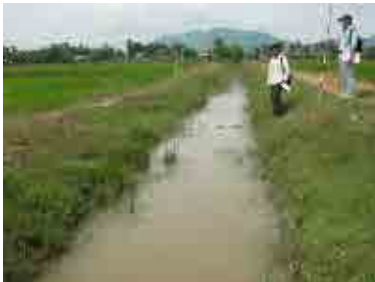
Canal No.: C24	Kind of structure(s): Canal	Remarks: Routine survey (every 500m)
Station: 0.00+500	Coordinate< Northing: 1223677 Easting: 448015

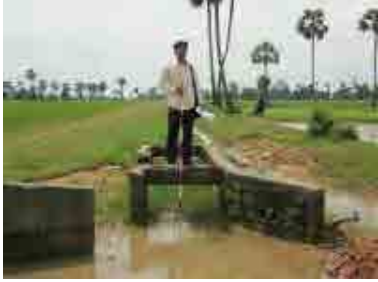
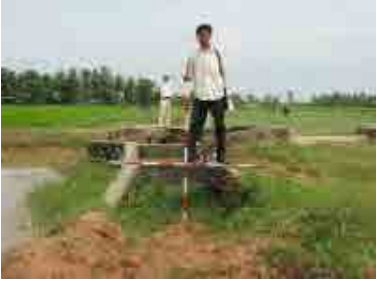
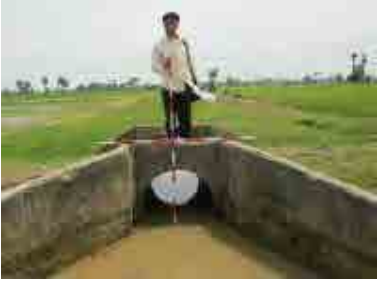
Canal No.: C24	Kind of structure(s): Pipe Culvert	Remarks: Canal turning point (Direction change from North to East)
Station: 0.00+810	Coordinate< Northing: 1223888 Easting: 448029

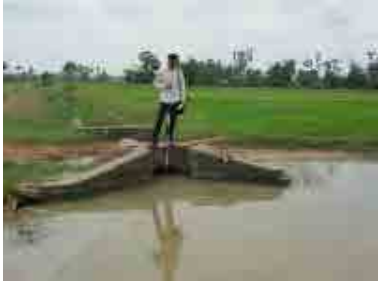
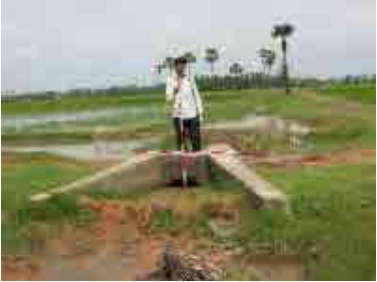
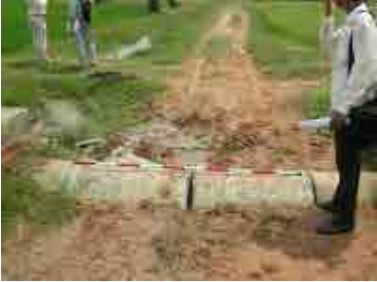
Canal No.: C24	Kind of structure(s): Pipe Culvert	Remarks: - Pipe culvert with groove - Routine survey
Station: 1.00	Coordinate< Northing: 1223883 Easting: 448015

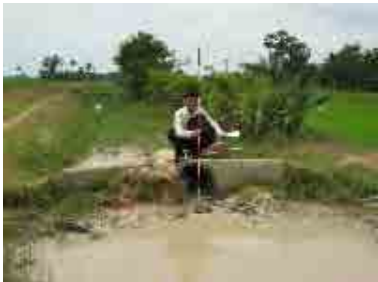
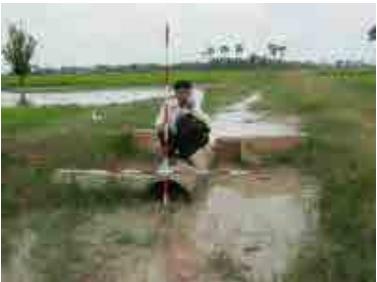
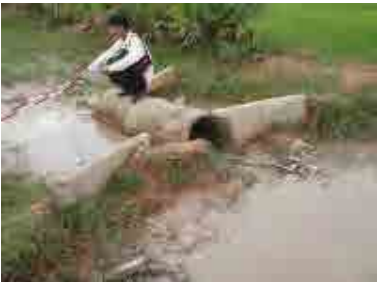
Canal No.: C24	Kind of structure(s): Pipe Culvert	Remarks:
Station: 1.00 + 110	Coordinate< Northing: 1223886 Easting: 448344

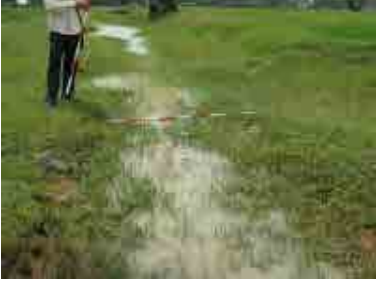
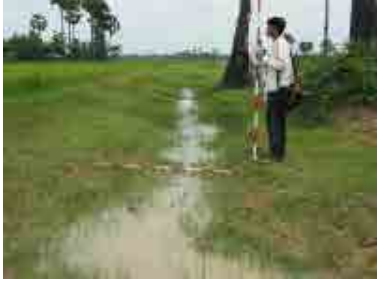
Canal No.: C24	Kind of structure(s): Canal	Remarks: - Routine survey
Station: 1.00+ 500	Coordinate< Northing: 1223890 Easting: 448702

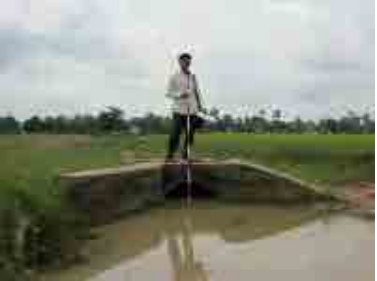
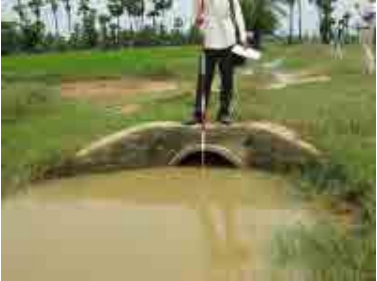
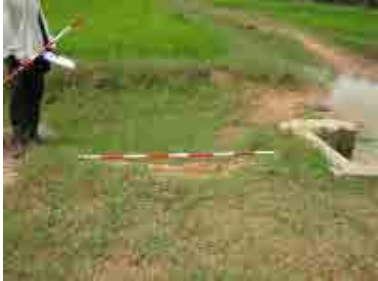
Up Stream View	Down Stream View	Side View

Canal No.: C24	Kind of structure(s): Pipe Culver	Remarks: - Pipe culvert with groove - In/Out flow from/to left bank
Station: 1.00 + 590	Coordinate< Northing: 1223886 Easting: 448783

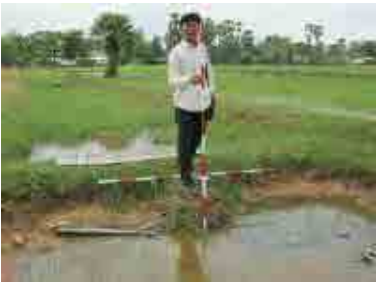
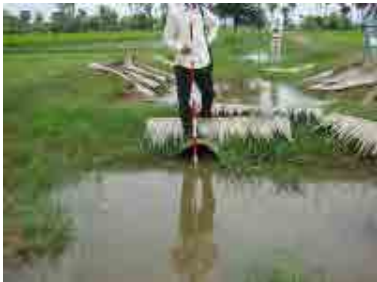
Up Stream View	Down Stream View

Canal No.: C24	Kind of structure(s): Pipe Culver	Remarks:
Station: 1.00 + 730	Coordinate< Northing: 1223889 Easting: 448897

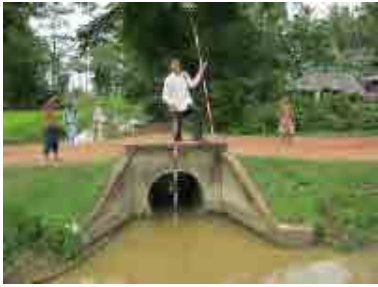
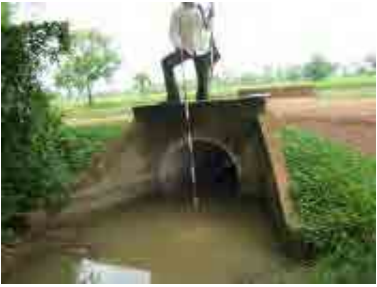
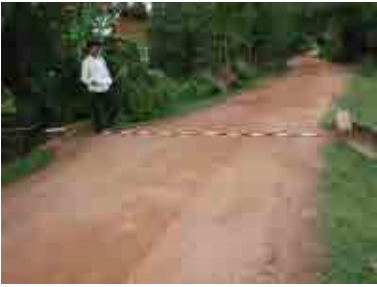
Up Stream View	Down Stream View	Side View

Canal No.: C24	Kind of structure(s): Pipe Culver	Remarks: Pipe culvert under commune road
Station: 1.00 + 940	Coordinate< Northing: 1223931 Easting: 449073

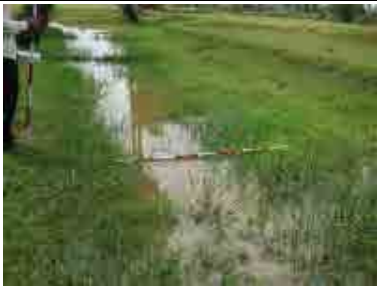
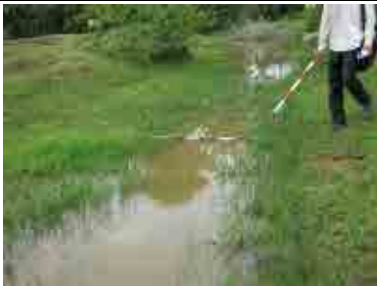
Up Stream View	Down Stream View

Canal No.: C24	Kind of structure(s): Canal	Remarks: Routine survey
Station: 2.00	Coordinate< Northing: 1223949 Easting: 449157

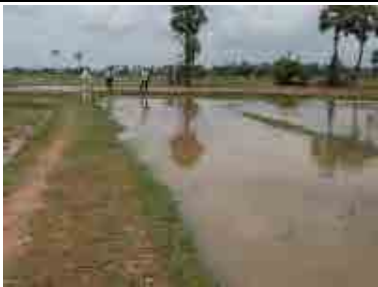
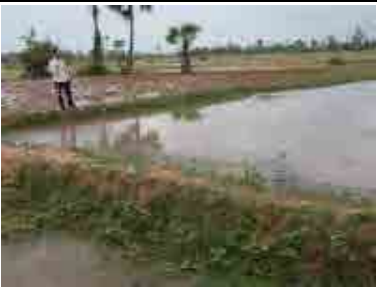
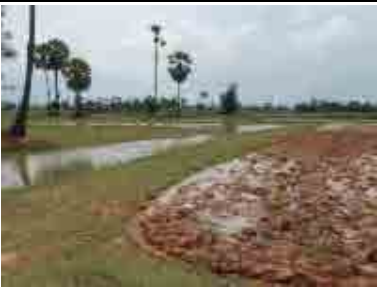
Up Stream View	Turning point (rightward)	Turning point(leftward)

Canal No.: C24	Kind of structure(s): Canal	Remarks: Turning point to the right(southward)
Station: 2.00+160	Coordinate< Northing: 1223949 Easting: 449327

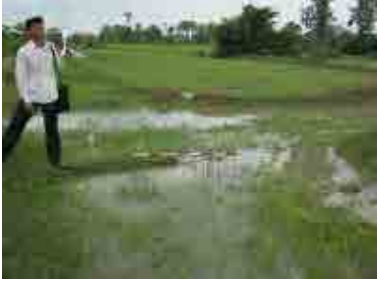
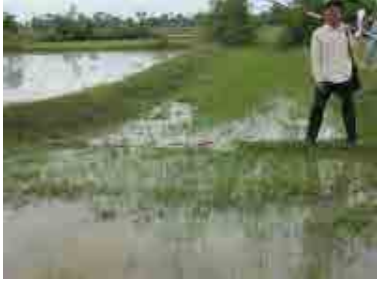
Up Stream View		Down Stream View

Canal No.: C24	Kind of structure(s): Canal	Remarks: Routine survey
Station: 2.00+500	Coordinate< Northing: 1223889 Easting: 449578

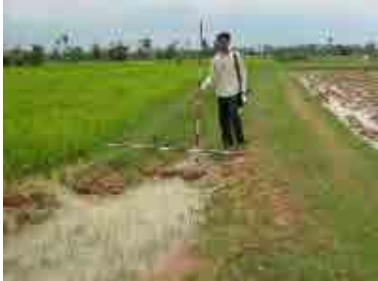
Tertiary Canal

Canal No.: C24	Kind of structure(s): Embankment	Remarks: Embankment across C24 canal
Station: 2.00 +740	Coordinate< Northing: 1223892 Easting: 449803

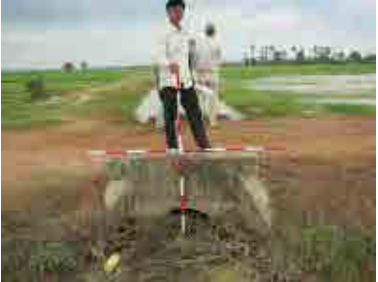
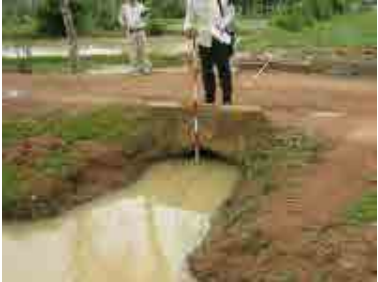
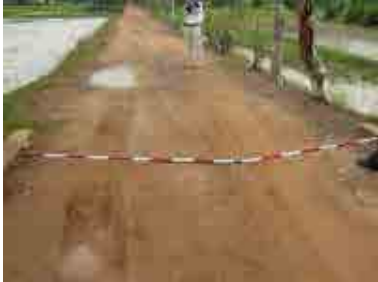
Up Stream View		Down Stream View

Canal No.: C24	Kind of structure(s): Pipe culvert	Remarks: Pipe culvert under commune road
Station: 2.00+960	Coordinate< Northing: 1223888 Easting: 449989

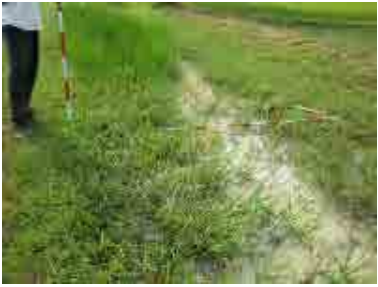
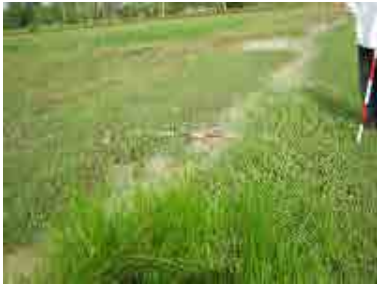
Up Stream View		Down Stream View

Canal No.: C24	Kind of structure(s): Embankment	Remarks:
Station: 3.00	Coordinate< Northing: 1223886 Easting: 450052	Routine survey

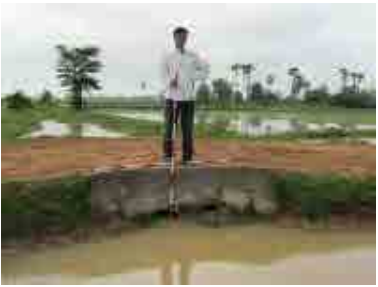
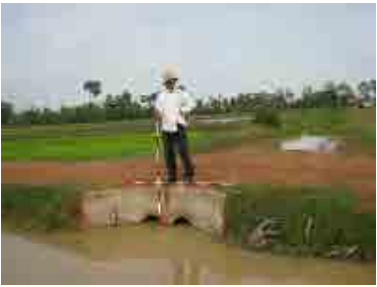
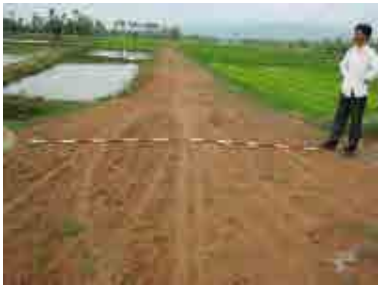
Up Stream View		Down Stream View

Canal No.: C24	Kind of structure(s): Pipe culvert	Remarks:
Station: 3.00+190	Coordinate< Northing: 1223880 Easting: 450205	Village Road Crossing

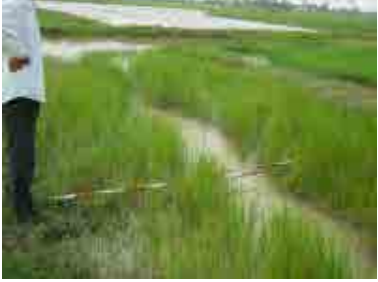
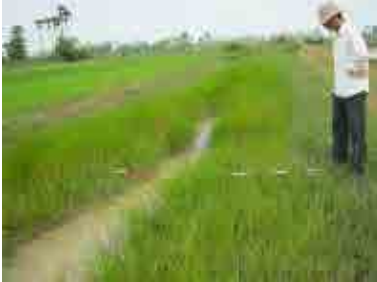
Up Stream View		Down Stream View

Canal No.: C24	Kind of structure(s): Embankment	Remarks: Routine survey
Station: 3.00+500	Coordinate< Northing: 1223879 Easting: 450494

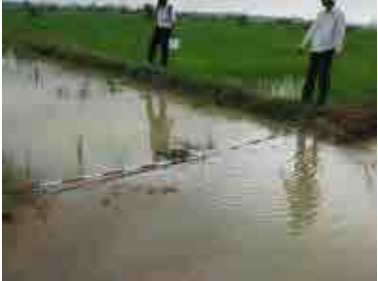
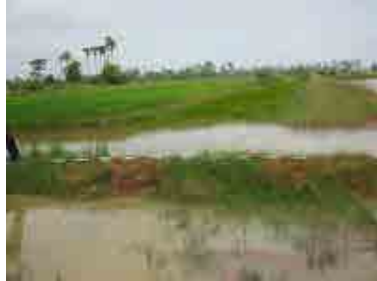
Up Stream View		Down Stream View

Canal No.: C24	Kind of structure(s): Embankment	Remarks: Embankment across C24 canal
Station: 3.00+ 520	Coordinate< Northing: 1223880 Easting: 450503

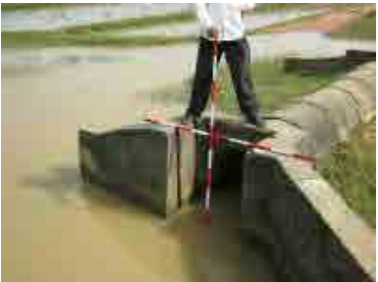
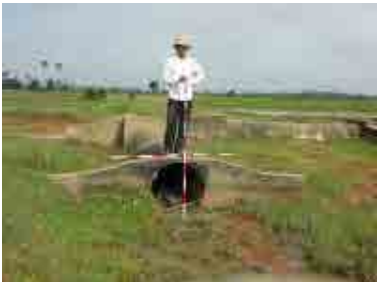
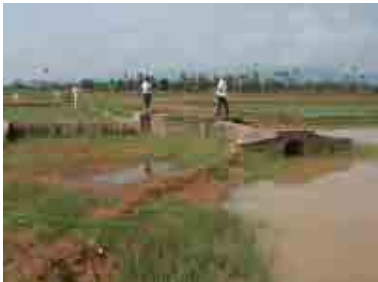
Up Stream View	Down Stream View	Structure

Canal No.: C24	Kind of structure(s): Division structure	Remarks: Routine survey Structure without almost function
Station: 4.00	Coordinate< Northing: 1223859 Easting: 451021

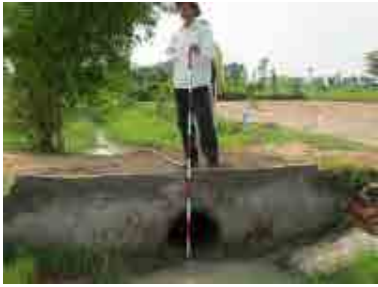
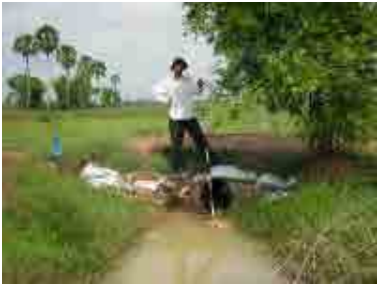
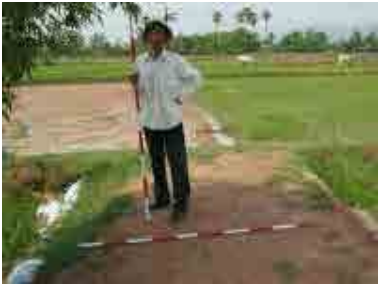
Up Stream View	Down Stream View	Side View

Canal No.: C24	Kind of structure(s): Pipe Culvert	Remarks:
Station: 4.00+420	Coordinate< Northing: 1223849 Easting: 451415

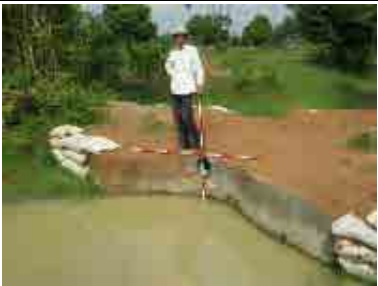
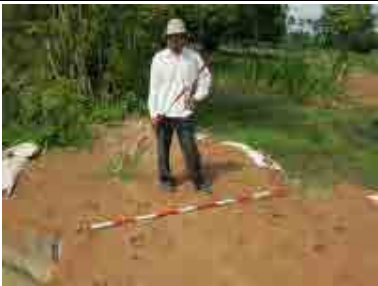
Up Stream View	Down Stream View	Side View

Canal No.: C24	Kind of structure(s): Canal	Remarks: Routine Survey
Station: 4.00 +500	Coordinate< Northing: 1223847 Easting: 451562

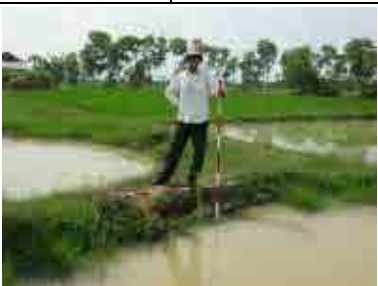
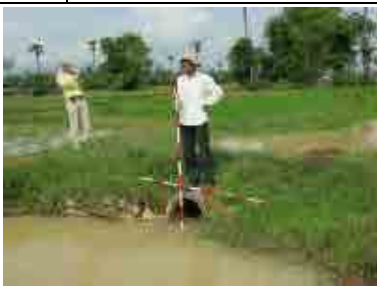
Up Stream View	Down Stream View

Canal No.: C24	Kind of structure(s): Pipe Culvert	Remarks: Private Road
Station: 4 +710	Coordinate< Northing: 1223848 Easting: 451727

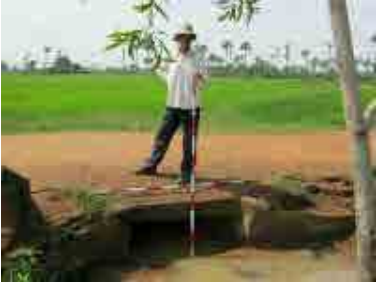
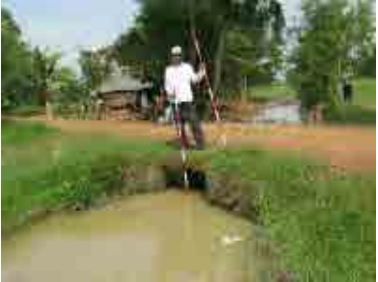
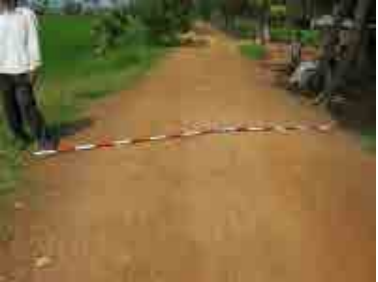
Canal No.: C24	Kind of structure(s): Culvert	Remarks: Commune Road Crossing C24 Canal
Station: 4.00 +830	Coordinate< Northing: 1223842 Easting: 451821

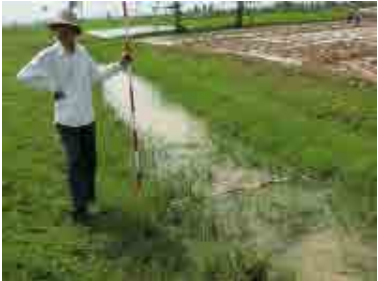
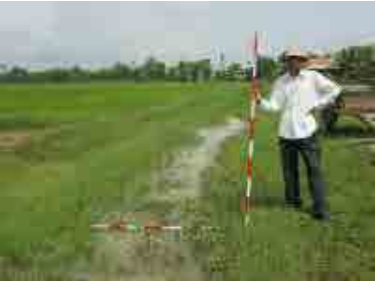
Canal No.: C24	Kind of structure(s): Canal	Remarks: Routine survey
Station: 5.00	Coordinate< Northing: 1223843 Easting: 451979

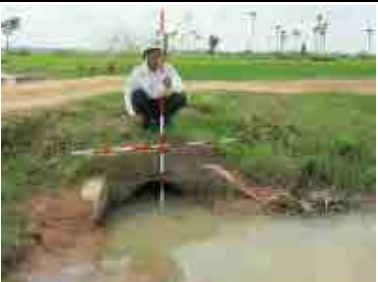
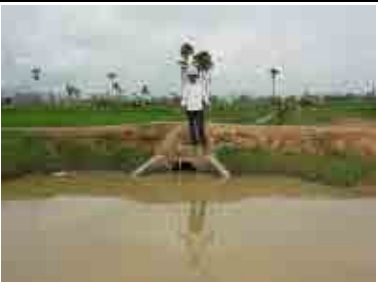
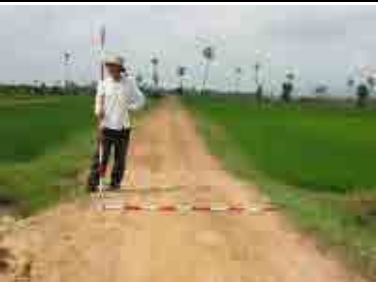
Canal No.: C24	Kind of structure(s): Pipe Culvert	Remarks: Routine survey
Station: 5.00+500	Coordinate< Northing: 1223827 Easting: 452484

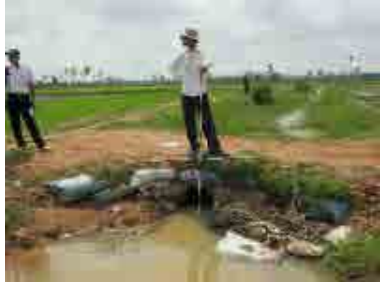
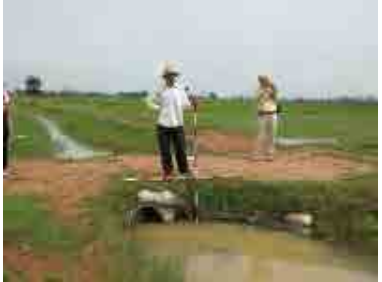
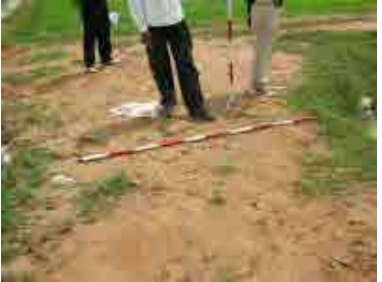
Canal No.: C24	Kind of structure(s): Pipe Culvert	Remarks:
Station: 5.00+720	Coordinate< Northing: 1223822 Easting: 452701

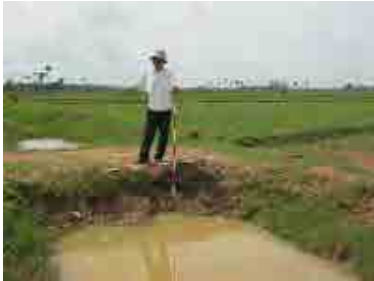
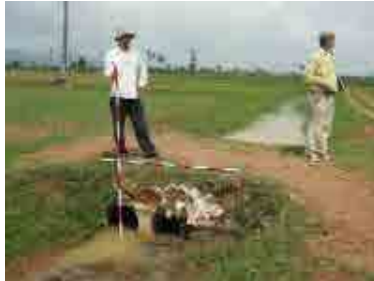
Canal No.: C24	Kind of structure(s): Pipe Culvert	Remarks: Double Pipe culvert
Station: 6.00	Coordinate< Northing: 1223820 Easting: 453002

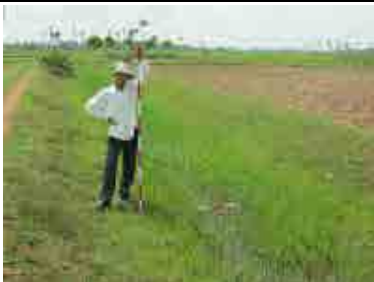
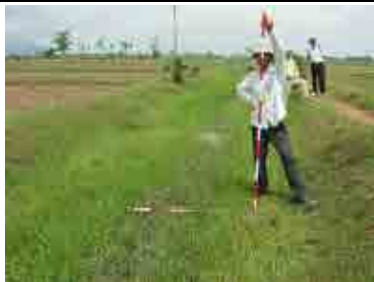
Canal No.: C24	Kind of structure(s): Canal	Remarks: E.P.
Station: 6.00+50(EP)	Coordinate< Northing: 1223818 Easting: 453058
