# ***ANNEX D***

## ***Attachment – 1***

*Results of Inventory Survey for  
Proposed Rehabilitation Works in  
Roleang Chrey Headworks Rehabilitation Sub-project*

**Results of Inventory Survey for Proposed Rehabilitation Works on North Main Canal (1/12)**

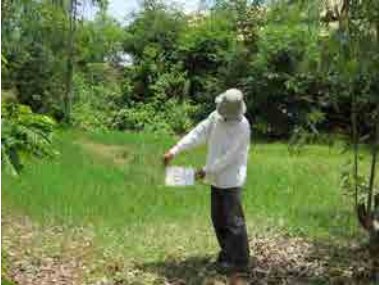
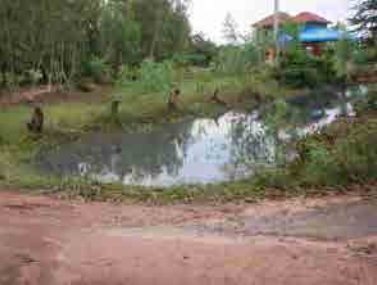
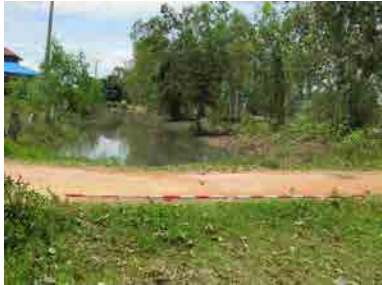
Canal No.: 3D	Kind of structure: Canal	Remarks: - Cross the National Road 130A
Station: 0.00(B.P.)	Coordinate< Northing: 1220131 Easting: 454726

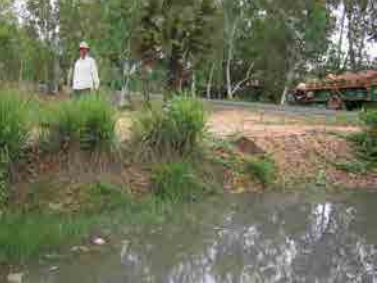
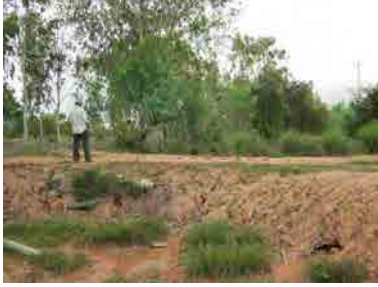
Canal No.: 3D	Kind of structure: Embankment	Remarks: Routine survey
Station: 0.00+80	Coordinate< Northing: 1220081 Easting: 454803

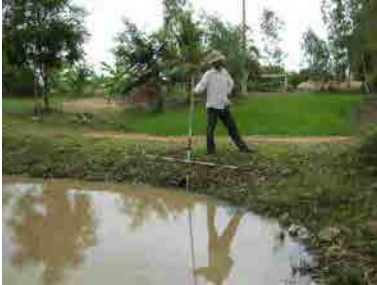
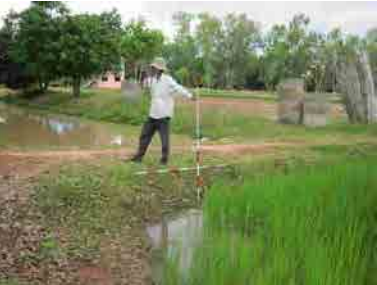
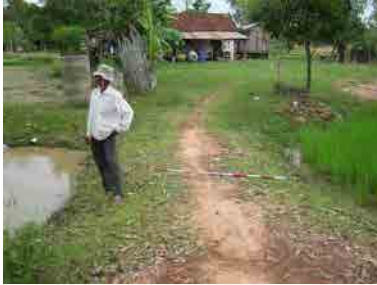
Canal No.: 3D	Kind of structure: Pipe culvert	Remarks: Routine survey
Station: 0.00+160	Coordinate< Northing: 1220047 Easting: 454848

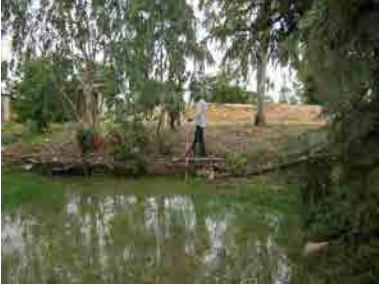
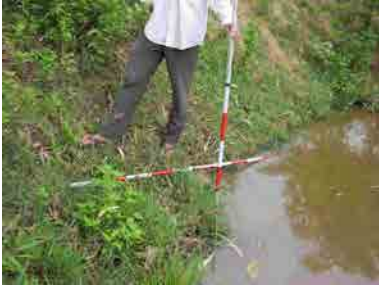
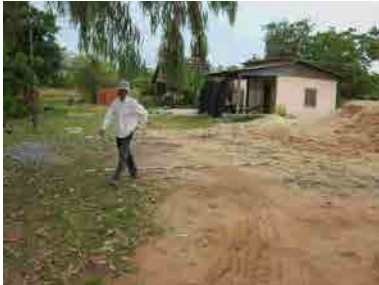
Canal No.: 3D	Kind of structure: Pipe culvert	Remarks:
Station: 0.00+240	Coordinate< Northing: 1220008 Easting: 454906	Routine survey

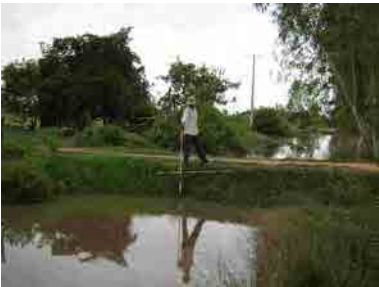
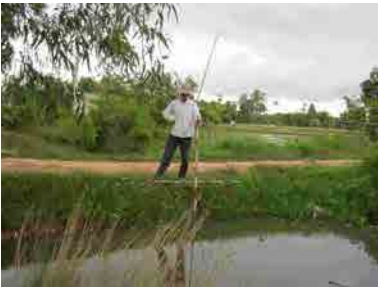
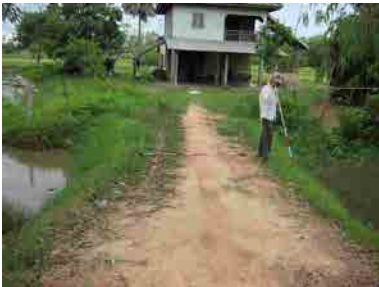
Canal No.: 3D	Kind of structure: Pipe culvert	Remarks:
Station: 0.00+280	Coordinate< Northing: 1219976 Easting: 454952	Routine survey

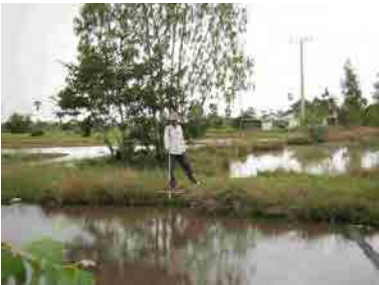
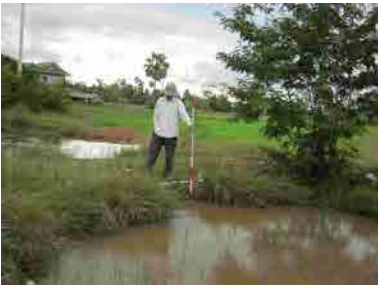
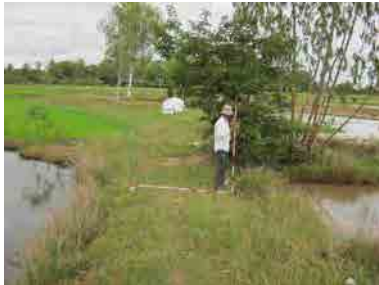
Canal No.: 3D	Kind of structure: Pipe culvert	Remarks:
Station: 0.00+360	Coordinate< Northing: 1219937 Easting: 455016	Routine survey

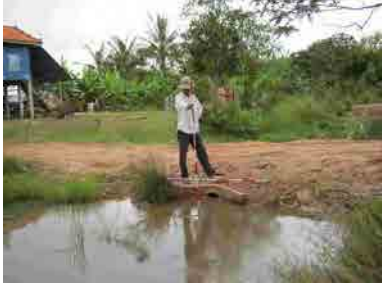
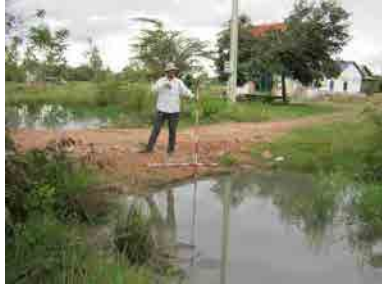
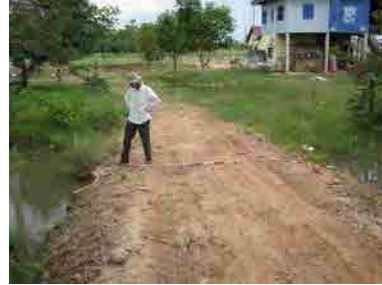
Canal No.: 3D	Kind of structure: Pipe culvert	Remarks:
Station: 0.00+480	Coordinate< Northing: 1219876 Easting: 455114	Routine survey

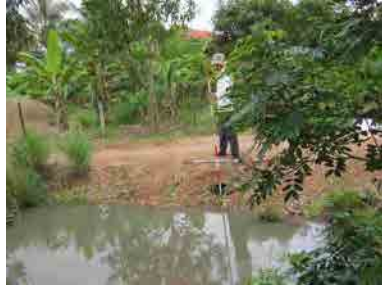
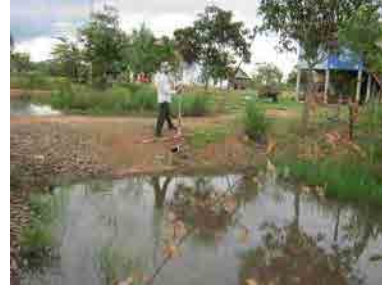
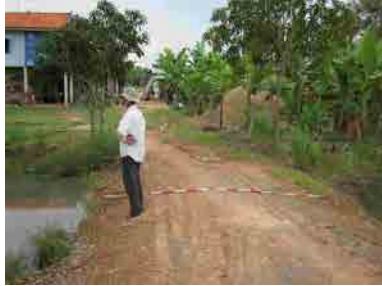
Canal No.: 3D	Kind of structure: Pipe culvert	Remarks:
Station: 0.00+500	Coordinate< Northing: 1219867 Easting: 455126	Routine survey

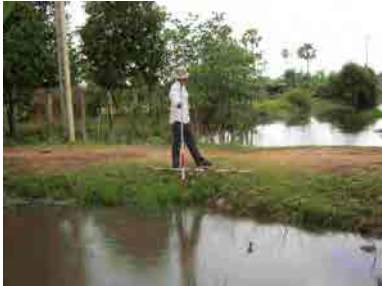
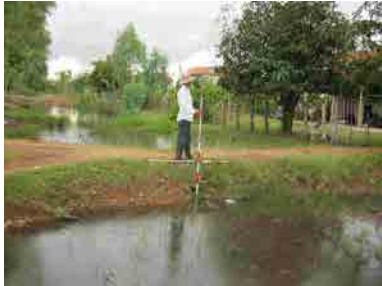
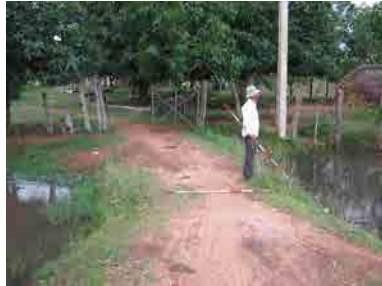
Canal No.: 3D	Kind of structure: Pipe culvert	Remarks:
Station: 0.00+540	Coordinate< Northing: 1219841 Easting: 455168	Routine survey

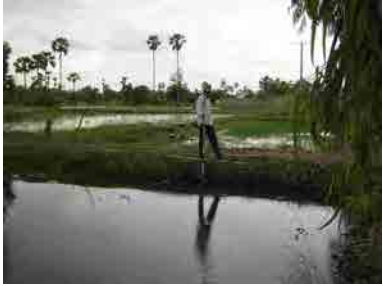
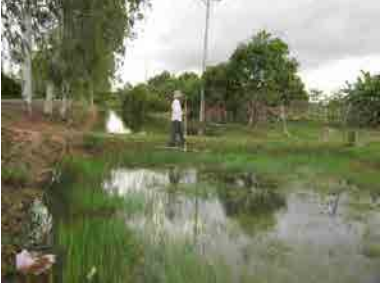
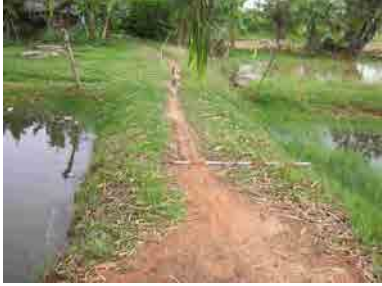
Canal No.: 3D	Kind of structure: Pipe culvert	Remarks:
Station: 0.00+640	Coordinate< Northing: 1219796 Easting: 455247	Routine survey

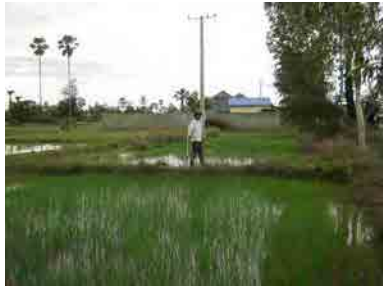
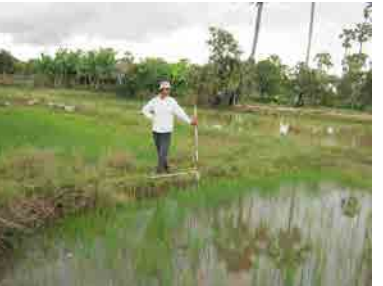
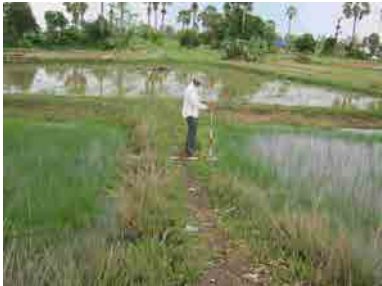
Canal No.: 3D	Kind of structure: Pipe culvert	Remarks:
Station: 0.00+660	Coordinate< Northing: 1219777 Easting: 455274	Routine survey

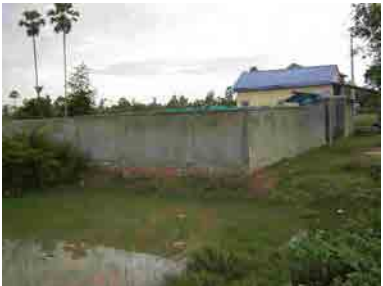
Canal No.: 3D	Kind of structure: House	Remarks:
Station: 0.00+700	Coordinate< Northing: 1219752 Easting: 455309	Routine survey

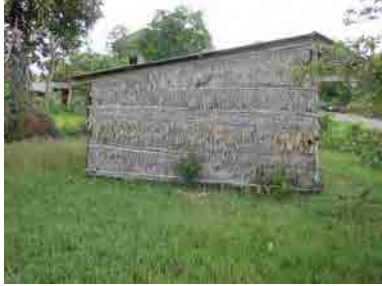
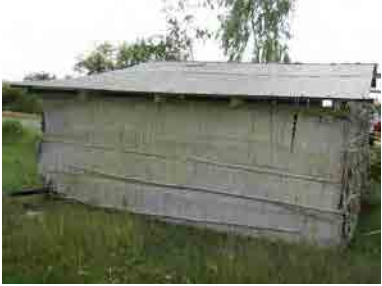
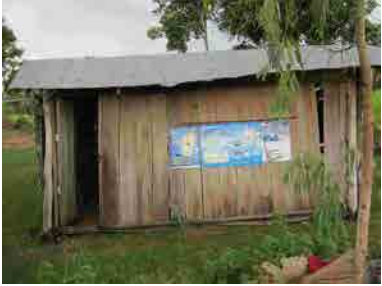
Canal No.: 3D	Kind of structure: House	Remarks: Routine survey Secondary B.P.
Station: 0.00+740	Coordinate< Northing: 1219711 Easting: 455374

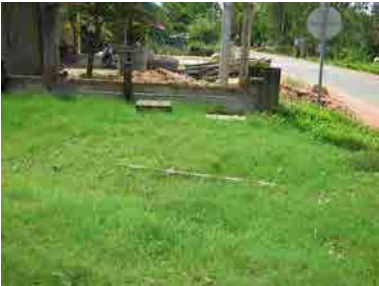
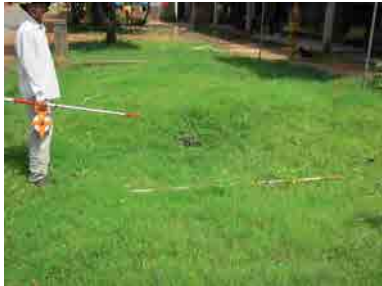
Canal No.: 3D	Kind of structure: Canal	Remarks: Routine survey
Station: 1.00+260	Coordinate< Northing: 1219485 Easting: 455810

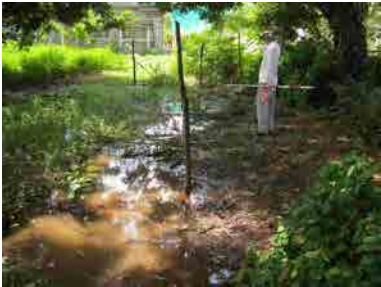
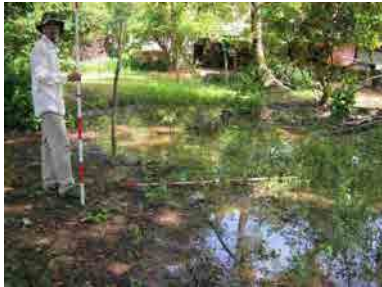
Canal No.: 3D	Kind of structure: Canal	Remarks: Routine survey
Station: 1.00+760	Coordinate< Northing: 1219409 Easting: 456291

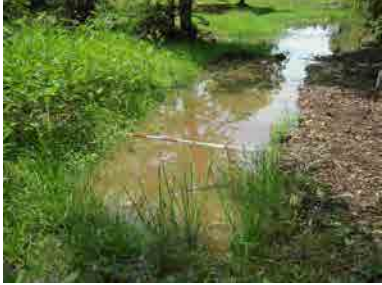
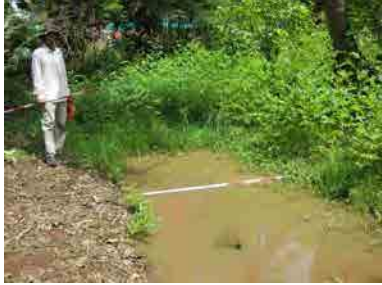
Canal No.: 3D	Kind of structure: Canal	Remarks: Routine survey Sub B.P.
Station: 2.00+50	Coordinate< Northing: 1219363 Easting: 456538	
<div style="display: flex; justify-content: space-around; align-items: center;"> <div style="text-align: center;">

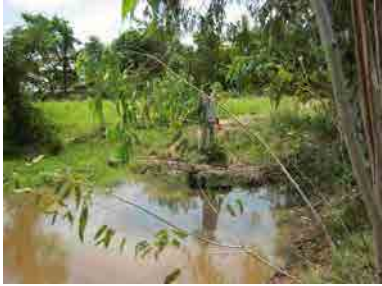
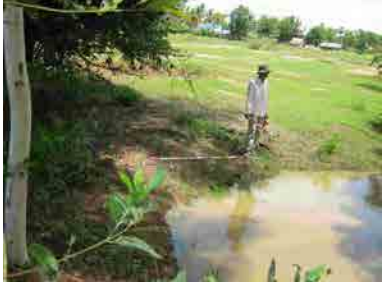
Canal No.: 3D	Kind of structure: Embankment	Remarks: Routine survey
Station: 2.00+140	Coordinate< Northing: 1219337 Easting: 456630	
<div style="display: flex; justify-content: space-around; align-items: center;"> <div style="text-align: center;">

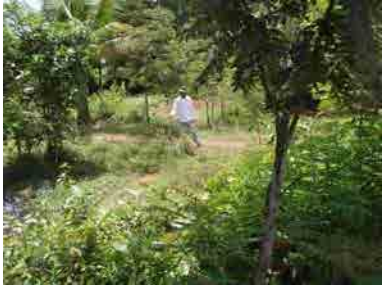
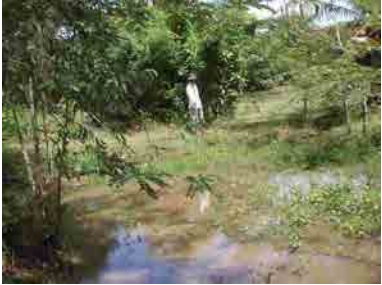
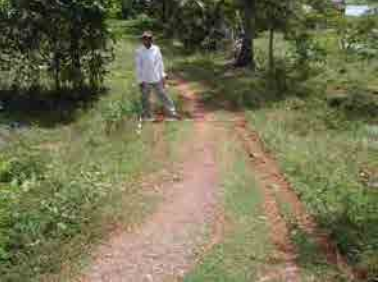
Canal No.: 3D	Kind of structure: Pipe culvert	Remarks: Routine survey
Station: 2.00+240	Coordinate< Northing: 1219322 Easting: 456704	
<div style="display: flex; justify-content: space-around; align-items: center;"> <div style="text-align: center;">

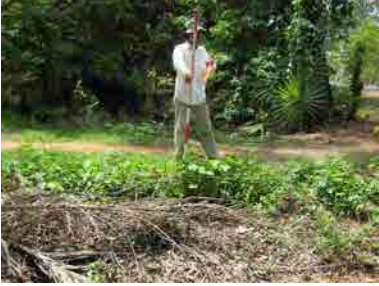
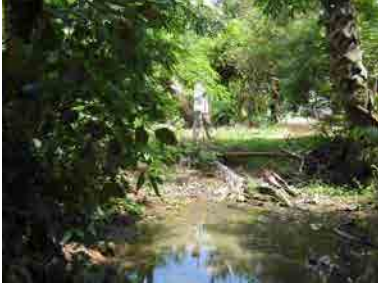
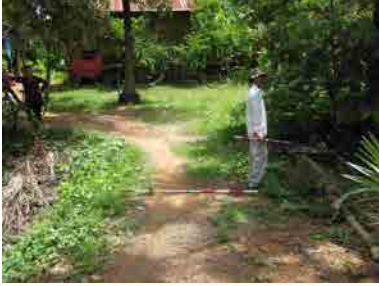
Canal No.: 3D	Kind of structure: Pipe culvert(small)	Remarks: Routine survey
Station: 2.00+300	Coordinate< Northing: 1219306 Easting: 456778

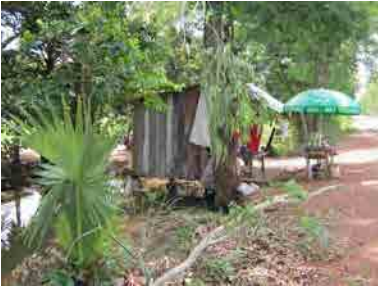
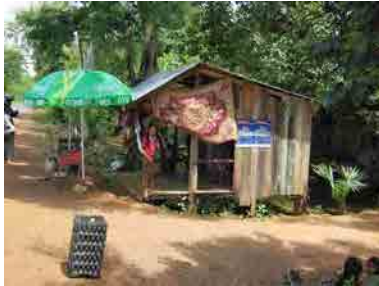
Canal No.: 3D	Kind of structure: House	Remarks: Routine survey
Station: 2.00+330	Coordinate< Northing: 1219291 Easting: 456821

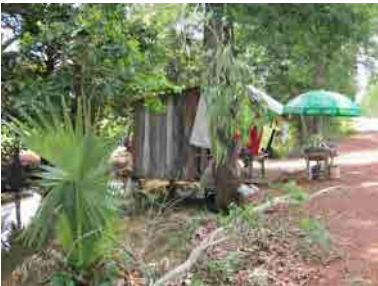
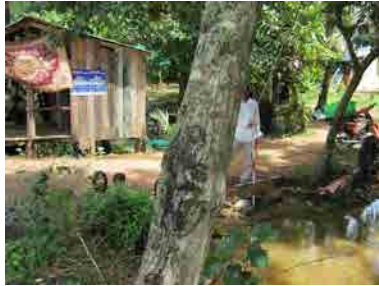
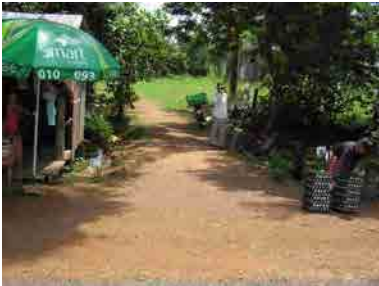
Canal No.: 3D	Kind of structure: Pipe culvert	Remarks: Routine survey
Station: 2.00+370	Coordinate< Northing: 1219282 Easting: 456865

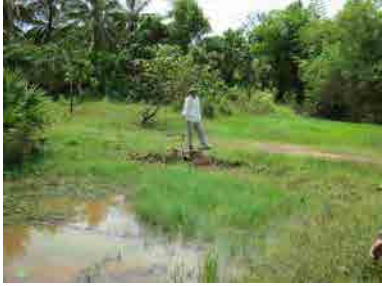
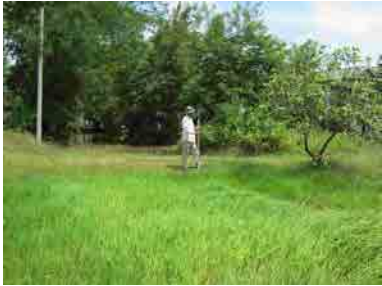
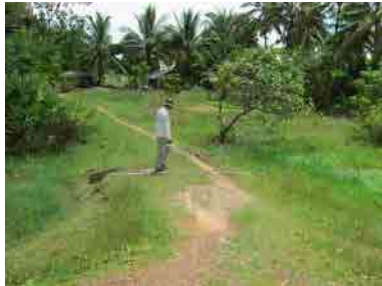
Canal No.: 3D	Kind of structure: Pipe culvert	Remarks: Routine survey
Station: 2.00+400	Coordinate< Northing: 1219274 Easting: 456903

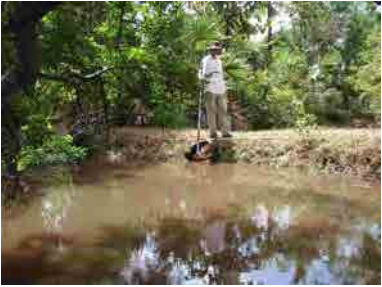
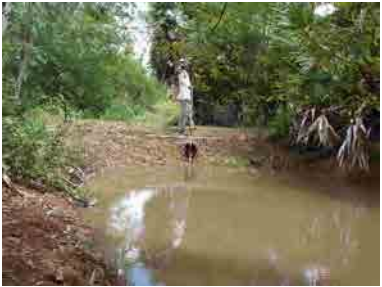
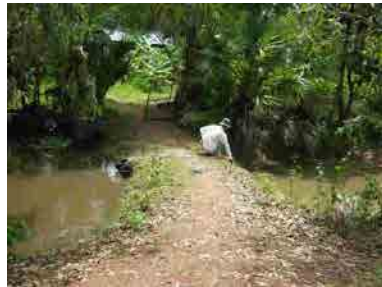
Canal No.: 3D	Kind of structure: Pipe culvert	Remarks: Routine survey
Station: 2.00+430	Coordinate< Northing: 1219264 Easting: 456929

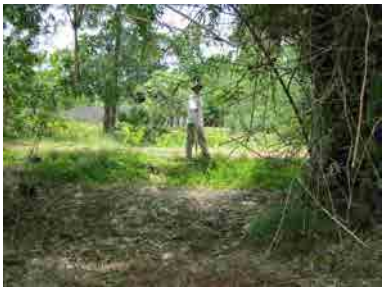
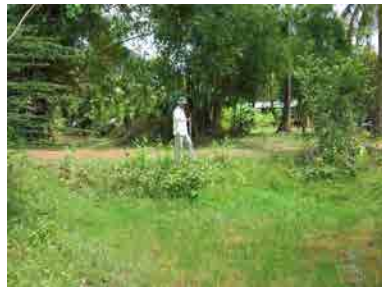
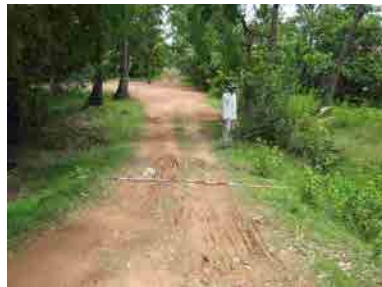
Canal No.: 3D	Kind of structure: Pipe culvert	Remarks: Routine survey
Station: 2.00+440	Coordinate< Northing: 1219259 Easting: 456956

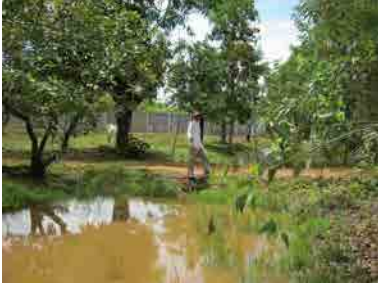
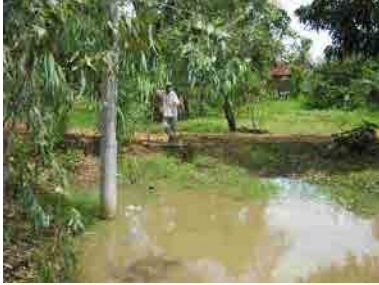
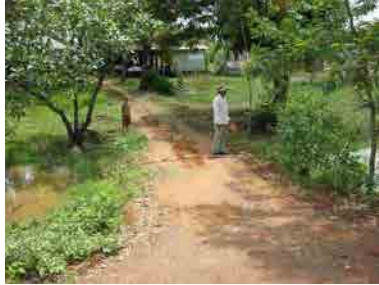
Canal No.: 3D	Kind of structure: Pipe culvert	Remarks: Routine survey
Station: 2.00+470	Coordinate< Northing: 1219245 Easting: 456995

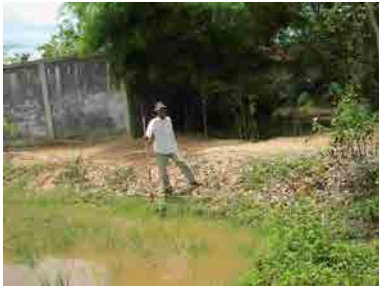
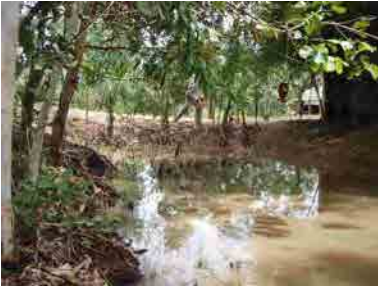
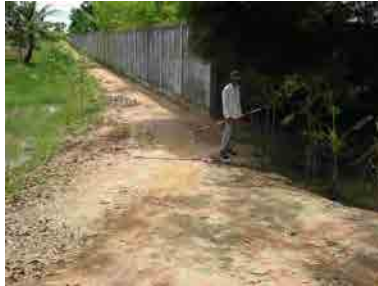
Canal No.: 3D	Kind of structure: Pipe culvert	Remarks: Routine survey
Station: 2.00+480	Coordinate< Northing: 1219244 Easting: 457017

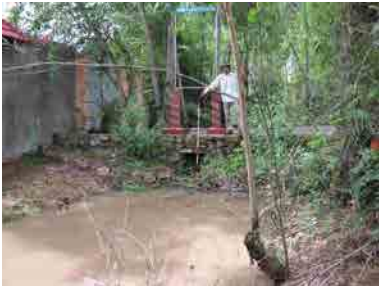
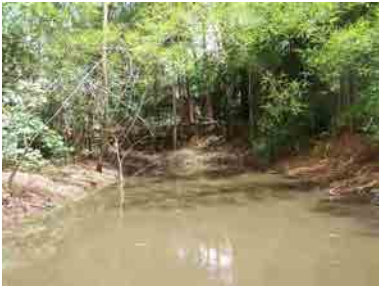
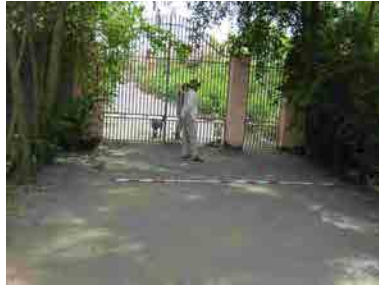
Canal No.: 3D	Kind of structure: Embankment	Remarks: Routine survey
Station: 2.00+530	Coordinate< Northing: 1219229 Easting: 457092

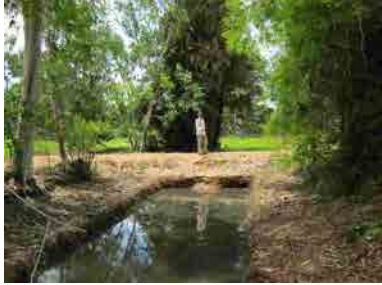
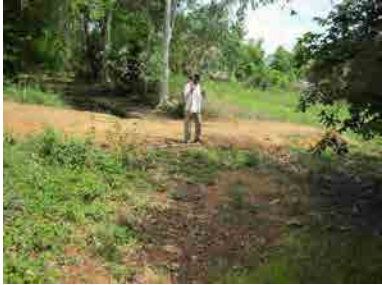
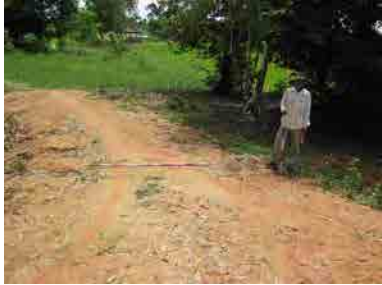
Canal No.: 3D	Kind of structure: Embankment	Remarks:
Station: 2.00+590	Coordinate< Northing: 1219208 Easting: 457151	Routine survey

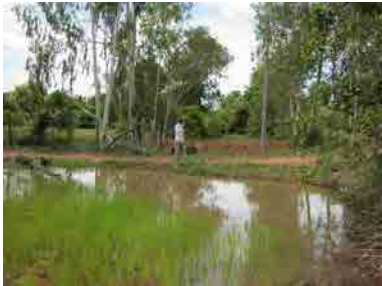
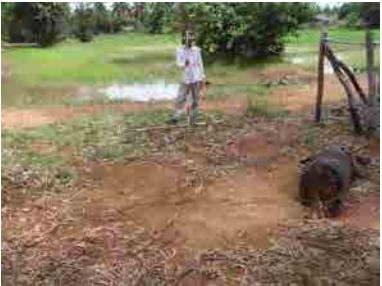
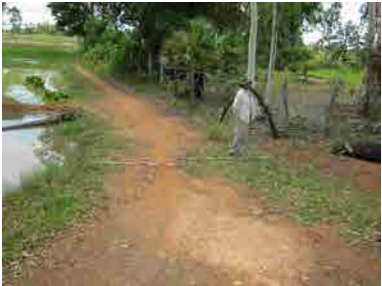
Canal No.: 3D	Kind of structure: Embankment	Remarks:
Station: 2.00+590	Coordinate< Northing: 1219209 Easting: 457160	Routine survey

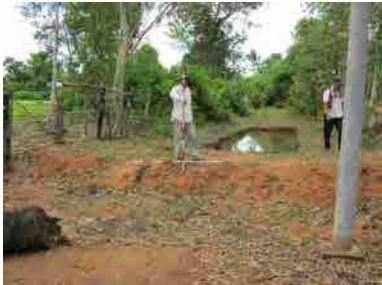
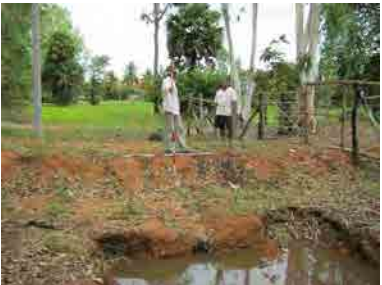
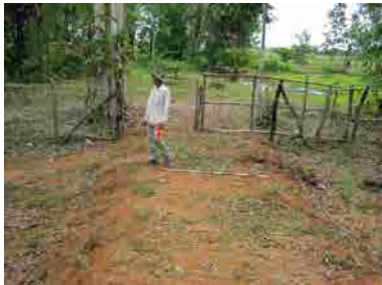
Canal No.: 3D	Kind of structure: Embankment	Remarks:
Station: 2.00+710	Coordinate< Northing: 1219176 Easting: 457277	Routine survey

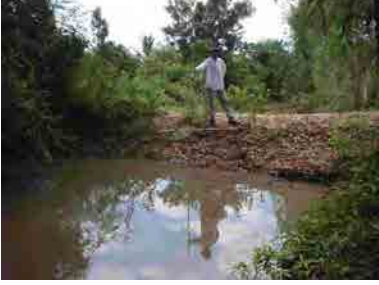
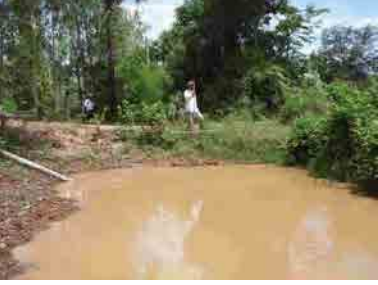
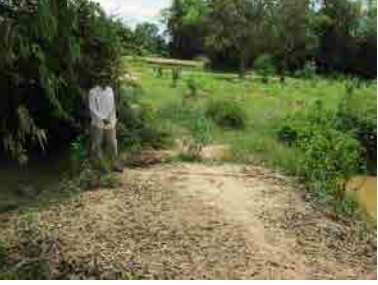
Canal No.: 3D	Kind of structure: Pipe culvert	Remarks: Routine survey
Station: 2.00+810	Coordinate< Northing: 1219154 Easting: 457367

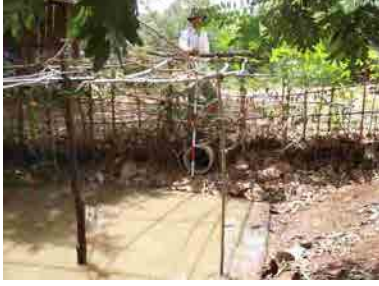
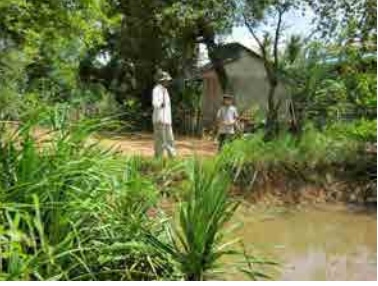
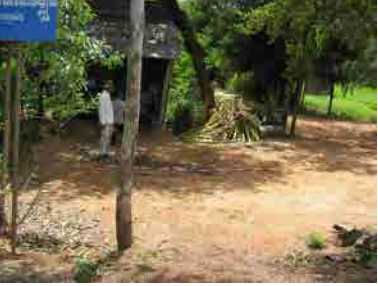
Canal No.: 3D	Kind of structure: Pip culvert	Remarks: Routine survey
Station: 2.00+890	Coordinate< Northing: 1219135 Easting: 457438

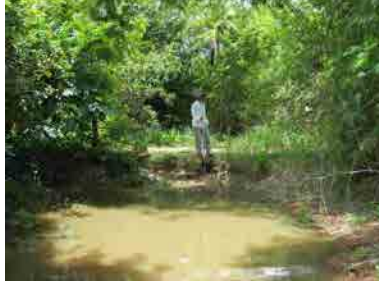
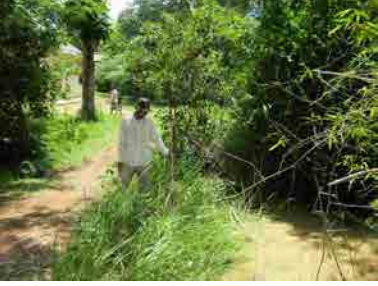
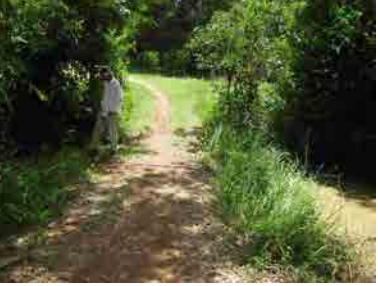
Canal No.: 3D	Kind of structure: Pipe culvert	Remarks: Routine survey
Station: 2.00+960	Coordinate< Northing: 1219122 Easting: 457503

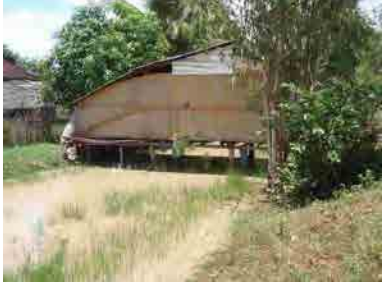
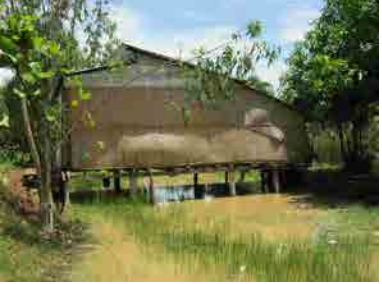
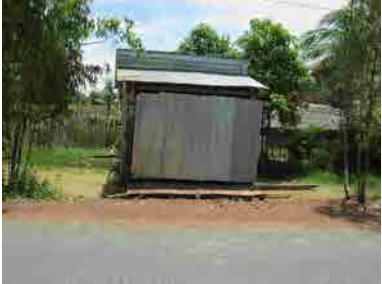
Canal No.: 3D	Kind of structure: House	Remarks: Routine survey
Station: 2.00+990	Coordinate< Northing: 1219109 Easting: 457543

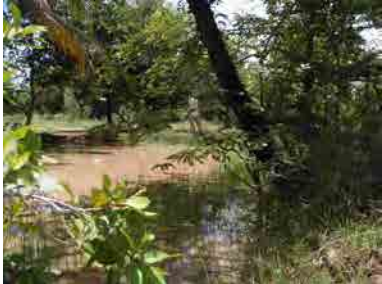
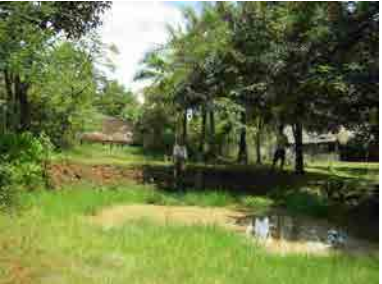
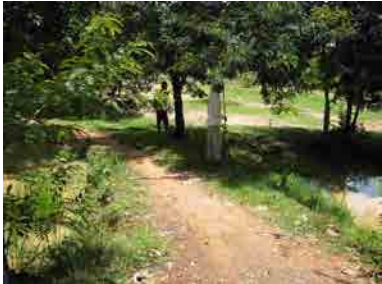
Canal No.: 3D	Kind of structure: Pipe culvert	Remarks: Routine survey
Station: 3.00+10	Coordinate< Northing: 1219103 Easting: 457568

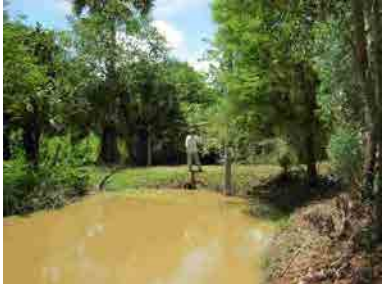
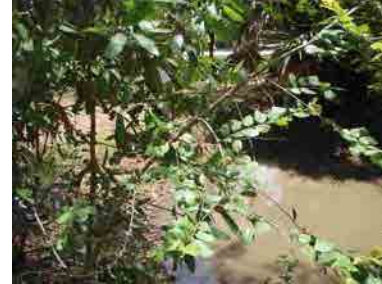
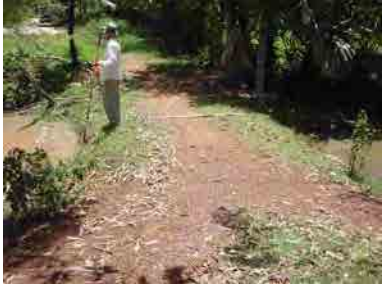
Canal No.: 3D	Kind of structure: Pipe culvert	Remarks: Routine survey
Station: 3.00+70	Coordinate< Northing: 1219086 Easting: 457635

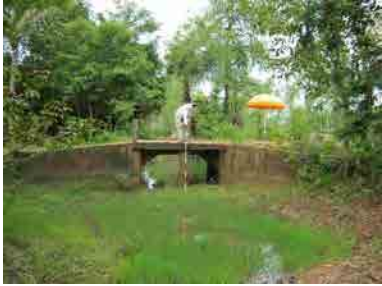
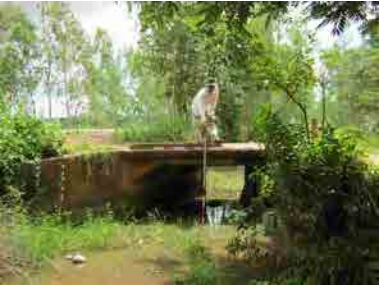
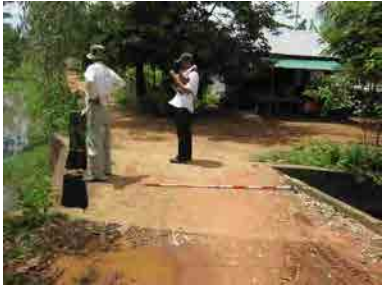
Canal No.: 3D	Kind of structure: Bridge	Remarks:
Station: 3.00+500	Coordinate< Northing: 1218929 Easting: 457998	There is a groove

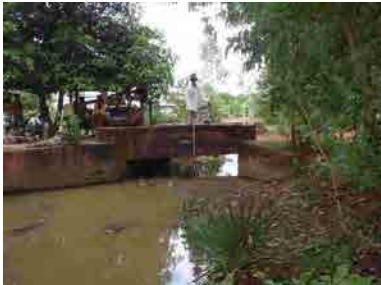
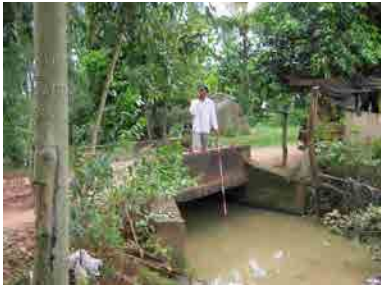
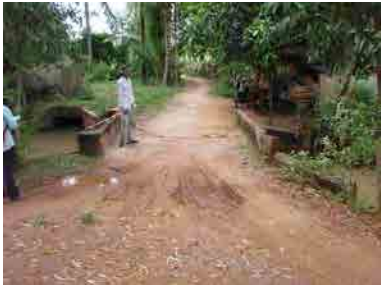
Canal No.: 3D	Kind of structure: Bridge	Remarks:
Station: 4.00+750	Coordinate< Northing: 1218396 Easting: 458991	There is a groove

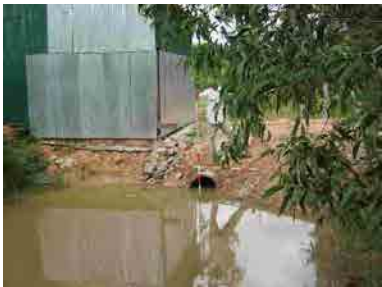
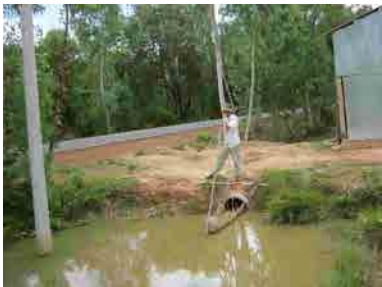
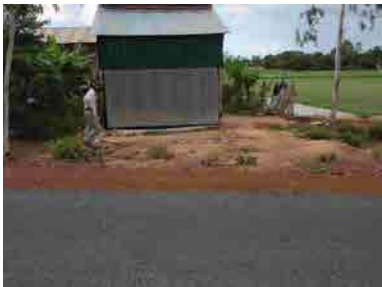
Canal No.: 3D	Kind of structure: Pipe culvert	Remarks:
Station: 4.00+840	Coordinate< Northing: 1218356 Easting: 459060	There is a house

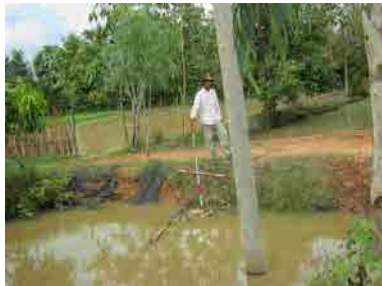
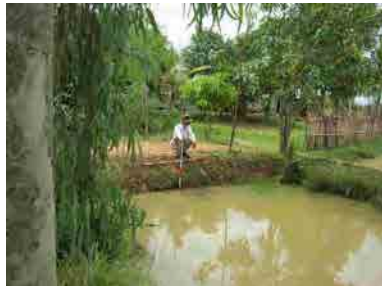
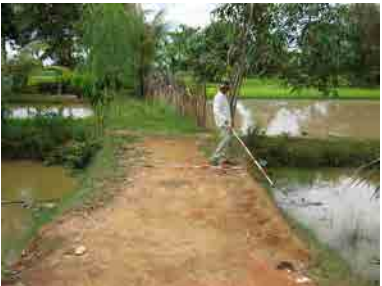
Canal No.: 3D	Kind of structure: Pipe culvert	Remarks:
Station: 4.00+940	Coordinate< Northing: 1218306 Easting: 459161	Routine survey

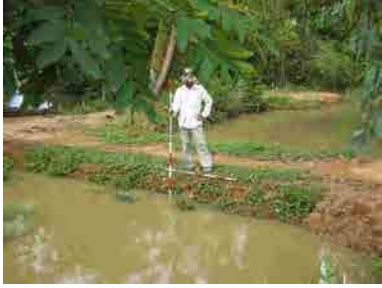
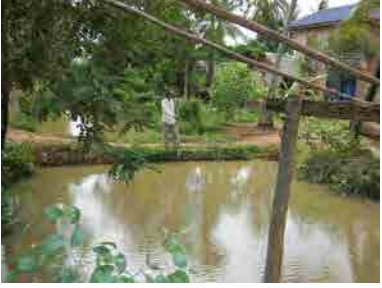
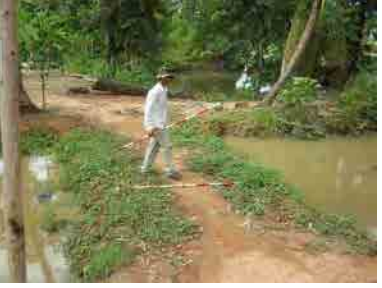
Canal No.: 3D	Kind of structure: Embankment	Remarks:
Station: 5.00+10	Coordinate< Northing: 1218273 Easting: 459220	Routine survey

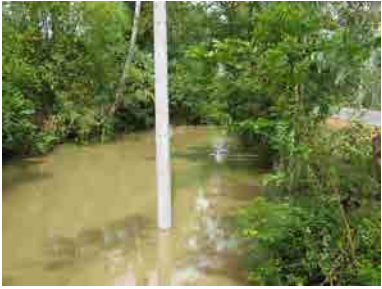
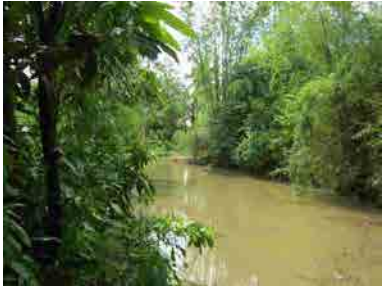
Canal No.: 3D	Kind of structure: Canal	Remarks:
Station: 5.00+40	Coordinate< Northing: 1218255 Easting: 459249	Routine survey Length: 4000m

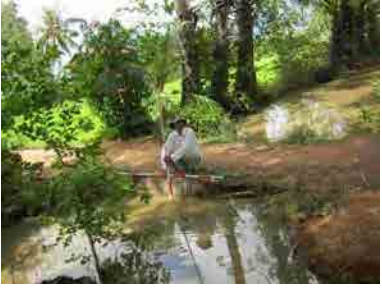
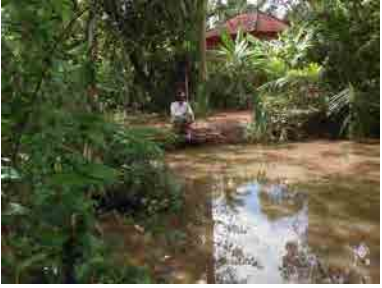
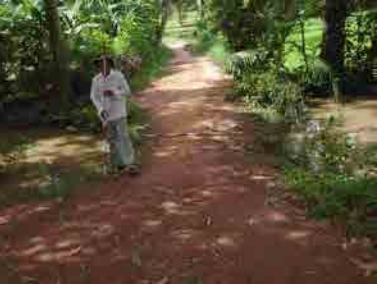
Canal No.: 3D	Kind of structure: Pipe culvert	Remarks:
Station: 5.00+80	Coordinate< Northing: 1218240 Easting: 459293	Routine survey

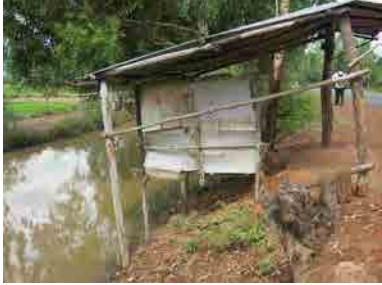
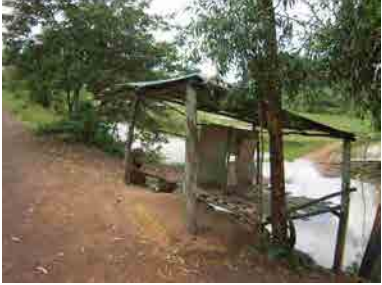
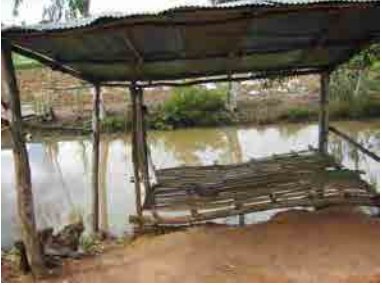
Canal No.: 3D	Kind of structure: House	Remarks:
Station: 5.00+270	Coordinate< Northing: 1218143 Easting: 459463	Routine survey

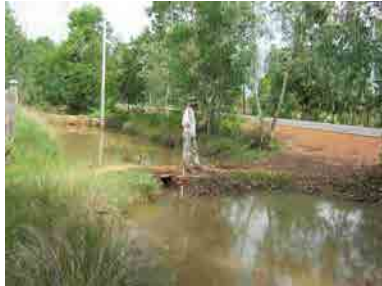
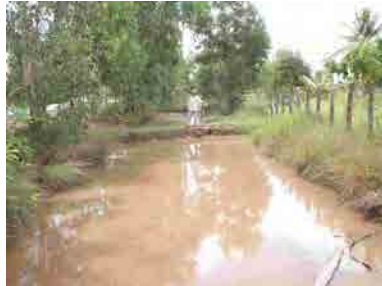
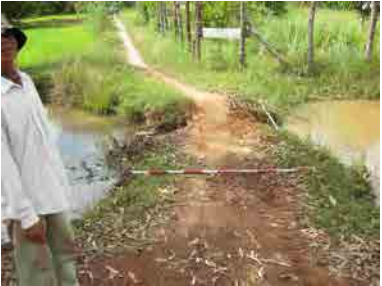
Canal No.: 3D	Kind of structure: Pipe culvert	Remarks:
Station: 5.00+410	Coordinate< Northing: 1218085 Easting: 459577	Routine survey

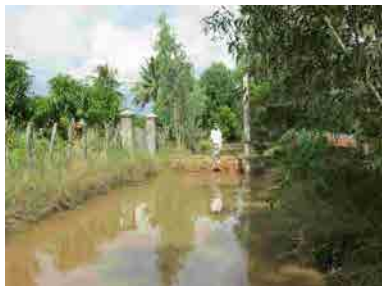
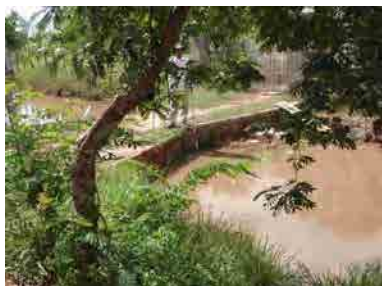
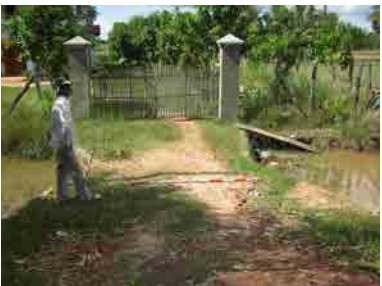
Canal No.: 3D	Kind of structure: Pipe culvert	Remarks:
Station: 5.00+440	Coordinate< Northing: 1218078 Easting: 459594	Routine survey

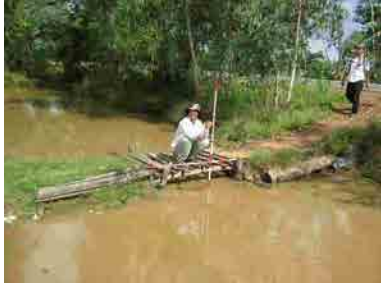
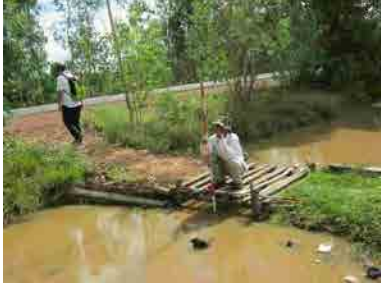
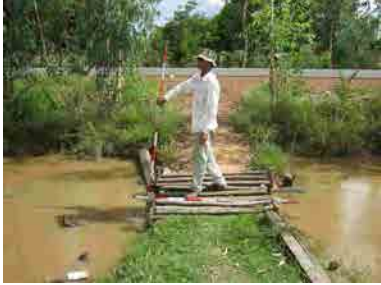
Canal No.: 3D	Kind of structure: Bridge(private)	Remarks:
Station: 5.00+460	Coordinate< Northing: 1218062 Easting: 459624	Made by wood

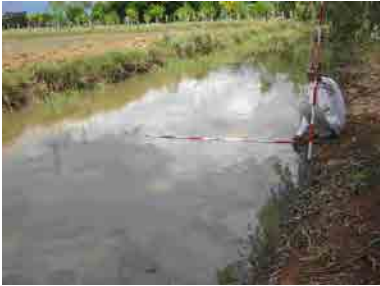
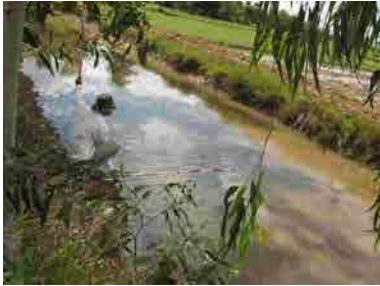
Canal No.: 3D	Kind of structure: Canal	Remarks:
Station: 5.00+550	Coordinate< Northing: 1218024 Easting: 459692	Routine survey Length: 4500m

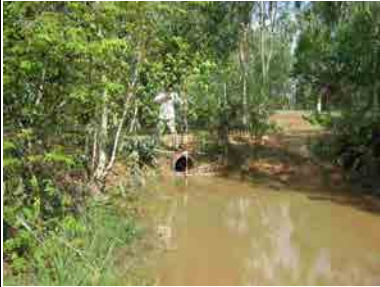
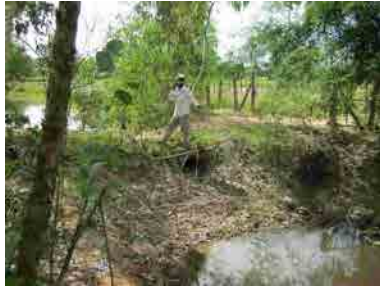
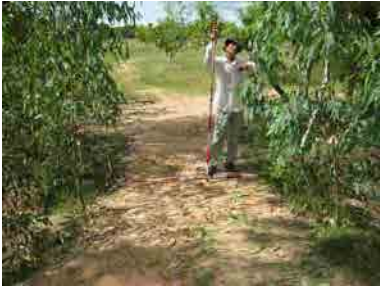
Canal No.: 3D	Kind of structure: Pipe culvert	Remarks:
Station: 5.00+610	Coordinate< Northing: 1217996 Easting: 459748	Routine survey

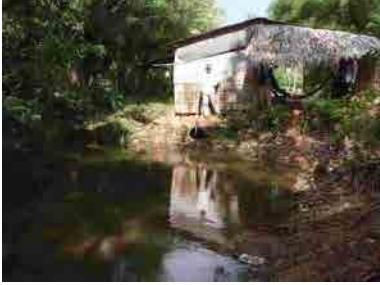
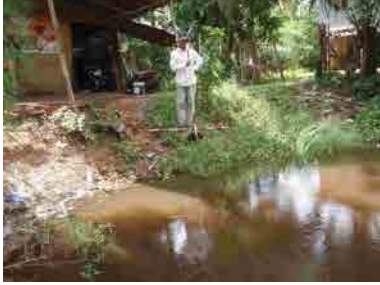
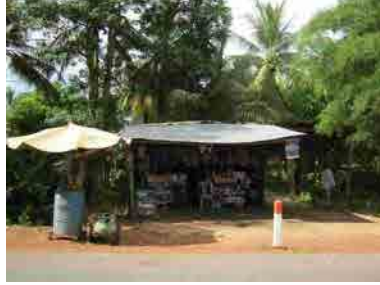
Canal No.: 3D	Kind of structure: Pipe culvert	Remarks:
Station: 5.00+650	Coordinate< Northing: 1217969 Easting: 459788	There is a house

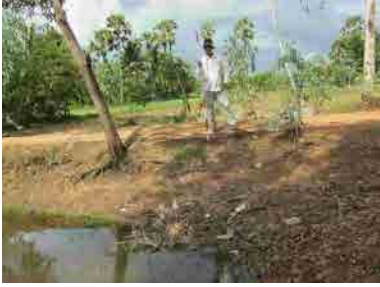
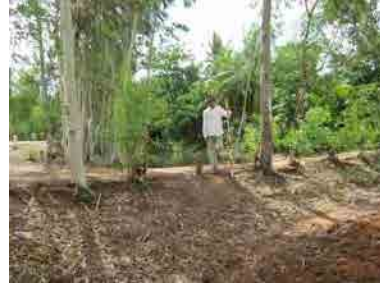
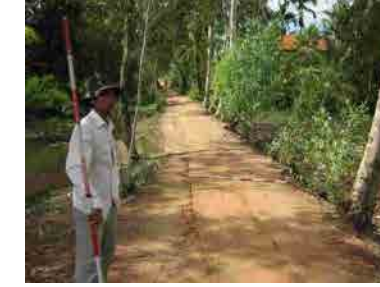
Canal No.: 3D	Kind of structure: Embankment	Remarks:
Station: 5.00+700	Coordinate< Northing: 1217941 Easting: 459835	There is a village road

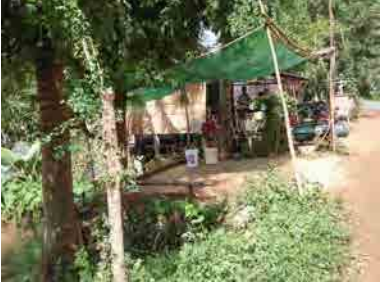
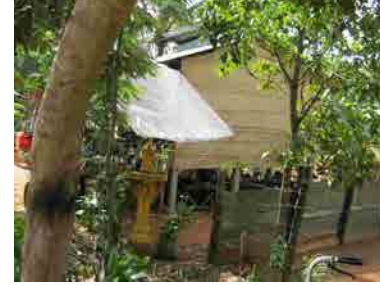
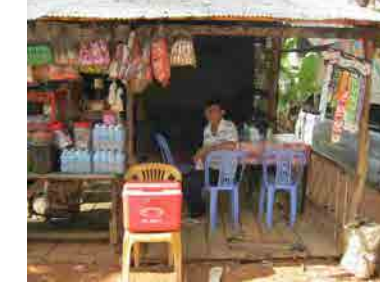
Canal No.: 3D	Kind of structure: House	Remarks:
Station: 5.00+810	Coordinate< Northing: 1217886 Easting: 459911	Routine survey

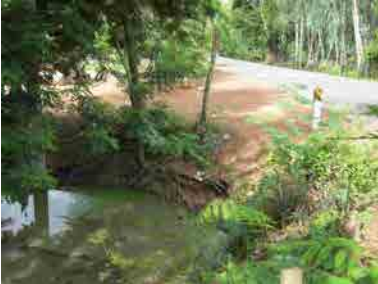
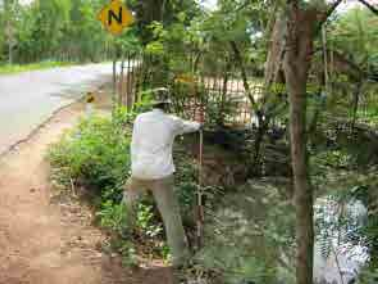
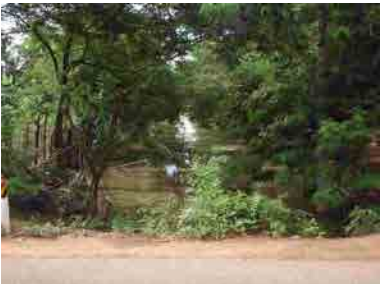
Canal No.: 3D	Kind of structure: Canal	Remarks:
Station: 6.00+50	Coordinate< Northing: 1217831 Easting: 460131	Routine survey Length: 5000m

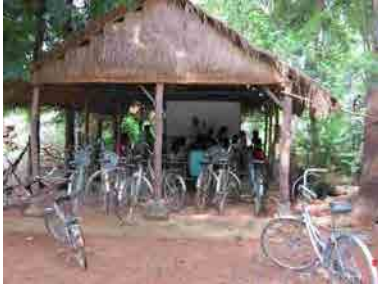
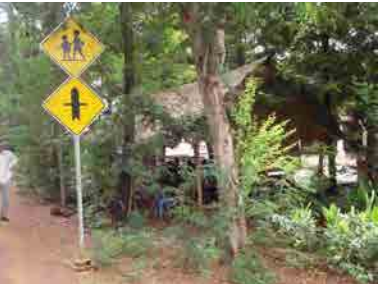
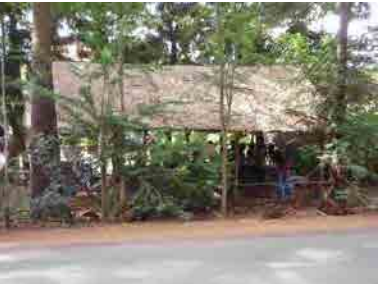
Canal No.: 3D	Kind of structure: School House	Remarks:
Station: 6.00+230	Coordinate< Northing: 1217807 Easting: 460293	Routine survey

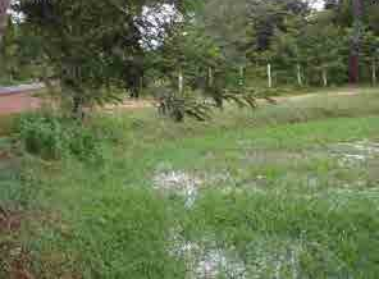
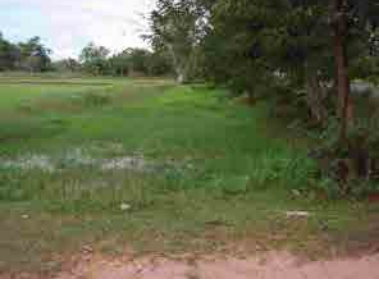
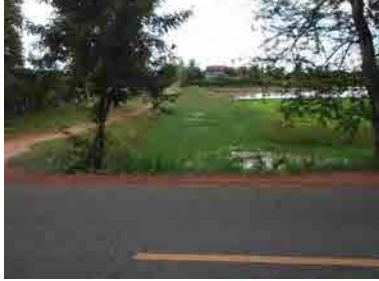
Canal No.: 3D	Kind of structure: Canal	Remarks:
Station: 6.00+410	Coordinate< <div style="display: inline-block; vertical-align: middle; margin-left: 10px;">                     Northing: 1217789                      Easting: 460473                 </div>	Third B.P.

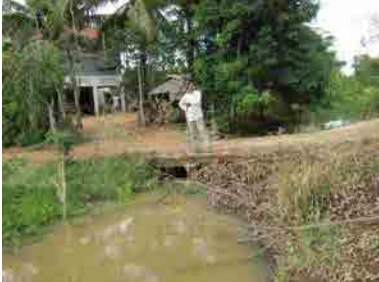
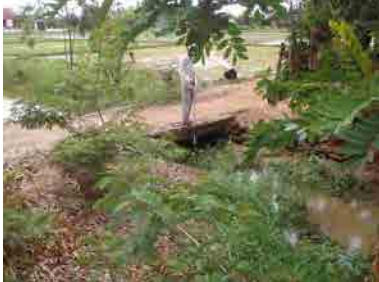
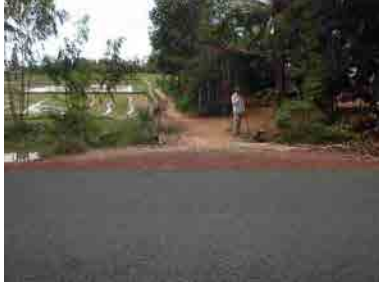
Canal No.: 3D	Kind of structure: Pipe culvert	Remarks:
Station: 6.00+520	Coordinate< <div style="display: inline-block; vertical-align: middle; margin-left: 10px;">                     Northing: 1217773                      Easting: 460577                 </div>	Routine survey

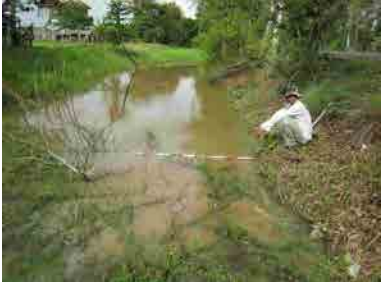
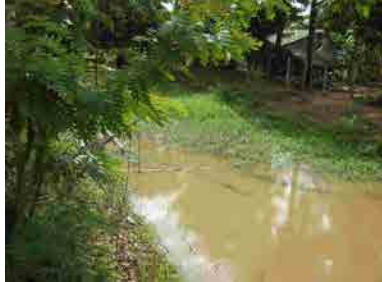
Canal No.: 3D	Kind of structure: Canal	Remarks:
Station: 6.00+550	Coordinate< <div style="display: inline-block; vertical-align: middle; margin-left: 10px;">                     Northing: 1217766                      Easting: 460608                 </div>	Routine survey Length: 5500m

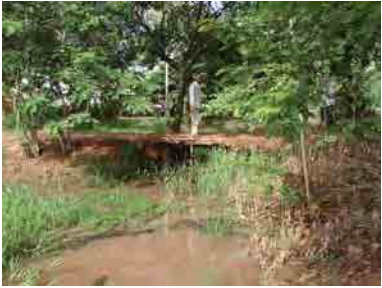
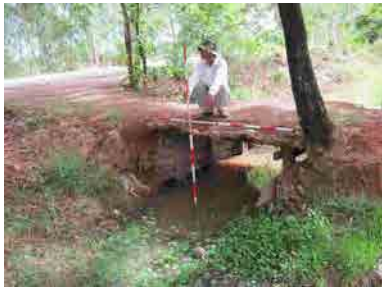
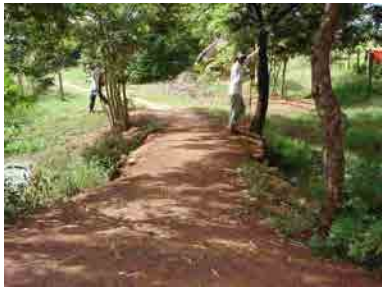
Canal No.: 3D	Kind of structure: Bridge (private)	Remarks:
Station: 6.00+650	Coordinate< Northing: 1217755 Easting: 460714	Routine survey

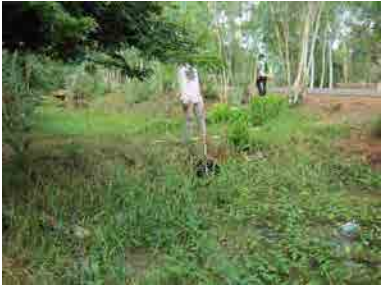
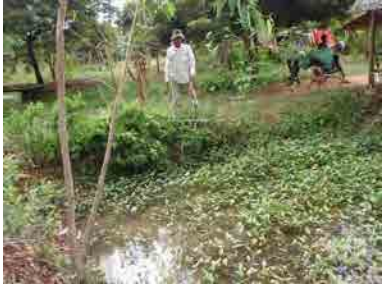
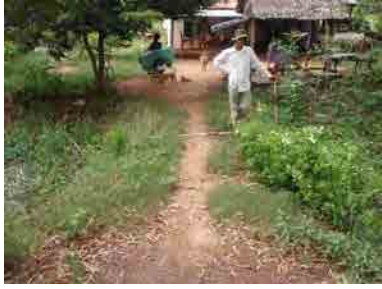
Canal No.: 3D	Kind of structure: Pipe culvert	Remarks:
Station: 6.00+670	Coordinate< Northing: 1217757 Easting: 460729	Routine survey

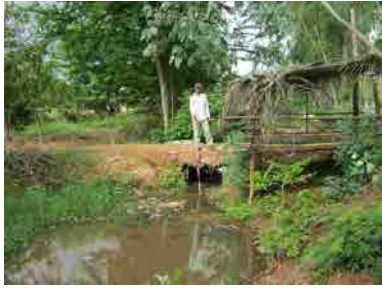
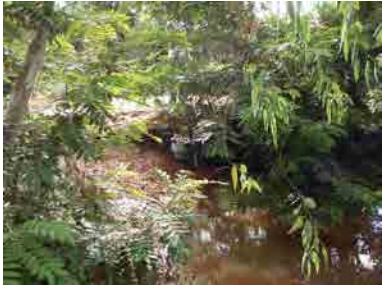
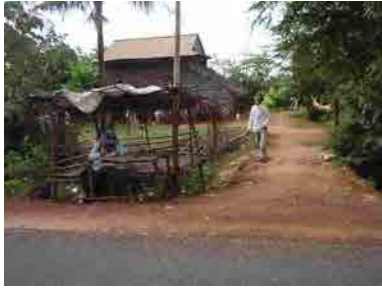
Canal No.: 3D	Kind of structure: Pipe culvert	Remarks:
Station: 6.00+710	Coordinate< Northing: 1217748 Easting: 460760	There is a house (cottage)

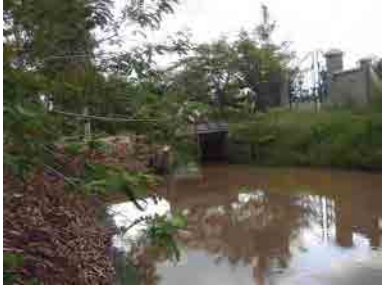
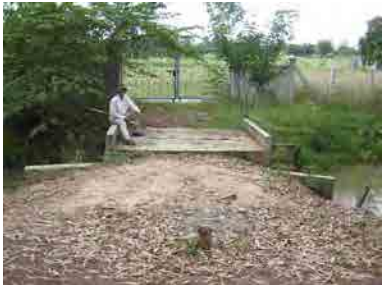
Canal No.: 3D	Kind of structure: Bridge (private)	Remarks:
Station: 6.00+750	Coordinate< Northing: 1217739 Easting: 460817	Routine survey

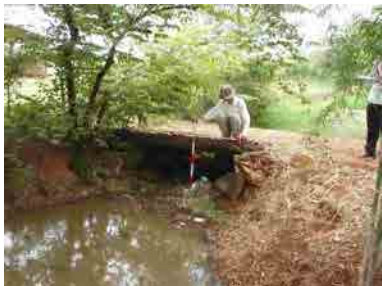
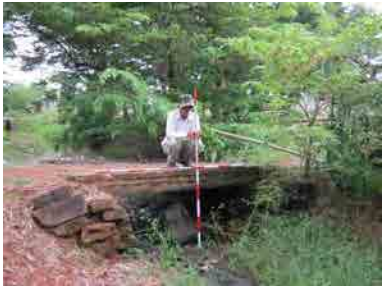
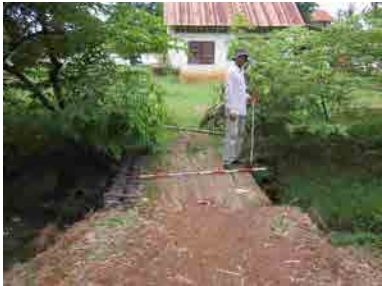
Canal No.: 3D	Kind of structure: Bridge (private)	Remarks:
Station: 6.00+790	Coordinate< Northing: 1217729 Easting: 460859	Routine survey

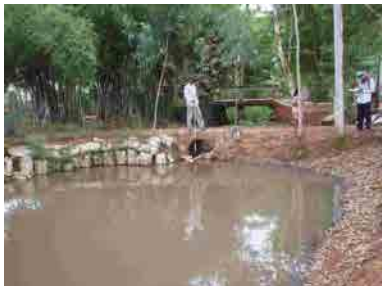
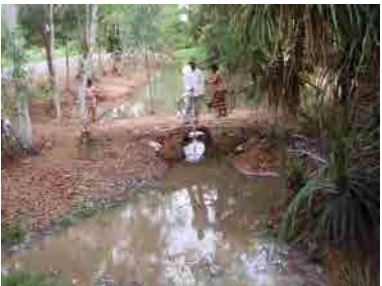
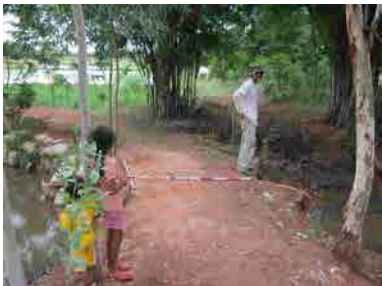
Canal No.: 3D	Kind of structure: Pipe culvert	Remarks:
Station: 6.00+910	Coordinate< Northing: 1217704 Easting: 460976	Routine survey

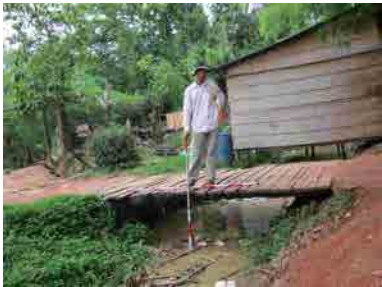
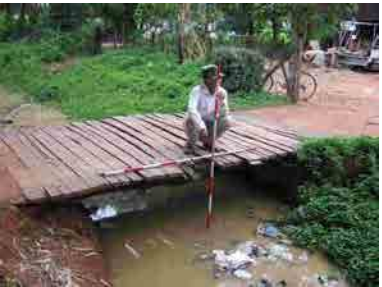
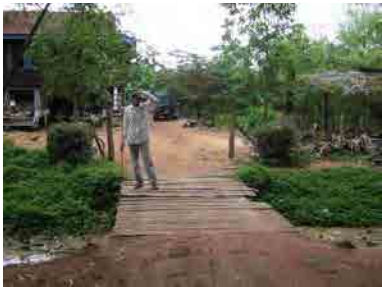
Canal No.: 3D	Kind of structure: Bridge (private)	Remarks:
Station: 6.00+970	Coordinate< Northing: 1217697 Easting: 461032	There is a house

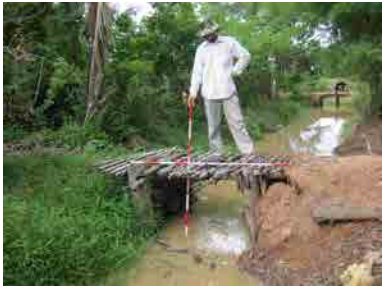
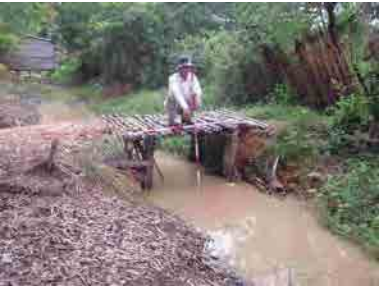
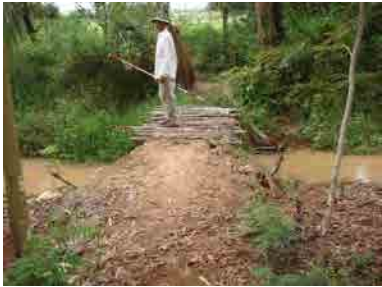
Canal No.: 3D	Kind of structure: Bridge (private)	Remarks:
Station: 6.00+990	Coordinate< Northing: 1217685 Easting: 461067	Routine survey
