# ***ANNEX D***

## ***Attachment – 1***

*Results of Inventory Survey for  
Proposed Rehabilitation Works in  
Roleang Chrey Headworks Rehabilitation Sub-project*

**Results of Inventory Survey for Proposed Rehabilitation Works on North Main Canal (1/12)**

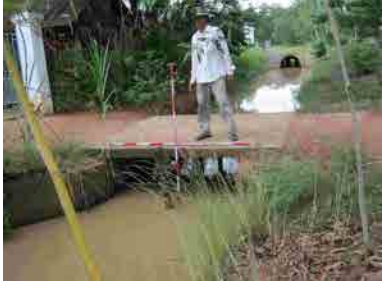
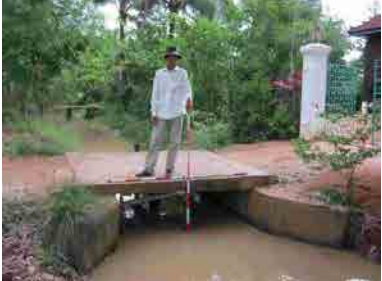
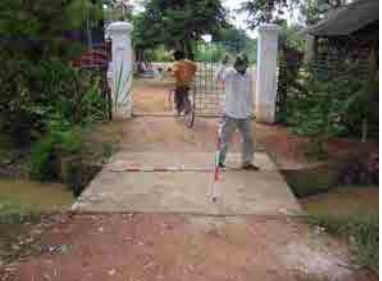
Canal No.: 3D	Kind of structure: Bridge (private)	Remarks:
Station: 7.00+20	Coordinate< <div style="display: flex; justify-content: space-between; padding: 0 10px;"> <span>Northing: 1217683</span> <span>Easting: 461093</span> </div>	Routine survey

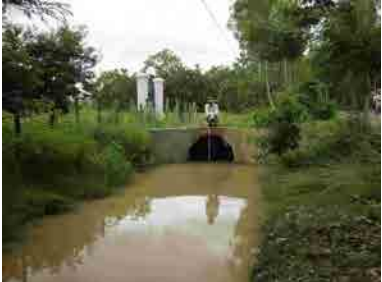
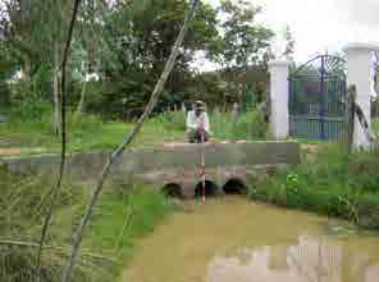
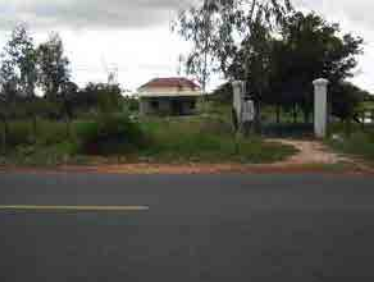
Canal No.: 3D	Kind of structure: Pipe culvert	Remarks:
Station: 7.00+50	Coordinate< <div style="display: flex; justify-content: space-between; padding: 0 10px;"> <span>Northing: 1217677</span> <span>Easting: 461120</span> </div>	Routine survey

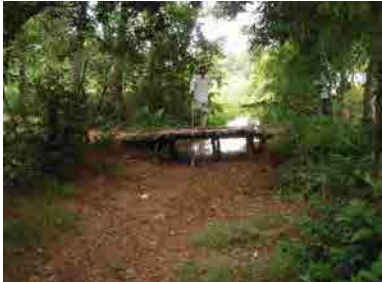
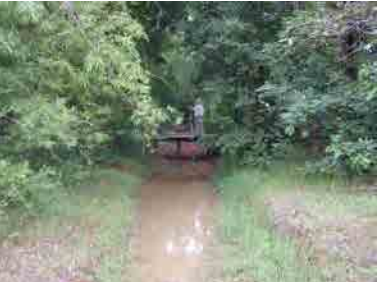
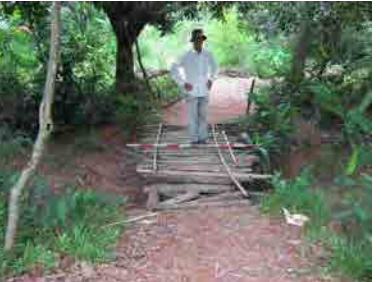
Canal No.: 3D	Kind of structure: Bridge (private)	Remarks:
Station: 7.00+220	Coordinate< <div style="display: flex; justify-content: space-between; padding: 0 10px;"> <span>Northing: 1217644</span> <span>Easting: 461275</span> </div>	Routine survey

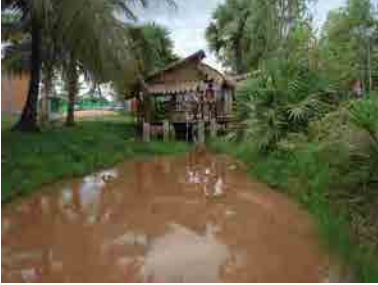
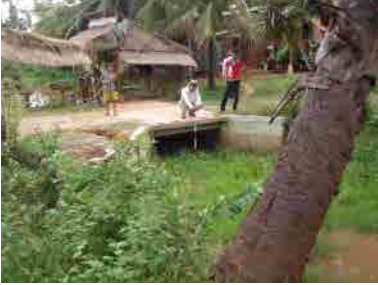
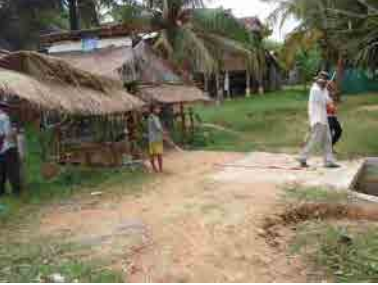
Canal No.: 3D	Kind of structure: Bridge (private)	Remarks:
Station: 7.00+340	Coordinate< Northing: 1217622 Easting: 461386	There is a house

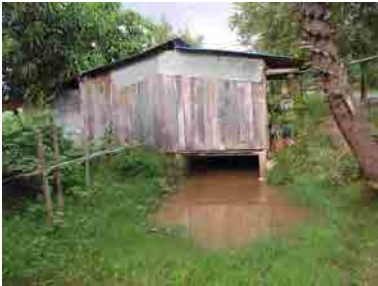
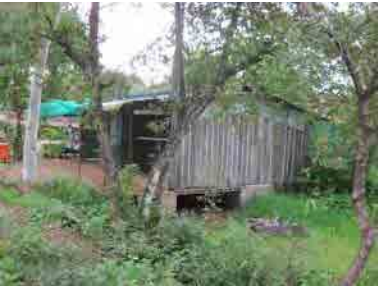
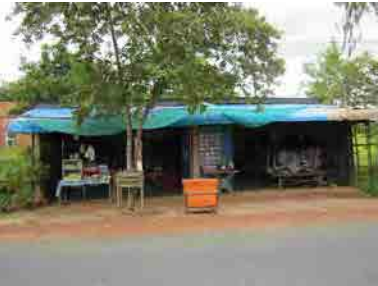
Canal No.: 3D	Kind of structure: House (Double)	Remarks:
Station: 7.00+360	Coordinate< Northing: 1217619 Easting: 461402	Routine survey

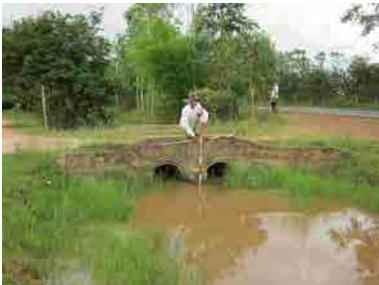
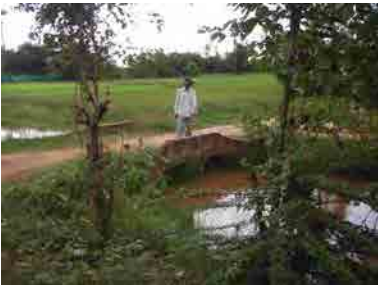
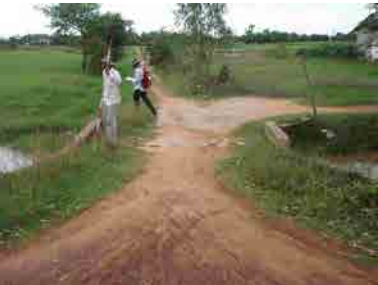
Canal No.: 3D	Kind of structure: Pipe culvert (Double)	Remarks:
Station: 7.00+450	Coordinate< Northing: 1217602 Easting: 461500	Routine survey

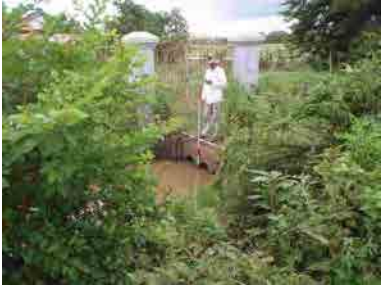
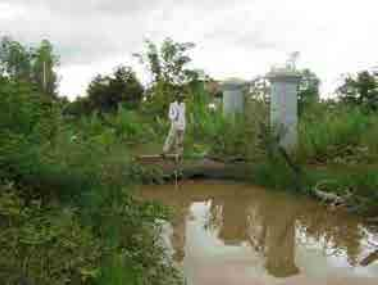
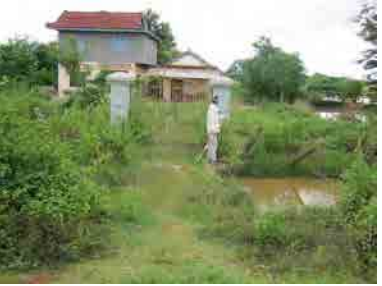
Canal No.: 3D	Kind of structure: Pipe culvert (Triple)	Remarks:
Station: 7.00+550	Coordinate< Northing: 1217581 Easting: 461575	Routine survey

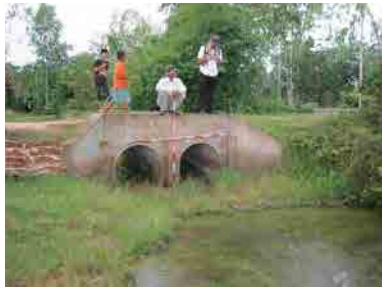
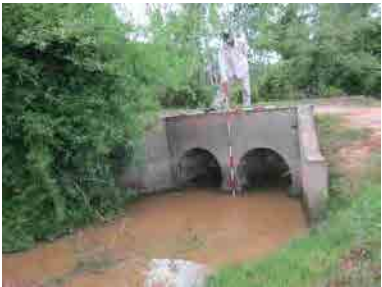
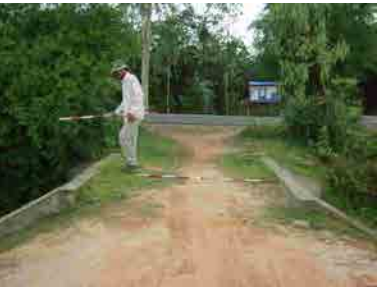
Canal No.: 3D	Kind of structure: Pipe culvert (Double)	Remarks:
Station: 7.00+720	Coordinate< Northing: 1217551 Easting: 461741	There is a groove

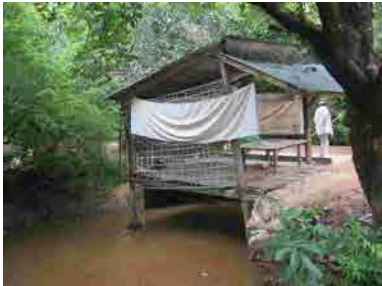
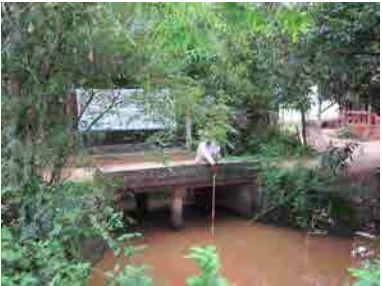
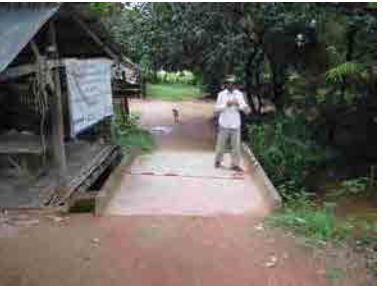
Canal No.: 3D	Kind of structure: Bridge (private)	Remarks:
Station: 7.00+900	Coordinate< Northing: 1217517 Easting: 461902	There is a house

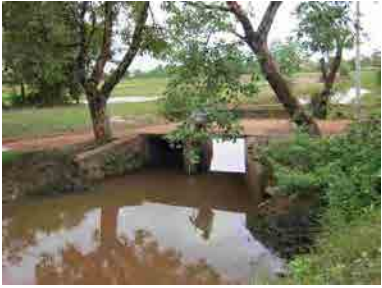
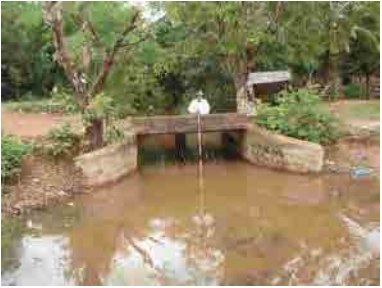
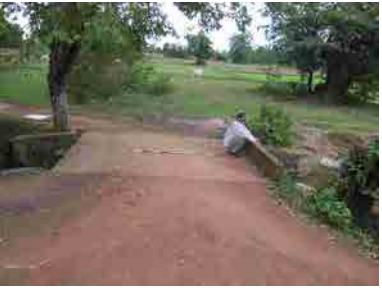
Canal No.: 3D	Kind of structure: Bridge (private)	Remarks: There is a groove
Station: 8.00+10	Coordinate< Northing: 1217494 Easting: 462014

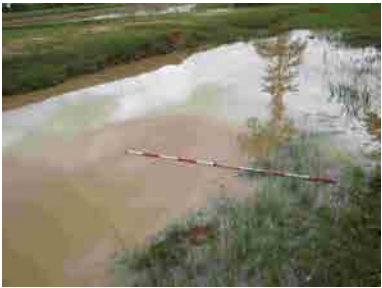
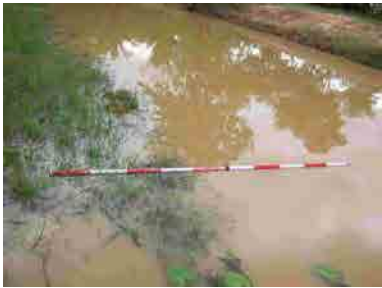
Canal No.: 3D	Kind of structure: Canal	Remarks: Routine survey Length: 7000m
Station: 8.00+50	Coordinate< Northing: 1217551 Easting: 461741

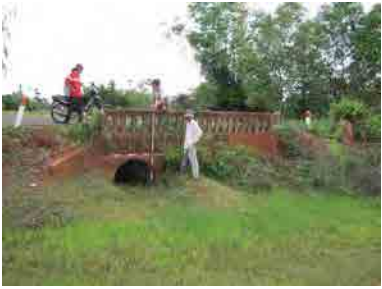
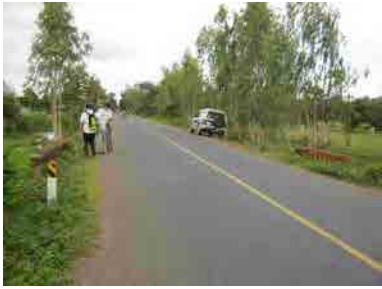
Canal No.: 3D	Kind of structure: Bridge (Pol Pot regime)	Remarks: There is a pipe culvert (triple)
Station: 8.00+240	Coordinate< Northing: 1217452 Easting: 462230

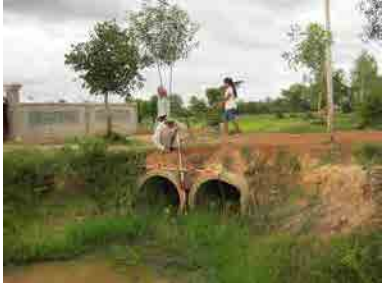
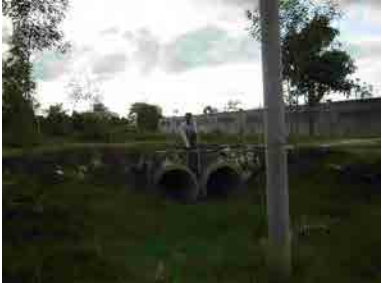
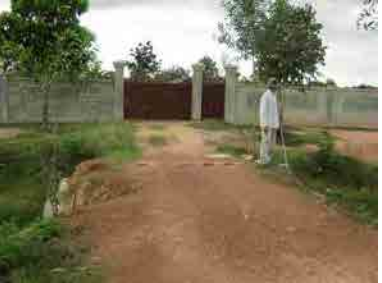
Canal No.: 3D	Kind of structure: Pipe culvert (Double)	Remarks:
Station: 8.00+320	Coordinate< <div style="display: flex; flex-direction: column; gap: 5px;"> <span>Northing: 1217441</span> <span>Easting: 462306</span> </div>	Routine survey
<div style="display: flex; justify-content: space-around; align-items: center;"> <div style="text-align: center;">

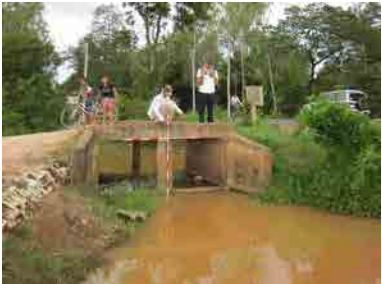
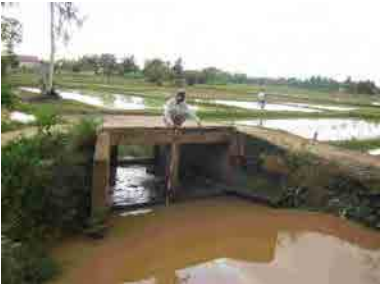
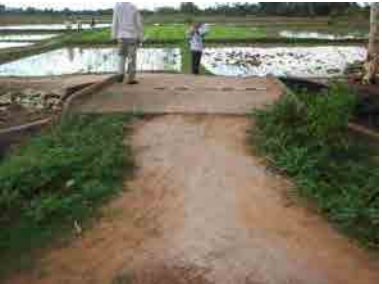
Canal No.: 3D	Kind of structure: Bridge (village)	Remarks:
Station: 8.00+510	Coordinate< <div style="display: flex; flex-direction: column; gap: 5px;"> <span>Northing: 1217411</span> <span>Easting: 462491</span> </div>	There is a groove
<div style="display: flex; justify-content: space-around; align-items: center;"> <div style="text-align: center;">

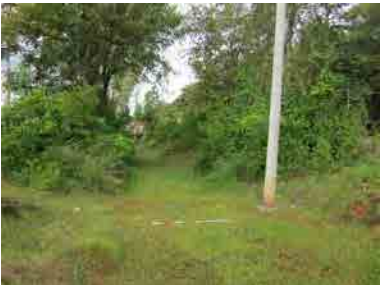
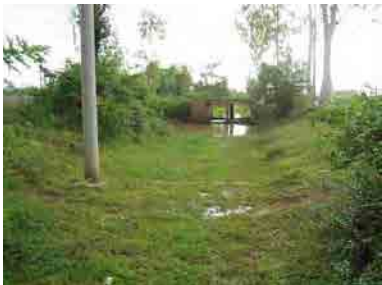
Canal No.: 3D	Kind of structure: Canal	Remarks:
Station: 8.00+530(EP)	Coordinate< <div style="display: flex; flex-direction: column; gap: 5px;"> <span>Northing: 1217400</span> <span>Easting: 462517</span> </div>	Routine survey
<div style="display: flex; justify-content: space-around; align-items: center;"> <div style="text-align: center;">

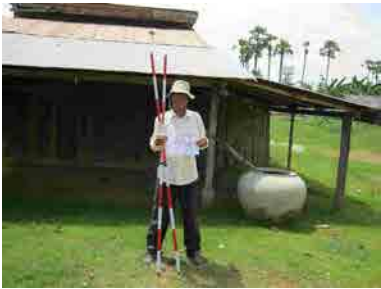
Canal No.: 3U	Kind of structure: House	Remarks: - Cross the National Road 130A
Station: 0.00(B.P.)	Coordinate< Northing: 1223101 Easting: 449634	
<div style="display: flex; justify-content: space-around; align-items: center;"> <div style="text-align: center;">

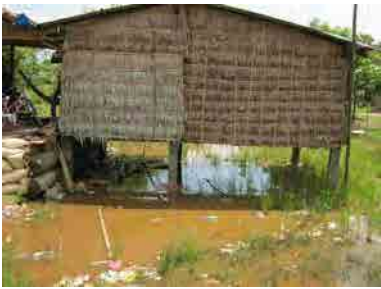
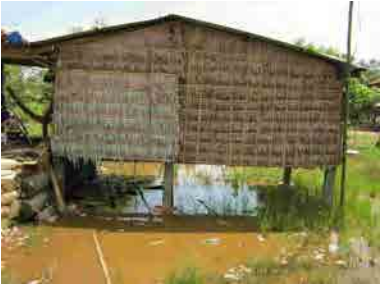
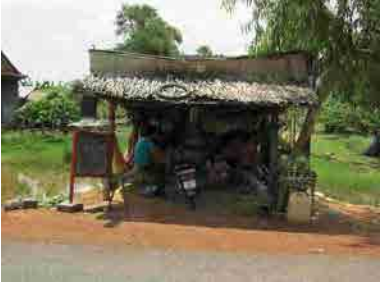
Canal No.: 3U	Kind of structure: House (Cottage)	Remarks: House is under canal
Station: 0.00+50	Coordinate< Northing: 1223100 Easting: 449674	
<div style="display: flex; justify-content: space-around; align-items: center;"> <div style="text-align: center;">

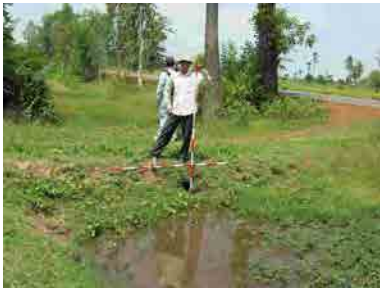
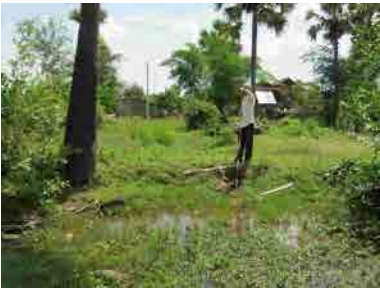
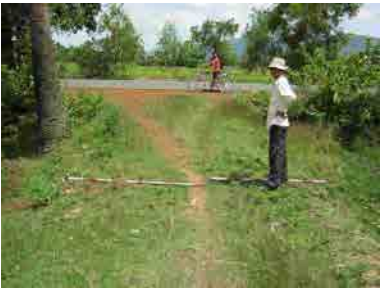
Canal No.: 3U	Kind of structure: Pipe culvert (Small)	Remarks: Routine survey
Station: 0.00+110	Coordinate< Northing: 1223103 Easting: 449731	
<div style="display: flex; justify-content: space-around; align-items: center;"> <div style="text-align: center;">

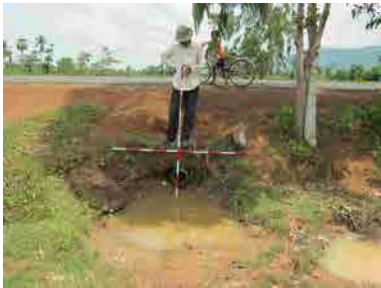
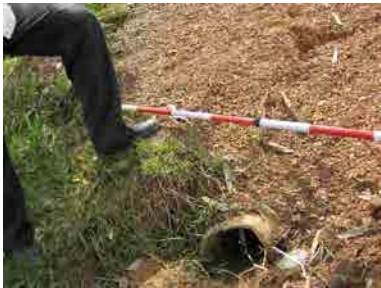
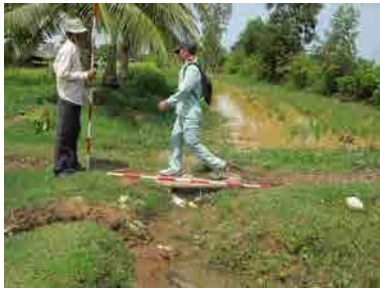
Canal No.: 3U	Kind of structure: Intake	Remarks:
Station: 0.00+180	Coordinate< Northing: 1223106 Easting: 449801	Routine survey

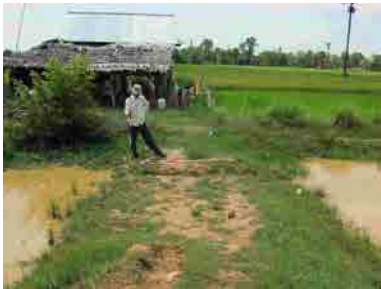
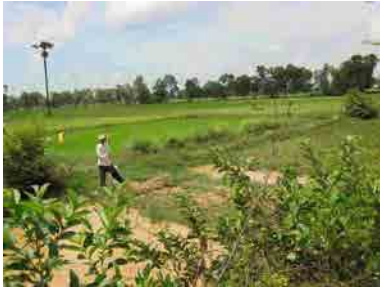
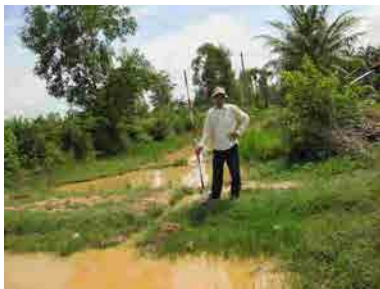
Canal No.: 3U	Kind of structure: Earth Check	Remarks:
Station: 0.00+230	Coordinate< Northing: 1223106 Easting: 449845	Routine survey

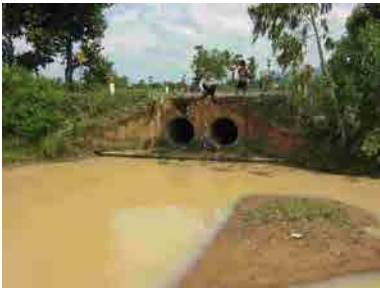
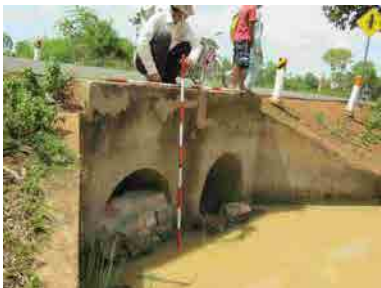
Canal No.: 3U	Kind of structure: Pipe culvert	Remarks:
Station: 0.00+260	Coordinate< Northing: 1223121 Easting: 449881	Pipe culvert is along the National road

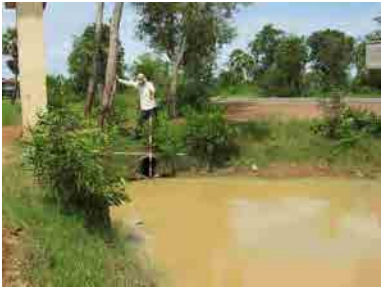
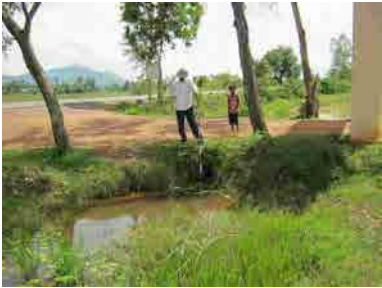
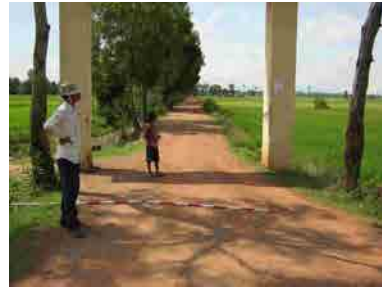
Canal No.: 3U	Kind of structure: Pipe culvert	Remarks: - Under commune road - There is a groove
Station: 0.00+360	Coordinate< Northing: 1223118 Easting: 449982

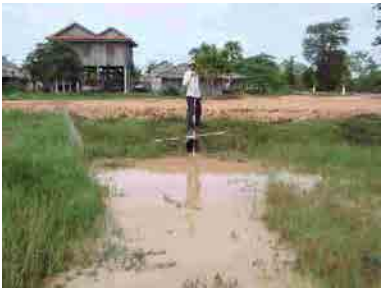
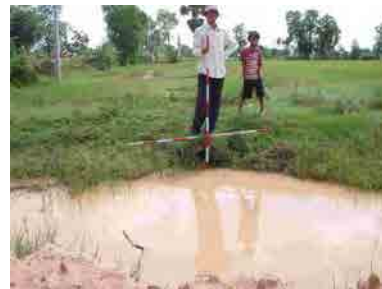
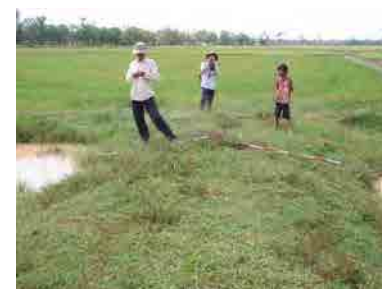
Canal No.: 3U	Kind of structure: Pipe culvert	Remarks: Routine survey
Station: 0.00+500	Coordinate< Northing: 1223122 Easting: 450087

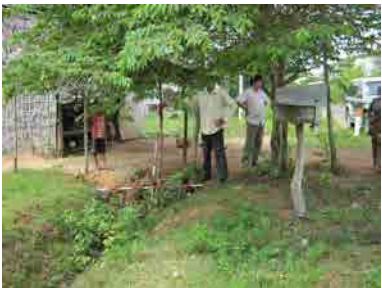
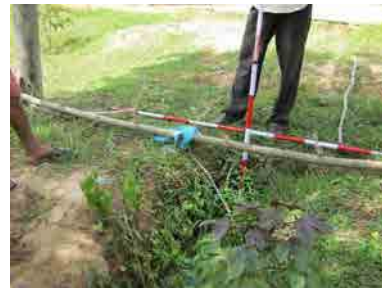
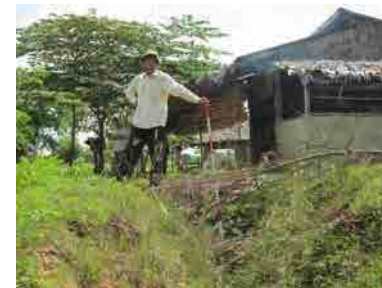
Canal No.: 3U	Kind of structure: Pipe culvert	Remarks: Pipe Culvert is under the land
Station: 0.00+550	Coordinate< Northing: 1223125 Easting: 450138

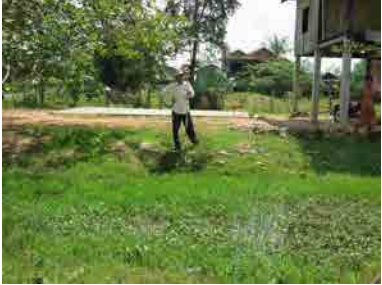
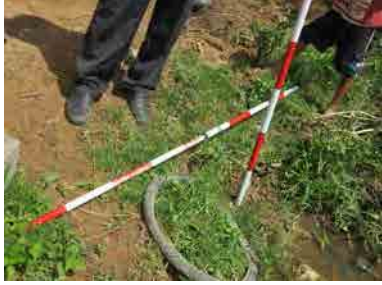
Canal No.: 3U	Kind of structure: Pipe culvert (Small)	Remarks: Pipe Culvert is under the land
Station: 0.00+600	Coordinate< Northing: 1223127 Easting: 450180	
<div style="display: flex; justify-content: space-around; align-items: center;"> <div style="text-align: center;">

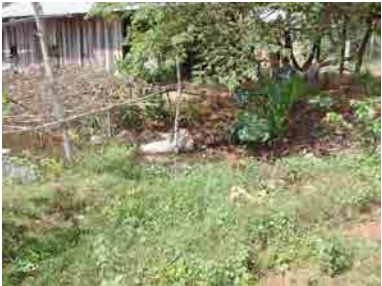
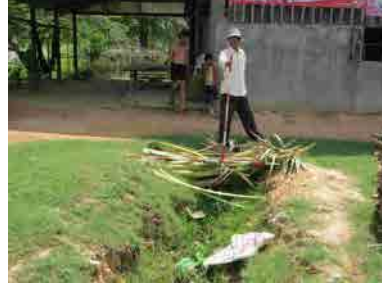
Canal No.: 3U	Kind of structure: Pipe Culvert	Remarks: Pipe Culvert is under the land
Station: 0.00+620	Coordinate< Northing: 1223117 Easting: 450232	
<div style="display: flex; justify-content: space-around; align-items: center;"> <div style="text-align: center;">

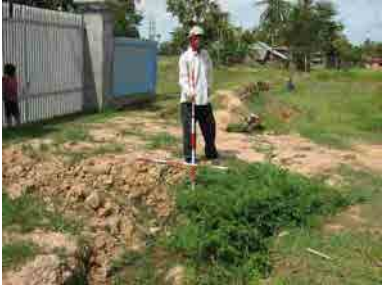
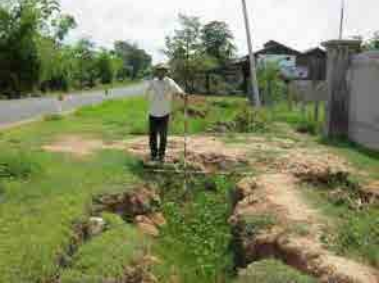
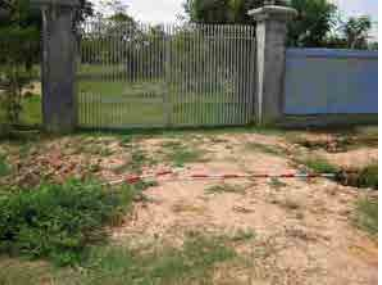
Canal No.: 3U	Kind of structure: Pipe culvert	Remarks: Pipe Culvert is under the land
Station: 0.00+660	Coordinate< Northing: 1223114 Easting: 450272	
<div style="display: flex; justify-content: space-around; align-items: center;"> <div style="text-align: center;">

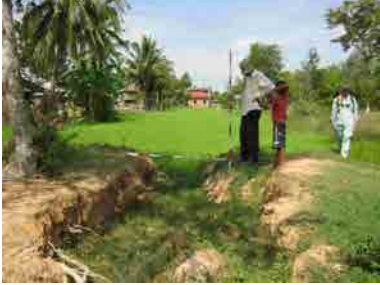
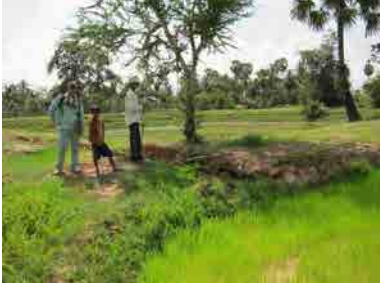
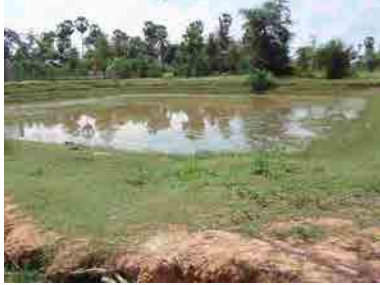
Canal No.: 3U	Kind of structure: Structure Party	Remarks:
Station: 0.00+710	Coordinate< Northing: 1223112 Easting: 450328	Routine survey

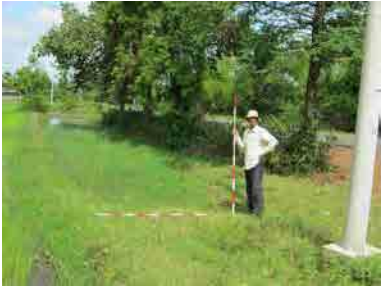
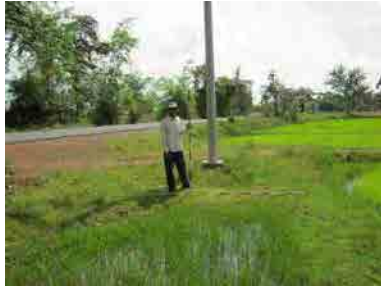
Canal No.: 3U	Kind of structure: Canal	Remarks:
Station: 0.00+790	Coordinate< Northing: 1223088 Easting: 450387	Routine survey Second B.P.

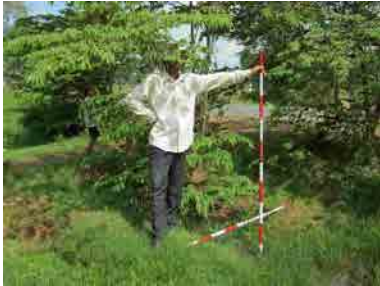
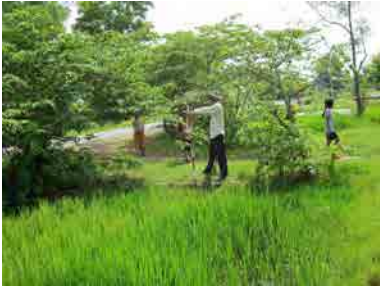
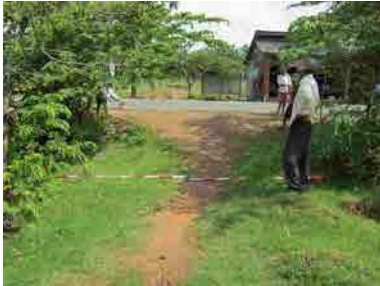
Canal No.: 3U	Kind of structure: Pipe culvert	Remarks:
Station: 0.00+950	Coordinate< Northing: 1223046 Easting: 450511	Routine survey

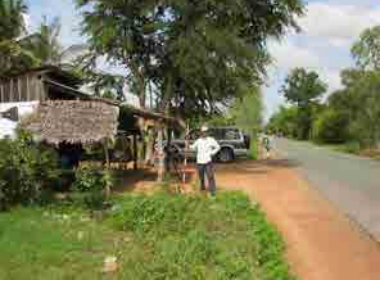
Canal No.: 3U	Kind of structure: Canal	Remarks: Routine survey House is along the canal
Station: 1.00+30	Coordinate< Northing: 1223024 Easting: 450573	
<div style="display: flex; justify-content: space-around; align-items: center;"> <div style="text-align: center;">

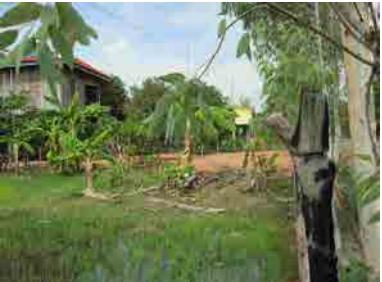
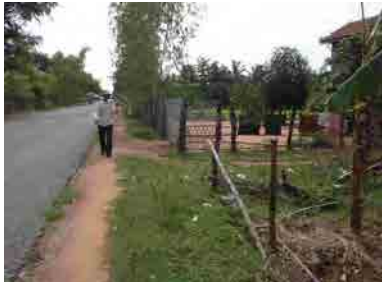
Canal No.: 3U	Kind of structure: Canal	Remarks: Private road is on the canal
Station: 1.00+100	Coordinate< Northing: 1222999 Easting: 450653	
<div style="display: flex; justify-content: space-around; align-items: center;"> <div style="text-align: center;">

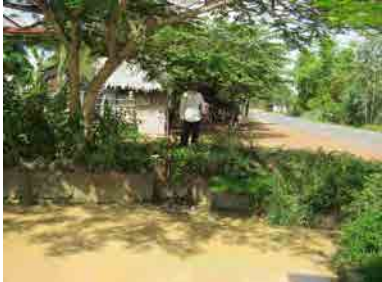
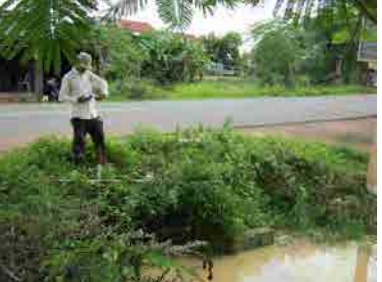
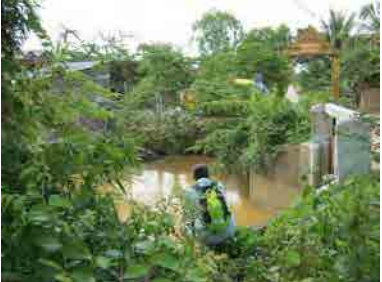
Canal No.: 3U	Kind of structure: Pipe Culvert	Remarks: There are Groove and Intake
Station: 1.00+510(EP)	Coordinate< Northing: 1222891 Easting: 450993	
<div style="display: flex; justify-content: space-around; align-items: center;"> <div style="text-align: center;">

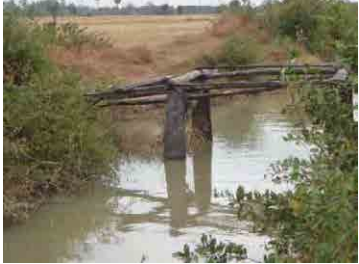
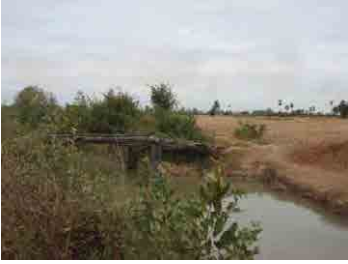
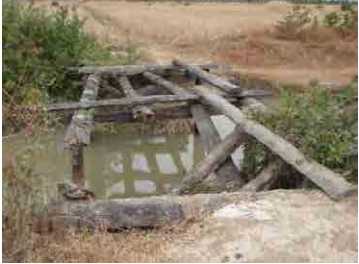
Canal No.: KC-1	Kind of structure(s): Wooden bridge	Remarks:
Station: 0.00+770	Coordinate< Northing: 1261001 Easting: 478718	Temporary

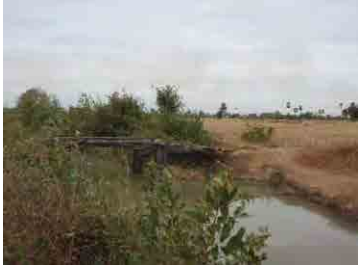
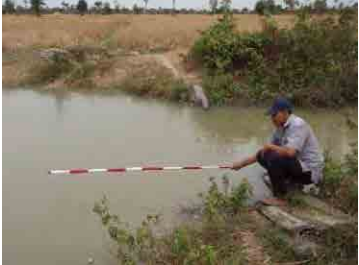
Canal No.: KC-1	Kind of structure(s): Foot path bridge	Remarks:
Station: 1.00+500	Coordinate< Northing: 1260994 Easting: 479318	Broken

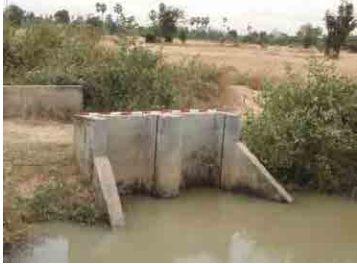
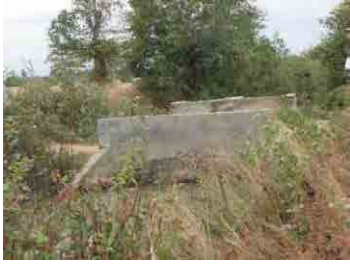
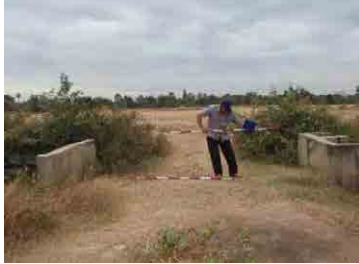
Canal No.: KC-1	Kind of structure(s): Bridge	Remarks:
Station: 1.00+710	Coordinate< Northing: 1261000 Easting: 479521	Bridge with groove

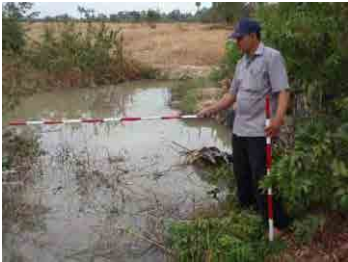
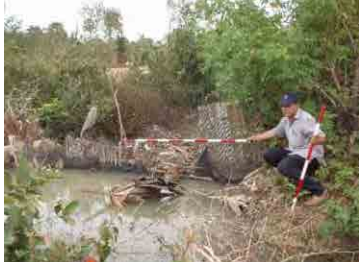
Canal No.: KC-1	Kind of structure(s): Check structure	Remarks:
Station: 2.00+280	Coordinate< Northing: 1260997 Easting: 480025	Check structure cum fish net by bamboo barrage (Temporary)

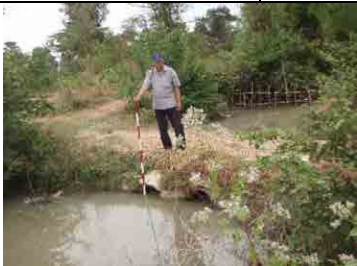
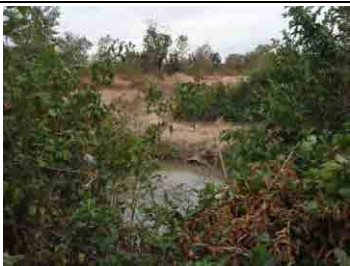
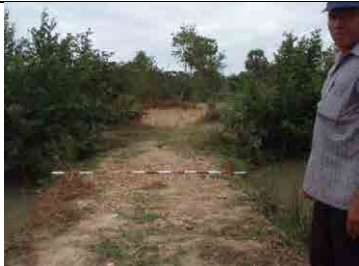
Canal No.: KC-1	Kind of structure(s): Pip culvert	Remarks:
Station: 2.00+390	Coordinate< Northing: 1261003 Easting: 480109	Pip culvert (Double)

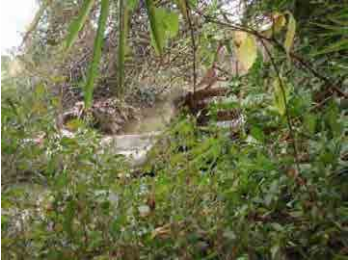
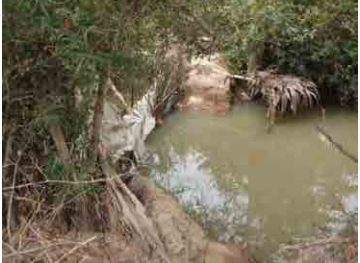
Canal No.: KC-1	Kind of structure(s): Check structure	Remarks:
Station: 2.00+450	Coordinate< Northing: 1261012 Easting: 480161	Check structure by bamboo net (Temporary)

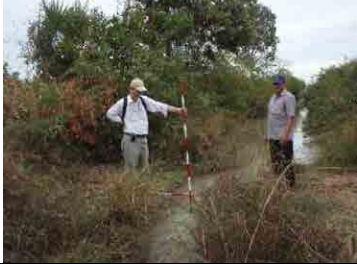
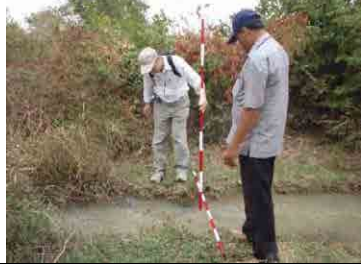
3,000	480597	1261003	Canal Section	Slope of canal is covered by thick grass and trees, no maintenance is made for long time	C	
3,020	480628	1261003	Turn Out (Broken)	Turnout was broken and location is higher than rice field	D	Pipe dia=0.3m
3,420	480994	1261005	Regulator	New structure and functioned well	A	Constructed by TSC, MOWRAM in Dec. 2010 (Financial Assistance of JICA)
4,020	480994	1261005	Drain Inlet W=4m, dia=1m	New structure and functioned well	A	Constructed by TSC, MOWRAM in Dec. 2010 (Financial Assistance of JICA)
4,060	481506	1261011	Drain Inlet W=4m, dia=1m	New structure and functioned well	A	Constructed by TSC, MOWRAM in Dec. 2010 (Financial Assistance of JICA)
4,180	: 481612	1261008	Pipe Culvert on commune road	New structure and functioned well	A	Constructed by TSC, MOWRAM in Dec. 2010 (Financial Assistance of JICA) (Double) W=4m, dia=1m
4,850	481943	1261011	E.P, Pipe Culvert on provincial road	New structure and functioned well	A	Constructed by TSC, MOWRAM in Dec. 2010 (Financial Assistance of JICA) (Double) W=6m, dia=1.5m

Canal No.: KC-1	Kind of structure(s): Canal Section	Remarks:
Station: 3.00+000	Coordinate< Northing: 1261003 Easting: 480597

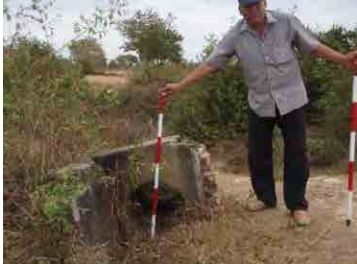
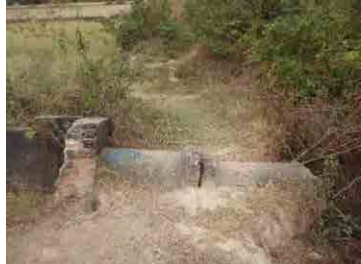
Canal No.: KC-1	Kind of structure(s): Turn out	Remarks:
Station: 3.00+020	Coordinate< Northing: 1261003 Easting: 480628	Broken

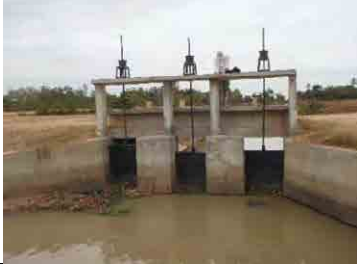
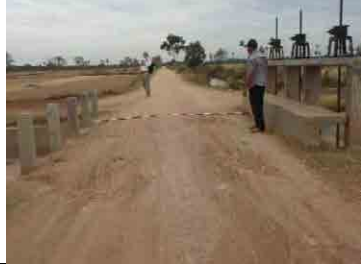
Canal No.: KC-1	Kind of structure(s): Regulator	Remarks:
Station: 3.00+420	Coordinate< Northing: 1261005 Easting: 480994	Regulator on commune road with 3 gates

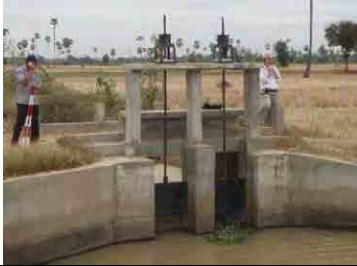
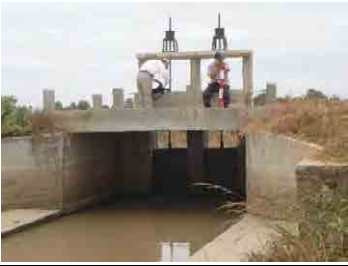
Canal No.: KC-1	Kind of structure(s): Regulator	Remarks:
Station: 3.00+420	Coordinate< Northing: 1261005 Easting: 480994	Regulator with 2 gates

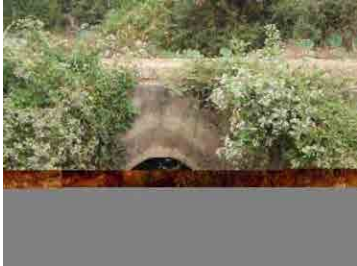
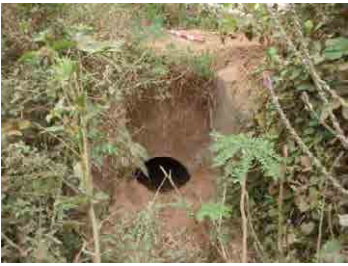
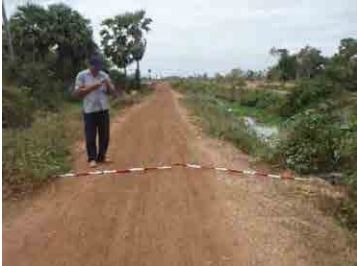
Canal No.: KC-1	Kind of structure(s): Drain Inlet	Remarks:
Station: 4.00+020	Coordinate< Northing: 1261005 Easting: 480994

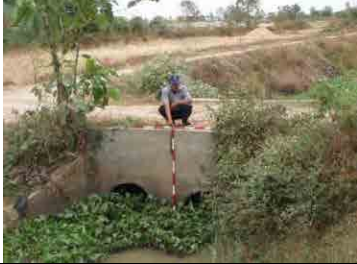
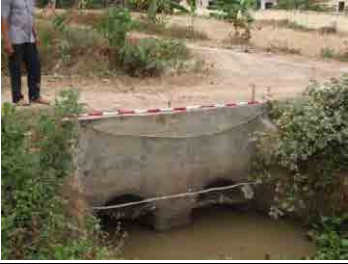
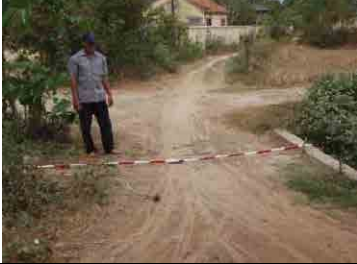
Canal No.: KC-1	Kind of structure(s): Pipe Culvert	Remarks:
Station: 4.00+180	Coordinate< Northing: 1261008 Easting: 481612	Double Culverts

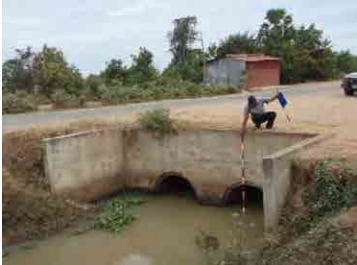
Canal No.: KC-1	Kind of structure(s): Pipe Culvert	Remarks:
Station: 4.00+850 (E.P)	Coordinate< Northing: 1261011 Easting: 481943	Double Culverts on Provincial Road

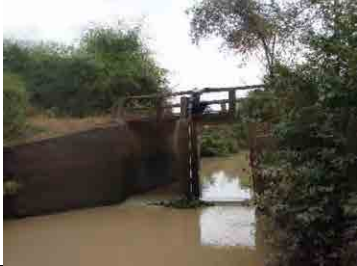
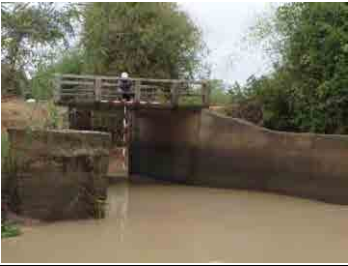
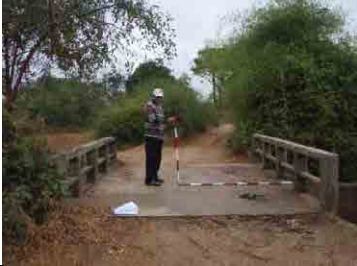
Sta.	E	N	Structure	Condition	Evaluation	Remarks
0	480212	1260282	B.P. Intake for KC-2 with bridge (public)	Existing weir exists about 100 m downstream, no gate is equipped	C	Bridge; W=4.8m, L=3.2m,
200	480345	1260284	Drain Inlet,	Pipe and wing wall is still in good condition	B	W=4m, L=1.2m, dia=0.6m
400	480597	1260289	Bridge on commune road	Bridge is still functioned	C	W=6.5m, L=3m
400	480597	1260289	Regulator	2 nos. of slide gates without lifting spindle and gear	C	W=3m, L=3m
500	480699	1260292	Canal Section	-	-	
800	4800960	1260299	Turnout	Outlet wall has been deteriorated	C	(Private), dia=0.3m
900	481101	1260298	Turnout dia=0.3 m	Outlet wall has been deteriorated	C	(Private), dia=0.3m
1,000	481211	1260302	Canal Section	Section is still remained, but covered by grass and trees	C	
1,400	481611	1260312	Drain Inlet	Broken	D	dia=0.3m
1,500	481682	1260310	Box Culvert with groove (public)	Structures looks new, not jeevable but for motor cycles	B	W=1.3m, L=1.5m

Canal No.: KC-2	Kind of structure(s): Bridge with groove	Remarks: No gate on the Intake
Station: 0.00 (B.P.)	Coordinate< Northing: 1260282 Easting: 480212

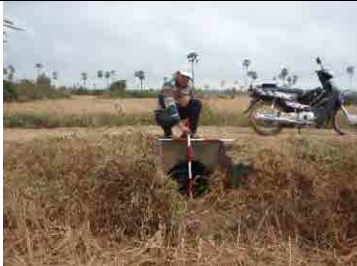
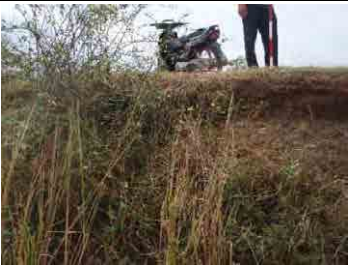
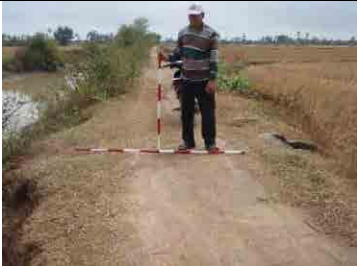
Canal No.: KC-2	Kind of structure(s): Drain Inlet	Remarks:
Station: 0.00+200	Coordinate< Northing: 1260284 Easting: 480345

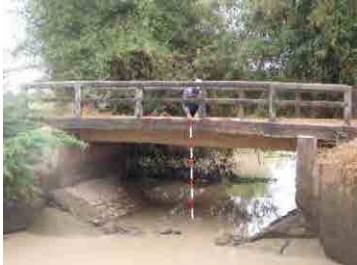
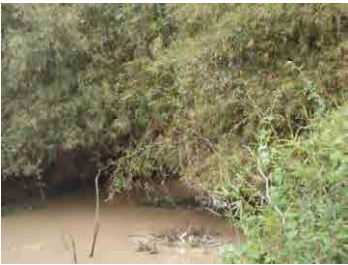
Canal No.: KC-2	Kind of structure(s): Bridge & Regulator	Remarks: On commune road
Station: 0.00+400	Coordinate< Northing: 1260289 Easting: 480597

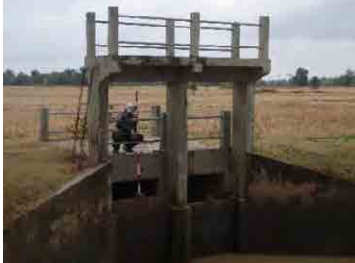
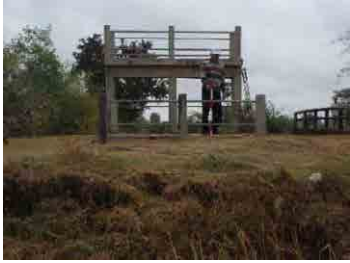
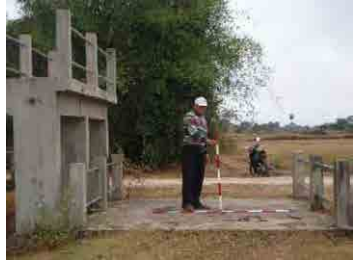
Canal No.: KC-2	Kind of structure(s): Turn-out (Off-take)	Remarks:
Station: 0.00+400	Coordinate< Northing: 1260289 Easting: 480597	No lifting gear, though gates were installed

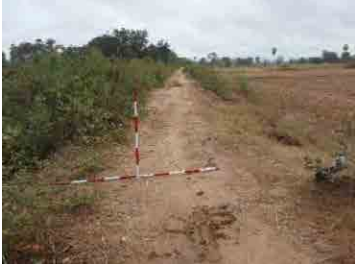
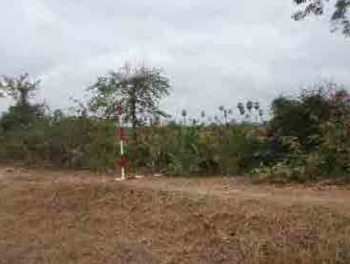
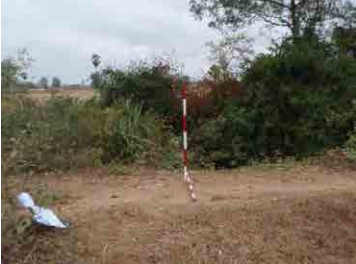
Canal No.: KC-2	Kind of structure(s): Canal Section	Remarks:
Station: 0.00+500	Coordinate< Northing: 1260292 Easting: 480699

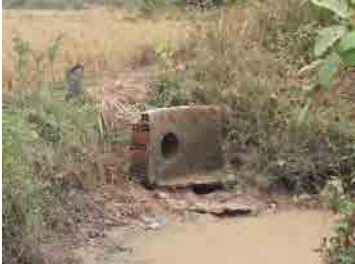
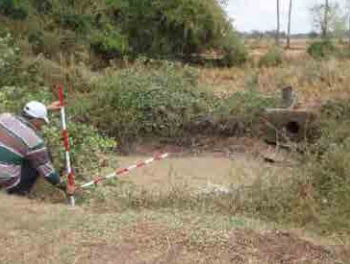
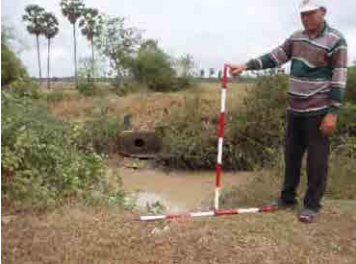
Canal No.: KC-2	Kind of structure(s): Turnout	Remarks:
Station: 0.00+800	Coordinate< Northing: 1260299 Easting: 4800960	(Private)

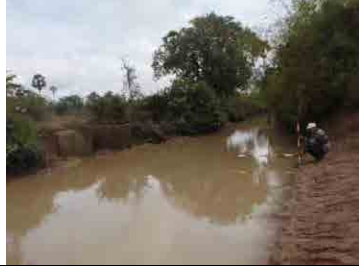
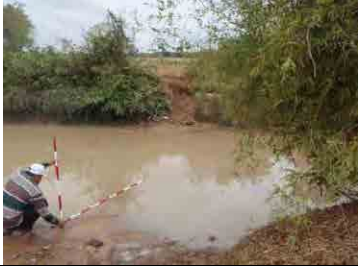
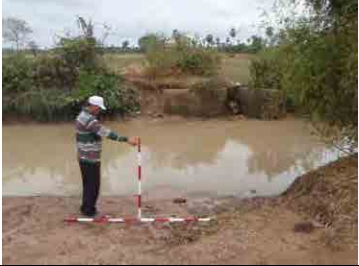
Canal No.: KC-2	Kind of structure(s): Turnout	Remarks: (Private)
Station: 0.00+900	Coordinate< Northing: 1260298 Easting: 481101

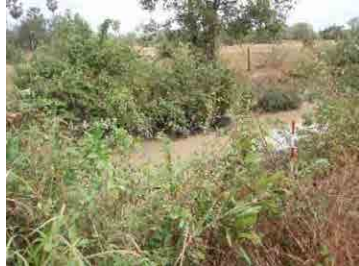
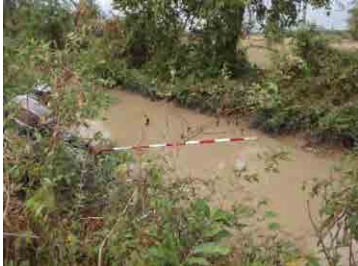
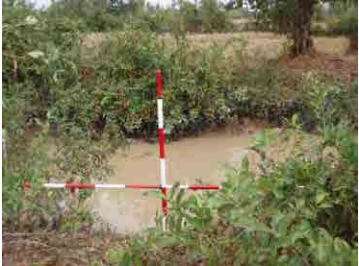
Canal No.: KC-2	Kind of structure(s): Canal Section	Remarks:
Station: 1.00+000	Coordinate< Northing: 1260302 Easting: 481211

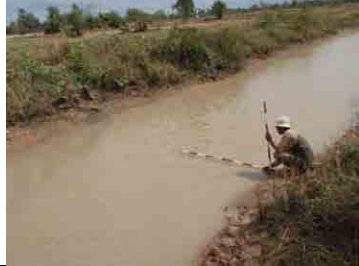
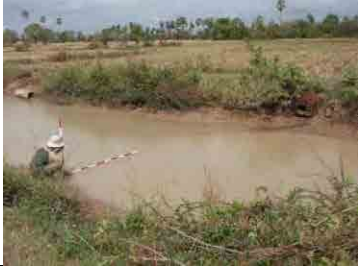
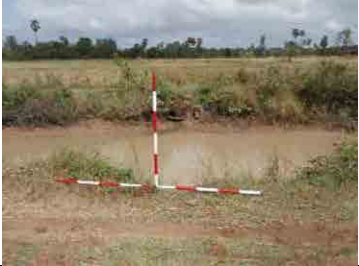
Canal No.: KC-2	Kind of structure(s): Drain Inlet	Remarks: (Broken)
Station: 1.00+400	Coordinate< Northing: 1260312 Easting: 481611

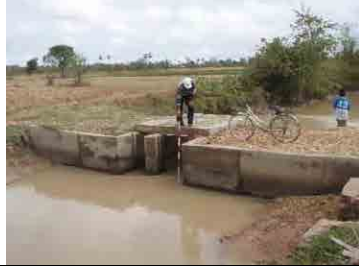
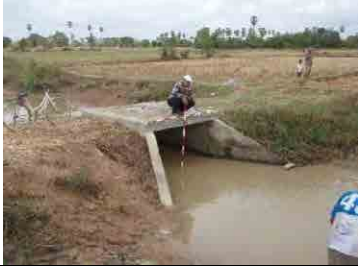
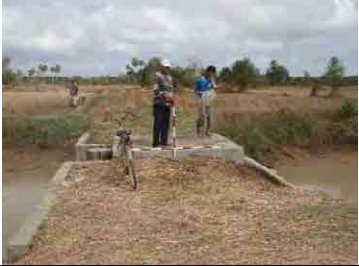
Canal No.: KC-2	Kind of structure(s): Box Culvert	Remarks:
Station: 1.00+500	Coordinate< Northing: 1260310 Easting: 481682	Box Culvert with groove

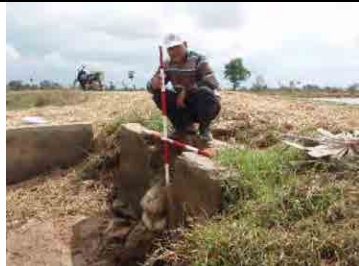
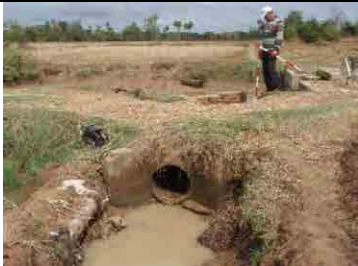
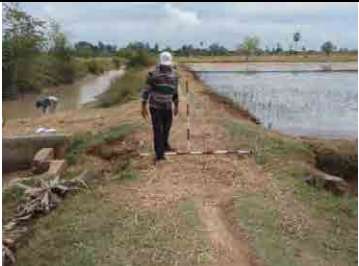
Canal No.: KC-2	Kind of structure(s): Drain Inlet	Remarks:
Station: 1.00+500	Coordinate< Northing: 1260310 Easting: 481682

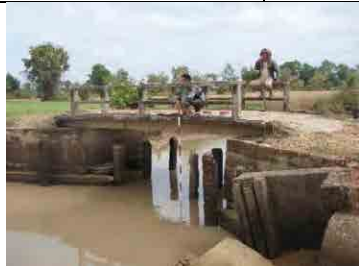
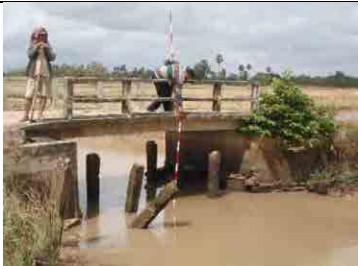
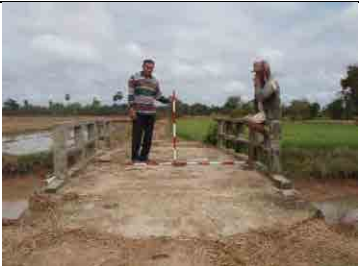
Drain inlet	Temporarily installed pipe	C	W=1.3m, L=1m, dia=0.3m
2,000	482075	1260316	Bridge on commune road	Reconstructed bridge but rather damaged	C	W=2.5m, L=4.8m
			Drain Inlet	Temporarily installed pipe	C	dia=0.6m
2,350	482476	1260324	Bridge (Private),	House access	C	W=2.5m, L=2.5m
2,400	482530	1260328	Wooden Bridge (Private),	House access	C	W=0.5m, L=5m
2,430	482583	1260329	Turnout	with Box Culvert with groove	C	W=4.5m, L=3.5m
			Bridge with groove Commune road	Surface of bridge is damaged lot	C	W=4 m, L=3.5m
2,450	482612	1260323	Pipe Culvert Private	Canal section is blocked by dike and small pipe is clogged	C	L=6m, dia=0.6m
2,500	482688	1260327	Wooden Bridge (Private)	Temporary bamboo bridge	-	W=0.5m, L=6 m
2,950	4883105	1260334	Canal Section	Section is still remained though eroded, and covered by grass	C	
3,000	483158	1260343	Pipe Culvert (Double), on village road	Rather in good condition	B	W=2.5m, L=2.5m, dia=1m

Canal No.: KC-2	Kind of structure(s): Bridge	Remarks:
Station: 2.00+000	Coordinate< Northing: 1260316 Easting: 482075

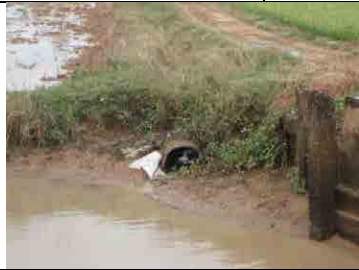
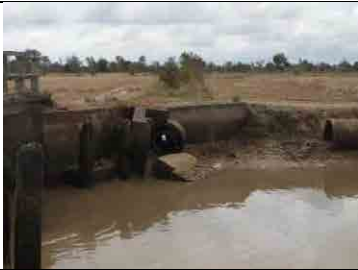
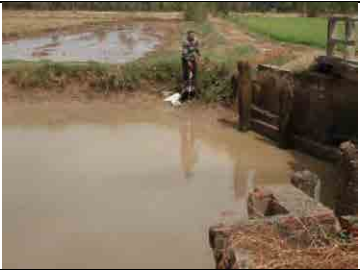
Canal No.: KC-2	Kind of structure(s): Drain Inlet	Remarks:
Station: 2.00+000	Coordinate< Northing: 1260316 Easting: 482075

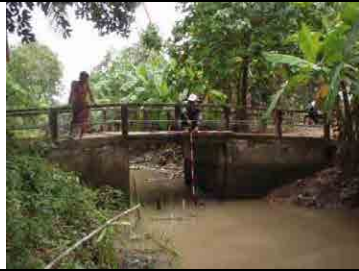
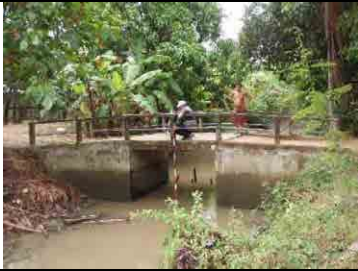
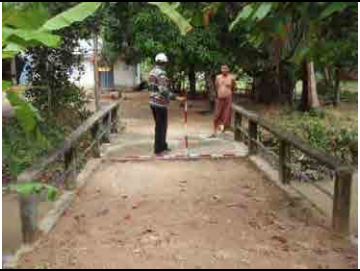
Canal No.: KC-2	Kind of structure(s): Bridge	Remarks: (Private)
Station: 2.00+350	Coordinate< Northing: 1260324 Easting: 482476

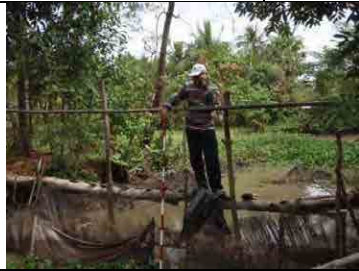
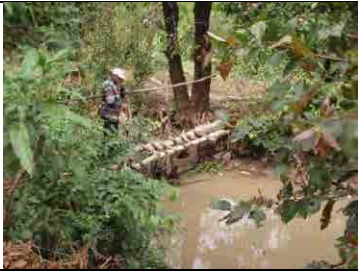
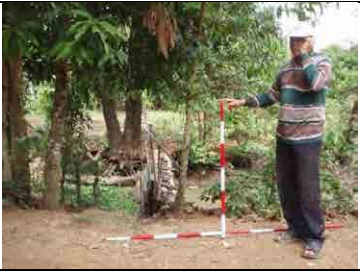
Canal No.: KC-2	Kind of structure(s): Wooden Bridge	Remarks: Foot path bridge (Private)
Station: 2.00+400	Coordinate< Northing: 1260328 Easting: 482530

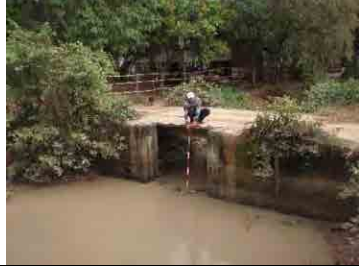
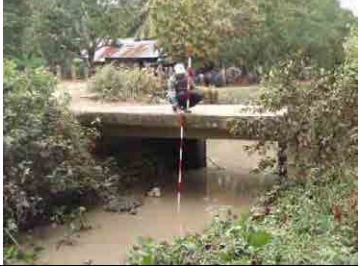
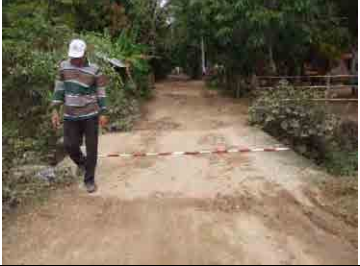
Canal No.: KC-2	Kind of structure(s): Box Culvert	Remarks: Box Culvert with groove
Station: 2.00+430	Coordinate< Northing: 1260329 East ing: 482583

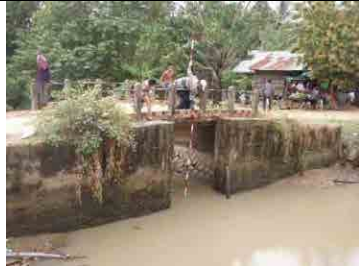
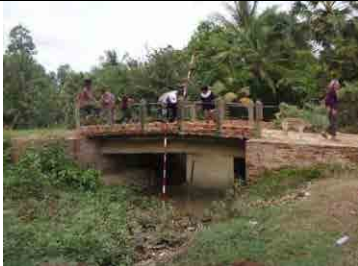
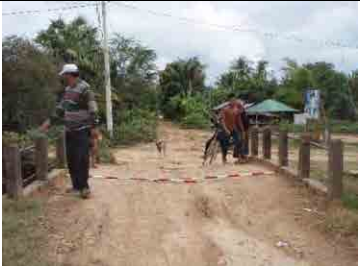
Canal No.: KC-2	Kind of structure(s): Turn Out	Remarks:
Station: 2.00+430	Coordinate< Northing: 1260329 East ing: 482583

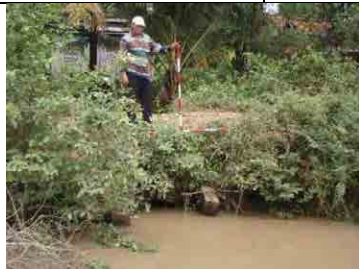
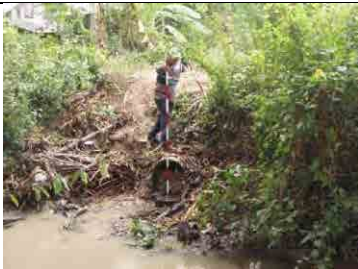
Canal No.: KC-2	Kind of structure(s): Pipe Culvert	Remarks:
Station: 2.00+450	Coordinate< Northing: 1260323 East ing: 482612

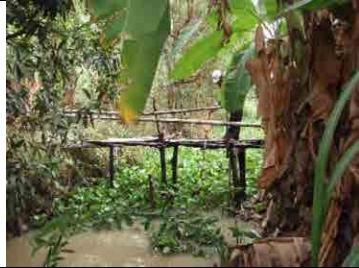
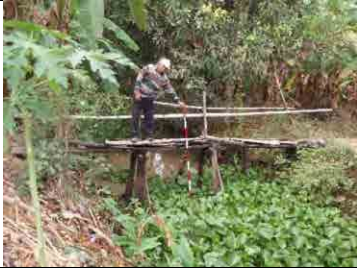
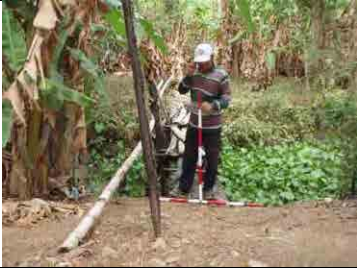
Canal No.: KC-2	Kind of structure(s): Wooden Bridge	Remarks: (Private)
Station: 2.00+500	Coordinate< Northing: 1260327 Easting: 482688

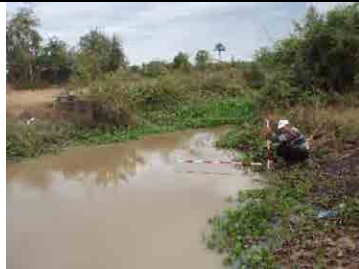
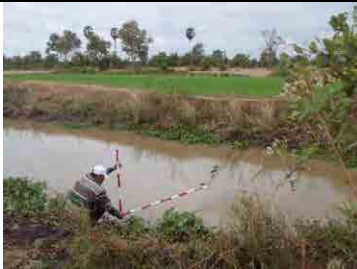
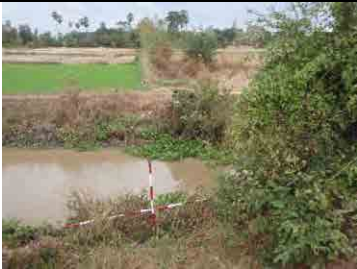
Canal No.: KC-2	Kind of structure(s): Canal section	Remarks:
Station: 2.00+950	Coordinate< Northing: 1260334 Easting: 4883105

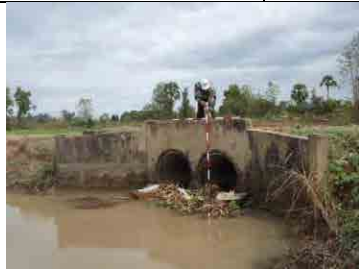
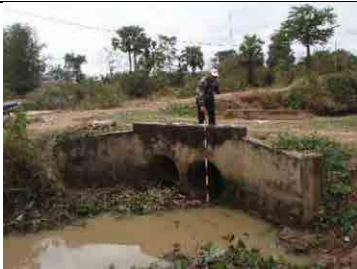
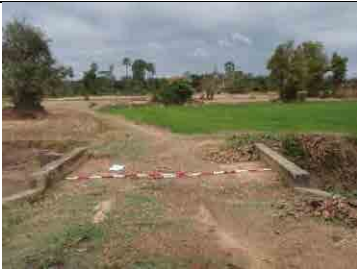
Canal No.: KC-2	Kind of structure(s): Pipe Culvert	Remarks: Double culverts
Station: 3.00+000	Coordinate< Northing: 1260343 Easting: 483158

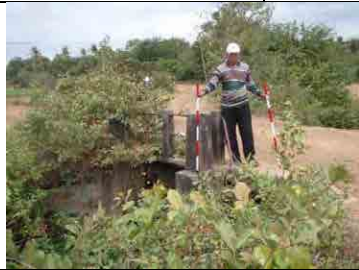
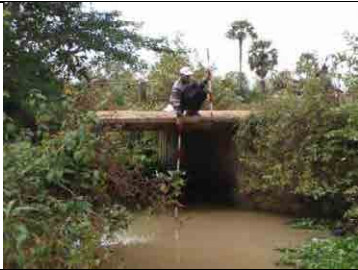
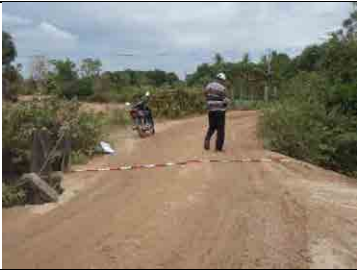
3,200	483372	1260347	Bridge with groove on commune road	Broken handrail	B	W=4.5m, L=4.5m

Canal No.: KC-2	Kind of structure(s): Bridge	Remarks:
Station: 3.00+200	Coordinate< Northing: 1260347 Easting: 483372	Bridge with groove
