# ***ANNEX D***

## ***Attachment – 1***

*Results of Inventory Survey for  
Proposed Rehabilitation Works in  
Roleang Chrey Headworks Rehabilitation Sub-project*

**Results of Inventory Survey for Proposed Rehabilitation Works on North Main Canal (1/12)**

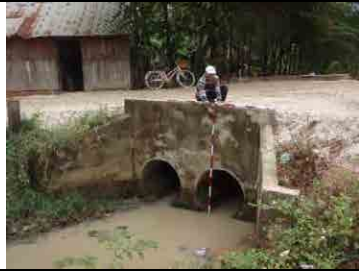
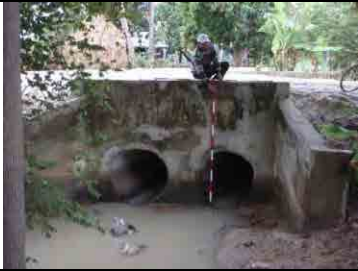
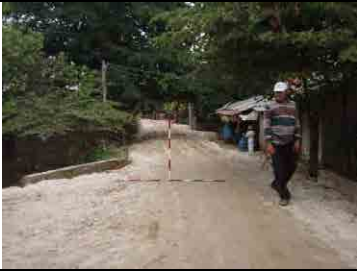
3,400	483619	1260347	Pipe Culvert (Double) on village road	Recently repaired	B	W=4m, L=5m, dia=1m
3,500	483693	1260341	Turnout	Burried by earth, not functioned	D	Pipe portion: W=4m, L=1m, dia=1m
3,700	483910	1260344	Turnout	Burried by earth, not functioned		Pipe portion: W=5m, L=1.2m, dia=0.6
3,800	483984	1260345	Wooden Bridge (Private)	House access	C	W=1.2m, L=6m
4,000	484211	1260347	Canal Section	Many water plants obstructs water flow	C	
4,150	484424	1260350	Check Structure	Check wall with groove, but no use at present	C	, W=2m, L=0.8m
			Bridge on village road	Good condtion	B	W=4m, L=8m
4,400	484605	1260354	Pipe Culvert (private; house access)	Good condtion	B	W=5m, L=4m, dia=0.8m (Double)
4,430	484635	1260356	Wooden Bridge (Private),	village area	C	W=2.5m, L=5m
4,500	484731	1260350	Canal Section	Section is covered by thick grass and trees	D	No use as canal at present
4,530	484772	1260354	E.P. Pipe Culvert (Private)	Access to School "Siem Reap	C	W=5m, L=3m, D=0.6m (3 culverts)

Canal No.: KC-2	Kind of structure(s): Pipe Culvert	Remarks:
Station: 3.00+400	Coordinate< Northing: 1260347 Easting: 483619	Double Pipe Culvert

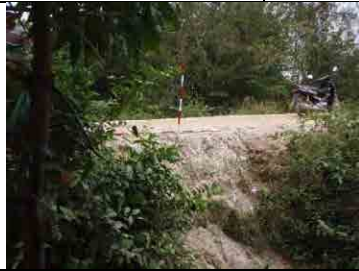
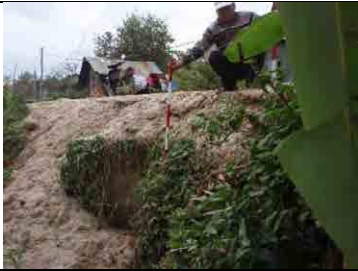
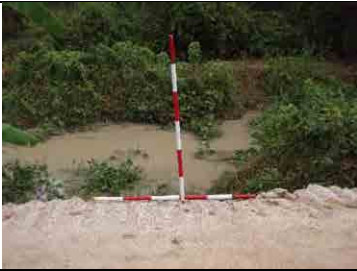
Canal No.: KC-2	Kind of structure(s): Turnout	Remarks:
Station: 3.00+500	Coordinate< Northing: 1260341 Easting: 483693

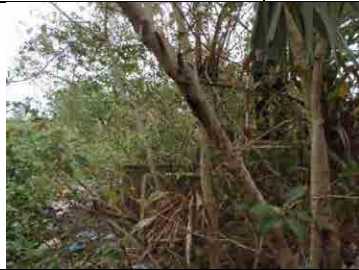
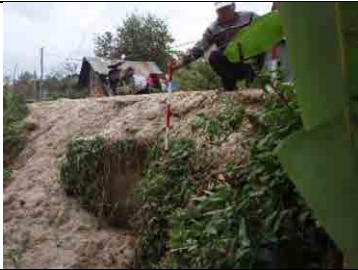
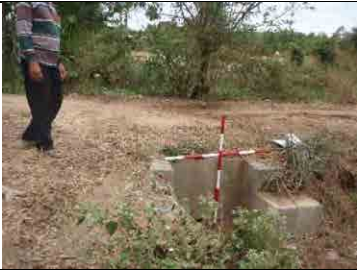
Canal No.: KC-2	Kind of structure(s): Turnout	Remarks:
Station: 3.00+700	Coordinate< Northing: 1260344 Easting: 483910

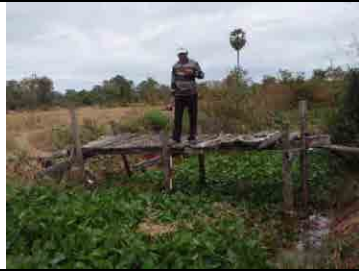
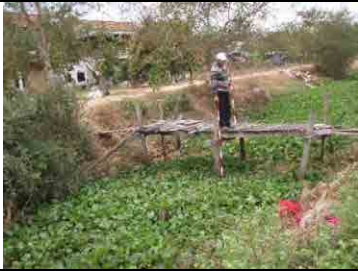
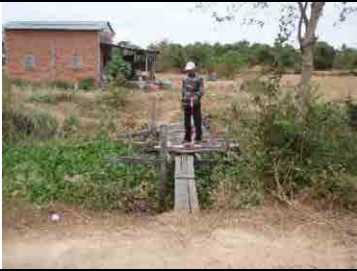
Canal No.: KC-2	Kind of structure(s): Wooden Bridge	Remarks: (Private)
Station: 3.00+800	Coordinate< Northing: 1260345 Easting: 483984

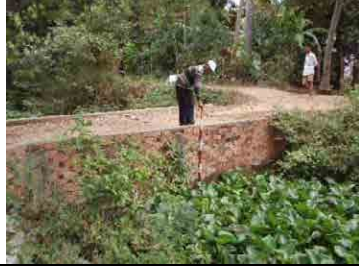
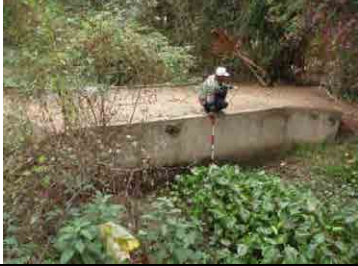
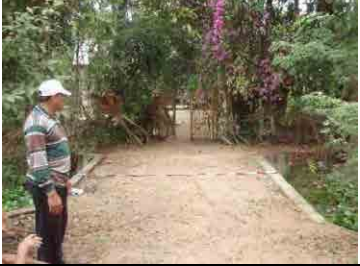
Canal No.: KC-2	Kind of structure(s): Pipe Culvert (Private)	Remarks: Double culverts
Station: 4.00+400	Coordinate< Northing: 1260354 Easting: 484605

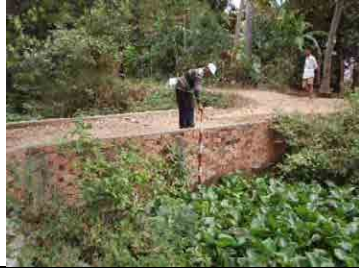
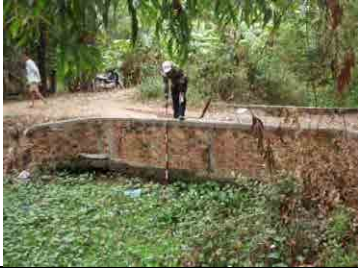
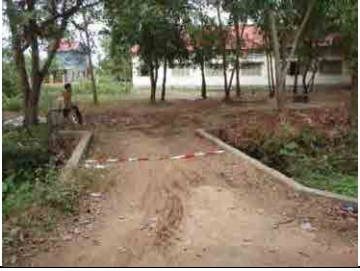
Canal No.: KC-2	Kind of structure(s): Pipe Culvert	Remarks: 3 culverts and road connected to School
Station: 4.00+530 (E.P)	Coordinate< Northing: 1260354 Easting: 484772

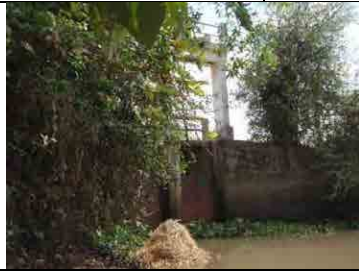
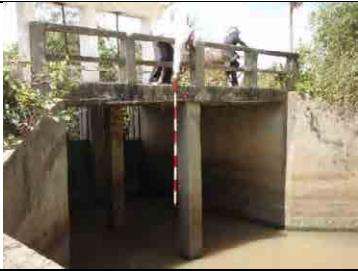
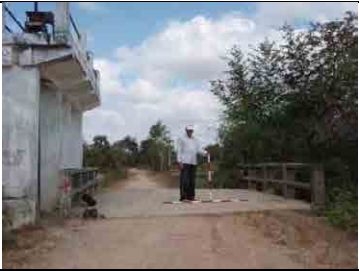
Canal No.: KC-3-1	Kind of structure(s): Intake on Stung Touch River	Remarks: 3 gates
Station: 0.00 (B.P)	Coordinate< Northing: 1258313 Easting: 4841835

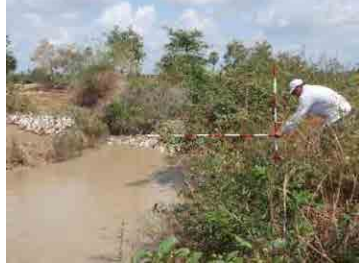
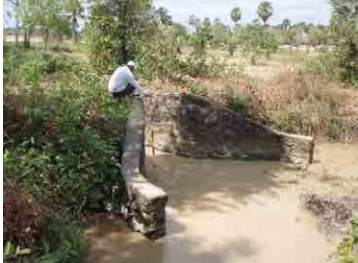
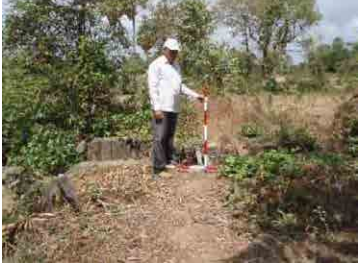
Canal No.: KC-3-1	Kind of structure(s): Regulator	Remarks:
Station: 0.00+800	Coordinate< Northing: 1258309 Easting: 482473	No slab floor and stop log (abandoned)

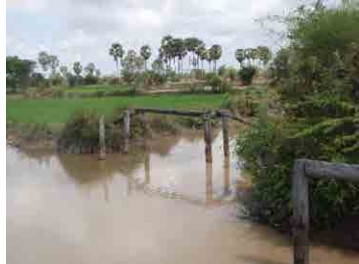
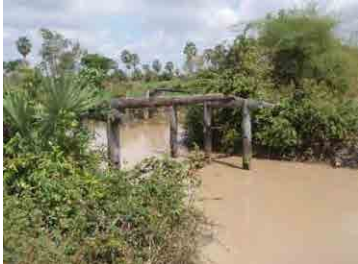
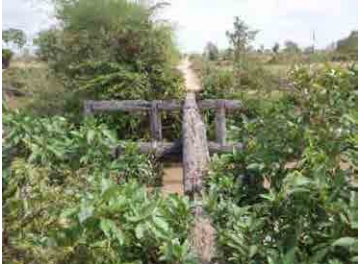
Canal No.: KC-3-1	Kind of structure(s): Wooden Bridge	Remarks:
Station: 0.00+900	Coordinate< Northing: 1258308 Easting: 482590	On commune road

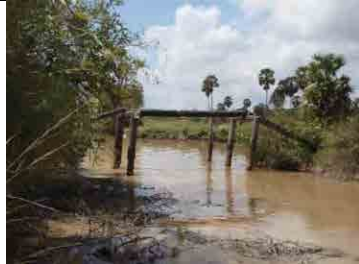
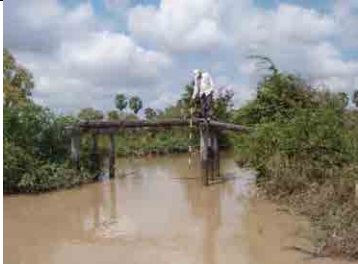
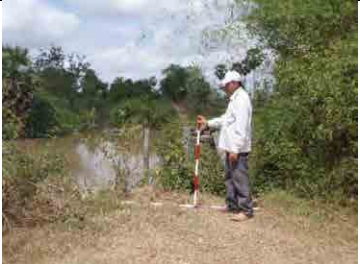
Canal No.: KC-3-1	Kind of structure(s): Wooden Bridge	Remarks:
Station: 0.00+900	Coordinate< Northing: 1258308 Easting: 482590	This bridge is connected to another canal (Canal 83, (local name)).

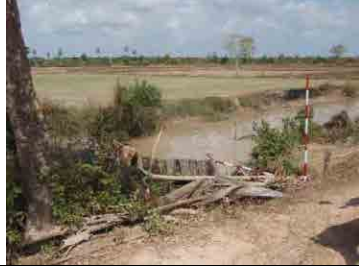
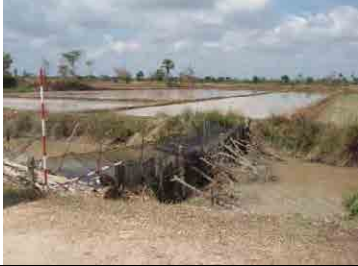
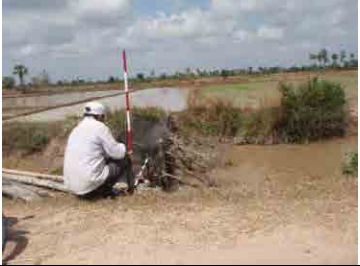
Canal No.: KC-3-1	Kind of structure(s): Turnout	Remarks: Broken
Station: 2.00+000	Coordinate< Northing: 1258319 Easting: 483675

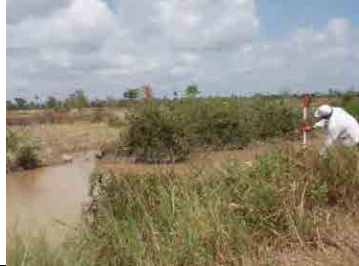
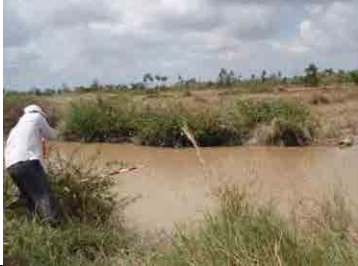
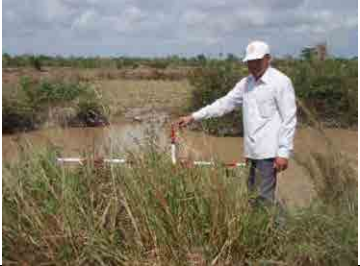
Canal No.: KC-3-1	Kind of structure(s): Check Structure	Remarks:
Station: 2.00+200	Coordinate< Northing: 1258320 Easting: 483893	Check Structure with groove No slab floor (Abandoned)

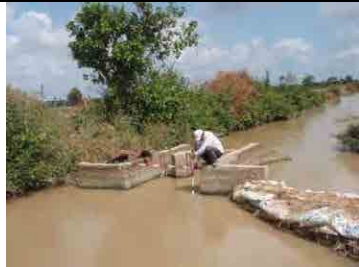
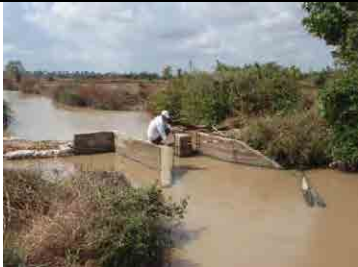
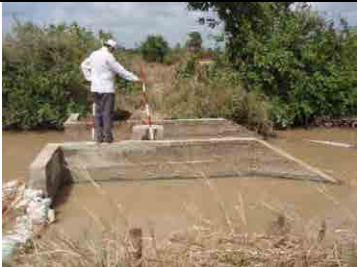
Canal No.: KC-3-1	Kind of structure(s): Turnout	Remarks:
Station: 2.00+300	Coordinate< Northing: 1258319 Easting: 483954	Broken

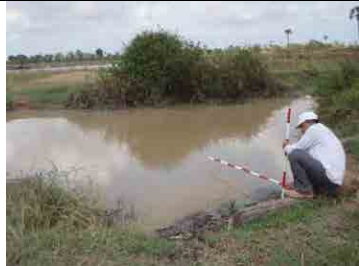
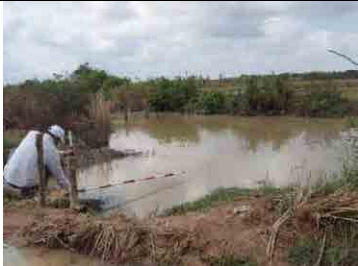
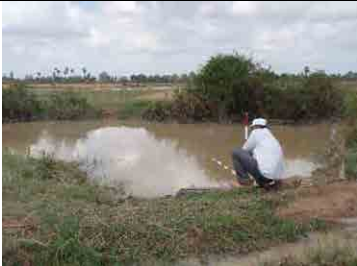
Canal No.: KC-3-1	Kind of structure(s): Box Culvert	Remarks:
Station: 2.00+900	Coordinate< Northing: 1258321 Easting: 484449	Box Culvert with groove (abandoned)

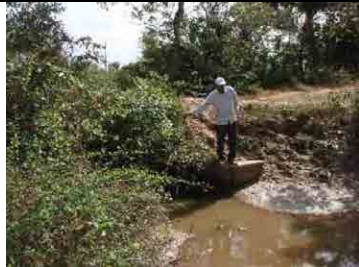
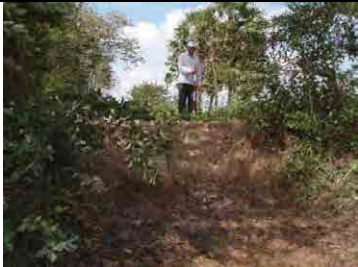
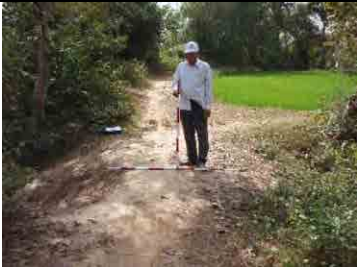
Canal No.: KC-3-2	Kind of structure(s): Canal Section	Remarks:
Station: 0.00+500	Coordinate< Northing: 1258308 Easting: 481417	Canal route was flooded

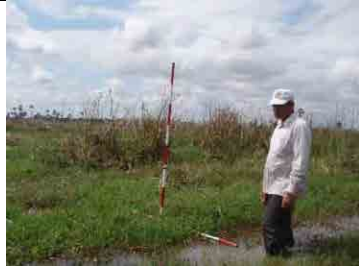
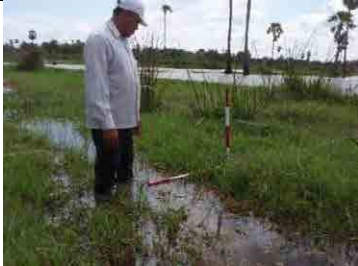
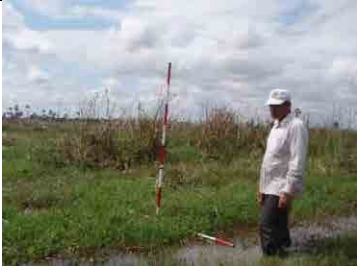
Canal No.: KC-3-2	Kind of structure(s): Canal	Remarks:
Station: 0.00+800 (E.P)	Coordinate< Northing: 1258397 Easting: 481069	Canal route was flooded about 0.8-1.2m

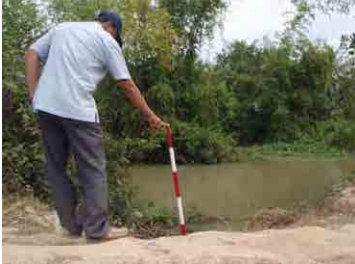
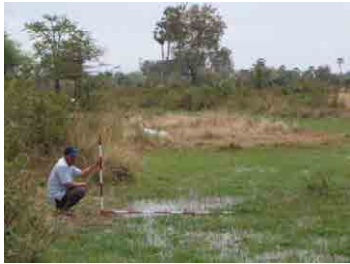
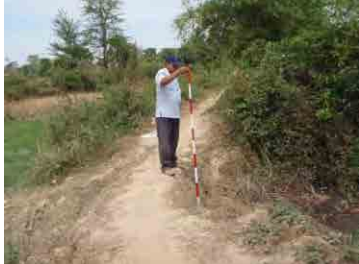
Canal No.: KC-4	Kind of structure(s): Intake	Remarks:
Station: 0.00(B.P.)	Coordinate< Northing: 1258142 Easting: 481618	Intake from Stung Touch

Sta.	E	N	Structure	Condition	Evaluation	Remarks
0	481618	1258142	B.P. Intake on Stung Toch	No structure is found and canal is clogged by debris and trees/grass	D	
500	481601	1257614	Canal Section	Canal is filled by earth for commune road	D	Across commune road
600	481594	1257535	Pipe Culvert on Commune road	Functioned as culvert	C	W=6m, L=6.5m, dia=1m
1,000	481593	1256931	Canal Section	No obstruction is found, though some grass grow on canal slope and banks	B	
1,500	481598	1256443	Canal Section	No obstruction is found, though some grass grow on canal slope and banks	B	
1,700	481593	1256175	Pipe Culvert, on village road	Broken	D	L=8m, dia=0.6m
2,000	481590	1255814	Canal Section	Upland and covering by trees and many sediment on the canal bed	D	
2,500	481598	1255543	Box culvert with groove under commune road	Sand bags are used for checking up the water level and storing water	C	W=5m, L=1.3m, H=2m
2,700	481601	1255380	Turnout	No outlet wall is provided; just temporary placing for drain and inlet the water	C	L=6m, dia=0.3m (Double)

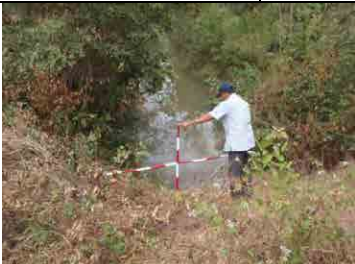
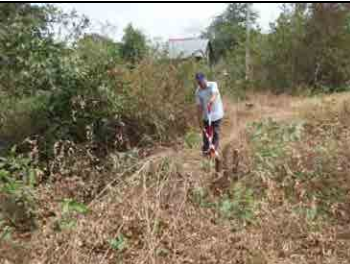
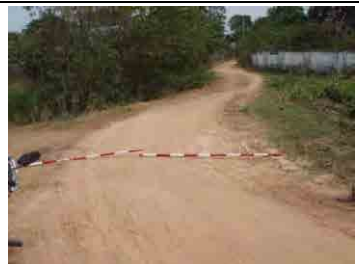
Canal No.: KC-4	Kind of structure(s): Canal Section	Remarks:
Station: 0.00+500	Coordinate< Northing: 1257614 Easting: 481601	Canal Section and commune road across canal

1. Canal section is dry from B.P. due to commune road blocked at St. 500m
2. From St. 2+0 to 2+700 is upland part of the canal KC-4.
3. Farmer constructed a embankment to divert water to rice fields.

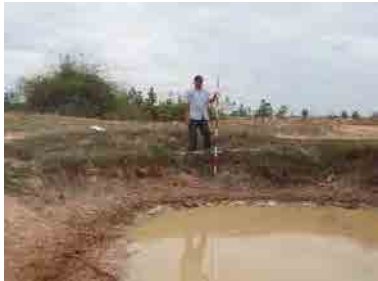
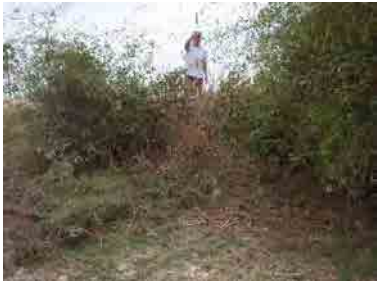
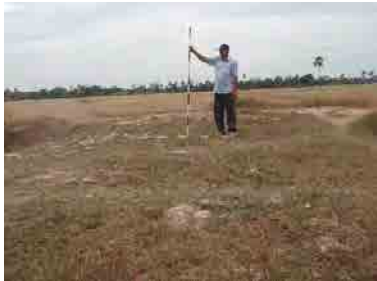
Canal No.: KC-4	Kind of structure(s): Canal Section	Remarks: Village road across canal in order to divert water to rice field.
Station: 3.00+100	Coordinate< Northing: 1254976 Easting: 481595

3,100	481595	1254976	Canal Section	Canal section is checked by earth dike for rain storing water	D	
3,500	481593	1254742	E.P. Box Culvert on commune road (flood kike)	Structurally in good condition, but no gate is provided	C	W=4.9m, L=1.4m, H=2m

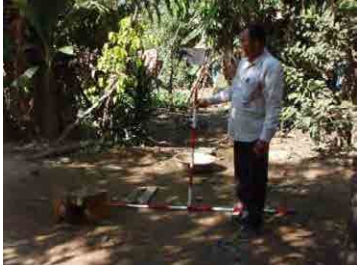
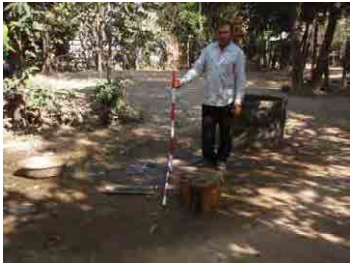
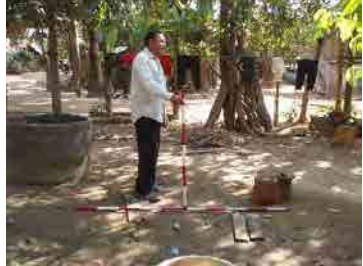
Canal No.: KC-5	Kind of structure(s): Intake on Stung Touch	Remarks:
Station: 0.00(B.P.)	Coordinate< Northing: 1257519 Easting: 482573	The canal was filled as used as house access in the village

Sta.	E	N	Structure	Condition	Evaluation	Remarks
0	482573	1257519	B.P. Stung Toch	The canal section was filled and used as house access in the village: the canal has not used for long time	D	Houses accesses in the village
300	482570	1257430	Pipe Culvert, Private	Temporary installation of pipe to house access	D	L=3m, dia=0.5m
500	482578	1257310	Box Culvert with groove on village road	Wooden planks are installed and functioned as check	B	W=3.5m, L=2m
800	482578	1257092	Turnout (private)	Temporary installation of pipe to divert water from the canal	C	Pipe: L=3m, dia=0.5m
1,000	482585	1256639	Canal Section	Bath banks of the canal is swamp, and right bank of the canal was lost	D	No canal shape remains, but road section only remained
1,500	482593	1256133	Canal Section	do.	D	do.
2,000	482597	1255597	Canal Section	Some canal section remains and used as pond	C	Making road across canal near canal section.
2,500	482598	1255131	Canal Section	do.	D	do.

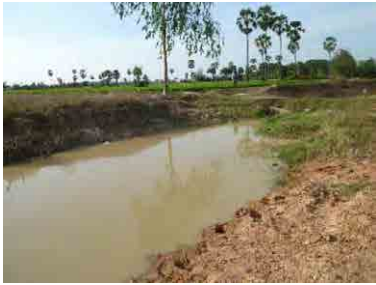
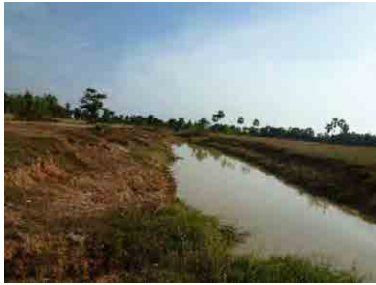
Canal No.: KC-5	Kind of structure(s): Canal Section	Remarks:
Station: 2.00+500	Coordinate< Northing: 1255131 Easting: 482598	Making road across canal near canal section

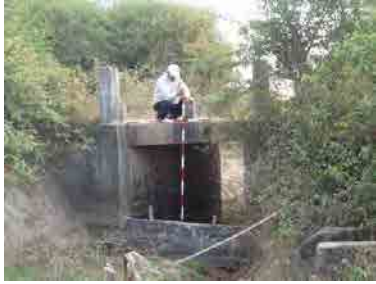
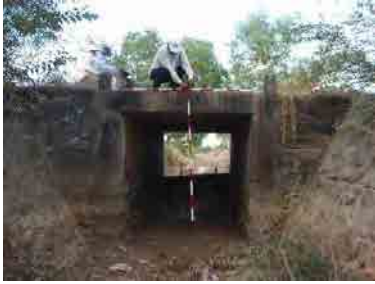
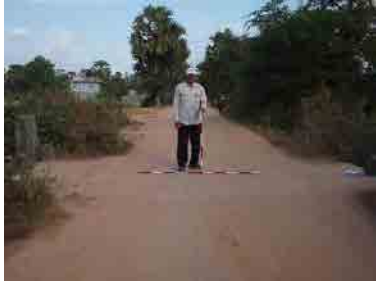
Canal No.: KC-5	Kind of structure(s): Bok Culvert	Remarks:
Station: 3.00+000 (E.P)	Coordinate< Northing: 1254769 Easting: 482585	Box Culvert with groove & Drain Inlet

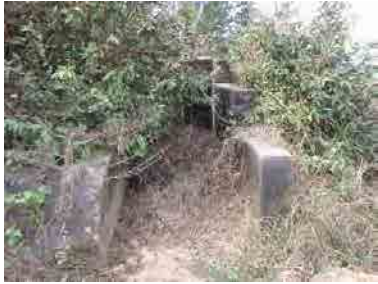
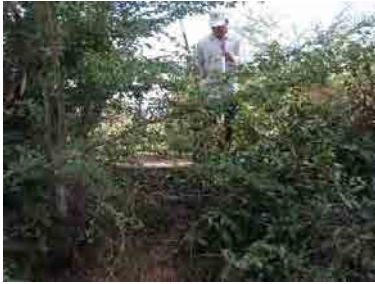
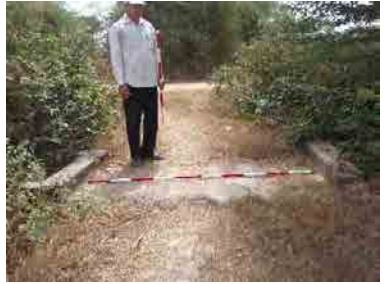
Canal No.: KC-5	Kind of structure(s): Box Culvert	Remarks:
Station: 3.00+000	Coordinate< Northing: 1254769 Easting: 482585	Box Culvert with groove & Drain Inlet

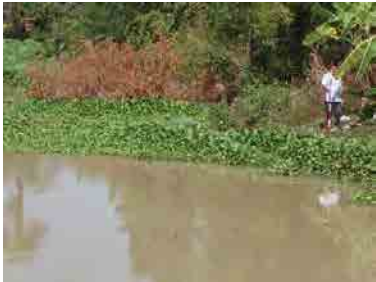
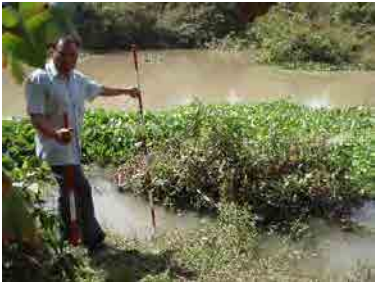
Canal No.: KD-1	Kind of structure(s): Intake	Remarks: Connected from Stung Toch
Station: 0.00 (B.P)	Coordinate< Northing: 1259314 Easting: 481106

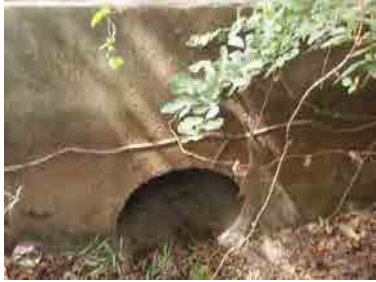
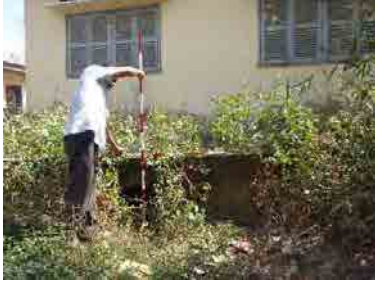
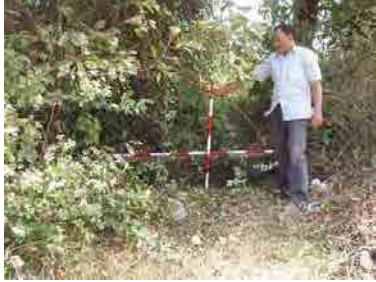
Canal No.: KD-1	Kind of structure(s): Pipe Culvert	Remarks: Pipe culvert under school building
Station: 0.00+250	Coordinate< Northing: 1259325 Easting: 481288

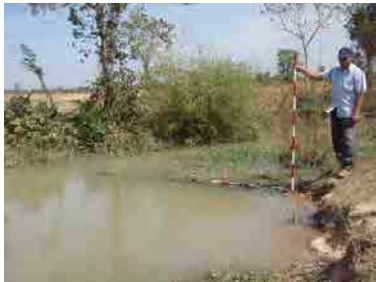
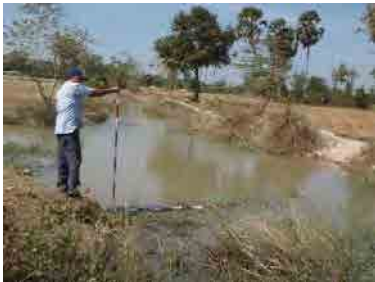
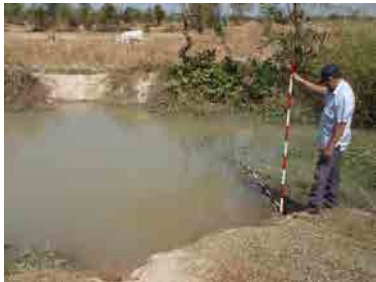
Canal No.: KD-1	Kind of structure(s): Canal Section	Remarks: Across canal 83 (local name)
Station: 0.00+550	Coordinate< Northing: 1259316 Easting: 481607

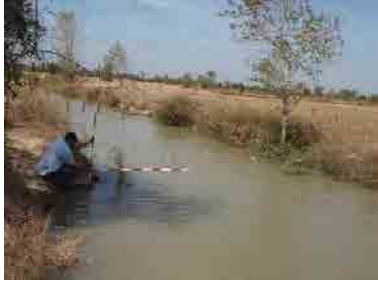
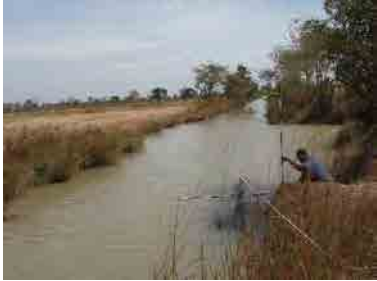
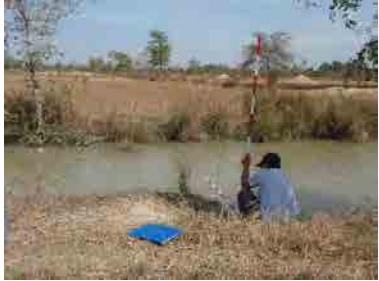
Canal No.: KD-1	Kind of structure(s): Canal Section	Remarks:
Station: 1.00+050	Coordinate< Northing: 1259324 Easting: 482063

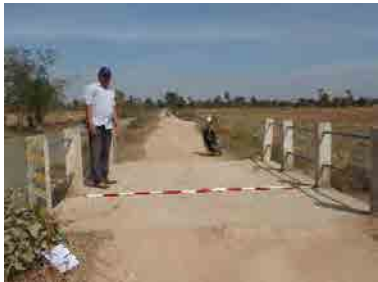
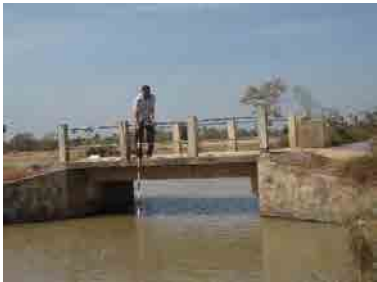
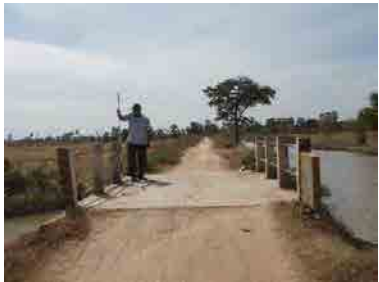
Canal No.: KD-1	Kind of structure(s): Bridge	Remarks: Commune Fund
Station: 1.00+550	Coordinate< Northing: 1259330 Easting: 442585

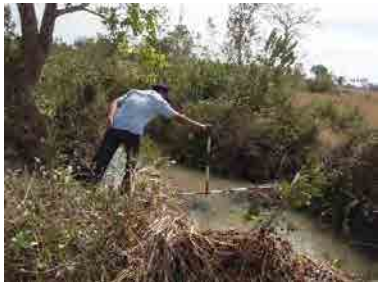
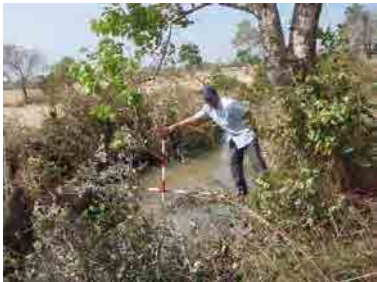
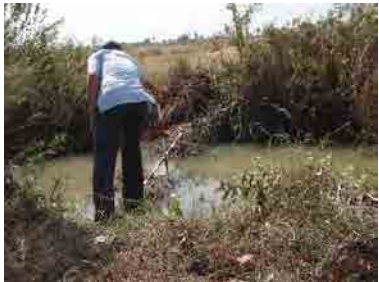
Canal No.: KD-1	Kind of structure(s): Canal section	Remarks:
Station: 1.00+750	Coordinate< Northing: 1259337 Easting: 442727

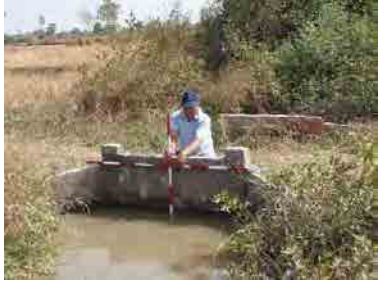
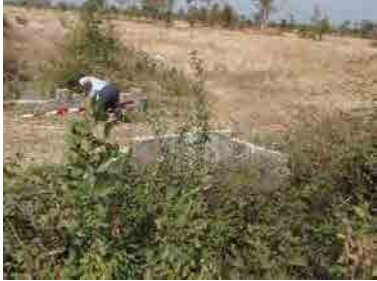
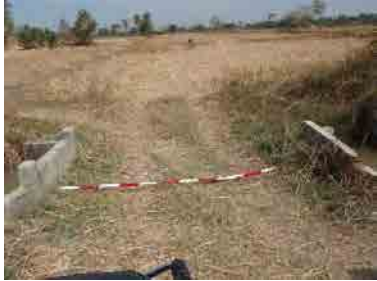
Canal No.: KD-1	Kind of structure(s): Pipe Culvert	Remarks:
Station: 2.00+050	Coordinate< Northing: 1259332 Easting: 482994	Across to rice field, Private

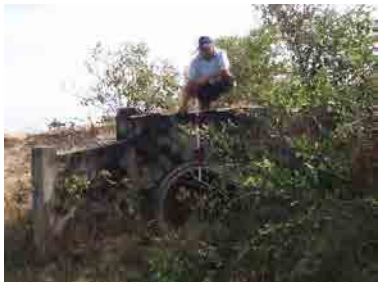
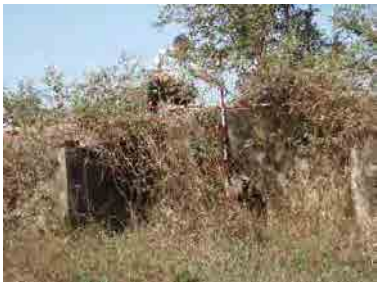
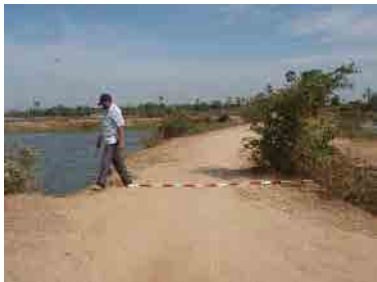
Canal No.: KD-1	Kind of structure(s): Pipe Culvert	Remarks:
Station: 2.00+250	Coordinate< Northing: 1259327 Easting: 483238	Commune road

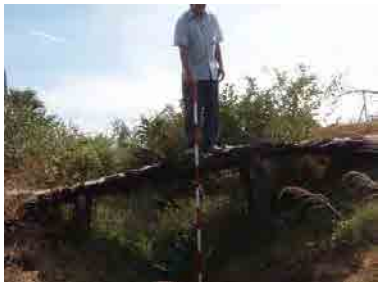
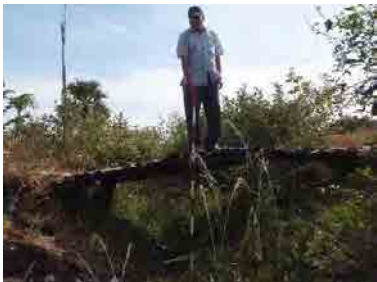
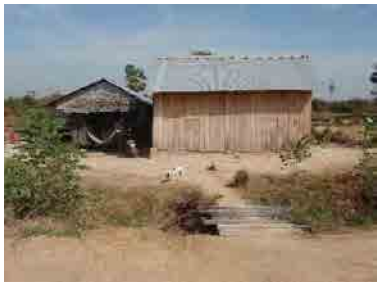
2,350	483363	1259333	Wooden Bridge, Private	House access	B	W=4m, L=1.2m
2,750	483659	1259334	Box Culvert, Commune road	Old culvert, but still functioned	B	Across canal 84 (local name), W=4m, L=1.2m
3,250	484127	1259337	Pipe Culvert, on commune road	The culvert was constructed by commune fund recently	B	W=1.5m, L=6.3m, dia=1m
3,550	484428	1259336	Turnout	Broken, hollow brick made structure	D	Near crossing point with canal 85 (local name)
3,750	484641	1259338	Canal Section	Section is obstructed by water plants and bush	D	Canal section with grass & bush
4,250	485154	1259346	E.P. Bridge, on NR-2	Flow section of the bridge is enough for flowing	B	W=12m, L=6m

Canal No.: KD-1	Kind of structure(s): Wooden Bridge	Remarks:
Station: 2.00+350	Coordinate< Northing: 1259333 Easting: 483363	Private

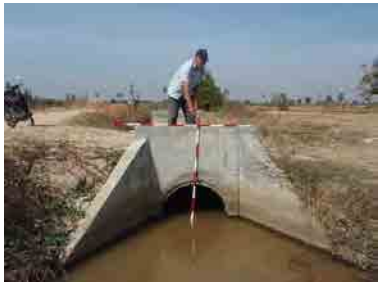
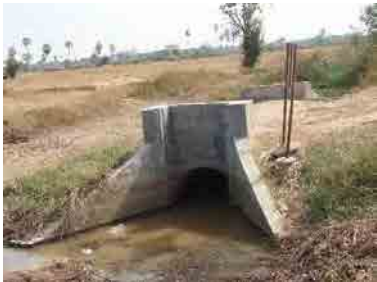
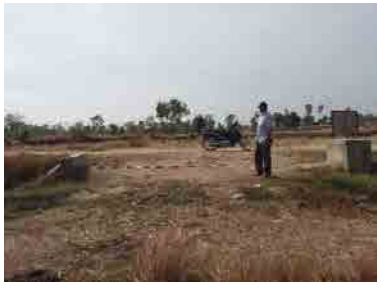
Canal No.: KD-1	Kind of structure(s): Pipe Culvert	Remarks: Commune Fund
Station: 3.00+250	Coordinate< Northing: 1259337 Easting: 484127

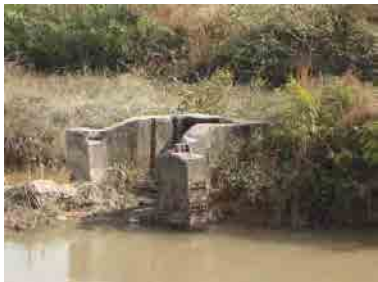
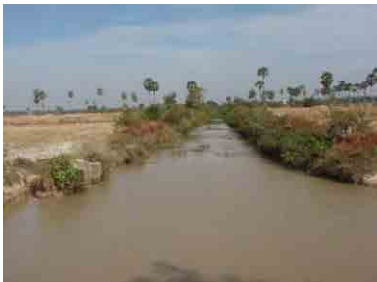
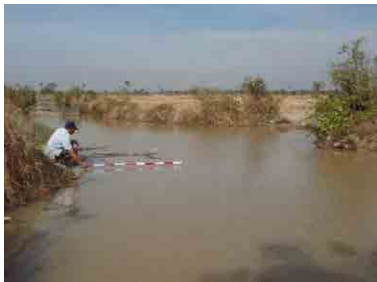
Canal No.: KD-1	Kind of structure(s): Off-take	Remarks: Across canal 85 (local name) Broken
Station: 3.00+550	Coordinate< Northing: 1259336 Easting: 484428

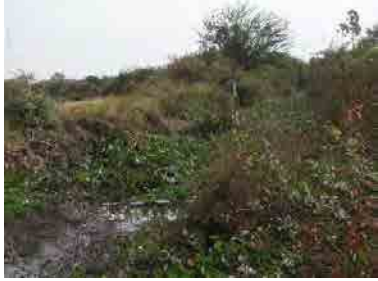
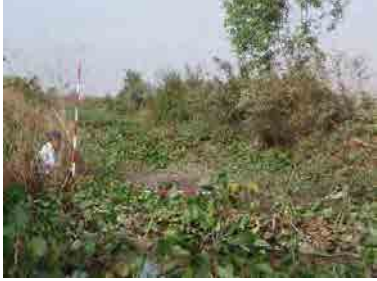
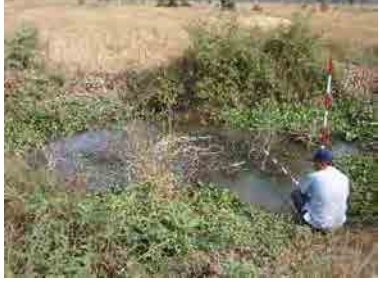
Canal No.: KD-1	Kind of structure(s): Canal section	Remarks:
Station: 3.00+750	Coordinate< Northing: 1259338 Easting: 484641	Canal section with grass & bush

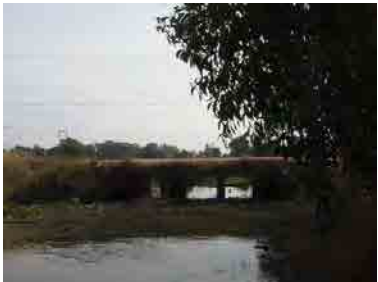
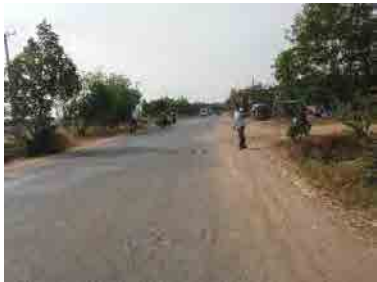
Canal No.: KD-1	Kind of structure(s): Bridge	Remarks:
Station: 4.00+250 (E.P)	Coordinate< Northing: 1259346 Easting: 485154	Bridge on NR.2

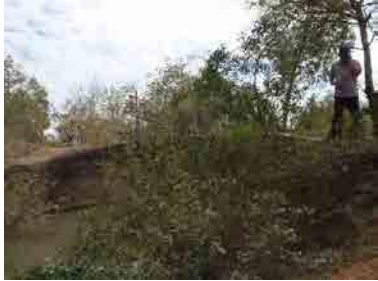
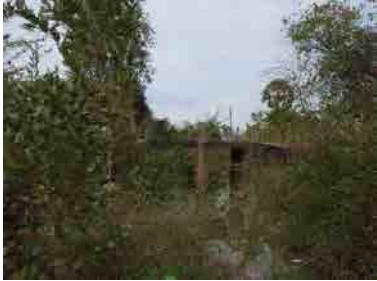
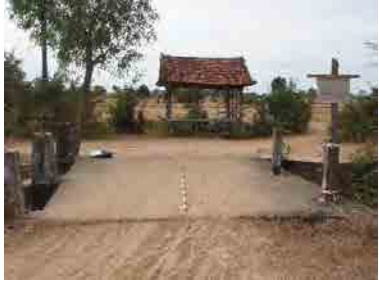
Canal No.:	Connection Canal	Kind of structure(s): Bridge	Remarks: Bridge with groove
Station: 0.00 (B.P)	Coordinate<	Northing: 1261020 Easting: 477997	Commune road

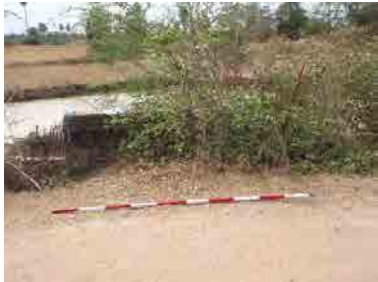
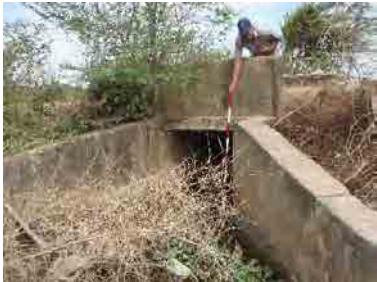
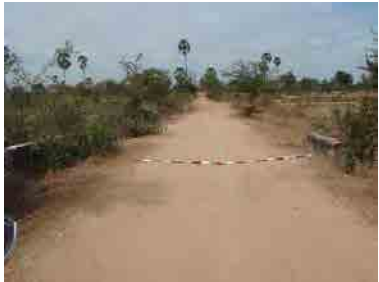
Canal No.:	Connection Canal	Kind of structure(s): Box Culvert	Remarks: Commune road
Station: 0.00+500	Coordinate<	Northing: 1260313 Easting: 478012

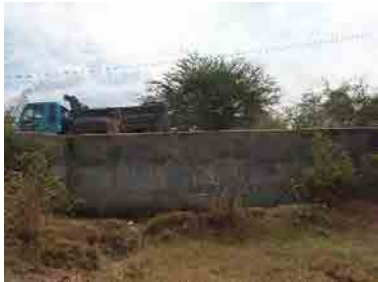
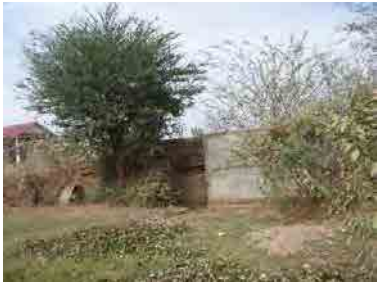
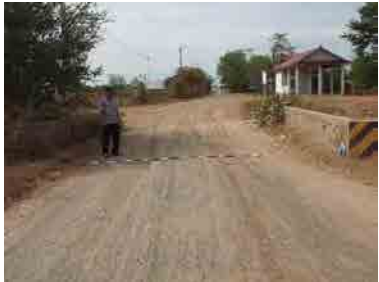
Canal No.:	Connection Canal	Kind of structure(s): Bridge (3 culverts)	Remarks: Bridge on provincial road
Station: 0.00+900	Coordinate<	Northing: 1259880 Easting: 478024

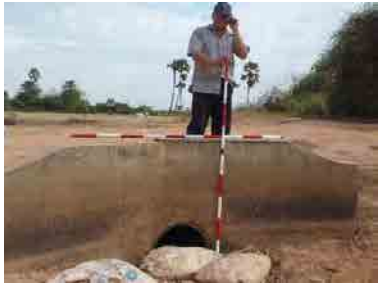
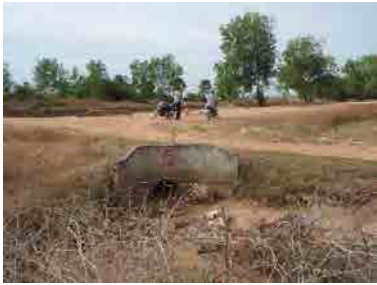
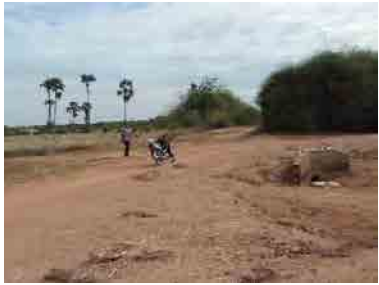
Canal No.: Connection Canal	Kind of structure(s): Earth bund and turnout	Remarks: Turnout was constructed by Word Vision in 2004
Station: 3.00+800	Coordinate< Northing: 1257008 Easting: 478043

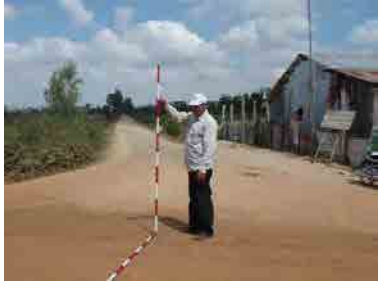
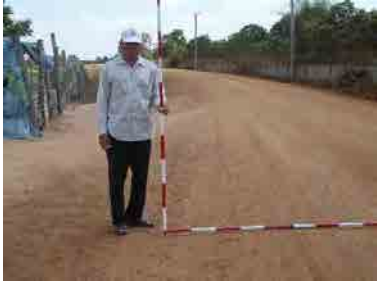
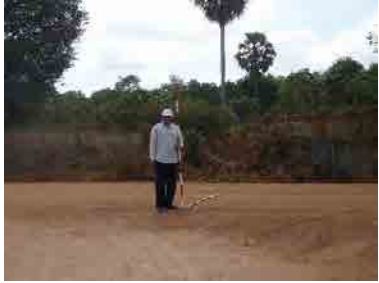
Canal No.: Flood dike	Kind of structure(s): Provincial road	Remarks:
Station: 0.00 (B.P)	Coordinate< Northing: 1254005 Easting: 4780409	Junction between Provincial and flood dike/ road

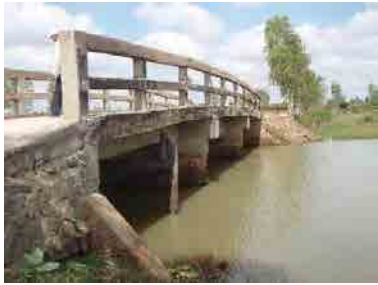
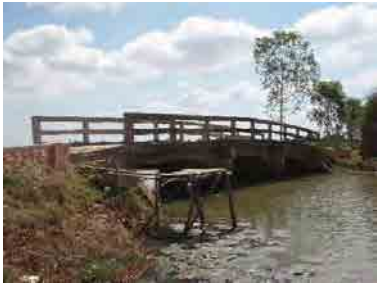
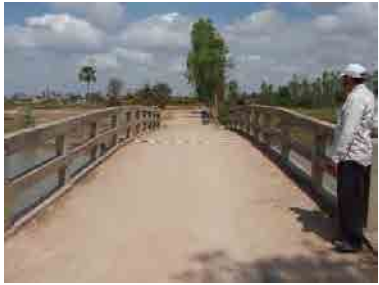
Canal No.: Flood dike	Kind of structure(s): Bridge	Remarks:
Station: 0.00+400	Coordinate< Northing: 1254393 Easting: 480396	On the Tonle Bati river

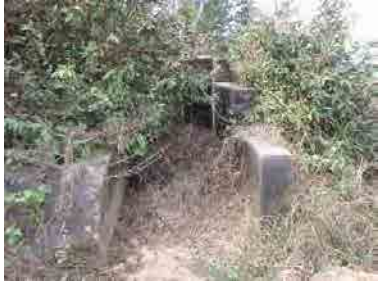
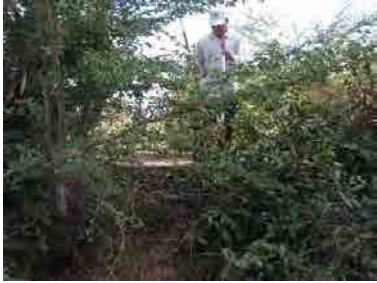
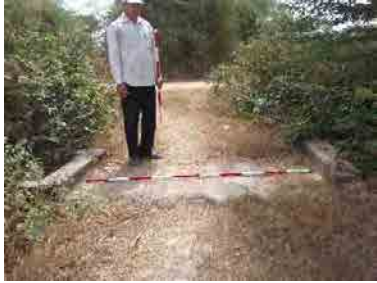
Canal No.: Flood dike	Kind of structure(s): Drain Inlet	Remarks:
Station: 3.00+000	Coordinate< Northing: 1254770 Easting: 482585	Box Culvert with groove & Drain Inlet

Sta.	E	N	Structure	Condition	Evaluation	Remarks
0	4780409	1254005	B.P. Dike/ Road	Dike/ Road surface is paved by laterite	A	Junction between Provincial road and dike/road
400	480396	1254393	Bridge, Commune road	Bridge is still in good condition, but submerged in 2010 flood	B	W=3.5, L=17m
500	480415	1254553	Dike/ Road Section	Gravel and sand pavement remain and surface is smooth	A	Junction to pagoda
800	480670	1254511	Dike/ Road Section	do.	A	Pagoda (Koh Sokroam)
1,000	480736	1254719	Dike/ Road Section	do.	A	
1,500	481199	1254737	Dike/ Road Section	do.	A	
2,000	481591	1254745	Box Culvert with groove	Occasionally used as drain outlet Need to improve (widening)	B	Outlet of KC-4 W=5m, L=2.5m
2,500	482084	1254756	Dike/ Road Section	Gravel and sand pavement remain and surface is smooth	A	
3,000	482585	1254770	Box Culvert with groove,	Culvert is in good condition	B	Outlet of KC-5 W=5.3m, L=2m, H=1.7 m
			Drain Inlet	Section is clogged by soils and grass	C	W=2m, L=1m

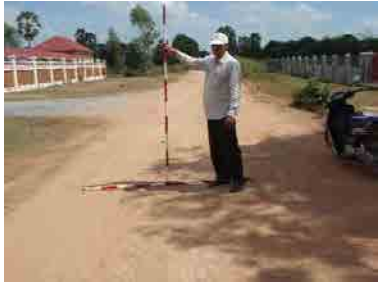
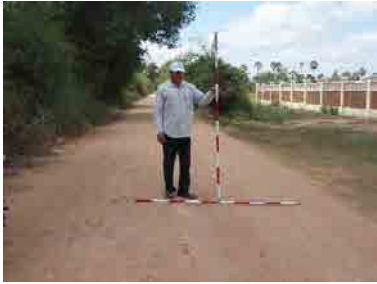
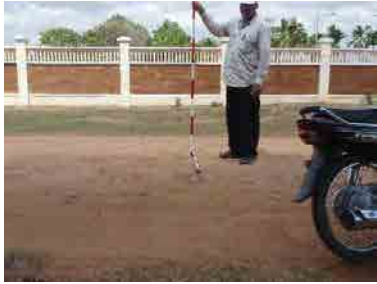
Canal No.: Flood dike	Kind of structure(s): Road Section	Remarks:
Station: 3.00+500	Coordinate< Northing: 1254794 Easting: 483144

3,500	483144	1254794	Dike/ Road Section	Gravel and sand pavement remain and surface is smooth	A	
4,000	483670	1254821	Dike/ Road Section	do.	A	
4,500	484155	1254857	Dike/ Road Section	do.	A	
5,000	484549	1254846	Bridge with regulator (2 gates)	Bridge is still in good condition	B	Outlet of Stung Toch river W=5.3m, L=2m, H=1.7 m
5,300	484832	1254905	Pipe Culvert	do.	B	W=5.3m, L=4m, dia=0.8m (3 pipes)
5,330	484873	1254908	Pipe Culvert,	do.	B	W=5.3m, L=1.2m, dia=1m
5,500	485108	1254922	Dike/ Road Section	Gravel and sand pavement remain and surface is smooth	A	
6,000	485600	1254958	E.P.	do.	A	NR.2

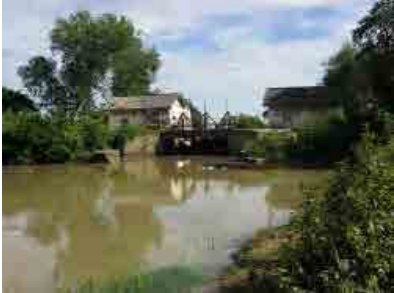
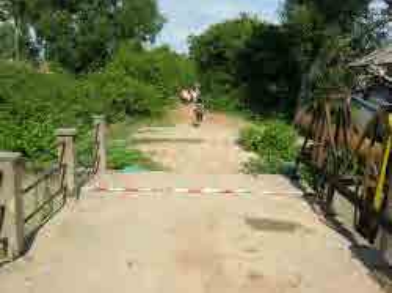
Canal No.: MC1	Kind of structure(s): Pumping Station No. 22-23 , Gate & Bridge	Remarks: Village Road
Station: 0.00(B.P.)	Coordinate< Northing: 1252808 Easting: 0484026	Routine Survey

Sta.	E	N	Structure	Condition	Eval uatio n	Remarks
0	0484026	1252808	Intake and Pumping Station, 3 pumps	One diesel engine was renewed in 2011. Gates are old, but still functioned	B	2 nos, of Gate (H=2.7m-3.2m, L=5.25m, W=3m)
200	0484028	1252644	Turning Point	No diversion structure for MC-3 was provided	-	Most flow from intake entered to MC-3
630	0484016	1252412	Bridge (Krang Knong Commune,	Steel girder made is still in good condition	A	L=15m, W=5m, Span=2.9m, Built 25-05-2006)
730	0484023	1252309	Houses (5 nos)	Temporary houses for farming	-	
850	0484022	1252190	Regulator with groove	Presently used as house access by placing plates and logs	D	(4 Span, @1.2m Canal Width= 12m
1,090	0484026	1251977	Canal section	Canal is wide and shallow, canal bed is covered by grasses	C	
1,160	0484028	1251913	Diversion Point	No diversion structure for MC-2 was provided	-	Most of water flow into MC-1 due to higher bed level of MC-2

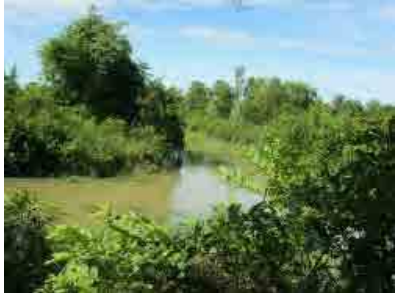
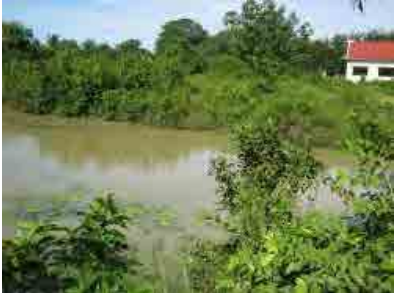
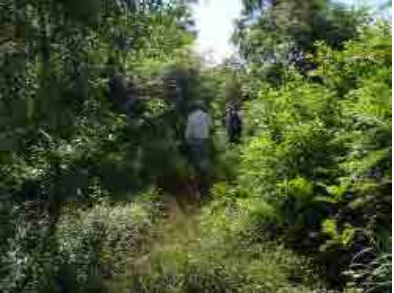
Canal No.: MC1	Kind of structure(s): Canal	Remarks: Turning Point
Station: 0.00+200	Coordinate< Northing: 1252644 Easting: 0484028	Routine Survey

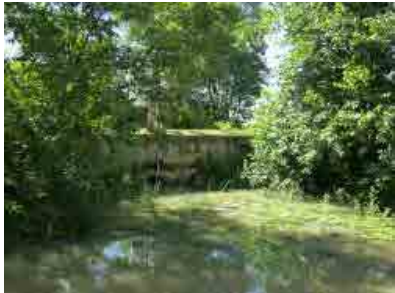
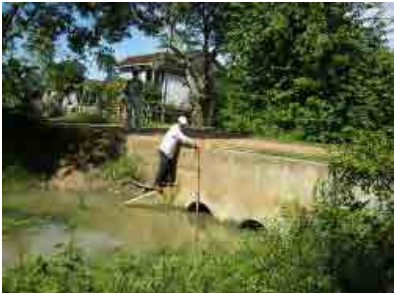
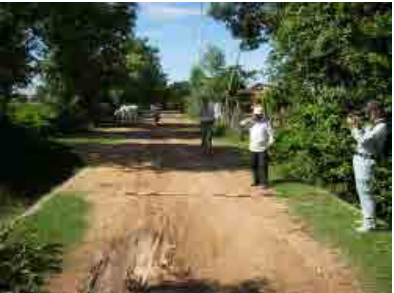
Canal No.: MC1	Kind of structure(s): Pipe Culvert(Private)	Remarks: Double Pipe Culvert
Station: 0.00+300	Coordinate< Northing: 1252631 Easting: 0484103	Commune Road

Sta.	E	N	Structure	Condition	Evaluation	Remarks	
0	0484103	1252631	Pipe Culvert (Double)	Road surface is damaged but culvert is functional	B	L=10.8m, W=4.5m, dia=1m	
250	0484332	1252629	Private Wooden Bridge (Broken)	Abandoned one canal section is covered by thick trees and grass	D		
360	0484442	1252631	Private Bridge	Piers are only remained (no slab plate), abandoned bridge	D		
510	0484579	1252630	Diversion Point, 500m	To lateral canal by pump	D	Lateral canal is higher than water level of MC3	
990	0485008	1252638	Pipe Culvert (Village Road)	Culvert is covered by thick grass	B	dia=1m, W=4m, built in May-2008)	
1,200	0485218	1252623	Optical Cable Line Point				
1,290	0485294	1252634	Small Private Bridge	Wooden house access	C	W=0.5 m	
1,340	0485339	1252630	Small Private Bridge	do.	C	W=0.5 m	
1,460	0485364	1252650	Turnout point to lateral canal	Turnout has no gate but groove; bridge on the lateral canal	C	Bridge & Groove (W=3.7m, L=2m)

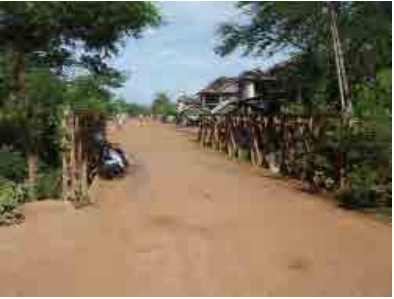
Canal No.: MC1	Kind of structure(s): Bridge	Remarks:
Station: 0.00+630	Coordinate< Northing: 1252412 Easting: 0484016	Krang Knong Commune Bridge Routine Survey

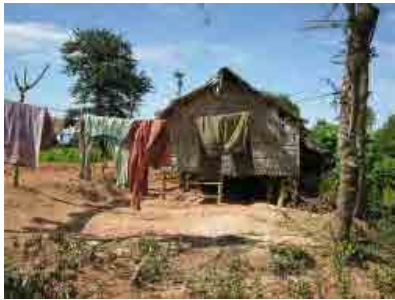
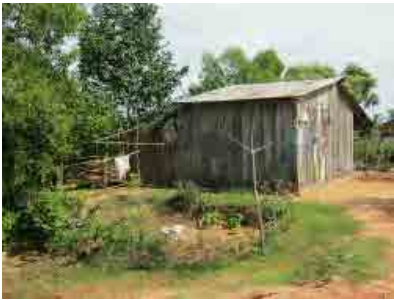
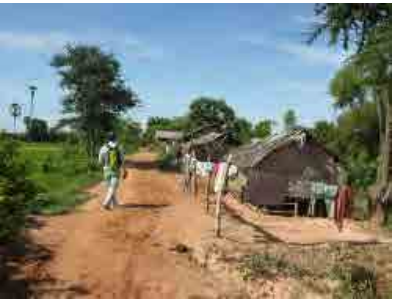
Canal No.: MC1	Kind of structure(s): Houses(Temporary)	Remarks:
Station: 0.00+730	Coordinate< Northing: 1252309 Easting: 0484023	Village Road Routine Survey

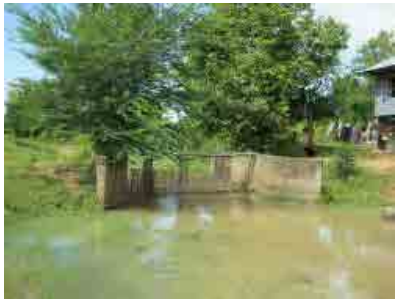
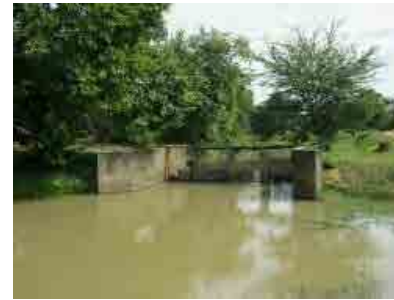
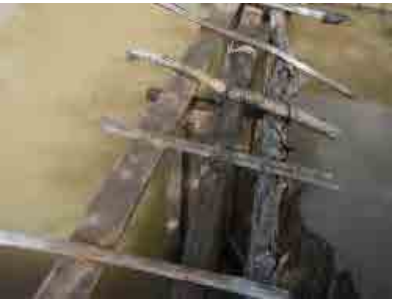
Canal No.: MC1	Kind of structure(s): Bridge(Wooden)	Remarks:
Station: 0.00+850	Coordinate< Northing: 1252190 Easting: 0484022	House Access Bridge with Concrete Wall

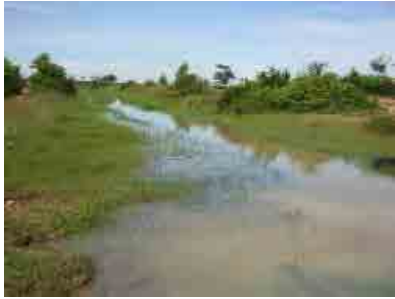
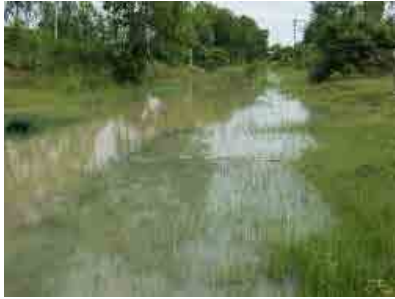
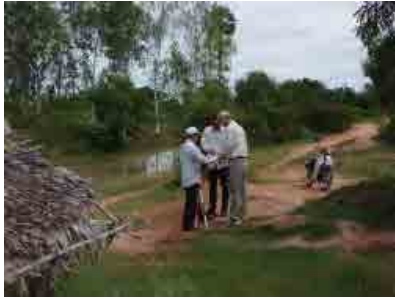
Canal No.: MC1	Kind of structure(s): Canal	Remarks:
Station: 1.00+90	Coordinate< Northing: 1251977 Easting: 0484026	Measurement Point

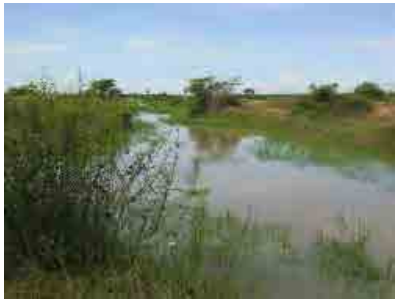
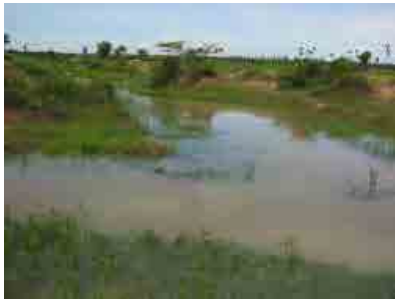
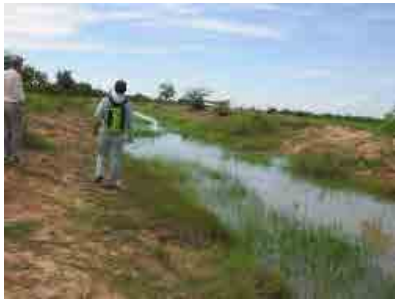
Canal No.: MC1	Kind of structure(s): Canal	Remarks:
Station: 1.00+160	Coordinate< Northing: 1251913 Easting: 0484028	Diversion Point of Canal L4 Routine Survey

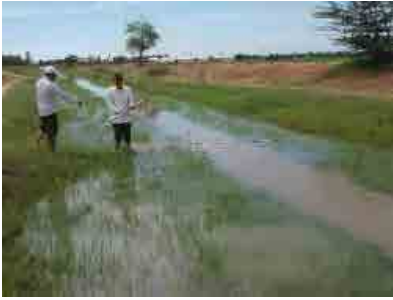
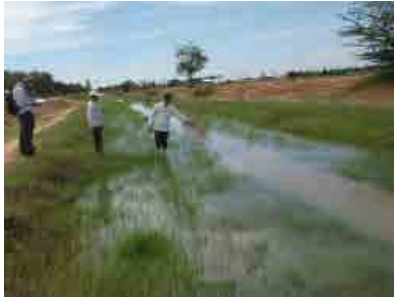
1,230	0484087	1251876	1000m, Canal Depth=0.7m	Canal section was re-shaped recently but many grasses on the canal bed	B	
1,580	0484361	1251712	Private Wooden Bridge	Motor cycle is passable	D	(Span=2m, L=10.2m, W=2.1m)
1,620	0484390	1251696	Private Pump	Pumped water is used for small scale factory	-	
1,770	0484496	1251631	Canal section	Canal section was re-shaped recently but many grasses on the canal bed	B	
2,170	0484795	1251437	Bridge across National Road N° 2,	The bridge is under repairing (Jan/2012)	A	W(outside)=6.2m, W(inside)=4m, L(outside)=5.9m, L(inside)=3.8m, H=2.3m
2,280	0484862	1251387	Canal section	Canal section was re-shaped recently	B	
2,780	0485172	1251024	Canal section	Canal section has been eroded heavily and many sediments on canal bed	C	
2,960	0485276	1250874	Bridge (on Village road)	3 span bridge is still new and flow area is secured	A	built on 26-03-1999, Span=3m, W=3m, L=12.3m, H=2m)

Canal No.: MC1	Kind of structure(s): Canal	Remarks:
Station: 1.00+230	Coordinate< Northing: 1251876 Easting: 0484087	Routine Survey Length: 1000m

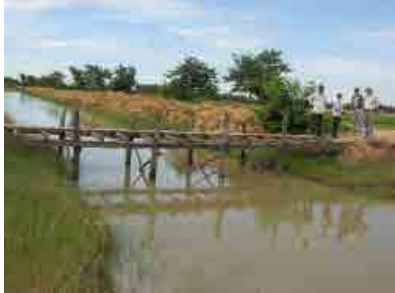
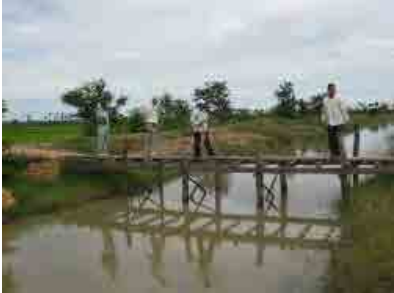
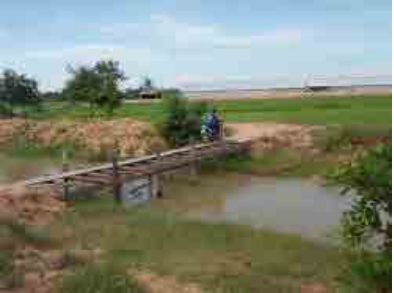
Canal No.: MC1	Kind of structure(s): Bridge (Private Wooden)	Remarks: Farm Access
Station: 1.00+580	Coordinate< Northing: 1251712 Easting: 0484361	Routine Survey

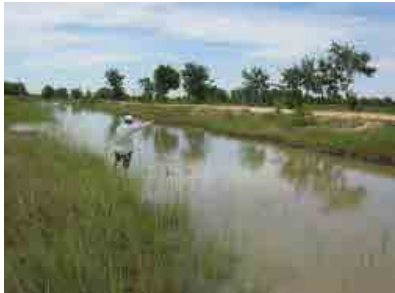
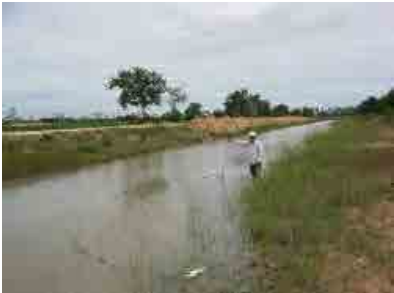
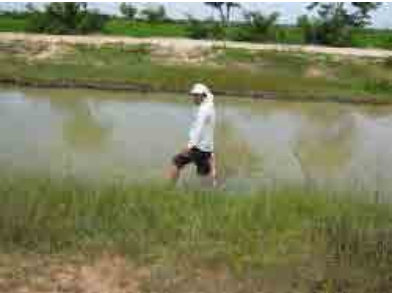
Canal No.: MC1	Kind of structure(s): Canal	Remarks: Routine Survey
Station: 1.00+770	Coordinate< Northing: 1251631 Easting: 0484496	Length: 1500m

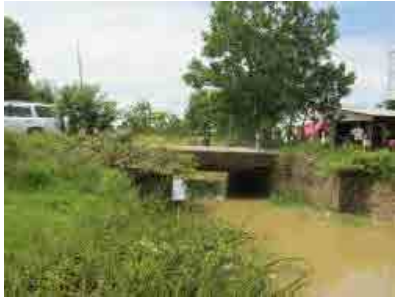
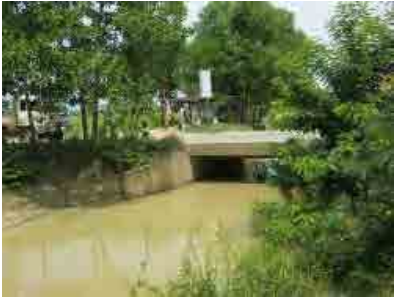
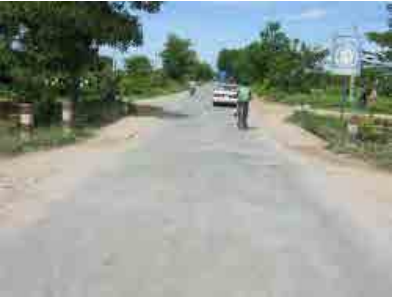
Canal No.: MC1	Kind of structure(s): Bridge (Concrete)	Remarks:
Station: 2.00+170	Coordinate< Northing: 1251437 Easting: 0484795	Bridge across National Road N° 2 Routine Survey

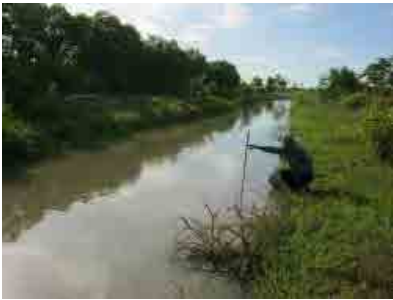
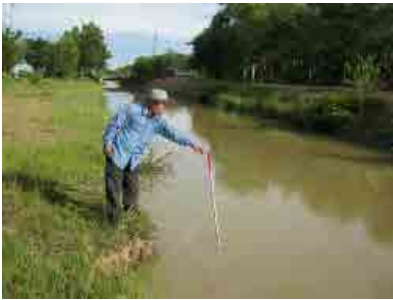
Canal No.: MC1	Kind of structure(s): Canal	Remarks:
Station: 2.00+280	Coordinate< Northing: 1251387 Easting: 0484862	Routine Survey Length: 2000m

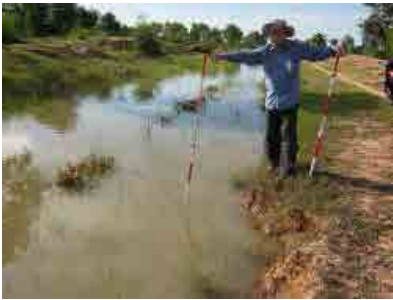
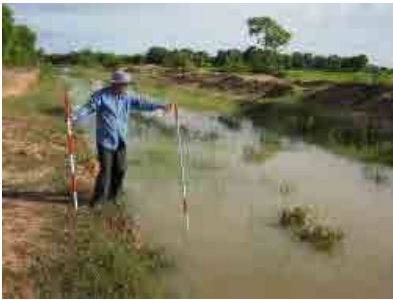
Canal No.: MC1	Kind of structure(s): Canal	Remarks:
Station: 2.00+780	Coordinate< Northing: 1251024 Easting: 0485172	Routine Survey Length: 2500m

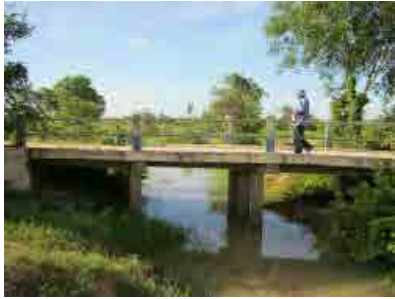
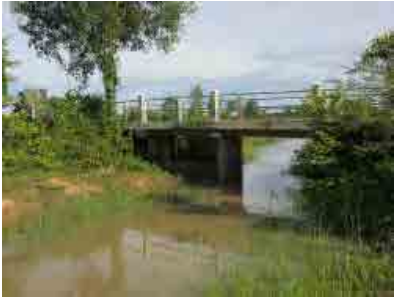
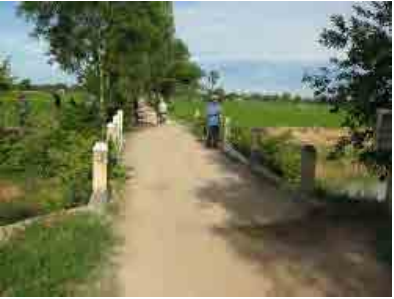
Canal No.: MC1	Kind of structure(s): Bridge (Village)	Remarks:
Station: 2.00+960	Coordinate< Northing: 1250874 Easting: 0485276	Village Road Routine Survey
