# ***ANNEX D***

## ***Attachment – 1***

*Results of Inventory Survey for  
Proposed Rehabilitation Works in  
Roleang Chrey Headworks Rehabilitation Sub-project*

**Results of Inventory Survey for Proposed Rehabilitation Works on North Main Canal (1/12)**

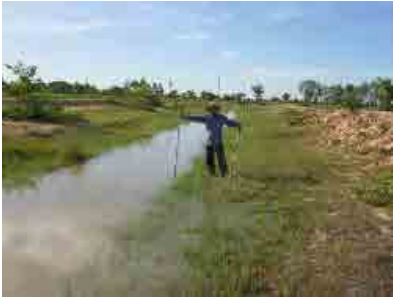
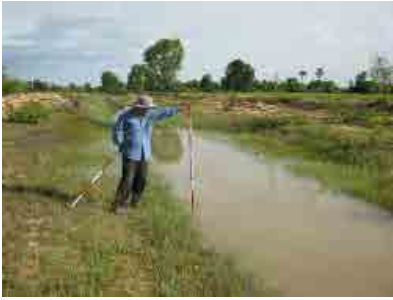
Canal No.: MC1	Kind of structure(s): Canal	Remarks:
Station: 3.00+320	Coordinate< Northing: 1250596 Easting: 0485465	Routine Survey Length: 3000m

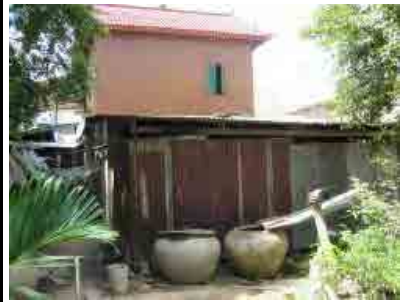
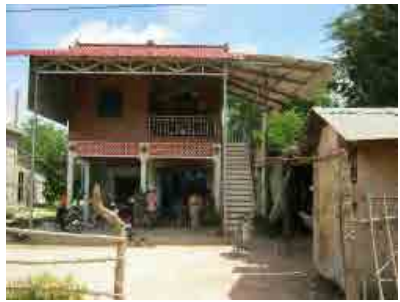
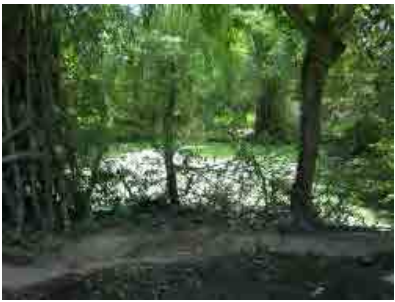
Canal No.: MC1	Kind of structure(s): Houses	Remarks: Rice fields are the downstream side across the rural road, and the house is on the upstream. This house owners has encroached the public property by filling land into the canal in order to make their own uses such as digging small pond and making their house wall surrounded by the thorny bamboo trees at the back of their house.
Station: 8.00+670(EP)	Coordinate< Northing: 1245729 Easting: 0486217

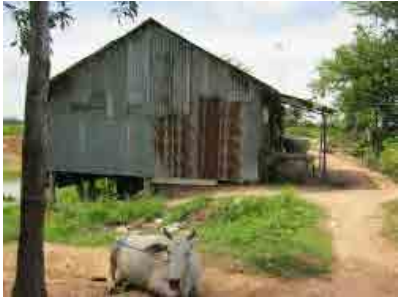
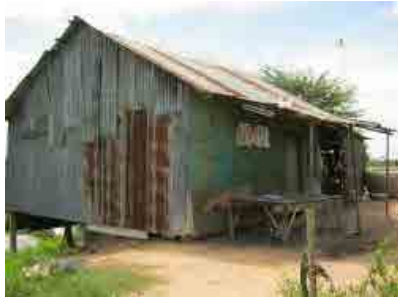
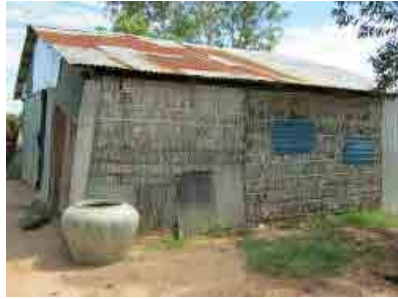
Canal No.: MC2	Kind of structure(s): Houses	Remarks:
Station: 1.00+360	Coordinate< Northing: 1250594 Easting: 0484043	Routine Survey There are two houses.

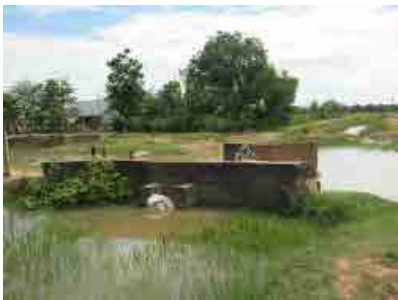
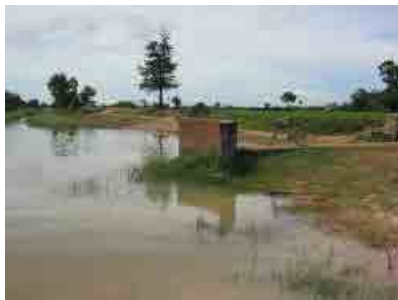
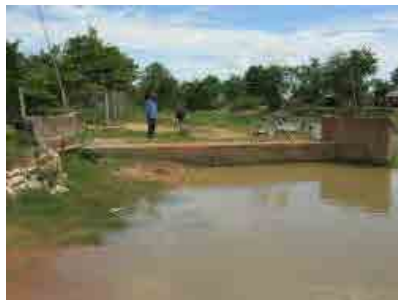
Canal No.: MC2	Kind of structure(s): Gate Structure	Remarks:
Station: 1.00+510	Coordinate< Northing: 1250449 Easting: 0484045	Diversion Point to Secondary Canal Length: 1500m Gate structure is on the left hand side of the Canal.

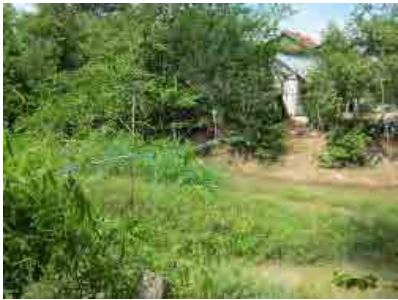
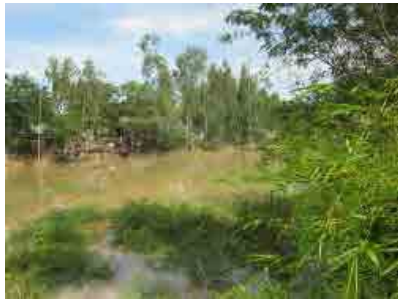
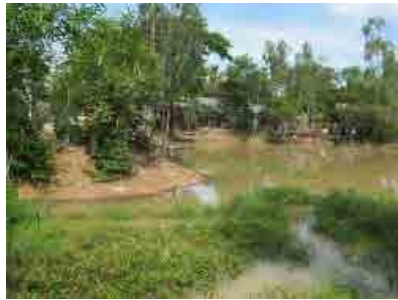
Canal No.: MC2	Kind of structure(s): Canal	Remarks:
Station: 1.00+640	Coordinate< Northing: 1250309 Easting: 0484022	Turning Point to Private Pond Routine Survey

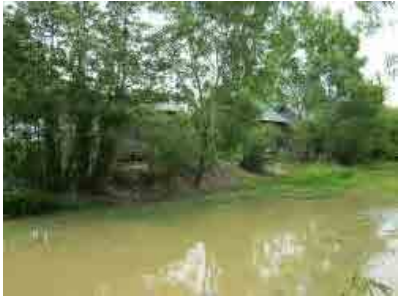
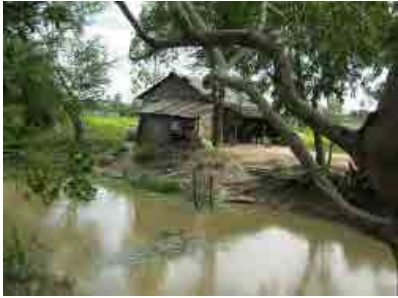
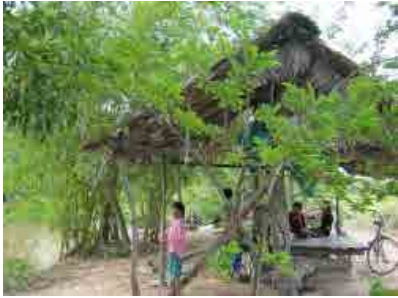
Canal No.: MC2	Kind of structure(s): Houses	Remarks:
Station: 2.00+900	Coordinate< Northing: 1249133 Easting: 0484045	There are 7 houses. Routine Survey

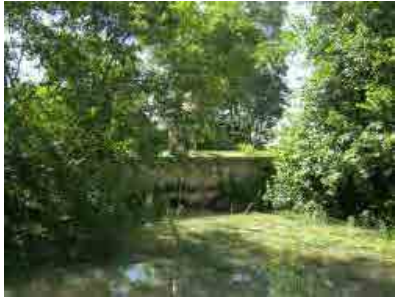
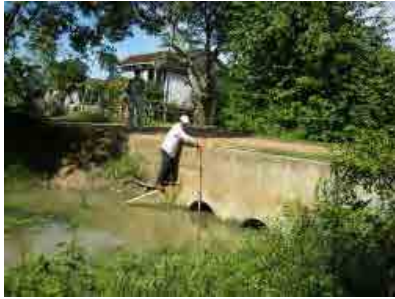
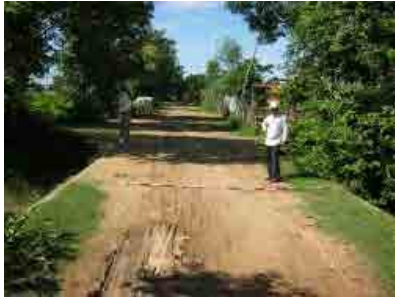
Canal No.: MC3	Kind of structure(s): Pipe Culvert(Double)	Remarks:
Station: 0.00(B.P.)	Coordinate< Northing: 1252631 Easting: 0484103	Village Road Routine Survey

Sta.	E	N	Structure	Condition	Evaluation	Remarks	
0	0484103	1252631	Pipe Culvert (Double)	Road surface is damaged but culvert is functional	B	L=10.8m, W=4.5m, dia=1m	
250	0484332	1252629	Private Wooden Bridge (Broken)	Abandoned one canal section is covered by thick trees and grass	D		
360	0484442	1252631	Private Bridge	Piers are only remained (no slab plate), abandoned bridge	D		
510	0484579	1252630	Diversion Point, 500m	To lateral canal by pump	D	Lateral canal is higher than water level of MC3	
990	0485008	1252638	Pipe Culvert (Village Road)	Culvert is covered by thick grass	B	dia=1m, W=4m, built in May-2008)	
1,200	0485218	1252623	Optical Cable Line Point				
1,290	0485294	1252634	Small Private Bridge	Wooden house access	C	W=0.5 m	
1,340	0485339	1252630	Small Private Bridge	do.	C	W=0.5 m	
1,460	0485364	1252650	Turnout point to lateral canal	Turnout has no gate but groove; bridge on the lateral canal	C	Bridge & Groove (W=3.7m, L=2m)

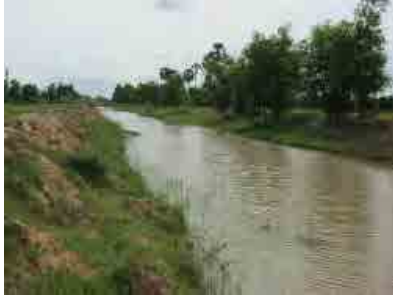
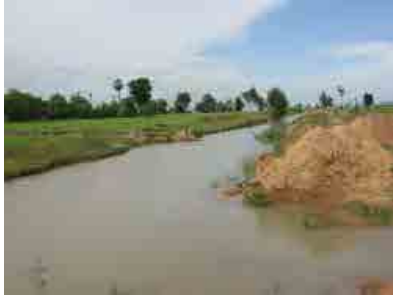
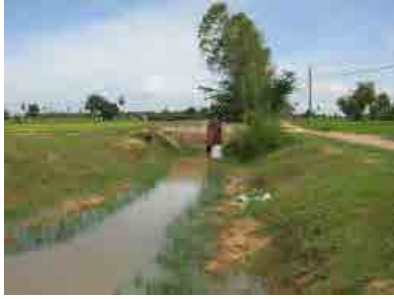
Canal No.: MC3	Kind of structure(s): Canal	Remarks: Diversion Point
Station: 3.00+20	Coordinate< Northing: 1252628 Easting: 0486857	Length: 3000m Dredged soils are dumped on canal ridge.

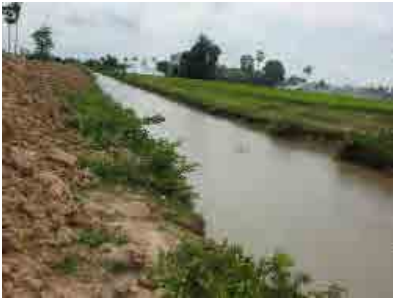
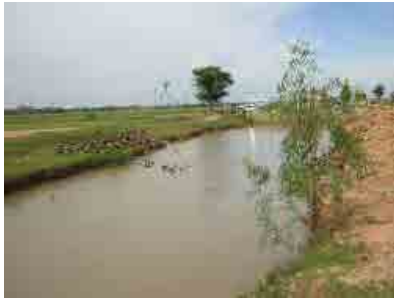
Canal No.: MC3	Kind of structure(s): Canal	Remarks:
Station: 3.00+540	Coordinate< Northing: 1252629 Easting: 0487328	Routine Survey Length: 3500m

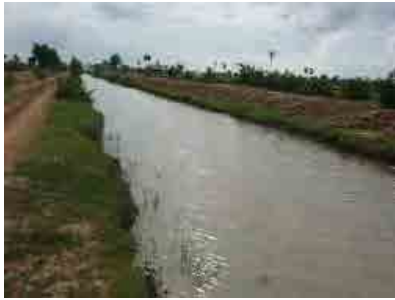
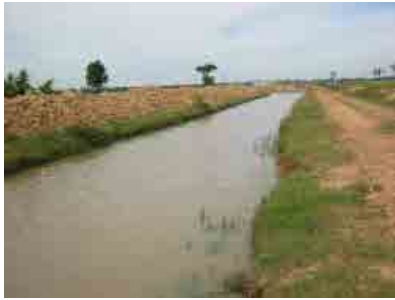
Canal No.: MC3	Kind of structure(s): Canal	Remarks: Routine Survey Length: 4000m
Station: 4.00+40	Coordinate< Northing: 1252636 Easting: 0487802

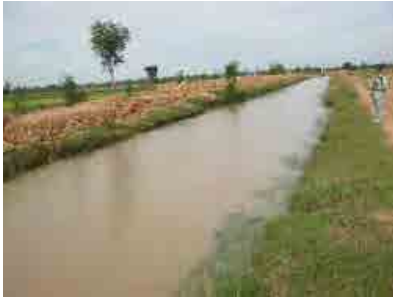
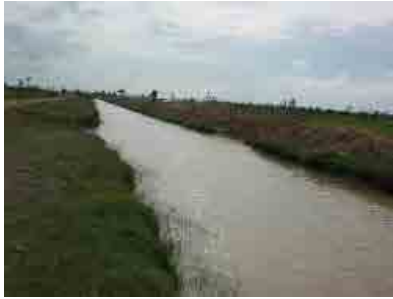
Canal No.: MC3	Kind of structure(s): Canal	Remarks: Routine Survey Length: 4500m Dredged soils are dumped on the ridge of canal in June 2011 by MOWRAM. Dredging was done for 4Km by MOWRAM.
Station: 4.00+550	Coordinate< Northing: 1252637 Easting: 0488264

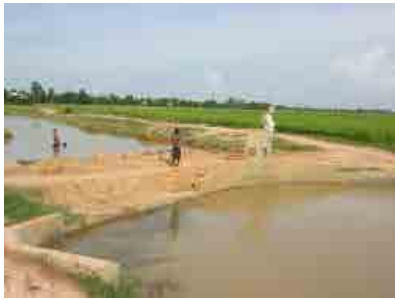
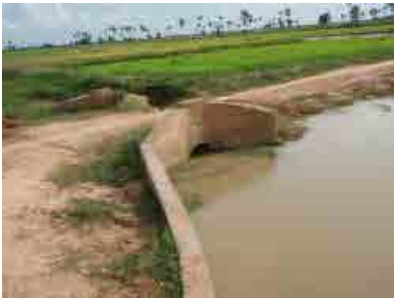
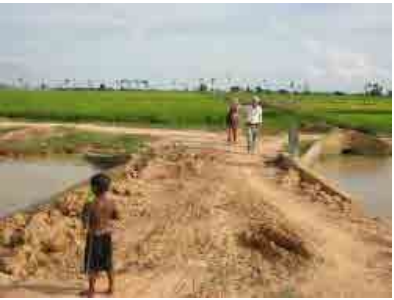
Canal No.: MC3	Kind of structure(s): Pipe Culvert (Private)	Remarks:
Station: 5.00+320	Coordinate< Northing: 1252639 Easting: 0489003	Farm Access Routine Survey

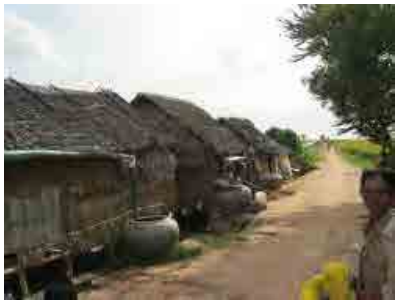
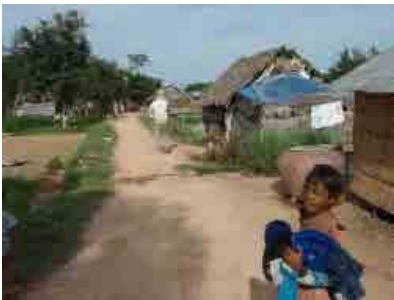
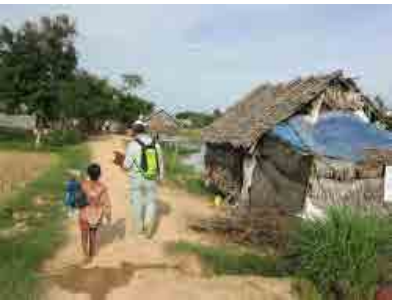
Canal No.: MC3	Kind of structure(s): Houses	Remarks:
Station: 5.00+450	Coordinate< Northing: 1252644 Easting: 0489130	Village Road Routine Survey

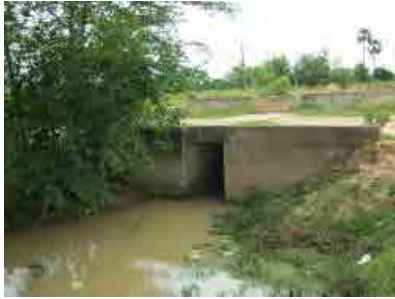
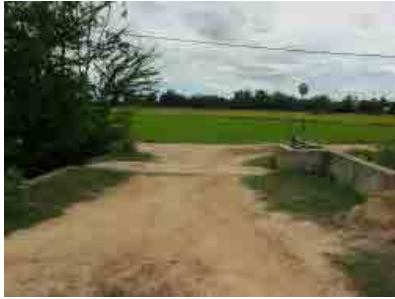
Sta.	E	N	Structure	Condition	Evaluation	Remarks
0	0486883	1252604	B.P, Intake with Gate	Gate frame and lifting gear were lost; gate is not functioned Canal section is well remained as designed	D	(H=1.5m, W=1m), Water Depth=0.8m), Width of Bridge =4.2m, Width of Canal=8.3m, Canal Depth =1.2m
520	0487152	1252173	Private Pipe Culvert	Farm access; function remain	C	(W=4.3m, dia=0.8m)
890	0487347	1251865	Private Pipe Culvert	Do.	C	(W=4m, dia=0.5m)
1,030	0487377	1251733	Canal section at 1,000 m	No erosion, slope is covered by grasses; well maintenance	B	
1,240	0487375	1251524	Private Pipe Culvert	No damage and well maintained	B	(dia=0.5m, W=4.7m, Built on 23-03-2008)
1,550	0487376	1251226	Canal section at 1,500 m	No erosion, slope is covered by grasses; well maintenance	B	
1,780	0487371	1250994	Private Pipe Culvert	No damage and well maintained	B	(dia=0.6m, W=3.8m)
2,050	0487115	1250994	Canal section at 2,000 m	Canal section become wide and shallow	C

Canal No.: L3	Kind of structure(s): Gate Structure	Remarks:
Station: 0.00(B.P.)	Coordinate< Northing: 1252604 Easting: 0486883	Along the Village Road Routine Survey

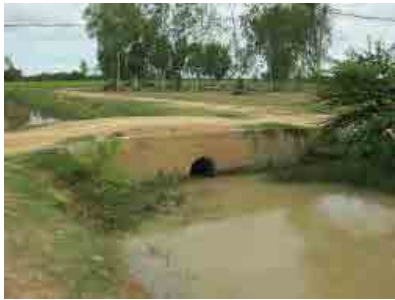
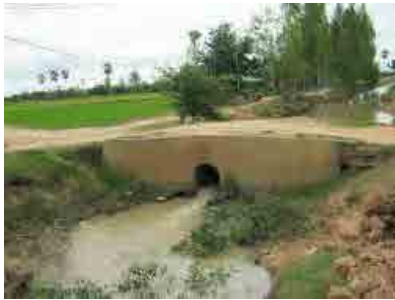
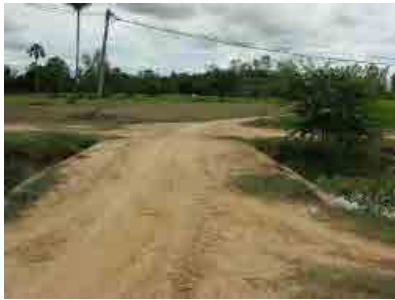
Canal No.: L3	Kind of structure(s): Pipe Culvert(Private)	Remarks:
Station: 0.00+520	Coordinate< Northing: 1252173 Easting: 0487152	Farm Access Length: 500m

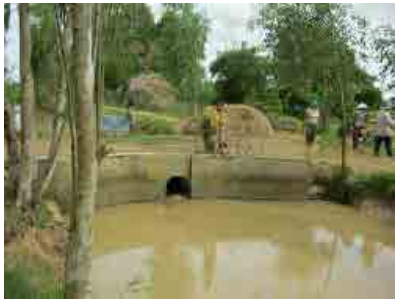
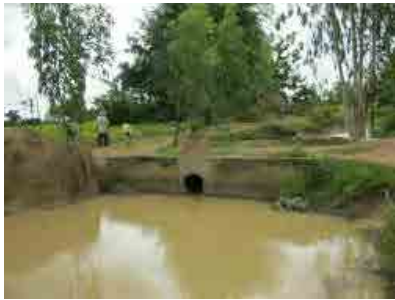
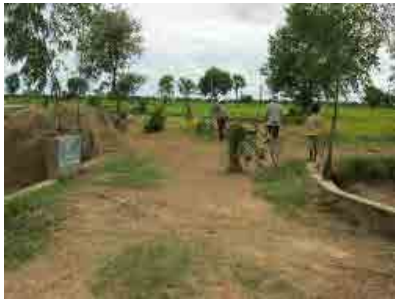
Canal No.: L3	Kind of structure(s): Pipe Culvert(Private)	Remarks:
Station: 0.00+890	Coordinate< Northing: 1251865 Easting: 0487347	Farm Access Routine Survey

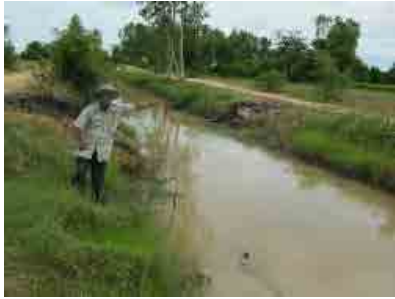
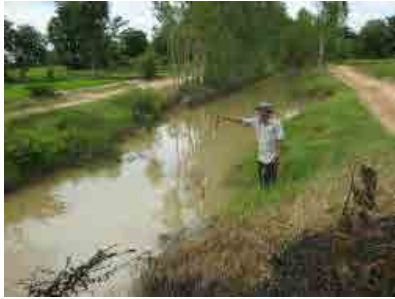
Canal No.: L3	Kind of structure(s): Canal	Remarks:
Station: 1.00+30	Coordinate< Northing: 1251733 Easting: 0487377	Routine Survey Length: 1000m

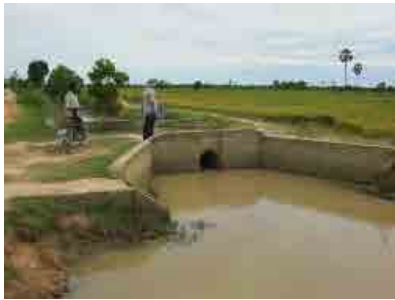
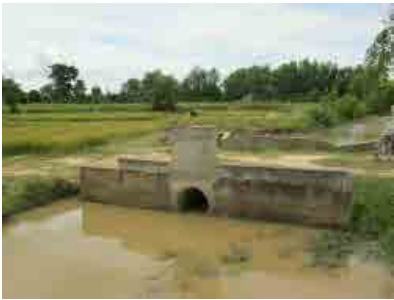
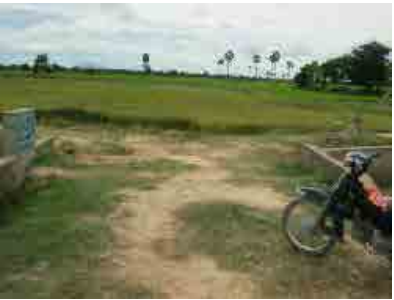
Canal No.: L3	Kind of structure(s): Pipe Culvert(Private)	Remarks:
Station: 1.00+240	Coordinate< Northing: 1251524 Easting: 0487375	Farm Access Routine Survey

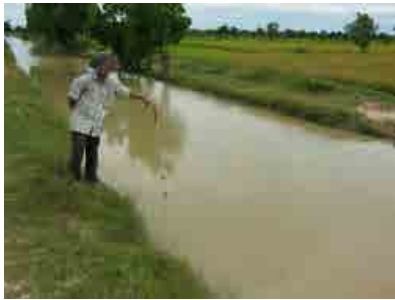
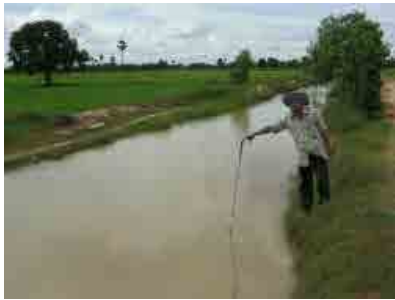
Canal No.: L3	Kind of structure(s): Canal	Remarks:
Station: 1.00+550	Coordinate< Northing: 1251226 Easting: 0487376	Routine Survey Length: 1500m

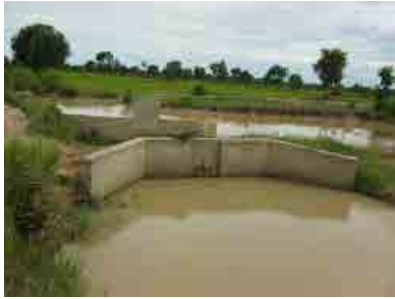
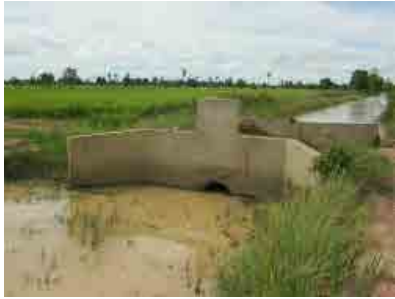
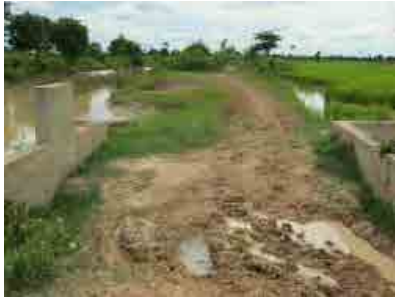
Canal No.: L3	Kind of structure(s): Pipe Culvert(Private)	Remarks:
Station: 1.00+780	Coordinate< Northing: 1250994 Easting: 0487371	Farm Access Routine Survey

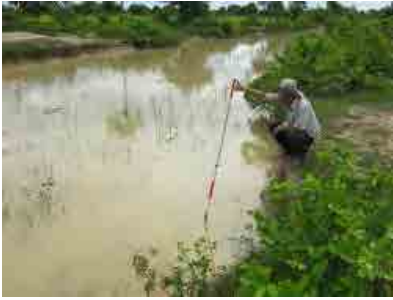
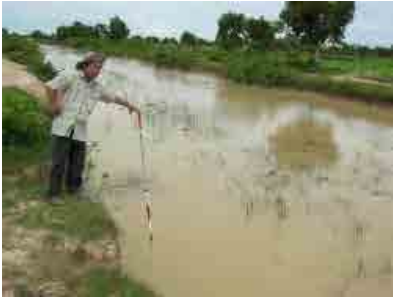
Canal No.: L3	Kind of structure(s): Canal	Remarks:
Station: 2.00+50(EP)	Coordinate< Northing: 1250994 Easting: 0487115	Routine Survey Length: 2000m

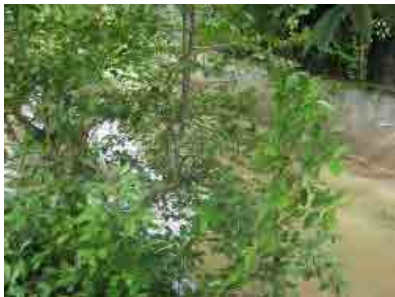
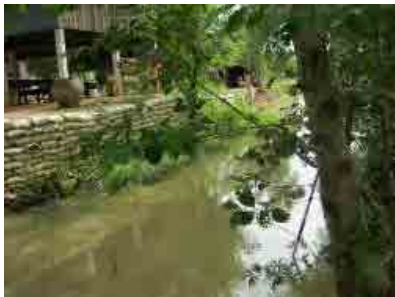
Canal No.: L4	Kind of structure(s): Canal	Remarks:
Station: 0.00+560	Coordinate< Northing: 1250995 Easting: 0485737	Routine Survey

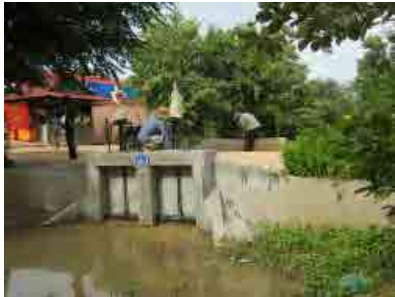
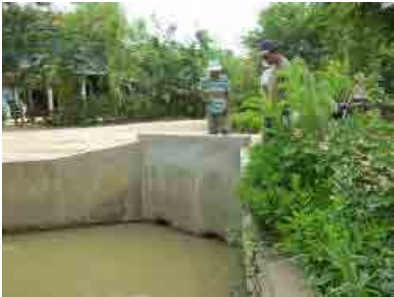
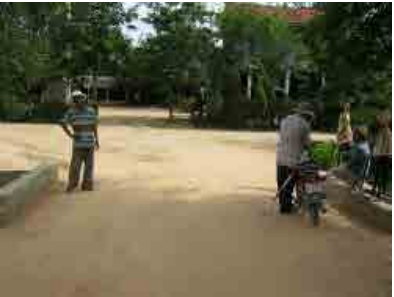
Canal No.: L4	Kind of structure(s): Gate Structure	Remarks:
Station: 0.00+640 (EP)	Coordinate< Northing: 1250992 Easting: 0485807	There are Bridge and Pipe Culvert

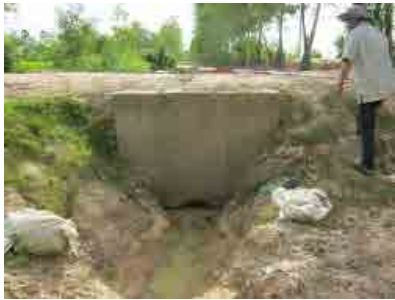
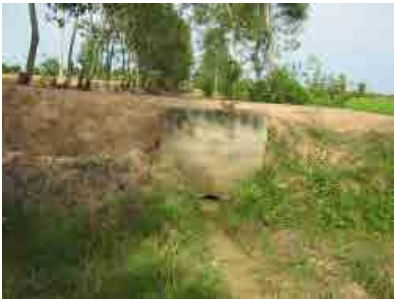
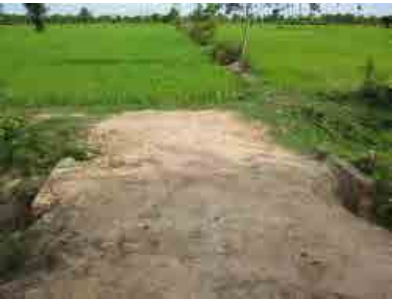
Canal No.: L5	Kind of structure(s): Pipe Culvert(Private)	Remarks: Farm Access Routine Survey
Station: 0.00+150	Coordinate< Northing: 1250442 Easting: 0485412

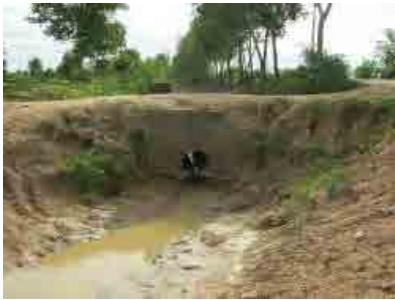
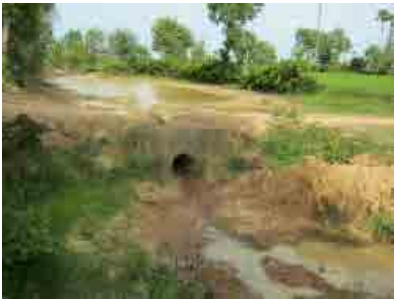
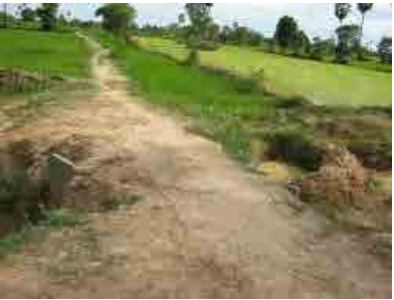
Canal No.: L5	Kind of structure(s): Pipe Culvert(Private)	Remarks: Farm Access Routine Survey
Station: 0.00+350	Coordinate< Northing: 1250442 Easting: 0485207

Sta.	E	N	Structure	Condition	Evaluation	Remarks
0	0485546	1250442	B.P. Diversion point from MC-1	Canal has been eroded and no sufficient flow has reached	-	
150	0485412	1250442	Private Pipe Culvert	Pipe has mostly clogged by soils Farm access	C	dia=0.5m, L=4.1m
350	0485207	1250442	Private Pipe Culvert	Pipe dia seems to be too small for conveying water Farm access	C	dia=0.4m, L=3.1m
500	0485066	1250442	Canal section at 500 m	The section has been eroded and become flat; many sediments on the bed	-	
710	0484870	1250446	Pipe Culvert on village road	Pipe has mostly clogged by soils	C	dia=0.8m, W=6m
1,000	0484562	1250450	Canal section at 1,000 m	The section has been eroded and become flat; many sediments on the bed	-	
1,110	0484442	1250449	Private Pipe Culvert & E.P.		C	dia=0.8m, W=5.2m

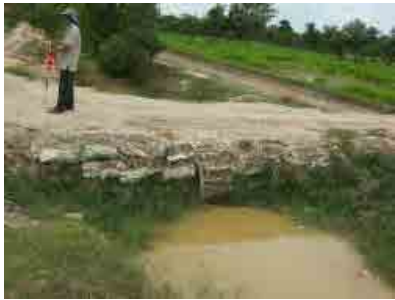
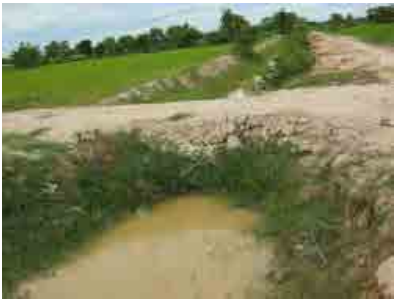
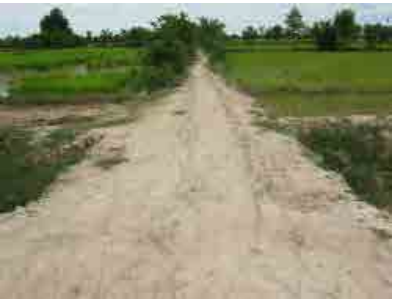
Canal No.: L6	Kind of structure(s): Pipe Culvert(Private)	Remarks:
Station: 0.00+300	Coordinate< Northing: 1249875 Easting: 0486265	Farm Access Routine Survey

Sta.	E	N	Structure	Condition	Evaluation	Remarks
0	0485978	1249877	B.P, Pipe Culvert Private	Inlet of the canal is considerably narrowed by this culvert To be removed	D	dia=0.5m, W=4.6m, Farm access
300	0486265	1249875	Pipe Culvert (Private)	Pipe might be clogged and no protection of embankment is done	D	dia=0.6m, W=4m Farm access
500	0486462	1249873	Pipe Culvert (Private)	Pipe is submerged by soils	D	dia=0.5m, W=4m
510	0486477	1249871	Pipe Culvert (Private)	House access	C	dia=0.4m, W=6m
660	0486627	1249874	Pipe Culvert Village road	Condition of road and protection of embankment is rather good	C	Double, , dia=0.4m & 0.5m, W=5.5m
760	0486731	1249869	Private Pipe Culvert	Farm access	C	dia=0.5m, W=3m
870	0486856	1249868	Pipe Culvert (Private)	Diversion Point	C	dia=0.5m, W=4m,
1,010	0487003	1249866	Canal section at 1,000 m	No shape of canal remained; canal become narrow and shallow considerably	-	
1,070	0487064	1249868	Pipe Culvert (Private)	Temporary farm access	C	dia=0.4m, W=1.9m

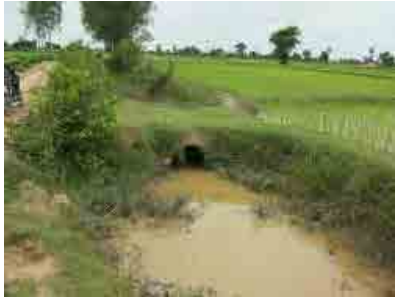
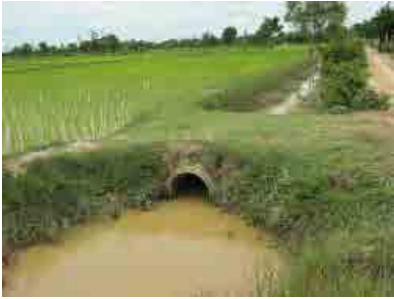
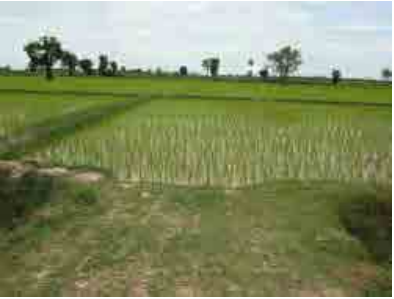
Canal No.: L6	Kind of structure(s): Pipe Culvert(Private)	Remarks:
Station: 1.00+210	Coordinate< Northing: 1249862 Easting: 0487208	Farm Access Routine Survey

1,210	0487208	1249862	Pipe Culvert (Private)	Farm access	C	dia=0.6m, W=4m
1,380	0487366	1249861	Diversion Point	No structure is found	-	
1,450	0487436	1249857	Pipe Culvert (Private)	Farm access	C	dia=0.3m, W=2m
1,510	0487491	1249857	Canal section at 1,500 m	Canal section remained, but less maintenance	-	
1,840	0487807	1249852	Pipe Culvert (Private)	Farm access	C	dia=0.4m, W=1m
1,920	0487879	1249853	Embankment	Canal is blocked by embankment	-	No moral to use the canal
2,010	0487966	1249852	2,000m & E.P.	Canal section is used as pond and rice field	-

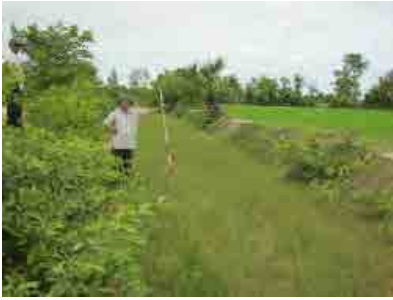
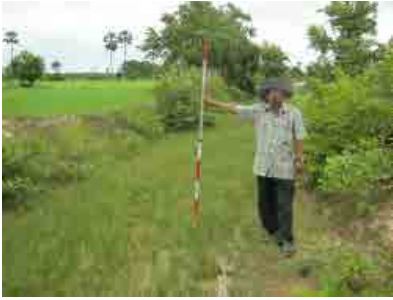
Canal No.: L7	Kind of structure(s): Canal	Remarks:
Station: 1.00	Coordinate< Northing: 1247169 Easting: 0485884	EP of Canal L8 and BP of Canal L7 Length: 1000m

1,000	0485884	1247169	Canal section at BP of L7 and L8, (1,000m from EP of L8)	Canal section remains, and some grass on the canal bed due to small discharge from MC-1	-	BP of L7 & L8
1,170	0485721	1247171	Embankment	Culvert is under construction (pipes are at site)	B	Future Pipe Culvert (dia=0.8m, W=5m)
1,180	0485702	1247172	Embankment	Do.	B	Future Pipe Culvert (dia=0.8m, W=5m)
1,510	0485383	1247170	Canal section at 500 m from BP of L7	Canal section remains, and rather in good condition, though some sediments on the canal bed	-	
1,700	0485201	1247169	Pipe Culvert (Private)	Farm access	C	W=3m, dia=0.5m
2,010	0484899	1247174	Canal section at 1,000 m from BP of L7	No water reached to this point, canal section remains without serious erosion	-	
2,200	0484693	1247172	Canal section at 1,200 m from BP of L7	Canal section is slightly eroded and covered by grass	-	EP of L7

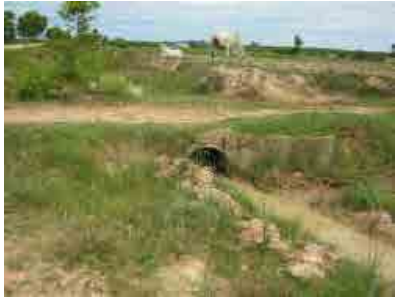
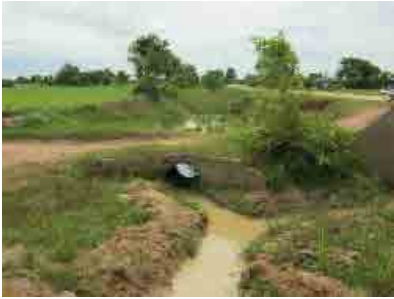
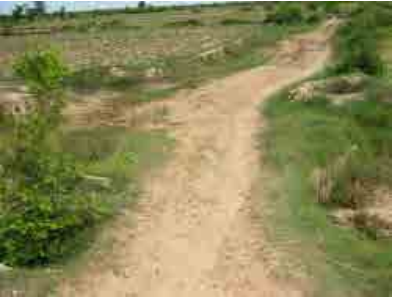
Canal No.: L7	Kind of structure(s): Canal	Remarks:
Station: 2.00+10	Coordinate< Northing: 1247174 Easting: 0484899	Routine Survey Length: 2000m

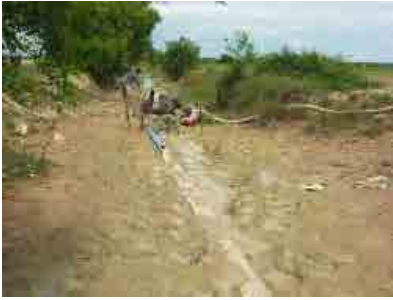
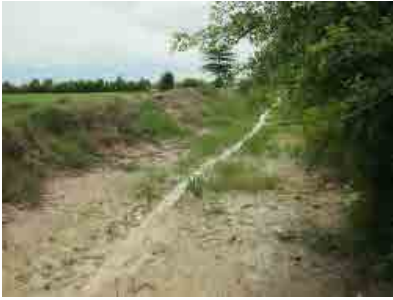
Canal No.: L7	Kind of structure(s): Canal	Remarks:
Station: 2.00+200 (EP)	Coordinate< Northing: 1247172 Easting: 0484693	Routine Survey

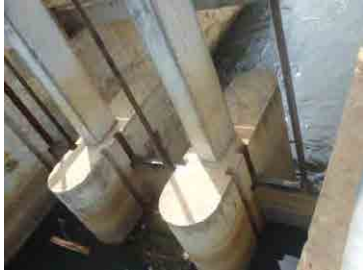
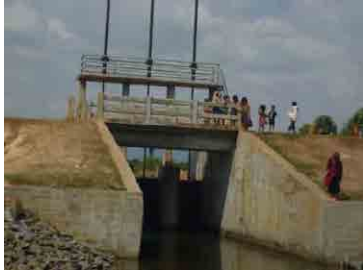
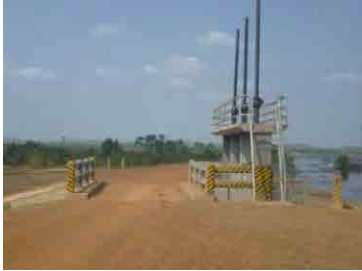
Canal No.: MC	Kind of structure: Intake KPOB KROUS Reservoir	Remarks:
Station:	Coordinate< Northing: 1238652 Easting: 443411

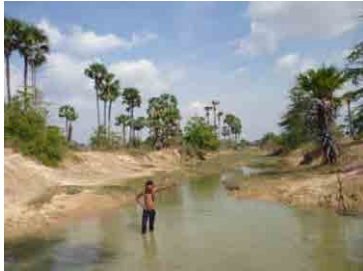
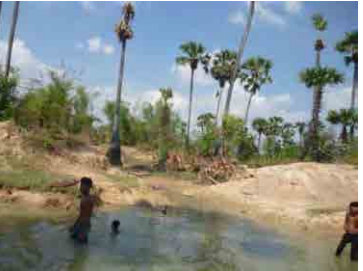
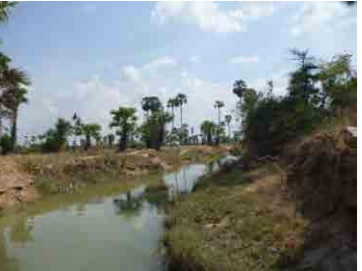
Canal No.: MC	Kind of structure: Secondary Canal	Remarks: At the left side but no structure.
Station:	Coordinate< Northing: 1238320 Easting: 443790

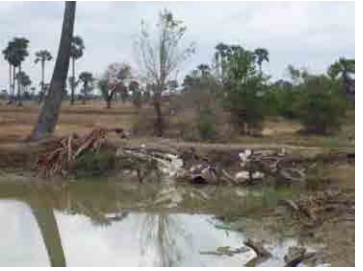
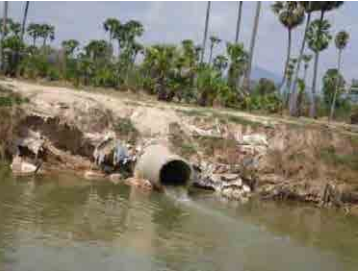
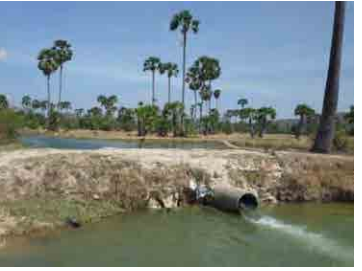
Canal No.: MC	Kind of structure: Pipe culvert	Remarks: Along the Main Canal
Station:	Coordinate< Northing: 1238128 Easting: 443812

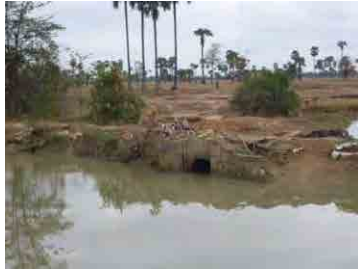
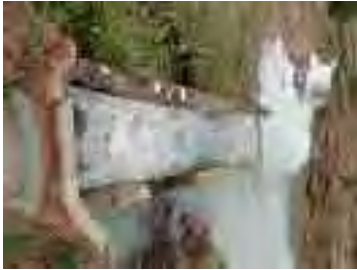
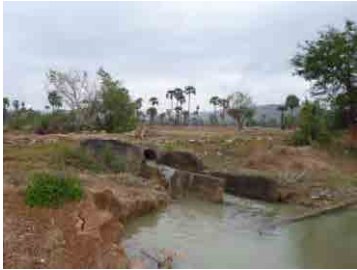
Canal No.: MC	Kind of structure: Secondary Canal	Remarks: At the right side has pipe culvert
Station:	Coordinate< Northing: 1237926 Easting: 443838

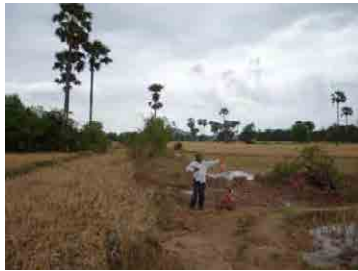
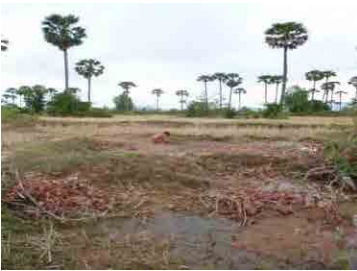
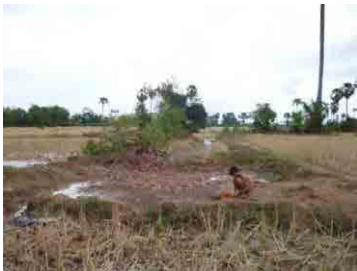
Canal No.: MC	Kind of structure: Secondary Canal	Remarks: At the right side but no structure.
Station:	Coordinate< Northing: 1237949 Easting: 444362

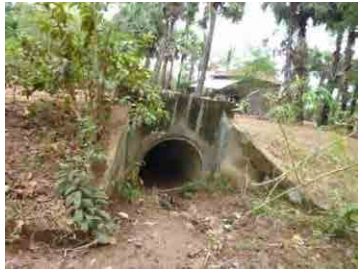
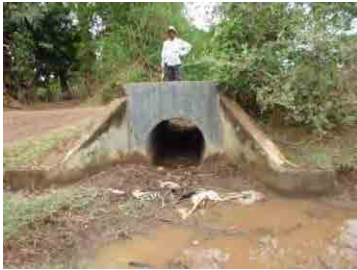
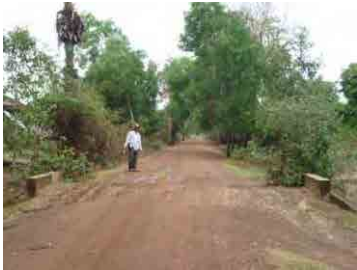
Canal No.: MC	Kind of structure: Road	Remarks: Crossing the Main Canal; has pipe culvert.
Station:	Coordinate< Northing: 1237960 Easting: 444851

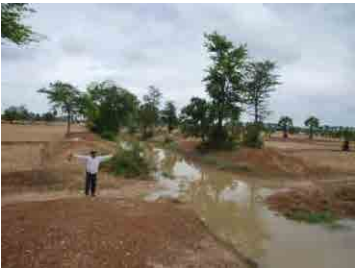
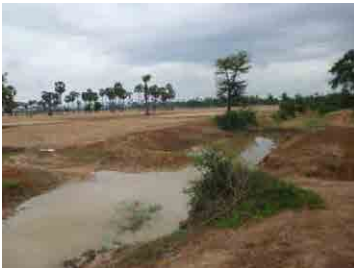
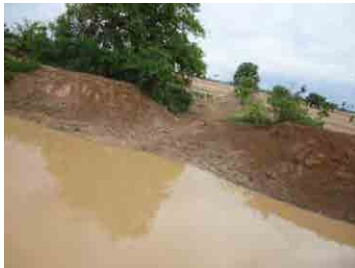
Canal No.: MC	Kind of structure: Secondary Canal	Remarks: Crossing main canal but no structure.
Station:	Coordinate< Northing: 1237973 Easting: 445509

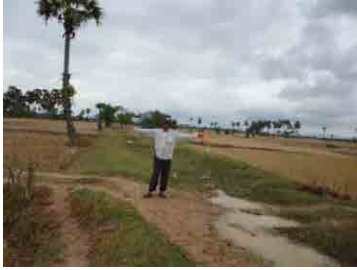
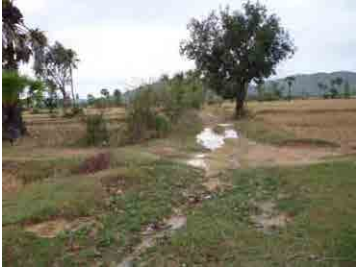
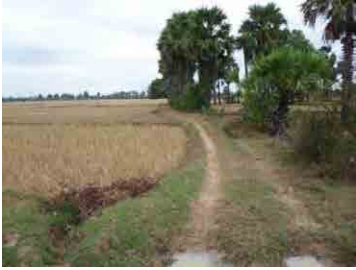
Canal No.: MC	Kind of structure: Road	Remarks: Crossing the main canal
Station:	Coordinate< Northing: 1237832 Easting: 446021

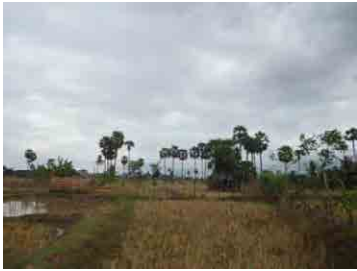
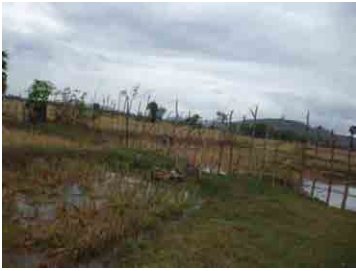
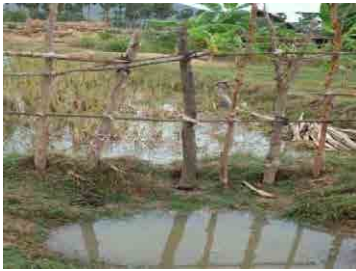
Canal No.: MC	Kind of structure: Garden house	Remarks: Based on the main canal
Station:	Coordinate< Northing: 1237506 Easting: 446050

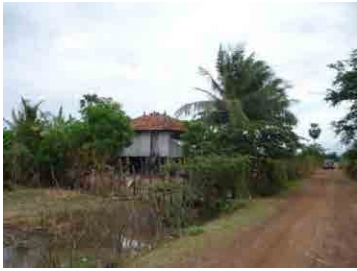
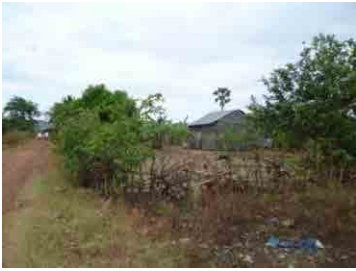
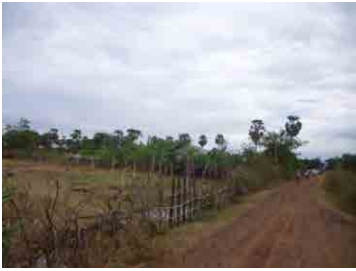
Canal No.: MC	Kind of structure: Garden house	Remarks: Based on the main canal.
Station:	Coordinate< Northing: 1236773 Easting: 446107

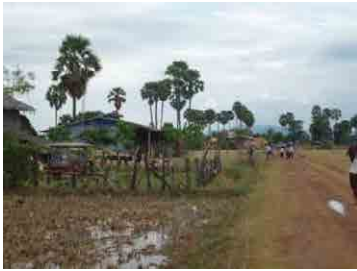
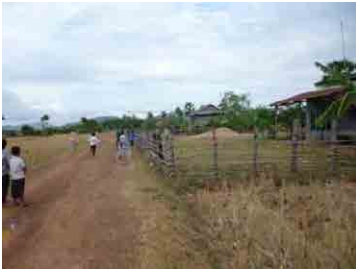
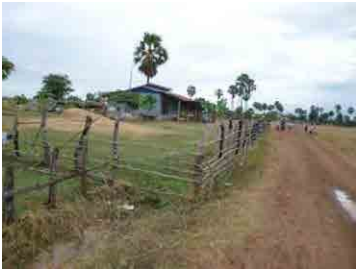
Canal No.: MC	Kind of structure: Garden house	Remarks: Based on the main canal.
Station:	Coordinate< Northing: 1236015 Easting: 446173

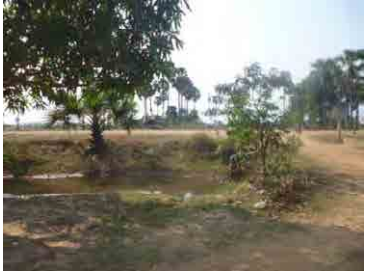
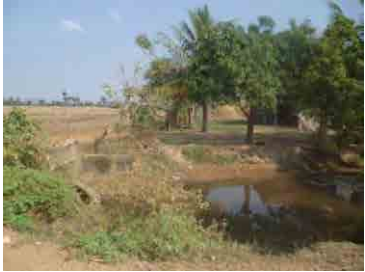
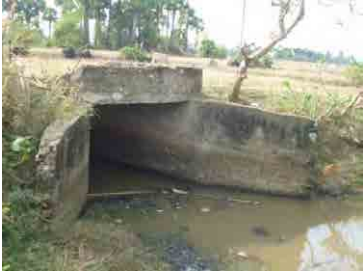
Canal No.: MC	Kind of structure: Secondary Canal	Remarks: Crossing main canal, have structure.
Station:	Coordinate< Northing: 1235674 Easting: 446195

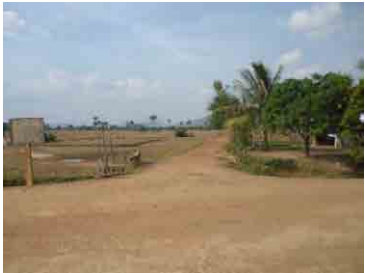
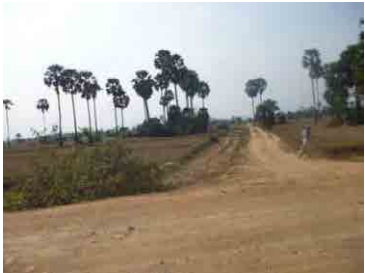
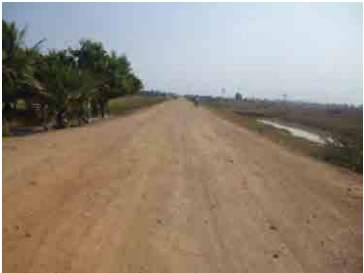
Canal No.: MC	Kind of structure: Road	Remarks: Crossing main canal.
Station:	Coordinate< Northing: 1235665 Easting: 446197

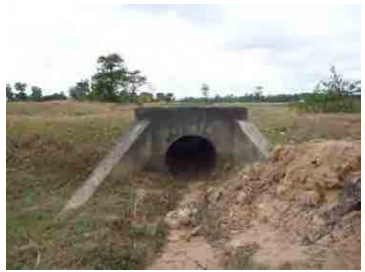
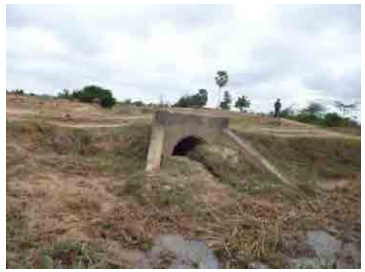
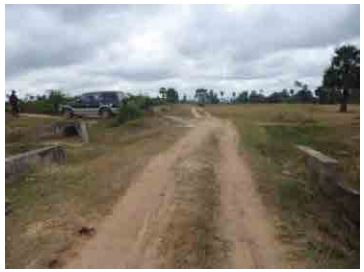
Canal No.: MC	Kind of structure: Pipe culvert	Remarks: At the right side
Station:	Coordinate< Northing: 1235357 Easting: 446225

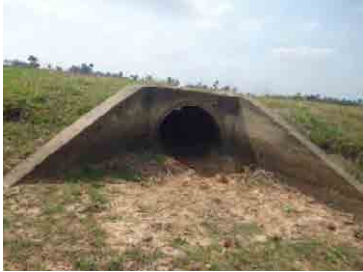
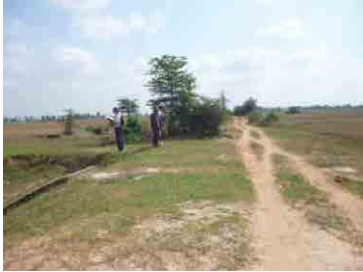
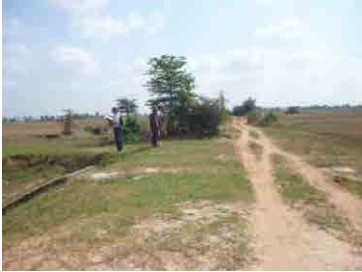
Canal No.: MC	Kind of structure: Secondary canal	Remarks: At the right side, has pipe culvert.
Station:	Coordinate< Northing: 1235300 Easting: 446799

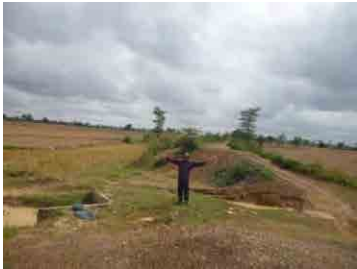
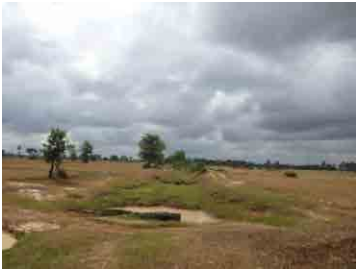
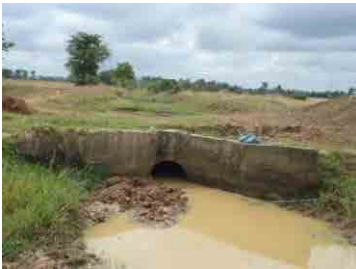
Canal No.: MC	Kind of structure: Secondary canal	Remarks: Secondary canal (Right), Drain (Left), has pipe culvert.
Station:	Coordinate< Northing: 1235269 Easting: 447288

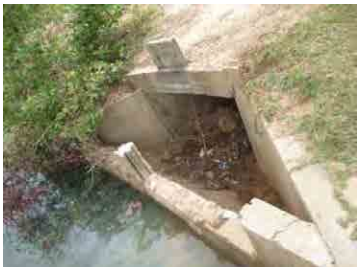
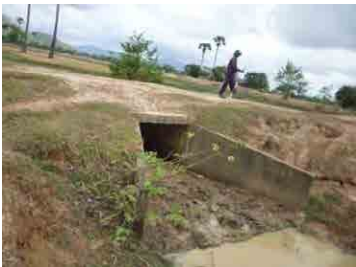
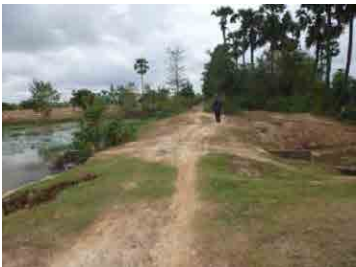
Canal No.: MC	Kind of structure: Secondary canal	Remarks: Crossing main canal, has box culvert.
Station:	Coordinate< Northing: 1235177 Easting: 448337

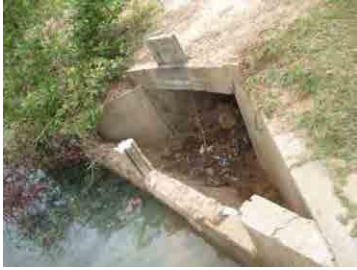
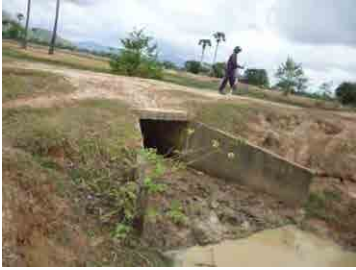
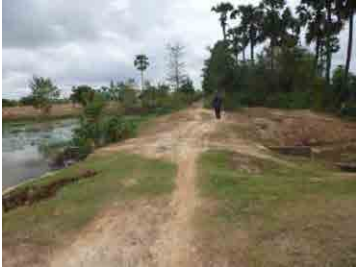
Canal No.: MC	Kind of structure: Secondary canal	Remarks: Crossing main canal; has box culvert.
Station:	Coordinate< Northing: 1235177 Easting: 448337

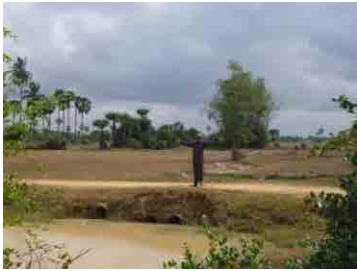
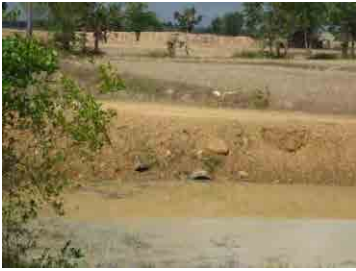
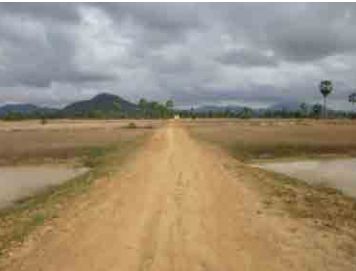
Canal No.: MC	Kind of structure: Road	Remarks: Crossing main canal; has pipe culvert.
Station:	Coordinate< Northing: 1235169 Easting: 448523

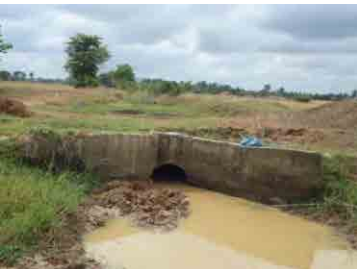
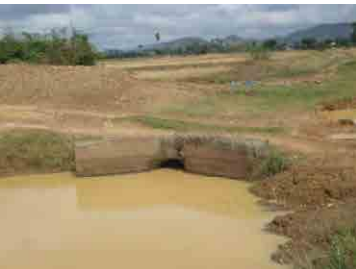
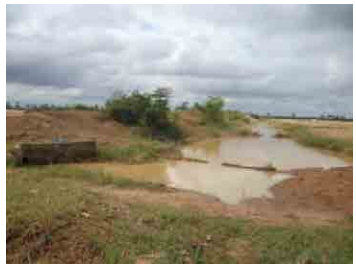
Canal No.: MC	Kind of structure: Secondary Canal	Remarks: At the right side
Station:	Coordinate< Northing: 1235160 Easting: 448636

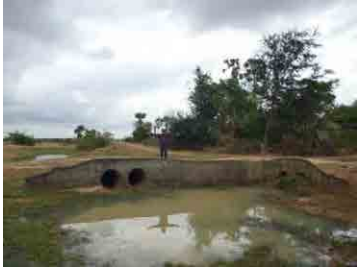
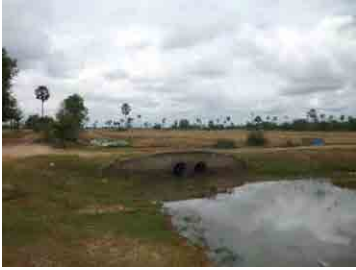
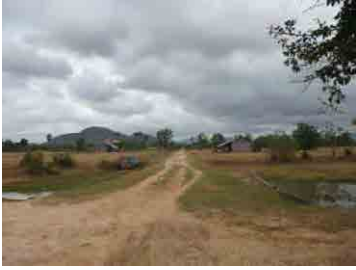
Canal No.: MC	Kind of structure: Secondary Canal	Remarks: Secondary canal (Right), Drain (Left), has two structures.
Station:	Coordinate< Northing: 1235021 Easting: 449351

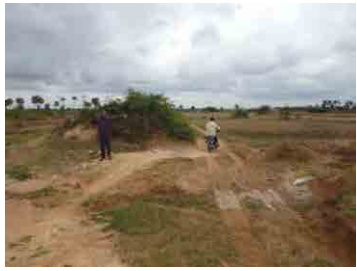
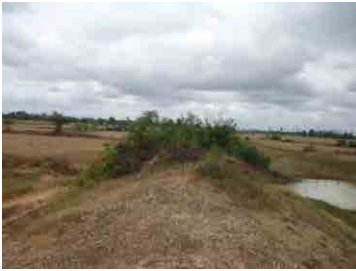
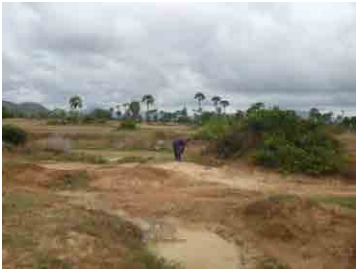
Canal No.: MC	Kind of structure: Secondary Canal	Remarks: At the right side.
Station:	Coordinate< Northing: 1235223 Easting: 449896

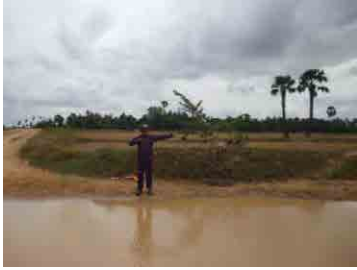
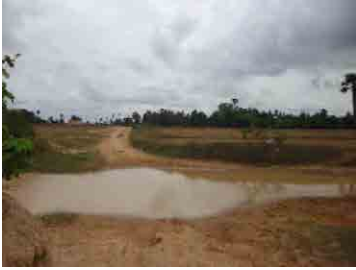
Canal No.: MC	Kind of structure: Secondary Canal	Remarks: At the right side.
Station:	Coordinate< Northing: 1235418 Easting: 451002

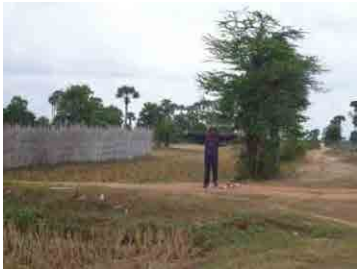
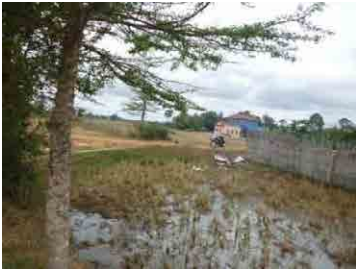
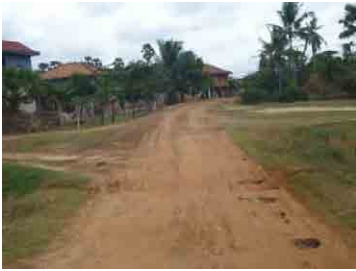
Canal No.: MC	Kind of structure: Secondary Canal	Remarks: At the left side.
Station:	Coordinate< Northing: 1235684 Easting: 451679

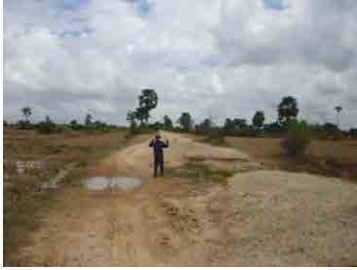
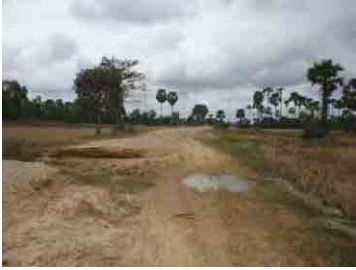
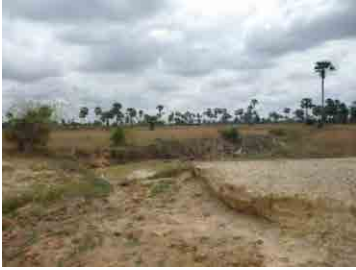
Canal No.: MC	Kind of structure: Secondary Canal	Remarks: At the right side.
Station:	Coordinate< Northing: 1235750 Easting: 451852

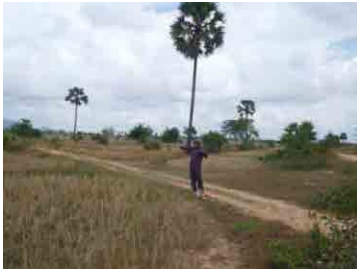
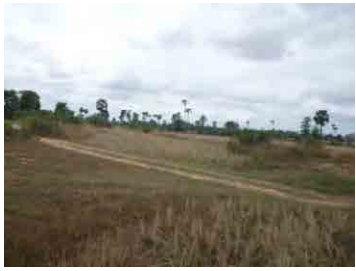
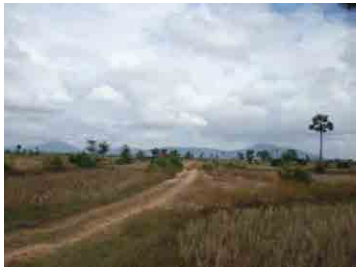
Canal No.: MC	Kind of structure: Secondary Canal	Remarks: At the left side.
Station:	Coordinate< Northing: 1235820 Easting: 452037

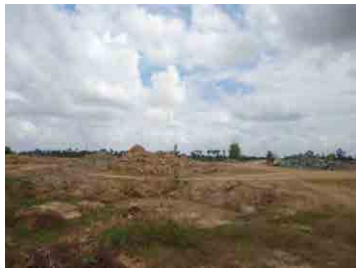
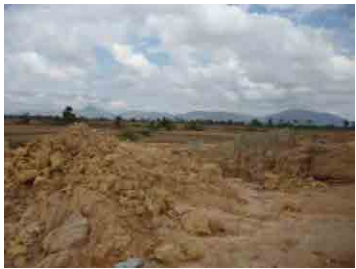
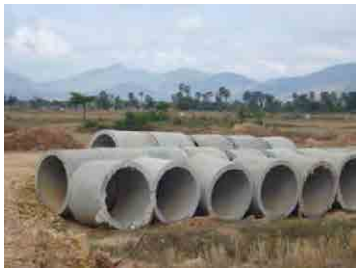
Canal No.: MC	Kind of structure: Road DONG DOUNG	Remarks: Under construction
Station:	Coordinate< Northing: 1235979 Easting: 452604

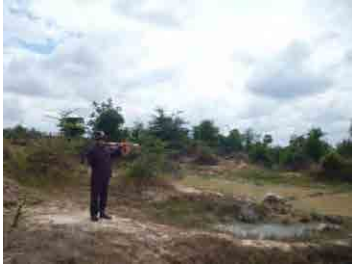
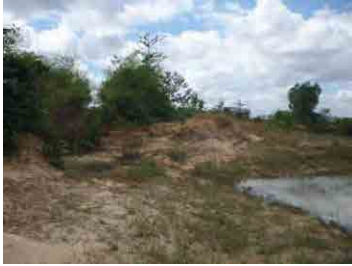
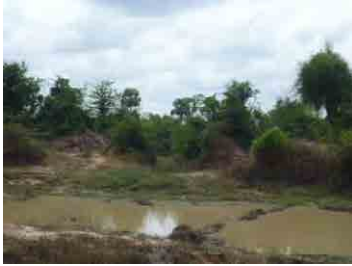
Canal No.: MC	Kind of structure: Secondary canal	Remarks: At the right side.
Station:	Coordinate< Northing: 1236056 Easting: 453251

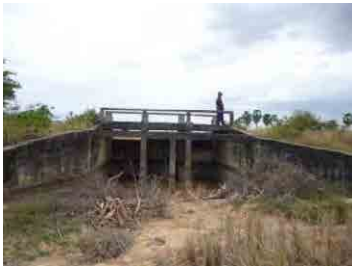
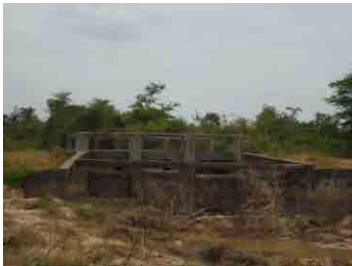
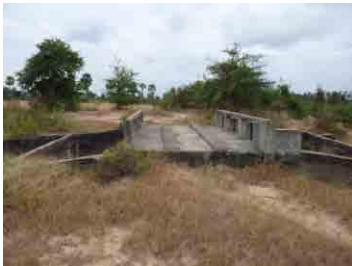
Canal No.: MC	Kind of structure:	Remarks: Check Structure
Station:	Coordinate< Northing: 1236049 Easting: 453267

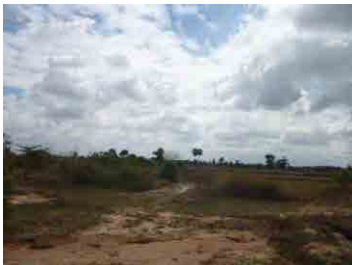
Canal No.: MC	Kind of structure: Secondary Canal	Remarks: At the right side
Station:	Coordinate< Northing: 1235998 Easting: 453773

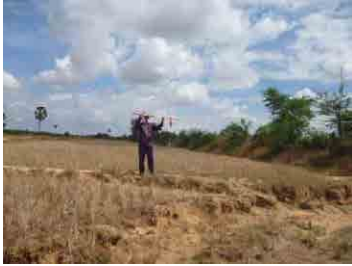
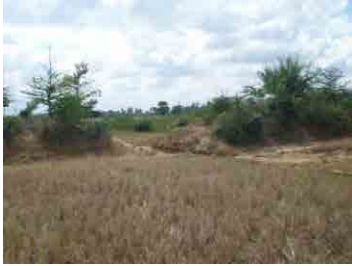
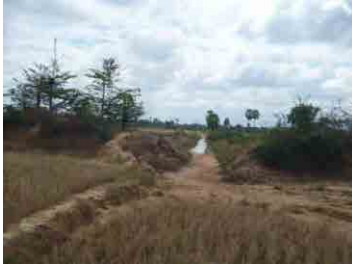
Canal No.: MC	Kind of structure: Secondary Canal	Remarks: At the right side
Station:	Coordinate< Northing: 1235970 Easting: 454236

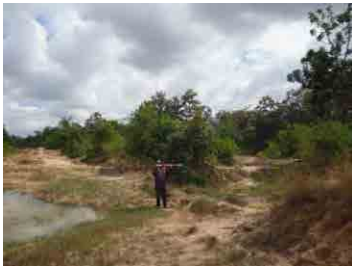
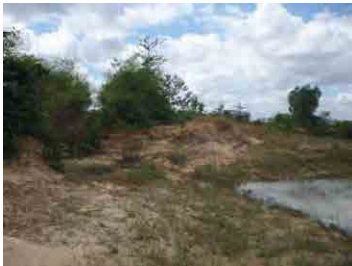
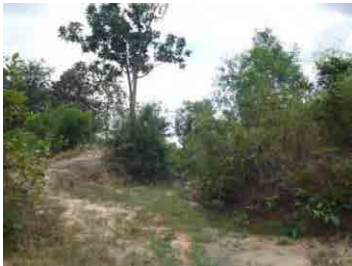
Canal No.: MC	Kind of structure: Secondary Canal	Remarks: At the right side
Station:	Coordinate< Northing: 1235964 Easting: 454302

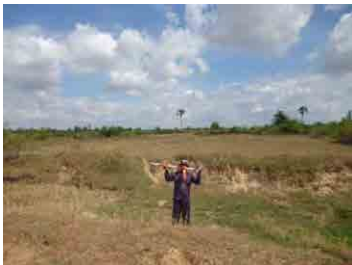
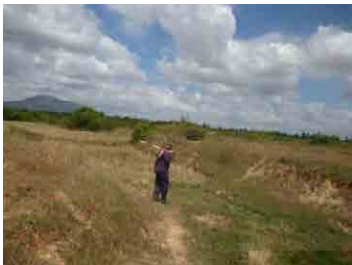
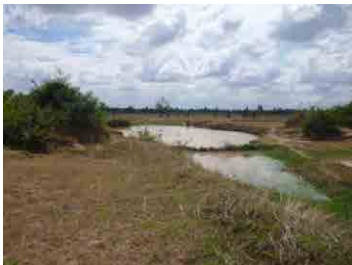
Canal No.: MC	Kind of structure: Secondary Canal	Remarks: At the left side
Station:	Coordinate< Northing: 1235955 Easting: 454516
