# ***ANNEX D***

## ***Attachment – 1***

*Results of Inventory Survey for  
Proposed Rehabilitation Works in  
Roleang Chrey Headworks Rehabilitation Sub-project*

**Results of Inventory Survey for Proposed Rehabilitation Works on North Main Canal (1/12)**

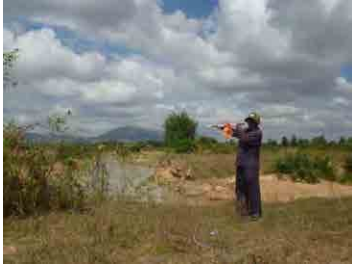
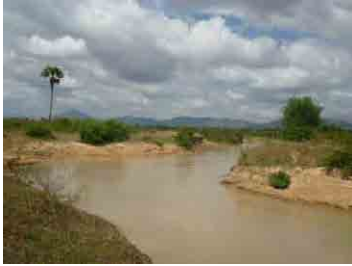
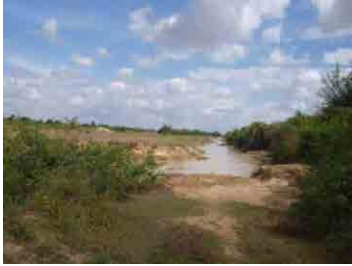
Canal No.: MC	Kind of structure: Secondary Canal	Remarks: At the left side
Station:	Coordinate< Northing: 1235959 Easting: 454701

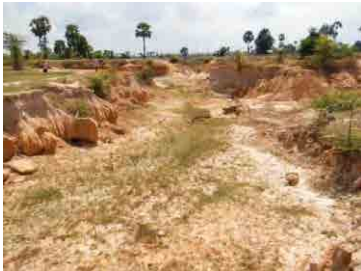
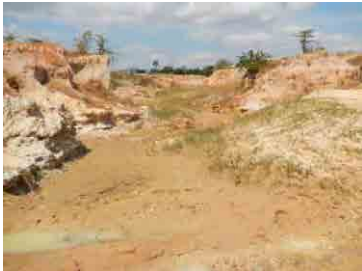
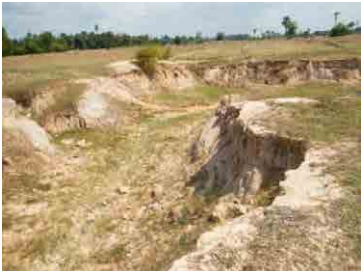
Canal No.: MC	Kind of structure: Secondary Canal	Remarks: At the left side
Station:	Coordinate< Northing: 1235935 Easting: 454847

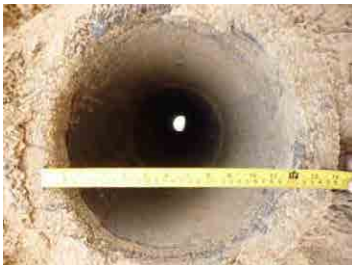
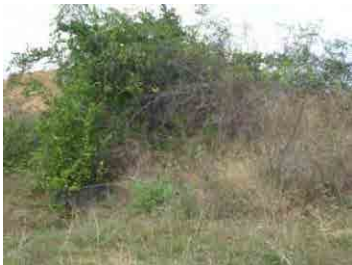
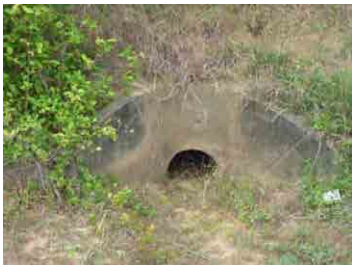
Canal No.: MC	Kind of structure: Pipe culvert	Remarks: To the field at the right side
Station:	Coordinate< Northing: 1235866 Easting: 455299

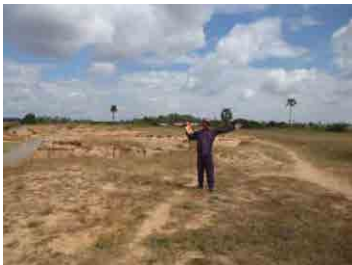
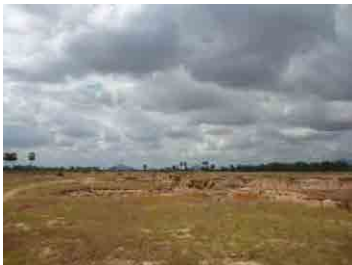
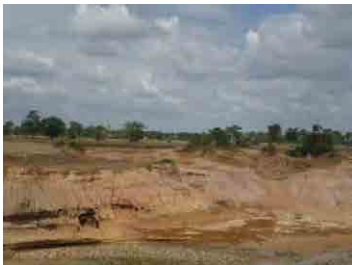
Canal No.: MC	Kind of structure: Road	Remarks: Crossing the main canal
Station:	Coordinate< Northing: 1235803 Easting: 457065

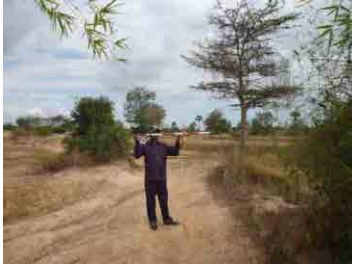
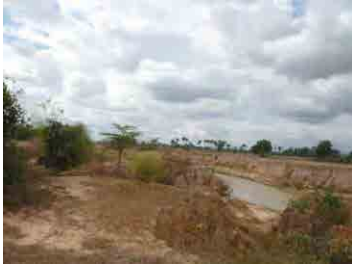
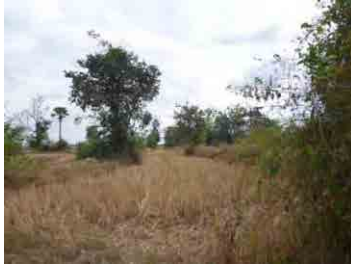
Canal No.: MC	Kind of structure: Secondary Canal	Remarks: At the right side
Station:	Coordinate< Northing: 1235794 Easting: 457999

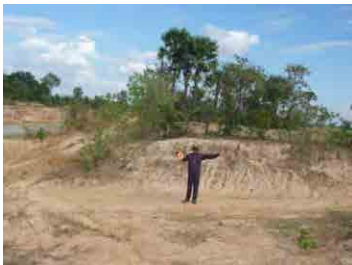
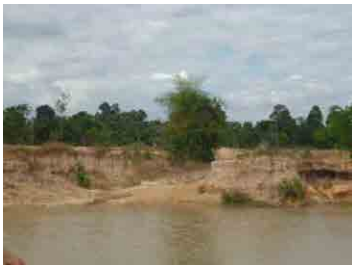
Canal No.: MC	Kind of structure: Road	Remarks: Crossing the main canal
Station:	Coordinate< Northing: 1235775 Easting: 459628

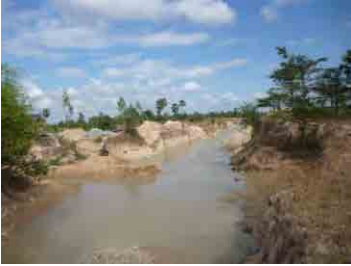
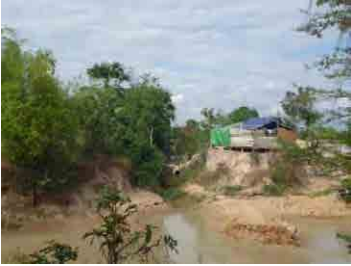
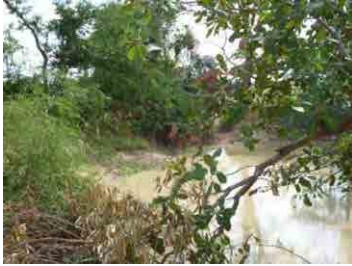
Canal No.: MC	Kind of structure: Secondary Canal	Remarks: Crossing the main canal
Station:	Coordinate< Northing: 1235755 Easting: 460233

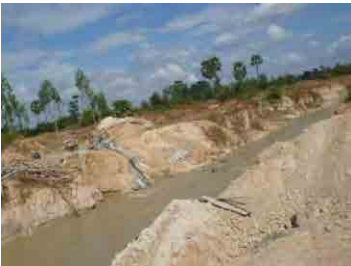
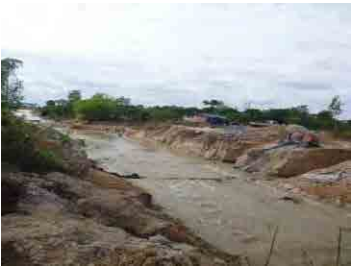
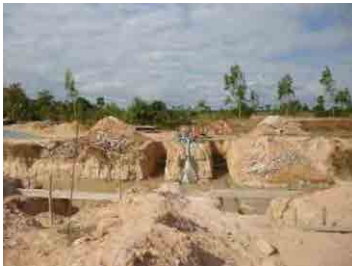
Canal No.: MC	Kind of structure:	Remarks: Check structure is under construction.
Station:	Coordinate< Northing: 1235756 Easting: 460277

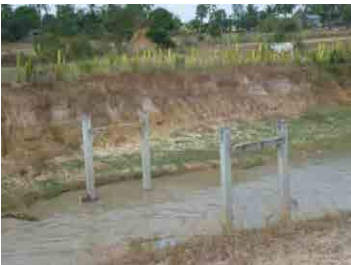
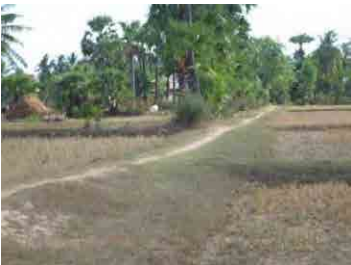
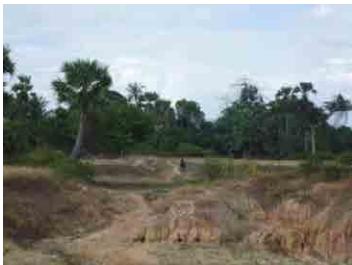
Canal No.: MC	Kind of structure: Road	Remarks: Crossing the main canal
Station:	Coordinate< Northing: 1235620 Easting: 460948

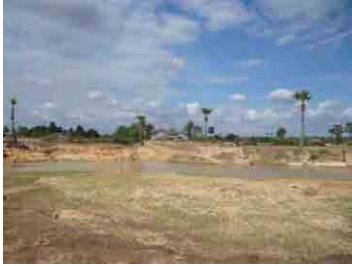
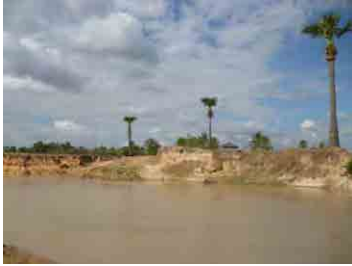
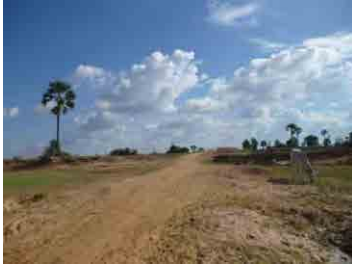
Canal No.: MC	Kind of structure: Road (24)	Remarks: Crossing the main canal
Station:	Coordinate< Northing: 1235530 Easting: 461397

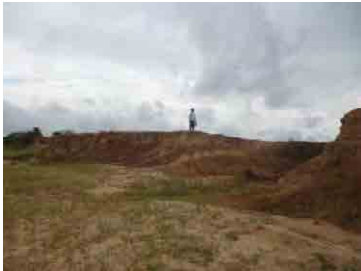
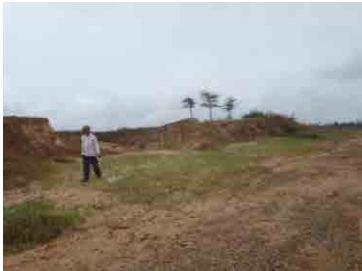
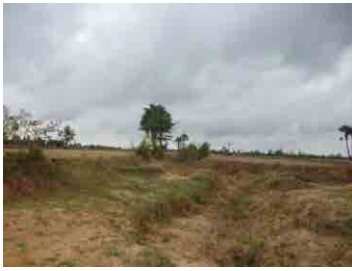
Canal No.: MC	Kind of structure: Secondary Canal	Remarks: At the right side
Station:	Coordinate< Northing: 1235319 Easting: 461934

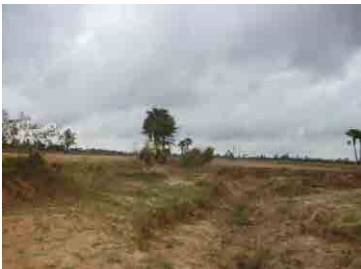
Canal No.: MC	Kind of structure: Secondary Canal	Remarks: At the right side
Station:	Coordinate< Northing: 1234957 Easting: 463677

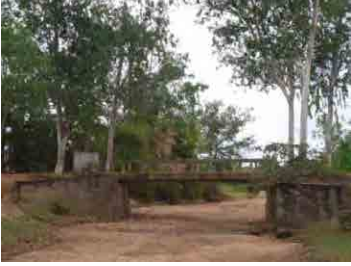
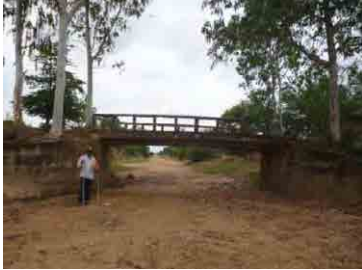
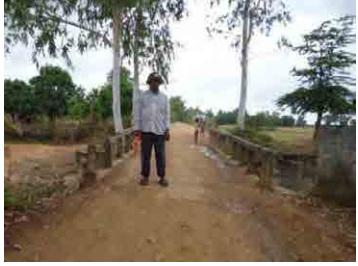
Canal No.: MC	Kind of structure: Road	Remarks: Crossing the main canal but has bridge.
Station:	Coordinate< <div style="display: flex; flex-direction: column; margin-left: 10px;"> <span>Northing: 1234900</span> <span>Easting: 464113</span> </div>	
<div style="display: flex; justify-content: space-around; align-items: center;"> <div style="text-align: center;">

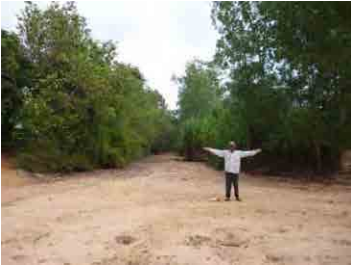
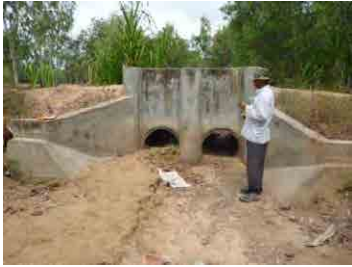
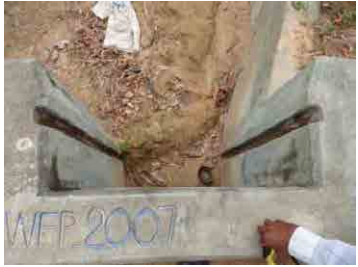
Canal No.: MC	Kind of structure: Secondary Canal	Remarks: Crossing the main canal but has double pipes at the right.
Station:	Coordinate< <div style="display: flex; flex-direction: column; margin-left: 10px;"> <span>Northing: 1234518</span> <span>Easting: 465434</span> </div>	
<div style="display: flex; justify-content: space-around; align-items: center;"> <div style="text-align: center;">

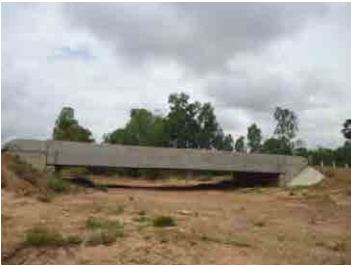
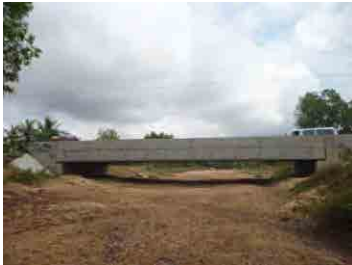
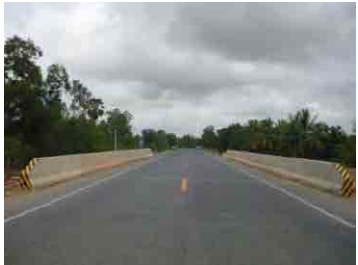
Canal No.: MC	Kind of structure: Bridge number 12	Remarks: Based on National road number 3
Station:	Coordinate< <div style="display: flex; flex-direction: column; margin-left: 10px;"> <span>Northing: 1234513</span> <span>Easting: 465648</span> </div>	
<div style="display: flex; justify-content: space-around; align-items: center;"> <div style="text-align: center;">

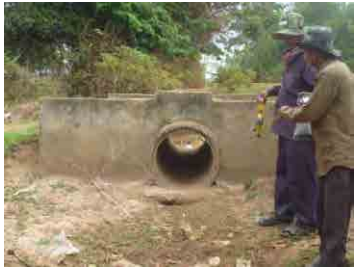
Canal No.: SC-3	Kind of structure: Pipe Culvert	Remarks: B.P. of SC-3 at Main Canal 35
Station:	Coordinate< Northing: 1237748 Easting: 444883

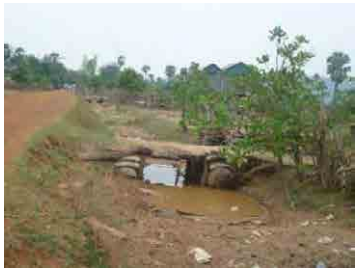
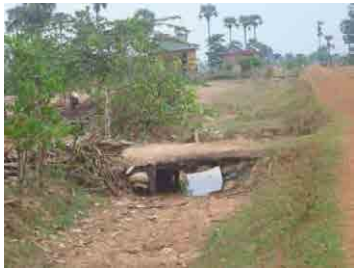
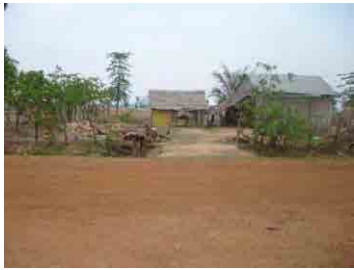
Canal No.: SC-3	Kind of structure: Wooden Bridge	Remarks: Wooden bridge for entrance
Station:	Coordinate< Northing: 1237434 Easting: 444927

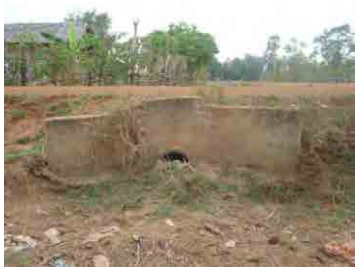
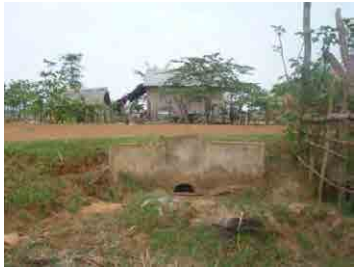
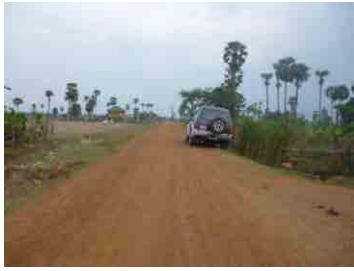
Canal No.: SC-3	Kind of structure: Turnout	Remarks: Pipe culvert (turnout) to the right tertiary canal
Station:	Coordinate< Northing: 1237423 Easting: 444927

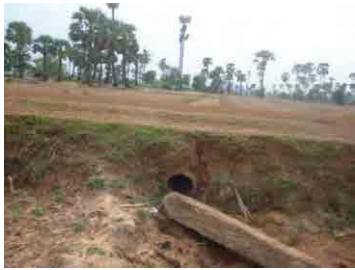
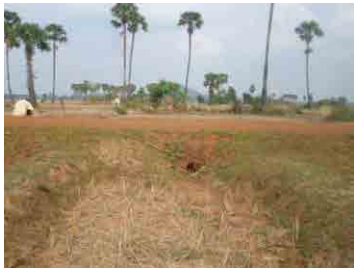
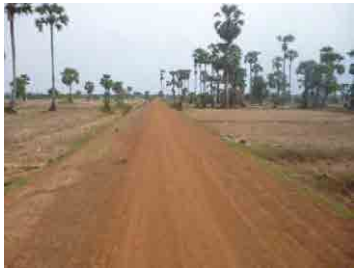
Canal No.: SC-3	Kind of structure: Turnout	Remarks: Pipe culvert (turnout) to the right tertiary canal (L = 300m)
Station:	Coordinate< Northing: 1237210 Easting: 444955

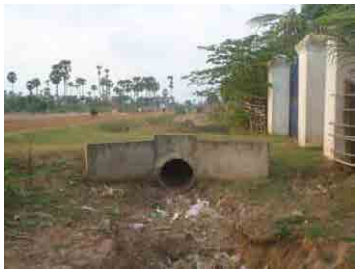
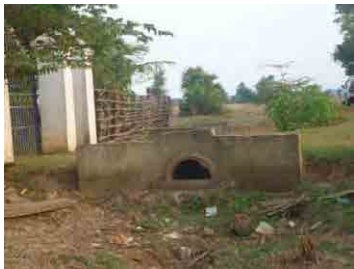
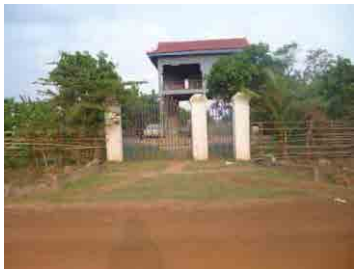
Canal No.: SC-3	Kind of structure: Pipe Culvert	Remarks: Pipe culvert for entrance
Station:	Coordinate< Northing: 1236868 Easting: 444999

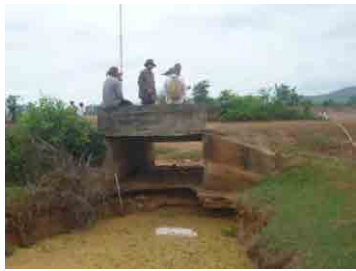
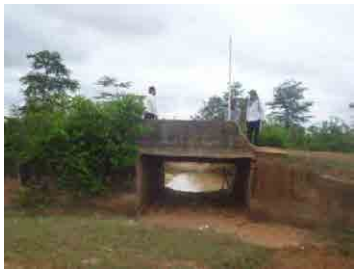
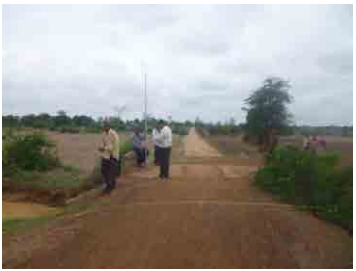
Canal No.: SC-3	Kind of structure: Box Culvert	Remarks: Box Bridge crossing secondary canal
Station:	Coordinate< Northing: 1236338 Easting: 445071

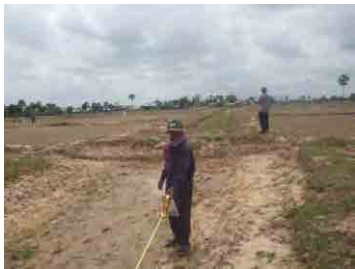
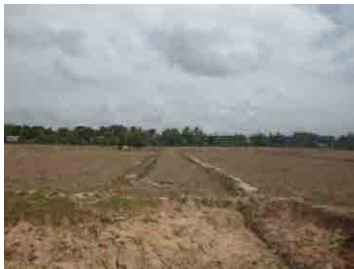
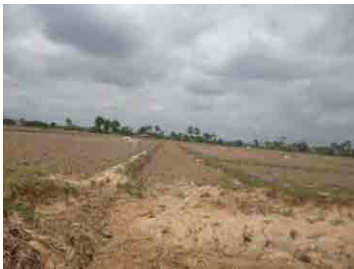
Canal No.: SC-3	Kind of structure: Turnout (no structure)	Remarks: Tertiary canal crossing without structure
Station:	Coordinate< Northing: 1235607 Easting: 445179

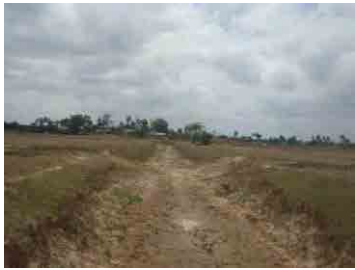
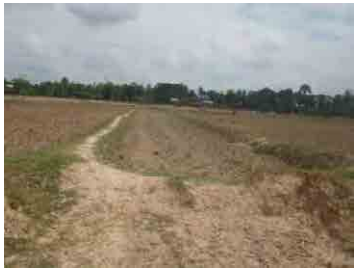
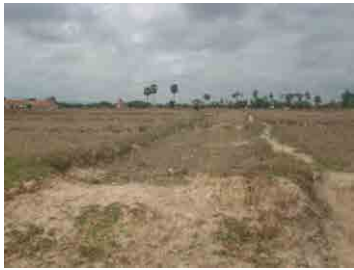
Canal No.: SC-3	Kind of structure: Turnout (no structure)	Remarks: Tertiary canal crossing without structure
Station:	Coordinate< Northing: 1235505 Easting: 445199

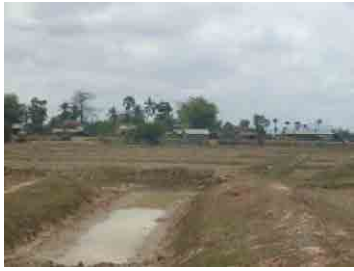
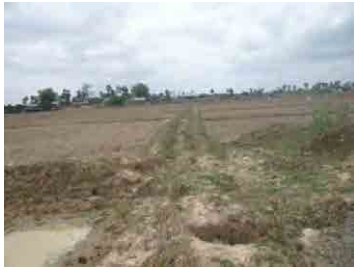
Canal No.: SC-3	Kind of structure: Canal	Remarks: Canal width becomes narrow.
Station:	Coordinate< Northing: 1235453 Easting: 445201

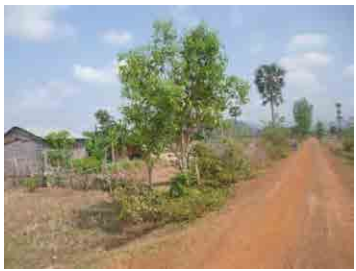
Canal No.: SC-5	Kind of structure: Entrance	Remarks: Entrance without structure
Station:	Coordinate< Northing: 1237237 Easting: 447562

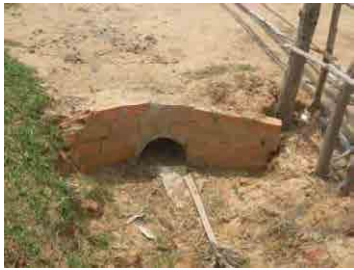
Canal No.: SC-5	Kind of structure: Pipe culvert	Remarks: Entrance with pipe culvert
Station:	Coordinate< Northing: 1236906 Easting: 447523

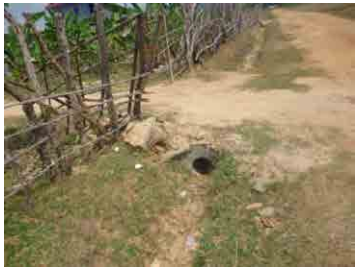
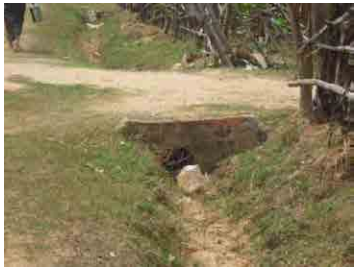
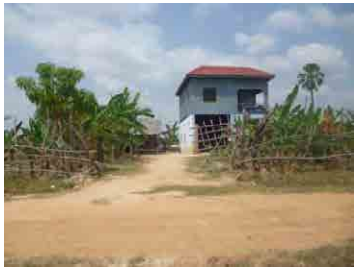
Canal No.: SC-5	Kind of structure: Pipe culvert	Remarks: Entrance with pipe culvert
Station:	Coordinate< Northing: 1236657 Easting: 447497

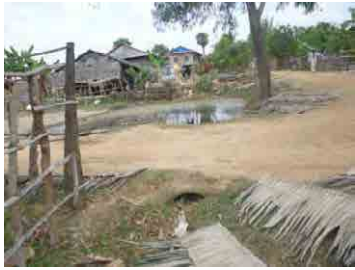
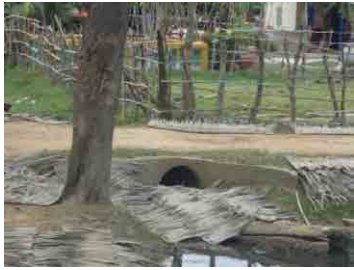
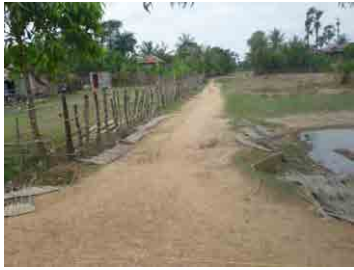
Canal No.: SC-5	Kind of structure: Pipe culvert	Remarks: Road Crossing with pipe culvert
Station:	Coordinate< Northing: 1226638 Easting: 447494

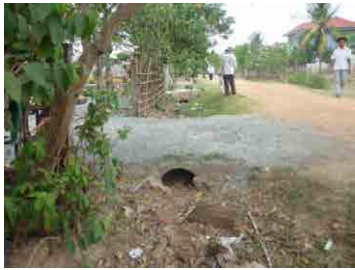
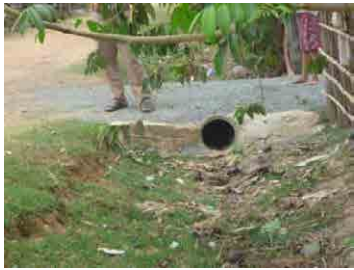
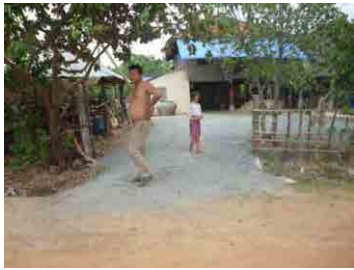
Canal No.: SC-5	Kind of structure: Pipe culvert	Remarks: Entrance with pipe culvert
Station:	Coordinate< Northing: 1236627 Easting: 447492

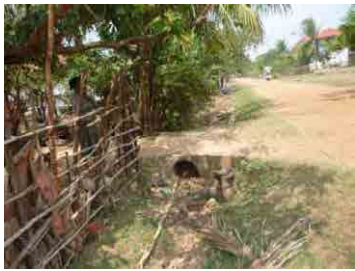
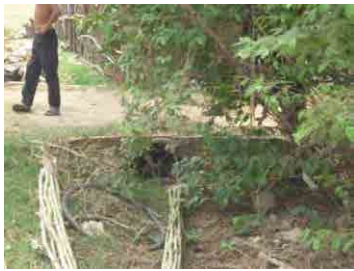
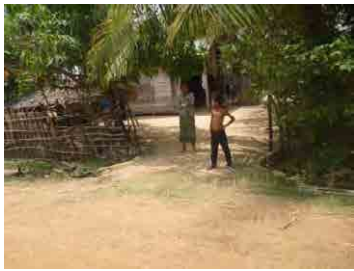
Canal No.: SC-5	Kind of structure: Pipe culvert	Remarks: Entrance with pipe culvert
Station:	Coordinate< Northing: 1236608 Easting: 447490

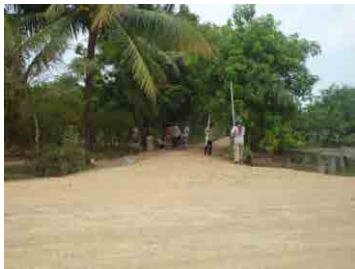
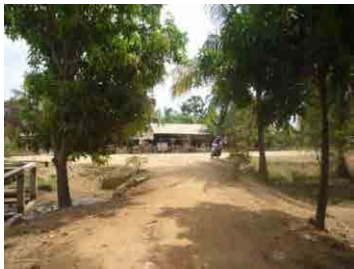
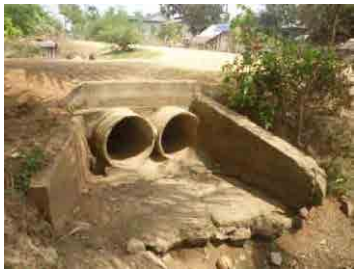
Canal No.: SC-5	Kind of structure: Pipe culvert(E.P.)	Remarks: E.P. of Secondary Canal No.5 with double pipe culvert
Station:	Coordinate< Northing: 1236608 Easting: 447490

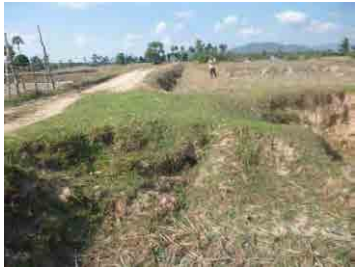
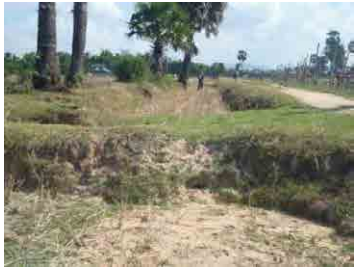
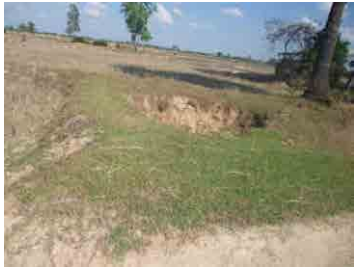
Canal No.: SC-7	Kind of structure: Pipe Culvert	Remarks: B.P. of Secondary Canal No.7 Pipe culvert along canal(D=1m)
Station:	Coordinate< Northing: 1235672 Easting: 446194

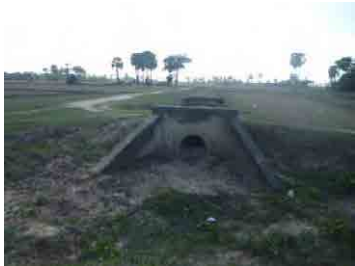
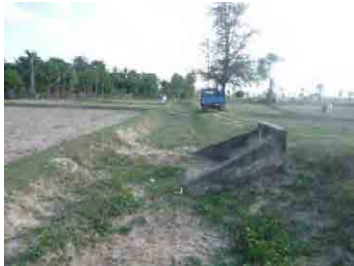
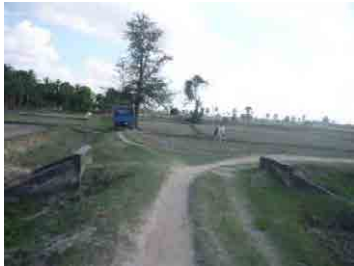
Canal No.: SC-7	Kind of structure: Turnout	Remarks: Pipe culvert (turnout) to the right tertiary canal
Station:	Coordinate< Northing: 1234808 Easting: 446291

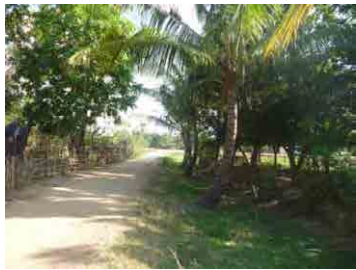
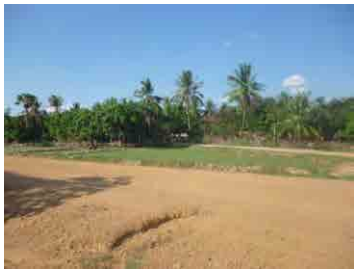
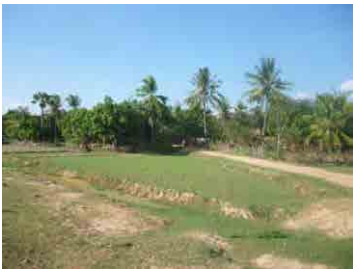
Canal No.: SC-7	Kind of structure: E.P.	Remarks: E.P. of Secondary Canal No.7 without structure
Station:	Coordinate< Northing: 1233979 Easting: 446393

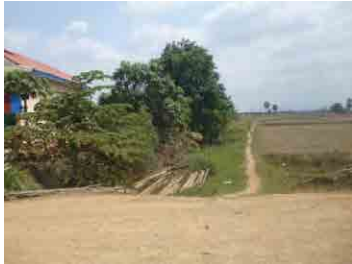
Canal No.: SC-8	Kind of structure: B.P.	Remarks: B.P. of Secondary Canal No.8 without structure
Station:	Coordinate< Northing: 1236105 Easting: 447209

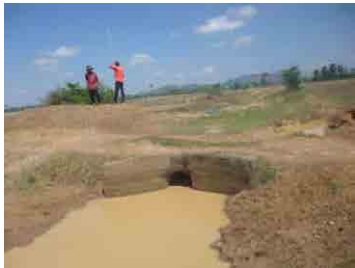
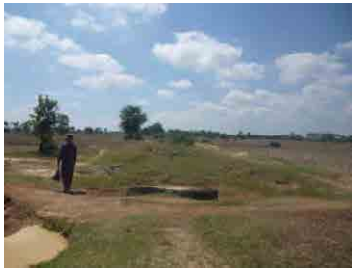
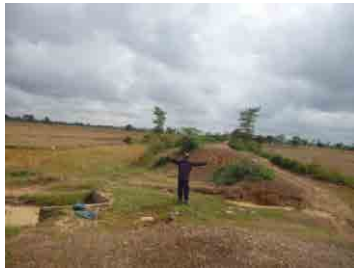
Canal No.: SC-8	Kind of structure: Pipe Culvert	Remarks: E.P. of Secondary Canal No.8
Station:	Coordinate< Northing: 1235272 Easting: 447289

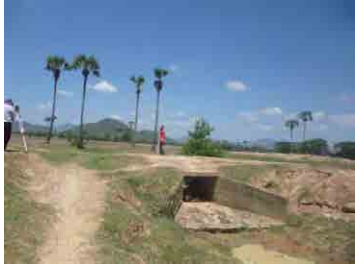
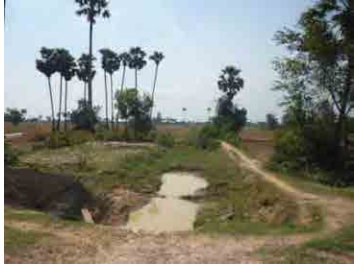
Canal No.: SC-9	Kind of structure: B.P.(Box Culvert)	Remarks: B.P. of Secondary Canal No.9 with box culvert
Station:	Coordinate< Northing: 1235179 Easting: 448338

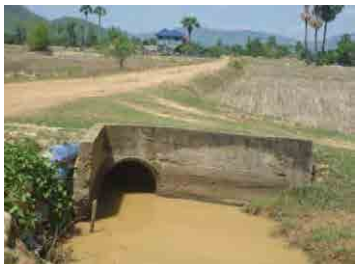
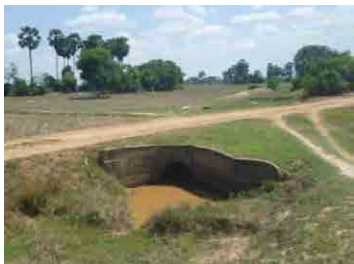
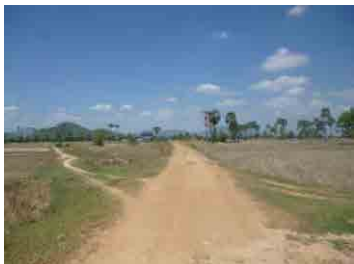
Canal No.: SC-9	Kind of structure: Pipe Culvert	Remarks: Road crossing above pipe culvert
Station:	Coordinate< Northing: 1234537 Easting: 448338

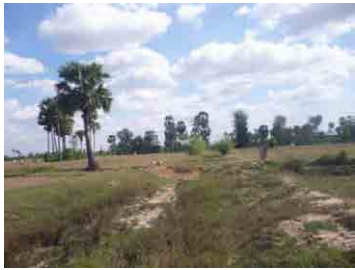
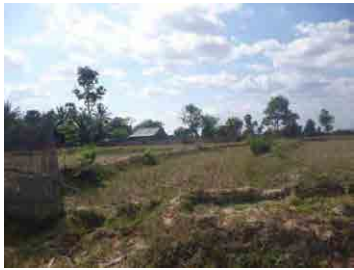
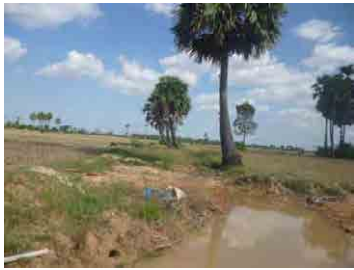
Canal No.: SC-9	Kind of structure: Canal crossing	Remarks: Tertiary canal crossing without structure
Station:	Coordinate< Northing: 1234233 Easting: 448340

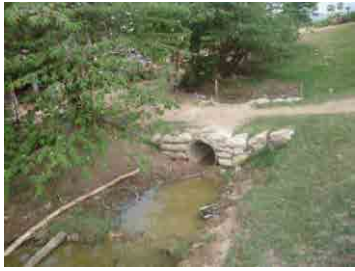
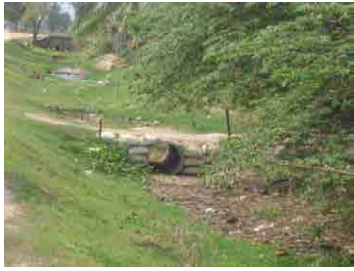
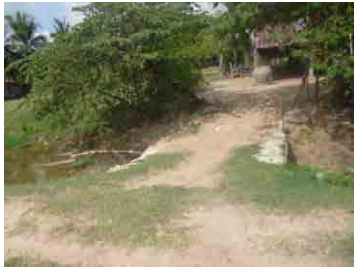
Canal No.: SC-9	Kind of structure: Pipe Culvert	Remarks: Pipe culvert for entrance
Station:	Coordinate< Northing: 12333107 Easting: 448357

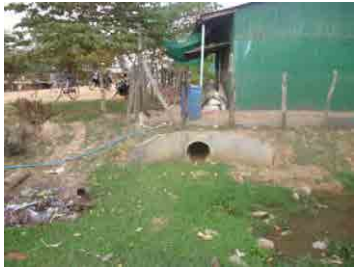
Canal No.: SC-9	Kind of structure: Turnout (Drain Inlet)	Remarks: Canal crossing with both-side pipe culverts.
Station:	Coordinate< Northing: 1233019 Easting: 448357

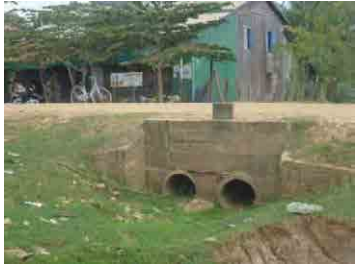
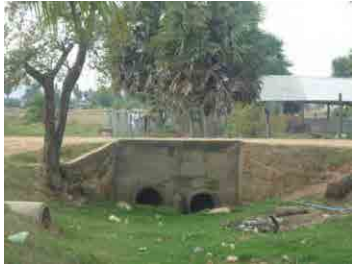
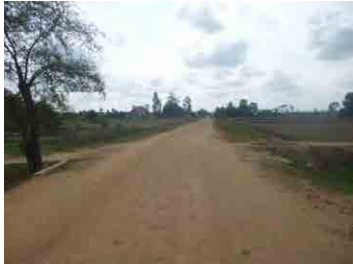
Canal No.: SC-9	Kind of structure: Turnout (Drain Inlet)	Remarks:
Station:	Coordinate< Northing: 1233019 Easting: 448357	E.P. of Secondary Canal No.9 Double pipe culvert under major road

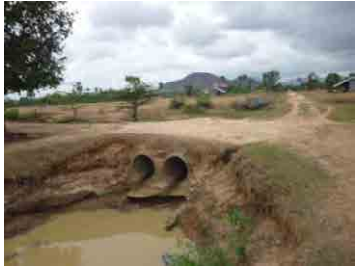
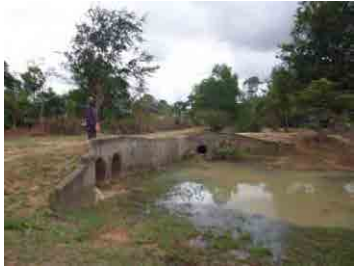
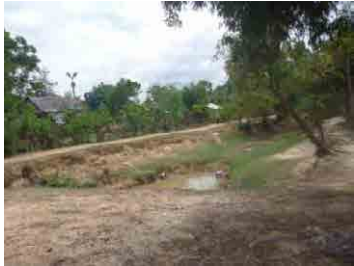
Canal No.: SC-11	Kind of structure: B.P. (Double Pipe Culvert)	Remarks: B.P. of Secondary Canal No.11
Station:	Coordinate< Northing: 1235192 Easting: 449349	Double culvert Turnout from Main Canal 35

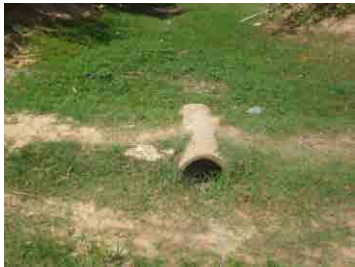
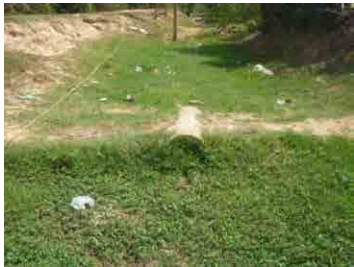
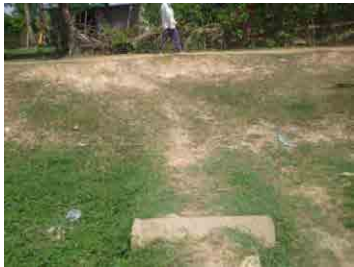
Canal No.: SC-11	Kind of structure: Pipe Culvert	Remarks: Pipe culvert for entrance
Station:	Coordinate< Northing: 1234920 Easting: 449350

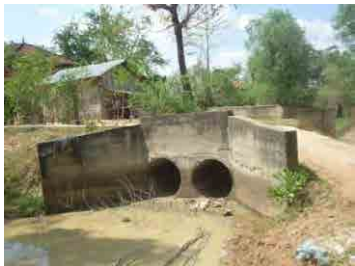
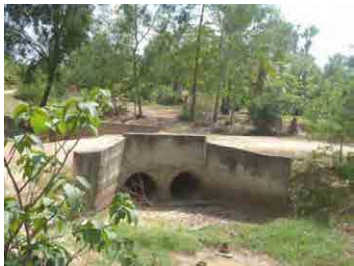
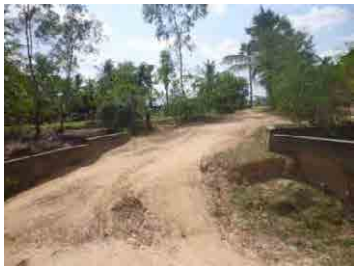
Canal No.: SC-11	Kind of structure: Pipe Culvert (Double)	Remarks: Double pipe culvert under major road
Station:	Coordinate< Northing: 1234747 Easting: 449352

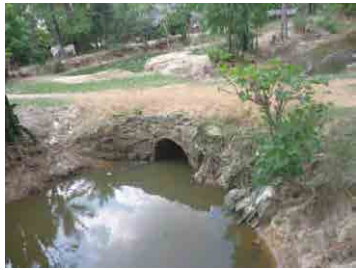
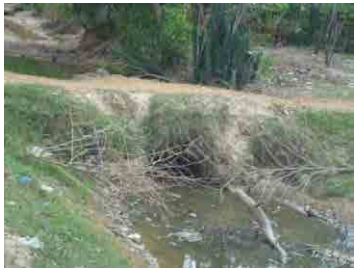
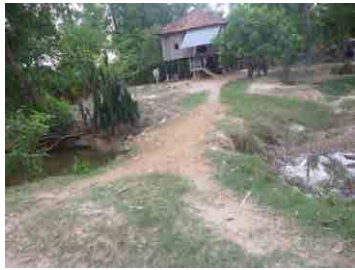
Canal No.: SC-11	Kind of structure: Pipe Culvert	Remarks: Pipe culvert for entrance
Station:	Coordinate< Northing: 1234607 Easting: 449352

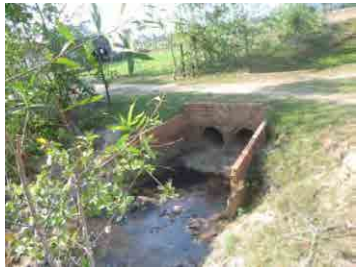
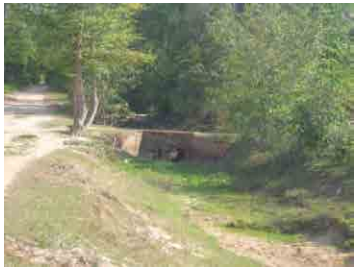
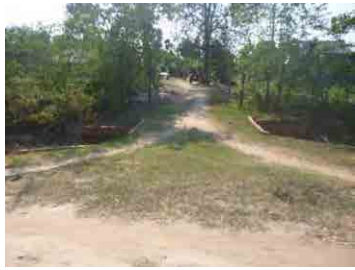
Canal No.: SC-11	Kind of structure: Pipe Culvert	Remarks: Pipe culvert for entrance
Station:	Coordinate< Northing: 1233991 Easting: 449361

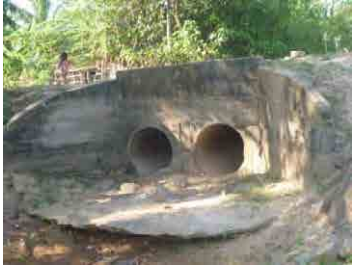
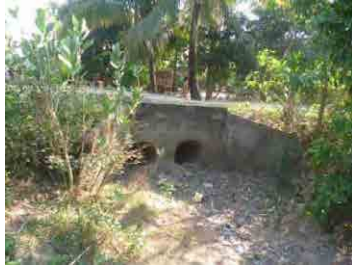
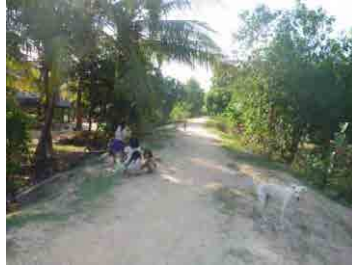
Canal No.: SC-11	Kind of structure: Pipe Culvert (Double)	Remarks:
Station:	Coordinate< Northing: 1233730 Easting: 449370	E.P. of Secondary Canal No.11

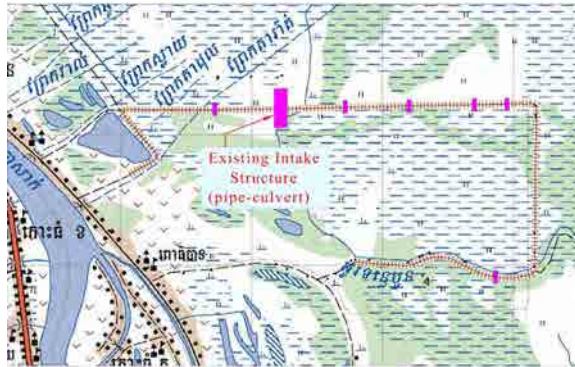
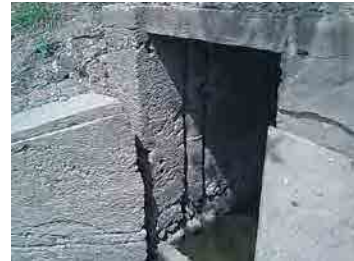
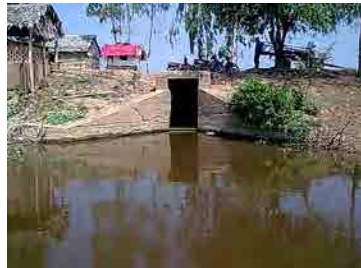
Station No.		Reservoir Name	Srass Pram Bei
Coordinate:	X = 510437	Name of structure(s)	
	Y = 1238385	Intake pipe culvert at the north reservoir embankment	
		Diameter culvert 1.2m (1 row)

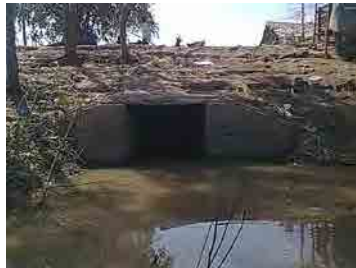
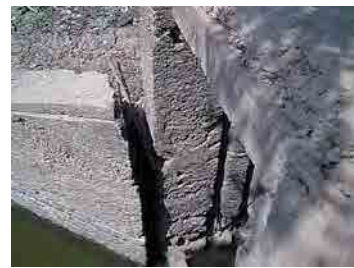
The structure is possible used and constructed in Pol Pot time.

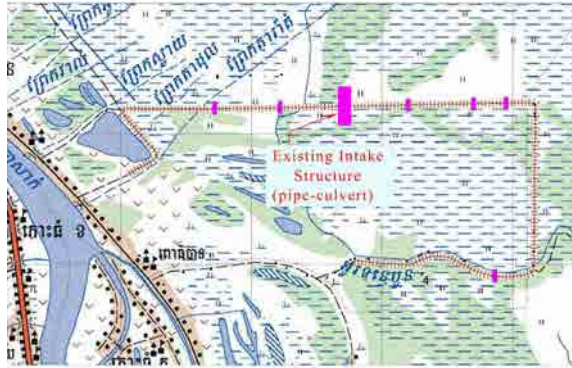
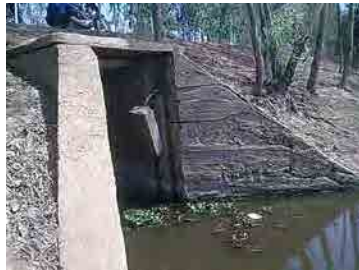
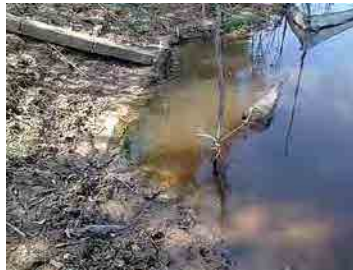
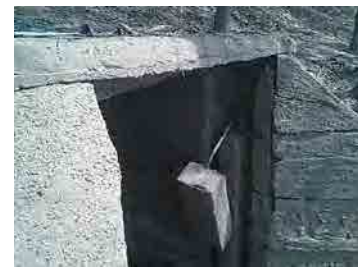
Station No.		Reservoir Name	Srass Pram Bei
Coordinate:	X = 511426	Name of structure(s)	Intake pipe culvert at the north reservoir embankment
	Y = 1238406	Diameter culvert 1.2m (1 row)

The structure is possible used and constructed in Pol Pot time.

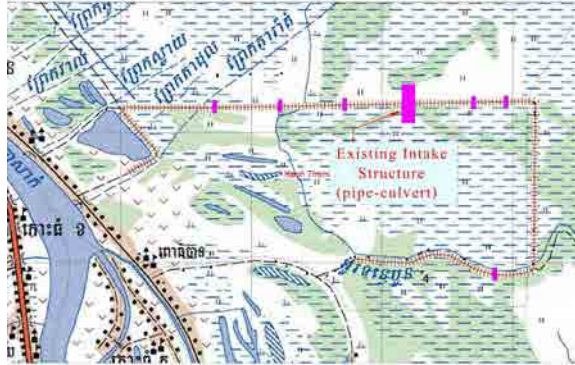
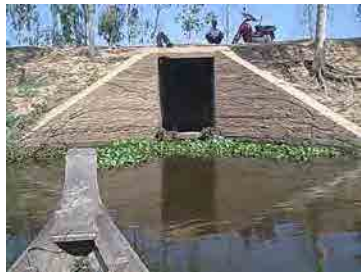
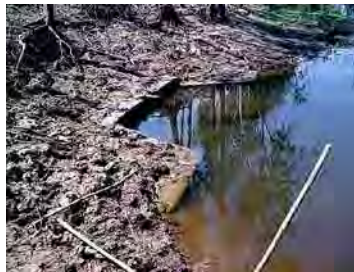
<b>Inventory Survey Form</b>		<b>Date 28.01.2012</b>	<b>No.4</b>
Station No.		Reservoir Name	Srass Pram Bei
Coordinate:	X = 512409	Name of structure(s)	
	Y = 1238426	Intake pipe culvert at the north reservoir embankment	
		Diameter culvert 1.2m (1 row)

The structure is possible used and constructed in Pol Pot time.

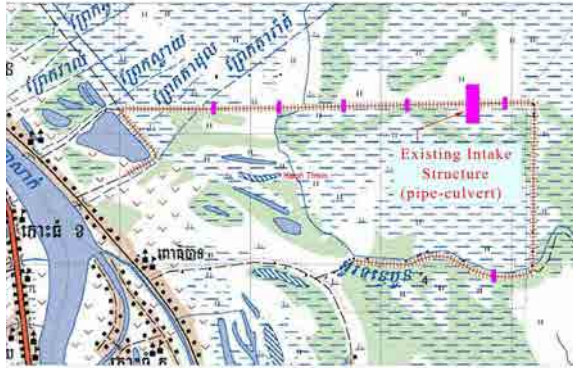
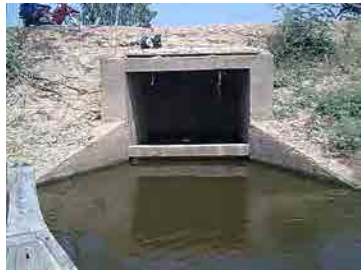
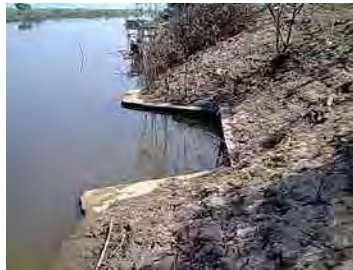
Station No.		Reservoir Name	Srass Pram Bei
Coordinate:	X = 513404	Name of structure(s)	Intake pipe culvert at the north reservoir embankment
	Y = 1238444	Diameter culvert 0.6m (2 rows)

The structure is possible used and constructed in Pol Pot time.

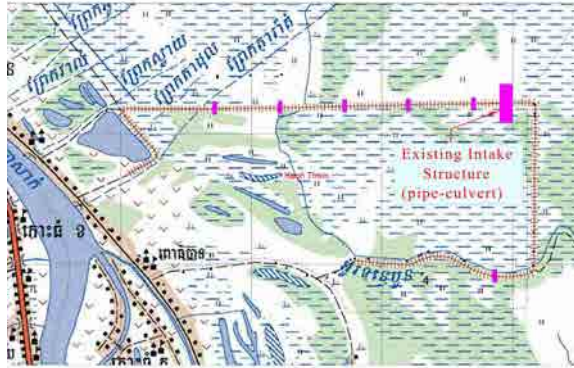
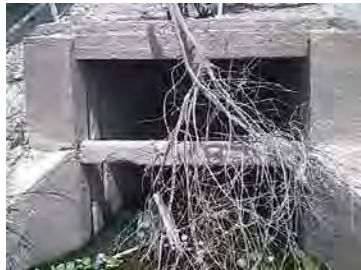
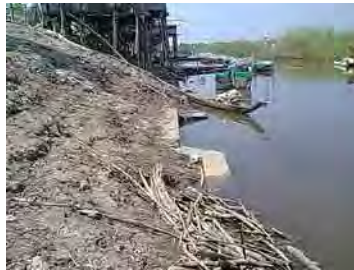
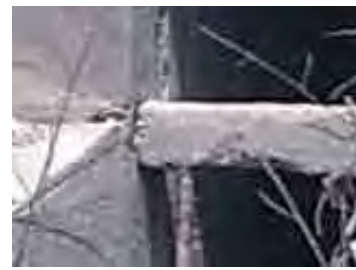
Station No.		Reservoir Name	Srass Pram Bei
Coordinate:	X = 513906	Name of structure(s)	
	Y = 1238453	Intake pipe culvert at the north reservoir embankment	
		Diameter culvert 0.6m (2 rows)

The structure is possible used and constructed in Pol Pot time.

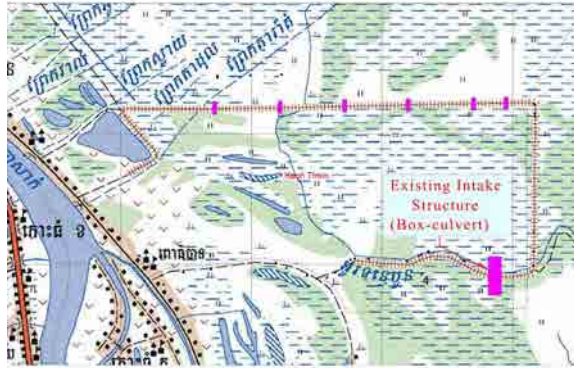
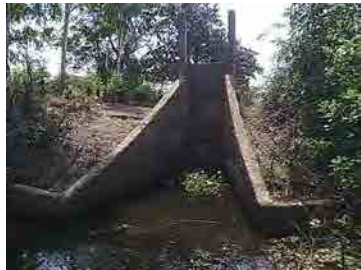
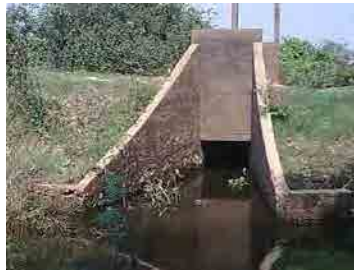
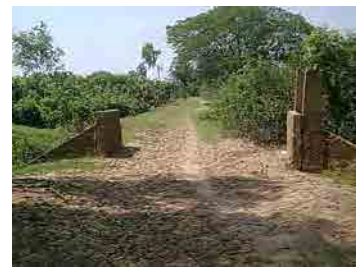
Station No.		Reservoir Name	Srass Pram Bei
Coordinate:	X = 514329	Name of structure(s)	Intake box culvert at the south reservoir embankment
	Y = 1236959	Box width 1m ( row)

The structure is possible used and constructed in Pol Pot time.

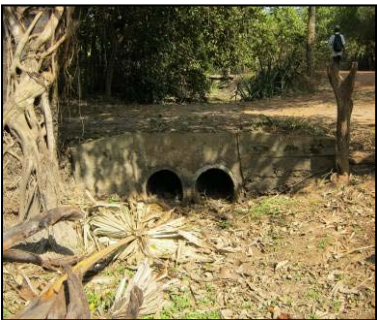
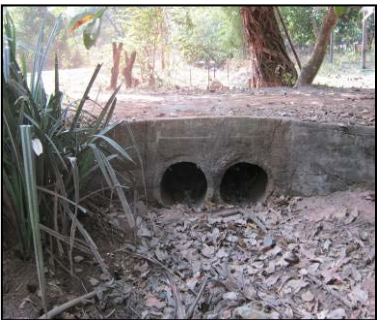
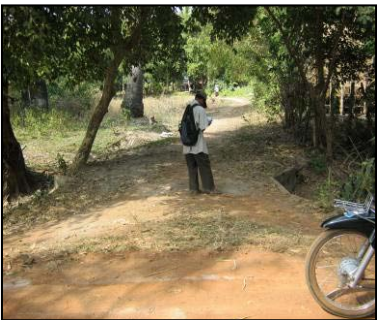
Canal No.: MC	Kind of structure: Pipe Culvert	Remarks: Pipe culvert crossing the canal to Beung Steng Village Dimension: Culvert 0.8m(1row)
Station:	Coordinate< Northing: 1330521 Easting: 441626

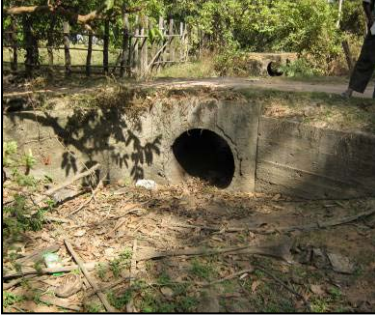
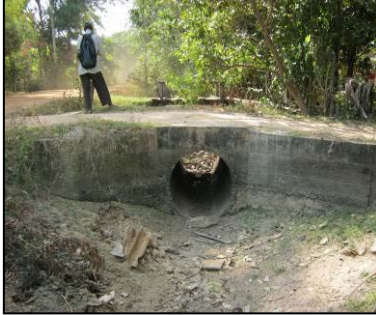
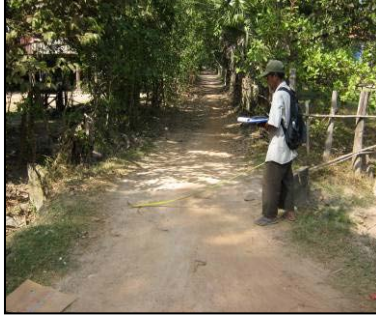
Canal No.: MC	Kind of structure: Pipe Culvert	Remarks: Pipe culvert to Wat village Dimension: Culvert 0.5m (2row)
Station:	Coordinate< Northing: 1330639 Easting: 442198

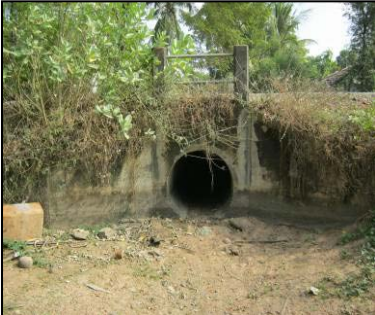
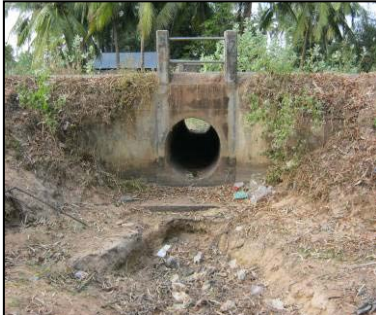
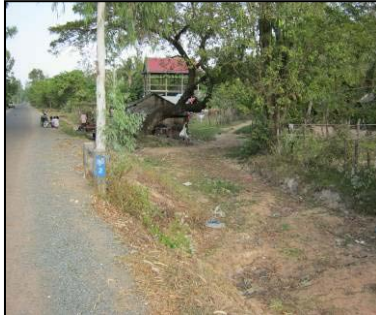
Canal No.: MC	Kind of structure: Pipe Culvert	Remarks: Pipe culvert crossing the canal on the asphalt road. Dimension: Culvert 1m (1row)
Station:	Coordinate< Northing: 1330788 Easting: 442390

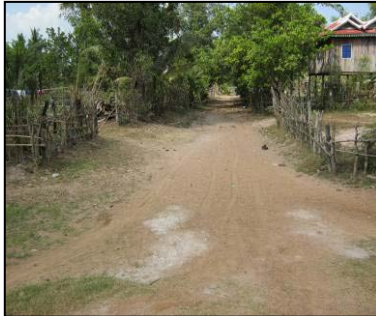
Canal No.: MC	Kind of structure: Road	Remarks: The road crossing the Main canal to Beung Steng Village but without structure.
Station:	Coordinate< Northing: 1330535 Easting: 441720

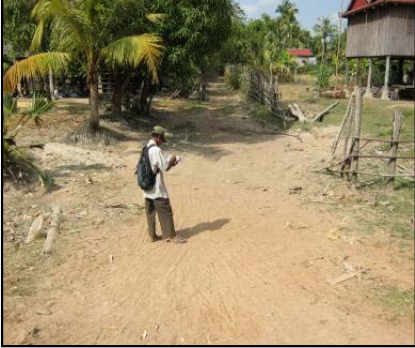
Canal No.: MC	Kind of structure: Road	Remarks: This rood crossing the canal to Wat Village.
Station:	Coordinate< Northing: 1330567 Easting: 441853

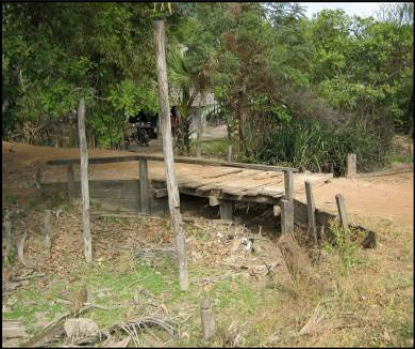
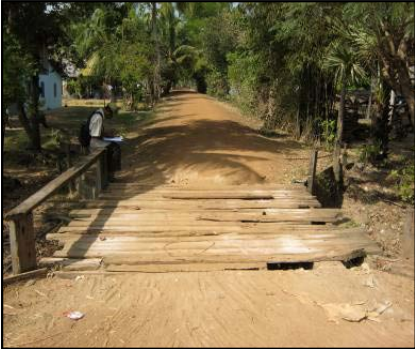
Canal No.: MC	Kind of structure: Wood Bridge	Remarks: Wood bridge crossing the canal to Wat village
Station:	Coordinate< Northing: 1330580 Easting: 441924

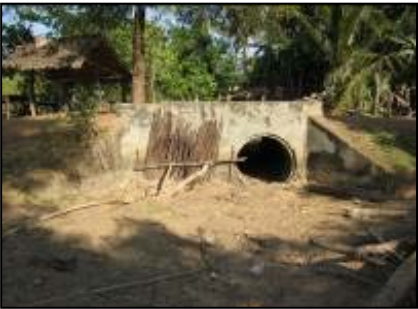
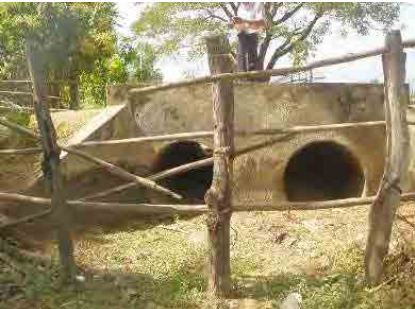
Canal No.: MC	Kind of structure: Pipe Culvert	Remarks: Pipe culvert on the access road crossing Main Canal. Diameter culvert 0,8m x2 (2 rows)
Station:	Coordinate< Northing: 1330833 Easting: 443228

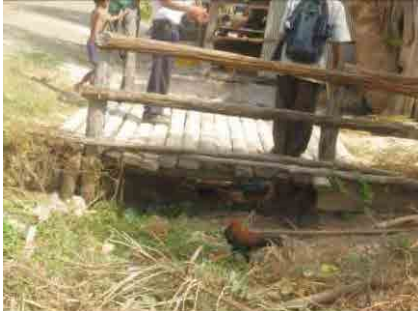
Canal No.: MC	Kind of structure: Wood Bridge	Remarks: Wood bright crossing the Main Canal. Diameter 4m x 6m
Station:	Coordinate< Northing: 1330931 Easting: 443931

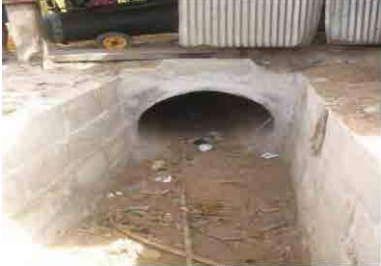
Canal No.: MC	Kind of structure: Pipe culvert	Remarks: Pipe culvert crossing the Main Canal. Diameter culvert 0,7m
Station:	Coordinate< Northing: 1330959 Easting: 444124

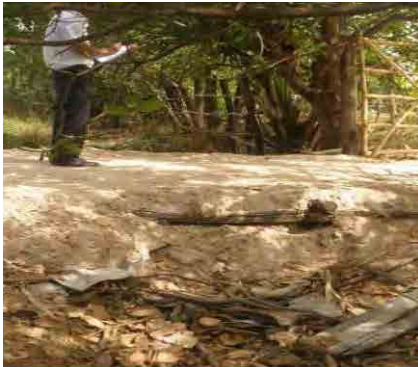
Canal No.: MC	Kind of structure: Wood Bridge	Remarks: Wood bright put the soil of the crossing the Main Canal. Diameter 6m x 4m
Station:	Coordinate< Northing: 1330966 Easting: 444188

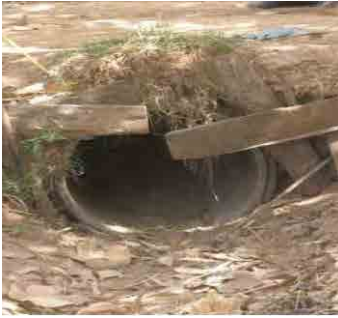
Canal No.: MC	Kind of structure: Pipe culvert	Remarks: Pipe Culvert crossing the Main Canal. Diameter Culvert 0.5m
Station:	Coordinate< Northing: 1330966 Easting: 444188

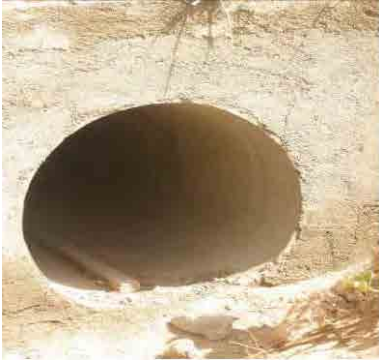
Canal No.: MC	Kind of structure: Pipe culvert	Remarks: Pipe culvert crossing the Main Canal. Diameter culvert 0.8m
Station:	Coordinate< Northing: 1330991 Easting: 444400

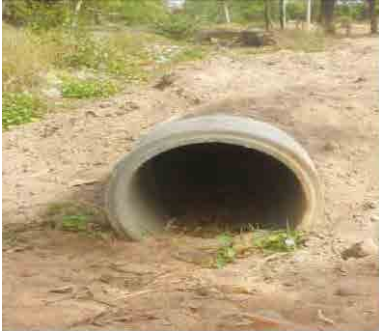
Canal No.: MC	Kind of structure: Pipe culvert	Remarks: Pipe culvert crossing the Main Canal. Diameter culvert 0.6m
Station:	Coordinate< Northing: 1330997 Easting: 444451

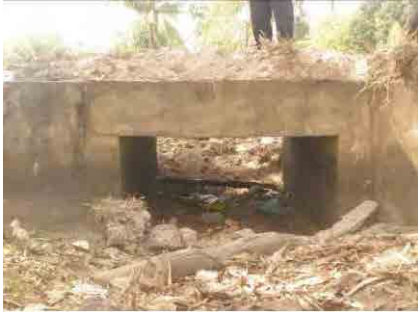
Canal No.: MC	Kind of structure: Box- culvert	Remarks: Box- culvert crossing the Main Canal. Diameter box-covert 1.5m x 0.8m
Station:	Coordinate< Northing: 1331003 Easting: 444483

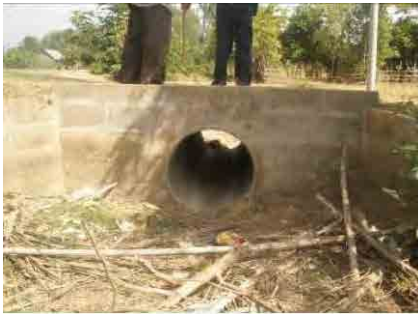
Canal No.: MC	Kind of structure: Pipe culvert	Remarks: Pipe culvert crossing the Main Canal. Diameter culvert 0.6m
Station:	Coordinate< Northing: 1331015 Easting: 444600

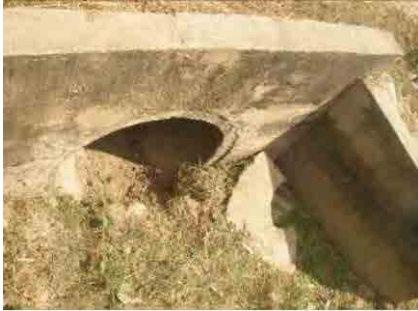
Canal No.: MC	Kind of structure: Pipe culvert	Remarks: Pipe culvert crossing the Main Canal. Diameter culvert 0.6m
Station:	Coordinate< Northing: 1331024 Easting: 444671

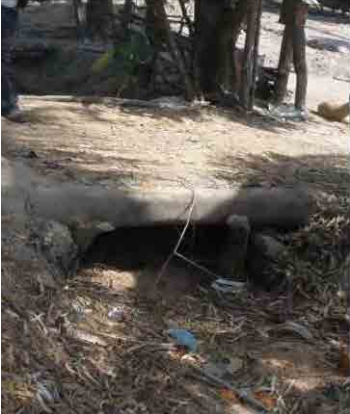
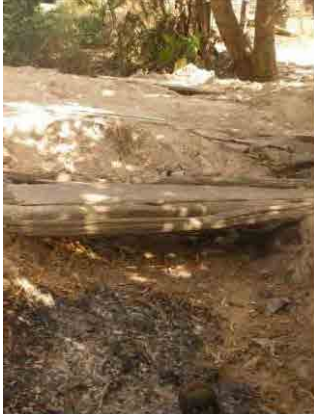
Canal No.: MC	Kind of structure: Wood Bridge	Remarks: Wood bright crossing the Main Canal. Diameter 5m x 3m
Station:	Coordinate< Northing: 1331043 Easting: 444808	
<div style="display: flex; justify-content: space-around;"> <div style="text-align: center;">

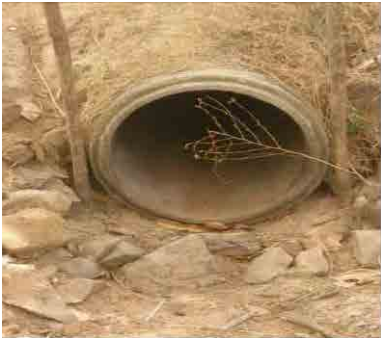
Canal No.: MC	Kind of structure: Pipe culvert	Remarks: Pipe culvert crossing the Main Canal. Diameter culvert 0.5m
Station:	Coordinate< Northing: 1331043 Easting: 444831

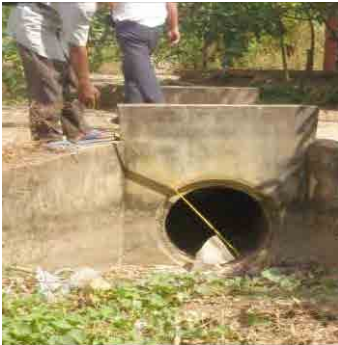
Canal No.: MC	Kind of structure: Pipe culvert	Remarks: Pipe culvert crossing the Main Canal. Diameter culvert 0.5 m
Station:	Coordinate< <div style="display: flex; flex-direction: column; gap: 5px;"> <span>Northing: 1331047</span> <span>Easting: 444880</span> </div>

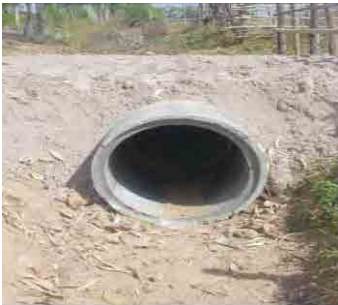
Canal No.: MC	Kind of structure: Pipe culvert	Remarks: Pipe culvert crossing the Main Canal. Diameter culvert 0.6m
Station:	Coordinate< <div style="display: flex; flex-direction: column; gap: 5px;"> <span>Northing: 1331053</span> <span>Easting: 444931</span> </div>

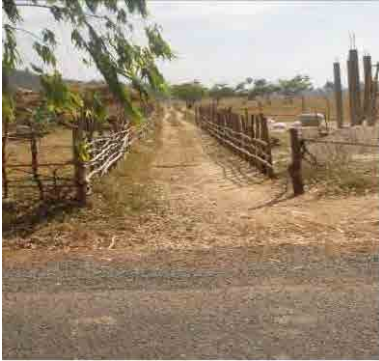
Canal No.: MC	Kind of structure: Secondary canal-7	Remarks: Secondary canal-7 crossing the Main Canal. Diameter b=2.0 m
Station:	Coordinate< Northing: 1331055 Easting: 444937

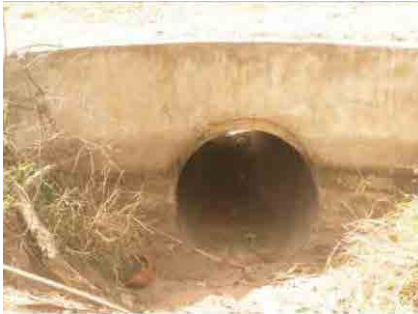
Canal No.: MC	Kind of structure: Pipe culvert	Remarks: Pipe culvert crossing the Main Canal. Diameter culvert 0.7m
Station:	Coordinate< Northing: 1331058 Easting: 444954
