# ***ANNEX D***

## ***Attachment – 1***

*Results of Inventory Survey for  
Proposed Rehabilitation Works in  
Roleang Chrey Headworks Rehabilitation Sub-project*

**Results of Inventory Survey for Proposed Rehabilitation Works on North Main Canal (1/12)**

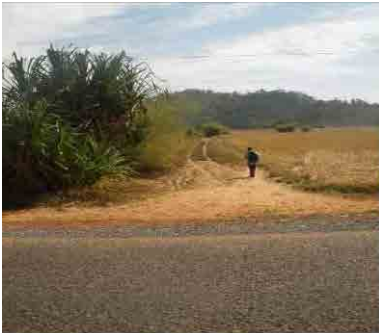
Canal No.: MC	Kind of structure: Secondary canal-6	Remarks: Secondary Canal-6 crossing the Main Canal. Diameter b=1.5m
Station:	Coordinate< Northing: 1330966 Easting: 444188

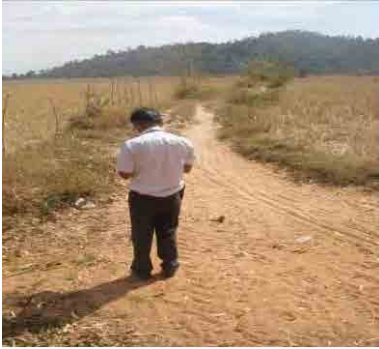
Canal No.: MC	Kind of structure: Road cow	Remarks: Road cow crossing the Main Canal. Diameter b=4 m
Station:	Coordinate< Northing: 1331161 Easting: 445834

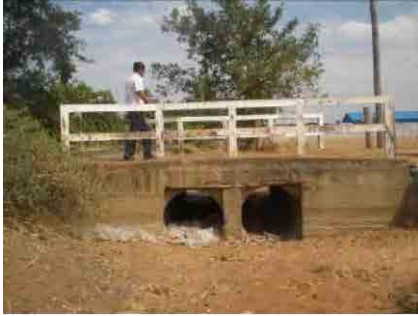
Canal No.: MC	Kind of structure: Pipe culvert	Remarks: Pipe culvert crossing the Main Canal. Diameter culvert 0.9m x 2 (2row)
Station:	Coordinate< Northing: 1331301 Easting: 446998

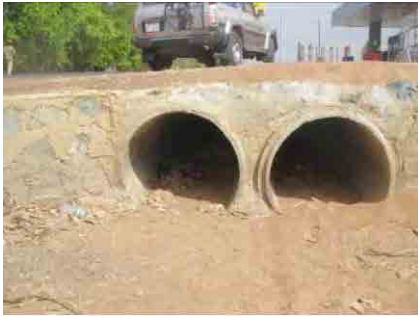
Canal No.: MC	Kind of structure: Pipe culvert	Remarks: Pipe culvert crossing the Main Canal. Diameter culvert 0.8m x 2 (2row)
Station:	Coordinate< Northing: 1331313 Easting: 447106

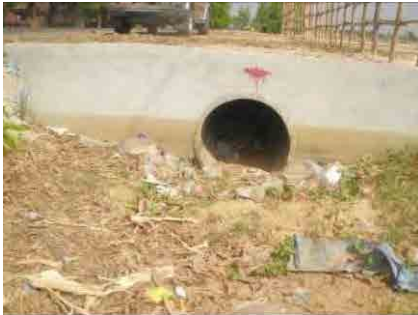
Canal No.: MC	Kind of structure: Pipe culvert	Remarks: Pipe culvert crossing the Main Canal. Diameter culvert 0.8 m
Station:	Coordinate< Northing: 1331339 Easting: 447310

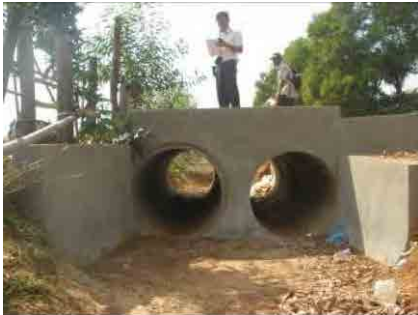
Canal No.: MC	Kind of structure: Pipe culvert	Remarks: Pipe culvert crossing the Main Canal. Diameter culvert 0.8m x 2 (2row)
Station:	Coordinate< <div style="display: flex; flex-direction: column; gap: 5px;"> <span>Northing: 1331344</span> <span>Easting: 447377</span> </div>

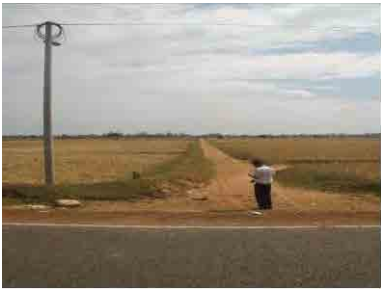
Canal No.: MC	Kind of structure: Secondary canal-3	Remarks: Secondary canal-3 crossing the Main Canal. Diameter b=2.5 m
Station:	Coordinate< <div style="display: flex; flex-direction: column; gap: 5px;"> <span>Northing: 1331360</span> <span>Easting: 447509</span> </div>

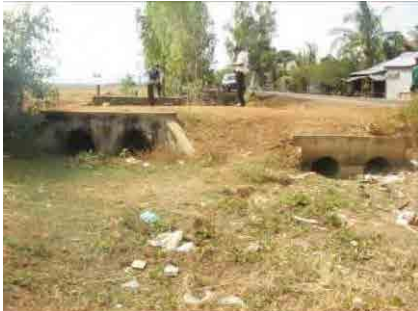
Canal No.: MC	Kind of structure: Pipe culvert	Remarks: Pipe culvert crossing the Main Canal. Diameter culvert 0.8m x 2 (2row)
Station:	Coordinate< <div style="display: flex; flex-direction: column; gap: 5px;"> <span>Northing: 1331388</span> <span>Easting: 447767</span> </div>

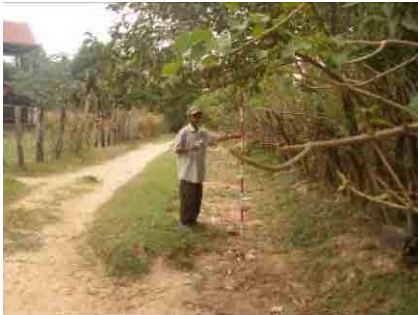
Canal No.: MC	Kind of structure: Secondary canal-2	Remarks: Secondary canal-2 crossing the Main Canal. Diameter b=2 m
Station:	Coordinate< Northing: 1330494 Easting: 442836

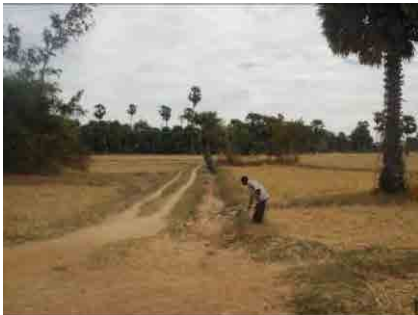
Canal No.: MC	Kind of structure: Secondary canal-1	Remarks: Secondary canal -1crossing the Main Canal. Diameter b=1 m
Station:	Coordinate< Northing: 1329755 Easting: 441228

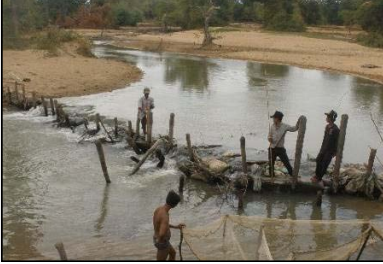
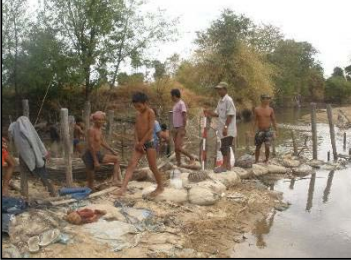
Canal No.: MC	Kind of structure: Secondary canal-1	Remarks: By people check crossing Daun Pue Strea
Station:	Coordinate< Northing: 1329755 Easting: 441228
