スリランカ国  
全国重要橋梁実態及び  
維持管理に係る情報収集・確認調査

ファイナル レポート（付属資料）

### 3.1 架け替え選定対象橋梁 79 橋の橋梁台帳 (現地調査結果)

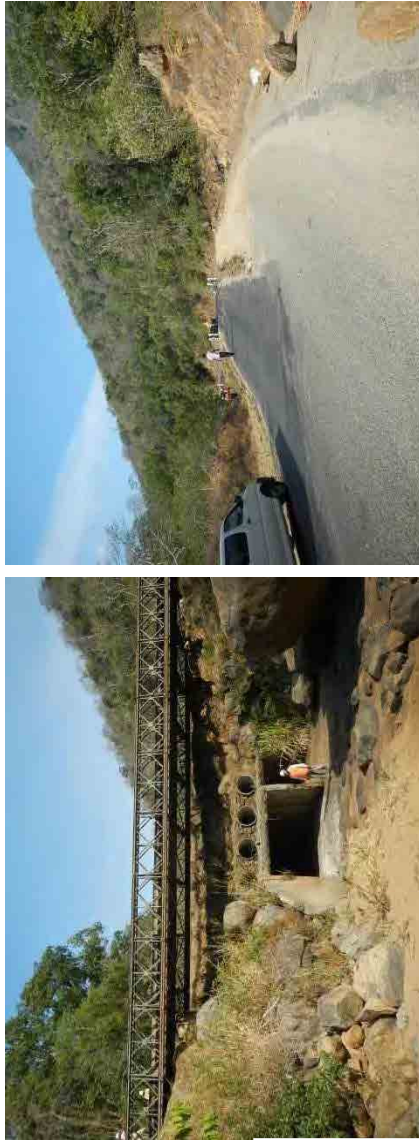
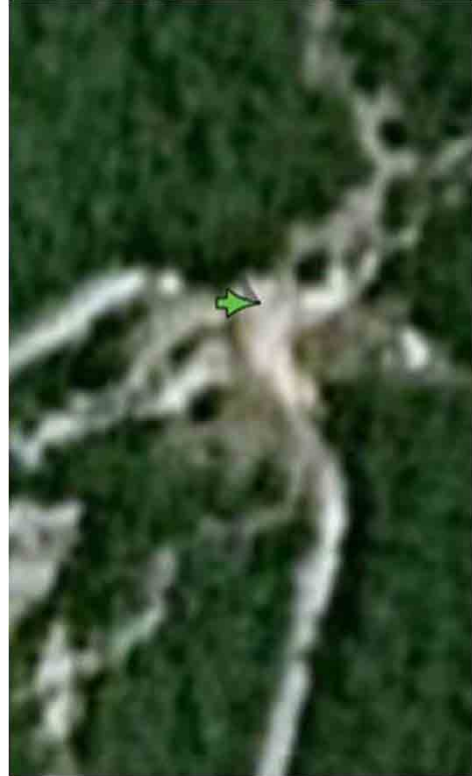
A 1-lane temporary bridge over the damaged embankment/ pipes and box culverts

- Superstructure Good RATE 1

- Substructure Good RATE 1

**Reconstruction is not recommended.**

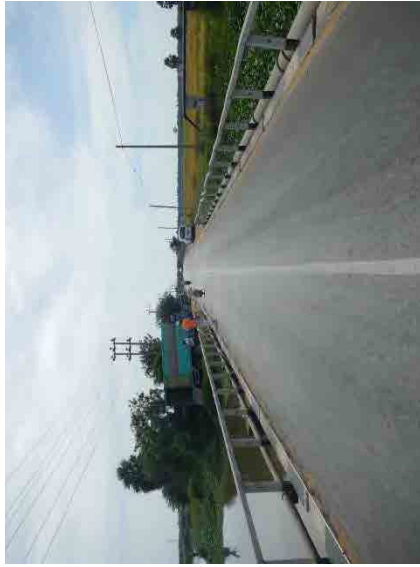
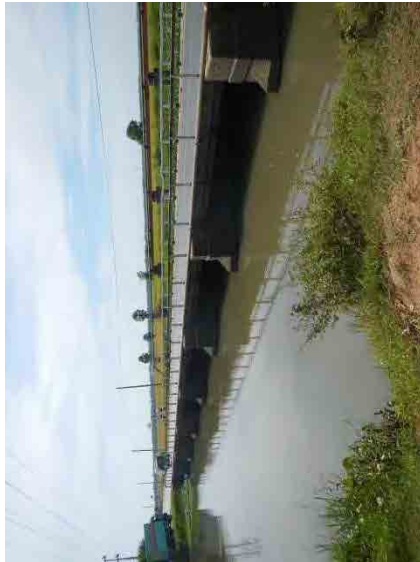
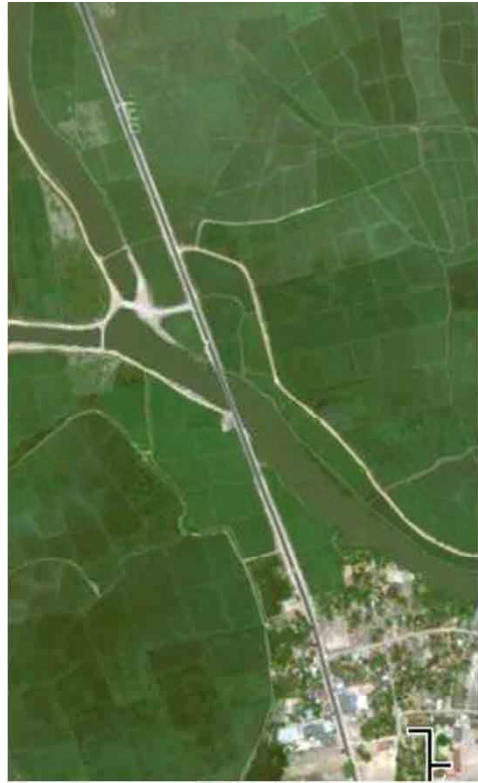
[BRIDGE ]  
 Curb-to-Curb of 5.30m wide is insufficient for 2-lane traffic of Class A Road.  
 Skewed bridge of 60 degree  
 Insufficient bridge elevation and opening for floods  
 [ SOUNDNESS ]\*\*  
 - Superstructure Good RATE 1  
 - Substructure Good RATE 1

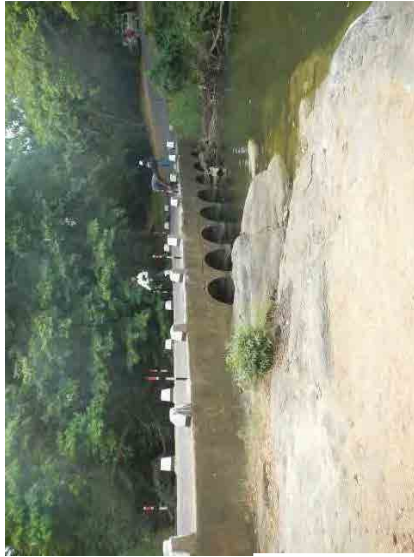
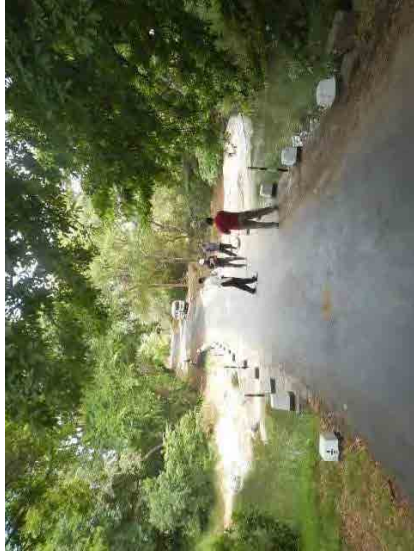
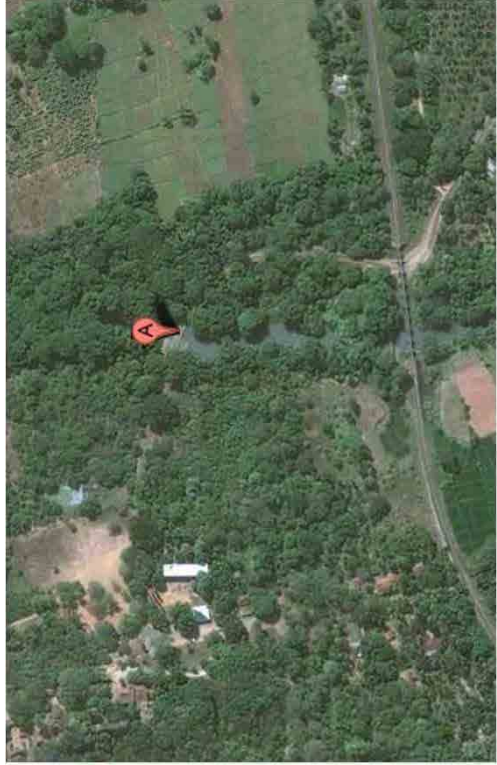
Narrow for 2-lane traffic  
Insufficient causeway elevation for floods  
[ SOUNDNESS ]\*\*  
- Superstructure Fair RATE 2

**Reconstruction is not recommended.**

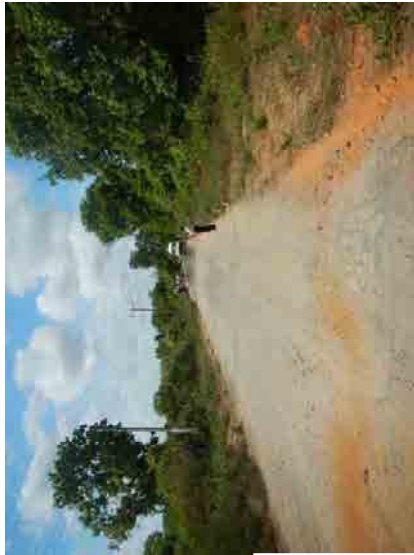
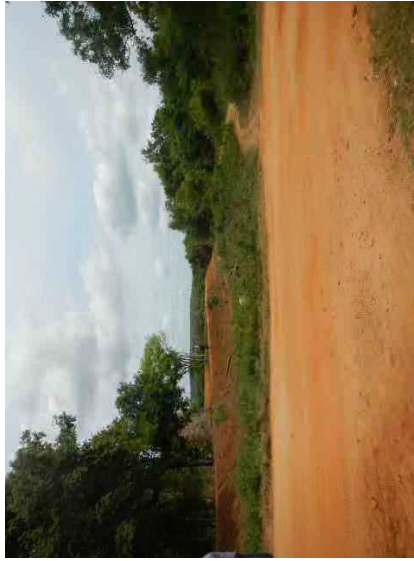
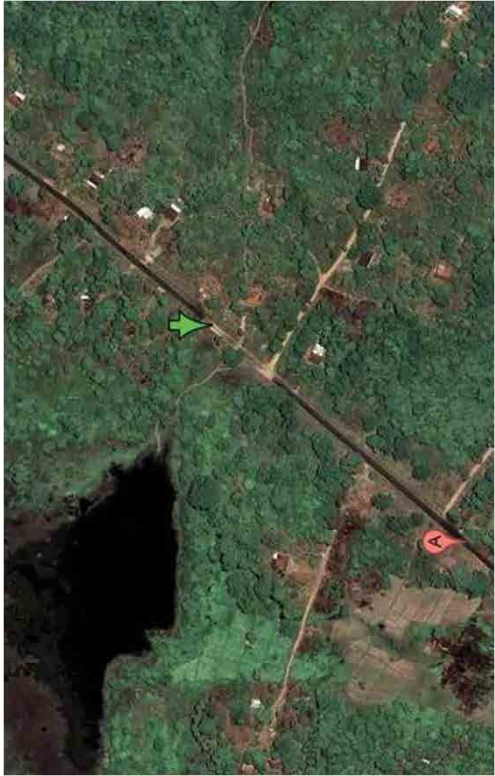
[BRIDGE ]  
 Narrow for 2-lane traffic  
 Insufficient causeway elevation for floods  
 [ SOUNDNESS ]\*\*  
 - Superstructure RATE  
 - Substructure RATE  
 - Others

< PROPOSAL >  
**New bridge more than 30m long is not recommended.**

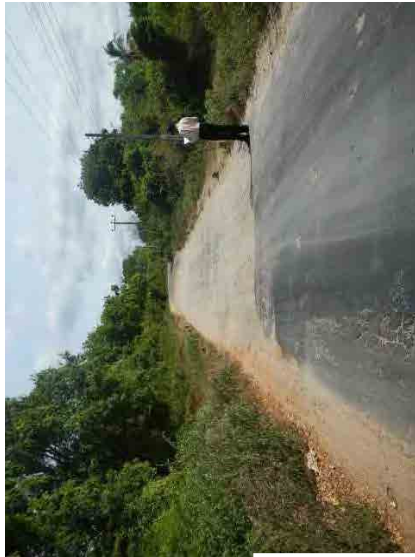
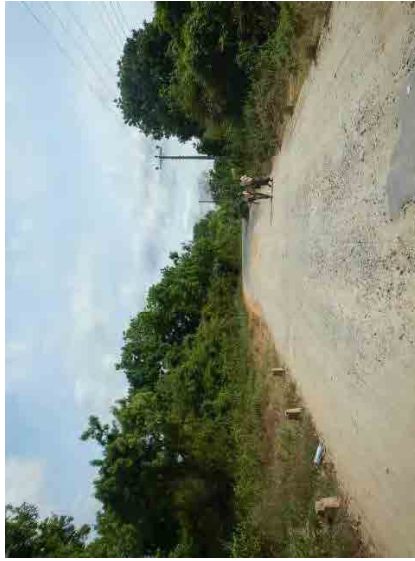
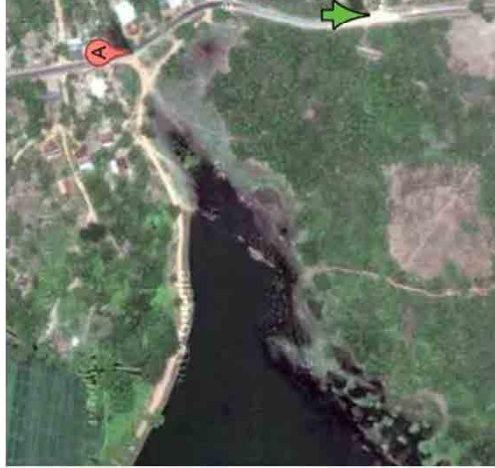
[BRIDGE ]  
Narrow for 2-lane traffic  
Insufficient causeway elevation for floods  
[ SOUNDNESS ]\*\*  
- Superstructure RATE

< PROPOSAL >  
New bridge more than 30m long is not recommended.

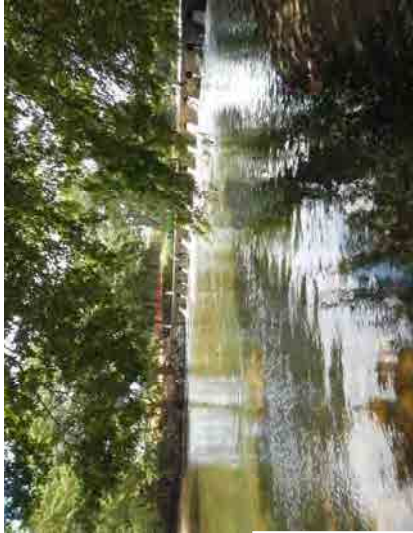
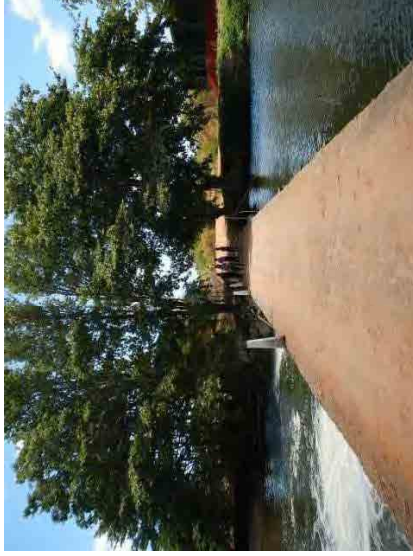
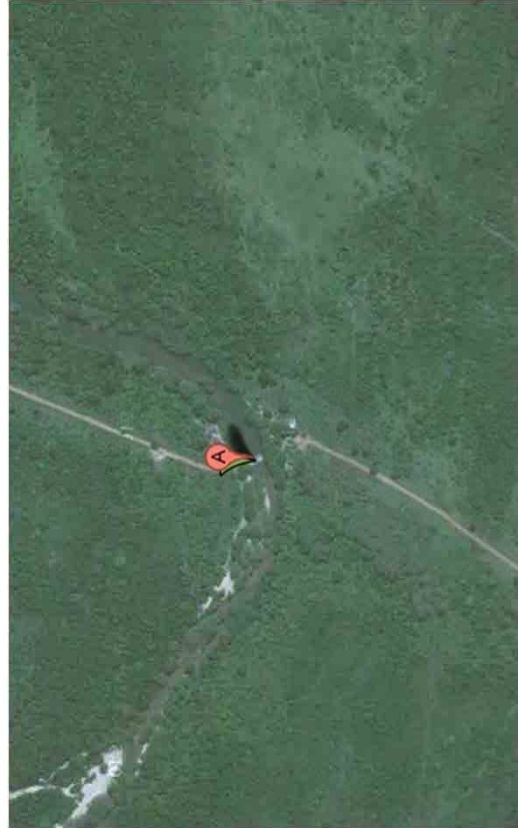
[BRIDGE ]  
Narrow for 2-lane traffic

**Reconstruction is not recommended because of Environmental problem.**
