国際協力機構（JICA）

スリランカ国  
災害脆弱地域における道路防災事業情報収集調査

ファイナルレポート（2/2）  
巻末資料

2012年12月

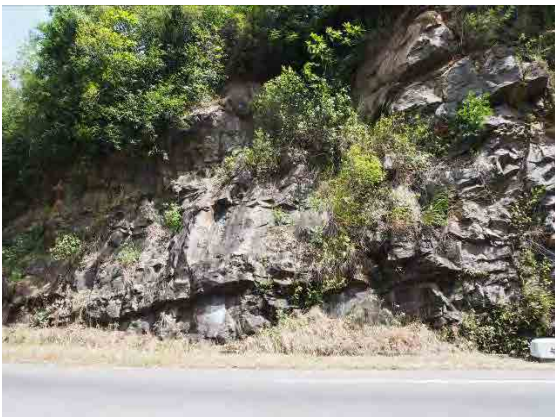
Possible disaster	<input checked="" type="checkbox"/> rock fall <input type="checkbox"/> collapse <input checked="" type="checkbox"/> rock mass failure <input type="checkbox"/> slide <input type="checkbox"/> nothing <input type="checkbox"/> other( )			20
Landslide surface anomalies	<input type="checkbox"/> large and new cracks <input type="checkbox"/> small and old cracks <input type="checkbox"/> slight deformation <input type="checkbox"/> no anomalies			
Environmental issue	<input type="checkbox"/> exist <input checked="" type="checkbox"/> no exist			1
Installed countermeasure	<input checked="" type="checkbox"/> No countermeasure/ no effect <input type="checkbox"/> Some effect <input type="checkbox"/> High effect <input type="checkbox"/> Completely effect			0
maintenance entity in the vicinity	RDA Ratnapura District, Pelmadulla EE Division,			sum Total (A)
Slope situation (photograph)	Situation photograph

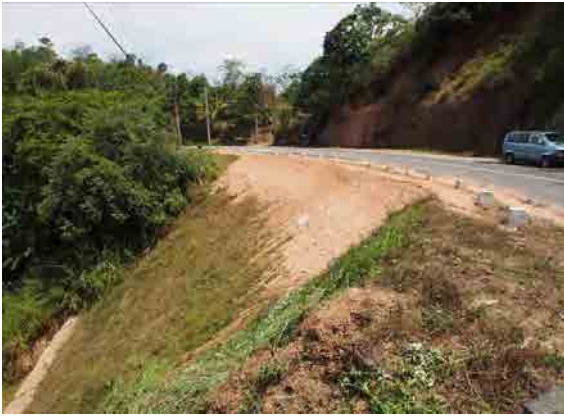
Possible disaster	<input type="checkbox"/> rock fall <input checked="" type="checkbox"/> collapse <input type="checkbox"/> rock mass failure <input type="checkbox"/> slide <input type="checkbox"/> nothing <input type="checkbox"/> other( )			15
Landslide surface anomalies	<input type="checkbox"/> large and new cracks <input type="checkbox"/> small and old cracks <input type="checkbox"/> slight deformation <input type="checkbox"/> no anomalies			
Environmental issue	<input type="checkbox"/> exist <input checked="" type="checkbox"/> no exist			1
Installed countermeasure	<input type="checkbox"/> No countermeasure/ no effect <input checked="" type="checkbox"/> Some effect <input type="checkbox"/> High effect <input type="checkbox"/> Completely effect			-10
maintenance entity in the vicinity	RDA Ratnapura District, Pelmadulla EE Division,			sum Total (A)
Slope situation (photograph)	Situation photograph			50

Reduced scale( 1 : )
Comment concerning slope situation	<p>Recorded Disaster : Damage on the pavement such as cracks and subsidence.</p> <p>Failure Type: Slope failure in the embankment slope, (possible) landslides involving the foundation of the embankment.,</p> <p>Geological Condition: Highly Weathered Gneiss, embankment material, (possibly) colluvium or valley deposit at the foundation of the embankment,</p> <p>Trigger of Failure: (Supposed) Raise in ground water, changes in the weight balance for the possible landslide,</p> <p>Featured Points: It is not yet clear whether there is landslide at the foundation of the embankment. Thus further investigation and monitoring are required.</p> <p>According to unconfirmed information, there were some movements at the lower slope under the gabion wall.</p> <p>The landform of the valley where the embankment sits on implies existence of small landslides. If the embankment was put on the head of the possible landslides, the landslide shall start its movement. There lacks however obvious information which supports the movement or existence of the landslide.</p> <p>Supposed countermeasures: For slope failure in embankment, gentler gradient of slope or reinforcement by sorts of geotextile. For landslide, further investigation is required</p>

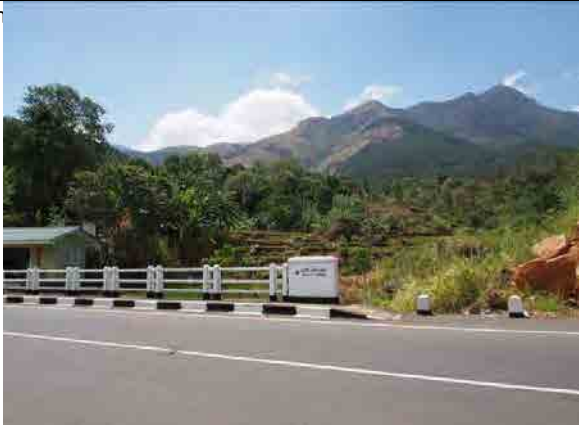
Possible disaster	<input type="checkbox"/> rock fall <input type="checkbox"/> collapse <input type="checkbox"/> rock mass failure <input type="checkbox"/> slide <input type="checkbox"/> nothing <input checked="" type="checkbox"/> other(Debris flow)			5
Landslide surface anomalies	<input type="checkbox"/> large and new cracks <input type="checkbox"/> small and old cracks <input type="checkbox"/> slight deformation <input type="checkbox"/> no anomalies			
Environmental issue	<input type="checkbox"/> exist <input checked="" type="checkbox"/> no exist			1
Installed countermeasure	<input checked="" type="checkbox"/> No countermeasure/ no effect <input type="checkbox"/> Some effect <input type="checkbox"/> High effect <input type="checkbox"/> Completely effect			0
maintenance entity in the vicinity	RDA Ratnapura District, Pelmadulla EE Division,			sum Total (A)
Slope situation (photograph)	Situation photograph			25

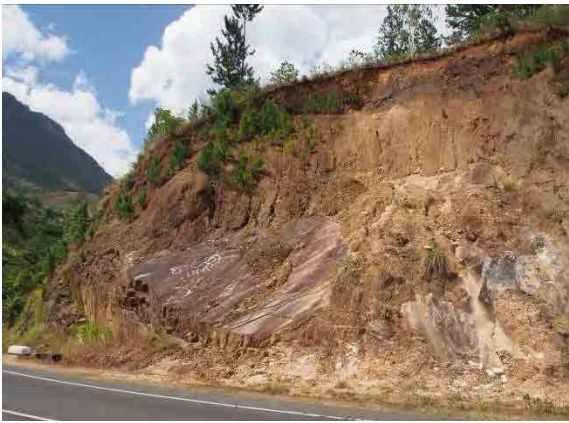
Possible disaster	<input type="checkbox"/> rock fall <input checked="" type="checkbox"/> collapse <input type="checkbox"/> rock mass failure <input type="checkbox"/> slide <input type="checkbox"/> nothing <input type="checkbox"/> other(    )			15
Landslide surface anomalies	<input type="checkbox"/> large and new cracks <input type="checkbox"/> small and old cracks <input type="checkbox"/> slight deformation <input type="checkbox"/> no anomalies			
Environmental issue	<input type="checkbox"/> exist <input checked="" type="checkbox"/> no exist			1
Installed countermeasure	<input checked="" type="checkbox"/> No countermeasure/ no effect <input type="checkbox"/> Some effect <input type="checkbox"/> High effect <input type="checkbox"/> Completely effect			0
maintenance entity in the vicinity	RDA Badulla District, Bandarawela EE Division,			sum Total (A)
Slope situation (photograph)	Situation photograph			110

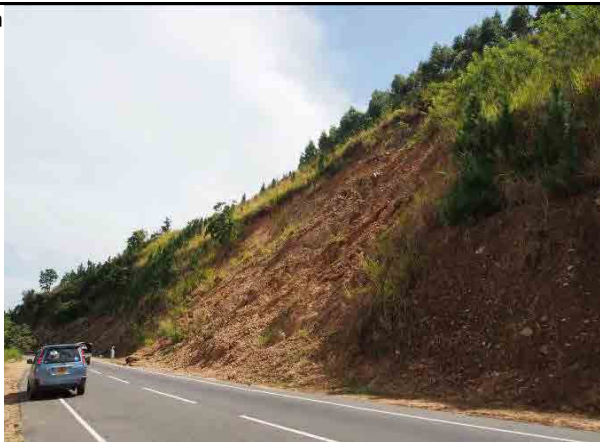
Possible disaster	<input type="checkbox"/> rock fall <input checked="" type="checkbox"/> collapse <input type="checkbox"/> rock mass failure <input type="checkbox"/> slide <input type="checkbox"/> nothing <input type="checkbox"/> other( )			15
Landslide surface anomalies	<input type="checkbox"/> large and new cracks <input type="checkbox"/> small and old cracks <input type="checkbox"/> slight deformation <input type="checkbox"/> no anomalies			
Environmental issue	<input type="checkbox"/> exist <input checked="" type="checkbox"/> no exist			1
Installed countermeasure	<input checked="" type="checkbox"/> No countermeasure/ no effect <input type="checkbox"/> Some effect <input type="checkbox"/> High effect <input type="checkbox"/> Completely effect			0
maintenance entity in the vicinity	RDA Badulla District, Bandarawela EE Division,			sum Total (A)
Slope situation (photograph)	Situation photograph			123

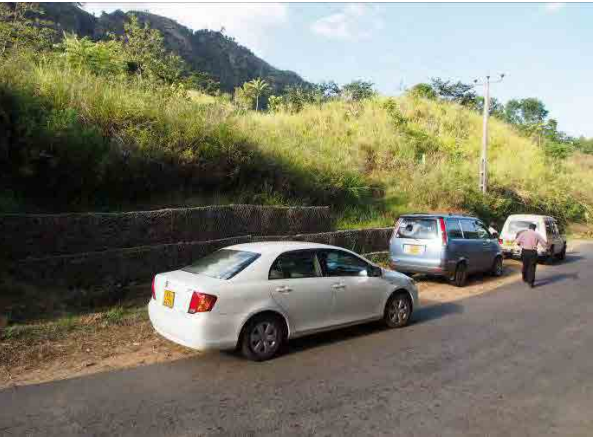
Possible disaster	<input type="checkbox"/> rock fall <input type="checkbox"/> collapse <input type="checkbox"/> rock mass failure <input checked="" type="checkbox"/> slide <input type="checkbox"/> nothing <input type="checkbox"/> other( )			10
Landslide surface anomalies	<input type="checkbox"/> large and new cracks <input type="checkbox"/> small and old cracks <input type="checkbox"/> slight deformation <input checked="" type="checkbox"/> no anomalies			-20
Environmental issue	<input type="checkbox"/> exist <input checked="" type="checkbox"/> no exist			1
Installed countermeasure	<input type="checkbox"/> No countermeasure/ no effect <input checked="" type="checkbox"/> Some effect <input type="checkbox"/> High effect <input type="checkbox"/> Completely effect			-10
maintenance entity in the vicinity	RDA Badulla District, Bandarawela EE Division,			sum Total (A)
Slope situation (photograph)	Situation photograph			10

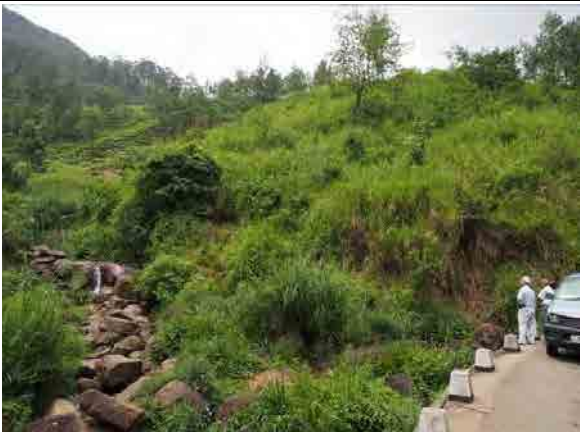
Possible disaster	<input type="checkbox"/> rock fall <input type="checkbox"/> collapse <input type="checkbox"/> rock mass failure <input checked="" type="checkbox"/> slide <input type="checkbox"/> nothing <input type="checkbox"/> other( )			10
Landslide surface anomalies	<input checked="" type="checkbox"/> large and new cracks <input type="checkbox"/> small and old cracks <input type="checkbox"/> slight deformation <input type="checkbox"/> no anomalies			30
Environmental issue	<input type="checkbox"/> exist <input checked="" type="checkbox"/> no exist			1
Installed countermeasure	<input checked="" type="checkbox"/> No countermeasure/ no effect <input type="checkbox"/> Some effect <input type="checkbox"/> High effect <input type="checkbox"/> Completely effect			0
maintenance entity in the vicinity	RDA Nuwara Eliya District, Nuwara Eliya EE Division,			sum Total (A)
Slope situation (photograph)	Situation photograph			25

Comment concerning slope situation	<p>Recorded Disaster : Periodical records of landslide activity. No damage on A005 but local residences and public building locating around the head scarp were damaged by the landslide. Another national road running around the head scarp was also damaged.</p> <p>Failure Type: Landslide.          Geological Condition: Colluvium,          Trigger of Failure: (Supposed) Rise of groundwater,</p> <p>Featured Points: The landslides at this location is composed of 3 blocks of landslides; 1 upper landslide and 2 lower landslides. The 2 lower landslides face the road of A005 and divided by a ridge of base rock.          The landslides are under investigation by NBRO. The total length of the landslides is estimated to be 900 ~ 1,000m.          No damage has been reported so far, but blockade by debris from the toe of the lower landslide can be considered as possible damage.</p> <p>Supposed countermeasures: Surface drainage system and underground drainage system</p>

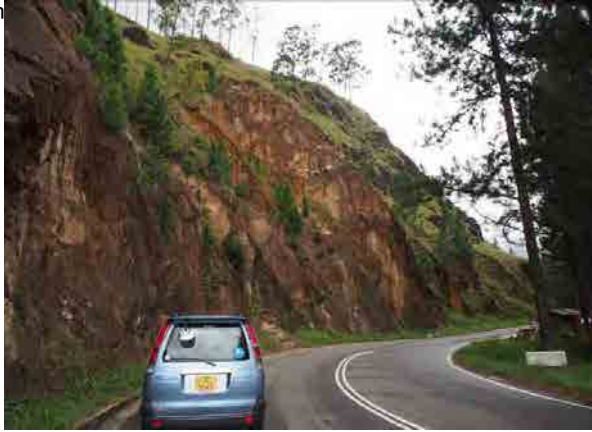
Possible disaster	<input checked="" type="checkbox"/> rock fall <input type="checkbox"/> collapse <input checked="" type="checkbox"/> rock mass failure <input type="checkbox"/> slide <input type="checkbox"/> nothing <input type="checkbox"/> other( )			20
Landslide surface anomalies	<input type="checkbox"/> large and new cracks <input type="checkbox"/> small and old cracks <input type="checkbox"/> slight deformation <input type="checkbox"/> no anomalies			
Environmental issue	<input type="checkbox"/> exist <input checked="" type="checkbox"/> no exist			1
Installed countermeasure	<input checked="" type="checkbox"/> No countermeasure/ no effect <input type="checkbox"/> Some effect <input type="checkbox"/> High effect <input type="checkbox"/> Completely effect			0
maintenance entity in the vicinity	RDA Nuwara Eliya District, Nuwara Eliya EE Division,			sum Total (A)
Slope situation (photograph)	Situation photograph			82

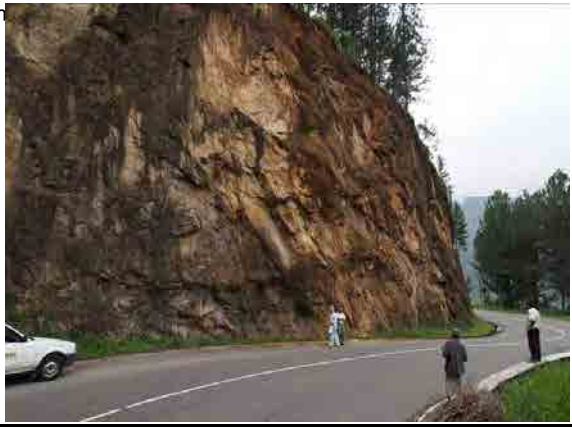
Possible disaster	<input checked="" type="checkbox"/> rock fall <input type="checkbox"/> collapse <input checked="" type="checkbox"/> rock mass failure <input type="checkbox"/> slide <input type="checkbox"/> nothing <input type="checkbox"/> other( )			20
Landslide surface anomalies	<input type="checkbox"/> large and new cracks <input type="checkbox"/> small and old cracks <input type="checkbox"/> slight deformation <input type="checkbox"/> no anomalies			
Environmental issue	<input type="checkbox"/> exist <input checked="" type="checkbox"/> no exist			1
Installed countermeasure	<input checked="" type="checkbox"/> No countermeasure/ no effect <input type="checkbox"/> Some effect <input type="checkbox"/> High effect <input type="checkbox"/> Completely effect			0
maintenance entity in the vicinity	RDA Nuwara Eliya District, Nuwara Eliya EE Division,			sum Total (A)
Slope situation (photograph)	Situation photograph			82

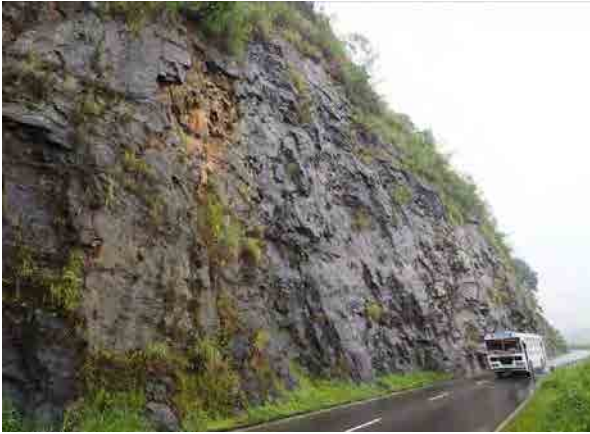
Possible disaster	<input checked="" type="checkbox"/> rock fall <input type="checkbox"/> collapse <input checked="" type="checkbox"/> rock mass failure <input type="checkbox"/> slide <input type="checkbox"/> nothing <input type="checkbox"/> other( )			20
Landslide surface anomalies	<input type="checkbox"/> large and new cracks <input type="checkbox"/> small and old cracks <input type="checkbox"/> slight deformation <input type="checkbox"/> no anomalies			
Environmental issue	<input type="checkbox"/> exist <input checked="" type="checkbox"/> no exist			1
Installed countermeasure	<input checked="" type="checkbox"/> No countermeasure/ no effect <input type="checkbox"/> Some effect <input type="checkbox"/> High effect <input type="checkbox"/> Completely effect			0
maintenance entity in the vicinity	RDA Nuwara Eliya District, Nuwara Eliya EE Division,			sum Total (A)
Slope situation (photograph)	Situation photograph

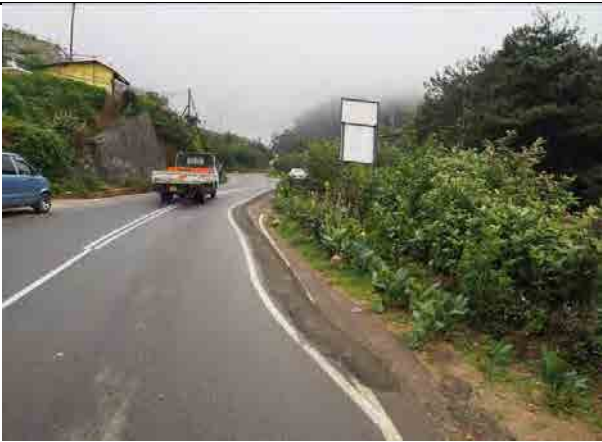
Possible disaster	<input type="checkbox"/> rock fall <input checked="" type="checkbox"/> collapse <input type="checkbox"/> rock mass failure <input type="checkbox"/> slide <input type="checkbox"/> nothing <input type="checkbox"/> other( )			15
Landslide surface anomalies	<input type="checkbox"/> large and new cracks <input type="checkbox"/> small and old cracks <input type="checkbox"/> slight deformation <input type="checkbox"/> no anomalies			
Environmental issue	<input type="checkbox"/> exist <input checked="" type="checkbox"/> no exist			1
Installed countermeasure	<input checked="" type="checkbox"/> No countermeasure/ no effect <input type="checkbox"/> Some effect <input type="checkbox"/> High effect <input type="checkbox"/> Completely effect			0
maintenance entity in the vicinity	RDA Nuwara Eliya District, Nuwara Eliya EE Division,			sum Total (A)
Slope situation (photograph)	Situation photograph

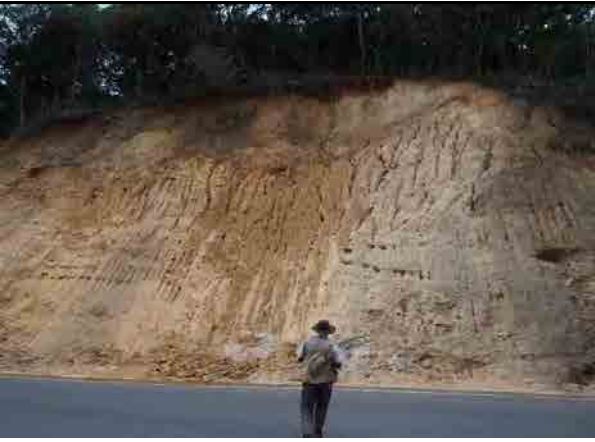
Comment concerning slope situation	<p>Recorded Disaster : Slope failures were seen at the site.            Failure Type: Slope failure in weathered rock.            Geological Condition: Weathered rock and residual soil.            Trigger of Failure: (Supposed) Rainfall,</p> <p>Featured Points: Gradient of slope is apparently too steep for the heavily weathered gneiss confirmed at the site. The heavily weathered gneiss showed fragile strength property. Gully erosion was also confirmed. Successive slope failures which can entail retrogressive development of failures behind the shoulder of the slope are anticipated.</p> <p>Supposed countermeasures: Drainage ditches along the shoulder of the slope along with vertical drainage. Reshaping the slope with stable angle or grating cribs with ground anchors.</p>

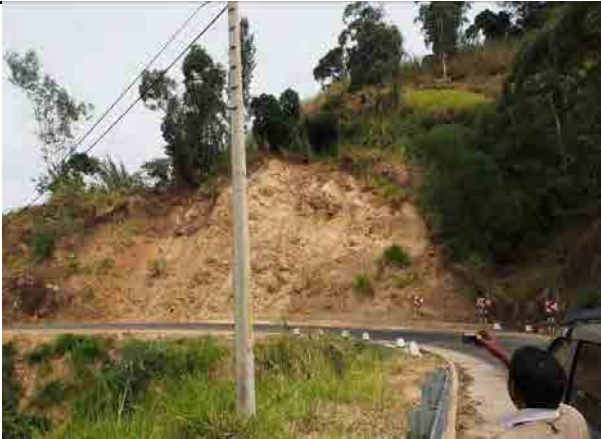
Reduced scale( 1: )
Comment concerning slope situation	<p>Recorded Disaster : Every rainy season, slope failures have occurred. In January 2007, the road was closed for 2 days due to the debris from the failure.                  Failure Type: Slope failure in residual soil and weathered rock.                  Geological Condition: Residual soil and weathered rock.                  Trigger of Failure: Rainfall, rise in ground water level,                  Topographic Condition: Water collectiong vally,</p> <p>Featured Points: Gradient of slope is apparently too steep for the heavily weathered rock and residual soil confirmed at the site. The actual gradient of slope at the section is 80 ~ 90 degrees.                  Gully erosion was also confirmed.                  In addition, many open cracks were confirmed behind the head scarp.                  Successive slope failures which can entail retrogressive development of failures behind the shoulder of the slope are anticipated.</p> <p>Supposed countermeasures: Reshaping the slope with stable angle or grating cribs with ground anchors. Removal of unstahe parts behind the shoulder. Drainage ditches along the shoulder of the slope along with vertical drainage.</p>

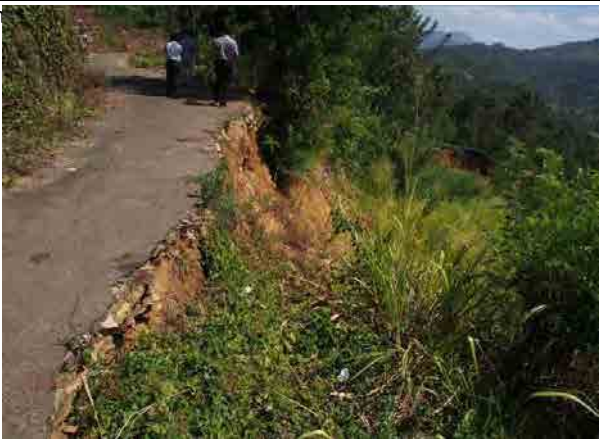
Comment concerning slope situation	<p>Recorded Disaster : From December 2010 when an accumulated precipitation recorded 400 mm, cracks related to one of head scarps appeared at the house of the regional director for the plantation. (This plantation is rehabilitated by PRPII project supported by JICA). In every rainy season, movements of the landslides are observed.</p> <p>As for the damage, severe damage has affected many buildings including a hospital for the plantation and a government office. A005 itself is not included in the landslide mass; the road is just beside the toe of the landslides. Thus when the landslides moved, debris from the toe of the landslides cover the road and RDA shall remove the debris.</p> <p>Failure Type: Landslide.            Geological Condition: Colluvium,            Trigger of Failure: (Supposed) Rise in groundwater,</p> <p>Featured Points: The type of landslide can be categorized as multiple landslide. The landslide mass was divided into more than 2 subdivided landslides. Head scarps were confirmed not only at the upper part but at middle of the landslide mass.            The landslides are under investigation by NBRO. Based on its initial investigation, NBRO estimated</p> <p>Supposed countermeasures: Surface drainage system and underground drainage system.</p>

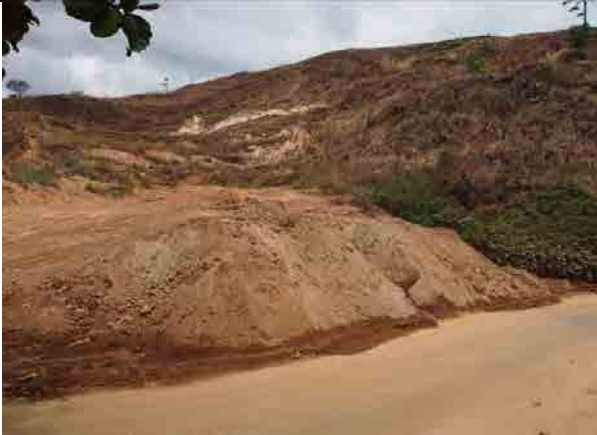
Reduced scale( 1 : )
Comment concerning slope situation	<p>Recorded Disaster : For more than 10 years, in every rainy season, the landslides moved toward A005 and the debris from the toe covered the road. Against each blockade by the debris, RDA needs to remove it from the road surface.</p> <p>Failure Type: Landslide.            Geological Condition: Mainly weathered rock along with colluvium,            Trigger of Failure: (Supposed) Rise in groundwater,            Topographic Condition: Water collecting valley, a stream is running along the road.</p> <p>Featured Points: The affecting landslide seems to be one of devided landslide from much wider landslide which was moved far past. The affecting landslide is mainly composed of weathered rock which seems to be low resistant against weathering and prone to alter into clay. At the head scarps at the shoulder and upper-middle of the affecting landslide, outcrops of weathered rocks can be observed.            At the toe of the landslide, a spring was observed.</p> <p>Supposed countermeasures: Surface drainage system and underground drainage system. Ground anchor at the toe.            Relocation of the bridge passing the stream can be an option.</p>

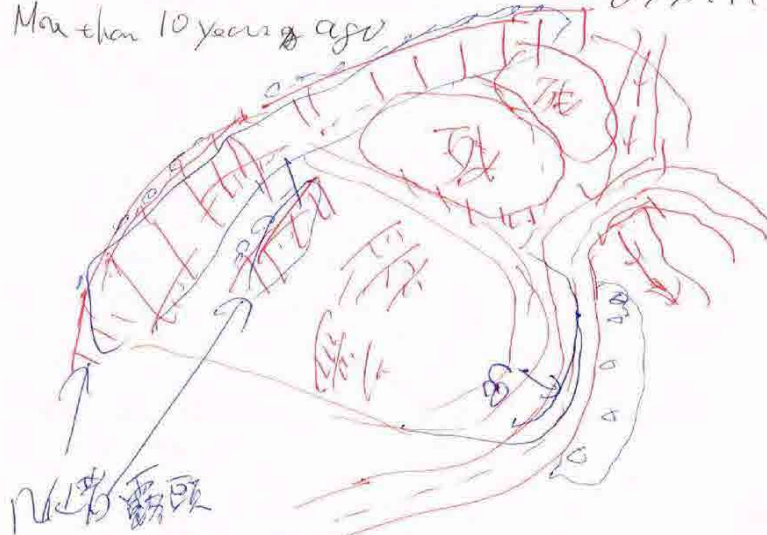
More than 10 years ago

Frang day in rainy season,

RDA needs to remove debris from the toe of

L/S

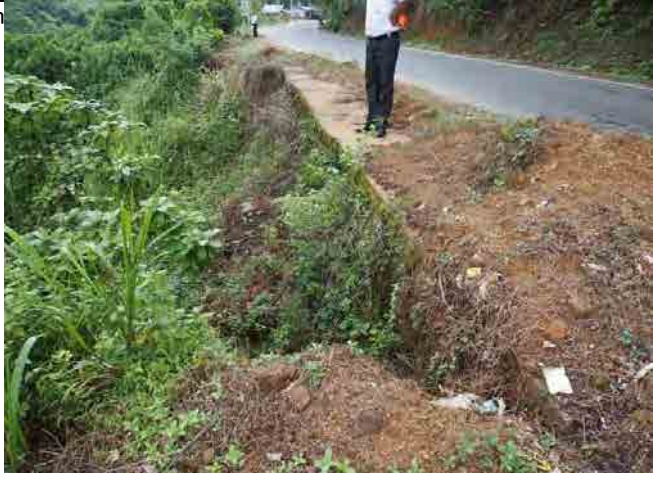
<p style="text-align: right;">Reduced scale( 1: )</p>			
Comment concerning slope situation	<p>Recorded Disaster : Slope failure in lower slope moved away the shoulder. Cracks appeared on the pavement.</p> <p>Failure Type: Slope failure in residual soil and weathered rock.          Geological Condition: Residual soil and weathered rock.          Trigger of Failure: (Supposed) Erosion of toe of the slope by Kelani River, and steeper gradient of slope.</p> <p>Featured Points: Slope failure by river erosion.</p> <p>Supposed countermeasures: Retaining wall against the erision as well as to reinforce the slope.</p>

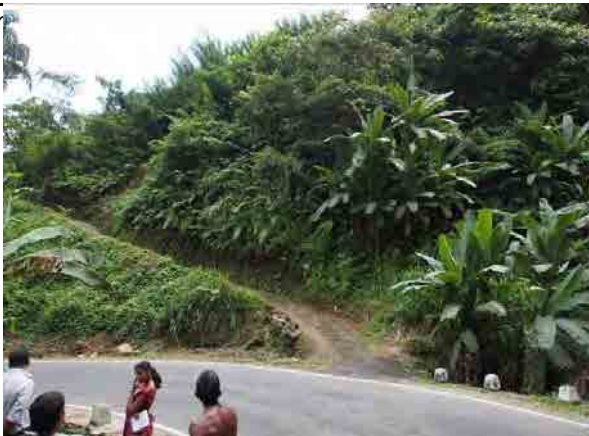
Reduced scale( 1 : )
Comment concerning slope situation	<p>Recorded Disaster : In 1989 and between 2005 and 2007, the landslide moved and the road was closed for several days. Landslide activities were seen during the rainy season. Damage on the pavement, possibly caused by infiltration of water to the pavement structure. Traces of slope failures on the slopes.</p> <p>Failure Type: Landslide or slope failure. Further investigation is required.          Geological Condition: Residual soil and colluvium or valley deposit.          Trigger of Failure: (Supposed) Raise in ground water.</p> <p>Featured Points: It is said to be landslide activities in 1989 and between 2005 and 2007. Thus another landslide activity is anticipated by local people. It is not clear, however, that the damage was caused by landslide or slope failure, because there was not clear evidence of landslide activities. There were, however, a lot of cracks on the pavement which imply infiltration of water to the pavement structure. This damage suggests high ground water level at this location.          Based on the site situation, debris flow can be a possible disaster.          Topographic Feature: Valley type landform with a stream.</p> <p>Supposed countermeasures: Further investigation is required to set up appropriate countermeasures. Based on the site situation, however, surface drainage system and underground drainage can be amongst appropriate countermeasures.</p>

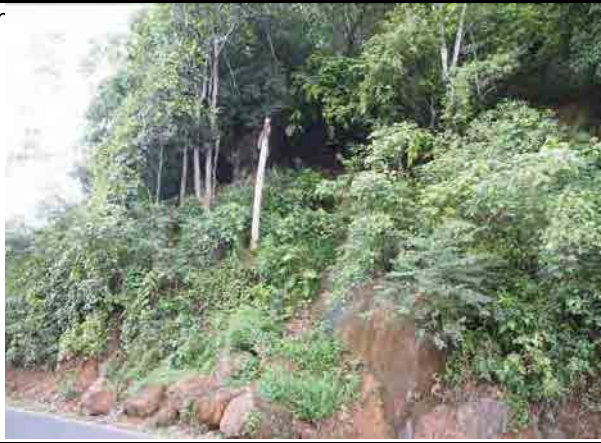
Comment concerning slope situation	<p>Recorded Disaster : Unclear. Fallen boulders, however, were seen on site.</p> <p>Failure Type: Rock fall, slope failure in colluvium.</p> <p>Geological Condition: At the ending part, massive rock with cracks, at the beginning part, colluvium..</p> <p>Trigger of Failure: (Supposed) Rainfall, erosion, and development of open cracks..</p> <p>Featured Points: Boulders were seen at the shoulder of cutting slope composed of colluvium. Boulders were also seen in the upper slopes. In addition, unstable parts of outcrop with cracks were seen at the shoulder of rocky slope.</p> <p>Supposed countermeasures: Further investigation is required to set up appropriate countermeasures. Based on the site situation, however, removal of boulders and unstable parts of rock can be amongst countermeasures along with fixing unstable parts with rock bolts or other fixing methods.</p>

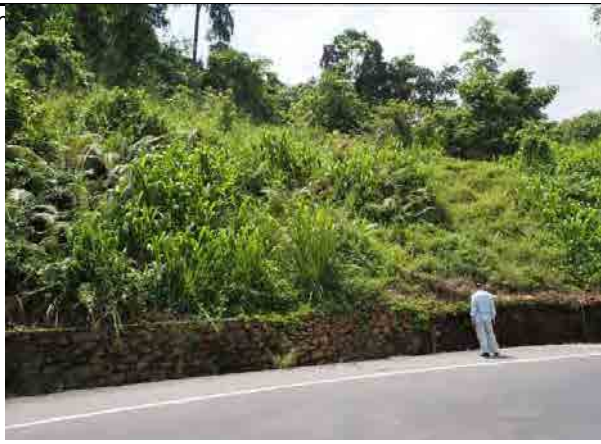
Comment concerning slope situation	<p>Recorded Disaster : Not every year, during rainy season. A part of gabion wall seemd to have been damaged and reconstructed.</p> <p>Failure Type: Multiple landslide. Geological Condition: (Probably) Colluvium. Trigger of Failure: (Supposed) Raise in ground water.</p> <p>Featured Points: Multiple landslide. According to the vegetation on the slope, groundwater level is supposed to be hgh. In addition, a spring were seen on the toe of the slope. Topographic Feature: Valley type landform with a stream.</p> <p>Supposed countermeasures: Further investigation is required to set up appropriate countermeasures. Based on the site situation, however, surface water drainge system and underground drainage can be amongst the supposed countermeasures.</p>

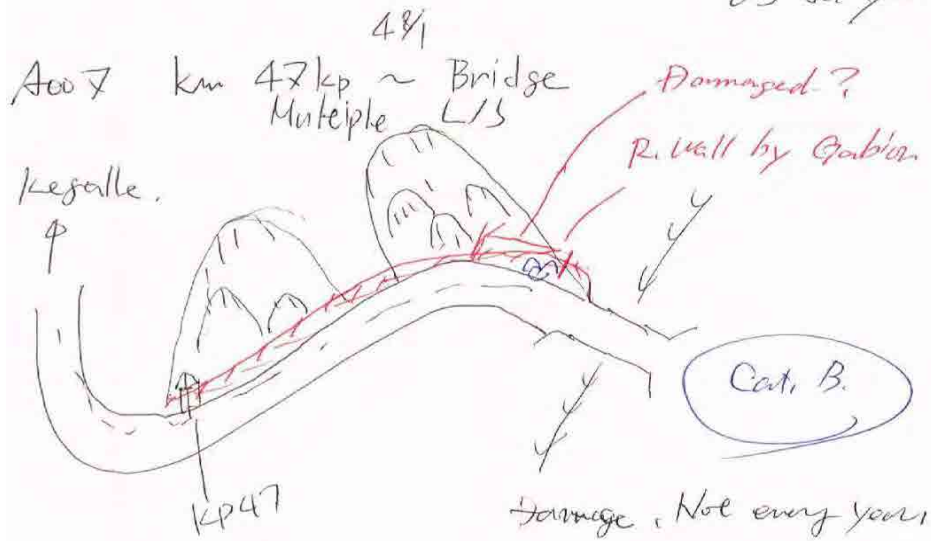
Detailed Investigation is required,  
very High water level (according to the  
Vegetation)

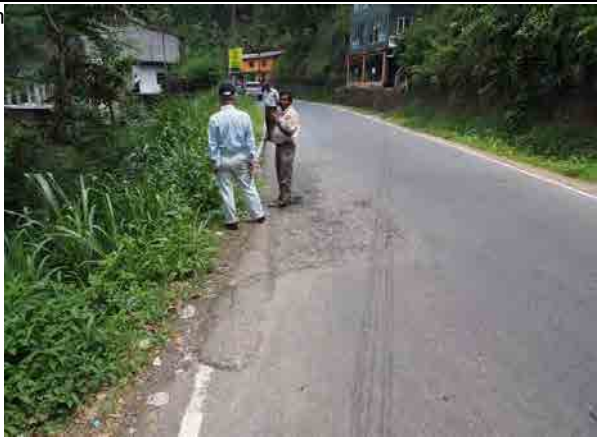
Comment concerning slope situation	<p>Recorded Disaster : Shoulder of the road collapsed. Cracks developed on the nearby pavement.</p> <p>Failure Type: Slope failure in residual soil.          Geological Condition: Residual soil.          Trigger of Failure: (Supposed) Rainfall, erosion, and steeper gradient of slope.</p> <p>Featured Points: There were 2 slope failures; one was under the shoulder and another was in the upper slope.</p> <p>Supposed countermeasures: Further investigation is required to set up appropriate countermeasures. Based on the site situation, however, grating cribs with ground anchors can be amongst the supposed.</p>

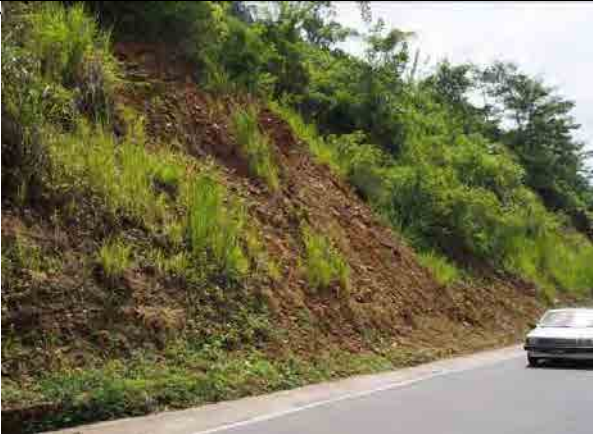
Comment concerning slope situation	<p>Recorded Disaster : Debris provided from the slope failure closed the road.</p> <p>Failure Type: Slope failure in residual soil and weathered rock.          Geological Condition: Residual soil and weathered gneiss rich in cracks. Vertical cracks attract the attention.          Trigger of Failure: (Supposed) Rainfall, erosion, and steeper gradient of slope.</p> <p>Featured Points: Springs were confirmed in the middle of the slope at the beginning side.</p> <p>Supposed countermeasures: Further investigation is required to set up appropriate countermeasures. Based on the site situation, however, drainage system and grating cribs with ground anchors can be amongst the supposed.</p>

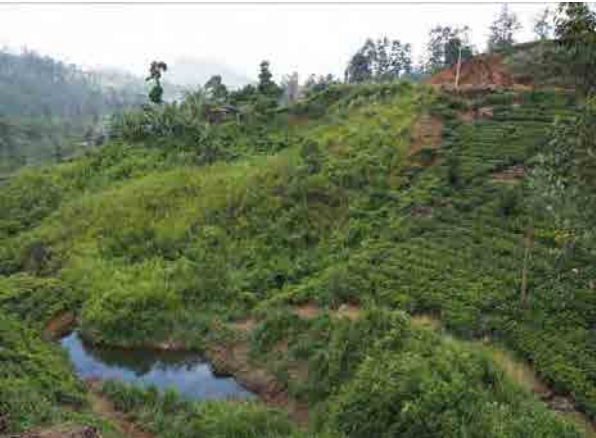
Comment concerning slope situation	<p>Recorded Disaster : Landslide in the lower slope moved and the foundation of the old road was moved away.</p> <p>Failure Type: Landslide.          Geological Condition: (Probably) Colluvium.          Trigger of Failure: (Supposed) Erosion at the toe of the landslide. Raise in ground water.</p> <p>Featured Points: The stream eroded the toe of landslide and activated the landslid. The moved landslide mass closed the stream and then created a pond. The watercourse of the stream was bended and circumnavigated the toe of the landslide. At the same time, the head scarp appeared crossing the old road and the foundation of the old roas was moved away along with the subsidence of the head.          Topographic Feature: Located at the slope surrounding the ridge.</p> <p>Supposed countermeasures: It is obious that the further erosion of the toe will reactivate the landslide movement. Thus counter-erosion shall be installed. Reinforcement to shoulder behind the head scarp may be considered.</p>

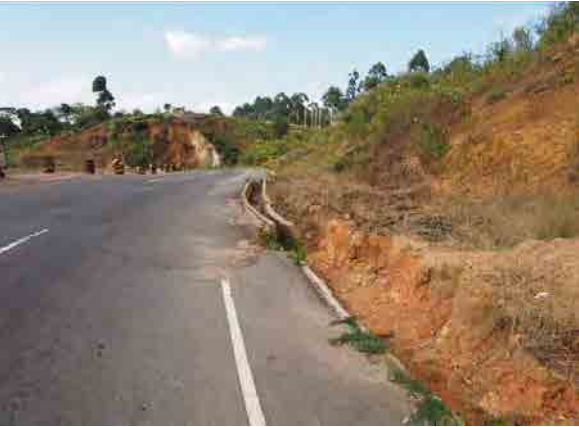
70
	Reduced scale( 1 : )			Environmental issue
Comment concerning slope situation	<p>Recorded Disaster : From 1996, landslide activities have been observed every 2 years. This landslide affects the road running at its middle and houses located downstream of its toe.</p> <p>Failure Type: Landslide. Geological Condition: Colluvium, Trigger of Failure: (Supposed) Rise in groundwater,</p> <p>Featured Points: When the toe of the landslide moves triggered by a rainfall , the body of landslide at the toe turns into fluid and strikes the houses with a high speed movement. A head scarp of a devided landslide locates just beside the road shoulder and poses a threat of subsidence or collapse of the foundation of the road. The initial investigation by NBRO was done in 2001 or 2002. The 2nd investigation was in 2011. The thickness of the landslide is said to be 20 meters or more. An improvement of the road was completed in 2009 ~2010.</p> <p>Supposed countermeasures: Surface drainage system and underground drainage system. Ground anchor or pile works to support the sholder affected by the devided landslide..</p>			70

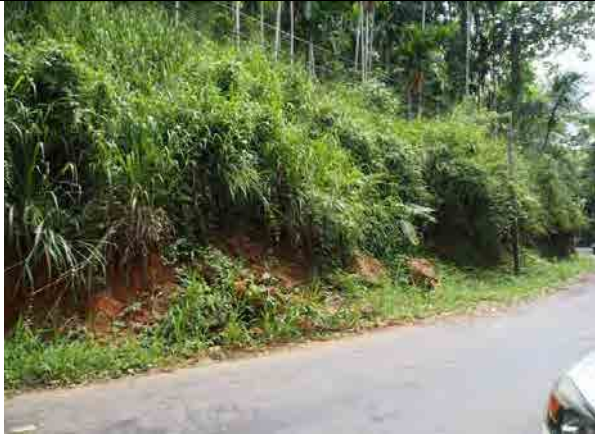
Reduced scale( 1: )
Comment concerning slope situation	<p>Recorded Disaster : From 2006, when plenty rainfall provided, the landslide moved. Debris provided from the toe of the landslide blocked the road.</p> <p>Failure Type: Landslide            Geological Condition: (Probably) Colluvium.            Trigger of Failure: (Supposed) Raise in groundwater.</p> <p>Featured Points:Land owner has not allowed RDA to access the slope. No investigation results are available.</p> <p>Supposed countermeasures: Further investigation is required to set up appropriate countermeasures. Based on the site situation, however, surface draiange system and underground drainage can be amongst the supposed.</p>

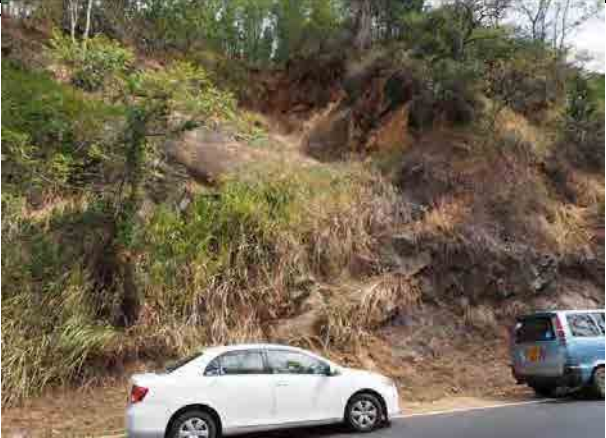
0
Comment concerning slope situation	Recorded Disaster : Jan 2007, during rainy season Failure Type: Slope Failure involving Rock Sliding, Geological Condition: Residual soil, Highly weathered ~ weathered rock with cracks, Supposed countermeasures: Fixed with rock bolts or removal of unstable parts.

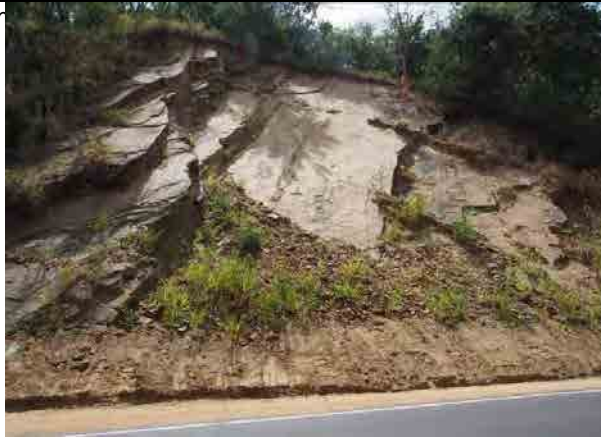
Environm ental issue
Comment concerning slope situation	<p>Recorded Disaster : Jan 2007, during rainy season            Failure Type: Rock Sliding,            Geological Condition: Highly foliated Gneiss, Dip slope condition,            Topographic Condition: Water collectiong vally,</p> <p>Supposed countermeasures: Fixed with rock bolts or removal of unstable parts.</p> <p>Note: From Km 29~ Km 31, overhanging rocks rocks were seen remaining unstable at shoulder of slopes.</p>			0

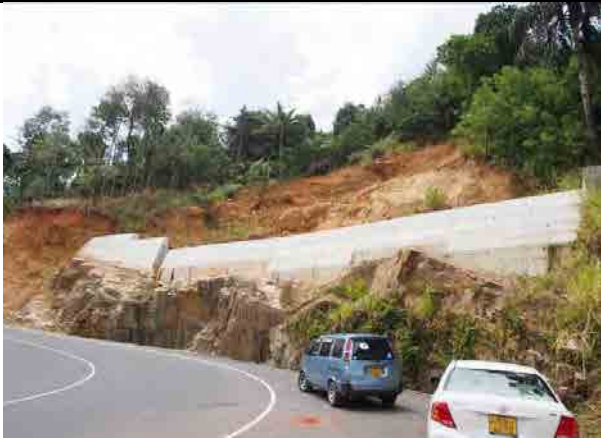
Comment concerning slope situation	<p>Recorded Disaster : 2011, during construction by Keangnam, slope of overburden collapsed after cutting with almost vertical angle. After removing deposits of the collapsed overburden, retaining well was constructed.</p> <p>Failure Type: Slope failure in residual soil,          Geological Condition: Residual soil, weathered rock          Trigger of Failure: Construction,          Topographic Condition: Water collectiong vally,</p> <p>Featured Points: After the construction of the retaining wall, the failure was settled.          Gradient of Slope is too steep for residual soil.</p> <p>Supposed countermeasures: (If additional countermeasures are required) Drainage ditches along the shoulder of the slope along with vertical drainage. Removal of deposits and reshaping of the slope with stable angle.</p>

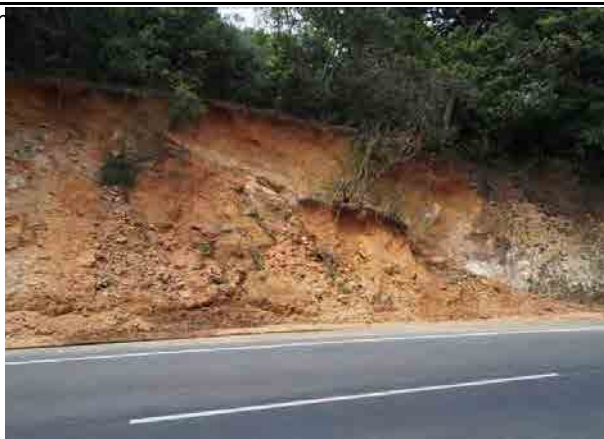
Environmental issue
	Reduced scale( 1: )			0
Comment concerning slope situation	<p>Recorded Disaster : 2011, rainy season,            Failure Type: Slope failure in residual soil and weathered rock,            Geological Condition: Residual soil, weathered rock (very weak and fragile),            Topographic Condition: Valley,</p> <p>Featured Points: A fresh failure was seen at the site.            Gradient of Slope is too steep for residual soil and weathered rock.</p> <p>Supposed countermeasures: Drainage ditches along the shoulder of the slope along with vertical drainage. Reshaping the slope with stable angle or retaining methods such as anchoring or R/B with grating cribs.</p>

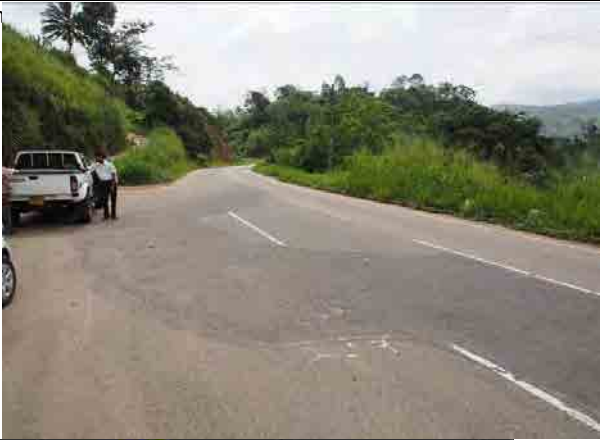
Comment concerning slope situation	<p>Recorded Disaster : Periodical records of landslide activity. In every rainy season, especially in December, gaps have developed on the pavement with an aperture of 4 ~ 6 inches (10 ~ 15cm). The gaps correspond to the head scarp of lower landslide.</p> <p>Failure Type: Landslide.          Geological Condition: Colluvium,          Trigger of Failure: (Supposed) Rise of groundwater,</p> <p>Featured Points: The landslides at this location involve not only road, but houses and railway. Two landslides are confirmed so far. The upper landslide is said to have been stabilized by the retaining wall constructed along the railway. The head scarp of the upper landslide may be located under the passage paved with concrete slab. The lower landslide still shows periodical movement during rainy seasons and damages the A-113 road with subsidence and open gaps which reaches 15cm. 3 piezometers were placed and observed by RDA.</p> <p>Supposed countermeasures: Surface drainage system and underground drainage system. Pile works or ground anchors to retain the road. Retaining wall against erosion by the Mahaweli river.</p>
