Appendix 3-2 Slope inspection sheets for Rank C and B

General Information Sheet

Management office	Ratnapura										
Management number	A004-134	Route No	A004	Location(m)	134/15	to	134	Distance	200	m	
Disaster	Rock fall	Name of Road		Landmark		latitude	N 06°37'20.18"	longitude	E 080°39'32.17"		
Schematic sketch				Reporter's name :	M. Enokida

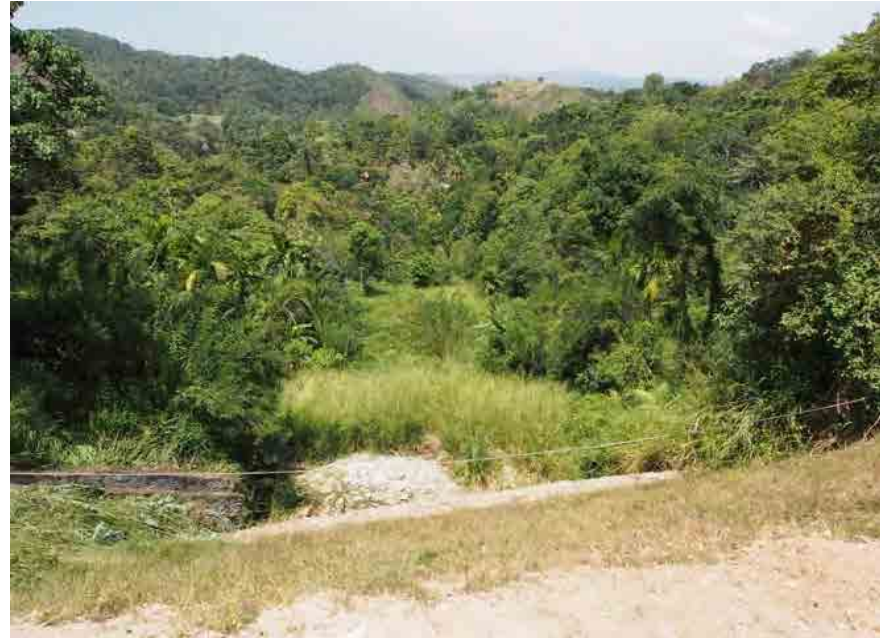
Situation under slope

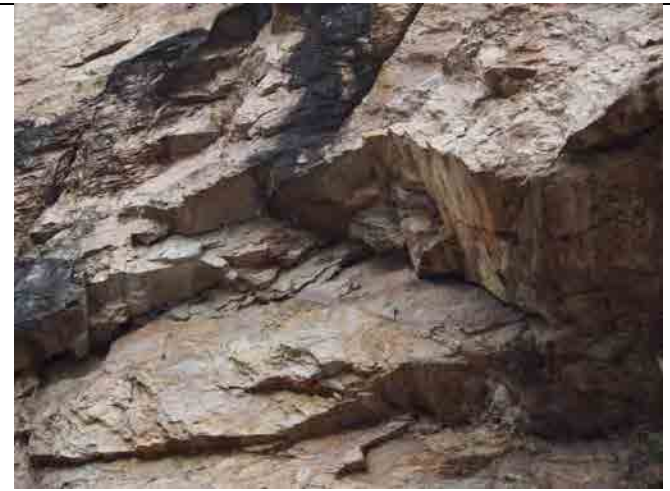
Sheeting joints notably developed parallel to the slope.

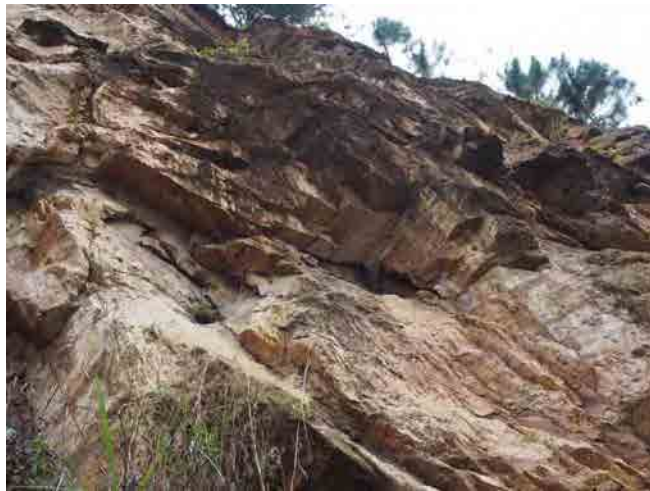
With foliation plunging to the slope, sheeting joints can form slip surfaces for rock slides.

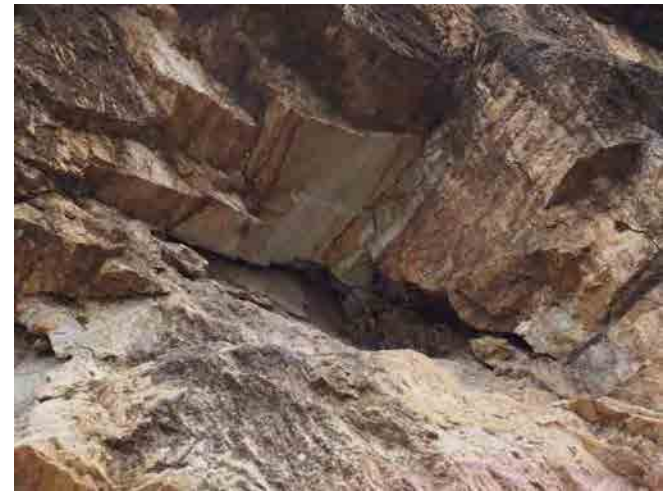
Close up view of the left. The sheeting joints have some aperture, making a rock mass apart from the out crop.

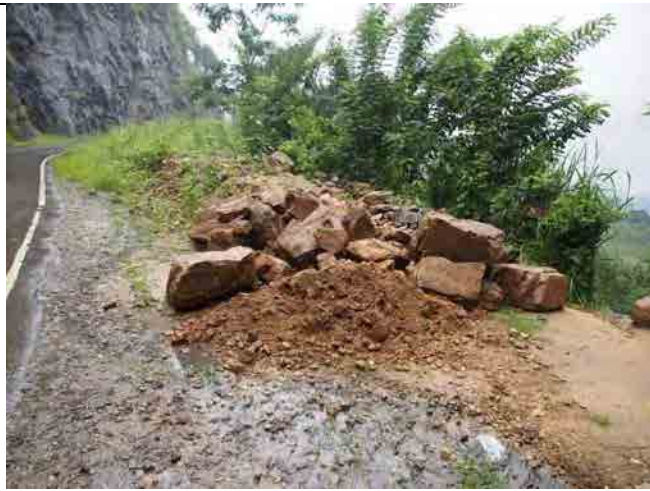
Debris cleared up to the shoulder of the road

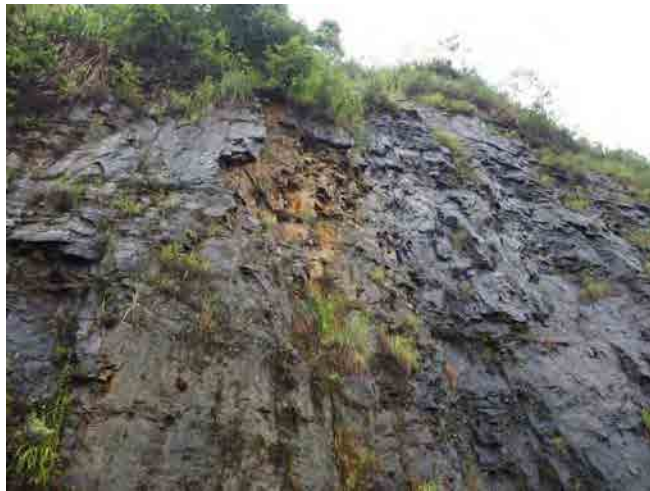
Traces of rock fall or minor rock slides which occurred recently.
The height from the road is around 30 meters.

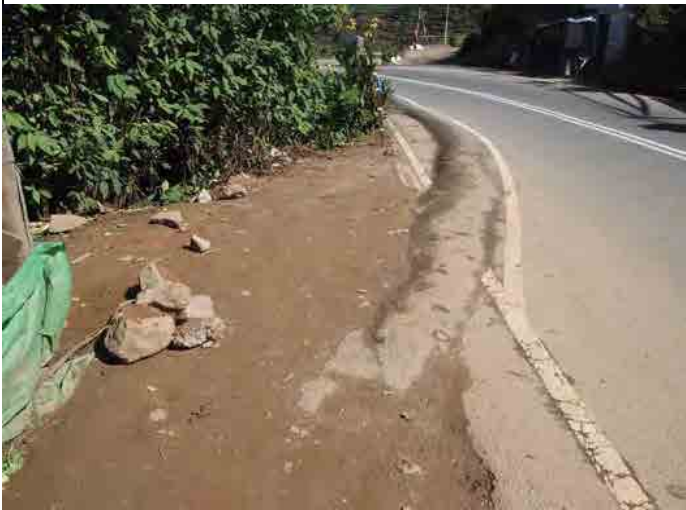
Full view of the slope from strat side

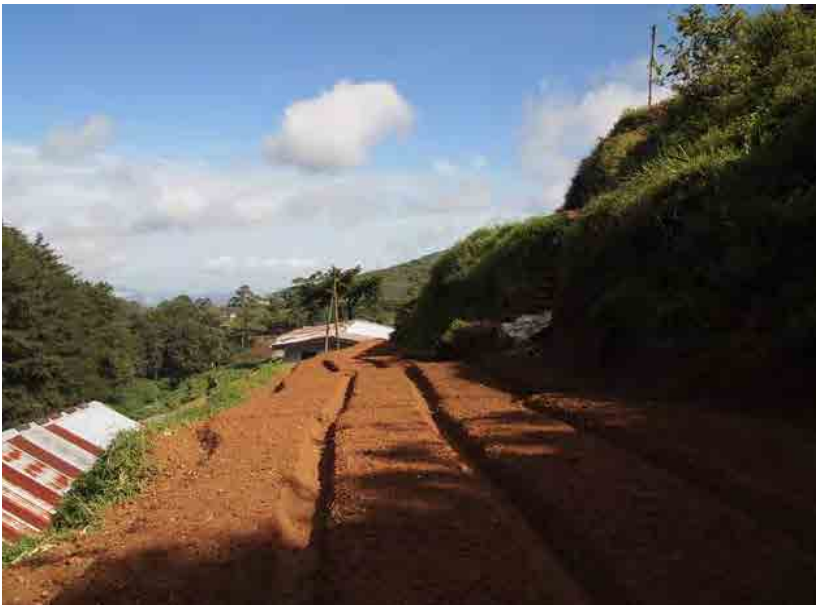
Condition of slope, house under slope

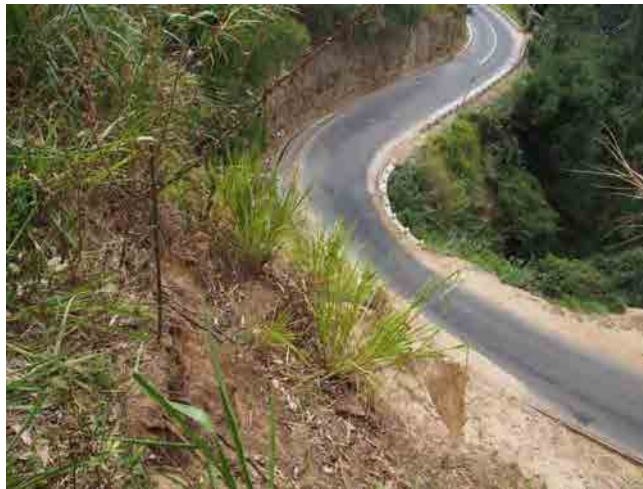
Seen from the shoulder of the failure

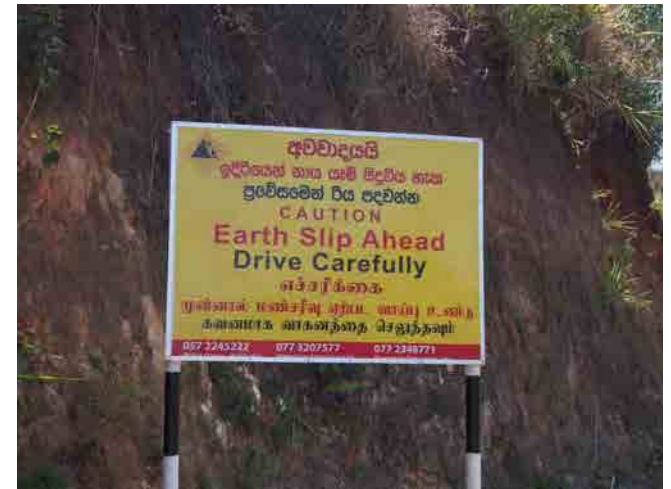
Signboard warning the landslide

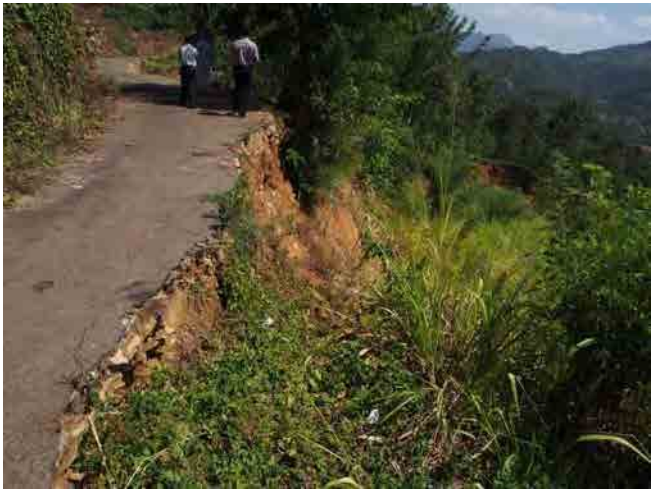
At the middle of the landslide.
A head scarp of a divided landslide developed along the paved road.

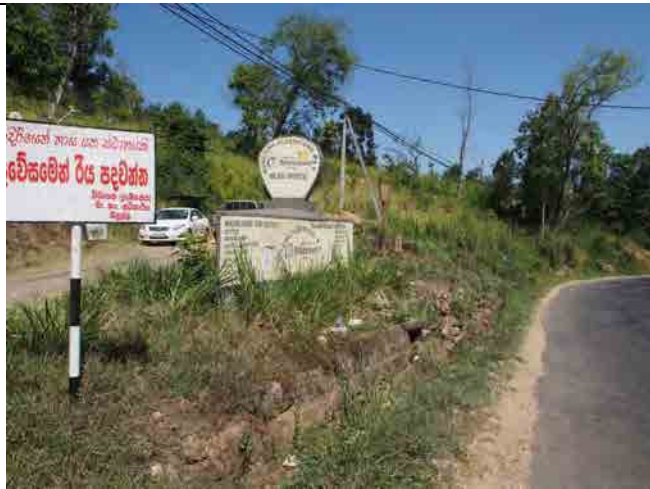
Toe of the landslide.
Hospitals and houses were destroyed by the landslide movement.

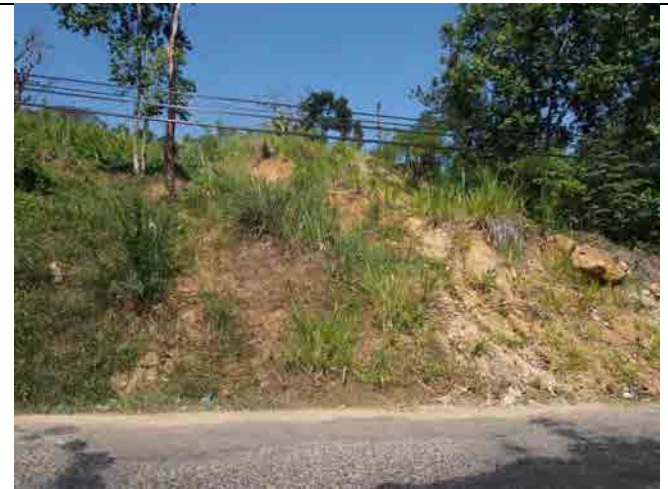
Toe of the landslide.
Debris from the landslide accumulated and closed the road when the landslide was activated.

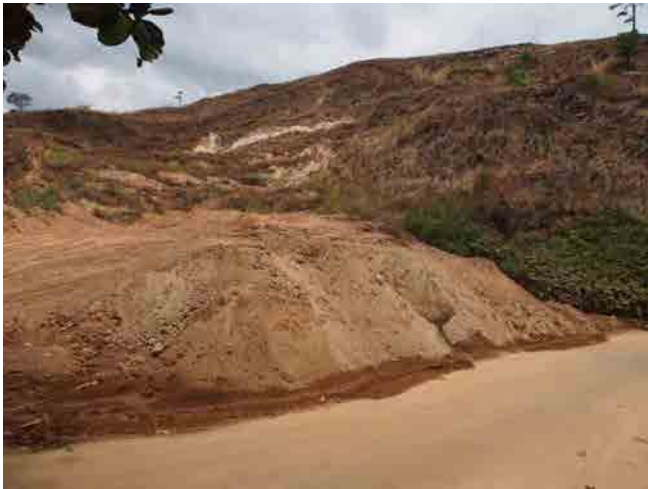
Full view of the landslide

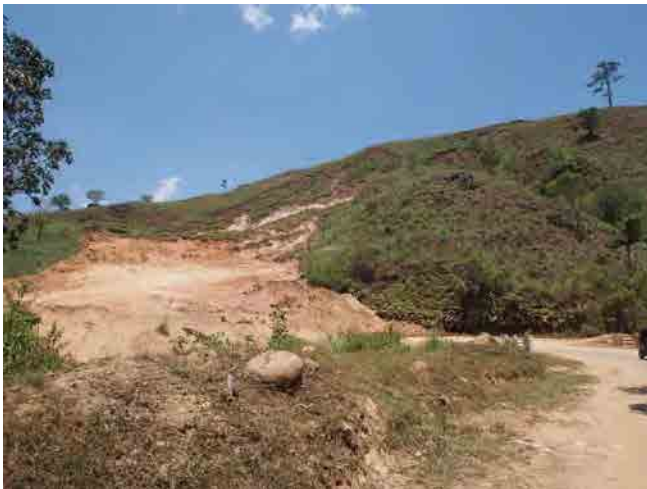
Seen from the opposite side of the small river.
Remaining mounds were clearly seen.

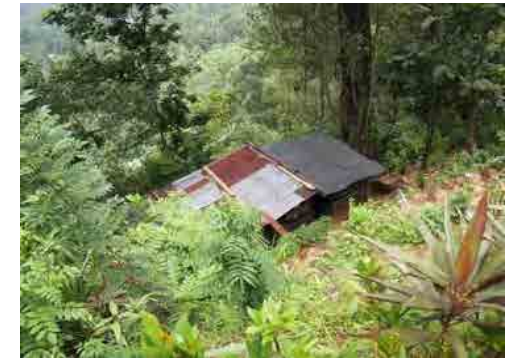
Condition of slope, house under slope

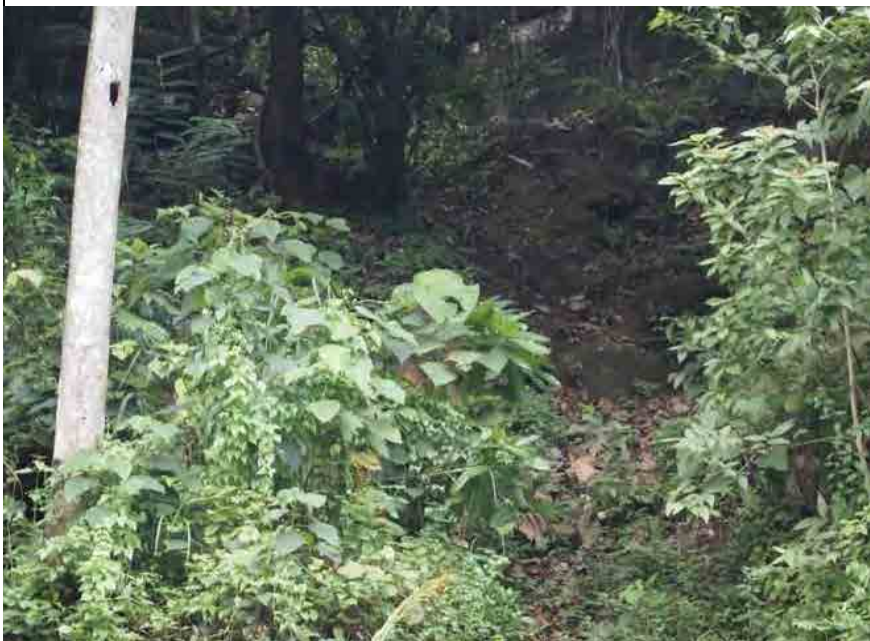
Condition of slope, state of road upper slope

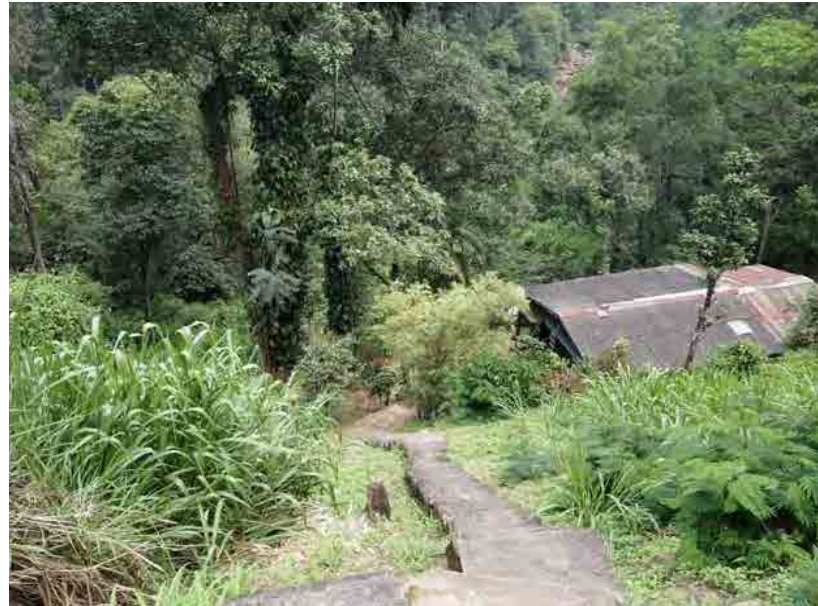
Condition of slope, house under slope

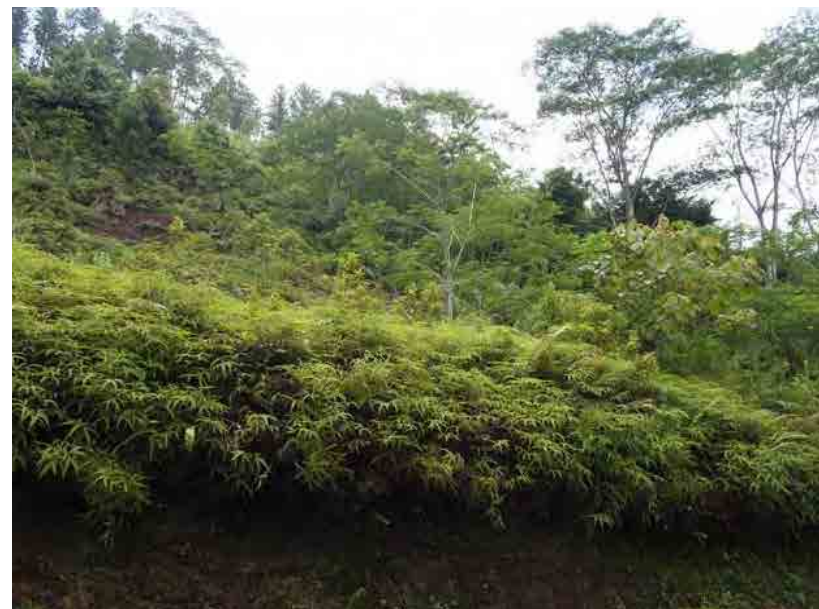
Adjoining old collapse ground

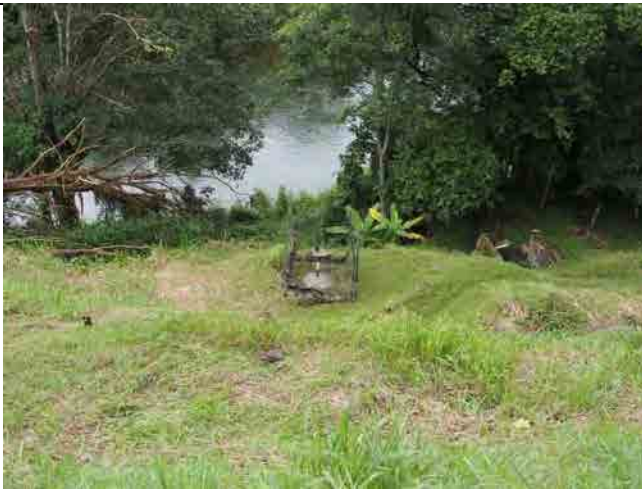
Piezometer installed at the lower part of the landslide.

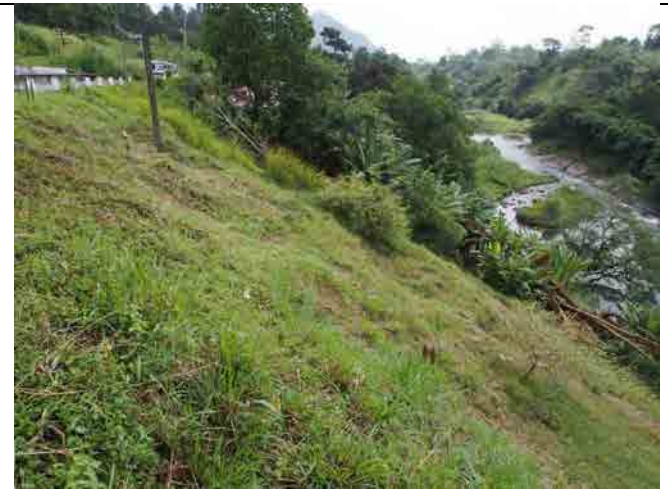
Condition of the lower part of the landslide.
