**The Data Collection Survey on Road
Protection against Natural Disaster
(Landslide-Disaster)**

**FINAL REPORT (2/2)
Appendix**

December, 2012

**KOKUSAI KOGYO CO., LTD.
ORIENTAL CONSULTANTS CO., LTD.
JAPAN CONSERVATION ENGINEERS CO., LTD.**

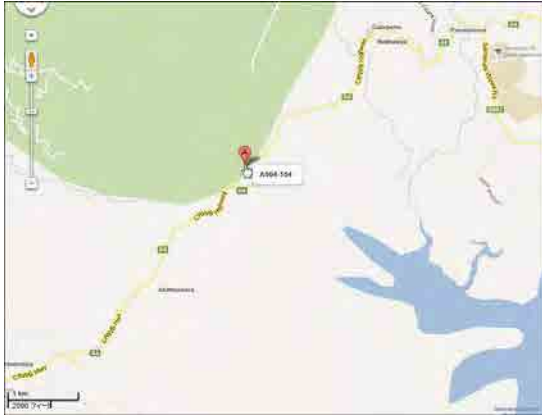
Reduced scale(1 :)			Environm ental issue 40
Comment concerning slope situation	<p>Recorded Disaster : Damage on the pavement such as cracks and subsidence.</p> <p>Failure Type: Slope failure in the embankment slope, (possible) landslides involving the foundation of the embankment.,</p> <p>Geological Condition: Highly Weathered Gneiss, embankment material, (possibly) colluvium or valley deposit at the foundation of the embankment,</p> <p>Trigger of Failure: (Supposed) Raise in ground water, changes in the weight balance for the possible landslide,</p> <p>Featured Points: It is not yet clear whether there is landslide at the foundation of the embankment. Thus further investigation and monitoring are required.</p> <p>According to unconfirmed information, there were some movements at the lower slope under the gabion wall.</p> <p>The landform of the valley where the embankment sits on implies existence of small landslides. If the embankment was put on the head of the possible landslides, the landslide shall start its movement. There lacks however obvious information which supports the movement or existence of the landslide.</p> <p>Supposed countermeasures: For slope failure in embankment, gentler gradient of slope or reinforcement by sorts of geotextile. For landslide, further investigation is required</p>

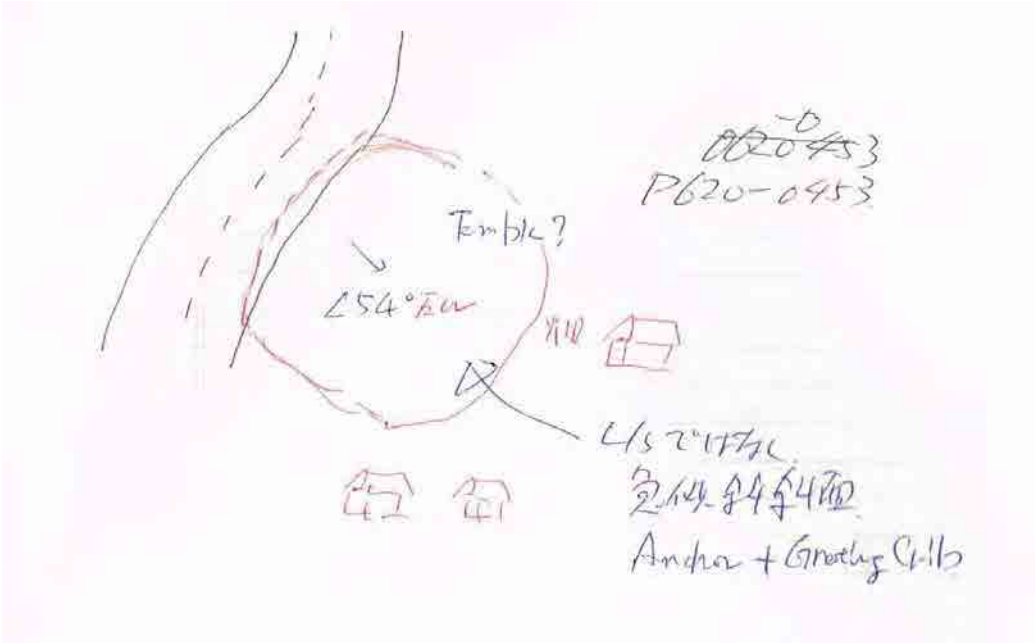
Environmental issue
Comment concerning slope situation	<p>Recorded Disaster : Damage at shoulder, subsidence and cracks on the pavement.</p> <p>Failure Type: Slope Slope failure. Geological Condition: Colluvium, Trigger of Failure: (Supposed) Relaxed shoulder caused by a too steep gradient of slope as 54 degrees,</p> <p>Featured Points: Steep slope composed of colluvium declines from the shoulder of the road. It is likely that the damage was caused by loose shoulder relaxed by the too steep gradient of slope.</p> <p>Supposed countermeasures: Drainage system along the shoulder, retaining wall or grating cribs with ground anchor if necessary.</p>			55

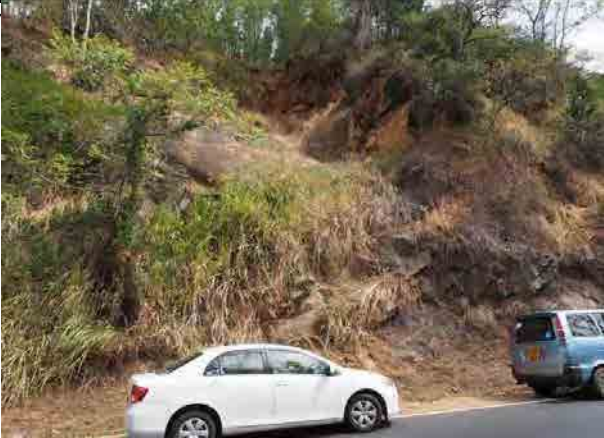
0
Comment concerning slope situation	<p>Recorded Disaster : Jan 2007, during rainy season Failure Type: Slope Failure involving Rock Sliding, Geological Condition: Residual soil, Highly weathered ~ weathered rock with cracks, Supposed countermeasures: Fixed with rock bolts or removal of unstable parts.</p>

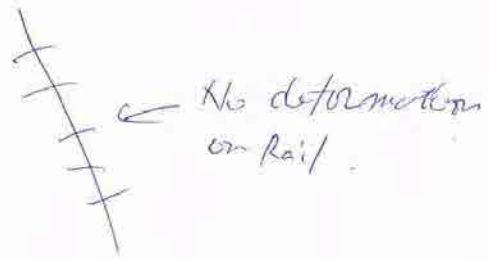
Embankment Part

Caused by Embk construction,
