Appendix 3-2 Slope inspection sheets for Rank C and B

General Information Sheet

Management office	Ratnapura												
Management number	A004-134	Route No	A004	Location(m)	134/15	to	134	Distance	200	m			
Disaster	Rock fall	Name of Road		Landmark		latitude	N 06°37'20.18"	longitude	E 080°39'32.17"				
Schematic sketch				Reporter's name :	M. Enokida

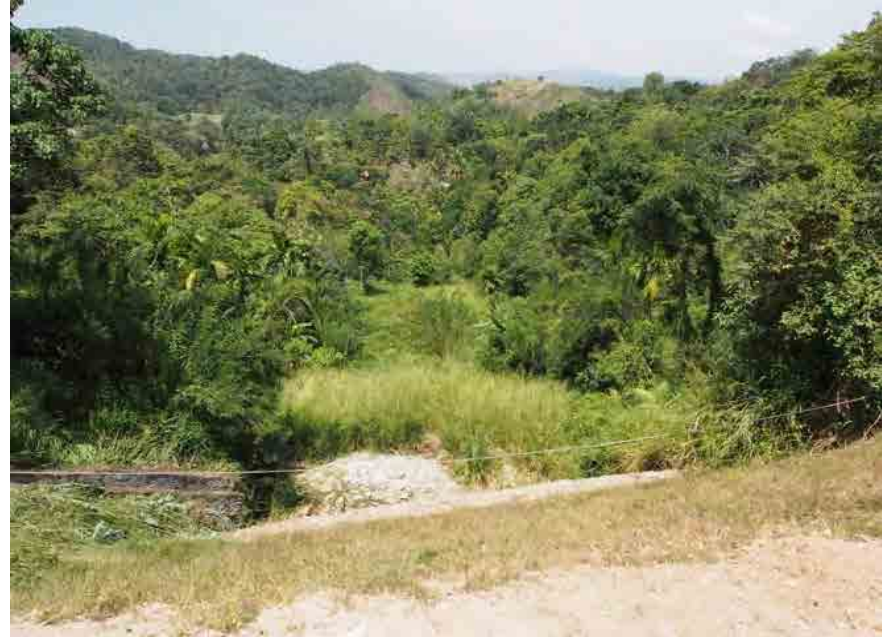
Situation under slope

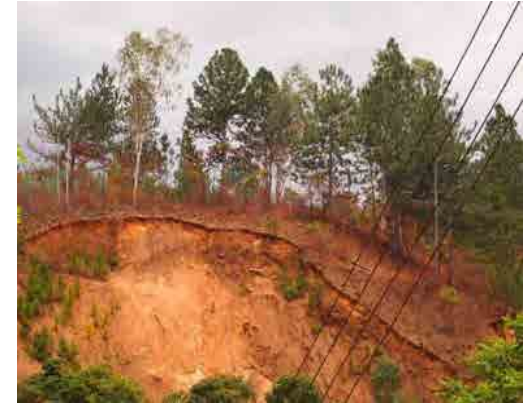
Situation of slope head

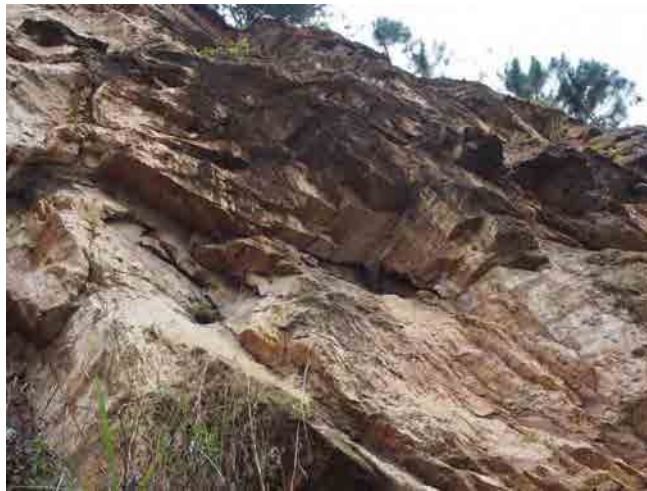
With foliation plunging to the slope, sheeting joints can form slip surfaces for rock slides.

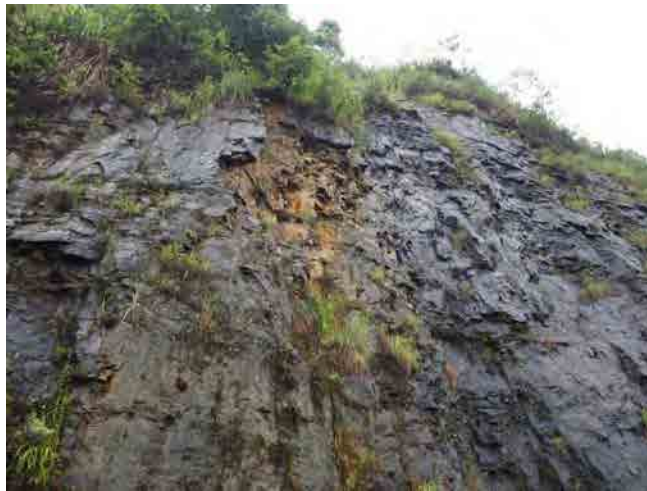
Traces of rock fall or minor rock slides which occurred recently. The height from the road is around 30 meters.

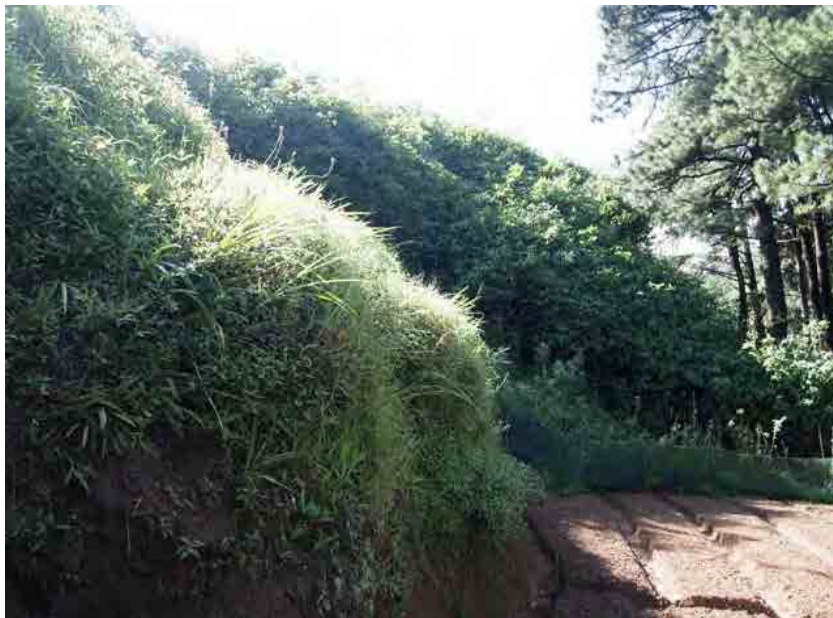
Condition of slope, state of road lower slope

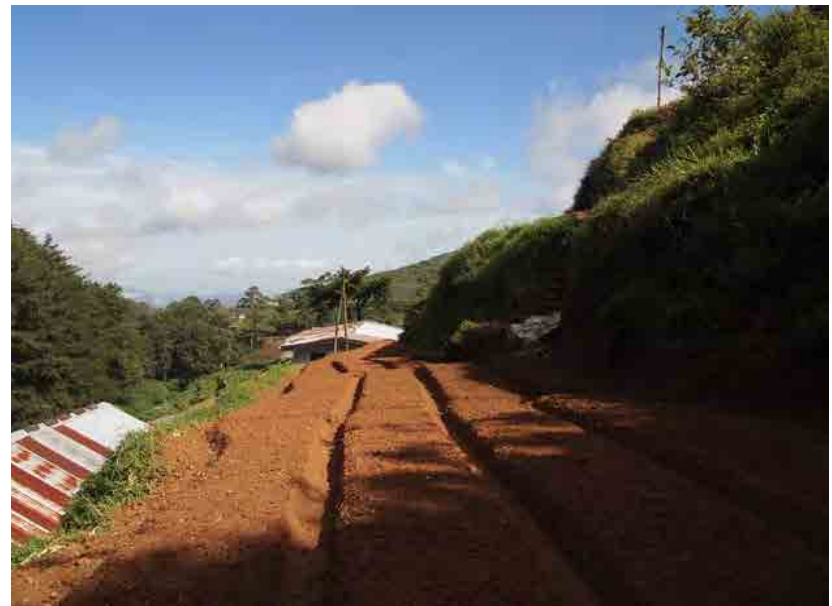
Condition of slope, house under slope

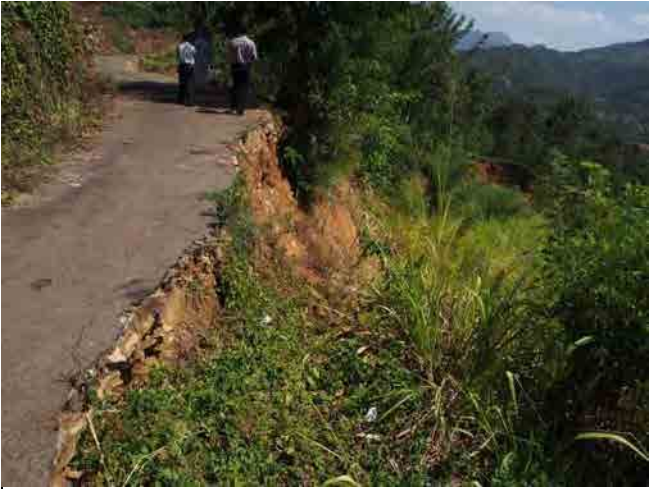
At the middle of the landslide.
A head scarp of a divided landslide developed along the paved road.

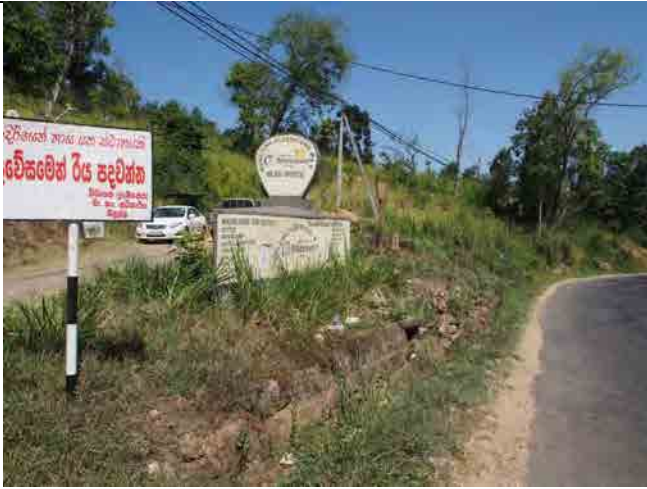
Toe of the landslide.
Hospitals and houses were destroyed by the landslide movement.

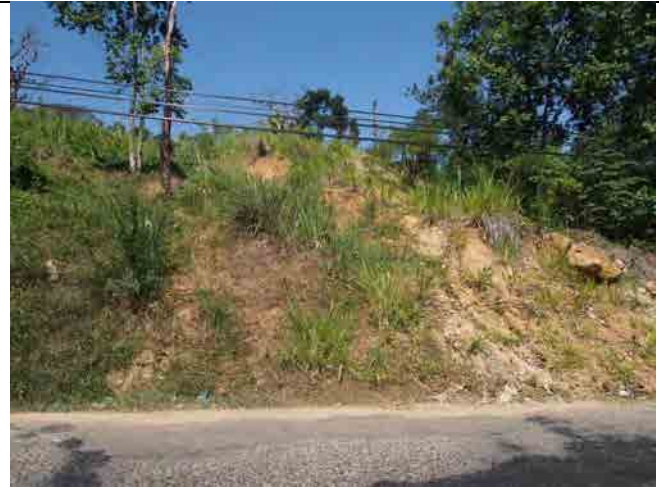
Toe of the landslide.
Debris from the landslide accumulated and closed the road when the landslide was activated.

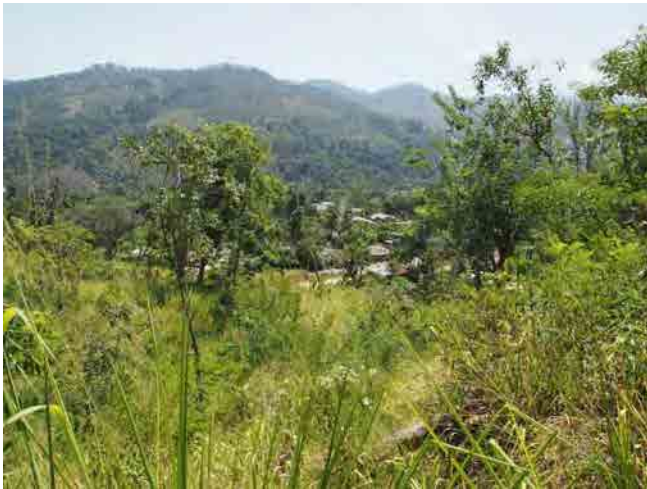
Seeing downward from the middle of the landslide.
Houses may be affected by the landslide movements.

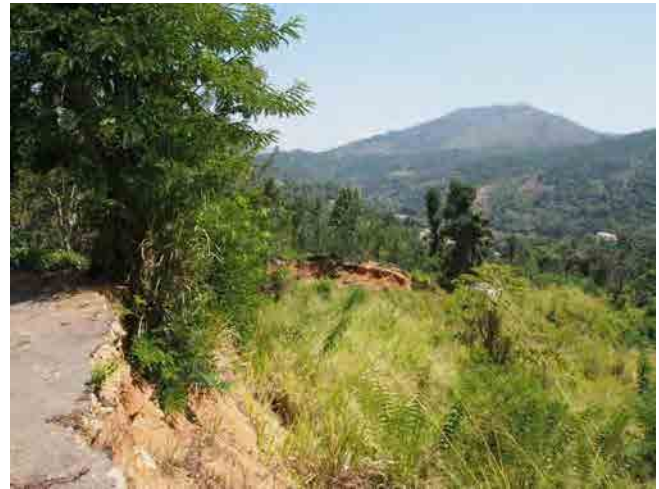
Escarpment of a divided landslide.

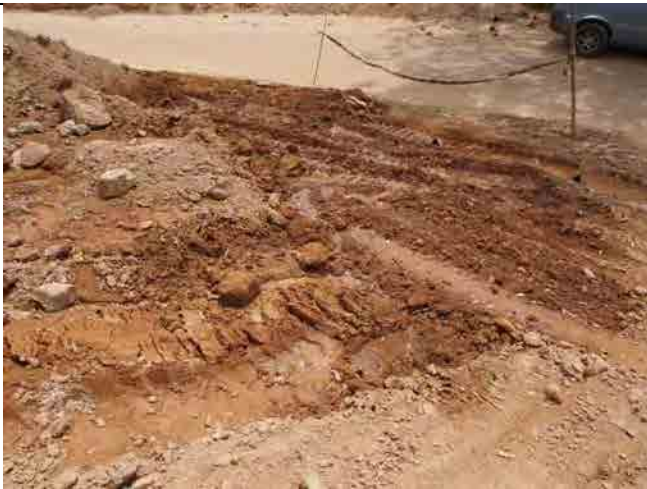
At the toe of the landslide, seepage of water was confirmed

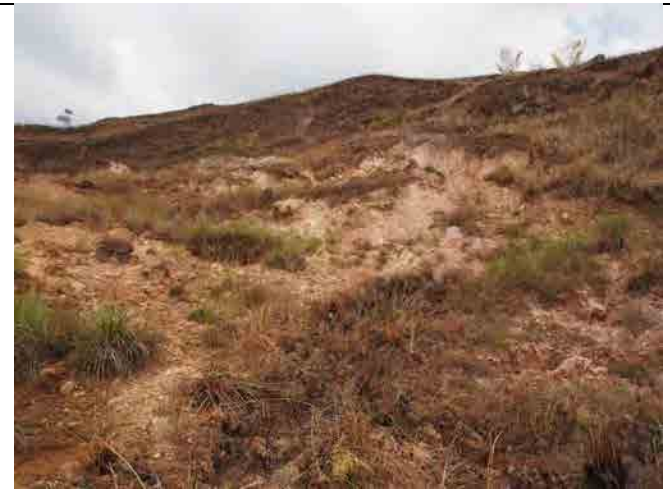
Head scarp
Along the main head scarp, several divided head scarps were confirmed.

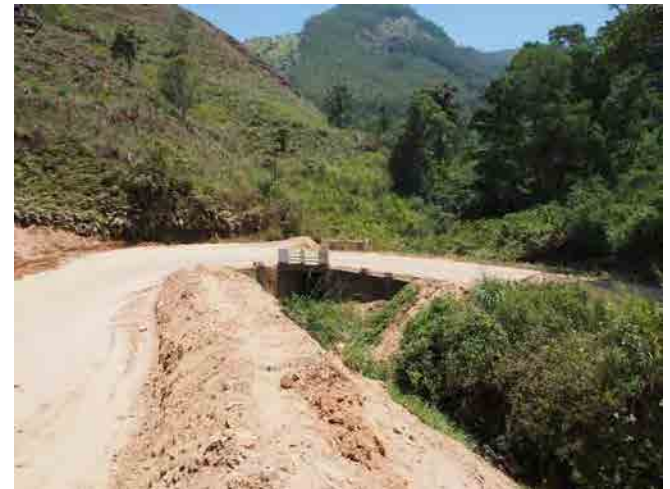
The bridge and the cleaned up debris.
Amount of the debris is so big that the river course is about to be closed.

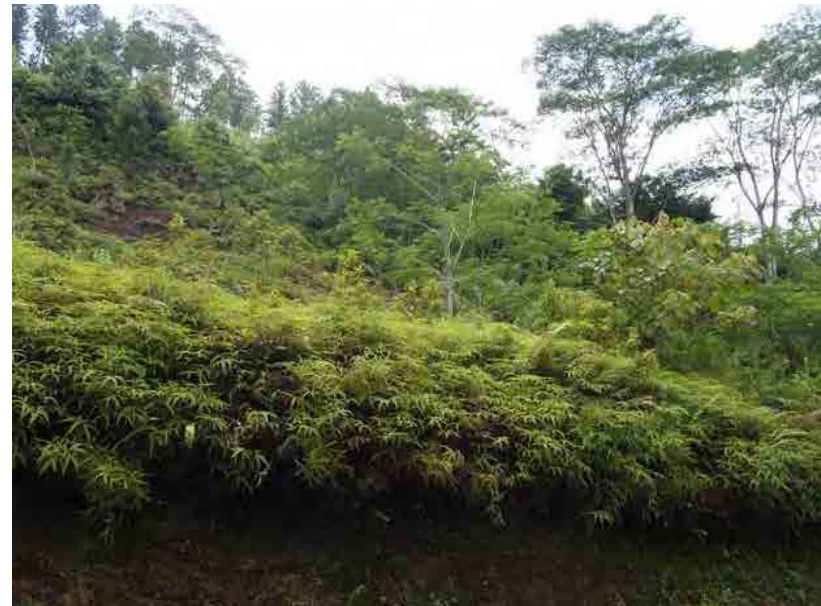
Adjoining old collapse ground

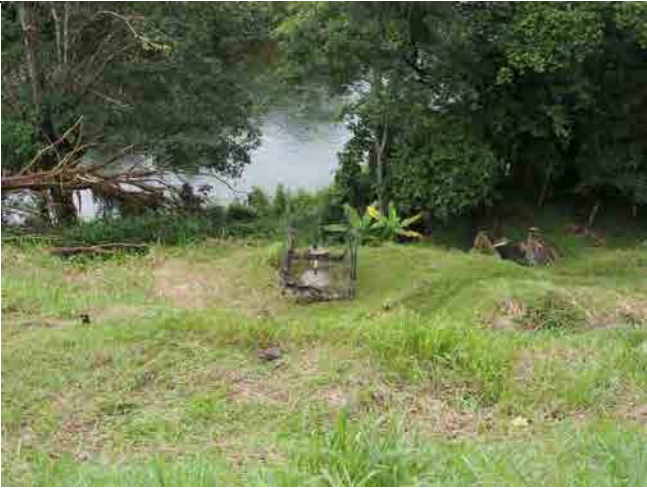
Piezometer installed at the lower part of the landslide.
